THE EFFECT OF COMPRESSIVE STRESS ON THE EXPANSION OF BRICKWORK AND ITS IMPLICATION IN BUILDINGS

A dissertation presented in fulfilment of the
requirements for the degree of
Master of Science in Engineering to the
Faculty of Engineering, University of the Witwatersrand,
Johannesburg

November, 1977

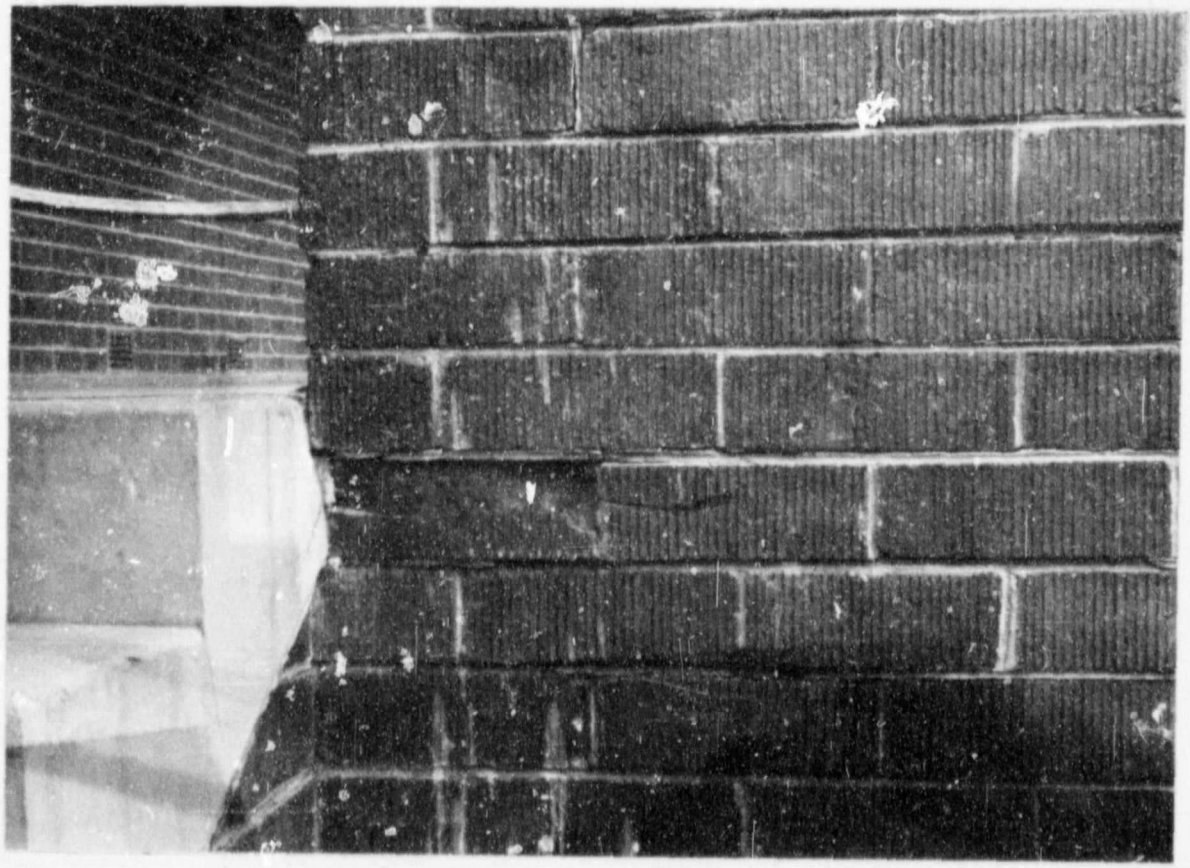
Figure 1 shows how a brick of fairly high strength at the end of a brick retaining wall of about 20 m in length has been crushed because of the forces developed due to the expansion of the bricks. Soil is retained by the brick wall to about the height of the crushed brick. The courses of brickwork above the crushed brick have moved horizontally disrupting the concrete to some extent. At the other end of the wall it was noted that the end portion, also against a flight of concrete steps, had been rebuilt.

FIGURE 1. Crushing of brick against concrete steps

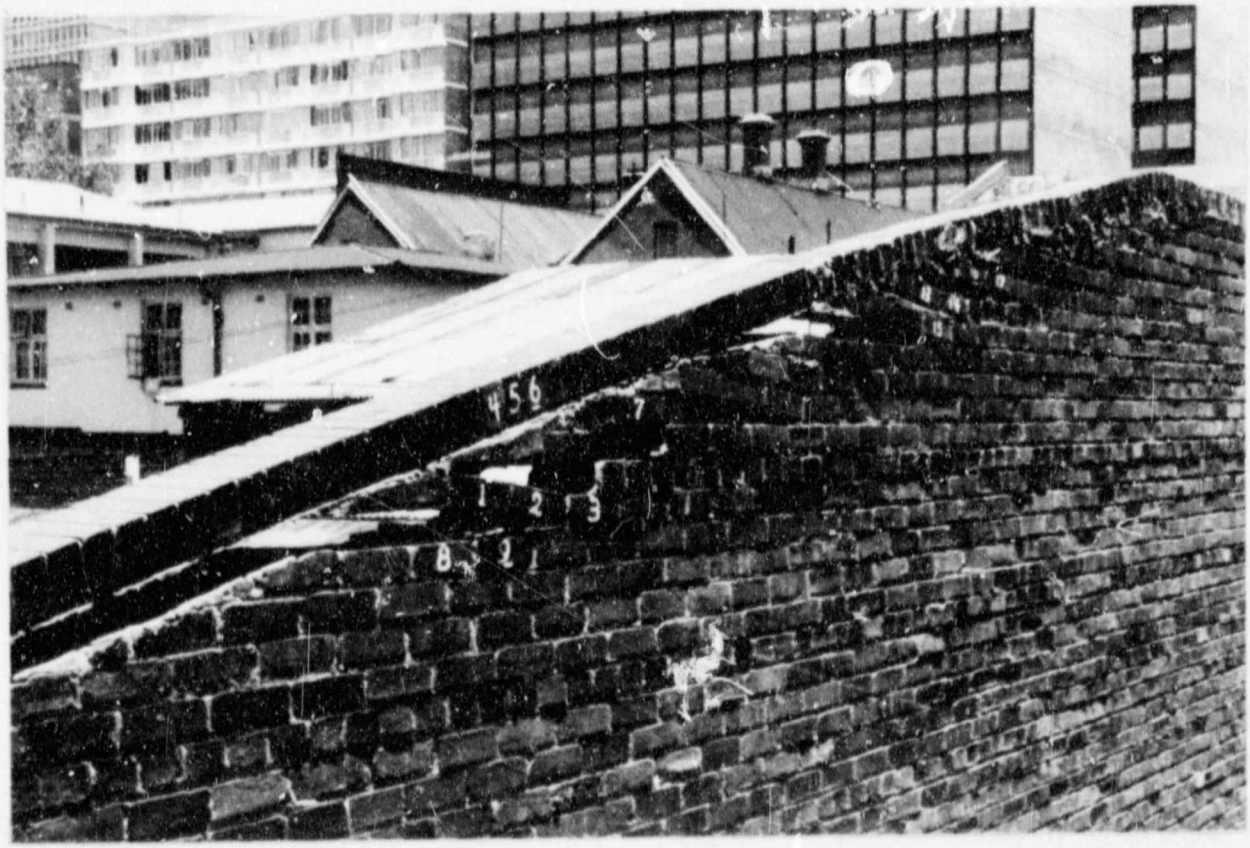
This wall was on the boundary of the property and formed a side wall of a building with a saw-toothed roof. There were three sloping sections of wall, two of which had been previously repaired at their ends and the middle section, 16,9 m in length, was about to be repaired. The disruption to the top of the middle section of the wall is shown on Figures 2 and 3. The wall had grown in height and the top

FIGURE 2. Disruption of top of sloping wall

sloping header course had expanded more than the other bricks, while strongly restrained at its bottom end and partially restrained at its top end. The expansion movement of the header course was up the slope and combined with a greater horizontal expansion of the upper courses at the highest part of the wall caused the disruption shown. No bricks were observed to have crushed in this wall. A number of bricks about 1,3 m up from the bottom of the wall were selected and Demec measuring disks were fixed to each brick at 203 mm centres horizontally, as described in Appendix B. When the epoxy resin had hardened Demec readings were taken. The mortar round each brick was drilled out in turn and a second Demec reading was taken immediately on removal of each brick from the wall. The bricks were capped with the capping mixture described in Appendix C before being remeasured. Most of the bricks had increased slightly in dimension over a period of 7 days while awaiting capping.

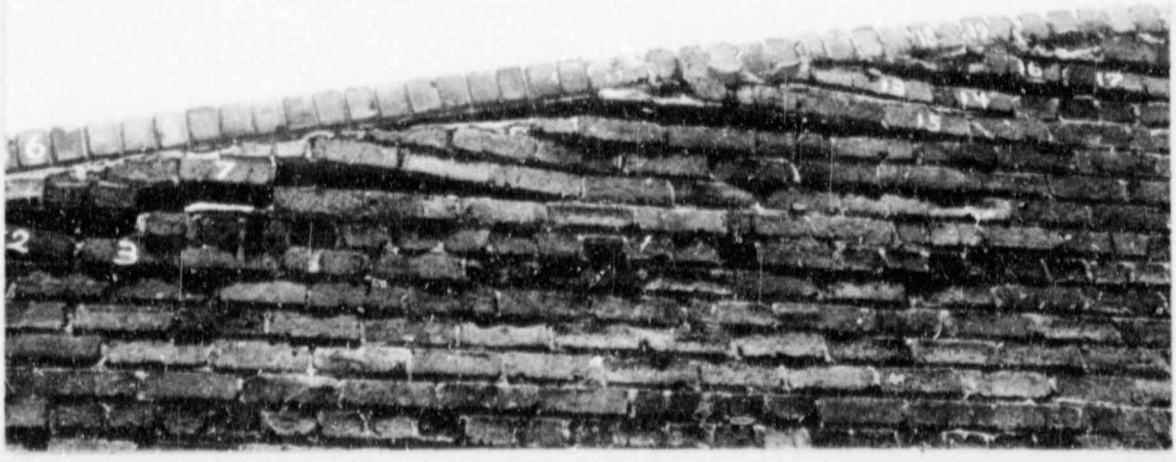
FIGURE 3. Disruption of top of sloping wall

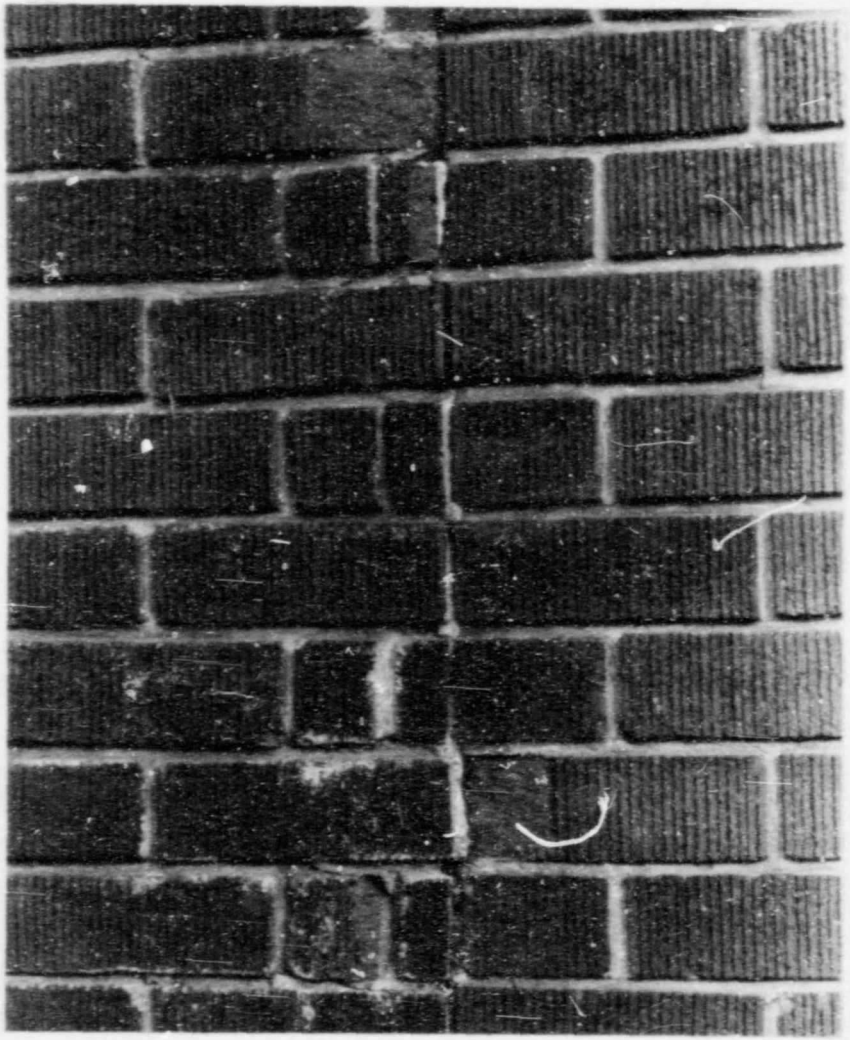
A wall about 2 m high and 9 m long was built on the same line between two heavily loaded walls about 6 m long which supported 5 storeys of a building above them. Although open vertical joints had been provided between the walls, when inspected the walls were very hard up against each other. As can be seen on Figure 6, the corners of bricks had flaked off at the vertical joints and some bricks adjacent to the joints had failed in compression. At the

FIGURE 6. Open joint that had closed

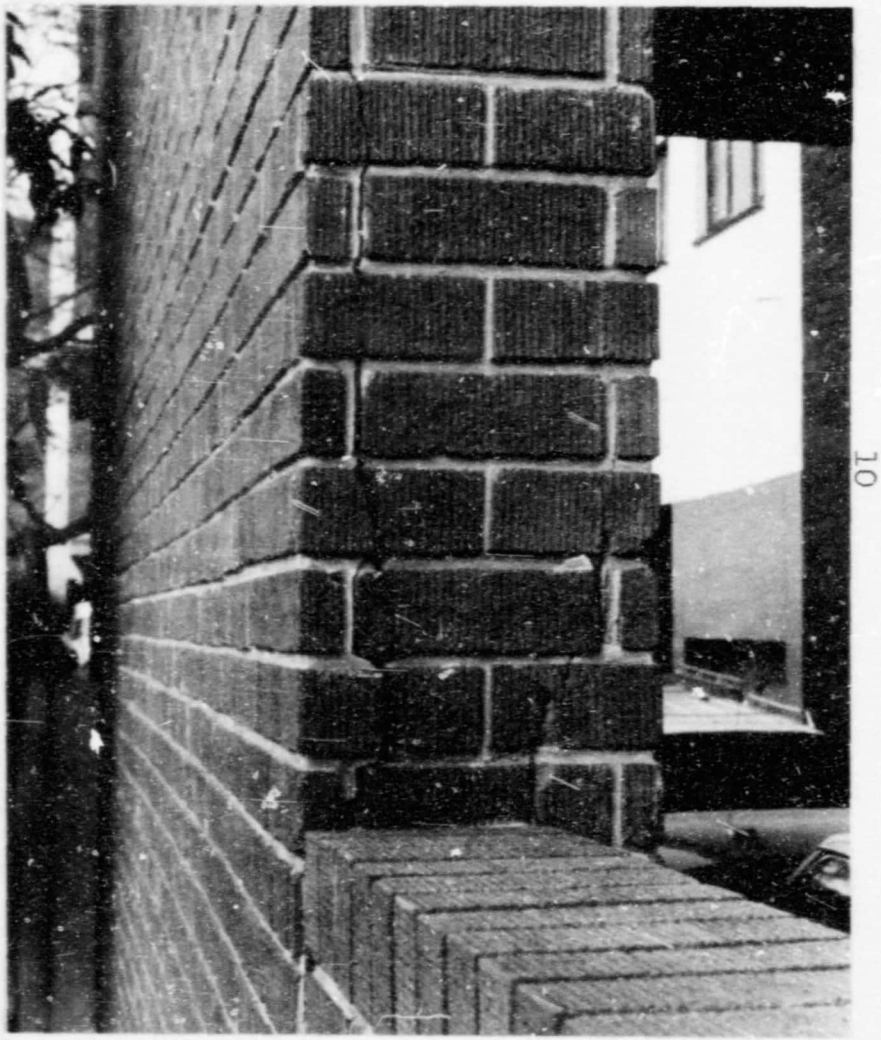
FIGURE 7. Compression damage to wall

2 m height the walls carrying the heavy vertical loads had been damaged by the top bricks of the lower wall forcing their way slightly into these walls, as shown on Figure 7.

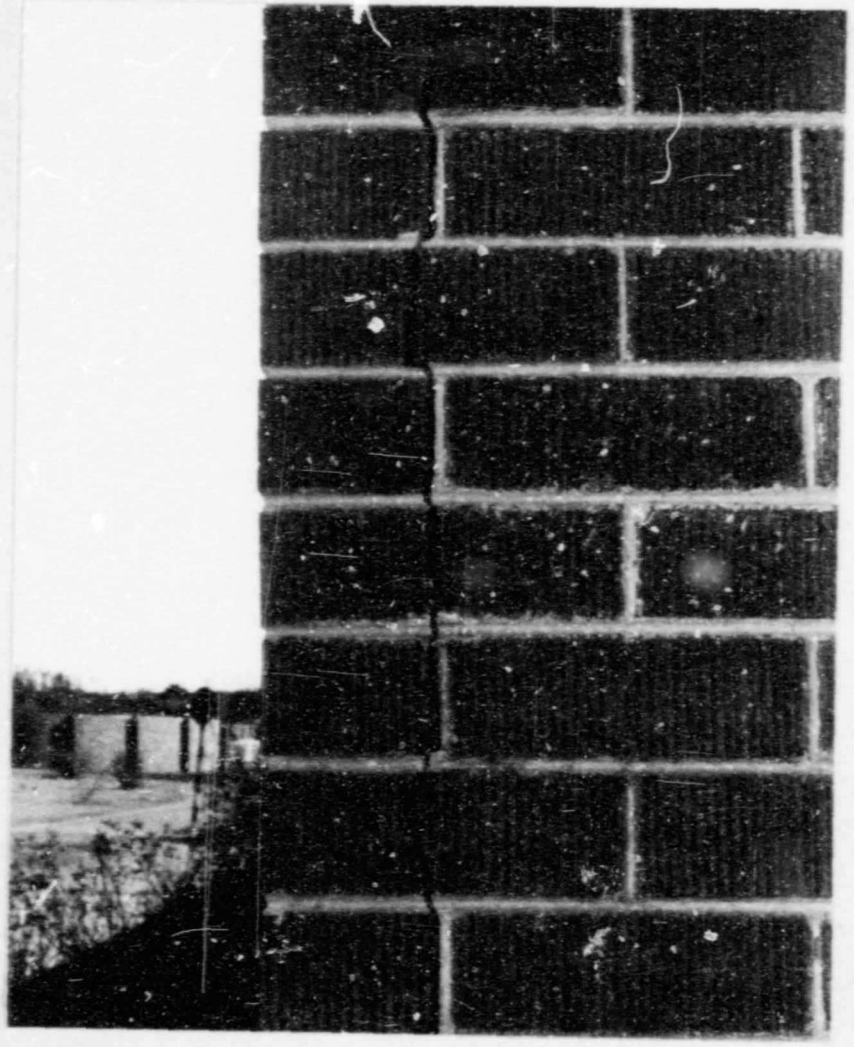
FIGURE 9. Vertical crack at corner of building.

A type of crack which commonly occurs in the external brickwork of buildings is a vertical crack 110 mm from the corner extending all the way up the building. This crack is caused by the two outer leaves of brickwork at right angles to each other expanding and pushing each other outward. They are no longer able to remain at right angles to each other and one or the other cracks. An example of such a crack is shown on Figure 9.
