School of Mining Engineering

UNIVERSITY OF THE
WITWATERSRAND,
JOHANNESBURG

ASSESSMENT OF FACE AREA HANGINGWALL STABILITY IN A HARD ROCK BORD AND PILLAR MINE

A research report submitted to the Faculty of Engineering and the Built Environment, University of the Witwatersrand, Johannesburg, in partial fulfilment of the requirements for the degree of Master of Science in Engineering.

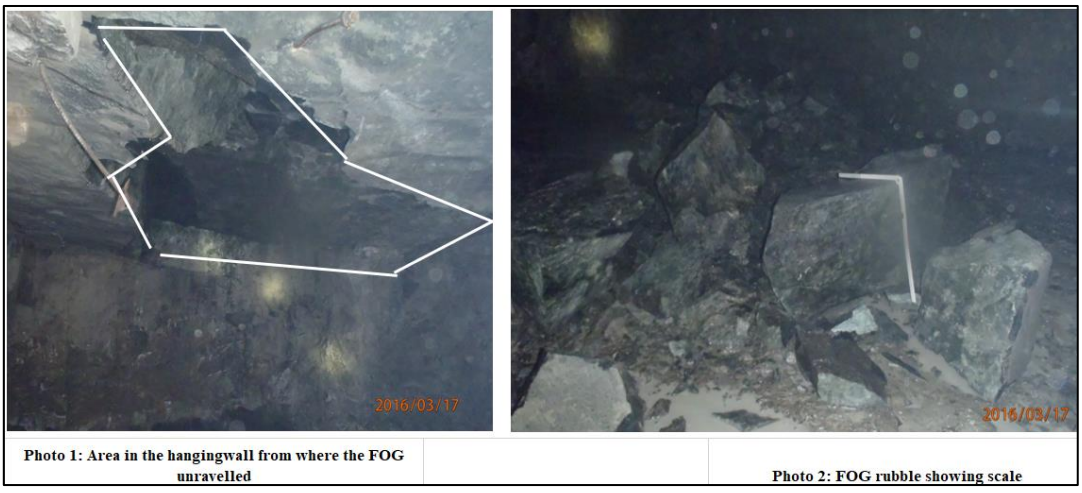
Figure 2-16. Photo of FOG that resulted from chromitite parting, vertical joints and water (Matsobane, 2016b).

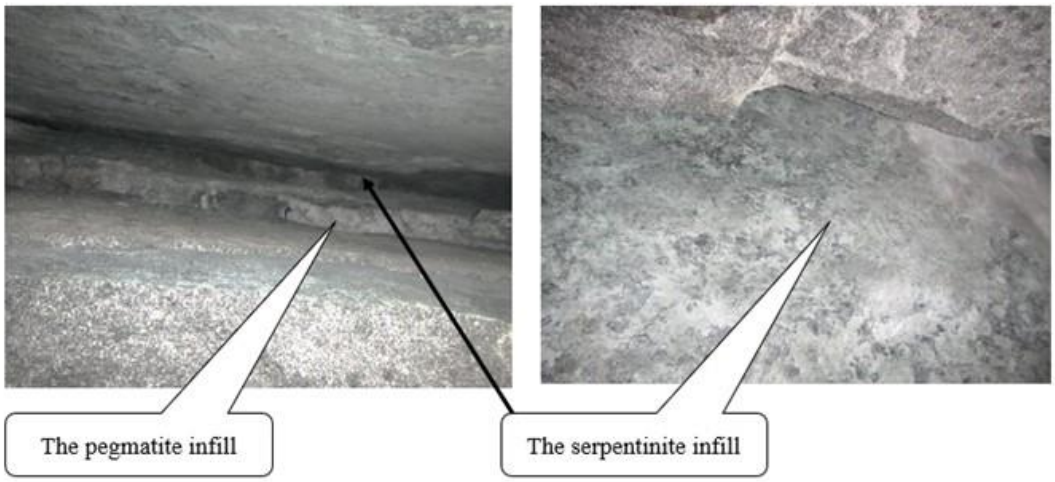
Figure 5-4. Pegmatite vein with serpentinite infill/coating on the sides.
