INVESTIGATING SLOPE STABILITY IN AN OPEN PIT MINE – A CASE STUDY OF THE PHYLLITES WESTERN WALL AT SENTINEL PIT

Master of Science in Mining Engineering

A research report submitted to the Faculty of Engineering and the Built Environment, University of the Witwatersrand, Johannesburg, in partial fulfilment of the requirements for the degree of Master of Science in Engineering.

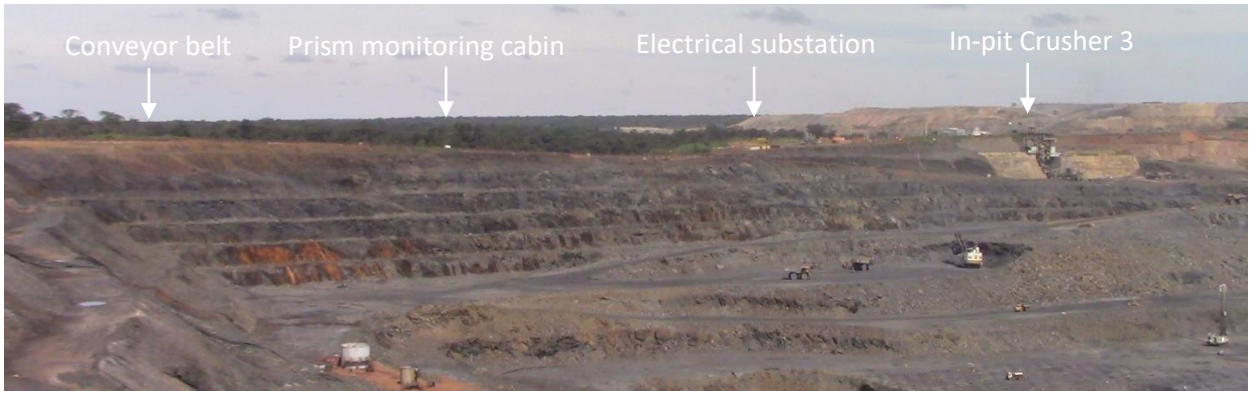
Sentinel Mine's western highwall is experiencing instability in the form of toppling and wedge failures. This study will focus on the slope stability and factors influencing the stability of the Western highwall. Mining commenced in 2013 with the installation of In-Pit Crushers (IPC); IPC3 is located in the western wall towards the northern side of the pit. Additional infrastructure on the western wall includes an overland conveyor from IPC3 to the processing plant, a prism monitoring cabin and an electrical substation which supplies power to the machinery in the open pit. All of this infrastructure could be adversely affected by wall instability (Figure 2). For this reason, the stability of this wall is very critical to this operation (Gray et al, 2015).

Figure 2: Western final wall and the infrastructure that lies above it

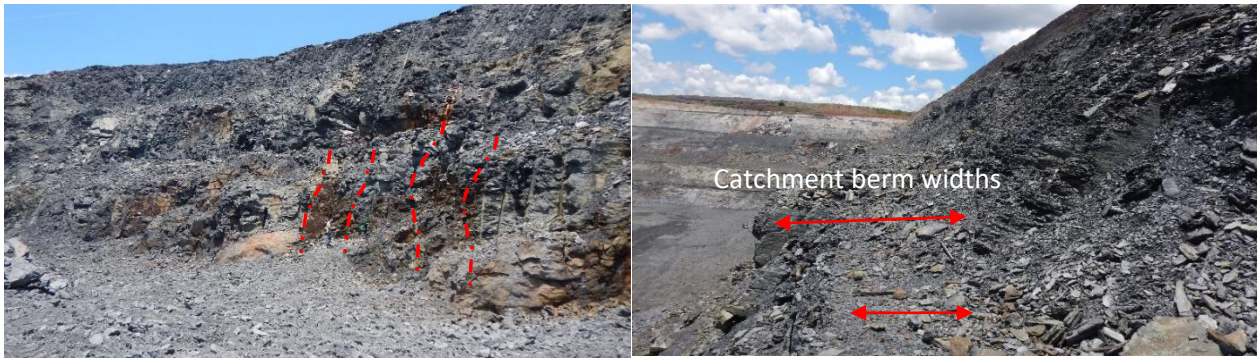
Figure 3: Close-up on a section of the western wall with localized failure and reduced catchment berm width.

The western wall of Sentinel Mine is predominantly comprised of phyllite. Localised failures of benches have occurred, which have resulted in reduced catchment berm widths, including resulting in an excessively high bench height in one instance.

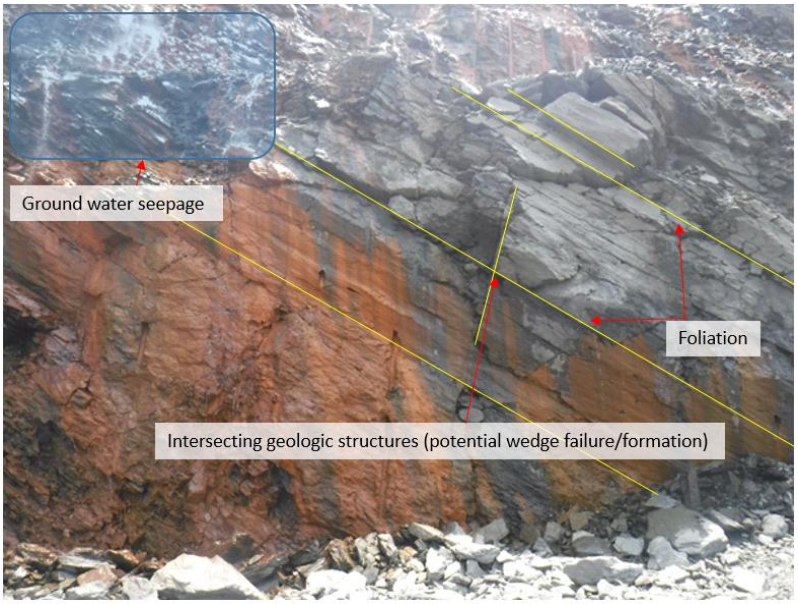
Generally, the predominant geological structure on the south side of the West wall (Figure 35) indicates foliation dipping 30° towards north with the dip direction being 348°.

Figure 35: Photograph taken from the southern side of the western wall showing Strata (foliation) dipping 30° towards the north

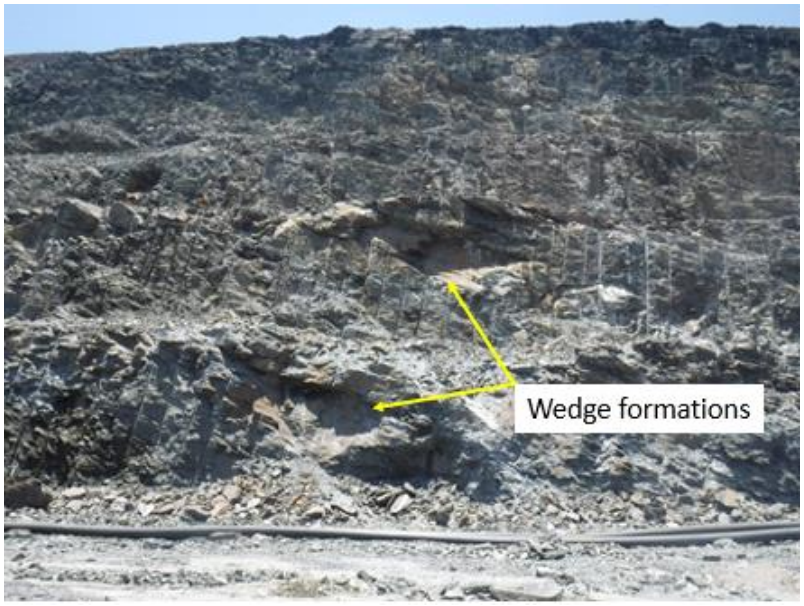
For the wall to yield favourable results after pre-splitting, the joints must intersect the face at greater than 30°. Anything less will cause fractures to intersect the jointing planes having large pieces of material fallout from the face during scaling of the wall. Figure 36 is a typical example of material falling out from the face during scaling of the wall. This is slightly in agreement with what Gray et al. (2015) discussed in the Trident project brief (NI-43101). The project brief mentioned that the dominant foliation dips towards north-northwest, at an average of 20-30°, typically parallel to the fold axial plane of the pervasive drag folds. These low foliation angles are more evident on the southern side of the western wall and the southern wall itself. The recumbent folding, detachments, and dominant foliation are likely expressions of top-north directed shearing. Both low-angle thrusting along detachment horizons and shear-related folding are evident in the phyllite stratigraphy at Sentinel.

Figure 36: Dislodged blocks of rock during scaling of the bench faces

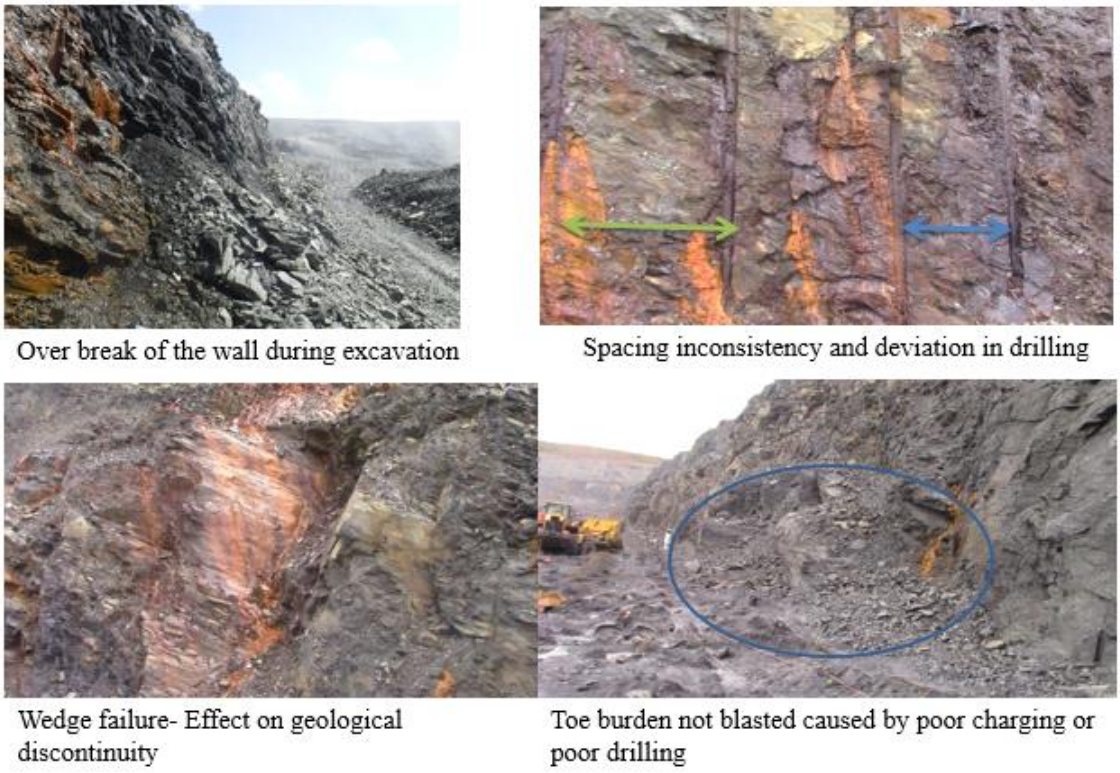
The pre and post blast photographs of the presplits are shown in Figures 37 to 40 with more photographs included in Appendix H. The results of some of the splits was crushing at the collar of the holes, overbreak and toes on the catchment berm. Generally, the west wall has suffered significant back break on the 1112 RL compromising the arresting capacity of the berm. The sentinel phyllite unit exhibits a moderate to high permeability on the south west corner of the pit. The observed aquifer is identified from the visible iron staining, slightly visible water seepage and water percolation on figure 37. For wedge instabilities to be kinematically possible, one of the three criterions discussed in Chapter 2.3.2 must be met. The water seepage on the wall assists in inducing release of the wedge.

Figure 37: A few examples of poor presplit results on the western wall

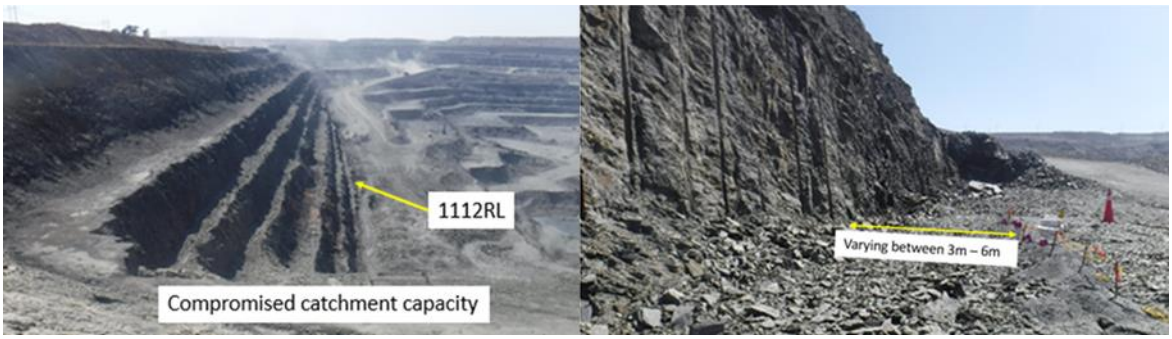
Figure 39: Photographs of the western wall from the southern perspective
