Back analysis of previously stooped Panels to improve the safety and productivity of future stooping operations at new Denmark colliery

Gonsalves, Ricardo

2024

University of the Witwatersrand, Johannesburg

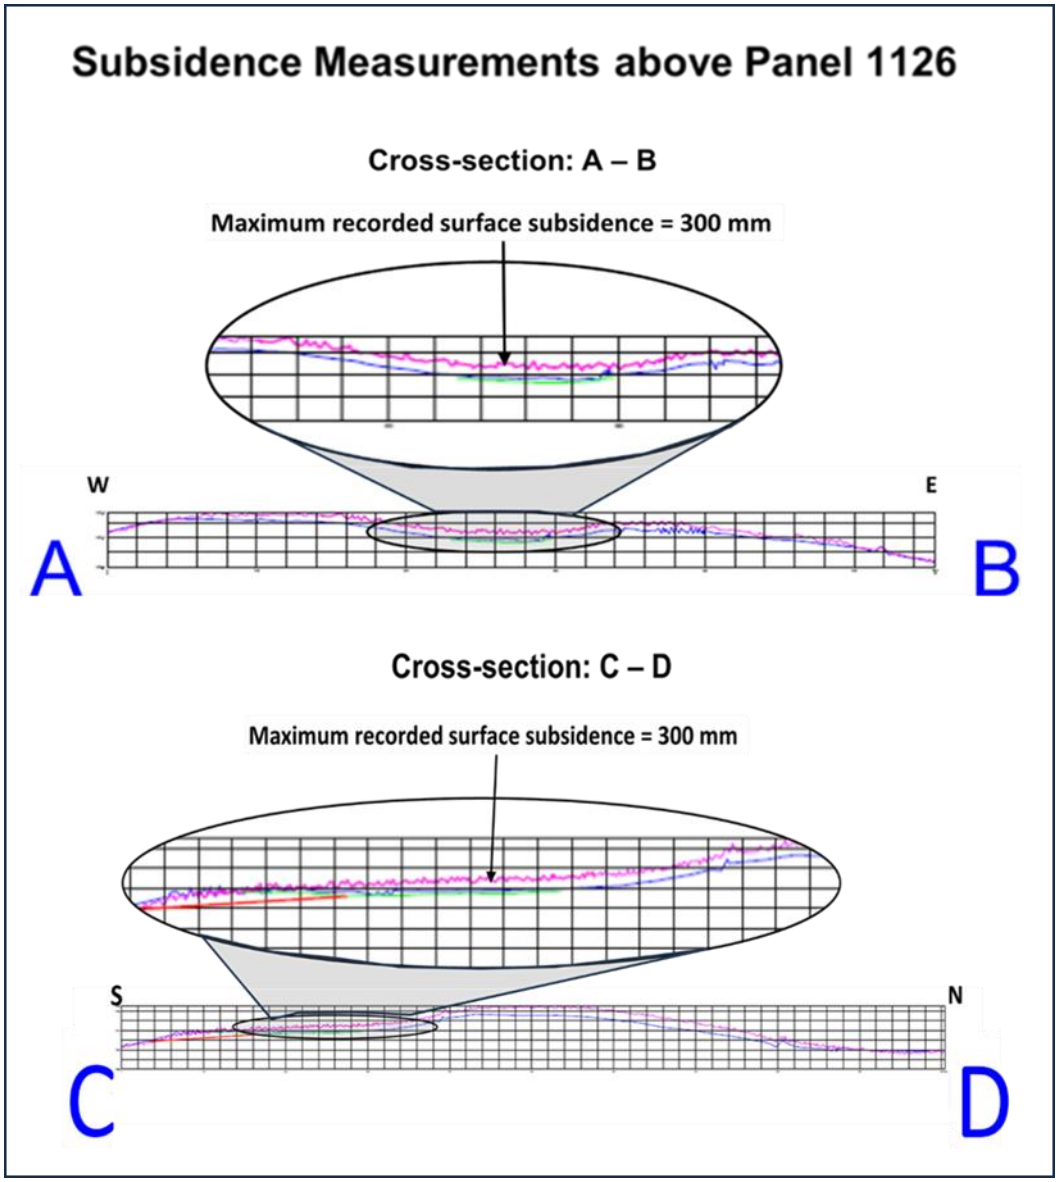
Figure 6-2: Subsidence measurements above Panel 1126.

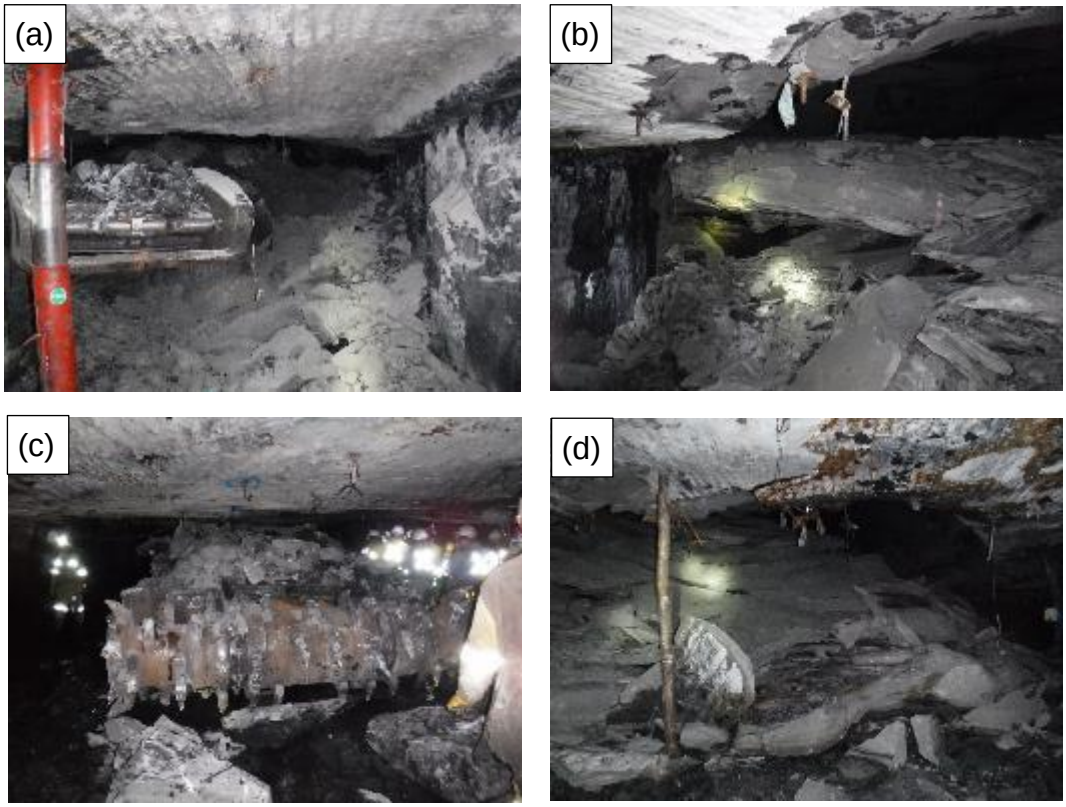
Figure 6-3: Eyethu goaf incident; (a) CM partially buried with only its conveyor boom visible from underneath the goaf material; (b) thick layer of sandstone lying on top of the CM indicating that the goaf only extended about 1.5 m into the immediate roof; (c) CM successful retrieved from the goaf; (d) goaf arrested by the breaker lines with the intact policeman stick indicating stable ground on the safe side.

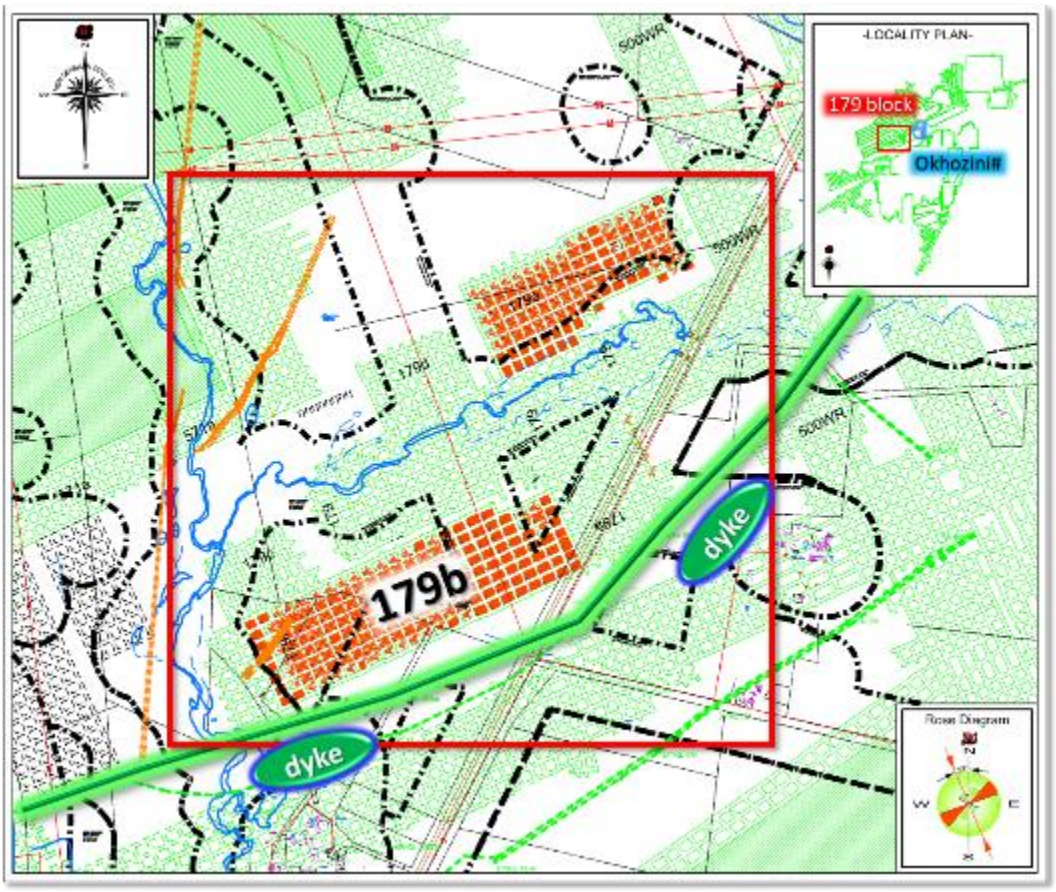
Figure 6-4: Eyethu Panel 179b with a nearby dyke to the south of it.

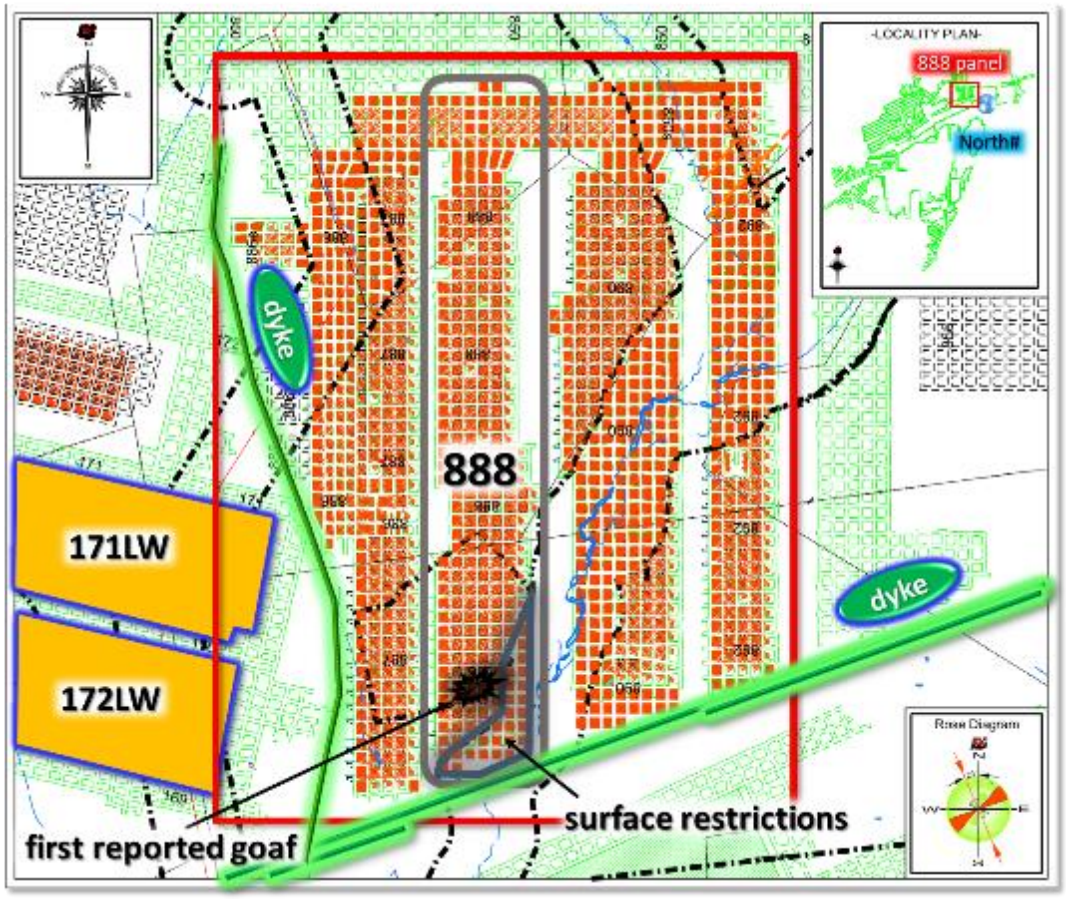
Figure 6-5: Panel 888 with nearby dyke and old longwall panels.

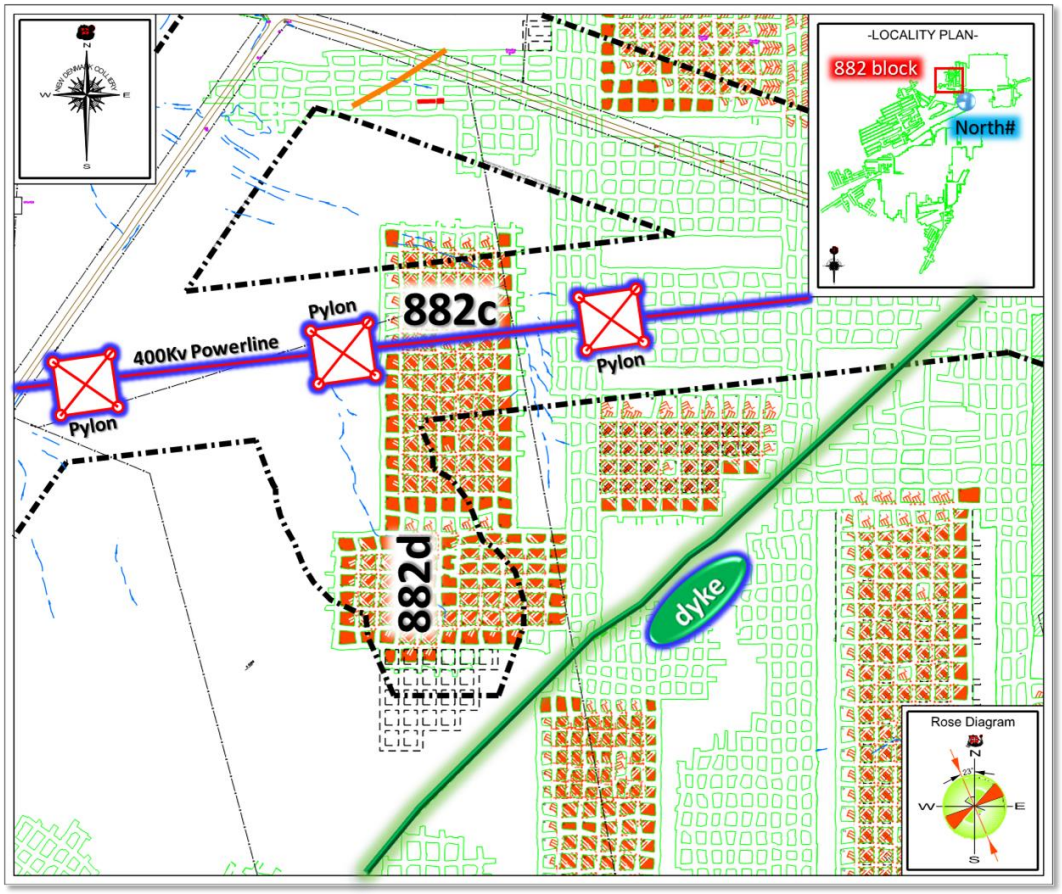
Figure 6-6: Panels 882c and 882d with nearby dyke and previously stooped panels.

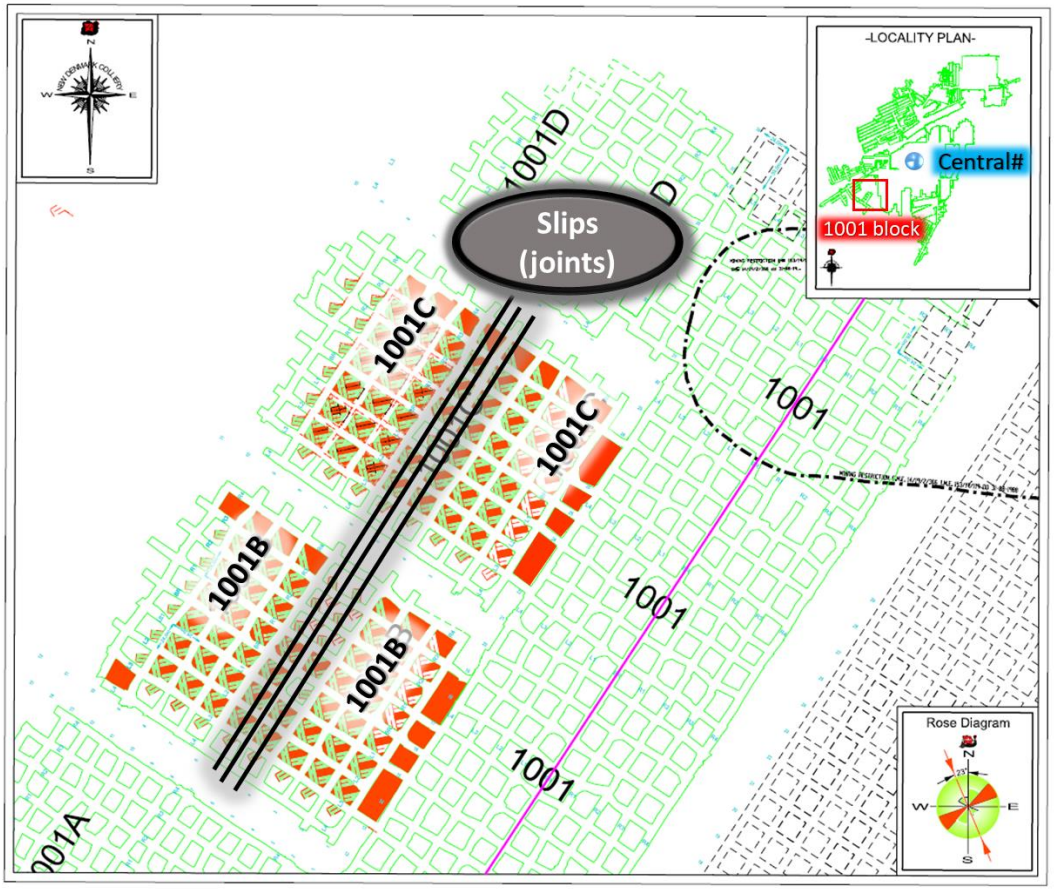
Figure 6-7: Panels 1001B and 1001C with multiple joints striking across them.

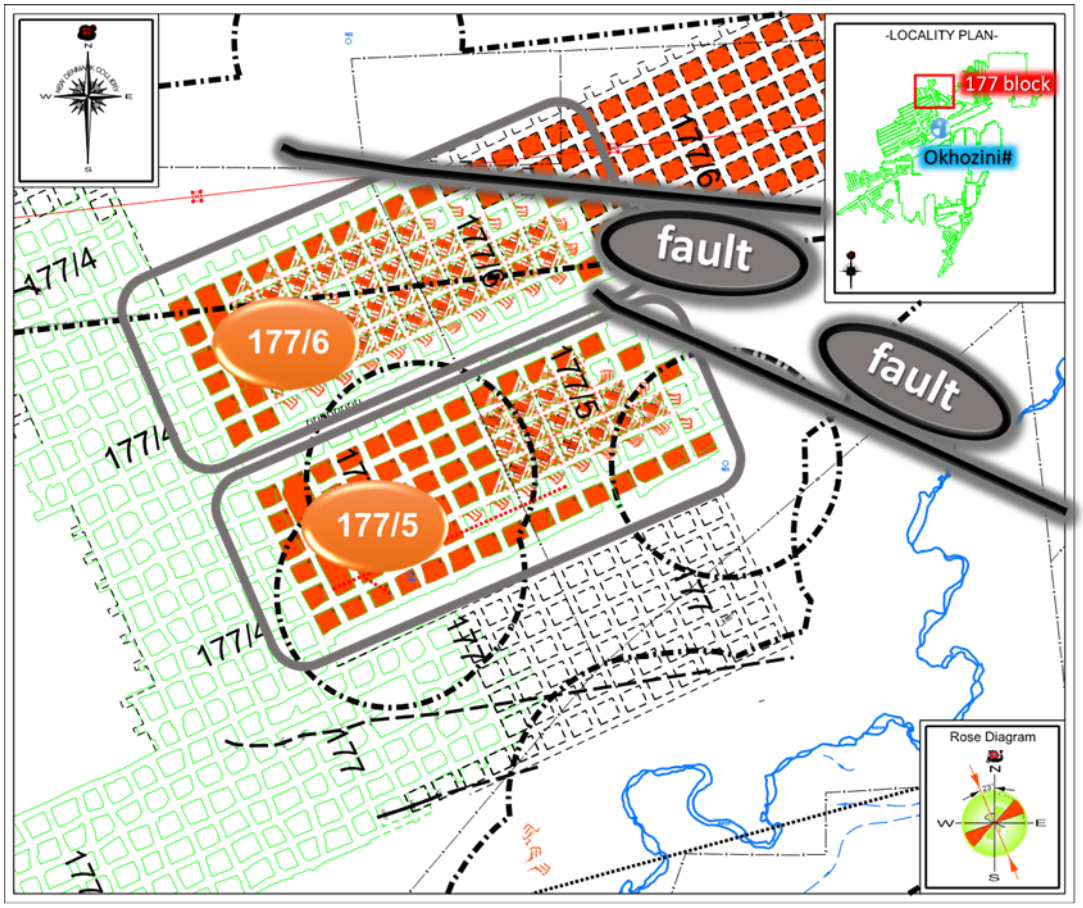
Figure 6-8: Panel 177/5 with limited stooping ground and a fault at the end of the panel.
