# IDENTIFICATION OF REFRACTORY MATERIAL FAILURES IN CEMENT KILNS

A dissertation submitted to the Faculty of Engineering and the  
Built Environment, University of the Witwatersrand,  
Johannesburg, in fulfilment of the requirements for the degree of  
Master of Science in Engineering

Johannesburg, 11 October 2016

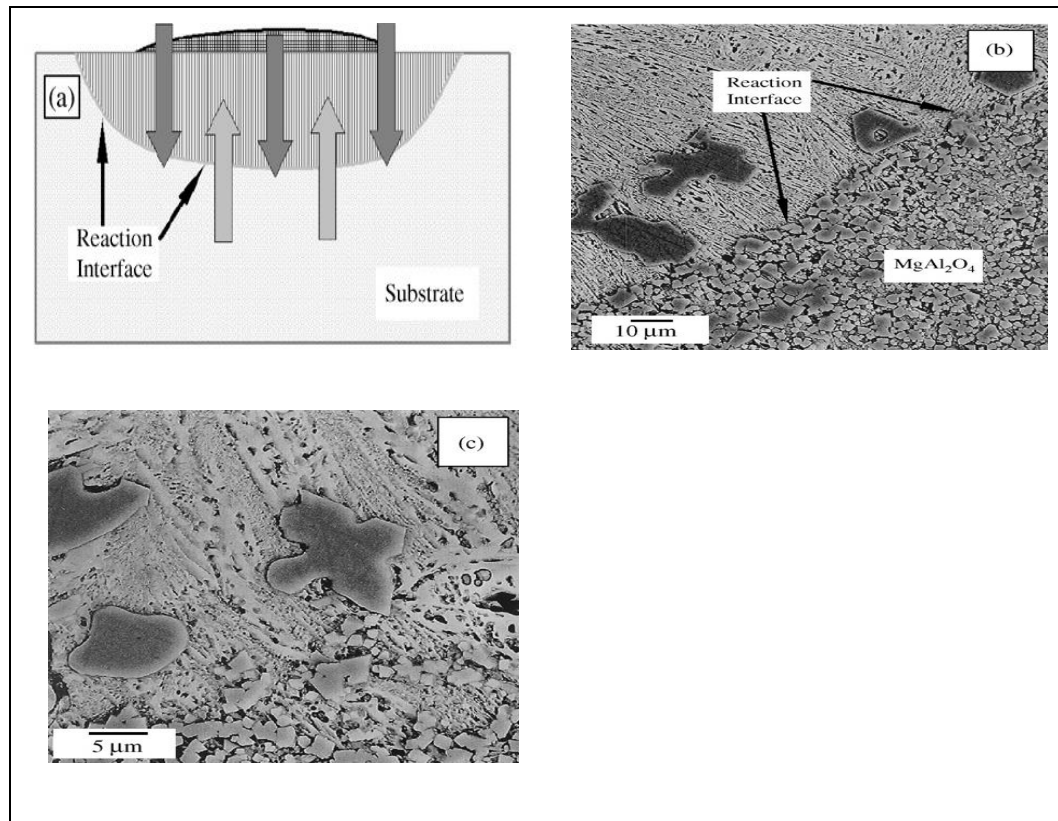
microstructure shows the presence of a devitrified glassy phase, liquid at 1500 °C which was produced by the chemical reaction between clinker and  $\text{MgAl}_2\text{O}_4$  (see figure 2-1).

Figure 2-1. SEM micrographs for the clinker– $\text{MgAl}_2\text{O}_4$  interface of the sample fired at 1500 °C for 1 min

(a) Sketch of the reaction mechanism; typical SEM micrographs, (b) and (c), of the cross-section for the clinker– $\text{MgAl}_2\text{O}_4$  interface of the sample fired at 1500 °C for 1 min

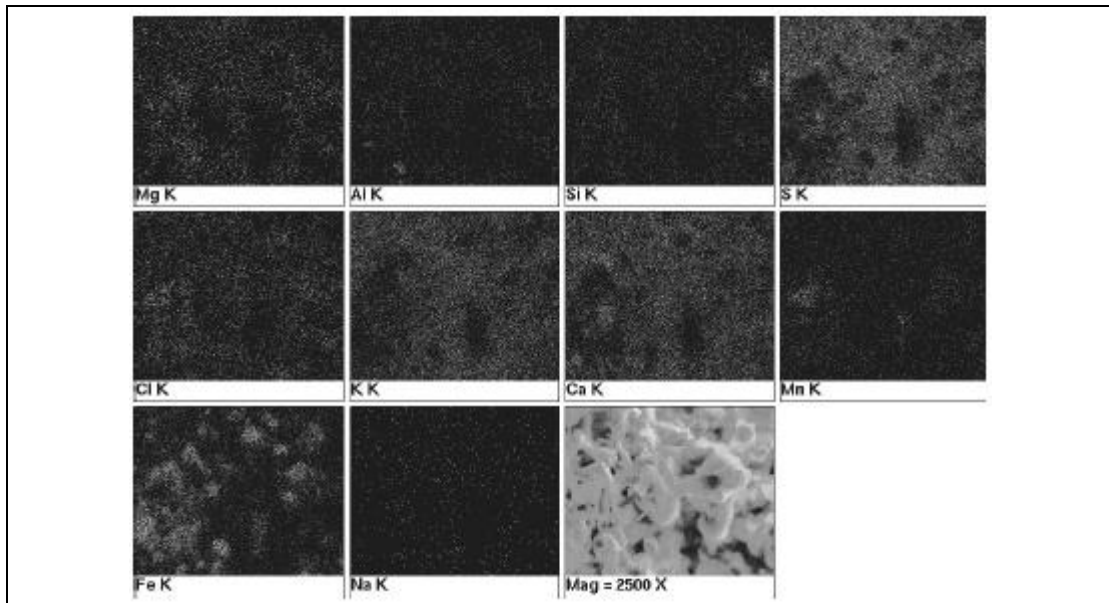
Potgieter et al. (2004) studied high-temperature chemical corrosion in the short and long kilns. The XRF analysis showed higher concentration of sulphur in the short kiln. This indicates that the corrosion that took place was sulphur dominant. The long dry kiln analysis showed a higher concentration of chloride and potassium which points to a chlorine type of attack of the kiln shell. The EDX spectra of each corrosion scale (Figure 2-1 and 2-2) confirmed the analysis from XRF. The X-ray map images of the individual elements indicated high levels of K and Cl with respect to other elements.

Figure 2-2. X-ray maps of corrosion scale from case 1 kiln

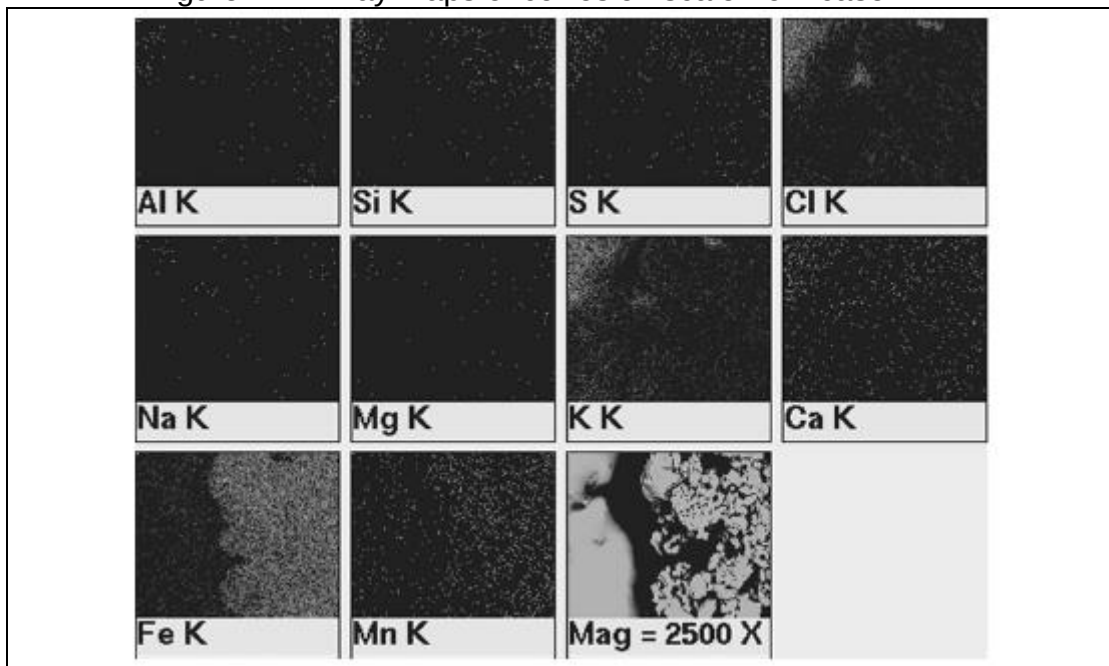
Figure 2-3. X-ray maps of corrosion scale from case 2 kiln

XRD results from the short kiln revealed the presence of various sulphur compounds. A further microscopic examination of the piece showed a tiny KCl crystal along the fissure boundaries. Sulphur from fuel can react in the oxidizing

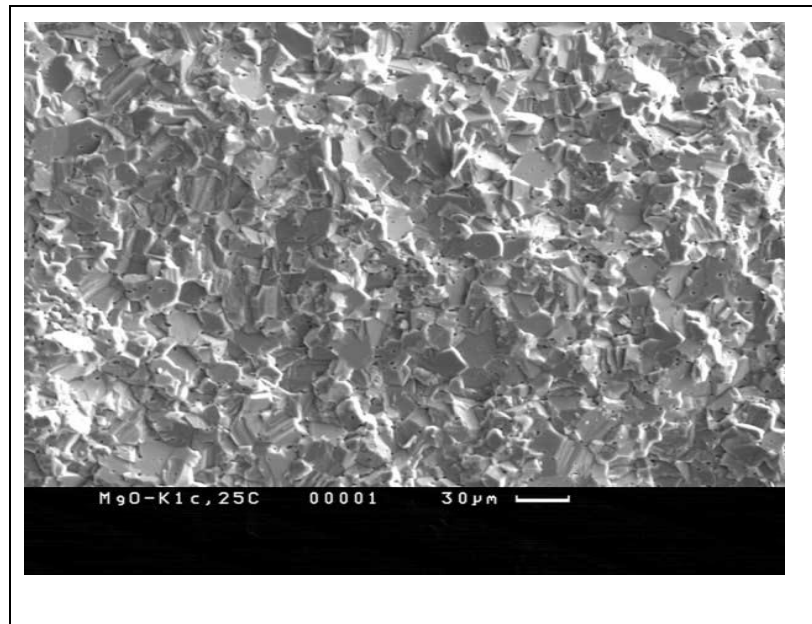
Fracture faces of pure MgO showed pronounced transgranular fracture (see figure 2-4), with clear grain faceting. Meanwhile composites showed a significant tendency towards intergranular fracture, which is more noticeable with higher spinel additions (see figure 2-5).

Figure 2-4. SEM photograph of a fracture face of pure MgO, showing pronounced transgranular fracture.

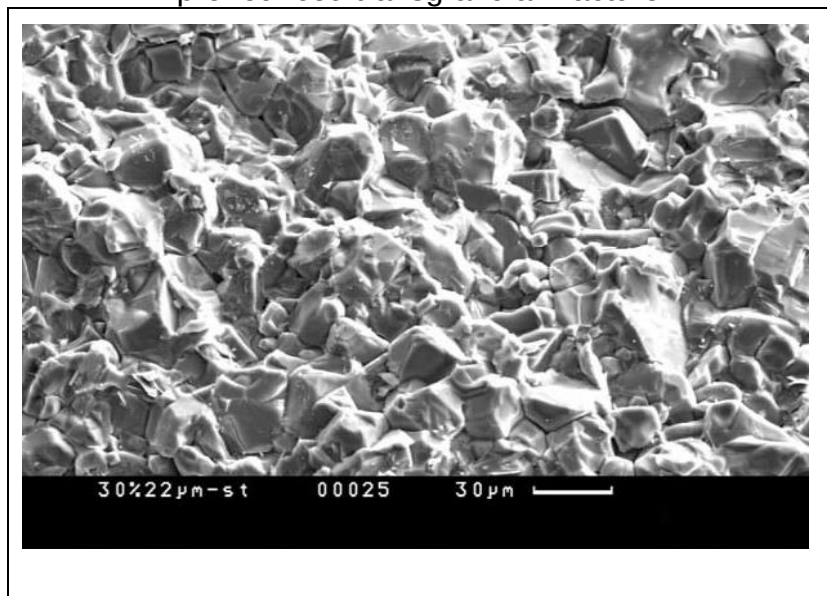
Figure 2-5. SEM photograph of a fracture face of 20% 22 μm spinel composites, showing predominantly intergranular fracture.

From SEM micrographs, it can be seen that there is an intergranular fracture (see figure 2-5) in all unused and damaged magnesia bricks. However, no major crack can be easily detected on all SEM microstructures. Therefore the thermal shock attack could not be described as a source of the refractory brick failure.

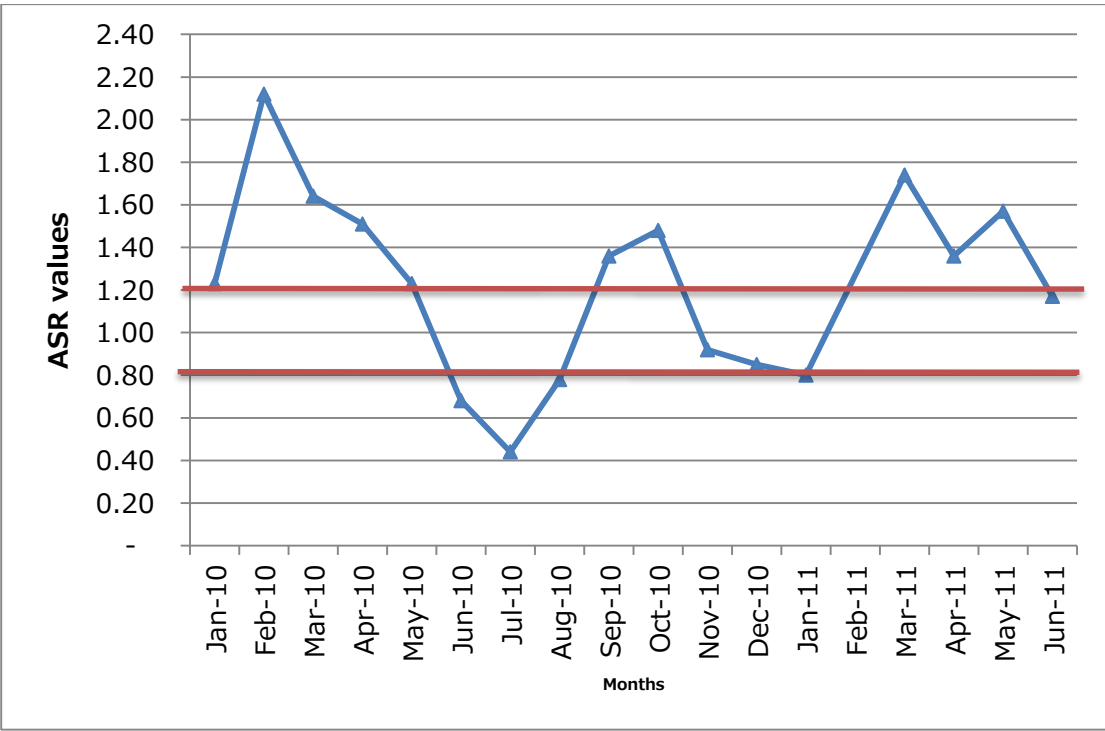
The clinker was analysed to determine the alkali sulphate values. The data were collected over a period of 17 months (see appendix C). In general, the collection of the samples was associated with the operating conditions where the alkali-sulphate ratio was outside the recommended range of 0.8 – 1.2 (see Figure 3-3). This could have contributed to chemical attack of the cement kiln refractory lining (Bartha and Sodje, 2001).

Figure 3-3. ASR of the study kiln
