**MINE GAS AND COAL DUST EXPLOSIONS AND METHANE OUTBURSTS - THEIR  
CAUSES AND PREVENTION**

**A Dissertation submitted to the Faculty of Engineering,  
University of the Witwatersrand, Johannesburg, for the Degree of  
Master of Science in Engineering**

**Johannesburg 1990**

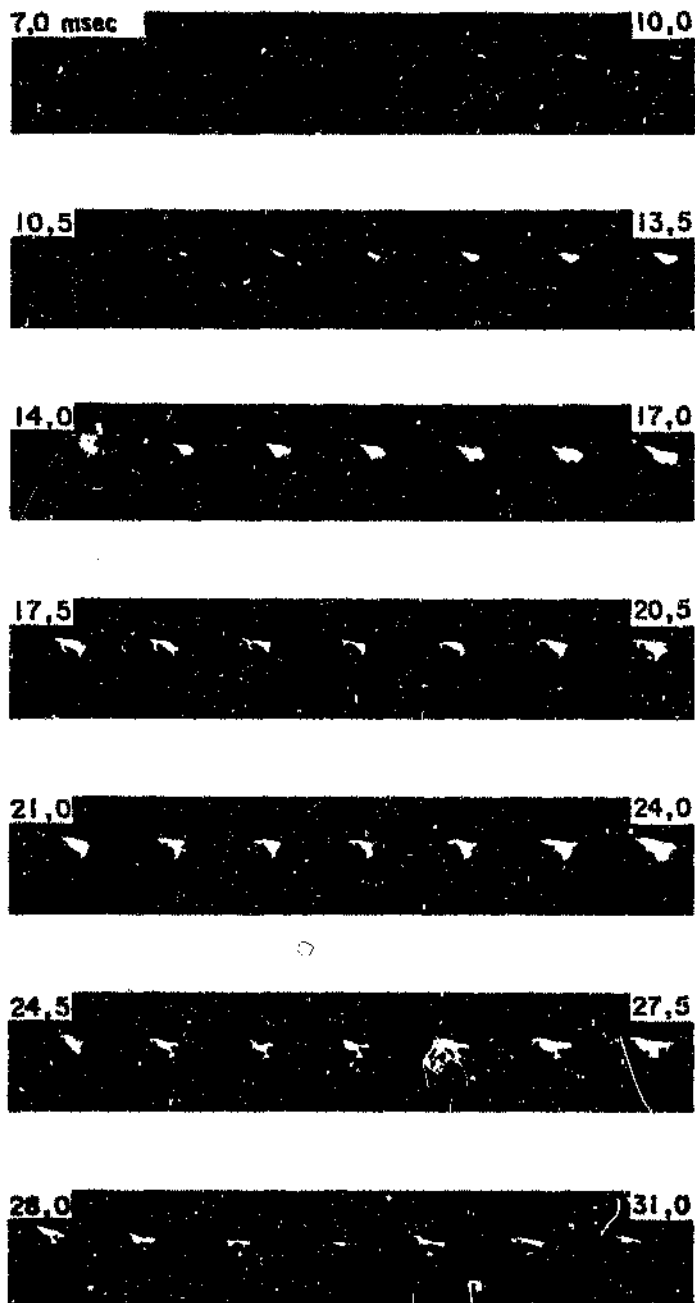
**Figure 12**

The only incendive results were obtained with multiple frictional impacts of low carbon steel on quartzitic sandstone, which shows

**HIGH SPEED FILM STRIP SHOWING IGNITION OF  
COAL-AIR-METHANE ORIGINATING AT FRICTIONAL HOT SPOT.  
Time is shown at top of each strip (in milliseconds)**

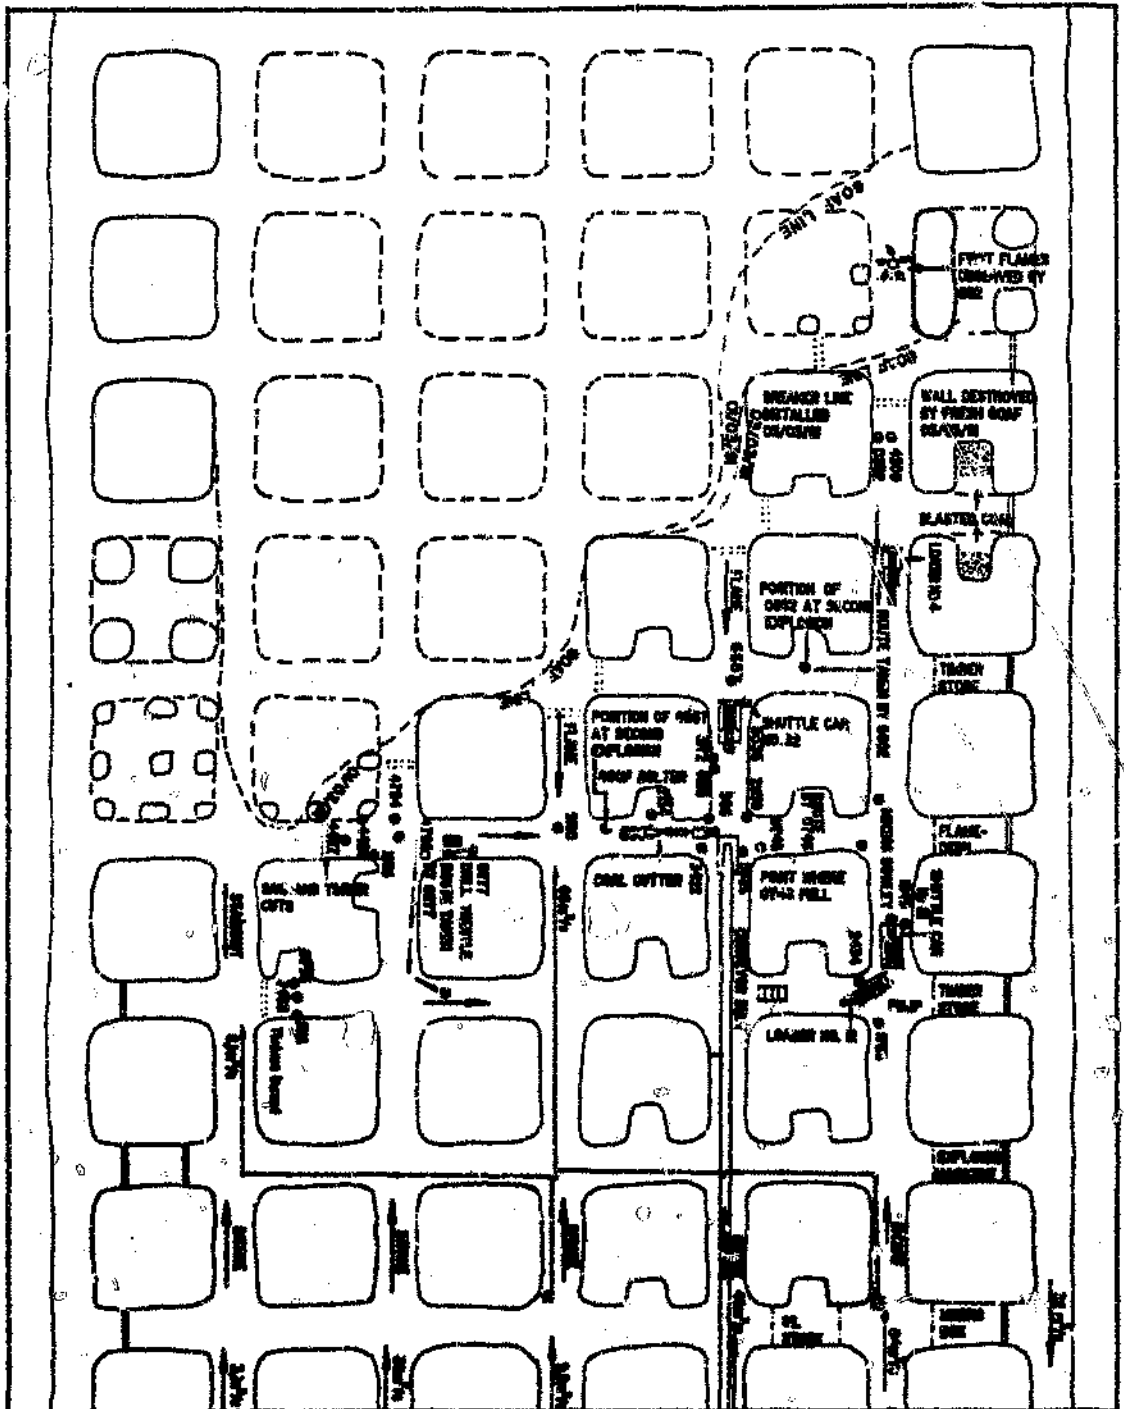
**Figure 17**

**IN SECTION B302 VLEI SHAFT ON 28/02/81 AT 07:20.**

Two weeks prior to the accident, the mine Ventilation Officer reported that 20 m<sup>3</sup>/sec was intaking into the section with 19 m<sup>3</sup>/sec in the return airway. Two fans shown on the plan Figure 17 were delivering 5.1 m<sup>3</sup>/sec to roadway No. 2 and 4.5 m<sup>3</sup>/sec to roadway No. 4. Each fan delivered air through a flexible ducting and an air curtain (as shown on Figure 17) to prevent recirculation of air. No recirculation was taking place according to his tests. A methanometer was used to test for methane and the goaf line and return airway (No. 7 road) were found to be free of gas.

Two fans were reinstalled in the section by the 3rd March 1981 and they are shown in position on Figure 17 (together with the air readings at that time).

At the accident I found that the area between roadways No. 1 and 2 had goafed as indicated on Figure 17. The area had not goafed solid and there was an open space above the broken rock.

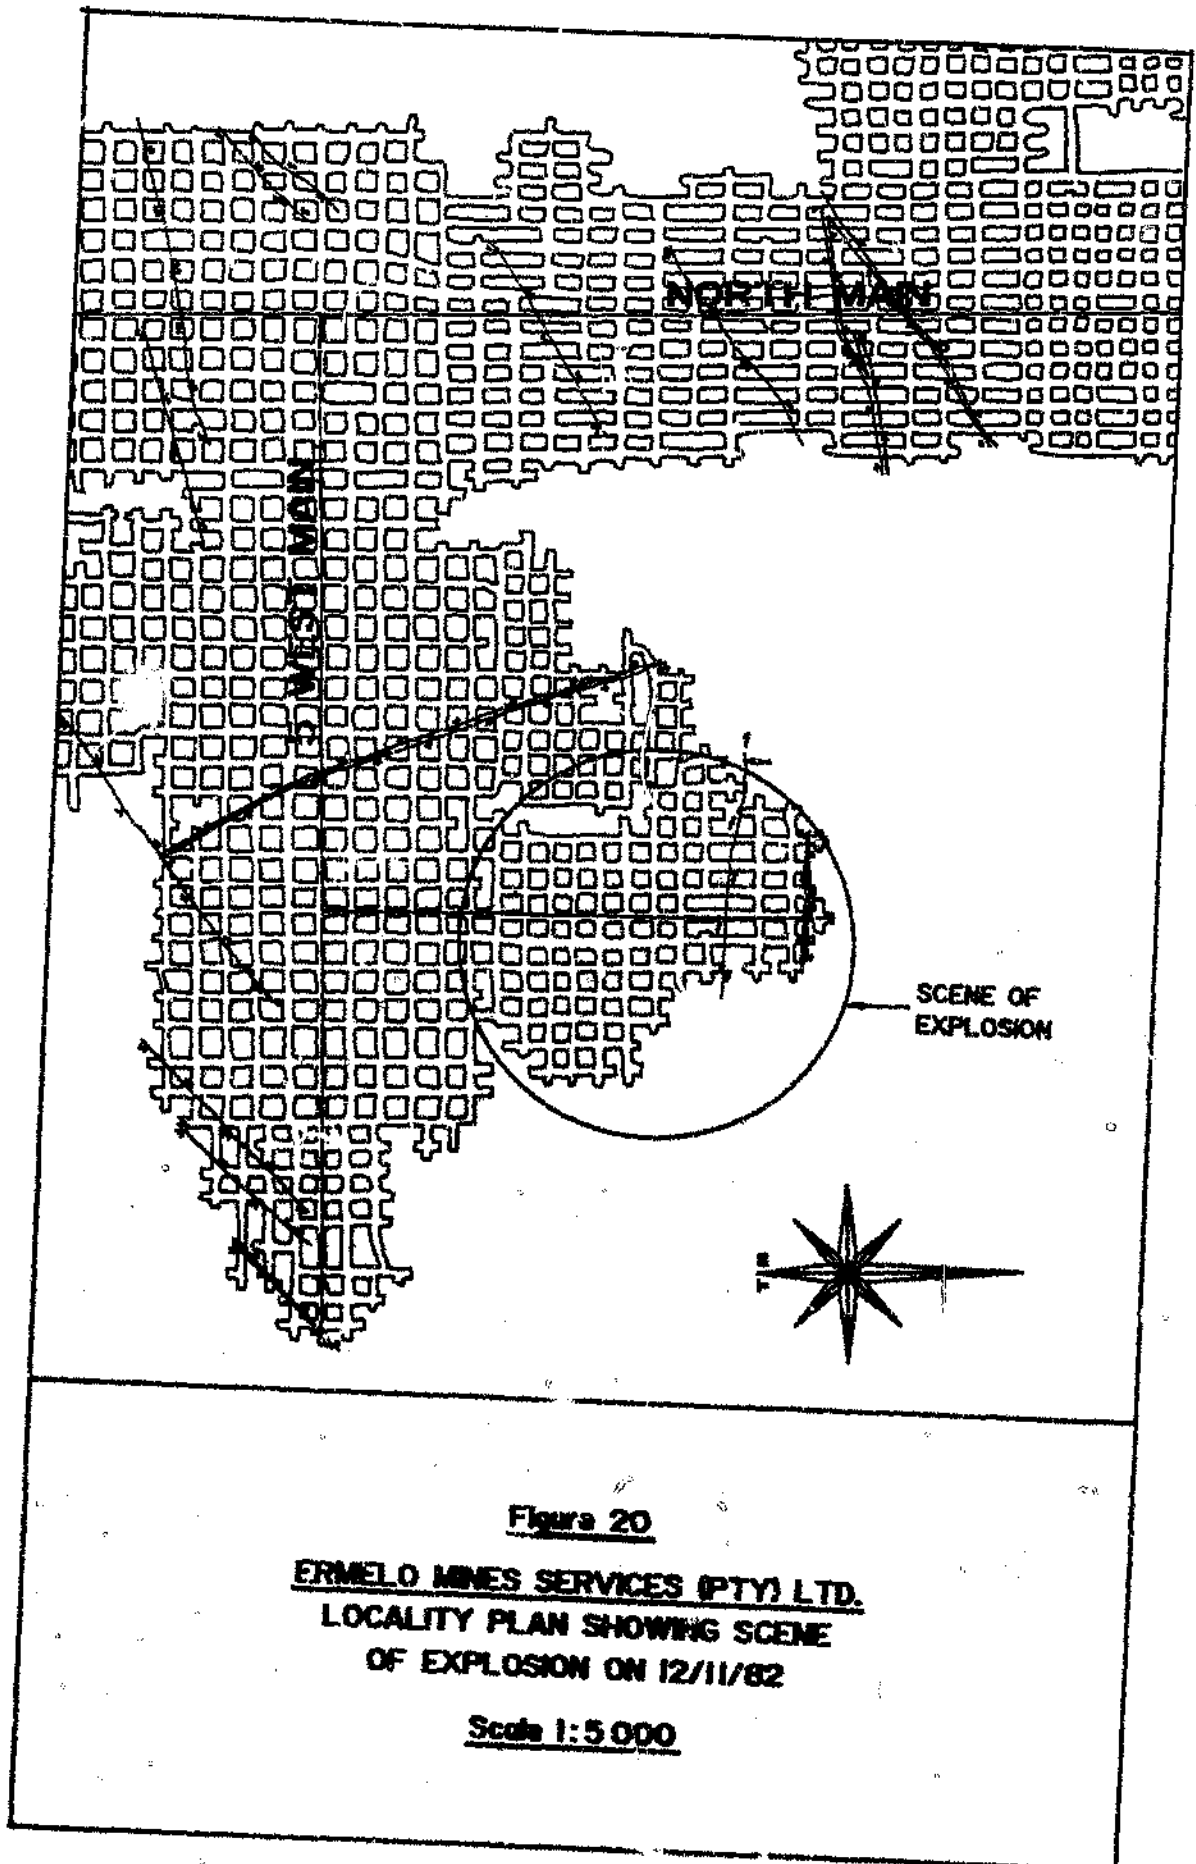
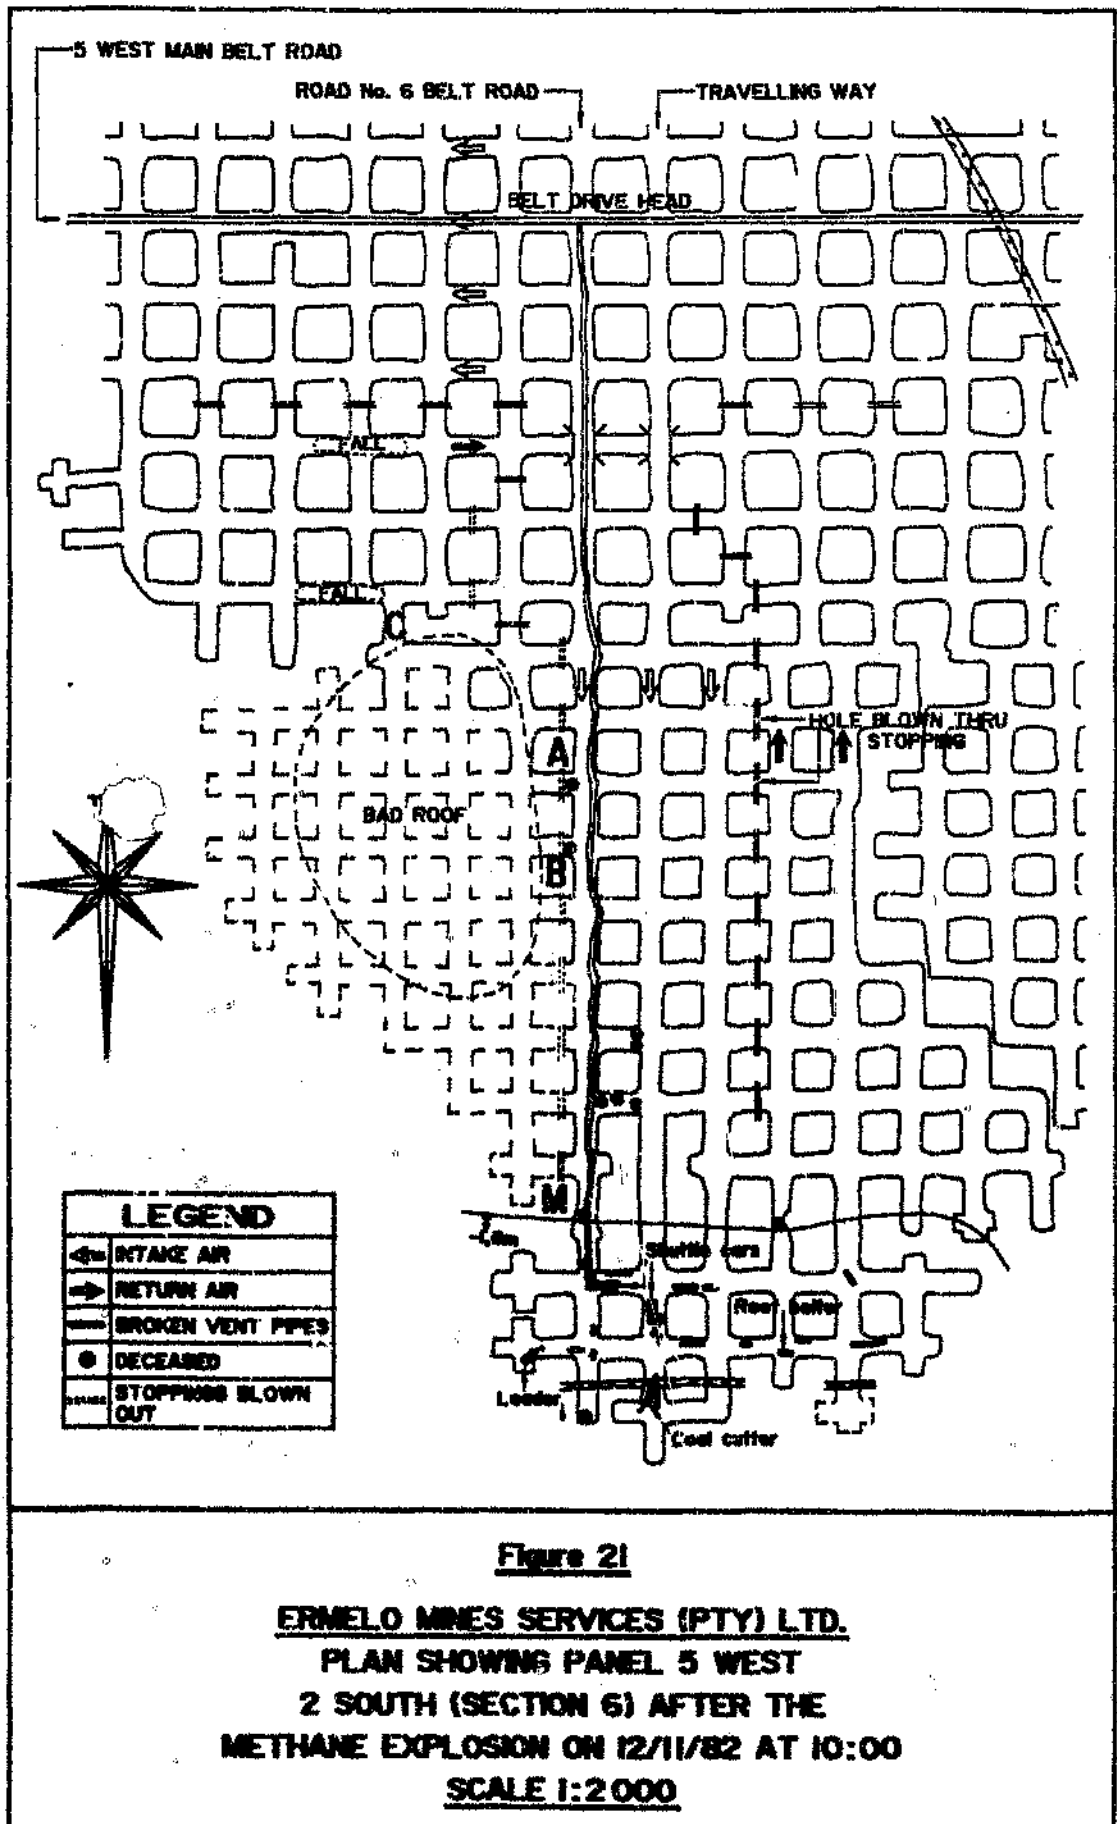
On the day before the explosion (11th November 1982) the plastic brattice cloth in the last right split (M on the plan Figure 21) was replaced by a brickwall thus isolating the "bad ground" area from the working section.  $12.4 \text{ m}^3/\text{sec}$  was measured in the three intakes on the 7th October 1989. The quantity of air leaking through the unplastered brick stoppings into the "bad ground" area was not measured but evidence was that there would be some

From evidence, the explosion originated in the sealed off "bad roof" area shown on plan Figure 21.

- All the brick stoppings between the belt road and the "bad roof" area were destroyed and the debris blown in an easterly direction across the belt road. 10 kg pieces of brick stoppings were blown 50 metres east of the travelling road.
- The conveyor belt was seriously damaged.
- All electric cables were seriously damaged.
- The extent of the debris is shown on the plan of the section (Figure 21).
- Plastic warning signs showed indications of burning as shown on the plan Figure 21 at positions X, Y and Z.
- No signs of burning or an explosion were evident anywhere in the section south of the 1,5 metre downthrow fault.
- No signs of scorching of timbers in the brushed area of the haulage and travelling way was evident.
- Both air crossings were destroyed.

- The major force of the explosion blast occurred at position A-B on the plan Figure 21.

main return airway at point C on the plan Figure 21. Hence it would be unlikely for methane to enter the belt road from the sealed off areas. No real change in the barometric pressure occurred during the day of the explosion.

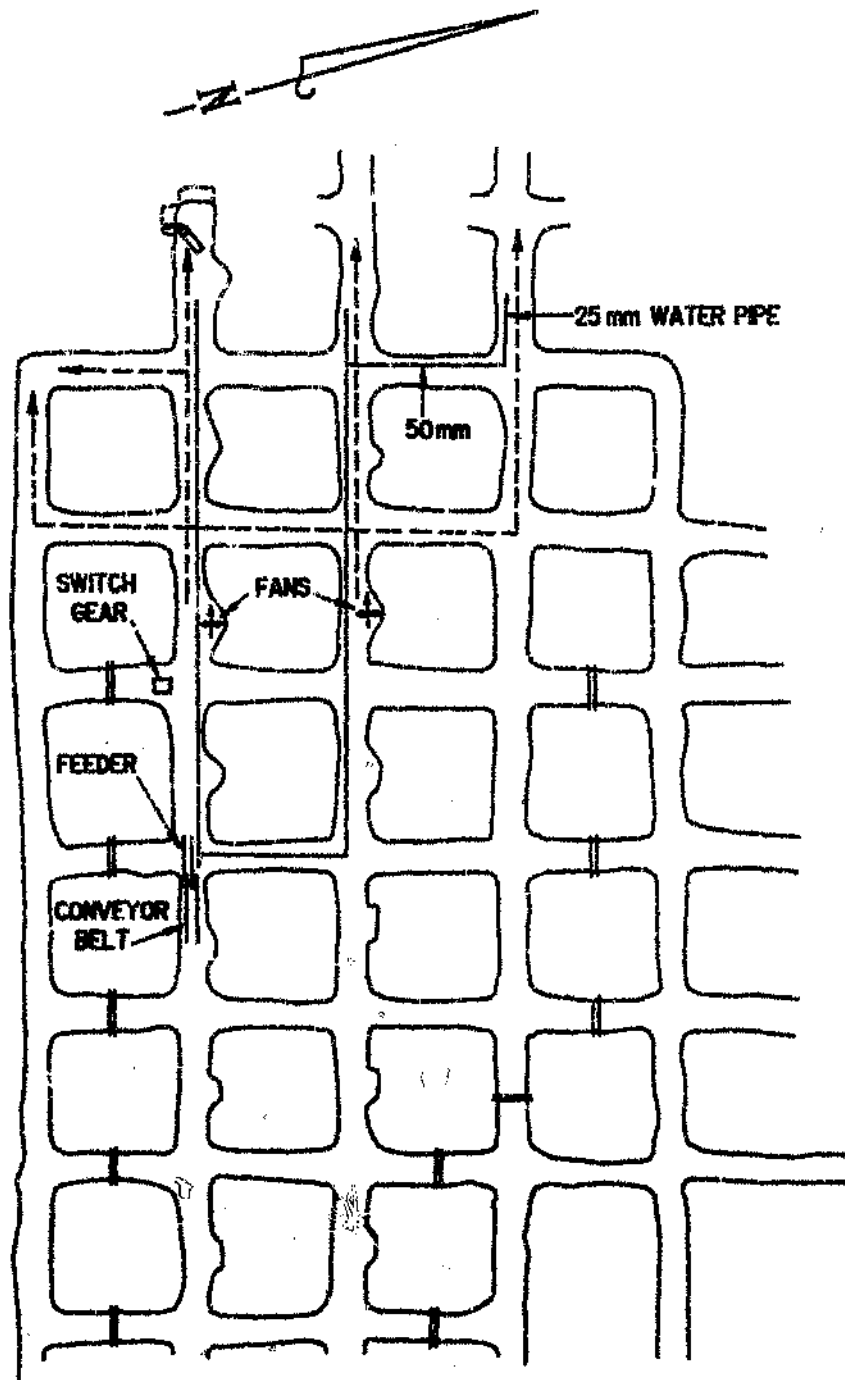
**Figure 28**

**DURBAN NAVIGATION COLLIERIES LTD.**  
**LOCALITY PLAN SHOWING SCENE OF FIRE**  
**IN 27 SECTION ON 21/09/68**

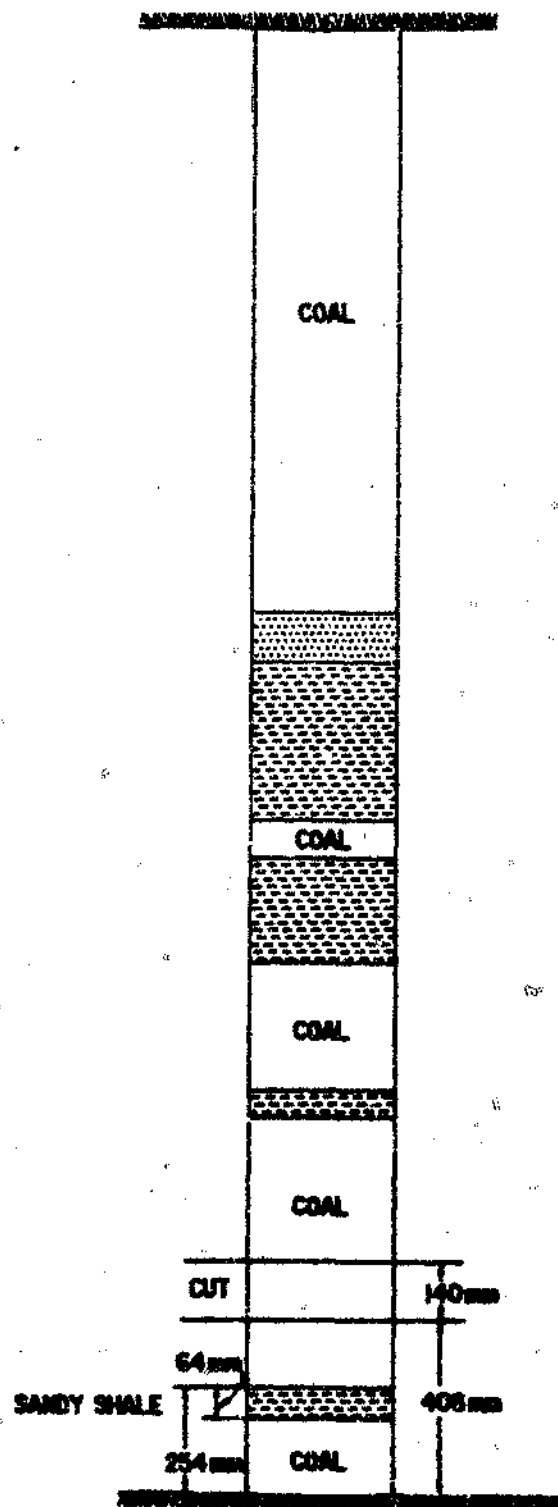
**Figure 29**

**DURBAN NAVIGATION COLLIERIES LTD.**  
**SECTION OF FACE AT SCENE OF FIRE ON 21/09/68**  
**Not to scale**

From my investigations into the ignition it appeared that whilst the coalcutter operator was undercutting the face as shown in Figure 30 there was the sound of an ignition of inflammable gas and flames appeared out of the undercut and spread to the adjacent undercut. These flames burnt to the height of about two metres. The coalcutter Driver switched off the power to the

I examined the coal face but did not find any coking of coal. During the inspection in loco I tested for inflammable gas with an Oldham methanometer and found 0.15% in the general body of the air with the force fan delivering its full quantity. I detected 1.2% in the undercut and by using a probe I detected 1.5% in the back of the undercut. I switched off the force fan and immediately layering of the methane took place; within five minutes there was a 450 mm layer containing +5% methane against the roof.

What is of technical interest is the fact that the tungsten insert on two of the picks had broken off, and that dry cutting could possibly have been taking place. Both these aspects are not uncommon practices where supervision is either lacking or weak or when the water supply to the section has been disrupted. The rapid build up of methane in the roadway when the auxiliary fan was stopped indicates that methane was being given off freely in the undercuts.

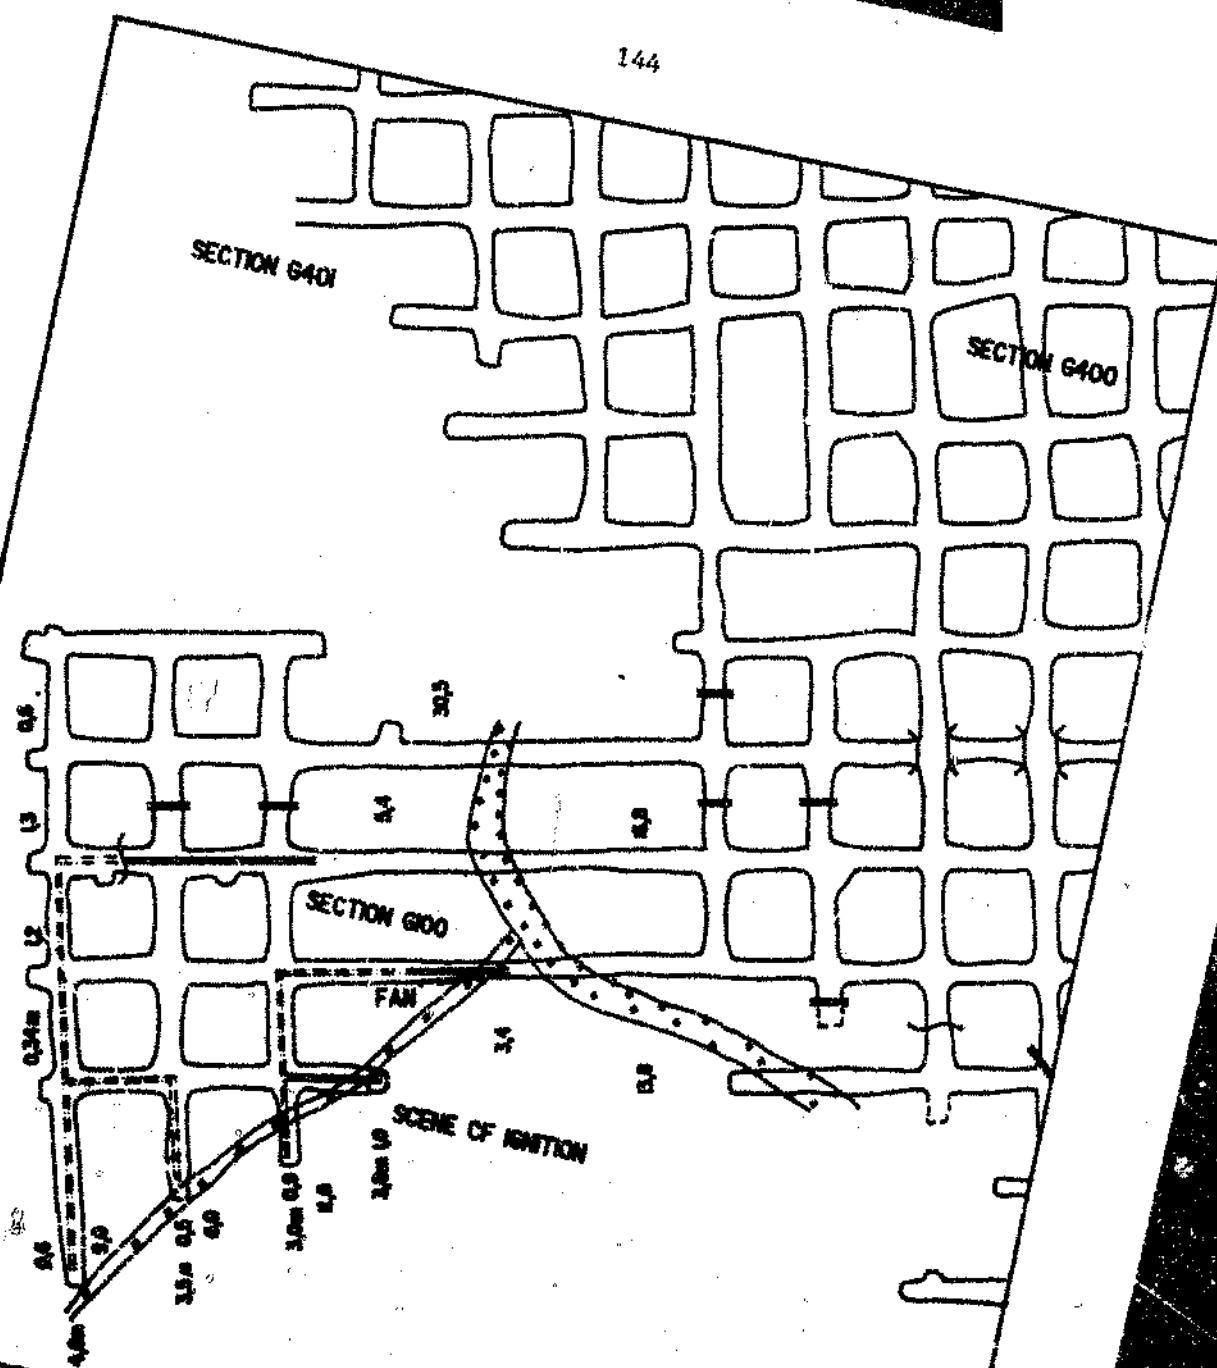
**FIGURE 3**  
**SPRINGFIELD COLLIERIES LTD.**  
**LOCALITY PLAN OF IGNITION IN SECTION G100 ON 4/11/83**  
**Not to Scale**

In a similar methane ignition incident at Springfield Colliery in November 1983, ventilation readings were taken immediately after the ignition in every face of the section. Figure 31 shows the locality of the section and the details of auxiliary fan positions, diameter of ducting, distance of ducting from faces, ventilation velocities and quantities. The ignition occurred in the second left hand companion back-over which was being advanced in burnt coal, and the face details are shown in Figure 32. The section was worked using trackless mechanised equipment (loaders and shuttlecars). The ventilation standards in the section were adequate as will be seen by referring to Figure 31.

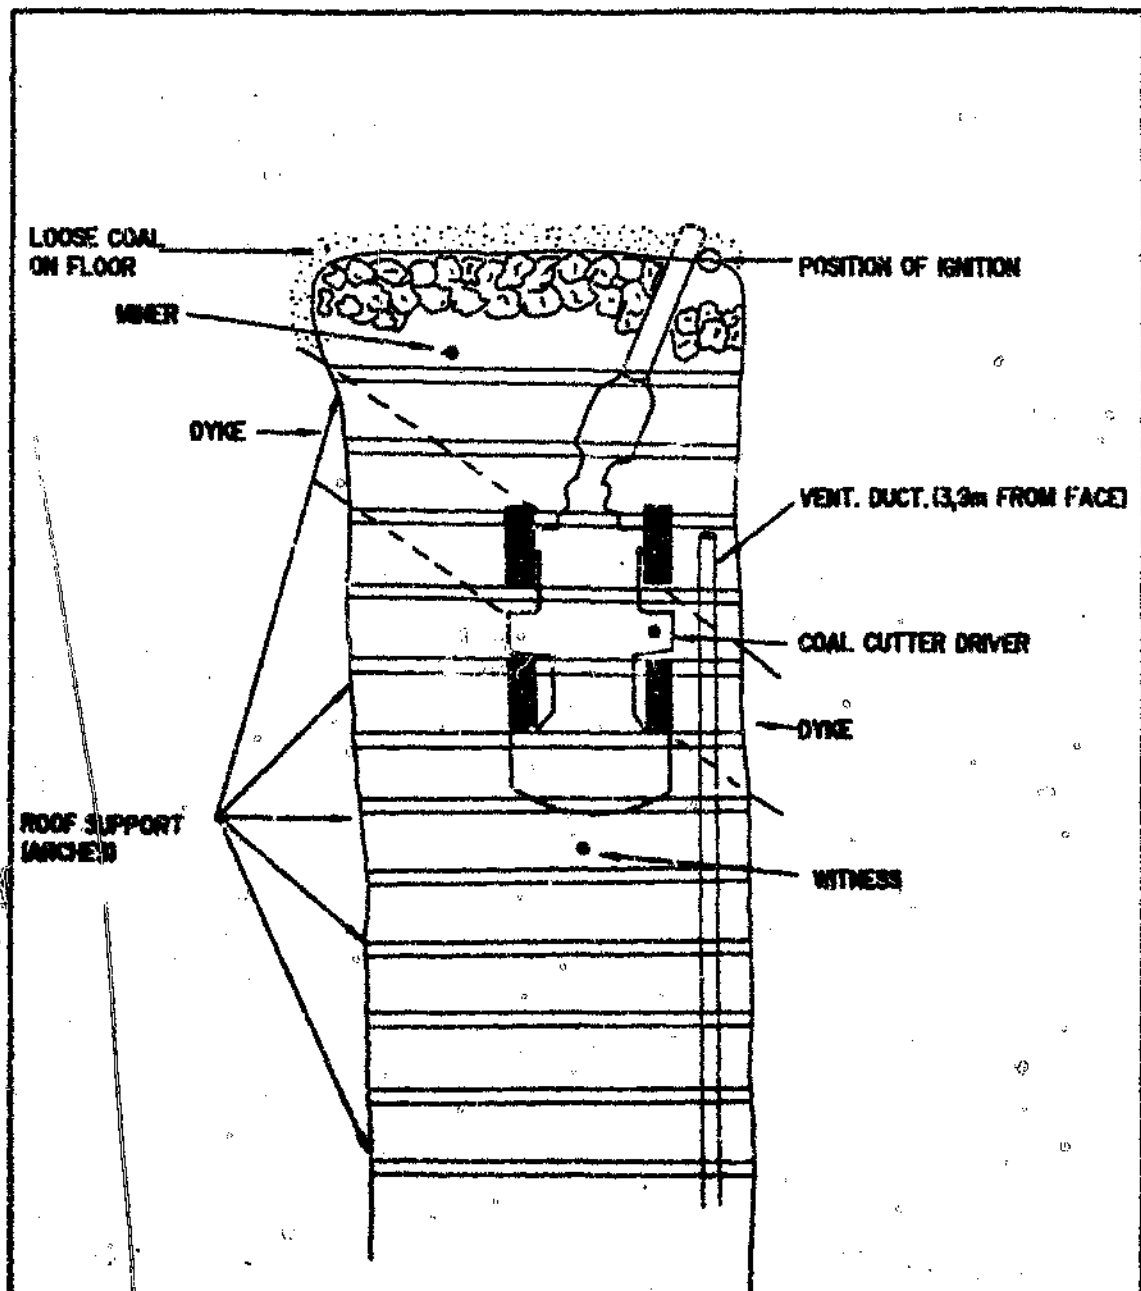
**Figure 32**

**SPRINGFIELD COLLIERIES LTD.**  
**PLAN SHOWING SCENE OF IGNITION**  
**IN SECTION 6100 ON 4/1/83 AT 10:30**

- Insufficient ventilation supplied to the pillar extraction sections. 20 m<sup>3</sup>/sec would appear to be insufficient.
- Inadequate supervision over the siting of fans. No brattice cloth curtains were erected in the section (Springfield) to course the ventilation along the 45° goaf line.

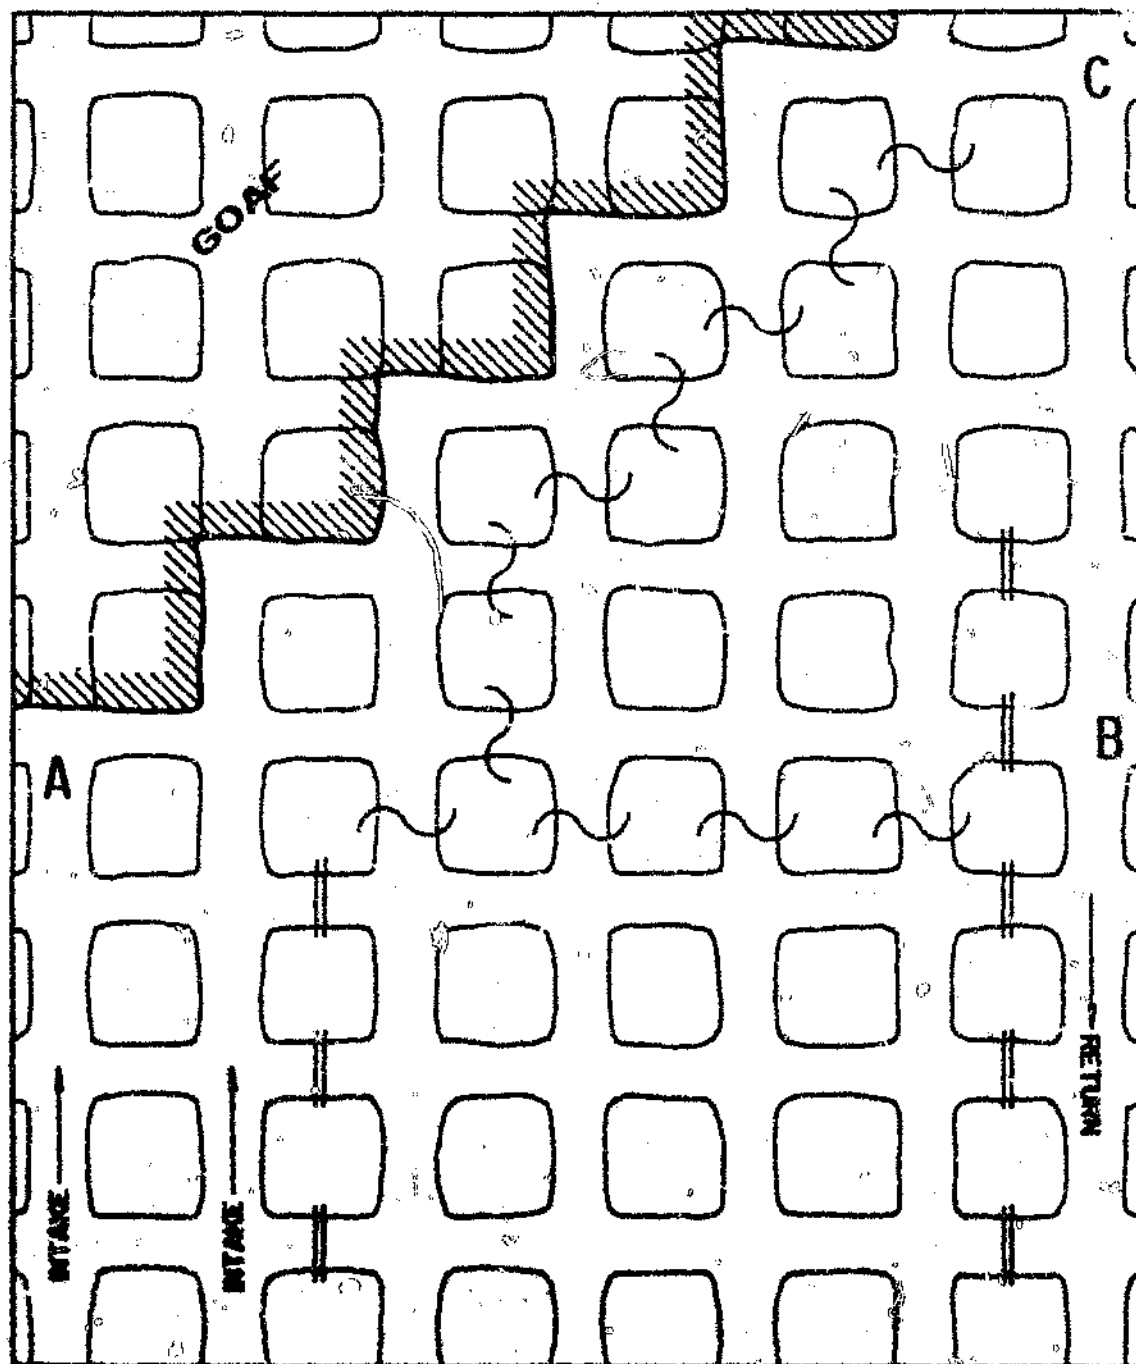
**Figure 33**

- The 45° goaf line worked in a stooping section to control the caving makes efficient ventilation of such a section difficult especially when the intake air enters the section at the lower end of the goaf as shown in Figure 33. The ventilation at point A has the tendency to travel across the section to the return airway at point B (the shortest route) and not to point C where adequate ventilation is required to remove the fumes of blasting and also methane accumulations. Any deficiency in the brattices along the line A-C as shown in Figure 33 will short circuit air to point B, with the possibility of an ignition at point C due to a lack of ventilation.

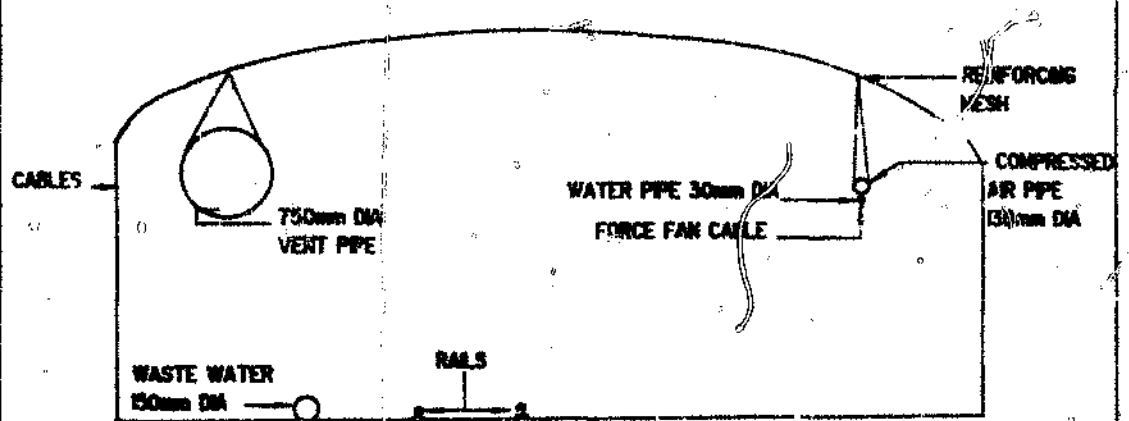
**Figure 7**

Figure 7 shows a typical cross section through the incline shaft looking North East.

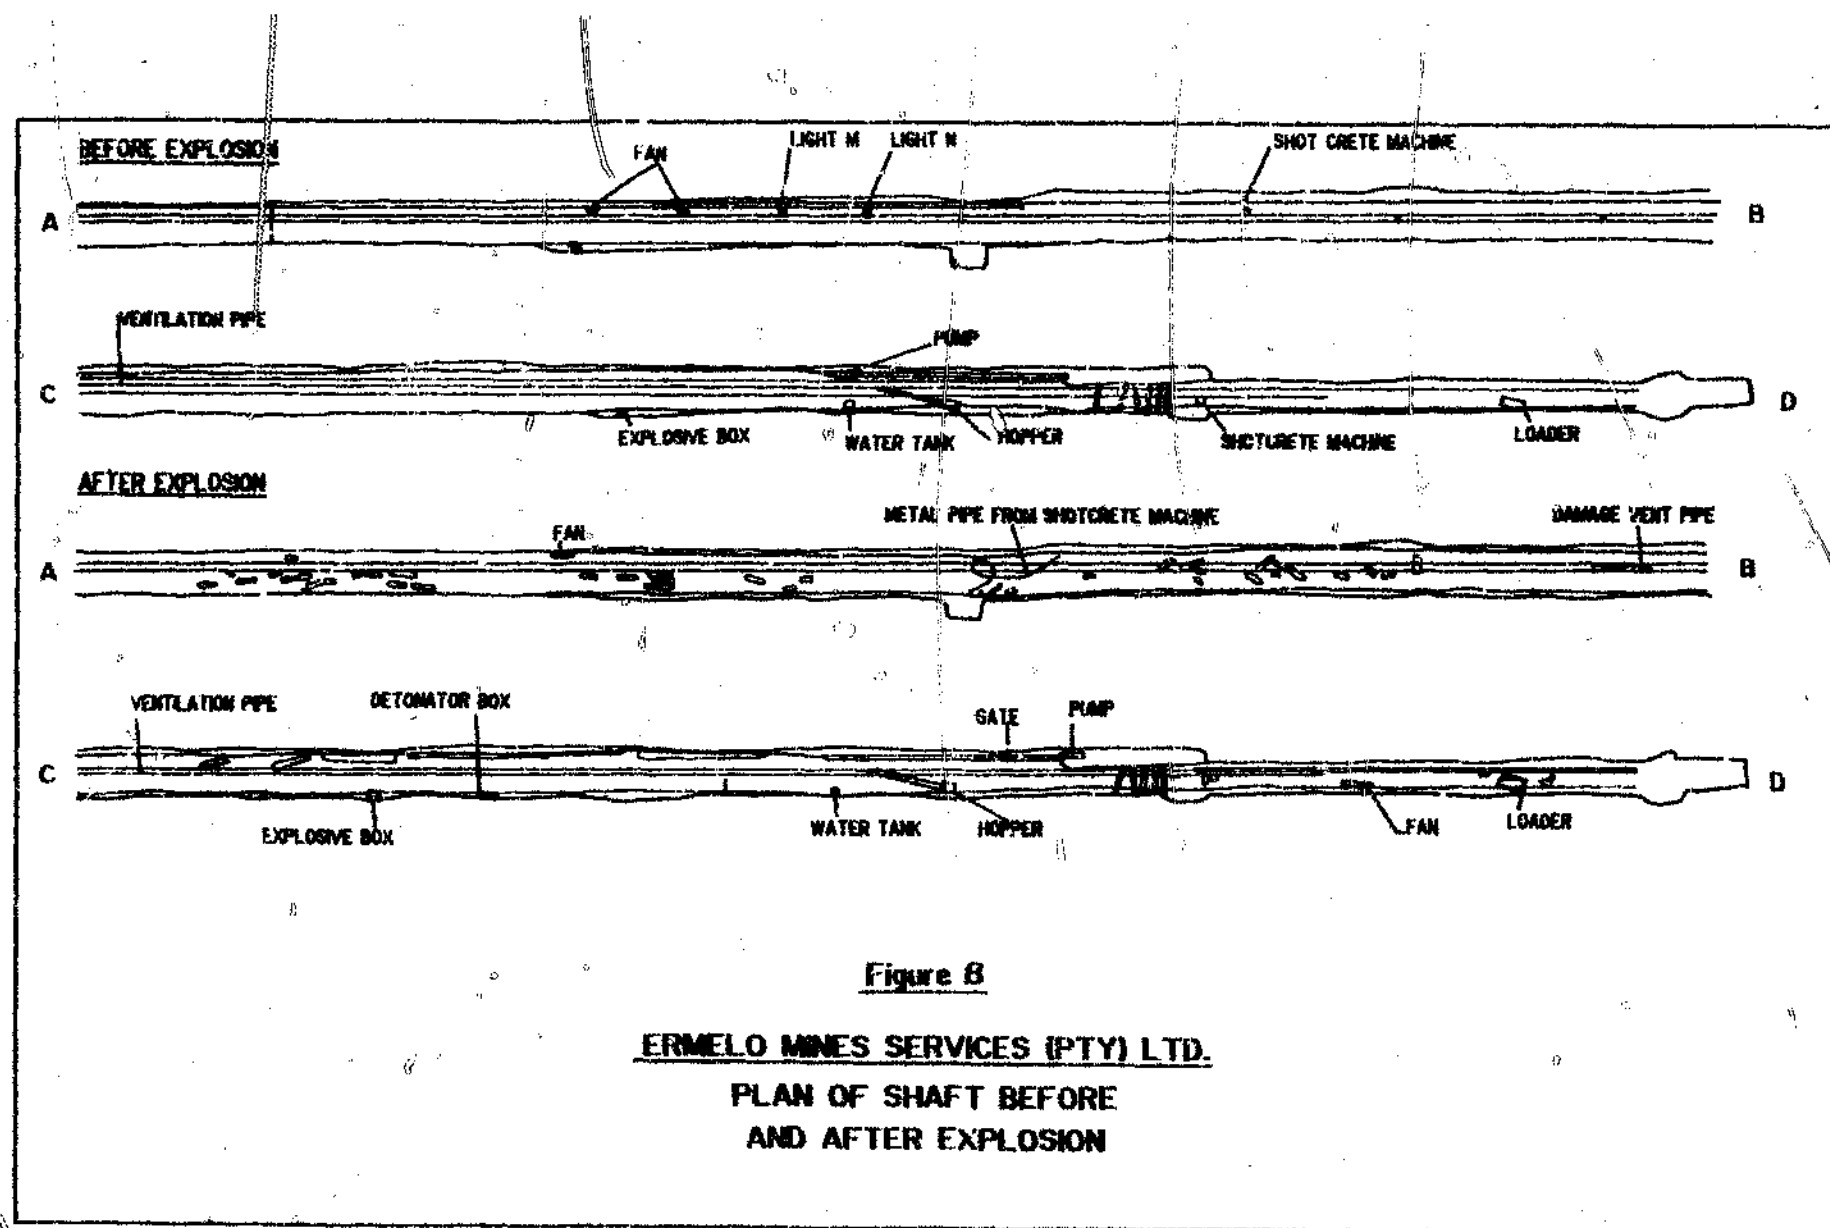
The scene and the shaft were surveyed and a plan was drawn up depicting the scene before and after the explosion. I submit this plan as Figure 8. I submit the locality plan of the shaft in relation to the rest of the mine workings as Figure 7.

The deceased was found near the pump station which is approximately 350 metres from the shaft portal as indicated on Figure 8.

In this area there were also badly burnt pieces of plastic, hoses and cables. A number of damaged hard hats were found in the shaft in the positions as indicated on the plan. The bottom of the shaft was full of water.

Approximately 300 metres from the portal, pieces of the wooden frame of the detonator box were found scattered from 300 to 320 metres from the portal as well as explosives cartridges.

The wire mesh, approximately 220 metres from the portal, was ripped away from the roof and a piece was lying on the floor approximately 200 metres from the portal. This had fallen as a result of the explosion.

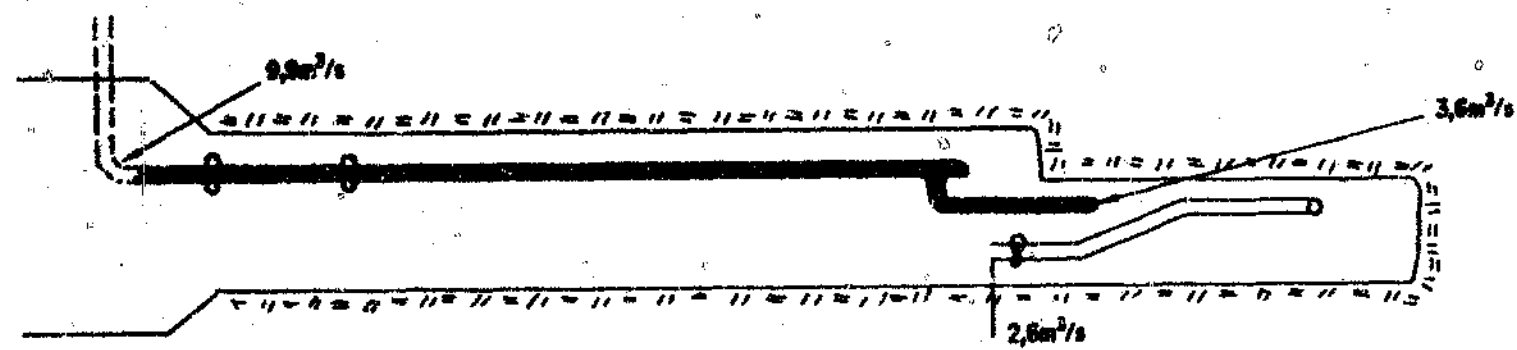
**Figure 8a**

Two flameproof exhaust fans in series exhausted 9,9 cubic metres of air per second and a force fan forcing 2,6 m<sup>3</sup>/sec was used to clear the toe of the shaft (see Figure 8a).

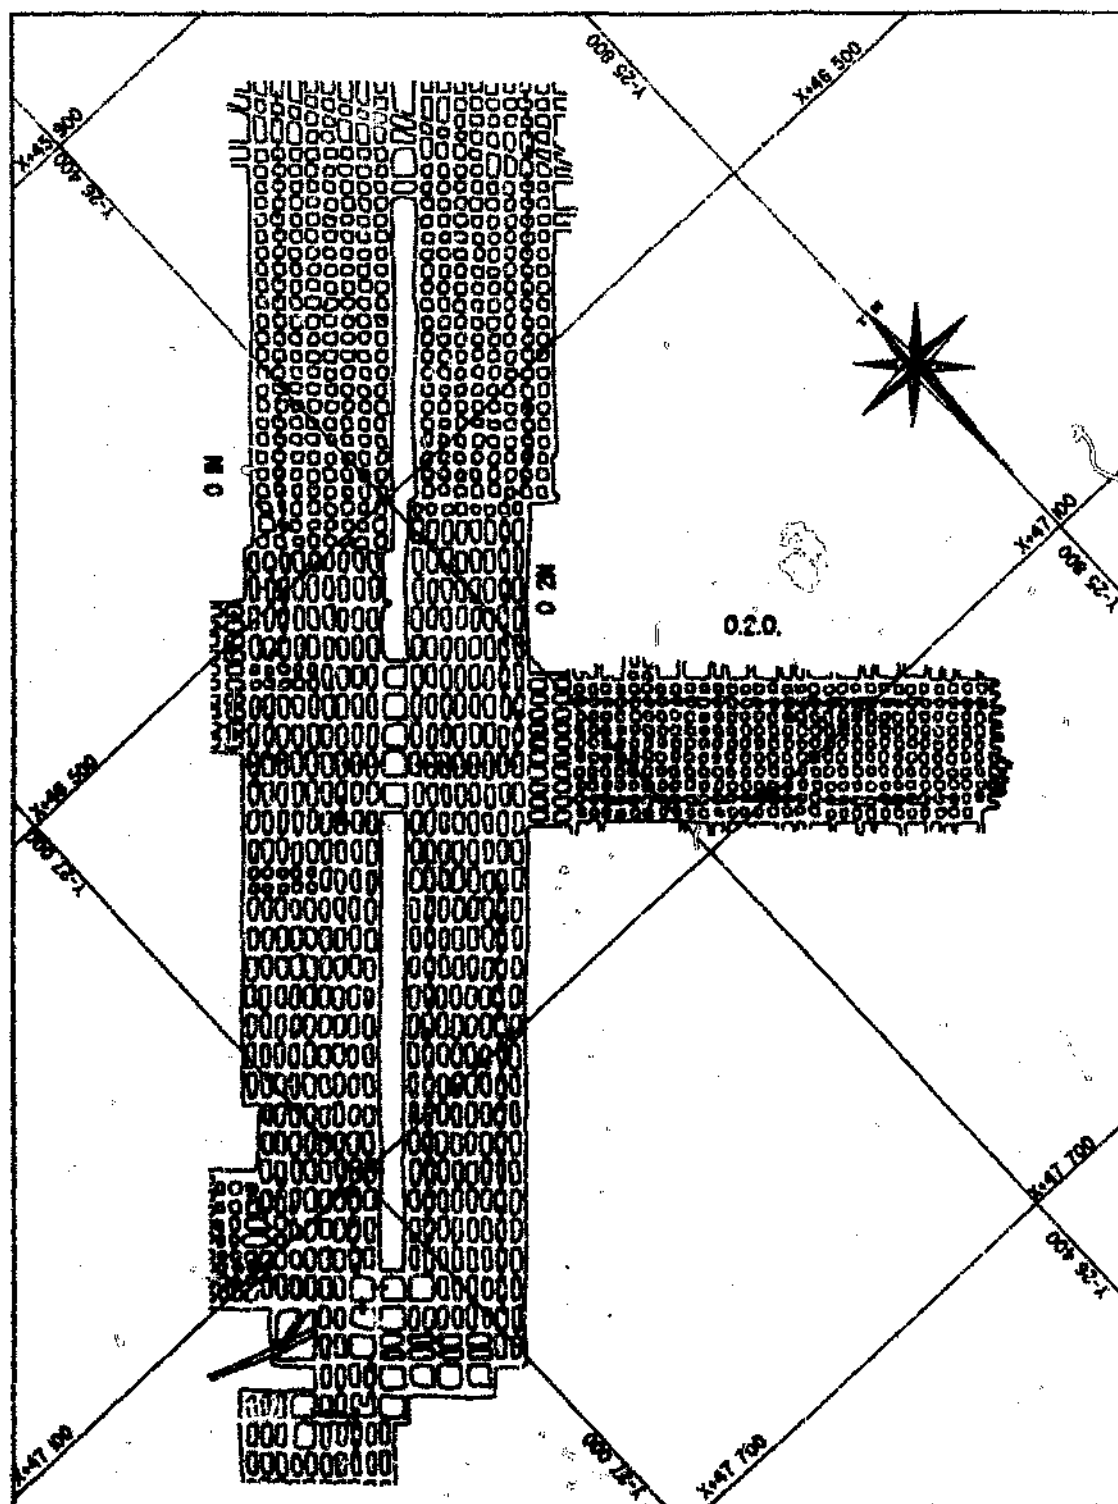
**Figure 10**

Figure 10 shows the underground workings at the colliery, the shaft bottom area, together with the upcast shaft, the Main North haulage (012-016), the main return airways (011-03) and the panel 0.2.0 where the explosion originated.

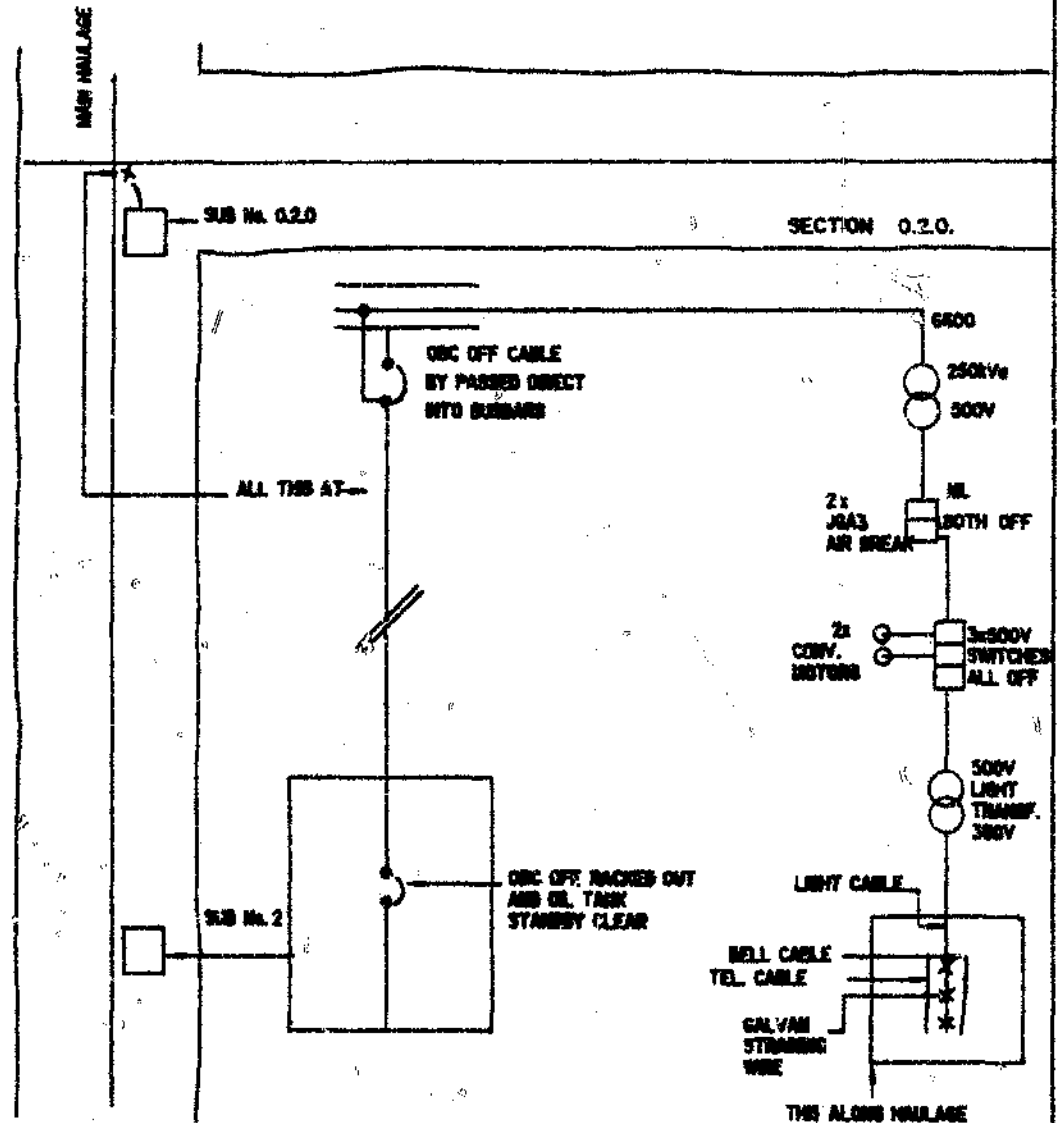
Figure IIUSUTU COLLIERY

SPARK COULD HAVE BEEN VIA

- (1) STRAINING WIRES IF SUPPORTED ON WOOD PEGS
- (2) CONVEYOR STRUCTURE - DOWN INCLINE SHAFT IF NOT EARTHED
- (3) STATIC ELECTRICITY IF CONVEYOR STRUCTURE WAS NOT EARTHED
- (4) TELEPHONE CABLES
- (5) BELL CABLES
- (6) ALONG ARMOURING OF POWER CABLE IF NOT PROPERLY EARTHED

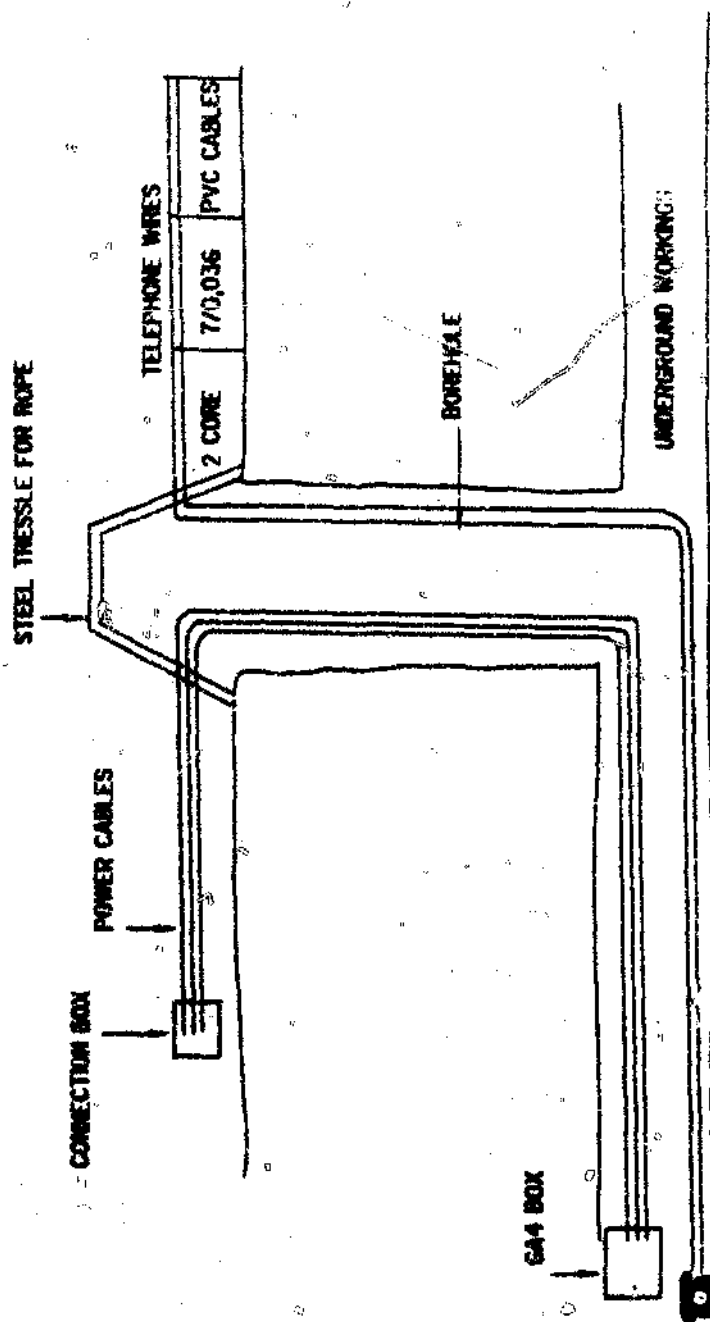
Figure 14 depicts the scene before the explosion. Section 4 was worked up until July 1960 and reports indicated that methane was being given off freely. The power cable from surface was used to supply power to Section 4 and the two core cable was connected to a telephone in Section 4.
