**MINE GAS AND COAL DUST EXPLOSIONS AND METHANE OUTBURSTS - THEIR  
CAUSES AND PREVENTION**

**A Dissertation submitted to the Faculty of Engineering,  
University of the Witwatersrand, Johannesburg, for the Degree of  
Master of Science in Engineering**

**Johannesburg 1990**

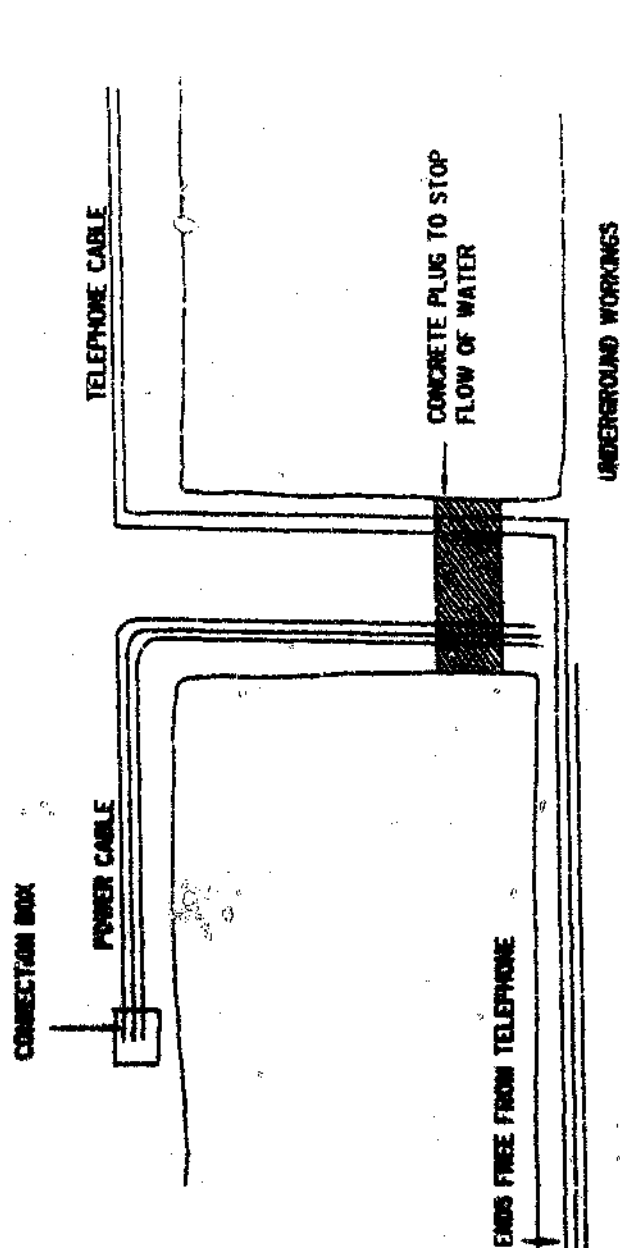
Figure 15

at the time of the explosion (14h50 on the 2nd December 1960). The borehole was closed with a concrete plug as shown in Figure 15.

A careful investigation for the ignition sources pointed only to a discharge of atmospheric electricity during a lightning storm from conductors passing through B.H. 225 to surface."

Several questions in this evidence remain unanswered. Was the borehole cased? If so, to what depth? Were the cables armoured? At the date of this incident, the Mining Industry tended to use paper insulated lead covered wire armoured cable. Was the armouring earthed at either end of the cable? The depth of the No. 2 coal seam from surface was 65 metres as shown in Figure 17.

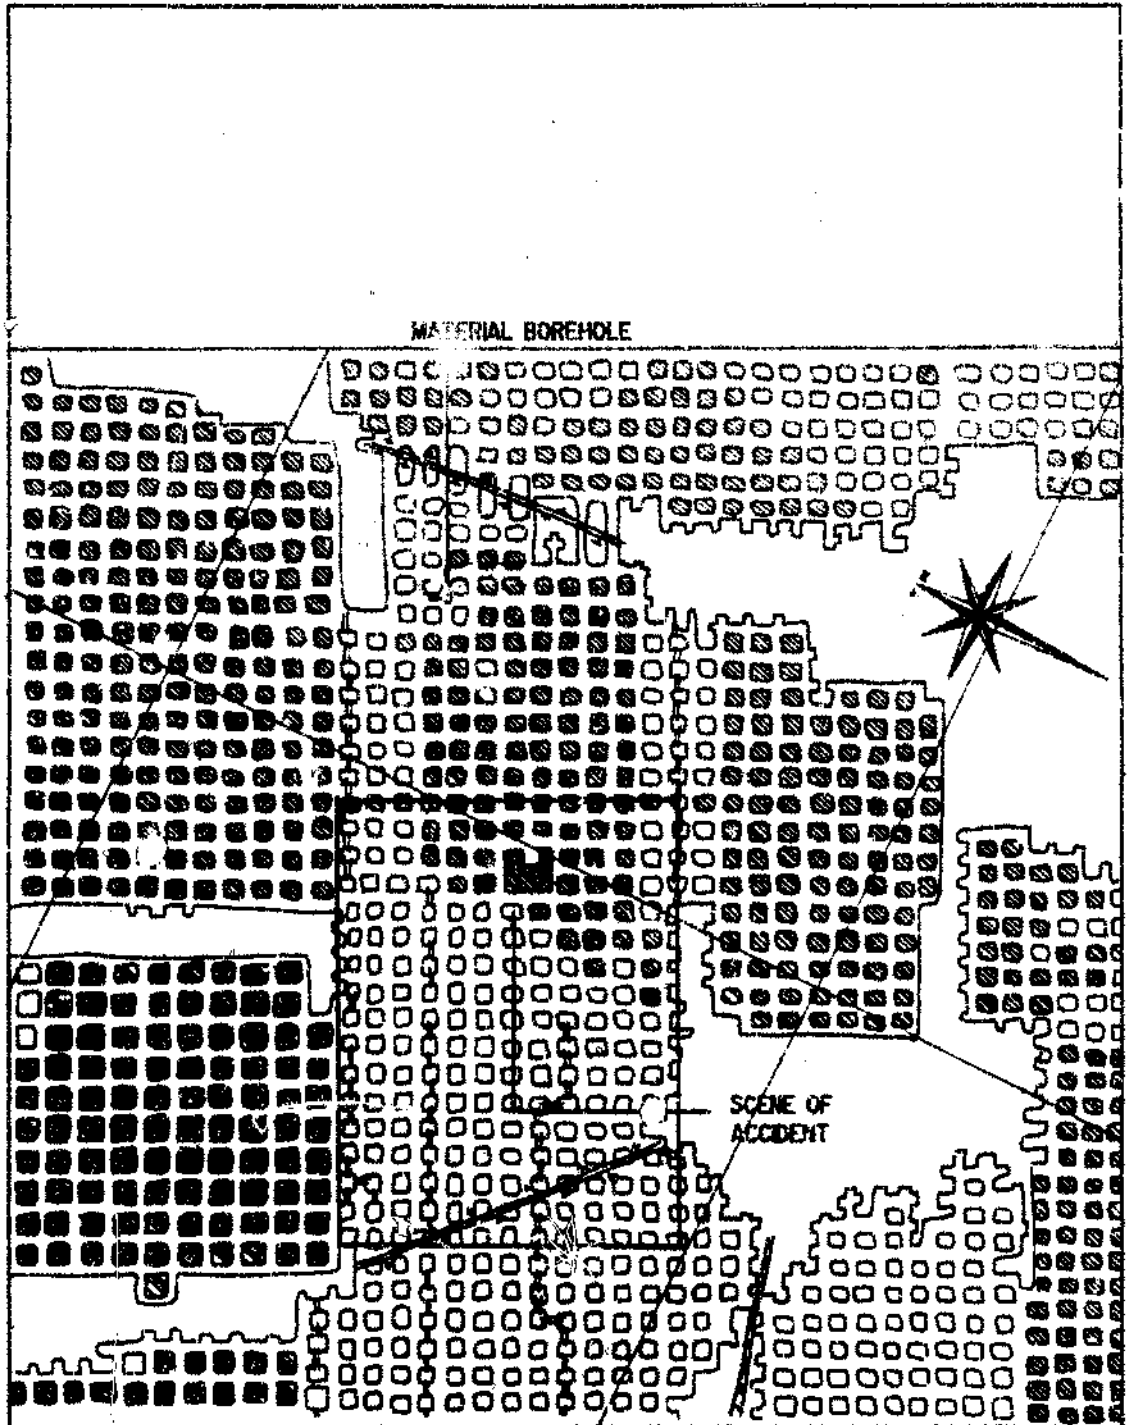
Figure 18 shows the locality plan of the stooping section together with the borehole which was cased with a steel pipe for 2 metres only at the surface. Management were unaware of the existence of this borehole.

17. Not all boreholes are recorded on mine plans. Hence the section working plans do not display boreholes and mine Officials are not aware therefore of these possible

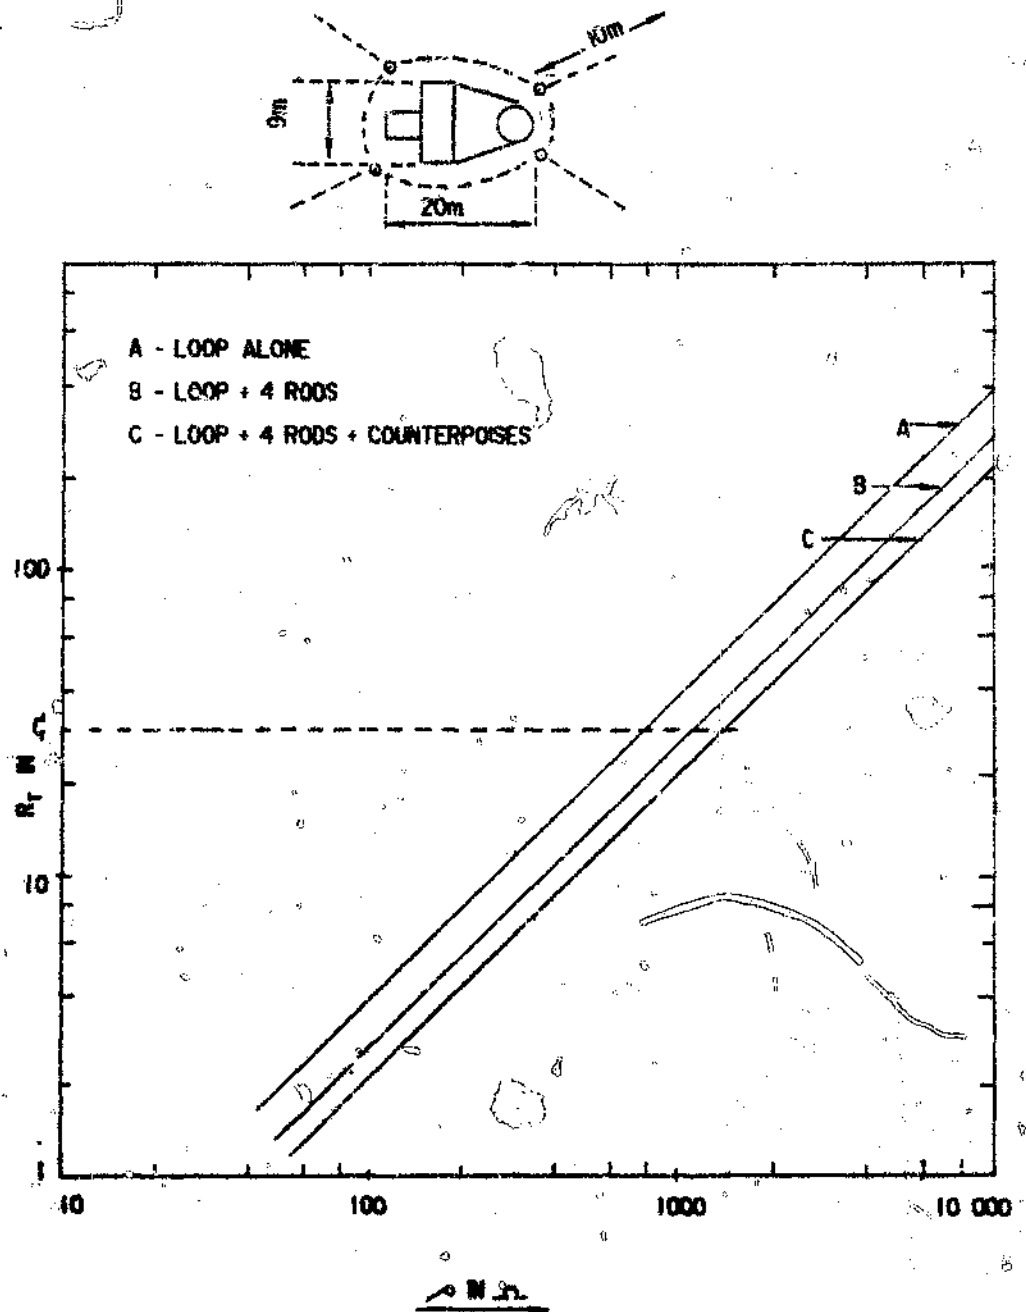
**Figure 19**

Figures 19, 20 and 21 illustrate typical earthing electrode arrangements and electrode resistances achievable under various soil resistivity conditions.

**VARIATIONS IN ELECTRODE RESISTANCE:-  
EXAMPLE OF RESULTS FOR FAN-HOUSING**

As a general principle at the collar or portal of a shaft, it is recommended that a copper ring conductor be buried round the shaft opening at a minimum depth of 0.5 m. and that it be connected at several points to the shaft steelwork and headframe, inclined conveyor structure or fan housing, whichever may be the case. Where a shaft conveyor delivers direct onto a stockpile, it may be useful to have the ring conductor encircling the latter. In order to obtain a satisfactorily low earthing impedance, it may be necessary to improve the earthing electrode system by adding radial buried conductors and/or vertical driven rods.

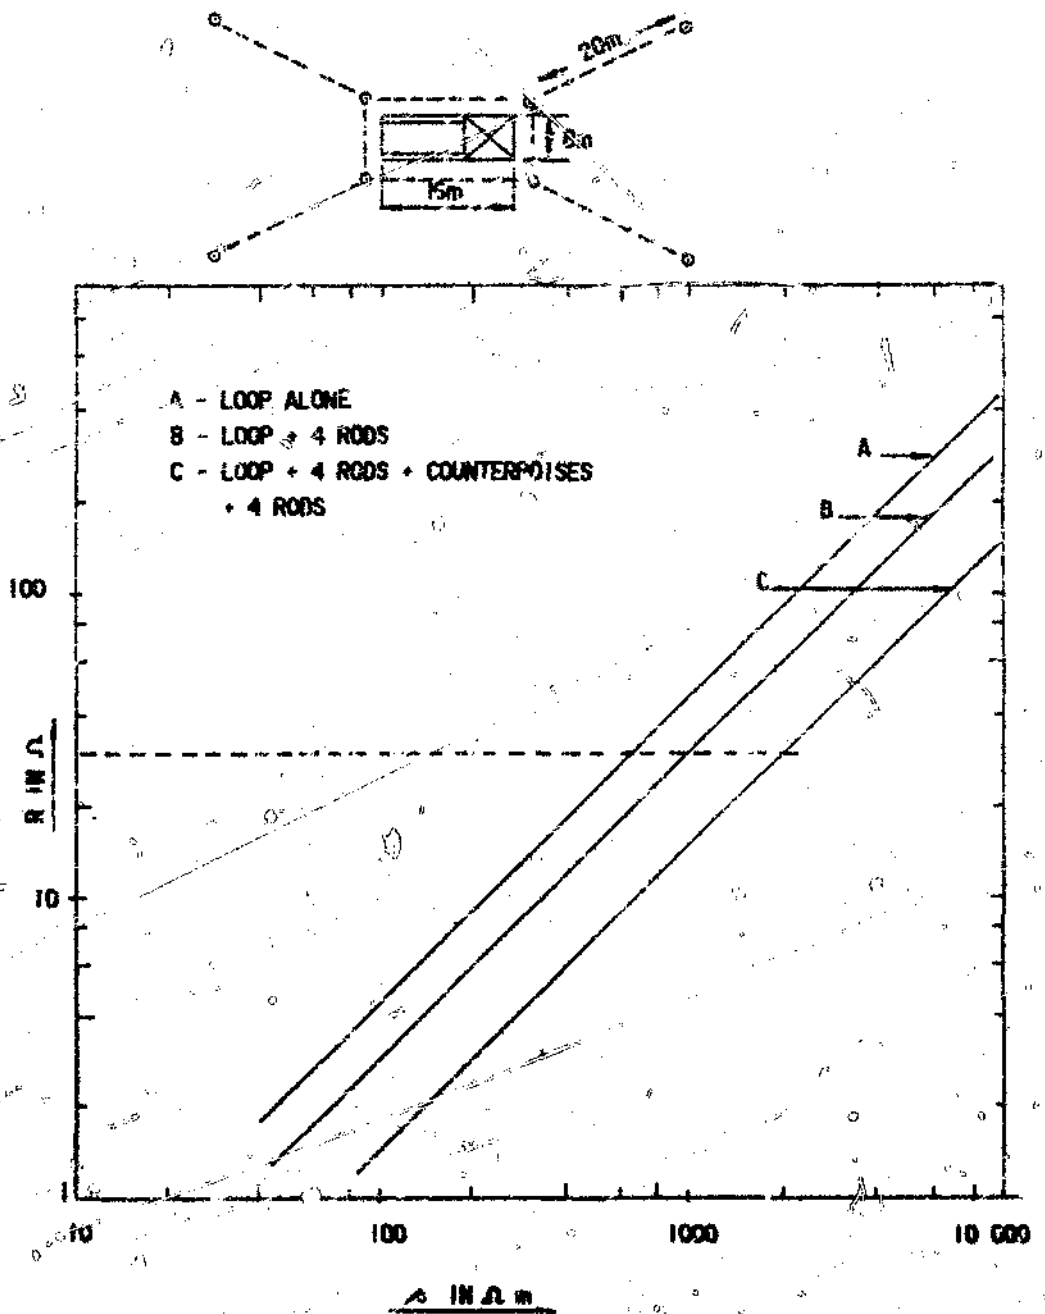
Figure 20

VARIATIONS IN ELECTRODE RESISTANCE  
EXAMPLE OF RESULTS FOR HEADGEAR

At the entrance to the shaft or adit, all pipes, rails, cables, conveyor structures and handrails, as well as all other continuous metalwork in the shaft, should be bonded together and to earth.
