**Mitigating against induced stress from the Merensky Reef pillars  
on the UG2 Reef mining environment,  
Tumela 1 Shaft, Anglo American Platinum**

Carol Hunter  
(Student number: 693554)

A research report submitted to the Faculty of Engineering and the Built Environment, University of the Witwatersrand, in partial fulfilment of the requirements for the degree of Master of Science in Engineering.

20 December 2019

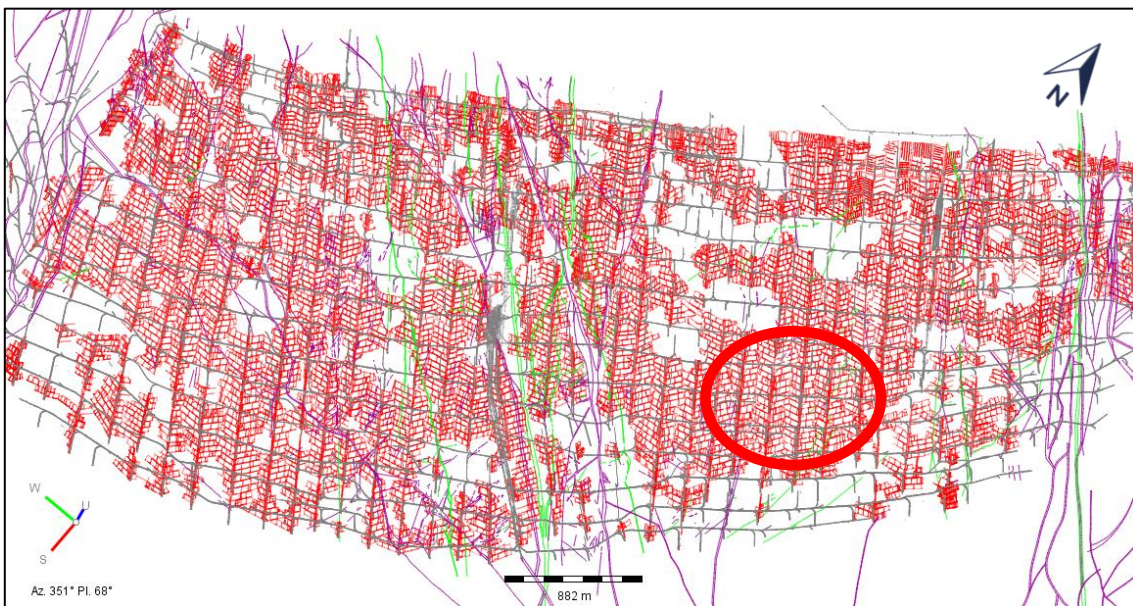
Figure 5: The Merensky Reef extraction at Tumela 1 Shaft. The circled area is where the highest rate of seismicity is occurring at Tumela 1 Shaft. The white areas indicate unmined areas (areas that will still be mined such as potholes)

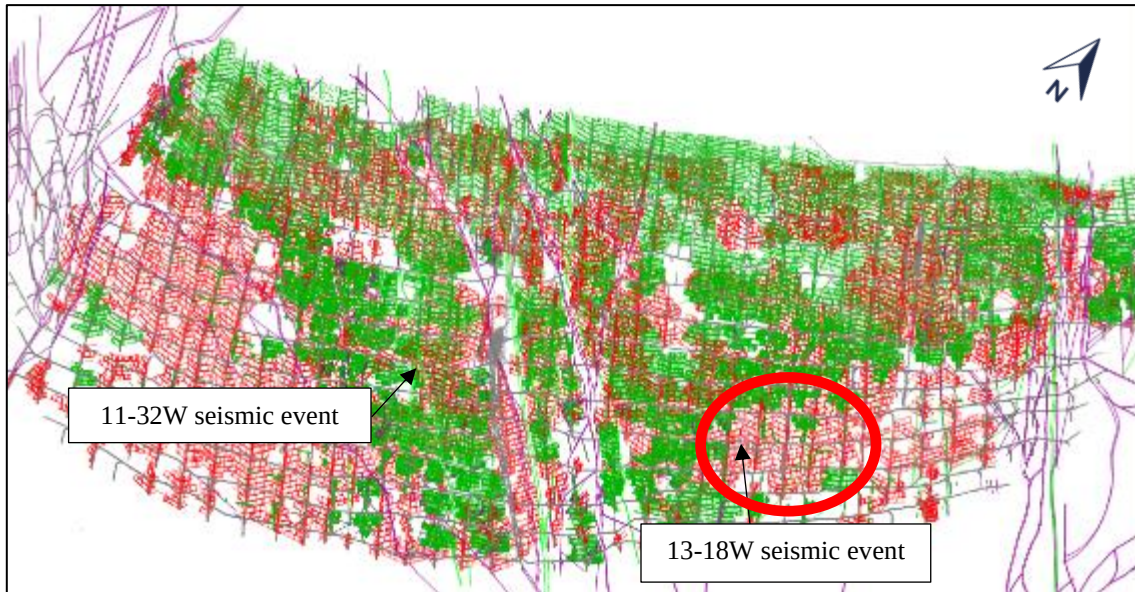
A flurry of large seismic events recorded during April 2017 in the area between 10 level and 15 level and between the 14W and 20W raiselines (circled area in Figure 6) raised concern about potential damage along the UG2 Reef stopes in this area. No significant UG2 Reef damage was reported from these events. On 2 May 2017, the record-breaking event of Tumela Mine at that time, a M2.6 event, was recorded at the 11-

Figure 6: Plan showing the locality of two major seismic events. The circled area is 14W to 20W raiselines where most of the seismicity was occurring

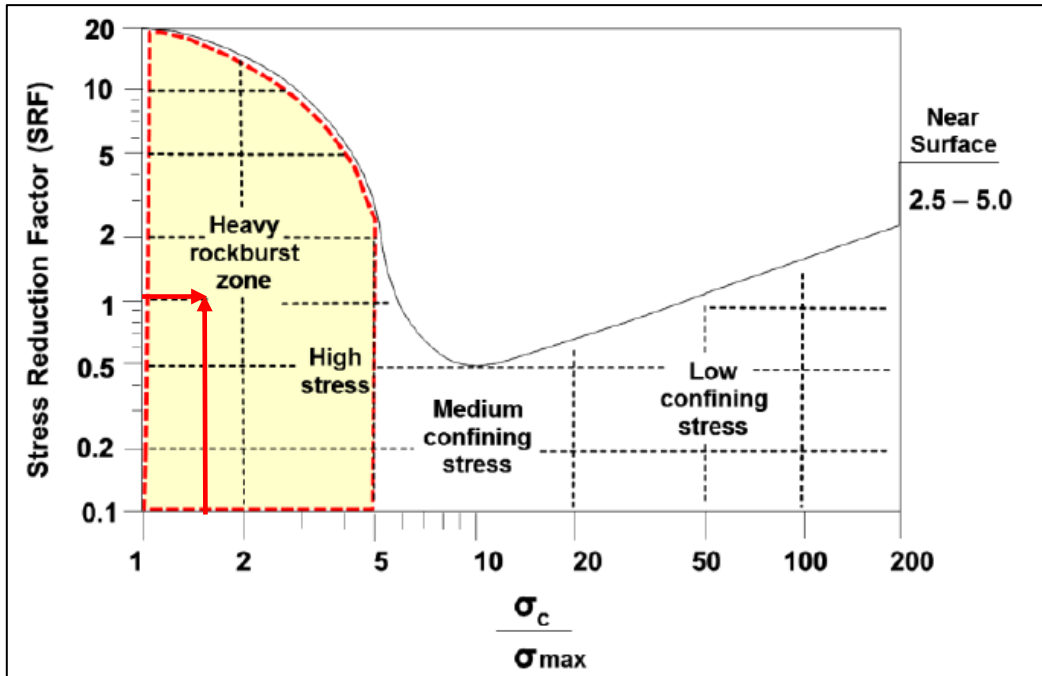
Figure 10 shows that the stress reduction factor (SRF) of the 14-23W UG2 crosscut at Tumela 1 Shaft is estimated to be approximately 1 and the  $\sigma_c/\sigma_{max}$  is estimated at approximately 1.6, which would place the excavation in a heavy rockburst zone. At the initiation of slabbing (spalling) as observed in April 2017, the  $\sigma_c/\sigma_{max}$  was estimated at approximately 3.3.

Figure 10: Graph showing the excavation behaviour as a function of compressive stress to the induced stress (Villaescusa *et al*, 2016). The arrows indicate the placement of the 14-23W UG2 crosscut

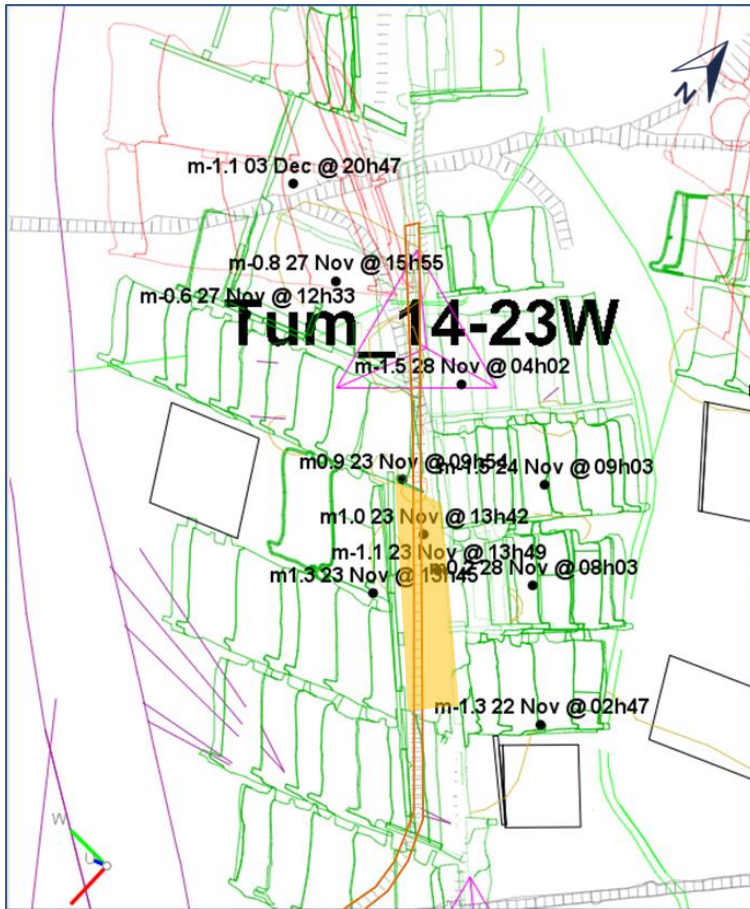
On the UG2 horizon, in the vicinity of 14-23W crosscut, three seismic events (M0.9, M1.0 and M1.3) were recorded on 23 November 2018 (Figure 15). Further investigation showed that the crosscut protection pillar failed dynamically resulting in the above-mentioned seismic events (Figure 16). 15-23W 1W panel was the

Figure 15: Plot showing all seismic events in the vicinity of 14-23W UG2 crosscut from 20 November 2018 to 31 December 2018. The orange area is the crosscut protection pillar

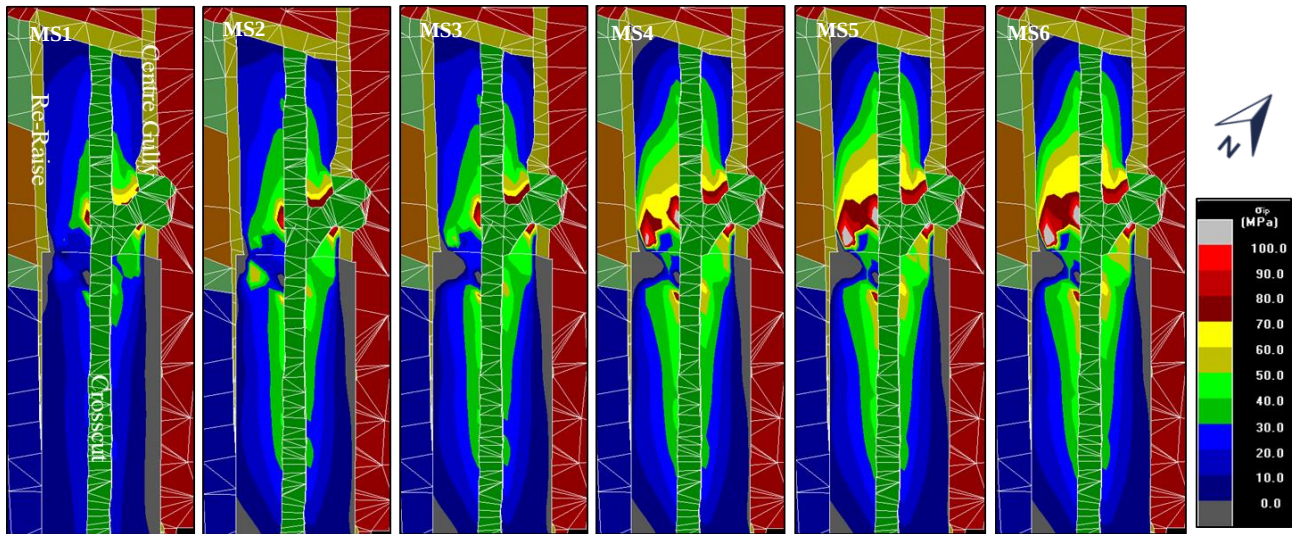
Figure 17: The stress changes (Sigma 1- in plane) made over the six mining steps as shown in MAP3D

A close-up MAP3D analysis over six mining steps was analysed and stress and strain changes were compared. In addition, the model incorporated all possible contributing factors, which may have changed the stress profile of the crosscut leading up to the dynamic failure, namely the winch cubby, the rolling reef (reef undulation) and that the crosscut has mined through the UG2 Reef. The UG2 Reef was modelled as on current layout so model analysis can be compared with underground observations. A number of these factors were confirmed by a sensitivity analysis through numerical modelling (Appendix 1) and a summary is shown in Table 1.

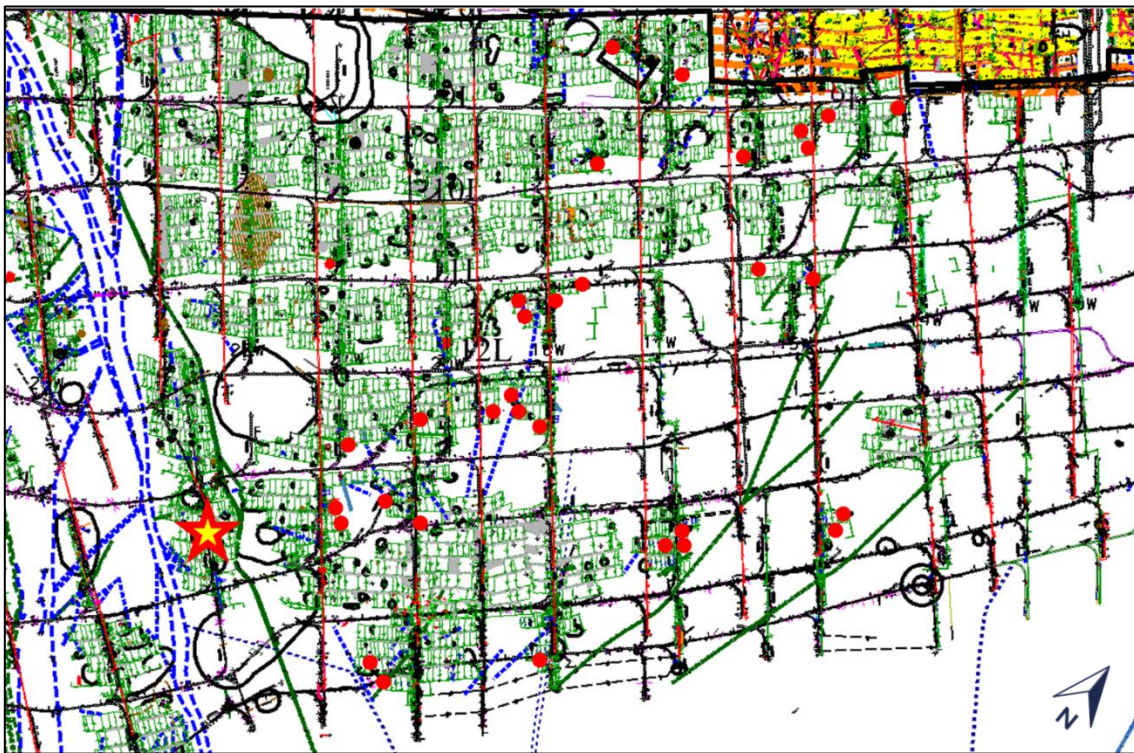
Figure 18 depicts the panels mining at the time of the 14-23W UG2 crosscut pillar dynamic failure. As indicated by the red star, the 15-23W 1W panel was the panel mining most out of sequence and closest to the shaft. This will indicate that panels this far behind the mining face are under considerably higher stress conditions than the panels mining in the correct sequence. The increase in stress due to depth is directed to the Merensky Reef regional pillars and remnants and this stress is induced onto the UG2 Reef mining. The highest stresses are concentrated at the edges of Merensky Reef remnants and under Merensky Reef regional pillars.

Figure 18: Plan showing 15-23W 1W panel (red star) and the mining panels at the time of the crosscut dynamic failure (red circles)

The sequencing of mining was incorrect and poorly controlled at the 15-23W stope. The panels should have been mined in an underhand configuration with the top panels leading the mining of the bottom panels and with acceptable leads and lags between the panels. Instead the western panels were mined first and the

panels were mined in a sequence from the bottom towards the top. This placed the crosscut pillar under higher than normal stresses as a “remnant” was created and with the accelerated rate of mining of 15-23W 1W, the stresses were unable to redistribute effectively. Non - adherence to common mining “rules” for higher stressed areas such as management of leads and lags and panel mining sequencing, can lead to dynamic pillar failure.

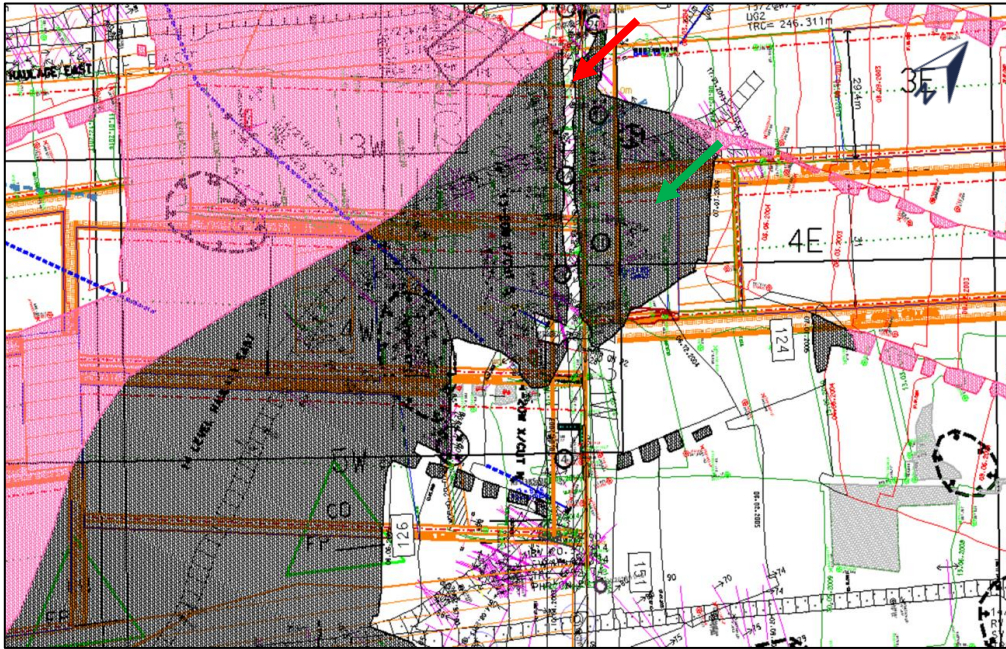
No prominent geological structures were observed in this centre gully, which eliminated the possibility of an unstable hangingwall block. Instead, as could be seen on plan (Figure 19), the raise on the Merensky Reef had split the remnant over the raise. This smaller portion of the remnant is 44 m long and 30 m wide. Closure was seen where this remnant is, which may have concentrated stress over this area.

Further investigation into the panels showed UG2 dynamic pillar failure at 14-20W 4E panel. This pillar was not oversized and was fully on-reef, thus suggesting that the rate of closure influenced the increased stress in the pillar and did not allow the pillar to release the stress by means of fracturing on the pillar edges. Instead the stress was released dynamically. If the local mine stiffness was high in comparison to the post peak stiffness of the pillar, dynamic failure would not occur as energy was absorbed by rock fracturing in the pillar (Maybee, 2000). This indicates a soft system at Tumela 1 shaft.

Figure 19: Plan showing the Merensky Reef remnant (black was off - reef and pink was - on reef projections) over UG2 panels. The red arrow indicates the centre gully of 14-20W, and the green arrow indicates the 4E in-stope pillar which dynamically failed

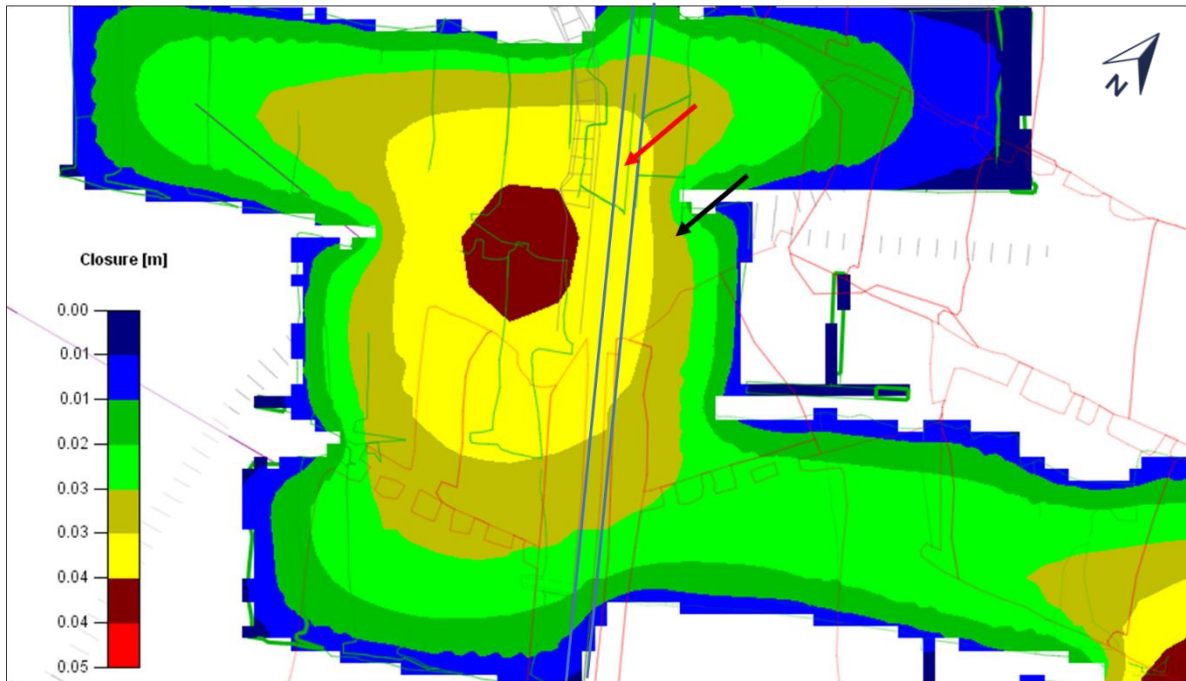
The elastic closure as determined by IMS Vantage modelling (Figure 20) indicates that maximum closure should not be more than 40 mm - 50 mm in the panel and 30 mm - 40 mm over the raiseline. The Cemrite 0.8 m x 0.8 m grout packs maximum deformation at peak load is approximately 61 mm at 2100 kN. The grout packs have crushed considerably to near failure indicating closure of more than 100 mm over the centre gully. This was collaborated by approximate closure measurements from failed timber elongates in the vicinity of these grout packs.

Figure 20: Expected closure at 14-20W panels (current state). The red arrow indicates the centre gully of 14-20W, and the black arrow indicates the 4E in-stope pillar which dynamically failed

Underground observations made at 14-20W UG2 centre gully and panels, in comparison with the IMS Vantage stress and closure modelling, indicate there is a significant in - elastic component of closure at 14-20W. 10 m in the hangingwall of the UG2 Reef package is the P1 marker. If this P1 marker is detaching, this would explain the excess loading on the grout packs and the resultant failure of these packs. Further investigation was done to determine if this marker has detached and is excessively loading the 14-20W raiseline.

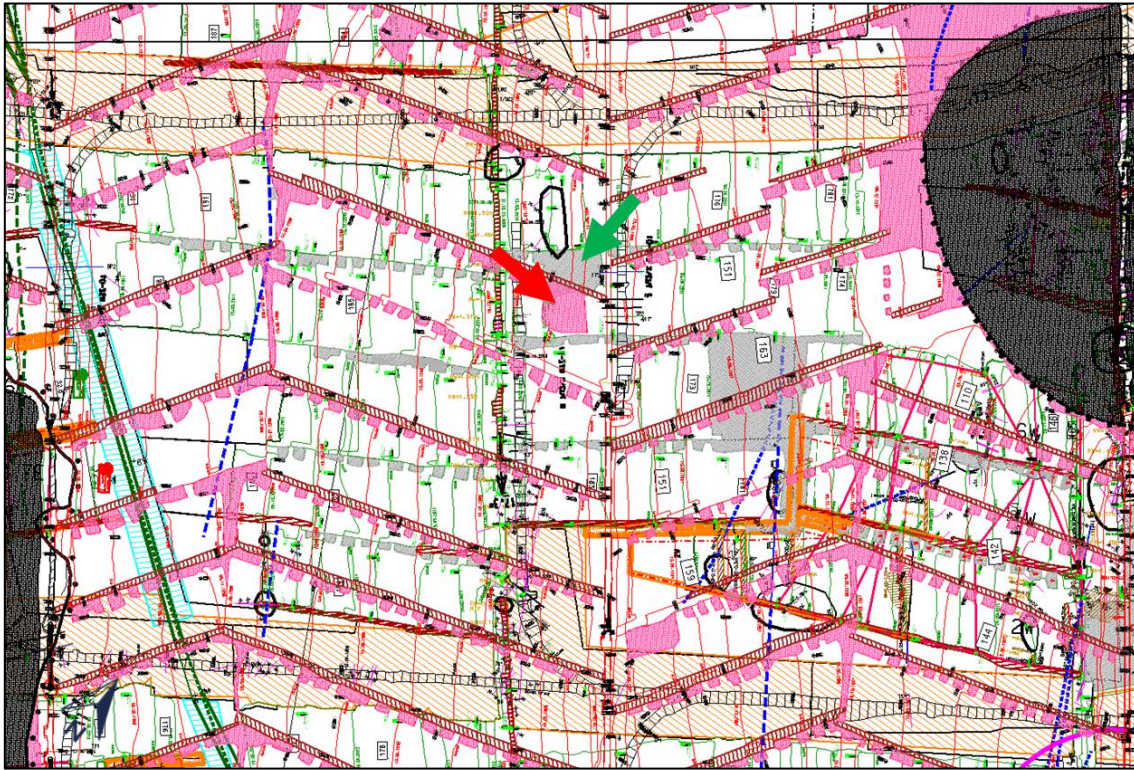
11-32W was visited after a M2.6 seismic event, which occurred on 2 May 2017 (Figure 27). At the time of the visit this was the largest magnitude event recorded for Tumela Mine. Both Merensky Reef and UG2 Reef had been mined in this area and was approximately 594 m below surface.

Figure 27: Plan showing the 11-32W UG2 Reef (green) and Merensky Reef stopes (red). The pink hatched areas were the Merensky Reef pillars and the grey hatched areas were the UG2 Reef pillars. The red arrow indicates the pillar which was the source of the event

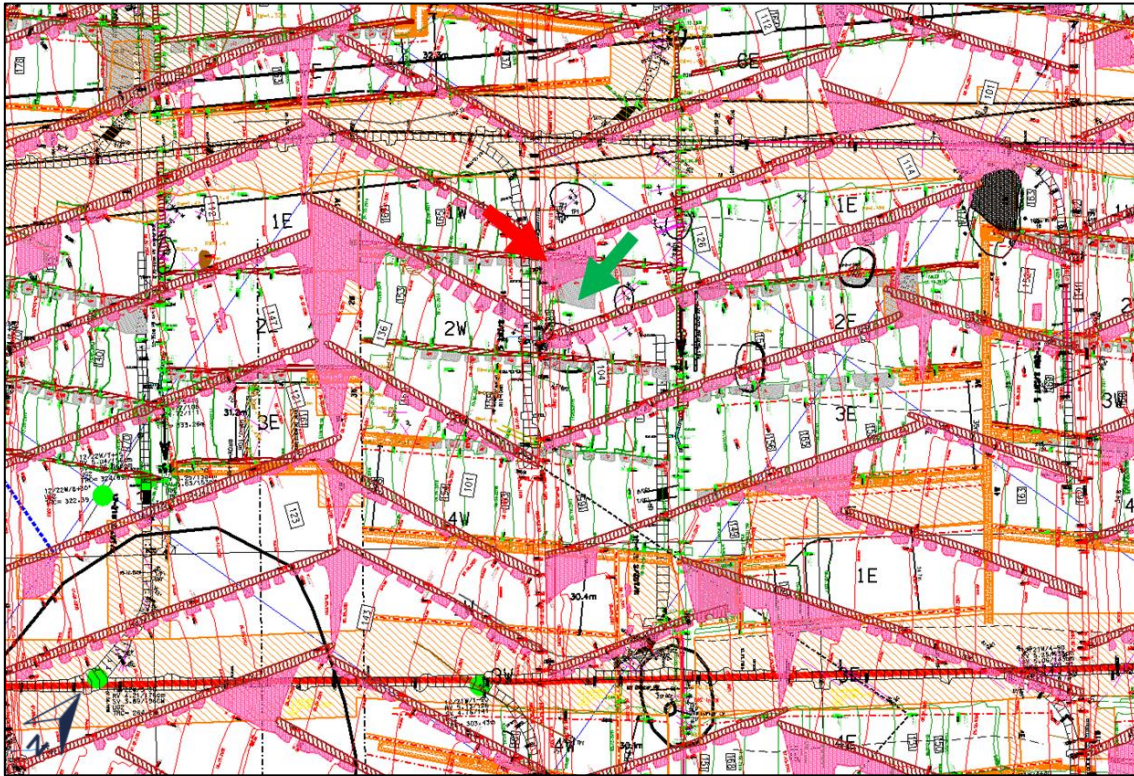
On 2 and 3 December 2016, an M1.4 event and a M1.1 event occurred in the vicinity of 12-21W (Figure 37). This area had previously exhibited signs of excessive loading and tensile fractures along the pillar boundaries on the UG2 Reef horizon, which was unusual considering that the area was completely overstoped by Merensky Reef mining. All UG2 Reef mining was stopped in the UG2 Reef panels after these seismic events. A visit was conducted to investigate what had occurred on the Merensky Reef horizon and to identify a possible cause for the higher stope closure rate. The depth of mining below surface of these panels was approximately 654 m and the middling between the Merensky and UG2 Reef was approximately 35 m.

Figure 37: Plan showing the 12-21W UG2 Reef (green) and Merensky Reef stopes (red). The pink hatched areas were the Merensky Reef pillars and the grey hatched areas were the UG2 Reef pillars

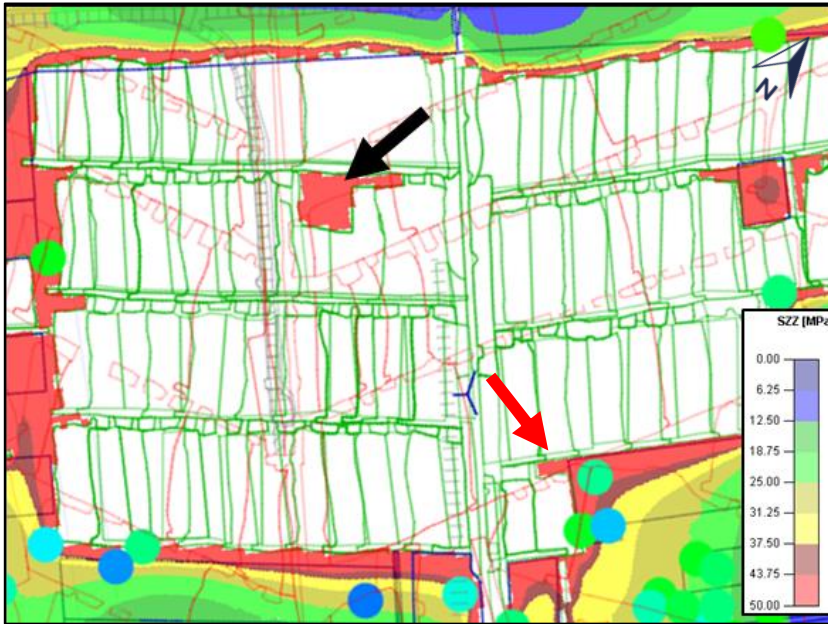
UG2 Reef in-stope pillar dynamic failure was seen in 12-21W 4E UG2 Reef panel (Figure 43). A UG2 Reef pillar or remnant in a critical state could be triggered to fail by failure on a nearby Merensky Reef pillar (van Aswegen, 2017). This pillar was longer than the standard dimensions and approximately 15 m from the face position. At the time of the failure no mining personnel were in the stope. The failed UG2 in-stope pillar was crushed into small blocks and no hangingwall shear was observed (Figure 44). The pillar itself failed dynamically as seen by pieces of rock found embedded in the timber elongates and no footwall heave was observed. Only an isolated area was affected. Curved hangingwall fractures around the pillar showed extension stress fractures in the hangingwall. In the vicinity of the pillar, grout packs had reached peak load and failed and bent timber elongates were observed.

Figure 43: A Plan showing the position of the failed UG2 Reef pillar (red arrow) and the failed Merensky Pillar (black arrow)

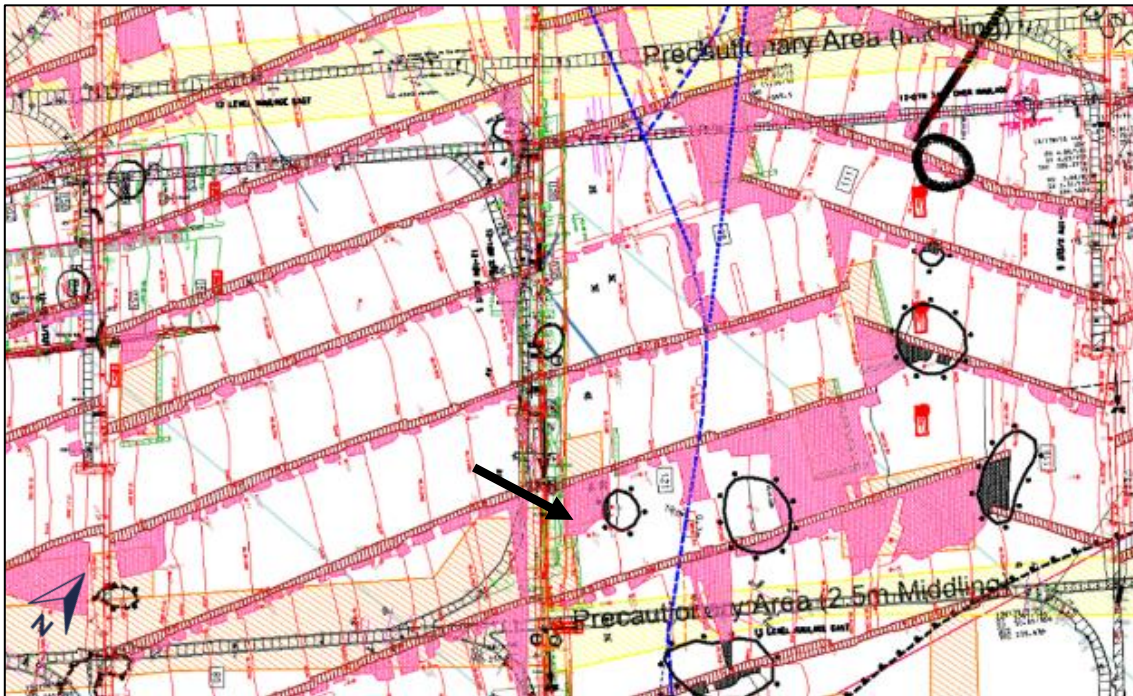
On 12 December 2017, M2.0, M2.2 and M2.5 events occurred on Merensky Reef elevation in the vicinity of 13-18W stopes. This behaviour was different from the usual seismic events experienced as these very large events occurred as a cluster and could have been a pillar run on the Merensky Reef elevation. Also,

the Merensky Reef stope had not yet been understoped by UG2 Reef. The mining front was within 200 m of this area (Figure 45).

Figure 45: Plan showing the 13-18W UG2 Reef (green) and Merensky Reef stopes (red). The pink hatched areas were the Merensky Reef pillars. The black arrow indicates the pillar of interest. This area has not been understoped by UG2 Reef mining

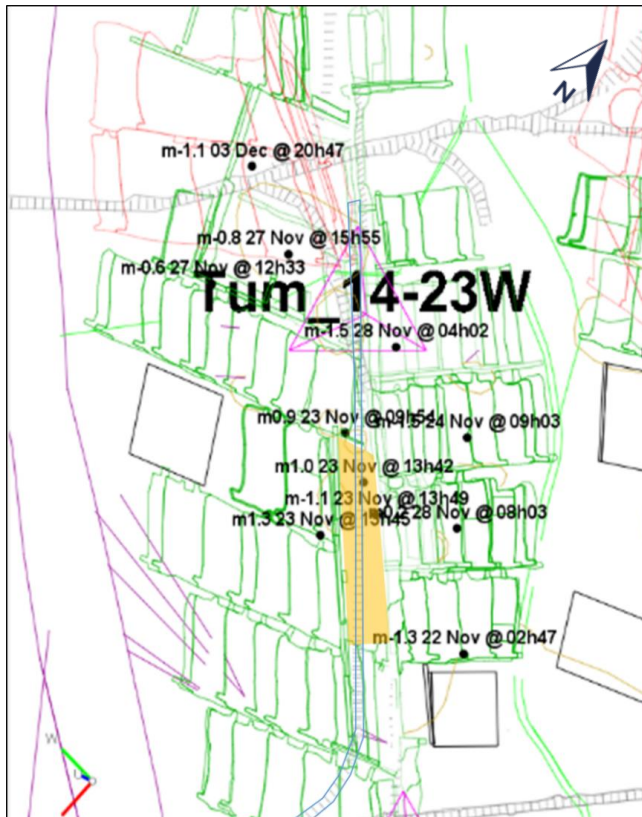
In the vicinity of 14-23 crosscut, three seismic events (M0.9, M1.0 and M1.3) were recorded on the UG2 horizon on 23 November 2018 (Figure 51). Further investigation showed that the crosscut protection pillar dynamically failed resulting in the above-mentioned seismic events. 15-23W 1W panel was the only panel blasting and was stopped after the seismic event due to the crosscut dynamic failure and the subsequent risk to mining personnel travelling in this area.

Figure 51: Plot showing all seismic events in the vicinity of 14-23W UG2 crosscut from 20 November 2018 to 31 December 2018. The orange area was the crosscut protection pillar

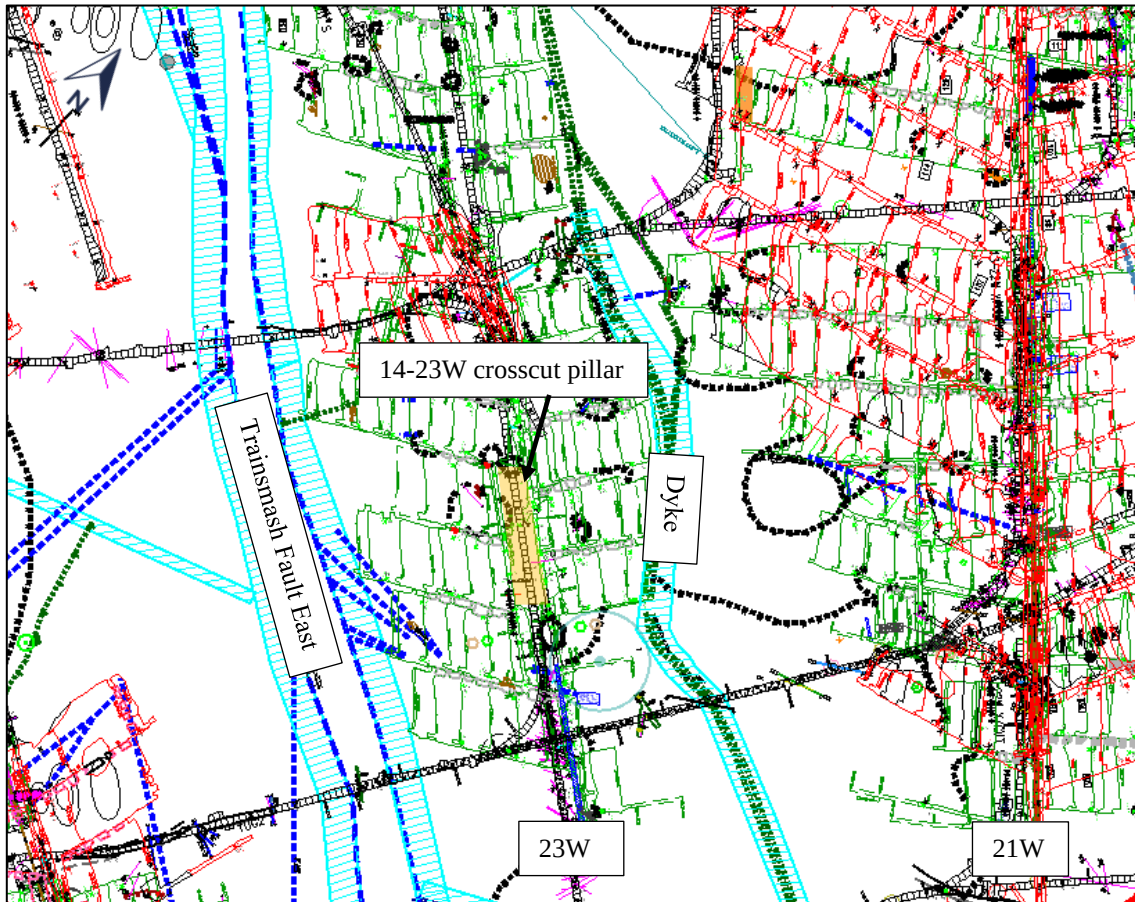
The 23W stoping line was situated between the major Trainsmash fault and a major dyke system. Tectonic stresses from these geological features may have contributed towards the overall field stress of the area. Reverse faults and closely spaced sympathetic jointing were observed in UG2 Reef panels already mined within this area (Figure 53). At 14-23W, the Merensky Reef was partially mined out above the panels at a slow advance per month. The failure to mine out all the panels on the Merensky Reef horizon showed there were poor ground conditions or a stress anomaly in the area, which were unable to be controlled by the support systems available at that time.

Figure 53: Plan showing the geology in the vicinity of the 14-23W UG2 crosscut. Red outlines showed the mined Merensky Reef areas and green outlines showed the UG2 Reef mined out areas

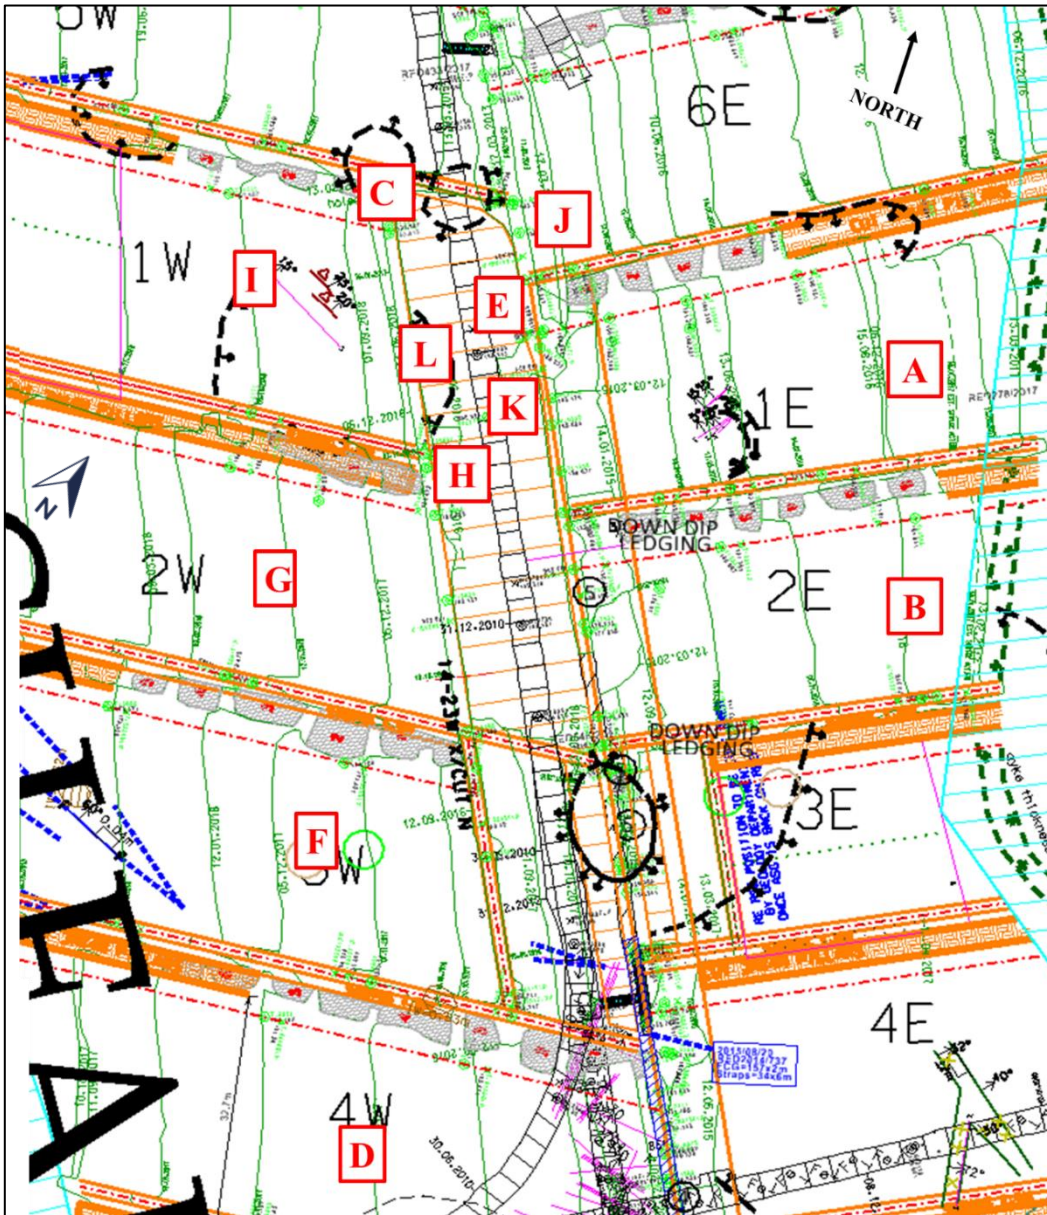
From the analysis of the timeline, the scaling of the crosscut accelerated after the cubby was blasted for 15-23W 1W UG2 panel and continued as 15-23W 1W UG2 panel was mining. The of mining of 15-23W 1W UG2 panel was very quick with an average advance of 20 m per month (mine call was 13 m per month). 15-23W 1W UG2 panel was the panel with the highest extraction per month at Tumela Mine at the time of the seismic event. This was possibly a result of this lagging panel being highly stressed, which meant a higher advance per blast.

Figure 54: Plan showing the sequence of events before dynamic failure at 14-23W crosscut

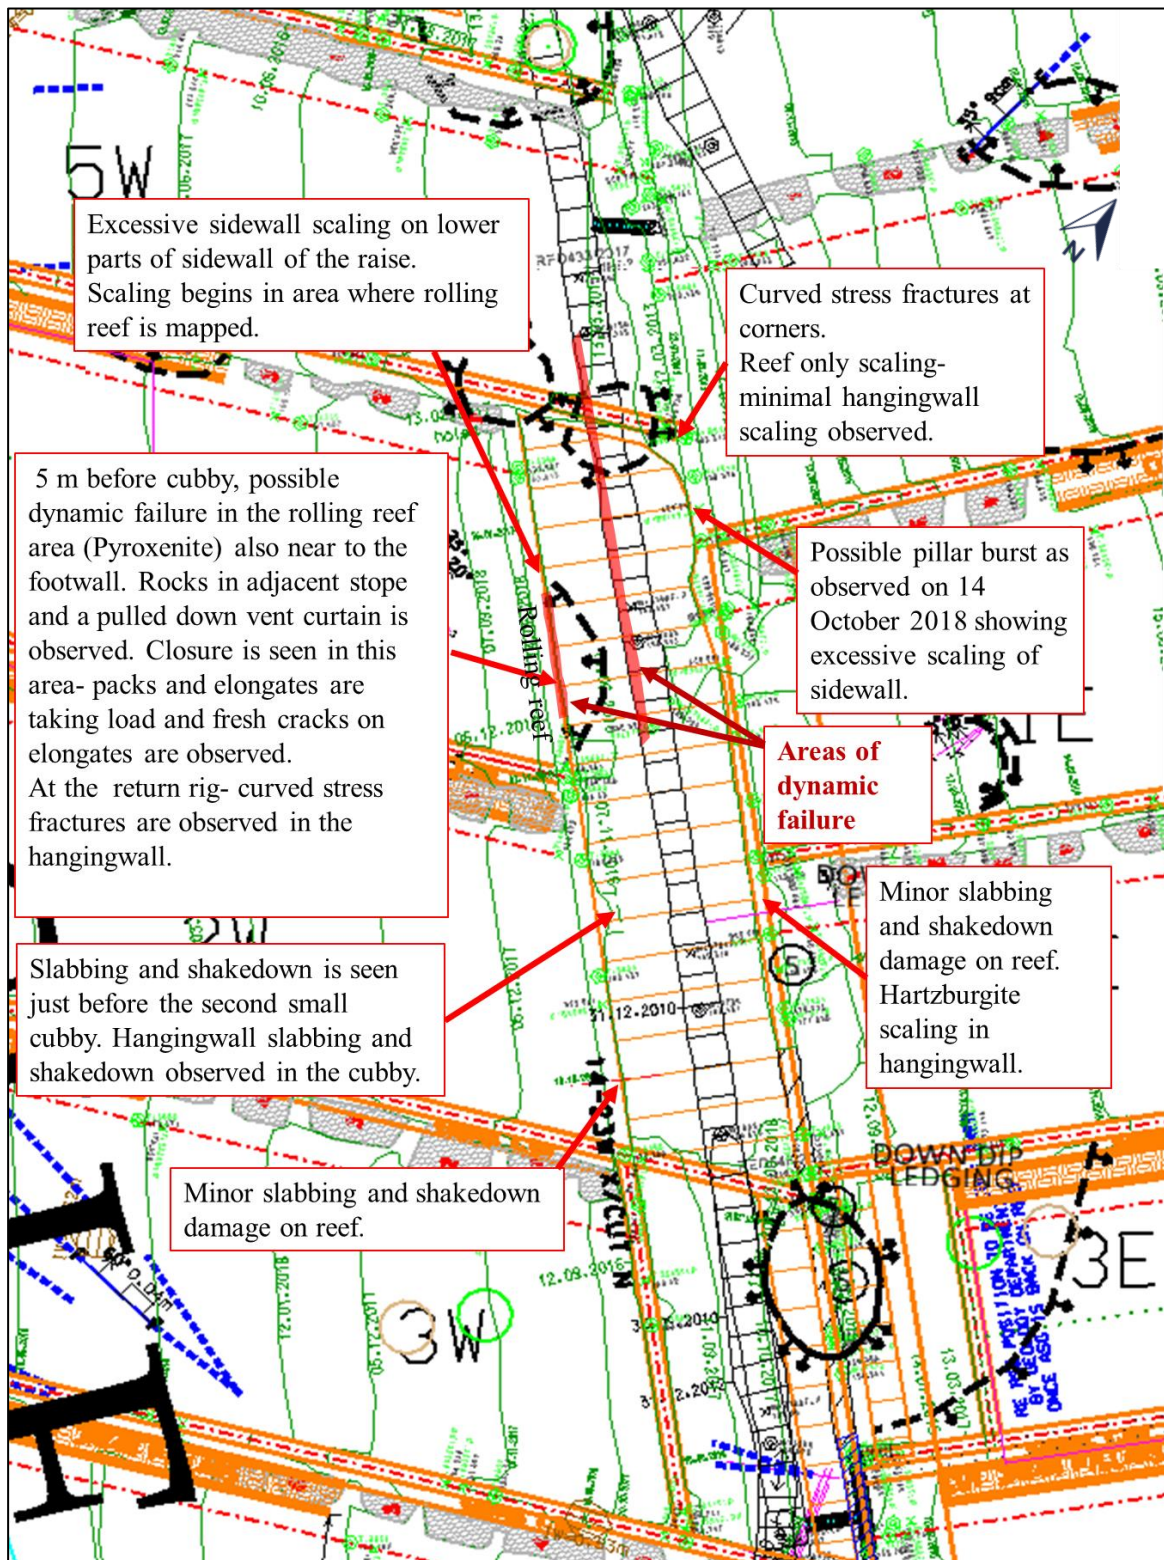
Figure 55: Underground observations on UG2 Reef elevation at the relevant locations

On 11 December 2018, a second visit was conducted to the crosscut. In addition, the crosscut pillar (spanning 15-23W and 14-23W UG2 raiselines) was inspected on reef down the re-raise on the western side and up the 15-23W raise on the eastern side of the crosscut. The following observations were made (Figure 55):

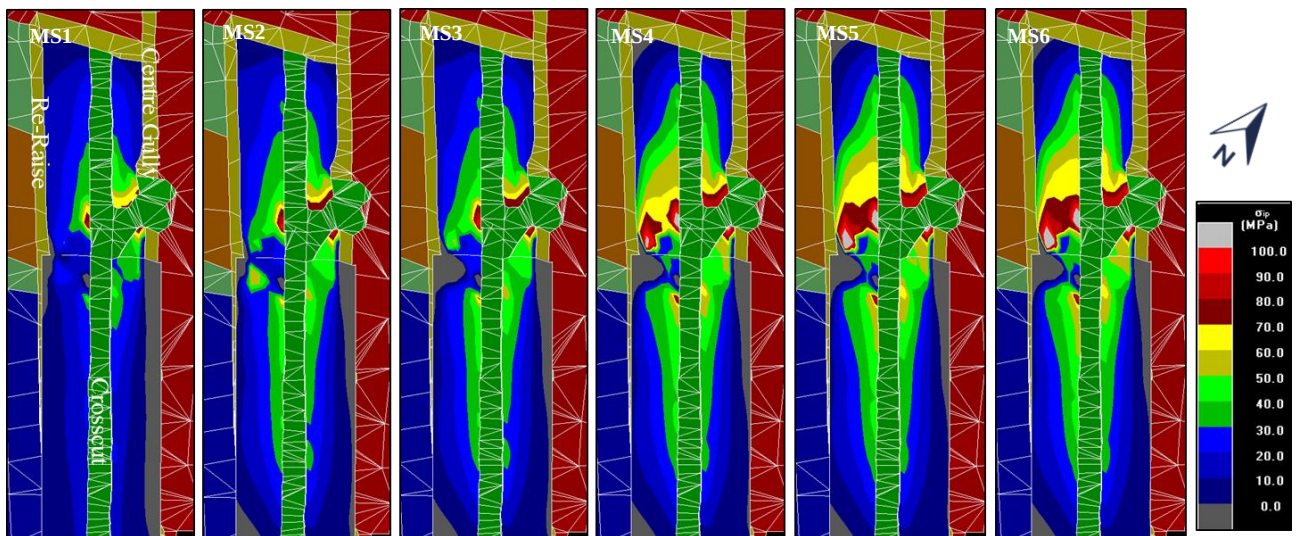
Figure 63: The stress changes (Sigma 1- in plane) made over the six mining steps as shown in MAP3D

Underground observations showed possible dynamic failure in the re-raise on the west side of the crosscut pillar and the adjacent areas in the crosscut. Excessive scaling was observed approximately 10 m before the reef intersection (step over position). These higher stress areas observed underground have been replicated in results from the MAP3D numerical model (Figure 63).

As the western panels began to mine, stress accumulation was observed at the travelling way position and in the western sidewall. At this time, secondary support was installed. As the western panels progressed, this area of higher stress built up, yet little change was observed in the stress level as the cubby was mined out (mining step 3). The highest stress changes were seen as the 15-23W 1W panels began to mine (mining step 4 -6). The highest stresses calculated by the model was in the same area of dynamic failure observed in the crosscut and the re-raise underground. In addition, another pocket of high stress was observed from the modelling results where excessive scaling of the crosscut was observed in the week prior to failure (approximately 10 m before the step over).

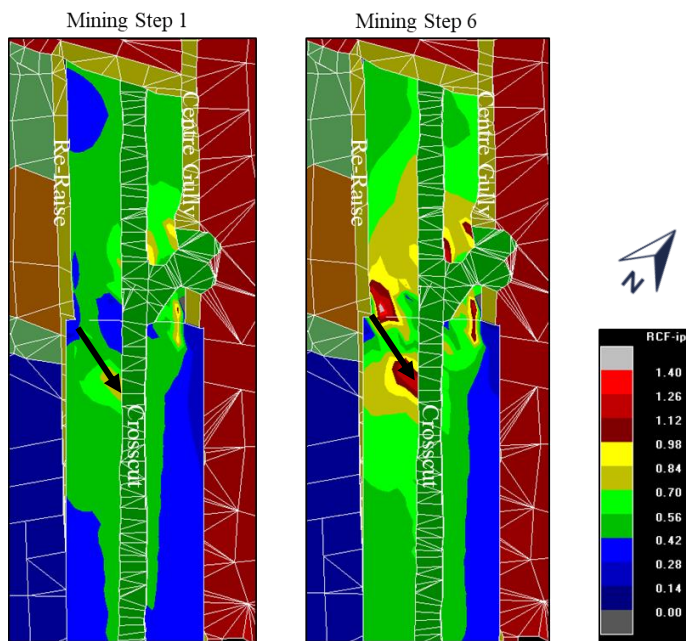
Figure 64: MAP3D plot showing the RCF at step 1 (when scaling was first noticed on the sidewall) and at step 6 (dynamic failure). The black arrows indicate the point of interest (the failure area)

In step 1, when scaling was first noticed on the sidewalls, the RCF value was approximately 0.9. At failure at mining step 6, at the same point of interest, the RCF had increased to 1.2. (Figure 64).

The values of RCF calculated by the model fall within the “average ground conditions ( $0.7 < \text{RCF} < 1.4$ )” range. For areas where there were anticipated stress changes (such as the 14-23W UG2 crosscut), according to Jager and Ryder (1999), primary support would require to be “fully grouted tendons or steel ropes, more than 1.8 m in length, on a basic 2.0 m or 1.5 m pattern” and secondary support would be “medium strength rope lacing and moderate strength wiremesh integrated with primary support tendons”. At 14-23W UG2 crosscut, the area of the dynamic failure was supported by 3.0 m long cable anchors, which were pre-stressed to 10 tons, 2.0 m full column grouted tendons and steel “Osro” straps. With reference to the RCF equation, this would be more than enough.

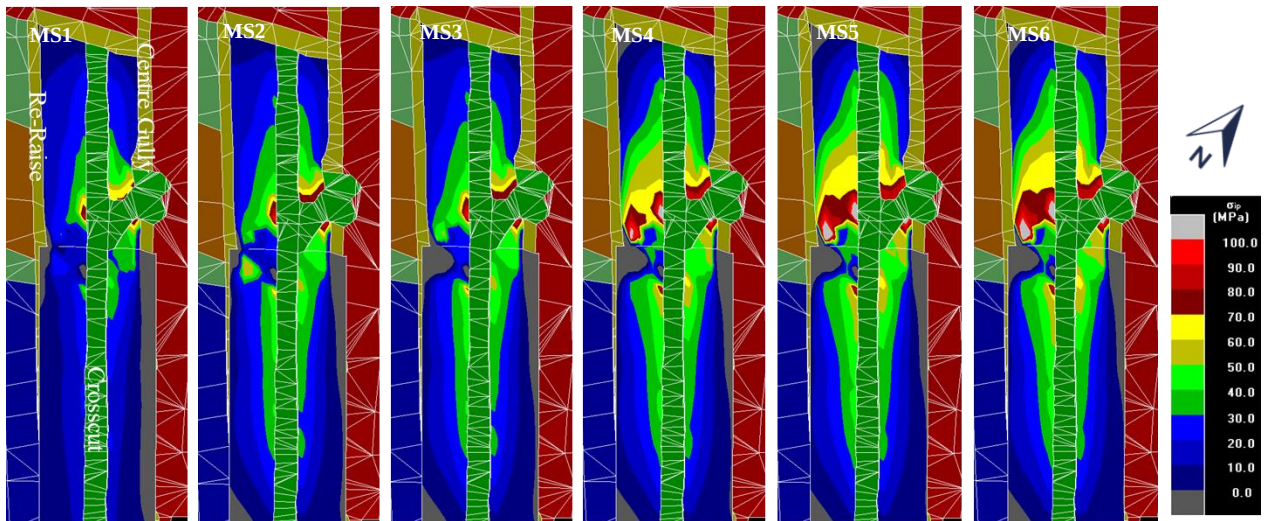
Figure 65: The stress changes (Sigma 1- in plane) made over the six mining steps as shown in MAP3D

From the time when 15-23W 1W mined consistently (8 September 2018) to the time of dynamic failure on 23 November 2018, 76 days had passed. A total of 1519 m<sup>2</sup> was blasted in 15-23W 1W in this time. This

was an advance of approximately 20 m a month (mine call was an average of 13 m per month). As determined by the model, an average increase of 30 MPa was induced in the rockmass in this period (Figure 65).

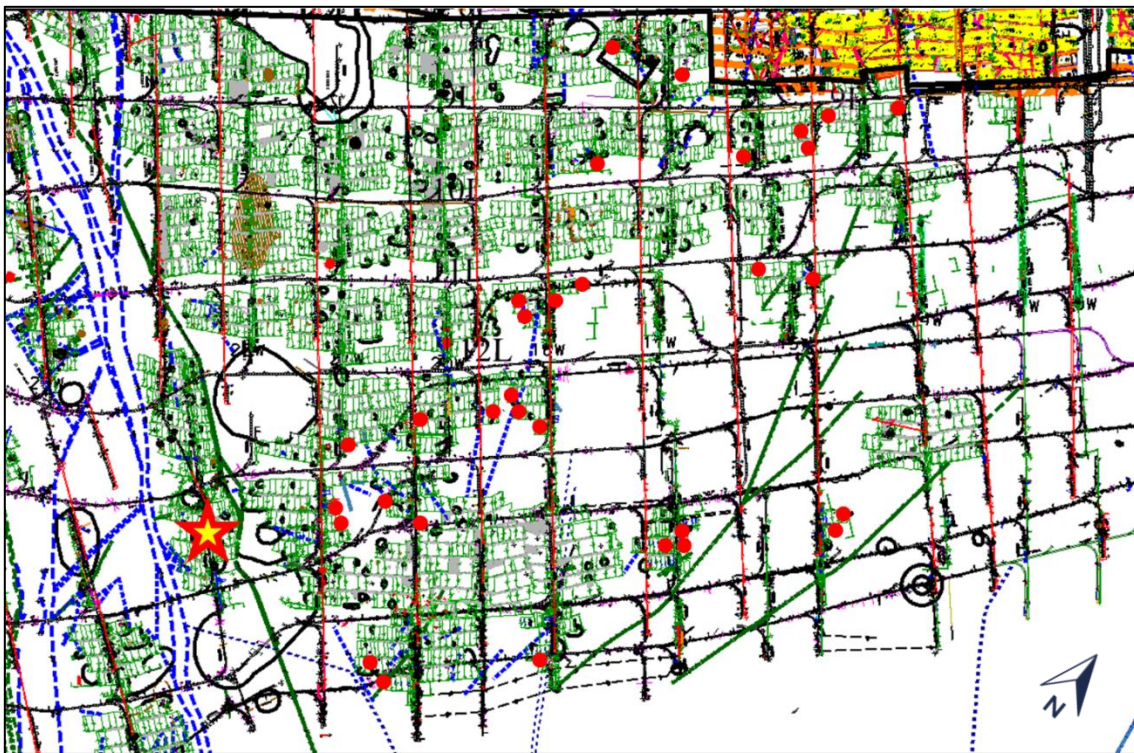
Figure 66: Plan showing 15-23W 1W panel (red star) and the mining panels at the time of the crosscut dynamic failure (red circles)

Figure 66 depicts the panels mining at the time of the 14-23W UG2 crosscut pillar dynamic failure. As indicated by the red star in the diagram below, the 15-23W 1W panel was the panel mining most out of sequence and closest to the shaft. This would indicate that panels this far behind the mining face were under considerably higher stress conditions than the panels mining in the correct sequence.

The sequencing of mining was incorrect and poorly controlled at the 15-23W stope. The panels should have been mined in an underhand configuration with the top panels leading the mining of the bottom panels and

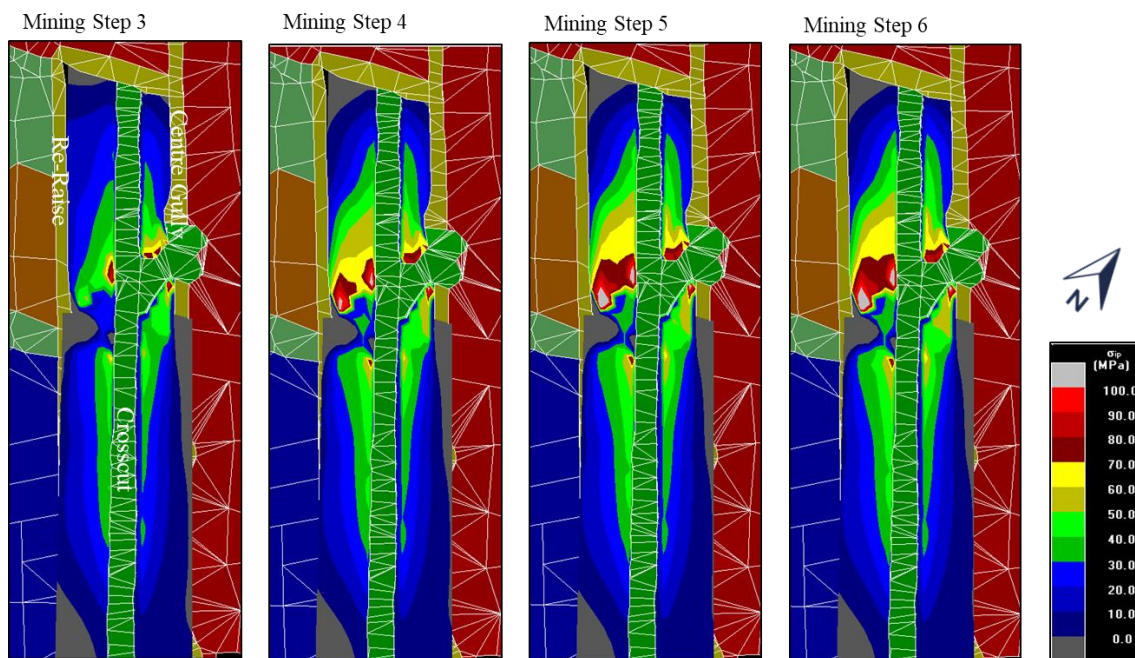
Figure 67: Scenario 1 Baseline model - Stress changes from the winch cubby being blasted between mining steps 4 to 6

The model was run with all geological factors and excavations considered at the time of failure. This was the “baseline model”, which the other scenarios were compared against. The baseline model depicts the crosscut already having been being developed through the UG2 Reef plane, the winch cubby blasted on reef for the mining of 15-23W 1W panel and the intersection of the rolling reef (Figure 67).

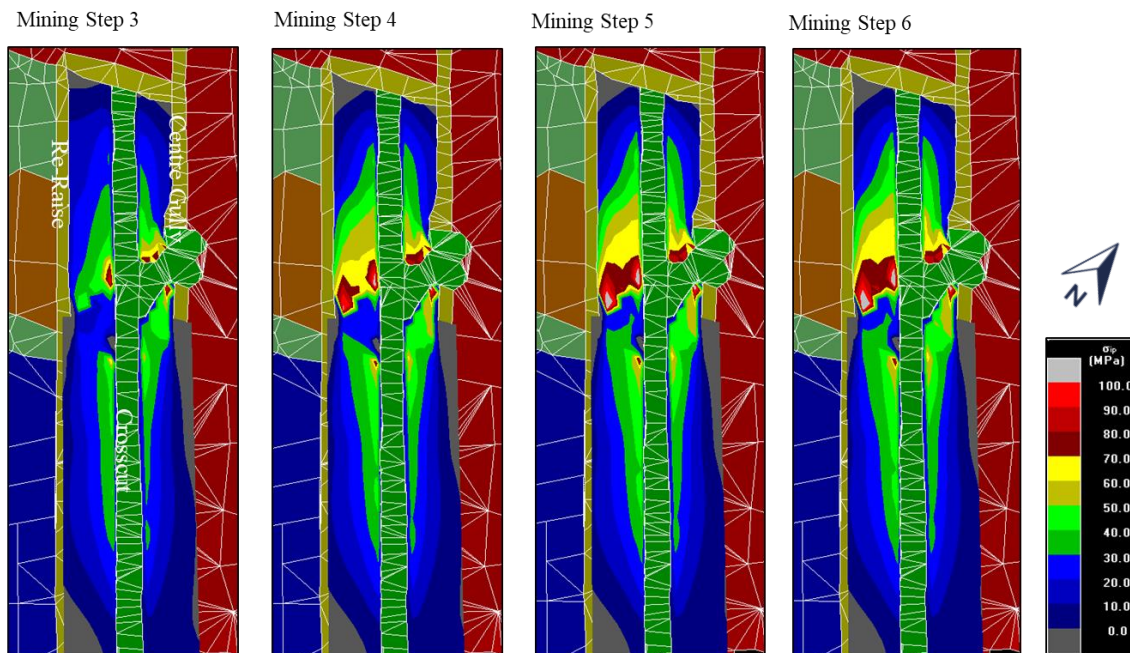
Figure 68: Scenario 2- Stress changes from the winch cubby not being blasted between mining steps 4 to 6

The blasting of the winch cubby was conducted in a breast configuration into the UG2 Reef hangingwall as the reef was undulating (rolling reef). This was at the same elevation as the crosscut. This possibly caused fractures to extend into the crosscut pillar and into the crosscut itself. After the winch cubby was completed, there was only a 2.5 m pillar between the cubby and the crosscut, which was possibly highly fractured. This would have caused a zone of very high stress adjacent to this on which dynamic failure could have potentially begun (Figure 68).

Results showed that there was little stress change and change in stress distribution between the baseline scenarios and if the cubby was not mined out. It could be concluded that the presence of the cubby was a small contributing factor on the dynamic failure of the crosscut (Figure 68).
