**Mitigating against induced stress from the Merensky Reef pillars  
on the UG2 Reef mining environment,  
Tumela 1 Shaft, Anglo American Platinum**

Carol Hunter  
(Student number: 693554)

A research report submitted to the Faculty of Engineering and the Built Environment, University of the Witwatersrand, in partial fulfilment of the requirements for the degree of Master of Science in Engineering.

20 December 2019

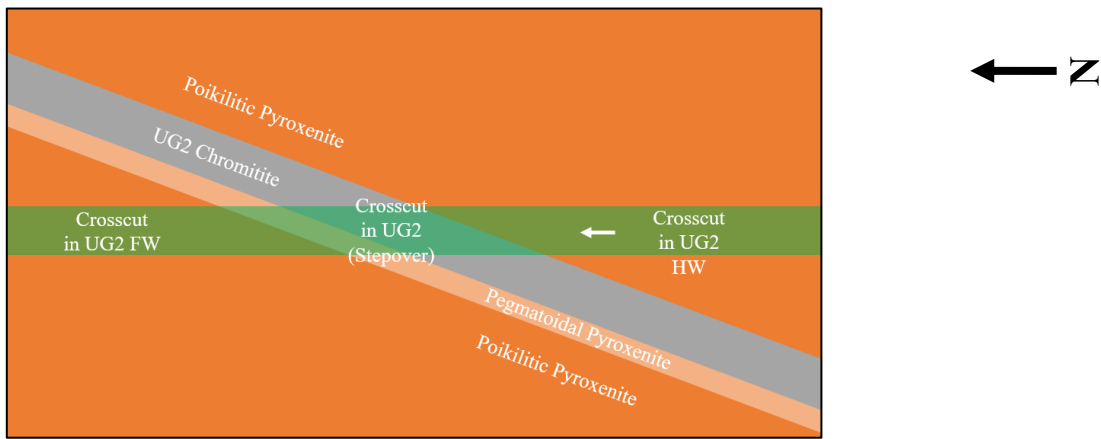
Figure 69: Diagram showing how the crosscut mines firstly through the UG2 Reef hangingwall, the UG2 Reef and then the UG2 Reef footwall

The crosscut was mined through the UG2 Reef and the travelling way was developed perpendicular to the crosscut. The portion of the crosscut, which failed dynamically was below the UG2 Reef and the portion, which scaled, was above the UG2 Reef (Figure 69).

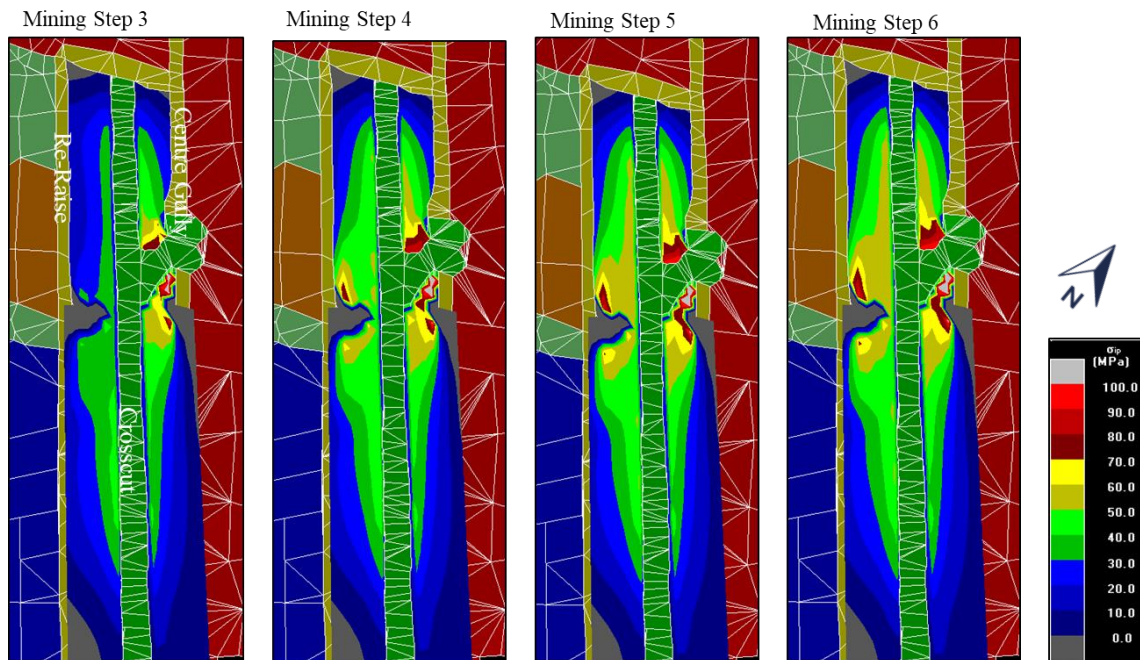
Figure 70: Scenario 3- Stress changes from no UG2 Reef/crosscut intersection (no rock type change) between mining steps 4 to 6

Results showed that a rock type change had a significant effect on the stress distribution and the level of stress in the crosscut and the re - raise. The stress decreased significantly from between 70-90 MPa to between 50 - 60 MPa once the rock type change aspect was removed. There was still a slight increase of stress by the mined - out winch cubby, but this was more due to geometry of the winch cubby (Figure 70).

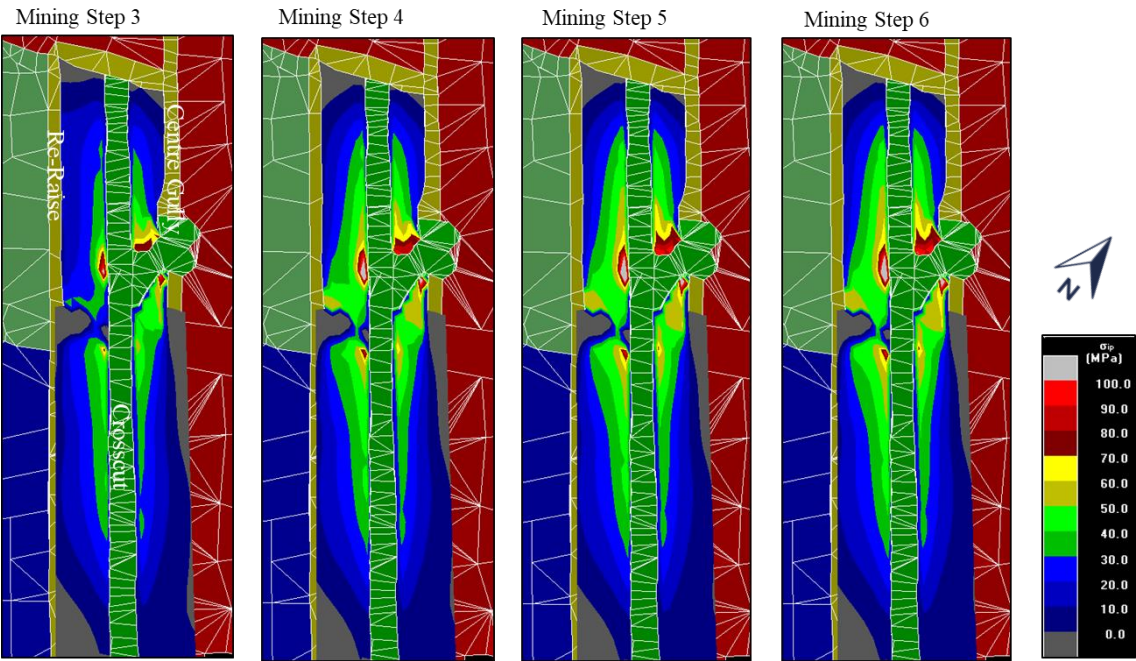
Figure 71: Scenario 4- Stress changes from no rolling reef present (no rock type change) between mining steps 4 to 6

d) Scenario 4: No rolling reef present, UG2 Reef was present and the winch cubby was mined out. Rolling reef in the panel and western re-raise caused pyroxenite to be exposed in the re - raise. It was observed that pyroxenite had been a possible source of the seismic event as the pyroxenite on both sides of

the crosscut pillar and in similar positions had failed dynamically. The pyroxenite was a rock of a higher strength, brittleness, and stiffness than the UG2 Reef chromite.

The rolling reef (and pyroxenite) present in the re-raise and potentially affecting the crosscut was taken out of the model for this scenario. Again, there was no rock type change from a less stiff UG2 Reef to a stiffer pyroxenite both in the crosscut and the western re-raise considered.

Results showed that, when the rolling reef rock type change was removed and the softer UG2 Reef was put in place of the stiffer Pyroxenite, this showed the most notable change in stress distribution and stress amount. The change in stress ranges from between 70 MPa - 90 MPa (Pyroxenite considered) to between 40 MPa - 50 MPa once the rock type change aspect was removed. There was still an increase of stress of up to approximately 100 MPa in the crosscut at the UG2 Reef intersection, but little stress in the re-raise (Figure 71).

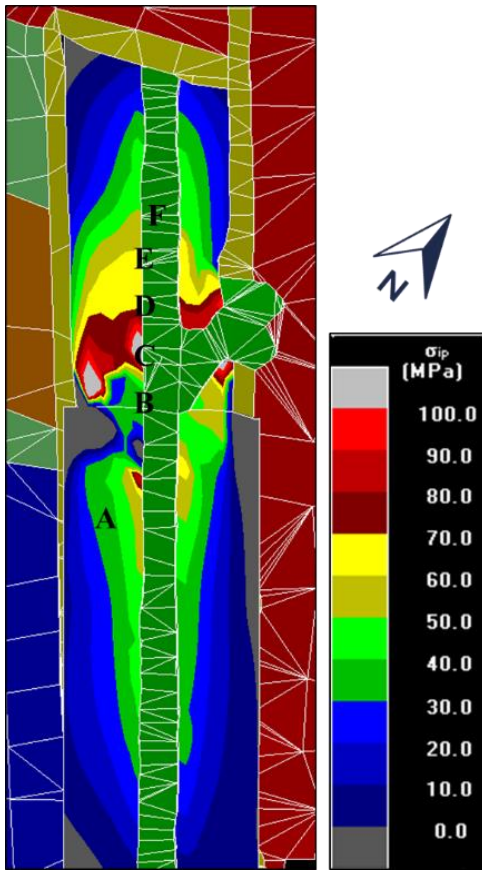
Figure 72: The locations of where the photos were taken in 14-23W crosscut

The following photos show the extent of the damage in 14-23W UG2 crosscut. The position of the damaged can be referenced in Figure 72.

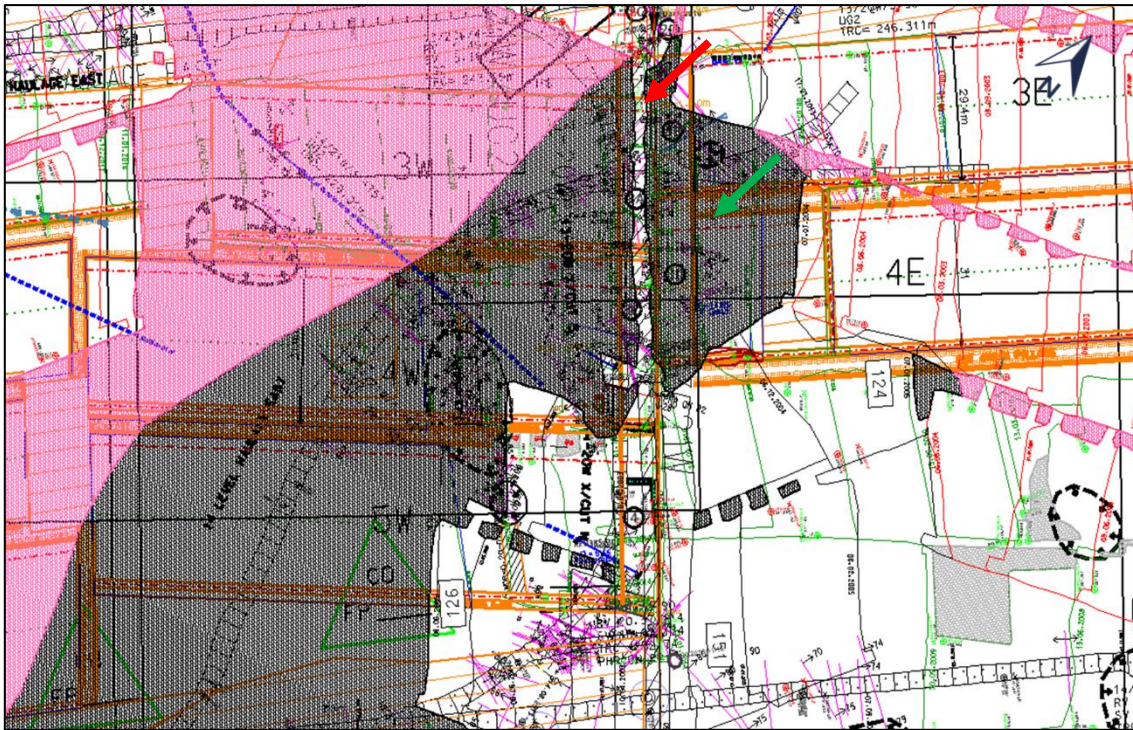
At 14-20W UG2 panels and centre gully (Figure 79), a request to investigate a report of grout packs taking load and excessive timber elongates breaking was made. It was observed that the 0.8 m x 0.8 m Cemrite grout packs installed along the centre gully showed vertical cracks and crushing from unexpected high closure. This was unusual, as the 14-20W panels were not close to being completely mined out. The rate of closure was expected to be minimal as there was a reduced span between unmined areas and the area was not deep in comparison to the other higher closure panels (714.7 m below surface). Further investigation into the panels showed UG2 dynamic pillar failure at 14-20W 4E panel. Excessive closure close to the face and support failure was observed at 14-20W 4W panel.

Figure 80: Plan showing the Merensky Reef remnant (black was off - reef and pink was - on reef projections) over UG2 panels. The red arrow indicates the centre gully of 14-20W, and the green arrow indicates the 4E in-stope pillar which dynamically failed

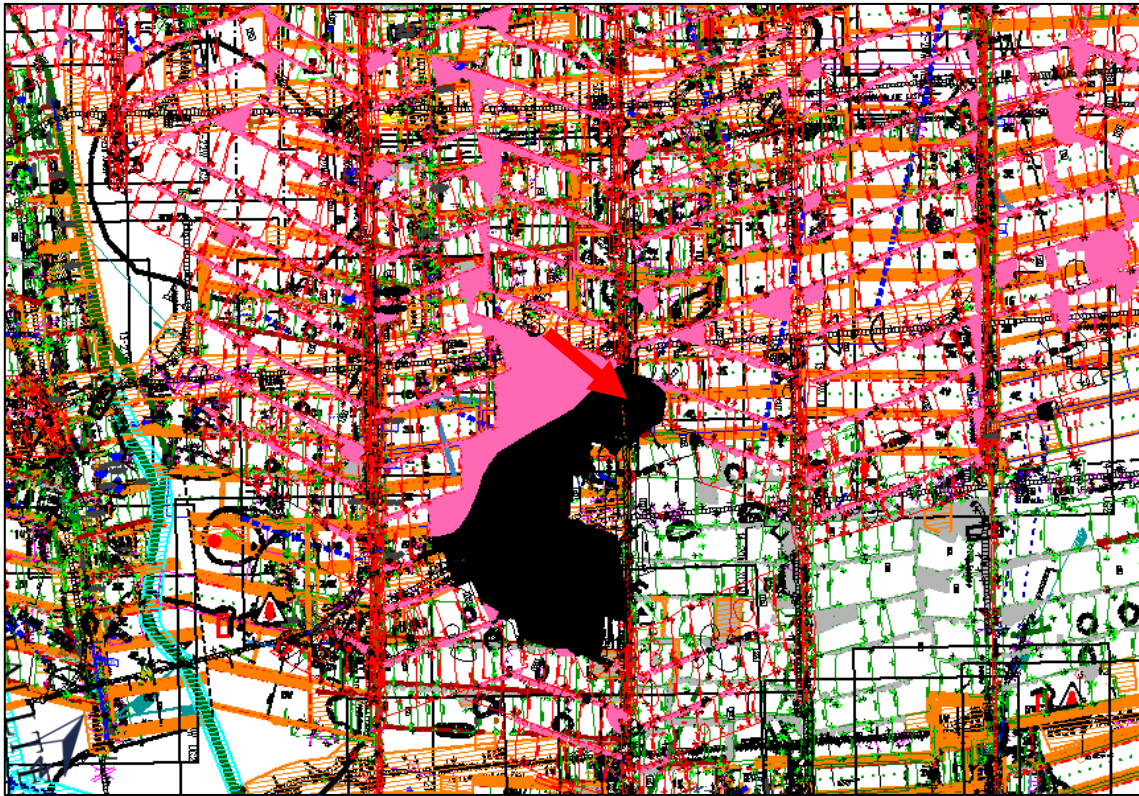
The west side of 14-20W and the east side of 14-21W were under higher stresses due to mining under a large Merensky Reef remnant. This remnant was 248 m long and 91 m wide at the narrowest point. The area was surrounded by both highly extracted UG2 Reef and Merensky Reef Mining (Figure 80).

Figure 81: The location of 14-20W raiseline (red arrow) within the Merensky remnant (pink and black area)

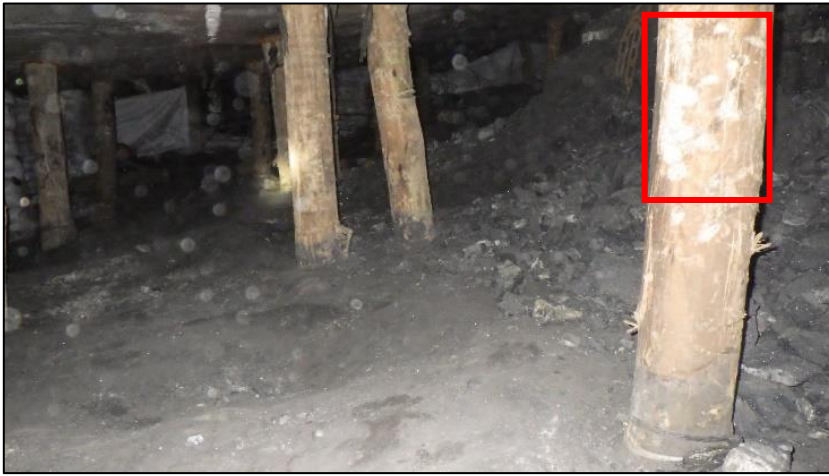
Possible dynamic failure of an in-stope pillar, approximately 10 m from the face, was observed at 14-20W 4E panel (Figure 81). This portion of the panel was under the Merensky Reef abutment and was approximately 20 m from the edge. Pillar rock could be seen approximately 7 m from the source pillar and the timber elongates at the edge of the pillar had reef embedded in them and marks from a high energy rock burst. The pillar was highly fractured on the one extremity, which resembles rock bursts observed in previously visited UG2 Reef panels such as 12-21W 4E UG2 panel (Figure 79).

Figure 82: The 14-20W 4E panel showing pillar remnants in the panel and the marks on the timber elongates

This pillar was not oversized and was fully on-reef, thus suggesting that the rate of closure influenced the increased stress in the pillar and did not allow the pillar to release the stress by means of fracturing on the pillar extremities. Instead the stress was released dynamically. If the local mine stiffness was high in comparison to the post peak stiffness of the pillar, dynamic failure would not occur as energy was absorbed by rock fracturing in the pillar (Maybee, 2000). This indicates a soft system at Tumela 1 shaft.

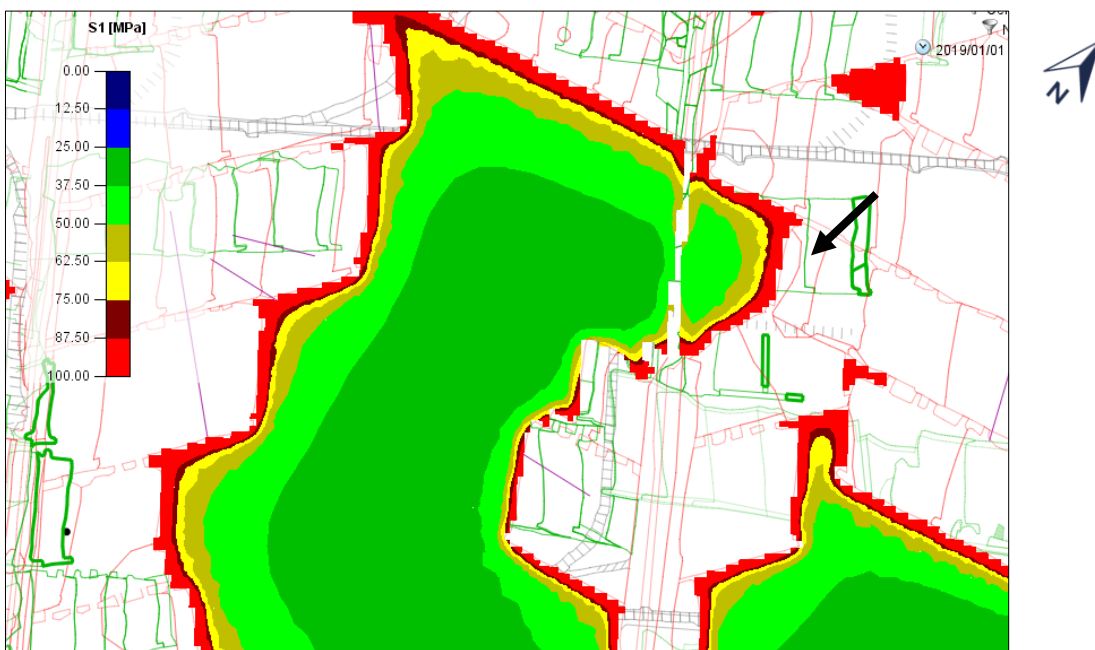
IMS Vantage modelling showed that the area was not expected to be highly stressed (Figure 82). The induced stresses on an area were expected to be 25-50 MPa so scaling was expected but not to the extent which was observed underground.

Figure 83: Stress modelled on Merensky Reef pillars i.e. stresses induced on the UG2 Reef by Merensky Reef remnant. Black Arrow indicates the dynamically failed in-stope pillar at 14-20W 4E

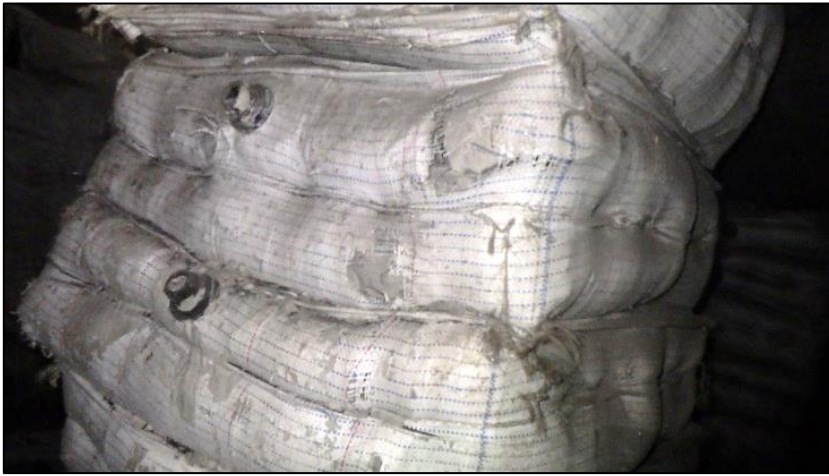
The grout packs on the shoulders of the 14-20W centre gully were observed to be taking excessive load and had reached peak strength. This was seen by vertical cracks in the grout packs (Figure 83). In addition, the footwall below the grout packs on the shoulder of the centre gully had been failing under this excessive load. This had resulted in the grout packs becoming unstable and there was an increased risk of these grout packs falling into the centre gully. This had caused a fatal in other mines in the past. Due to the footwall become loose under the grout packs, the grout packs were not providing the required support resistance for the centre gully (Figure 84). No tensile cracks in the hangingwall of the centre gully were observed, but due to the high rate of closure and little support resistance (as the grout packs were unable to sustain load), the formation of tensile cracks was expected to occur more frequently. The 14-20W centre gully requires rehabilitation with cable anchors and new grout packs.

Figure 84: Damaged pack in centre gully

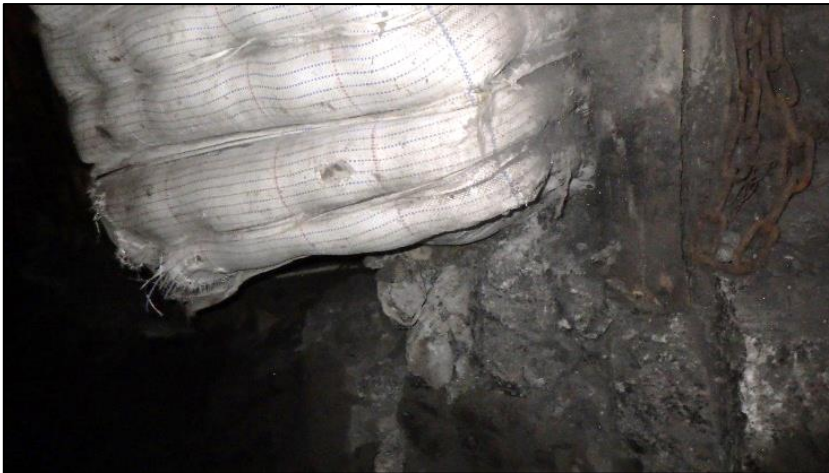
Figure 85: Damaged pack in centre gully showing the footwall failure below the grout pack

To continue to mine 14-20W panels, the safety of the mining personnel travelling and working in this area had to be the primary consideration therefore, the full rehabilitation of 14-20W centre gully was required. An alternative travelling way was created, as to ensure people did not travel in the centre gully before rehabilitation takes place. 3.0 m cable anchors were installed to reinforce the beam and to cater for this wider area created when unstable grout packs were removed. Since the currently installed grout packs had failed or were supporting on residual strength, all current grout packs (from 2E ASG and below) had to have a new grout pack installed directly behind the original grout pack. Closure robots had been installed and visual monitoring of the new grout packs was being conducted to ensure they did not take additional load.

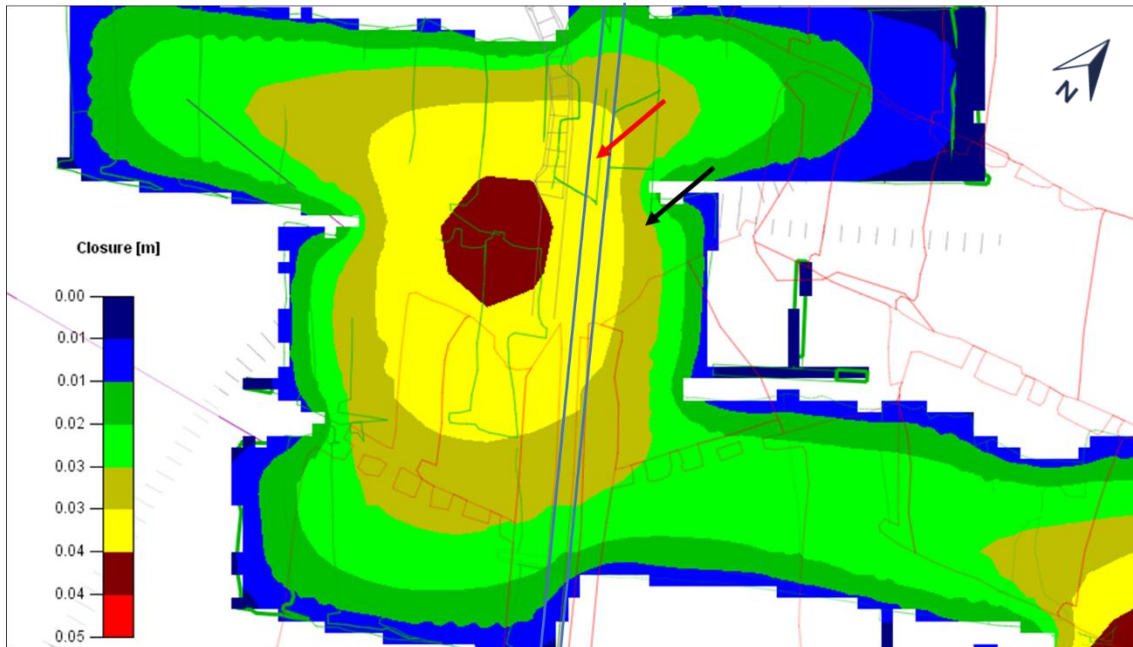
The elastic closure as determined by IMS Vantage modelling (Figure 85) indicates that maximum closure should not be more than 40-50 mm in the panel and 30-40 mm over the raiseline. The Cemrite 0.8 m x 0.8 m grout packs maximum deformation at peak load was approximately 61 mm at 2100 kN. The grout packs had crushed considerably to near failure indicating closure of more than 100 mm over the centre gully. This was collaborated by rough closure measurements from failed timber elongates in the vicinity of these grout packs.

No prominent geological structures were observed in this centre gully, which eliminated the possibility of an unstable hangingwall block. Instead, as could be seen on plan, the raise on the Merensky Reef had split

Figure 86: Expected closure at 14-20W panels (current state). The red arrow indicates the centre gully of 14-20W, and the black arrow indicates the 4E in-stope pillar which dynamically failed

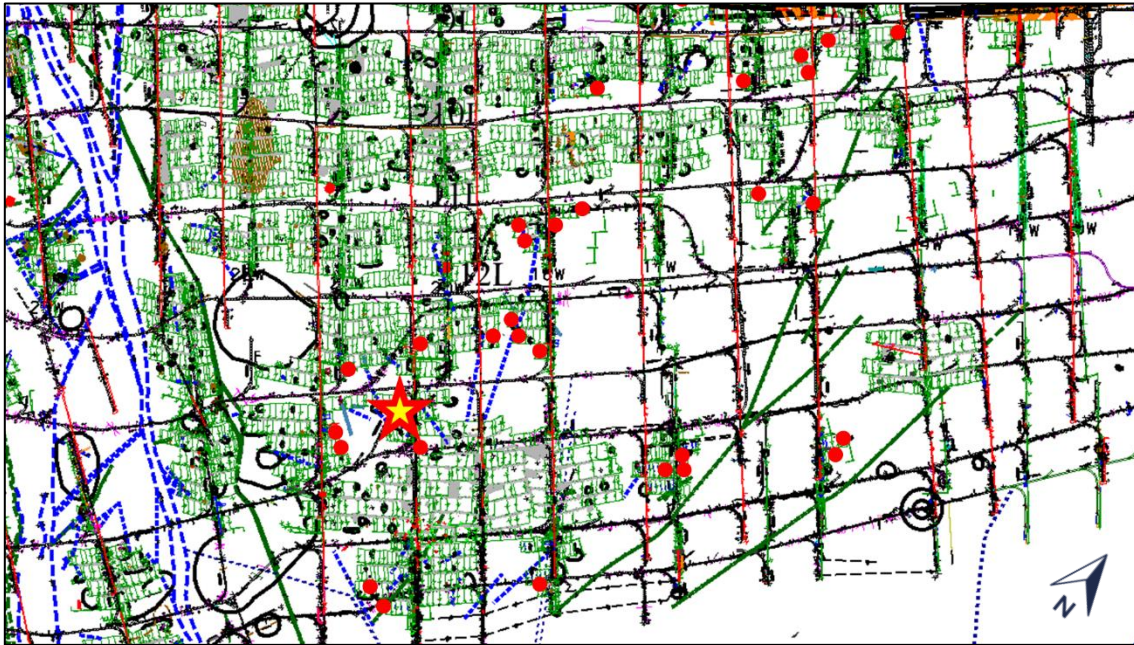
The stresses had probably increased even more due to the overall mining sequence being not conducted according to a proper layout for higher stressed areas (underhand configuration or “Christmas tree”, Figure 86). With the larger Merensky Reef pillars at the 17W, 16W, 15W and 14W raiselines having recently failed (as seen by large recorded seismic events), this had potentially put even more stress on this large Merensky Reef remnant area, which may have resulted in higher closure rates.

Figure 87: Plan showing the panels mined out and the position of 14-20W (red star) in relation to other mining panels

Underground observations made at 14-20W UG2 centre gully and panels, in comparison with the IMS Vantage stress and closure modelling, indicate there was a significant in - elastic component of closure at 14-20W. 10 m in the hangingwall of the UG2 Reef package was the P1 marker. If this P1 marker was detaching, this would explain the excess loading on the grout packs and the resultant failure of these packs. Further investigation would be done to determine if this marker had detached and was excessively loading the 14-20W raiseline.
