# **GENERATOR PLANT CONDITION ASSESSMENT AT DUVHA POWER STATION**

A research report submitted to the Faculty of Engineering and the Built Environment, of the University of the Witwatersrand, in partial fulfilment of the requirements for the degree of Master of Science in Engineering.

Johannesburg 2010

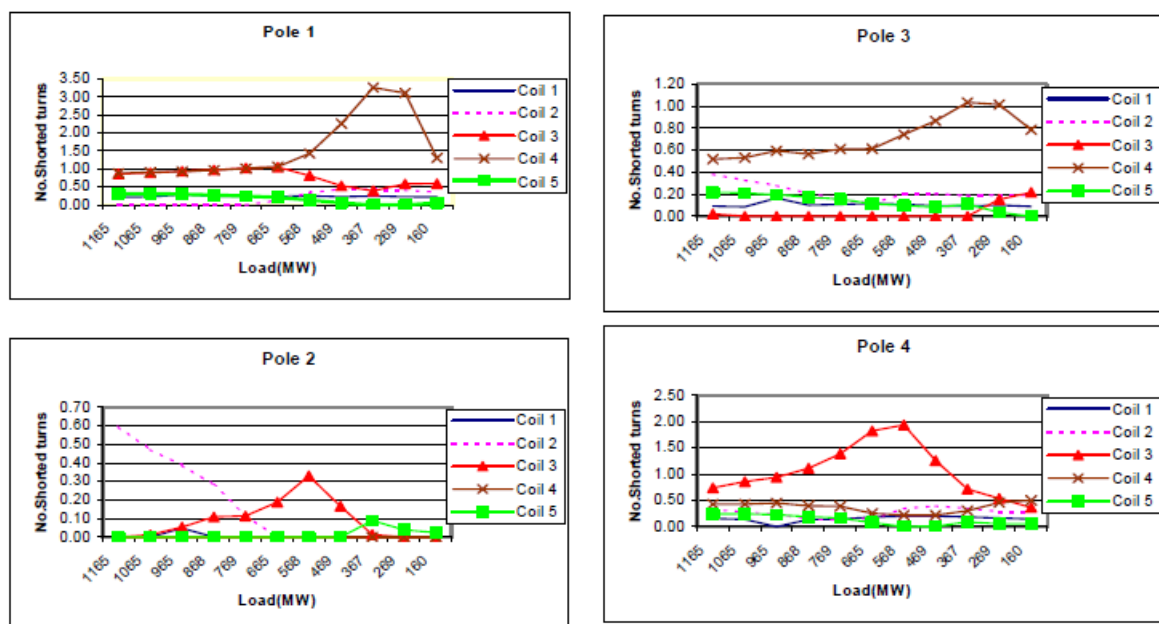
Initial readings on full load indicated the presence of 3 or 4 inter-turn faults see figure 13.

**Figure 13. Original RFM identification of 4 inter-turn faults [13]**

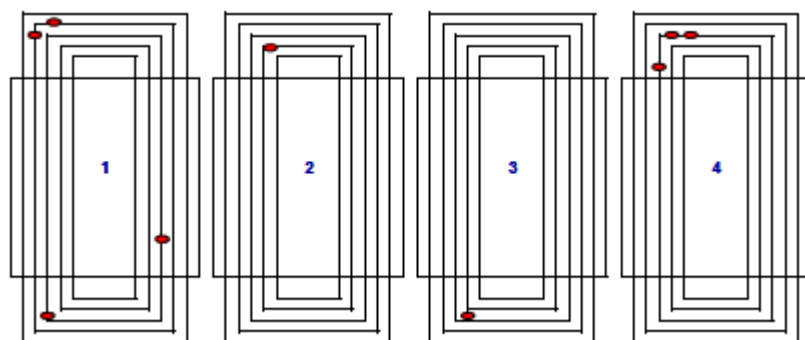
A detailed study was conducted using the OEM's Rotor Flux Monitoring (RFM) equipment, which identified 8 inter-turn faults and their location: pole and coil. This meant that if the customer's data had only been used, then at best the work program for the repair would have to have been doubled and at worst not all faults would have been identified and repaired.

**Figure 14. Location & Position of 8 inter-turn faults identified by OEM RFM [13]**

Figure 14, shows the fault position in each of the poles. In total 8 faults in 5 coils were identified.

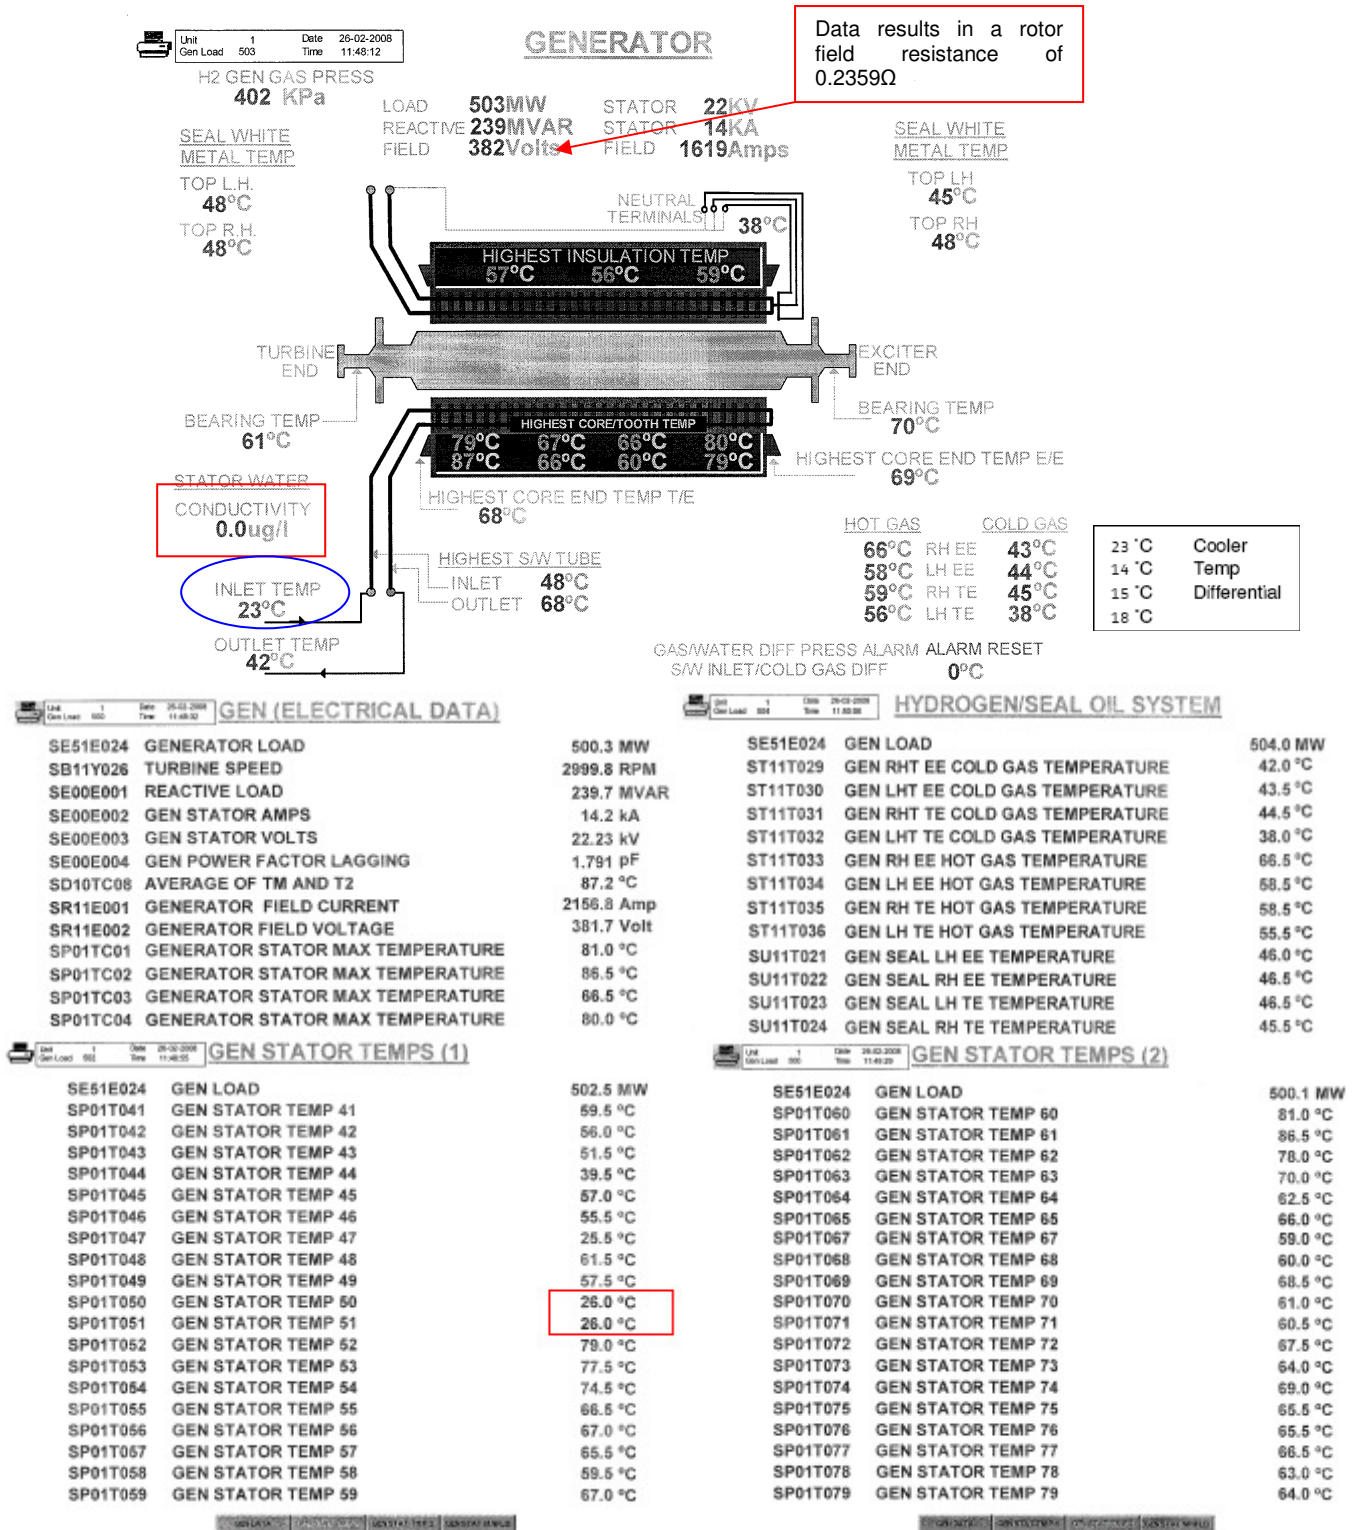
Figure 19. Duvha Unit 1 Running Data Snapshot

At the time of the snapshot data capture, Duvha unit 1 was on load at 503MW, 239MVAR, 14.4kA, 22.2kV, with its output data included in Appendix A1: Figure 19 and Table of Plant Walk-Down data. The generator was running within the designed parameters as defined in the operation and maintenance manuals.

For the stator water system the stator inlet and outlet pressures were not set to the recommended design specification, the inlet and outlet pressures should be 365kPa and 110kPa, respectively. Refer to Appendix A1: Figure 19, Table of Plant Walk-Down data.

The excitation system and instrumentation brush gear were operating within permissible parameters with no standing alarms on the operator's desk when reviewed during the plant visit. However, the calculated rotor winding resistance from the measured rotor voltage and current, yielded unrealistic values and are indicative of errors in the base parameter measurements. Refer to Appendix A1: Figure 19, Generator extract, red information box.

The seal oil/gas differential pressures were not correct as the turbine end was 120kPa and exciter end was 145kPa with the permissible minimum recommended pressure being 140kPa. The low differential pressure at the turbine end being the one of concern. Refer to Appendix A1: Figure 19: Table of Plant Walk-Down data.

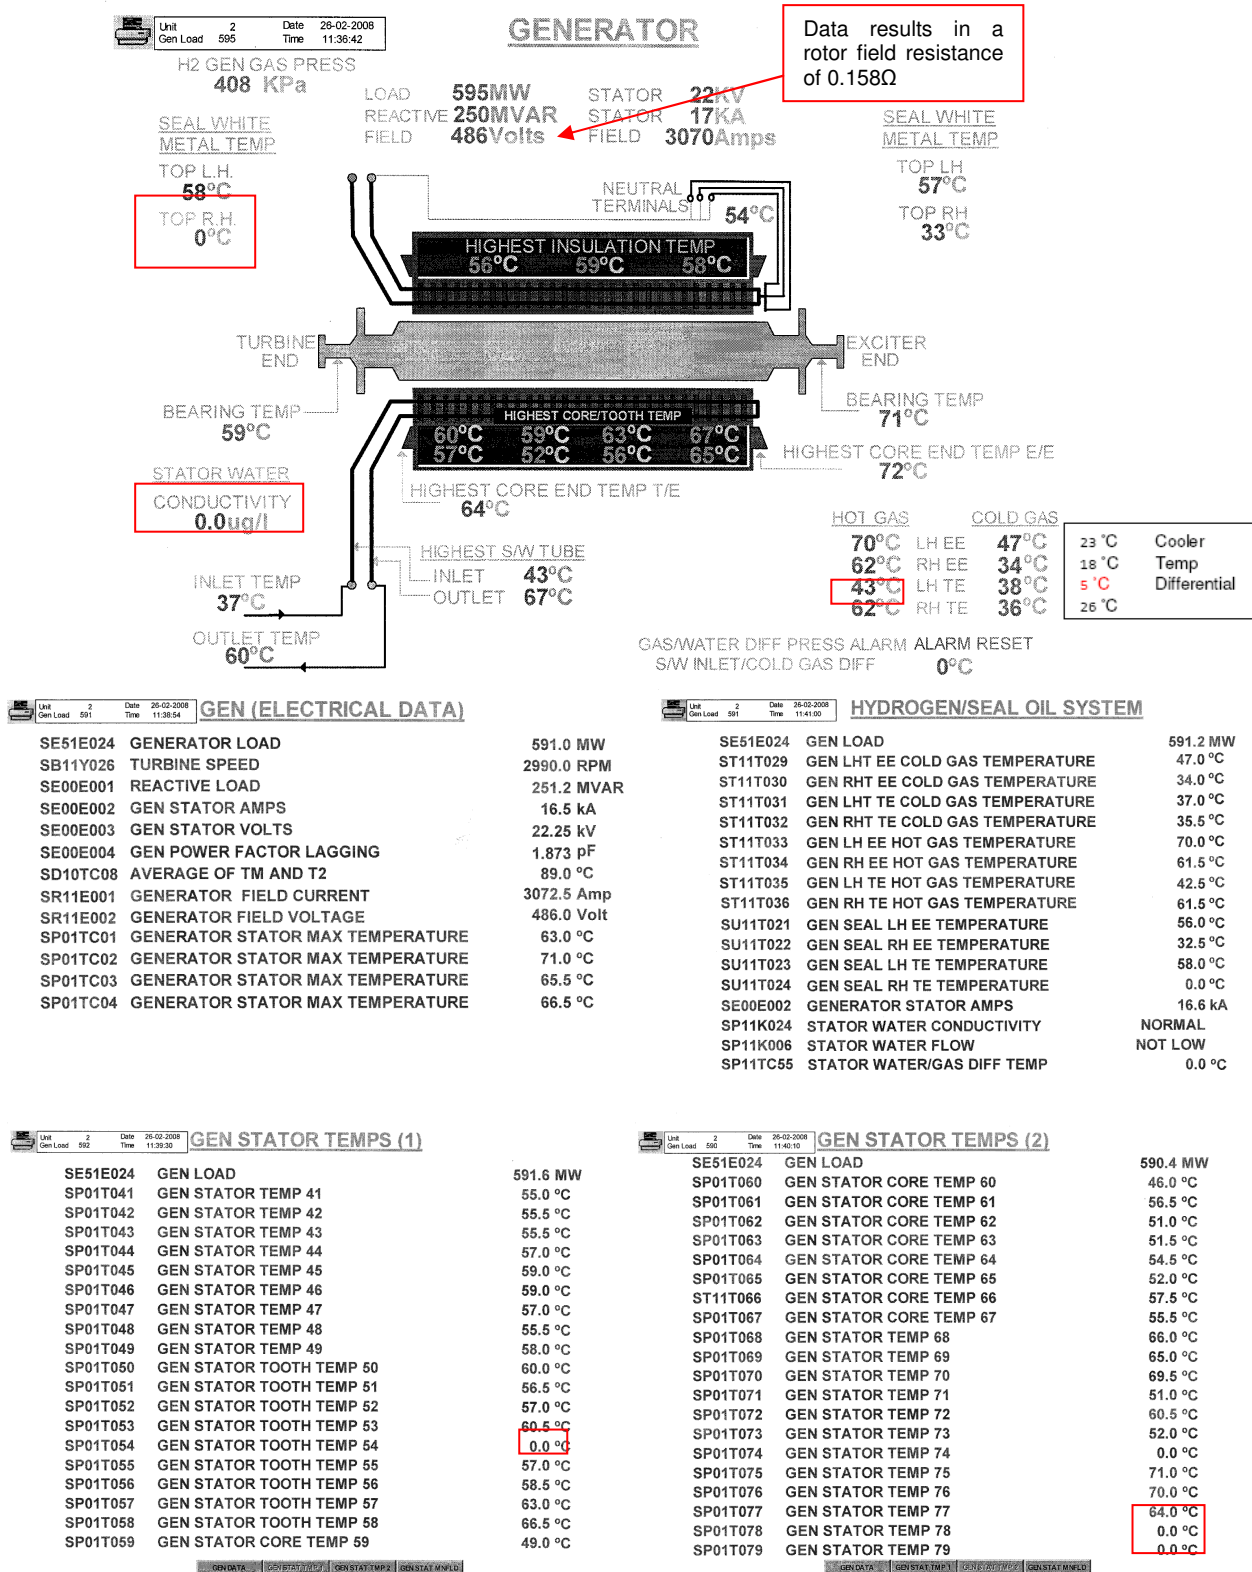
Figure 20. Duvha Unit 2 Running Data Snapshot

At the time of the snapshot data capture, Duvha unit 2 was on load at 595MW, 250MVAR, 16.7kA, 22.2kV, with its output parameters included in Appendix A1: Figure 20 and Table of Plant Walk-Down data. These values indicate that the generator was running within the designed parameters. There is however a concern again with the instrumentation accuracy.

The stator water system according to the plant gauges were within permissible parameters with the inlet pressure a little high at 370kPa and the flow under the design recommended flow of 21l/sec. The stator water generator inlet temperature was at 43°C, which is at the alarm value i.e. 43°C. Refer to Appendix A1: Figure 20 and Table of Plant Walk-Down data.

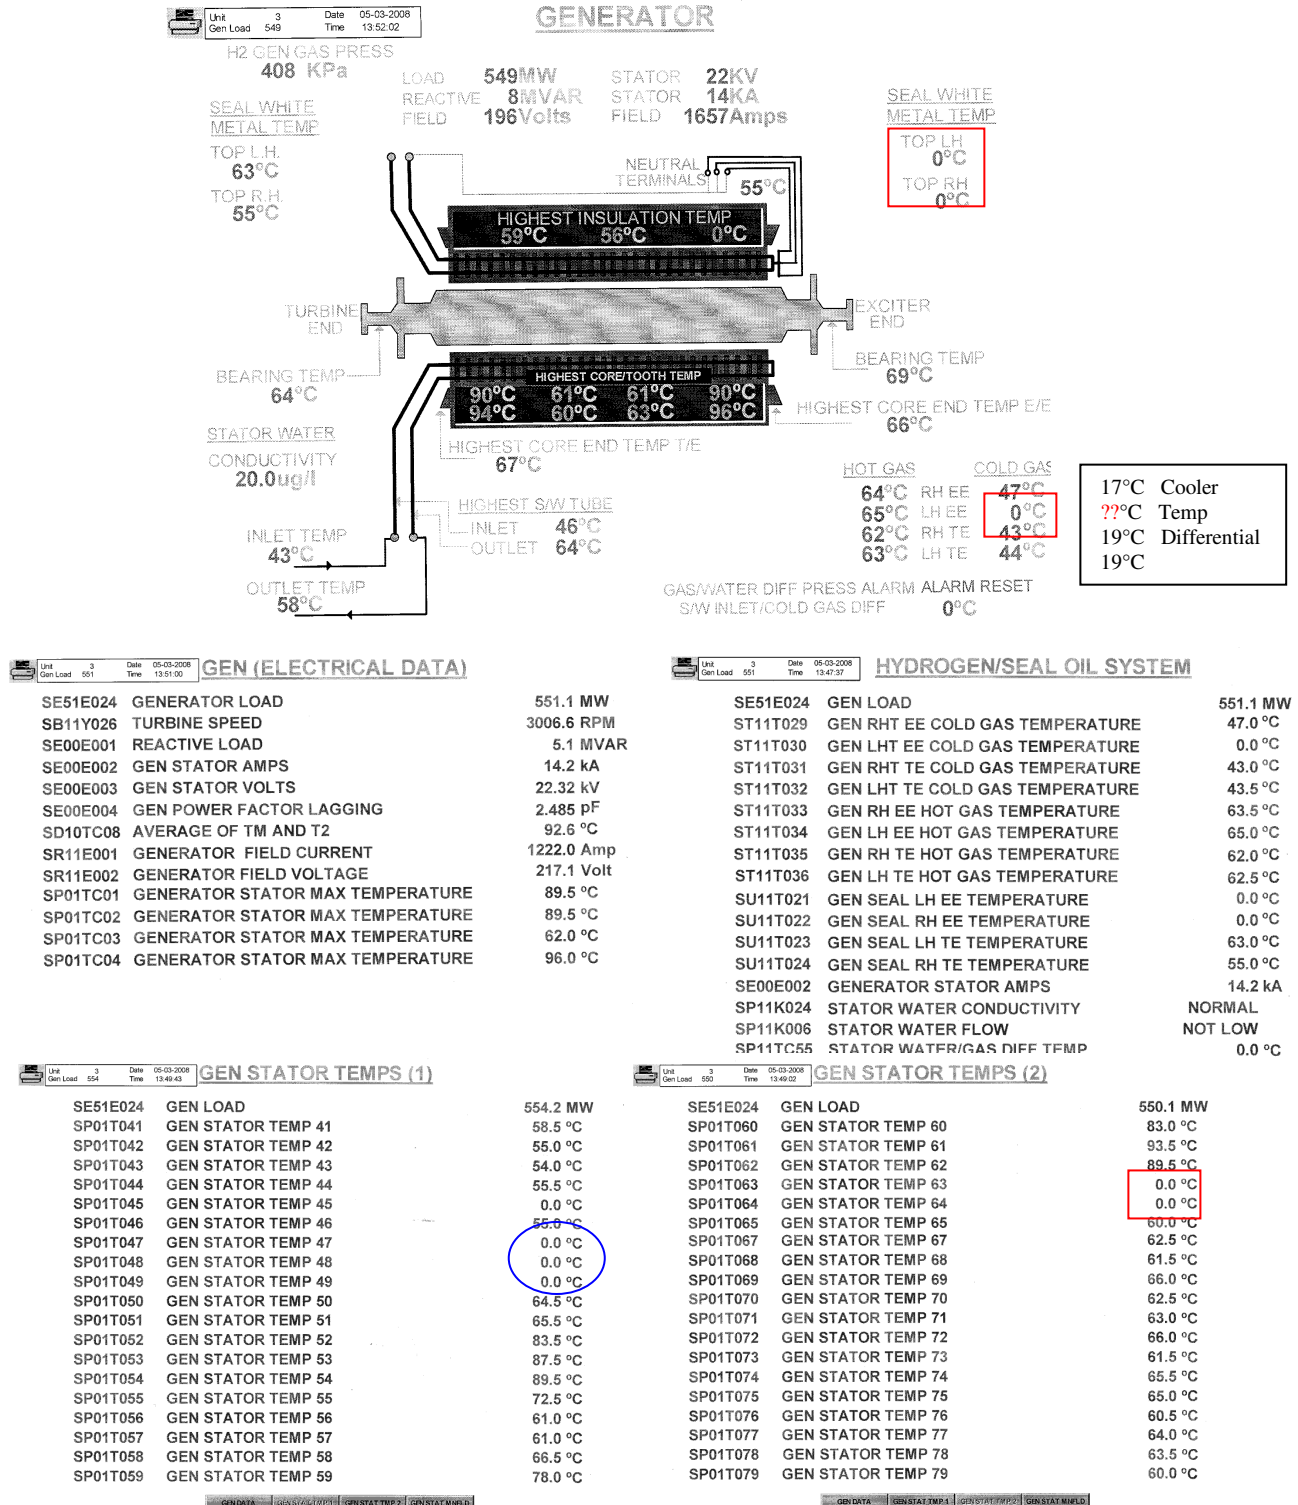
Figure 21. Duvha Unit 3 Running Data Snapshot

At the time of the snap shot data capture, Duvha unit 3 was on load at 549MW, 5MVA<sub>r</sub>, 14.2kA and 22.3kV, with its output parameters included in Appendix A1: Figure 21 and Table of Plant Walk-Down data. These values indicate that the generator was running within the designed parameters. There is again the concern that the instrumentation accuracy is a problem, with many discrepancies between the plant gauges and the operator's mimic.

The stator water system according to the plant gauges were not within permissible parameters with the inlet pressure at 365kPa, the outlet pressure at 90kPa and with the flow rate at 22l/sec. Refer to Appendix 1, Figure 21: Table of Plant Walk-Down Data.

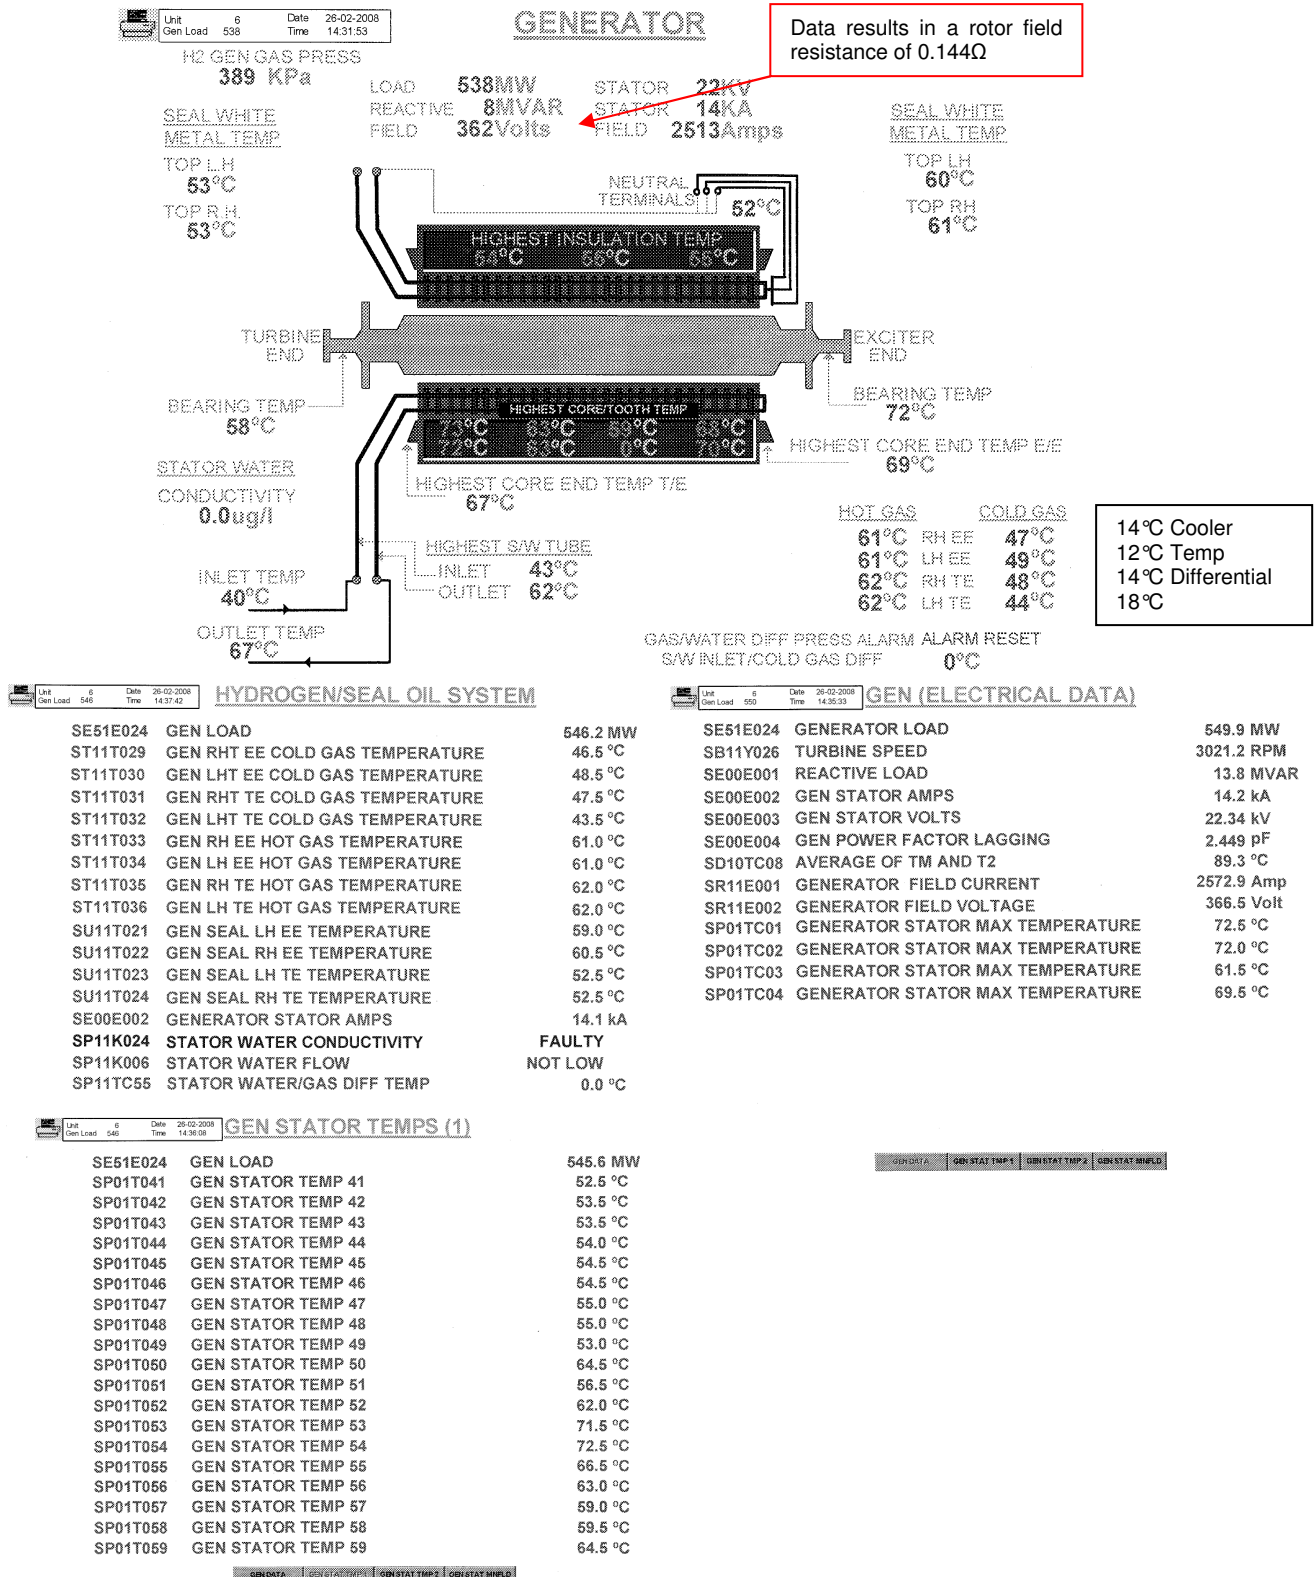
Figure 24. Duvha Unit 6 Running Data Snapshot

At the time of the snap shot data capture, Duvha unit 6 was on load at 549MW, 13.8MVA<sub>r</sub>, 14.2kA and 22.34kV, with the process parameters captured in Appendix A1, Figure 24 and Table of Plant Walk-Down data.
