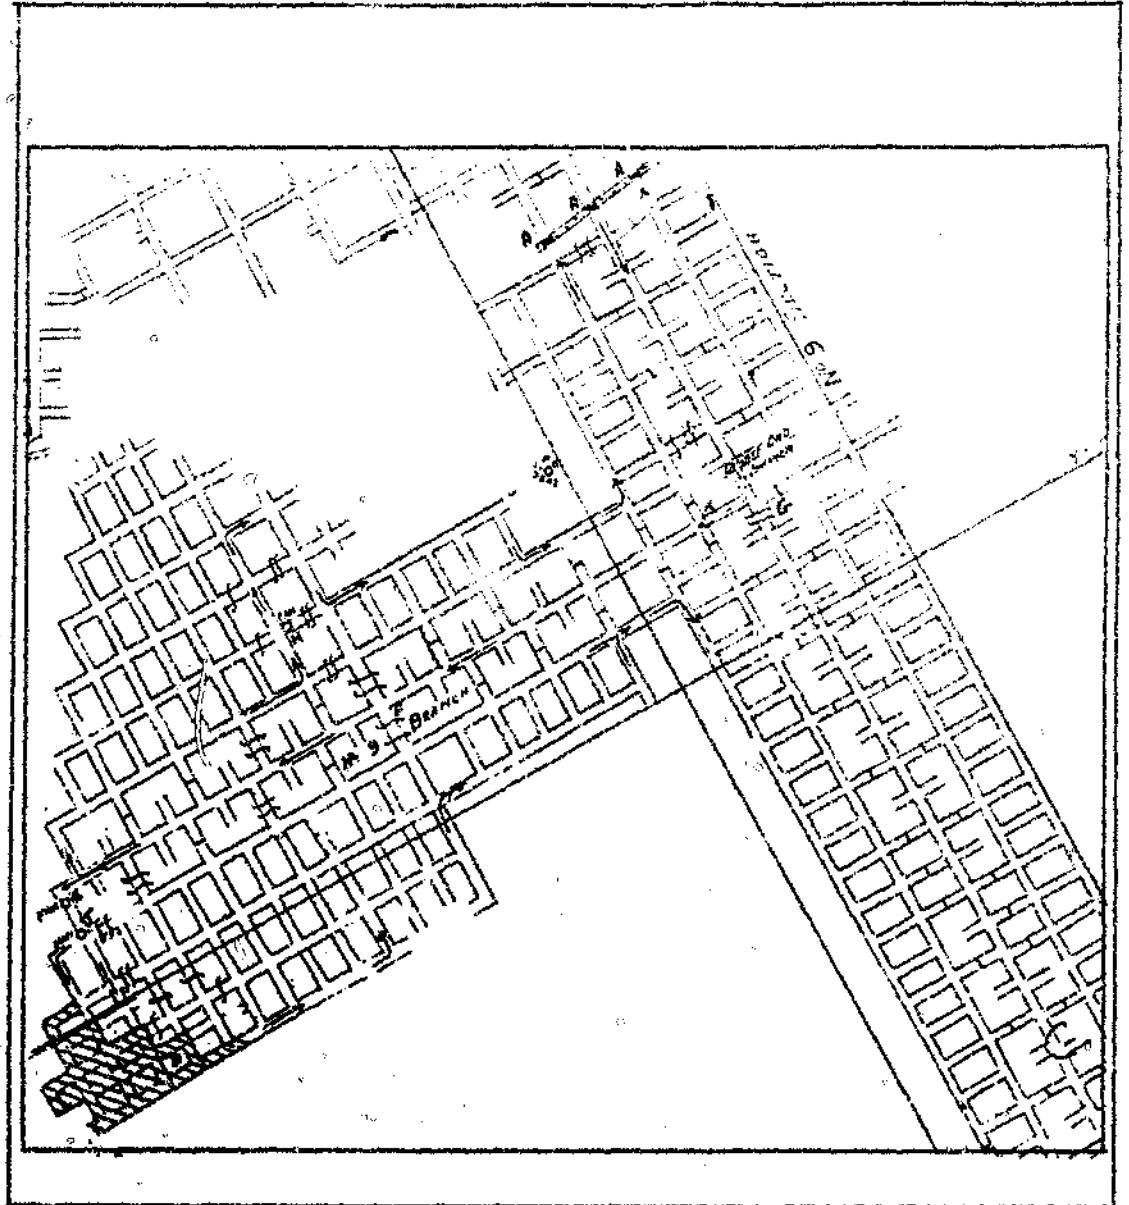
Figure 6

PLAN OF SECTION - CAMBRIAN COLLIERY

I then made arrangements to build stoppings in the dyke at the points marked A (Figure 6). The initial seals were completed at

Figure 6, a plan of the section, depicts the ventilation arrangements, position of fans, gate end switches and the final seals erected after the explosions. Bleeding air over the goaf to remove methane was not practiced at this colliery. Apart from the fact that there was insufficient ventilation in the section (fans were put in to boost the section ventilation) the leakage of ventilation through the brattices in the section could have been high especially at brattice G on the main haulage.

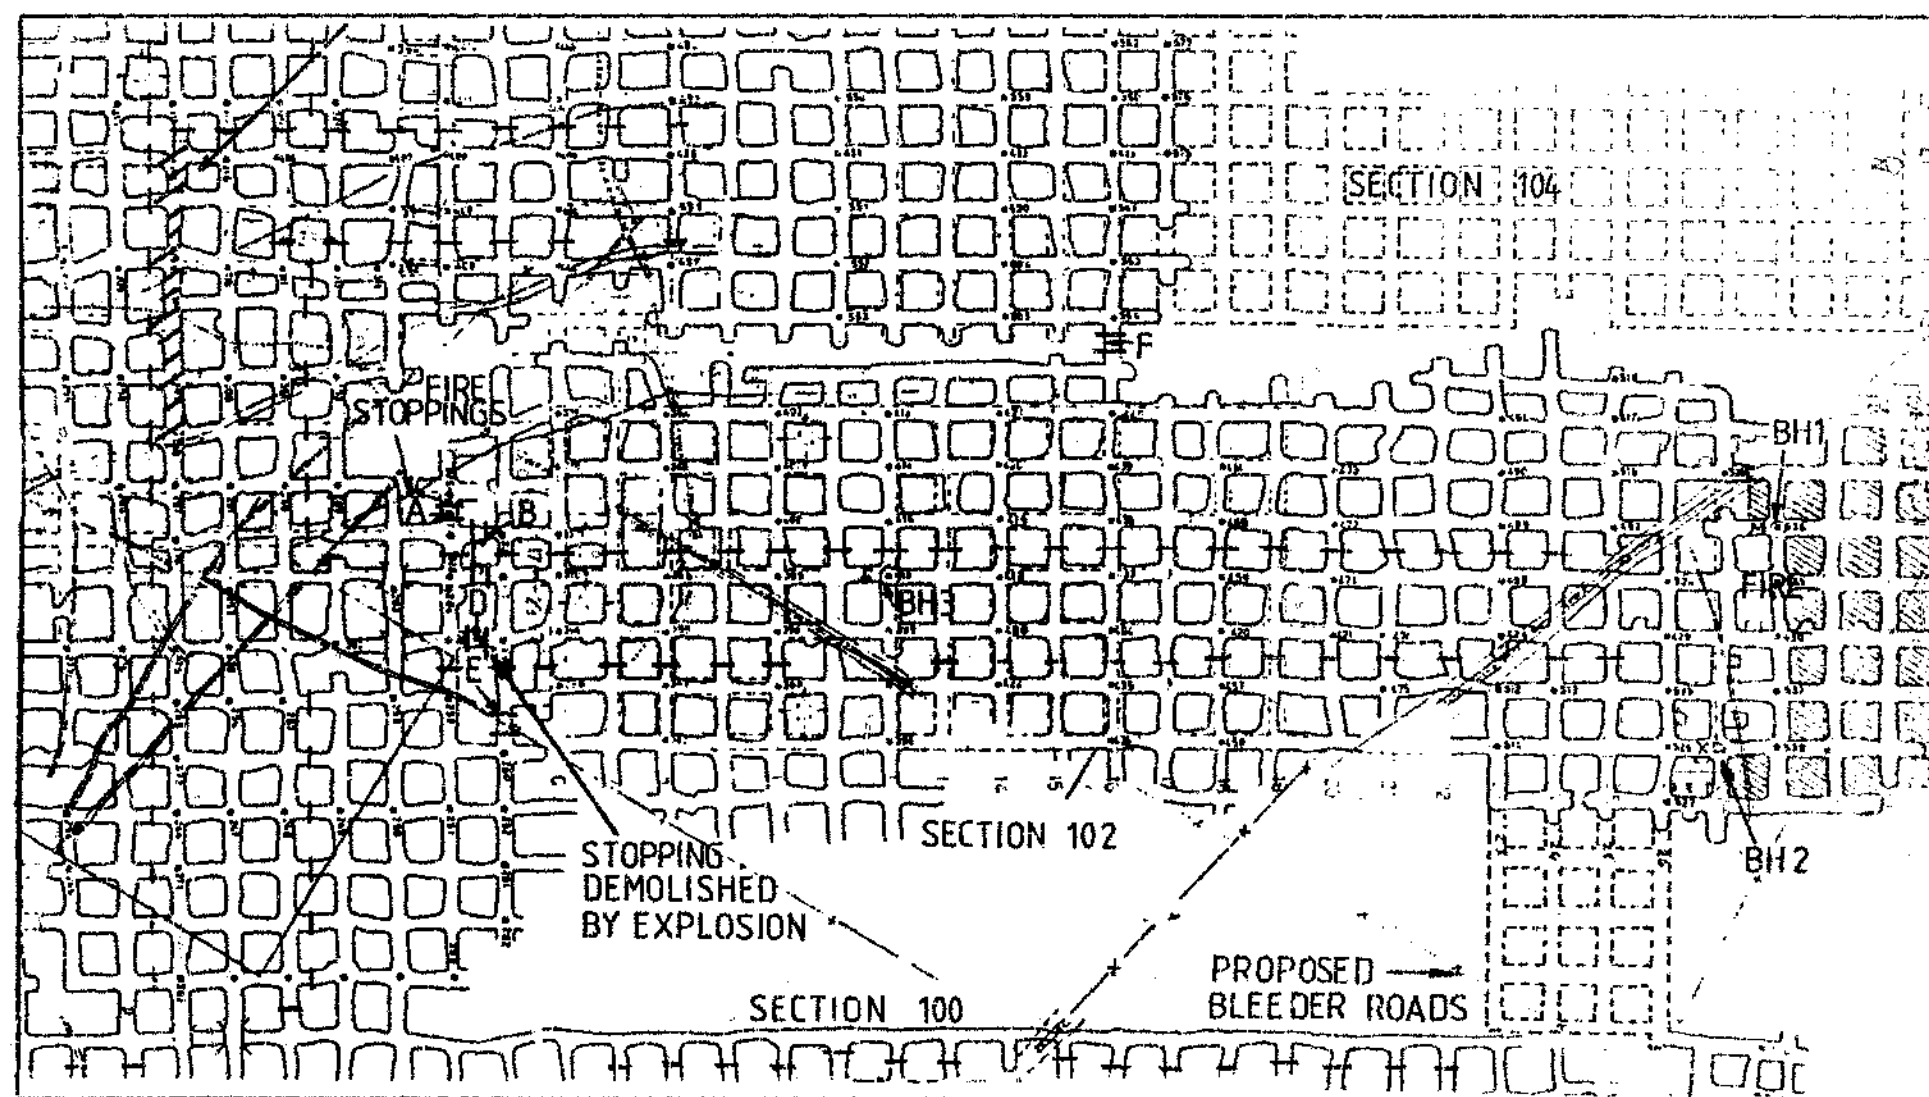
Figure 10

Once ventilation had been re-established in the section and methane had been cleared from the goaf, a decision was taken by mine management to establish bleeder roads to ventilate the goaf before proceeding with any further pillar extraction. This plan of action is shown on Figure 10. The logic behind this decision was that the goaf contained large quantities of methane and that this danger should be removed by ventilating the goaf.

BALGRAY SHOWING PLAN TO INSTAL BLEEDER ROADS

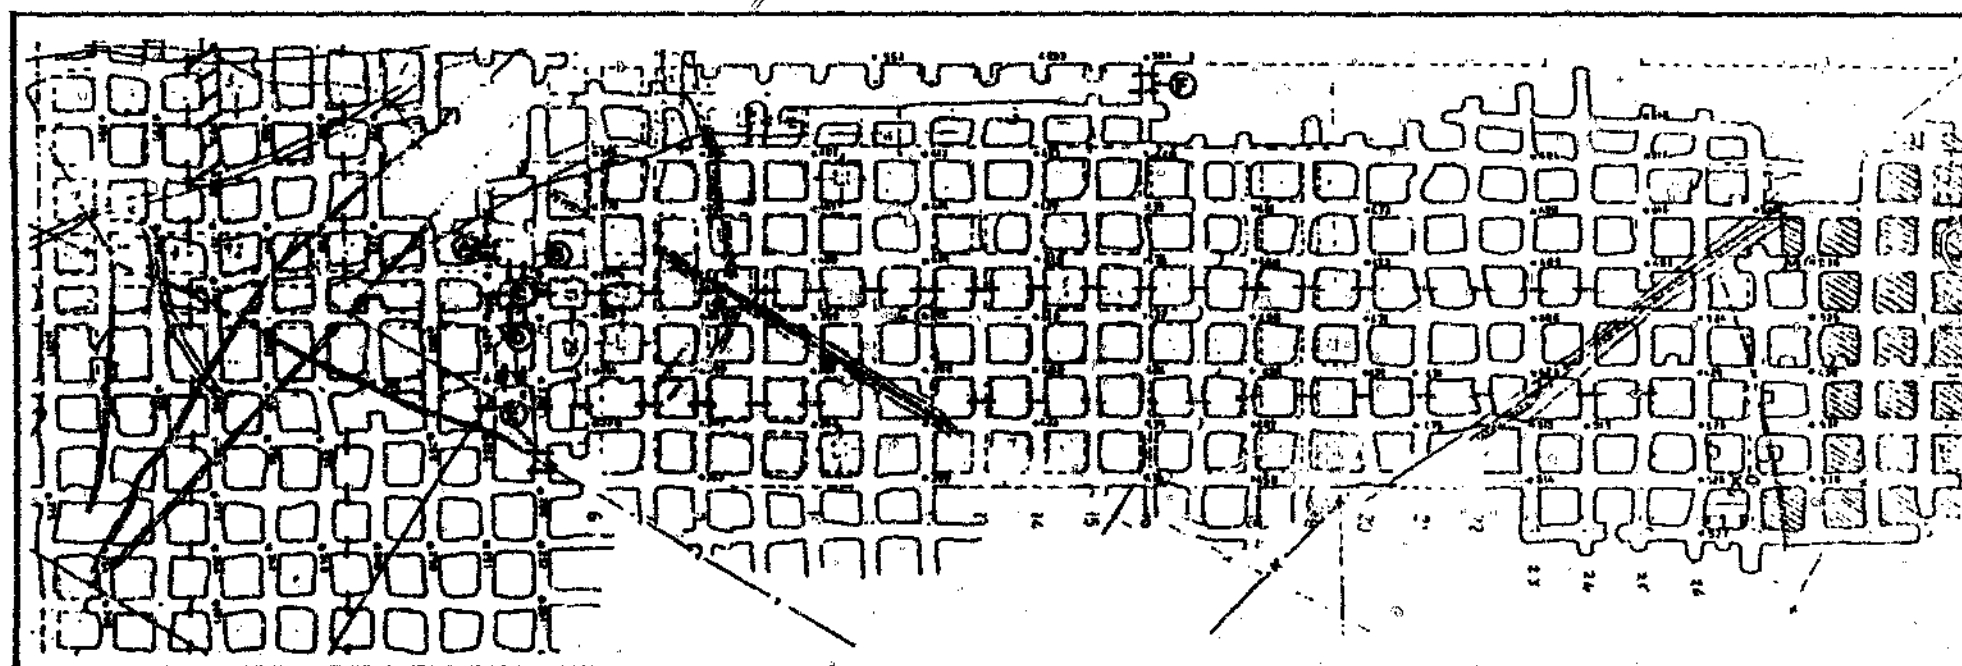
Figure 11  
PLAN TO SEAL OFF SECTION AT BALGRAY  
WITH 6 STOPPINGS  
AFTER NEXT 2 EXPLOSIONS

Following these three explosions a decision was taken to seal the section with 6 stoppings as shown on Figure 11. The installation was completed at 23h55 on the 26th April 1979.

Figure 11 shows the 6 numbered stoppings which were installed.

It was also decided to seal the panel as quickly as possible and thus only the inner walls were to be built initially and the outer walls and sandbagging were to be subsequently completed. On completion of the inner walls, all personnel were to be withdrawn from the mine for 24 hours. An essential requirement.

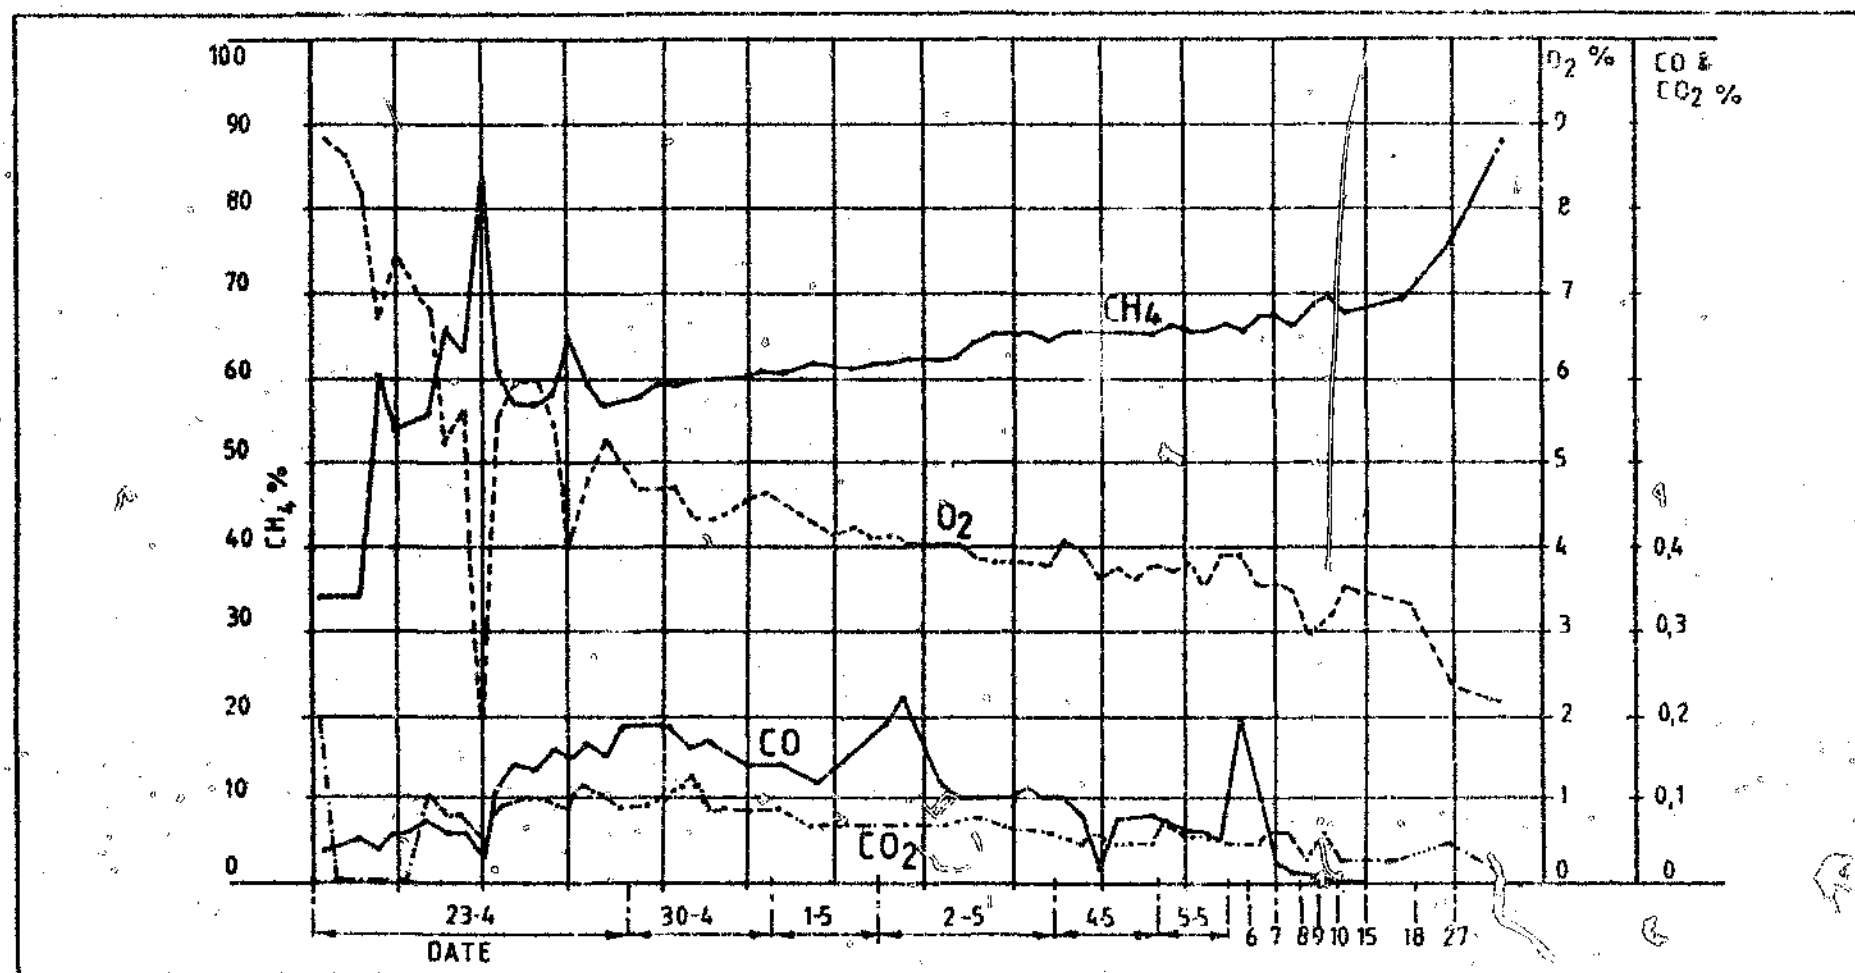
Figure 12  
RESULTS OF GAS SAMPLES TAKEN AT SURFACE BOREHOLE  
BALGRAY COLLIERY

Figure 12 is a graph of the gas samples taken at the borehole after the damaged seals had been replaced on the 30th April 1978. This was a crucial day since the decision had been taken to replace the blown out stopping. The percentage methane in the goaf was approximately 60% and the oxygen percentage was at 4,5 - a mixture clearly outside the explosive triangle (after Coward). The author was present and in charge of the building operations. Of concern to the team at the building site ("D" on Figure 11) was the gas analysis at 13h00 (2n hour before the final sealing) which is shown below:

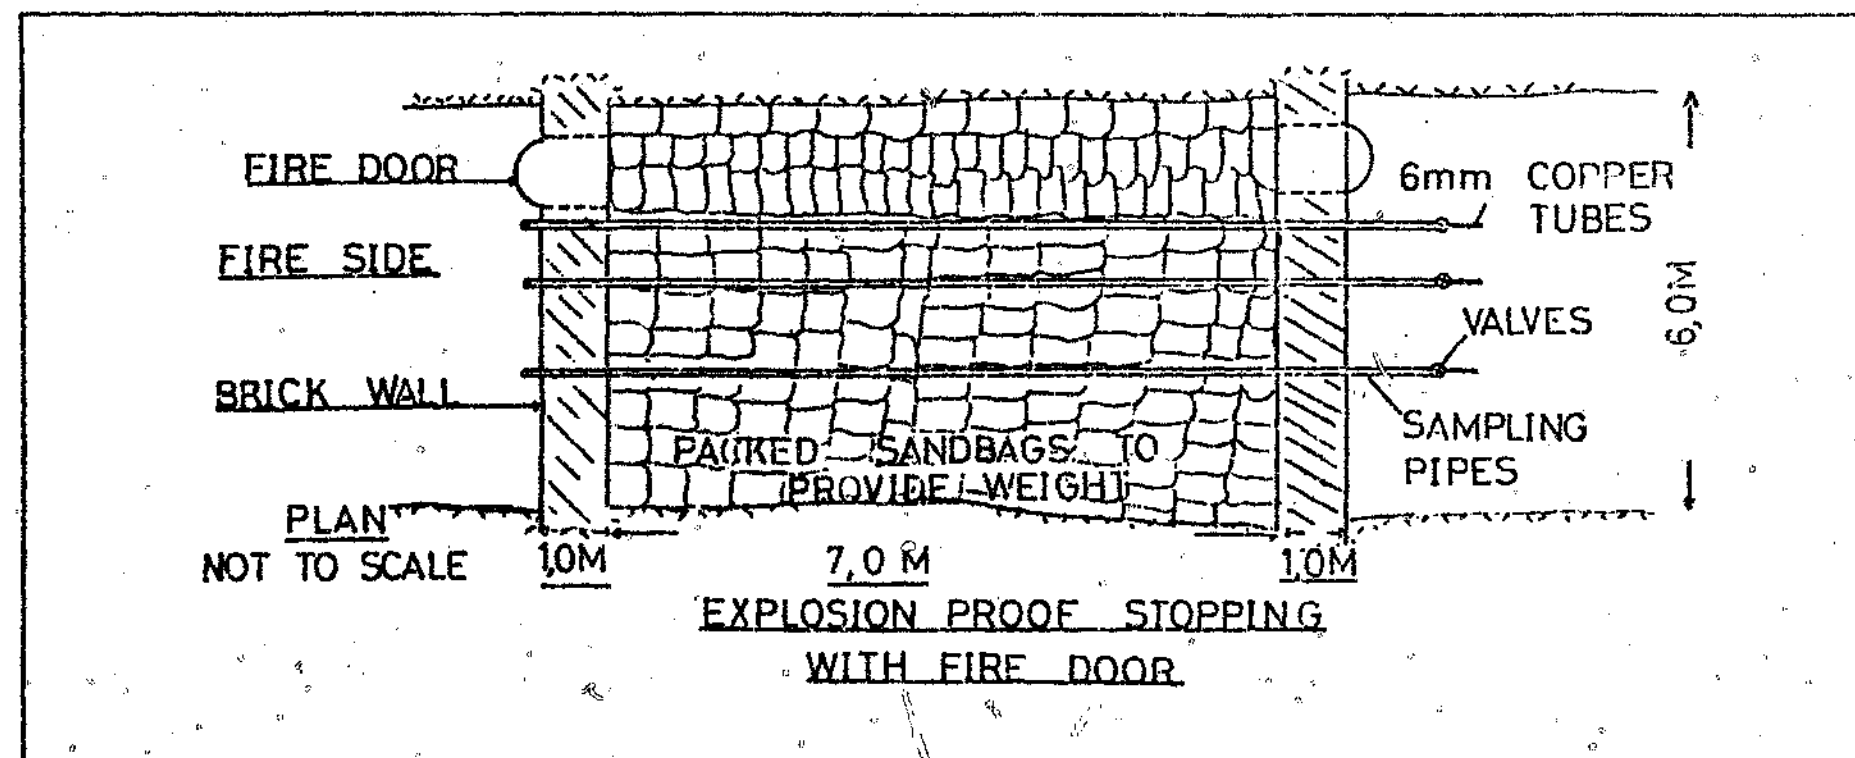
Figure 13  
TYPE OF SEAL USED  
BALGRAY COLLIERY

Figure 13 depicts the type of seal that was finally erected on the 6 roadways shown on Figure 11. This seal was considered explosion proof.

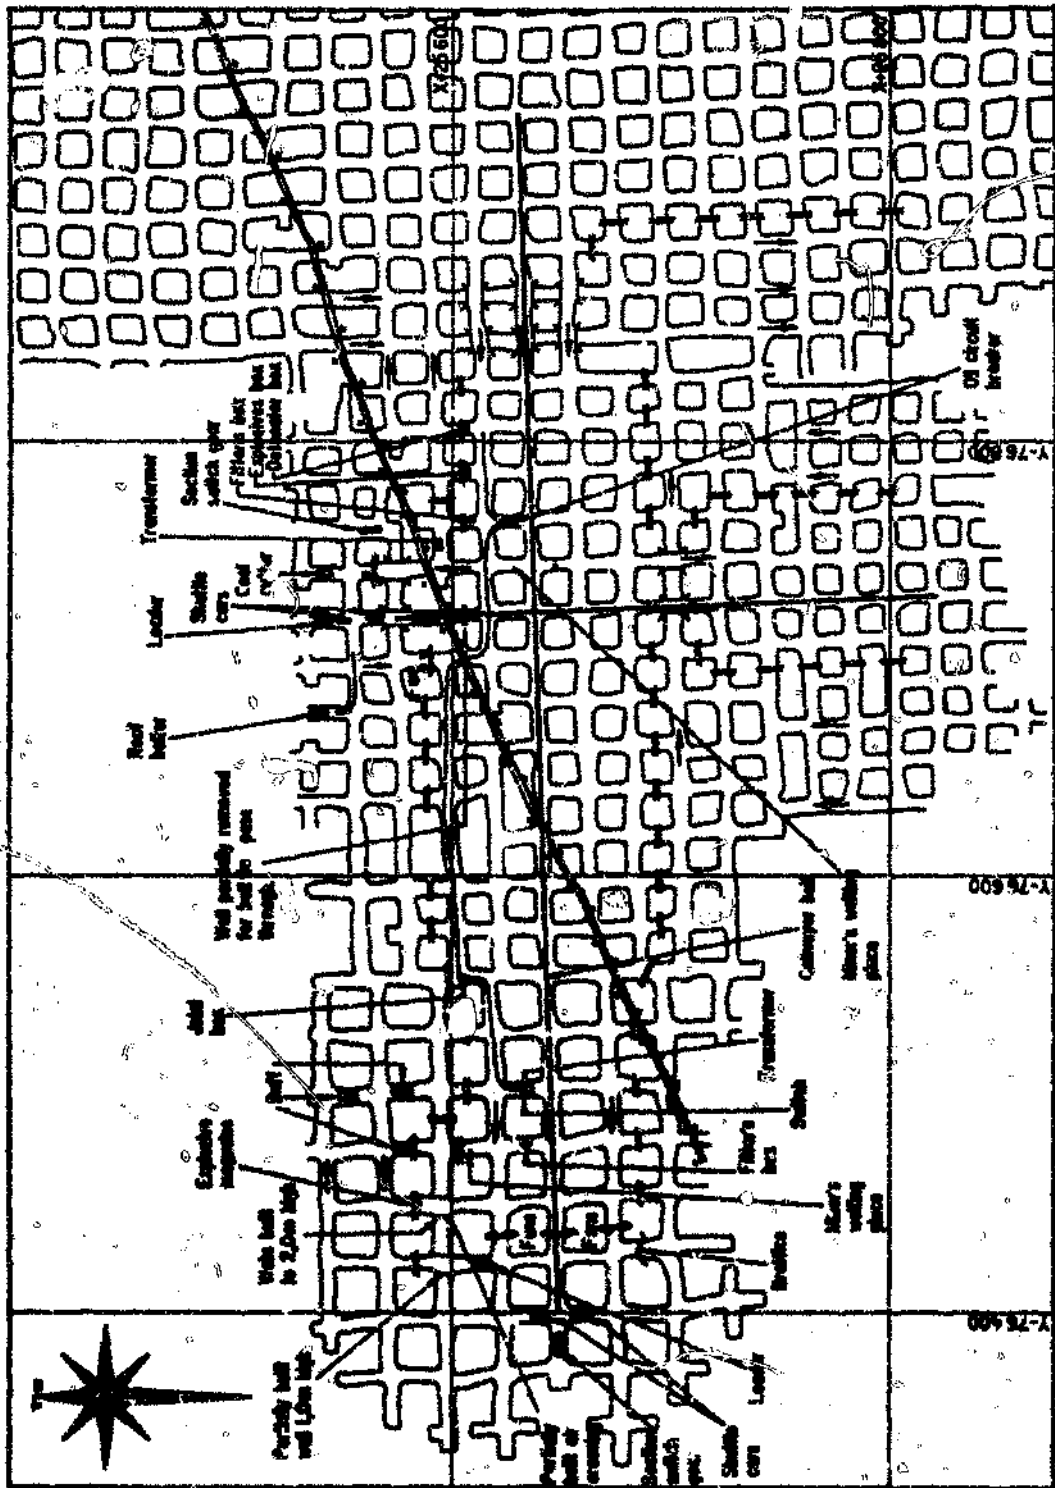
### Figure 3

One hour after the fan had been switched on again, the electricity supply at the distribution substation was switched on near the shaft. Due to a defect in the switchgear in the intermediate substation, the current flowed through to the section. En route a 6.6 kV joint box exploded and ignited a tongue of methane which resulted in the explosions.

**ERMELLO MINES SERVICES (PTY) LTD.  
PLAN SHOWING SECTION 7 WEST MAIN  
BEFORE METHANE IGNITION  
ON 25/02/84 AT 19:00  
Not to scale**

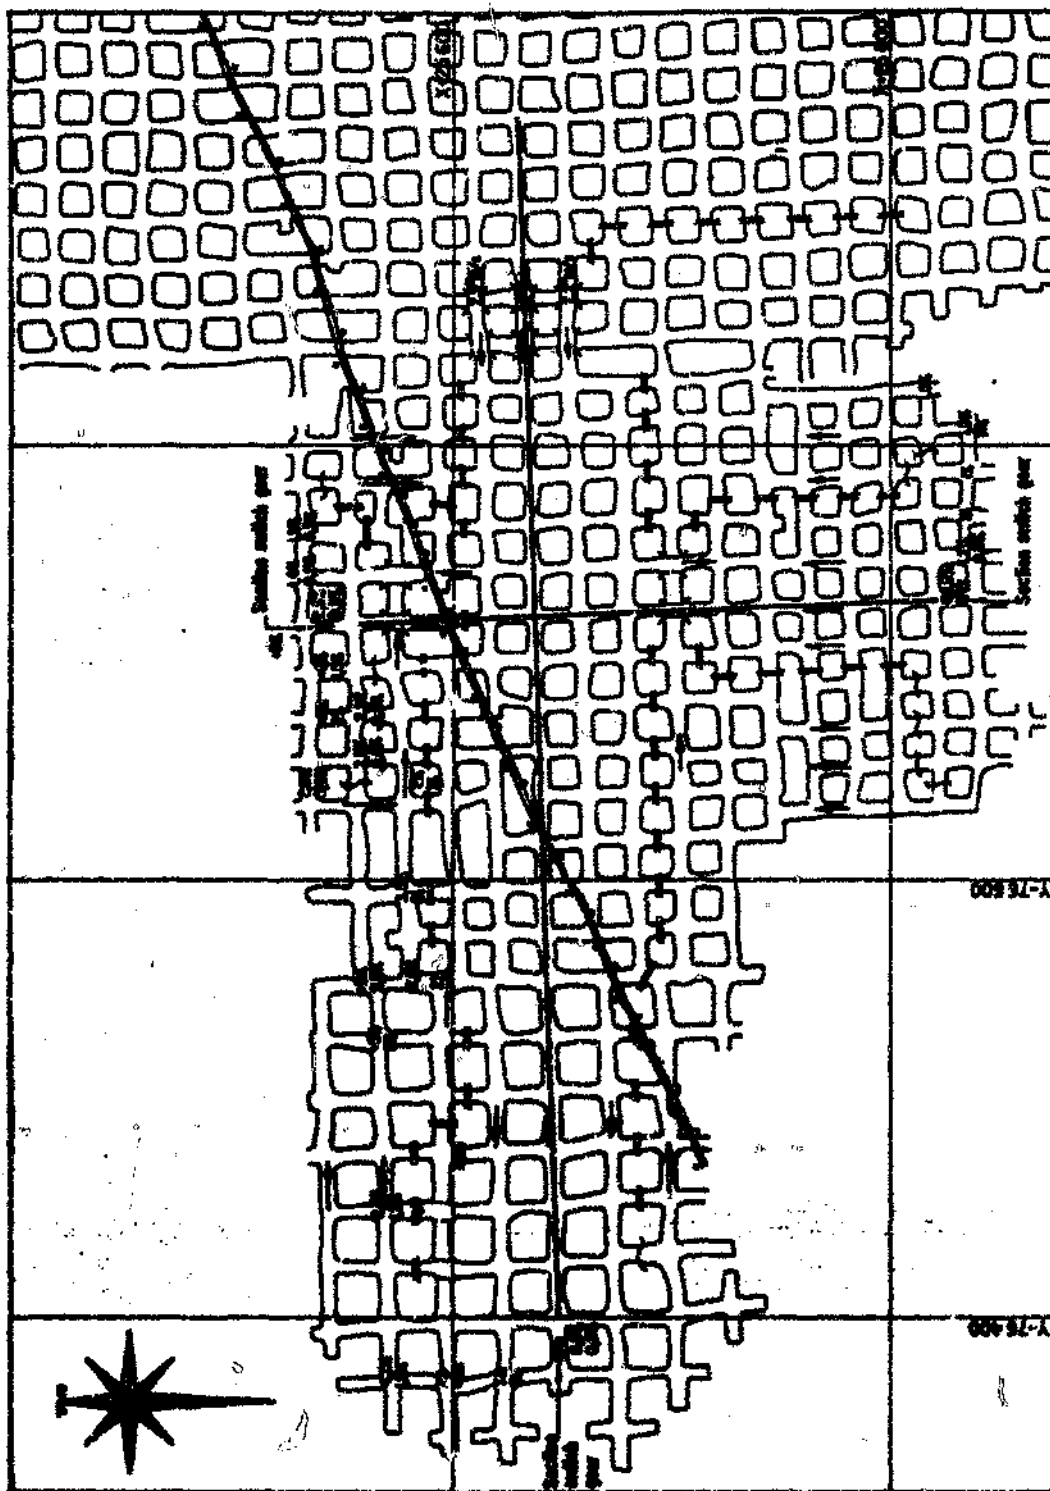
**Figure 5**

During a test carried out subsequently, the main fan was switched off for 3 hours and tests for gas were carried out. The results are indicated on Figure 5. Considerable methane build-ups were encountered in Section 10 and the right hand side of Section 3 in spite of the fact that there was still  $7 \text{ m}^3/\text{s}$  air flowing through these sections.

**ERMELO MINES SERVICES (PTY) LTD.  
PLAN SHOWING CH<sub>4</sub> BUILD UP  
3 HOURS AFTER SWITCHING OFF  
POWER AND FANS - TRIAL**

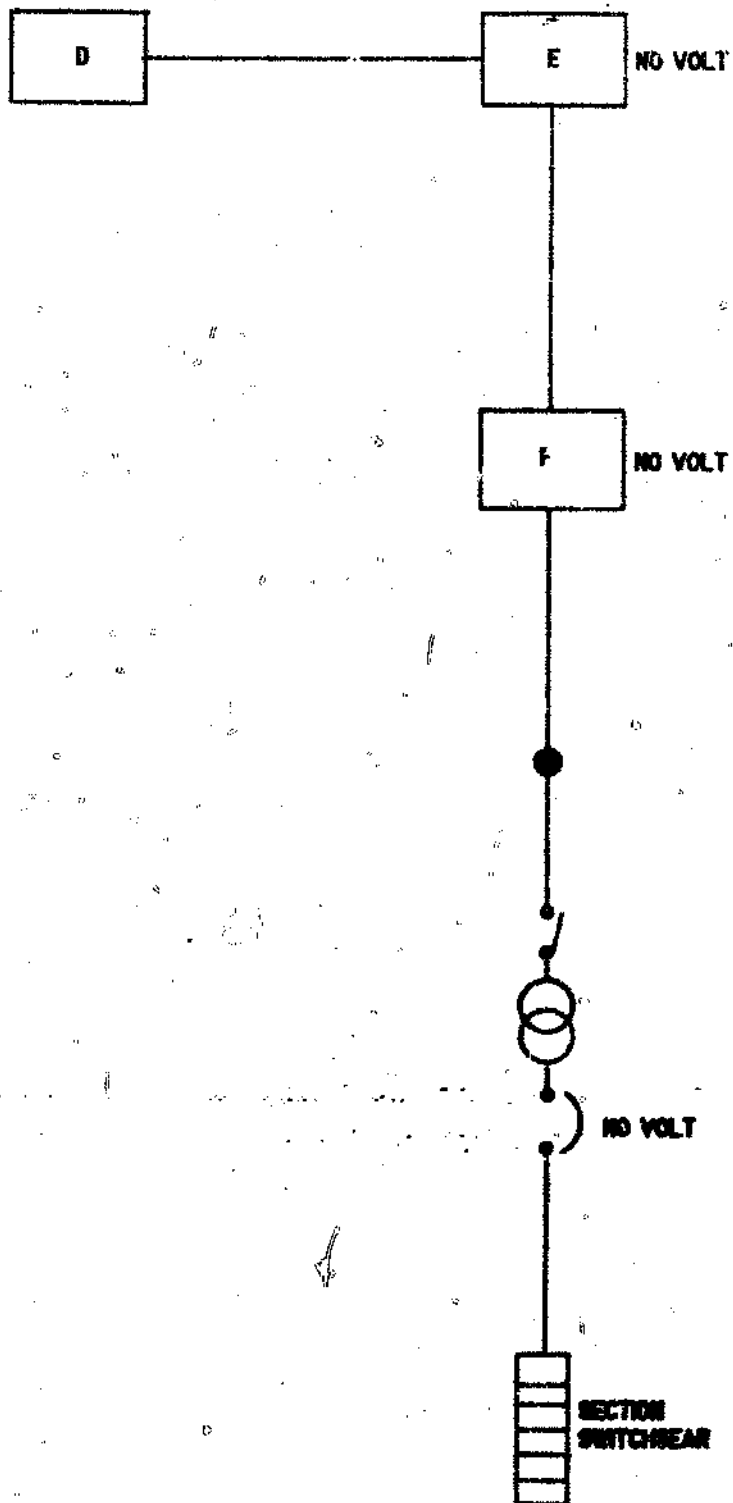
**Figure 6**

Figure 6 shows the electrical distribution into the mine.

**ERMELO MINES SERVICES (PTY) LTD.  
DIAGRAM OF ELECTRICAL RETICULATION  
FROM SURFACE TO SECTION 7 WEST**

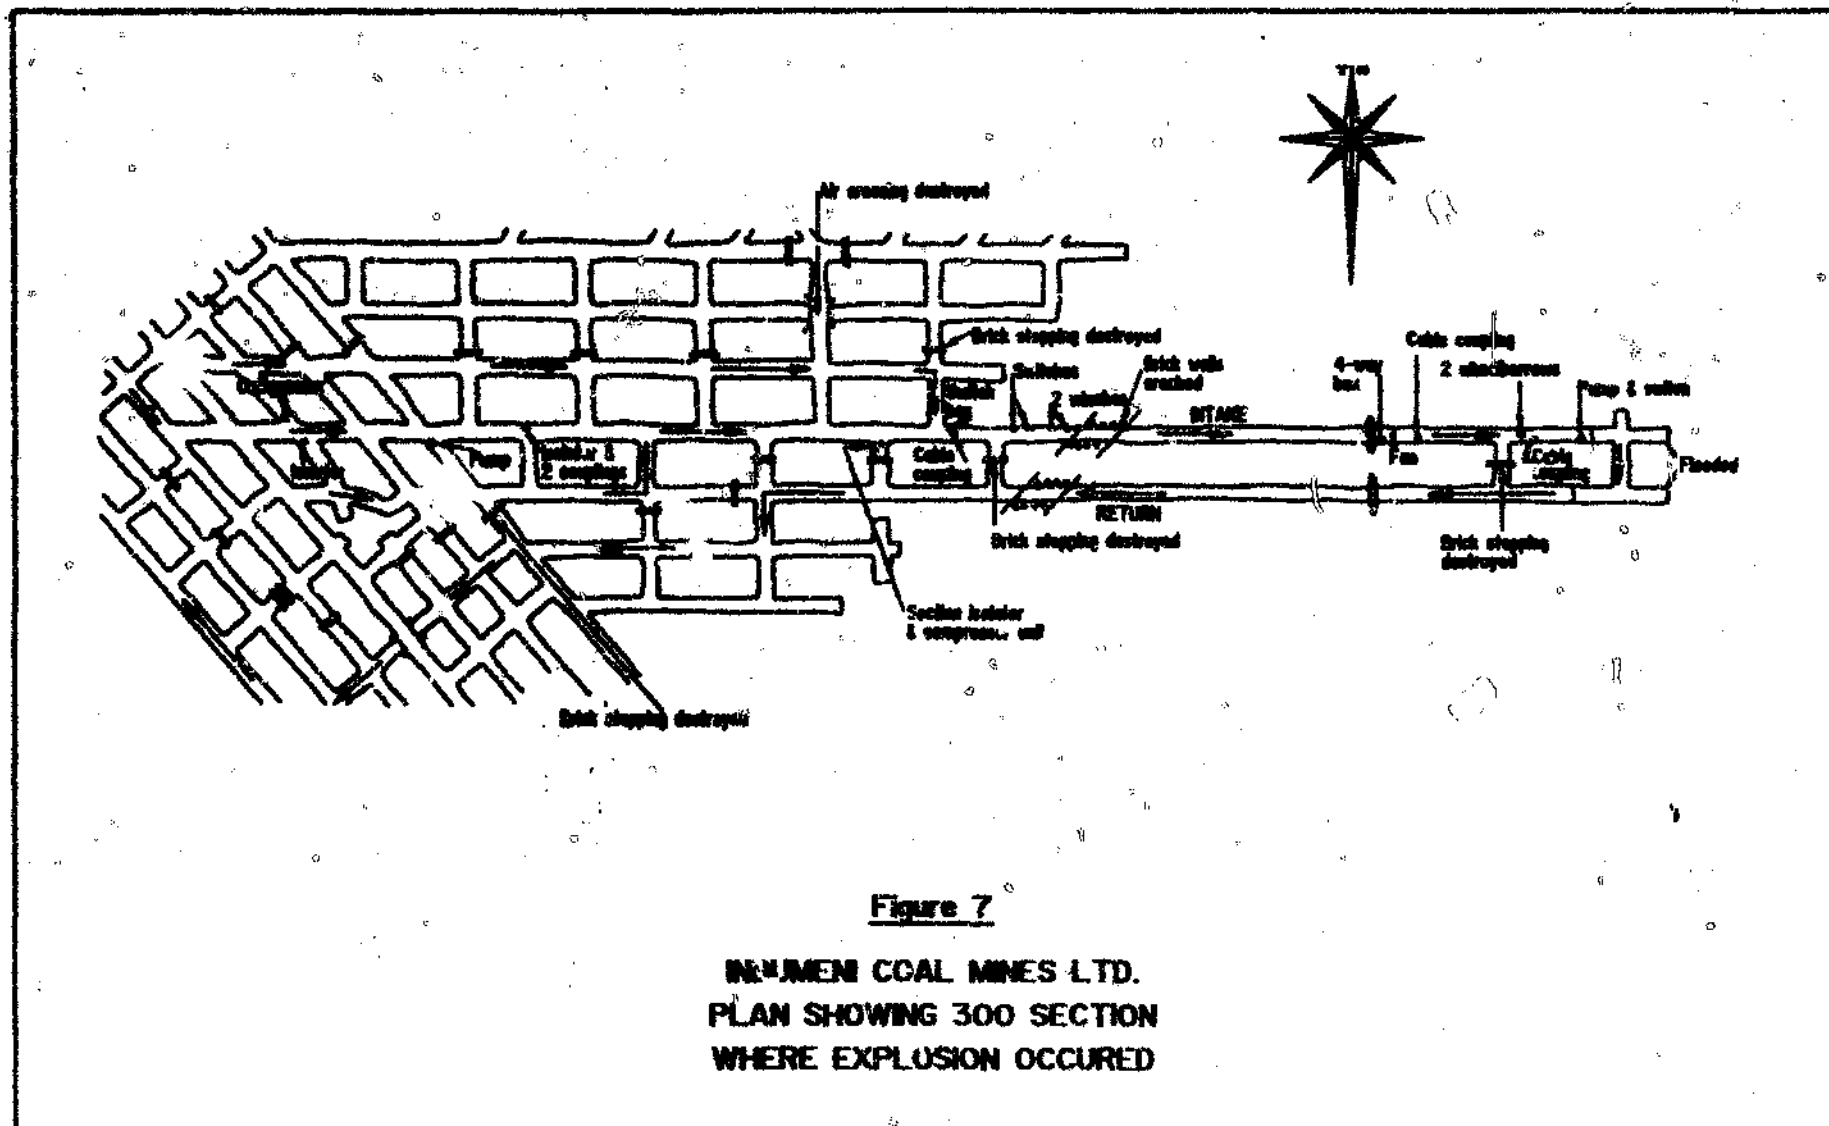
- There had been an explosion in the Main road A of Section 300 as shown on Figure 7.
- That 3 bodies, one White and two Black, had been located.
- That the electrical switch near the pump motor had been left open with the cover off and the cover bolts neatly packed on one flange of the switch box. The position of the pump is reflected on Figure 7.
- That the water level in Road A was some 1,2 metres below or inbye of the pump position.
- That at a position approximately 5,5 metres inbye from where the water started in A, the level of the water was approximately 1 metre below the roof.

On this occasion, after replacing the contactor coil, he had the power restored to the switch at the No. 2 section isolator before replacing the flameproof cover. He wished to test the switch by starting the pump. When the contacts opened, an arc was drawn between the contactors of sufficient intensity to ignite the methane/air mixture in the roadway. The switch was 500 volts and the spark or flash could have been as much as 25 mm in length. The switch was 30 cm above the floor of the roadway.

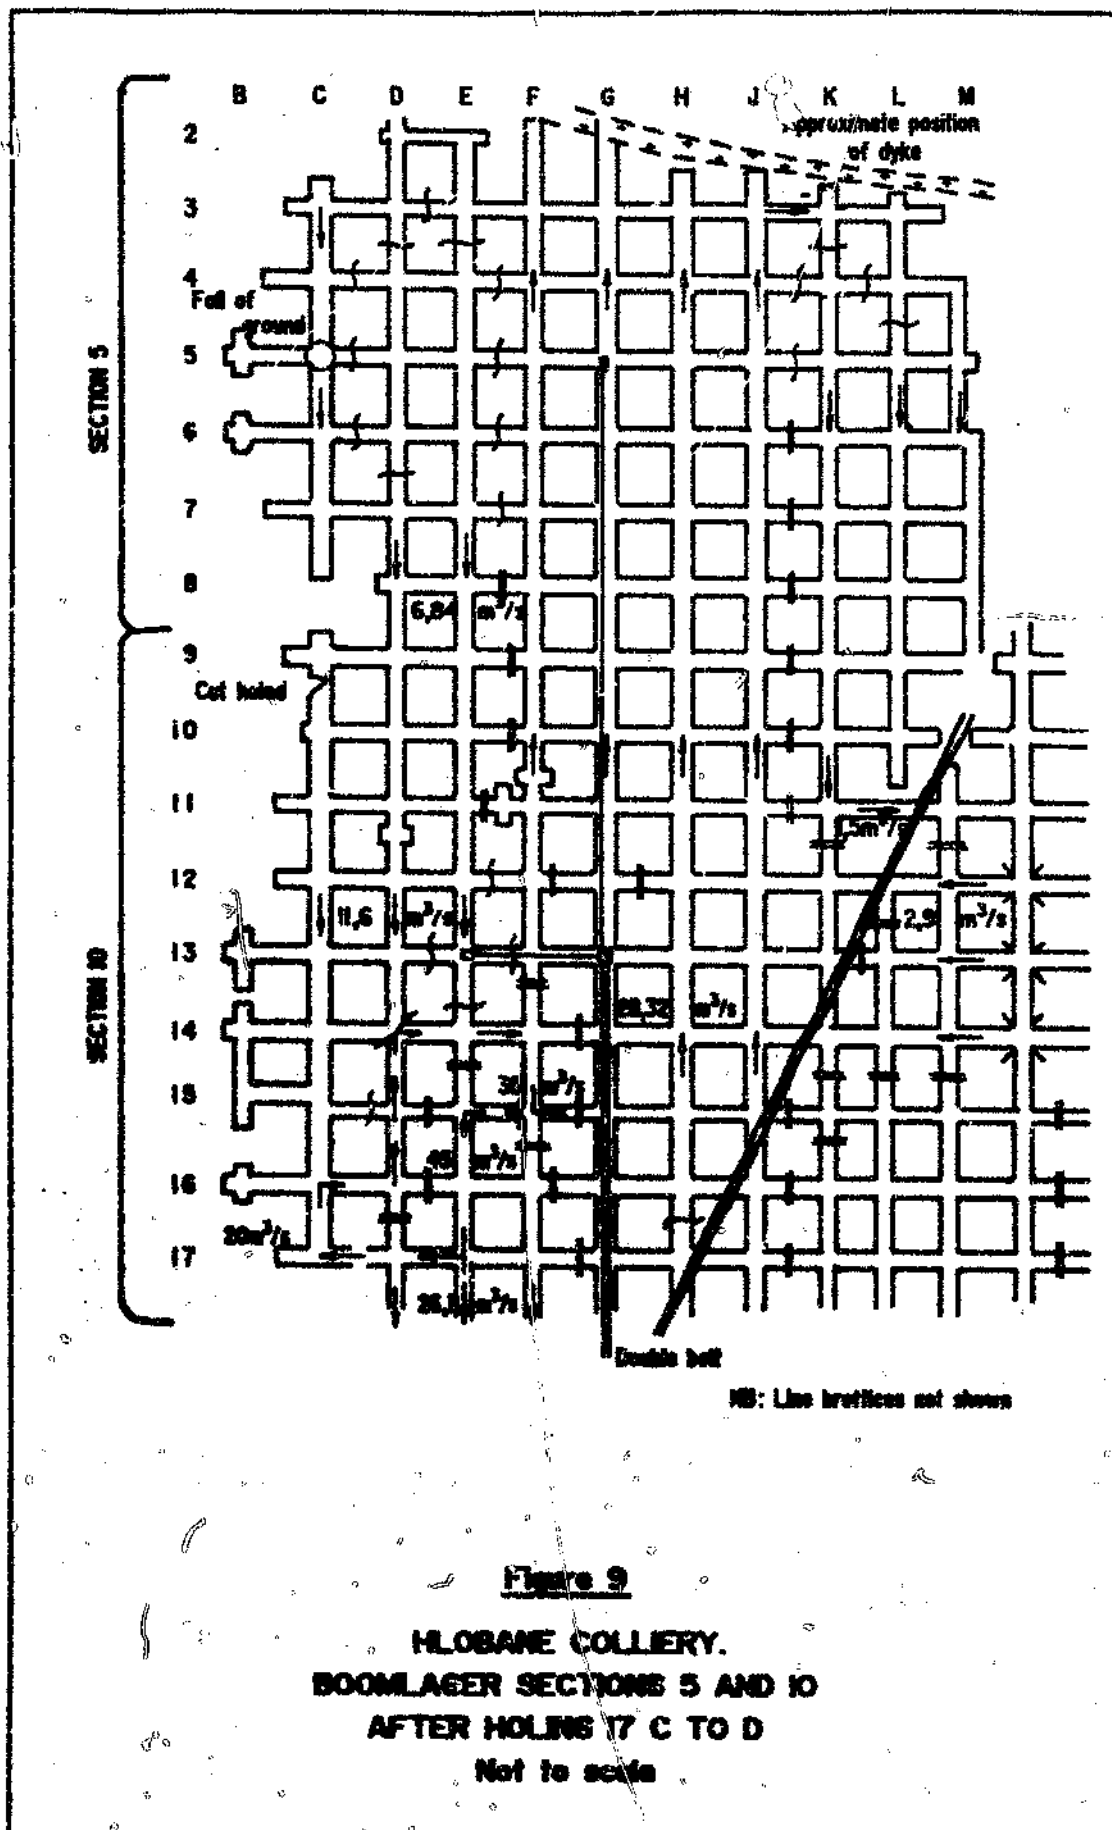
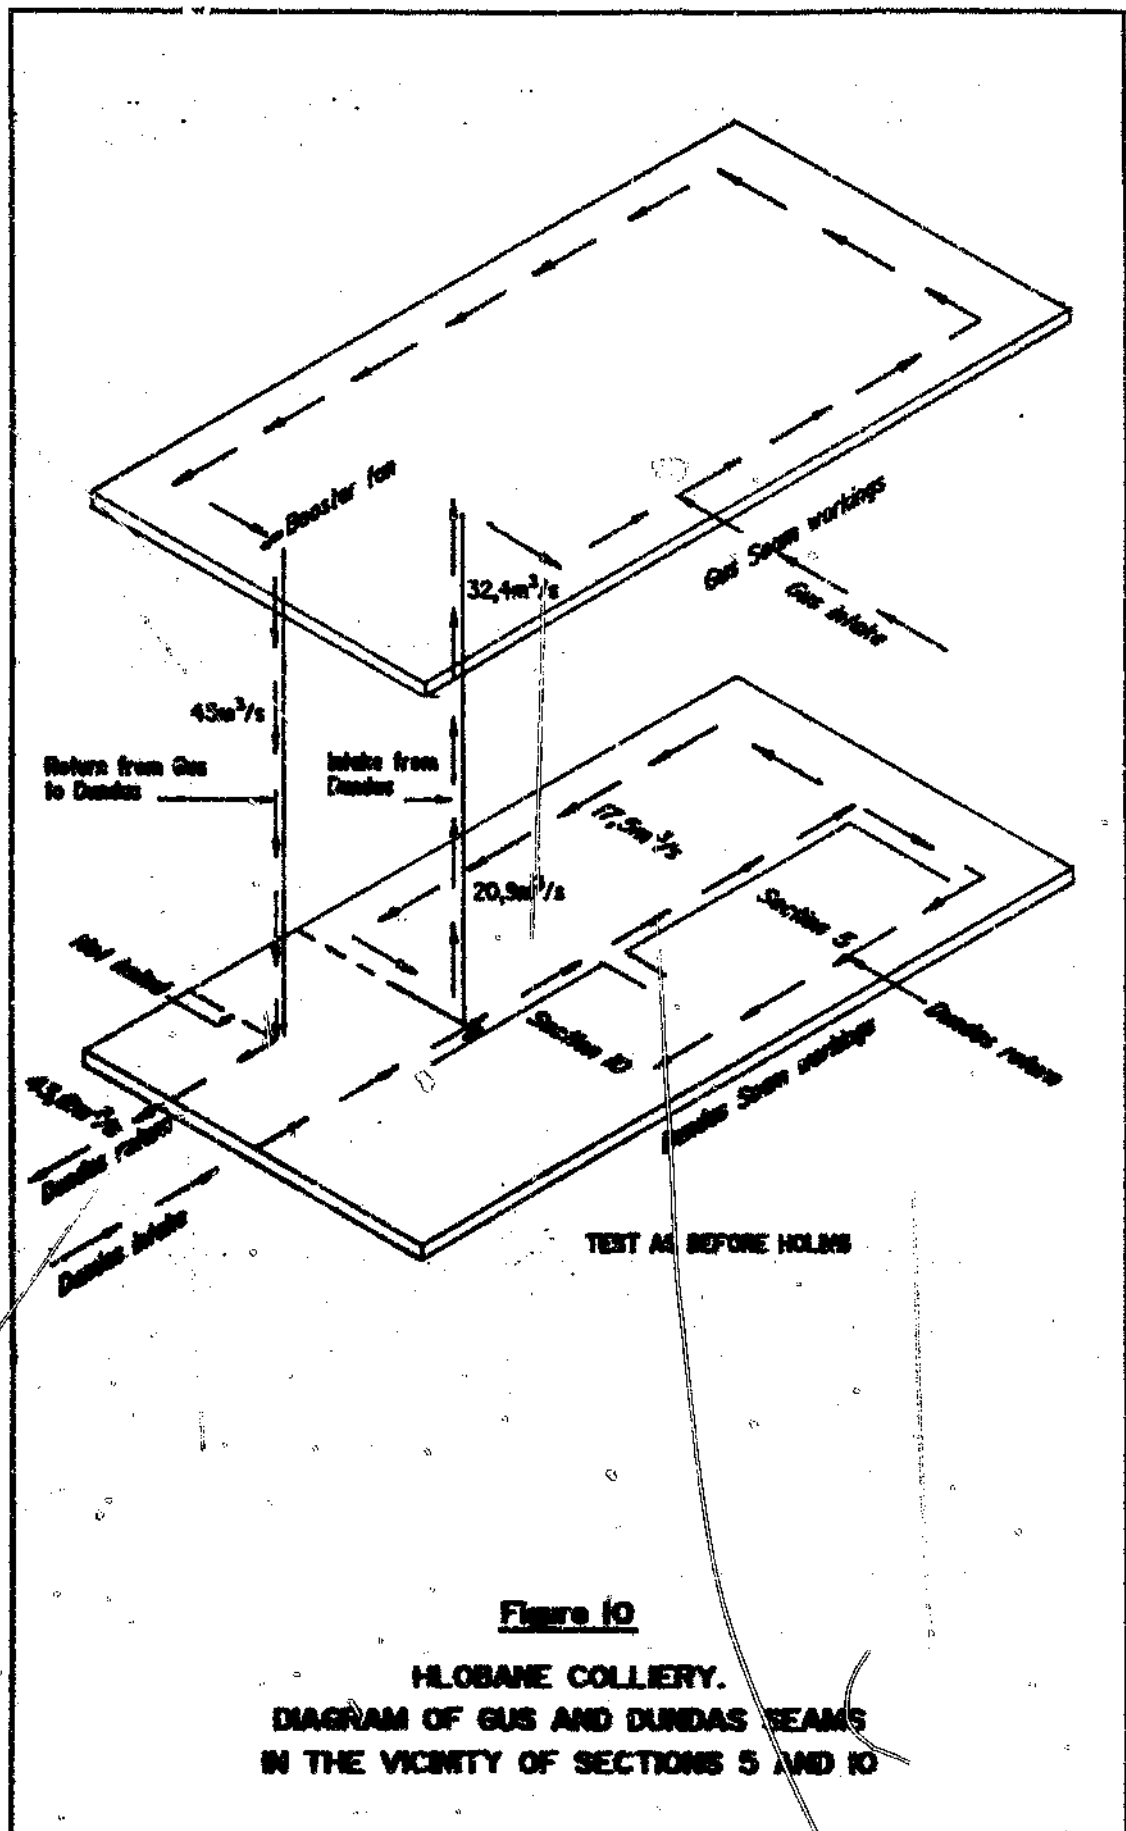
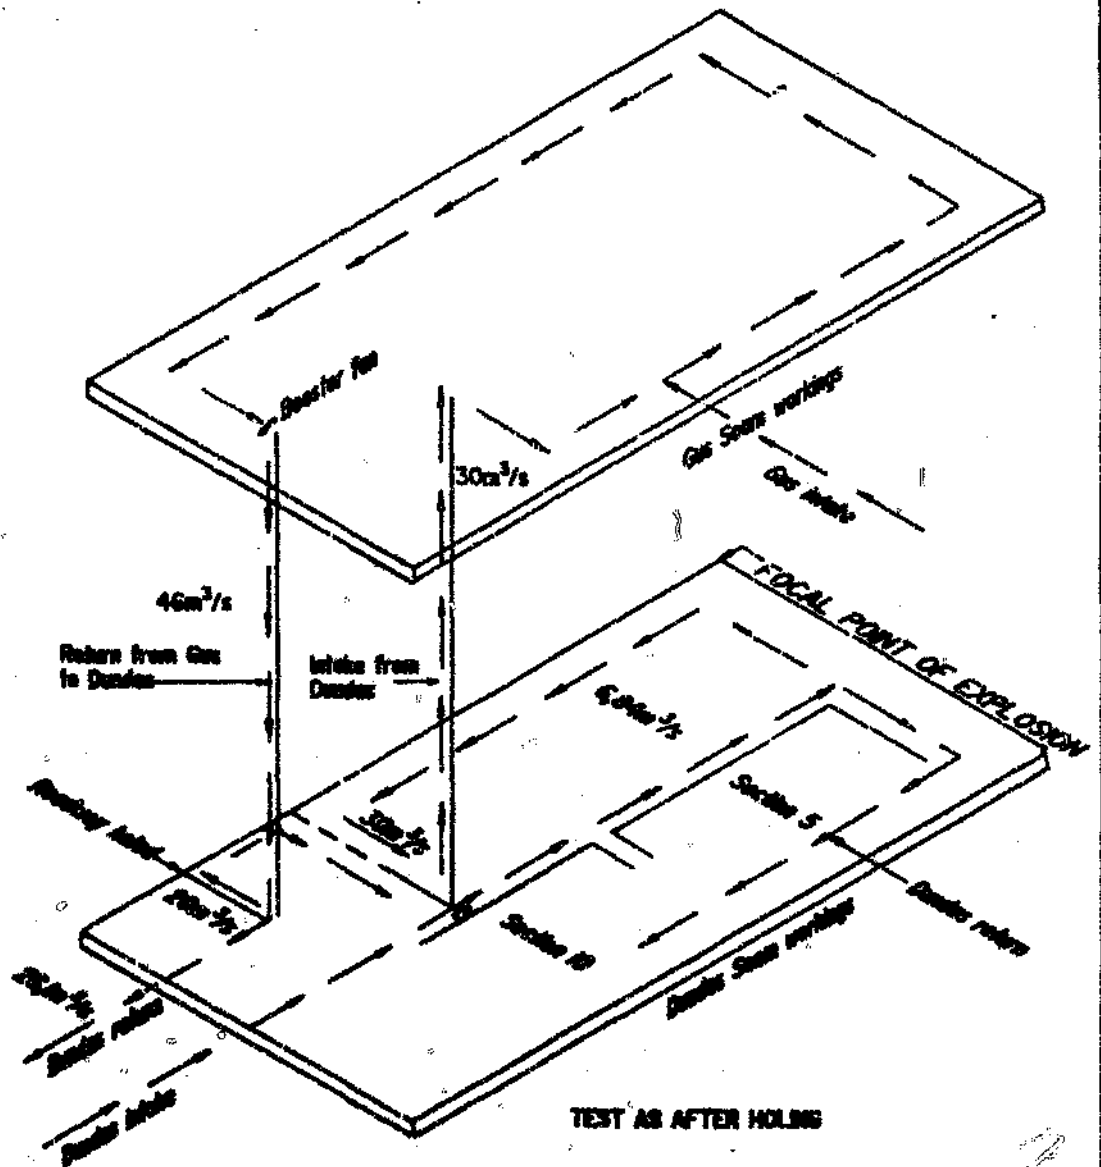
**Figure 11**

On 10th September 1983, a cut was made which holed through the remaining coal in roadway No. 17 between intersections C and D, Figure 9. The miner in charge of section 10 reported this fact to his shiftboss who gave him no instructions. Later during the shift, the coal was blasted down. Because of the booster fan on the Gus seam, Figure 10, the air in the return airway was under higher pressure than in section 10, and air was thus blown into the section through the holing, reversing the flow of air on the left hand side of section 10. This disrupted the ventilation, and the supply of air to section 5 was reduced by some 60%. A diagrammatic representation of the ventilation after the holing is shown on Figure 11. The figure of 60% reduction in the ventilation of section 5 was arrived at by an experimental reconstruction of the ventilation arrangements after the accident. Under these circumstances, all the brattices, stoppings and so on, were in perfect condition. It is reasonable to assume that these ideal conditions would not have been the case on 10 September 1983 and that the reduction in the supply of air to section 5 was thus in excess of 60%.

**HLOBANE COLLIERY  
DIAGRAM OF GUS AND DUNDAS SEAMS  
IN THE VICINITY OF SECTIONS 5 AND 10**
