Investigation of the Mechanisms and Control Measures for Fireside Corrosion in Eskom Fossil  
Fuel Boilers

**MSc DISSERTATION**

**Kedimetse Gloria Moloko (9808755G)**

02 October 2019

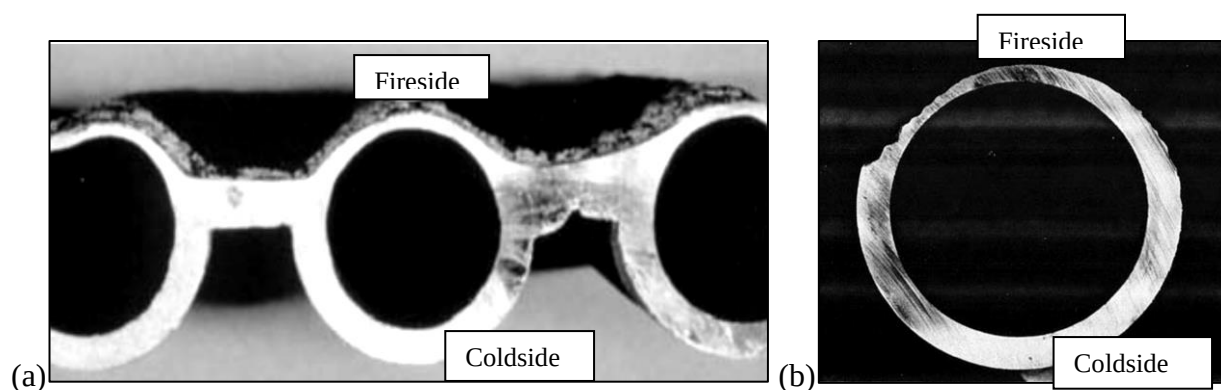
Furnace wall tubes affected by fireside corrosion will demonstrate significant wall thinning on on the crown of the fireside of the tube. As shown in Figure 2.6, the thinned area is usually covered with hard deposits and loosely bonded ash on the outer layers. Corrosion often occurs in definite patterns associated with the direction of the flame, and has been linked to flame impingement (Reid et al., 1945). Flame impingement creates severely reducing conditions, high heat fluxes, and leads to the generation of corrosive species. The damage usually affects more than one tube at any given location and may cover extensive areas.

**Figure 2.6: Typical appearance fireside corrosion showing (a) wall thinning and hard scale, (b) significant wall loss underneath the scale on the fireside (Dooley and McNaughton, 2007).**

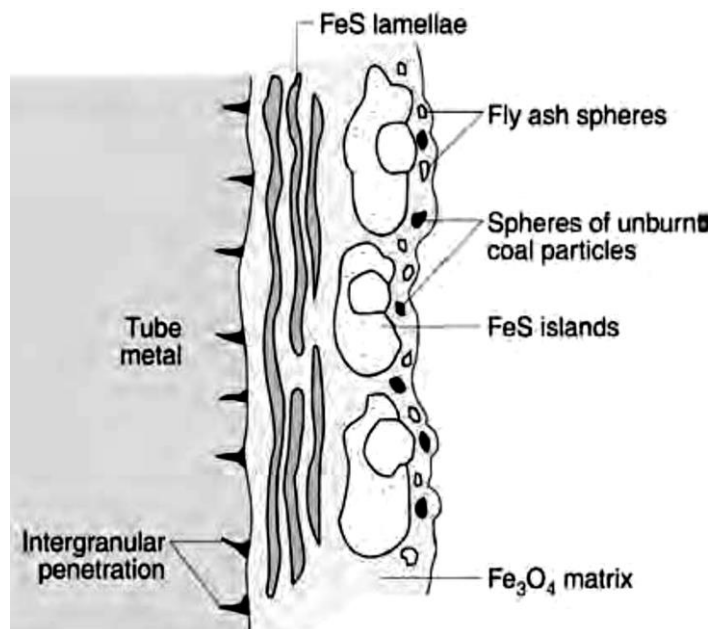
The precise morphology of the attack will vary somewhat with the particular environment and tube material. In general, however, the attack occurs on the crown of the tube where thick magnetite scales containing sulphide bands and islands are formed as shown in Figures 2.7. Unburned coal particles from the furnace, iron oxides, and iron sulphides are found in scale overlaid by sintered deposits. If a tube burst occurs, it is often in this location. Cracks perpendicular to the longitudinal direction may be evident as illustrated in Figure 2.7.

**Figure 2.7: General structure of the fireside corrosion scale formed on a furnace wall tube under reducing environments (Wells et al., 1997).**

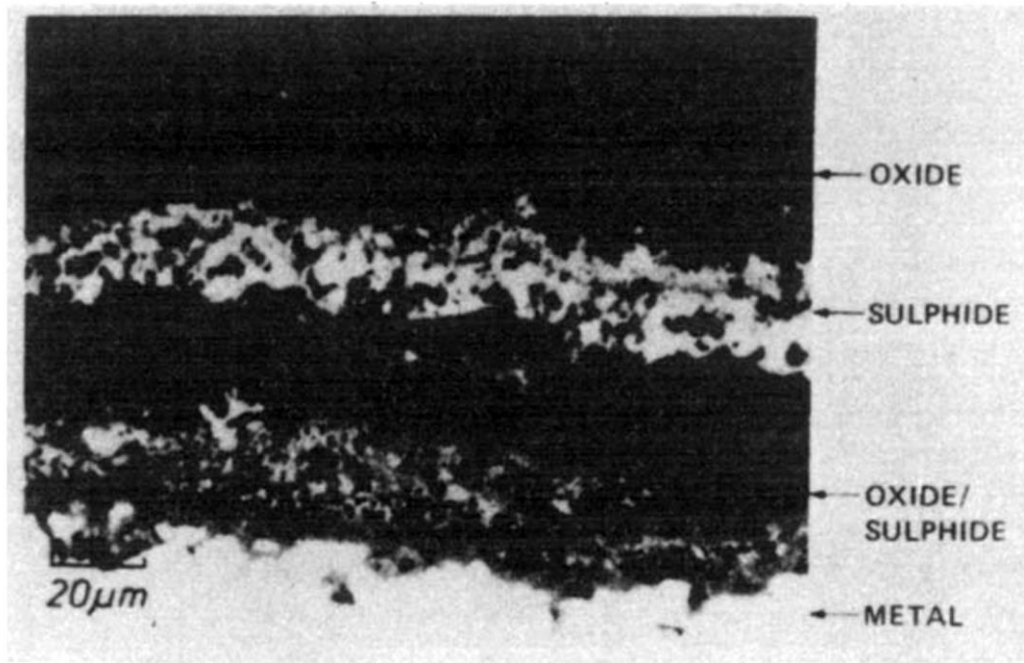
Clarke and Morris (1980) found that in areas of persistently high corrosion, the furnace wall tubes formed thick magnetite scales containing distinct sulphide islands and bands, leading to high rates of metal dissolution, Fig. 2.9.

**Figure 2.9: Thick oxide/sulphide corrosion scale from area of high CO concentration (Clarke and Morris, 1980).**

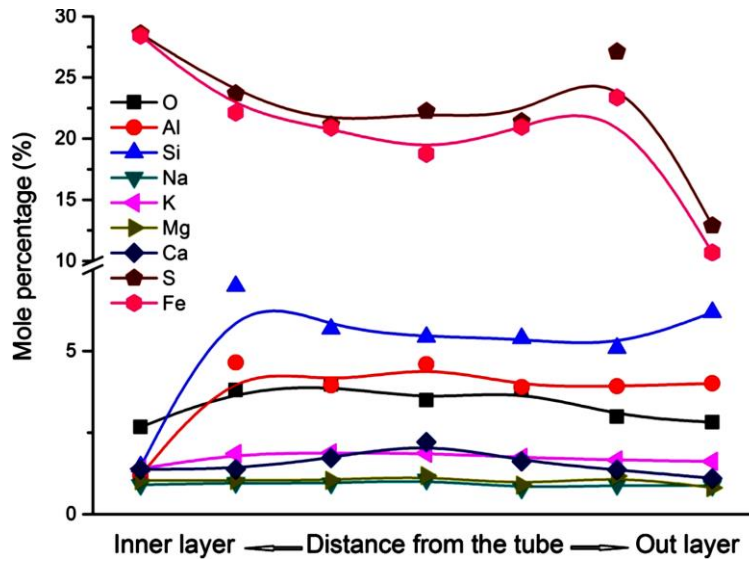
Hong and Yong (2002) state that high temperature corrosion of the water-cooled wall caused by sulphur in a coal-fired power plant can be divided into two types, namely sulphide type and sulphate type. Through this investigation of fireside corrosion at water-cooled wall from a coal-fired power plant in China, Yu et al. (2017) found that the corrosion products were composed mostly of iron-containing sulphide and magnetite and as a result classified the corrosion in this power plant as the sulphide. The general elemental distribution (including S, Fe, Si, Al, Na, K, and Ca) in the different layers of the corrosion product is shown in Fig. 2.10. He further states that the main reason for high temperature corrosion from the sulphide type is due to the large amount of  $\text{H}_2\text{S}$ , detached sulphur, and the unstable  $\text{FeS}$  that would be formed in the oxygen-deficient ambience when a high sulphur coal is burned.

**Figure 2.10: Elemental distributions of corrosion products along the section layer**  
(Yu et al., 2017).

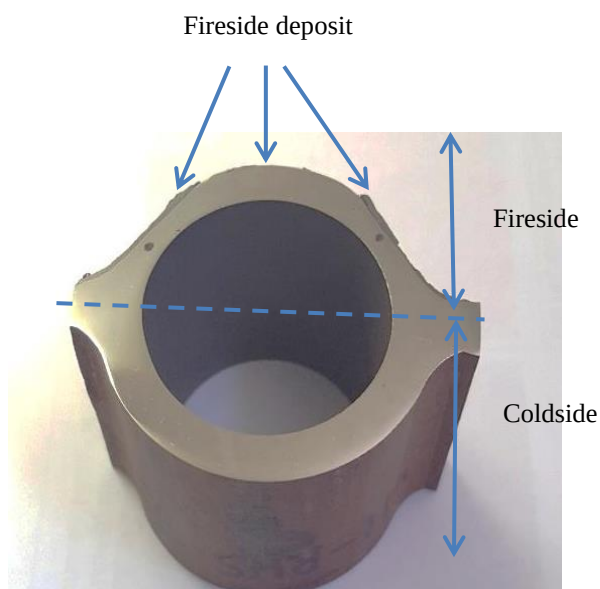
Cross sections of the tubes with attached fireside deposit were prepared for SEM-EDS. Two tube ring cross sections with the deposit still intact were removed from each tube using dry cutting to avoid contamination from fluids and metallographically prepared. Figure 3.1 illustrates the way the fireside deposit was analysed and characterised.

**Figure 3.1: Cross section samples of the tube prepared for microstructural examination and SEM analysis of the fireside deposit at 10 o'clock, 12 o'clock and 2 o'clock positions.**

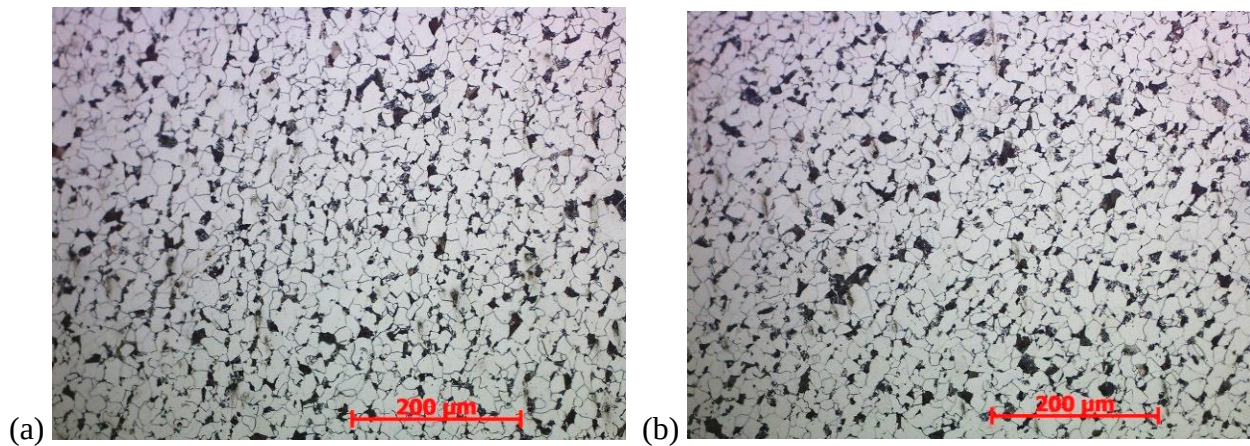
The microstructure observed on tubing from the three power stations was the same on both fireside and coldside; it consisted of well-spheroidised and degenerated carbides, still grouped in the original pearlitic pattern, in a ferrite matrix. A spheroidised microstructure is typical of service exposed 16Mo3 tubing operating at moderately elevated temperatures. A similar appearance between the fireside and coldside indicates that the flame-exposed (fire-) side of the tubing was not significantly hotter than the casing (cold-) side. The exception was seen on the ruptured areas which consisted of deformed grains.

**Figure 4.8: Station C side wall tubing (a) on the fireside and (b) on the coldside.**

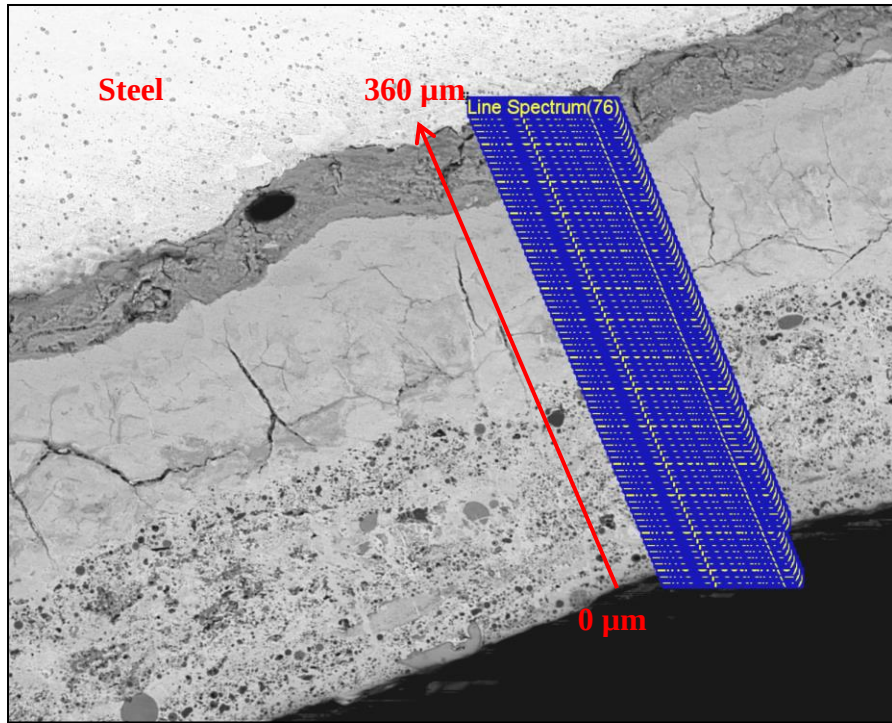
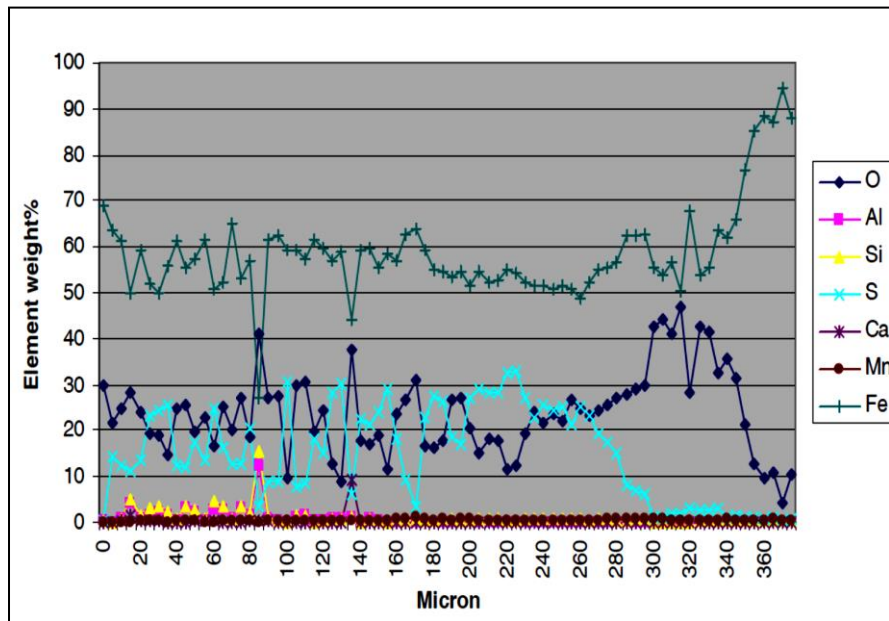
The SEM analyses for units 3, 1 and 4 in station A respectively are presented in Figures 4.9, 4.10 and 4.11 and show the following distribution of elements in the fireside deposits:

Middle layer: High iron and moderate sulphur and oxygen.

Outer layer: High levels of iron, moderate sulphur and oxygen with low concentration of Al, Si, and Ca (fly ash particles).

**Figure 4.9: Station A Unit 3 sidewall tube showing (a) line map of the fireside deposit and (b) Elemental distribution in the fireside deposit as per EDS line map.**

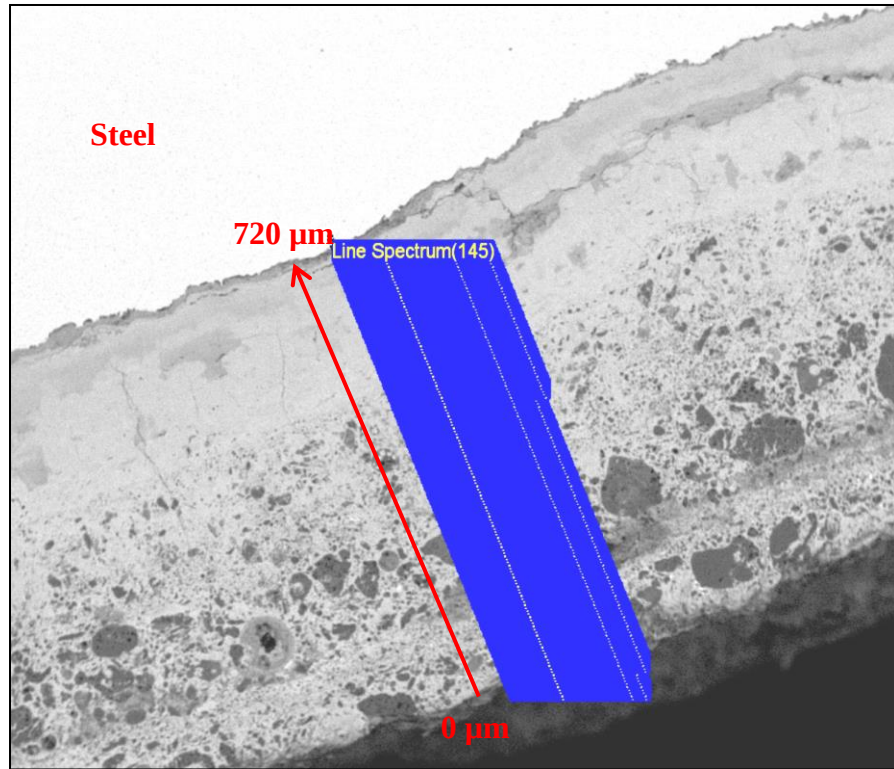
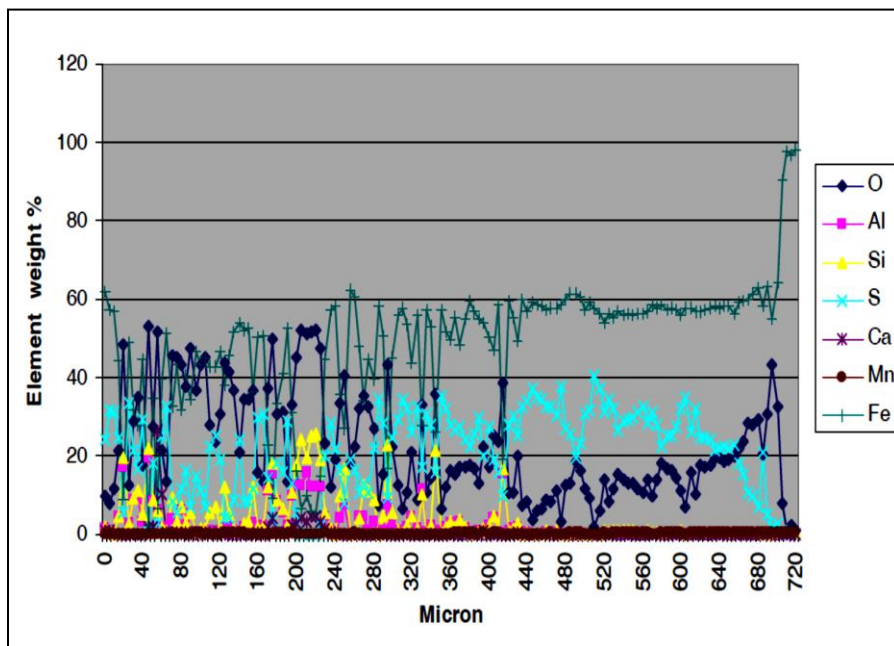
Figure 4.10: Station A Unit 1 sidewall tube showing (a) EDS line map of the fireside deposit and (b) Elemental distribution in the fireside deposit as per EDS line map.

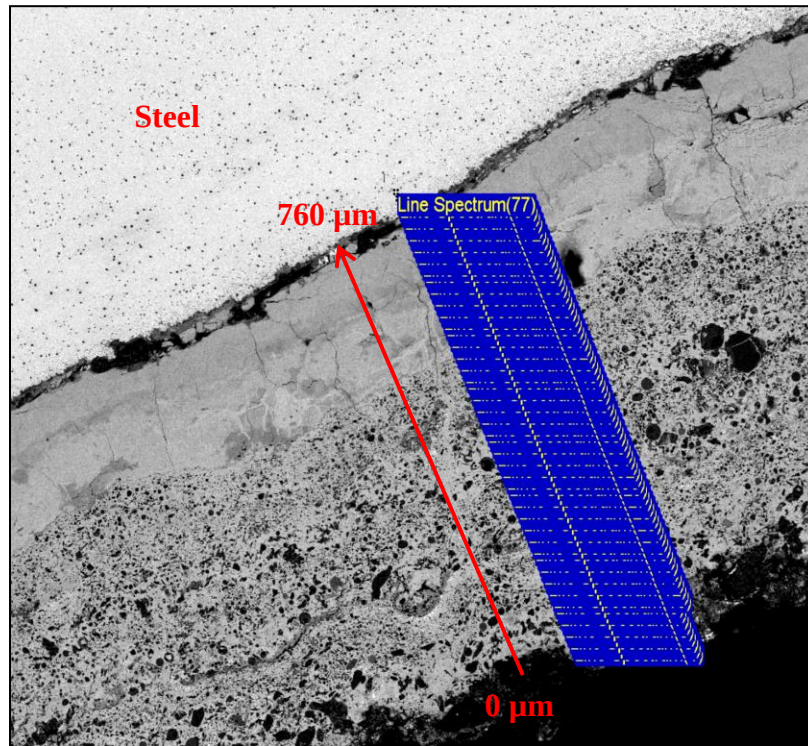
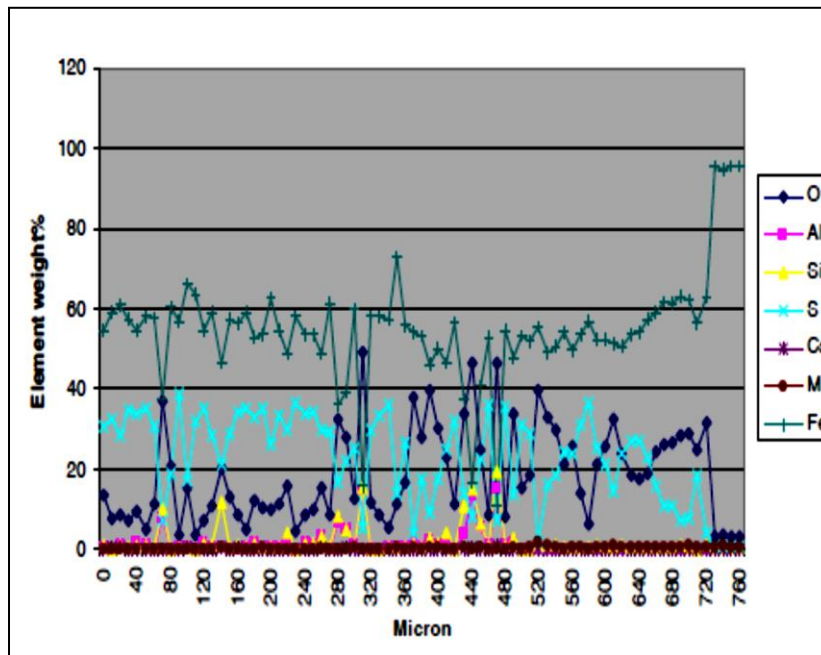
Figure 4.11: Station A Unit 4 sidewall tube showing (a) EDS line map of the fireside deposit and (b) Elemental distribution in the fireside deposit as per EDS line map.

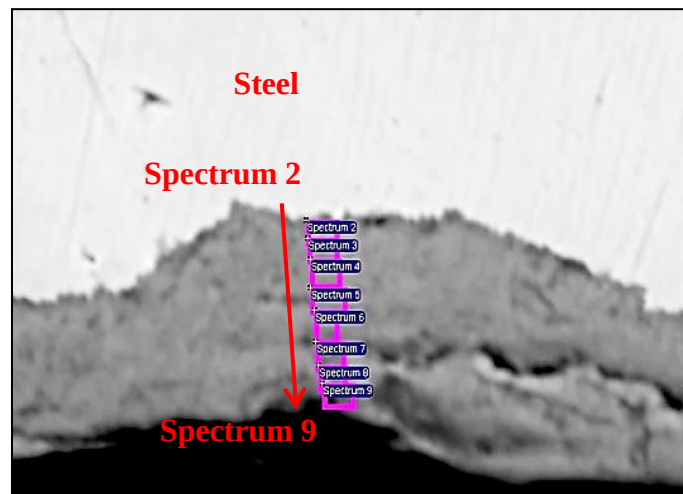
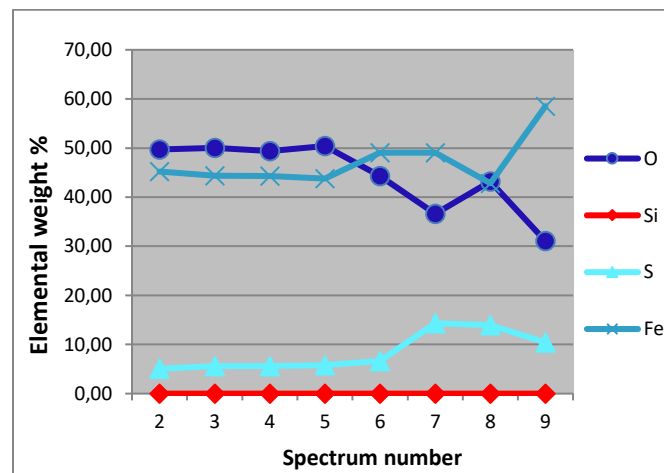
Figures 4.12, 4.13 and 4.14 show SEM analyses of tubing from units 8, 3, and 1 in Station B respectively, and this showed the following with the following elemental distribution in the fireside deposits:

Middle layer: High iron and oxygen, with moderate to high concentration of sulphur.

Outer layer: High levels of iron, and low to moderate levels of oxygen sulphur.

**Figure 4.12: Station B Unit 8 sidewall tube showing (a) EDS line map of the fireside deposit and (b) Elemental distribution in the fireside deposit as per EDS line map.**

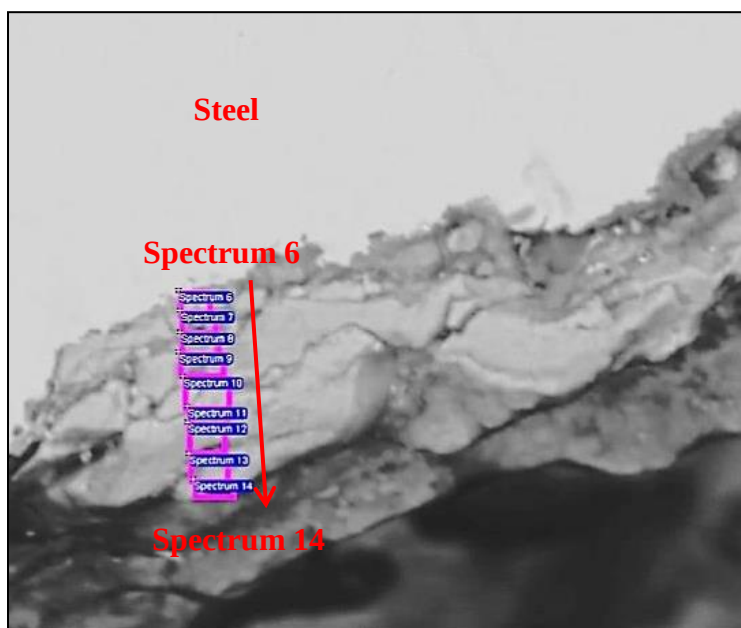
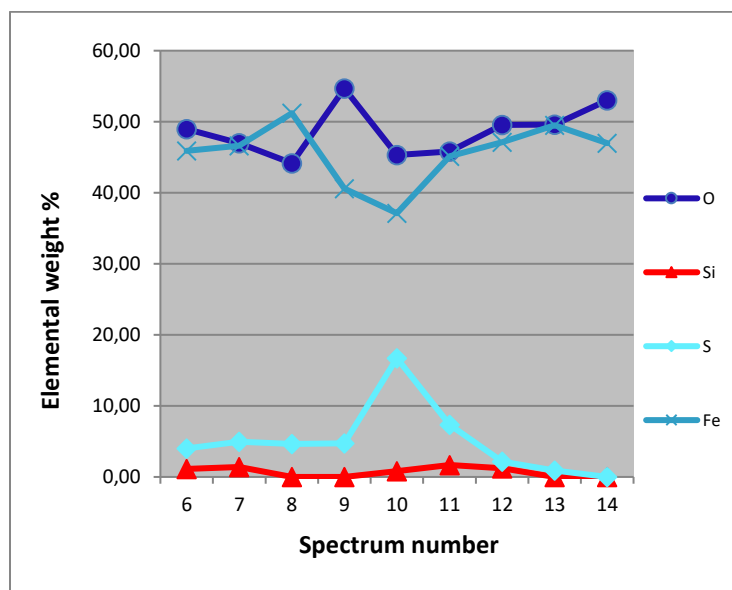
**Figure 4.13: Station B Unit 3 sidewall tube showing (a) EDS line map of the fireside deposit and (b) Elemental distribution in the fireside deposit as per EDS line map.**

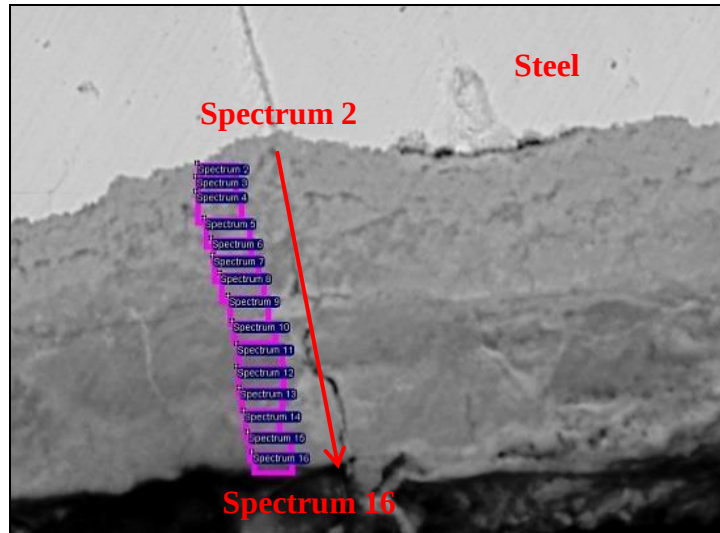
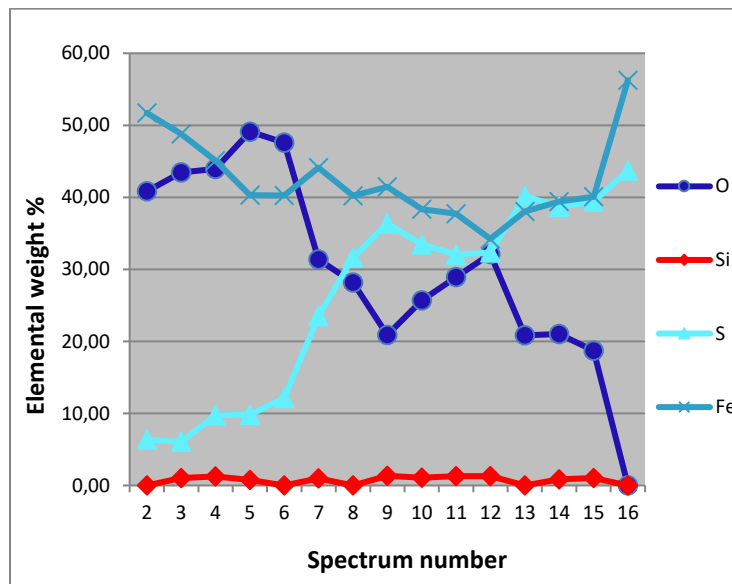
**Figure 4.14: Station B Unit 1 sidewall tube showing (a) EDS line map of the fireside deposit and (b) Elemental distribution in the fireside deposit as per EDS line map.**

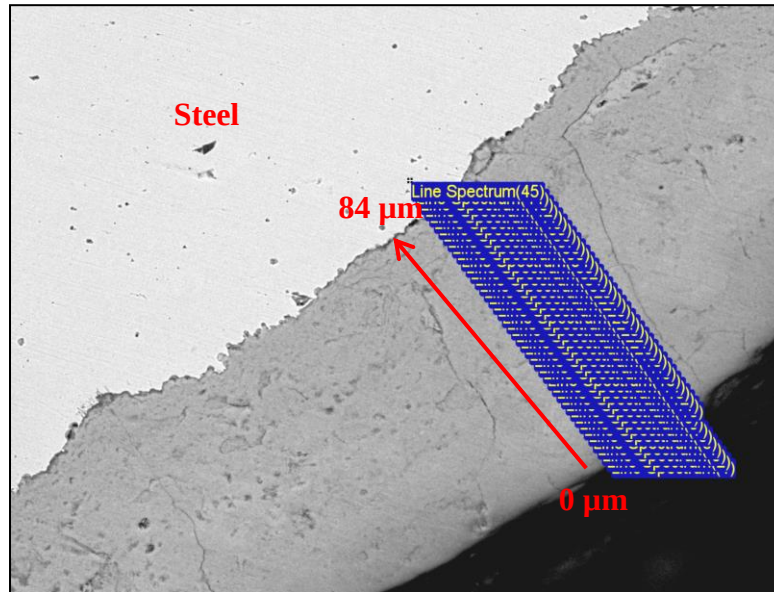
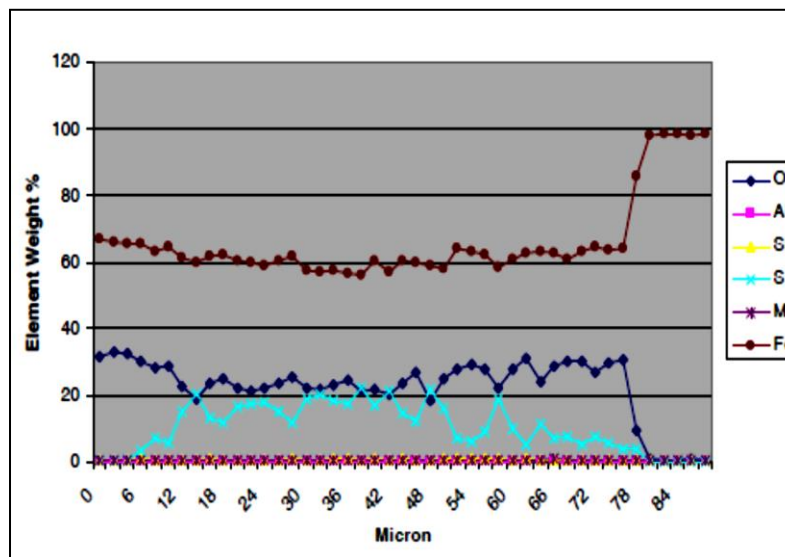
Figures 4.15 and 4.16 show SEM analyses of tubing from units 4 and 6 in Station C respectively, and this showed the following with the following elemental distribution in the fireside deposits:

Middle layer: High iron and moderate sulphur and oxygen.

Outer layer: High levels of iron, moderate oxygen and low sulphur, traces of Si and Al.

**Figure 4.15: Station C Unit 4 sidewall tube showing (a) EDS line map of the fireside deposit and (b) Elemental distribution in the fireside deposit as per EDS line map.**

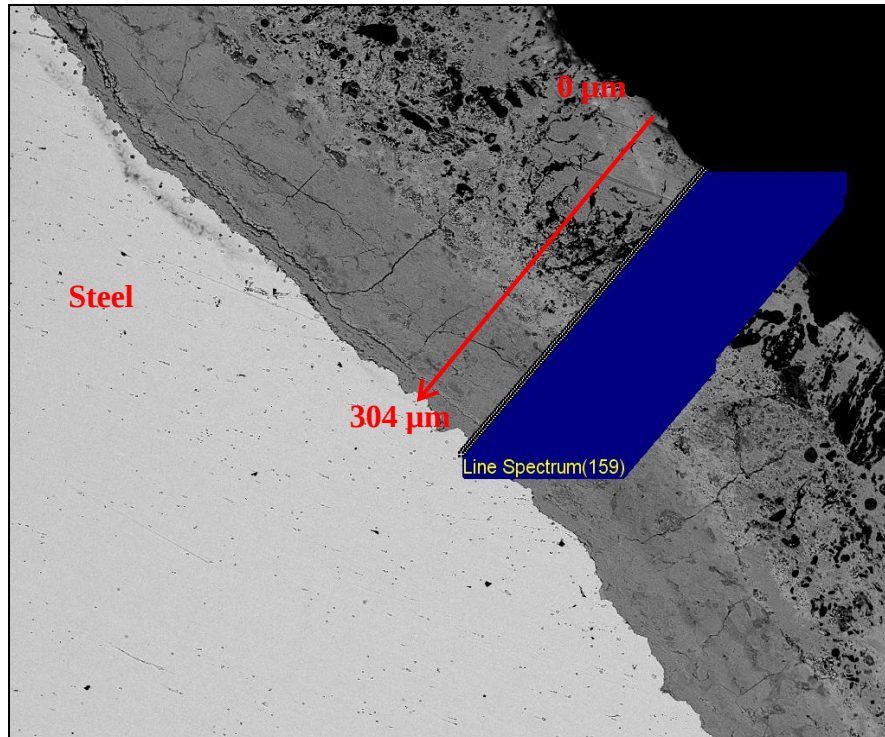
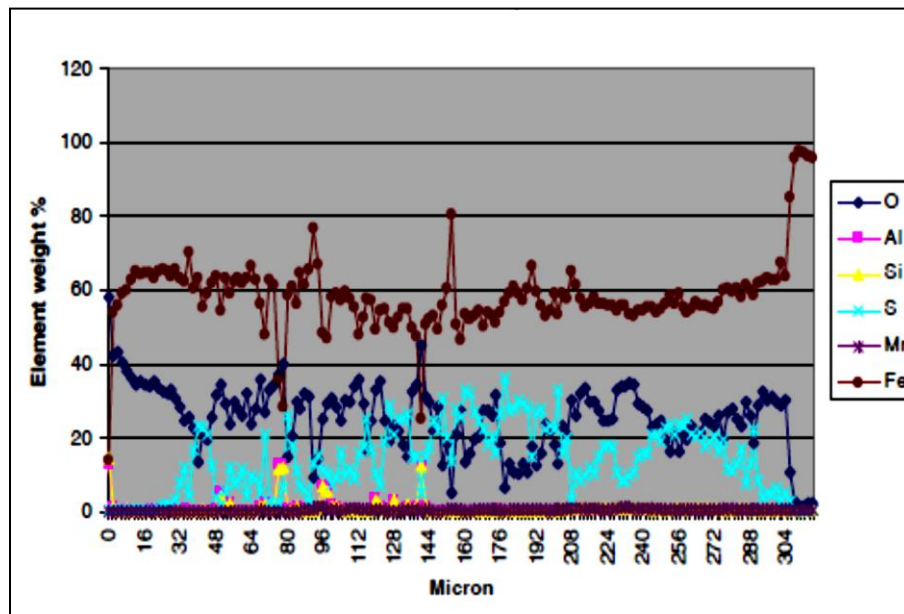
Figure 4.16: Station C Unit 6 sidewall tube showing (a) EDS line map of the fireside deposit and (b) Elemental distribution in the fireside deposit as per EDS line map.

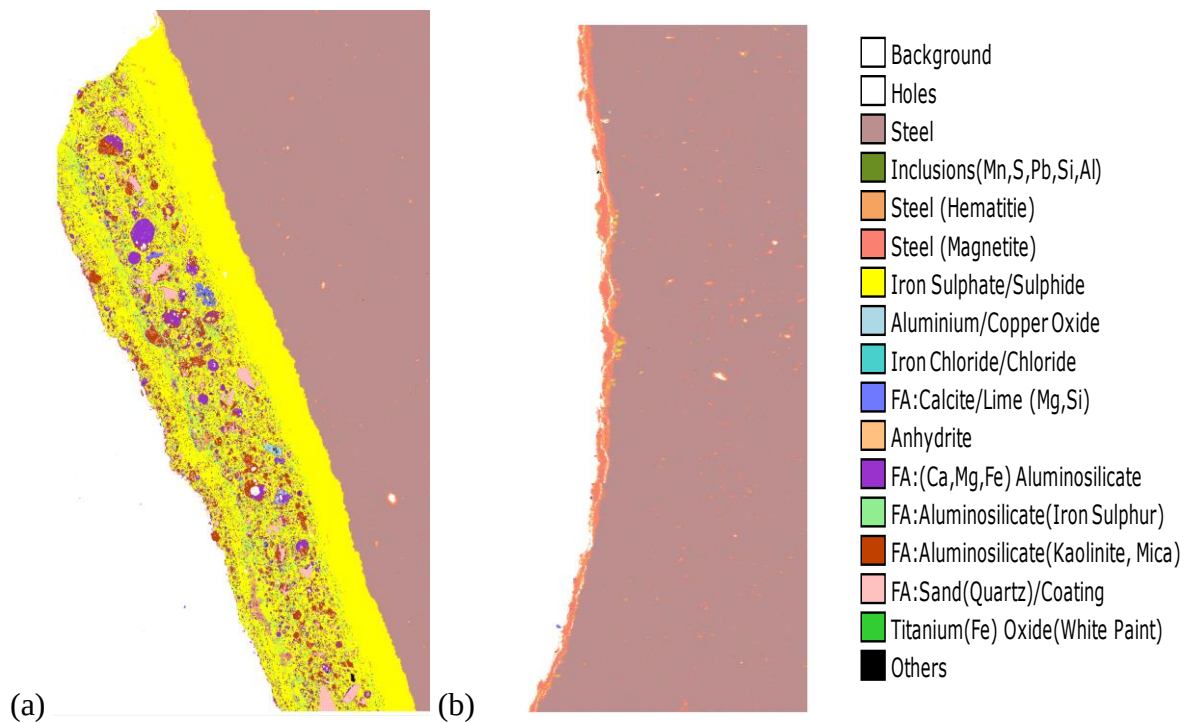
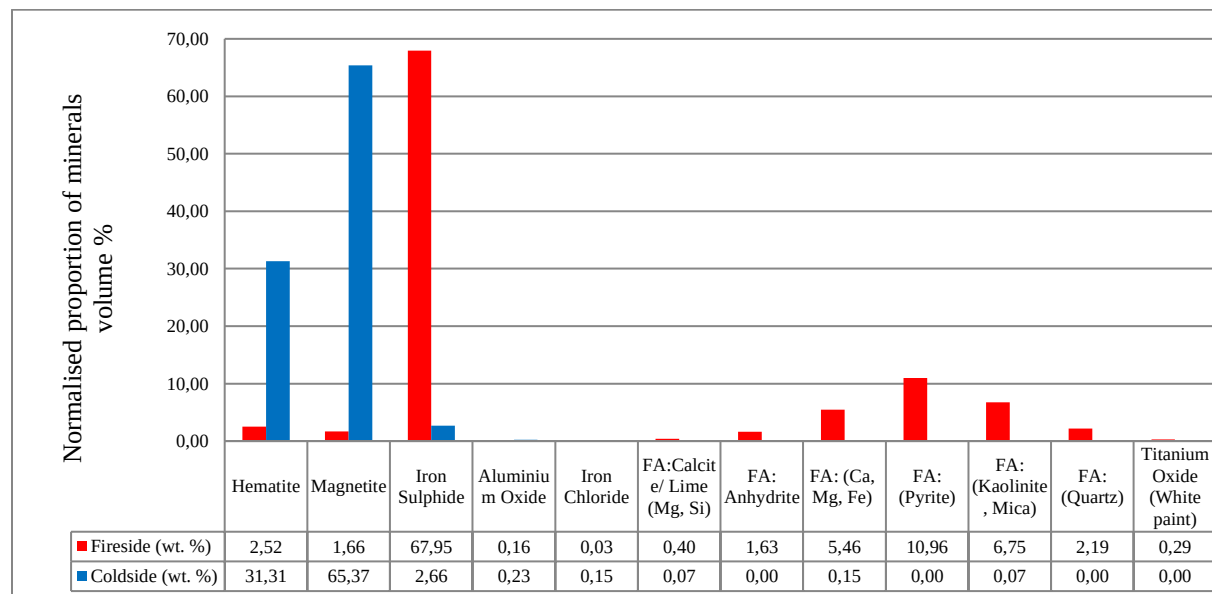
Fe-sulphide + Fe-oxide + FA,  
as shown by Figure 4.17 and 4.18.

**Figure 4.17: Qualitative image presentation of mineralogy composition in the deposit on (a) fireside and (b) non-fireside surfaces of Station A Unit 1 tubing.**

**Figure 4.18: Quantitative mineralogy estimates of fireside and non-fireside deposits of Station A Unit 1 sidewall tubing.**

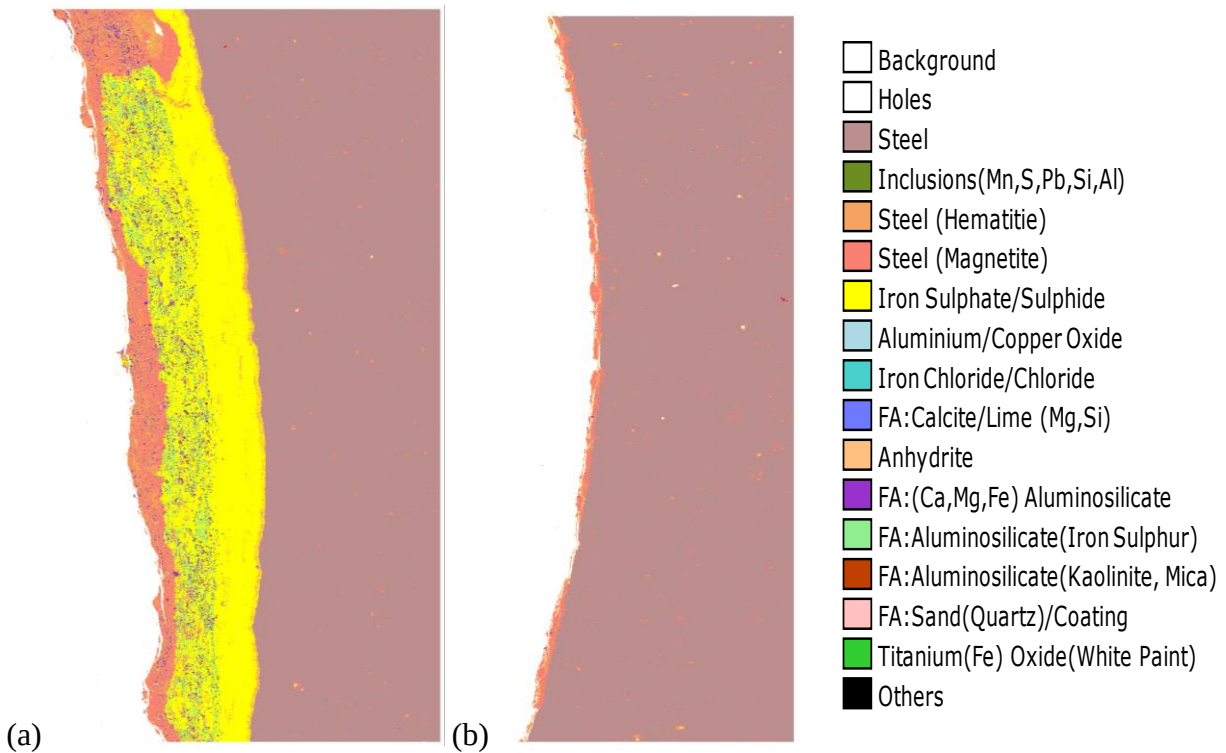
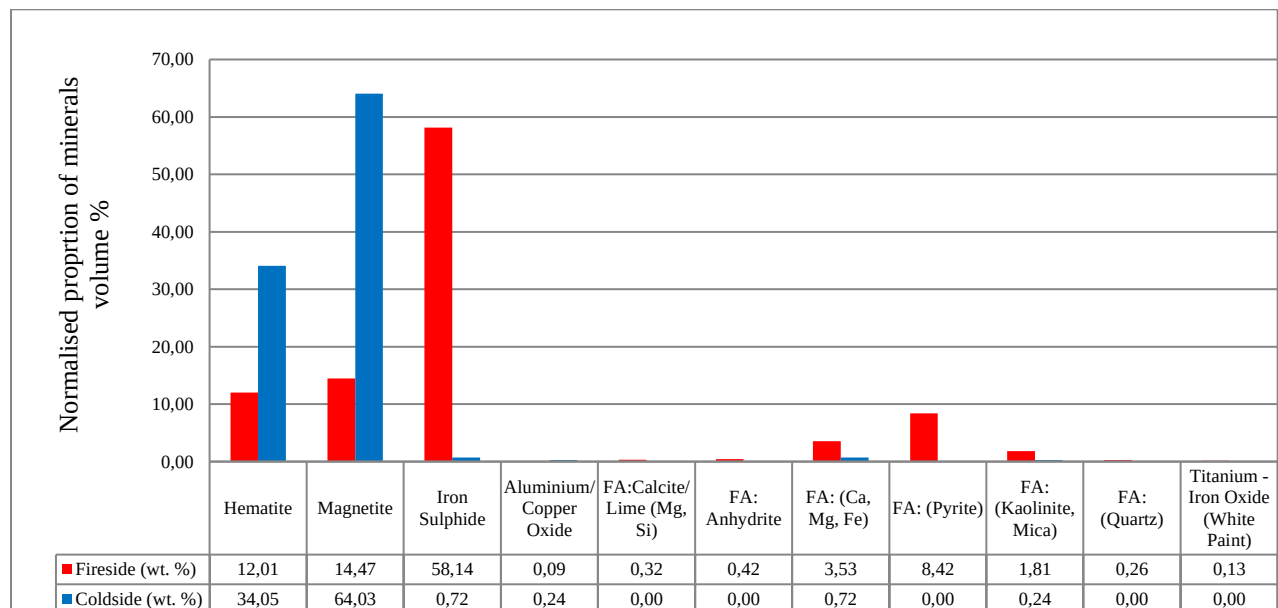
Fe-oxide + FA,  
as illustrated by Figure 4.19 and 4.20.

**Figure 4.19: Qualitative image presentation of mineralogy composition in the deposit on (a) fireside, (b) coldside surfaces of Station A Unit 3 tubing.**

**Figure 4.20: Quantitative mineralogy estimates of fireside and coldside deposits of Station A Unit 3 sidewall tubing.**

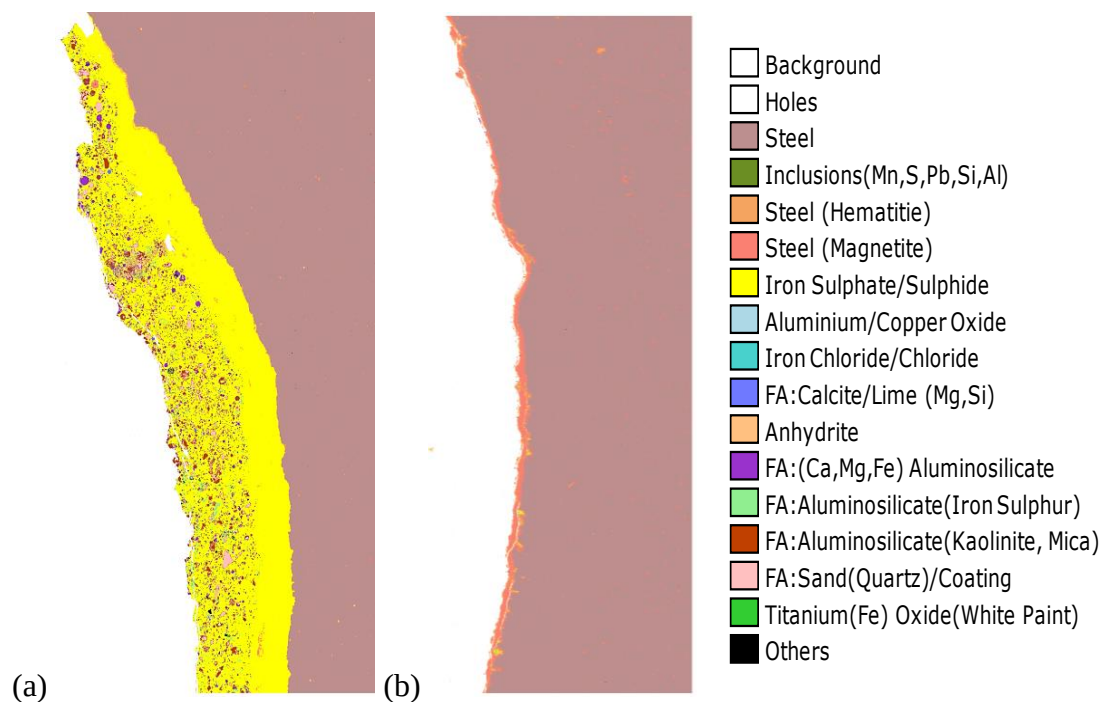
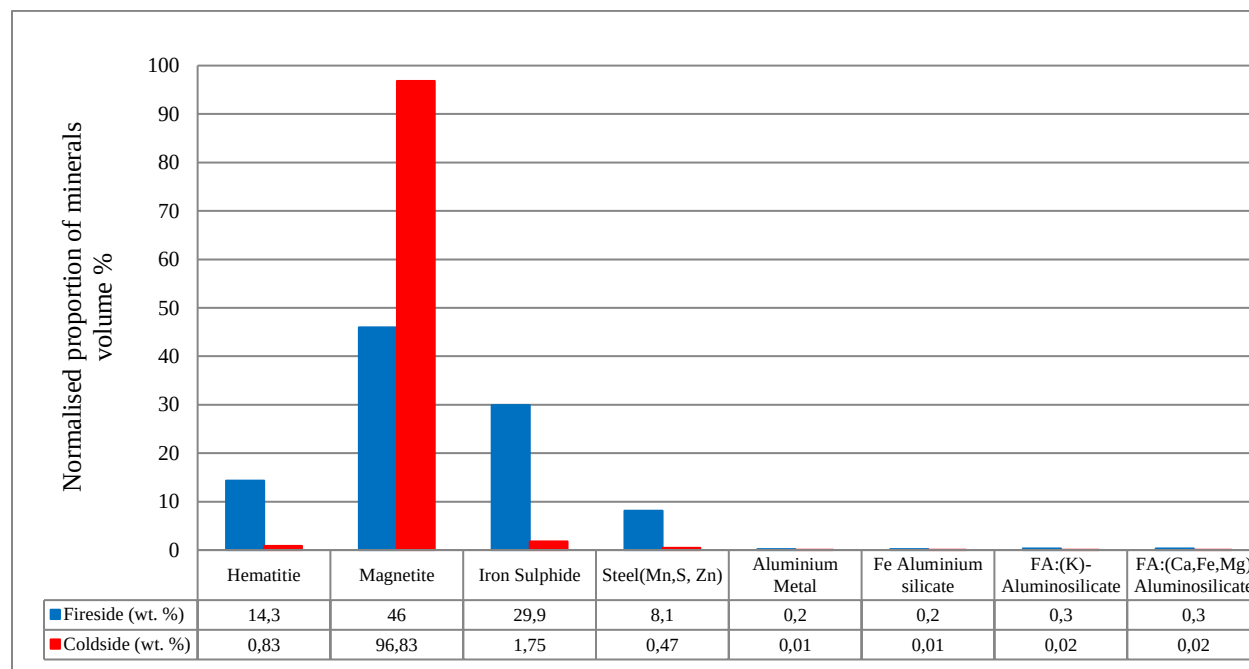
Fe-oxide + FA,  
as indicated in Figure 4.21 and 4.22.

**Figure 4.21: Qualitative image presentation of mineralogy composition in the deposit on (a) fireside, (b) coldside surfaces of Station A Unit 4 tubing.**

**Figure 4.22: Quantitative mineralogy estimates of fireside and coldside deposits of Station A Unit 4 sidewall tubing.**

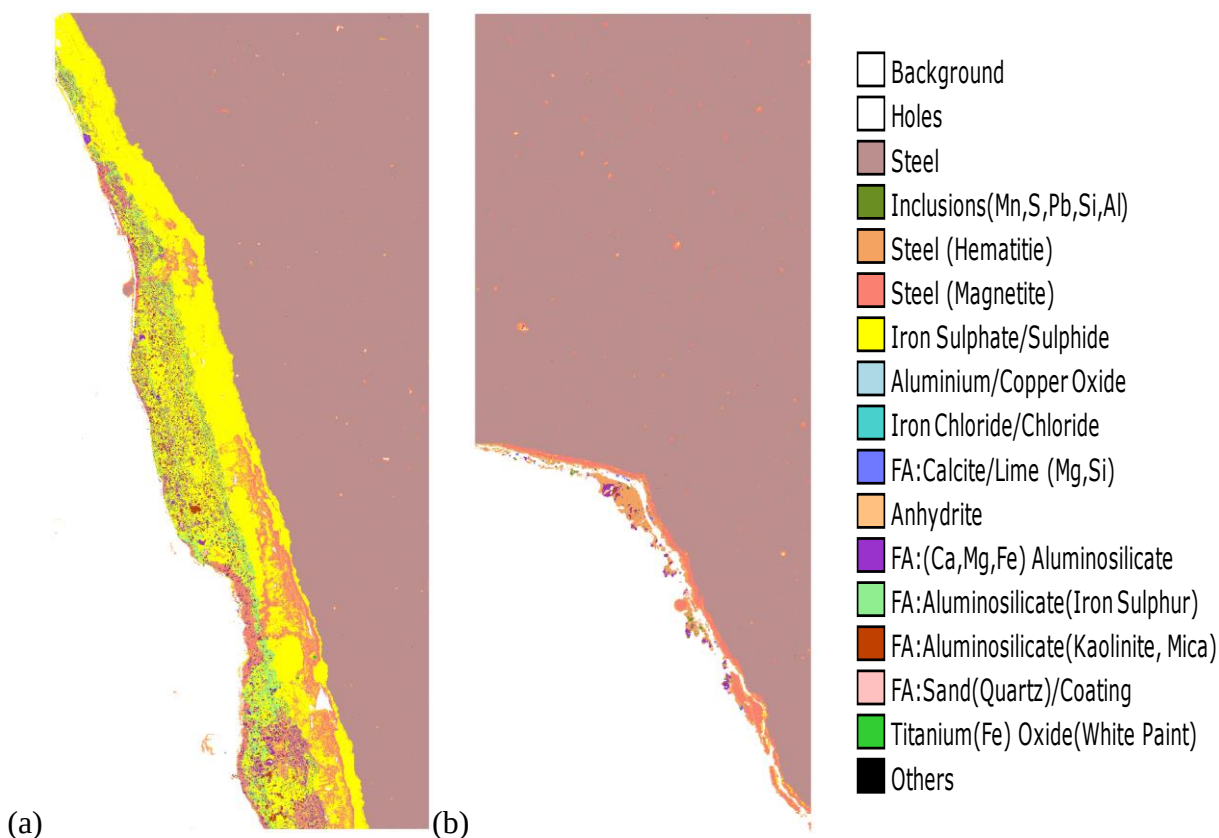
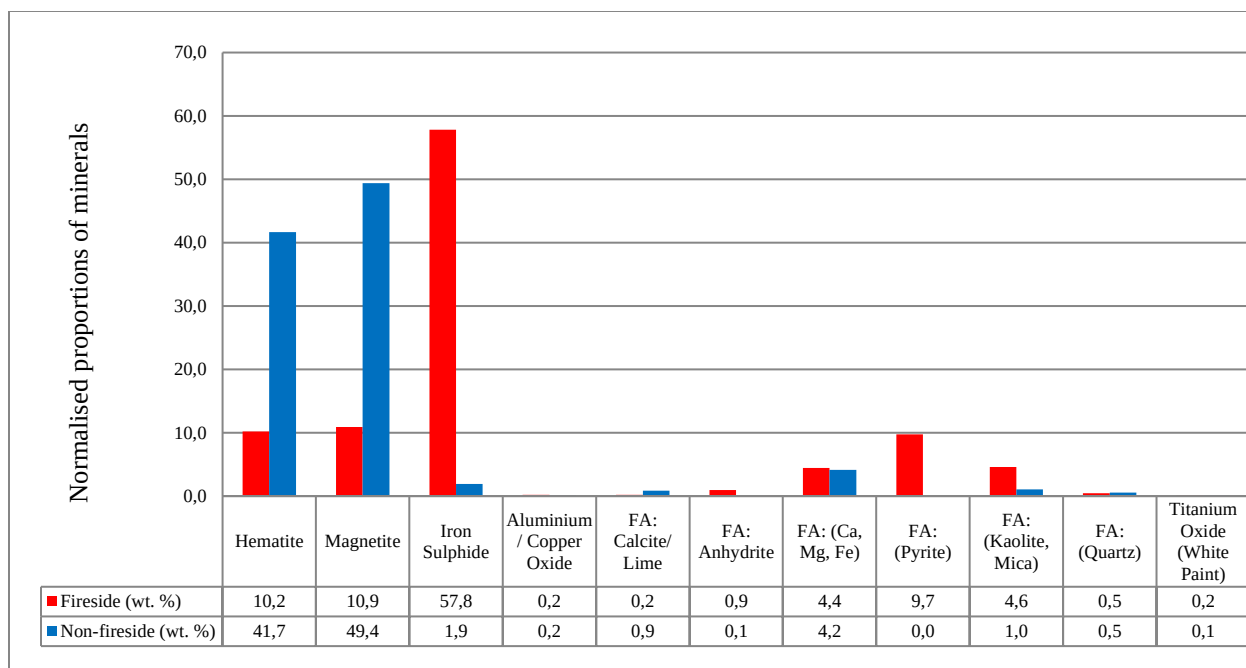
Similarly to station A, a three layered fireside deposit was also observed on Station C tubing samples with relatively thick Fe-sulphide rich layer detected in the inner and middle layers. These results are aligned with the findings of high iron and sulphur concentrations in the middle layers detected by SEM-EDS. The volume percentages of Fe-sulphide were measured as high as 67 to 69 volume %, while the iron oxide (hematite and magnetite) levels were in the range of 21 to 30 volume %. The concentration of fly ash particles ranged from 0.3 to 9 volume % and the fireside deposit thickness was measured to the maximum of 0.53 mm. Tubing of Unit 4 of Station C had three layered fireside deposits with the following sequence:

The morphology and composition of the fireside deposit from the two power stations, A and C, was found to be similar. The fireside deposit is three layered with iron sulphide rich inner layer formed on the surface of the steel, followed by the middle layer made up of a combination of iron sulphide and iron oxide, and covered by iron-oxide rich outer layer with fragments of fly ash particles (quartz ( $\text{SiO}_2$ ), mullite ( $\text{Al}_2(\text{Al}_3\text{Si}_2)\text{O}_{10}$ ) and ferrian ( $\text{Ca}_3\text{AlFeSi}_2\text{O}_{12}$ )). In all samples there was no evidence of sodium or potassium associated with the sulphur. The presence of sulphide phases, namely pyrrhotite and pyrite, coexisting with iron oxide is indicative of substoichiometric conditions in the furnace or on the tube surface.

formed on the metal surface which is largely composed of magnetite containing islands of iron sulphide, as is seen in the fireside deposit of Station A and C tubing. Sulphide deposits allow higher rates of transport (diffusion) of iron cations than oxides, the strength and adherence of the deposit decrease with increasing FeS content, while its growth rate and permeability increase significantly. These deposits are also brittle and poorly adherent, so they readily crack and spall. The result is increased metal wastage (i.e. wall thinning), which becomes the dominant factor in tube life.

**Figure 4.23: Qualitative image presentation of mineralogy composition in the deposit on (a) fireside, coldside surfaces of Station C Unit 4 tubing.**

**Figure 4.24: Quantitative mineralogy estimates of fireside and coldside deposits of Station C Unit 4 sidewall tubing.**

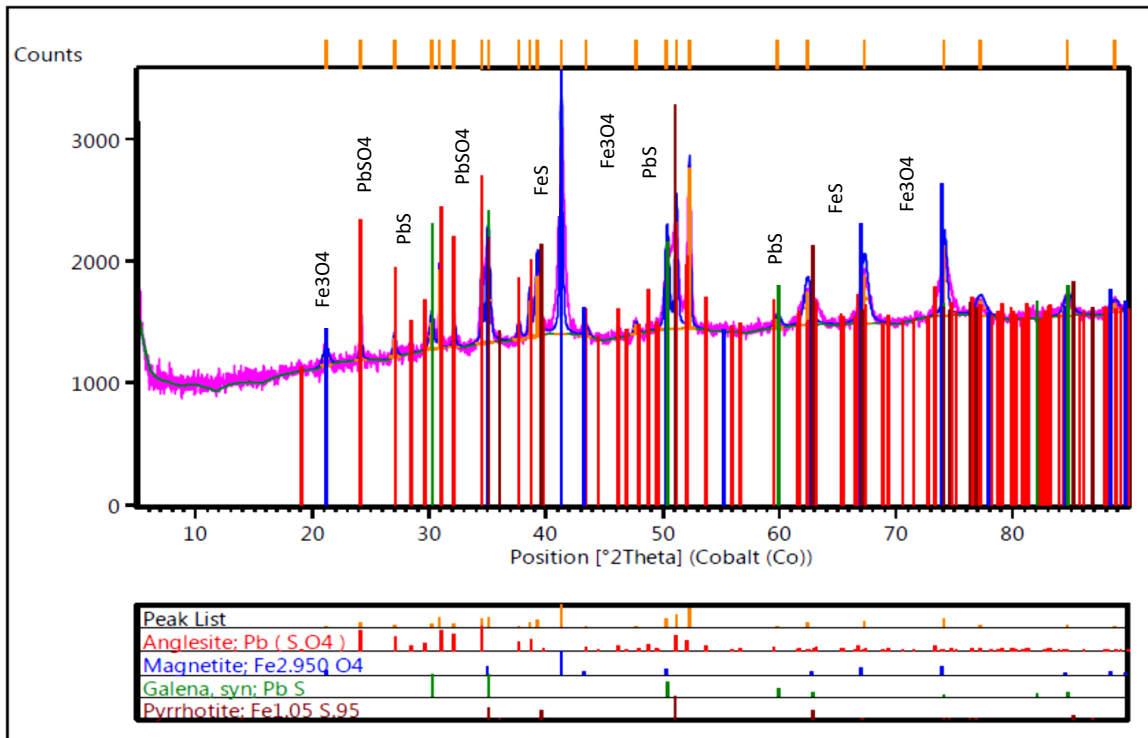
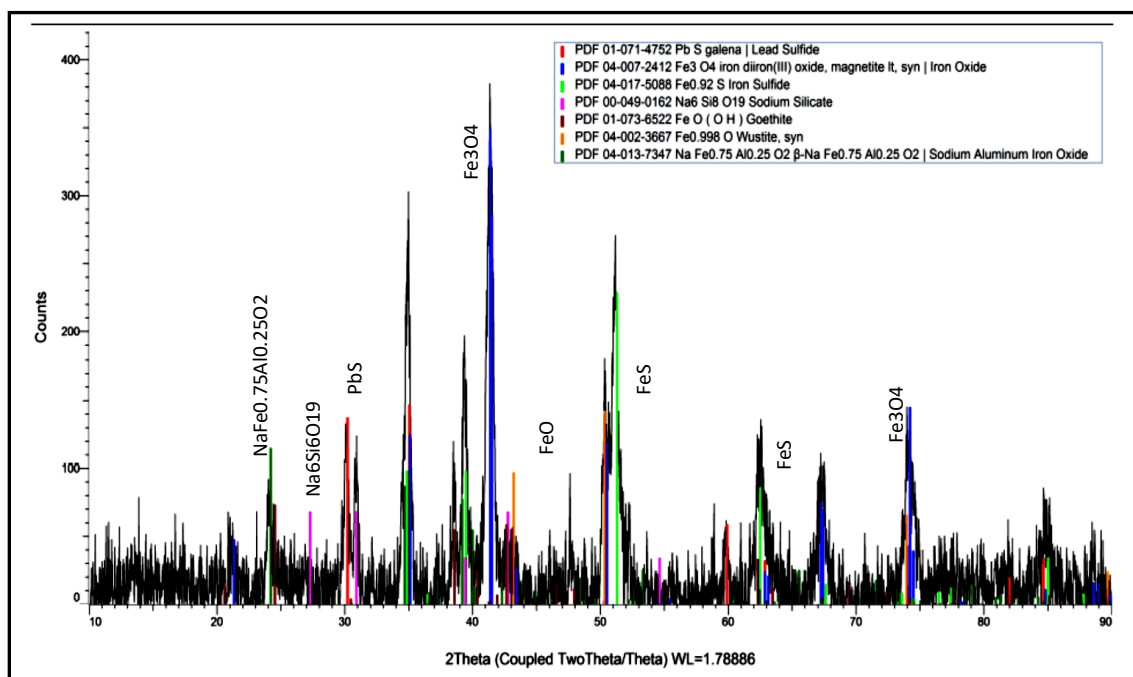
The XRD analysis of Station A fireside corrosion deposit revealed the presence of iron-oxide and iron sulphide. Figure 4.25 and 4.26 show the XRD analysis results for station A; iron-oxide was in a form of  $\text{Fe}_2\text{O}_3$  and  $\text{Fe}_3\text{O}_4$ , while iron-sulphide was detected as pyrrhotite in small quantities within a range of 1.4 - 3.7 weight %. Small to moderate quantities of quartz and mullite were also detected which is indicative of the presence of fly ash particles.

Figure 4.25: Analysis of front wall tube fireside deposit from Unit 2 of Station A.

Figure 4.26: Analysis of sidewall tube fireside deposit from Unit 1 of Station A.
