Investigation of the Mechanisms and Control Measures for Fireside Corrosion in Eskom Fossil  
Fuel Boilers

**MSc DISSERTATION**

**Kedimetse Gloria Moloko (9808755G)**

02 October 2019

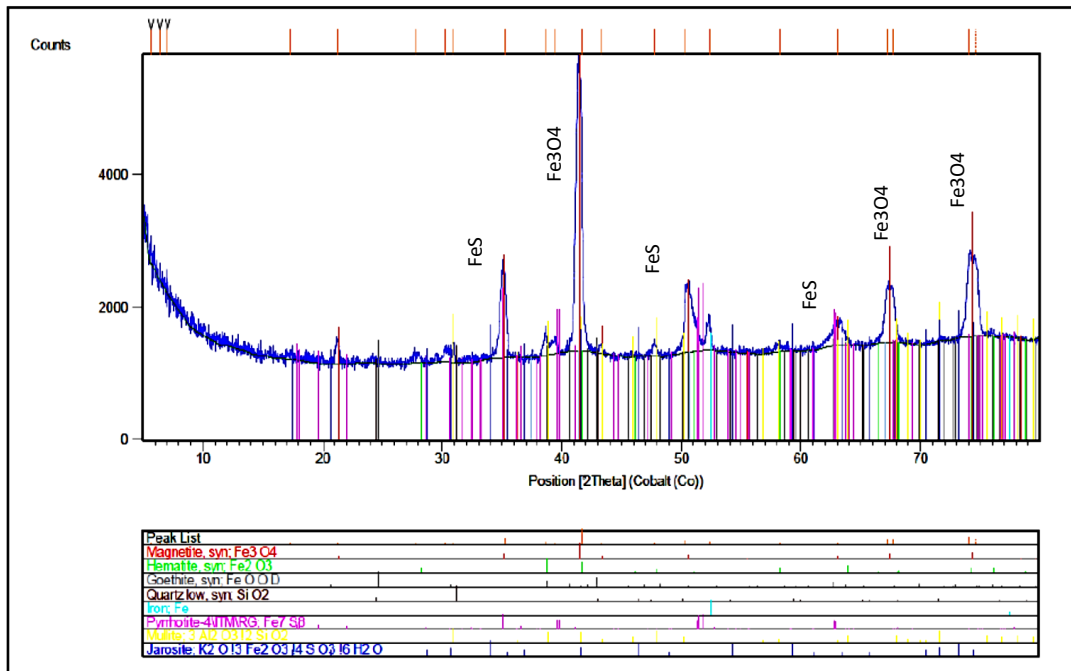
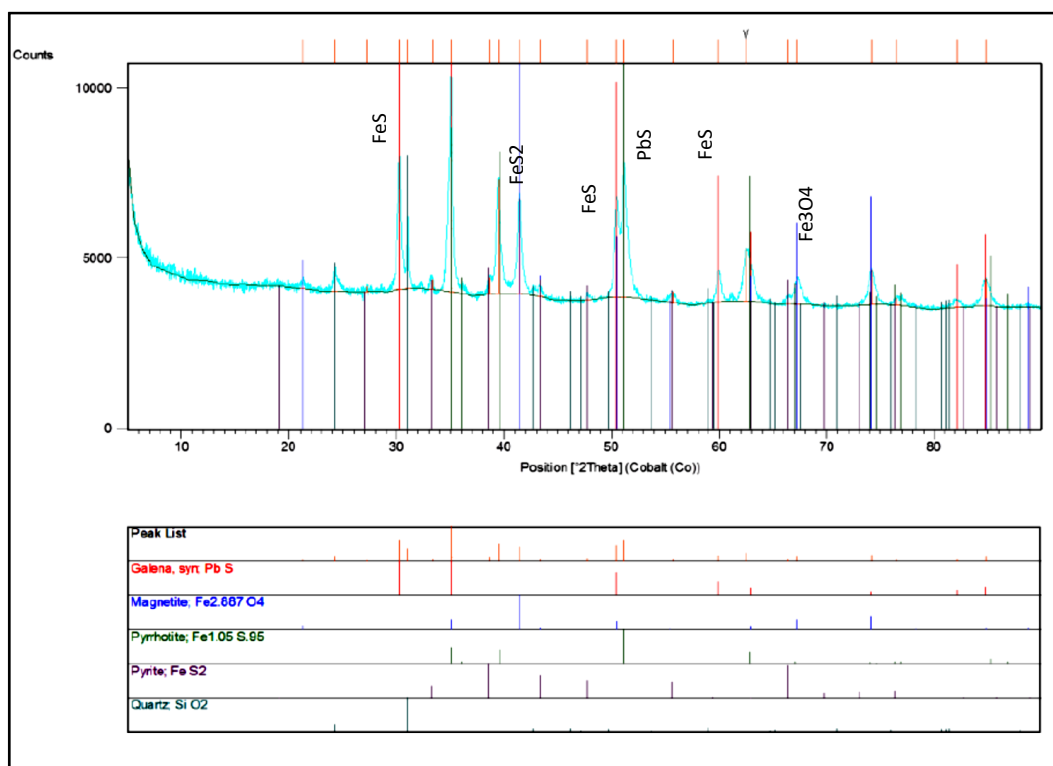
The fireside deposit on Station B's tubing consisted of iron-oxide predominantly as magnetite and low levels of hematite. Iron-sulphur rich phases detected include pyrrhotite, pyrite and traces of galena ( $\text{PbS}$ ); fly ash particles were detected through mullite, quartz and jarosite ( $\text{K}_2\text{O} \cdot 3\text{Fe}_2\text{O}_3 \cdot 4\text{SO}_3 \cdot 6\text{H}_2\text{O}$ ). For Unit 1, pyrrhotite was measured in small quantities ranging from 3.7 - 5.6 weight % as shown in Figure 4.27, whereas for Unit 3 high levels of pyrrhotite were measured in the range of 40 - 50 weight % as shown by Figure 4.28. The difference in the morphology of Unit 1 and Unit 3 fireside deposits may be an indication of the furnaces operating

under different combustion conditions. The high concentration of pyrrhotite in Unit 3 may be indicative of prolonged reducing conditions in the furnace and/or on the tube.

Figure 4.27: Analysis of the division wall tube fireside deposit from Unit 1 of Station B.

Figure 4.28: Analysis of the division wall tube fireside deposit from Unit 3 of Station B.

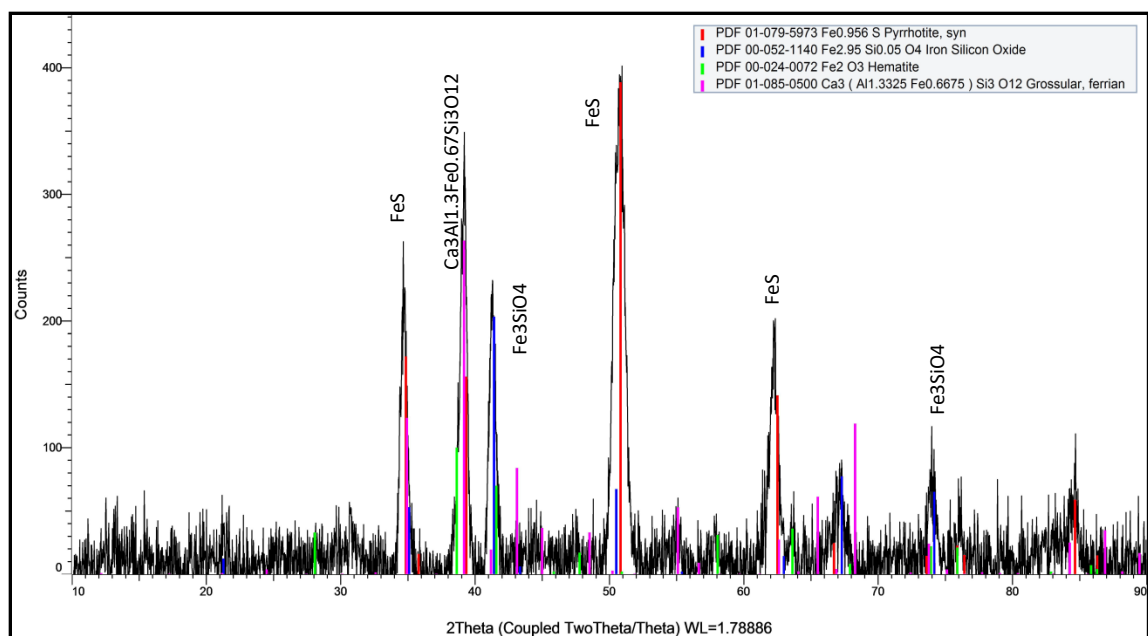
Both units of Station C showed fireside deposits consisting of predominantly pyrrhotite. Figure 4.29 shows low concentration of magnetite in Unit 4 and trace concentrations of ferrian. Analysis of Unit 6 revealed high magnetite concentration and low goethite ( $\text{FeO(OH)}$ ) as shown by Figure 4.30. Only qualitative analysis was done on units 4 and 6. The difference in the morphology of units 4 and 6 fireside deposits is indicative of the furnaces operating under different combustion conditions. Unit 6 fireside deposits consisted of both high concentrations of pyrrhotite and iron oxide phases; this shows existence of both oxidising and reducing conditions. In Unit 4, it appears that substoichiometric conditions (i.e. mostly reducing) were in existence for a longer time, which resulted in high formation pyrrhotite and minimal iron oxide phases. The effect of fly ash is also shown through the detection of ferrian.

Figure 4.29: XRD analysis of sidewall tube fireside deposit from Unit 4 of Power Station C.

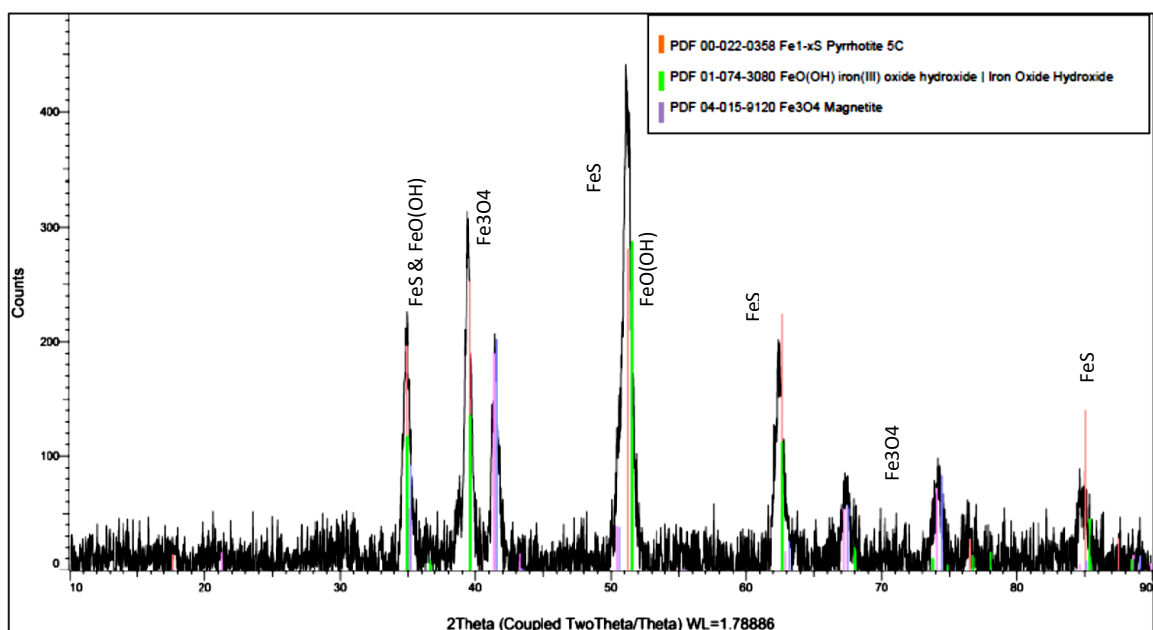
Figure 4.30: XRD analysis of sidewall tube fireside deposit from Unit 6 of Power Station C.

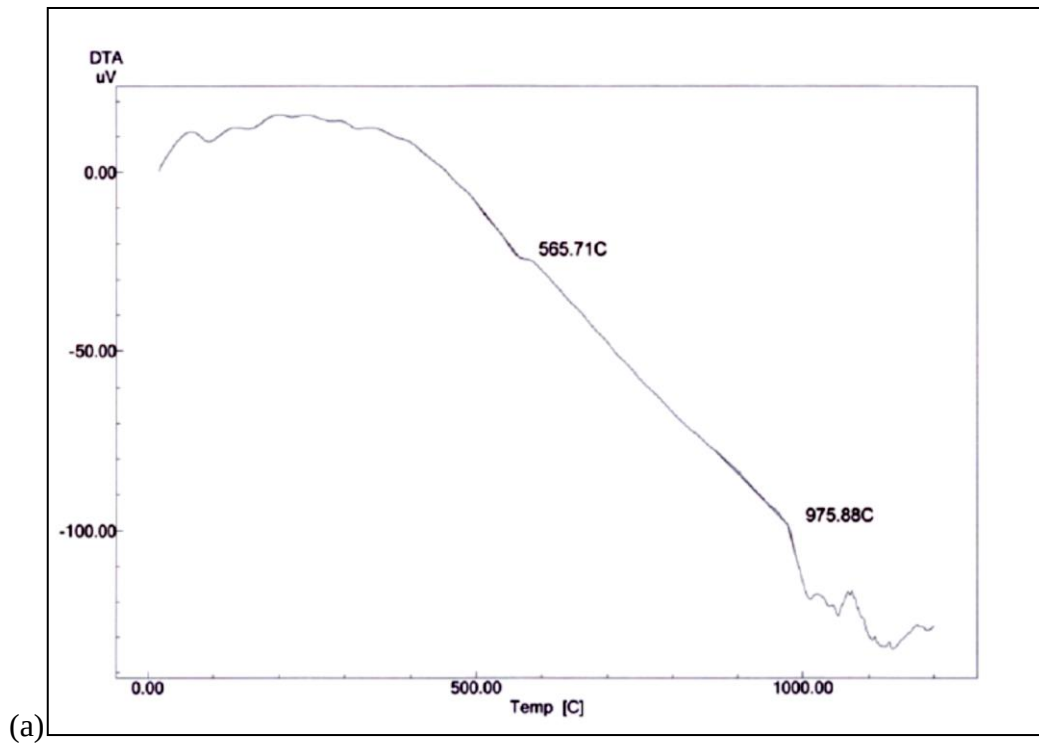
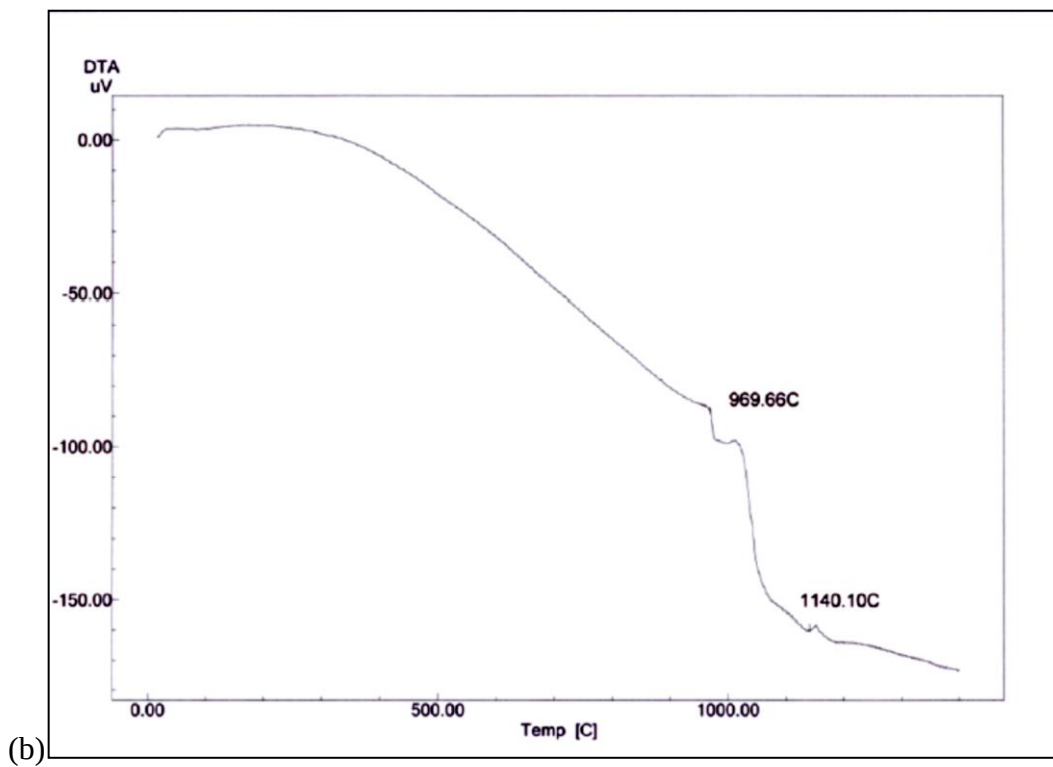
**Figure 4.31: Thermal behaviour of the fireside deposit on Station A tubing samples.**

Only samples from stations A and B were analysed with DTA. The thermal analysis of station A tubing showed peaks generally at temperatures ranging from 950 to 1250°C. The exception was seen on one tube where lower temperature activity was indicated at 565°C. A similar trend was observed on samples from station B; higher temperature peaks were detected at 977°C and 1240°C, while one lower temperature activity was indicated at 541°C, as shown by Figures 4.30 to 4.31.

The low temperature peaks, at 541 and 565°C, measured on the samples of station A and B are likely an indication of kaolinite transformation into metakaolinite which occurs at temperatures around 500°C and/or pyrite's oxidation into FeS and Fe<sub>2</sub>O<sub>3</sub> which between 475°C and 525°C. The thermal peaks measured at higher than 900°C may be representation of metakaolinite transformation into other forms of aluminosilicate such as mullite at 925°C and 1100°C forms such as mullite (Bryers, 1995).

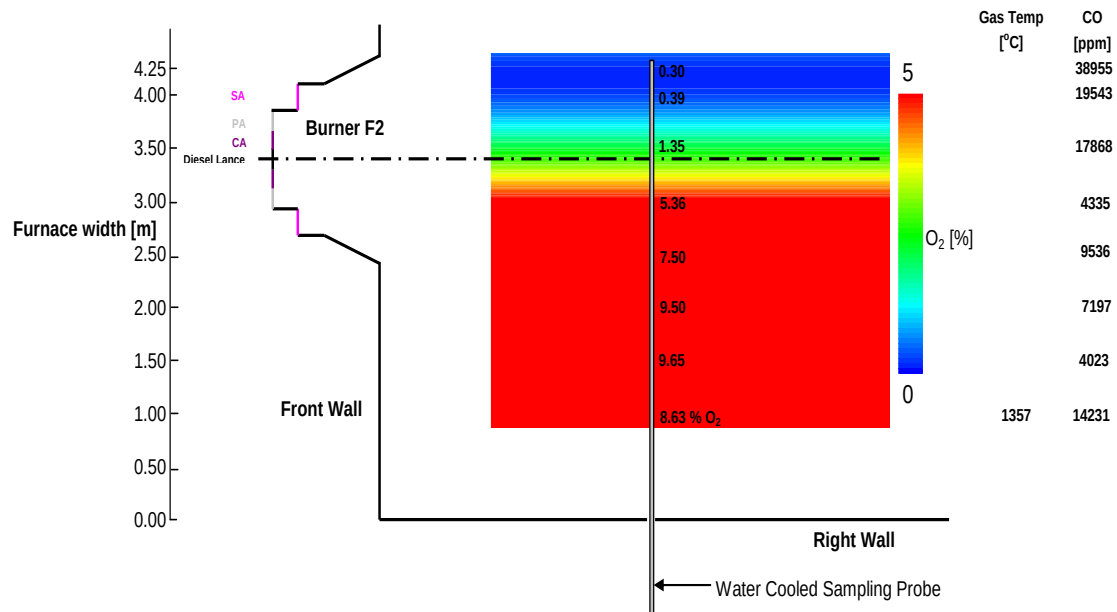
Figure 4.33: CO and O<sub>2</sub> distribution at Gun Blower 12, Test 1 conducted at 576 MW/hr.

Test 1 was performed at a load of 576.0 MW and the results obtained showed that the CO measurements at gun blower 12 and furnace exit levels were significantly higher than the recommended, which is maximum 2000 ppm, as shown in Figure 4.33. This is according to Benedetto Riso from RECOM Services GmbH, who provides Computational Fluid Dynamic combustion modelling of industrial furnaces and boilers (Van Wyk, 2010).

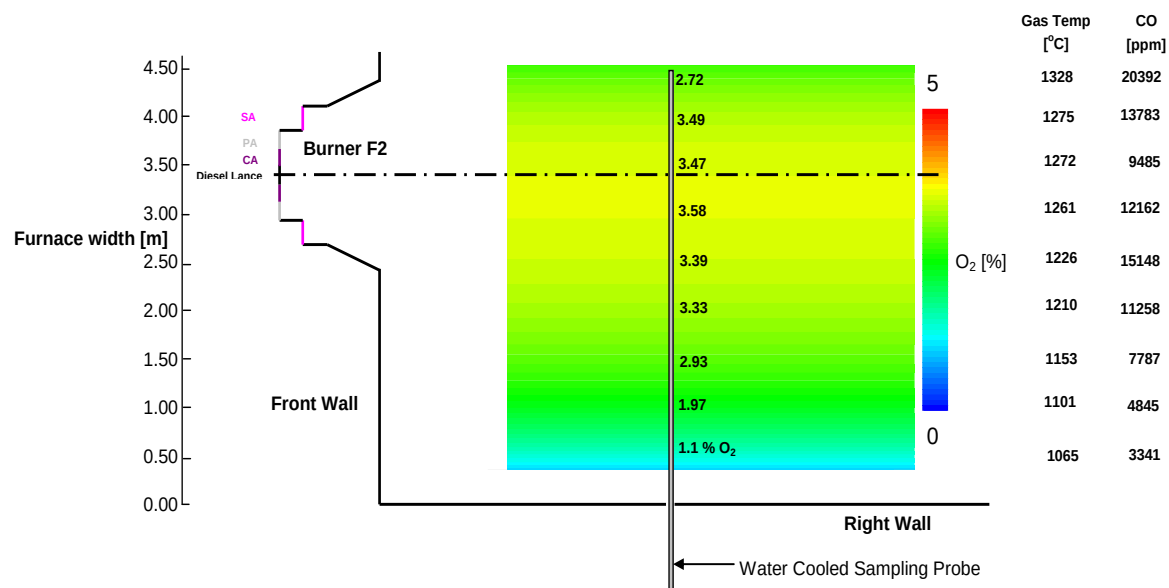
Figure 4.34: CO and O<sub>2</sub> distribution at Gun Blower 12, Test 2 performed at 584 MW/hr.

Test 2 was carried out at 584 MW at gun blower 12 and furnace exit levels. Figure 4.34 shows high CO levels, greater than 2000 ppm, measured at gun blower 2. Distribution of O<sub>2</sub> at gun blower 2, Figure 4.34, and economizer outlet, Figure 4.35, varies significantly from 3.5% to 0.8%, which is a clear indication of substoichiometric conditions in the furnace.

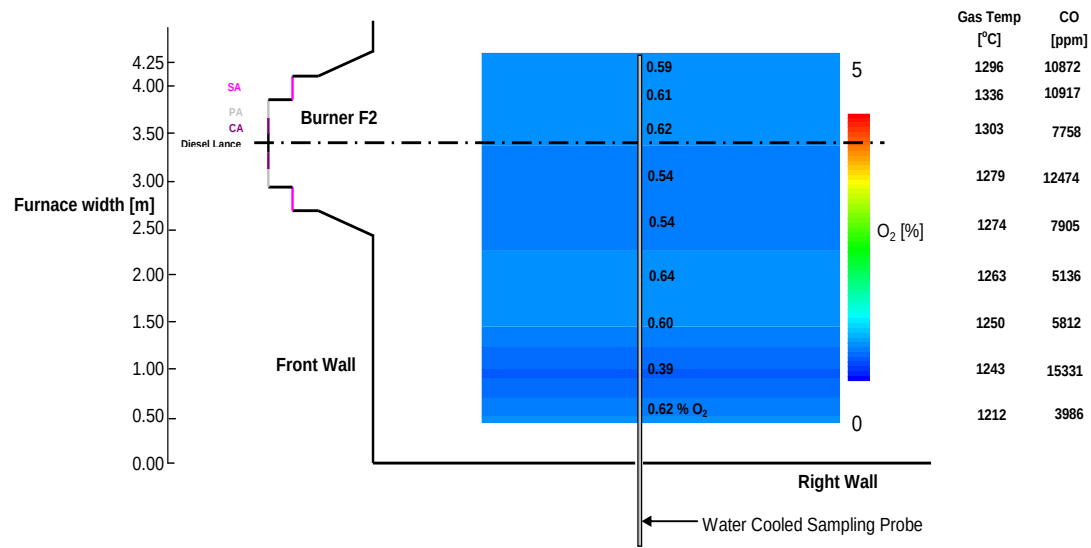
Figure 4.36: CO and O<sub>2</sub> distribution at Gun Blower 12, Test 3 performed at 567 MW/hr.

Test 3 was conducted at 567 MW at the same location as Test 2. Again varying O<sub>2</sub> levels were seen at gun blower 2, Figure 4.36, and economizer outlet (left hand side), Figure 4.37. The CO measurements at gun blower 12 were still higher than 2000 ppm. The substoichiometric conditions and high CO levels are some of the parameters that drive sulphidation corrosion.

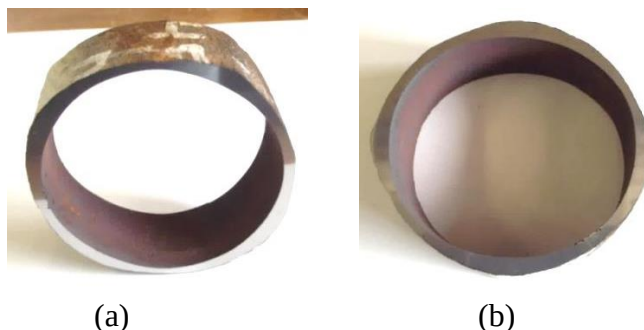
Strong brown deposits sintered on the fireside of the tube. Figure A.7 (b) shows an inconsistent wall thinning around the tube. No scale or deposit on the non-fireside of the tube. No indication of wall thinning or deposit on the coldside of the tube.

**Figure A.7: Division wall tube sample from Unit 3 of Station B, showing (a) fireside deposit and (b) wall thinning on the fireside.**

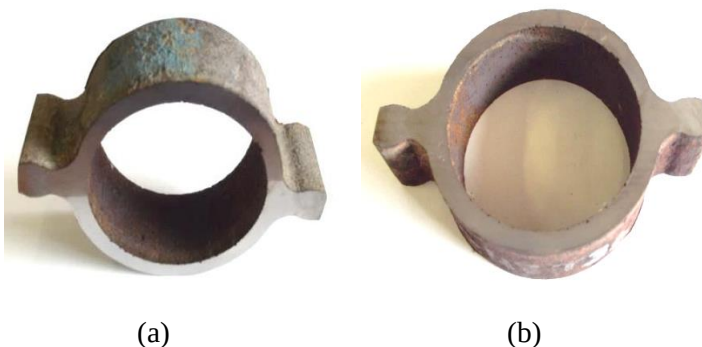
Weak fly ash deposits on the fireside of the tube. No signs of localized or preferred wall thinning around the tube circumference. No indication of wall thinning or deposit on the coldside of the tube.

**Figure A.8: Side wall tube sample from Unit 8 of Station B, showing (a) fireside deposit and (b) wall thinning on the fireside.**

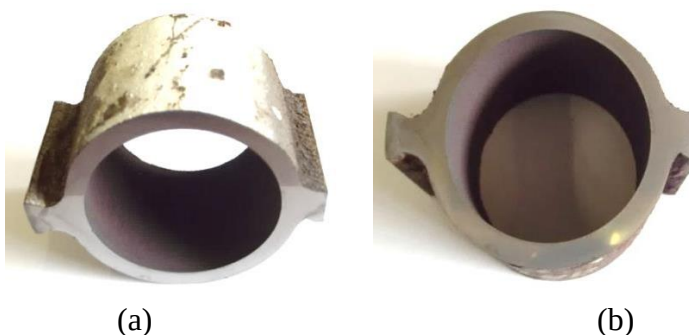
Weak fly ash deposits on the fireside of the tube. Uniform wall thinning is visible on the fireside of the tube. No indication of wall thinning or deposit on the cold side of the tube.

**Figure A.9: Division wall tube sample from Unit 10 of Station B, showing (a) fireside deposit and (b) wall thinning on the fireside.**

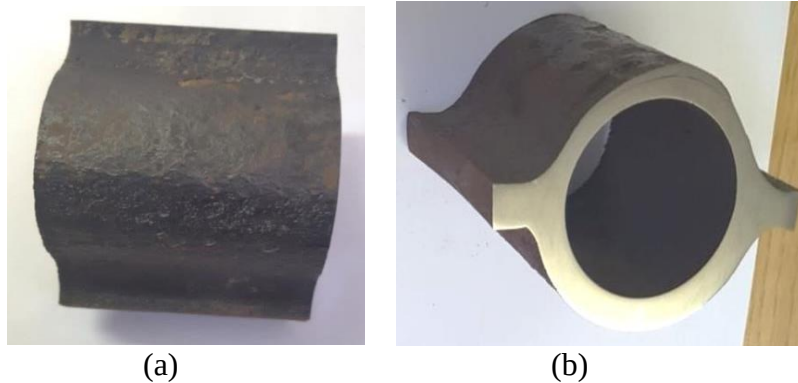
A very strong bonded metallic deposit was covering the fireside of the tube. Wall thinning can be seen on the fireside of the tube at 10 o'clock and 2 o'clock locations. There's no indication of wall thinning or deposit on the coldside of the tube.

**Figure A.10: Side wall tubing samples from Unit 4 of Station C, showing fireside deposit and wall thinning on the fireside.**

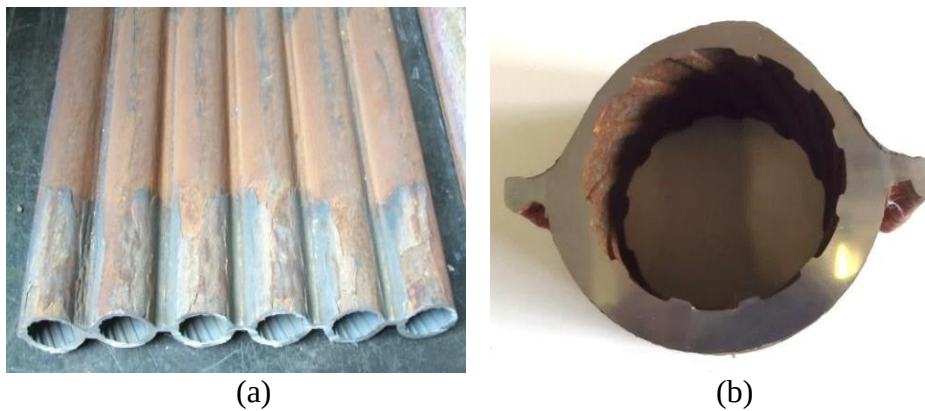
A grey layer of sintered deposit is covering the fireside of the tube. The wall thinning on the fireside of the tube was located at the 10 o'clock and 2 o'clock positions. The coldside did show any sign of wall thinning or scaling.

**Figure A.12: Division wall tubing samples from Unit 6 of Station C, showing fireside deposit and wall thinning on the fireside.**

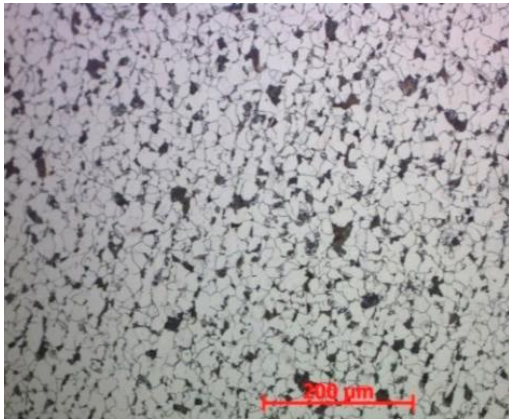
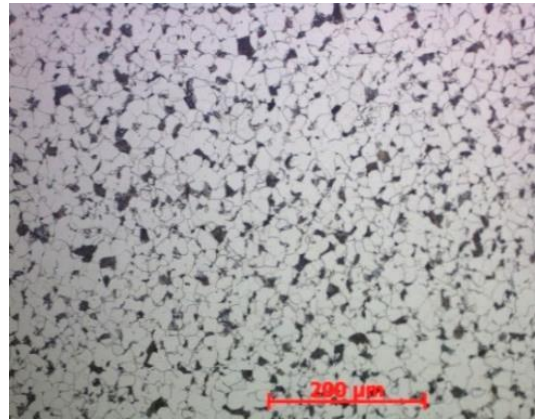
**Figure D.1: Microstructure of side wall tube 181 on the (a) fireside and (b) coldside.**

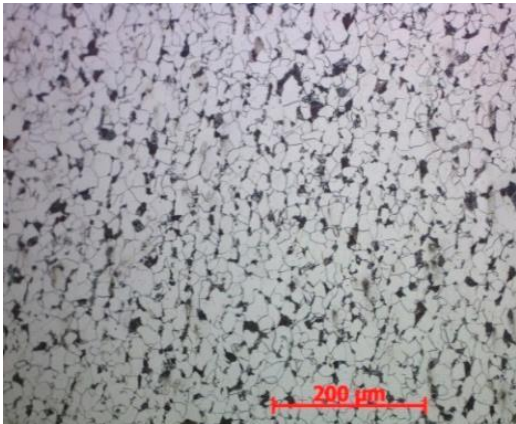
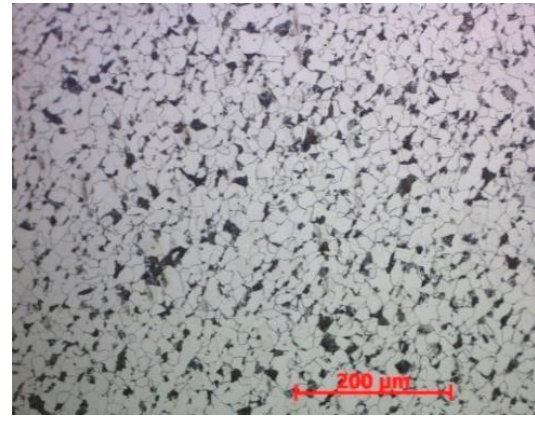
**Figure D.2: Microstructure of side wall Tube 49 on the (a) fireside and (b) coldside.**

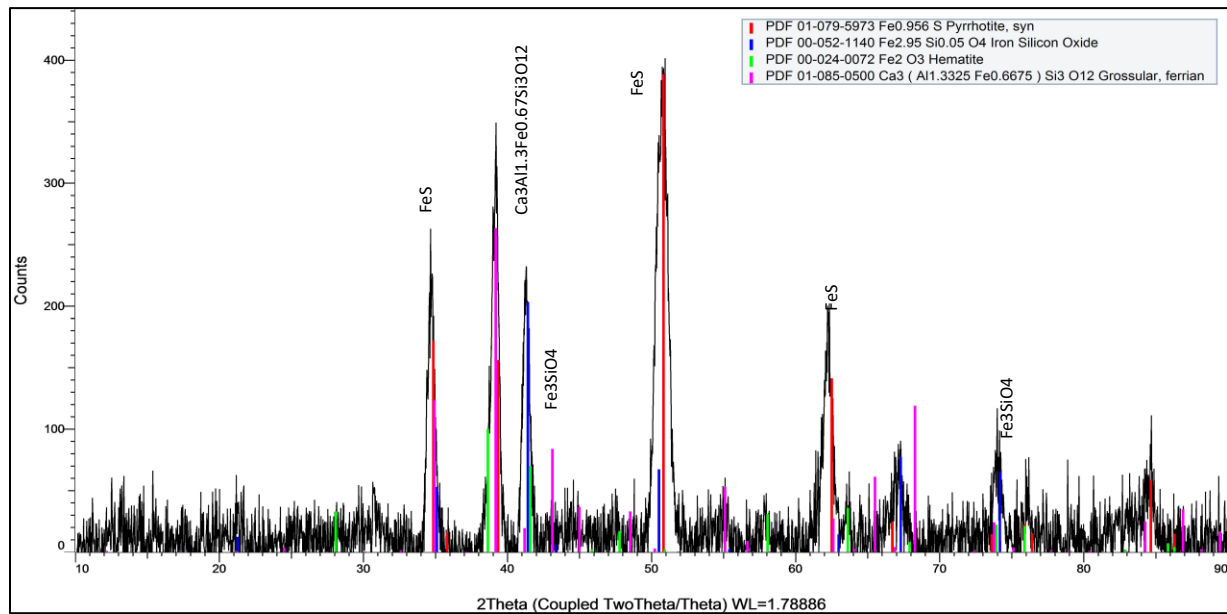
Figure G.5: XRD analysis of sidewall tube fireside deposit from Unit 4 of Power Station C.

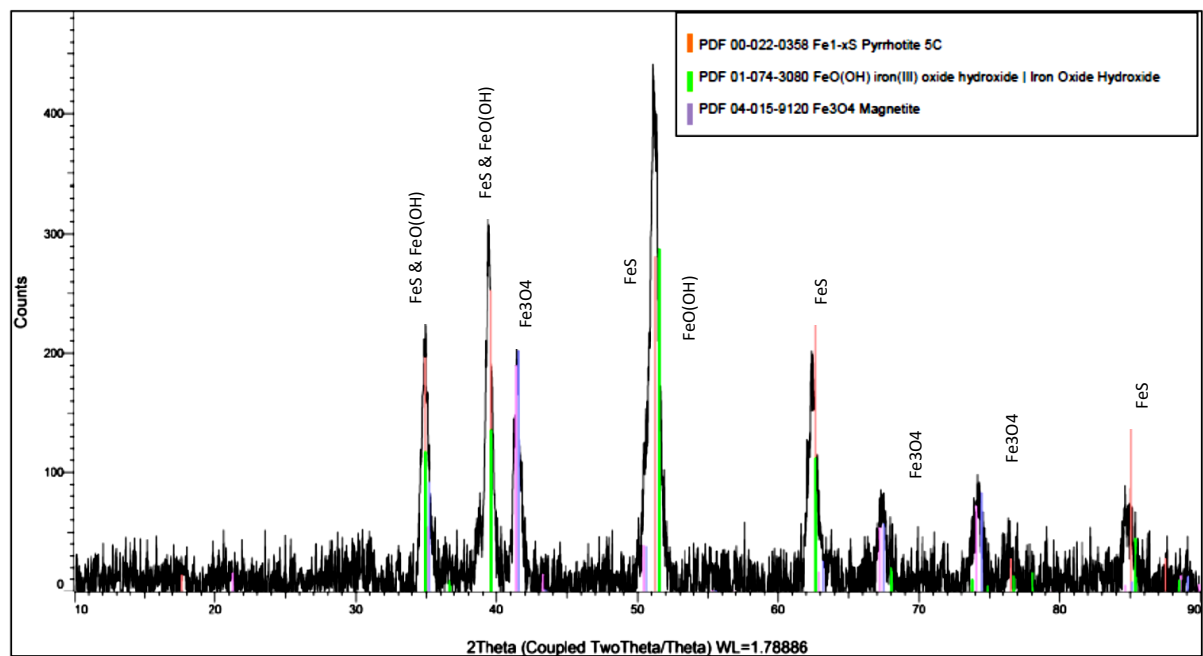
Figure G.6: XRD analysis of sidewall tube fireside deposit from Unit 6 of Power Station C.
