**Mine gas and coal dust explosions and methane outbursts - their causes and prevention.**

**Flint, John Derek**

**1990**

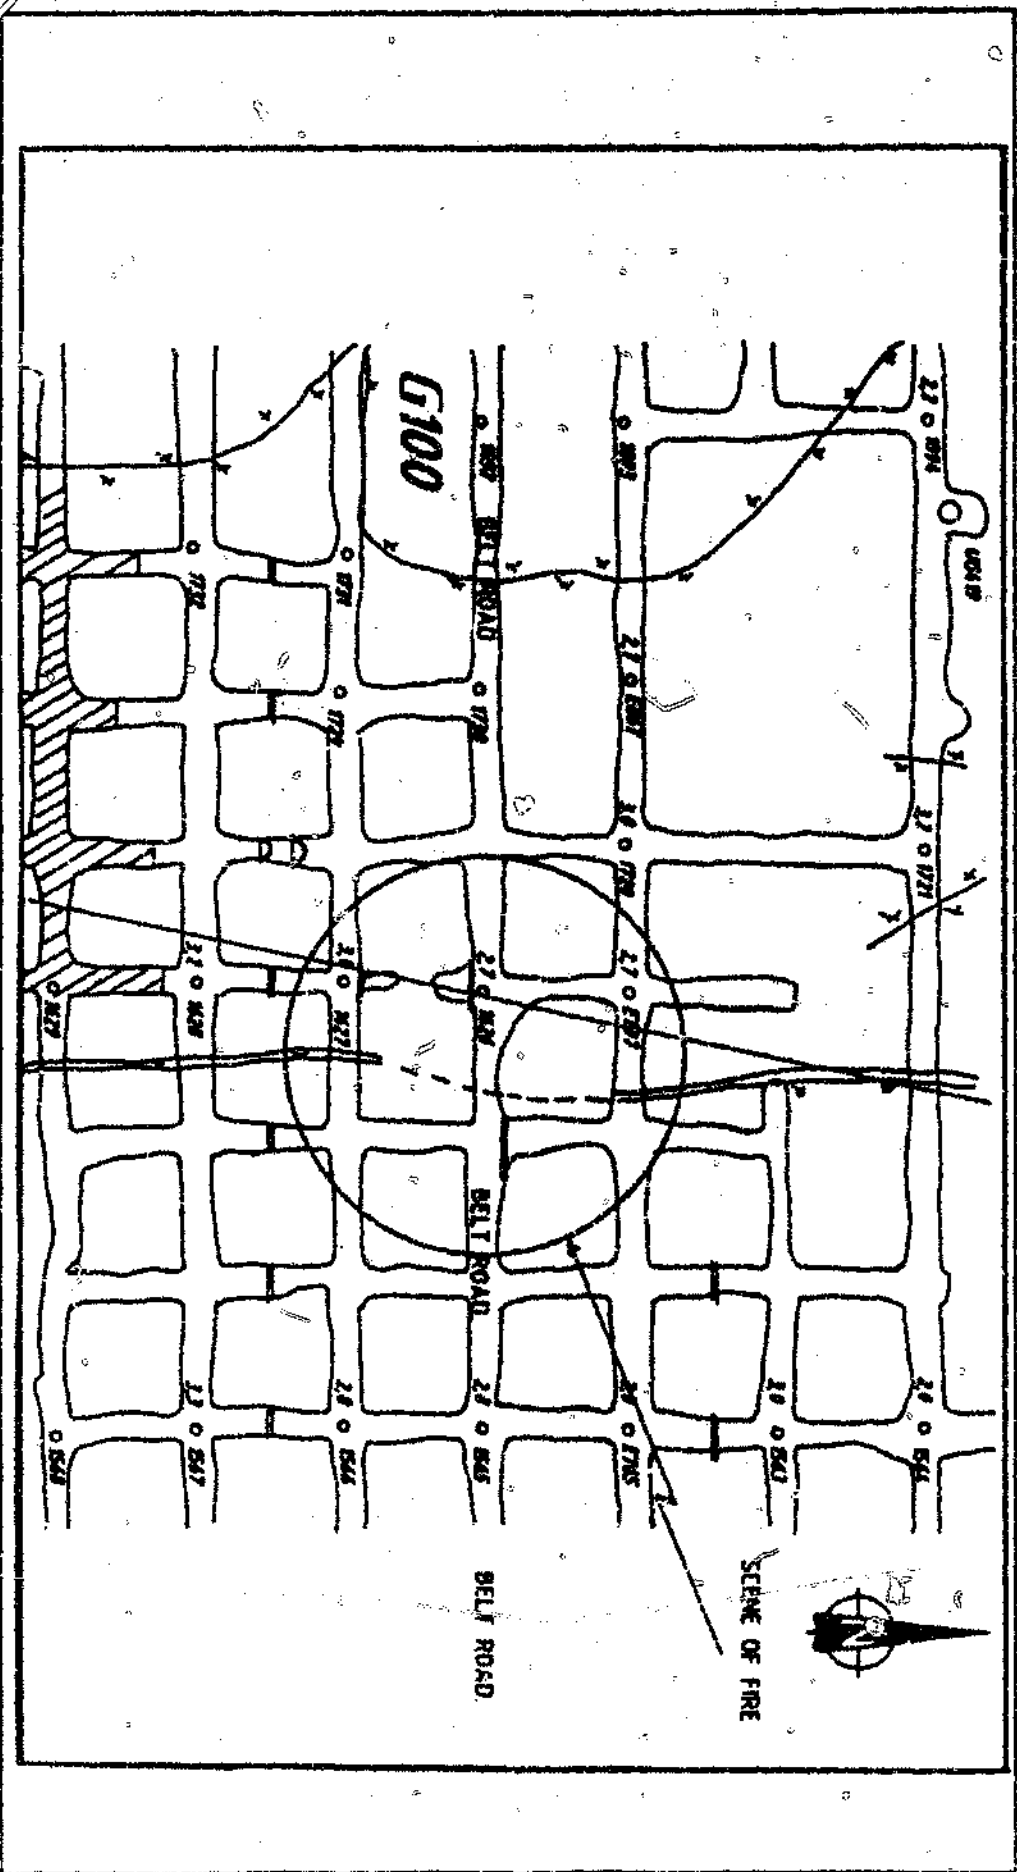
Figure 9  
 SPRINGFIELD COLLIERY  
 LOCALITY PLAN OF FIRE

Refer to the attached plan (Figure 9) showing the locality and scene of the fire. The fire was most probably caused by friction created by a bottom roller that jammed. The area where the fire occurred has a cross sectional area of  $4 \text{ m}^2$  as opposed to the normal  $16 \text{ m}^2$ . This restriction was caused by poor ground conditions which necessitated the installation of heavy steel and timber support. As a result of this aspect, a high intake air velocity, over a period of time, had blown fine coal and scrap paper off the conveyor belt at that point. The belt was also poorly aligned with the one side of the structure attached to the steel sets. This caused some coal to spill off the belt. All this coal and rubble accumulated below the belt and eventually caused the roller to become jammed.

The heat generated by the friction ignited nearby scrap paper which was blown into the adjacent timber support. Prior to the incident, scrap paper had been placed between these supports and this paper caught alight and, in turn, set some of the timber

sets on fire. Figures 10, 11 and 12 show details of the affected area.

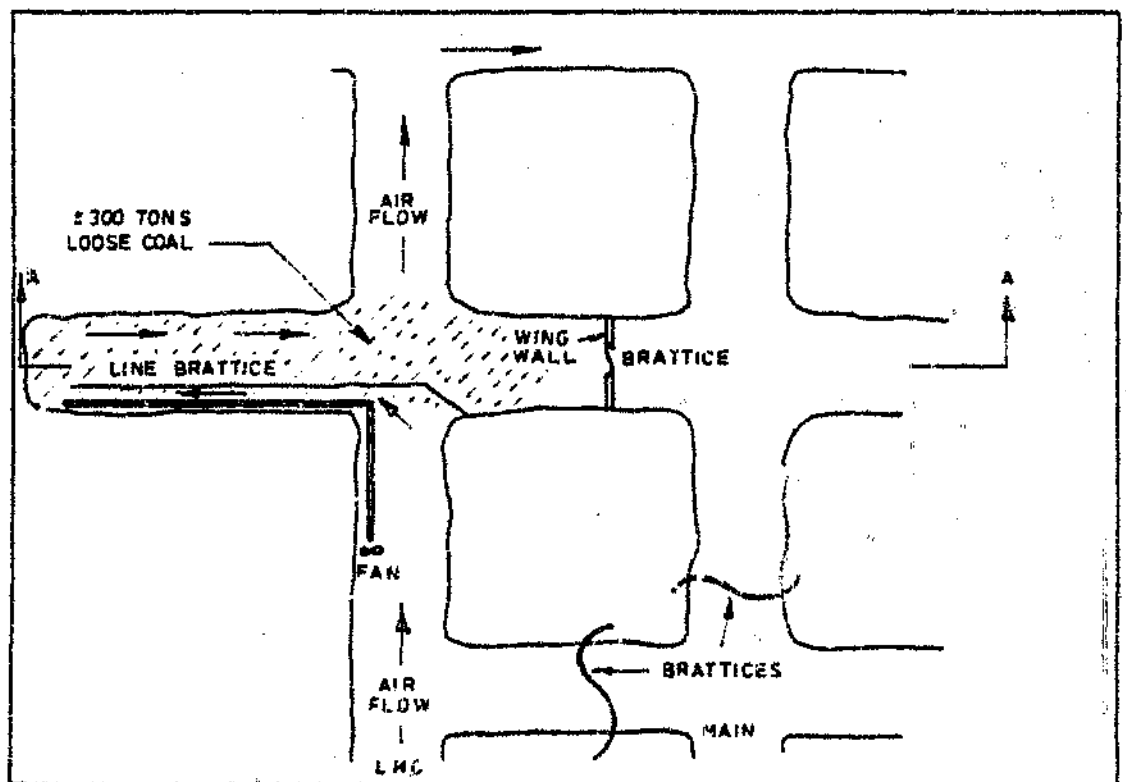
Figure 7

- a. To load out all loose burnt coal in order to prevent a fire.
- b. As a result of a. to establish the geological features which gave rise to the outburst of gas which produced about 300 tons of burnt coal.

PLAN AND SECTIONS OF ROADWAY SHOWING METHANE OUTBURST  
OCTOBER 1969

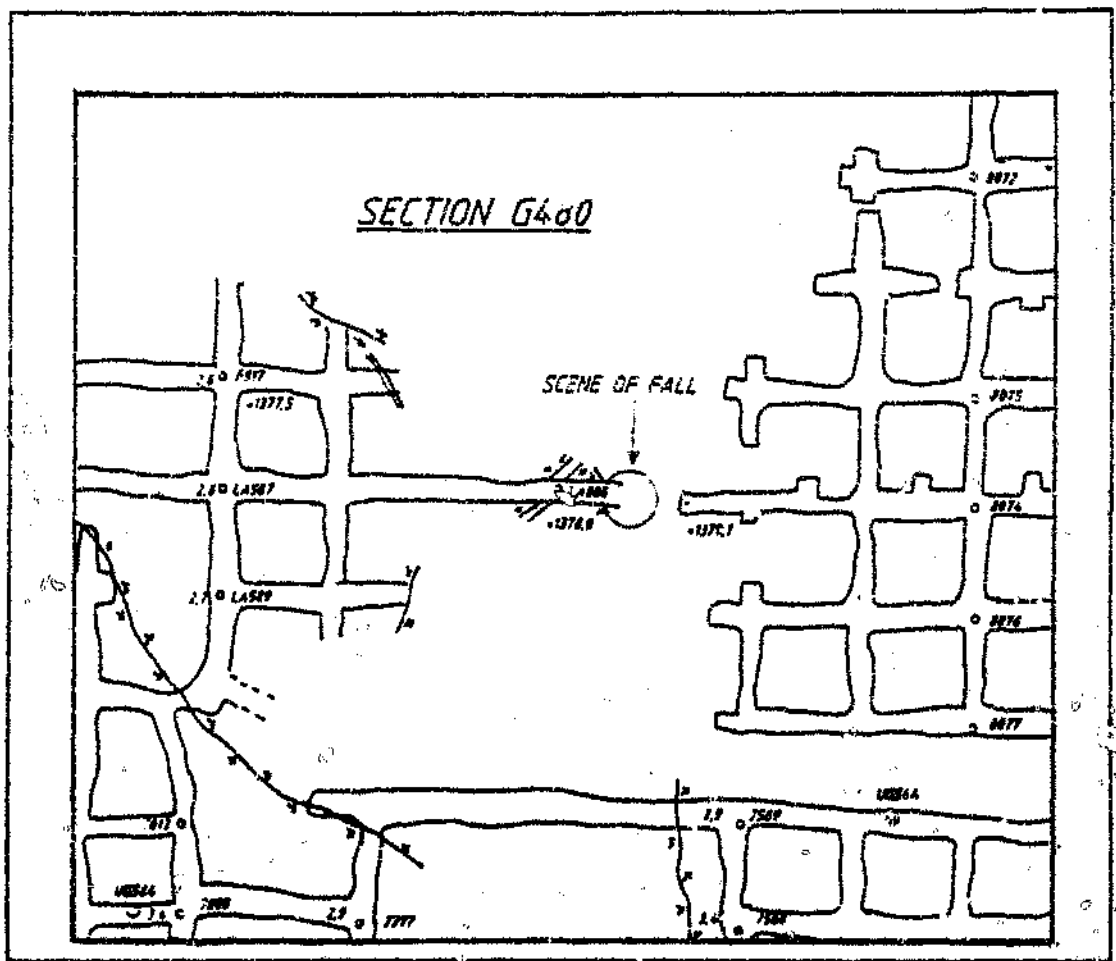
**Figure 10**

In order to install the arch girder set No. 36, the miner blasted three drill holes, using 1 200 grams of explosive in total in the bottom left hand corner of the face at 08h30. No methane was present before blasting. After waiting for 10 minutes for the blasting fumes to clear, the miner returned to inspect the results of the blast. When he was 20 metres from the face, there

PLAN OF GROOIVLEI SHAFT-SECTION G480  
SHOWING LOCATION OF OUTBURST MARCH 1989

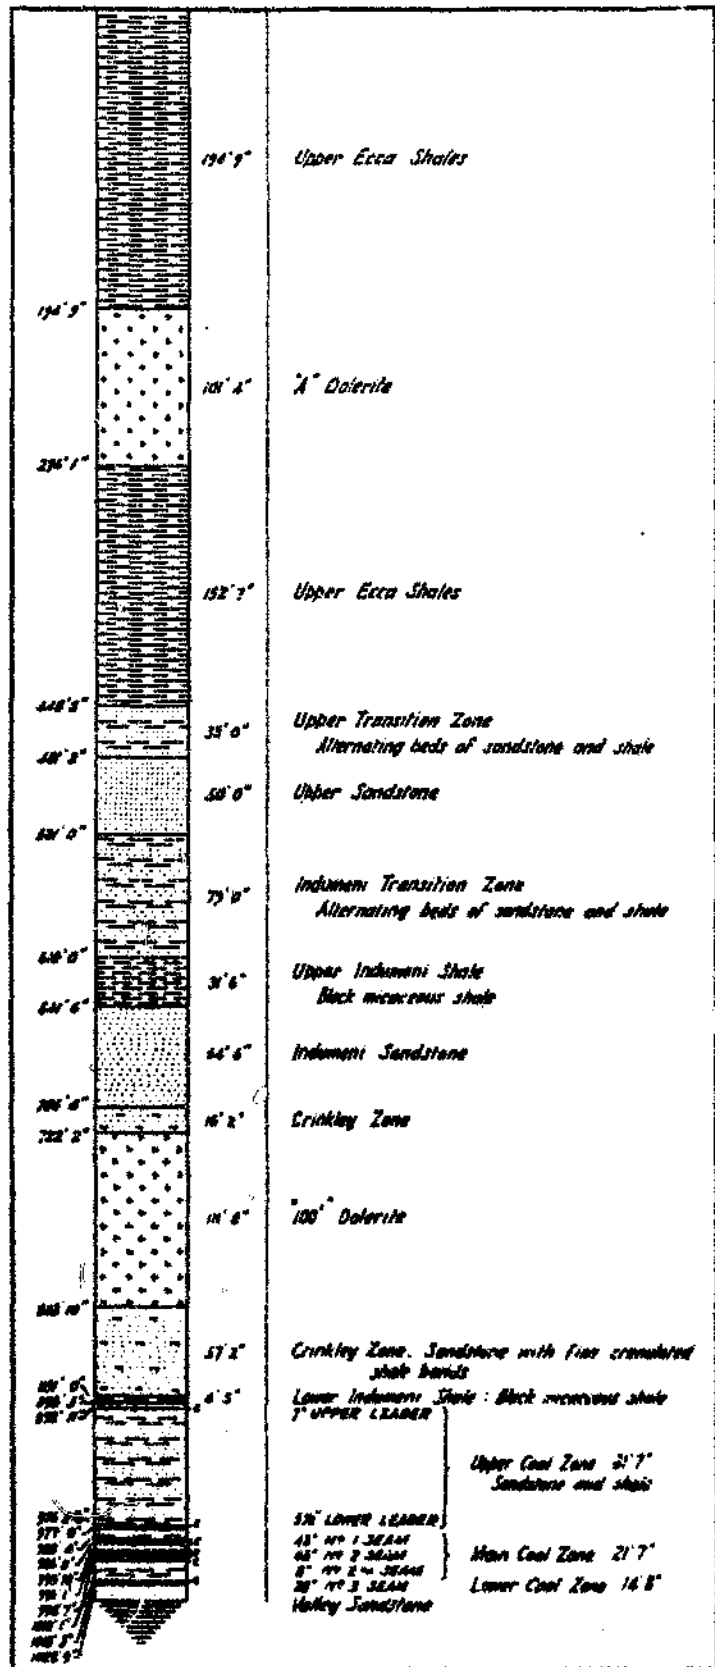
Figure 13a

TYPICAL BOREHOLE SECTION ADJACENT TO  
METHANE OUTBURST  
INDUMENI COLLIERY

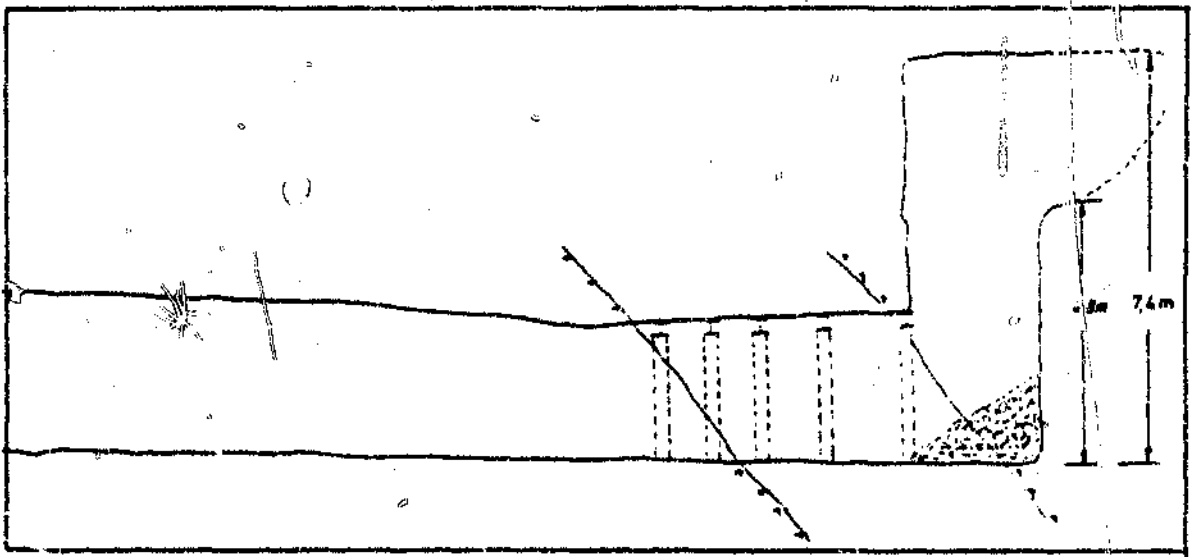
Figure 11

The fact that massive burnt coal at the Grootvlei shaft presents a danger due to instantaneous methane outbursts is supported by another incident in September 1982. The third left hand companion (Figure 10) of the section was being worked backover to hole with the advancing heading which had been stopped on a dyke. The holing was necessary to secure a return airway on the left hand side of the section. A section through the coal seam is shown in Figure 11. The roof, floor and sides of the roadway were being worked in burnt coal.

# PLAN AND SECTION OF OUTBURST IN SECTION G480

was an outburst of methane gas from the roof which dislodged approximately 200 tons of burnt coal. This coal lay 16 metres back from the face. The miner was not injured.

On investigation of the area after the incident it was noted that a cavity some 10 metres high had been formed above the last arch as indicated in Figure 11. The debris - mainly burnt coal - had been blown out into the roadway. The distance to hole into the No. 2 road remained at  $\pm$  4 m and it was decided that before any further excavation should be attempted the following work should be carried out:

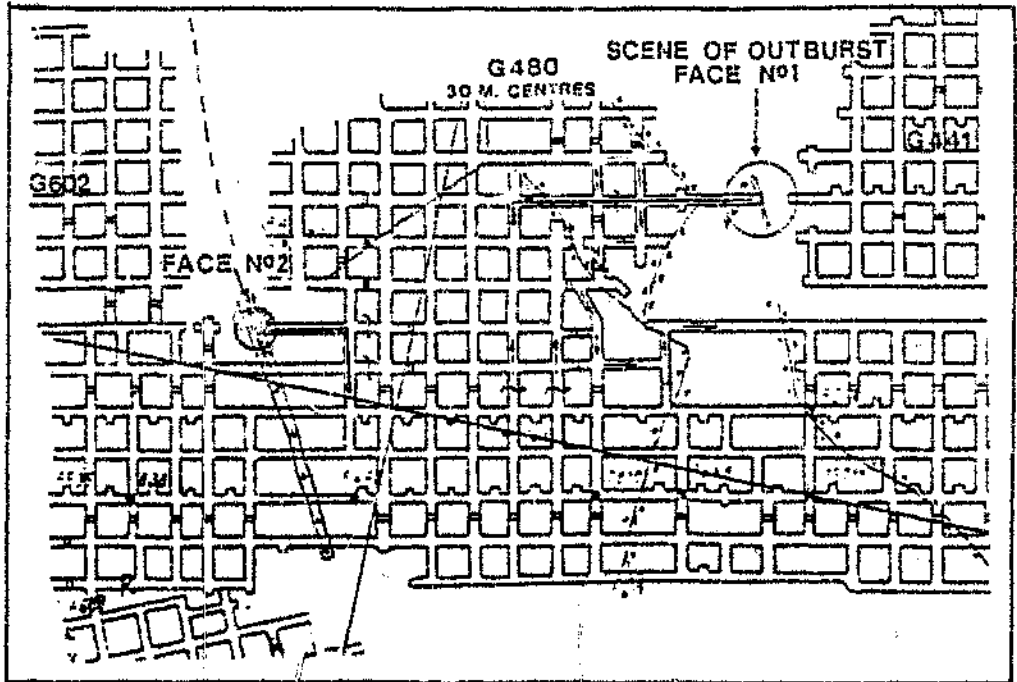
Figure 12 depicts the result of a recent methane outburst in the South Rand Coalfield in March 1989. The outburst occurred 18 hours after a floor roll in the roadway had been blasted and while the mechanical loader was loading out the blasted material. Four men were affected in the face by the methane and made use of their self rescue appliances to return safely to the fresh air intake.

Photograph No. 1 shows the mechanical loader almost totally buried by fine coal which after 24 hours showed signs of spontaneous combustion (80 ppm of CO was detected under the boom of the loader).

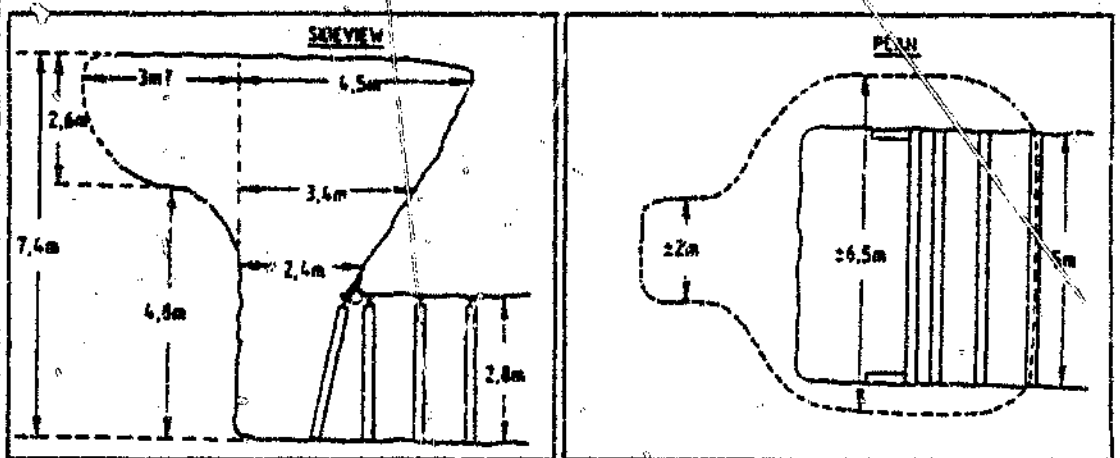
Figure 12 depicts the result of a recent methane outburst in the South Rand Coalfield in March 1989. The outburst occurred 18 hours after a floor roll in the roadway had been blasted and while the mechanical loader was loading out the blasted material. Four men were affected in the face by the methane and made use of their self rescue appliances to return safely to the fresh air intake.

PLAN SHOWING AREA OF MOST RECENT OUTBURST  
AT SPRINGFIELD COLLIERY

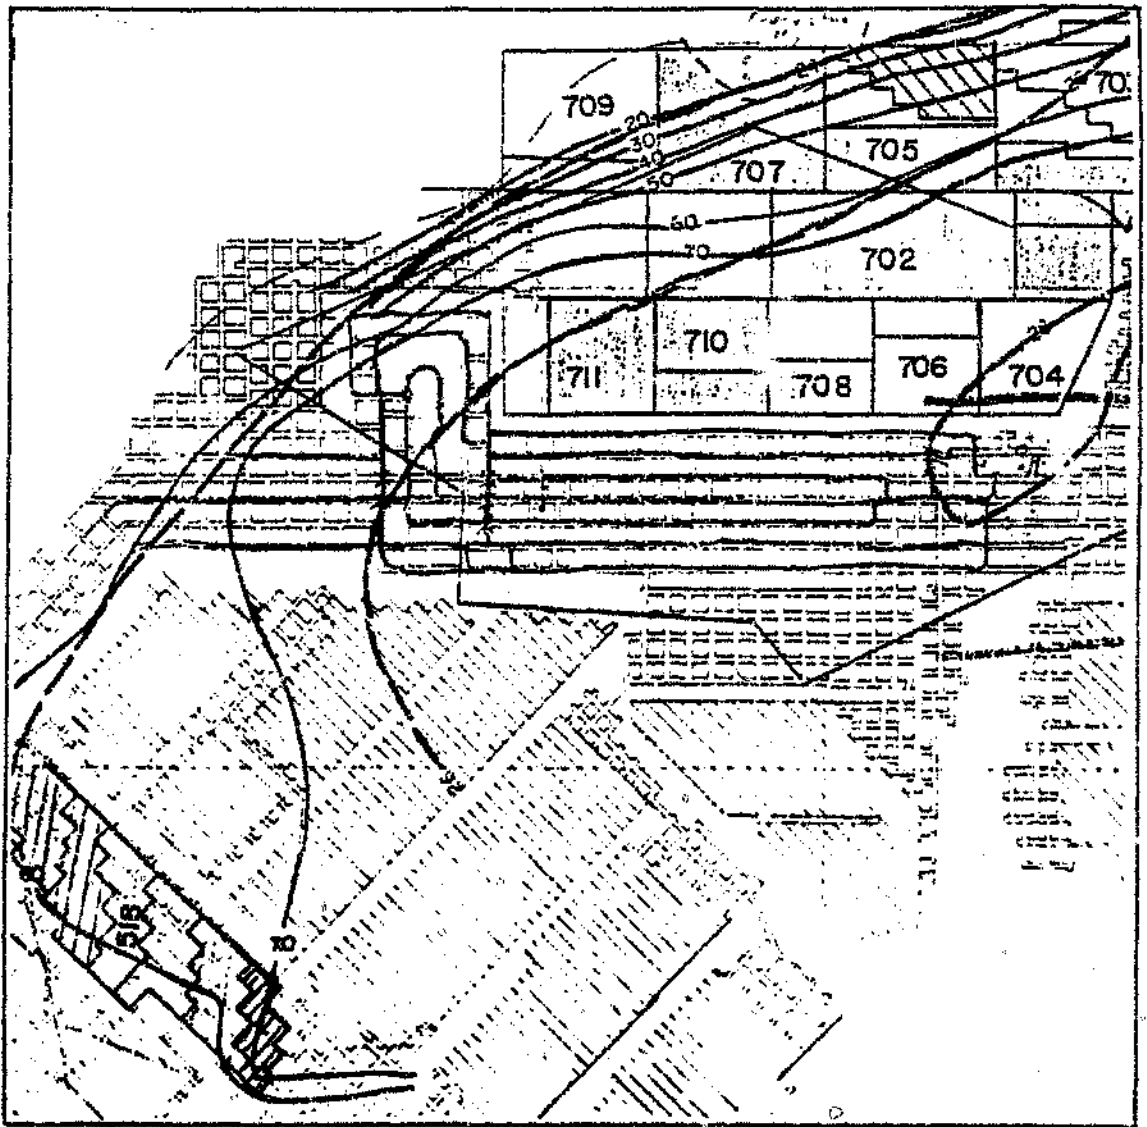
Figure 13

GENERAL LAYOUT OF UNDERGROUND  
WORKINGS

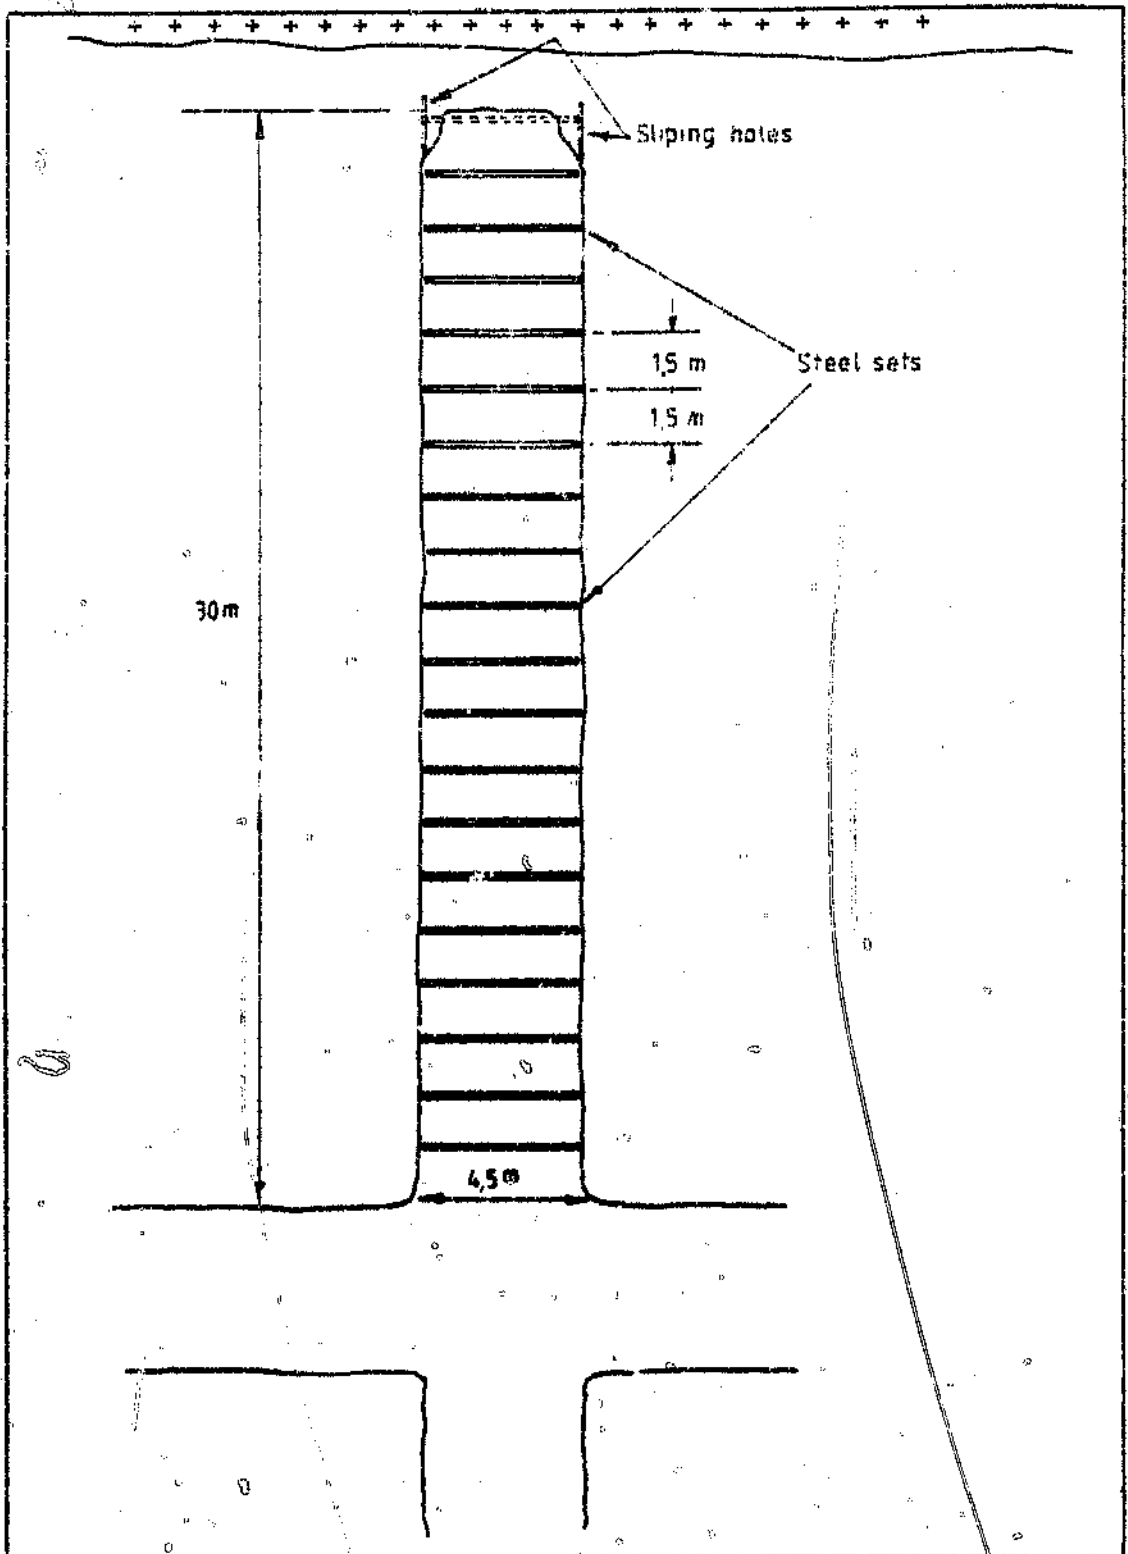
In June 1970 an instantaneous methane outburst had occurred in the first left hand companion of section 700. This roadway had developed to within a metre of the dyke shown on Exhibit A. It had become necessary to install a steel girder set in the face one metre beyond the last set since roof conditions were poor in the burnt coal zone. Three slipping holes were drilled on either side of the face as shown in Figure 15 to square off the face in preparation for the girder set installation. The six shotholes were blasted simultaneously and immediately thereafter there was a further blast followed by a large dust cloud and methane gas which enveloped the miner and several of his crew who were standing in the second left hand companion at pag 1410 on Figure 14 Exhibit A. The section ventilation was temporarily reversed and the crew make an attempt to escape eastwards into the intake airway.

PLAN OF FACE SHOWING SLIPPING HOLES  
AND GIRDER SETS PRIOR TO OUTBURST

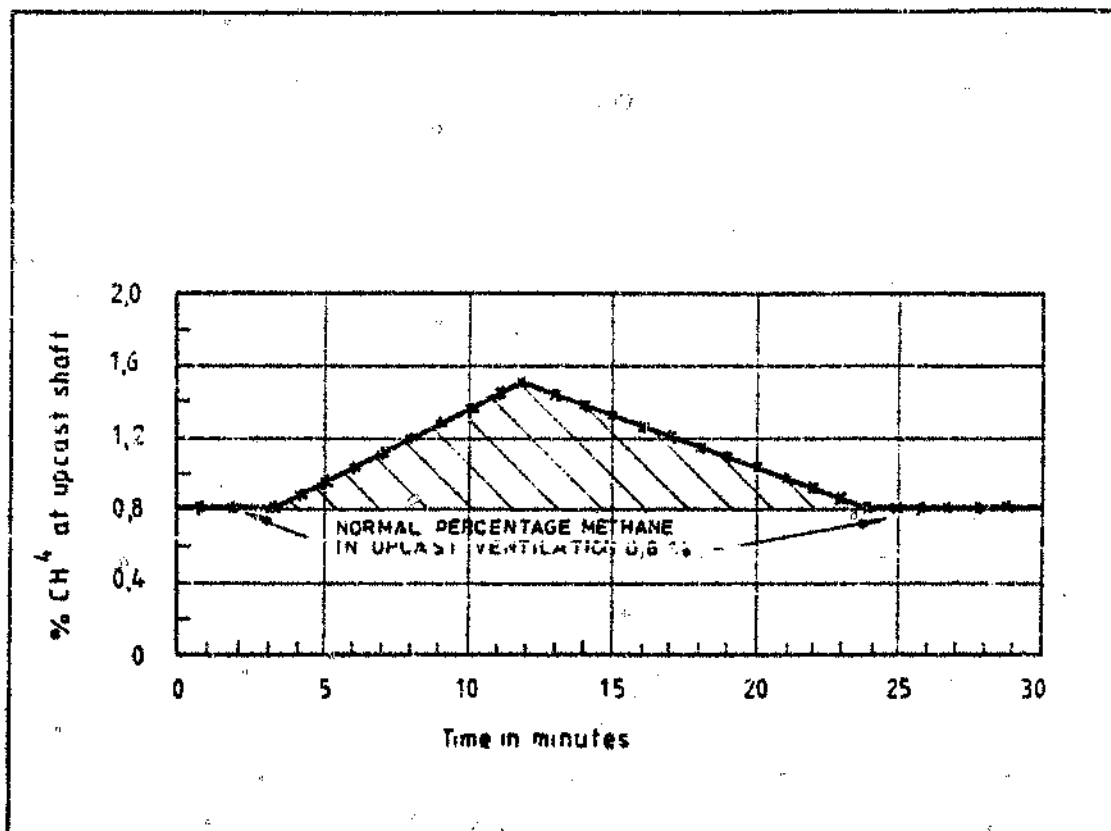
Figure 16 depicts the percentage methane in the upcast shaft prior to and after the outburst. Based on an upcast quantity of  $189 \text{ m}^3/\text{second}$  the area shown hatched on the graph indicates the total volume of methane desorbed from the face, roof and sides of the second left hand companion.

GRAPH SHOWING PERCENTAGE OF METHANE RECORDED ON AN  
AUTOMATIC METHANE RECORDER AT THE MAIN UPCAIST SHAFT  
BEFORE AND AFTER AN OUTBURST

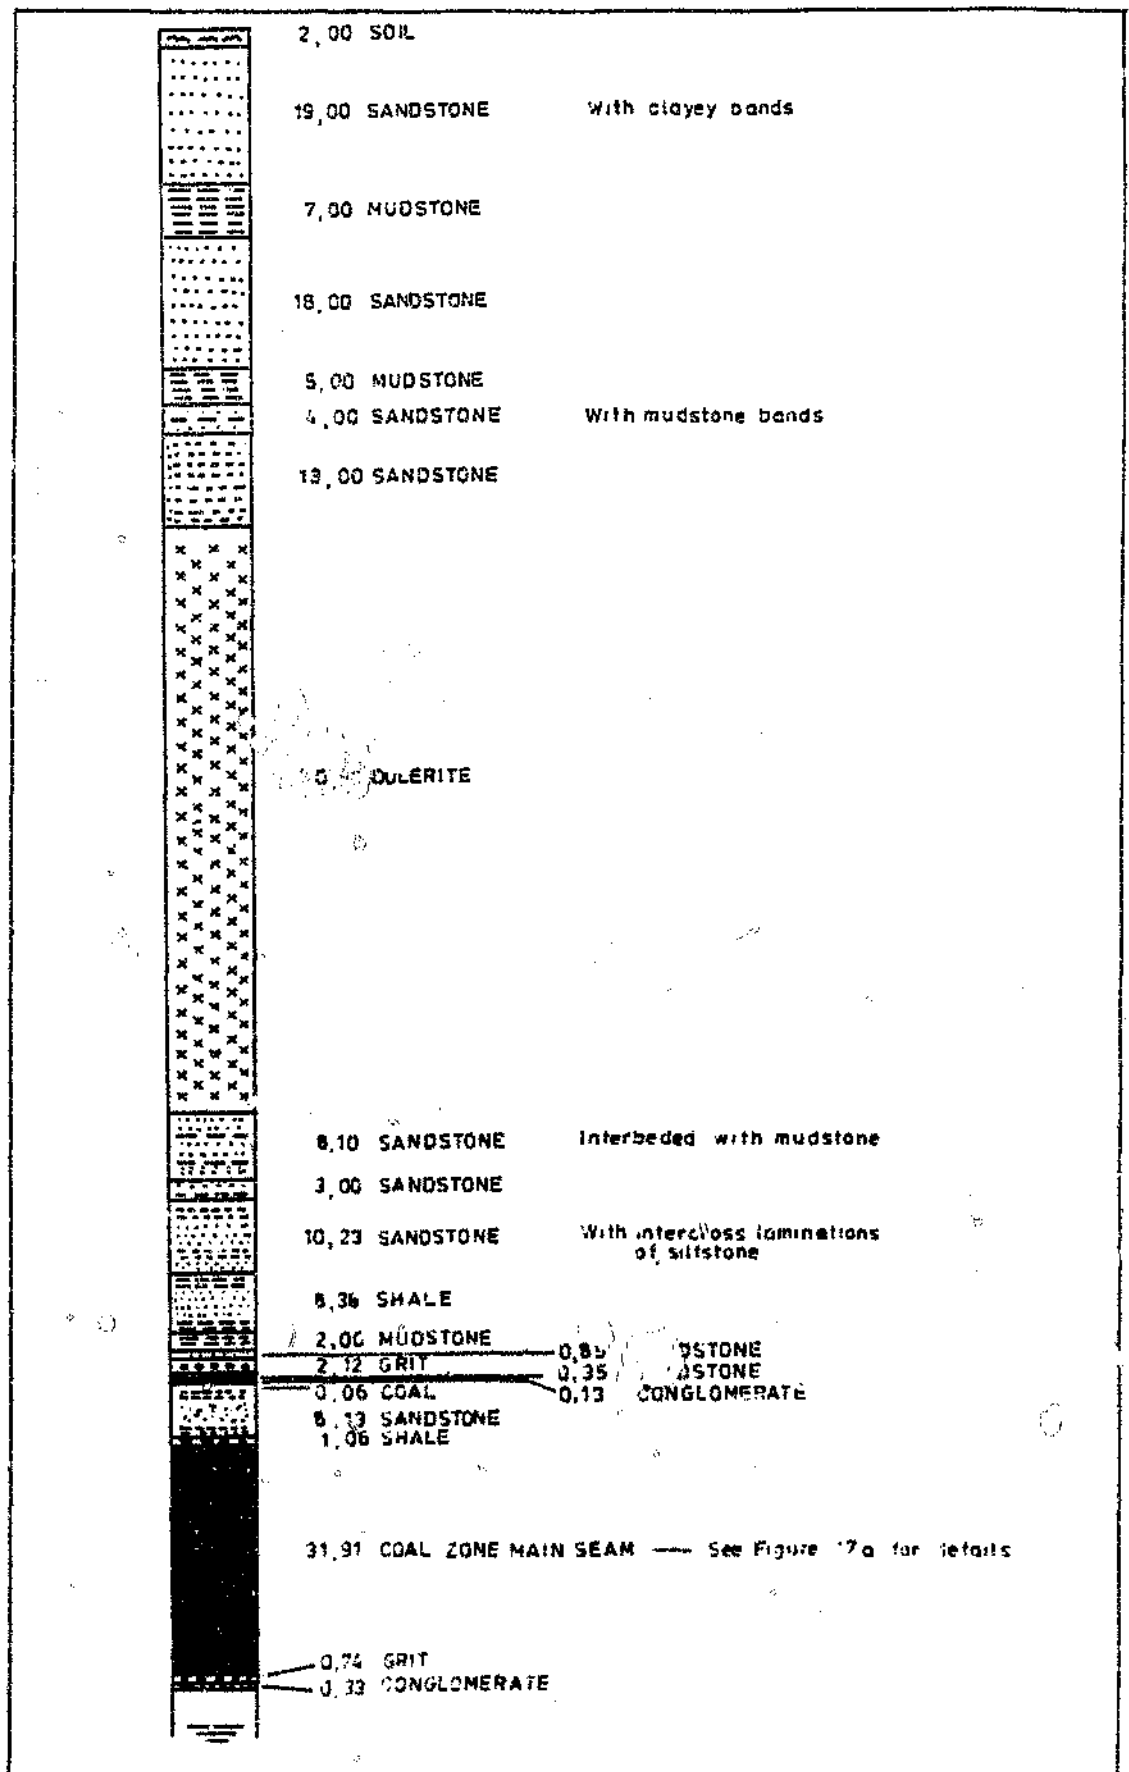
Figure 17 shows a seam section from Borehole number 92 situated 300 metres to the east of Borehole number 2005. The coal measures are overlain by a dolerite sill some 80,9 metres thick and lying at a depth of between 68 and 148,9 metres from surface.

BOREHOLE SECTION 300 METRES FROM THE BOREHOLE  
WHERE RODS WERE BLOWN OUT AND TO ABA VET  
DRILL CRACK

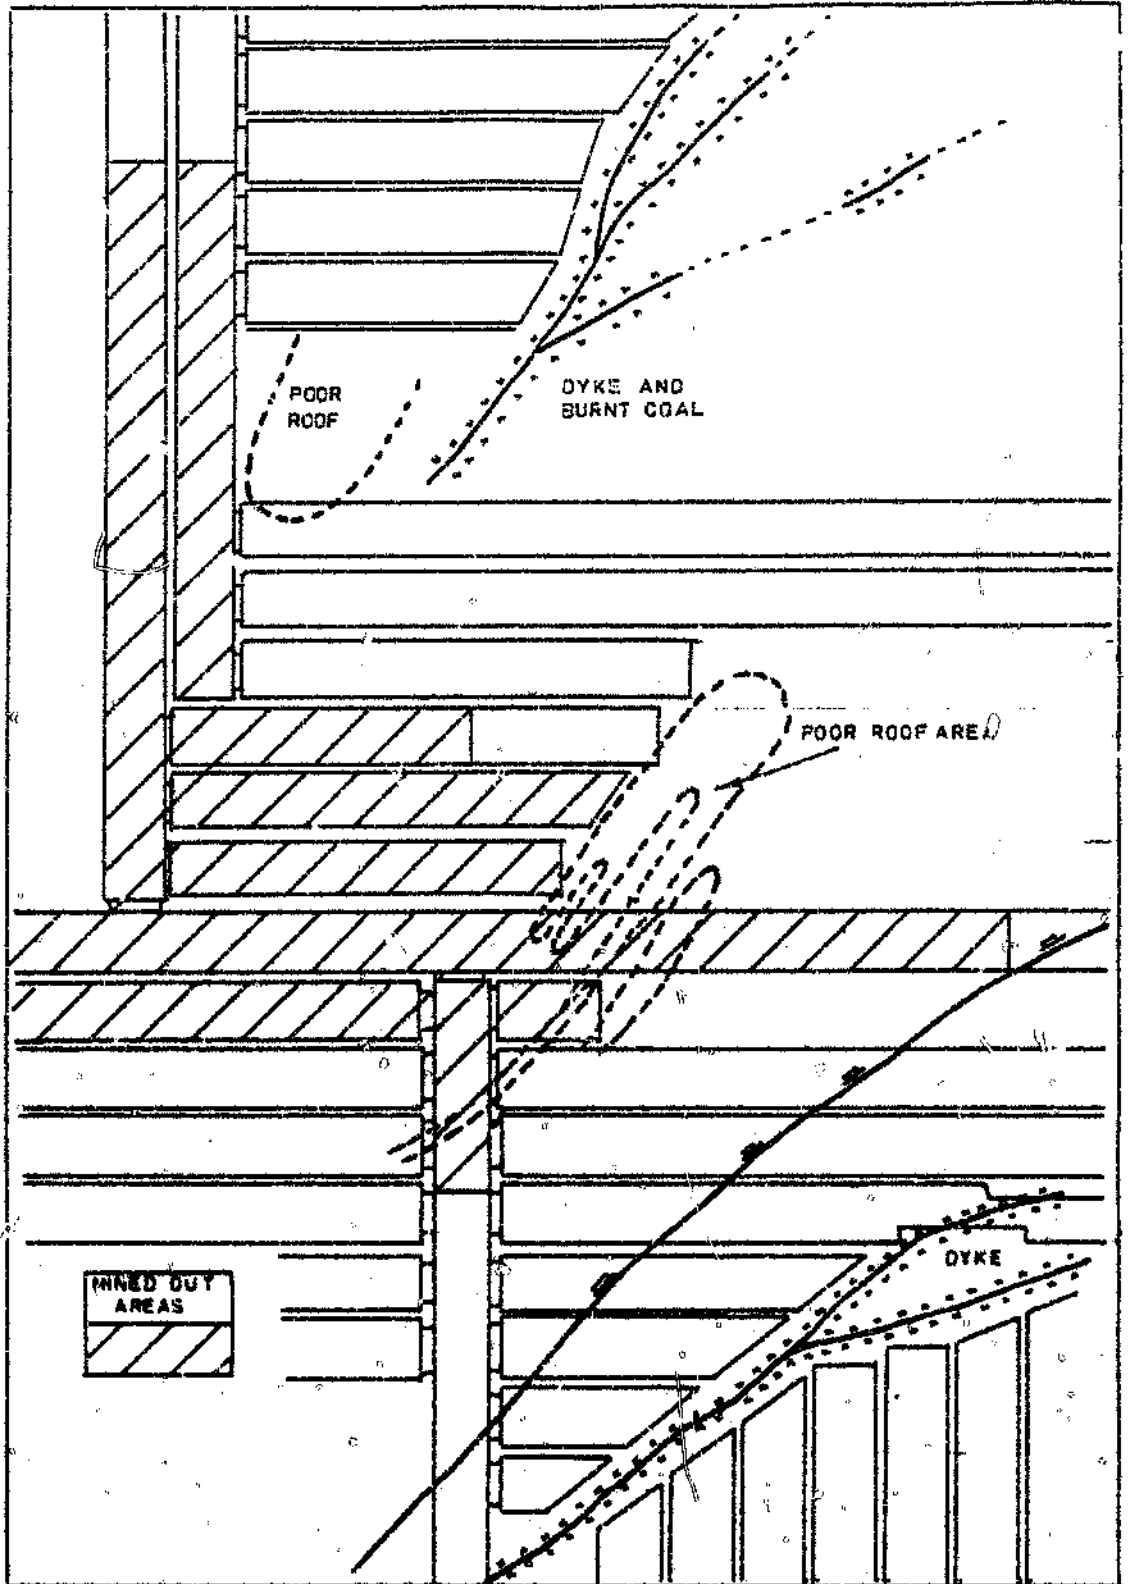
Figure 18  
TYPICAL EXAMPLE OF HAZARD PLAN  
SHOWING POOR ROOF AREAS AND AREAS  
CONSIDERED TO BE OUTBURST PRONE

Middleton (1988) states that as far as Cynheidre Colliery in Wales is concerned "the complex nature of the geological conditions around the colliery workings renders correlation with outburst incidence very tenuous". From evidence in South Africa it is possible to draw a "hazard" plan of the future underground workings showing not only 'roof' hazards but possible areas prone to outbursts - this plan would be used by the mine officials who become firstly aware of future poor roof conditions but also outburst zones. Dolerite dykes and sills, structurally disturbed coal which has little compressive strength and contains a considerable degree of microfracturing which accounts for its dull appearance and friable consistency should be marked on the plans. Figure 18 is an example of this recommendation.

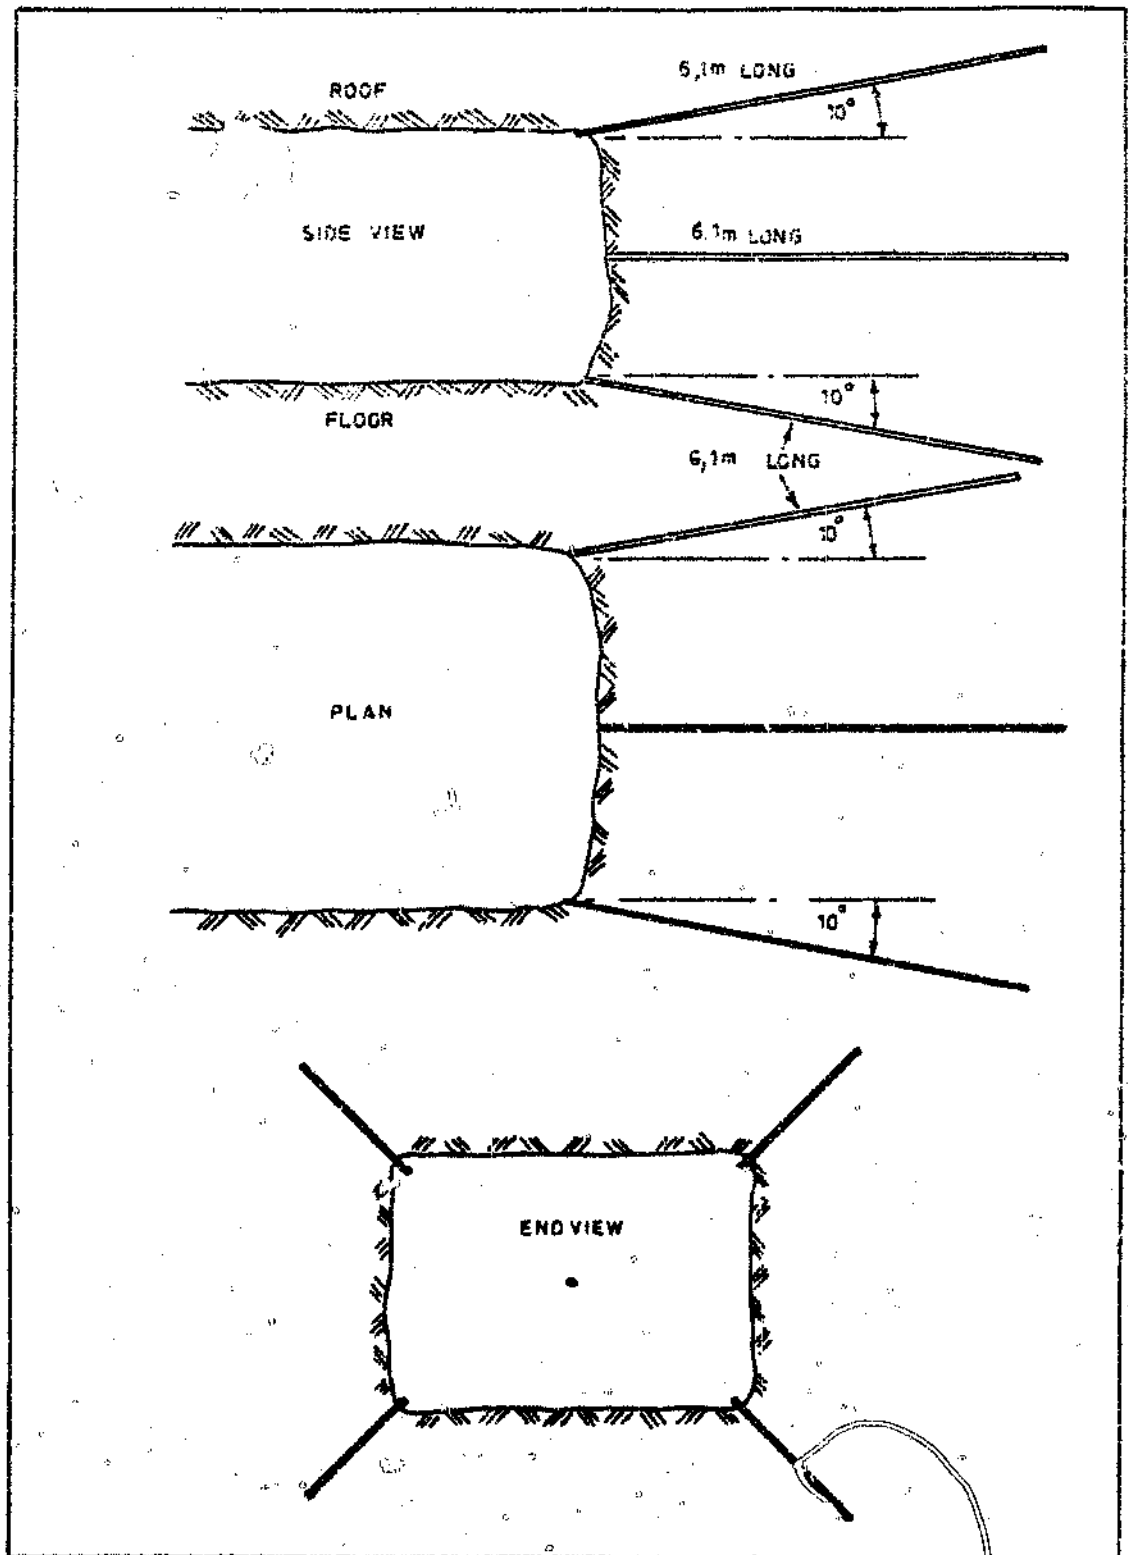
Figure 19  
GAS DRAINAGE PILOT HOLES  
(BURNT COAL ZONES)  
DRILLED PRIOR TO EACH CUT

Figure 19 shows the method used in massive burnt coal drivages in the South Rand and Natal coalfields whereby a series of 38 mm holes each 6 metres in length are drilled before cutting drilling and blasting the face. This precaution was taken after the gas outburst incident in 1969 in Section 7 in the South Rand coalfield and also at Indumeni Colliery.

- all work is to cease in the place
- power in the section is to be switched off
- the Section Managers are to be notified and they are to develop a further plan of action.

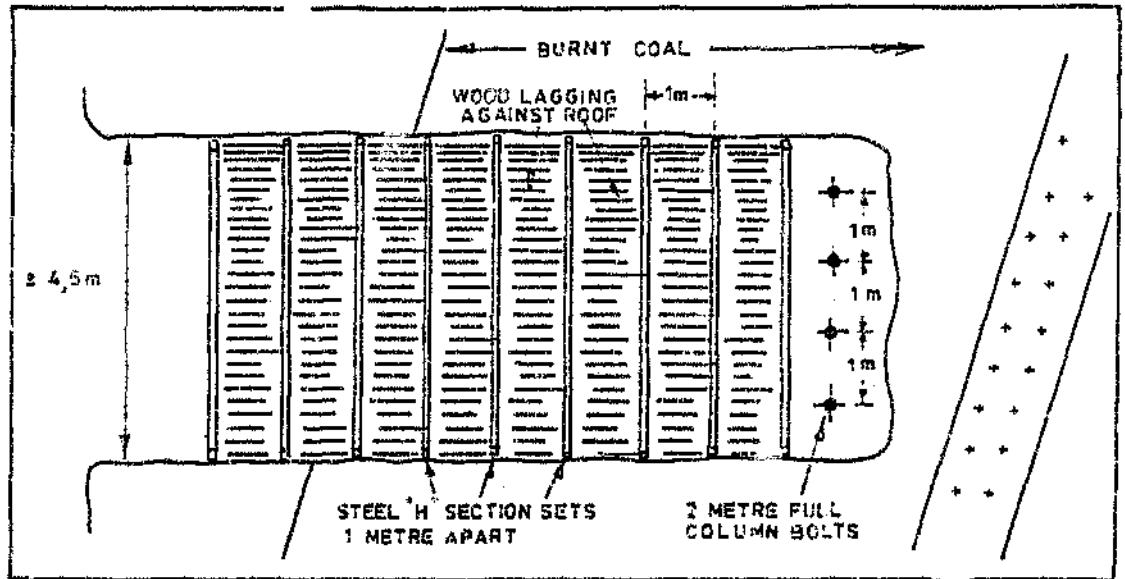
PLAN SHOWING SUPPORT OF ROADWAY  
IN MASSIVE BURNT COAL

It follows from a safety view point therefore that attempts should be made to support highly stressed roof in burnt coal drives with 2 metre long steel wire cables in conjunction with full column resin. Should it still be necessary to use steel arches or square sets then these may be installed. Figure 20 depicts the type of support envisaged in burnt coal to prevent falls of roof coal during an outburst. This practice is supported by Fargraves.

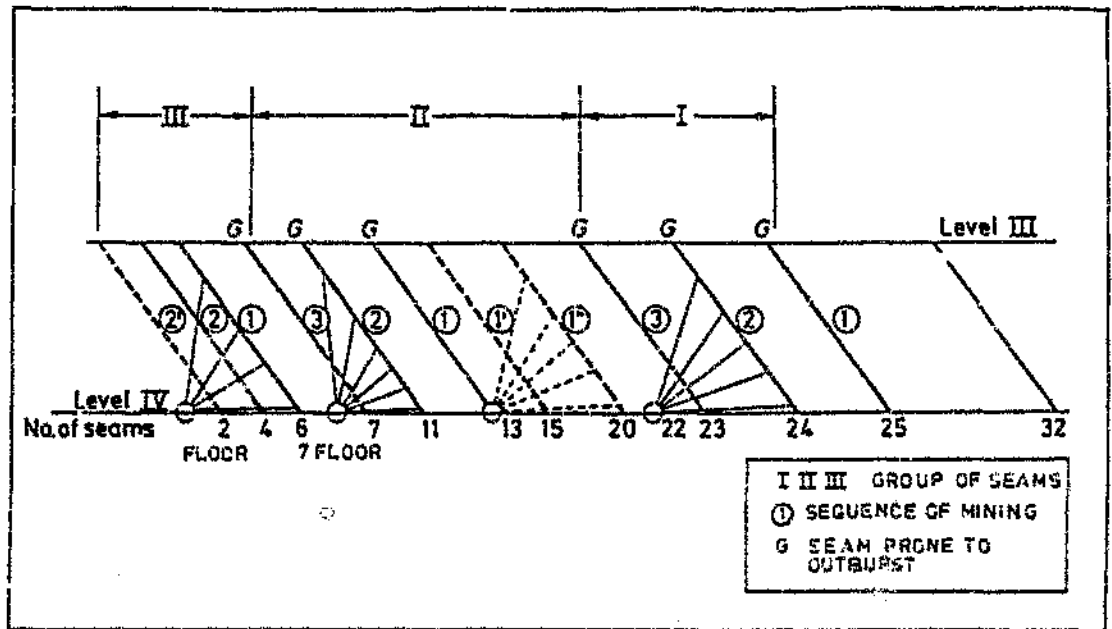
SEQUENCE OF MINING SEAMS AT ISTVÁN SHAFT

Hitherto this particular circumstance has only arisen once in South Africa but the system is termed protective seam mining. Figure 22 illustrates the method. Neighbouring seams above or

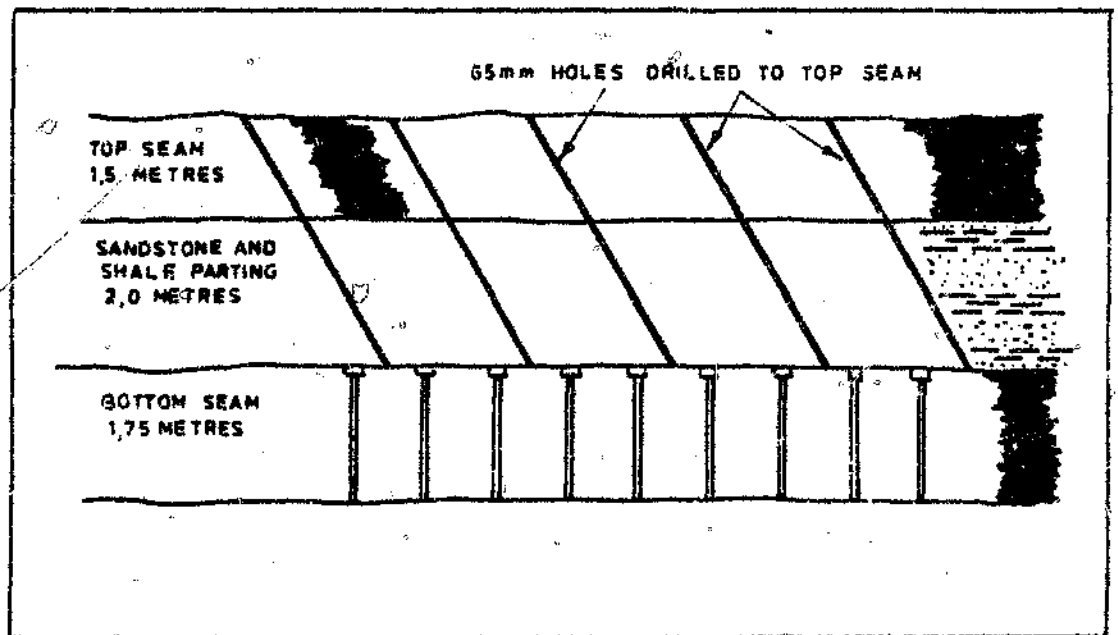
METHANE DRAINAGE HOLES DRILLED FROM BOTTOM SEAM  
WORKINGS TO TOP SEAM - INDUMENT

Figure 23 depicts the method of drilling adopted at a colliery in Natal which was prone to methane outbursts. Development was carried out in the lower seam and 65 mm diameter boreholes were drilled into the top seam. Methane was bled from these holes and pressures of 698 kPa (100 lbs/square inch) were measured at the collar of the hole in the roof. This high pressure is indicative of the permeability of the normal coal measures at this colliery (Watson and Ogilvie, 1970 and 1971).
