CHAPTER 6ANALYSIS OF CRACK IN BEAM TO COLUMN JOINT6.1 Description of Building and Cracks

**Author** Boardman Vivian Reginald

**Name of thesis** The Effect Of Compressive Stress On The Expansion Of Brickwork And Its Implication In Buildings. 1977

University of the Witwatersrand, Johannesburg

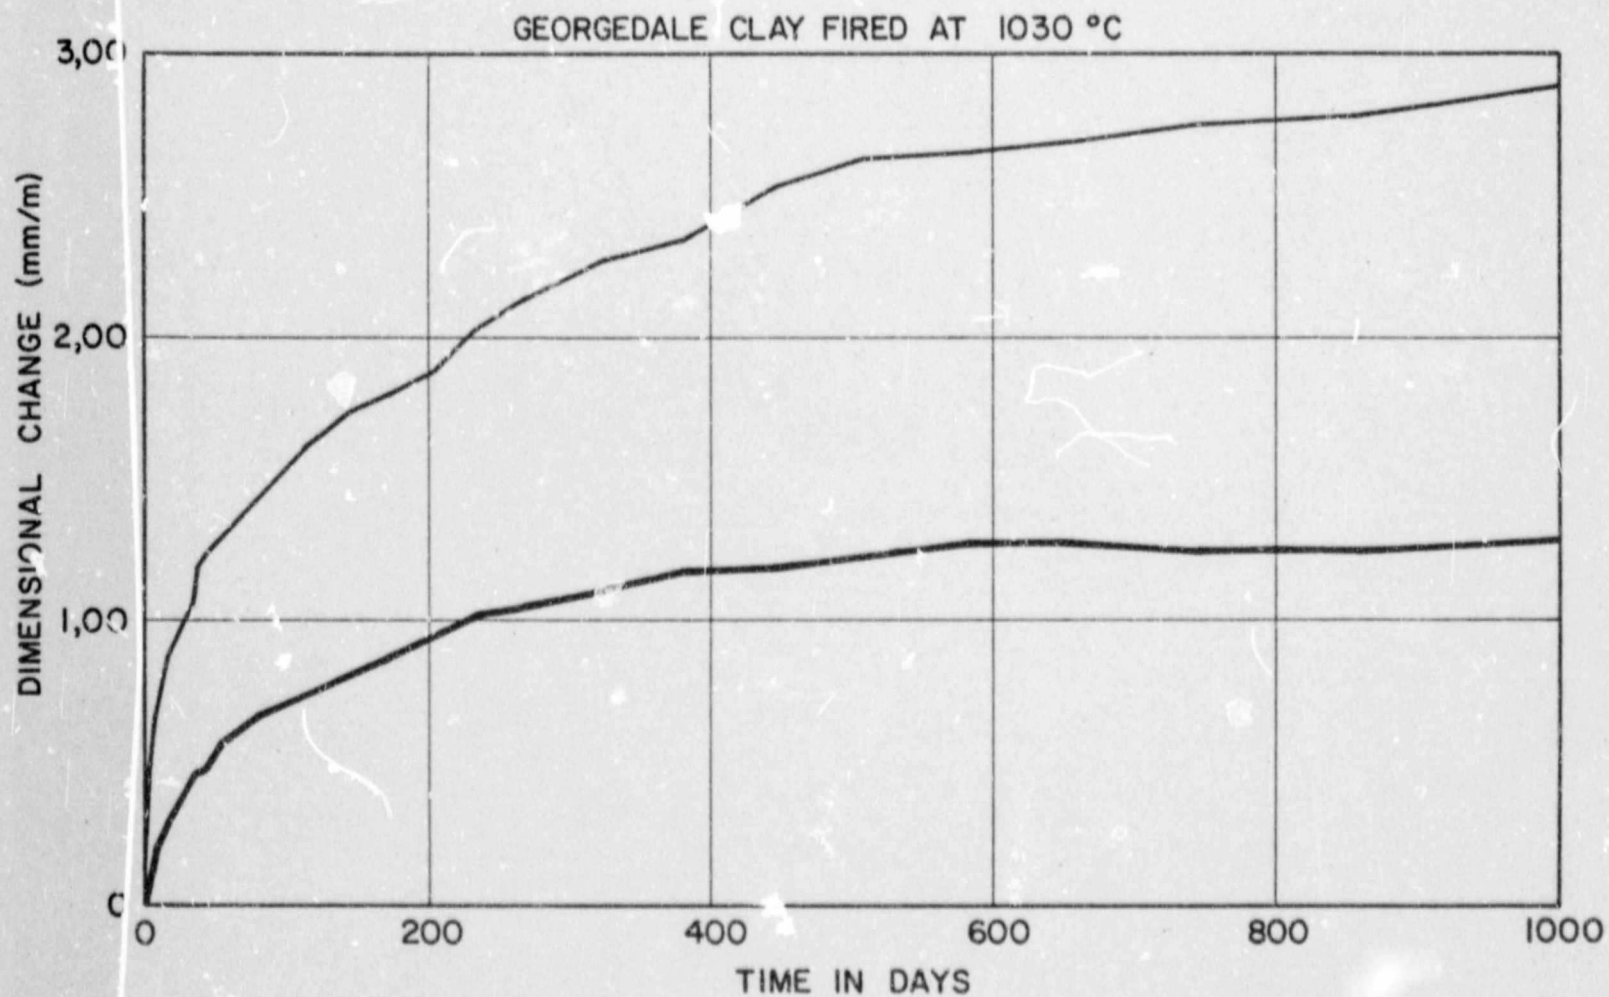
The difference in transverse expansion on these Figures was probably due to some internal vertical cracks in the one brick. A number of bricks after firing had to be discarded because of the development of visible cracks which would have affected results required for comparison purposes.

FIGURE 34  
*Brick in humidity room; - load 10 MPa (1450lb/in<sup>2</sup>)*

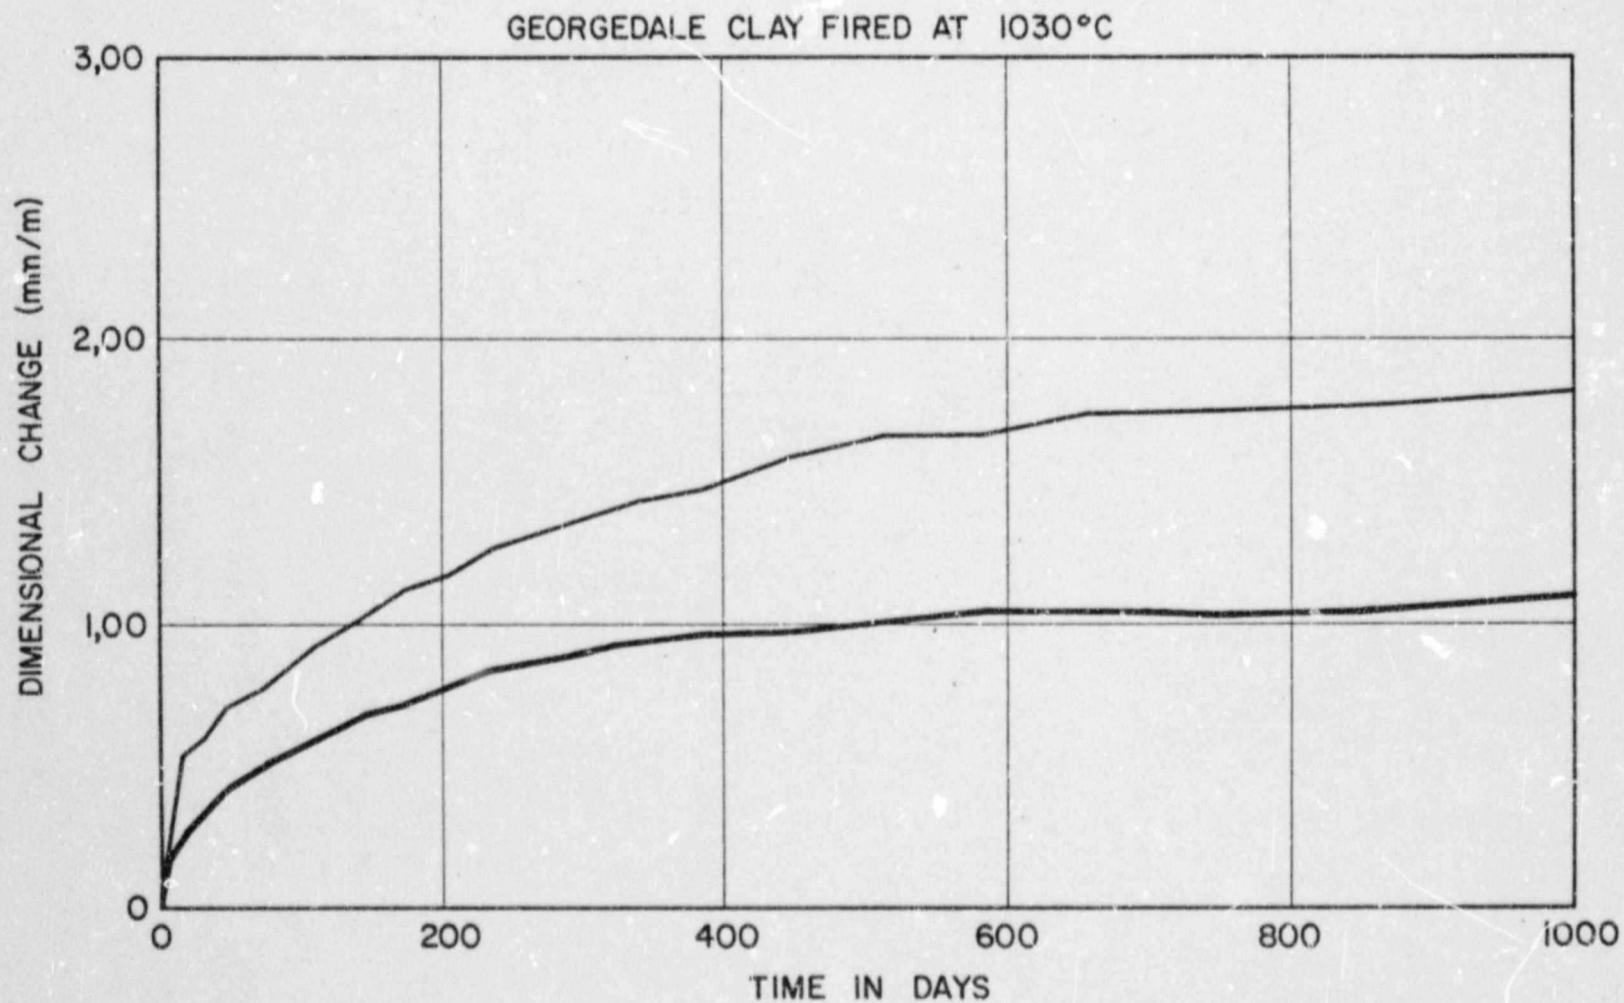
FIGURE 35  
*Brick in humidity room - load 10 MPa (1450 lb/in<sup>2</sup>)*

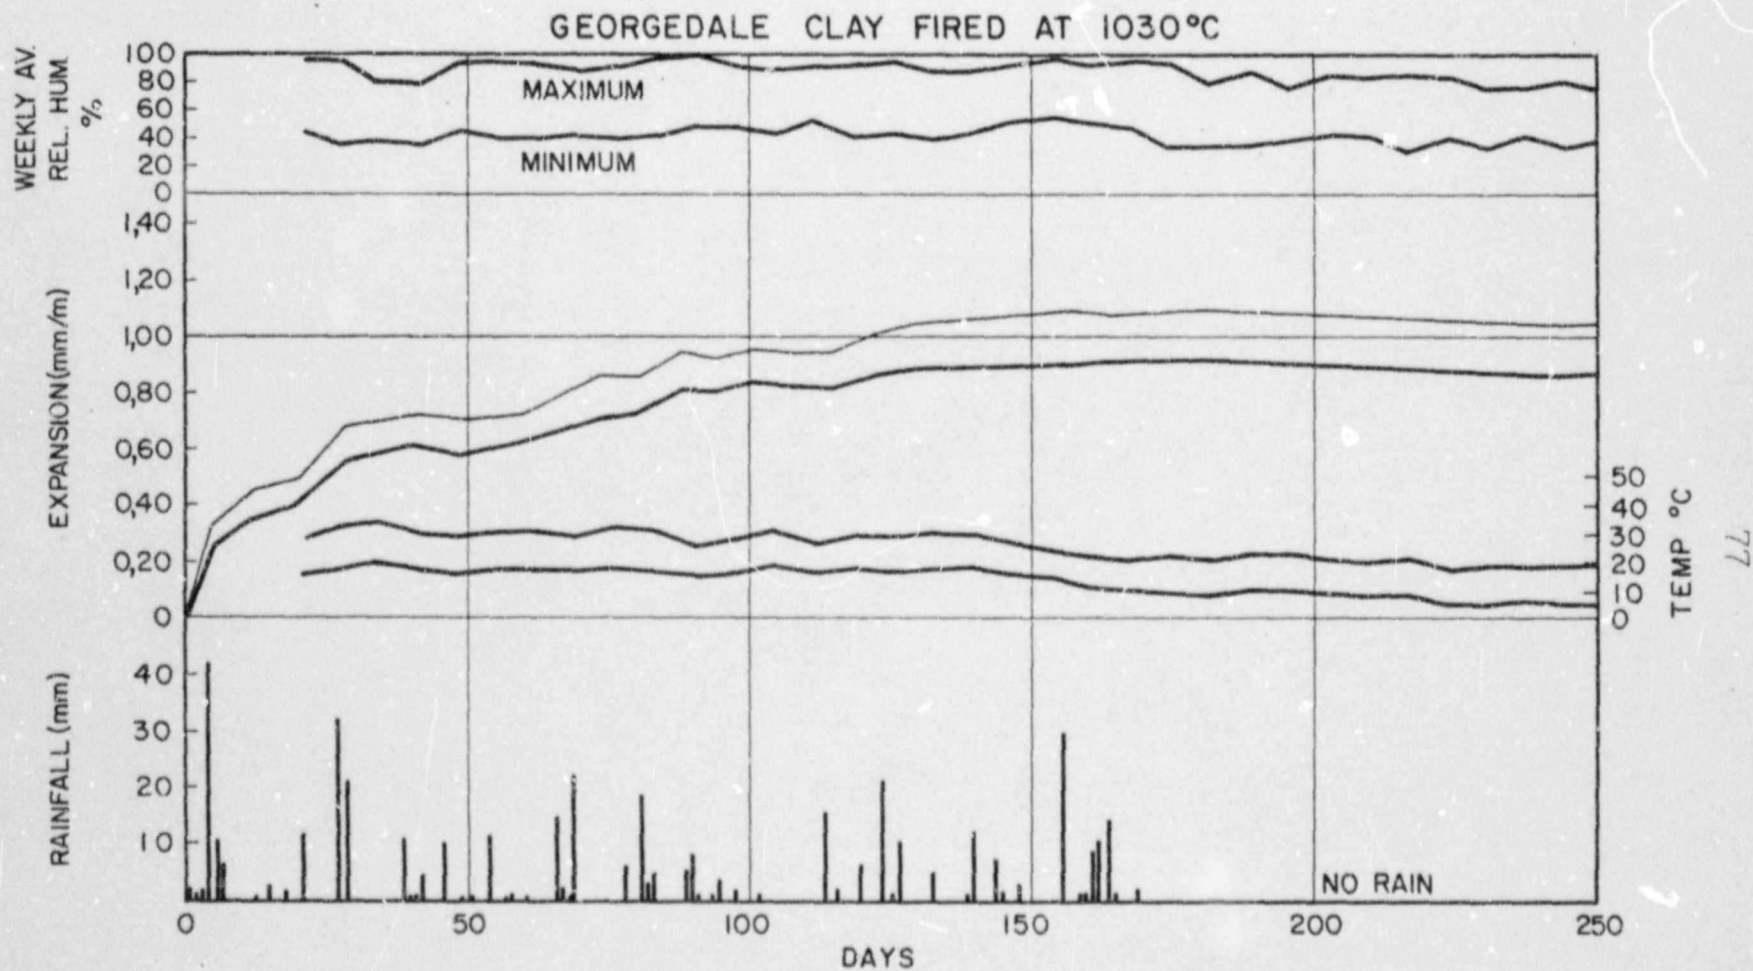
Figures 36 and 37 show the expansion of two Georgedale bricks fired at 1030 °C, loaded to 0,7 MPa and exposed to the weather on the roof. Their expansion patterns are seen to be almost identical for the 250 days they are compared. Their expansions are also almost identical to those of the unloaded Georgedale bricks fired at 1030 °C and exposed on the roof. The loaded bricks also reduced in length with the onset of the cold dry weather and increased in length when the wet warmer weather started. See Figure 38. The flat portion

FIGURE 36  
*Brick exposed on roof - load 0,7 MPa*

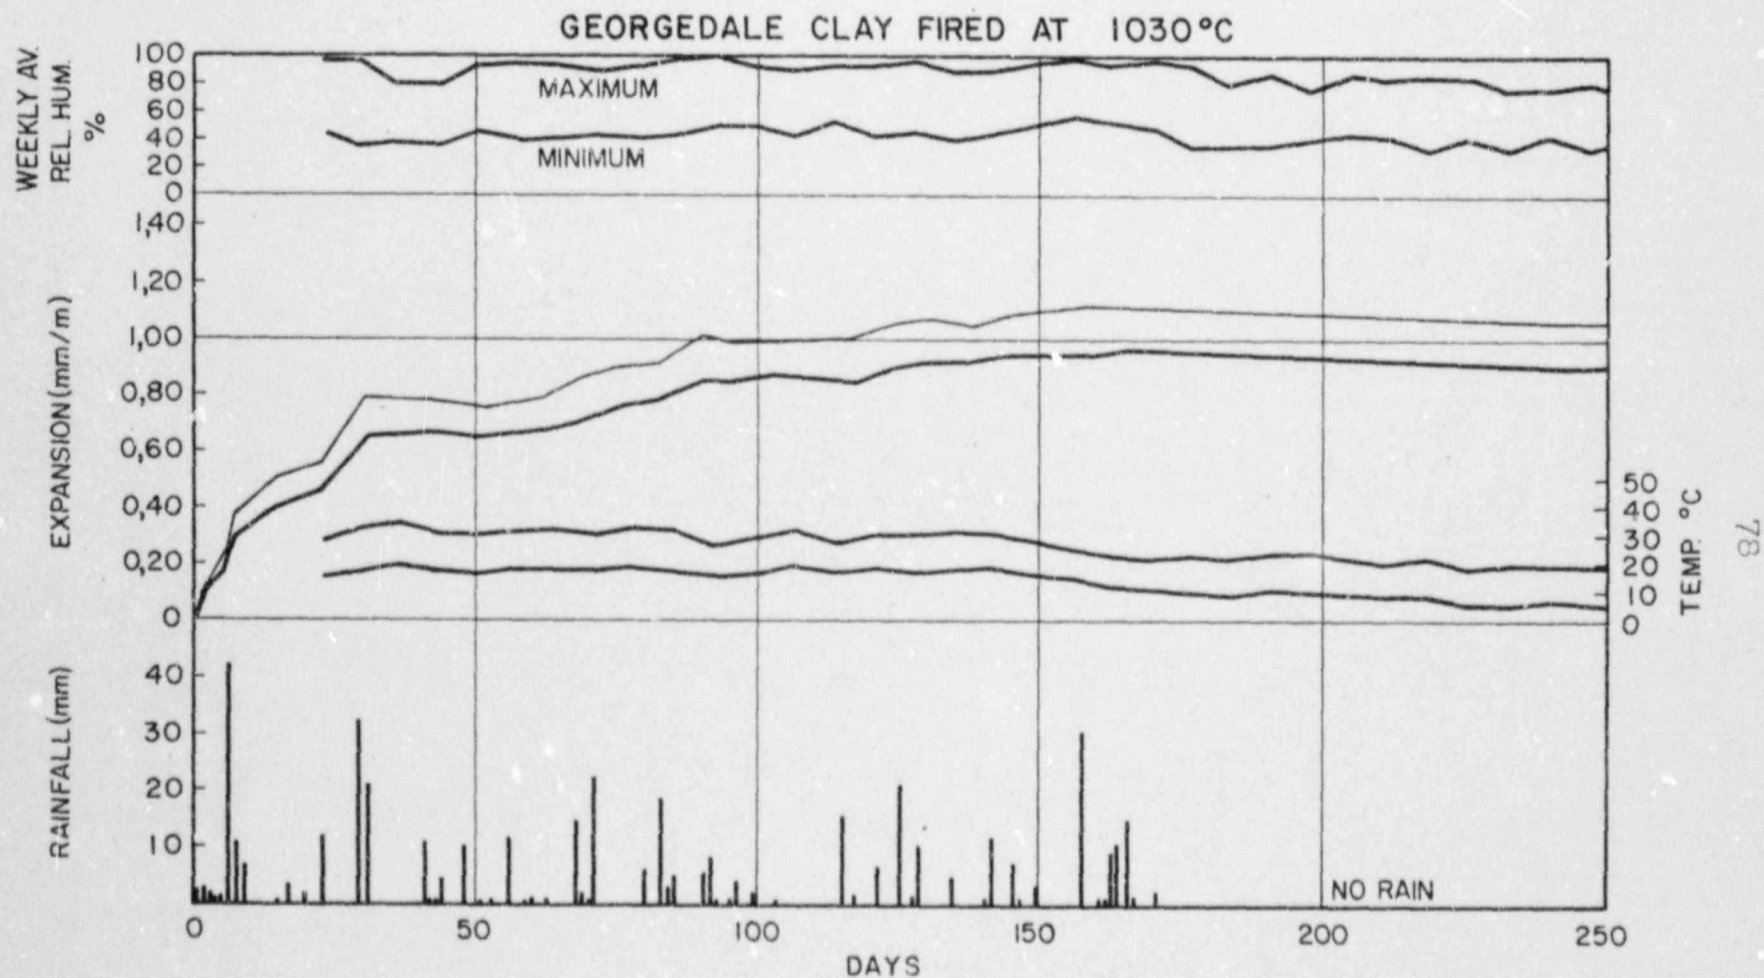
**FIGURE 37**  
*Brick exposed on roof - load 0,7 MPa*

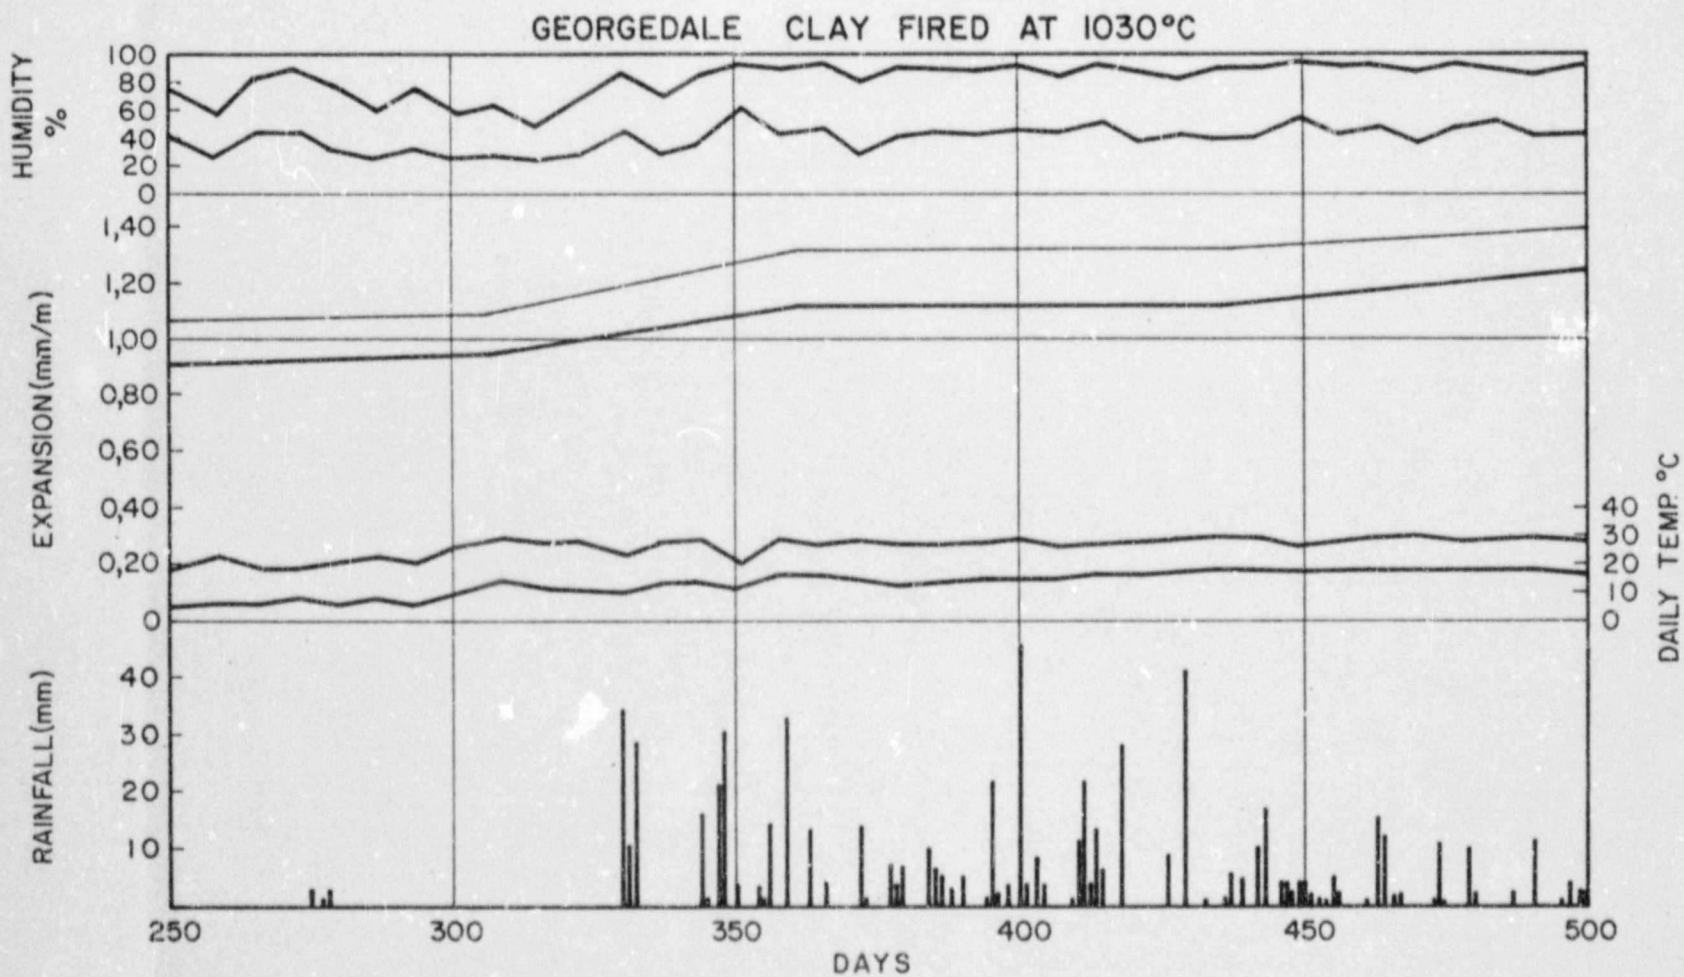
FIGURE 38  
*Brick exposed on roof - 0,7 MPa (101LB/IN<sup>2</sup>) load*

of the graph during the height of a particularly wet period was probably due to the reduced number of hours of sunshine and thus less radiant heating of the bricks in spite of the warm air conditions shown on the graph. It is seen that when the rain reduced after 450 days and the minimum temperatures increased there was again an expansion. The behaviour of the loaded and unloaded bricks is compared on Figure 39 where the closeness of their behaviour is demonstrated. When a brick is not loaded both the transverse and longitudinal moisture expansion strains are similar, but when loaded the transverse strain becomes higher.

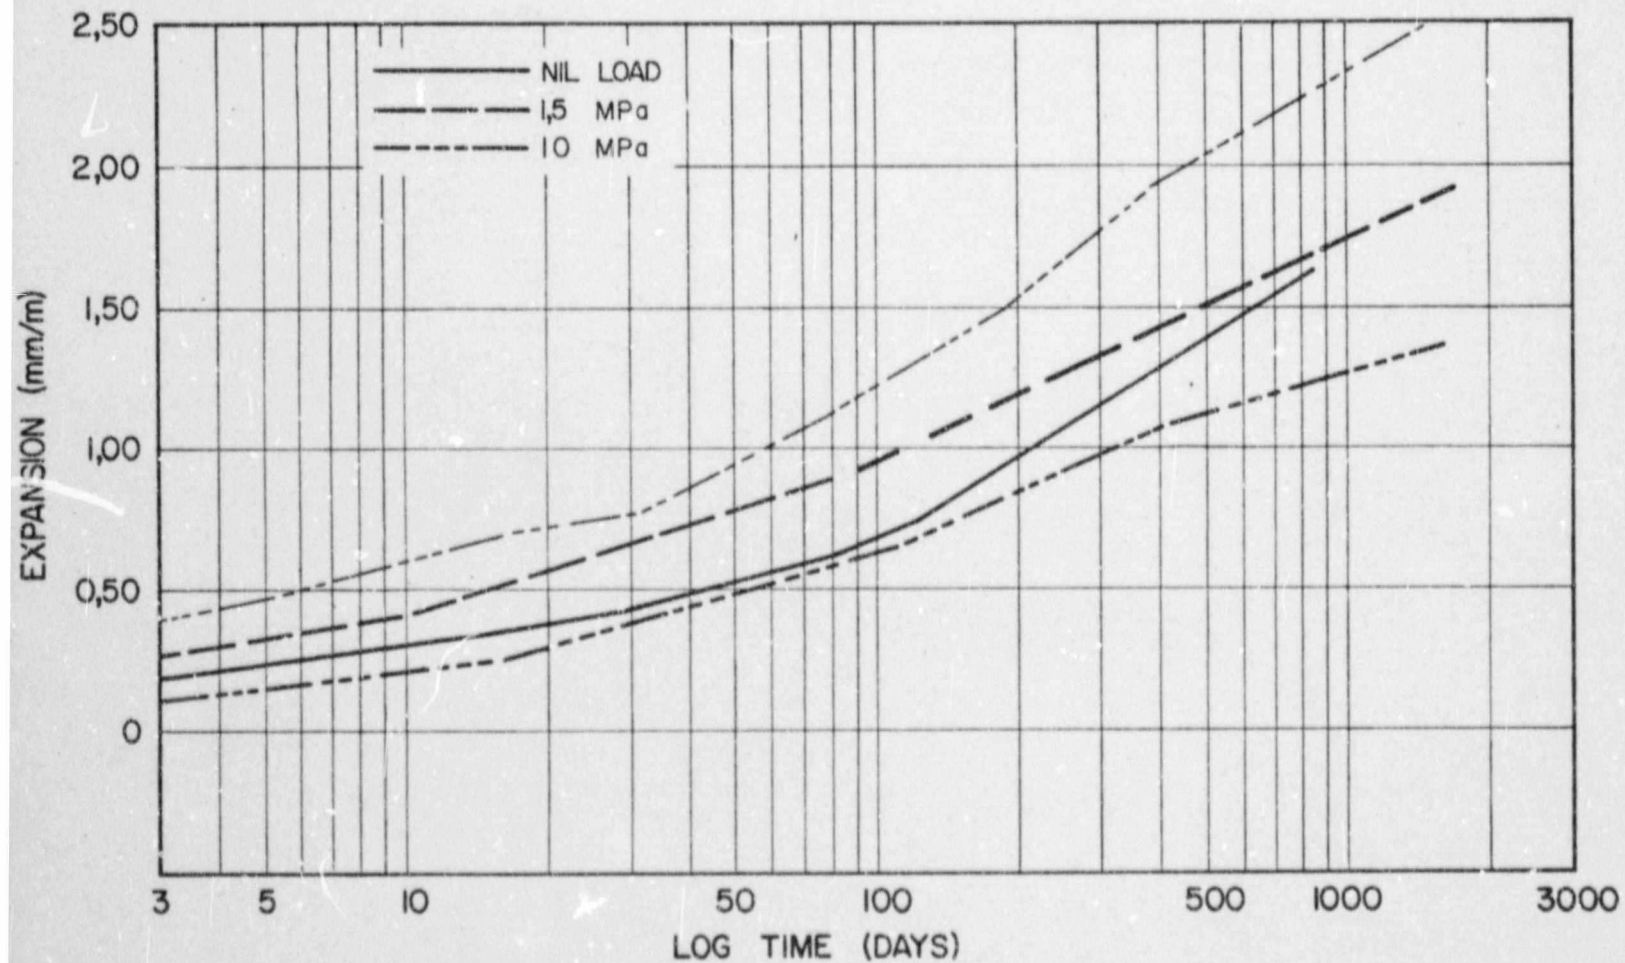
FIGURE 40

Three George Dale bricks fired at 1030 °C were exposed in the fog room under three loading conditions, viz. not loaded and loaded to 1,5 and 10 MPa. These bricks are compared on Figure 40. It is surprising that the unloaded brick had such a low initial expansion when compared with the loaded bricks but this was an average of the expansions of three bricks and the 10 MPa the average of two bricks. Although the loads did not apparently do much to prevent expansion, the increased expansion of the unloaded brick on the log-time scale after 100 days appears to have been suppressed to a large extent in the loaded bricks.

*Georgedale clay bricks fired at 1030°C: different loads in fog room.*

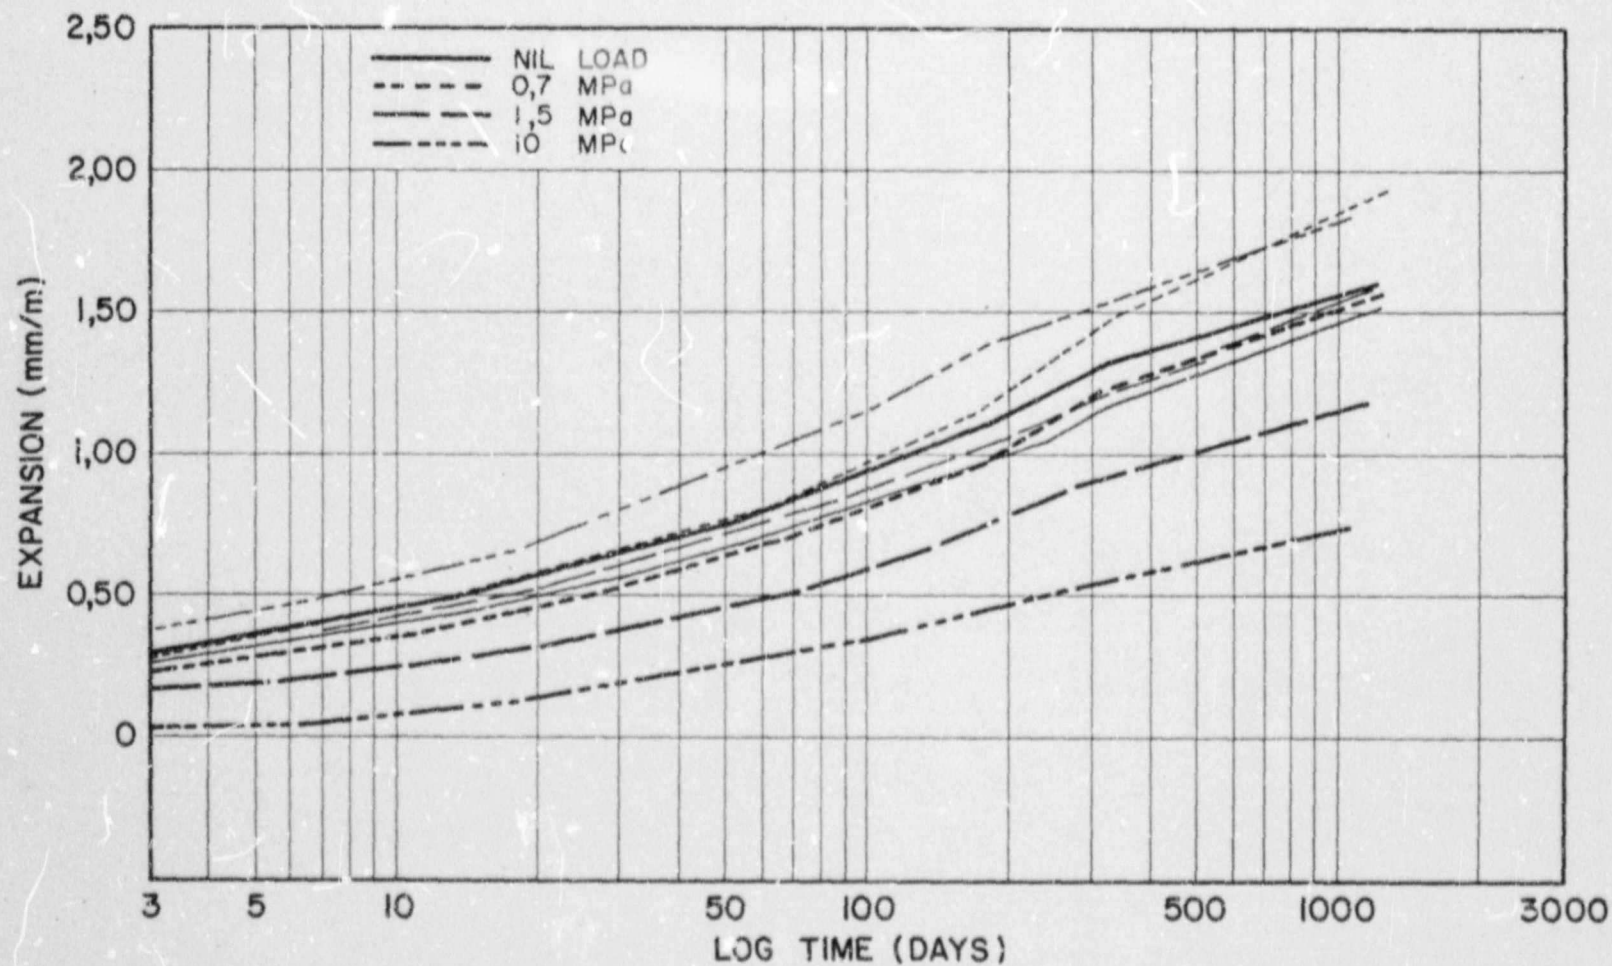
FIGURE 4I

Bellville bricks fired at 1020 °C were placed in the fog room under four different compressions, viz. nil load, 0,7 MPa, 1,5 MPa and 10 MPa. Figure 41 shows the expansions of these bricks. The higher the compression the less the expansion was. The slight discontinuities in the curves between 200 and 300 days were because of a temporary breakdown of the machinery controlling the temperature and humidity of the humidity room. This information is also presented on Figure 42(b) where expansion is plotted against

*Bellville clay bricks fired at 1020°C: different loads in fog room*

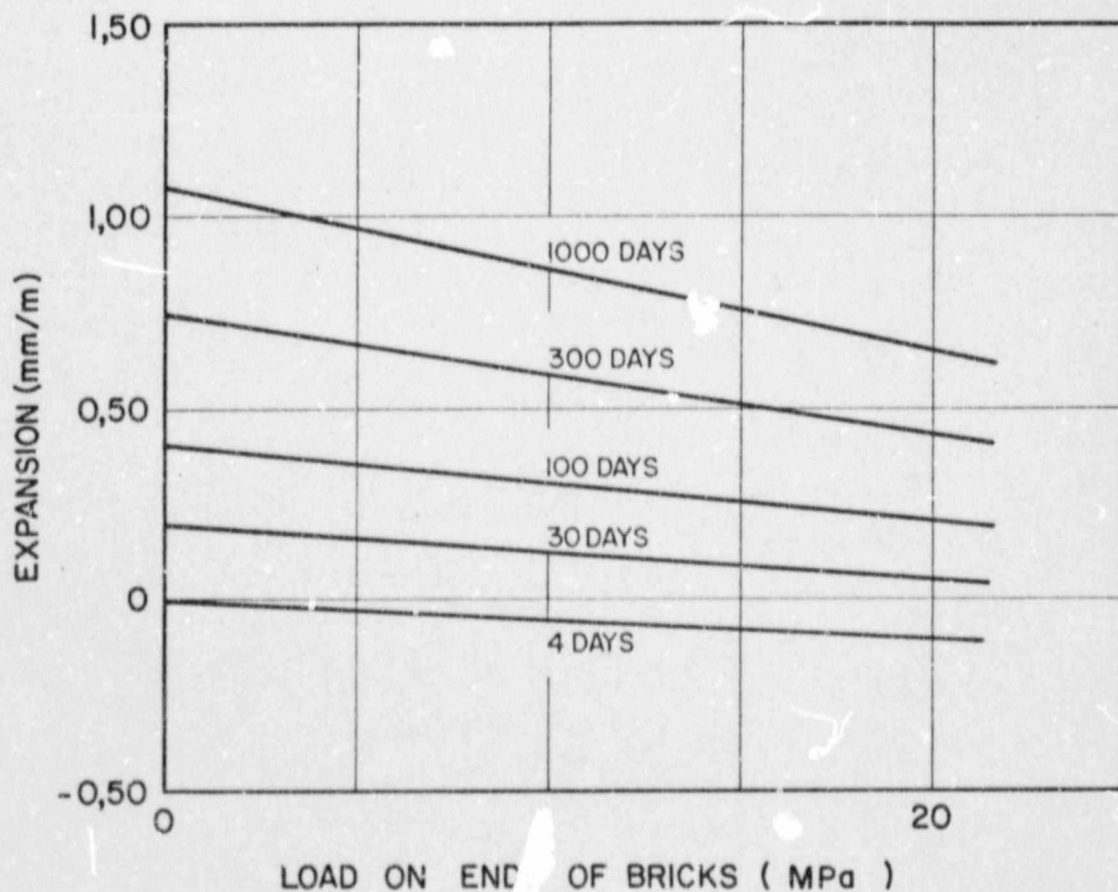
(a) ON ROOF

*Expansion of Bellville bricks under load*

The above expansions were plotted against log time on Figure 47 and the effect of cold dry periods can be clearly seen by the dips in the graphs. On Figure 42(a) the expansion has been plotted against the stresses in the bricks but the bricks loaded to 0,7 and 1,5 MPa have been ignored because of the closeness of their expansions to those of the unloaded bricks and because the 1,5 MPa stress caused less restraint on the expansion than the 0,7 MPa stress, an unlikely state of affairs. At 1000 days the heavily loaded brick had expanded 70% of the expansion of the unloaded brick. Thus high restraint on the Bellville bricks has only a small effect on the expansion. In other words under stresses close to the failing stresses the bricks continued to expand a large amount as is shown on Figure 48. The two loaded bricks had expanded very similar amounts up to 100 days but the initial transverse expansion of the one brick was very high and after 30 days started increasing so rapidly that it would have failed if it had not been removed from the frame. This indicates that the bricks were loaded close to their long-term ultimate strength.

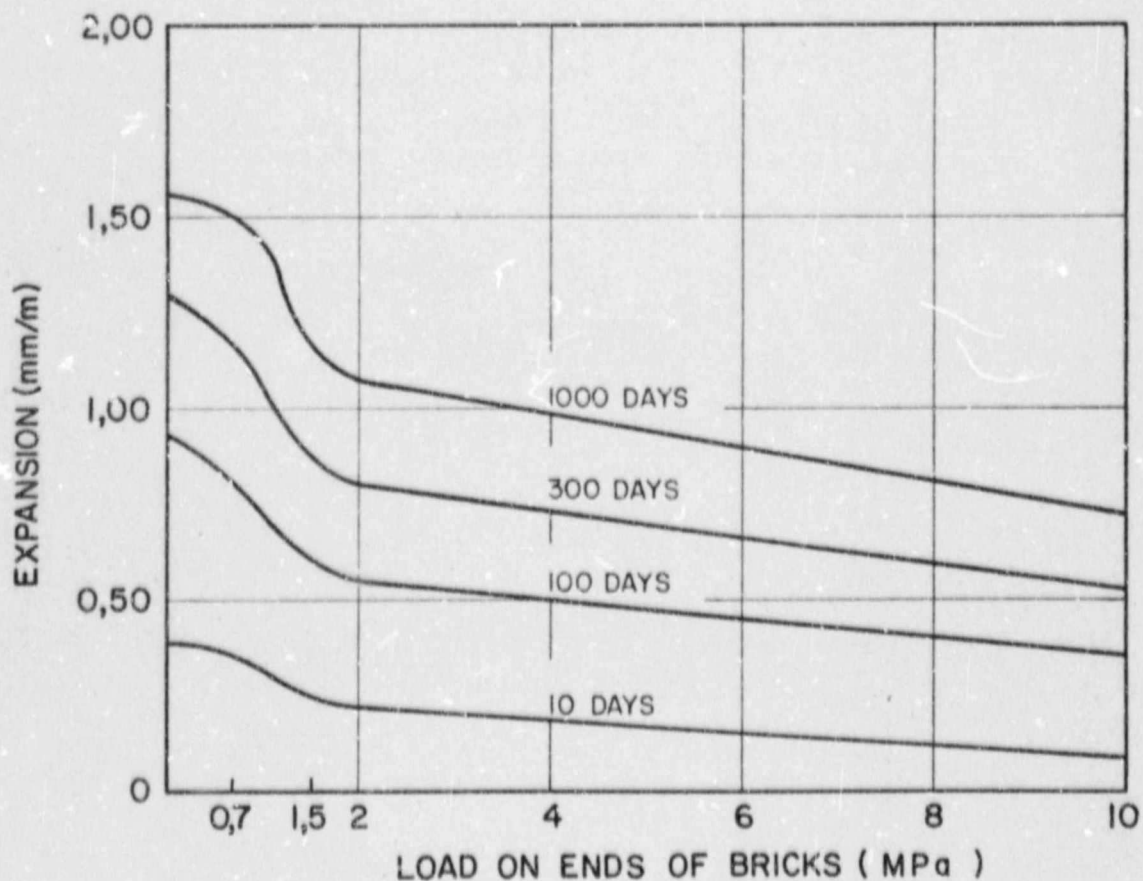
(b) IN FOG ROOM

the load on the ends of the bricks for different periods of exposure in a moist atmosphere. For light stresses up to 2 MPa there is a reduction of expansion of up to 40% over the first 300 days, but this reduces to about 30% at 1000 days. At a compression of 10 MPa there is a reduction of expansion from 80% at 4 days to 55% at 1000 days.

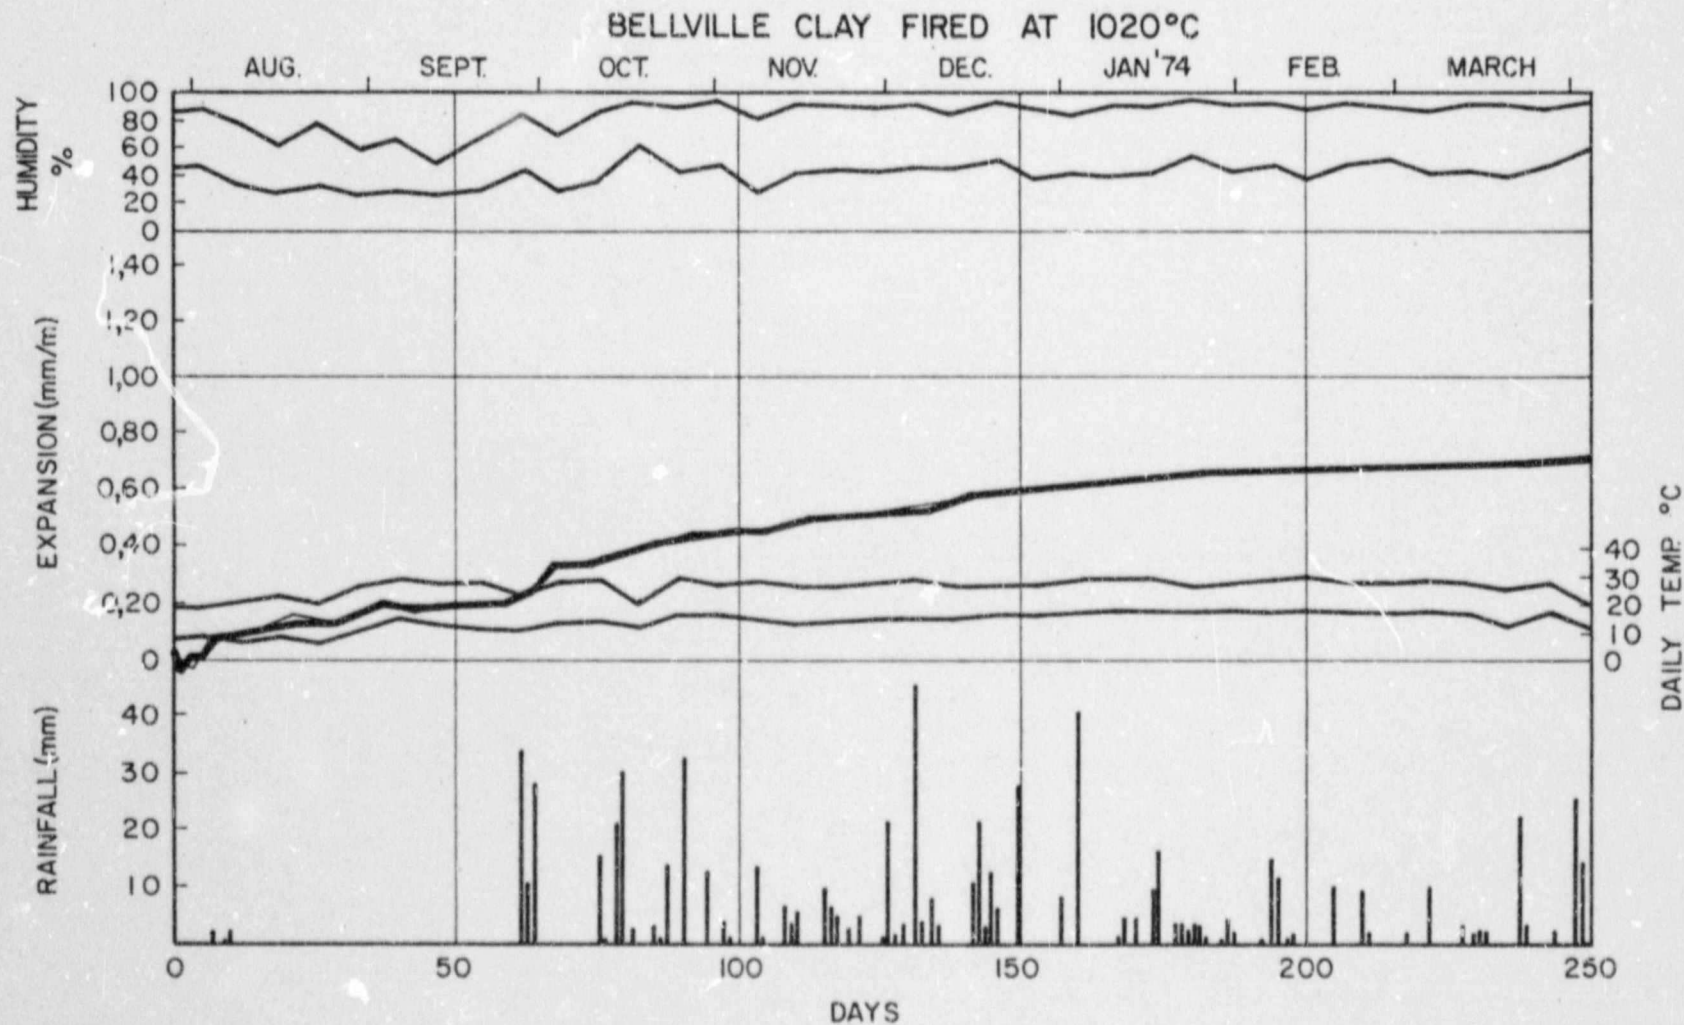
FIGURE 43

Bellville bricks fired at 1020 °C were exposed on the roof within a day of each other under four loading conditions, viz. nil load, 0,7, 1,5 and 20 MPa. Figures 43 to 46 show the first 250 days expansion plotted against time. Information is given on these graphs on daily rainfall, maximum and minimum daily temperatures and maximum and minimum daily relative humidities. The effect of the weather conditions on the expansions can be seen. After relatively low expansions during the dry period just after exposure, a sharp increase in expansion took place as soon as the bricks were wetted by three consecutive good rainfalls and throughout the warm wet periods the expansions continued at a slightly decreasing rate. The initial reduction in length was due to the temperature of the laboratory in which the zero readings were taken being warmer (22 °C) than the conditions on the roof when readings were taken early the next morning (8 °C). In the case of the brick stressed to 20 MPa it was subject to a noticeable creep over the first few days and then a slower creep during the next 20 days, after which the expansions became greater than the continuing creep. The bricks without loads and the bricks with loads of 0,7 and 1,5 MPa expanded about the same amount so that these loads had little effect over the first 250 days, but the brick stressed to 20 MPa had its expansion considerably reduced, being at 250 days about 40% of that of the bricks without loads, but if the obvious creep is allowed for the expansion is 55%. Again the marked effect of load on the transverse expansions can be seen, being the same as the

*Brick exposed on roof - no load*

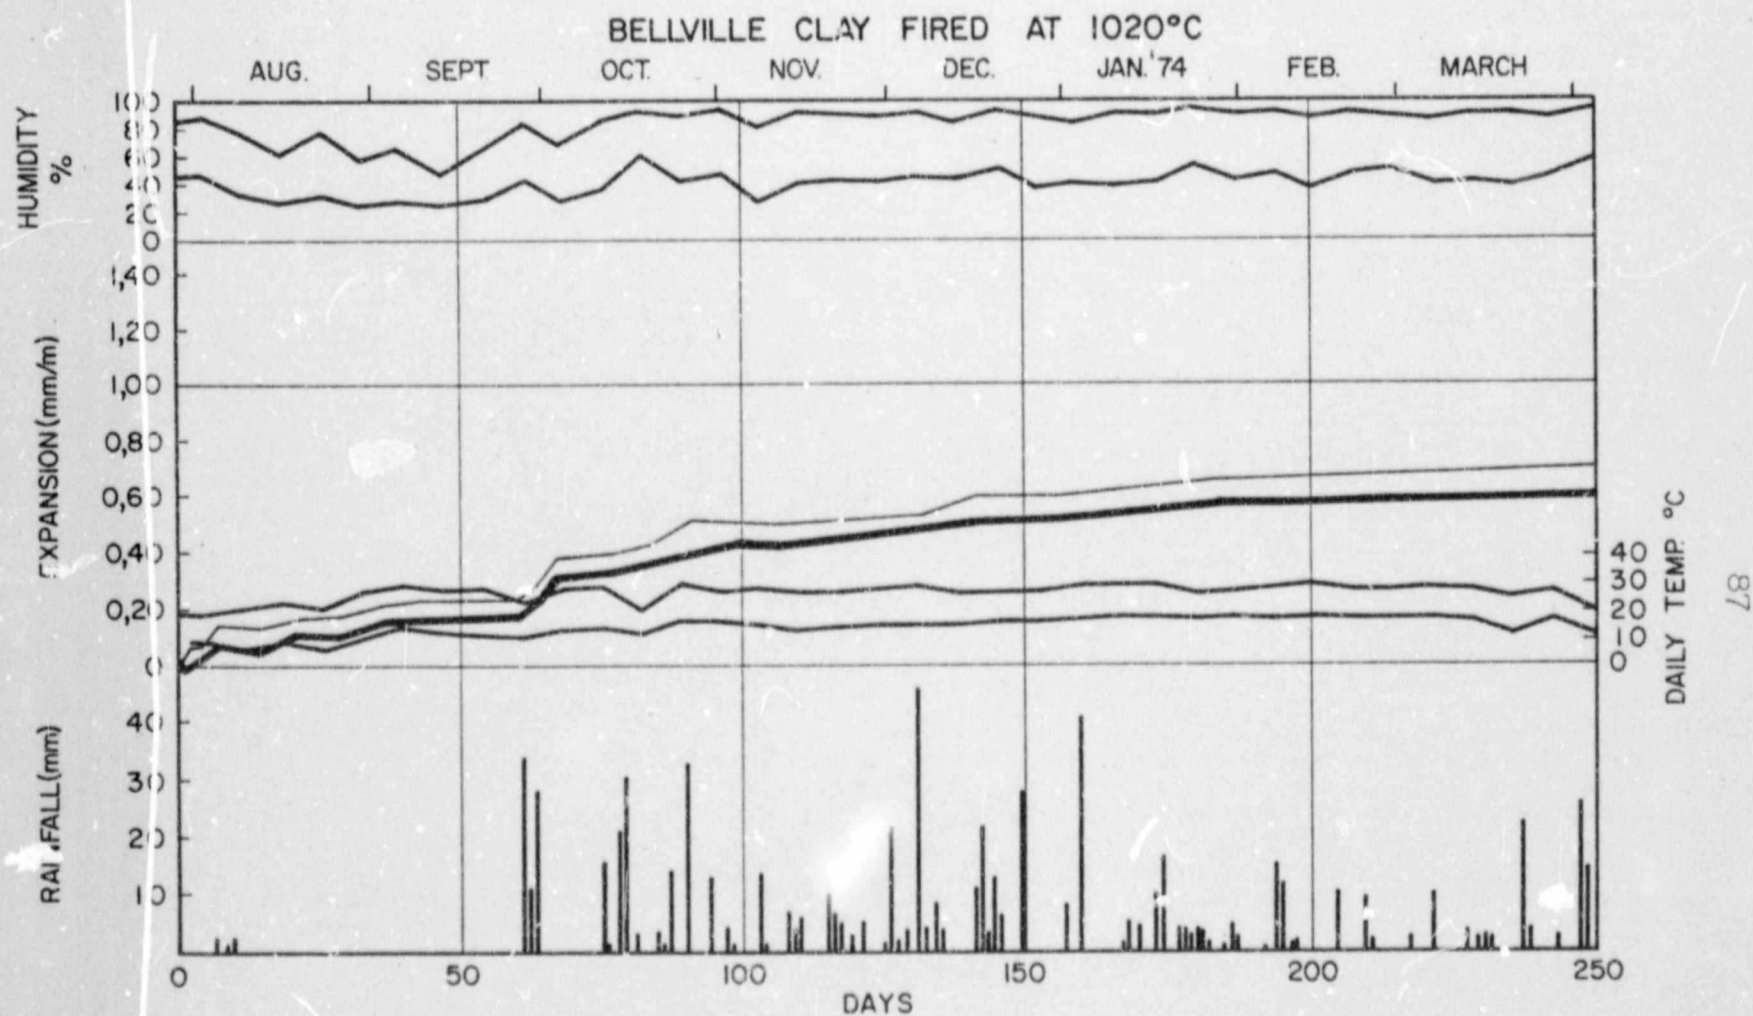
FIGURE 44

*Brick exposed 0.7 roof - 0.7 MPa load*

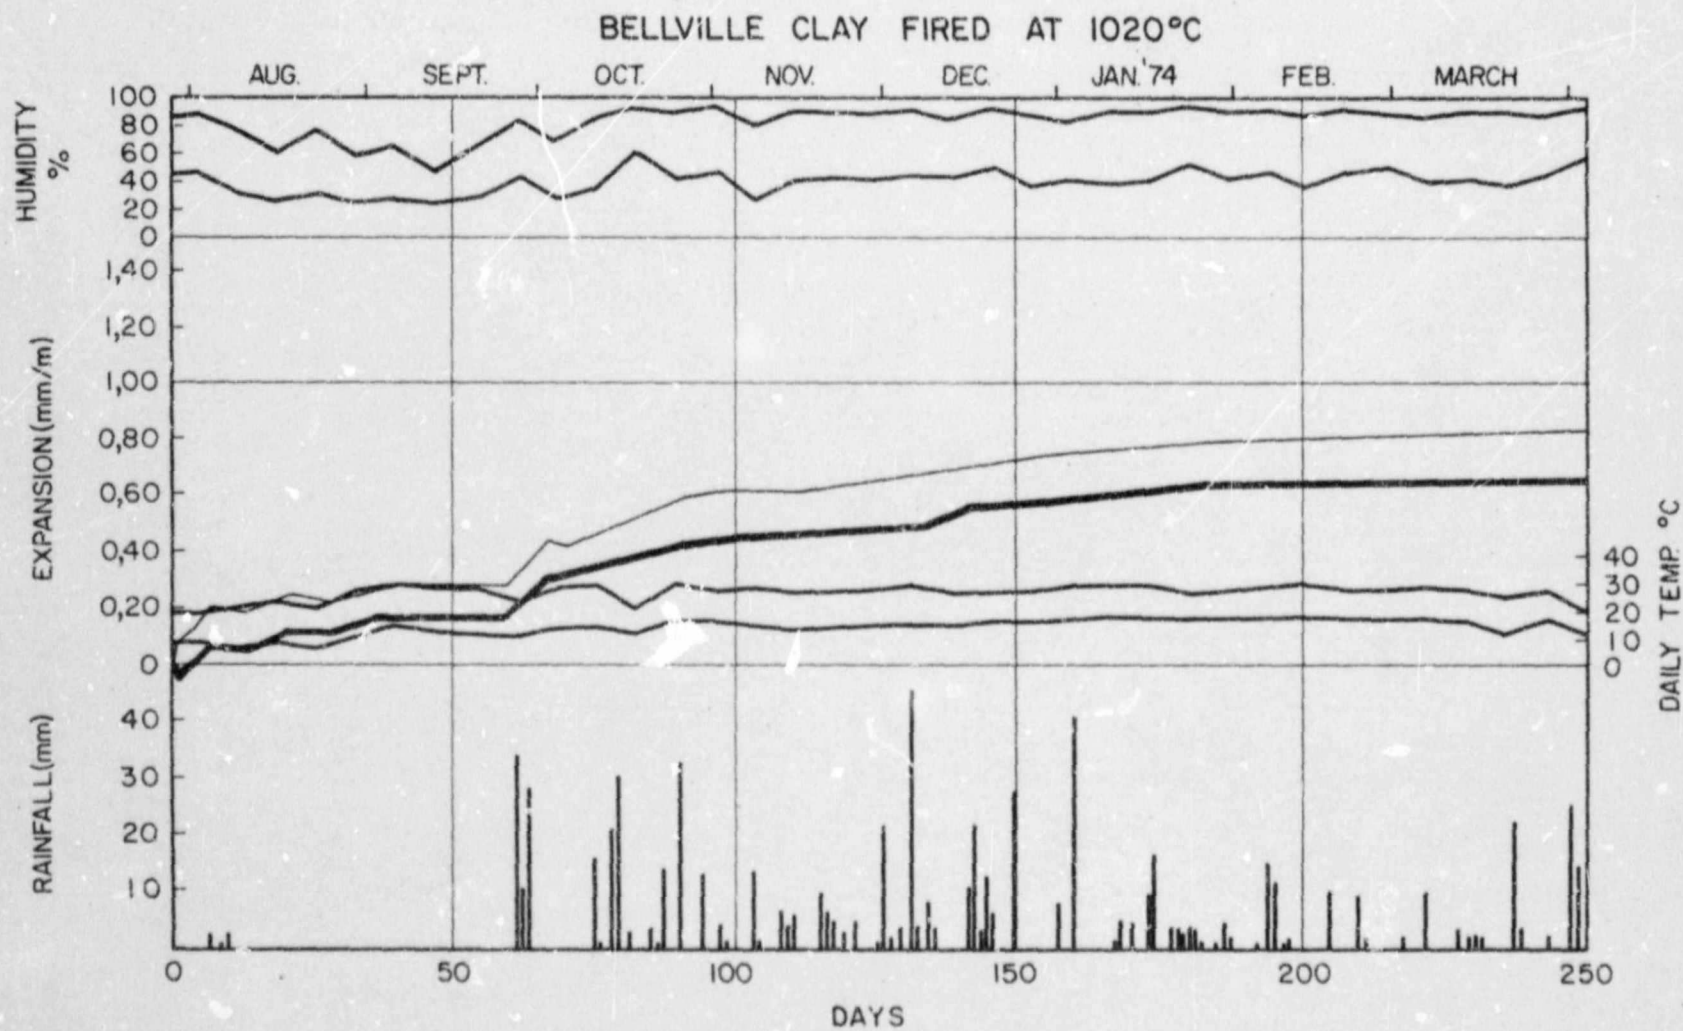
FIGURE 45

*Brick exposed on roof - 1,5 MPa load*

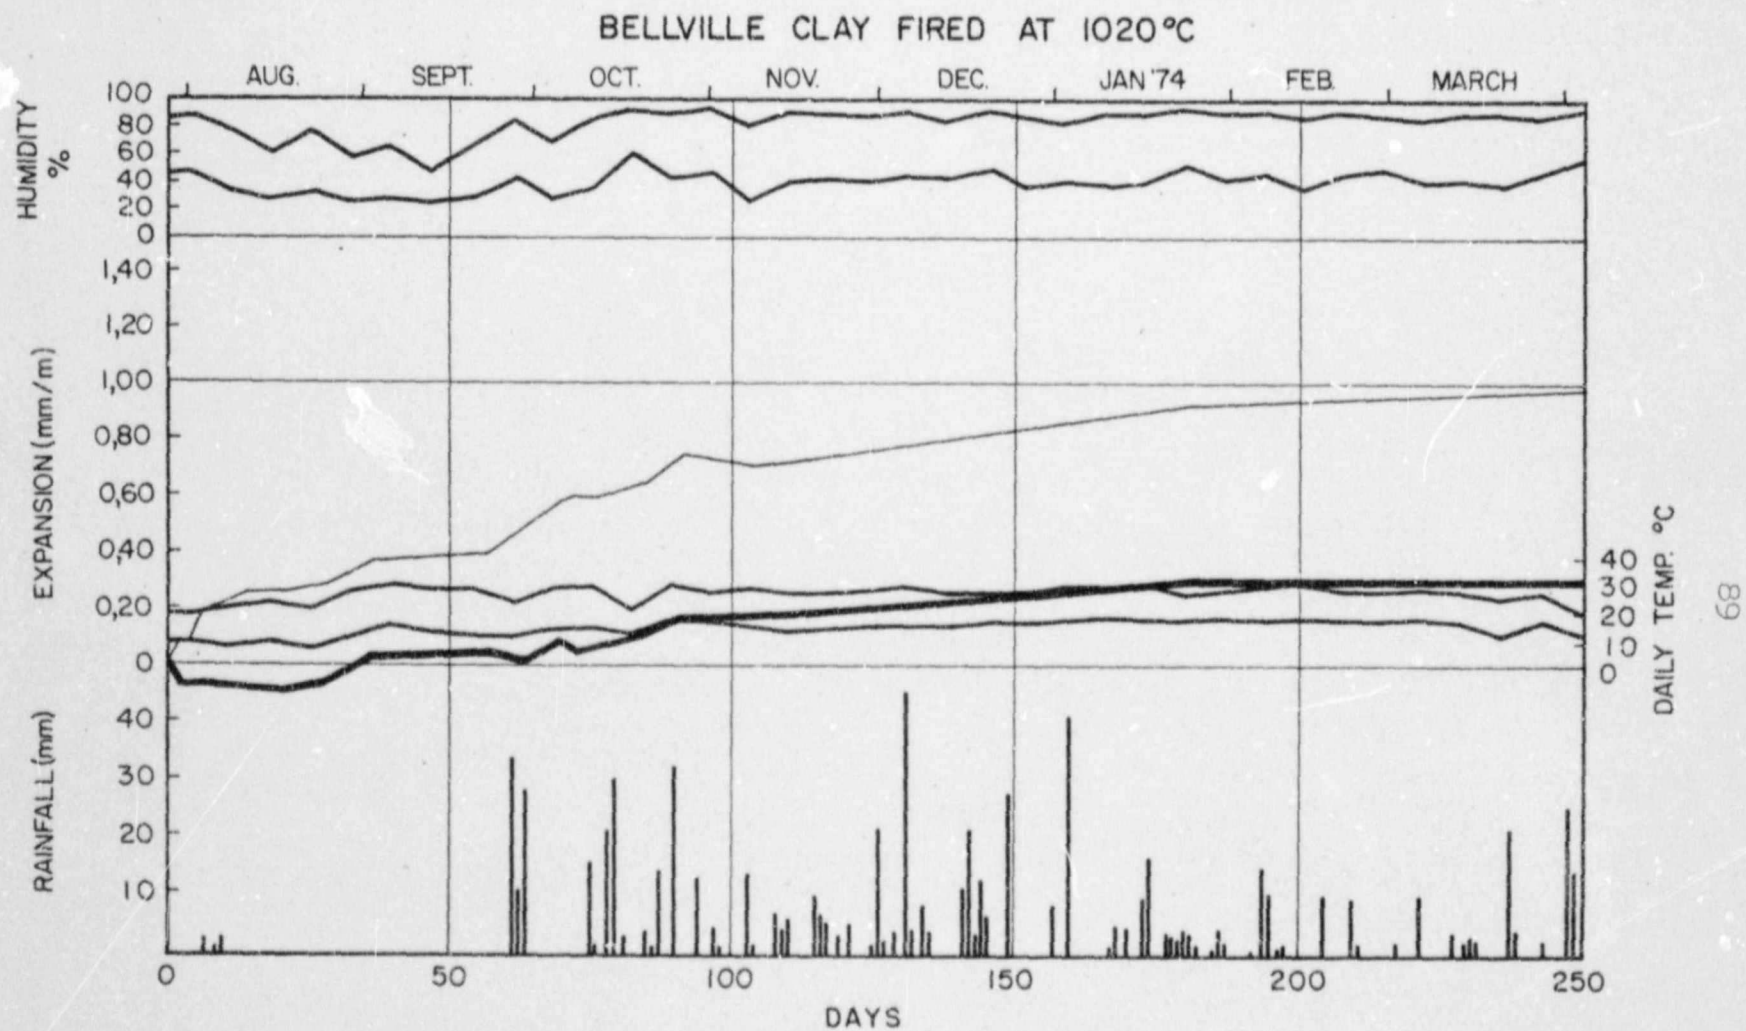
FIGURE 46  
*Brick exposed on roof -20 MPa load*

longitudinal expansion under nil load and becoming increasingly greater as the loads increased.
