CHAPTER 6ANALYSIS OF CRACK IN BEAM TO COLUMN JOINT6.1 Description of Building and Cracks

**Author** Boardman Vivian Reginald

**Name of thesis** The Effect Of Compressive Stress On The Expansion Of Brickwork And Its Implication In Buildings. 1977

University of the Witwatersrand, Johannesburg

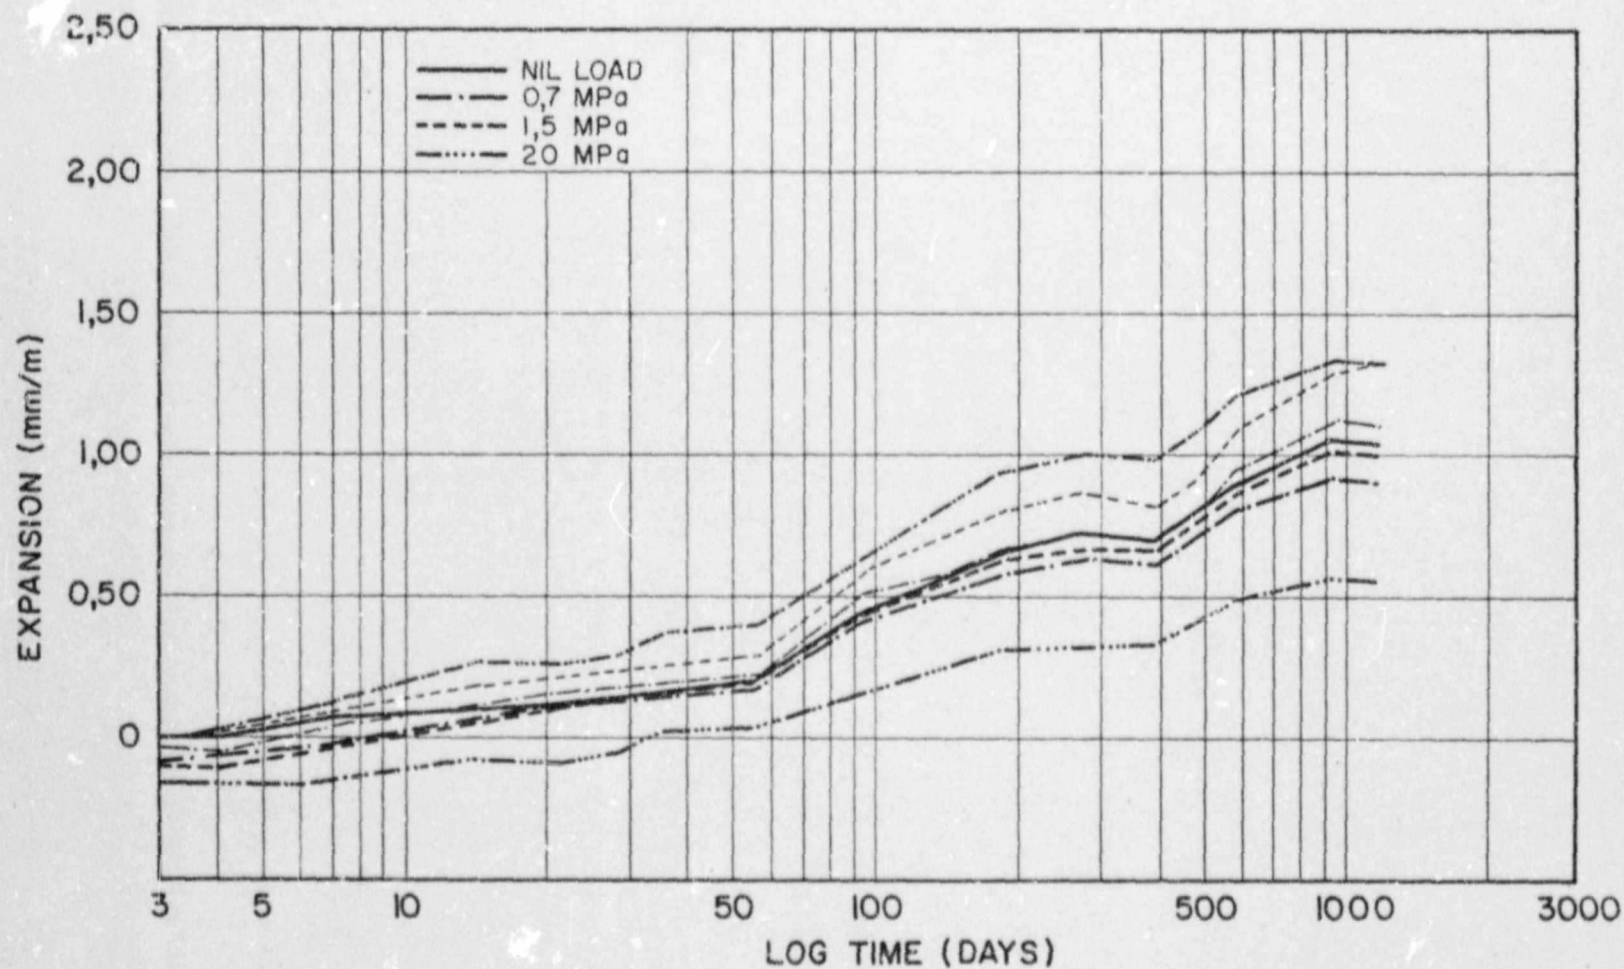
FIGURE 47

The above expansions were plotted against log time on Figure 47 and the effect of cold dry periods can be clearly seen by the dips in the graphs. On Figure 42(a) the expansion has been plotted against the stresses in the bricks but the bricks loaded to 0,7 and 1,5 MPa have been ignored because of the closeness of their expansions to those of the unloaded bricks and because the 1,5 MPa stress caused less restraint on the expansion than the 0,7 MPa stress, an unlikely state of affairs. At 1000 days the heavily loaded brick had expanded 70% of the expansion of the unloaded brick. Thus high restraint on the Bellville bricks has only a small effect on the expansion. In other words under stresses close to the failing stresses the bricks continued to expand a large amount as is shown on Figure 48. The two loaded bricks had expanded very similar amounts up to 100 days but the initial transverse expansion of the one brick was very high and after 30 days started increasing so rapidly that it would have failed if it had not been removed from the frame. This indicates that the bricks were loaded close to their long-term ultimate strength.

*Bellville clay bricks fired at 1020°C: different loads on roof*

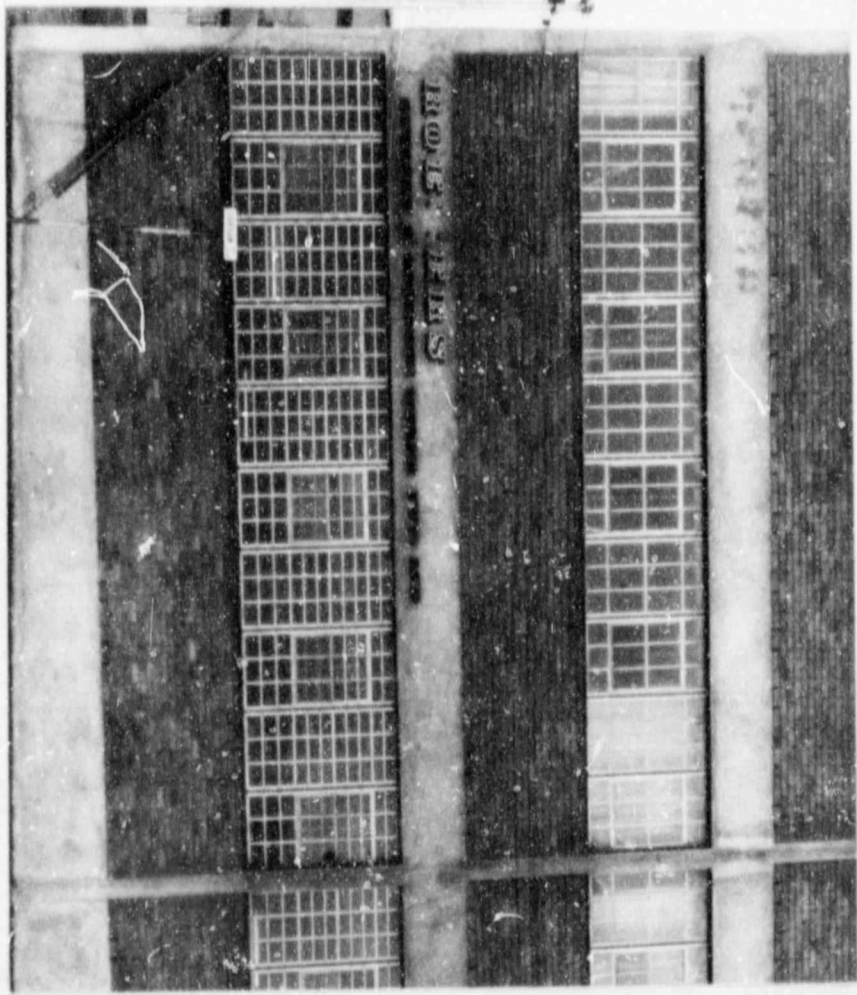
The building, a portion of which is shown in Figure 52 is a reinforced concrete frame building with brick infilling panels. The building stands on the corner of two streets and the external walls facing onto these streets consist of brick walls about half the height of and between the columns of each storey with a continuous band of fenestration from the top of the brick walls to the underside of the concrete beams above. The two external walls bounding other properties are brick infilling walls in the concrete frame with a few small windows let into the walls on the upper storeys.

FIGURE 52. Portion of building analysed.
