**THE LOCATION, HAZARD ASSESSMENT AND SEALING OF  
UNSAFE MINE OPENINGS IN THE CENTRAL  
WITWATERSRAND GOLD MINING BASIN**

A dissertation submitted to the Faculty of Engineering and the Built Environment, University of the Witwatersrand, in fulfilment of the requirements for the degree of Master of Science in Engineering by research only

Johannesburg, 2009

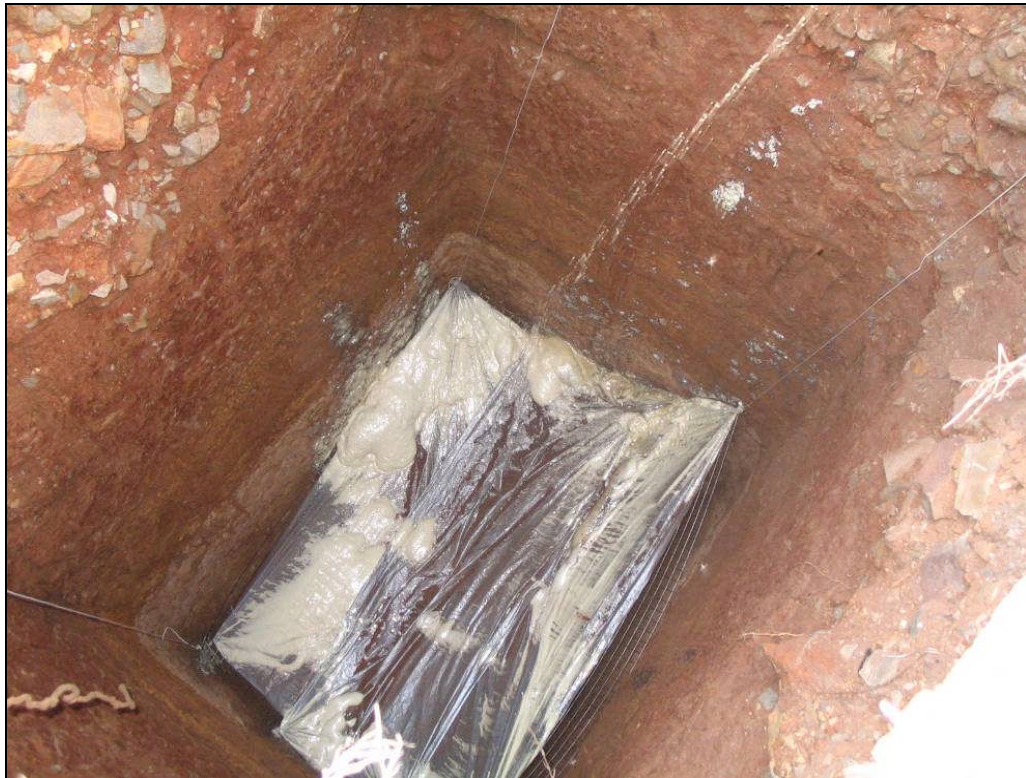
Figure 5.4: Base of plug being lowered into position

A layer of wire mesh (5mm thick strands), covered by a sheet of thin (20 micron) plastic was lowered by ropes to the appropriate depth to form the base of the plug (Figure 5.4). PUF was then produced on surface using a mechanical mixer with an applicator nozzle system which was supplied by the contractor (McArthur's Packaging). As far as could be ascertained this was the only known portable system available for hire in the Witwatersrand area. This system was chosen so that the foam could be mixed consistently, delivered quickly and placed accurately.

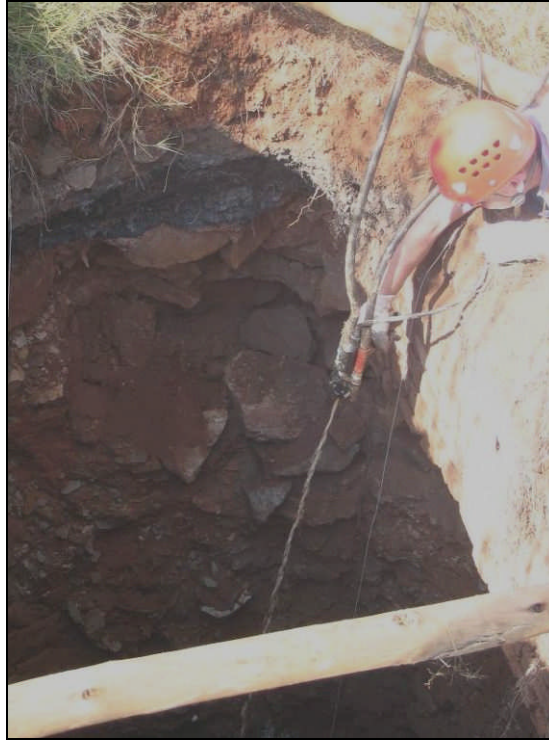
Figure 5.5: Thin stream of foam mixture being delivered from the applicator nozzle

The two components (the isocyanate and polyol resin) were mixed at a ratio of 1:1 respectively using an initial mix temperature of 60° C. This resulted in a 'cream time' of 15-20s at which point it was then discharged through the applicator nozzle, at a delivery rate of 3,2kg/min, into the hole, Figure 5.5. 'Cream time' is taken as the reaction time of the two components which results in the mixture changing from a clear liquid to an opaque, creamy or viscous mixture.

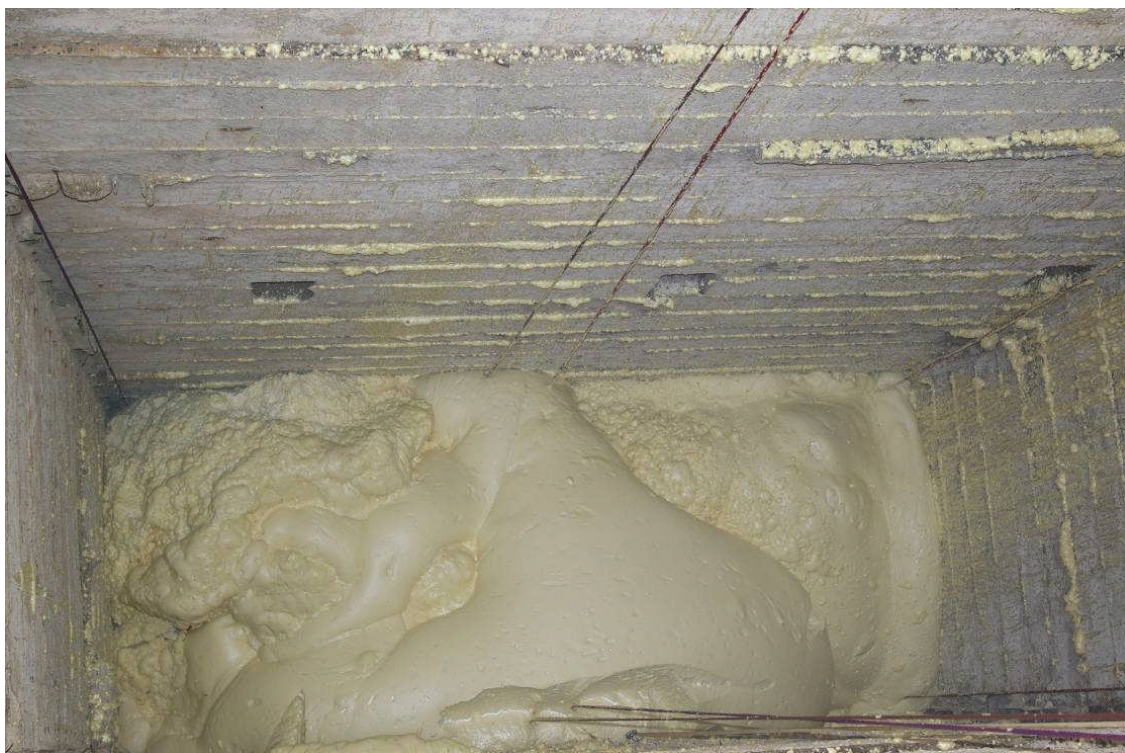
Figure 5.9. S & J 15B: PUF plug being created in mine shaft

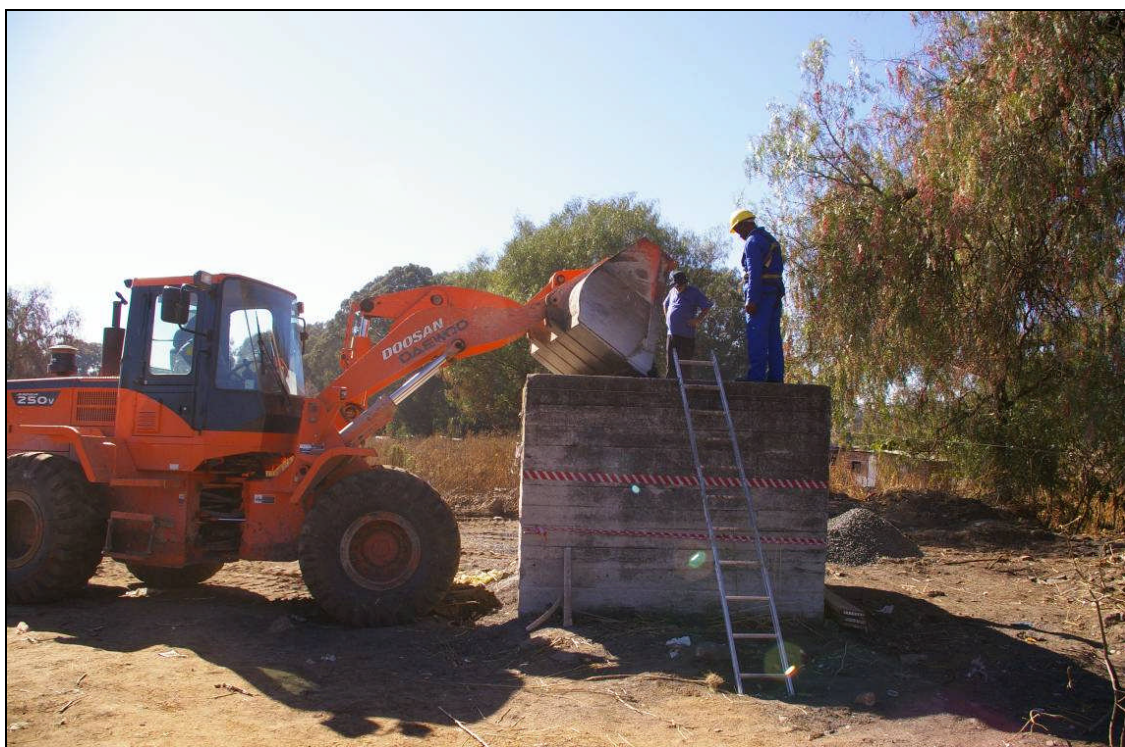
4. It was initially hoped to use water to load the foam plug but a watertight seal could not be achieved so concrete gravel (19mm) was used instead. A front end loader was used to place the stone in the shaft (Figure 5.10). Care had to be taken when placing the gravel with the front end loader not to drop it from height and cause damage to the foam which is vulnerable too puncturing. A thin layer of gravel was thus initially hand placed before using the front end loader.

5. Measured amounts of gravel were then continually added to induce failure. However even after the loading of a total of 36m<sup>3</sup> of gravel i.e a layer 2,8m thick and weighing 80tonnes, it was decided that the test be halted as failure had still not taken place.

Figure 5.10. S & J 15B: Gravel load being placed on PUF plug

6. As the PUF was only being used here on a test basis, the Consulting Engineer felt it prudent to seal this shaft with a 1,5m thick concrete plug which was placed in the upper portion of the shaft.

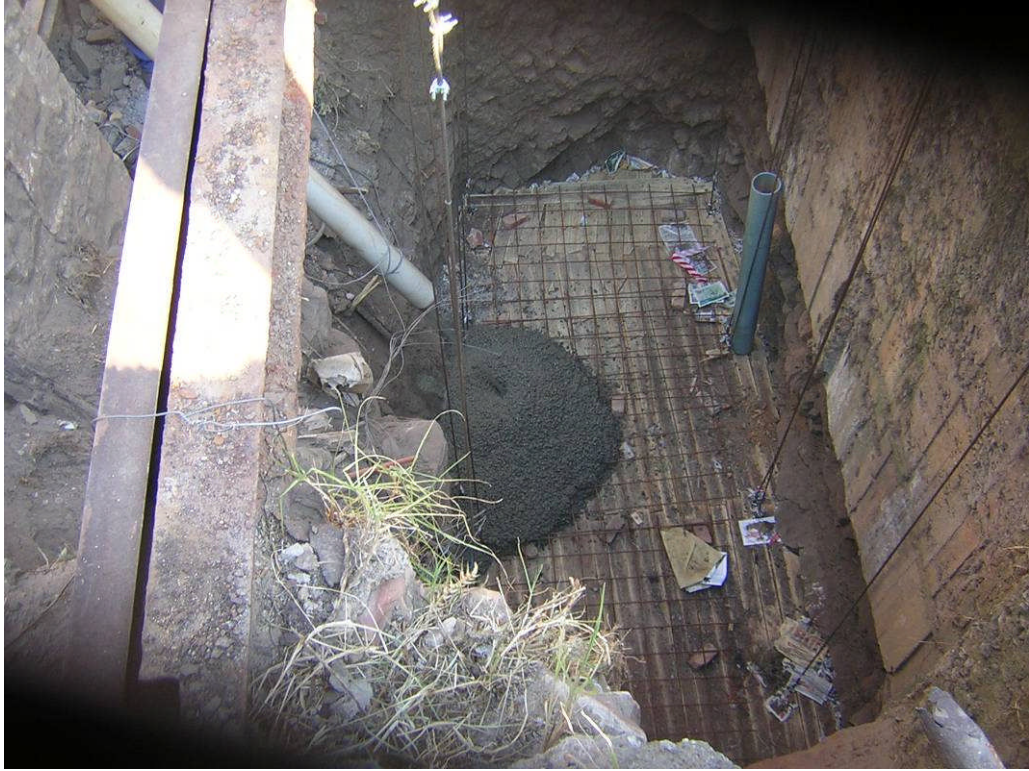
Figure 5.14. Sacrificial formwork, suspended by steel cables from steel girders, prior to the casting of the primary slab

at depth. This formwork consisted of a wooden platform that was suspended via steel cables from steel girders placed across the top of the opening. A 300mm primary, reinforced (10mm diameter steel at 200mm centres with two layers of Ref.617 mesh), slab was then cast onto the suspended formwork, Figure 5.12 , to provide a safe platform for the workers. Once this had achieved adequate strength (typically 24 hours), a secondary, thicker (600mm), similarly reinforced slab was then cast and allowed to cure for 48 hours. The insertion of these two reinforced slabs allowed for the creation of sufficient bearing capacity to carry the load of the successive layers (up to 3m) as they too in turn were allowed to cure. The wet concrete was delivered to the work surface via a chute. The main plug was then placed in 1m lifts until the design thickness had been achieved. A similar design was used for inclined shafts, Figure 5.13.

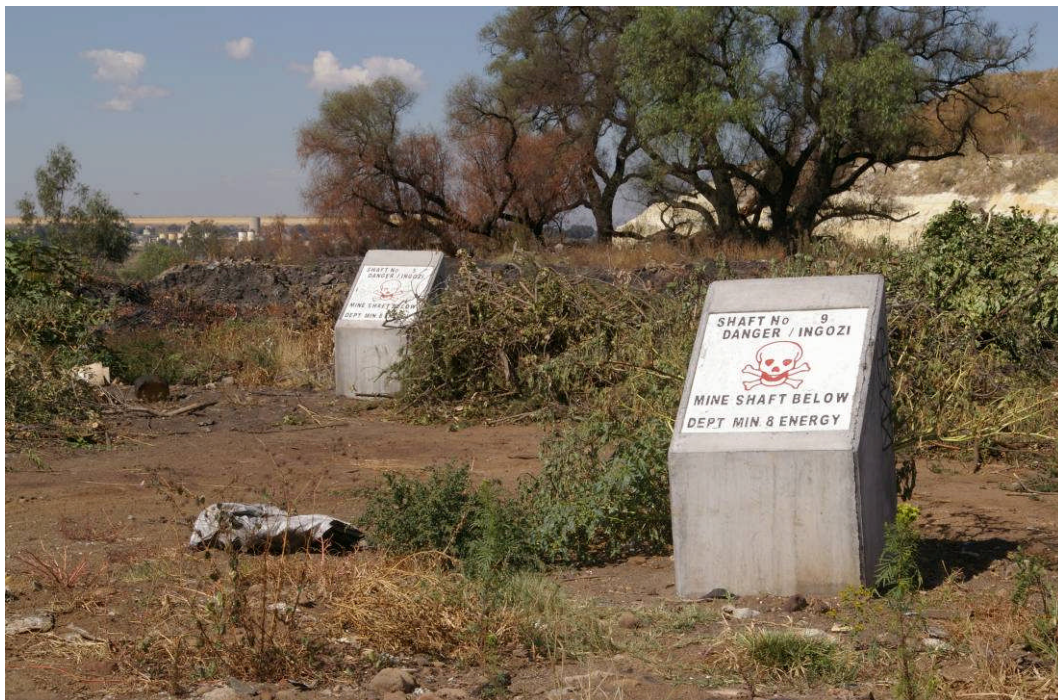
Figure 5.17. Typical landmark placed on sealing of a mine opening

This landmark consists of a 2,5ton, 30MPa strength concrete block, approximately 1,85m high and 0,9m wide which is placed on top of the domed surface of the newly sealed mine opening, Figure 5.17. It thus is sufficiently hard and heavy to ensure that criminal attempts to remove it or deface it will be very difficult. It is hoped that this will ensure longevity. A graphical depiction of a mining headgear is recessed onto the side of the landmark to indicate to all persons, irrespective of their reading capabilities, that some sort of mine hole is beneath this monument. The official hole number is also encribed as well as reference to the Dept. Minerals and Energy. Thus should any person require further details regarding this hole it can be traced to the Department.
