**Name of thesis** Corrosion Of Aluminium Alloys In Static And Recirculating Mine Waters. 1988

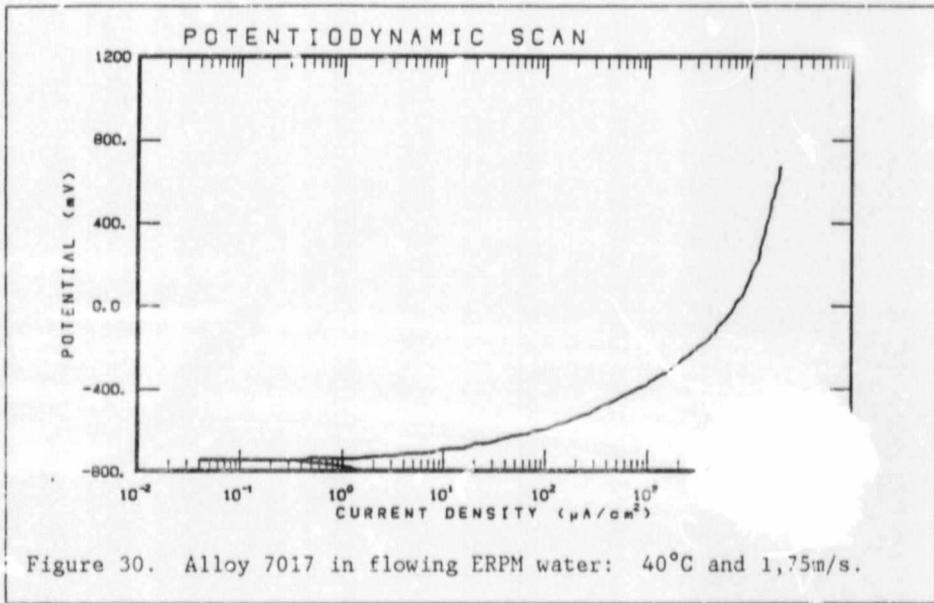
All the aluminium alloys with the exception of 7017 (Figure 30) exhibited a region of spontaneous passivation before pitting occurred. This region was fairly limited and the corrosion currents were usually around  $10\mu\text{A}/\text{cm}^2$  when pitting occurred, a typical example is shown in Figure 31. Summarised data from the tests are given in Table 6.2.

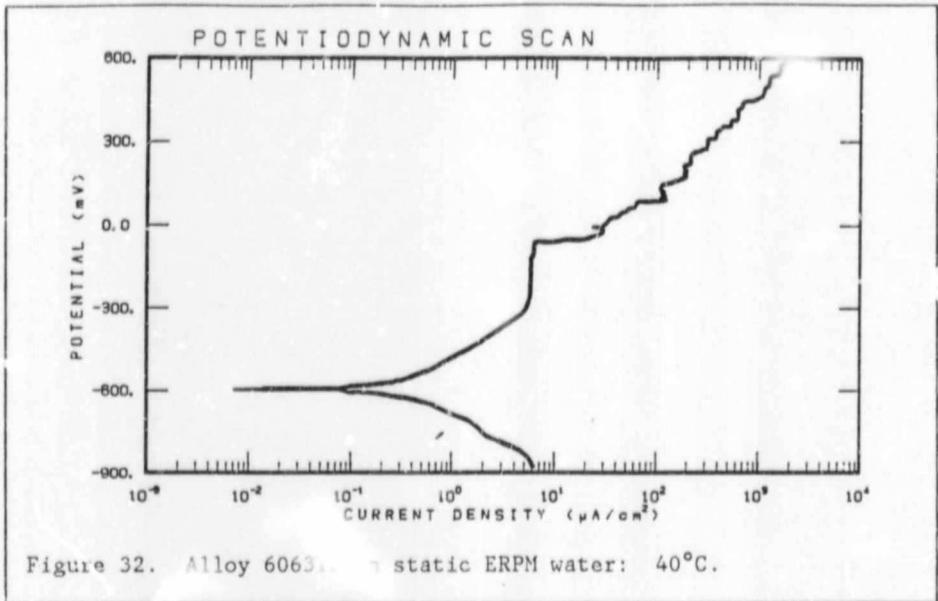
The passive ranges were generally very well defined as can be seen in Figure 32. Figure 33 shows the potentiodynamic curve produced with 316L stainless steel with a large passive region which contrasts with Figure 34 (alloy 7017) where there is no passive region at all.

The passive ranges were generally very well defined as can be seen in Figure 32. Figure 33 shows the potentiodynamic curve produced with 316L stainless steel with a large passive region which contrasts with Figure 24 (alloy 7017) where there is no passive region at all.

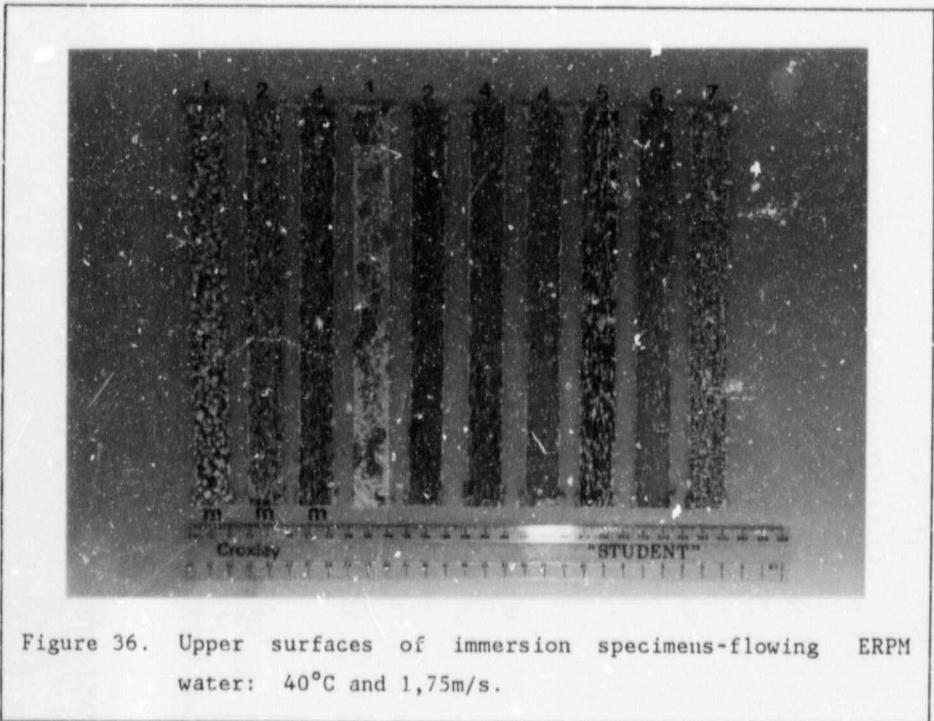
Figure 36. Upper surfaces of immersion specimens-flowing ERPM water: 40°C and 1,75m/s.

They were all seen to have numerous small areas of a white corrosion product on a background of grey or black. The upper surfaces of the specimens are shown in Figure 36. The first three specimens from the left were in mill finish form, and the remainder were those polished to 500 grit.

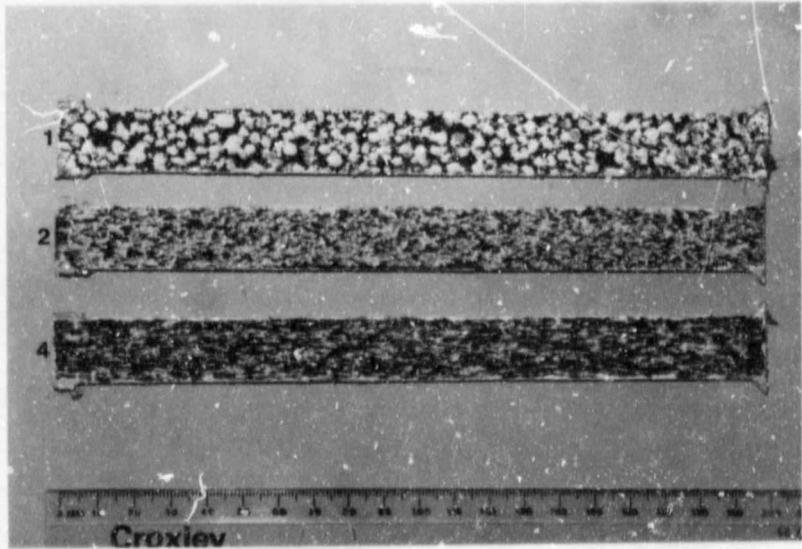
Figure 37. Immersion specimens-"Mill Finish"-Flowing ERPM water: 40°C and 1,75m/s.

The mill finish specimens (Figure 37) appear to have experienced "worse" corrosion than the corresponding ground finish specimens (Figure 38), with the exception of the Alclad specimens.

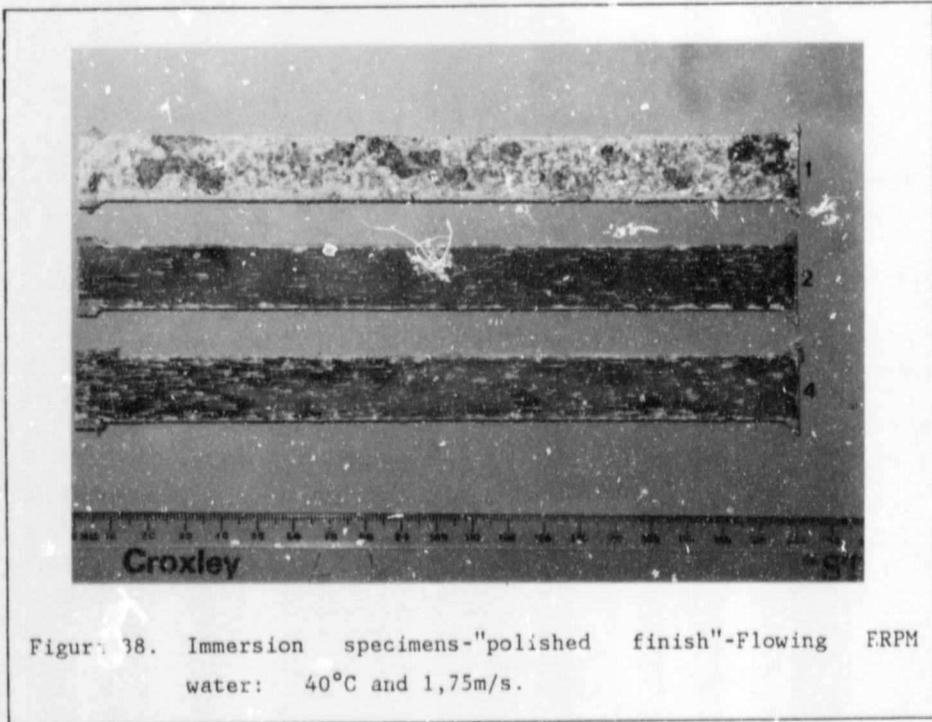
Figure 38. Immersion specimens-"polished finish"-Flowing FRPM water: 40°C and 1,75m/s.

The severe attack of the ground finish Alclad specimen was due to the non-clad reverse face **not** being coated with the masking lacquer. This caused galvanic corrosion of the cladding layer, which is anodic to the base metal. The protection given to the base metal can be seen in Figure 39 which shows the reverse face of the Alclad specimen. It is coated with a grey/black corrosion product but did not appear to have suffered pitting. This was confirmed once this surface coating was removed and the original polishing marks were still visible.

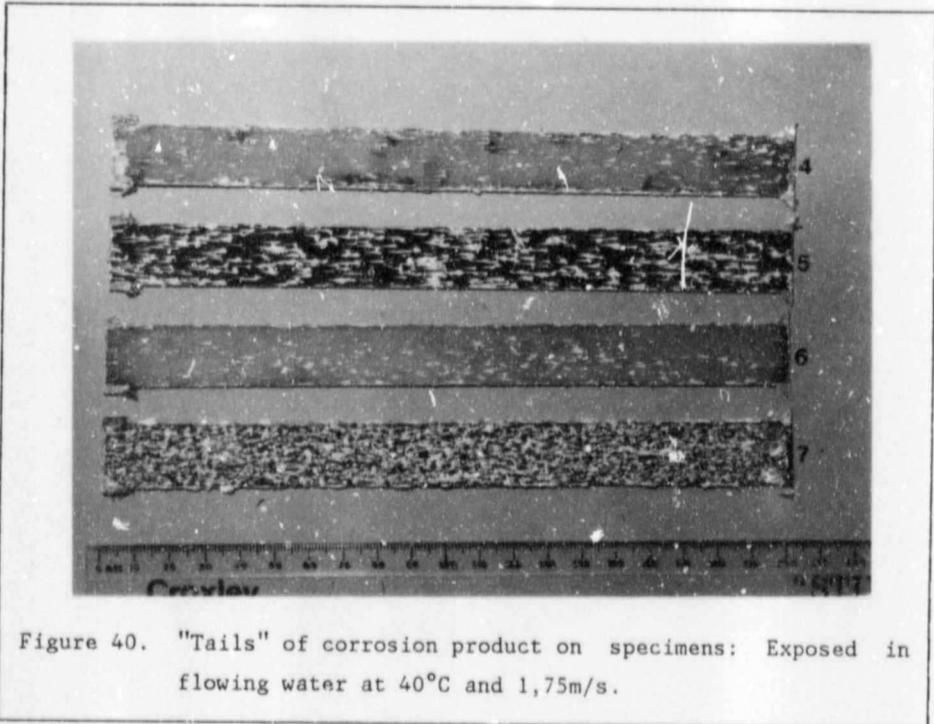
Figure 40 shows the upper face of alloys (top to bottom) 5251, 6063TB, 6063TF, and 7017. Note the "tails" of corrosion product from each pit indicating the direction of flow from right to left. Alloy 7017 appears to have experienced the most serious corrosion with more voluminous corrosion products found on its surface than with the other alloys.

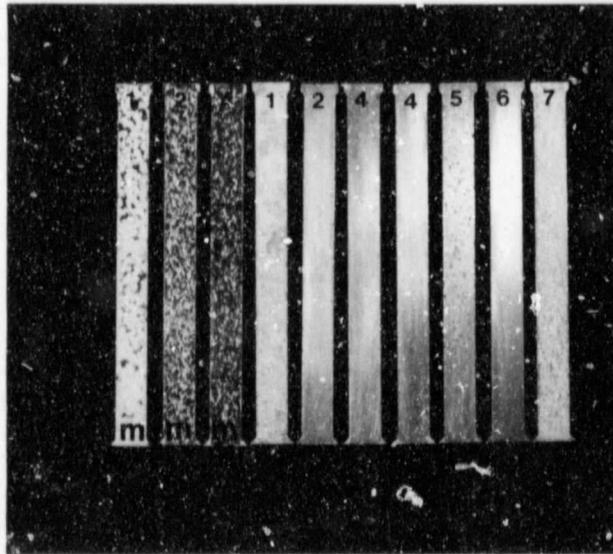
Figure 41. Immersion specimens from flowing ERPM water: After removal of corrosion product.

After cleaning in the chromic/phosphoric acids mixture the specimens were found to generally retain their polished surface. Figure 41 shows the upper surfaces of the specimens. The locations of the pits were as indicated by the corrosion product seen on the surfaces before cleaning. The "mill finish" Alclad specimen showed large scale removal of the cladding although shining portions of it remained. Due to the galvanic effects previously described, there was none of the original cladding surface left on the other Alclad specimen. Alloy 7017 had none of the original surface visible but no pits were visible. The surface was extremely rough and the corrosion appeared to be in the form of general corrosion with exfoliation.

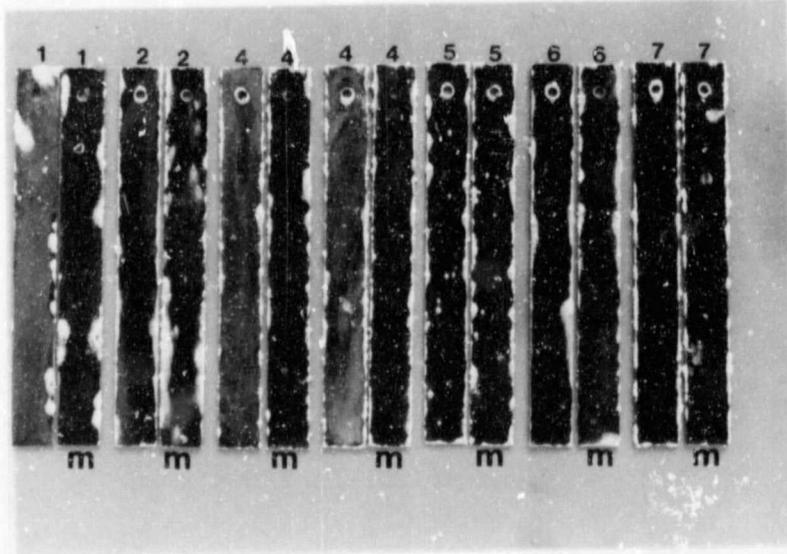
Figure 42. Front surfaces of specimens immersed in static ERPM water: 40°C. (m="mill finish").

On removal, the specimens were found to be covered with a thin brown corrosion product and had localised areas of a very loosely adherent, voluminous, white corrosion product. Typical specimens are those shown in Figures 42 and 43. These photographs show the front and back surfaces respectively of pairs of specimens that were immersed in the same tank. As the specimens dried the brown appearance changed to a mainly grey colour. The right hand specimen of each pair is the "mill finish" specimen

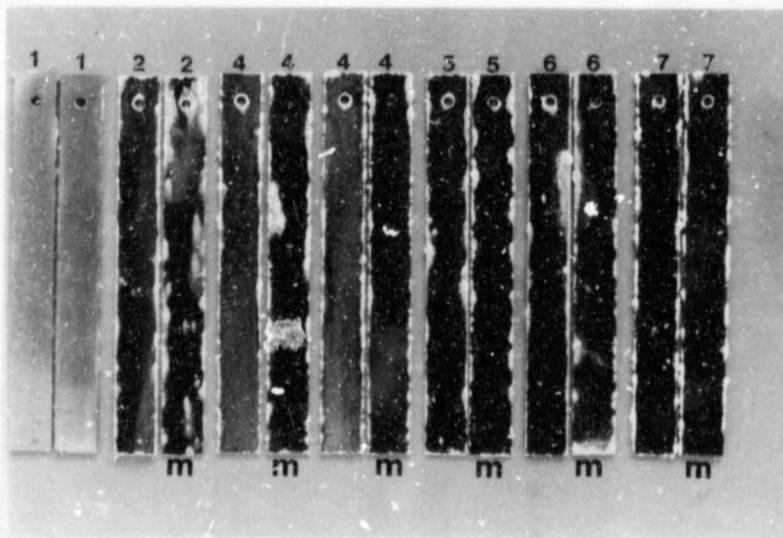
Figure 43. Rear surfaces of specimens immersed in static ERPM water: 40°C (m="mill finish").

The corrosion product on the "mill finish" specimens surfaces appears to be rougher. However it is interesting to note that these specimens had a lower corrosion rate than the polished ones.

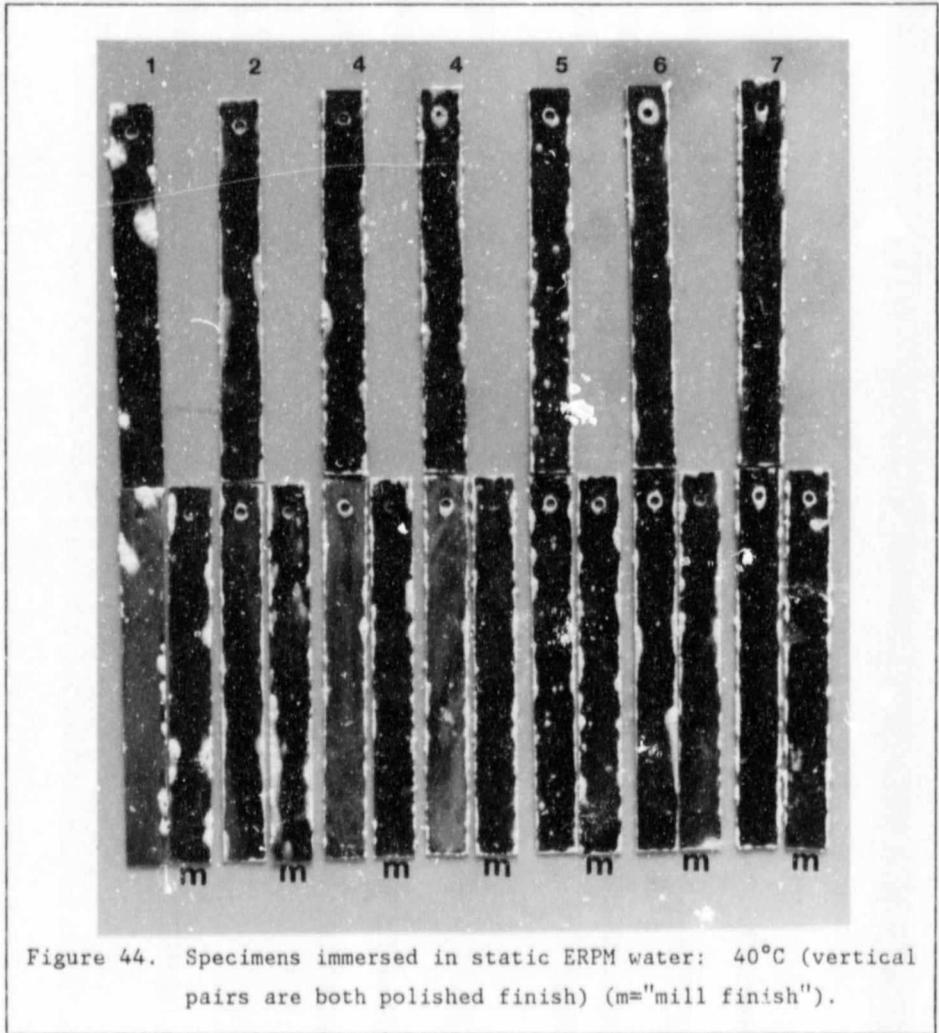
Figure 44 shows these specimens together with another set of polished finish specimens. Considerable corrosion has occurred at the specimen edges even though they were coated with a masking compound. This is due to partial lifting of the coating in places and the formation of localised crevices. However, examination of the severity of this corrosion at the edges does indicate that it was less severe than if the edges had not been masked.

This crevice attack confirms the electrochemical test results, which showed that these alloys had poor resistance to crevice corrosion in this environment.

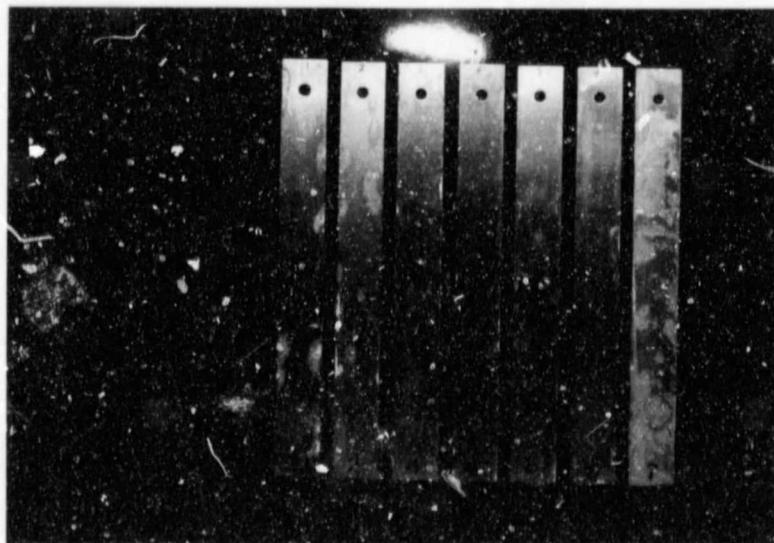
Figure 45. "Mill Finish" specimens exposed in static ERPM water: 40°C, after cleaning.

After cleaning, the extent of the pitting was visible. It was far less than that seen on the specimens exposed under flow conditions. Figures 45 and 46 show surfaces of "mill finish" and polished finish specimens respectively. The original surfaces with scratches or polishing marks are clearly visible, except on alloy 7017. The "mill finish" alloy 7017

specimen had been machined on one surface and the corrosion had clearly followed the line of the machining marks as expected.

There are far more pits on the "mill finish" alloys 3004 and 5251 than on their polished counterparts. However, this trend was reversed with alloy 6063TB. As noted before, there is no way that the different "mill finishes" can be vigorously compared. Differences in the processing variables may greatly effect the surface of the material. Thus the comparison between the "mill finish" and polished finish specimens is essentially an empirical one.

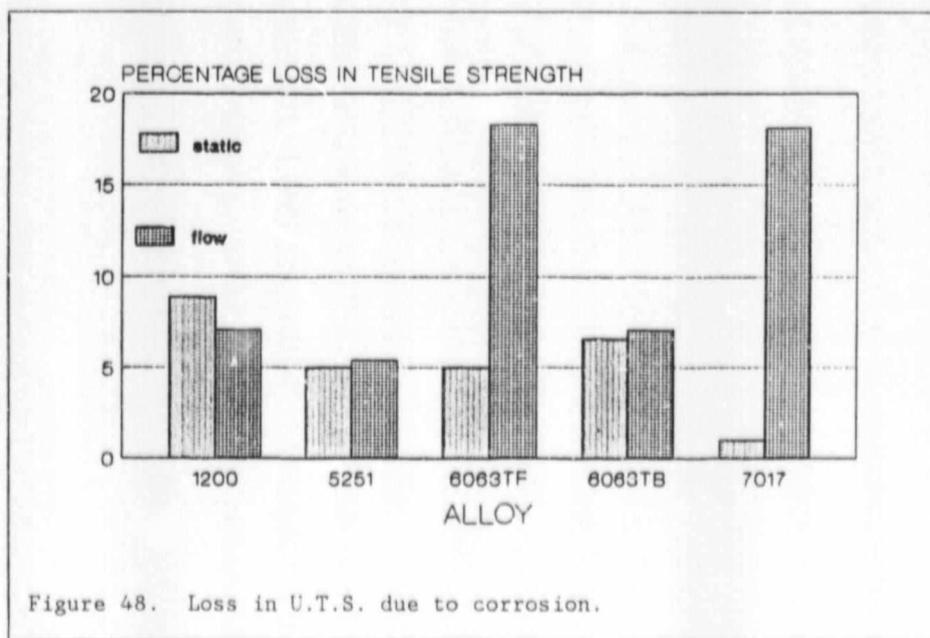
The results from these tests are shown in Figure 48. The percentage change in the ultimate tensile strength (UTS) for Alclad is not shown as in each case there was a strength increase. This will be discussed later in section 6.2.7. The known experimental error in these tests was approximately 2,5% and to this must be added the distribution of the pits in the specimen, i.e. a pit at the edge of a specimen creates a far higher stress concentration effect than one away from the edge. However, these tests do give an idea of the degree of loss in mechanical properties that are caused by corrosion.

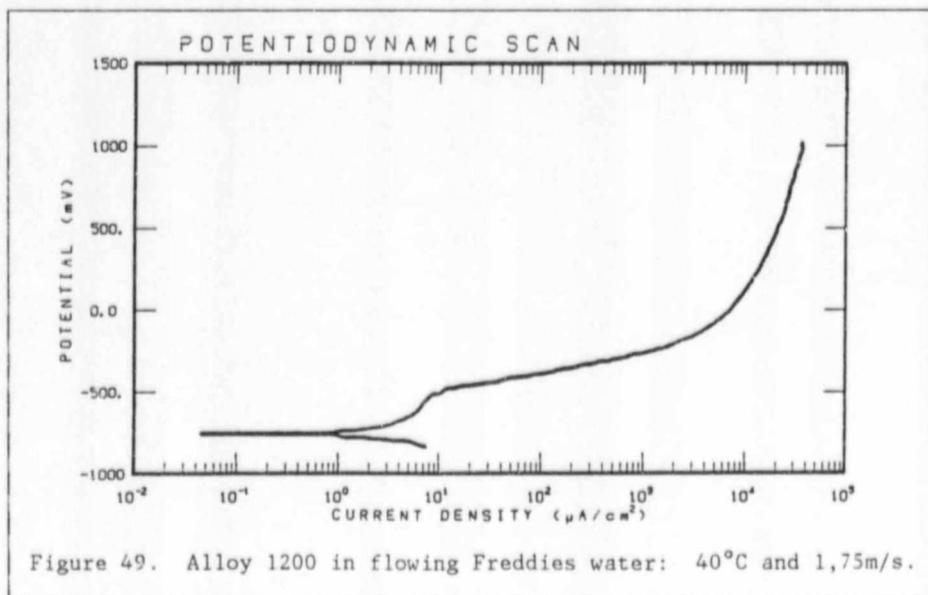
All of the aluminium alloys confirmed the statement above, on stable film formation, except for alloy 7017. They exhibit a region of passivity on the potentiodynamic curve, even though this region was fairly limited in most cases. Figure 49 shows this behaviour, but note that here the passive range is only of the order of 200mV, with the pitting potential  $E_{pp}$  being -540mV. Alloy 7017 showed no passivity whatsoever, as did mild steel in this water. Figure 50 shows a typical curve where no spontaneous passivation took place.

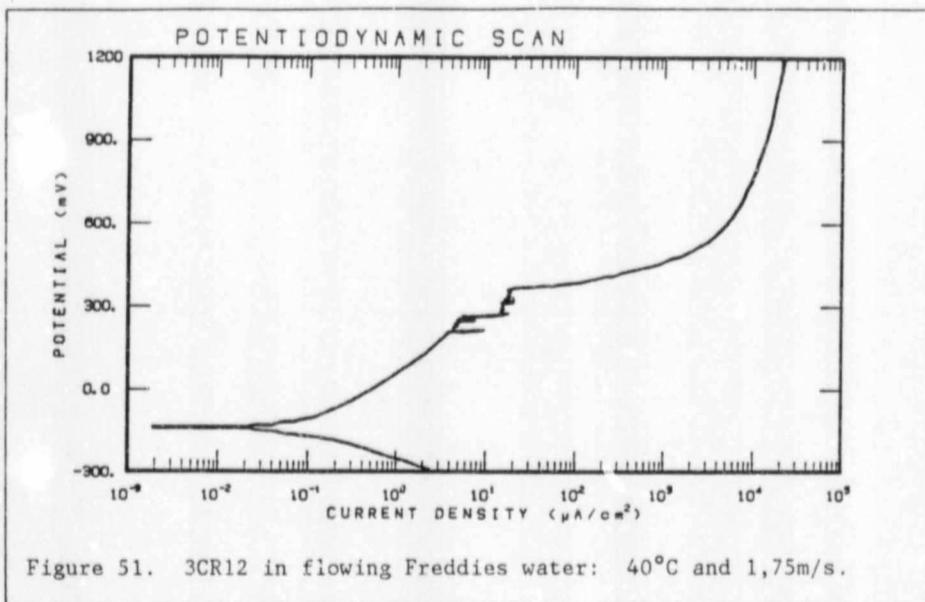
3CR12 showed a limited passive range of around 400mV with  $E_{pp} = 263\text{mV}$ . Figure 51 shows the behaviour of the alloy in this environment and it is interesting to note the "noise" on the curve around  $E_{pp}$ . This was repeatedly found with this alloy and indicates breakdown and then repair of the passive film. i.e. even before  $E_{pp}$  is reached, the film has become somewhat unstable.

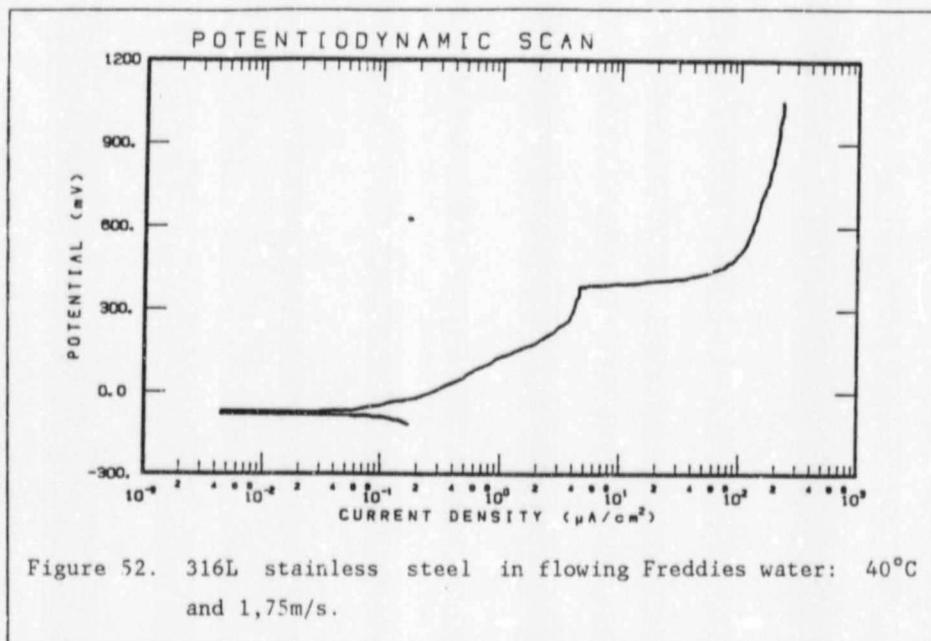
For comparison purposes limited tests were carried out on three stainless steels viz. types 316L, 317L and SAF2205. Even these alloys had fairly limited passive regions under flow conditions in this water, Figure 52 shows the potentiodynamic curve for type 316L stainless steel. It shows that spontaneous passivation took place up to 375mV ( $E_p$ ), but above this potential breakdown of the passive film would lead to pitting. Types 317 and 2205 stainless steels exhibited similarly shaped potentiodynamic curves.

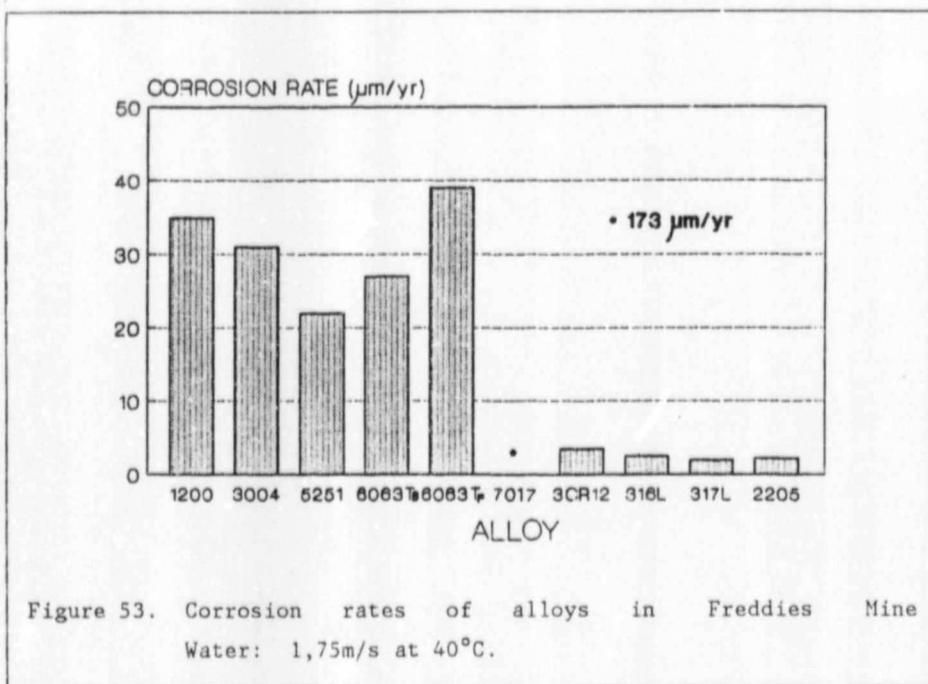
The average corrosion rates for each of the test materials except for 7017 are shown in Figure 53.

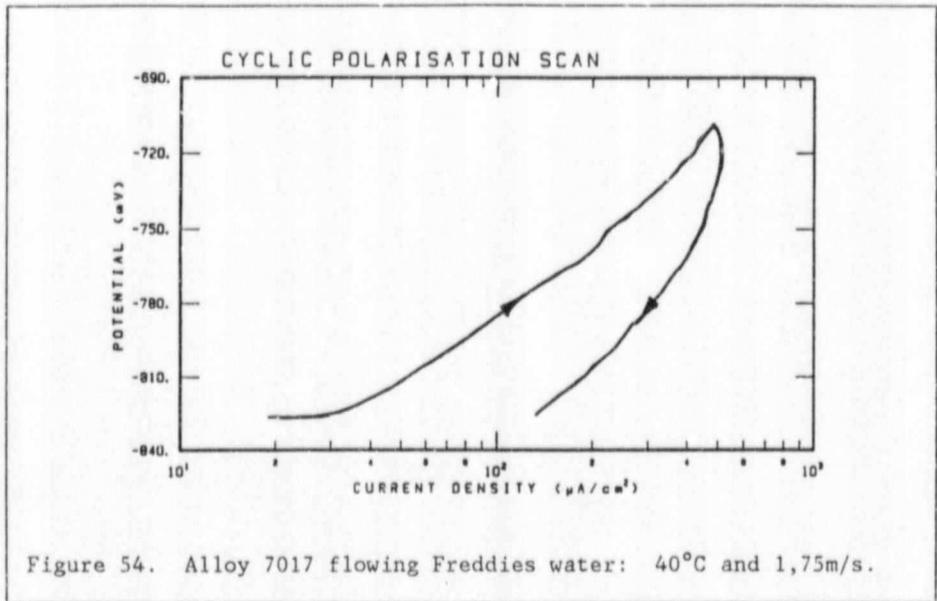
As was expected from the high concentrations of sulphate and chloride ions, pitting corrosion was the dominant mode of damage suffered by these aluminium alloys. Alloy 7017 showed no sign of passivity and the return curve of the cyclic polarisation scan remained well to the right of the forward curve. Figure 54 shows this and the large current rise with such a small potential change. Alloy 1200 does not re-passivate during the reverse scan. Alloy 6063TF shows similar behaviour.

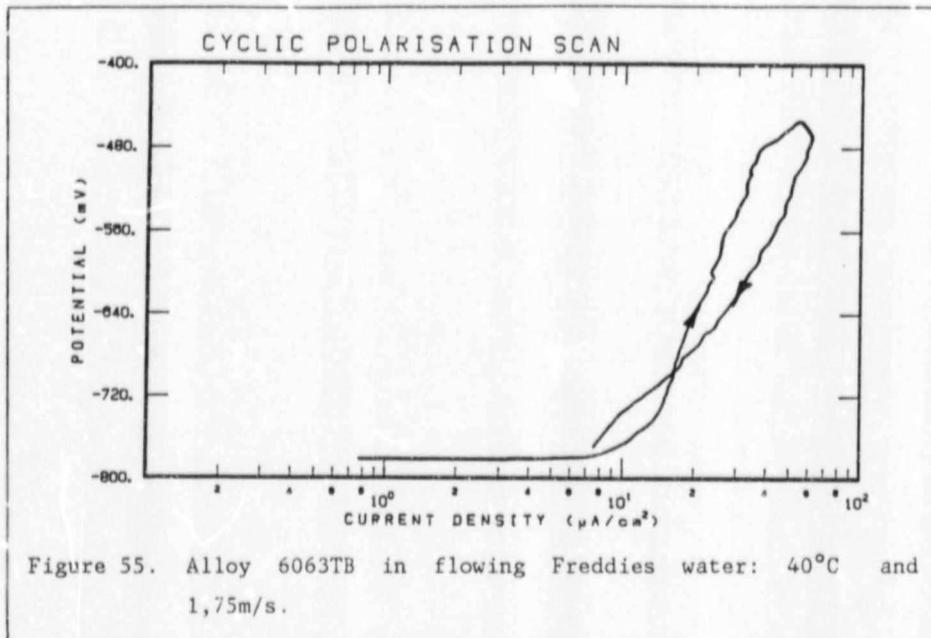
Alloy 6063TB just re-passivates before  $E_{\text{corr}}$  is reached on the reverse scan (Figure 55). However this gives a perfectly passive region of only 83mV out of a passive range of 313mV. It is also very important to note that the whole curve is at highly anodic potentials.

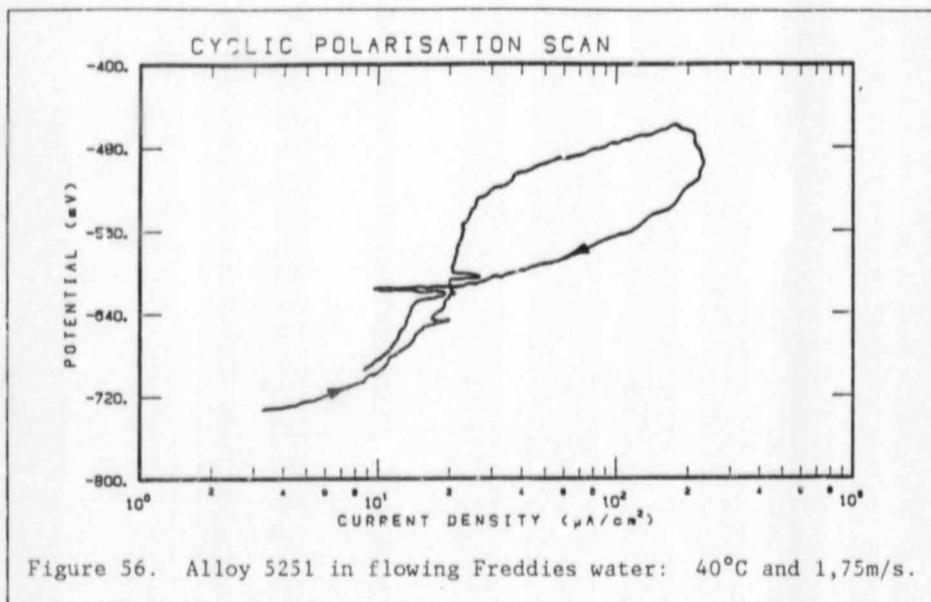
The reverse curve intersects the forward curve on the pitting scans for both 3004 and 5251. Alloy 3004 has a passive range of 160mV and a perfectly passive range of 70mV; too limited for use in this environment. Alloy 5251 is slightly better with passive and perfectly passive ranges of 200mV and 116mV respectively - still extremely limited. Figure 56 shows the pitting curve for alloy 5251. Both these alloys exhibit a large hysteresis loop in the pitting curve and hence they have low resistance to crevice corrosion.

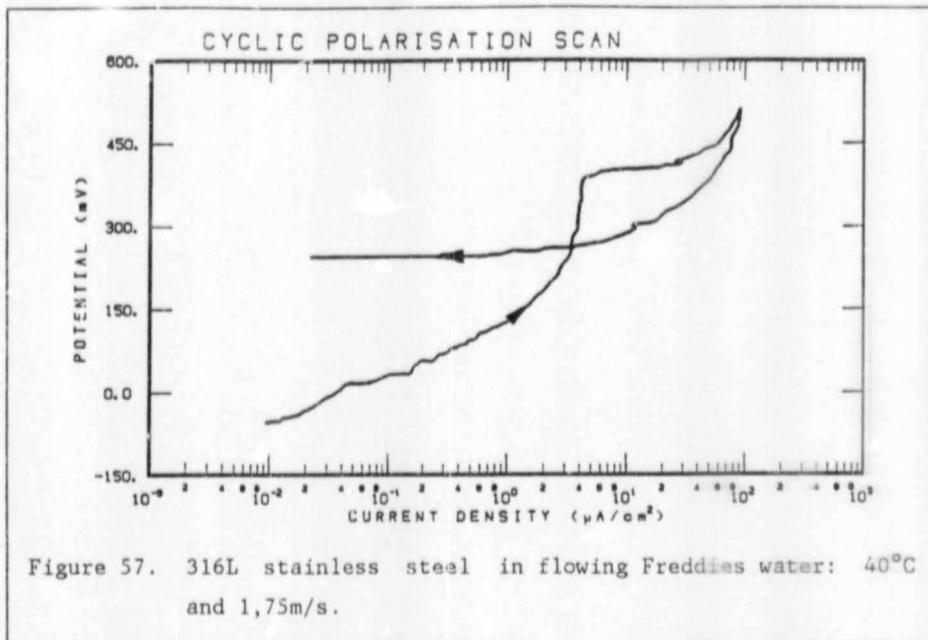
3CR12 managed to re-passivate in some tests but in others it did not. This indicates that it is a "borderline" situation for this alloy and very small changes in the test environment/procedure can make a big difference in the result. The stainless alloys all managed to re-passivate once pitting had initiated. Figure 57 shows a pitting curve for type 316L stainless steel. The reverse scan intersected the forward curve at 262mV and so the regions of passivation and perfect passivation are 488mV and 318mV respectively. The hysteresis loop indicates poor crevice corrosion resistance even, for these highly alloyed materials.

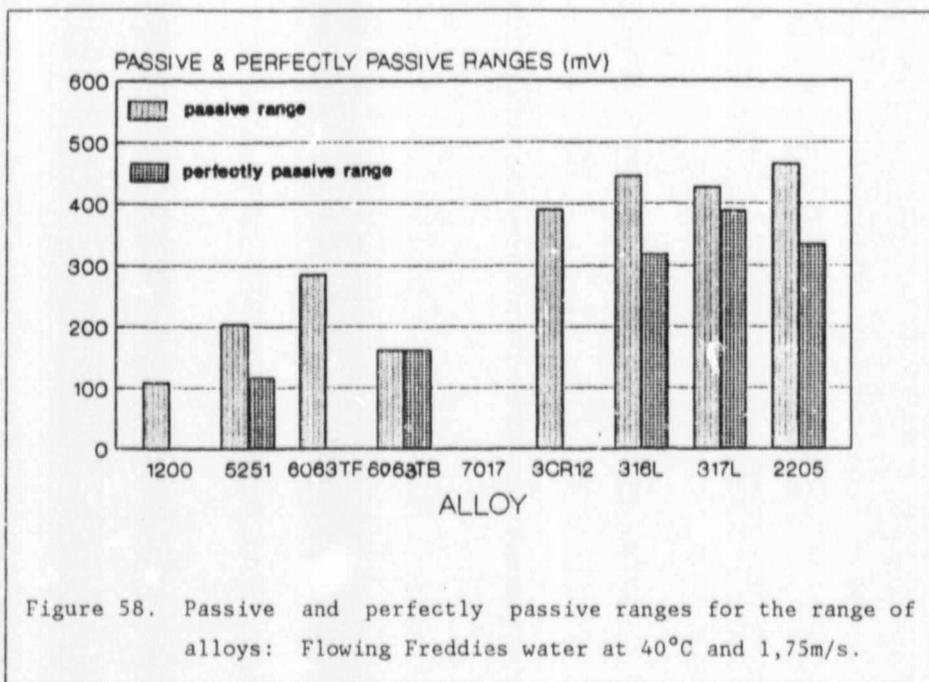
Table 6.11 summarises the data gained from the pitting scans, whilst the passive and perfectly passive ranges are shown graphically in Figure 58.
