6.2.3 POTENTIODYNAMIC SCANS IN FREDDIE'S WATER - STATIC CONDITIONS.

6.2.4 CYCLIC POLARISATION SCANS IN FREDDIES WATER, STATIC CONDITIONS.

6.2.5 TOTAL IMMERSION TESTS - FLOW CONDITIONS.

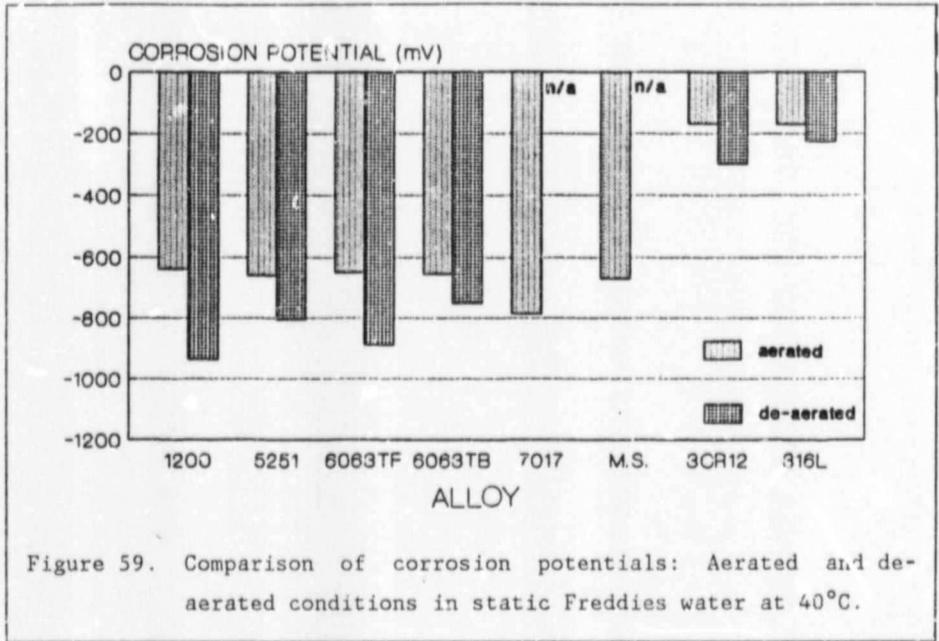
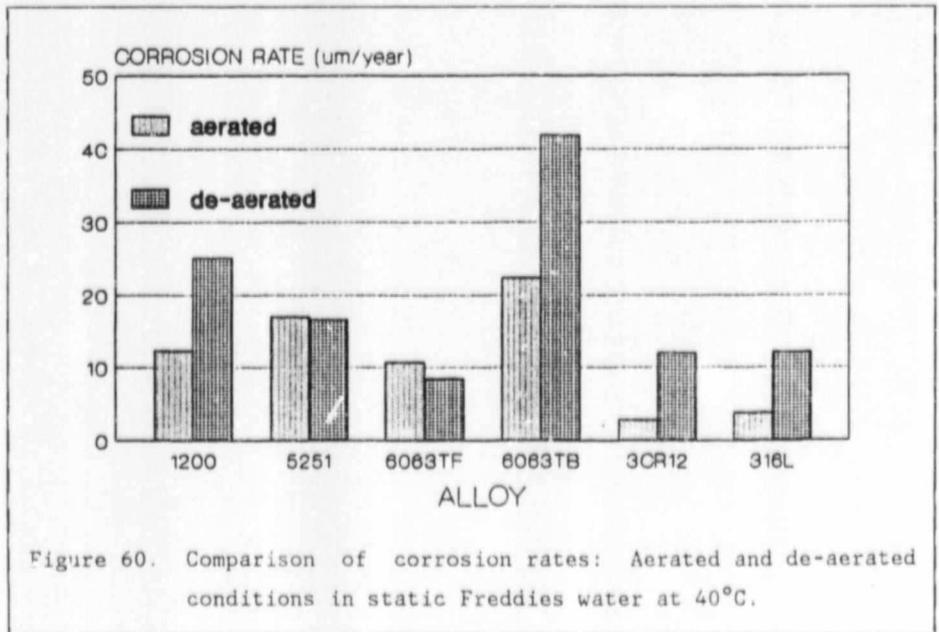
Figures 59 and 60 show comparisons of the E_{corr} and corrosion rate values under aerated and de-aerated conditions.

De-aeration appeared to have two separate effects. Firstly it had a strong effect on the free corrosion potentials and depressed them considerably. For example, E_{corr} for alloy 1200 went from -639mV in aerated conditions, to -937mV in de-aerated conditions. The second effect was the increase in the corrosion rate. This can be expected with active/passive metals as without oxygen present the passive film will not be able to repair itself where it has broken down. Table 6.13 contains the E_{corr} and corrosion rate values.

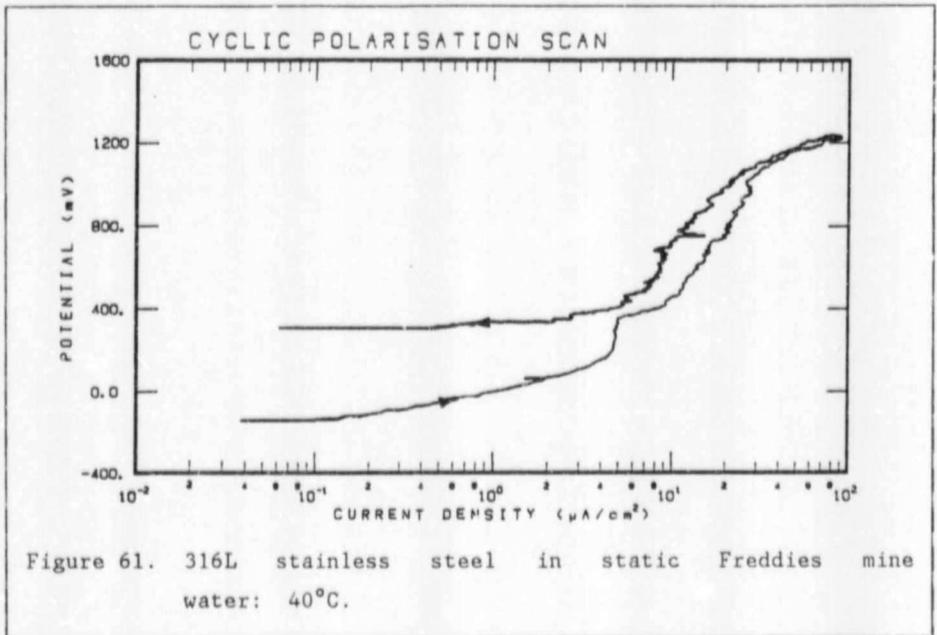
passive and perfectly passive ranges being the same. Thus there is no hysteresis loop, an indication of satisfactory crevice corrosion resistance. Alloys 1200 and 3004 had large hysteresis loops, as did 3CR12 and so poor crevice corrosion behaviour can be expected from them. Figure 61 illustrates the pitting behaviour of 316L stainless steel, while Figure 62 shows that of alloy 1200.

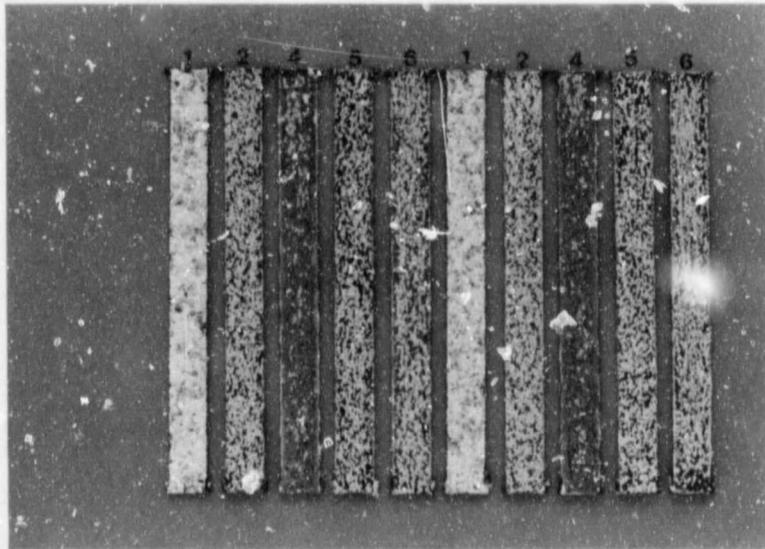
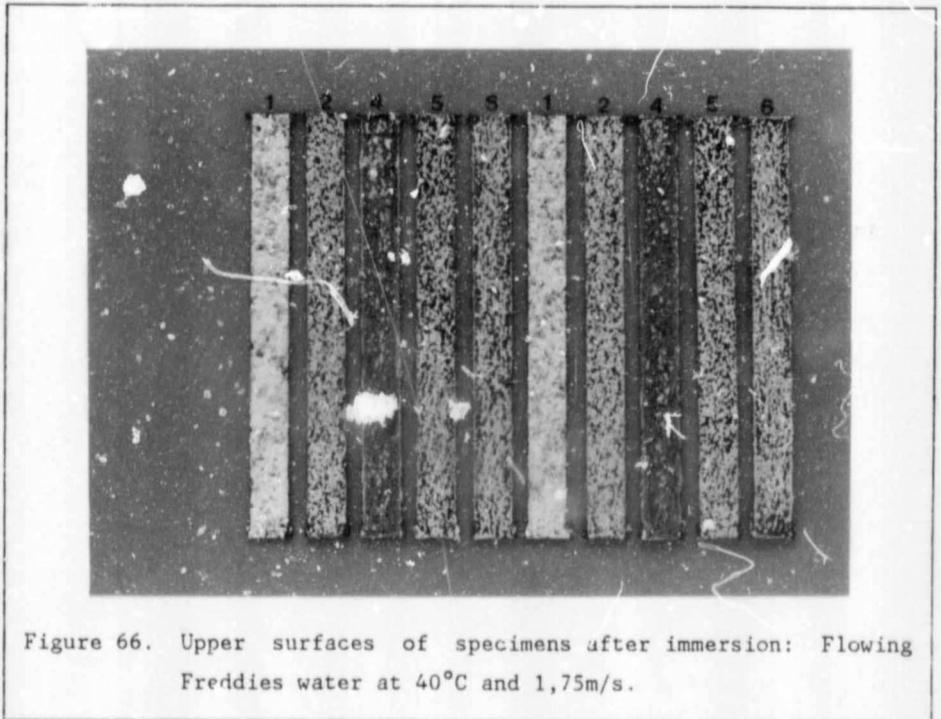
Figure 66. Upper surfaces of specimens after immersion: Flowing
Freddies water at 40°C and 1,75m/s.

specimens. From left to right the specimens are Alclad, 1200, 5251, 6063TB, and 6063TF and then another set in the same order. The most severe attack appears to be on the Alclad specimens although this is more general corrosion than a pitting type. Visually ranking the alloys according to the extent of the pitting from least to most the order would be; 5251, 6063TF, 6063TB and then 1200.

Examination of the specimens also revealed that the corrosion product "cap" on each pit is elongated in the direction of solution flow. (Flow direction is top to bottom in the above two photographs). It is interesting to note that there appears to be little difference in the "amount" of pitting on the upper and lower surfaces. Pitting is usually regarded as being more severe where the pits will grow downwards by gravitational effects.

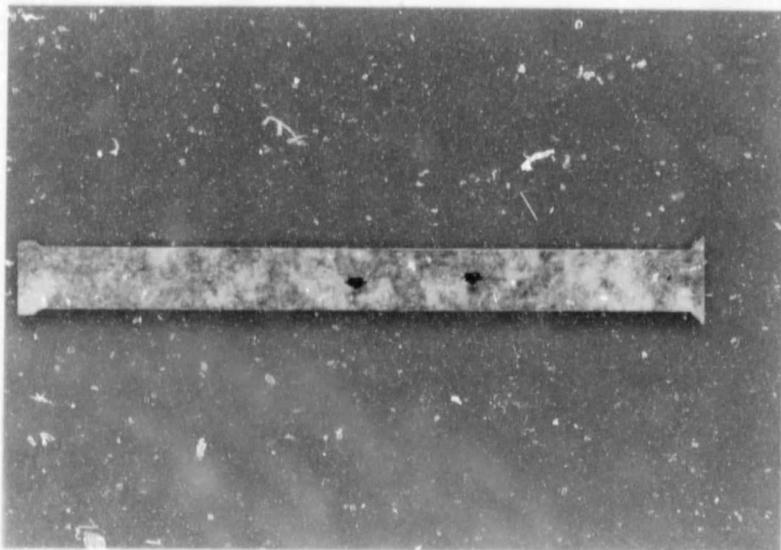
Figure 68. Cleaned Alclad specimen after immersion: In flowing
Freddies water at 40°C and 1,75m/s.

After cleaning it was found that severe pitting had occurred. The Alclad specimens had very little of the original surface of the cladding left (indicated by the arrows in Figure 68). Figure 69 shows the upper surface of the first set of specimens and it can be seen that the pitting does follow the pattern that was indicated by the corrosion product on the specimens before they were cleaned.

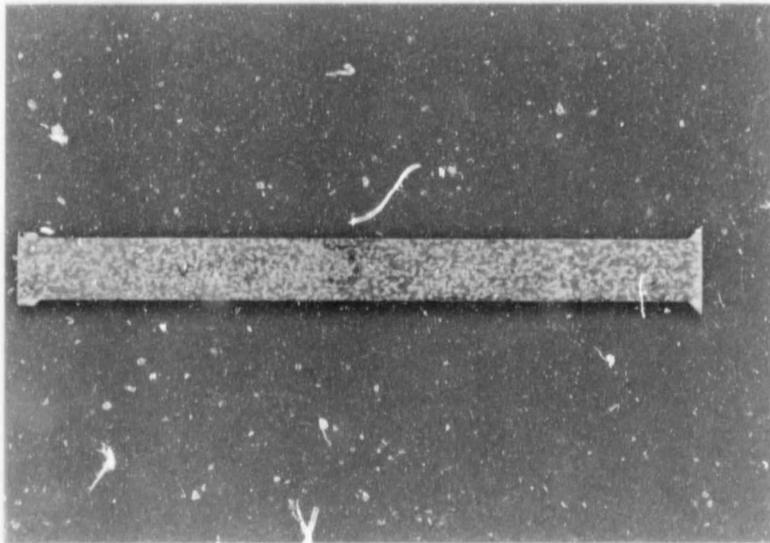
Figure 70. Cleaned surface of alloy 6063TB after immersion: Flowing Freddies water at 40°C and 1,75m/s.

Particularly interesting is that alloy 6063TB contains numerous pinhole pits as well as the much shallower and broader type (Figure 70). The other specimens had very few such pits with such a high aspect ratio.

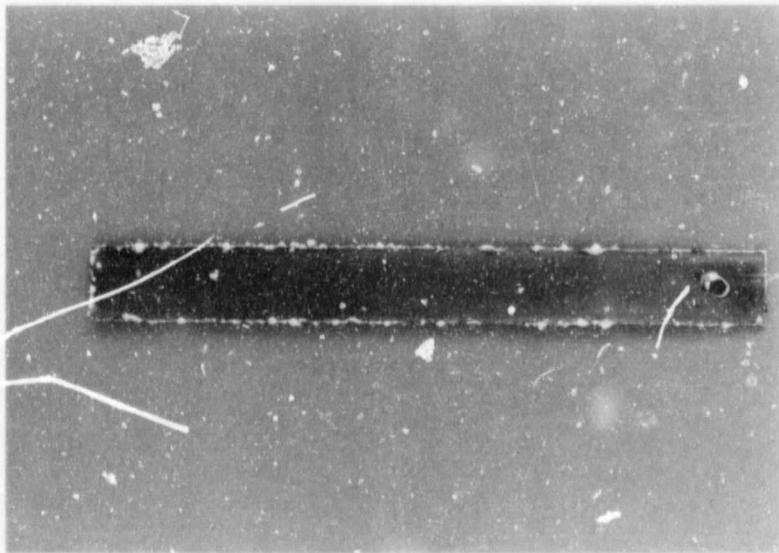
Figure 71. Alloy 1200 after immersion in static Freddies water: 40°C.

On removal from the immersion tanks the specimens were covered with a lightly adherent, powdery, white corrosion product mainly at the edges, and a light brown/grey adherent corrosion product over the rest of the specimen (Figure 71). This white corrosion product was found at positions where the masking lacquer had partially lifted resulting in the formation of crevices. The Alclad specimens had corroded over larger areas progressing mainly from the edges. Figure 72 shows one set of these specimens, left to right in the following order; Alclad, 1200, 3004, 5251, 6063TB, 6063TF and 7017. Alloy 7017 shows general corrosion/exfoliation over most of its area and one portion where very severe corrosion has occurred. Other specimens of this material also showed similar, though not as severe localised areas of attack.

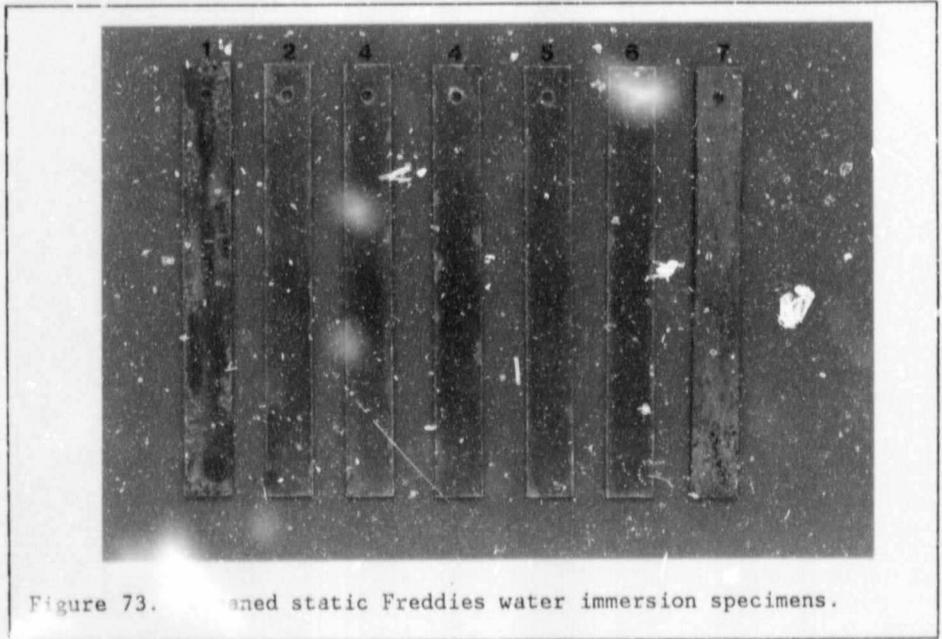
Figure 73. Corroded static Freddie's water immersion specimens.

After being cleaned (Figure 73) it can clearly be seen that most of the corrosion has initiated from the edges of the specimens. Pits had formed in some of the Alclad specimens also at positions away from the edges.

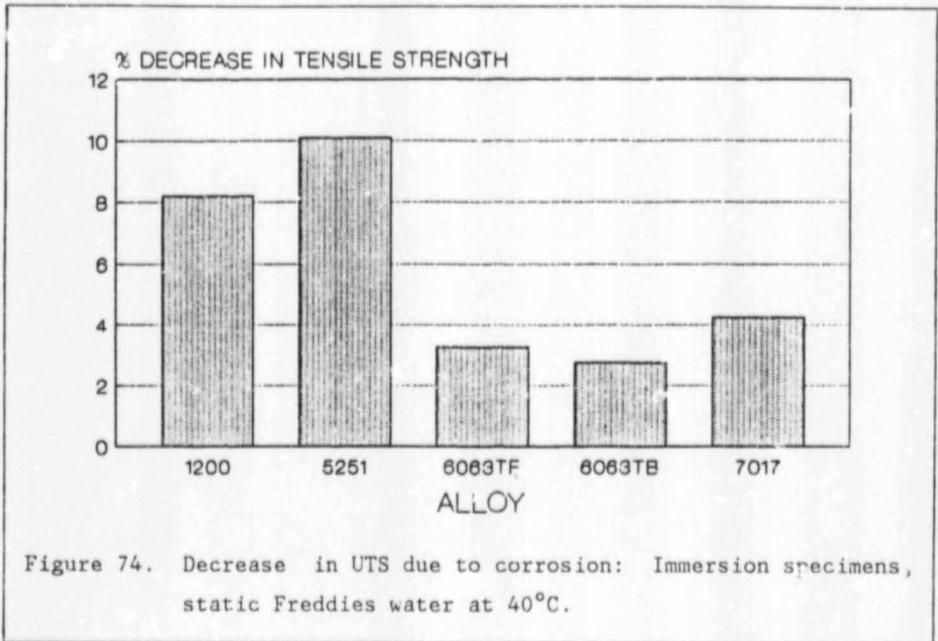
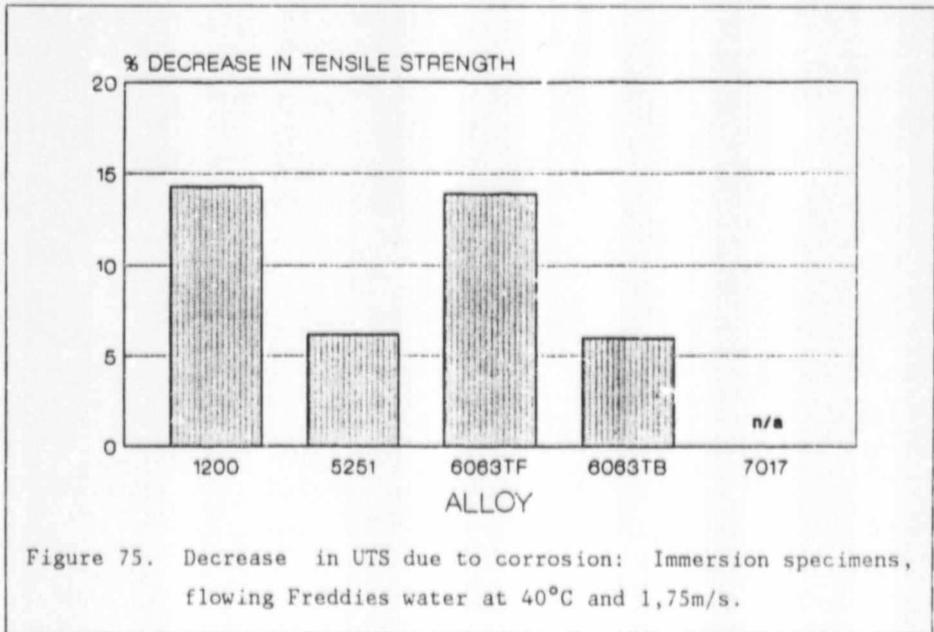
The percentage change in the ultimate tensile strength (UTS) of each alloy was determined after corrosion testing. All the Alclad specimens had a **gain** in tensile strength. There are two probable causes for this. The first is that the low strength cladding yields first and this is where the failure begins and so with this layer removed the initiation of failure is delayed. The second is that the increases are less than 5% which is within possible experimental error. The average decrease in UTS is shown in Figures 74 and 75.

As only 2 to 3 test specimens were available the results are highly dependent on the location of pits on the specimens. If a pit is at the edge of a test sample, then obviously it will have a far greater effect than if it is elsewhere.

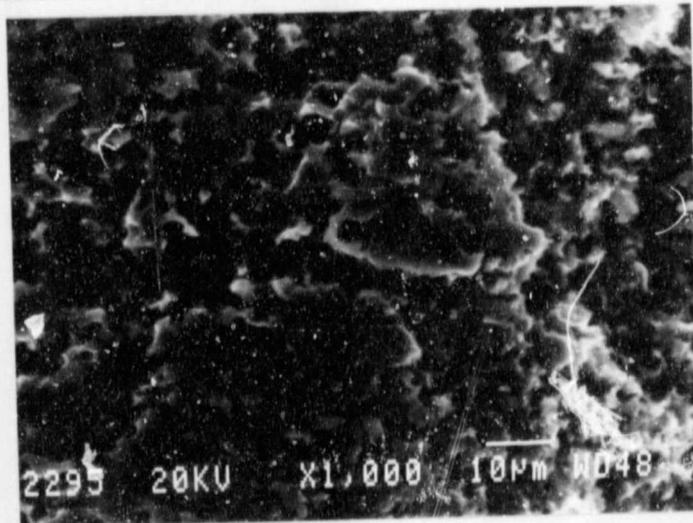
Figure 76. Pitted cladding layer on Alclad specimen: (1000x).

The Alclad layer tended to be so severely corroded especially under flow conditions, that pieces would become detached from the surface. Figures 76 and 77 show views of the pitted area and a section through a corroded specimen, showing severe corrosion of the cladding layer. Cracking has taken place below the surface so that large portions become detached. Where the base metal had been exposed it was free of pits due to the cathodic protection by the cladding. A scratch appeared to be the site of initiation of the small pit (10 μ m) shown in Figure 78.

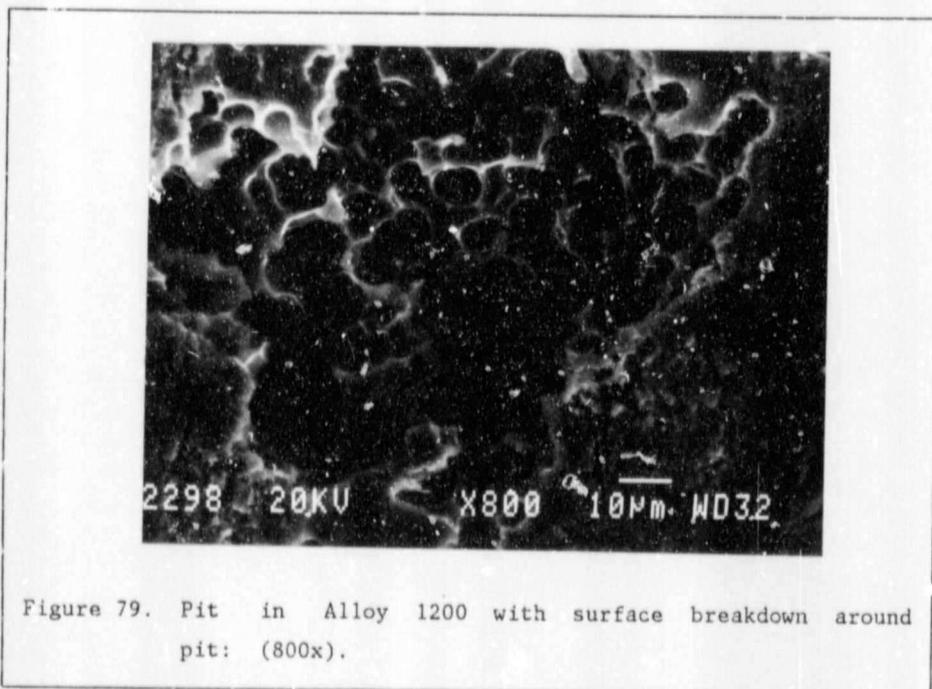
Under static conditions the pits were generally of circular shape. Figure 79 shows a recently initiated pit where little penetration has occurred yet. The surface at the edges of the pit is breaking down. The cross section through a pit in this material shows the typical open, hemispherical pit that was encountered in this material. This pit is approximately 0,25mm deep.

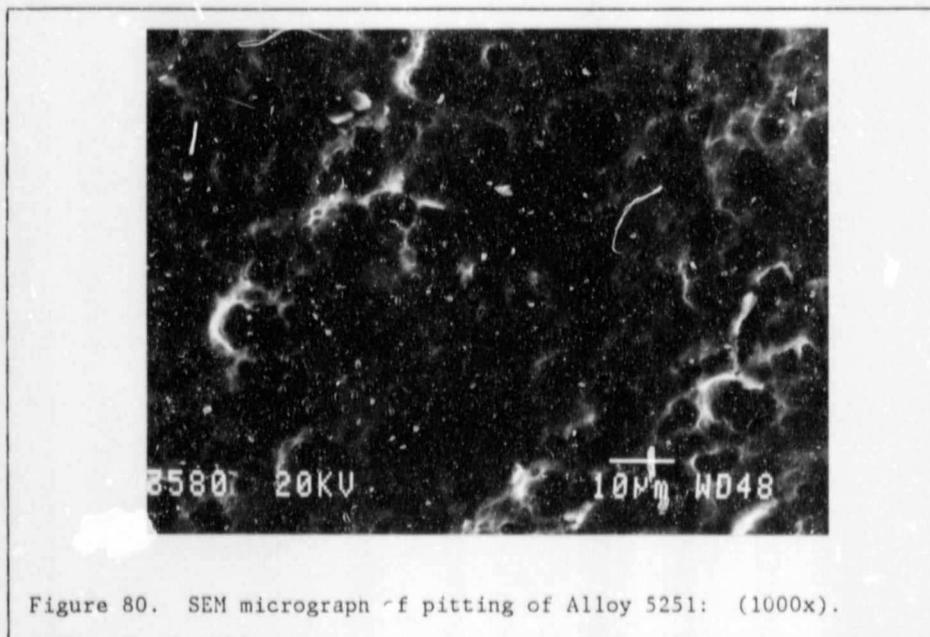
Figure 80. SEM micrograph of pitting of Alloy 5251: (1000x).

and will thus undergo preferential corrosion as shown in Figure 80. The silicon tends to bring the solid solution potential closer to that of aluminium.

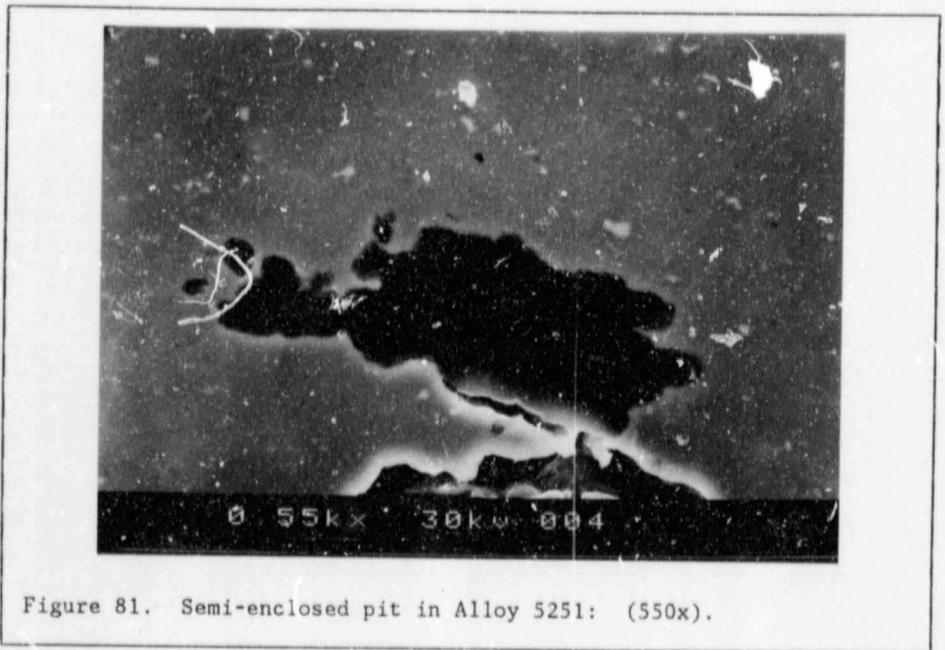
Figure 81. Semi-enclosed pit in Alloy 5251: (550x).

Although this alloy is known for good pitting resistance it did show severe pitting. From the surface the pits did not appear to be "large", but this alloy tended to form horizontal or semi-enclosed pits as seen in Figure 81. In Figure 82 numerous interlinked pits are shown, which together have penetrated nearly 50% through the material thickness (1,2mm thick). Some intergranular cracking along was observed due to the selective attack of precipitates at the grain boundaries.

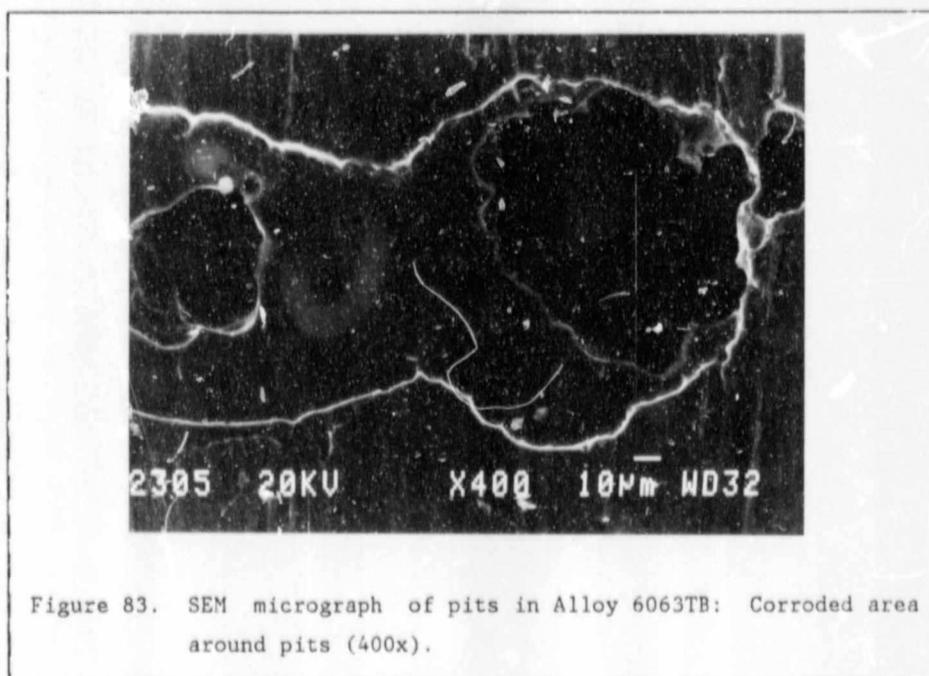
Figure 83 shows pits formed under static conditions. The area covered by the corrosion product around the pit has undergone a form of crevice attack. Alloy 6063TB tended to form a more undercut type pit, while that of 6063TF was more hemispherical.

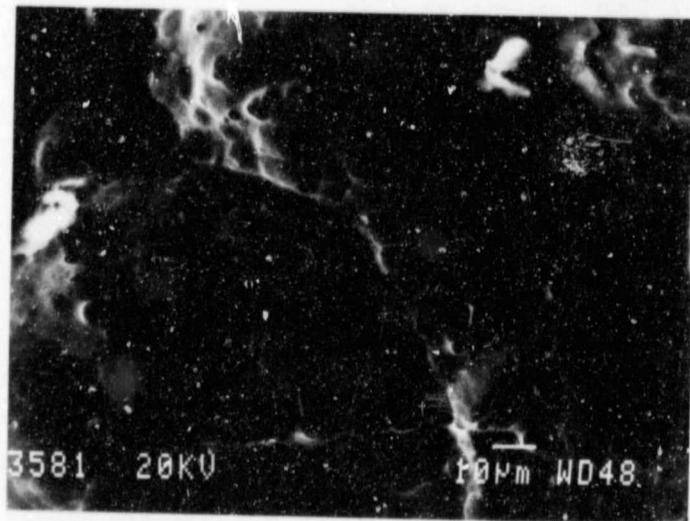
Figure 84. SEM micrograph of Alloy 6063TB: Selective attack of grain boundaries and precipitates (700x).

Selective corrosion of these particles at the grain boundaries took place under both static and flow test conditions. Figure 84 shows this. This pattern of attack on these two alloys could be predicted from the microstructures showing semi-continuous precipitates at the grain boundaries. Van Horn (9) gives the potential of Mg_2Al_3 as $-1,24V$ compared with that of $-0,85V$ for 99,95% Al in a 53g/l solution of NaCl.

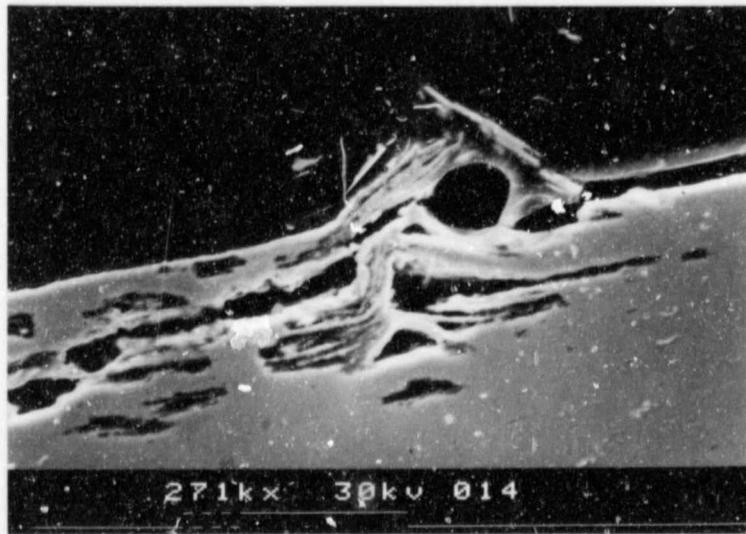
Figure 85. SEM micrograph of a section through Alloy 7017: Exfoliation (271x).

This alloy underwent general corrosion/exfoliation attack, rather than pitting. Figure 85 shows this mode of attack with corrosion proceeding parallel to the surface before portions of the material break away. This corrosion follows the lines of banding of the particles (and the elongated grains parallel to the surface) which consist of Al+Zn and Al+Zn+Mg which are anodic to aluminium.

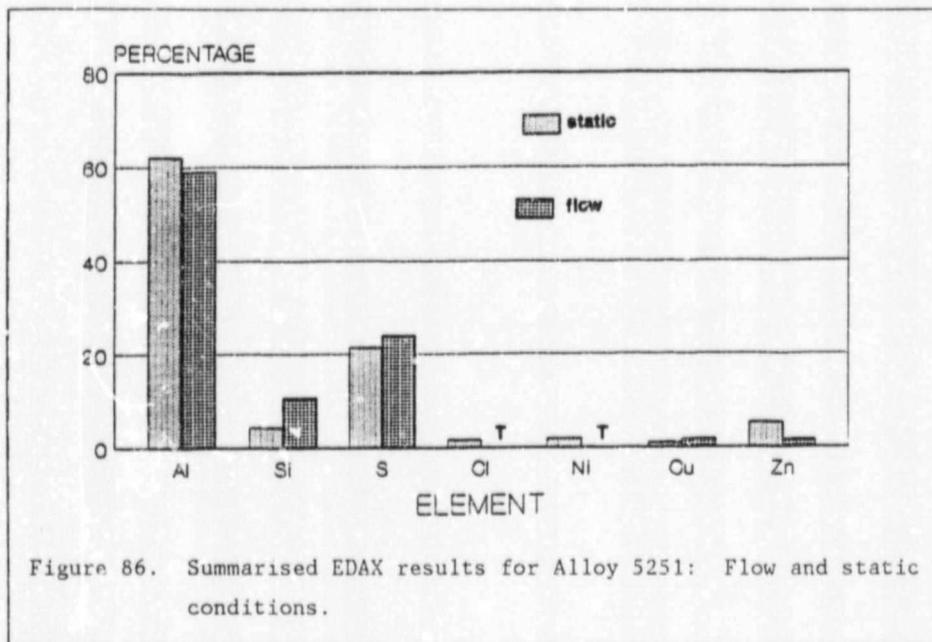
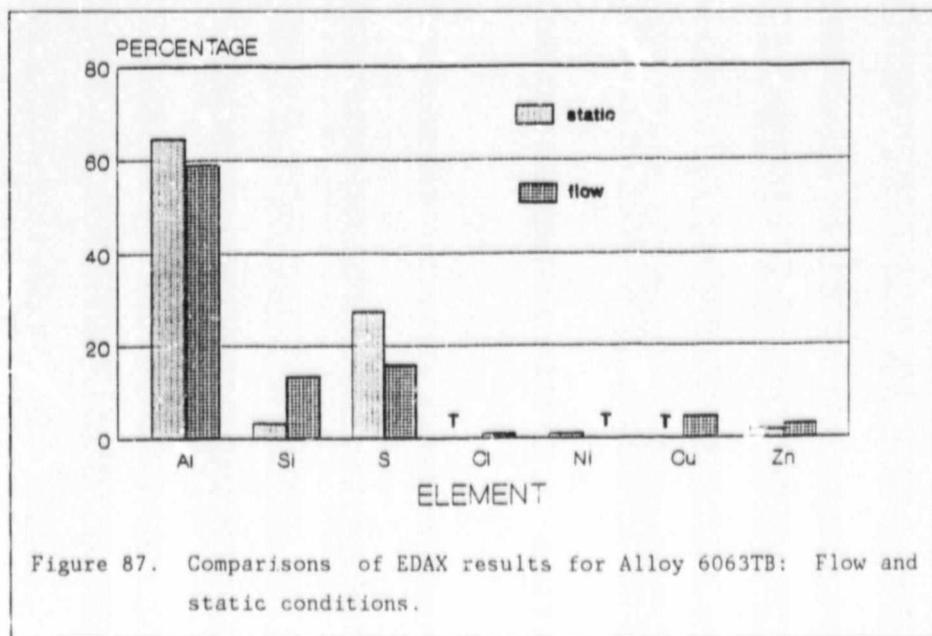
Of considerable interest were the difference in the analysis for static and flow conditions for Freddie's Water. The bar charts shown in Figures 86 and 87 show comparisons of EDAX results produced under static and flow conditions for two alloys.

These results and others show higher levels of copper in the corrosion product under flow conditions than under static. Uhlig (45) states that traces of Cu^{2+} as low as 0,1ppm will plate out on an aluminium surface. The waters used had copper concentrations of 0,25 and 0,2ppm for Hercules and Freddie's water respectively.

The higher levels of copper in the corrosion products from flow conditions, can probably be explained by the fact that the Cu^{2+} ions have a far greater chance of coming into contact with the aluminium surface under flow conditions.

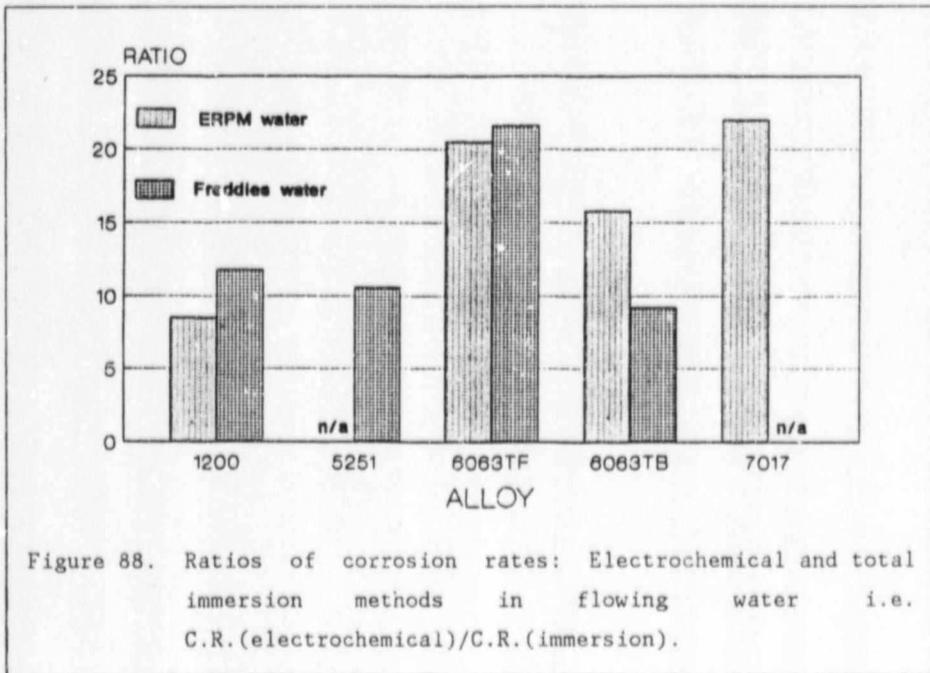
The ratio between the corrosion rates produced by immersion testing and those produced by electrochemical tests were calculated for each alloy and then plotted on the bar graph shown below.

The average ratios (immersion:electrochemical) for flow conditions were: 17,0:1 for Hercules Water and 13,3:1 for Freddie's water. For static conditions the ratios were much lower and these are shown in Figure 89.

The higher ratio found under flow conditions is mainly due to the shapes of the specimens used. Since only flat specimens (i.e. sheet material) were available for the testing, coupons inserted into the test rig were used. Being at the centre of flow they would experience higher flow velocities and shear stresses than at the walls of the tube. Tubular specimens of the diameter for which the corrosion behaviour is required, would probably yield the most realistic results. This is however, frequently impractical for test purposes.

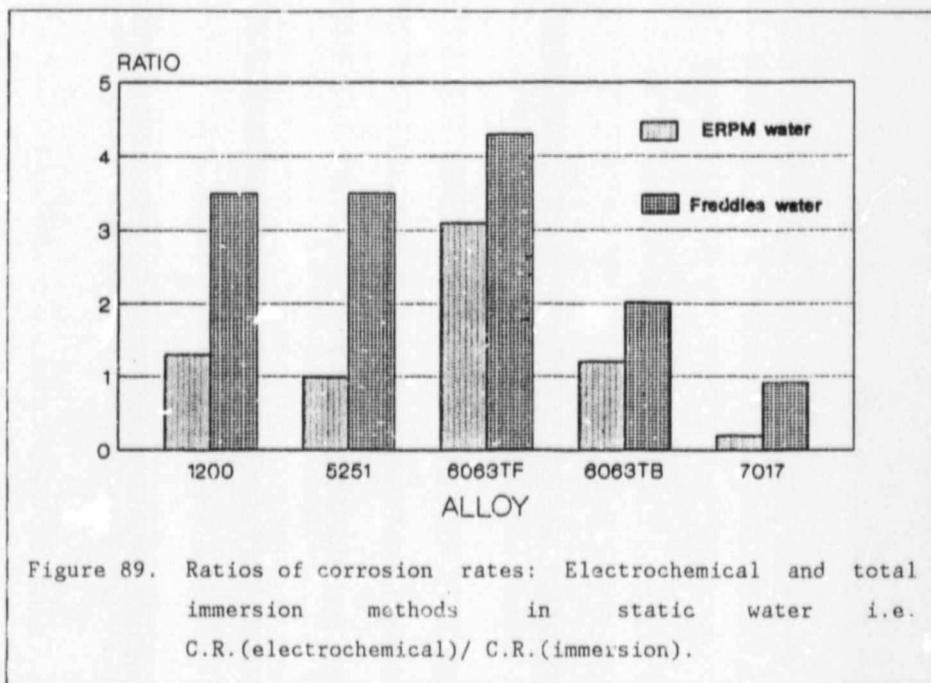
Average ratio were: 1,34:1 for Hercules Shaft and 2,45:1 for Freddie's.

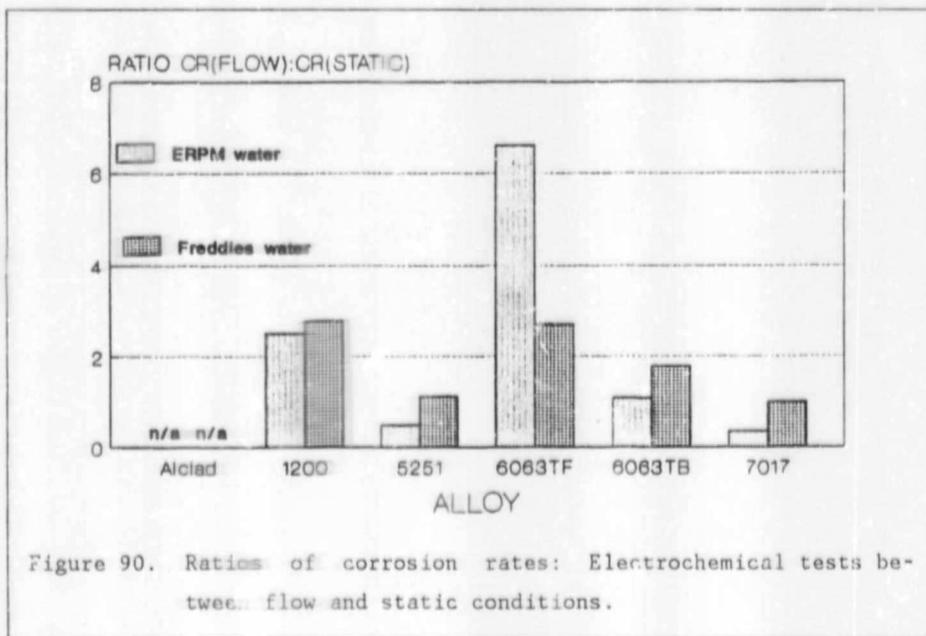
The data obtained from the various tests were used to draw comparisons between flow and static conditions. i.e. C.K.(Flow)/C.R.(Static). These are summarised in the following figures.

The first and obvious inference drawn from these curves is that the flow rate markedly increases the general corrosion rate. The effect also appears to vary depending both upon the alloy and the composition of the water. Alloy 6063TB for example generally appears to be affected the most by flow. It also recorded the poorest performance in terms of general corrosion and pitting in a number of the tests. This implies a less stable passive film which is thus also more likely to be effected to a greater extent by the flow water velocity.

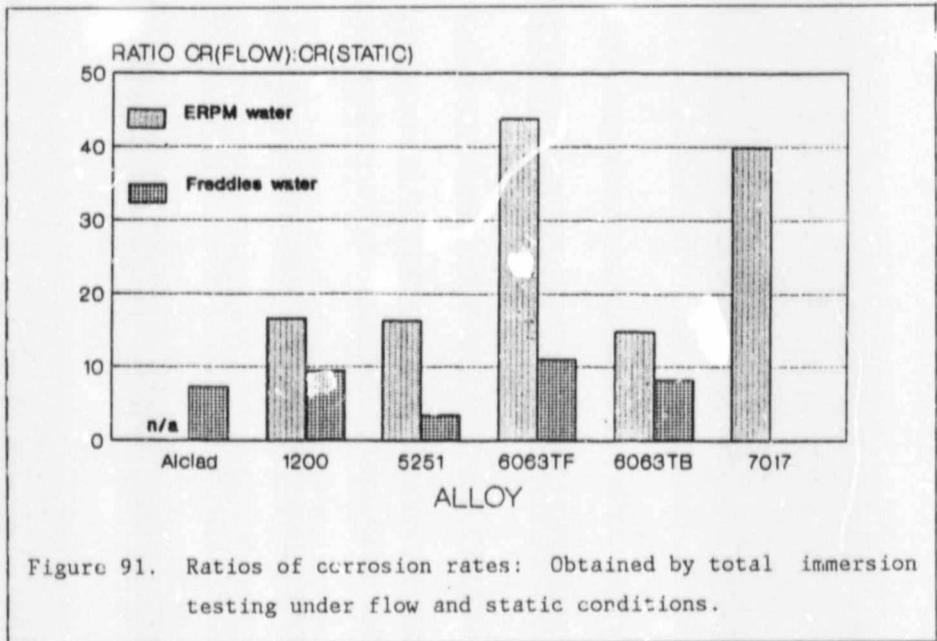
Interestingly the corrosion rates for alloy 7017 were little influenced by water velocity in the electrochemical tests, whilst in the total immersion tests there was a marked effect. As previously discussed the mode of corrosion for this alloy in these waters was by exfoliation. In the short term tests (electrochemical), there is no time for bulk metal loss by this process. In the longer term tests, severe breakup of the surface occurred. This would be aided by water velocity, both in that increased mass transport of oxygen to the corroding surface would occur and also the mechanical action of the water would loosen surface debris. The increase in mass transport to the corroding surface becomes more im-

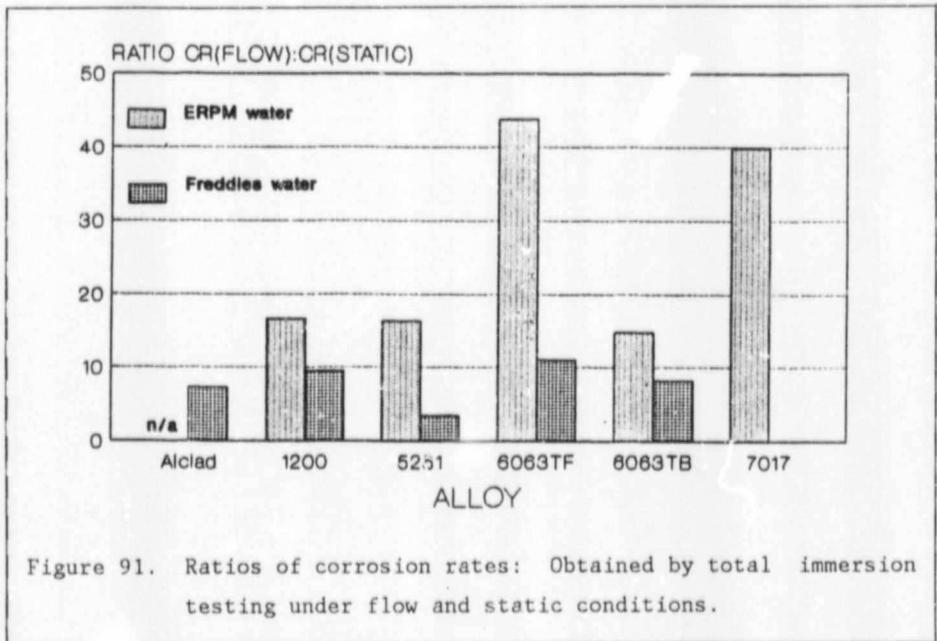
Figure 91. Ratios of corrosion rates: Obtained by total immersion testing under flow and static conditions.

The first and obvious inference drawn from these curves is that the flow rate markedly increases the general corrosion rate. The effect also appears to vary depending both upon the alloy and the composition of the water. Alloy 6063TB for example generally appears to be affected the most by flow. It also recorded the poorest performance in terms of general corrosion and pitting in a number of the tests. This implies a less stable passive film which is thus also more likely to be effected to a greater extent by the flow water velocity.

Interestingly the corrosion rates for alloy 7017 were little influenced by water velocity in the electrochemical tests, whilst in the total immersion tests there was a marked effect. As previously discussed the mode of corrosion for this alloy in these waters was by exfoliation. In the short term tests (electrochemical), there is no time for bulk metal loss by this process. In the longer term tests, severe breakup of the surface occurred. This would be aided by water velocity, both in that increased mass transport of oxygen to the corroding surface would occur and also the mechanical action of the water would loosen surface debris. The increase in mass transport to the corroding surface becomes more im-
