SOUTH AFRICAN ARCHITECTURAL RECORD

OCTOBER 10
1952

CONTENTS FOR OCTOBER 1952

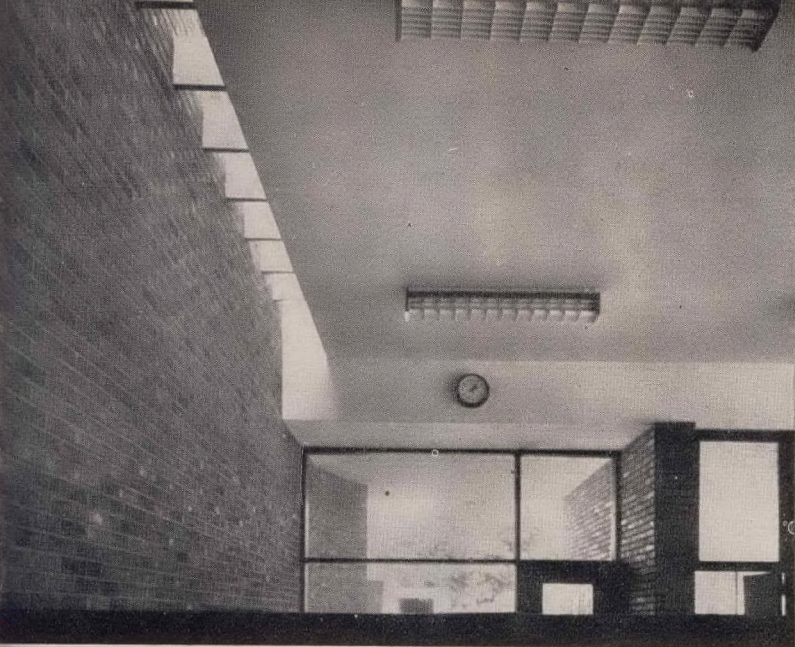
View of banking hall looking towards entrance porch and showing continuous roof lights.

As the North wall of the Banking hall is on the boundary, cross ventilation and light on this side is provided by a continuous roof light which illuminates the face-brick internal wall on this side, creates interest, and provides a spatial effect which makes the interior of the hall an interesting volume. The facades which have been carefully thought out provide interest on each side, and not merely on the street front as is so often the case in buildings designed on an internal plot. Face-brickwork has been used extensively, internally and externally to good effect. The floor finish is asphalt tile and the roof is carried out in concrete with inverted beams, built up with hollow tiles and finished in Pabcoweld roofing and coolite spray.

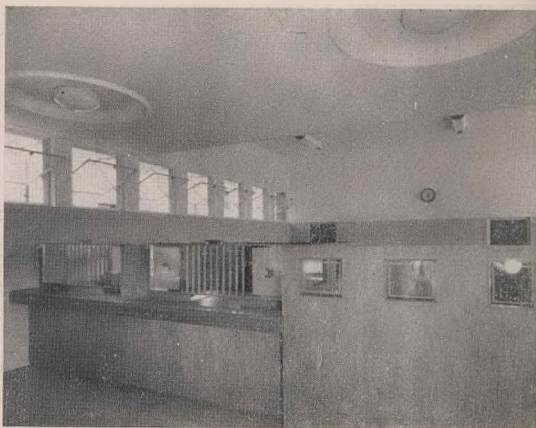
View of interior of banking hall showing tellers cubicles and clerestory lighting.

In this building, as in the previous bank in Pinetown, all the facades have been carefully designed to present a complete overall unity. The finish externally is mainly facebrick work with plaster surrounds, and internally the walls and ceilings are finished in plaster, floors in asphalt tile and the counters in natural wood. Hollow tile roof construction is used for the roof, which is waterproofed and finished with painted bituminous sheeting.

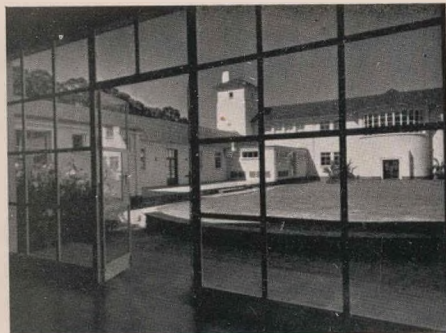
1. View from foyer to lecture theatre looking towards main entrance hall staircase.
2. View of interior of lecture theatre.

The ceilings under timber roofs are of flush fibrous plaster board, except in the Lecture Hall where acoustic tiles have been used. The false ceilings in the corridors, which enclose the air conditioning ducts, are of Masonite tempered hardboard screwed to branderling, and readily removable when repairs to the ducts or other services are required.

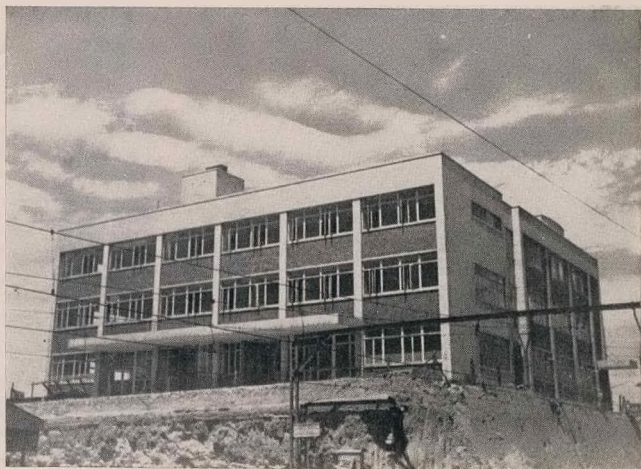
The Hospital on its islanded site immediately before its demolition.

Shortly after the War, plans were drawn up by the South African Railways and Harbours Administration for the extensions and reconstruction of the Johannesburg Railway Station, which had become too small for the greatly increased traffic it was called upon to handle. The extension of the station involved the expropriation and demolition of a number of buildings, among them that housing the Dental and Oral Hospital of the University of the Witwatersrand. This building was a three-storey reinforced-concrete framed structure occupying a site approximately 100 feet square, which had been completed in the second half of 1942.
