**Name of thesis** The Nature Of Failure Through The Intact Materials In The Step Joint Mechanism For Rock Slopes. 1973

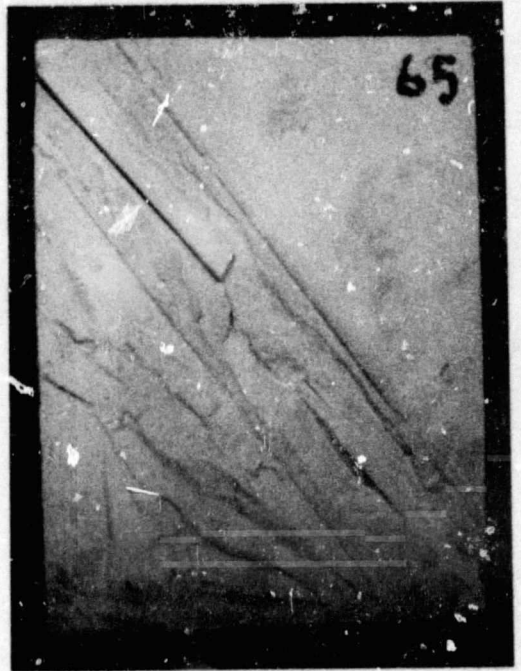
SAMPLE NO. 65

$$\alpha = 49\frac{1}{2}^{\circ}$$

$$W = 14,0 \text{ kN}$$

$$L_2 = 142 \text{ mm}$$

$$L_3 = 71 \text{ mm}$$

$$L_4 = 142 \text{ mm}$$

MODE OF FAILURE .

Shear occurred along both joints and through the intact material between the joints.

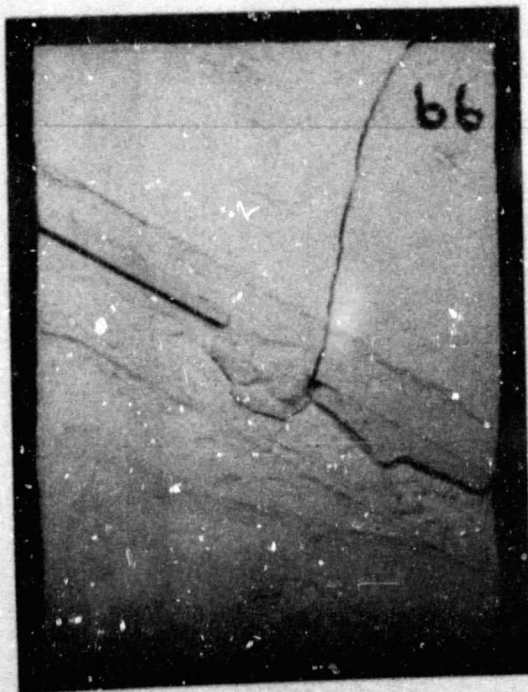
SAMPLE NO. 66

$$\alpha = 30^\circ$$

$$W = 45,6 \text{ kN}$$

$$L_2 = 106 \text{ mm}$$

$$L_3 = 53 \text{ mm}$$

$$L_4 = 106 \text{ mm}$$

MODE OF FAILURE

A branch crack developed downwards from the bottom of the upper crack. Failure occurred by shearing along both joints and through the intact material between the joints.

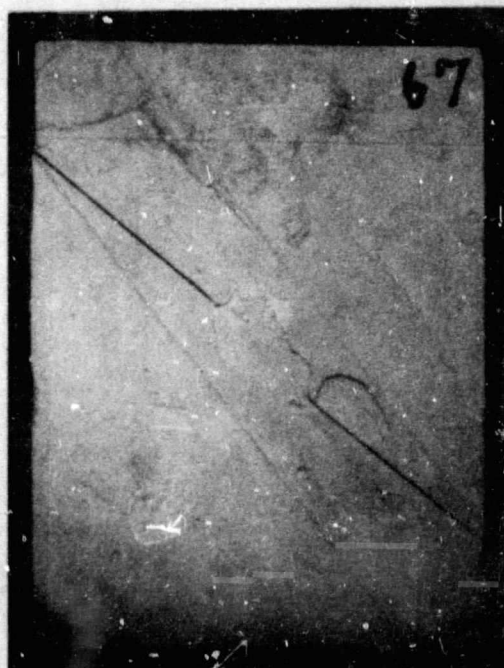
SAMPLE NO. 67

MODE OF FAILURE

A branch crack grew upwards from the lower joint and resulted in a tension fracture. Shear occurred along both joint surfaces through the intact material between the joints.

$$\alpha = 40^\circ$$

$$W = 19,2 \text{ kN}$$

$$L_2 = 119 \text{ mm}$$

$$L_3 = 59 \text{ mm}$$

$$L_4 = 119 \text{ mm}$$

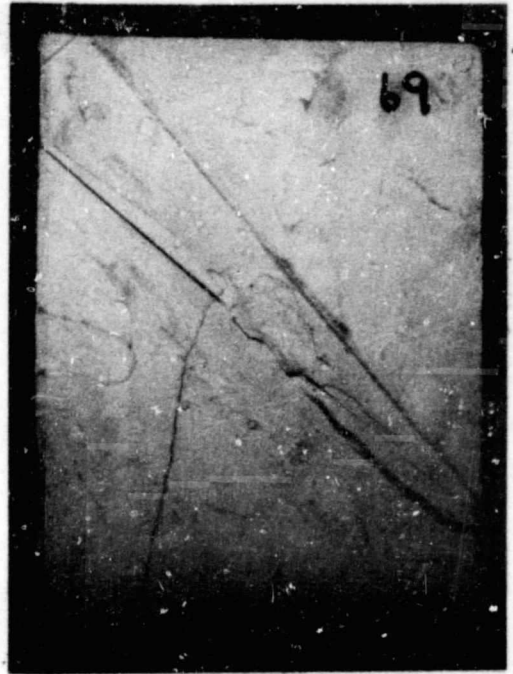
SAMPLE NO. 69

$$\alpha = 40^\circ$$

$$W = 19,5 \text{ kN}$$

$$L_2 = 119 \text{ mm}$$

$$L_3 = 59 \text{ mm}$$

$$L_4 = 119 \text{ mm}$$

MODE OF FAILURE

At maximum load, a branch crack appeared and the load reduced. The jack was pumped, the load increased and further shear movement occurred along the joints and their extensions through the intact material.
