AN ASSESSMENT OF SUPPORT SYSTEMS TO MINE  
ISOLATED BLOCKS OF GROUND AT THUTHUKANI  
SHAFT, KDC

A research report submitted to the Faculty of Engineering and the Built Environment,  
University of the Witwatersrand, Johannesburg, in partial fulfillment of the requirements  
for the degree of Master of Science in Engineering.

Johannesburg 2013

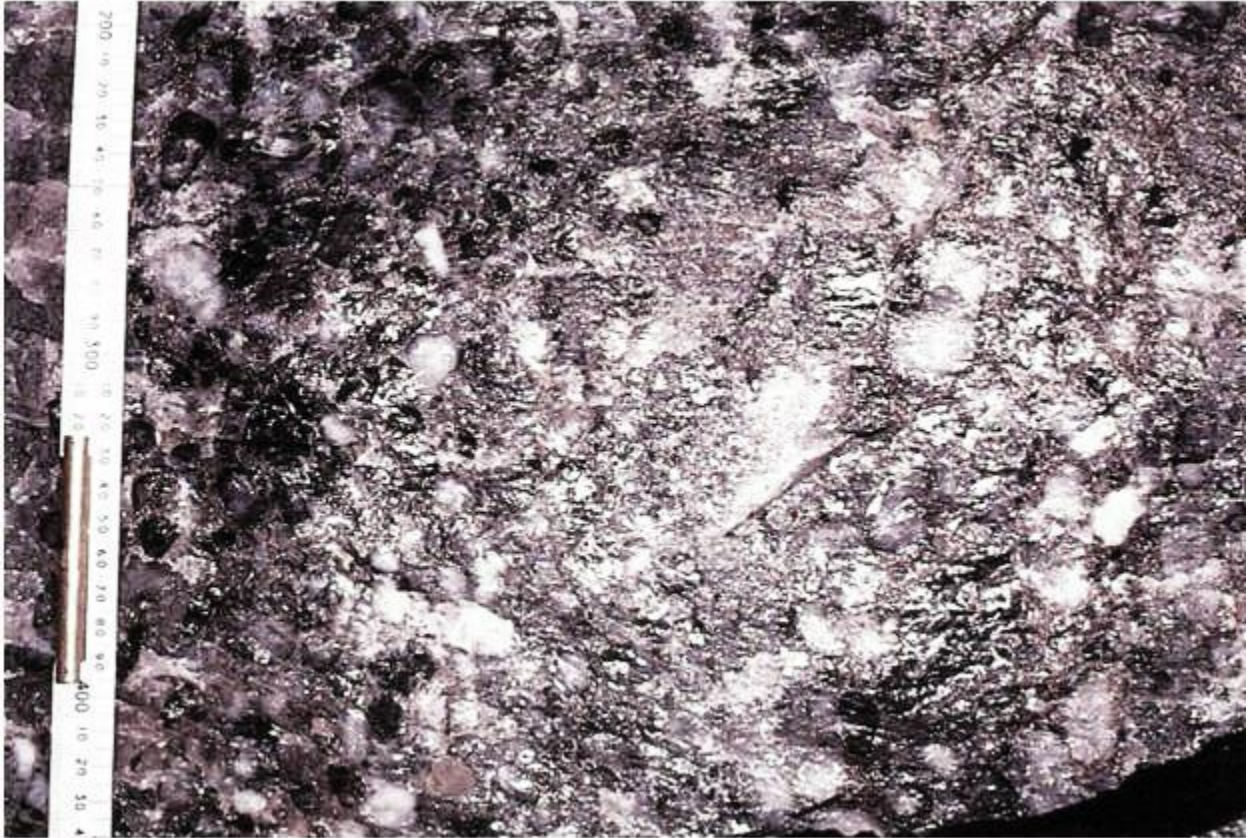
**Figure 1.3.3 No. 2 Klood Reef.**

The No. 2 Kloof Reef, in turn, is overlain by the Hanging wall marker, a band of quartzites with scattered pebbles, and with a conglomerate lag at the bottom and top of the bed. Above the Hanging wall marker are the scattered pebble and glassy quartzite markers with distances of 12 and 17 meters respectively above the No.2 Kloof Reef.

**Figure 1.3.3** is a photograph of the No. 2 Kloof Reef.

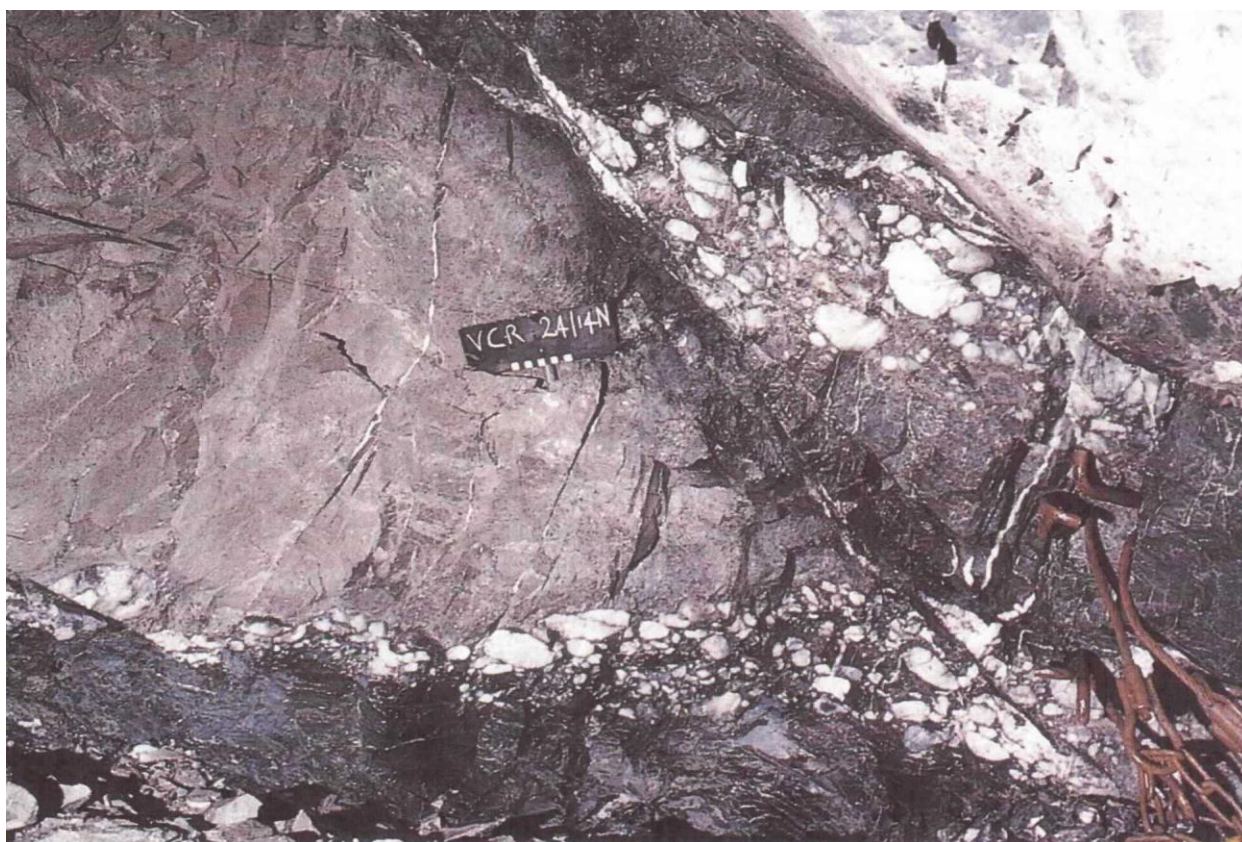
**Figure 1.3.6 VCR Inter-reef lava.**  
(Source: KDC East, Internal Collection)

The *Inter-reef* Lava type generally consists of a dark matrix, with clast-supported conglomerate (bottom band). The internal lava can reach thicknesses of 3-5 meters. The upper band is less well developed, comprising of planar bedded quartzite, often pyroclastic, and sometimes a thin conglomerate band may be present.

This type of reef is illustrated in **Figure 1.3.6**.

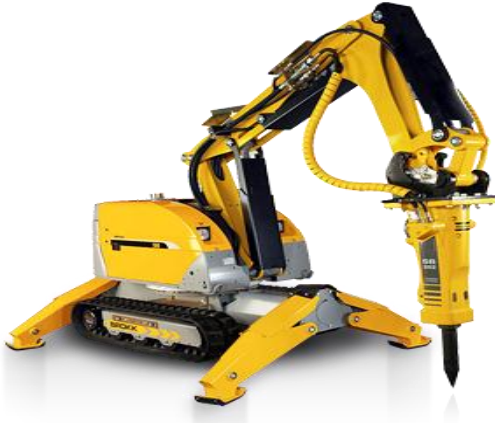
**Figure 2.3.1 The BROKK 400.**

One of the interventions at Thuthukani Shaft was the introduction of the “BROKK” machines. These machines were initially developed in Sweden for the cleaning of large industry kilns. Due to the high temperatures, experienced in these furnaces, the “BROKK” machine was used to do the cleaning, remotely.

The machine was then adapted to be used in the underground environment and is capable of conducting most of the Opening-up processes, remotely, with the operator situated between ten to twenty meters, in a safe area, behind the machine.

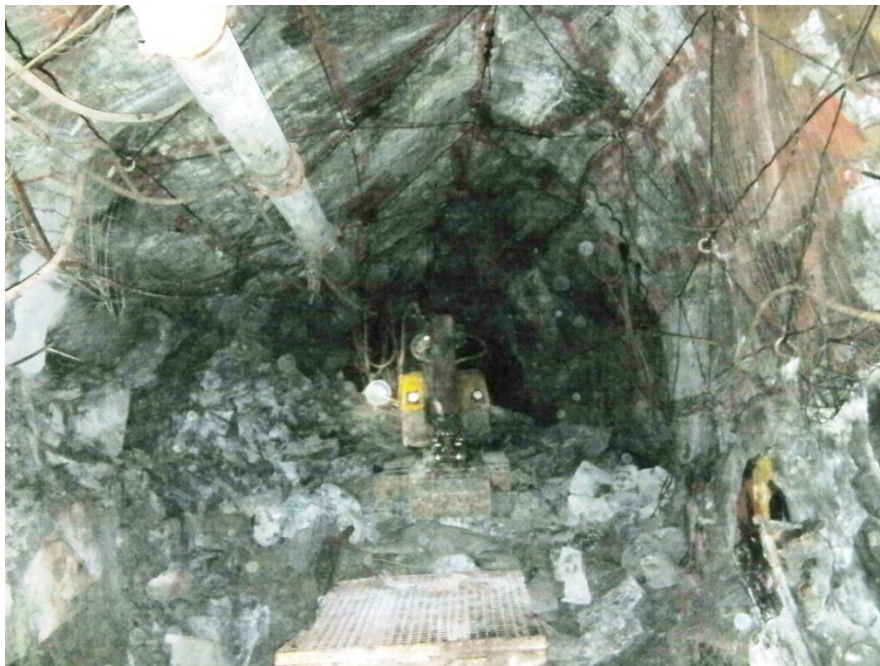
**Figure 2.3.2 The BROKK machine at Thuthukani Shaft, KDC.**

**Figure 2.3.2** depicts a BROKK machine in an Opening-up environment at Thuthukani Shaft, KDC. The BROKK is a trackless system and is capable of conducting work in areas where tracks are seriously damaged or worn out. It is also capable of being driven over muck piles and work in a retreat manner, barring, loading and moving rubble to a more stable area where the rubble is loaded onto a hopper and transported out of the workings by locomotive.

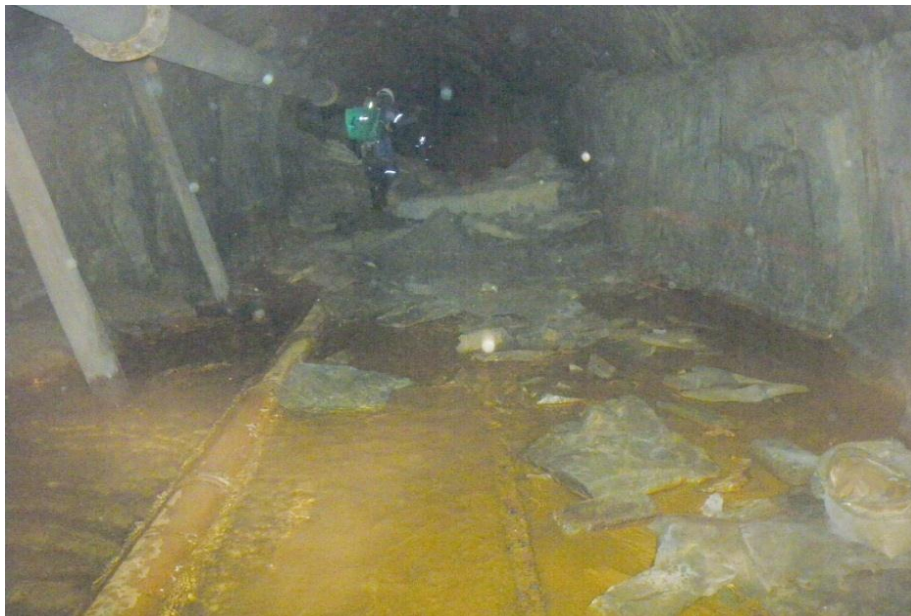
**Figure 2.4.1** Opening-up reconnaissance visit.

Opening-up is categorized into four groups ranging from 25% opening-up, up to 100% opening-up which is total closure of a tunnel or access way. **Figure 2.4.1** depicts a member of a reconnaissance team inspecting a fall of ground on a reconnaissance visit. The reconnaissance visit member is looking at a typically 50% opening-up situation leading from a 25% opening-up situation. It is important to understand that once barring of the side walls and hanging walls take place, the muck pile being inspected will increase in volume. One can also notice the extent of deterioration of the track work and the reddish-brown colour of the stagnant water caused by oxidation of the infrastructure.

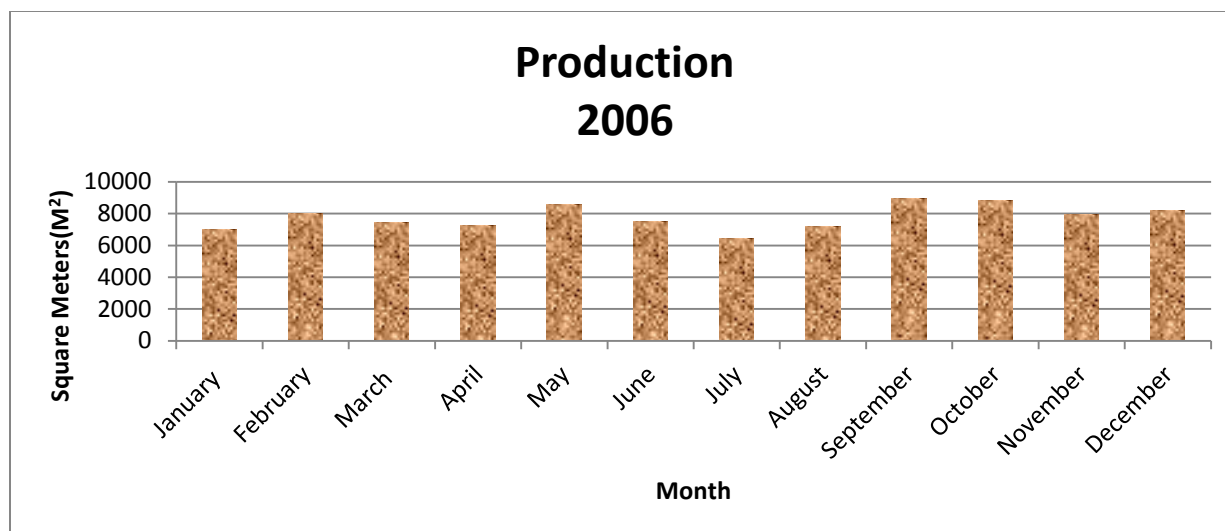
**Figure 3.3.2 Monthly production results for 2006.**

The monthly average production result for 2006 was approximately 7500 square meters. Production output was hampered in July 2006 as a result of two notices for the suspension of work operations issued by the Department of Minerals and Energy (DME) in the form of a Section 54, for sub-standard work conditions. Conditions had to be first rectified, audited and presented to the DME prior to production operations continuing in the affected workplaces.

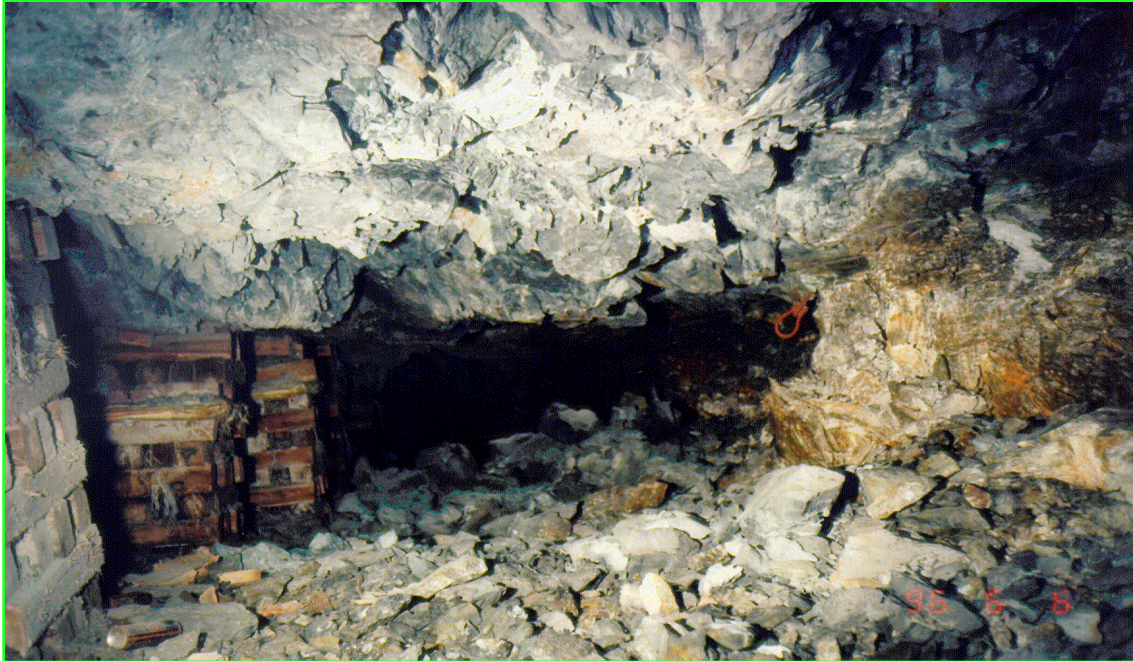
**Figure 5.5.2 Panel with no Pre-conditioning conducted.**  
(Source: Toper, 2003)

Improved hanging wall conditions, face advance and fragmentation have been noticed. **Figure 5.5.2** and **5.5.3** indicate panels without Pre-conditioning and with Pre-conditioning respectively. A significant difference in the hanging wall, face and fragmentation condition can be noticed.

**Figure 5.5.3** indicates much better hanging wall conditions as compared to **Figure 5.5.2**. This improvement of the hanging wall conditions caused by implementing pre-conditioning of the face and side walls helps in maintaining a consistent and more solid beam of rock in the hanging wall. This results in more stable hanging wall conditions which are more robust when a seismic event occurs. The hanging wall in **Figure 5.5.2** is more prone to a shake down and localized falls of ground due to its blocky and fractured nature.

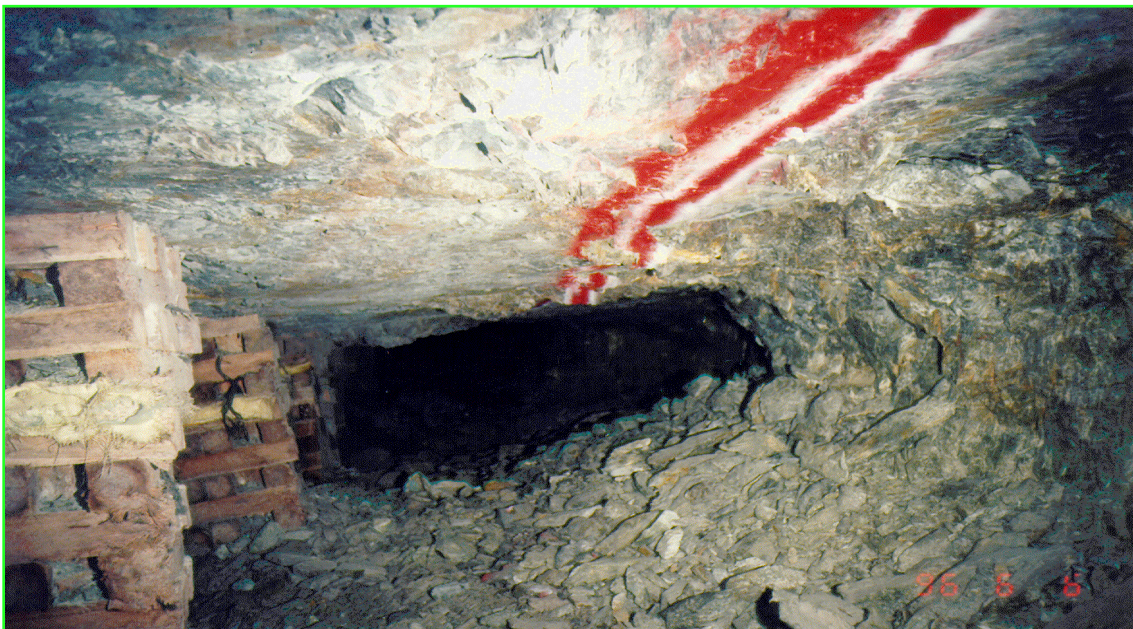
**Figure 5.5.3 Panel with Pre-conditioning conducted.**  
(Source: Toper, 2003)

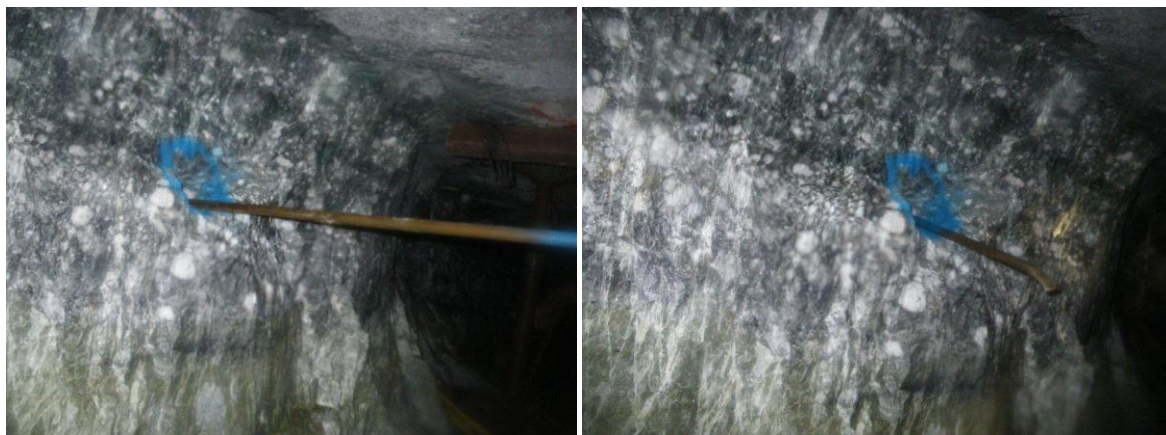
**Figure 5.6.1** Checking of a Pre-conditioning hole at Thuthukani Shaft, KDC.  
(Source: Personal Collection)

**Figure 5.6.1** shows two pictures where a pinch bar is used to check the depth of the remaining socket of a previously blasted Pre-conditioning hole, after it had been cleared of all remaining explosives and washed out.

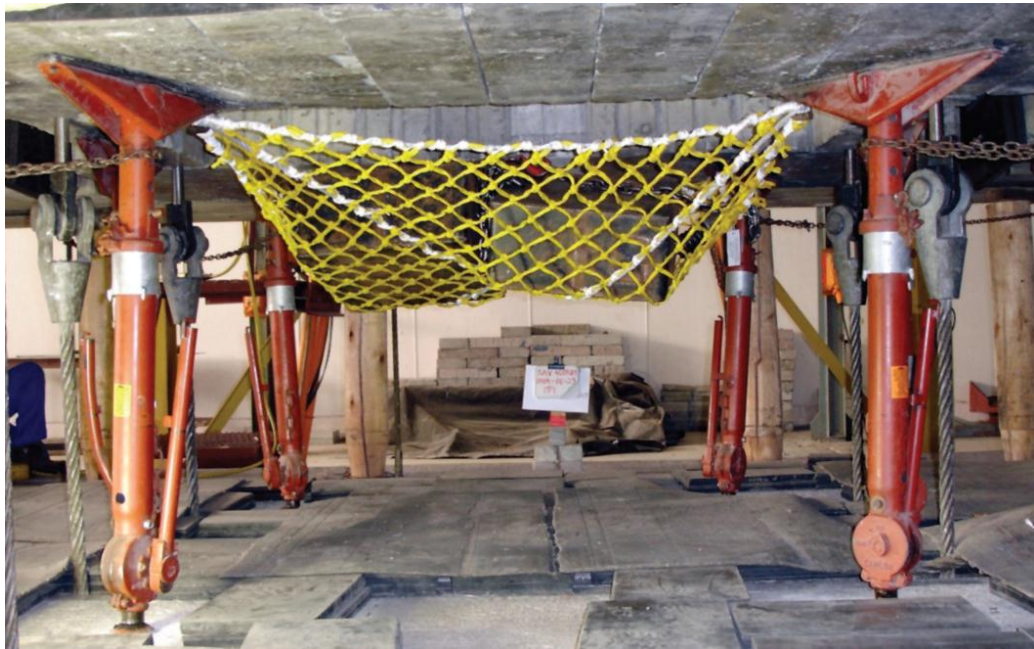
**Figure 6.2.1 Safety net test at the Savuka testing facility.**  
(Source: Skarbovig, 2010)

In-stope netting is widely used in the gold and platinum industry nowadays. **Figure 6.2.1** above, indicates a safety net test at Savuka, showing the 450 kg twin drop mass arrested by the safety net. The diagonal and perimeter net reinforcement ropes attached to the Camlok prop hooks can be noted. **Figure 6.2.2** indicates a typical installation of in-stope netting.

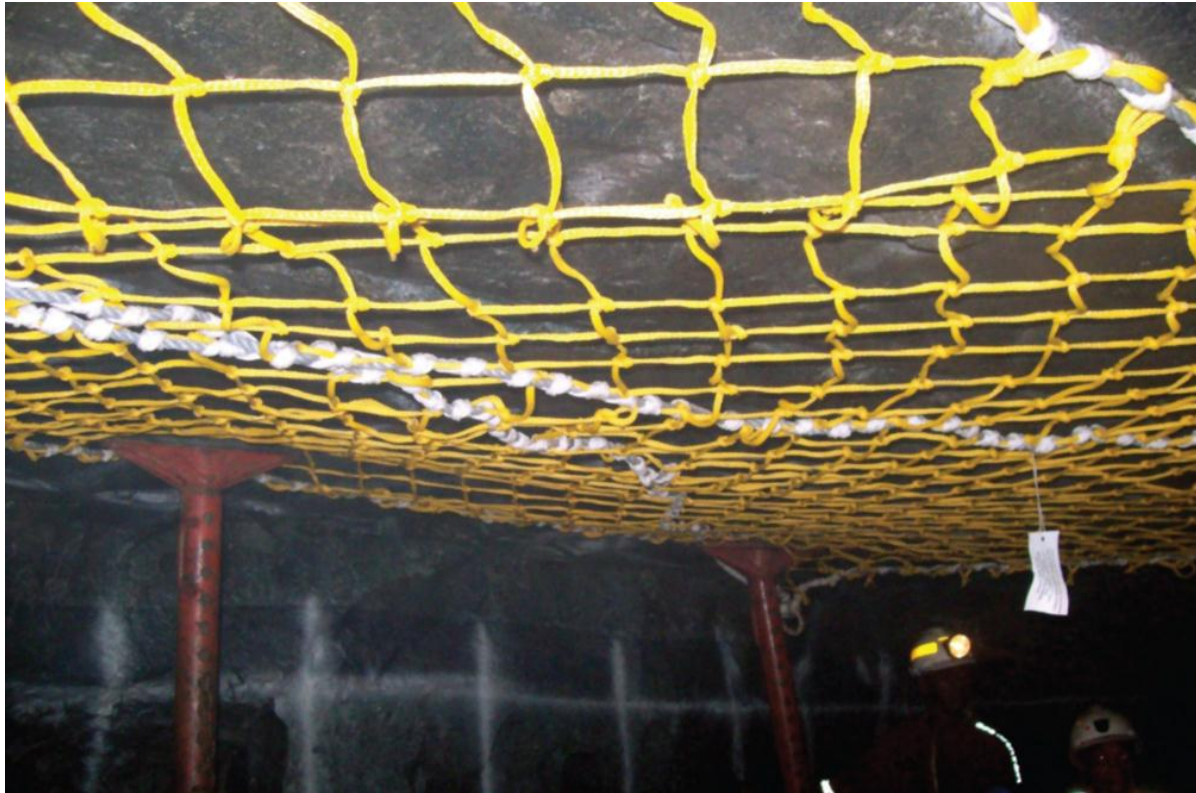
**Figure 6.2.2 Typical installation of in-stope netting.**

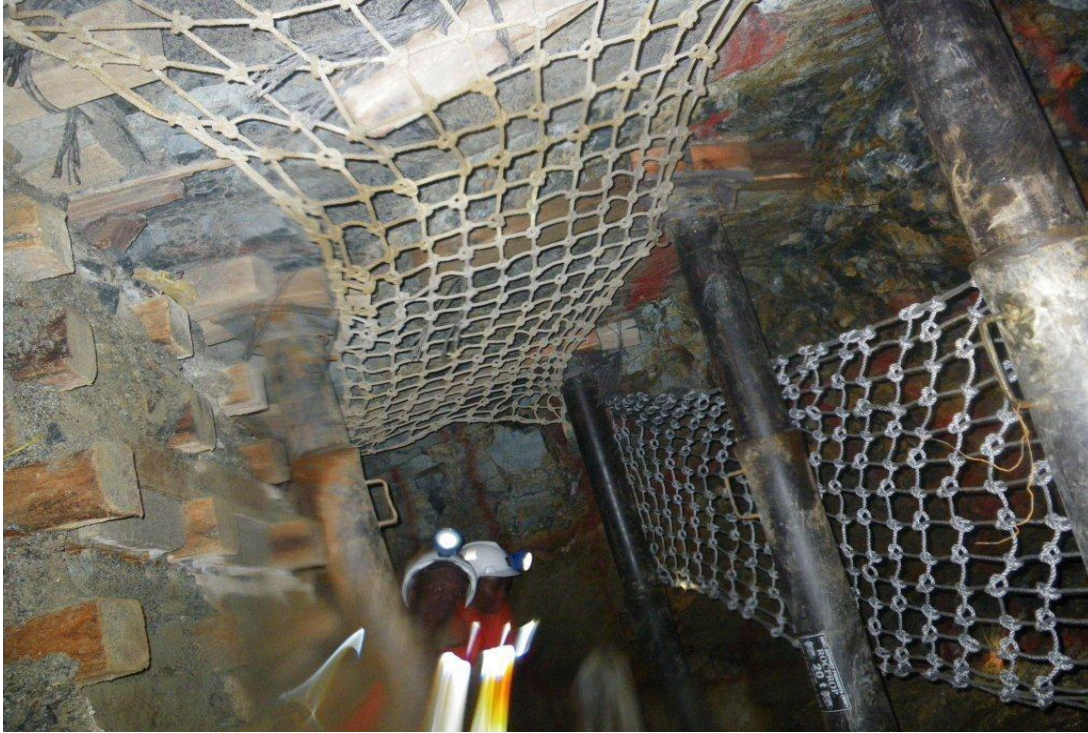
**Figure 6.3.1** In-stope netting at Thuthukani Shaft, KDC.

In practical examples where large amounts of rocks have been ejected from the hanging wall, it gave the workforce “a bit of time” to escape. **Figure 6.3.1** indicates the installation of in-stope netting in one of the stopes at Thuthukani Shaft, KDC. The nets are installed between the last line of packs and the face. Additional nets are installed on the face to arrest the ejection of rock from the face in the event of a face burst. Blast holes are drilled through the apertures in the net.

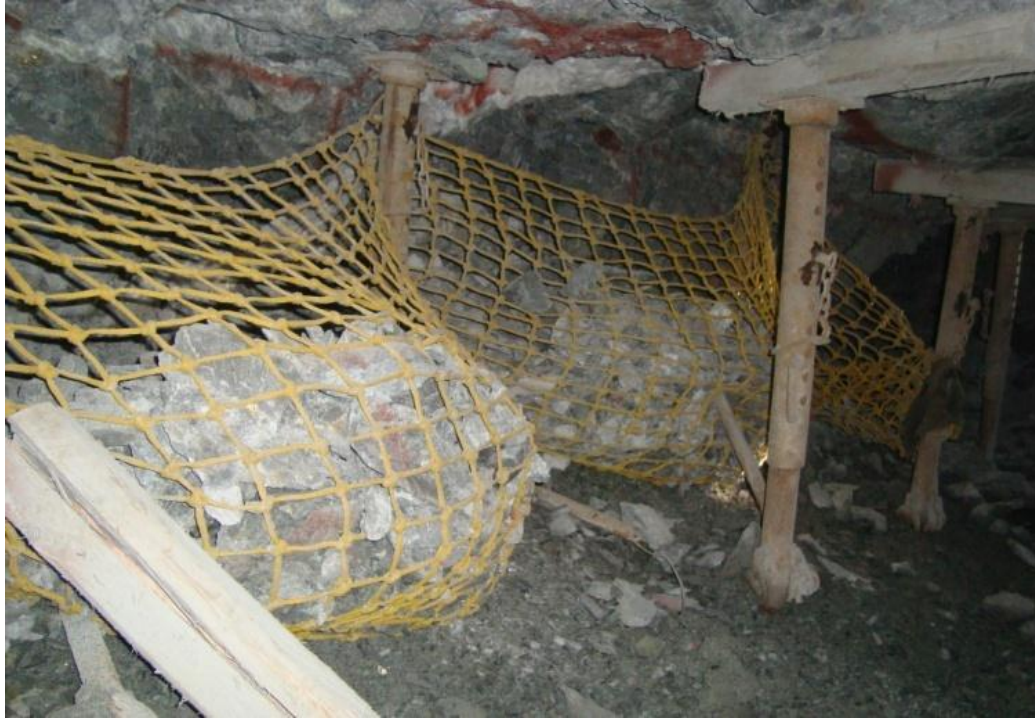
**Figure 6.3.2** indicates an incident at Thuthukani Shaft, KDC, where in-stope netting installed on the face arrested the rock ejected from the face in a face burst event. If the in-stope netting was not installed on the face, the ejected rock would have been ejected into the back areas and possibly injured persons working there. The installation of in-stope netting on the face is not standard practice; it is carried out as an additional safety precaution and is becoming a more common practice when mining isolated blocks of ground at Thuthukani Shaft, KDC.

**Figure 6.3.2** In-stope netting used on the face at Thuthukani Shaft, KDC.  
(Source: Personal Collection)

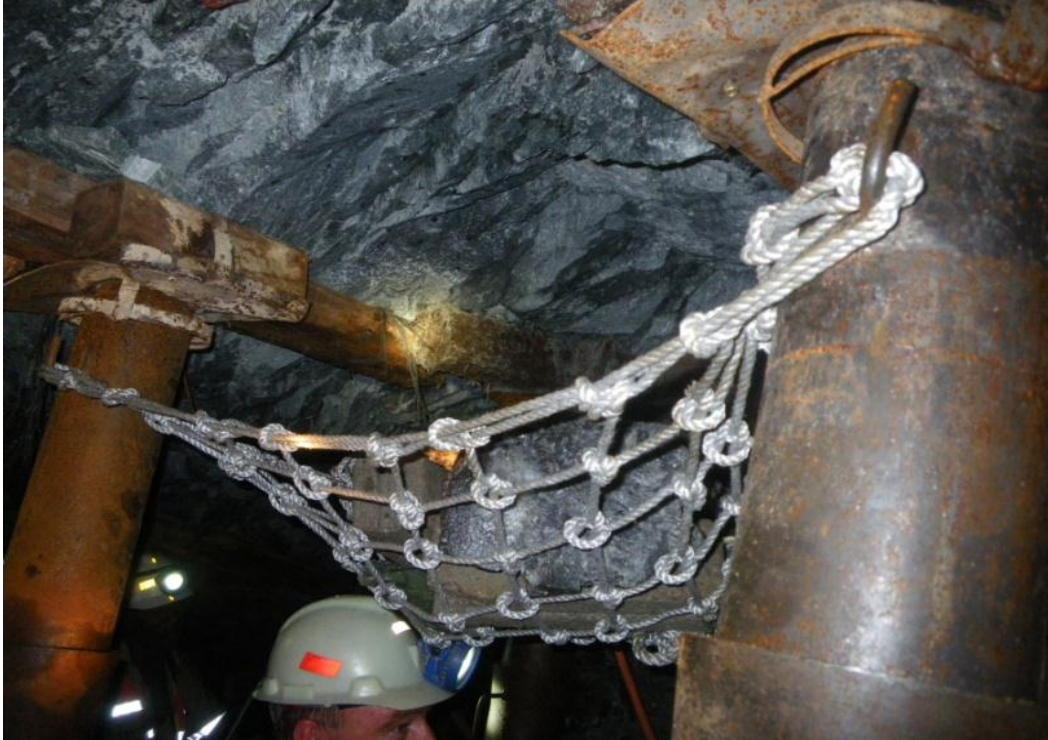
**Figure 6.3.3** depicts a production supervisor inspecting the arresting of a fall of ground by the in-stope netting at Thuthukani Shaft, KDC. It is clear that the rock arrested by the net would have caused serious injury to persons that were working underneath the net had the net not been installed.

**Figure 6.3.3 In-stope netting in action at Thuthukani Shaft, KDC.**

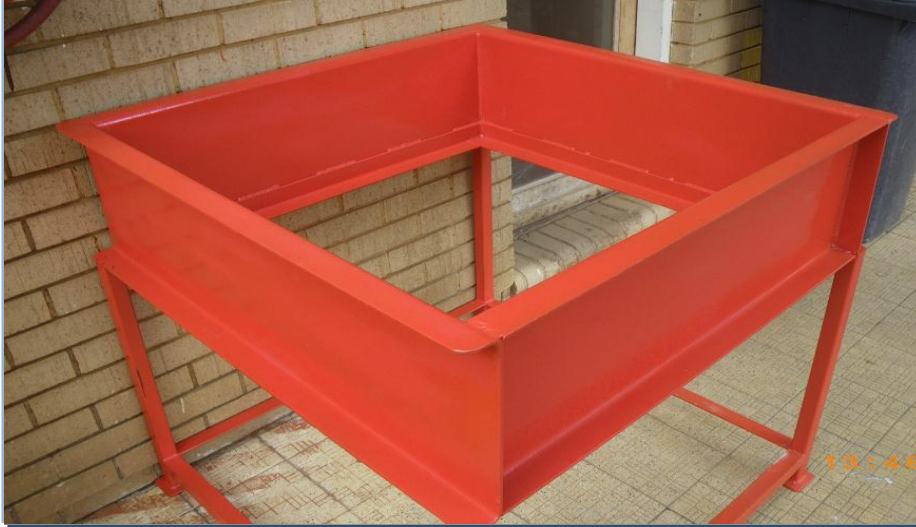
**Figure 7.2.1 Steel Box.**

**Figure 7.2.1** depicts a steel box that was created to demonstrate the effects of rock bolting. The box contains four solid steel side walls which were welded together with the top and bottom of the box left open.

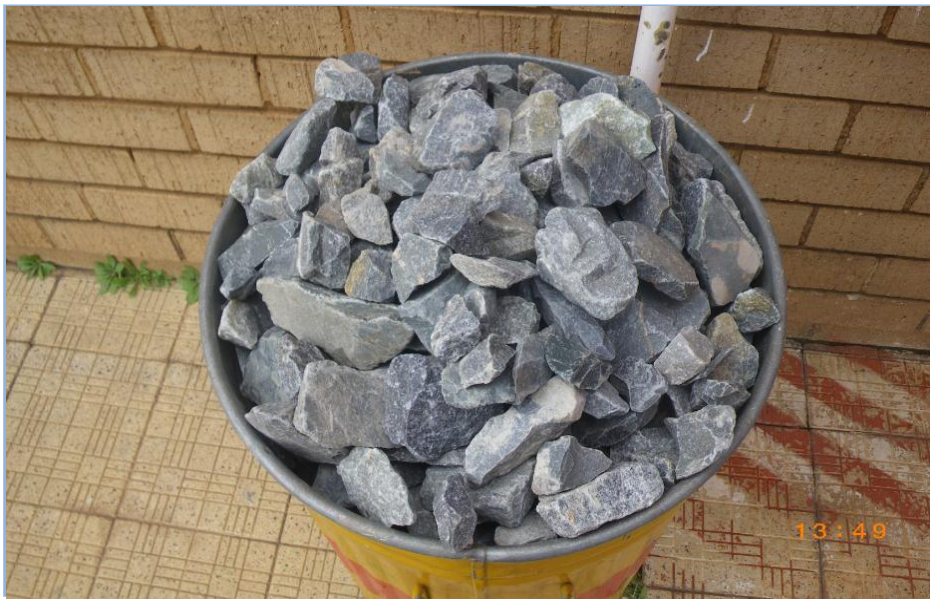
**Figure 7.2.2 Broken Rock.**

**Figure 7.2.2** depicts a bucket of broken rock that will represent the broken and fractured rock that we normally find in the hanging wall of underground workings. This is only a representation and the rocks found underground will be much larger.

**Figure 7.2.4** depicts the broken rock, indicated in **Figure 7.2.2**, which is poured into the steel box and onto the wooden board. The rocks are spread evenly onto the wooden board and amongst the bolts that protrude out.

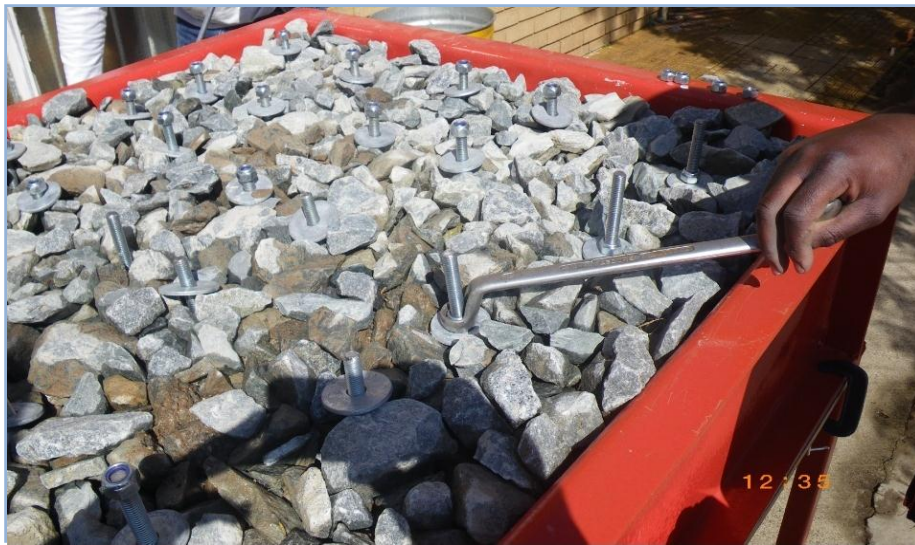
**Figure 7.2.5** Tightening the bolts.  
(Source: Gold Fields, 2012)

**Figure 7.2.5** depicts the steel box being filled with more rocks, which is compressed into the steel box and washers and nuts being fastened onto the bolts.

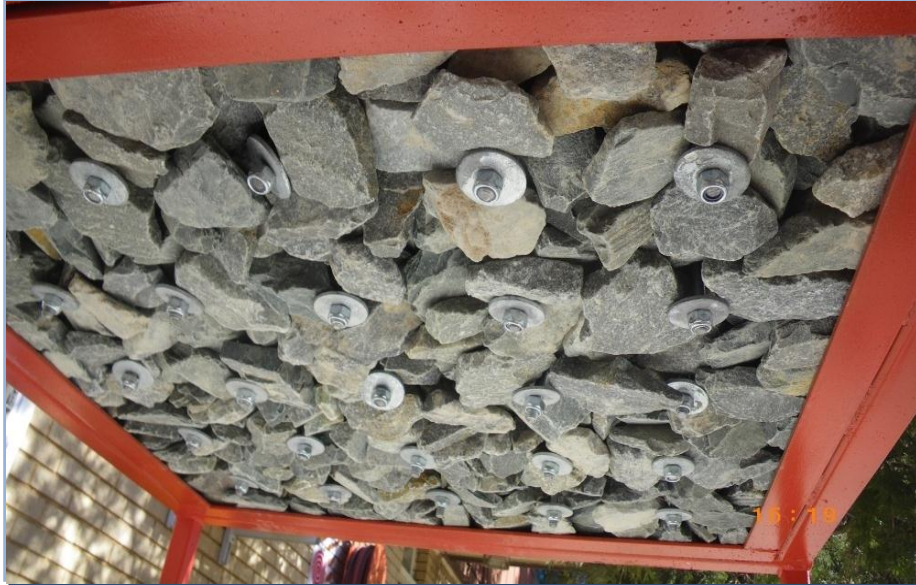
**Figure 7.2.6** The bottom of the steel box showing the beam created.

**Figure 7.2.6** depicts the steel box, being viewed from underneath, where the G-clamps and wooden board have been removed. The compressed rock and tensioned bolts form a beam of rock.

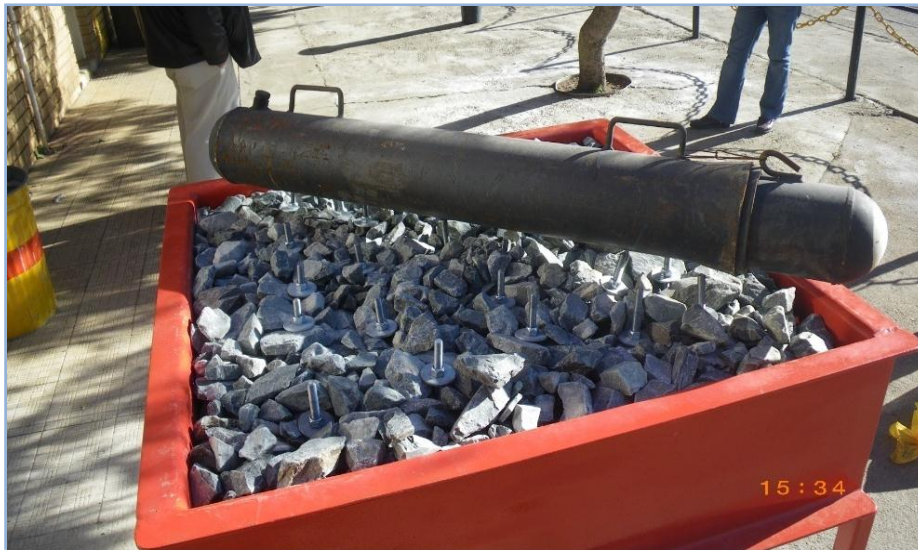
**Figure 7.2.7** A rock prop is placed on top of the beam created demonstrating the strength of the beam created.

**Figure 7.2.7** depicts a rock prop, which is in excess of twenty kilograms in mass, placed on the beam that was created with the bucket of rocks and bolts. This is an indication of the strength of the beam formed.

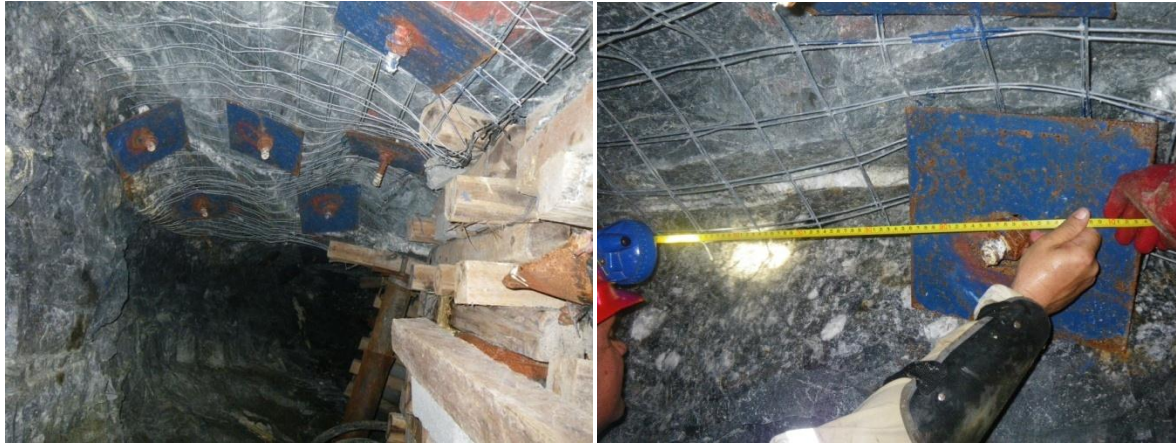
**Figure 7.6.1** Rock consolidation at Thuthukani Shaft, KDC.

**Figure 7.6.1** shows two pictures indicating rock consolidation with abutment plates and wire mesh. The spiral bolt is used as a drill steel and is drilled into the hanging wall, the drill machine is removed and rock consolidation resin is pumped through the spiral bolt into the rock mass. This resin permeates into all the fractured zones, intersected by the spiral bolt, and consolidates the rock mass. Abutment plates with wire mesh are used to further reinforce the installation and rock consolidation.

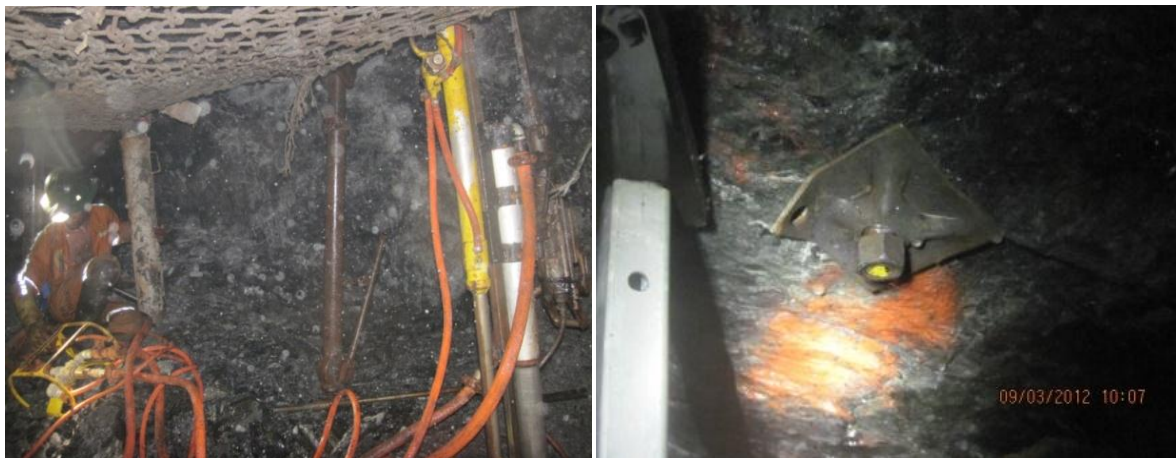
**Figure 7.6.2** In-stope bolting at Thuthukani Shaft, KDC.

**Figure 7.6.2** shows the drilling of in-stope bolting and the installed bolt. In-stope bolting was only introduced to the support standard in 2012 and the different methods and equipment will now be tested in an effort to make in-stope bolting effective and as user friendly as possible.
