# PERFORMANCE OF SILICONE RUBBER MATERIALS UNDER HIGH VOLTAGE DIRECT CURRENT USING THE INCLINED PLANE TEST

A research report submitted to the faculty of Engineering and the  
Built Environment, University of the Witwatersrand, in fulfilment  
of the requirements for the degree of Master of Science of  
Engineering

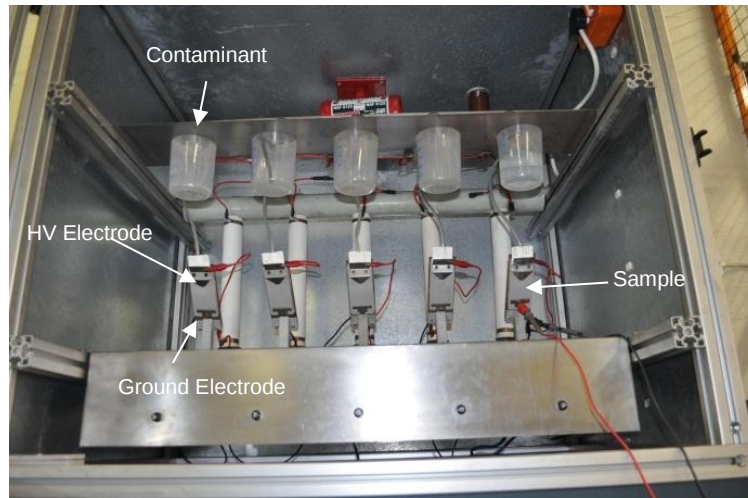
In order to conduct the experiment, an inclined plane test (IPT) setup was utilised, shown in Figure 1. The IPT chamber is supplied by a single phase 230 V / 12 kV step-up transformer. This setup was used for the ac tests. For the positive dc tests a Spellman 50 kV dc, 80 mA stand-alone supply was used to charge a smoothing capacitor of 66  $\mu$ F coupled to the necessary peripheral equipment for protection and switching. For the negative dc tests a half wave rectifier circuit was constructed. This setup used an 80 kV (peak inverse voltage), 500 mA diode arrangement in series with a 100  $\Omega$  resistor. This was then used to charge the 66  $\mu$ F capacitor, and coupled to the necessary peripheral equipment.

The insulator sample is mounted on an insulated stand at an angle of 45° to the horizontal. The high voltage (HV) and ground electrodes are connected to the top and bottom of the sample respectively, as shown in Figure 1.

**Figure 1: Inclined plane test setup**

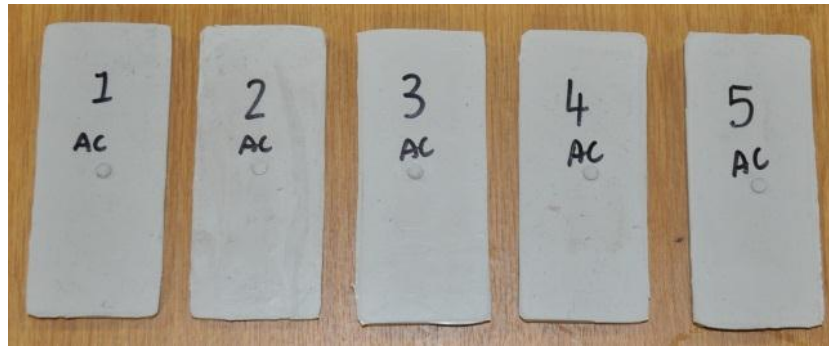
All the samples used for the ac and dc tests were manufactured from the same batch of silicone rubber, thus ensuring consistency in the test samples. The samples were manufactured from high temperature vulcanised (HTV) silicone rubber in slabs of approximately 118 x 50 x 6 mm. Figure 2 shows the virgin test samples (ac test samples prior to energisation).

**Figure 2: AC test samples prior to energisation**

The control sample was a virgin sample of silicone rubber material as shown in Figure 2.

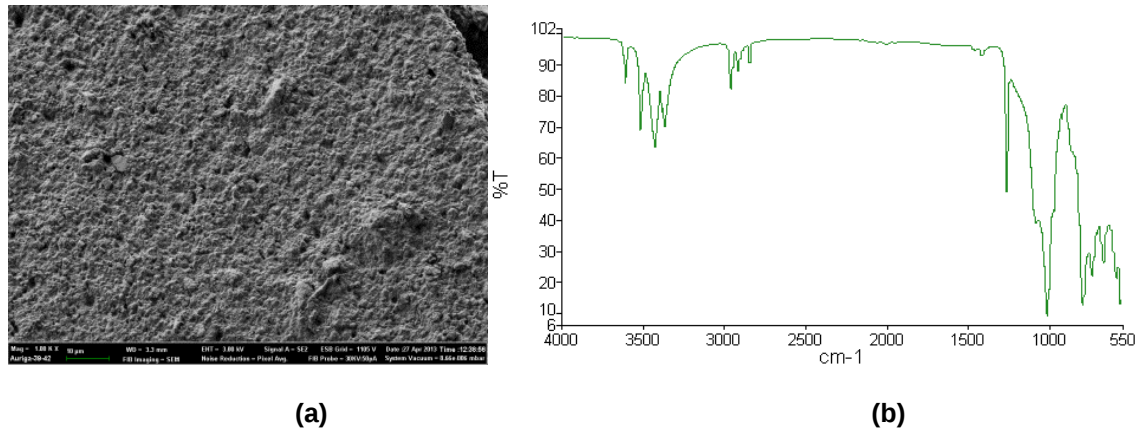
**Figure 3: (a) Cross-sectional view of the control sample and (b) the FTIR spectrum**

Cross sections of control samples show a relatively uniform surface texture with occasional large inclusions, shown in Figure 3a. FTIR spectra in Figure 3b showed characteristic N-H stretching peaks between 3200 and 3500 wave numbers (w/n), C-H stretching below 3000 and C-O / C-H stretching between 1500 and 1000 w/n

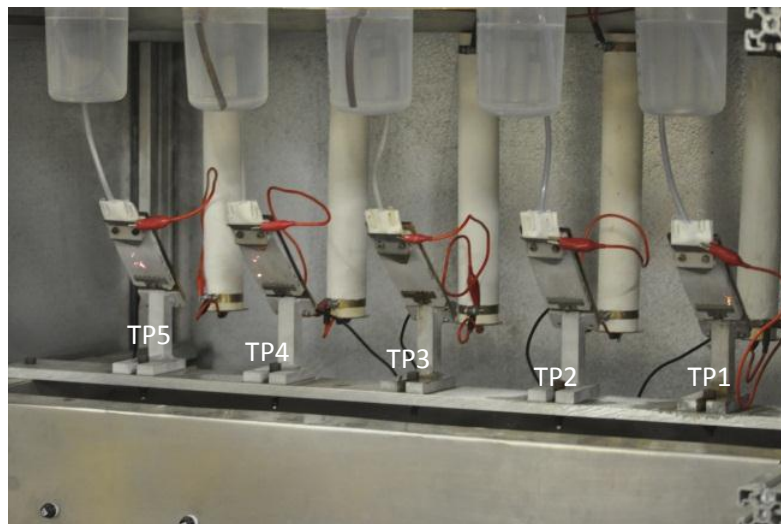
In the ac test 4.5 kV rms was applied to the samples, and 4 samples were energised (test positions 1, 2, 4 & 5). Scintillations and discharge activity was noted on voltage application, shown in Figure 4. After approximately 45 minutes of energisation it was observed that 'track' marks were clearly visible on the samples (along the contamination path). Figure 5a shows the 'track' marks and the beginning of the local arc spots and erosion. Figure 5b shows the heating caused by the leakage current activity.

**Figure 4: Discharge activity noted on voltage application**

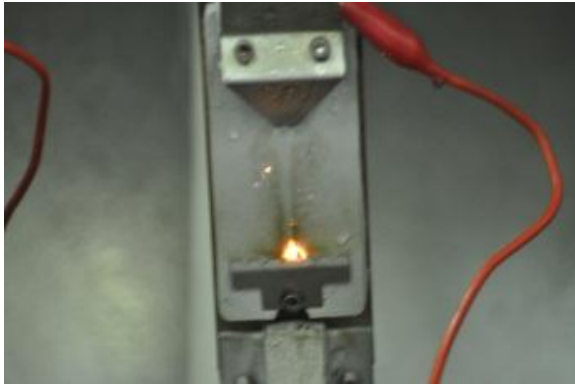
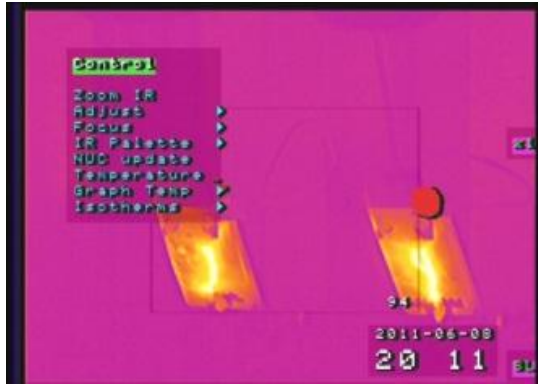
**Figure 5: (a) Track marks on the material surface; (b) Infra-red image of heating caused by leakage current flow**

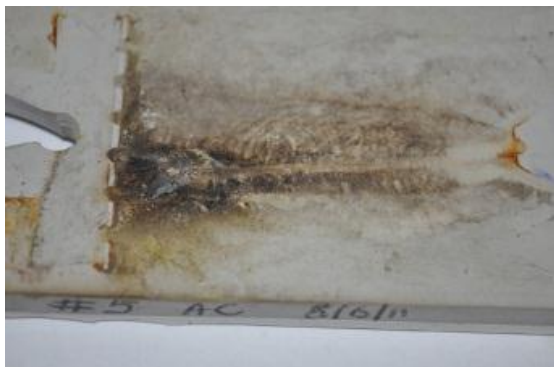
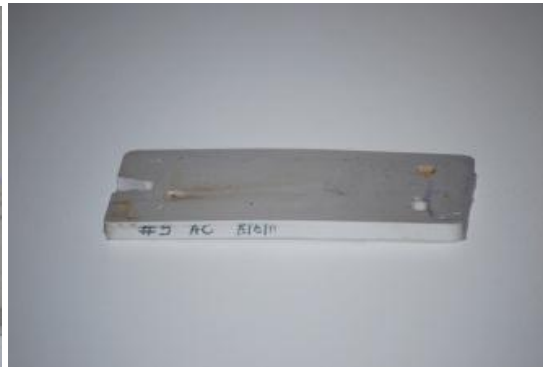
All the samples in the ac tests ran the full 6 hours, with signs of localised arc spots and erosion at the ground electrode. Sample 5 was cleaned after the test and revealed minimal erosion of negligible depth, shown in Figure 6.

**Figure 6: (a) Sample 5 after 6 hours of energisation; (b) sample after cleaning**

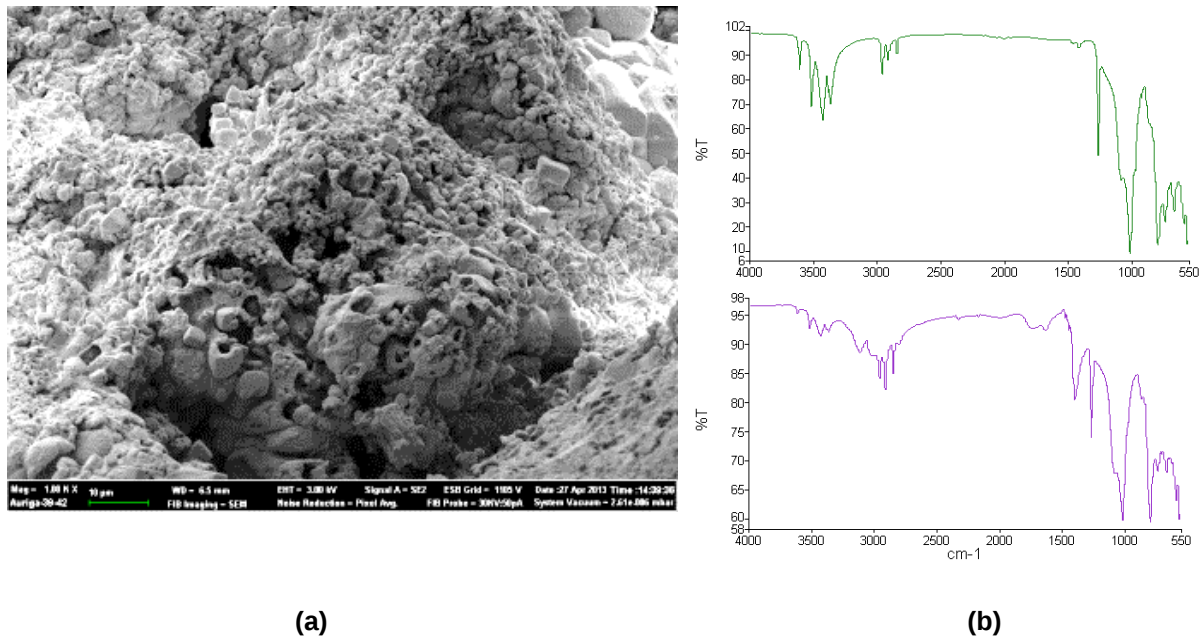
**Figure 7: (a) Cross-sectional view of the ac sample and (b) the comparison in FTIR scan**

The ac sample had a surface texture that was characterised by distinct cuboidal and plate-like inclusions (Figure 7a). Figure 7b shows the spectrum from the damaged spot (purple spectrum) resembling that of the control (green spectrum) except for the appearance of peaks above 1500 w/n. There are also peaks between 3300 and 3000 that are not seen in the control sample.

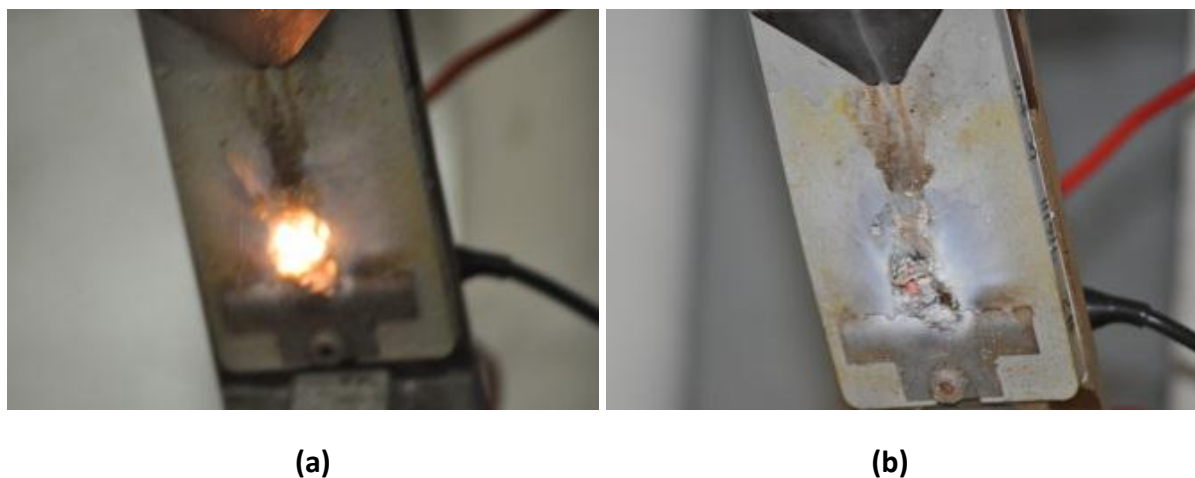
In the positive dc test at 4.5 kV only 3 samples were energised. After 5 minutes scintillations were observed to be more vigorous than the ac test, and after 15 minutes tracks were visible along the entire length from the HV to the ground electrode. After approximately 40 minutes sample 2 (test position (TP) 2) showed serious erosion and evidence of a hole being burnt into the material at the ground electrode, shown in Figure 8.

**Figure 8: (a) Burning on sample 2 at ground electrode and; (b) erosion noted on sample 2**

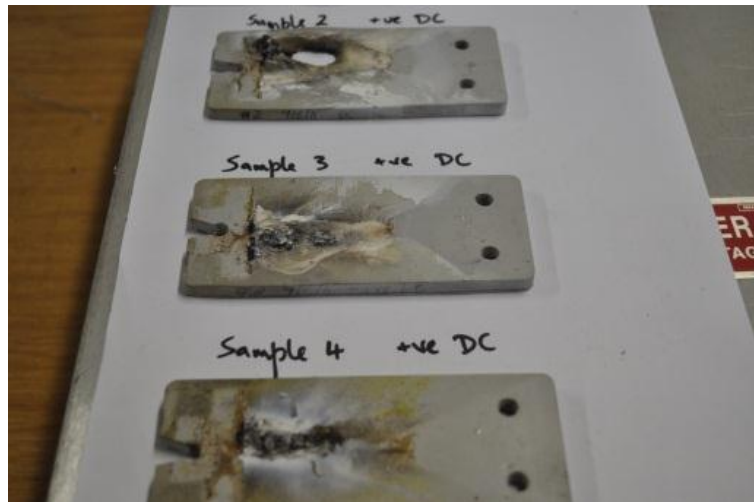
The test was finally stopped after 95 minutes. Figure 9 shows the samples after testing. The maximum (1 minute max) current recorded (on sample 3, tp1) after 65 minutes was 75 mA, with an average of 47.6 mA.

**Figure 9: All three samples showing signs of severe erosion**

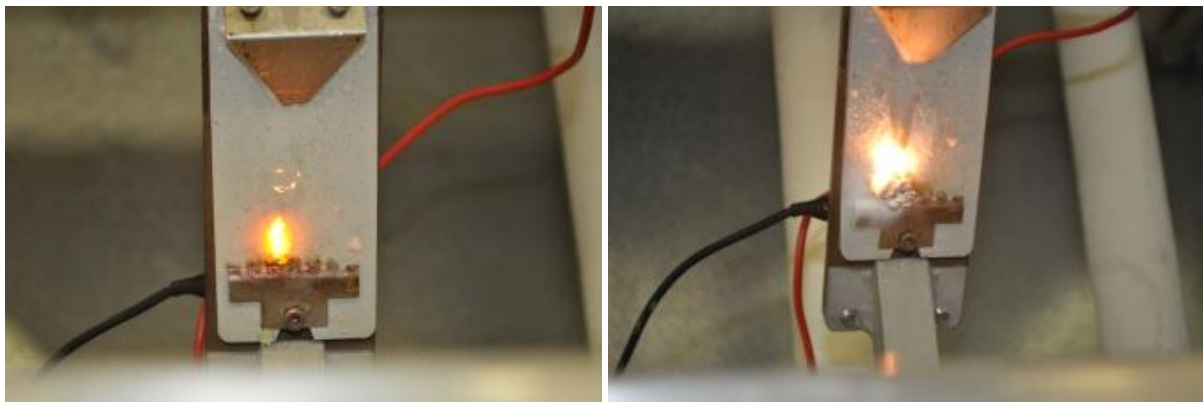
In the negative dc test at 4.5 kV, it was observed that an arc root had formed on sample 2 after 5 minutes, and aggressive erosion began after 20 minutes, shown in Figure 10.

**Figure 10: (a) Formation of the arc root, and (b) the starting of erosion.**

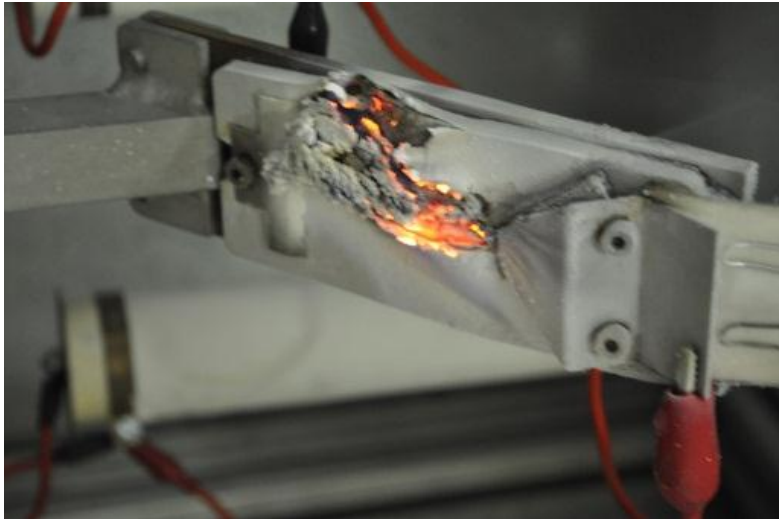
Approximately 42 minutes after the test had started, the arcing had caused erosion from the lower electrode to the upper one, as shown in Figure 11.

**Figure 11: Severe erosion on sample 2 after 42 minutes**

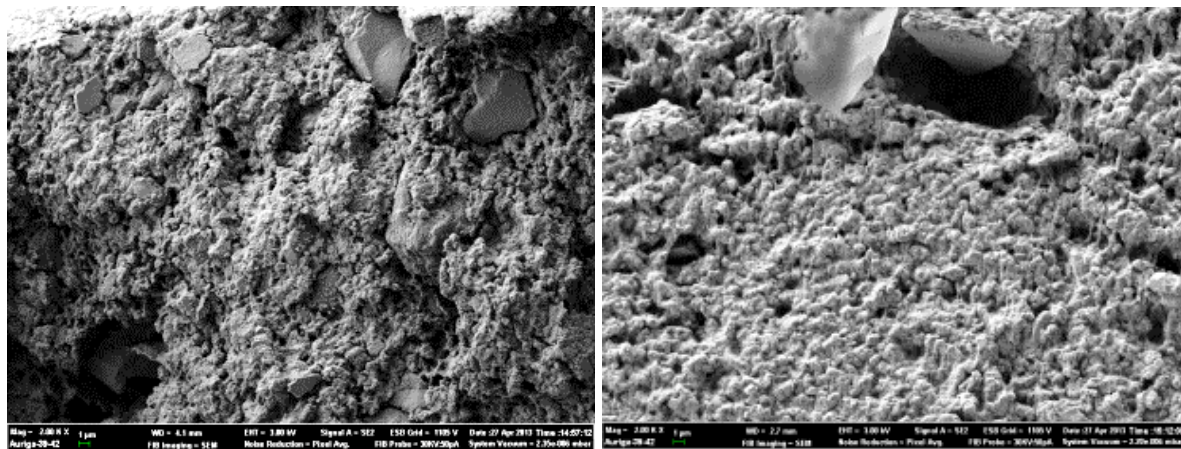
**Figure 12: Cross-sectional views of (a) +4.5 kV dc and (b) -4.5 kV dc**

Figure 12 shows a segregated texture induced by the dc energisation in both positive and negative cases. The regular occurrence of large inclusions gives the positive sample a courser appearance than the negative. The FTIR spectra in Figure 13 shows an attenuation of the N-H peaks around 3500 w/n in both positive and negative samples. However, there are no visible differences from the control spectra at around 1200-1500, but the disappearance of peaks around 2800 is noted.

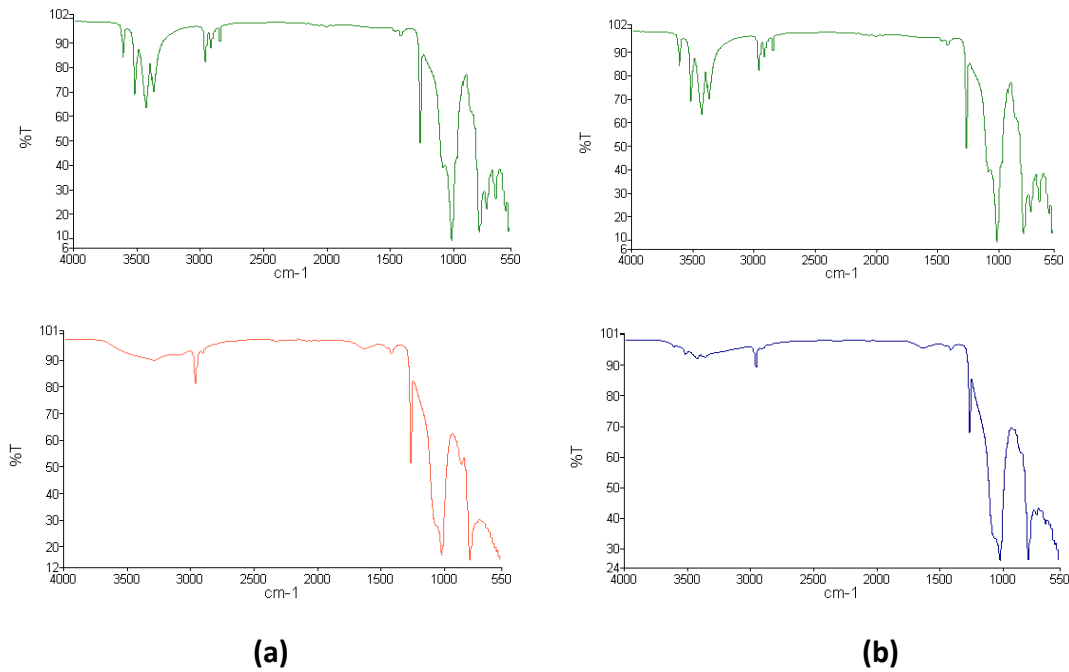
**Figure 13: FTIR comparisons between (a) +4.5 kV dc (pink) and (b) -4.5 kV dc (blue) against the control (green)**

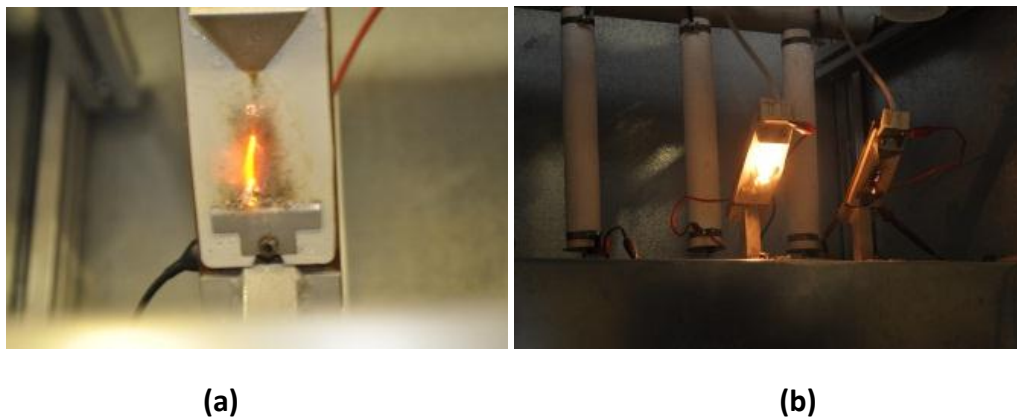
It was observed that in the positive dc test a localised arc spot developed on sample 2 (TP2) after only 17 minutes, while the other two samples developed arc spots a few minutes later. Approximately 30 minutes into the test saw the beginning of erosion on sample 2, shown in Figure 14, and 10 minutes later small flames were noted.

**Figure 14: (a) Arcing and the starting of erosion in sample 2, and (b) small flames observed after 40 minutes**

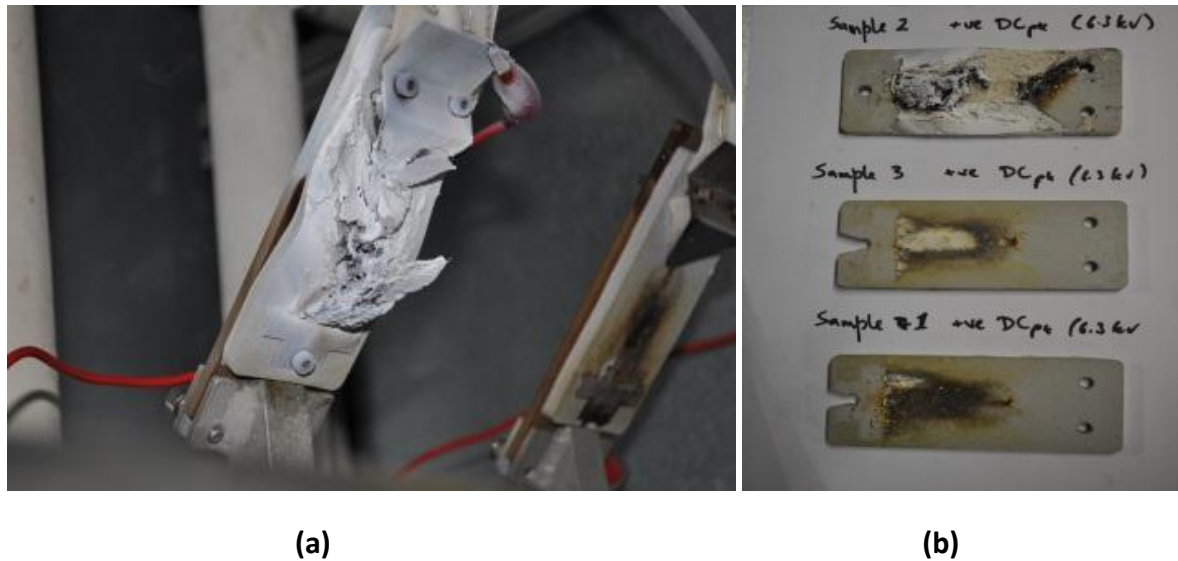
The test was stopped after 58 minutes, with sample 2 having been burnt all the way through, shown in Figure 15.

**Figure 15: (a) Sample 2 burnt all the way through, and (b) all 3 samples after the test.**

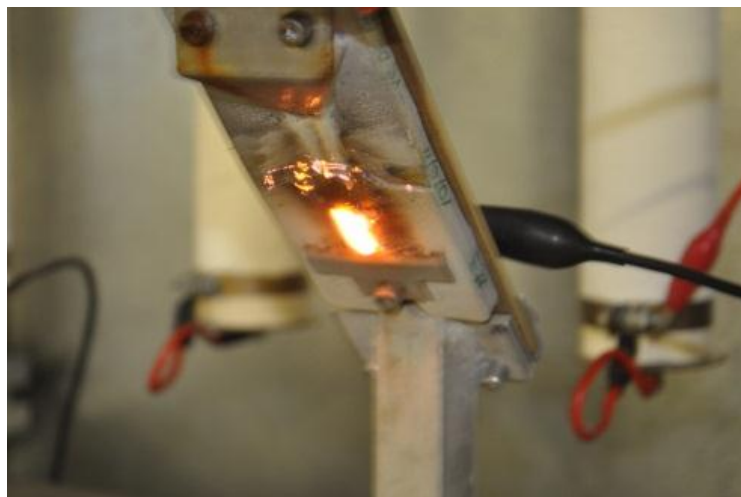
For the negative dc test at 6.3 kV it was observed that while there were arc roots developed, as in the previous tests, aggressive erosion was not prevalent as in the negative 4.5 kV dc case. Visually, there were more scintillations across the surface of the samples, shown in Figure 16.

**Figure 16: Development of arc roots with scintillations across the sample surface**

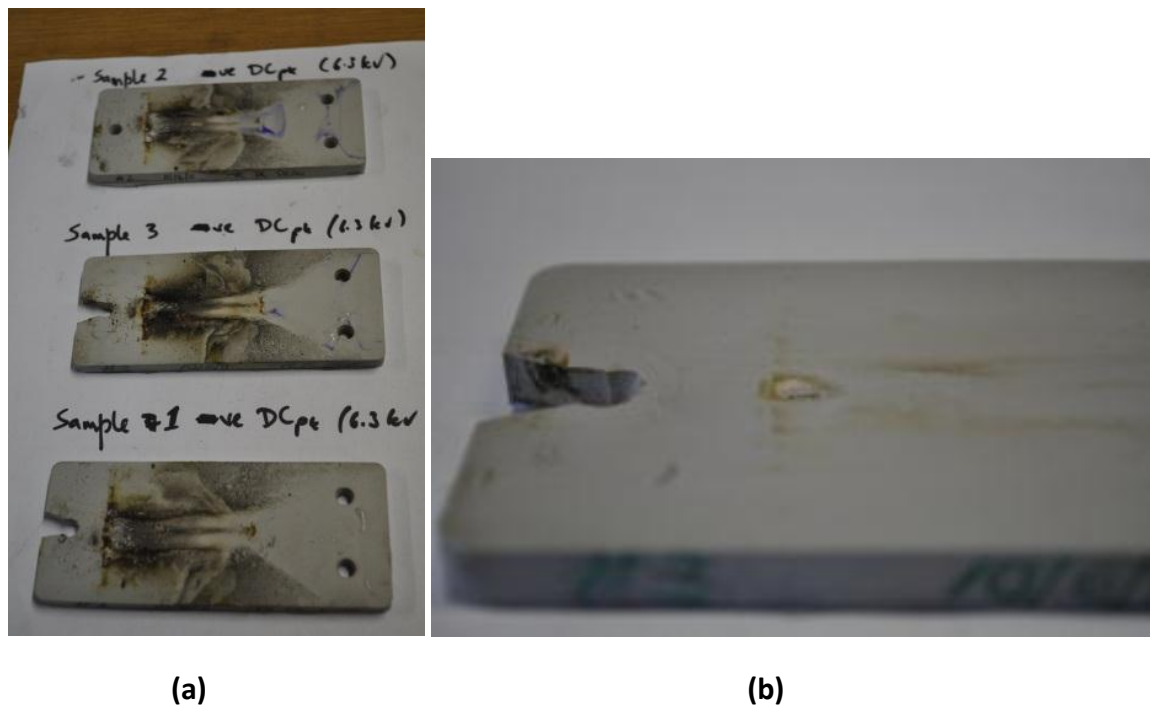
one-minute maximum current recorded was 44.02 mA, with a maximum of 54.8 mA, but no erosion took place. The test ran the entire duration of 6 hours with no failure. Figure 17 shows the samples at the end of the test. It is noted that there was minimal erosion.

Figure 17: (a) The samples at the end of the negative 6.3 kV dc test and, (b) sample 3 after cleaning.

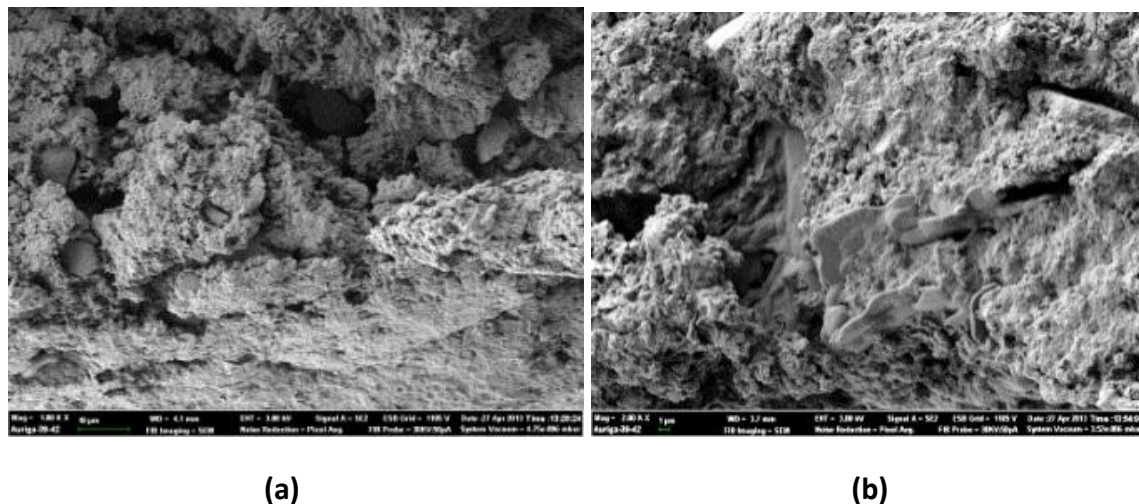
Figure 18: Cross-sectional views of (a) +6.3 kV dc and (b) -6.3 kV dc

Both the positive and negative samples show a segregated texture, as can be seen in Figure 18, however, the segregation appears to be finer in the positive case. When compared against the control sample, the FTIR spectra for both the positive and negative samples indicate an attenuation of the peaks around 3500 w/n, shown in Figure 19. In contrast, the peaks between 1200 and 1500 w/n became more pronounced in both positive and negative, when compared to the control sample.

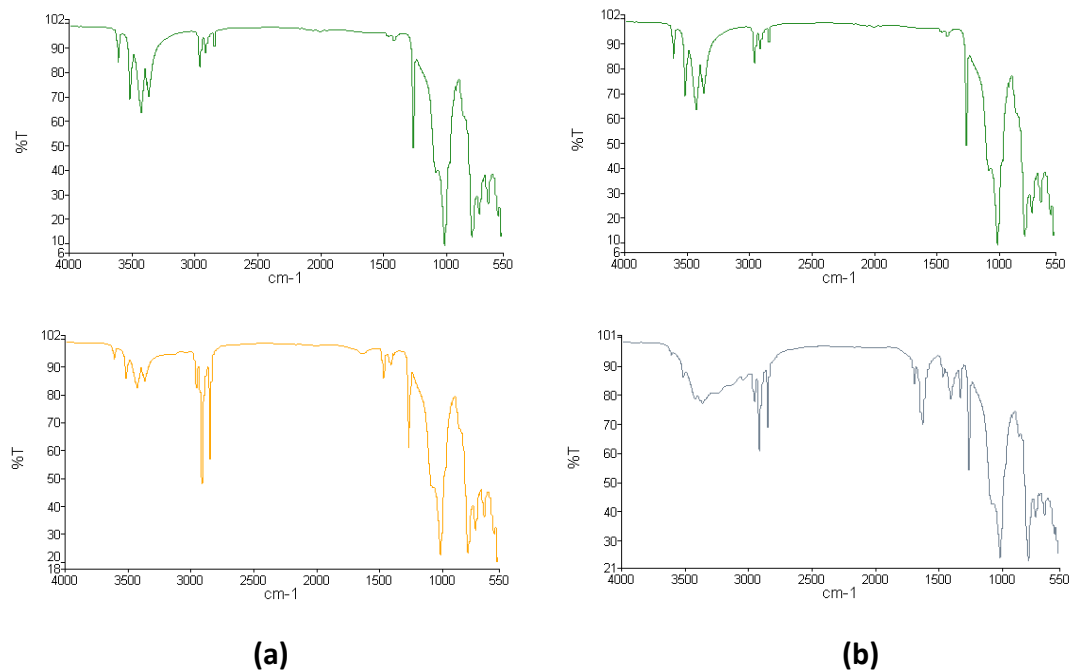
**Figure 19: FTIR comparisons between (a) +6.3 kV dc (orange) and (b) -6.3 kV dc (blue) against the control (green)**

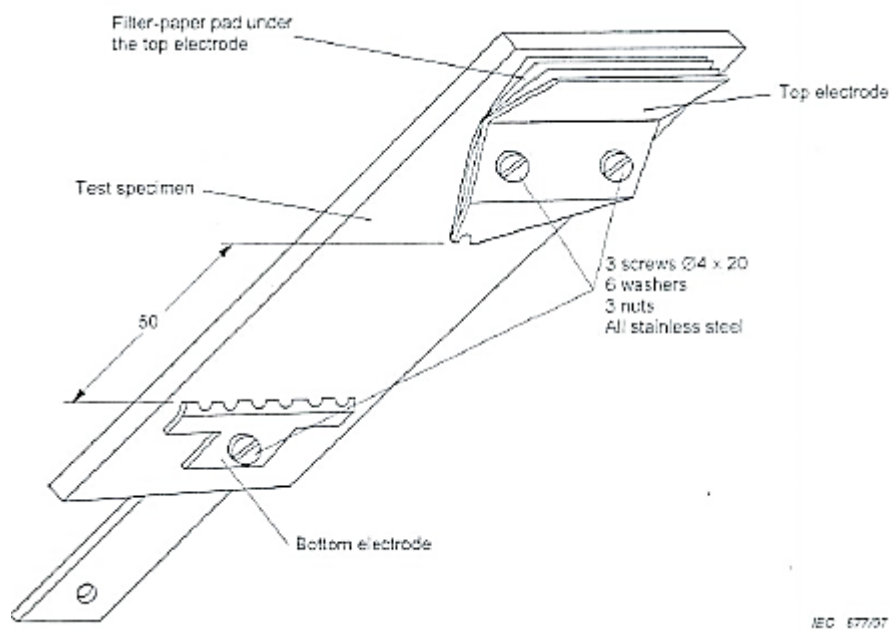
**Figure B.1: Assembly of the electrodes – contaminant flows from top to bottom**

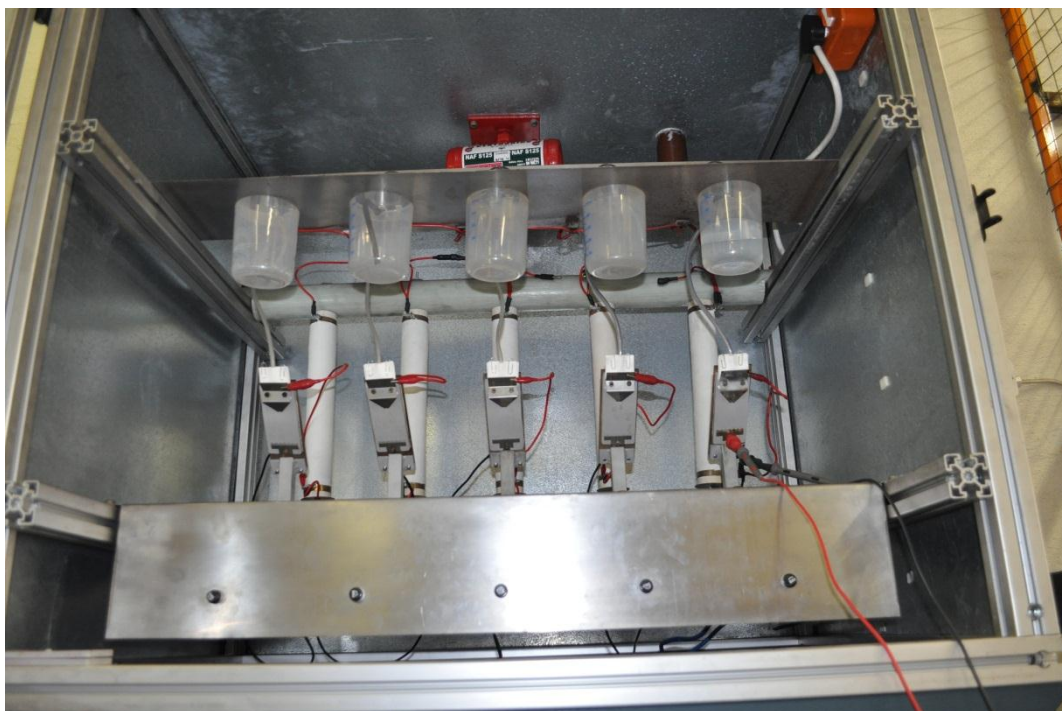
The dielectric sample under test is placed on a 45 degree angle and a contaminant made from deionised water, ammonium chloride and a soaping agent Triton X-100 (isooctylphenoxypolyethoxyethanol,  $[(C_{14}H_{22}O(C_2H_4O)_n); n=9-10]$ ) drips down the underside of the sample between two electrodes energised with a specified voltage [2]. This is shown in Figure B.1. The contaminant emerges from a hole in the top electrode, via a peristaltic pump, and flows down the surface of the sample to the bottom (grounded) electrode, which has a series of teeth to permit the passage of contaminant without damming up. The required conductivity of the contaminant, according to IEC 60587, should be 2.53 mS/cm. The conductivity used for all the tests in this study was 2.7 mS/cm. Experiments conducted by Seifert et al [3] showed maximum erosion with a contaminant conductivity of 2.5 mS/cm at 5.5 kV. Figure B.2 shows the actual test setup used for this research.

**Figure B.2: Actual incline plane test setup used for this study**

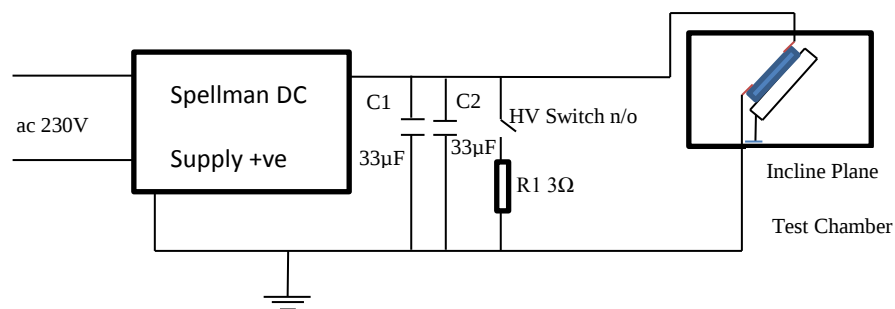
For the positive dc tests a Spellman 50 kV dc, 80 mA stand-alone supply was used to charge a smoothing capacitor of 66  $\mu\text{F}$  coupled to the necessary peripheral equipment for protection and switching, shown in Figure B.3. The tests voltages used were 4.5 kV and 6.3 kV. For the negative dc tests a half wave rectifier circuit was constructed. This setup used an 80 kV (peak inverse voltage), 500 mA diode arrangement in series with a 100  $\Omega$  resistor. This was then used to charge the 66  $\mu\text{F}$  capacitor, and coupled to the necessary peripheral equipment, shown in Figure B.4. The test voltages were selected as 4.5 kV and 6.3 kV. The test configuration used for the ac tests was the same as for the positive dc (Figure B.3) with the exclusion of the Spellman dc supply. The ac was supplied through a 230 V / 12 kV single phase step-up transformer.

**Figure B.3: Circuit diagram for positive dc setup**

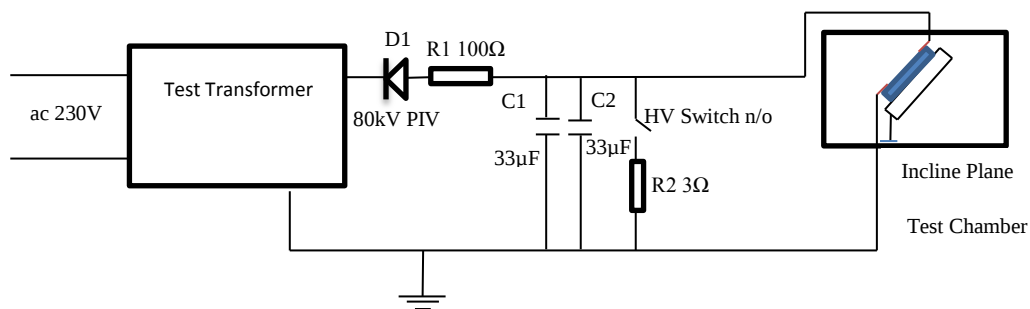
**Figure B.4: Circuit diagram for negative dc setup**

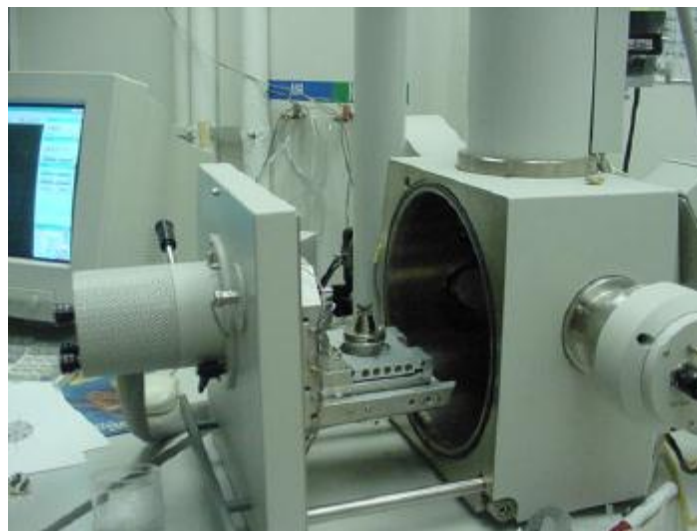
A scanning electron microscope (SEM) is a type of electron microscope that produces images of a sample by scanning it with a focused beam of electrons. The electrons interact with atoms in the sample, producing various signals that can be detected and that contain information about the sample's surface topography and composition. The electron beam is generally scanned in a raster scan pattern, and the beam's position is combined with the detected signal to produce an image. SEM can achieve resolution better than 1 nanometer. Specimens can be observed in high vacuum, in low vacuum, and (in environmental SEM) in wet conditions. The most common mode of detection is by secondary electrons emitted by atoms excited by the electron beam. The number of secondary electrons is a function of the angle between the surface and the beam. On a flat surface, the plume of secondary electrons is mostly contained by the sample, but on a tilted surface, the plume is partially exposed and more electrons are emitted [4]. By scanning the sample and detecting the secondary electrons, an image displaying the tilt of the surface is created. Figure B.5 shows a typical scanning electron microscope, similar to the one used at the CSIR for the purposes of the analysis of the silicone rubbers samples in this study.

**Figure B.5: Typical scanning electron microscope**

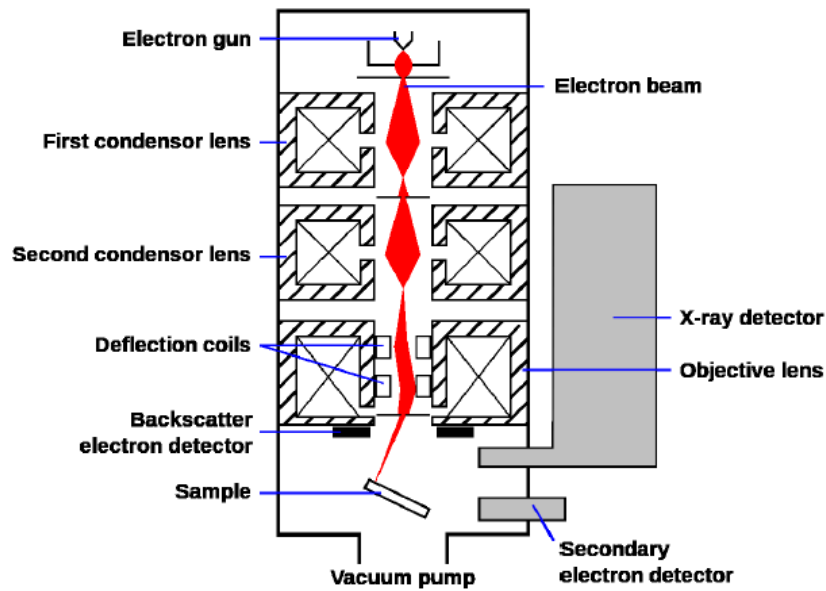
In a typical SEM, an electron beam is thermionically emitted from an electron gun fitted with a tungsten filament cathode. Tungsten is normally used in thermionic electron guns because it has the highest melting point and lowest vapour pressure of all metals, thereby allowing it to be heated for electron emission, and because of its low cost. The electron beam, which typically has an energy ranging from 0.2 keV to 40 keV, is focused by one or two condenser lenses to a spot about 0.4 nm to 5 nm in diameter. The beam passes through pairs of scanning coils or pairs of deflector plates in the electron column, typically in the final lens, which deflect the beam in the x and y axes so that it scans in a raster fashion over a rectangular area of the sample surface. When the primary electron beam interacts with the sample, the electrons lose energy by repeated random scattering and absorption within a teardrop-shaped volume of the specimen known as the interaction volume, which extends from less than 100 nm to approximately 5  $\mu\text{m}$  into the surface. The size of the interaction volume depends on the electron's landing energy, the atomic number of the specimen and the specimen's density. The energy exchange between the electron beam and the sample results in the reflection of high-energy electrons by elastic scattering, emission of secondary electrons by inelastic scattering and the emission of electromagnetic radiation, each of which can be detected by specialized detectors. The beam current absorbed by the specimen can also be detected and used to create images of the distribution of specimen current. Electronic amplifiers of various types are used to amplify the signals, which are displayed as variations in brightness on a computer monitor. Each pixel of computer video memory is synchronized with the position of the beam on the specimen in the microscope,

and the resulting image is therefore a distribution map of the intensity of the signal being emitted from the scanned area of the specimen. Figure B.6 shows a schematic diagram of a SEM. Figure B.7 shows a SEM image of the control sample of the silicone rubber material used for the incline pane testing, with varying magnifications.

Figure B.6: Schematic diagram of a SEM

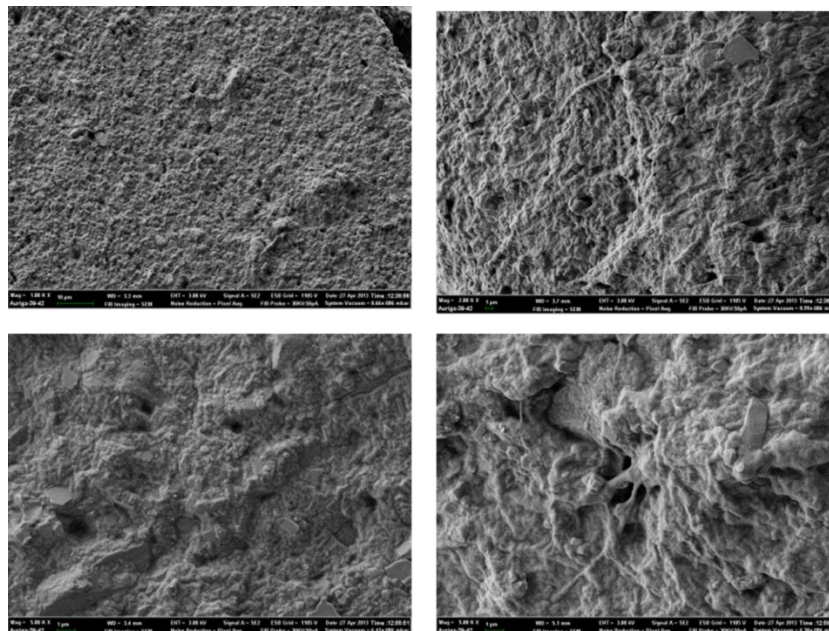
Figure B.7: SEM images of the silicone rubber control sample

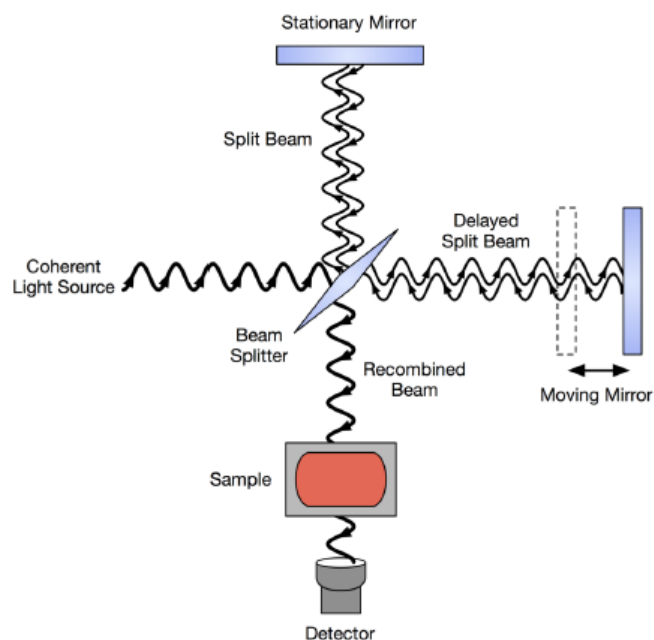
Fourier transform spectroscopy shines a beam containing many frequencies of light at once, and measures how much of that beam is absorbed by the sample. Next, the beam is modified to contain a different combination of frequencies, giving a second data point. This process is repeated many times. Afterwards, a computer takes all these data and works backwards to infer what the absorption is at each wavelength. The beam described is generated by starting with a broadband light source - one containing the full spectrum of wavelengths to be measured. The light shines into a Michelson interferometer - a certain configuration of mirrors, one of which is moved by a motor. As this mirror moves, each wavelength of light in the beam is periodically blocked, transmitted, blocked, transmitted, by the interferometer, due to wave interference. Different wavelengths are modulated at different rates, so that at each moment, the beam coming out of the interferometer has a different spectrum. Computer processing is required to turn the raw data (light absorption for each mirror position) into the desired result (light absorption for each wavelength). The processing required turns out to be a common algorithm called the Fourier transform (hence the name, "Fourier transform spectroscopy"). The raw data is sometimes called an "interferogram". Figure B.8 shows a schematic diagram of a Michelson interferometer, configured for FTIR. Figure B.9 shows the FTIR spectrum obtained for the control sample of silicone rubber used in the Incline Plane Test showing the absorption peaks of the constituents.

**Figure B.8: Schematic diagram of a Michelson interferometer, configured for FTIR**

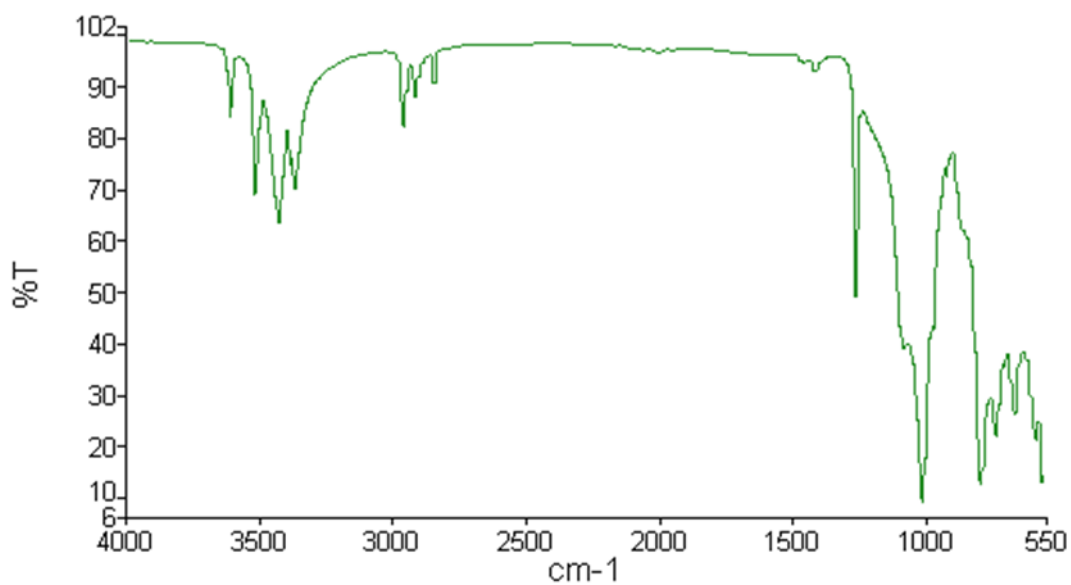
**Figure B.9: FTIR spectrum of the control sample of HTV silicone rubber**

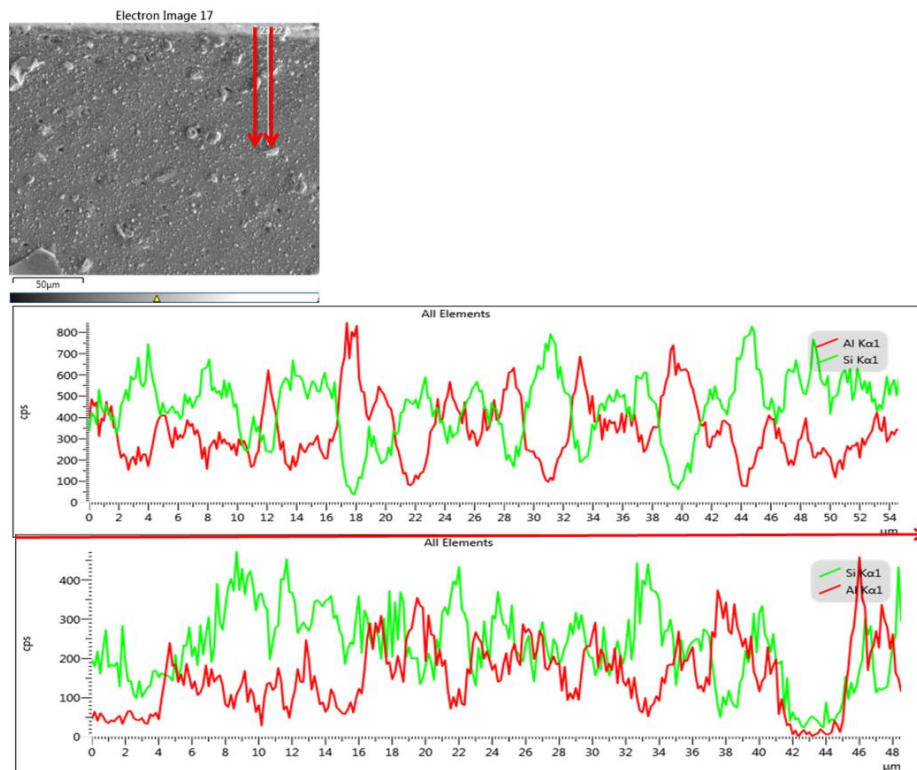
Electron beam excitation is used in electron microscopes, scanning electron microscopes (SEM) and scanning transmission electron microscopes (STEM). X-ray beam excitation is used in X-ray fluorescence (XRF) spectrometers. A detector is used to convert X-ray energy into voltage signals; this information is sent to a pulse processor, which measures the signals and passes them onto an analyser for data display and analysis. The most common detector now is Si(Li) detector cooled to cryogenic temperatures with liquid nitrogen; however newer systems are often equipped with silicon drift detectors (SDD) with Peltier cooling systems. Figure B.10 shows an EDS scan of the silicone rubber control sample used for the Incline Plane Test.

**Figure B.10: EDS scan of the silicone rubber control sample used for the IPT tests**

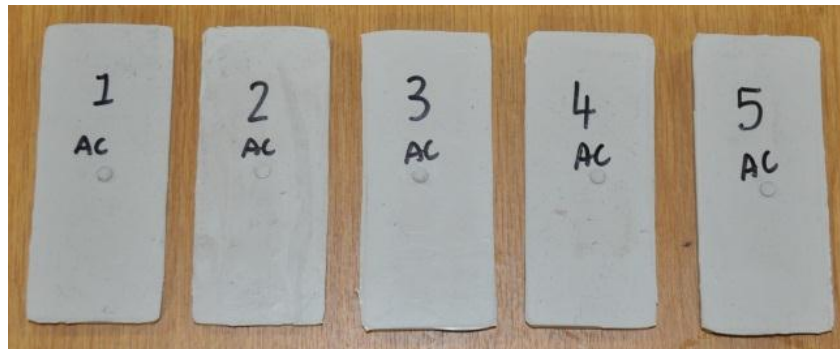
Figure C.1 shows the ac samples prior to energisation.

**Figure C.1: AC test samples prior to energisation**

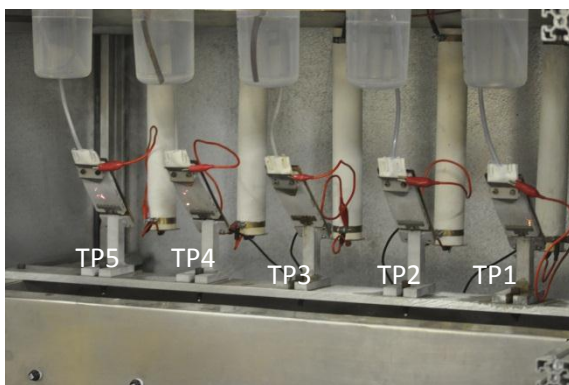
In the ac test 4.5 kV rms was applied to the samples, and 4 samples were energised in test positions TP1, TP2, TP4 and TP5, as shown in Figure C.2. Scintillations and discharge activity was noted upon voltage application, shown in Figure C.2 and Figure C.3.

**Figure C.2: Discharge activity at start**

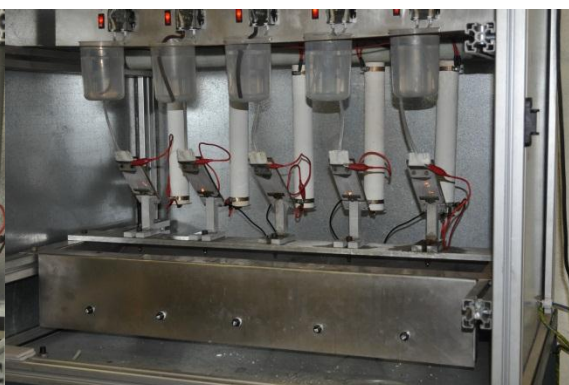
**Figure C.3: Discharge activity**

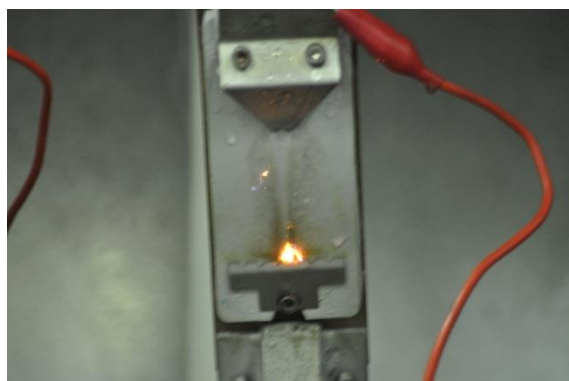
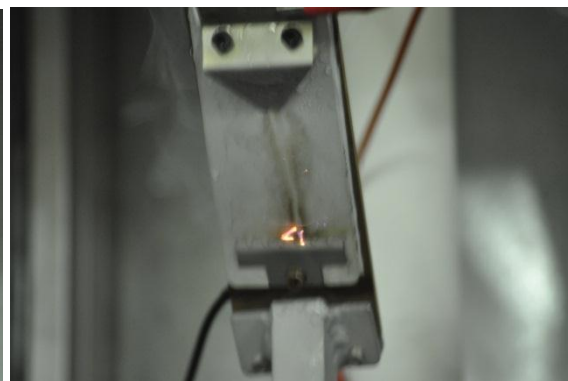
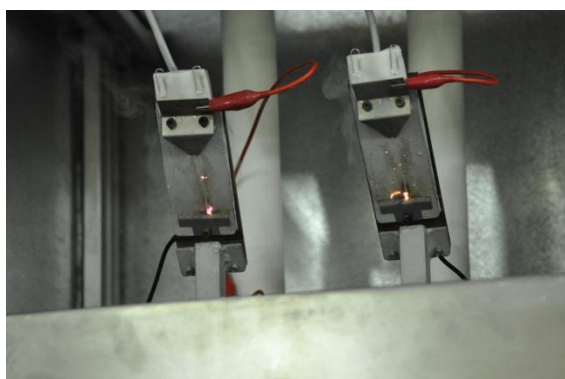
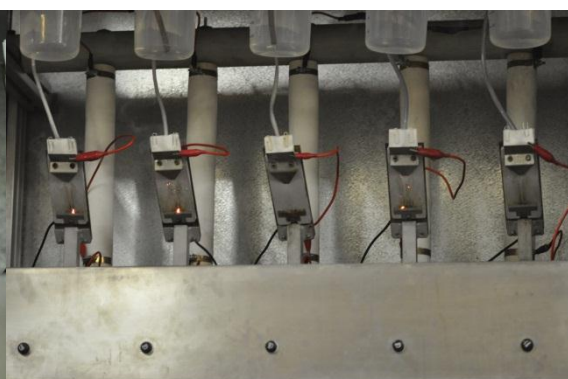
The scintillations seemed to be restricted to the near the ground electrode, as was much of the “blackening” of the surface that was noted. After approximately 45 minutes of energisation it was observed that “track” marks were clearly visible on the surface of the samples, along the contamination flow path. This is shown in Figures C.4 – C.7.

**Figure C.4: Visible “track” marks**

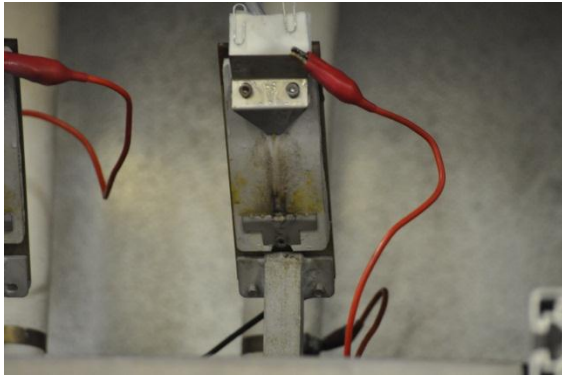
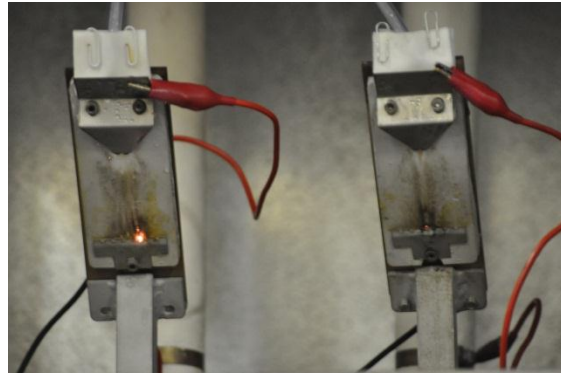
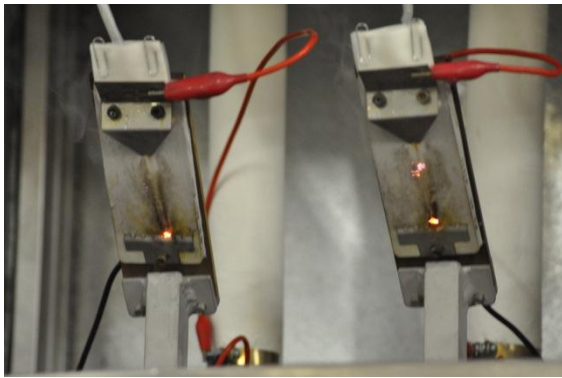
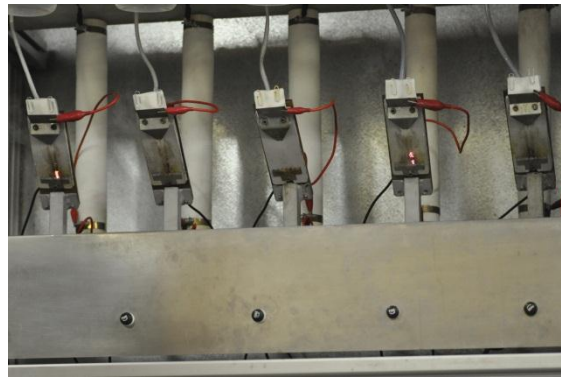
After approximately 4.5 (four and a half) hours of energisation it was observed that there was a greater degree of visible blackening of the “track” path along the contamination flow path, as well as a yellow-brown discolouration of the material surface. This is shown in Figures C.8 – C.11.

**Figure C.8: Greater degree of blackening**

**Figure C.9: Yellow-brown discolouration**

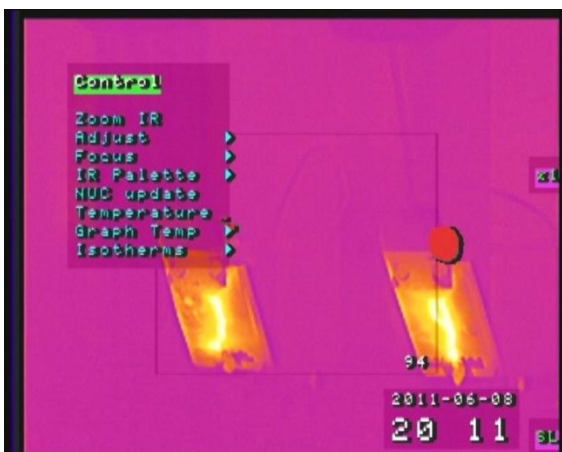
During the testing infra-red (IR) images of the heating caused by leakage current flow was captured using a multi-spectral camera. These are shown in Figures C.12 and Figure C.13. The IR image, particularly in Figure C.12, clearly shows the leakage current path. It is largely this current (depending on the amplitude of current) that causes damage and ageing of the material, leading to tracking and erosion.

**Figure C.12: IR image of leakage current**

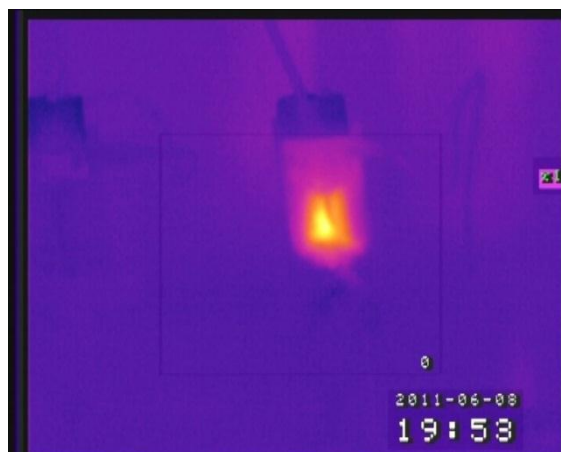
**Figure C.13: IR image**
