# PERFORMANCE OF SILICONE RUBBER MATERIALS UNDER HIGH VOLTAGE DIRECT CURRENT USING THE INCLINED PLANE TEST

A research report submitted to the faculty of Engineering and the  
Built Environment, University of the Witwatersrand, in fulfilment  
of the requirements for the degree of Master of Science of  
Engineering

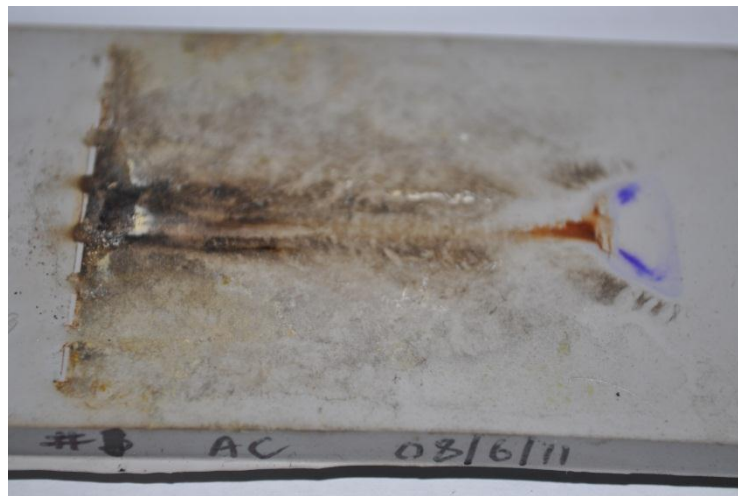
All the sample in the ac test ran the full 6 hours, maximum test duration according to IEC 60587 [1], with signs of localised arc spots and erosion at the ground electrode as can be seen in Figure C.14.

**Figure C.14: Erosion and arc spots at ground end**

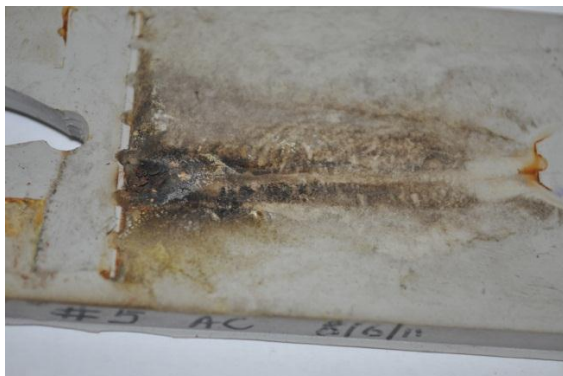
Sample 5 was cleaned after the test and revealed minimal erosion of negligible depth, as shown in Figure C.15 and Figure C.16.

**Figure C.15: Sample 5 after energisation**

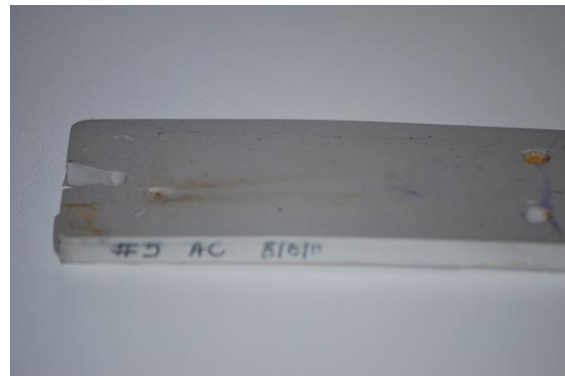
**Figure C.16: Sample 5 after being cleaned**

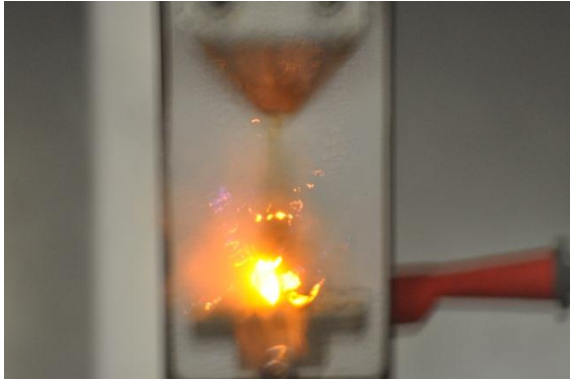
**Figure C.17: More vigorous scintillations**

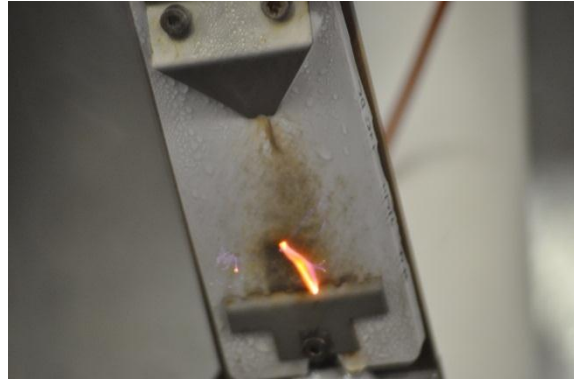
**Figure C.18: Development of arc**

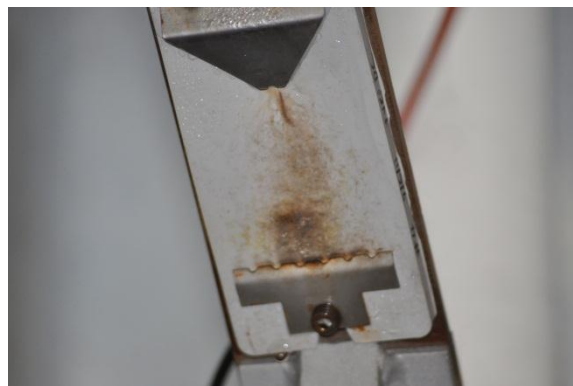
In the positive dc test at 4.5 kV only 3 samples were energised. This was due to the Bakelite stand for sample 1 in test position 1 (TP1) being burnt due to contaminant dripping along the back of the stand. Sample 1 was thus removed from the circuit and replaced by sample 3 in TP1. The leakage current measurement was captured on Sample 3. After 5 minutes scintillations were observed to be more vigorous than the ac test, as shown in Figure C.17 and Figure C.18. After 15 minutes discolouration was visible along the entire length from the HV to the ground electrode, shown in Figure C.19.

**Figure C.19: Discolouration along length**

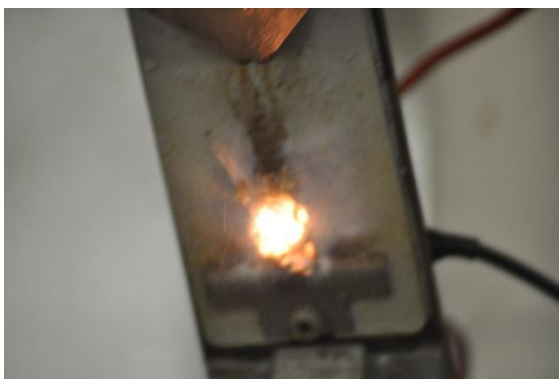
After approximately 40 minutes, sample 2 (TP2) “failed” according to the standard [1], where the sample displayed serious erosion and evidence of burning a hole near the ground electrode, shown in Figure C.20 and Figure C.21.

**Figure C.20: Burning of sample 2**

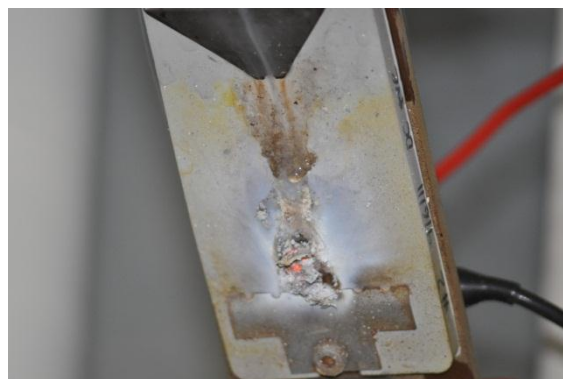
**Figure C.21: Erosion at ground electrode**

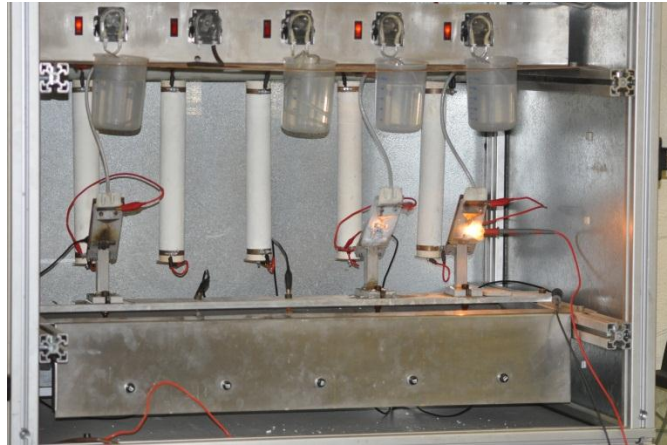
Forty seven minutes after energisation sample 3 (TP 1) developed localised arc root and began erosion similar to sample 2, shown in Figure C.22.

**Figure C.22: Formation of arc root on sample 3, TP1**

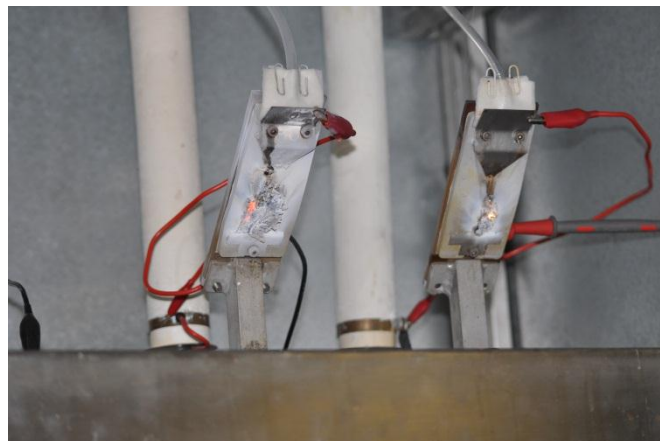
The erosion on sample 2 had progressed to the upper electrode approximately 55 minutes after energisation, and the arc spot/erosion on sample 3 had progressed to approximately 30% of the distance between the electrodes. These can be seen in Figure C.23. It was observed that once erosion of the sample began and the surface of the material was altered, the flow of the contaminant was no longer uniform. This could explain why the erosion was not confined to a single track, but occurred across the material surface.

**Figure C.23: Erosion on sample 2 (left) and sample 3 (right)**

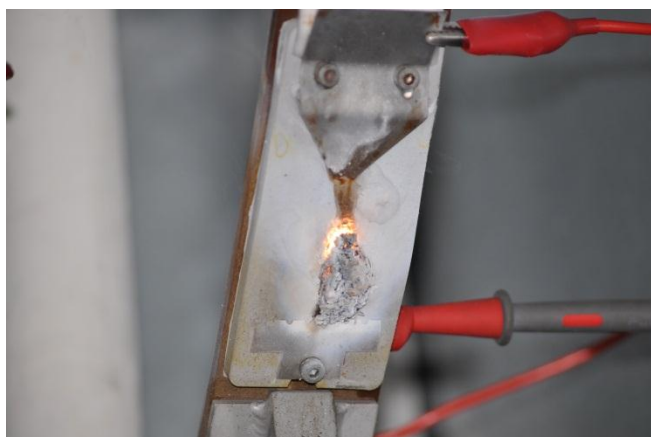
After approximately 64 minutes the track/erosion on sample 3 had progressed to 60% of the distance between electrodes, shown in Figure C.24. The maximum current observed on sample 3 was 75.92 mA.

**Figure C.24: Length of erosion on sample 3 progressed to 60%**

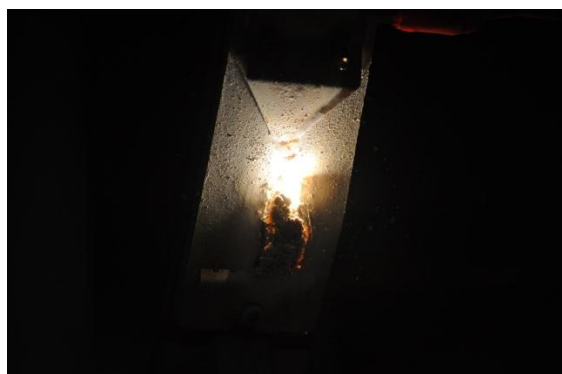
Approximately 75 minutes after energisation, flames were observed on sample 2, Figure C.25, and the contaminant flow was subsequently stopped. Five minutes later the contaminant flow on sample 3 was stopped to prevent the samples from being completely destroyed. The test was finally stopped after 95 minutes. Figure C.26 shows the samples after being removed from the test, with all three samples displaying signs of severe erosion.

**Figure C.25: Flame observed on sample 2**

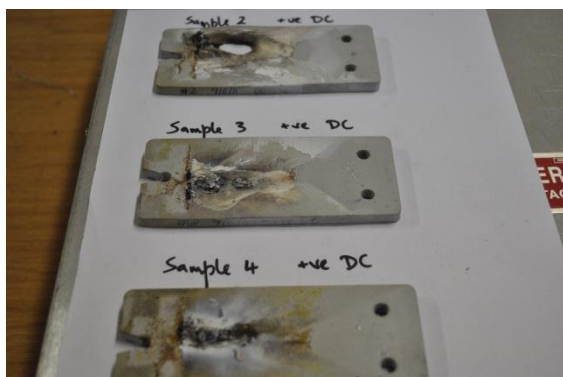
**Figure C.26: Samples after testing**

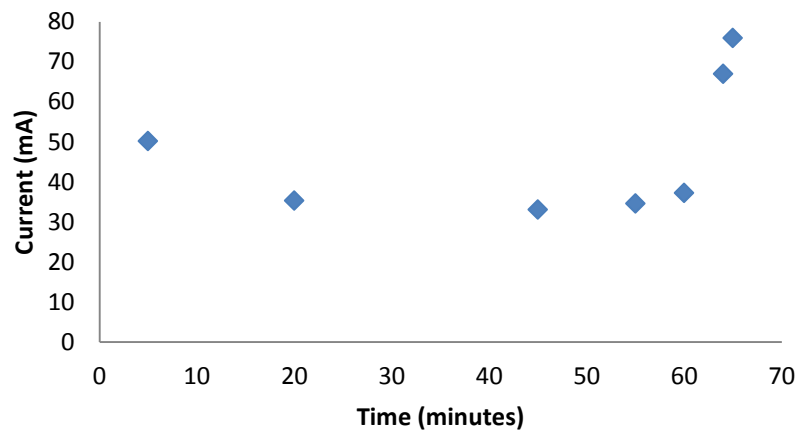
The current was captured as the maximum current over a 1 minute period, measured approximately every 15 minutes. The maximum (1 minute max) current recorded (on sample 3, tp1) after 65 minutes was 75 mA, with an average of 47.6 mA, shown in Table C.1. Figure C.27 shows the plot of the leakage current.

**Figure C. 27: Leakage current graph**

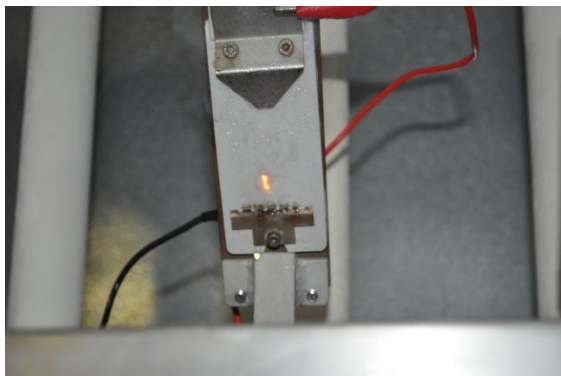
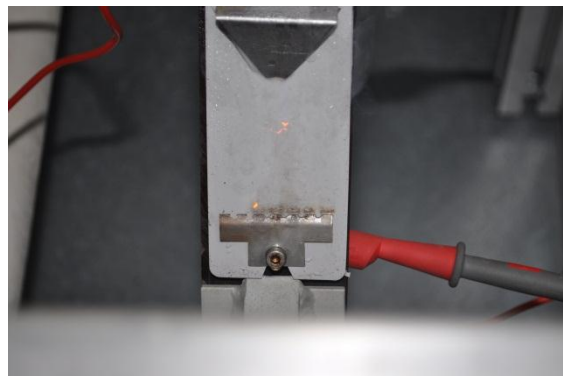
Similar to the positive 4.5 kV test only three samples were energised in the same test positions as before. It was noted that scintillations across the surface appeared almost as soon as the voltage was applied, and appeared even as early as -2 kV. The initial negative energisation seemed to have more surface discharges, compared to the positive case. These scintillations can be seen in Figure C.28 and Figure C.29.

**Figure C.28: Surface scintillations**

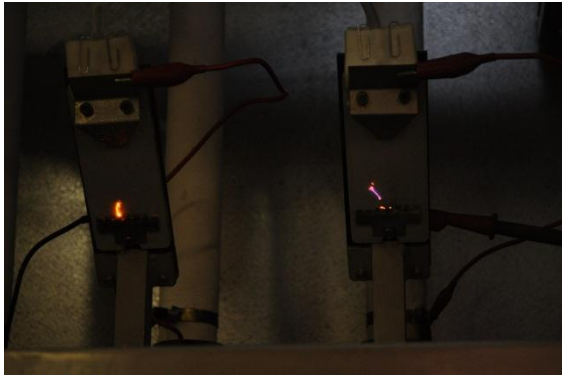
Within approximately 2 minutes some partial arcs were observed, shown in Figure C.30, and within 5 minutes it seemed like an arc root had formed at the ground electrode on sample 2 in TP 2, shown in Figure C.31.

**Figure C.30: Partial arcs observed**

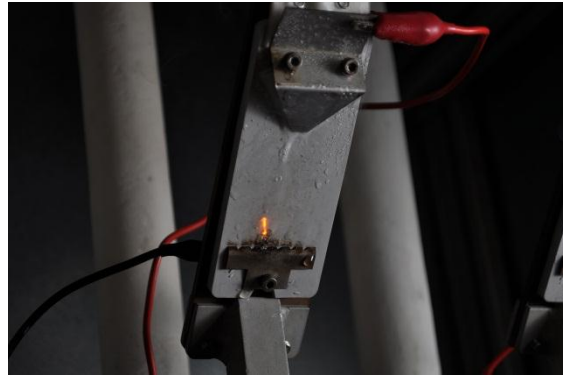
**Figure C.31: Beginning of arc root on sample 2**

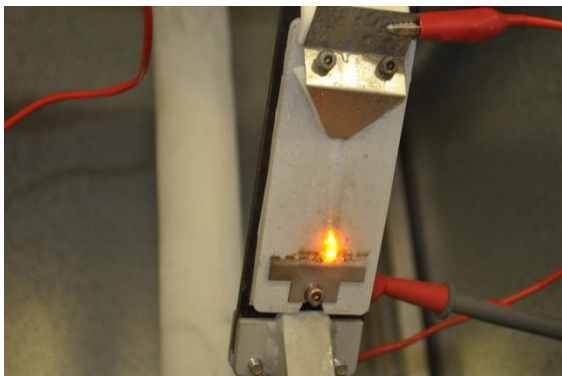
A further 2 minutes later and the arc root on sample 1, TP1 become more pronounced, shown in Figure C.32. Twenty minutes after energisation, it was noted that erosion of sample 2 had covered 30% of the distance between electrodes at the ground electrode, shown in Figure C.33. After a further 3 minutes the tracking had progressed to approximately 50% of the gap. This can be seen in Figure C.34. Forty two minutes after energisation, the erosion had progressed from the ground electrode to the upper electrode, as shown in Figure C.35.

**Figure C.32: Arc root on Sample 1**

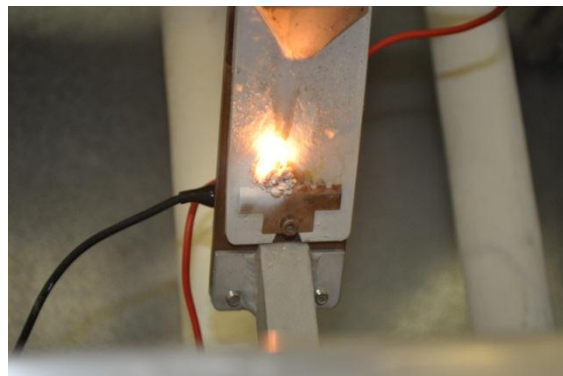
**Figure C.33: Burning on sample 2**

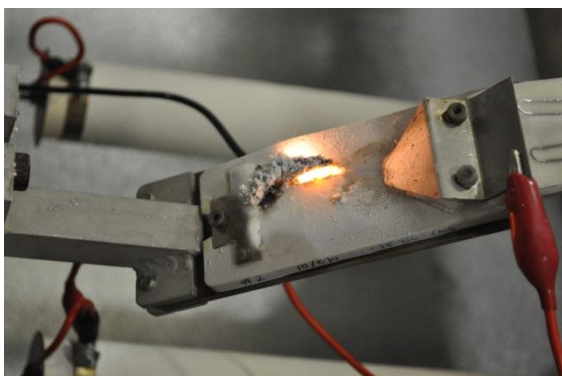
**Figure C.34: Erosion approx. 50% of gap**

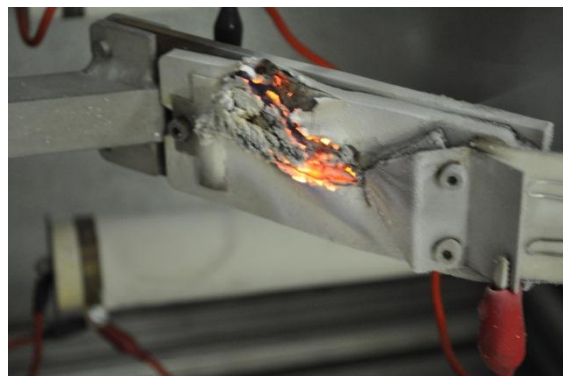
**Figure C.35: Sample 2 after 42 minutes**

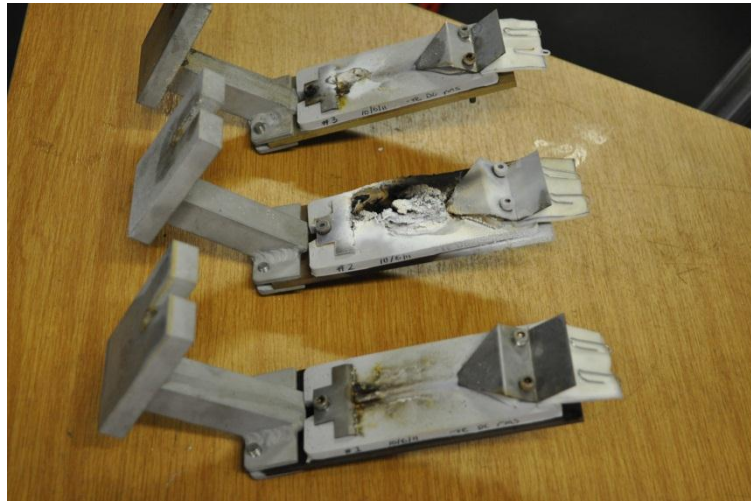
erosion (see Figure C.36), and the test was eventually stopped 112 minutes after voltage application. A one-minute maximum current was recorded periodically for the duration of the test (on sample 1, TP 1). The average current recorded was 27.3 mA, with a maximum of 50 mA being observed.

**Figure C.36: DC samples showing varying stages of erosion**

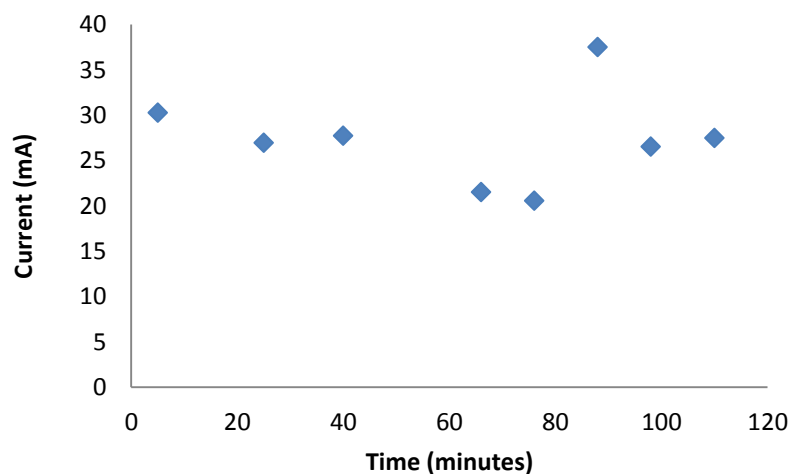
Table C.2 gives the current reading measurements on Sample 1, TP1 and Figure C.37 shows the plot of the leakage current.

**Figure C.37: Leakage current graph**

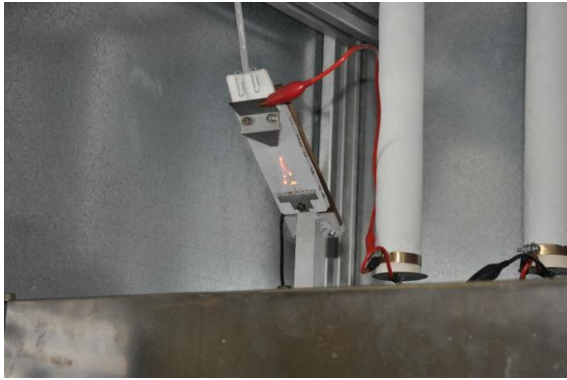
In the positive 6.3 kV test, sample 1, 2 and 3 were energised in TP1, TP2 and TP5 respectively. It was observed after 10 minutes of energisation that the black mark covered approximately 60% of the gap length and that the scintillations and arcs were fairly long in nature. These are shown in Figure C.38 and Figure C.39.

**Figure C.38: “Long” scintillations observed**

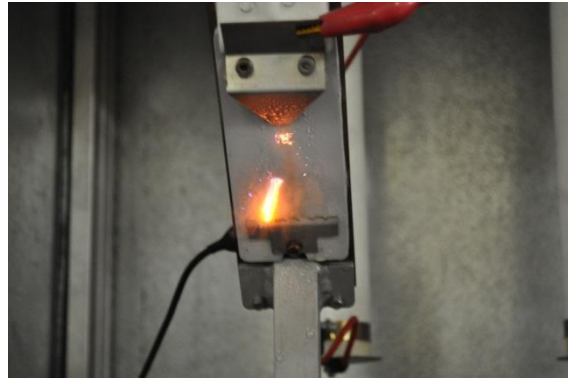
**Figure C.39: “Long” arcs observed**

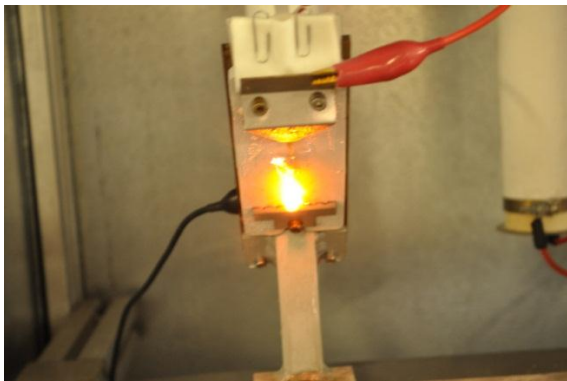
It was observed that in this test a localised arc spot developed on sample 2 (TP2) after only 17 minutes, while the other two samples developed arc spots a few minutes later. It was also quite noticeable that the arcs seem to be more vigorous and much brighter than in the previous tests. This is shown in Figure C.40. After 30 minutes, erosion on sample 2 was clearly visible at the ground electrode, shown in Figure C.41.

**Figure C.40: Brighter arcs**

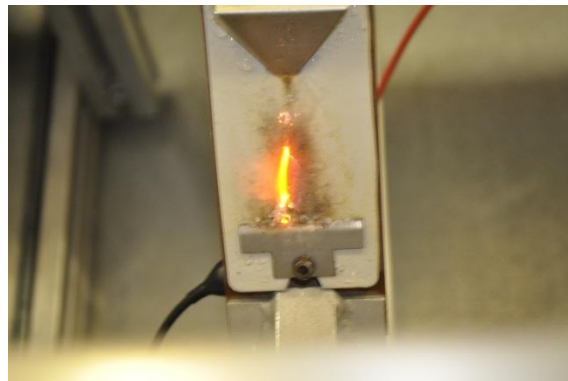
**Figure C.41: Erosion on sample 2**

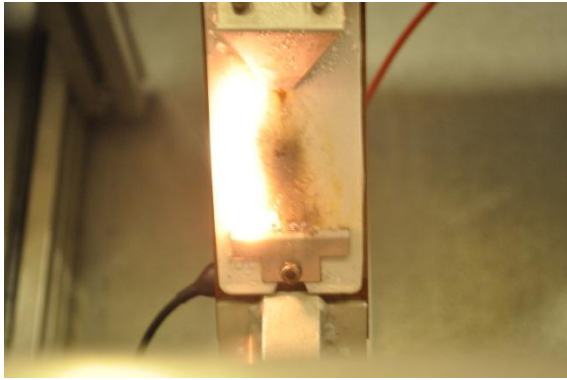
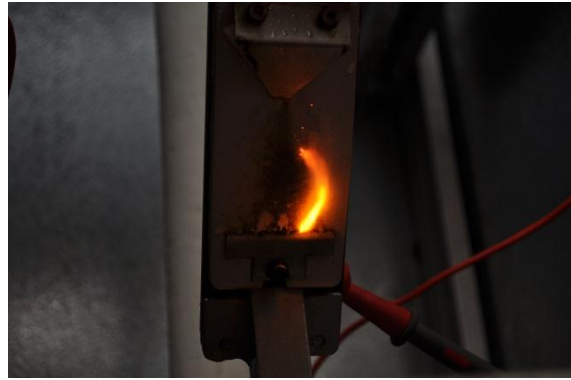
**Figure C.42: Arc completely bridging gap      Figure C.43: Arc bridging 60% on sample 1**

After approximately 35 minutes, arcs had completely bridged the gap between the electrodes on sample 3, and on sample 1, the arcs covered approximately 60% of the gap length. These can be seen in Figure C.42 and Figure C.43 respectively.

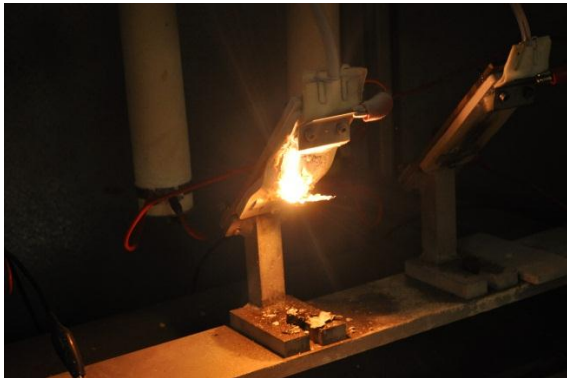
**Figure C.44: Sample 2 burning**

Forty minutes after voltage application there were flames noticed on sample 2, and after 58 minutes the test was stopped with sample 2 having burnt all the way through to the Bakelite stand. These are shown in Figure C.44 and Figure C.45 respectively.

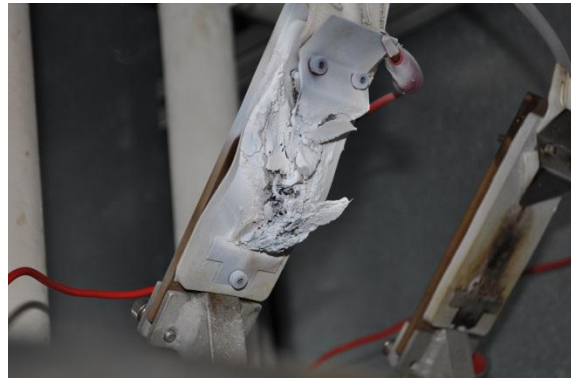
**Figure C.45: Sample 2 after 58 minutes**

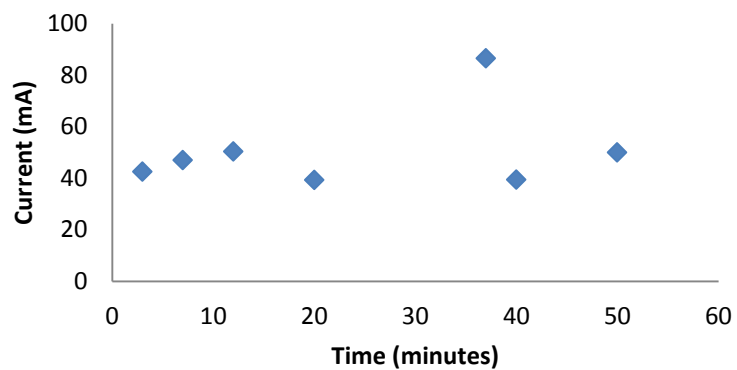
**Figure C.46: Leakage current graph**

The erosion on sample 1 at the end of the test was approximately 30% of the gap length, while on sample 3 the erosion was approximately 65%. The maximum current recorded after 50 minutes was 100 mA, while the average current over the test duration was 50.6 mA. These measurements are presented in Table C.3, and Figure C.46 shows the plot of the leakage current.

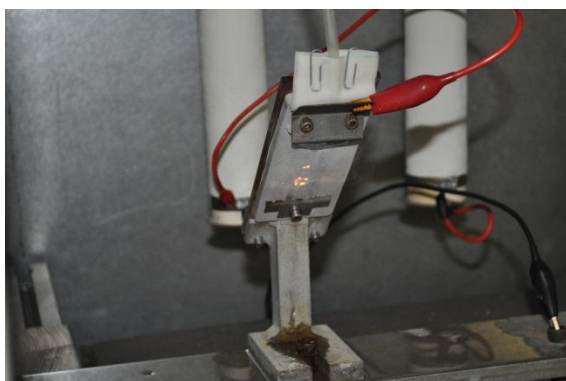
**Figure C.47: Scintillations across surface**

In the negative 6.3 kV test, sample 1, 2 and 3 were energised in TP1, TP3 and TP5 respectively. It was observed that the activity started as the voltage was being increased, almost as low as 2.5 kV. The current was measured on sample 1. In comparison to the negative 4.5 kV test, visually there seemed to be more scintillations across the surface of the samples, shown in Figures C.47 and C.48.

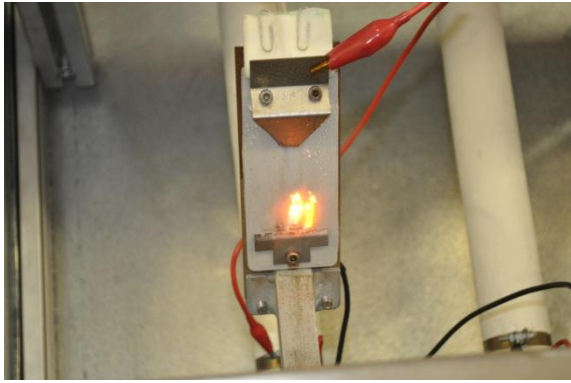
**Figure C.49: Formation of arc roots**

While it was observed that while arc roots seem to develop at the ground electrode, shown in Figure C.49 and Figure C.50, aggressive erosion was not prevalent as in the negative 4.5 kV dc case.

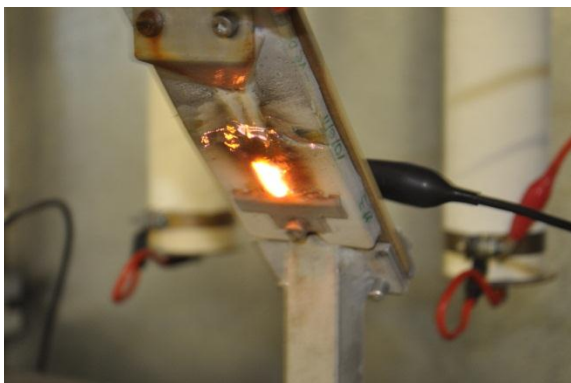
**Figure C.51: No erosion observed**

After approximately 5.5 hours no burning or significant erosion of the sample was observed and the sample surfaces appeared significantly blackened, more so than observed in the other tests. This can be seen in Figure C.51 and Figure C.52.

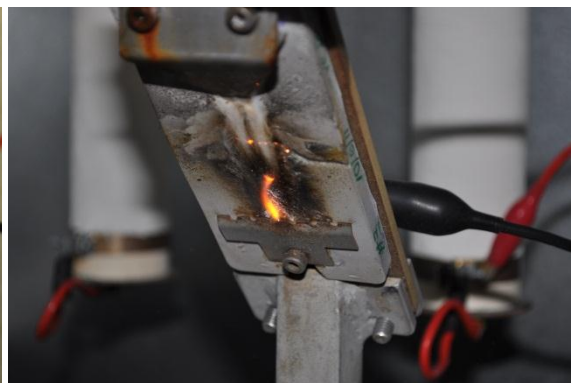
**Figure C.52: Blackening on surface**

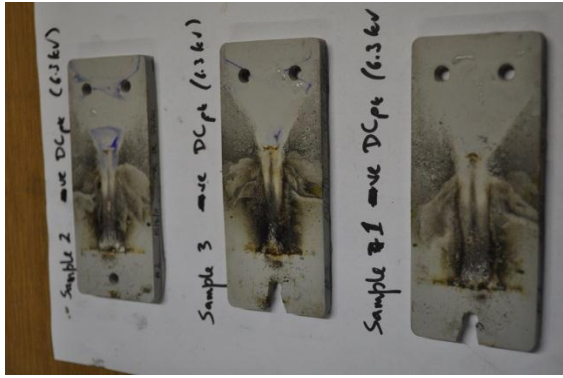
**Figure C.53: Samples after test**

After 6 hours the test was stopped, with no significant tracking or erosion observed on any of the samples. This was a similar result to the ac test. The condition of the samples once removed from the test can be seen in Figure C.53. The sample after cleaning with ethanol is shown in Figure C.54, and the lack of erosion of the material can clearly be seen. This result is similar to that observed in the ac case.

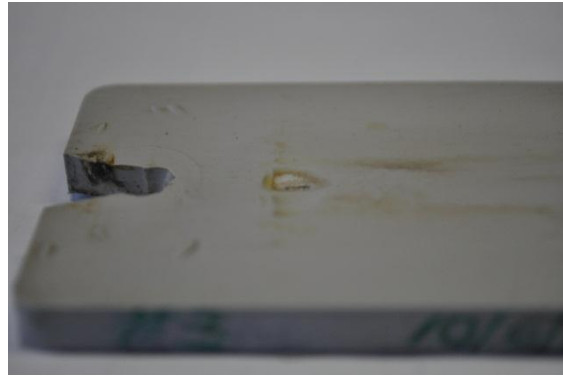
**Figure C.54: Sample 3 after cleaning**

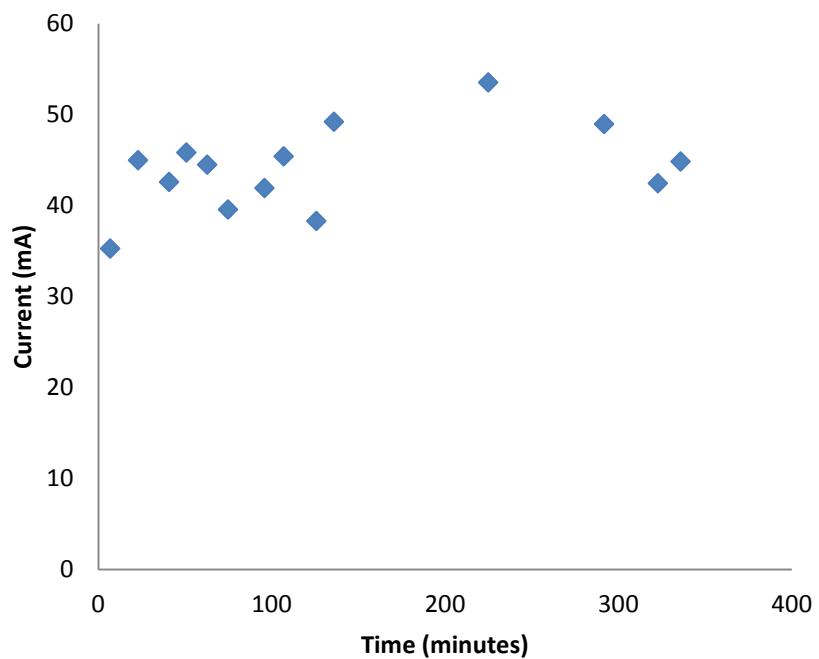
**Figure C.55: Leakage current graph**

The average one-minute maximum current recorded was 44.02 mA, with a maximum of 54.8 mA. All the recorded currents are given in Table C.4, and Figure C.55 shows the graph.

It is noted that the average current in the negative 6.3 kV case was higher than the 4.5 kV test, and it is postulated that in this scenario, the higher currents cause evaporation of the contaminant almost instantaneously and therefore prevented any possible arc root from establishing for too long. This would then prevent the erosion that was observed in the lower voltage test.

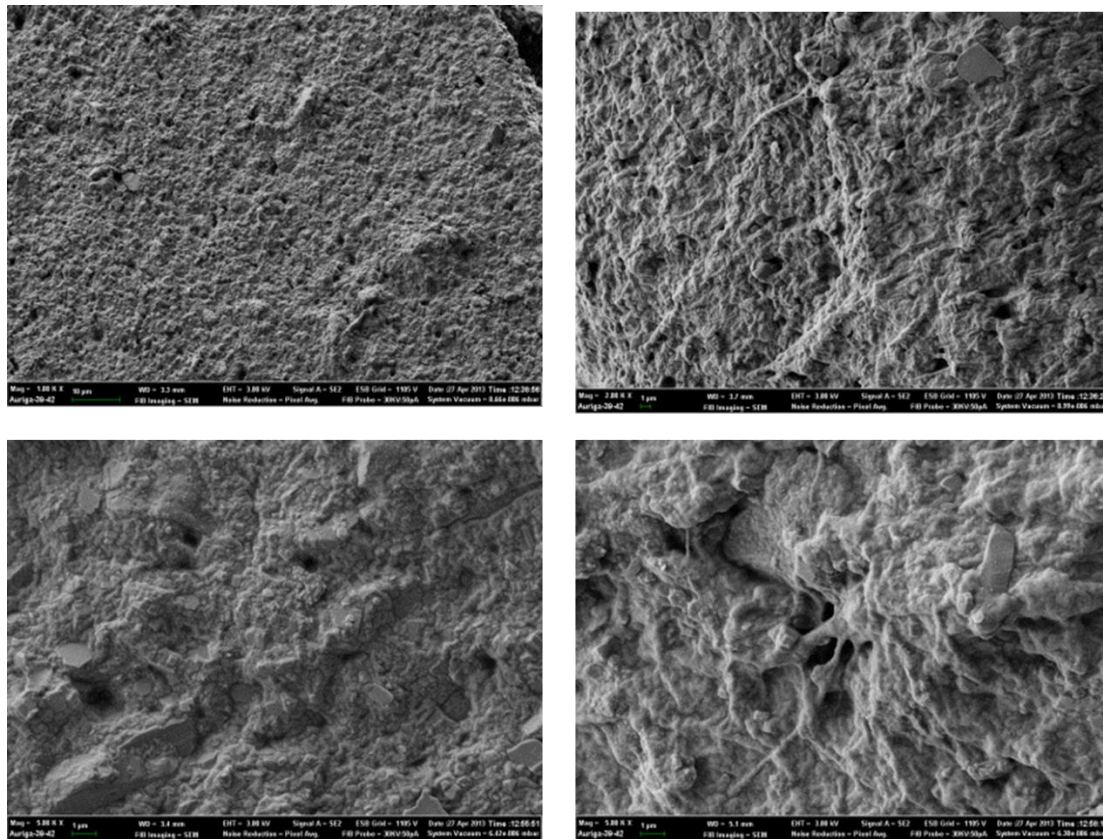
**Figure D.1: SEM analysis of the control sample**

The cross sections of the control sample show a relatively uniform surface texture with occasional large inclusions, as shown in Figure D.1.

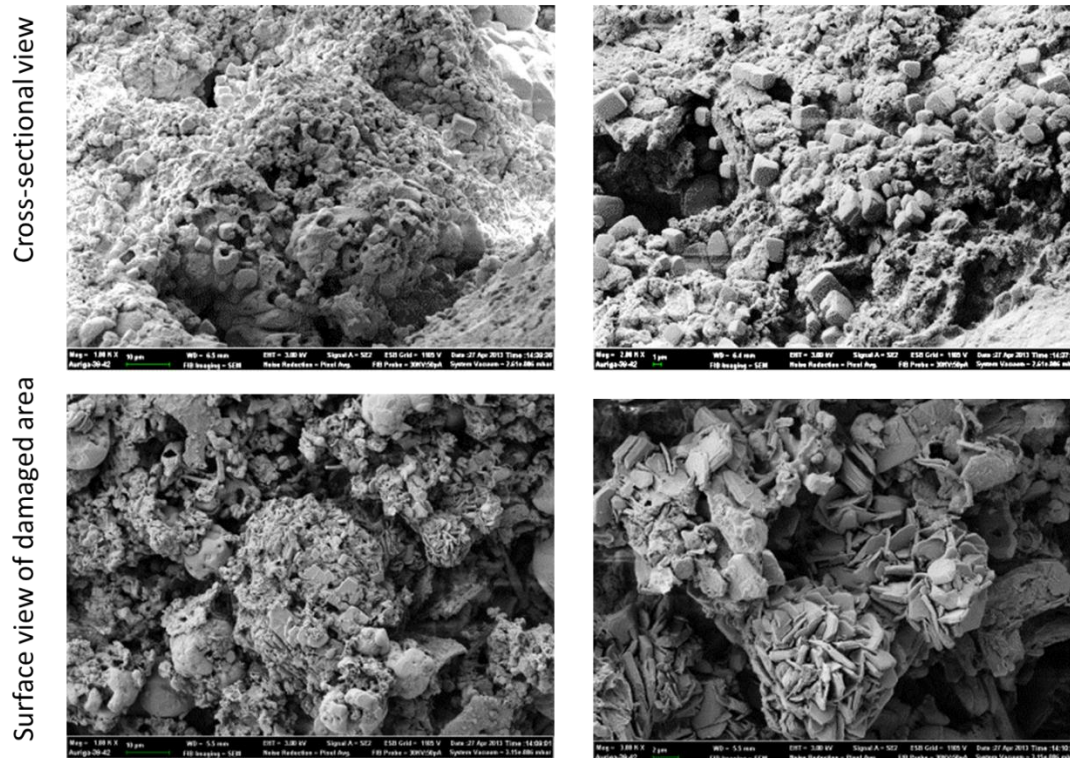
**Figure D.2: SEM analysis of ac samples**

In the ac sample the texture was dominated by distinct cuboidal and plate-like inclusions, the latter often arranged in rosette-like patterns, as shown in Figure D.2. Although speculative, views of the damaged area suggest that the matrix evenly binding inclusions in the Control sample seems to have been etched away, revealing the contour of these inclusions.

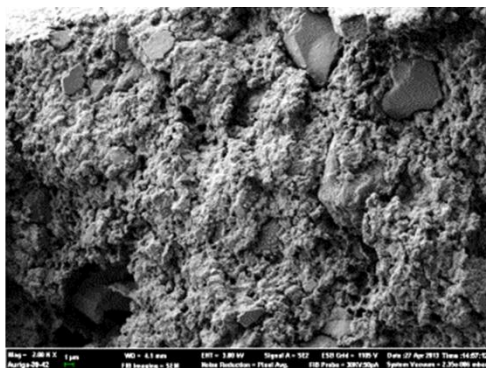
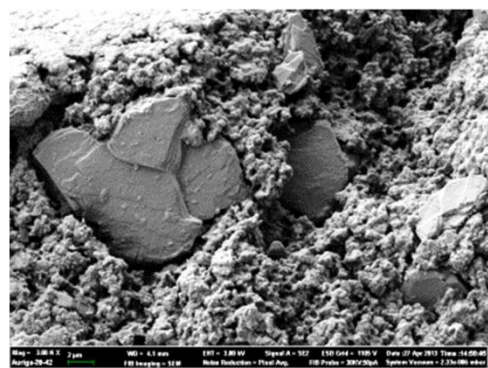
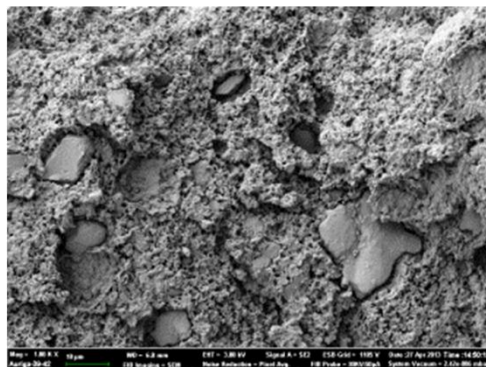
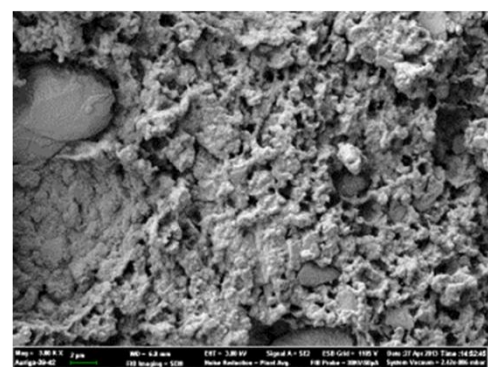
Cross-sectional view

Surface view of damaged area

Figure D.3: SEM analysis of positive 4.5 kV dc sample

In the positive and negative 4.5 kV dc samples, a segregated texture can be observed when compared to the control sample. This is shown in Figure D.3 and Figure D.4 respectively. There is also the noticeable difference to the ac sample with the lack of the rosette-like patterns. The positive sample displays some degree of inclusions, which is not seen in the negative sample, which gives the sample a coarser appearance.

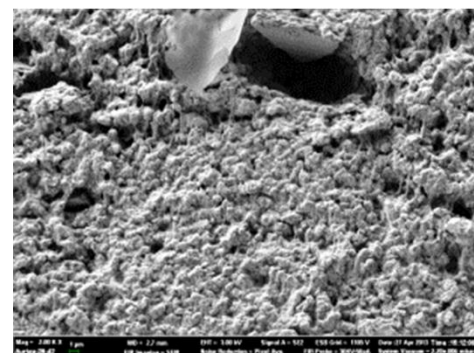
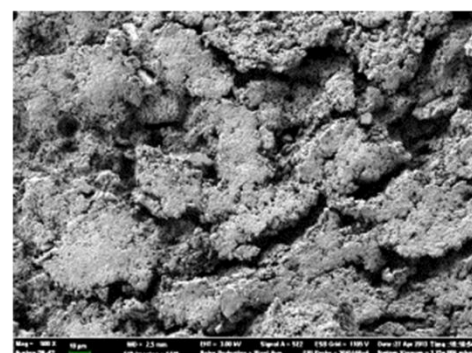
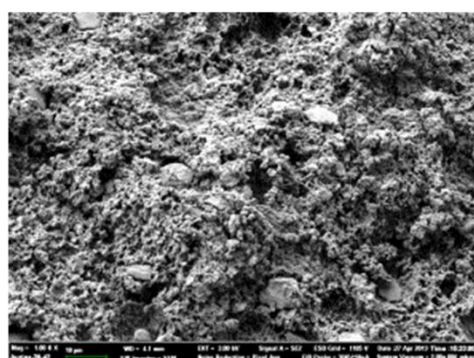
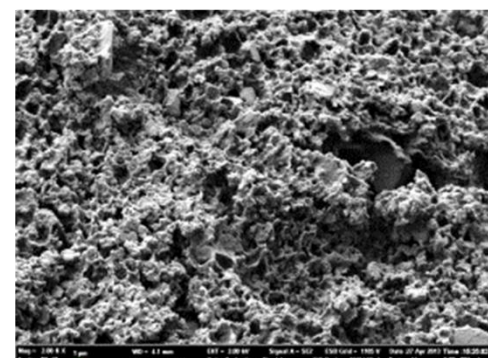
Cross-sectional view

Surface view of damaged area

Figure D.4: SEM analysis of negative 4.5 kV dc sample

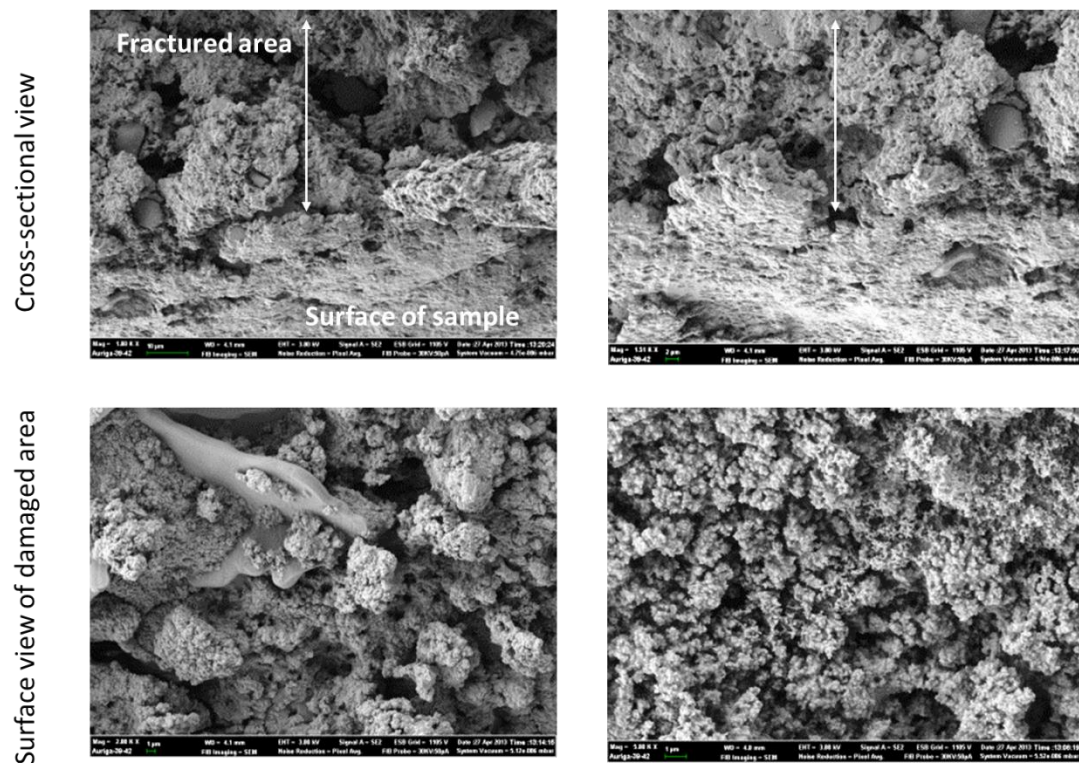
Figure D.5: SEM analysis of positive 6.3 kV dc sample

In the positive and negative 6.3 kV dc samples, a segregated texture was again visible in both surface and cross-sectional views of the damaged areas. This is shown in Figure D.5 and Figure D.6 respectively. The segregation appears to be finer in the positive dc case than in the negative sample.

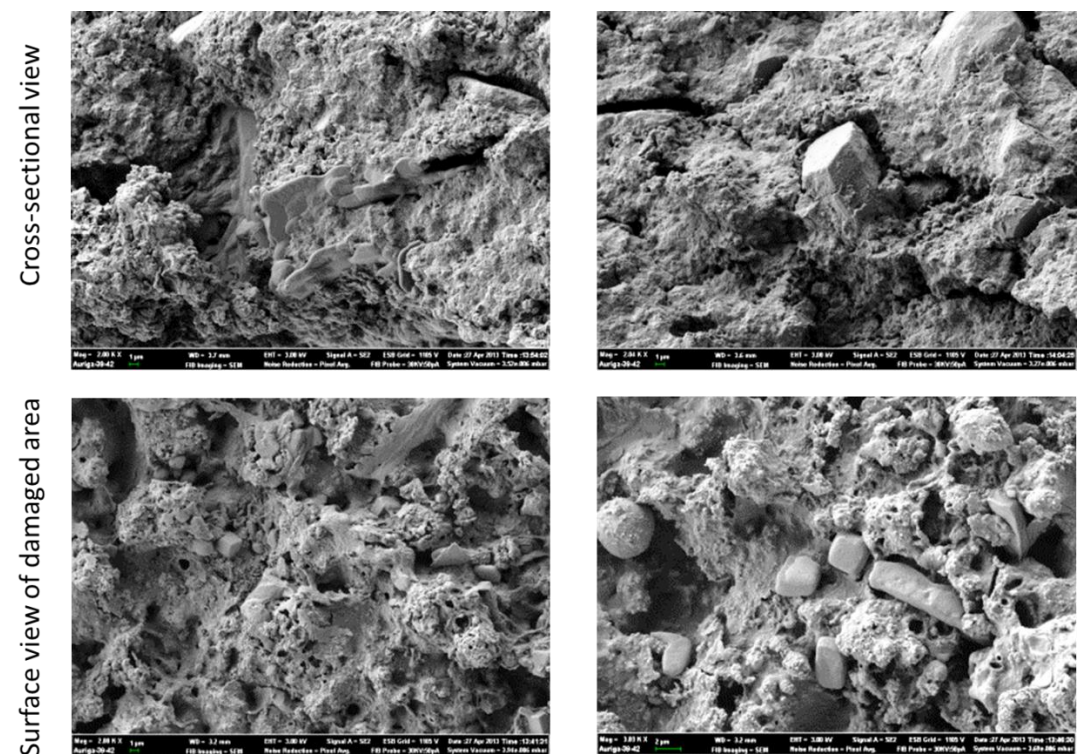
Figure D.6: SEM analysis of negative 6.3 kV sample

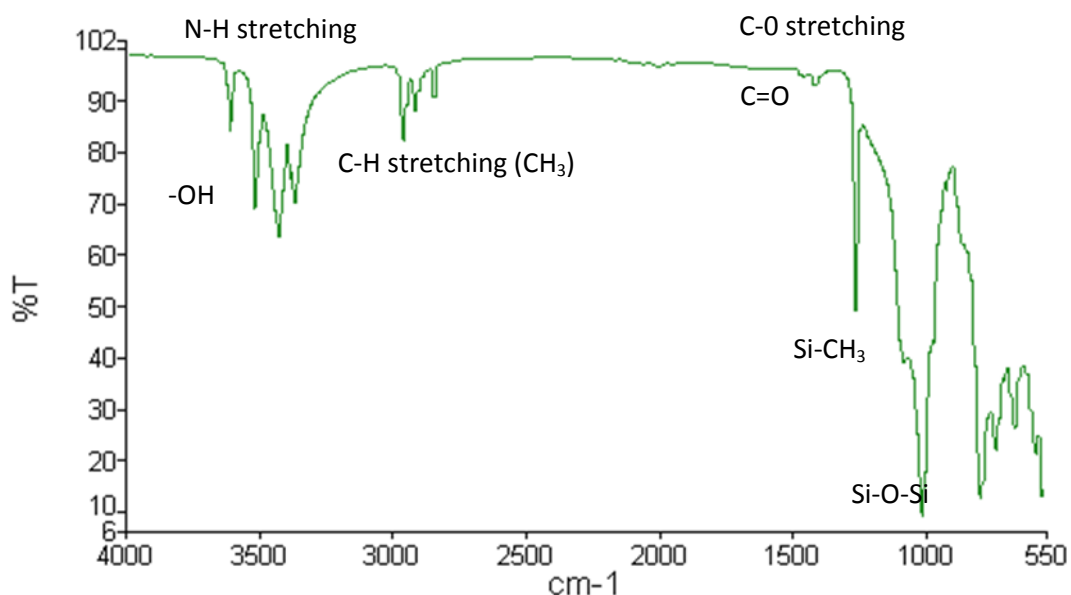
**Figure D.7: FTIR spectra of the control sample**

The FTIR spectra of the control sample, shown in Figure D.7, show characteristic N-H stretching peaks between 3200 cm<sup>-1</sup> and 3500 cm<sup>-1</sup>, C-H stretching below 3000 cm<sup>-1</sup> and C-O / C-H stretching between 1500 cm<sup>-1</sup> and 1000 cm<sup>-1</sup>.

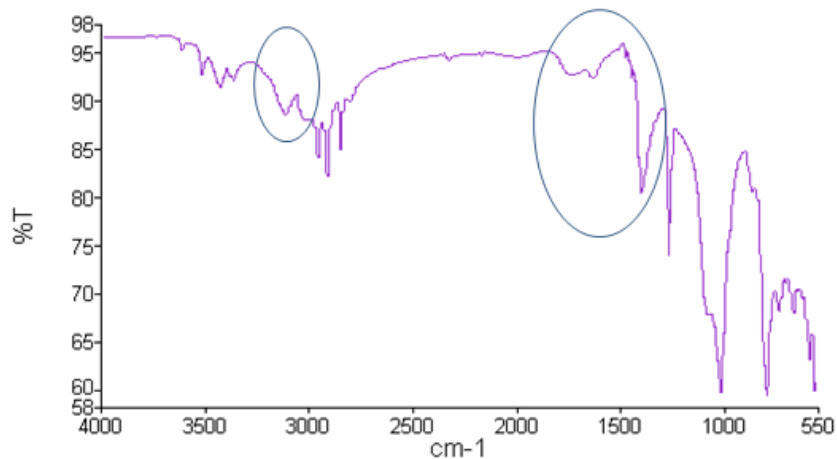
**Figure D.8: FTIR spectrum of AC sample – 1cm away from damage area**

Figure D.8 and Figure D.9 show the FTIR spectra from the ac sample, indicating an area 1cm away from the damage area and the damage area respectively. The spectrum roughly resembles that of the control sample except for the appearance of peaks above  $1500\text{ cm}^{-1}$ . There are also peaks between  $3300$  and  $3500\text{ cm}^{-1}$  that are not seen in the control sample. At approximately  $1270\text{ cm}^{-1}$  we notice the attenuation of the Si-CH<sub>3</sub> stretching which indicates damage to these bonds due to the discharge activity or burning of the rubber material. This argument is further strengthened by the appearance of the peaks at approximately  $2900\text{ cm}^{-1}$  (CH<sub>3</sub>). This could possibly be the formation of -CH<sub>3</sub> radicals as a result of the damage to the Si-CH<sub>3</sub> bonds. We also notice the attenuation of the N-H / OH bonds which could mean the damage to the hydroxyl groups, that either come from moisture in the sample or the Alumina Tri-hydrate (Al<sub>2</sub>O<sub>3</sub>·3H<sub>2</sub>O - which is used in the formulation of polymeric insulators to give them their tracking and erosion resistance).

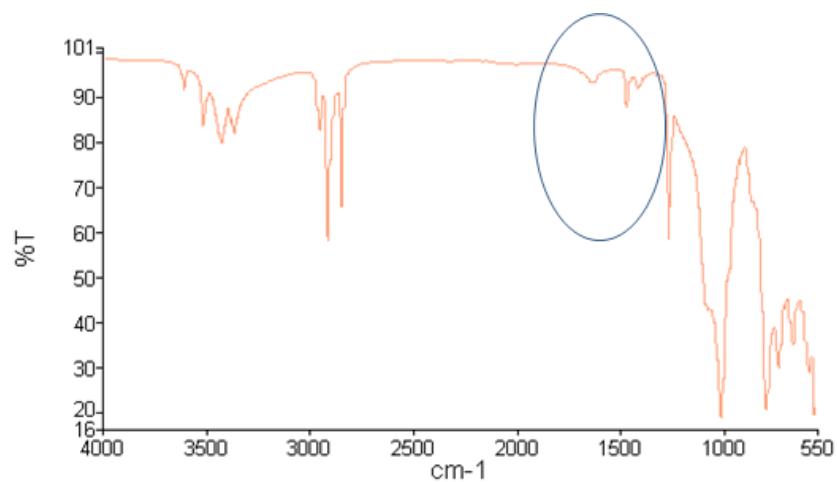
**Figure D.9: FTIR spectrum of AC sample – damage area**

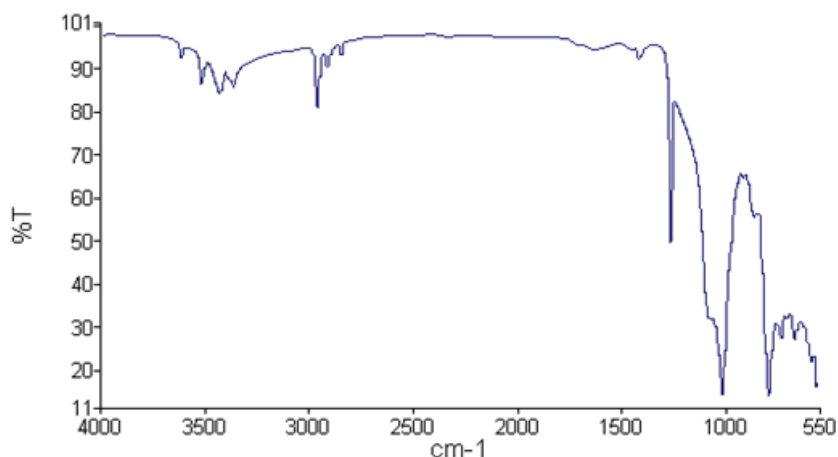
**Figure D.10: FTIR of positive 4.5 kV dc sample – 1 cm away from damage area**

Figure D.10 and Figure D.11 show the FTIR spectrum of the positive 4.5 kV dc sample, 1 cm away from the damage area and at the damage area respectively. Clearly noticeable is the attenuation of the N-H peaks around  $3500\text{ cm}^{-1}$ . This effect was visible in both the damage area and 1 cm away. The peaks are, however, less attenuated 1 cm away from the damage area, than in the damage area itself. This provides some indication that the sample in the damage area was subjected to a greater degree of burning, and that the area 1 cm away is more indicative of damage due to leakage current. There is still some evidence of the  $\text{CH}_3$  peaks. There is also slight indication of the formation of  $\text{C=O}$  bonds at approximately  $1600\text{ cm}^{-1}$ , which could indicate oxidation of the side chains. The  $\text{Si-CH}_3$  bonds seem not to have been affected too much and  $\text{Si-O-Si}$  bonds seem to show a slight attenuation, indicating possible change in the back-bone structure.

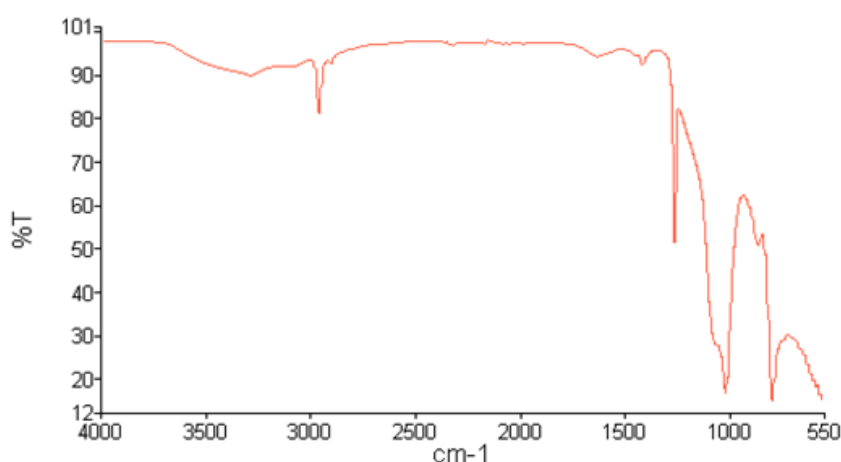
**Figure D.11: FTIR of positive 4.5 kV dc sample – damage area**

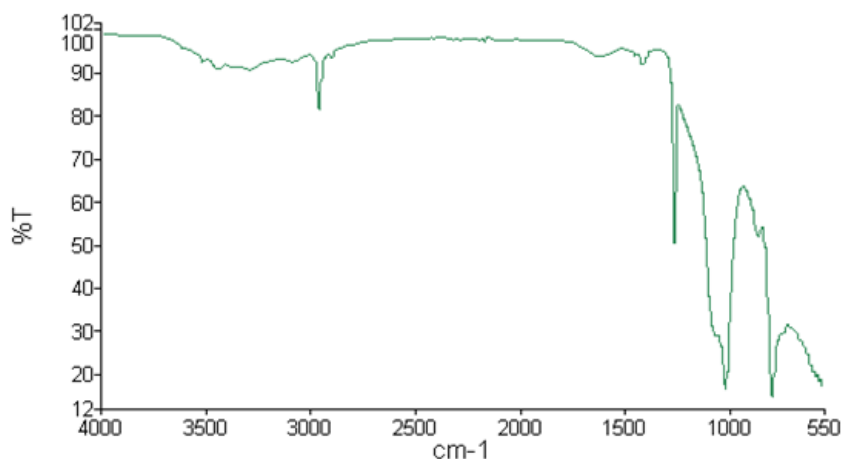
**Figure D.12: FTIR of negative 4.5 kV dc sample – 1cm away from damage area**

Figure D.12 and Figure D.13 show the FTIR spectrum of the negative 4.5 kV dc sample, 1 cm away from the damage area and at the damage area respectively. Similar to the positive 4.5 kV sample is the attenuation of the N-H / OH peaks around  $3500\text{ cm}^{-1}$ . There is still some evidence of the  $\text{CH}_3$  peaks. There is also slight indication of the formation of C=O bonds at approximately  $1600\text{ cm}^{-1}$ , which could indicate oxidation of the side chains. The Si- $\text{CH}_3$  bonds in the damage area seem to be more attenuated than 1 cm away, which could be a result of the burning. The Si-O-Si bonds seem to have been attenuated slightly more in comparison with the positive case, possibly indicating that the negative polarity has a greater effect on the back-bone structure.

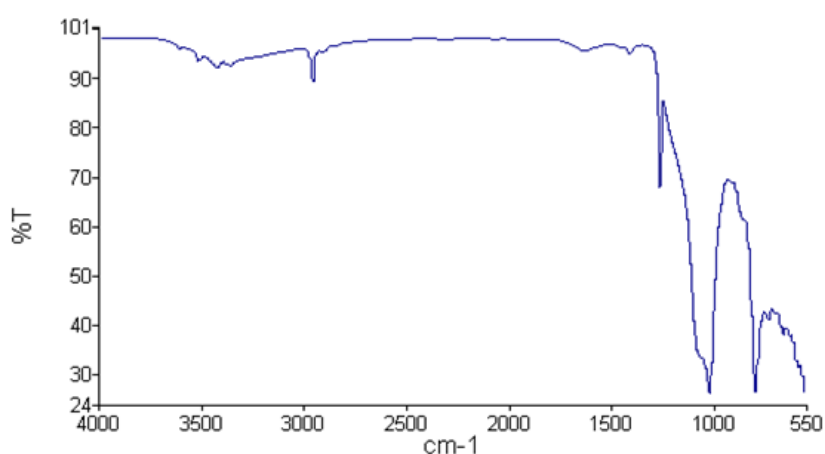
**Figure D.13: FTIR of negative 4.5 kV dc sample – damage area**

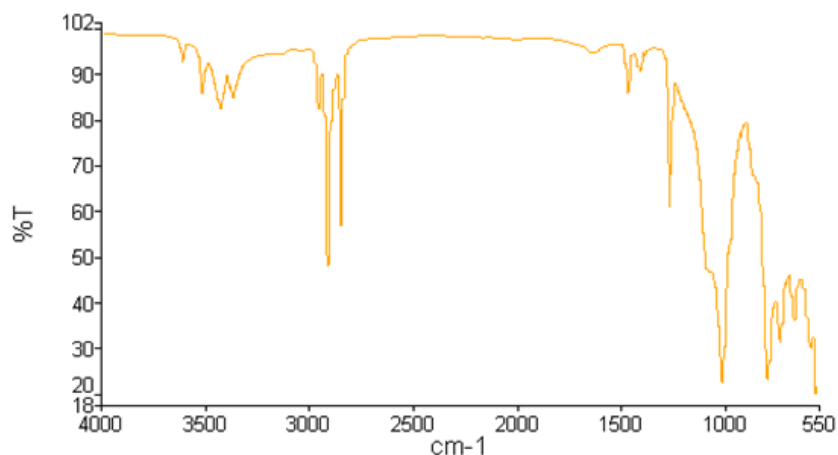
**Figure D.14: FTIR of positive 6.3 kV dc sample – 1 cm away from damage area**

Figure D.14 and Figure D.15 show the FTIR spectrum of the positive 6.3 kV dc sample, 1 cm away from the damage area and at the damage area respectively. Both spectra show an attenuation of the peak around  $3500\text{ cm}^{-1}$ , N-H / OH peak, corresponding to the depletion of the alumina trihydrate filler material. Also noticeable is the slight increase in the peaks around  $1600\text{ cm}^{-1}$  indicating the formation of the C=O bonds, possibly pointing to the increase in oxidation of the side chains. The spectrum 1 cm away from the damage area shows an increase in the  $\text{CH}_3$  peaks, possibly indicating the formation of  $\text{CH}_3$  free radicals. The attenuation of the Si-O-Si bonds also seem to be visible.
