# PERFORMANCE OF SILICONE RUBBER MATERIALS UNDER HIGH VOLTAGE DIRECT CURRENT USING THE INCLINED PLANE TEST

A research report submitted to the faculty of Engineering and the  
Built Environment, University of the Witwatersrand, in fulfilment  
of the requirements for the degree of Master of Science of  
Engineering

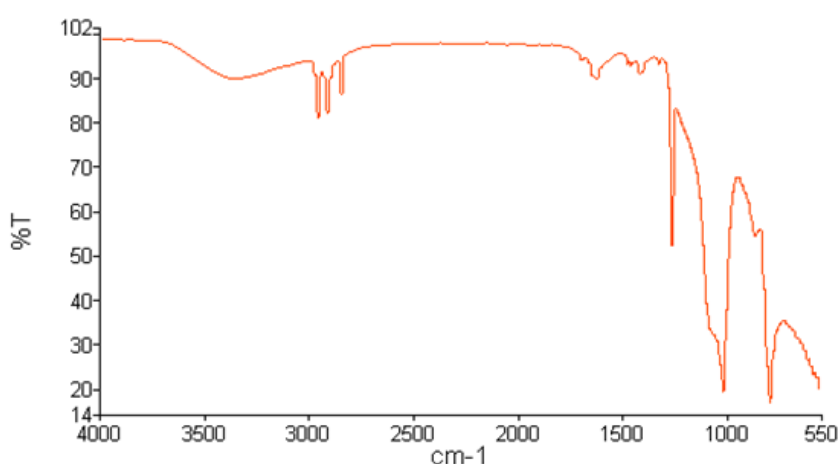
**Figure D.15: FTIR of positive 6.3 kV dc sample – damage area**

Figure D.14 and Figure D.15 show the FTIR spectrum of the positive 6.3 kV dc sample, 1 cm away from the damage area and at the damage area respectively. Both spectra show an attenuation of the peak around  $3500\text{ cm}^{-1}$ , N-H / OH peak, corresponding to the depletion of the alumina trihydrate filler material. Also noticeable is the slight increase in the peaks around  $1600\text{ cm}^{-1}$  indicating the formation of the C=O bonds, possibly pointing to the increase in oxidation of the side chains. The spectrum 1 cm away from the damage area shows an increase in the  $\text{CH}_3$  peaks, possibly indicating the formation of  $\text{CH}_3$  free radicals. The attenuation of the Si-O-Si bonds also seem to be visible.

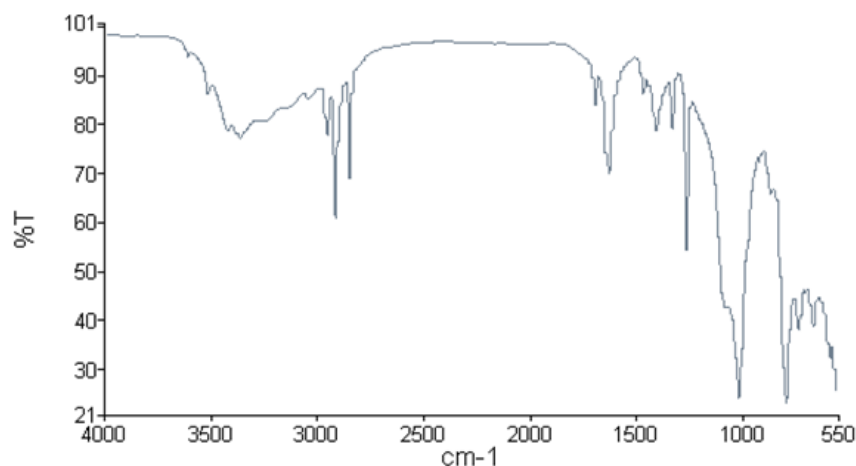
**Figure D.16: FTIR of negative 6.3 kV dc sample – 1 cm away from damage area**

Figure D.16 and Figure D.17 show the FTIR spectrum of the negative 6.3 kV dc sample, 1 cm away from the damage area and at the damage area respectively. Both spectra show an attenuation of the N-H / OH peaks, with less observed in the spectrum 1 cm away but with a greater increase in the CH<sub>3</sub> peaks, indicating the formation of the free radicals. The attenuation of the OH peaks signifies the depletion of the ATH filler material, but less so than in the positive sample. However, there is a significant increase in the peak around 1600 cm<sup>-1</sup> which indicates the increase in oxidation of the material. There is a slight decrease in the Si-CH<sub>3</sub> peak. Similar to the negative 4.5 kV case, the attenuation of the Si-O-Si bonds seem to be greater in the negative polarity case compared to the positive polarity.

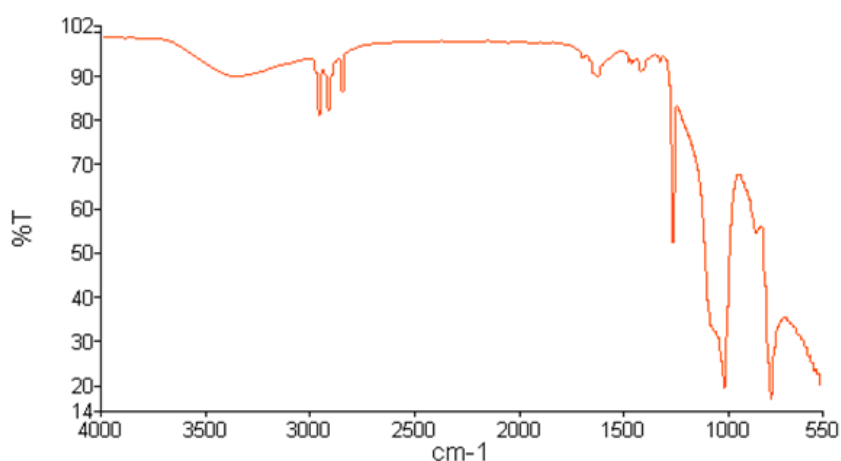
**Figure D.17: FTIR of negative 6.3 kV dc sample – damage area**

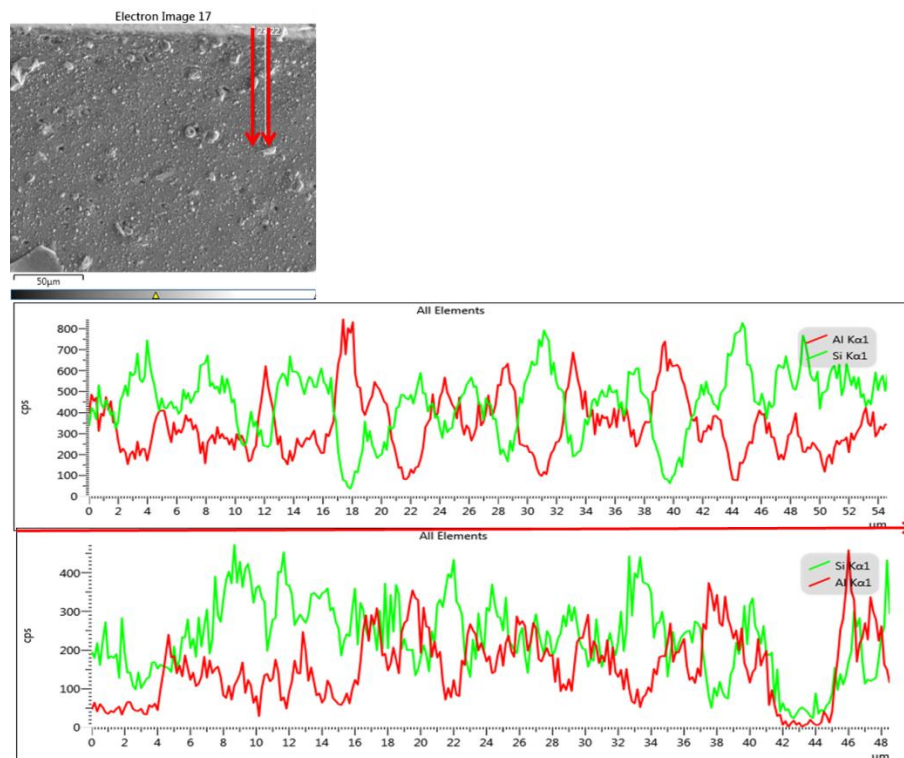
Figure D.18: EDS scan of the control sample with two linescans

The EDS linescans were performed across the edge of the damaged areas on all the supplied samples, and the results provide an indication of the levels of silicon (Si) and aluminium (Al) or aluminium trihydrate (Al<sub>2</sub>O<sub>3</sub>·3H<sub>2</sub>O). Figures D.18 – D.23 provide the results of the EDS linescans including an electron scan of the area in which they were measured.

It is evident that Si and Al decrease dramatically as the damage area is approached. There is an occasional spike of chlorine (Cl) in the same area, but this is not consistent across all the samples.

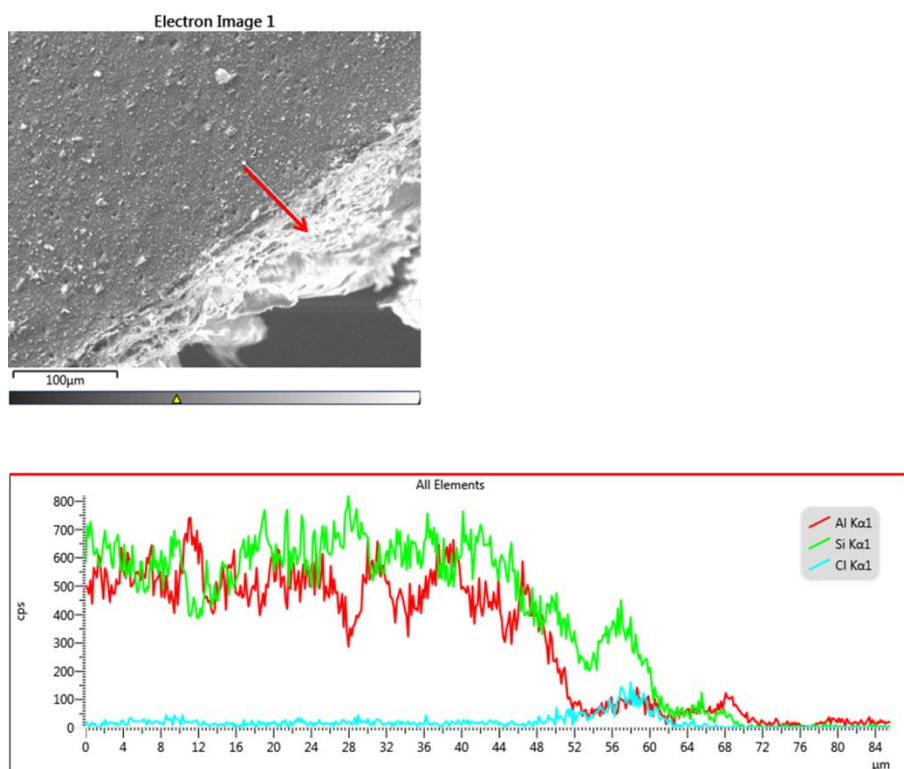
Figure D.19: EDS scan of the ac sample

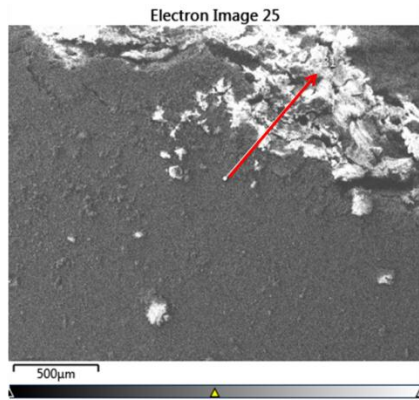
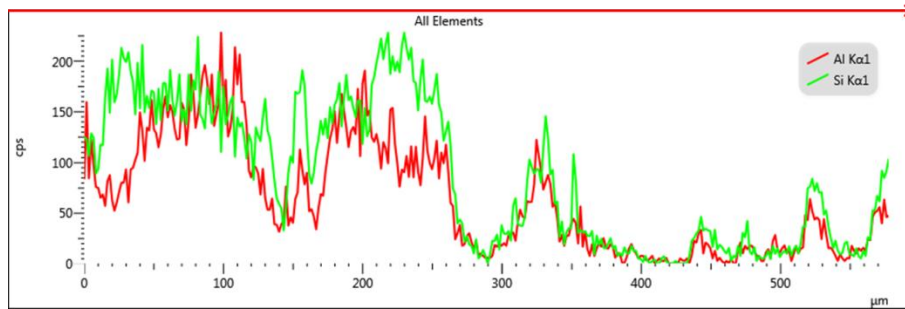
**Figure D.20: EDS Scan of positive 4.5 kV dc sample**

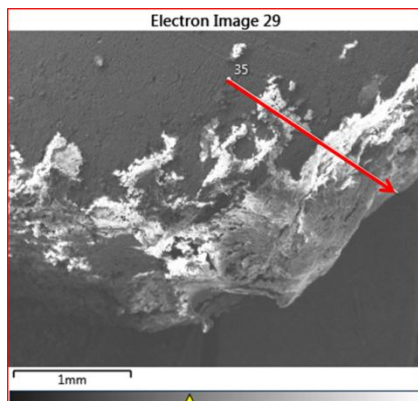
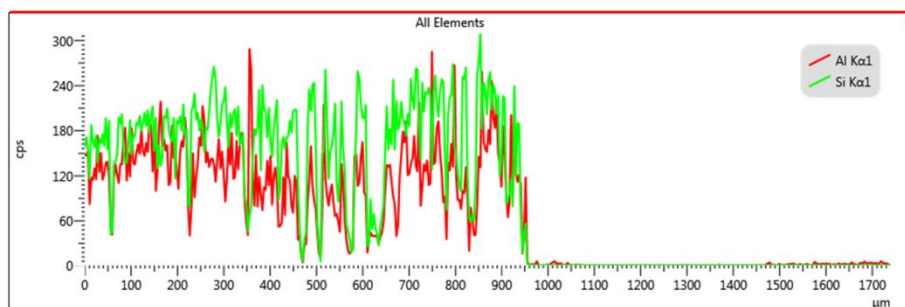
**Figure D.21: EDS scan of negative 4.5 kV dc sample**

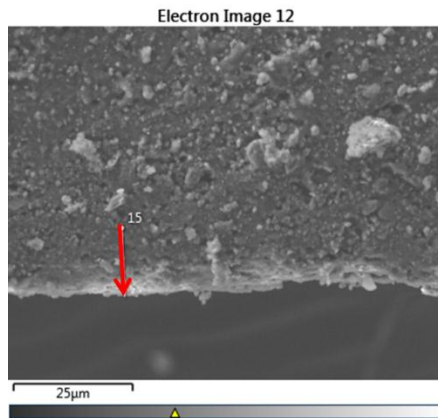
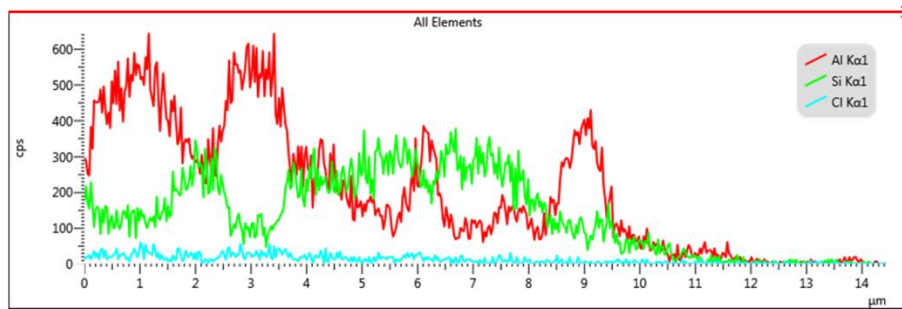
**Figure D.22: EDS scan of positive 6.3 kV dc sample**

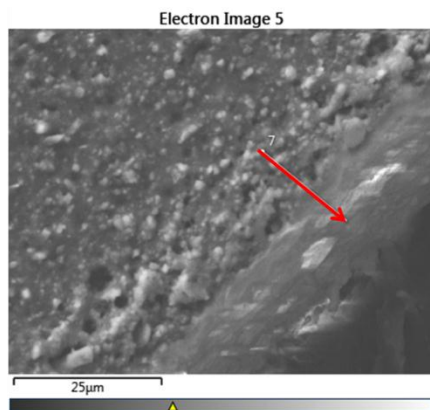
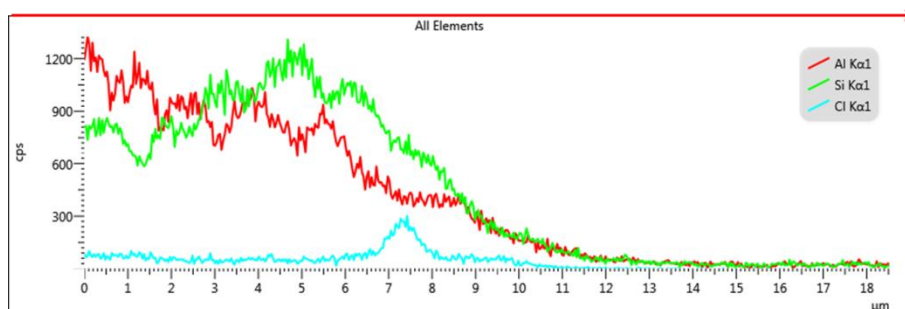
**Figure D.23: EDS Scan of negative 6.3 kV dc sample**

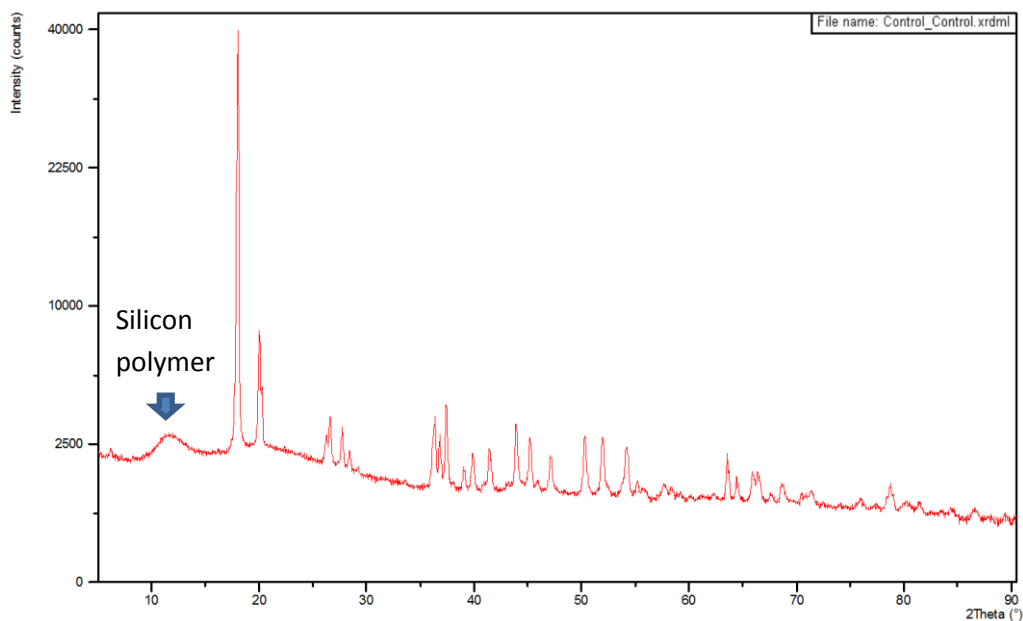
**Figure D.24: XRD result for the control sample**

This technique was used to determine the change in the physical structure of the polymer material due to damage / ageing with the different voltage applications. In addition, the clustering of the filler particles on the surface can also be determined by this technique. The diffraction method obtained is a plot of the intensity versus 2 theta angle. Figures D.24 – D.29 show the results of the XRD scans.

The figures show a wide angle scan of the silicon rubber samples. The low intensity hump between 10 – 15 degrees (indicated by the arrow head in the figures) show the silicon polymer, while the other peaks observed are due to the crystalline ATH filler material [3]. In all of the figures, D.25 – D.29, with respect to the control sample, Figure D.24, there is a noticeable increase in amplitude and somewhat narrowing of the hump between 10 – 15 degrees. This suggests that the filler particles are present in larger crystallites than in the control sample. It is also observed that in the lower dc voltage samples, Figure D.26 and Figure D.27, that there is a significant (almost 50%) reduction in the amplitude of the ATH peak (approximately situated at 18 degrees), whilst in the higher dc voltages this value increased slightly. In the ac sample, Figure D.25, the peak of the filler almost doubled in amplitude. The observations indicate that the silicon polymer becomes more crystalline and

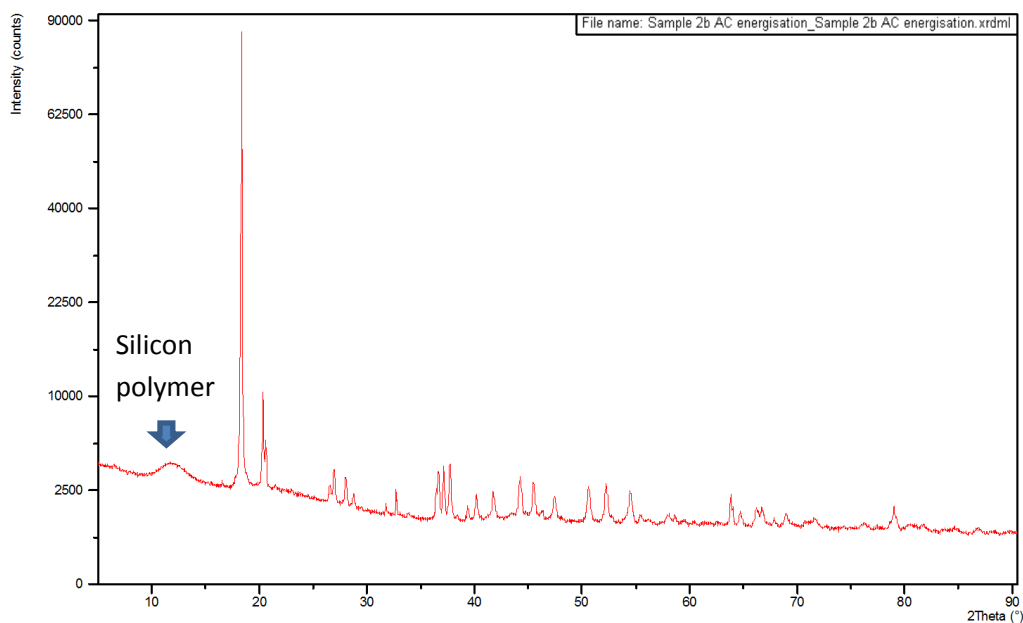
**Figure D.25: XRD result for the ac sample**

that the crystalline size of the filler material also increases in some cases. This supports the view that the energisation of the samples and the dry band arcing observed during the testing causes permanent changes in the structure of the material, more so in the lower voltage dc applications.

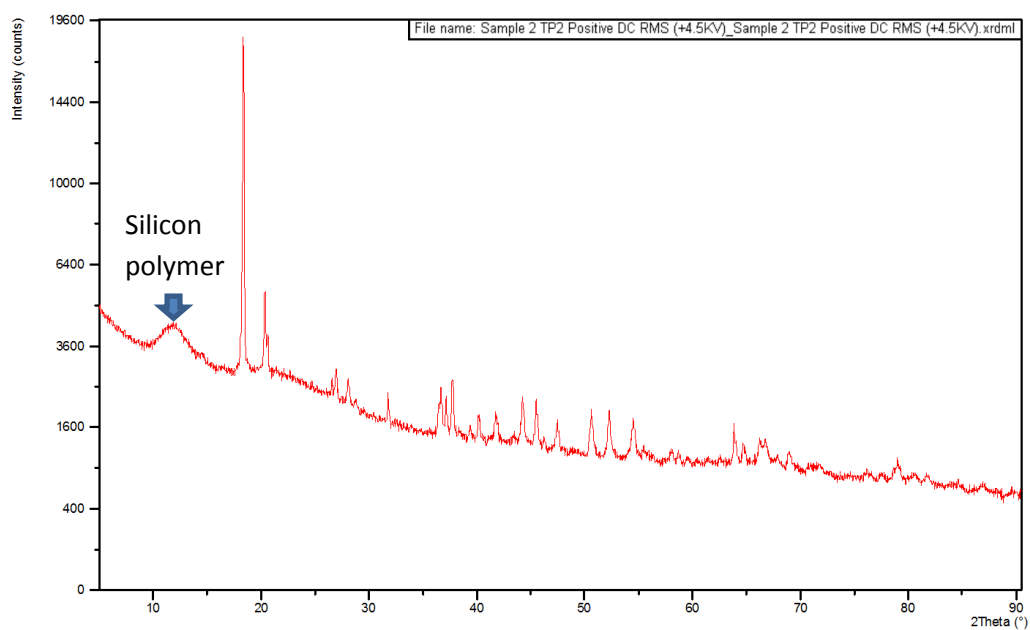
**Figure D.26: XRD result for the positive 4.5 kV dc sample**

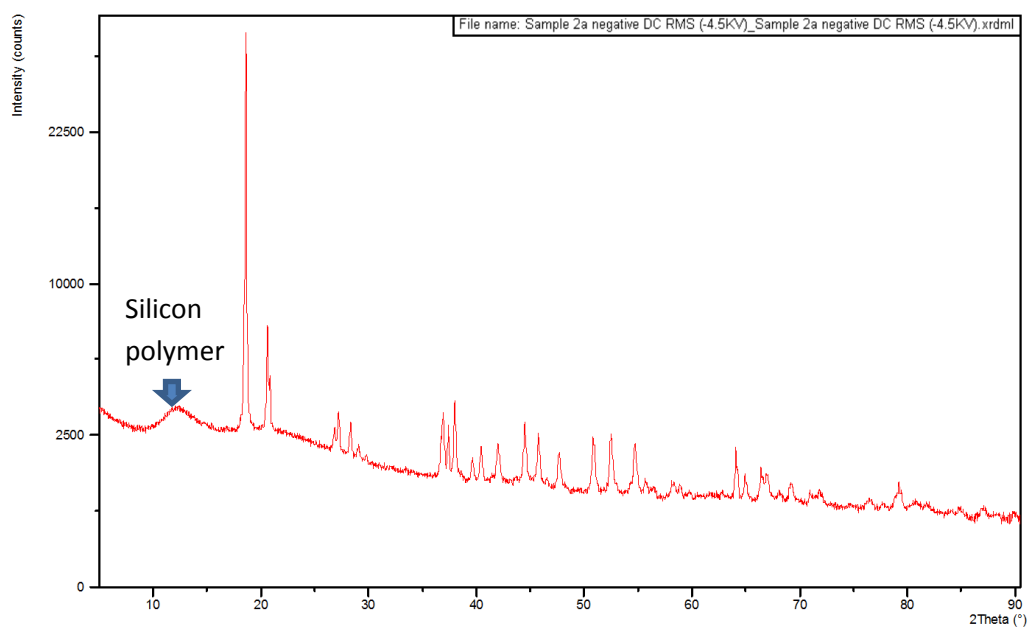
**Figure D.27: XRD result for the negative 4.5 kV dc sample**

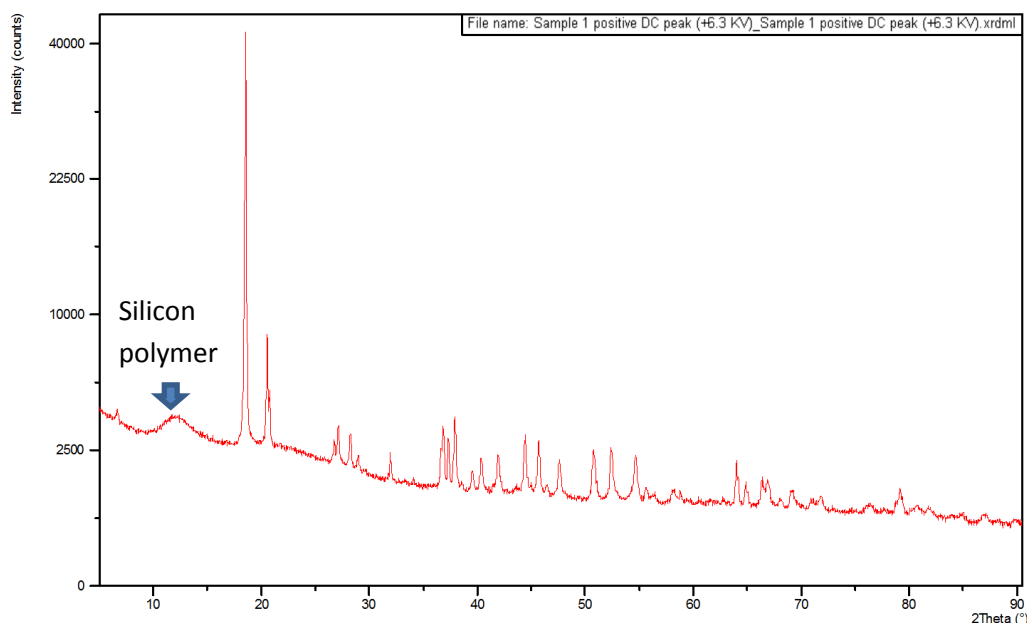
**Figure D.28: XRD result for the positive 6.3 kV dc sample**

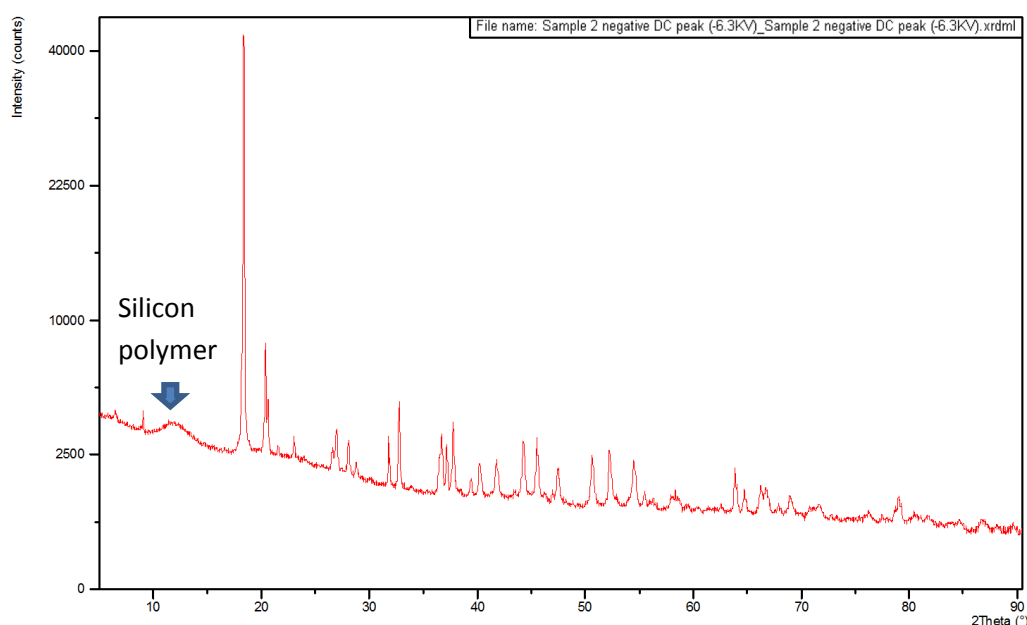
**Figure D.29: XRD result for the negative 6.3 kV dc sample**

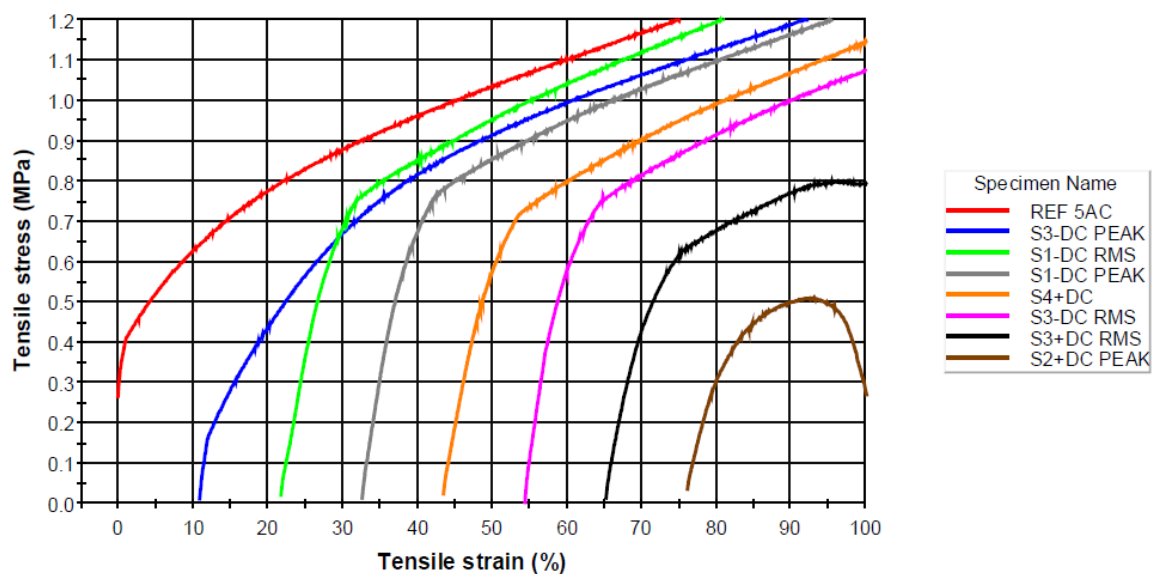
**Figure D.30: Tensile test on damaged / aged samples**

The test is rather subjective as it was expected that samples with the most amount of damage, i.e. with the largest amount of material loss due to tracking and erosion, will exhibit the lowest tensile strength. This was confirmed by the test. Sample “S2 +DC PEAK” and “S3 +DC RMS”(brown and black curves respectively) experienced the most amount of material loss, and hence exhibited the lowest tensile strengths respectively. An interesting observation was that while samples “S1 –DC PEAK”, “S1 –DC RMS” and “S3 –DC PEAK” exhibited a similar appearance to the ac sample (“REF 5AC”) and also experienced negligible surface damage and erosion, none of them exhibited the same tensile strength. All were lower, albeit by a relatively small margin. This could indicate that perhaps the dc energisation had indeed modified or weakened the structure of the polymer material.

The tensile testing was done to determine the relative strength of the damaged / aged polymer samples. The machine used to conduct the testing was an Instron Advanced Video Extensometer, calibrated up to a 100 KN. Since the control sample was used for previous tests, the reference sample used was the ac energized sample, due to the fact that it exhibited the least amount of visible damage. Each sample was had a pre-load of 20 N applied to take up any slack in the machine or sample. A rate of extension of 10 mm/minute was applied until a 10% strain / deformation was observed, and then the rate was increased to 20 mm/minute. Figure D.30 shows the results of the testing.
