**Author** Goodman Hubert John

**Name of thesis** The Nature Of Failure Through The Intact Materials In The Step Joint Mechanism For Rock Slopes. 1973

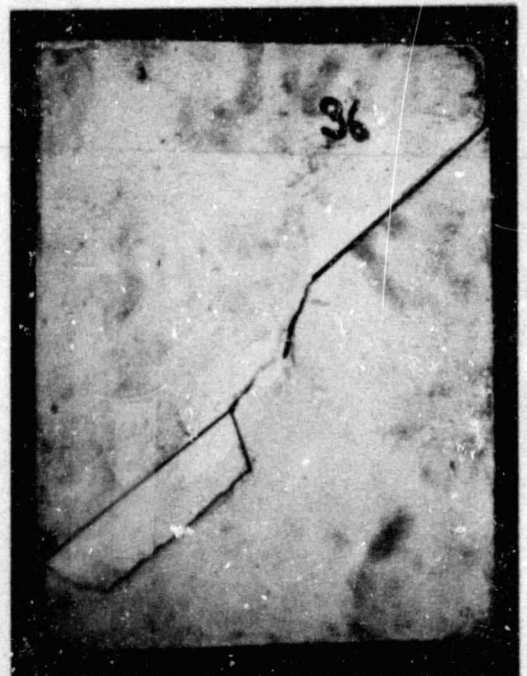
SAMPLE NO. 36

Shear movement took place along both joint surfaces and a combined shear and tension failure occurred through the intact material.

d = 25 mm

L = 74 mm

W = 24,2 kN

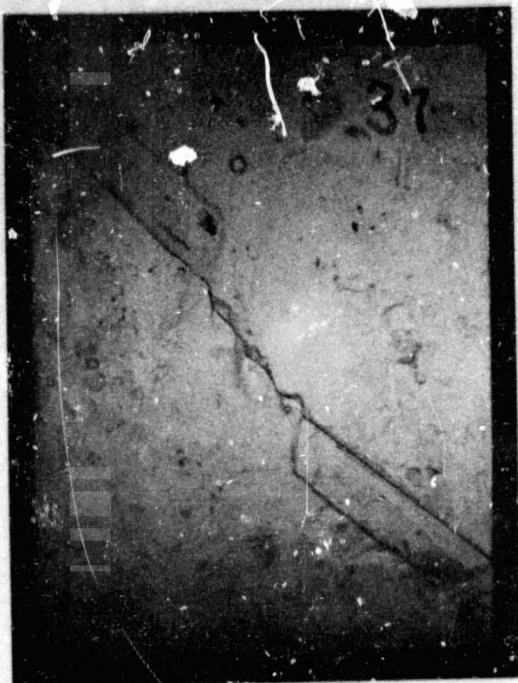
SAMPLE NO. 37

d = 25 mm

L = 74 mm

W = 24,3 kN

Shear took place along both joint surfaces. Through the intact material a combined shear and tension failure took place, whose failure surface was approximately along the most direct path between the two joint ends.

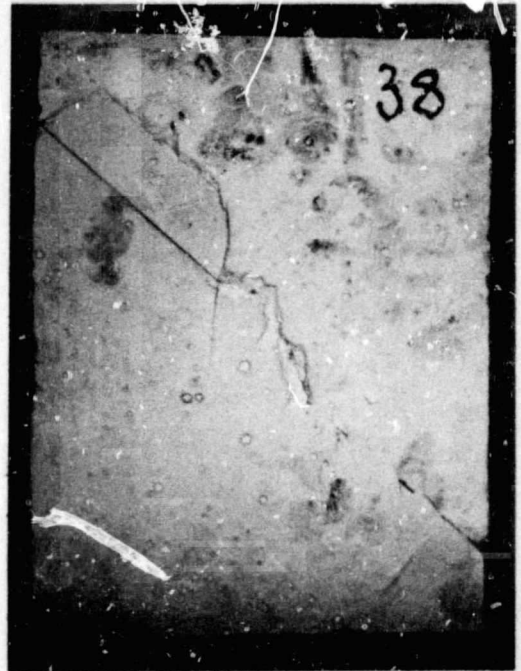
SAMPLE NO. 38

d = 25 mm

L = 74 mm

W = 28,0 kN

Shear movement occurred along both joint surfaces. The combined shear and tension failure surface, through the intact material, closely followed the shortest path between the two joint ends.

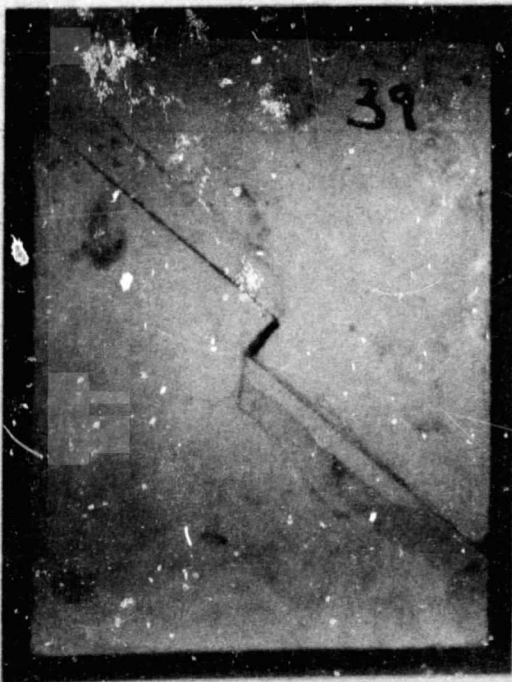
SAMPLE NO. 39

Shear took place along the joint surfaces. There was a tension fracture through the intact material between the joints.

This sample failed as the arm was being lowered onto it. Its failure load can, therefore, be stated as less than 2,7 kN.

d = 25 mm

L = 0 mm

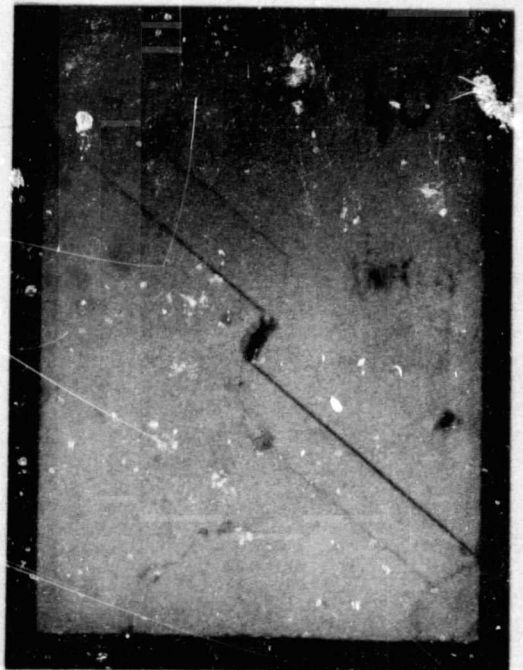
SAMPLE NO. 40

Shear movement took place along both joint surfaces and there were two tension fractures through the intact material.

This sample failed as the arm was being lowered onto it. Its failure load can, therefore, be stated as less than 2,7 kN.

d = 25 mm

L = 0 mm

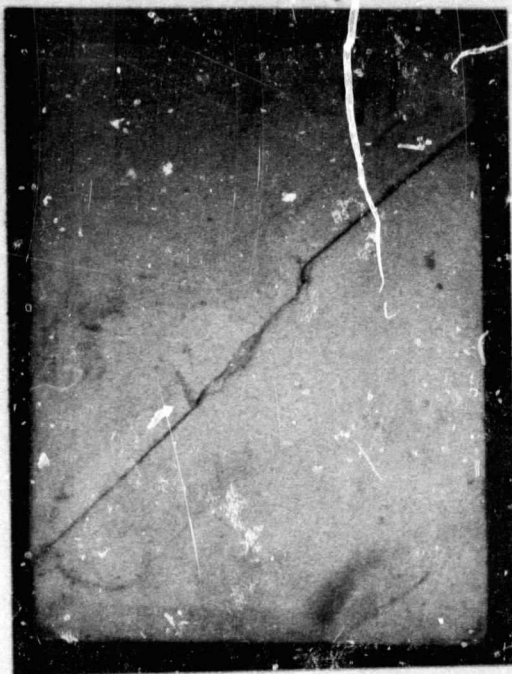
SAMPLE NO. 41

Joint pieces slipped during  
casting

W - not recorded

Shear occurred along both joint surfaces. A combined shear and tension failure through the intact material left a failure surface marked with striations.

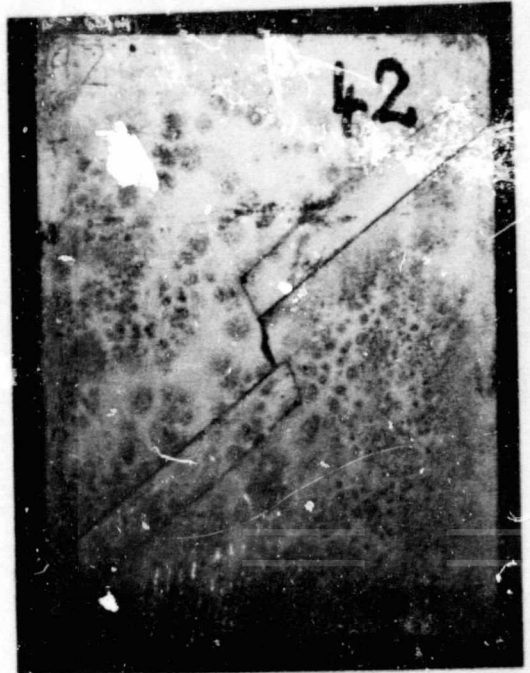
SAMPLE NO. 42

d = 25 mm

L = 0 mm

Shear movement took place along the joints and a tension fracture occurred through the intact material.

This sample failed as the arm was being lowered onto it i.e. failure load less than 2,7 kN.

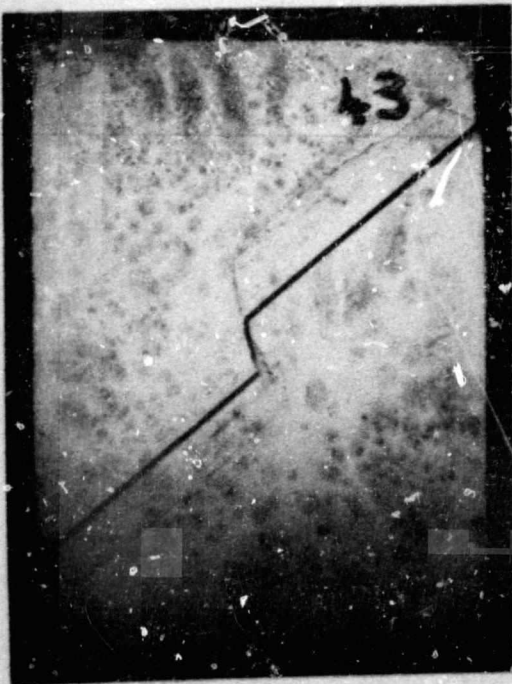
SAMPLE NO. 43

Shear occurred along both joints. A tension fracture occurred through the intact material between the joints.

$d = 25$  mm

$L = 0$  mm

$W = 13,6$  kN

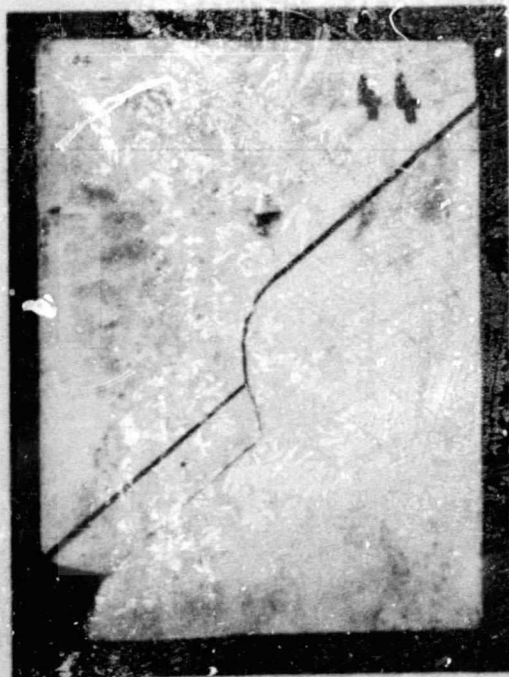
SAMPLE NO. 44

Shear movement took place along both joint surfaces and a combined shear and tension failure took place through the intact material between the joints. The corner broke off at a later stage, just before the sample was photographed.

d = 25 mm

L = 36 mm

W = 17, 9 kN

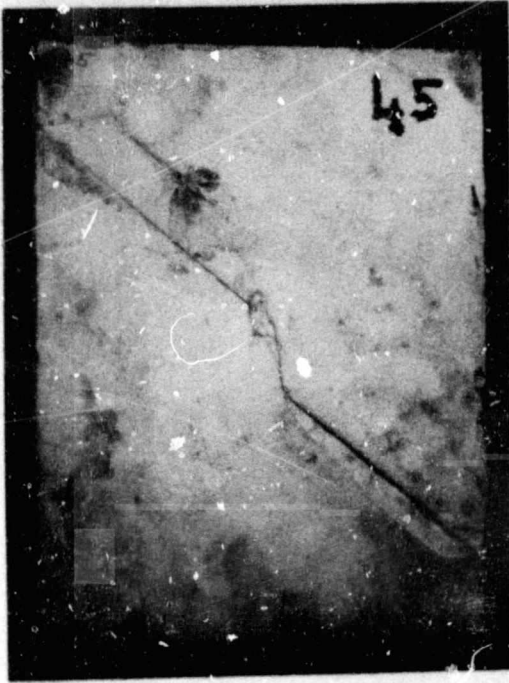
SAMPLE NO. 45

d = 25 mm

L = 36 mm

W = 61,9 kN

Shear movement took place along both joint surfaces and a combined shear and tension failure took place through the intact material, leaving a failure surface close to the direct path between the two joint ends.

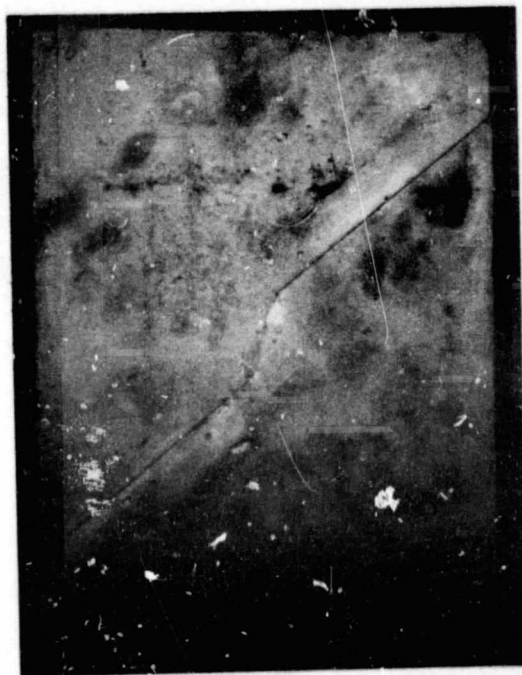
SAMPLE NO. 46

d = 25 mm

L = 36 mm

W = 14,0 kN

Shear movement took place along both joint surfaces. A combined shear and tension fracture took place through the intact material between the joints.

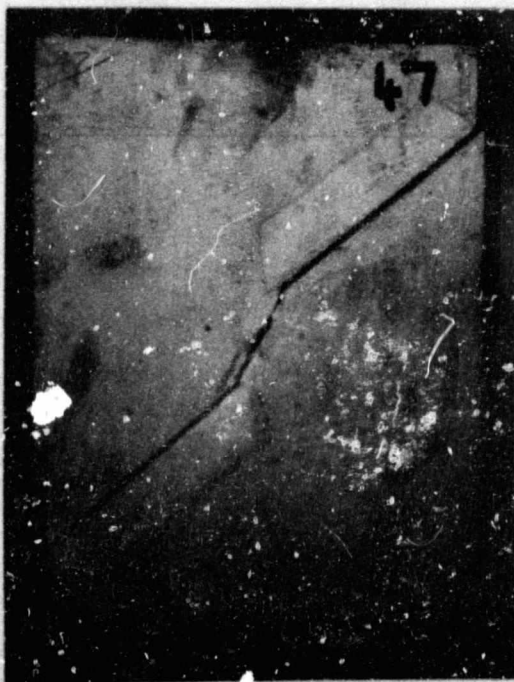
SAMPLE NO. 47

Shear movement took place along both joint surfaces. The combined shear and tension failure through the intact material has left marked striations on its failure surface.

d = 25 mm

L = 36 mm

W = 49,4 kN

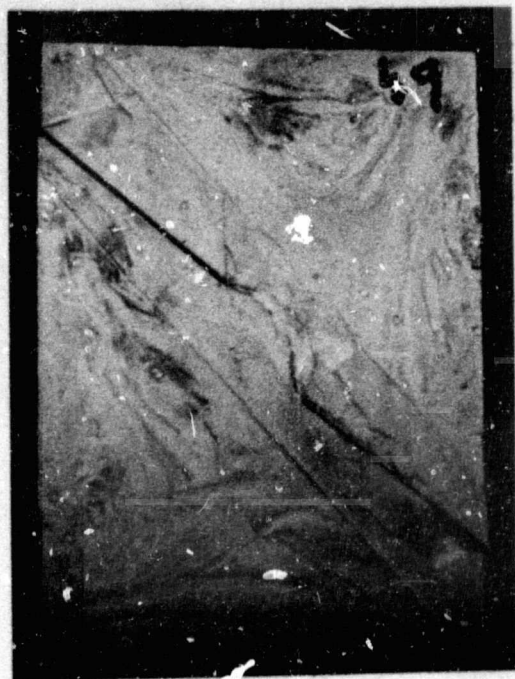
SAMPLE NO. 49

d = 25 mm

L = 74 mm

W = 52,4 kN

Shear movement took place along both joint surfaces. A combined shear and tension failure took place through the intact material between the joints.

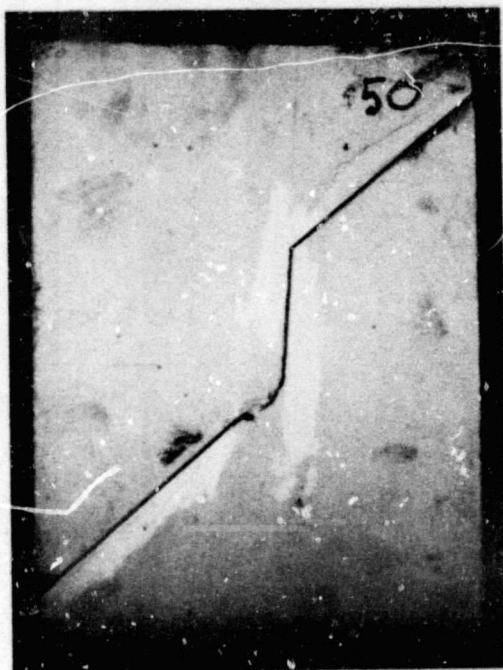
SAMPLE NO. 50

$$\alpha = 40^\circ$$

$$\psi = 87^\circ$$

$$S = 38 \text{ mm}$$

$$t = -25 \text{ mm}$$

$$W = 13,2 \text{ kN}$$

Peak load was reached and a crack formed along the  $\psi$ -joint. The sample had not failed but the load had reduced. Further load was applied. Shear took place along both  $\alpha$ -joints and through the intact material up to the  $\psi$ -joint, along which the sample separated.

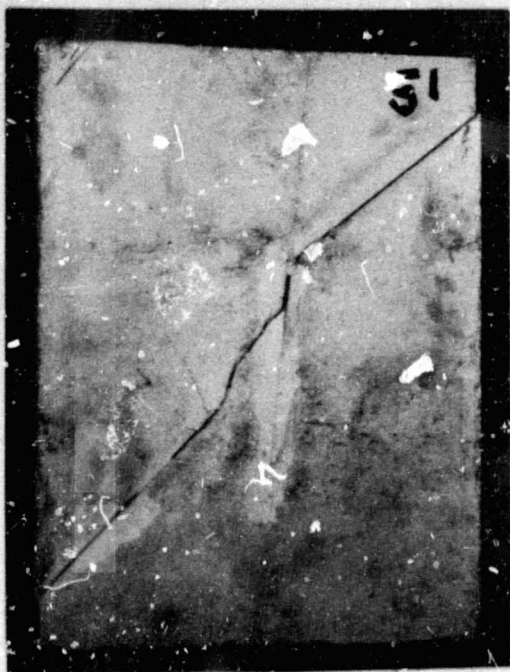
SAMPLE NO. 51

Joint pieces slipped during  
casting

Shear movement took place along both  $\alpha$ -joints and separation took place along the  $\psi$ -joint. A combined shear and tension fracture occurred through the intact material. This failure surface bears striations.

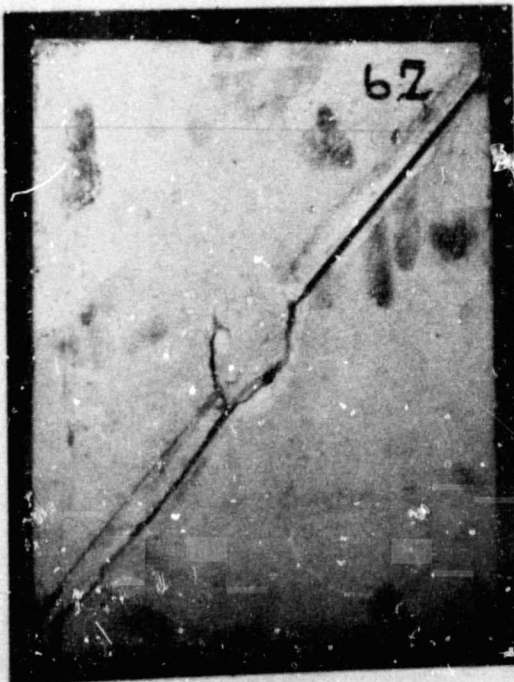
SAMPLE NO. 62

A crack formed downwards from the bottom of the top joint. Failure then occurred by shearing along the joints and through the intact material.

A piece spalled off one side of the intact material, between the joints.

The joint piece broke off later.

$$\alpha = 50^\circ$$

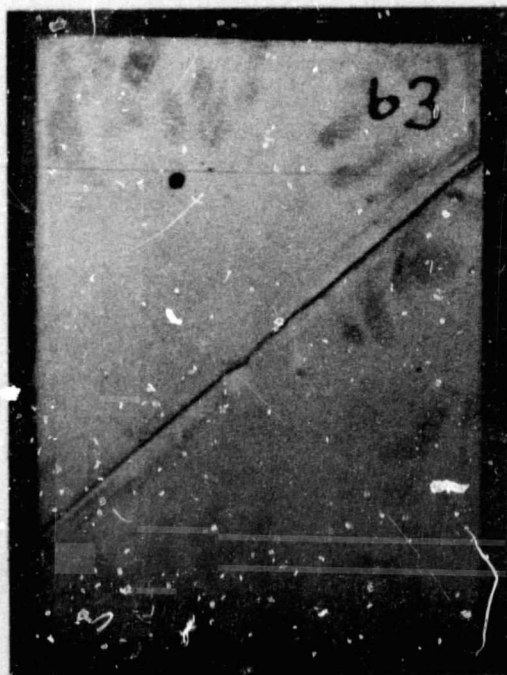
Shear movement occurred along both joint surfaces as well as through the intact material. Striations were left on the shear failure surface through the intact material.

$$L_4 = 119 \text{ mm}$$

$$L_5 = 0 \text{ mm}$$
