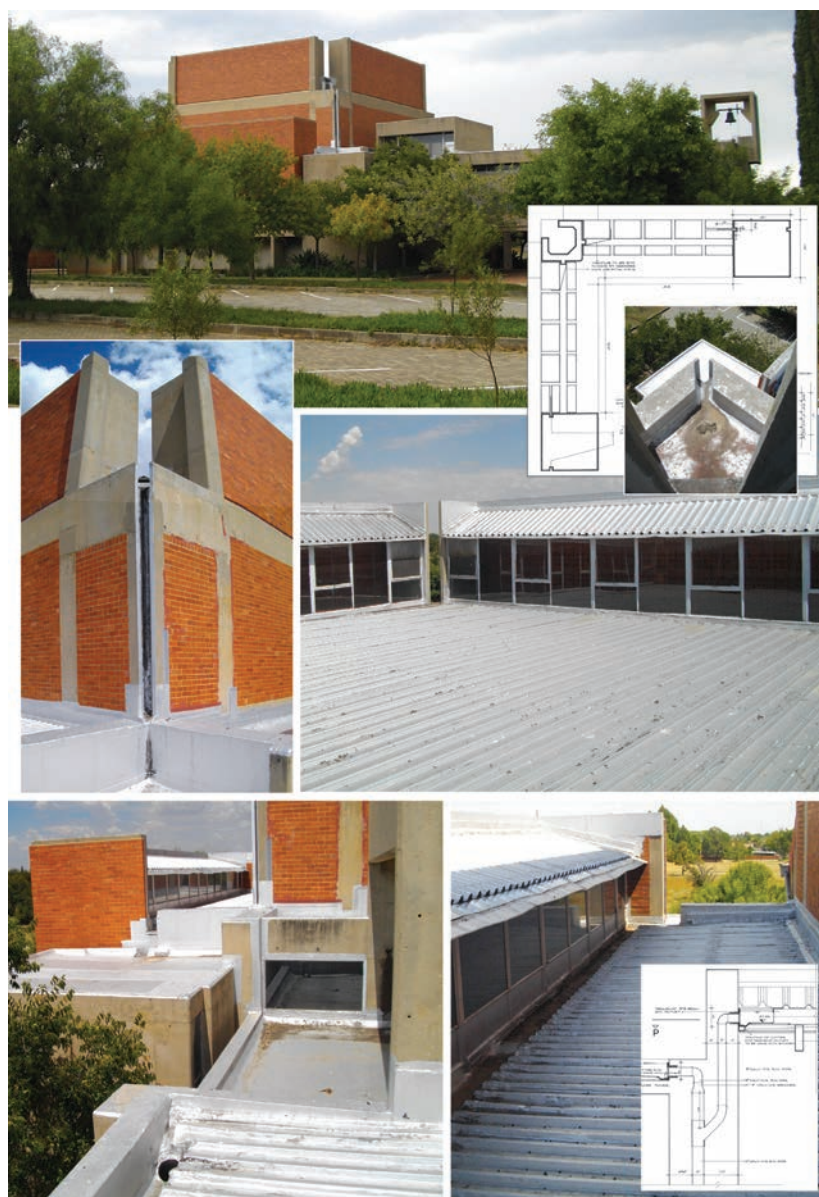
16 NGK Welkom-Wes. Seating in nave and gallery with construction details (Uytenbogaardt Papers).  
17 Drainage details, NGK Welkom-Wes. Clockwise from top left: General view from north-east; Plan detail of a recessed open corner channel (Uytenbogaardt Papers); Square roof of two auditorium corner columns shaped as a sump; Clerestory monitors to auditorium roof; Clerestory monitor on a side gallery showing bend to the box gutter; Details of built-in stormwater pipes (Uytenbogaardt Papers); View from the roof of the oppersaal towards the monitor of the eastern gallery showing various waterproofing attempts; Drainage by way of recessed open corner channels on the exterior of the auditorium.

to similar detailing, exacerbated by the bends to the box gutters to negotiate the side walls before discharging onto the roofs of the same stair towers. Below this level, unlike Kahn, Uytenbogaardt opted not to conceal services in ducts but had downpipes built-in (Fig 17).
