**The Extraction of Pillars, largely by Trackless Mining Methods, at  
Randfontein Estates Gold Mining Company (Witwatersrand) Ltd**

**A Dissertation submitted to the Faculty of Engineering,  
University of the Witwatersrand for the degree  
Master of Science in Engineering**

**July 1998**

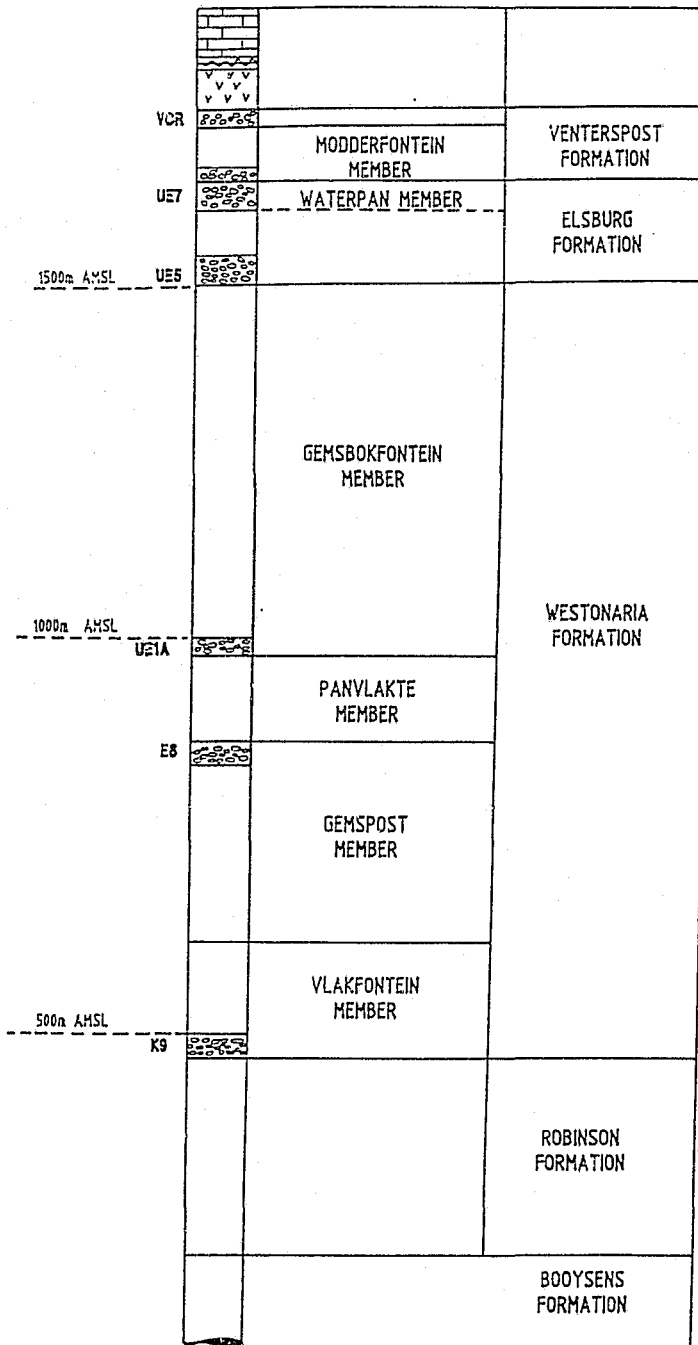
Figure 2.1

**GENERALIZED STRATIGRAPHIC COLUMN OF COOKE 1 SHAFT**

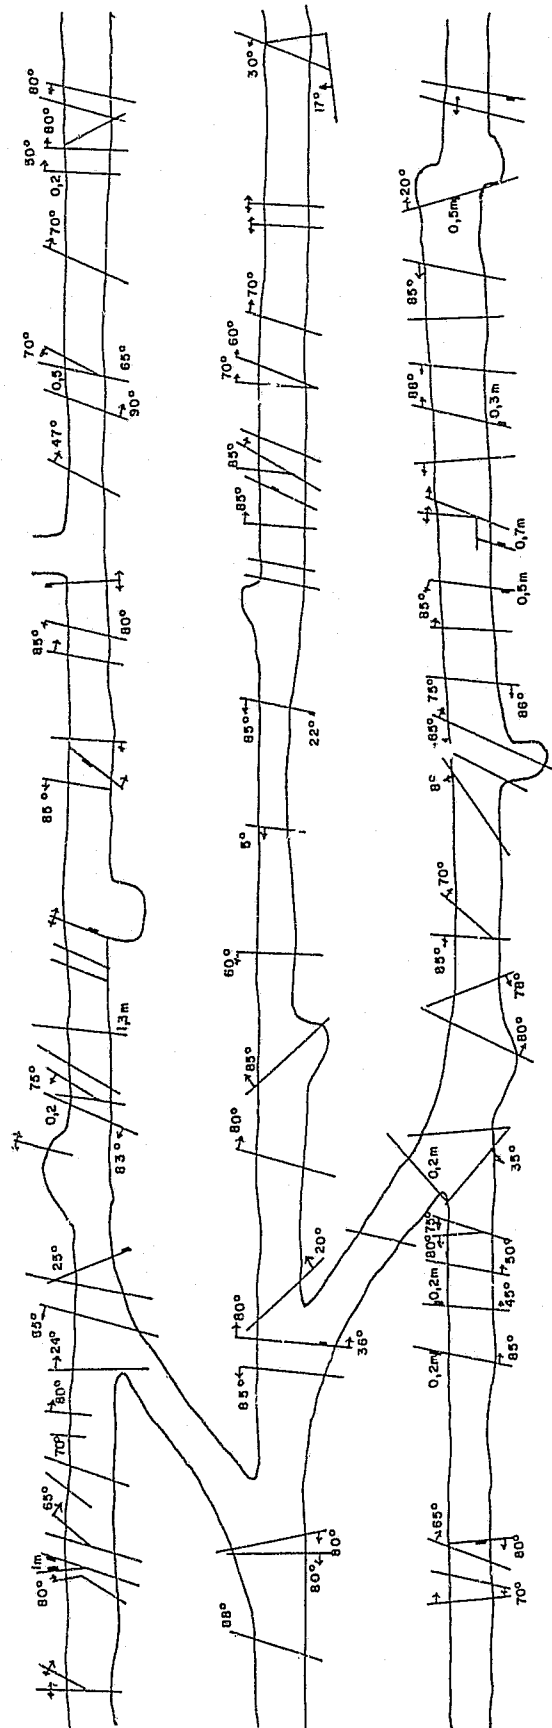
Portion of 95 pillar  
showing incidence of  
faulting.

The general geology of the 95 East Pillar was well known as a result of previous mining activities in the late 1970's. There were numerous faults cutting across the pillar at right angles to the longitudinal axis of the pillar in a north-south direction displacing the reef up to 4.5m. Figures 2.2 and 2.3. The reef is shaded and the results of the faulting on the reef position is clearly visible. The result of this faulting will be seen under the section on Mining of the 96 pillar.

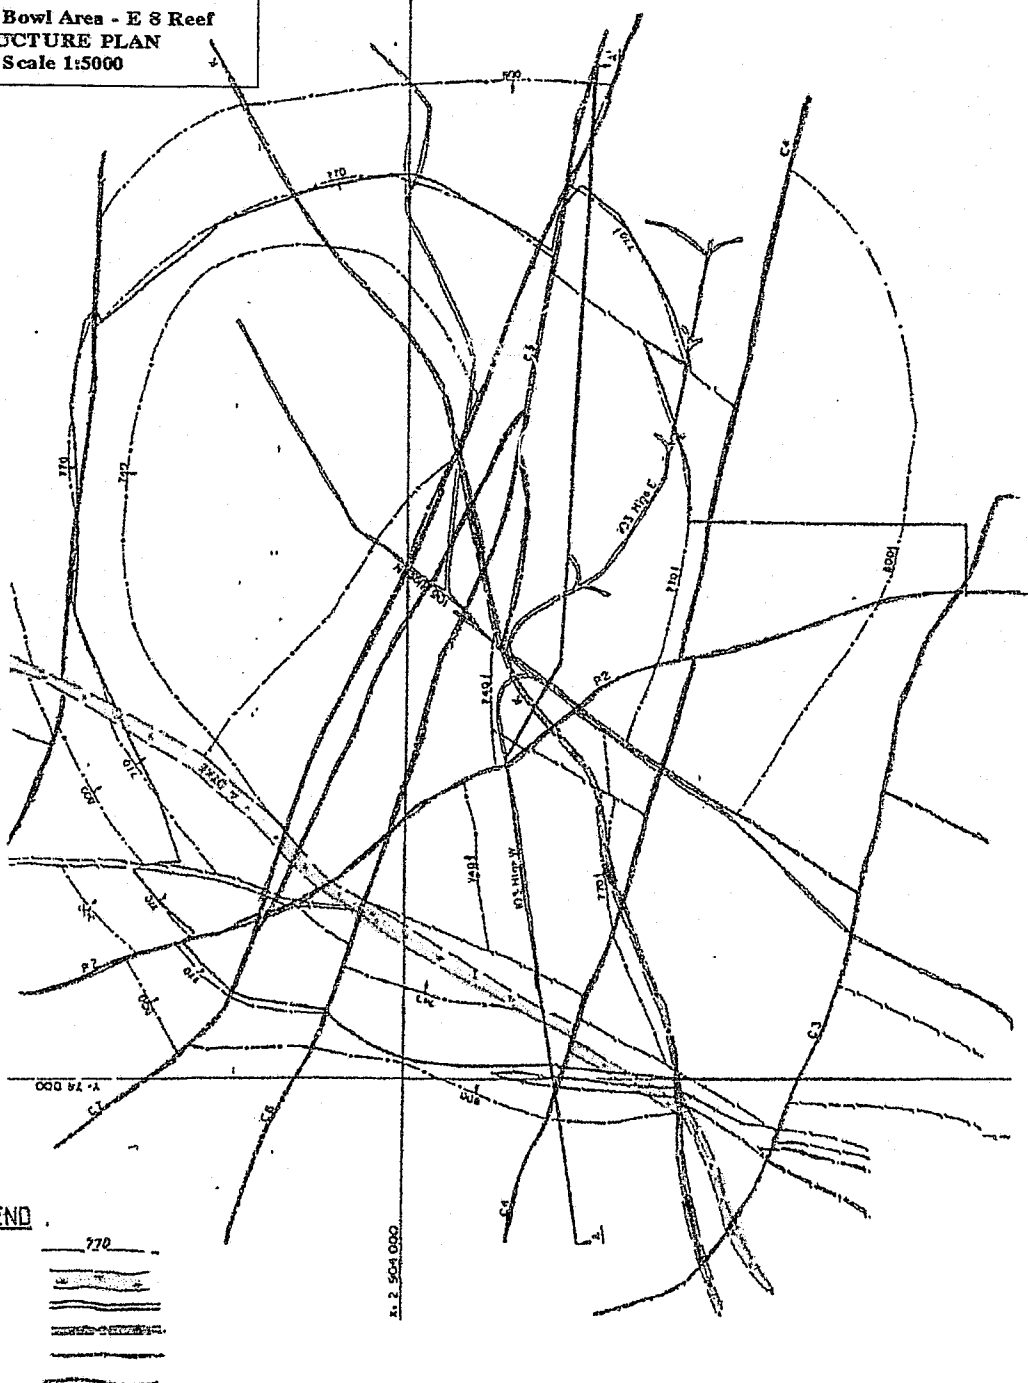
Figure 2.4

Structure Plan - Bowl Area

The second area, known locally as the Bowl Area, (Figure 2.4) because its structure resembled a bowl, had previously been left unmined because of its complicated structure, due to faulting and the presence of two major dykes.

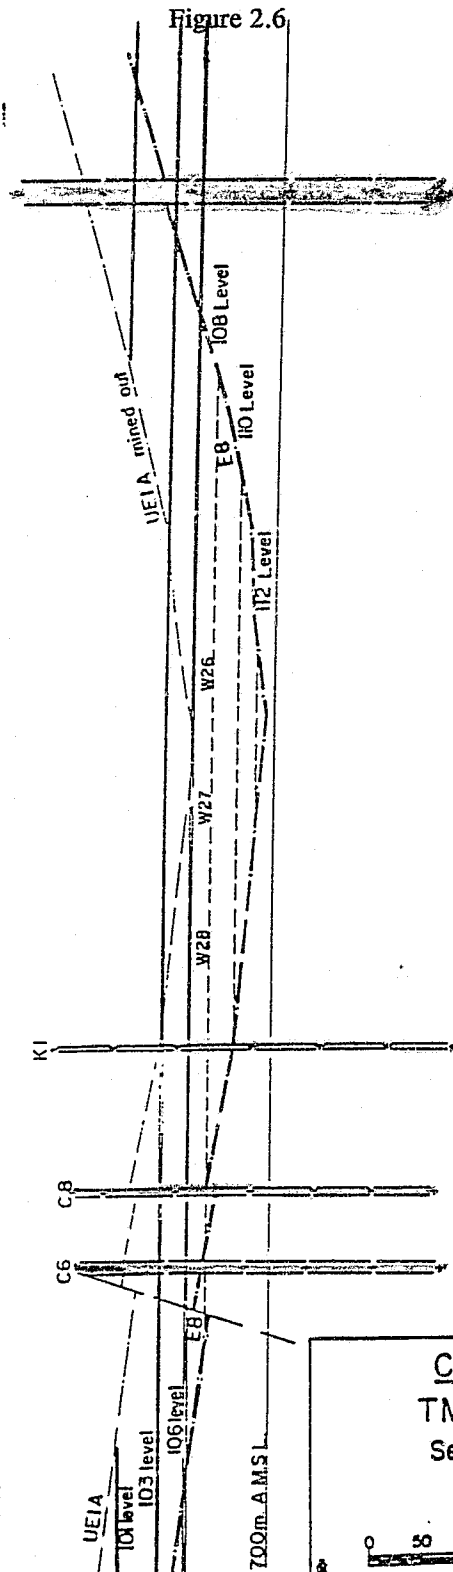
Figure 2.6

**Cooke I Shaft**  
**TM3 Bowl Area**  
**Section S/E - N/W**  
**W20 Line (A-A')**

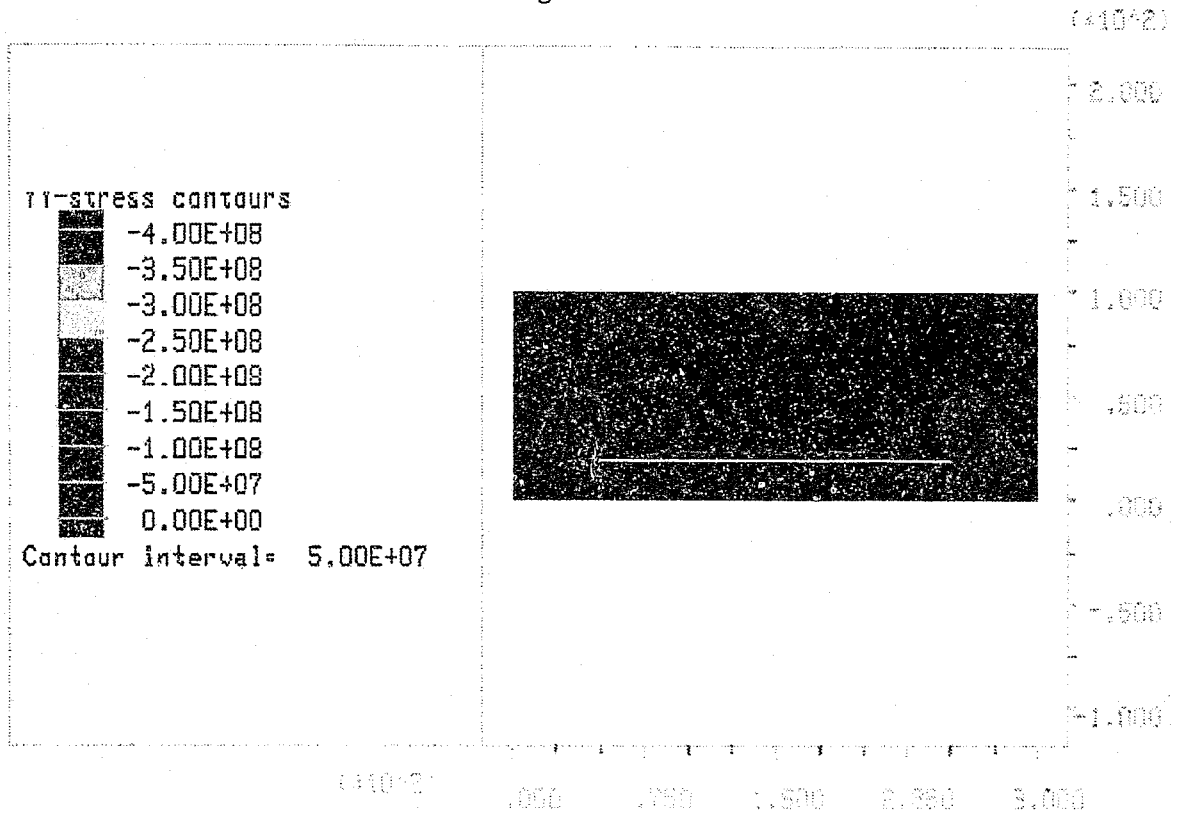
**Figure 4.1**

**The Pink Area is the tensile zone in which the vertical stress is tensile.**

**Depth = 1000m**

4.2.1 According to elastic theory extended volumes of rock in the hanging wall are subjected to tensile stresses which result in a large "Tensile Zone". Figure 4.1. In this tensile zone is a substantial volume of rock which is subjected to tensile stresses, permitting wide spaced tensile fractures to form. This creates the potential for large scale falls of ground.

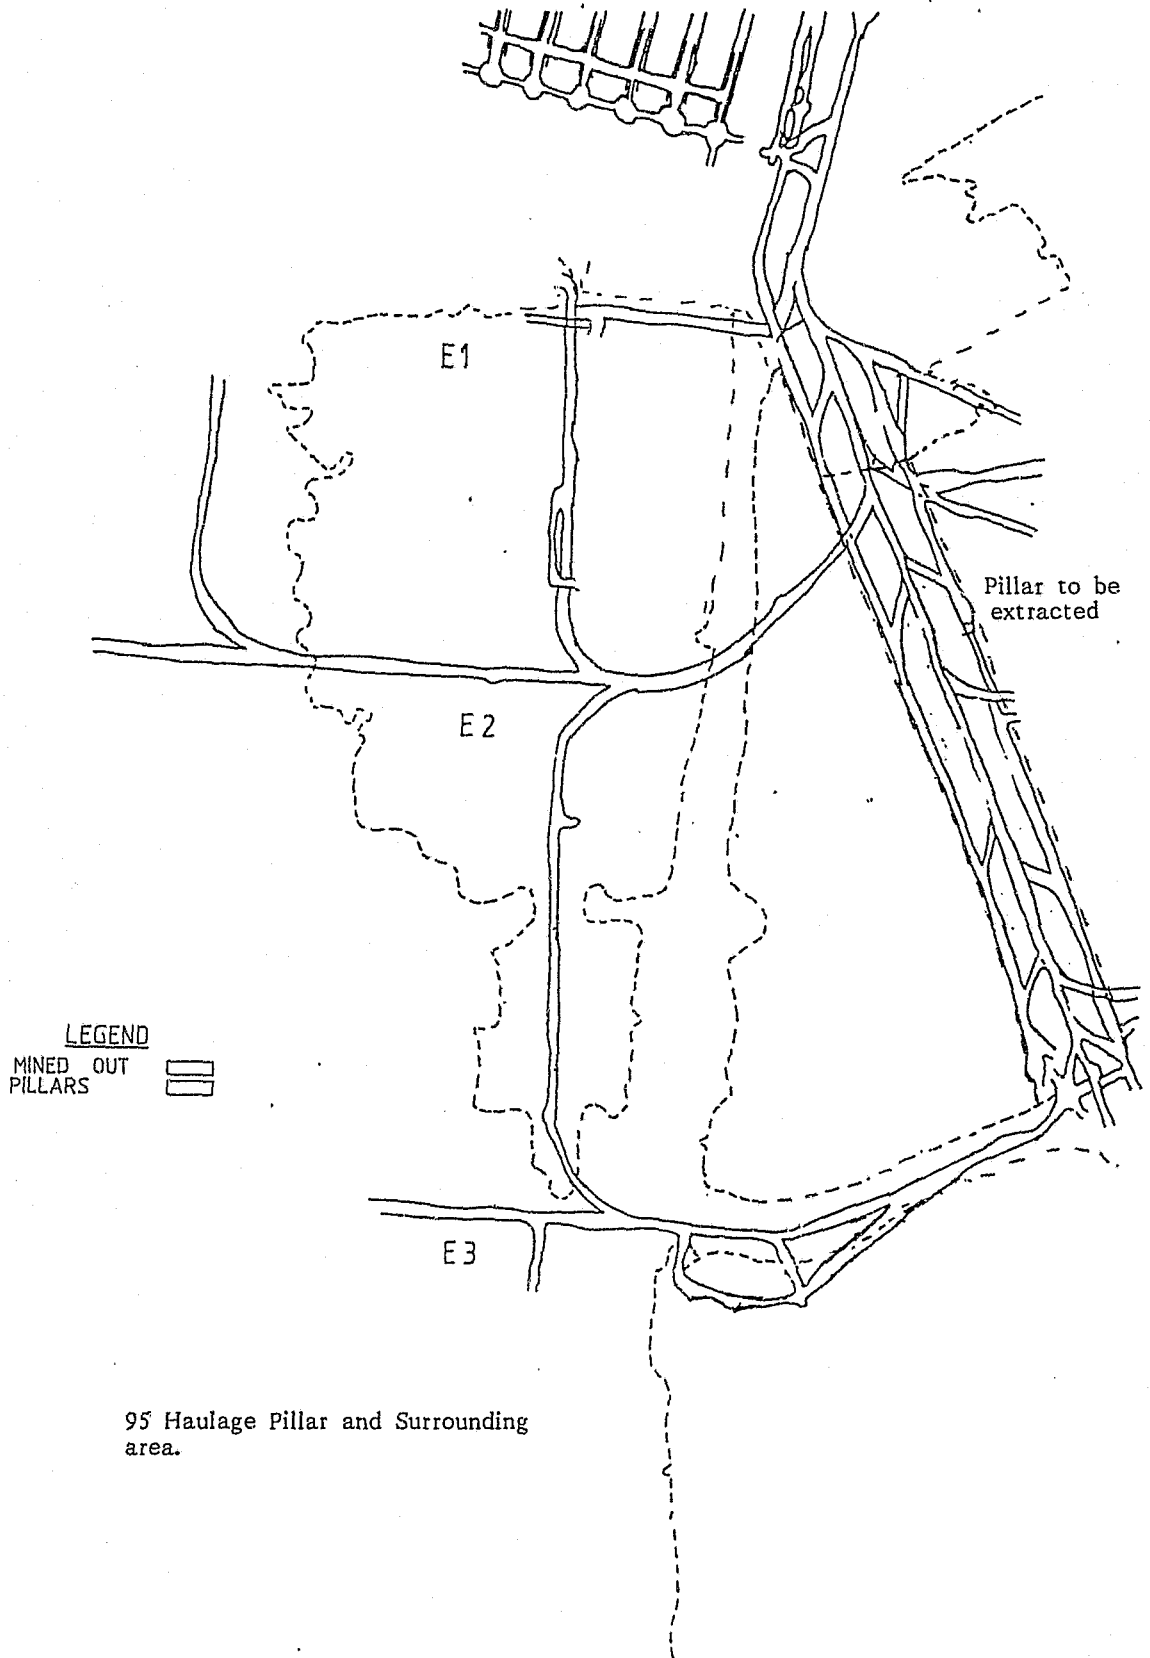
Figure 5.2

95 Haulage Pillar and Surrounding area.

The configuration of the 95 haulage pillar is depicted on Figure 5.2. This was a high grade (with grades in excess of 20g/ton) pillar which would not yield high tonnages but would contribute significantly to the gold output of the shaft.

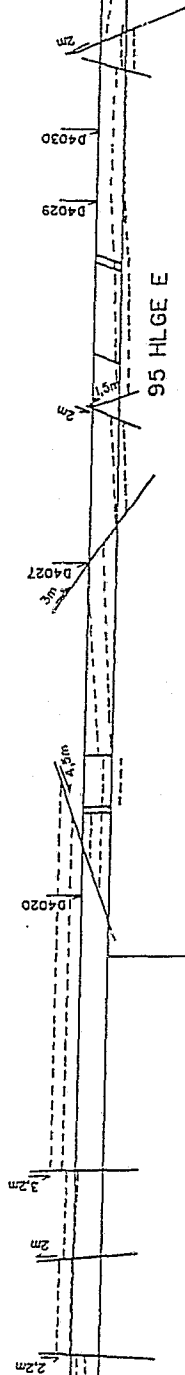
Figure 5.4

SECTION OF 95 PILLAR AREA  
E-W SECTION FOR HLGE PILLAR

The amount of faulting (Figure 5.4) would make conventional extraction very difficult.

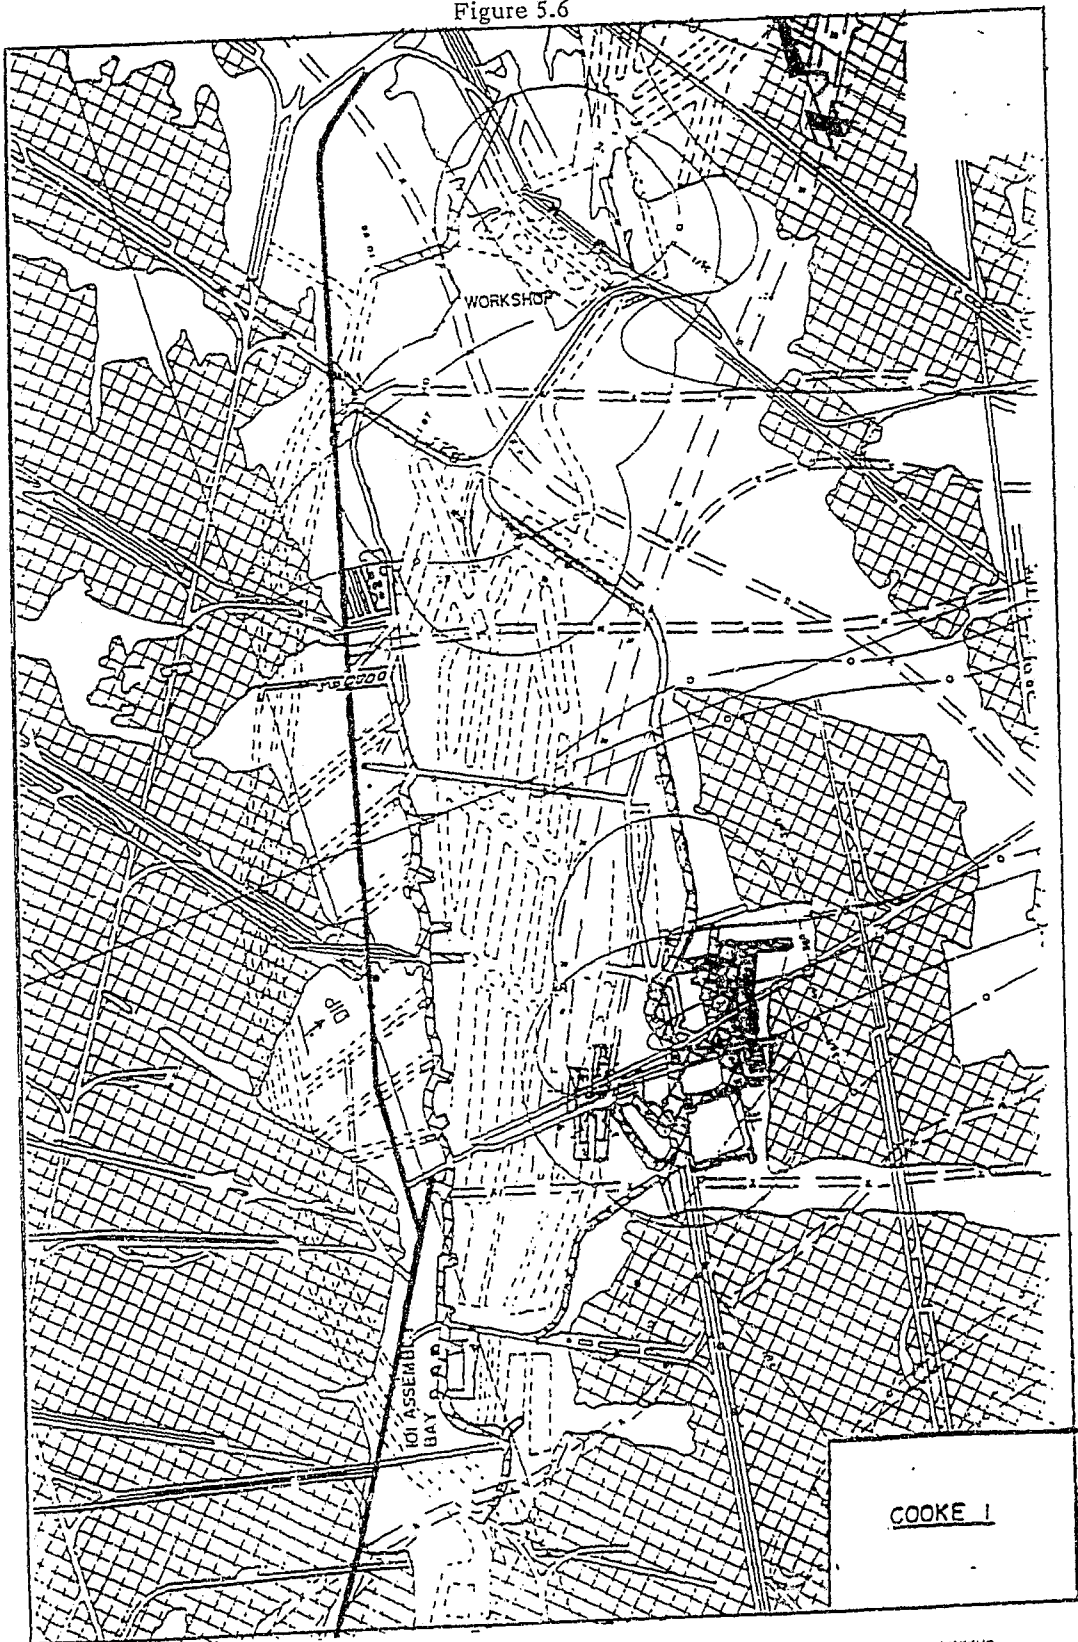
Figure 5.6

Steep mining layout shown in context with the whole pillar area.

#### 5.3.1.1 Steep Mining Layouts (Figure 5.6)

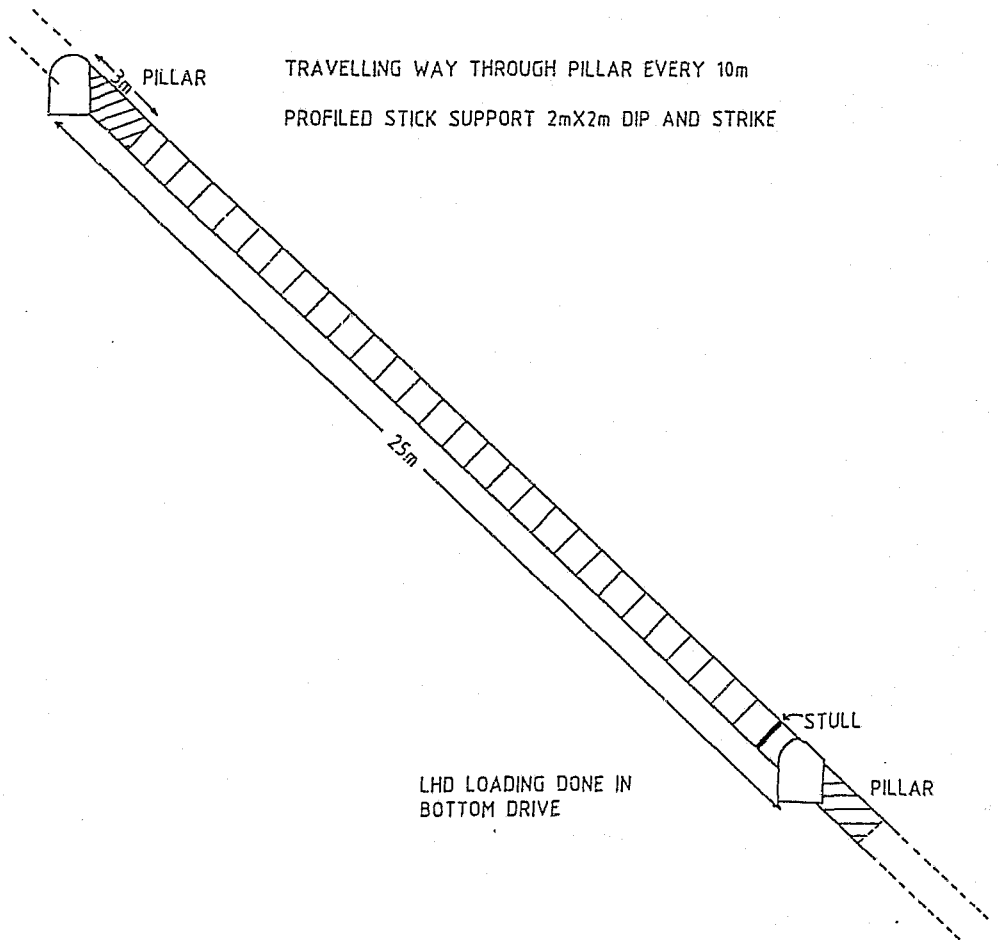
FIGURE 5.7

SECTION STEEP MINING LAYOUT

The stopes could either be serviced by footwall haulages with x-cuts to reef or reef drives (Figure 5.7) provided the necessary protective measures were taken for travelling below the stopes. New methods of rock handling could be applied<sup>13</sup>.

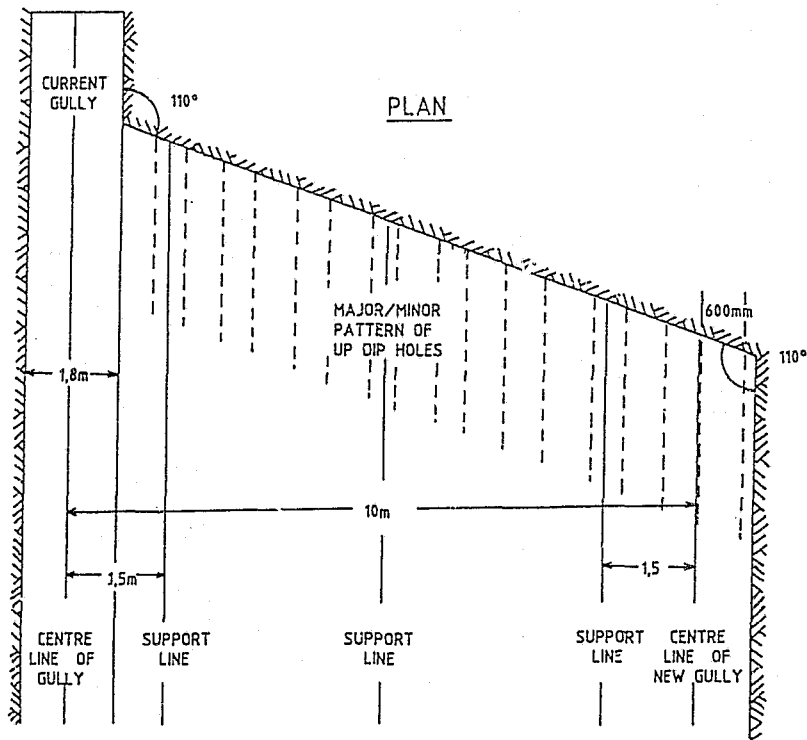
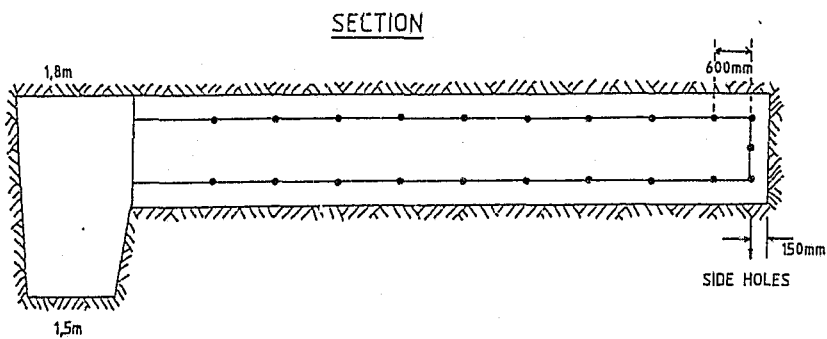
FIGURE 5.8

### UP DIP STOPE PANEL LAYOUT

PLAN AND SECTION OF DRILL  
HOLE PATTERN FOR STOPING  
WIDTHS 120cms OR LESS

updip extraction<sup>14</sup> method (Figure 5.8) and the breast method on the computer and should difficulties be foreseen only then would more work be done on the underhand and/or the overhand mining layouts.

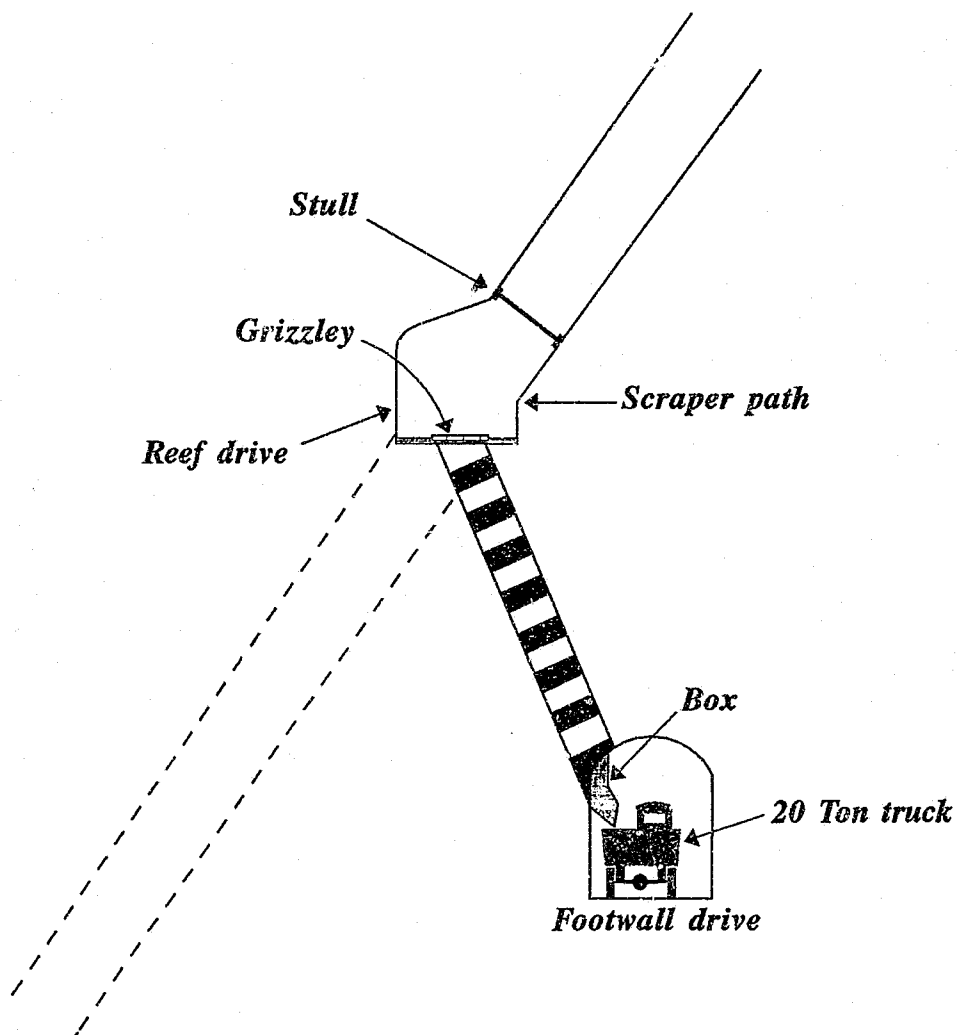
*Figure 5.9*

**SECTION OF STEEP AREA WHERE FOOTWALL DRIVE WAS  
UTILISED FOR ORE COLLECTION AND TRANSPORT.**

The method decided upon was to put up raises and stope east and west from these raises. Cleaning in the majority of cases was by gravity directly into LHD roadways. In certain cases where it was possible, a short boxhole was put up to the centre raise and the blasted ore scraped along a scraper path to a grizzly. The orepass was equipped with a box and pneumatically controlled door to facilitate loading directly into dump trucks (Figure 5.9).

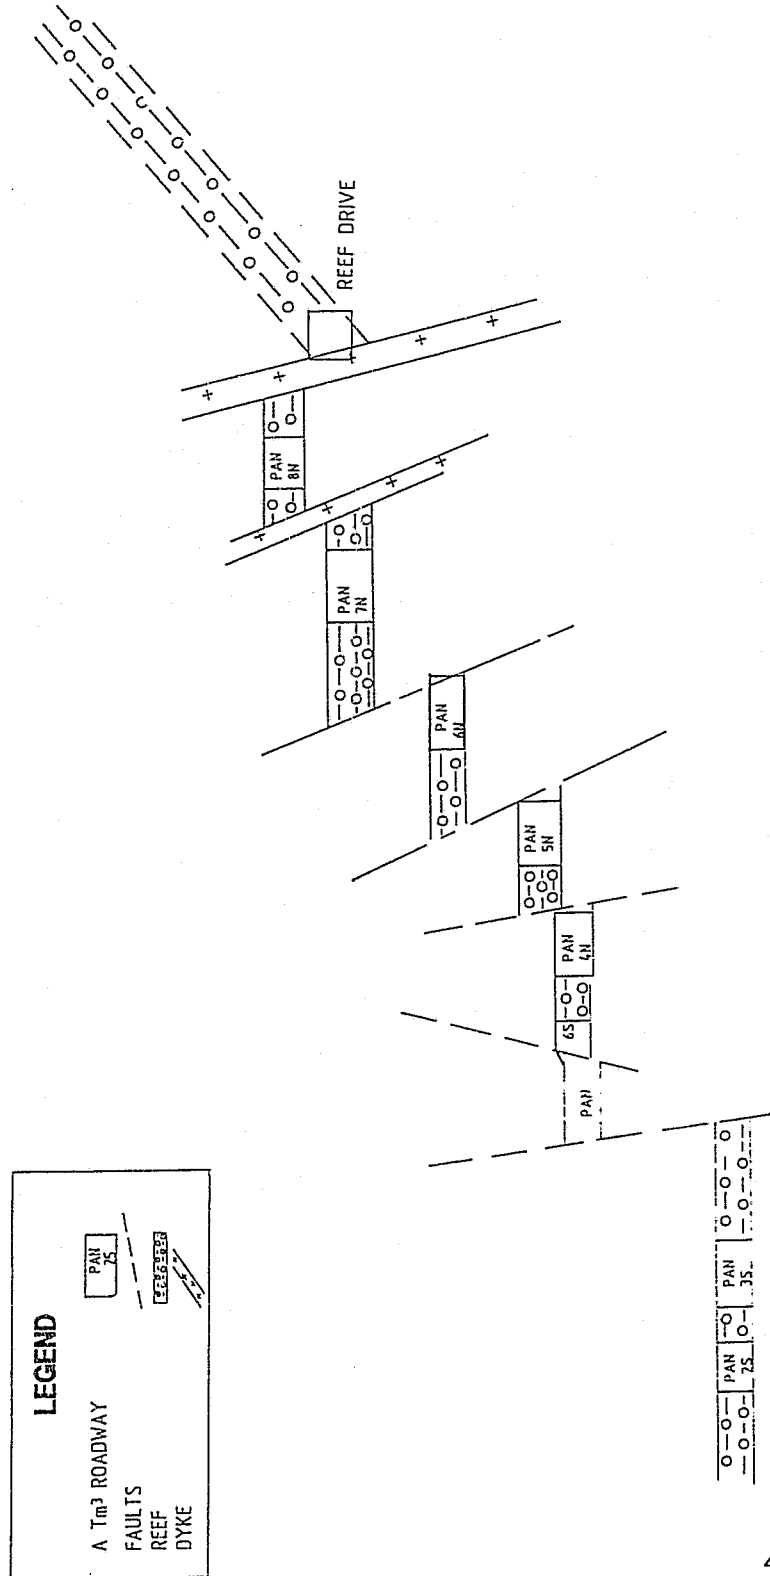
FIGURE 5.10

DIAGRAMATIC SECTION THROUGH STACK ZONE  
NOT TO SCALE

The final layout is depicted in Figure 5.10 and 5.11. To date only trackless mining method has the potential to make the mining of this zone feasible.

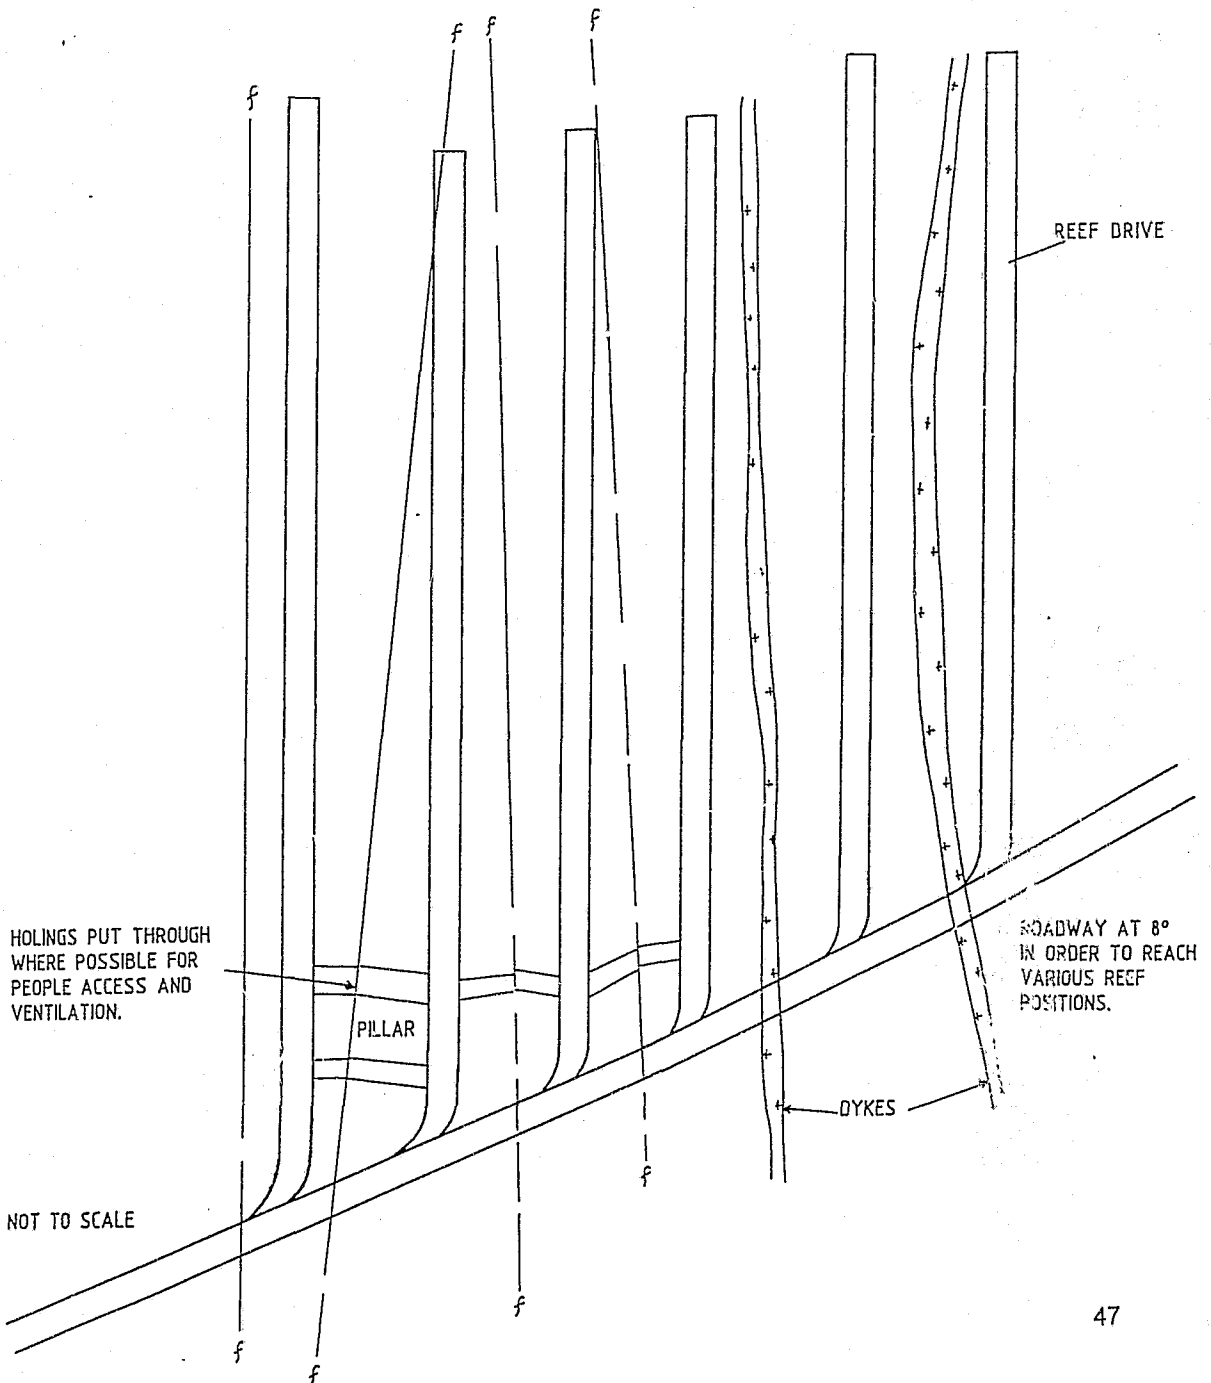
FIGURE 5.11

DIAGRAMATIC LAYOUT OF PANNELS THAT WOULD BE MINED IN THE STACK ZONE

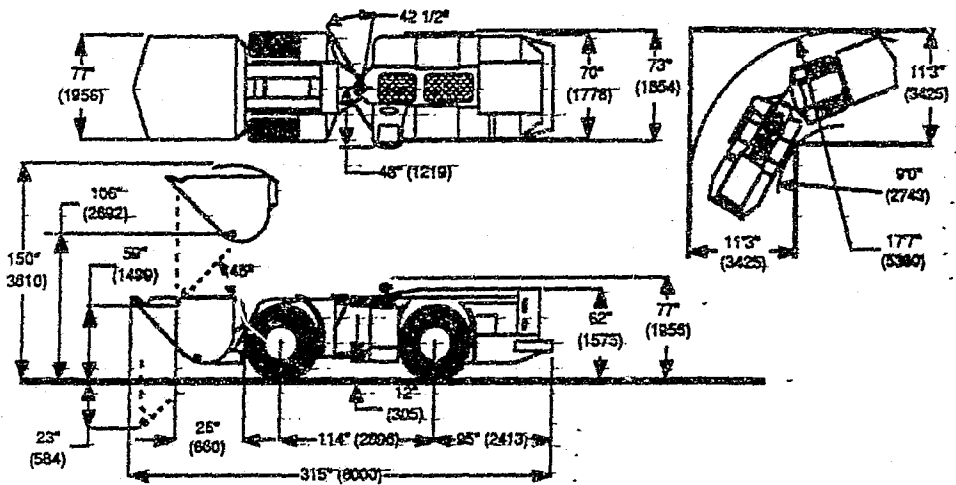
# MODEL ST-31

7.2.1 The LHD unit selected for this area was a 2,5m<sup>3</sup> (3,5 yard<sup>3</sup>) unit. The details of this unit are shown in Figure 7.1 and from this can be seen that the height of 2,05m to the top of the cab as well as the narrow width of 1,9m made it ideally suited to this operation. In addition, the tipping height of 2,4m meant it could easily discharge its load into the 4 ton rail bound hoppers. The use of a larger unit (3,5m<sup>3</sup>) would have resulted in the LHD being far under utilized and apart from the unfavourable dimensions would have resulted in higher unit costs per ton mined.

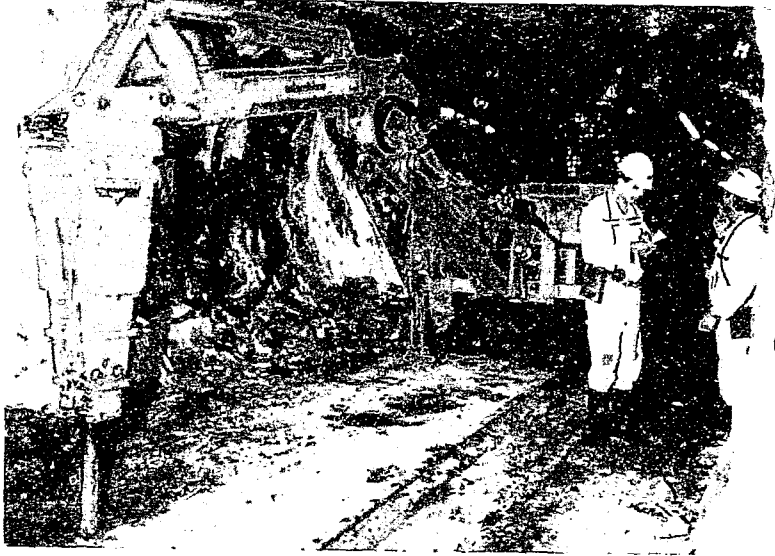
Plate 7.2

Scaler Unit

7.2.2 The only other piece of trackless equipment applied to this project was a scaler (Plate 7.2). This was probably the most critical piece of equipment both in opening up and subsequent mining operations. Working in fractured or potentially fractured rock requires a lot of time to make it safe but with the use of the scaler this work could be safely and very effectively done including the breaking up of large rocks prior to loading by the LHD.

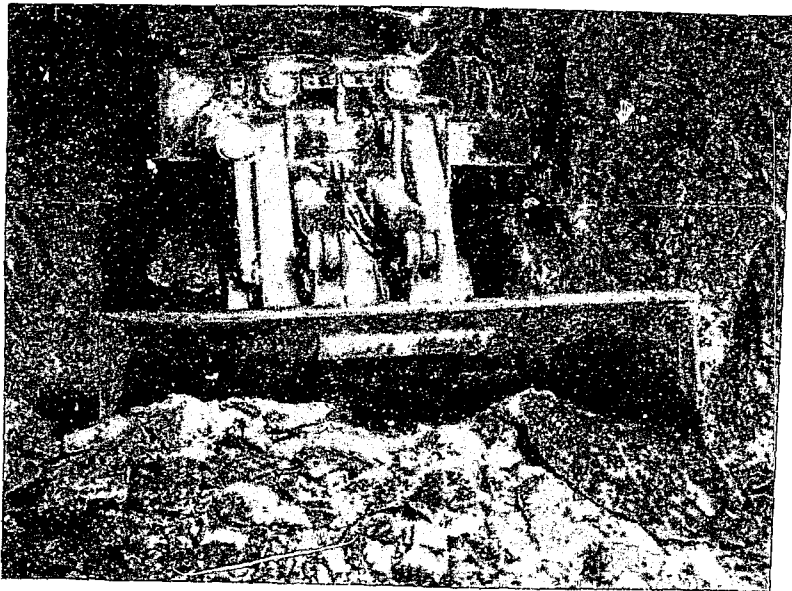
Plate 7.3

3,5m<sup>3</sup> L.H.D.

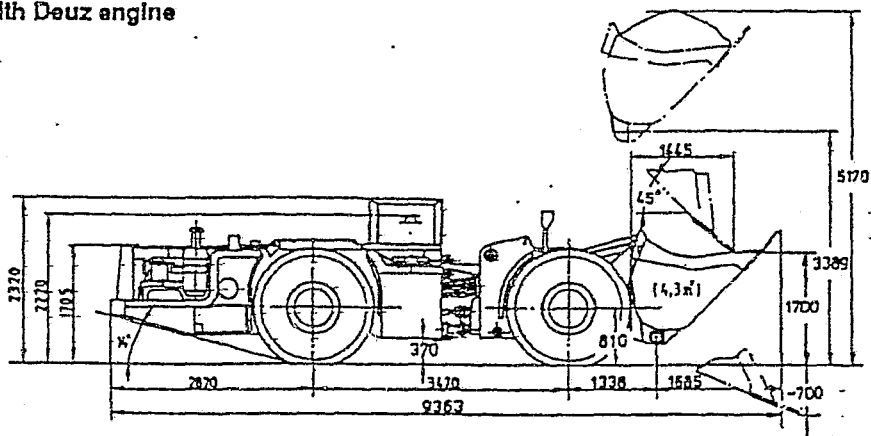
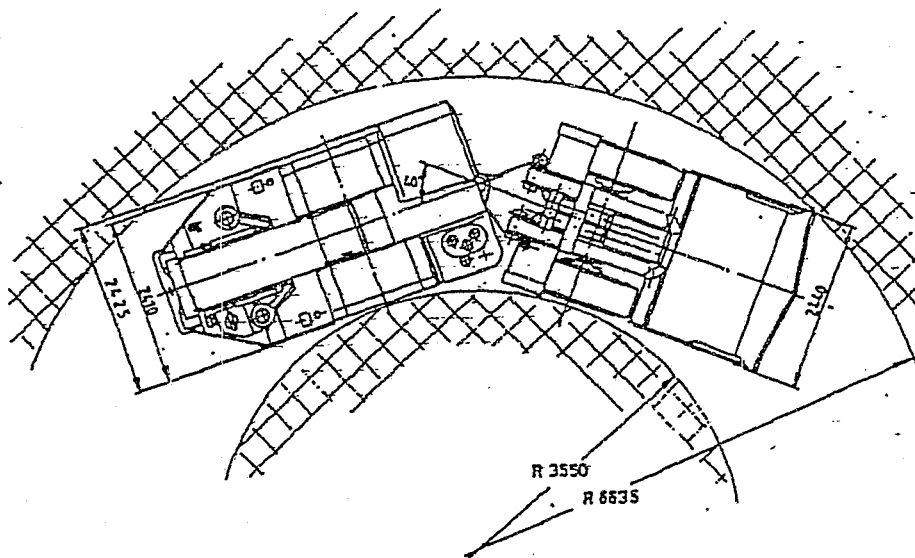
**With Deutz engine**

3,5 m³ LHD

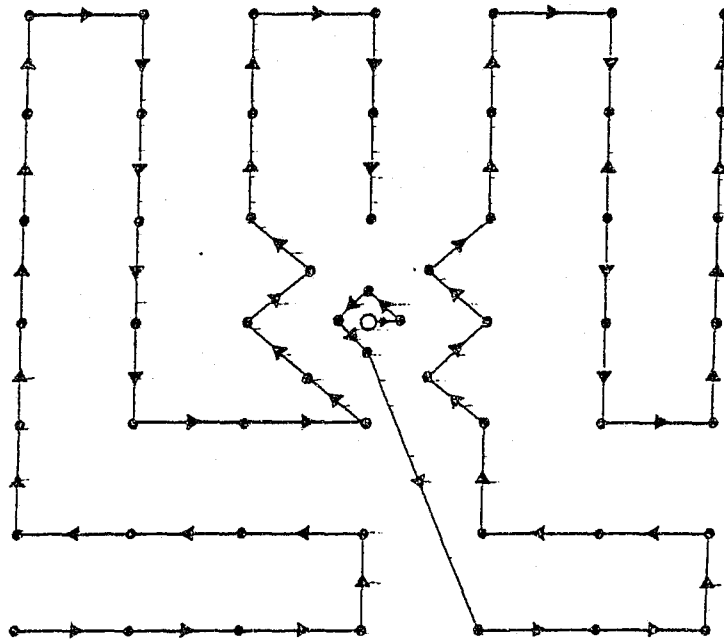
Figure 7.3

L.H. BOOM DRILL 29 HOLES

R.H. BOOM DRILL 28 HOLES

A typical drilling cycle for a twin boom drill rig is shown in figure 7.3.

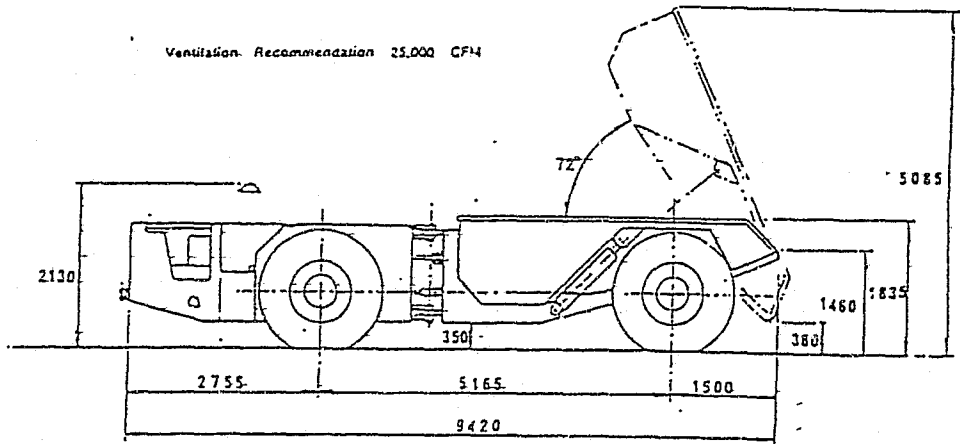
Figure 7.4

## Gradeability

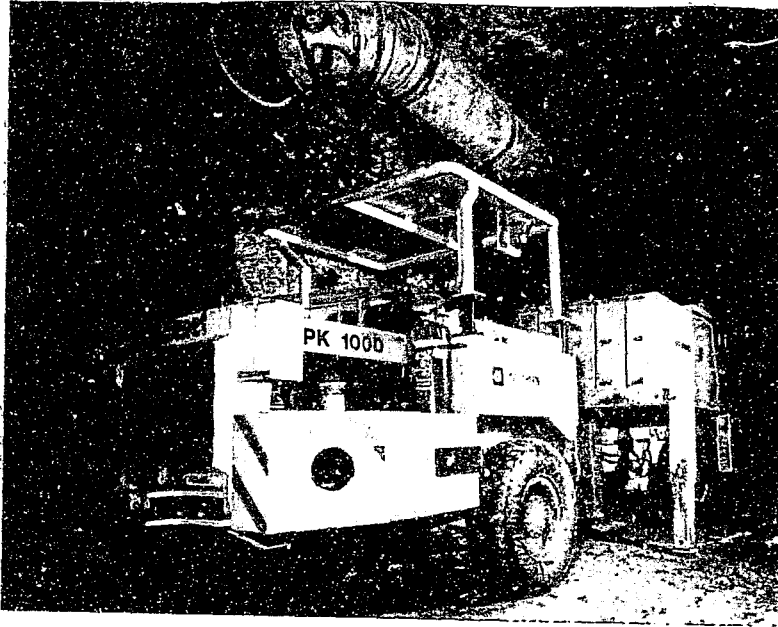
Plate 7.4

A typical utility vehicle is shown in Plate 7.4.

The height of the loading deck is too high for efficient work and although the units were supplied with cranes, these soon became unserviceable and the result was manual loading and unloading of equipment.

Utility Vehicle

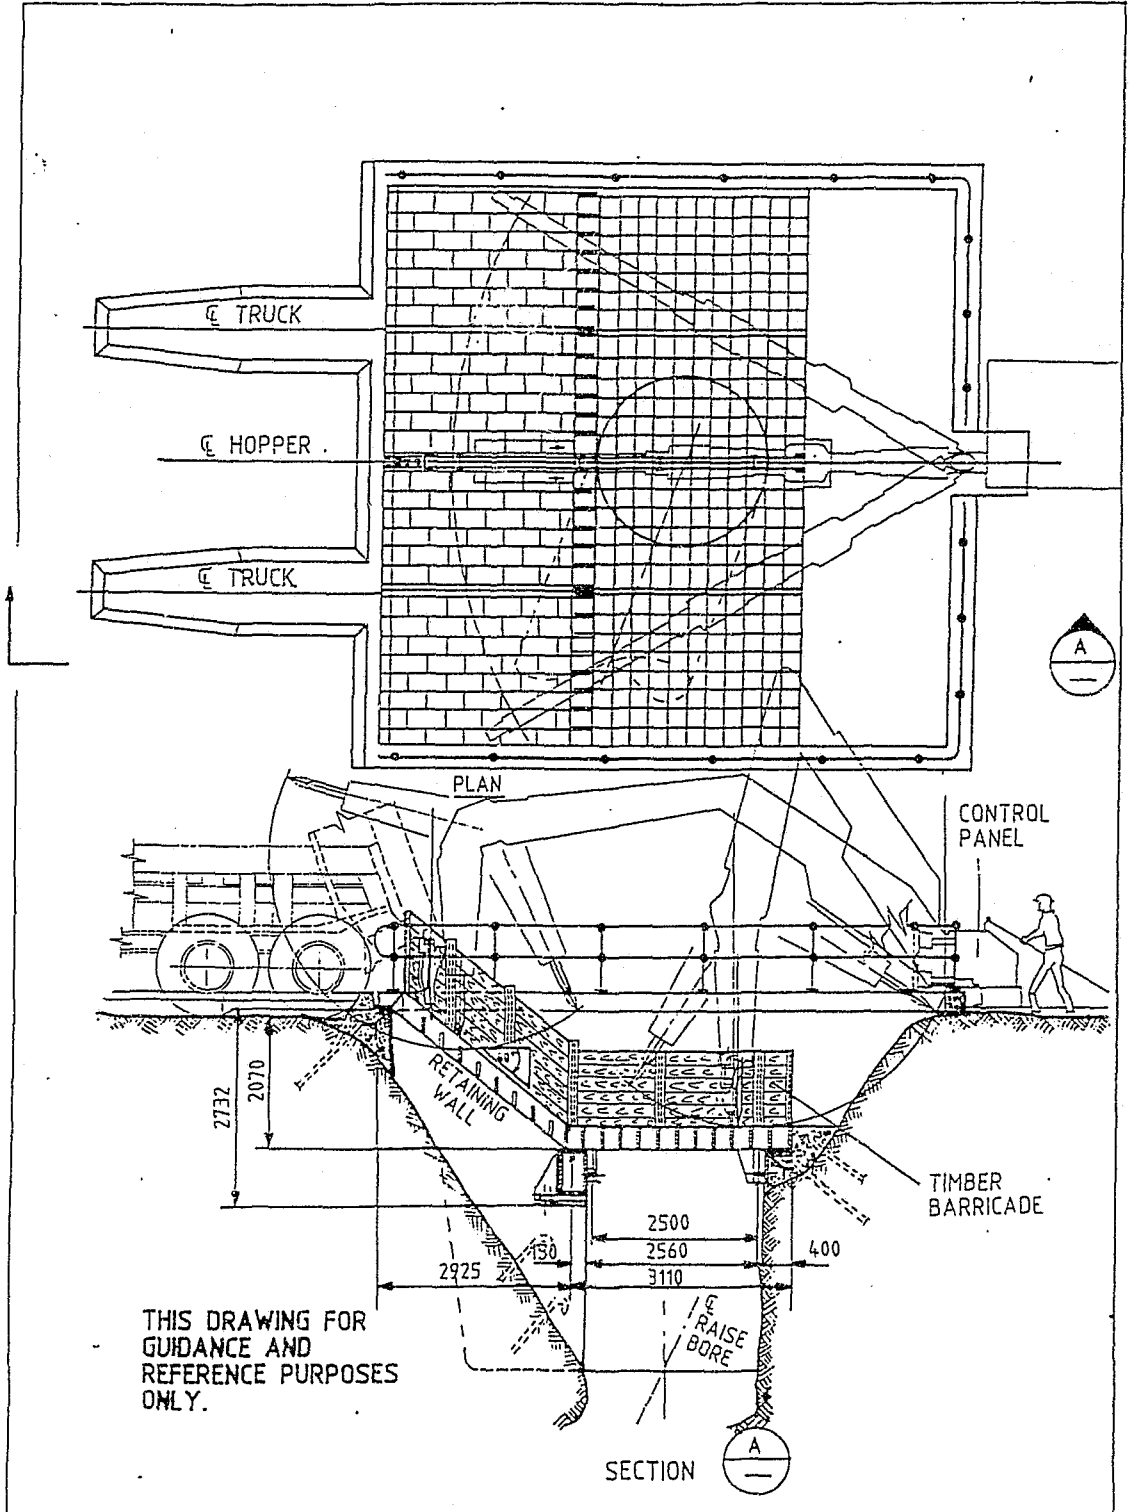
Figure 7.5  
TM<sup>3</sup> Grizzly Layout

This is a major construction done in most TM<sup>3</sup> operations and its distance needs be kept within the economic tramming distance for the vehicles utilized in the project. The tip is equipped with a stationary rockbreaker and a composite grizzly as depicted in Figure 7.5.

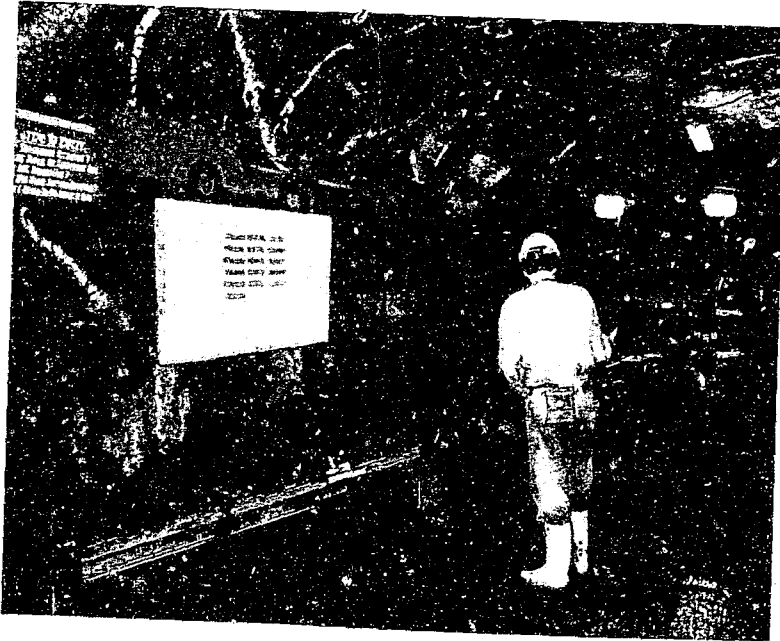
Plate 7.6

U/G/Workshop

Although no significant problems occurred, possibly because of the attention paid to this aspect, strict control must be exercised to protect the health of the maintenance crew. Plate 7.6.

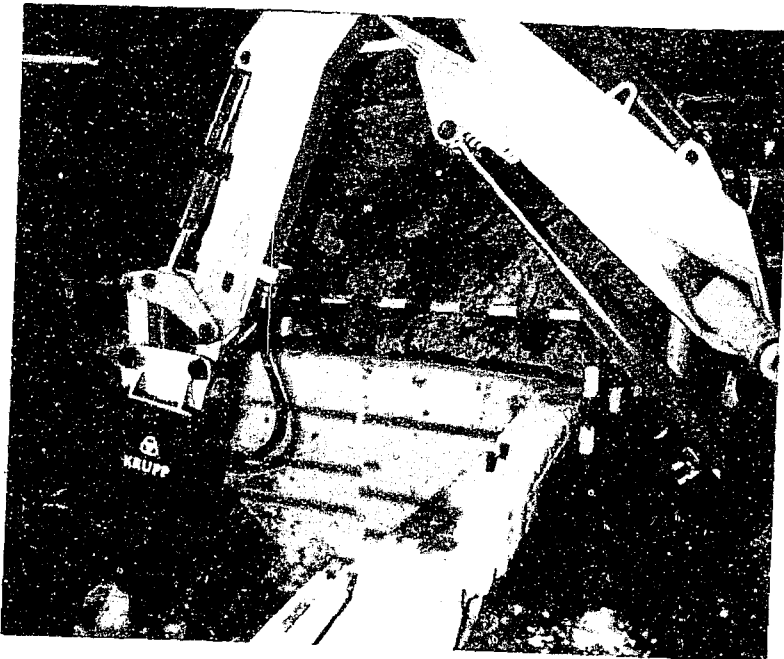
Plate 7.7

Stationary Rock Breaker
