**The Extraction of Pillars, largely by Trackless Mining Methods, at  
Randfontein Estates Gold Mining Company (Witwatersrand) Ltd**

**A Dissertation submitted to the Faculty of Engineering,  
University of the Witwatersrand for the degree  
Master of Science in Engineering**

**July 1998**

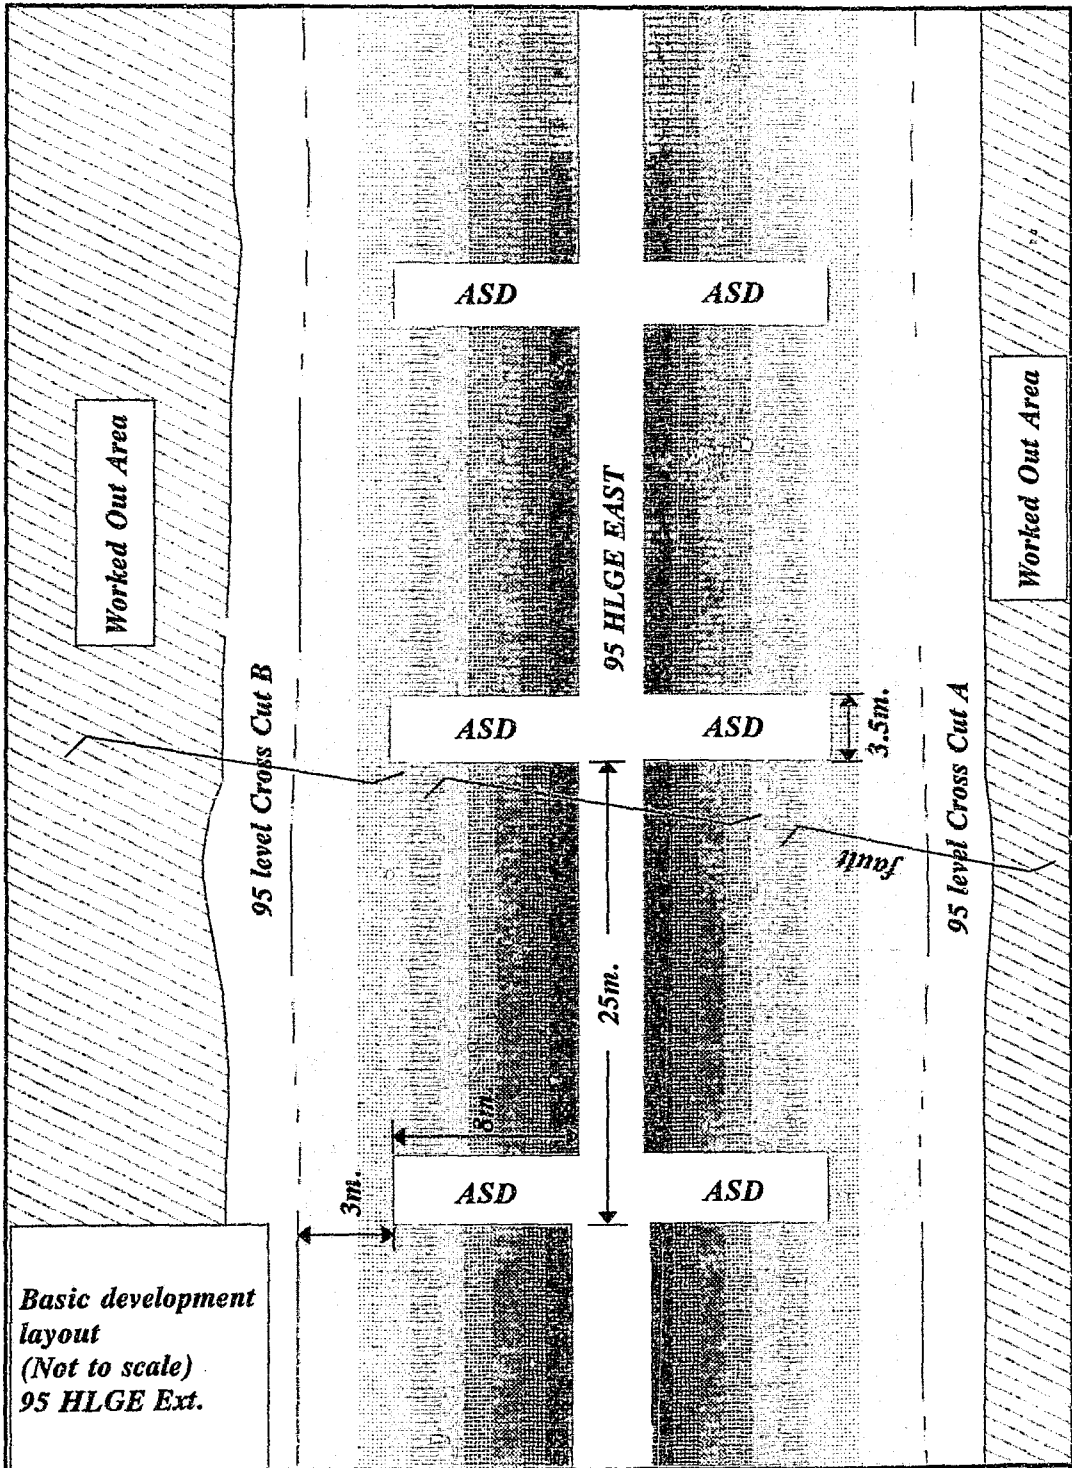
Figure 8.2

The pillar was then pre-developed by blasting 3,5m wide x 2,5 metre high (full reef width) drives at approximately 25 metre centre (figure 8.2). In order to minimize areas of potential problems a rigid pattern could not be adhered to and cognizance had to be taken of the positions of faults when laying out this development.

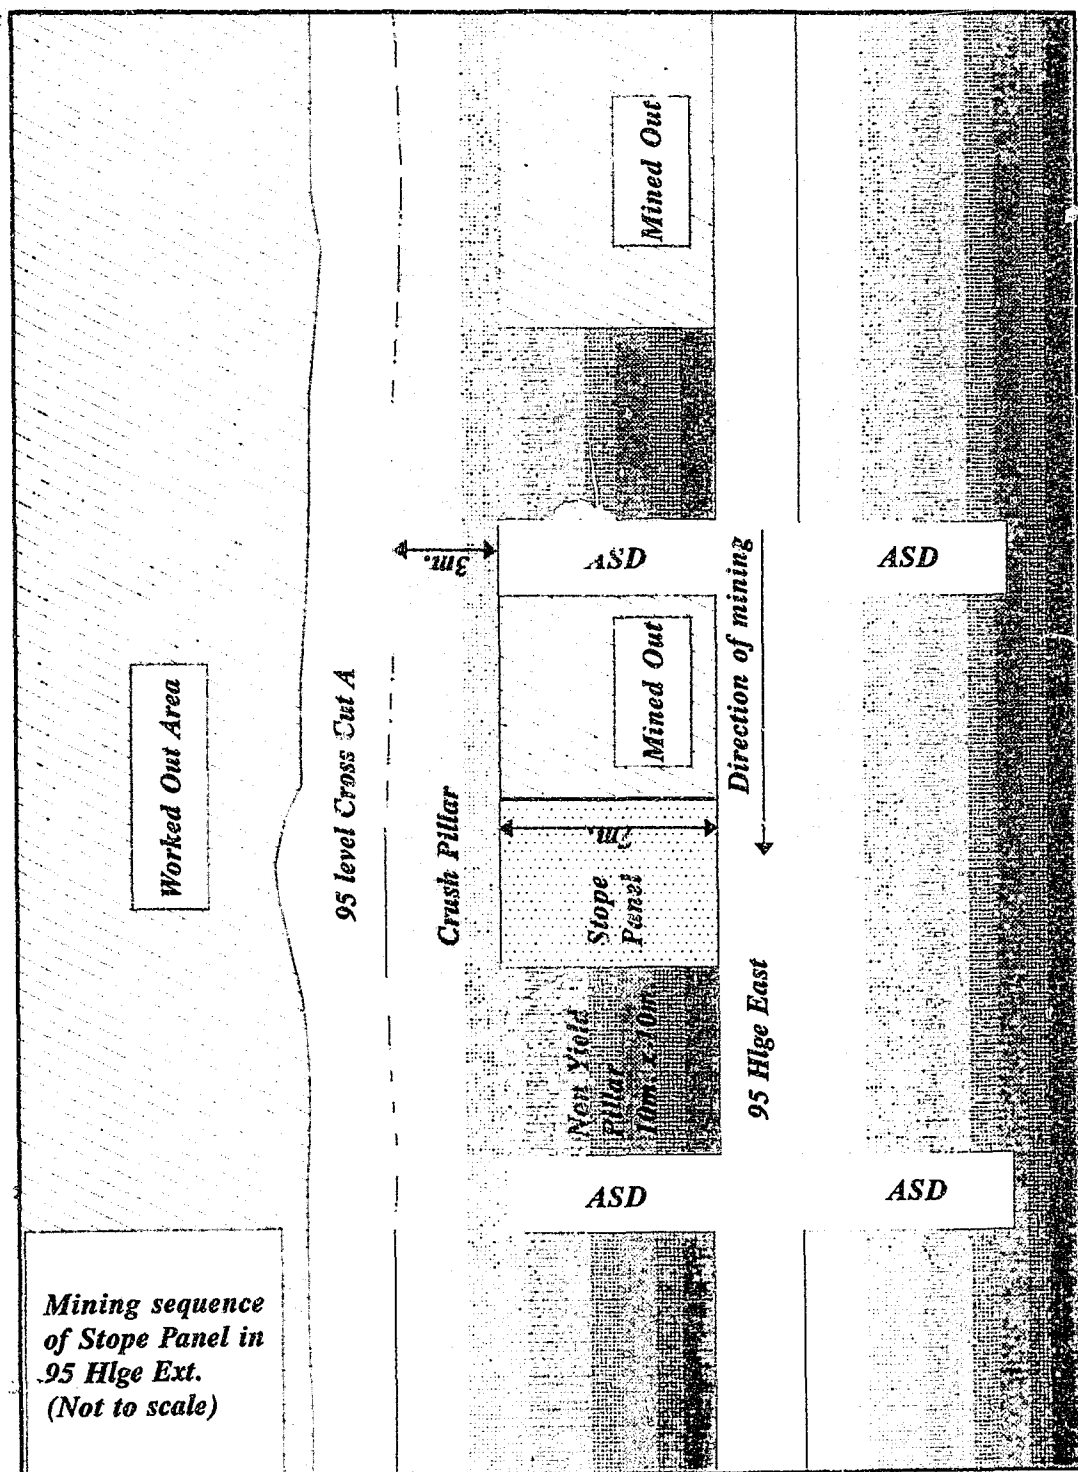
Figure 8.3

The planned development was modelled on the Rock Engineering computer prior to any work commencing, in order to ensure that no unacceptable stress patterns were evident. The layout resulted in seventeen panels being made available, each having a length of  $\pm 7$  meters. The panels were advanced from the breaking point created by the development, along the direction of elongation as shown in figure 8.3.

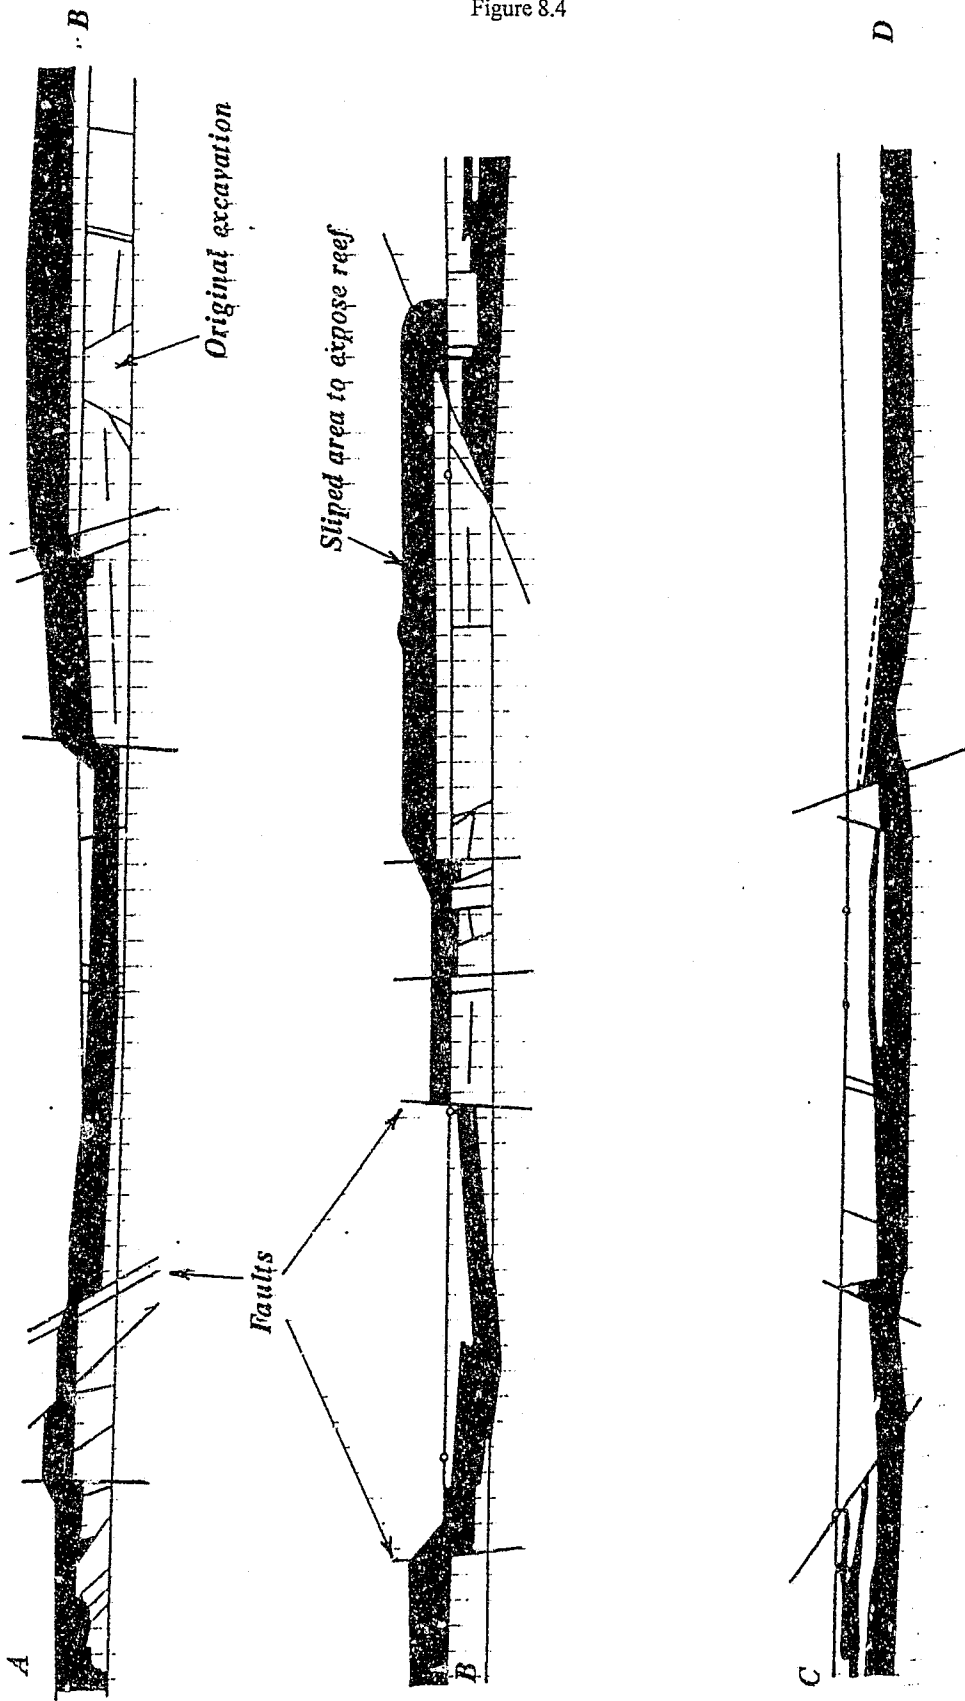
As can be appreciated, this resulted in an apparently very disjointed layout with roadways having to negotiate highs and lows. The reef exposure after the footwall lifting and hanging wall slipping is shown in figure 8.4.

Section of 95 Pillar indicating slipping to expose the reef.  
Indicating the amount of hangingwall and footwall slipping necessary to expose the reef  
(shown in black).

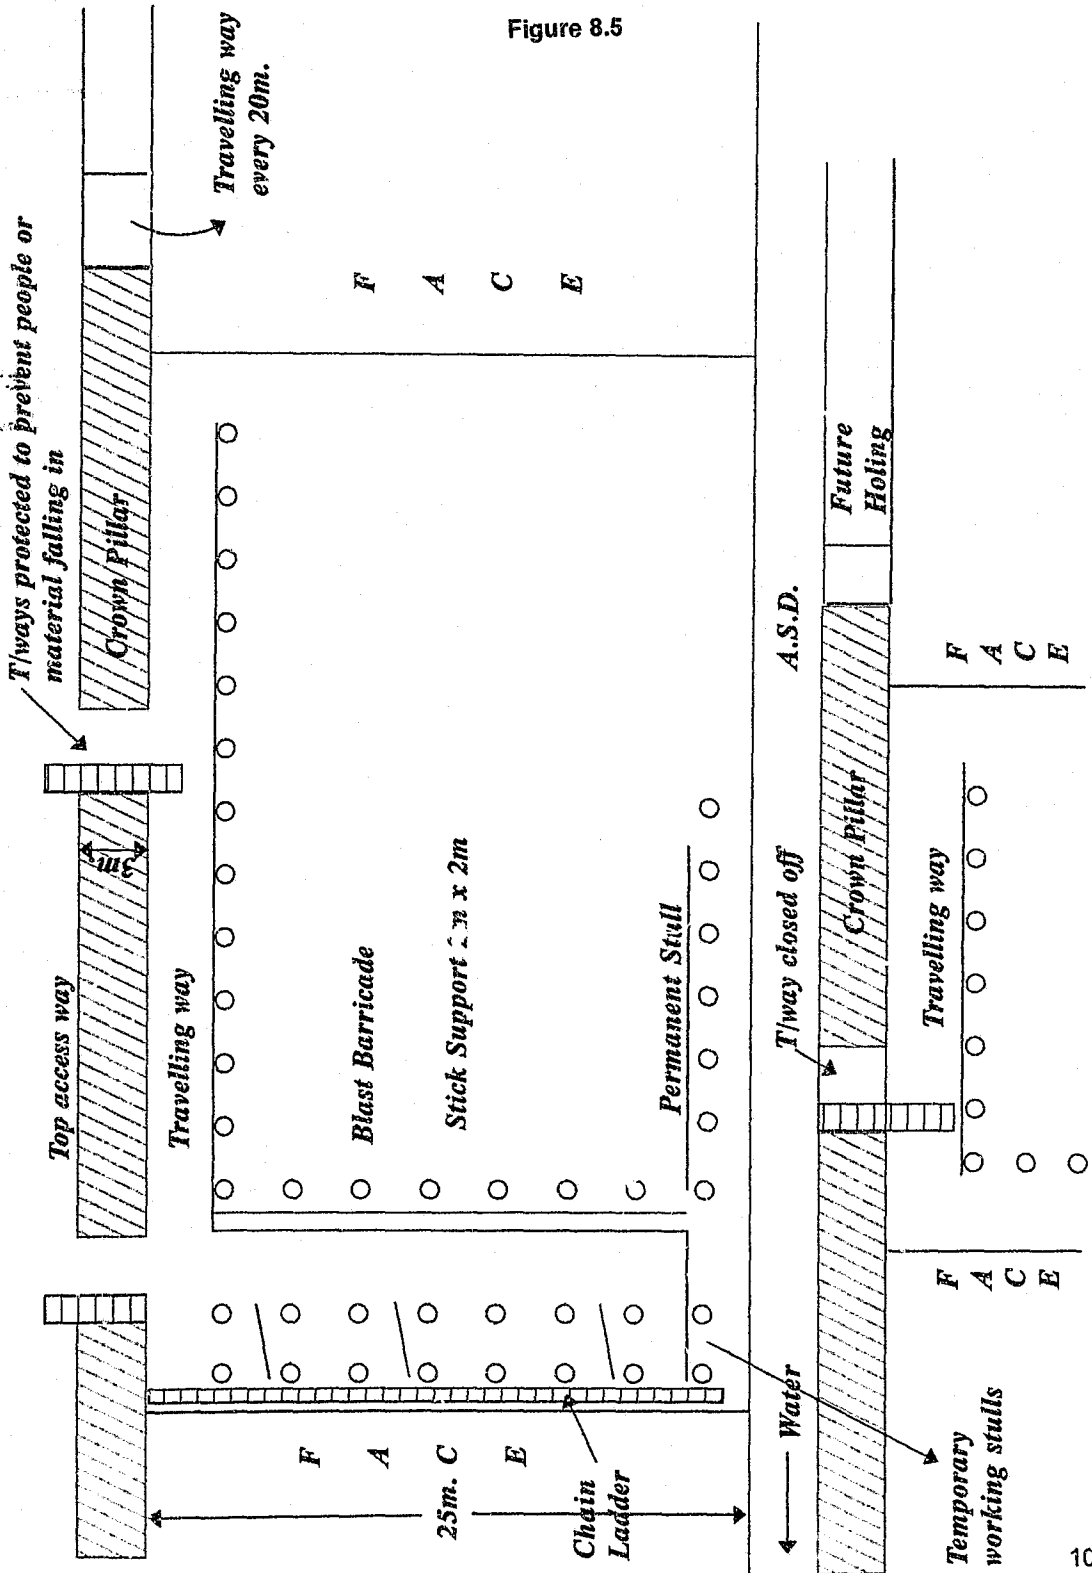
Figure 8.5

The area was to be mined with breast faces from each of the raise connections with a continuous crown pillar. Figure 8.5. indicates the method of mining. Drilling and blasting took place on the dayshift. On the night shift an LHD would load the rock from the blast which had gravitated to the roadway below the face. Loading was done on the night shift to ensure that the minimum number of people would be in the area below the face when barring and drilling were taking place.

Vertical Projection  
Diagrammatic layout of steep stopping area

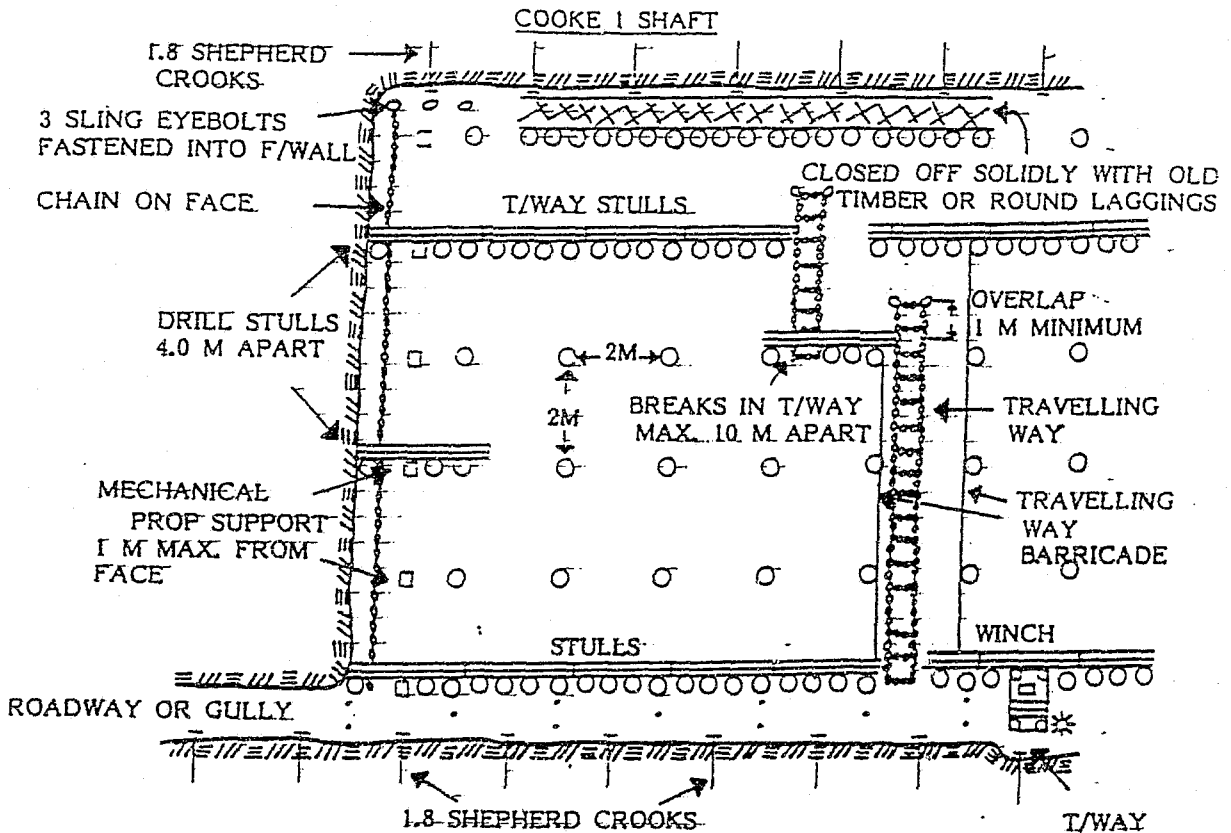
M.S. 8.8

1,2 metre long holes were drilled at 70° to the face with a spacing of 60 cms. Holes are marked in a staggered pattern with 2 rows of holes for stoping widths of less than 120cms and 3 rows where the stoping width increased to beyond 120cms. Drilling was done using hard held jackhammers and airlegs. Special chain ladders had to be used and anchored to enable the machine crews to have a safe place to stand and to facilitate drilling. Figure 8.6.

8.8 NARROW STEEP STOPING (DIP OVER 30°)

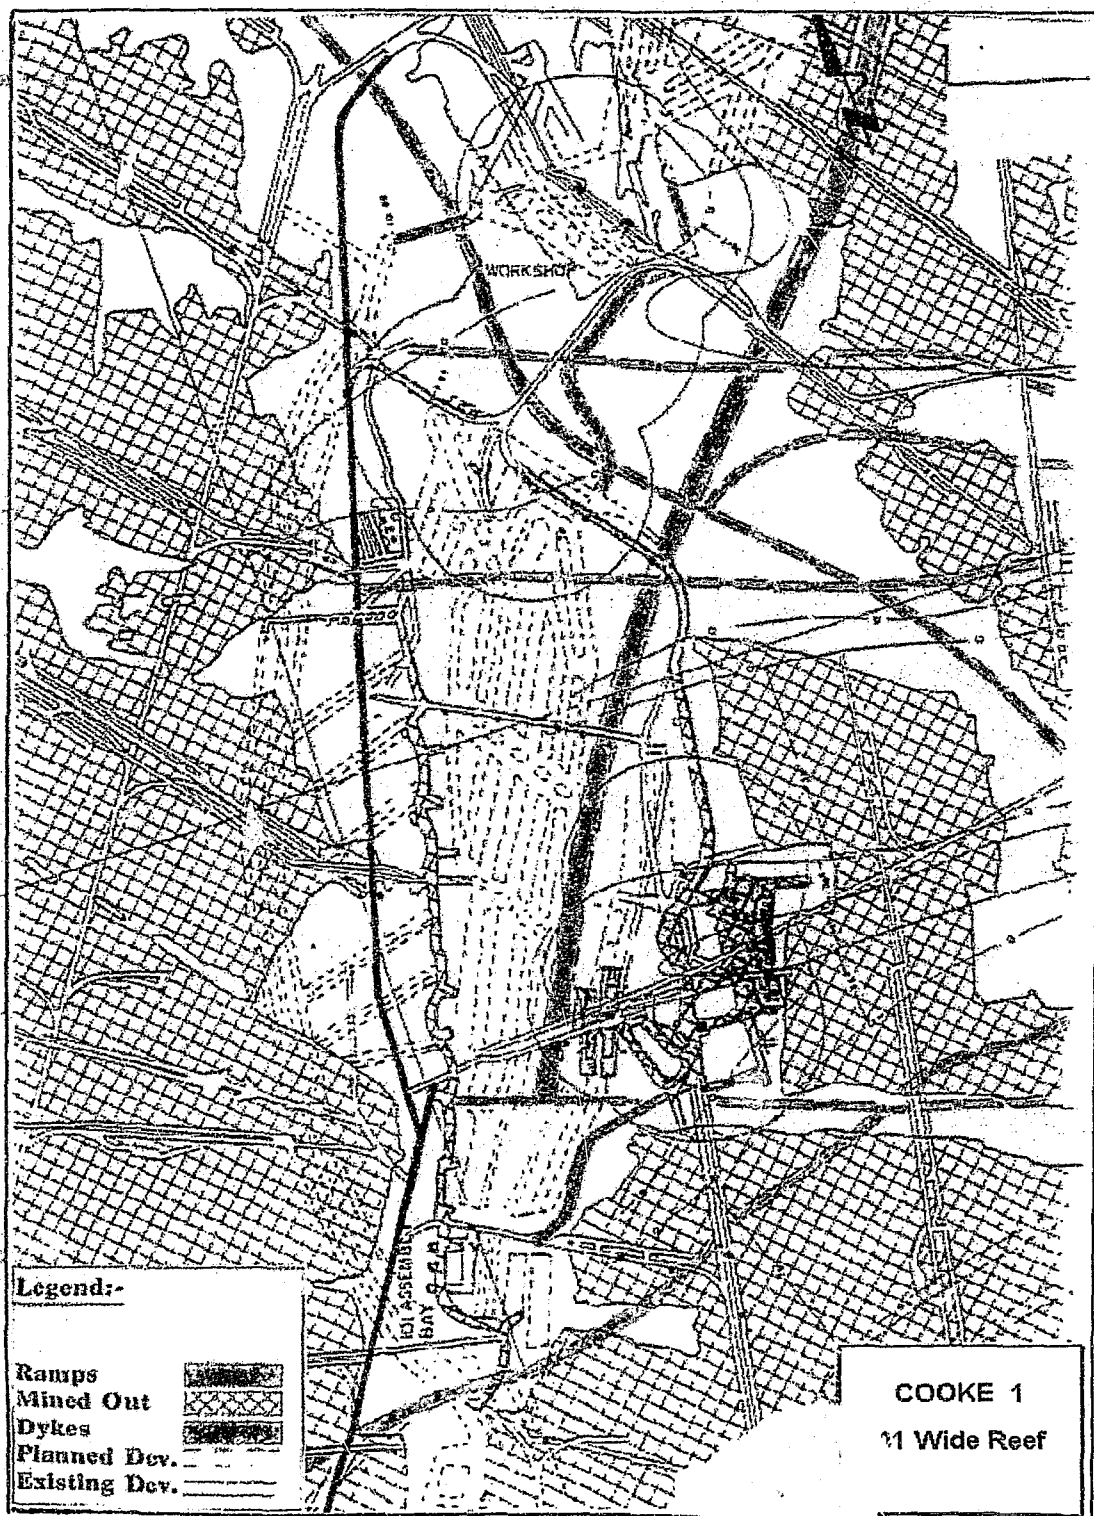
Figure 8.7

The mining was as per layout shown in figure 8.7 with access to the various elevations obtained from an 8° access ramp developed on reef.

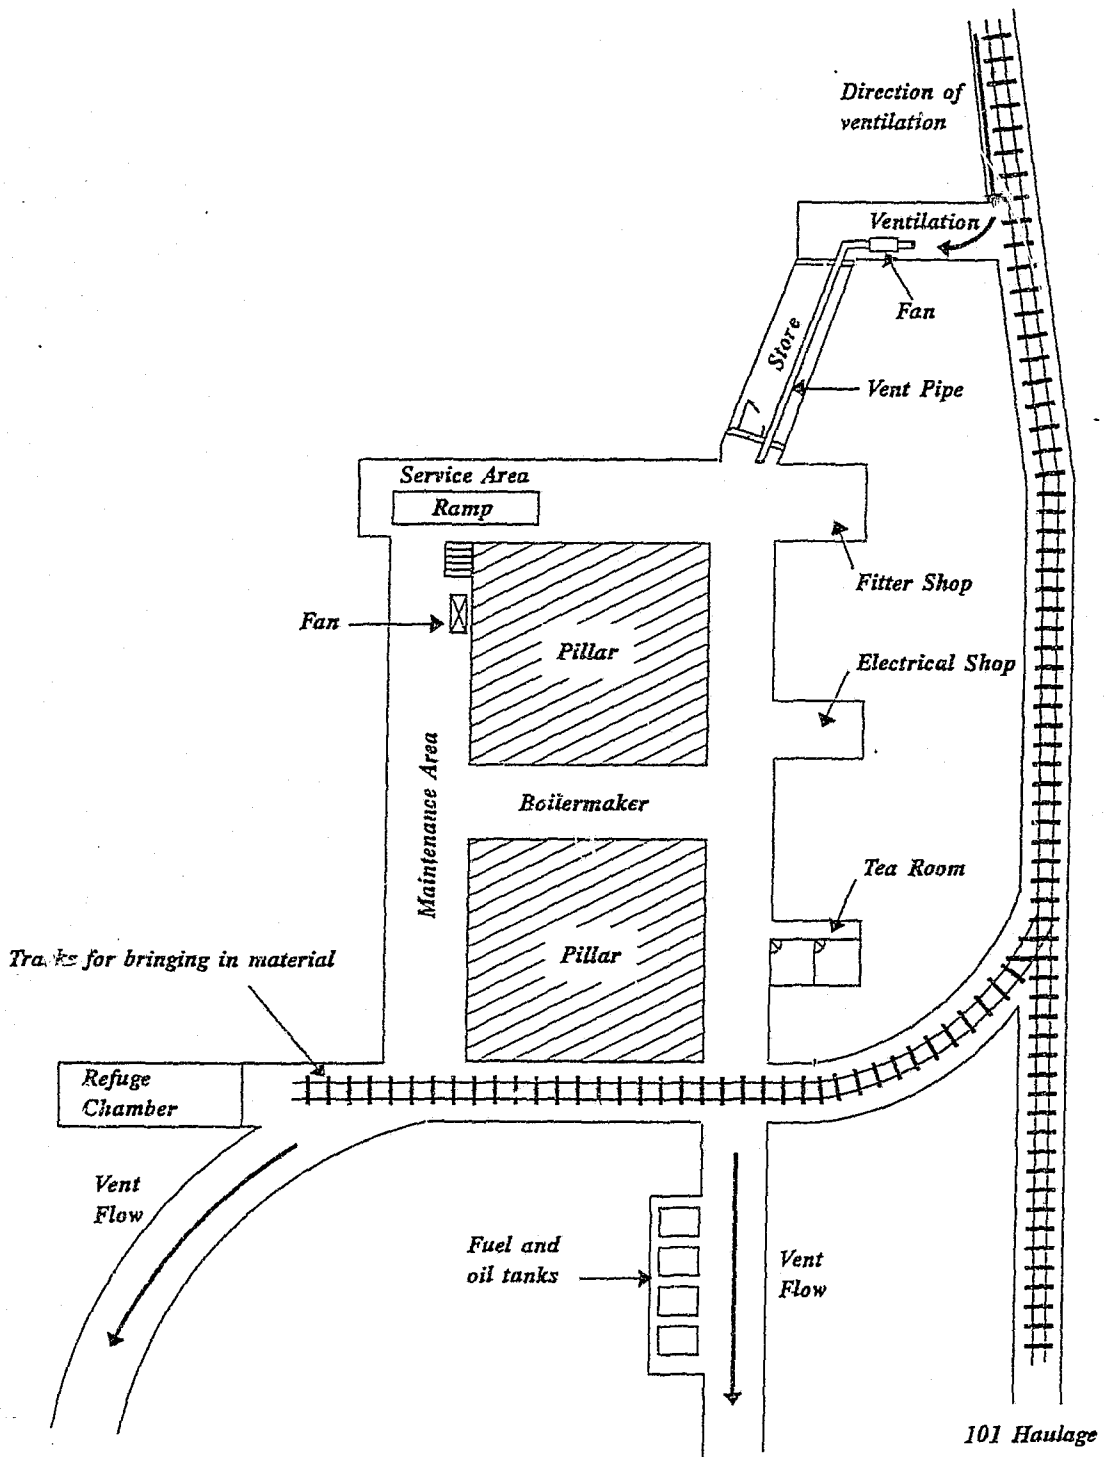
Figure 8.8

Critical to a trackless mining operation is the provision of workshop facilities. In this case a workshop was provided on 101 level Figure 8.8. This is described in greater detail under trackless equipment chapter. Access roadways to the mining areas were developed. In some cases roadways through the previously mined areas had to be established in order to gain access to an existing ore pass. A TM<sup>3</sup> grizzly and impact breaker were sited at each major tip.

SCHEMATIC LAYOUT OF 101 WORKSHOP AREA

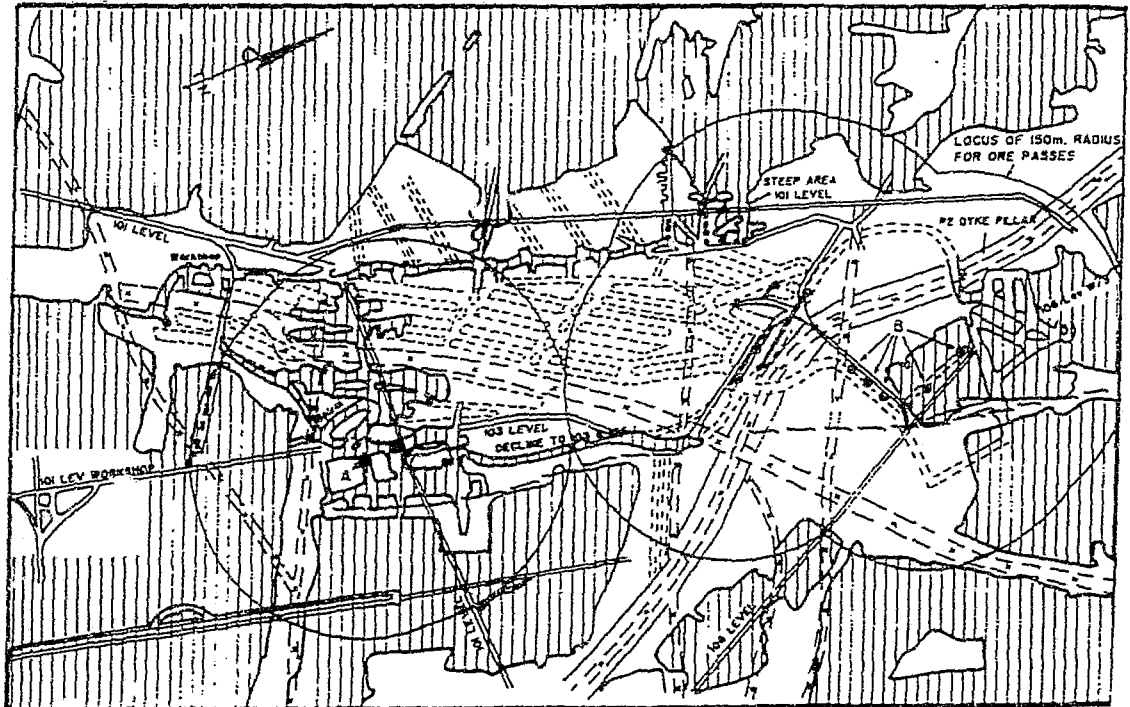
Figure 8.9

An example of the mining layouts is shown in figure 8.9. Roadways 7 metres wide were laid out with a 7 metre pillar. Holings were effected at 30 metres centres to facilitate tramming as well as the ventilation system.

Structural plan, showing how the reef body was to be mined at Cooke 1

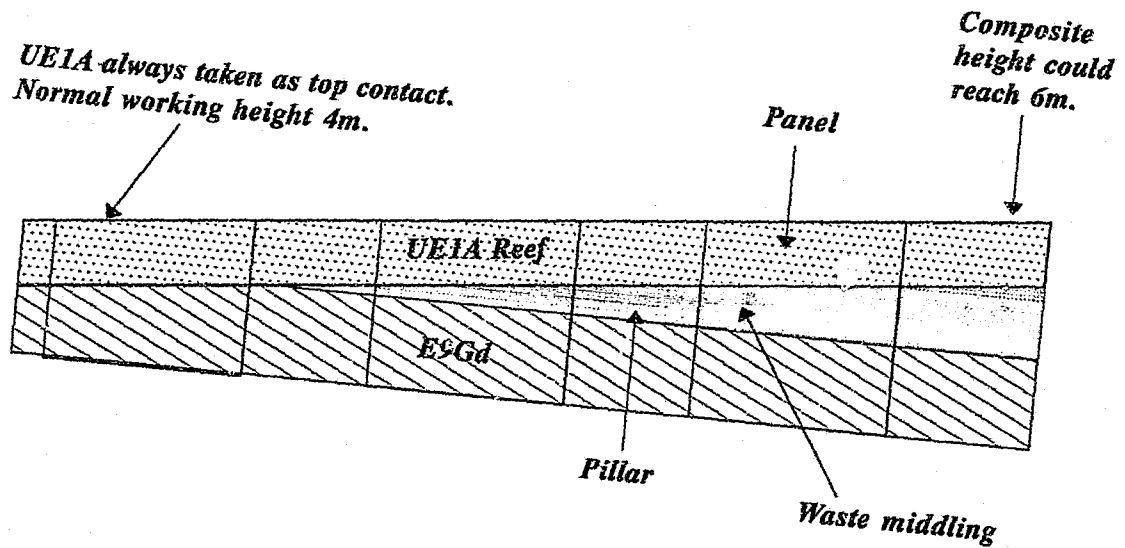
A schematic section as depicted in Figure 8.10 indicates the reef relationships and roadway layouts.

### Mining Layout

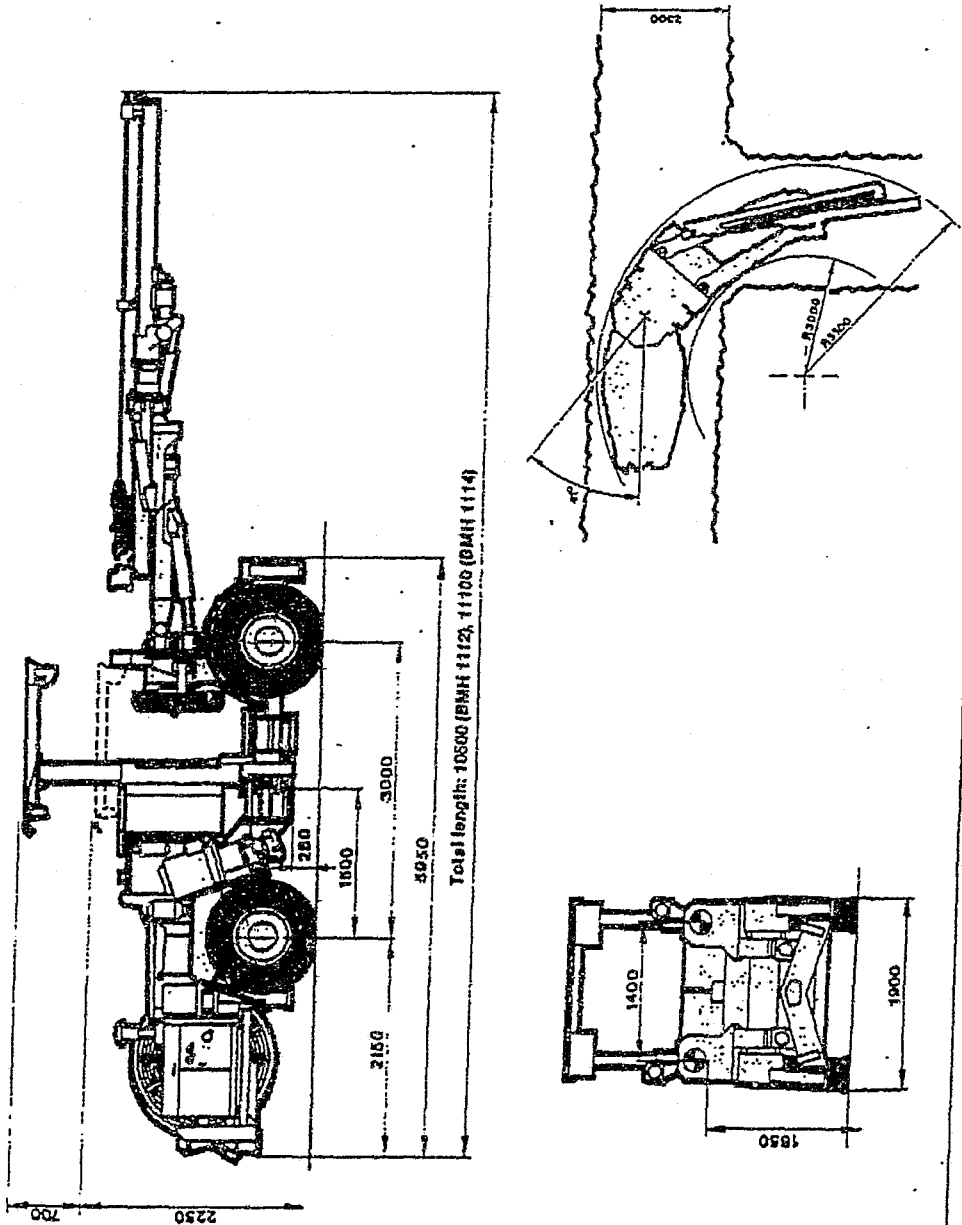
Figure 8.11

An Electro Hydraulic drill rig (Fig 8.11) was used to drill the faces. The drill rig was capable of 1 to 2 headings per shift, depending on travelling time of the rigs between faces, and operated on a two shift basis. The planning was 3 rounds in two shifts which, except for when a few major breakdowns occurred was regularly achieved on a monthly basis. The hole length of 3,2 metres with 45mm diameter holes were used on a pattern as shown in figure 8.12.

# High capacity hydraulic drill rig for medium sized tunnels and mine production

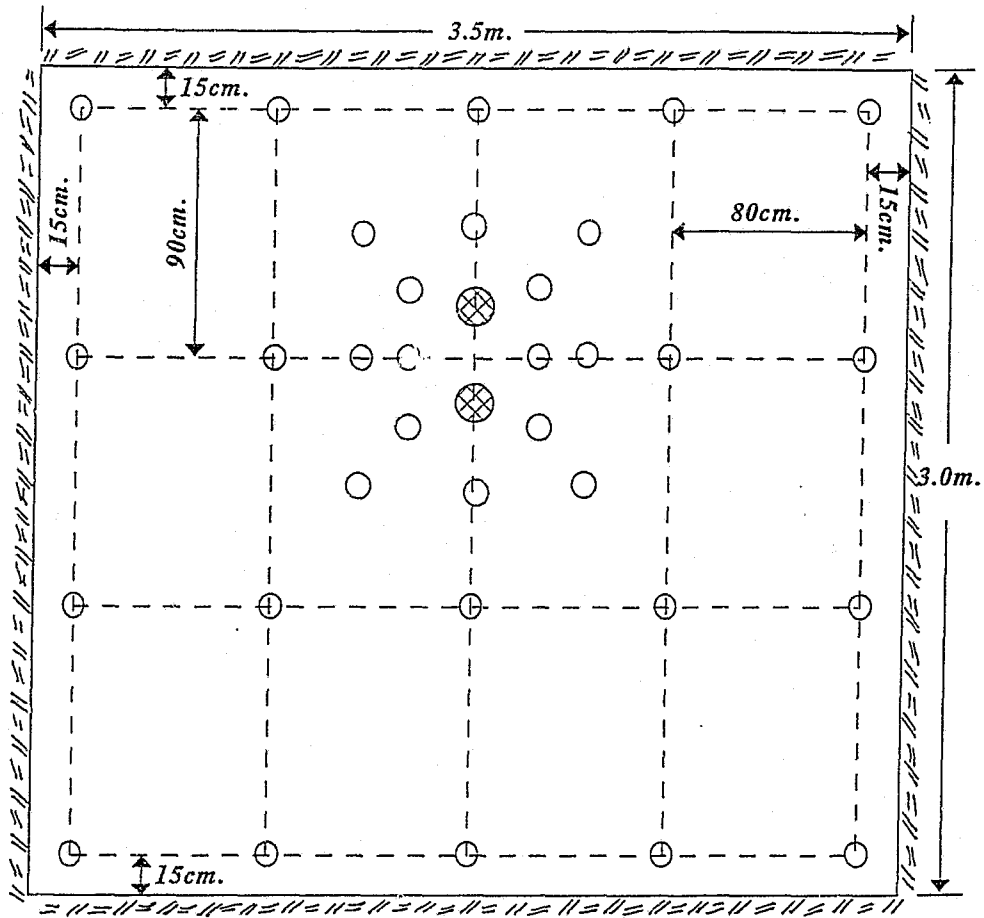
TM<sup>3</sup> ADVANCED STRIKE DRIVE (A.S.D.)

The two stab holes

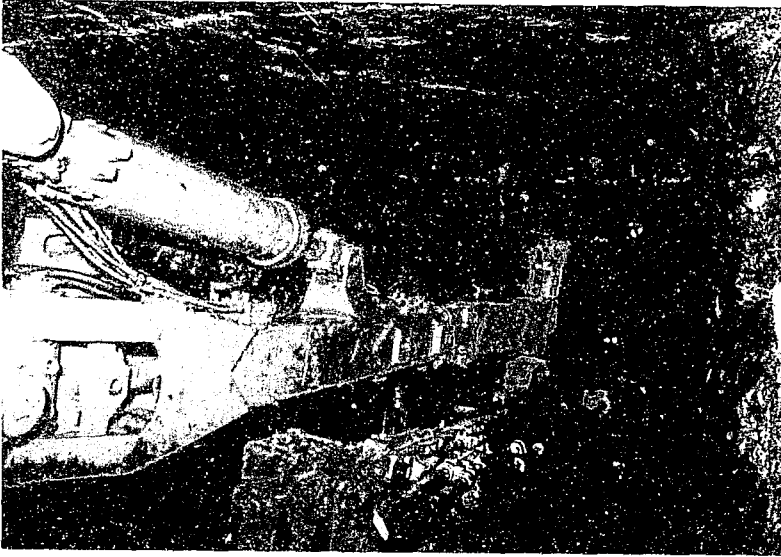
Plate 8.9

Three electro hydraulic drill rigs, drilling a 3,2m hole were used and a typical unit is depicted in plate 8.9.

Electro Hydraulic Drill Rig Drilling Face

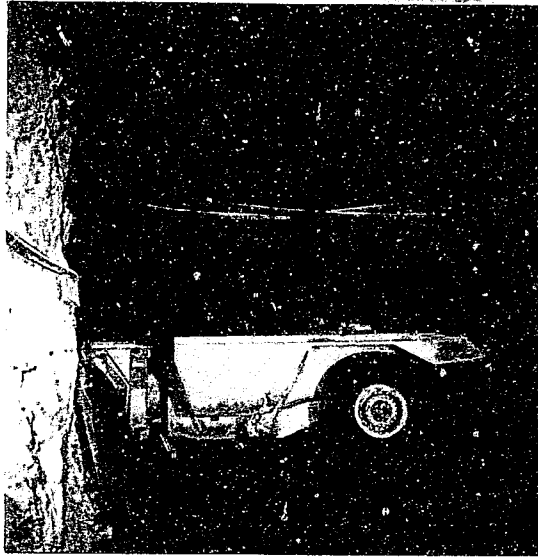
Plate 8.10

LHD Loading Dump Truck

Initially two 20 ton dump trucks (Plates 8.10 and 8.11) and one 15 ton truck was allocated to the project. Further into the project, particularly as the distances increased it was found the 15 ton was not a suitable choice and after a major structural failure was replaced with a third 20 ton truck. As the project wound down the truck complement was again reduced to two.

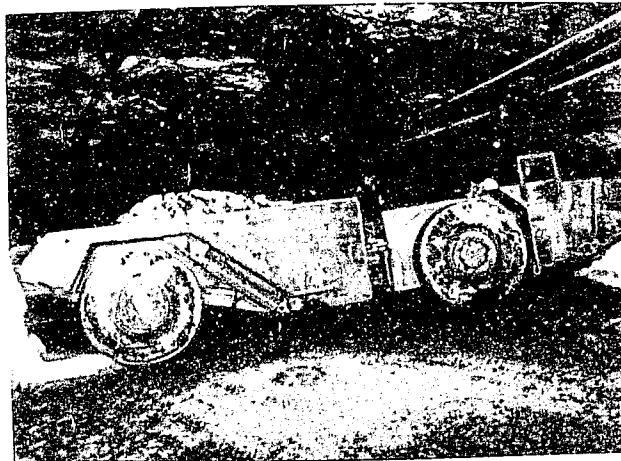
Plate 8.11

Fully Loaded Dump Truck

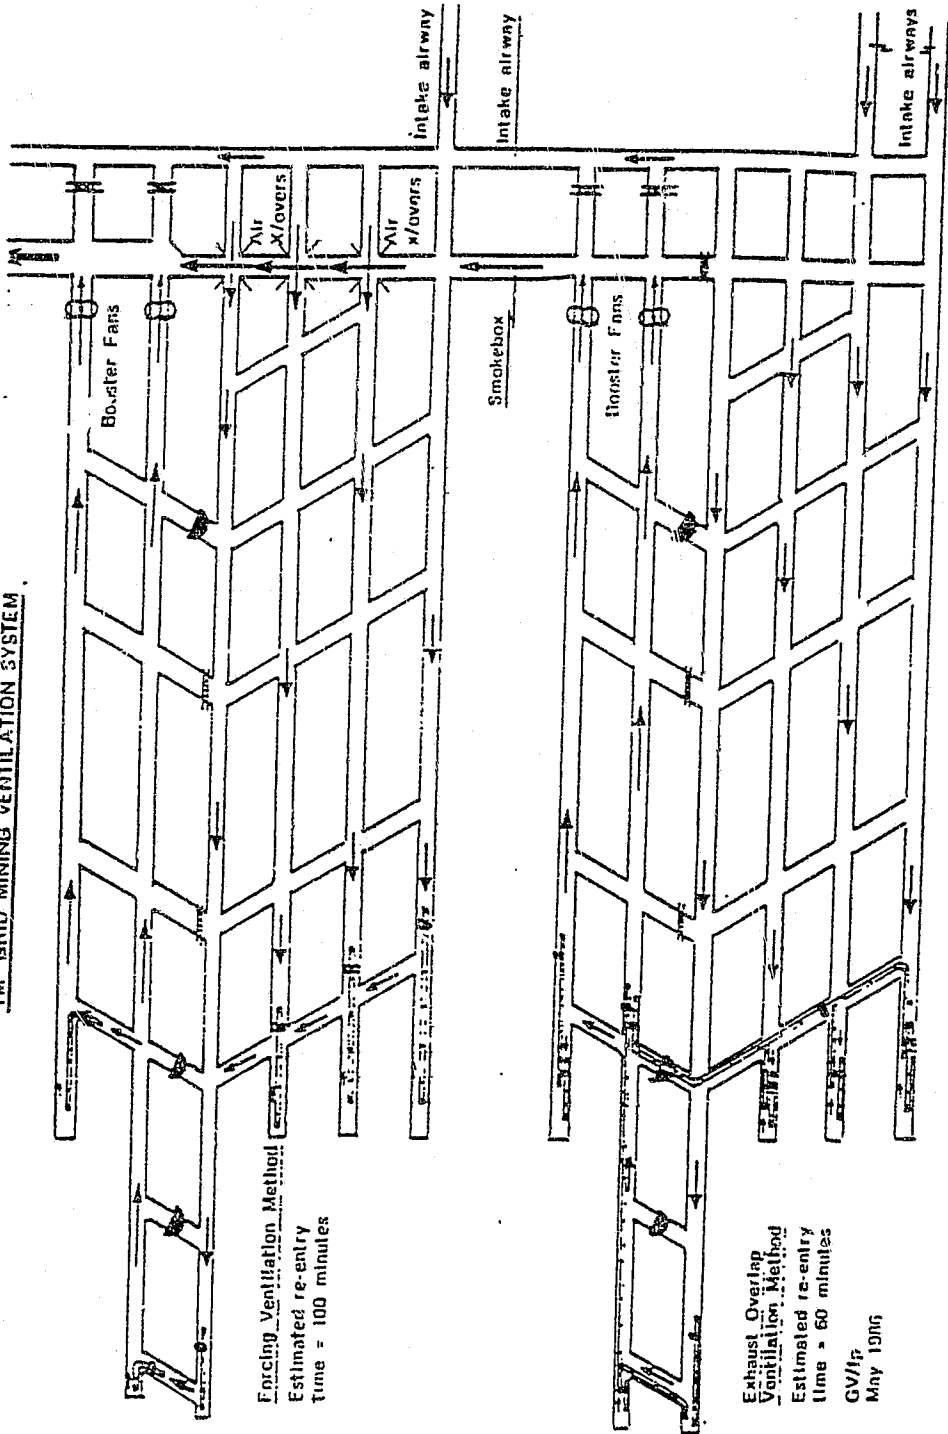
Figure 9.1

TM<sup>3</sup> GRID MINING VENTILATION SYSTEM

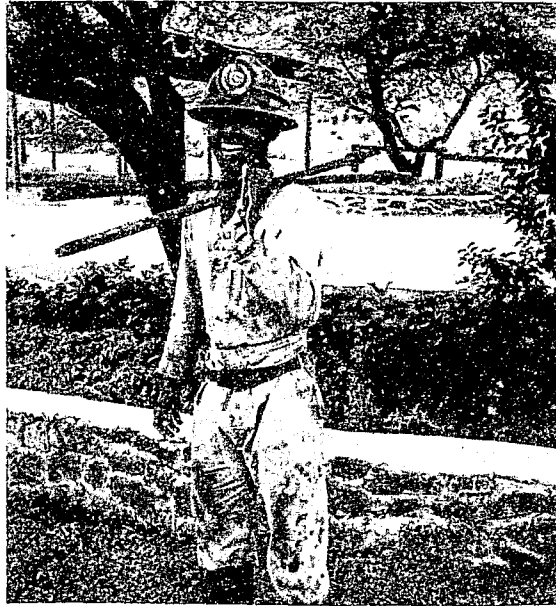
Plate 10.3

Operator with 2 Bits

In all the narrow areas at Cooke 1 conventional face drilling using pneumatic, hand held jackhammers with suitable airlegs were generally used. Initially integral steel was supplied but later in the project detachable bits were used. Plate 10.1. This was partially a cost saving exercise and possibly to a greater degree one of ergonomics. The crews are reluctant to carry large numbers of drill steels. Plate 10.2 while with detachable bits they are only required to carry two drill steels and two drill bits. Plate 10.3.

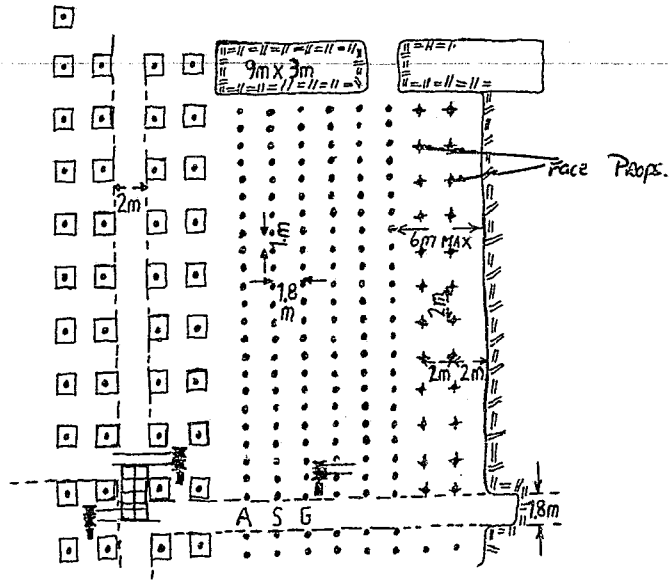
Figure 11.1

Mine Std Narrow Support

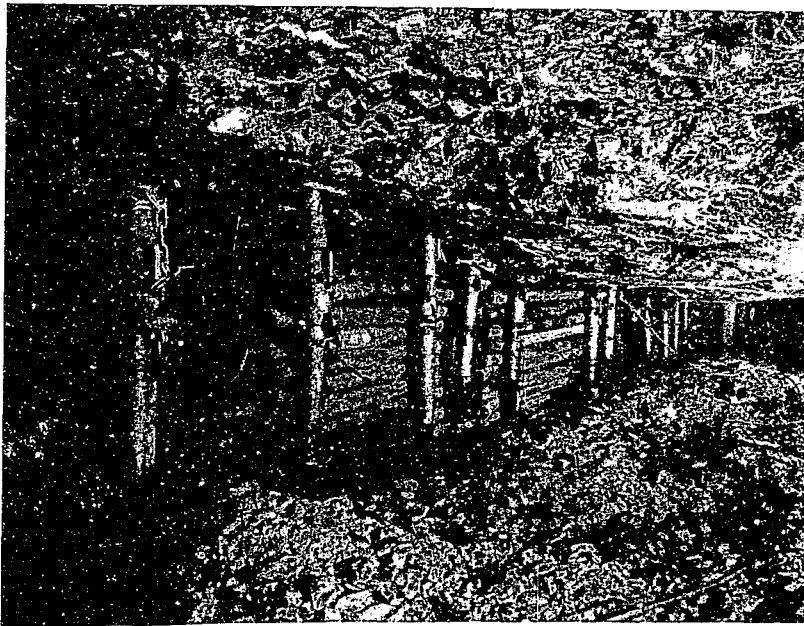
Plate 11.0

Hydraulic Props on Face

No problems were encountered. However, stricter control was exercised in the removal of these mechanical props before the blast. Plate 11.0, indicates the Hydraulic props with the blasting barricade suspended against them. When the permanent timber support was installed these were moved forward and kept within 6 metres of the face.

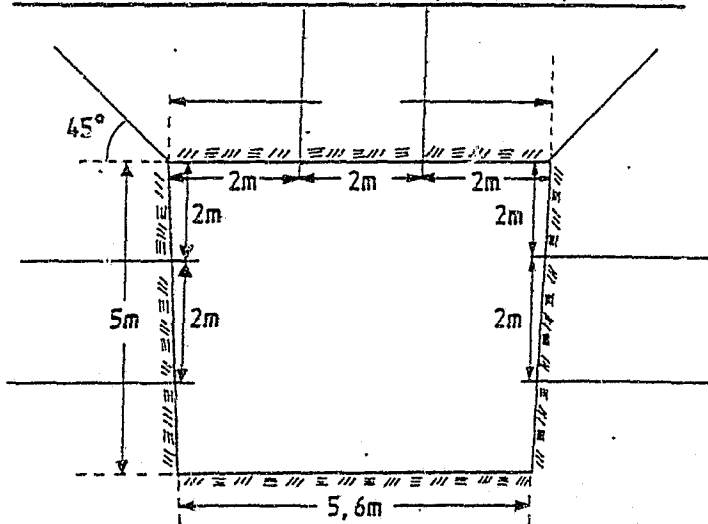
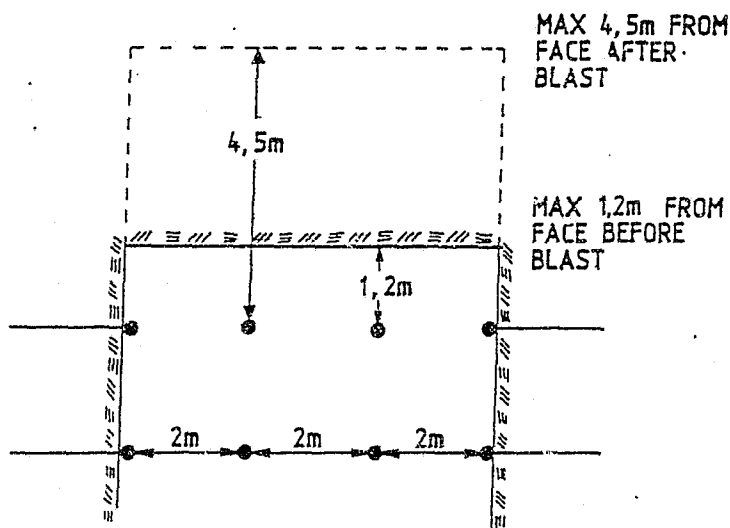
SUPPORT PATTERNS

RE-BAR INSTALLATION. 2,7m x 2,5mm Ø

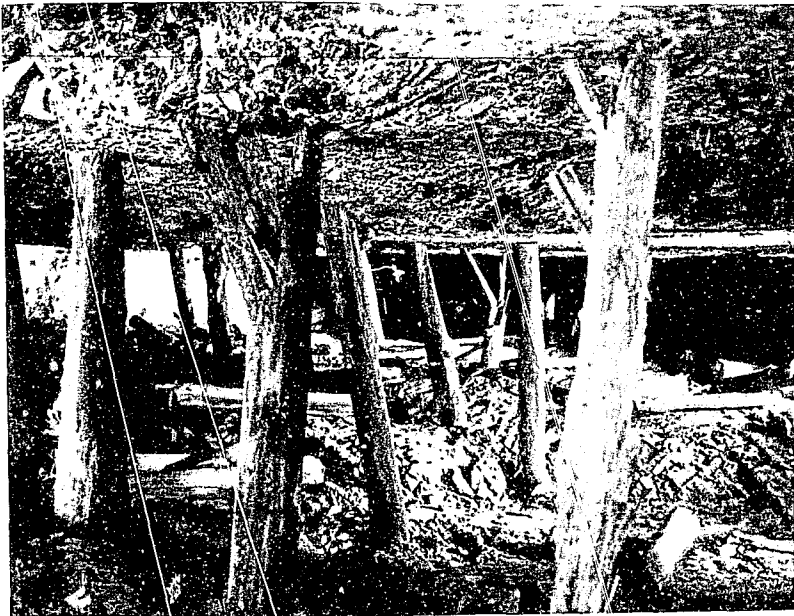
Plate 11.1

Traversing old areas

The support in these areas varied from sticks to grout packs as shown on plates 11.1 and 11.2. As can be seen from these plates the support had taken little pressure since it was mined up to 15 years earlier. The new support on immediate ledges comprised stick packs spaced at 2 metre centres along the shoulders. A stick pack is a pencil stick or profiled stick surrounded by a wedged skeleton pack. Figure 11.4. Other sticks or support which came out during blasting or were damaged or suspect were replaced with pencil sticks on a 2m x 2m pattern.

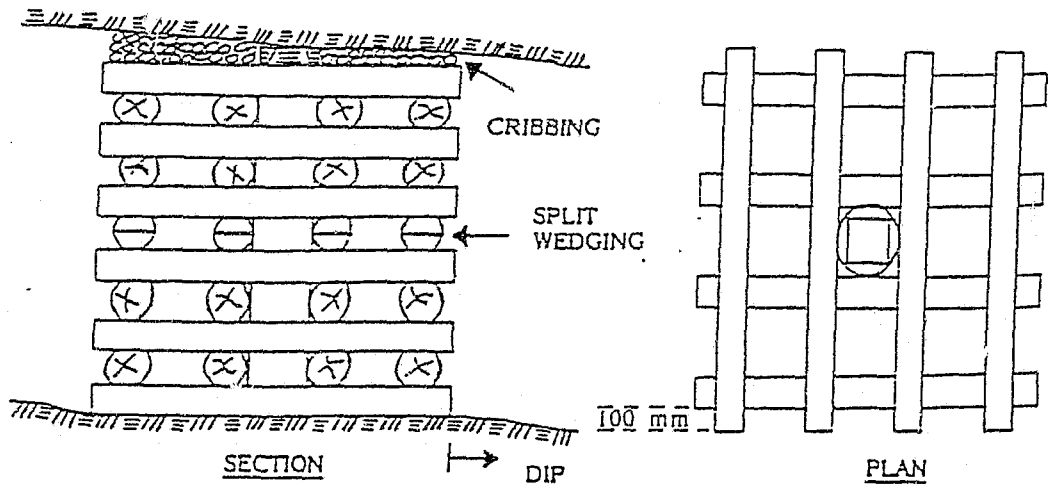
## 8.5.6 15 POINTER E.P.S. PACKS.

1. INSTALLATION

- 1.1 PACK POSITIONS ARE TO BE MARKED OFF BEFORE INSTALLATION BEGINS.
- 1.2 FOOTWALL IS TO BE PROPERLY CLEANED AND BARRED SOLID.
- 1.3 BOTTOM LAYER OF 1,1 M SLABS ARE TO BE INSTALLED ON DIP.
- 1.4 THE INNER 1,1 M SLABS ARE TO BE INSTALLED AGAINST THE YIELDING PROP.
- 1.5 THE OUTER 1,1 M SLABS ARE TO BE INSTALLED 100 mm FROM THE END OF THE UNITS.
- 1.6 CRIBBING MUST BE TIGHTLY INSTALLED BETWEEN THE TOP LAYER OF 1,1 M SLABS AND THE HANGING WALL.
- 1.7 SPLIT WEDGING MUST BE DONE ON THE FACE SIDE OF THE PACK.

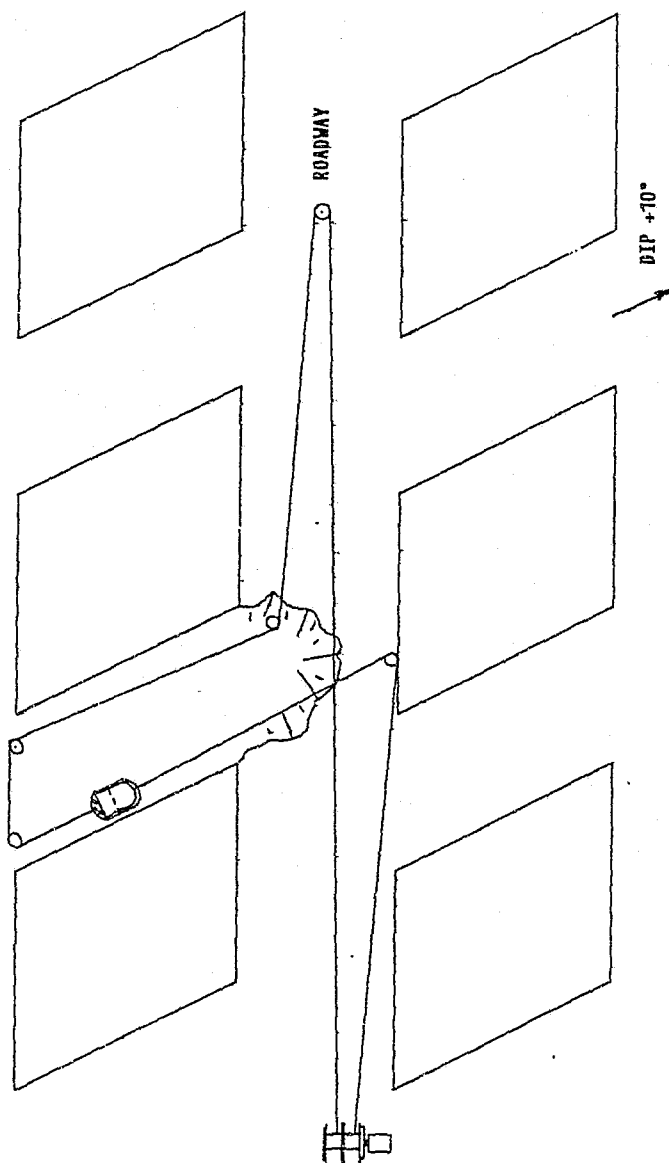
Figure 12.1

CLEANING USING SCRAPER WINCH IN THE  
AREAS WHERE DIP EXCEEDED 10°

In an attempt to speed up the cleaning of ore of the wide areas which had a true dip of around  $10^{\circ}+$  it was decided to install a 75kW winch and then to scrape out the material in the bords, figure 12.1. Under normal conditions where rubber tyred vehicles had run over an area effectively compacting the ballast, it would have been a futile operation to try and clear this material, however, in this case because the dip of the stulls was such that it was decided to drill and blast the pillar holings with two blasts up dip and one blast from the roadway above down dip. The sequence is depicted in figure 12.2. The material from the 3<sup>rd</sup> blast was initially left until the roadway faces were some distance ahead. The material was then scrapped down and loaded out on the lower roadway. This was found to have some advantages. As the dozer was hard pressed in another area where the pillars were showing signs of taking a lot of pressure and it was thought that the area might be lost. The roadways not required for tramming in the area where the scraper was installed were ripped by the dozer which then went back to the higher priority area and the scraper was used to remove the vappings. As hand cleaning
