**The Extraction of Pillars, largely by Trackless Mining Methods, at  
Randfontein Estates Gold Mining Company (Witwatersrand) Ltd**

**A Dissertation submitted to the Faculty of Engineering,  
University of the Witwatersrand for the degree  
Master of Science in Engineering**

**July 1998**

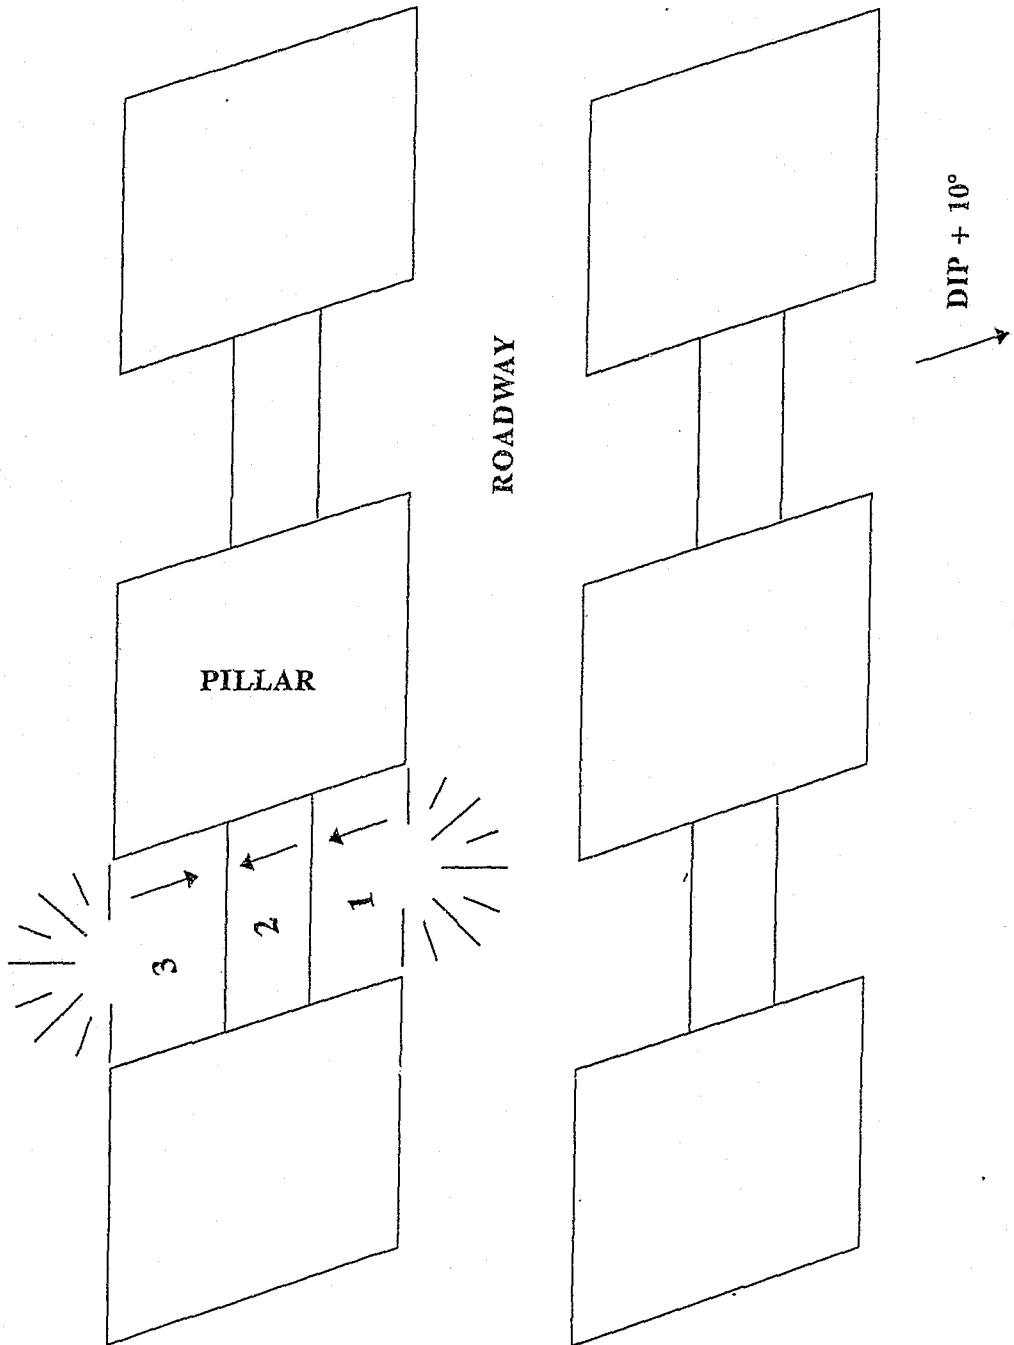
Figure 12.2

SEQUENCE SHOWING BLASTING OF PILLAR  
HOLINGS WHERE THE MINOR DIPS EXCEEDED  $10^\circ$

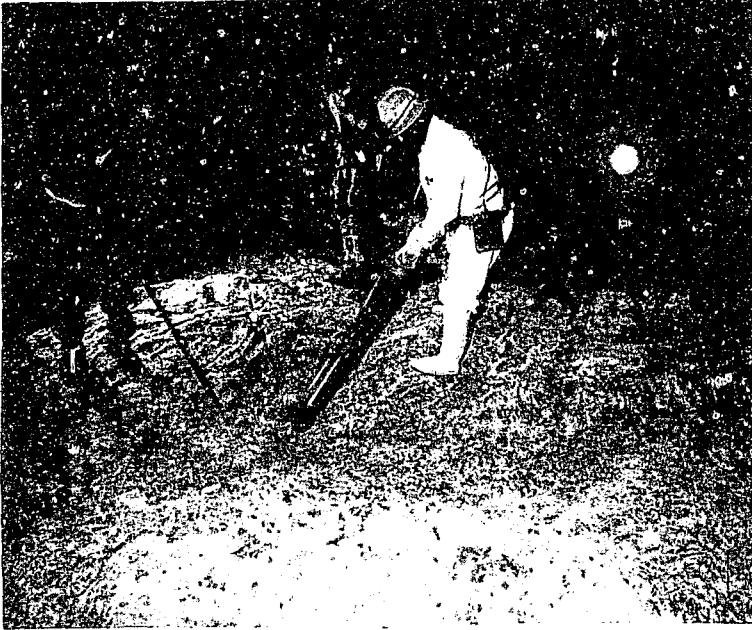
**Plate 12.6**

**Transvac Crew working**

The unit operates with a small crew (Plate 12.6) who loosens any compacted material and vacuums up the fines and stones up to 100mm in diameter. Larger rocks block the nozzle and have to be removed. Reef too big for the unit is either broken up to a suitable size or loaded into wheelbarrows and taken to the loading area. Waste rock is discarded into the swept area and left.

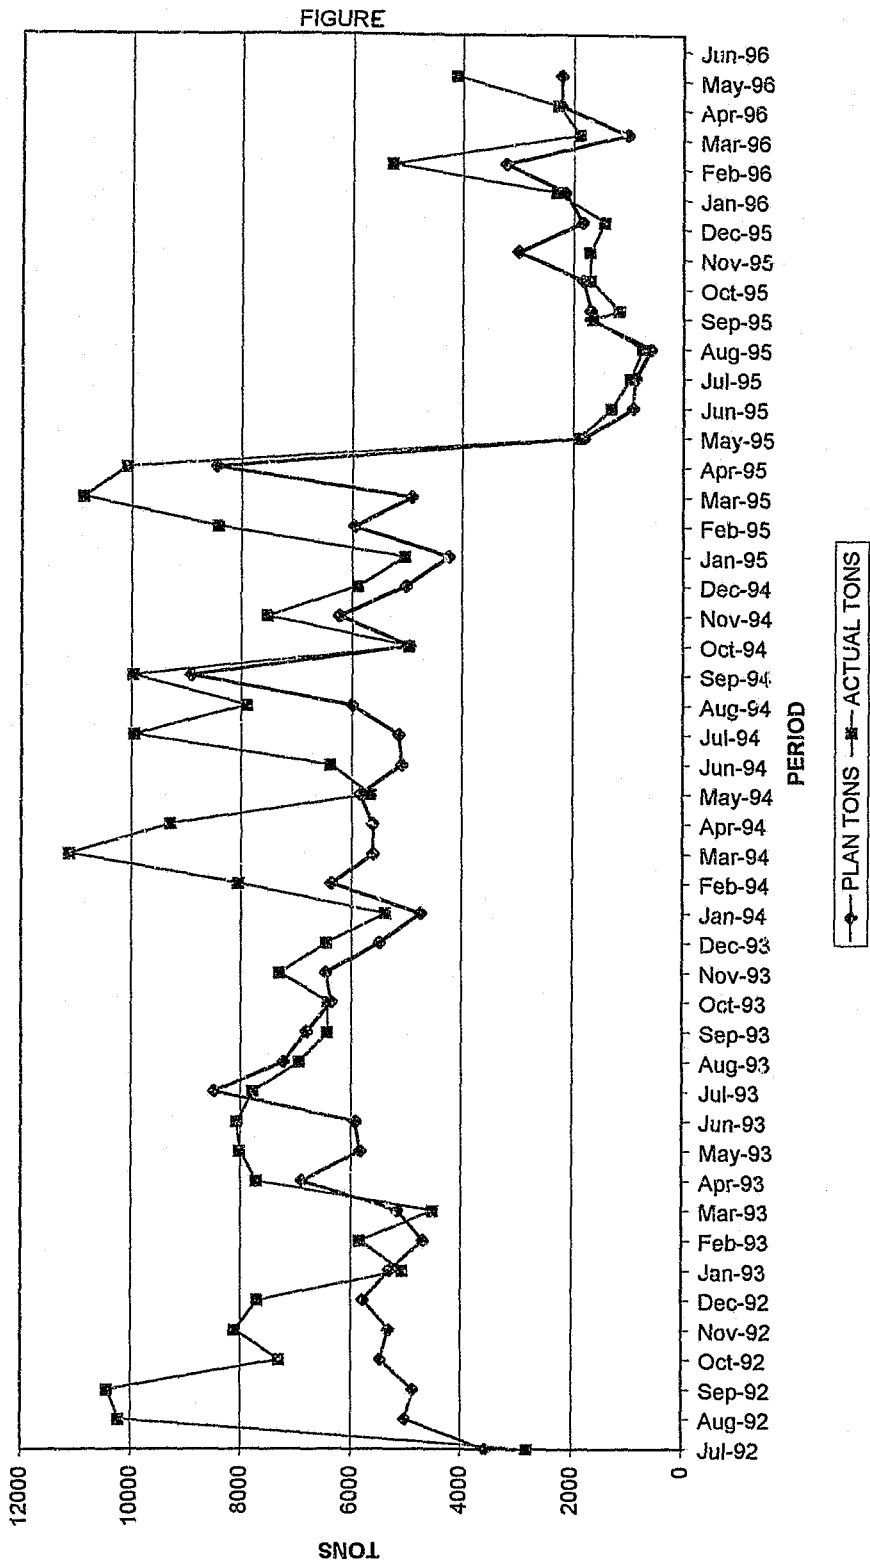
Figure 13.0

95#PILLAR - COOKE 1 TONS BROKEN

This operation was planned as a low tonnage operation but still planned to have a high productivity rate which was achieved. Figure 13.0.

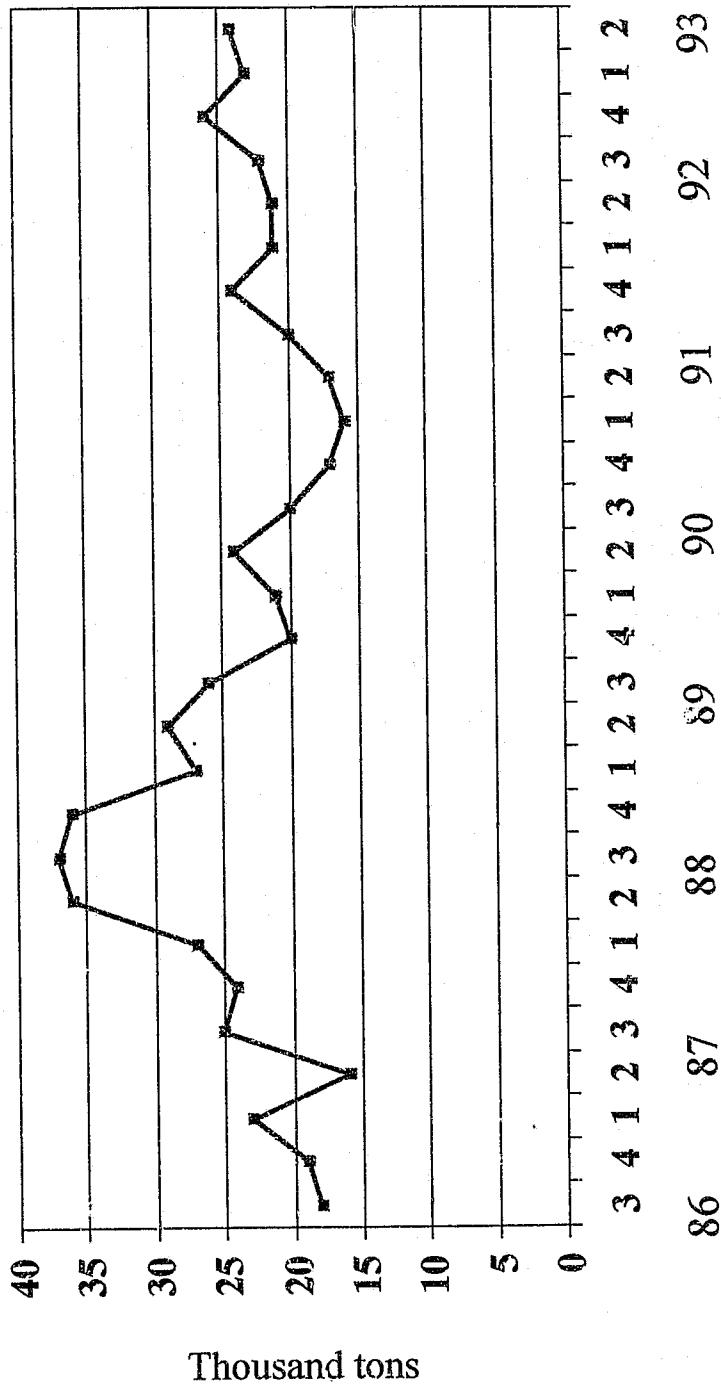
Figure 13.1

# 101 Window/Bowl - Pillar Extraction

## Tons Broken

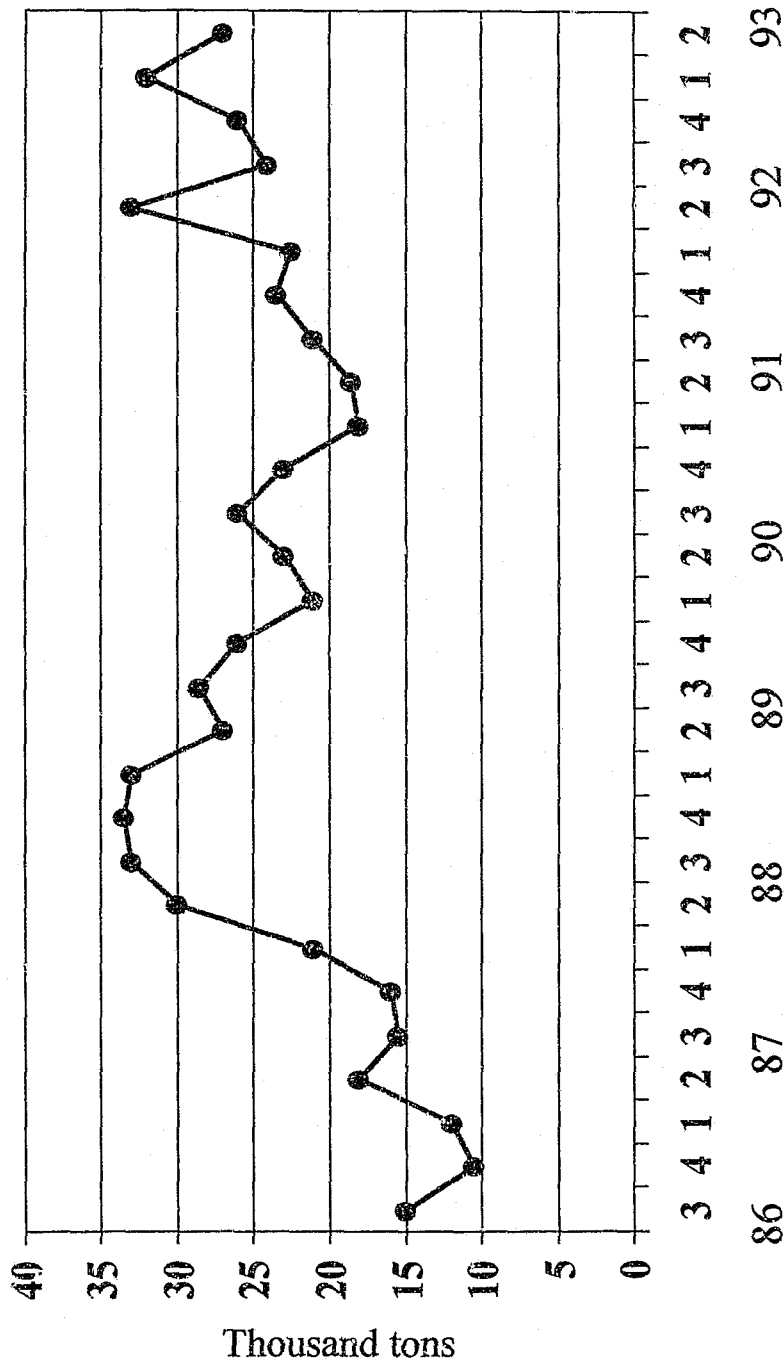
Figure 13.2

# 101 Window/Bowl - Pillar Extraction

## Tons Milled

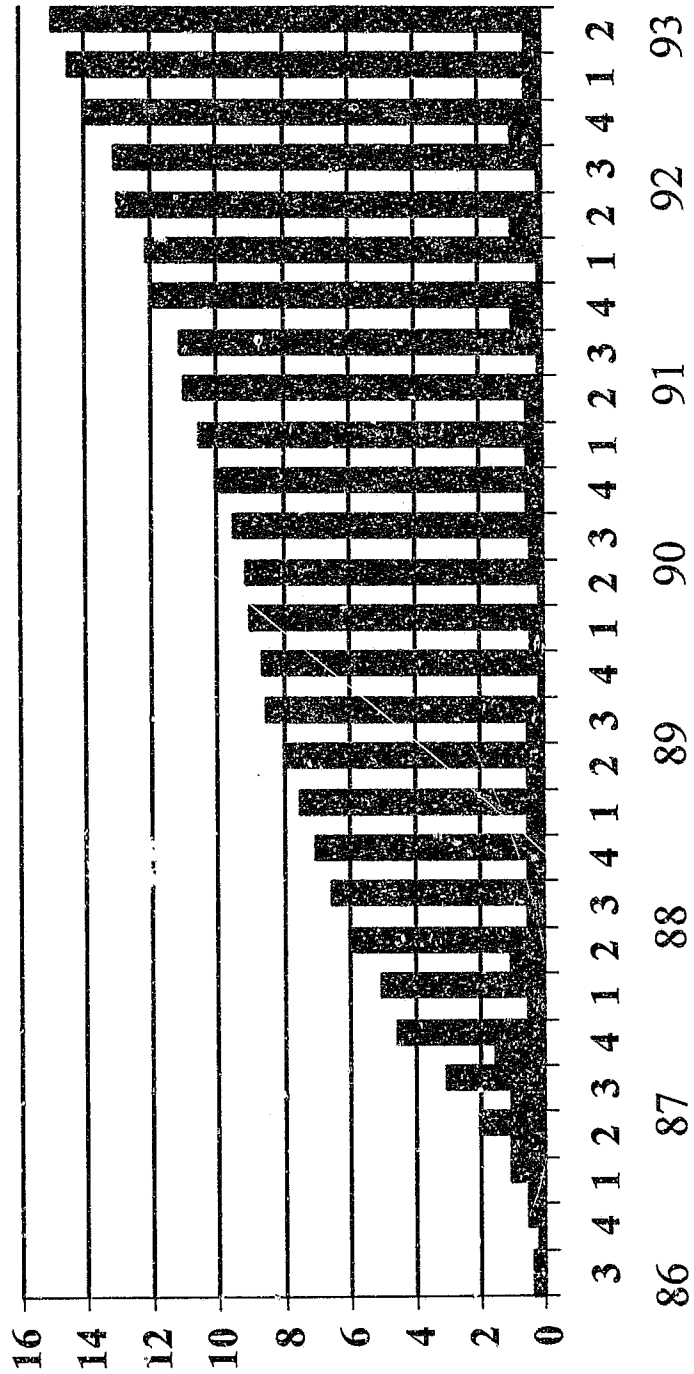
# 101 Window/Bowl - Pillar Extraction

## Profit Contribution

■ Monthly Profits ■ Cumulative Profits

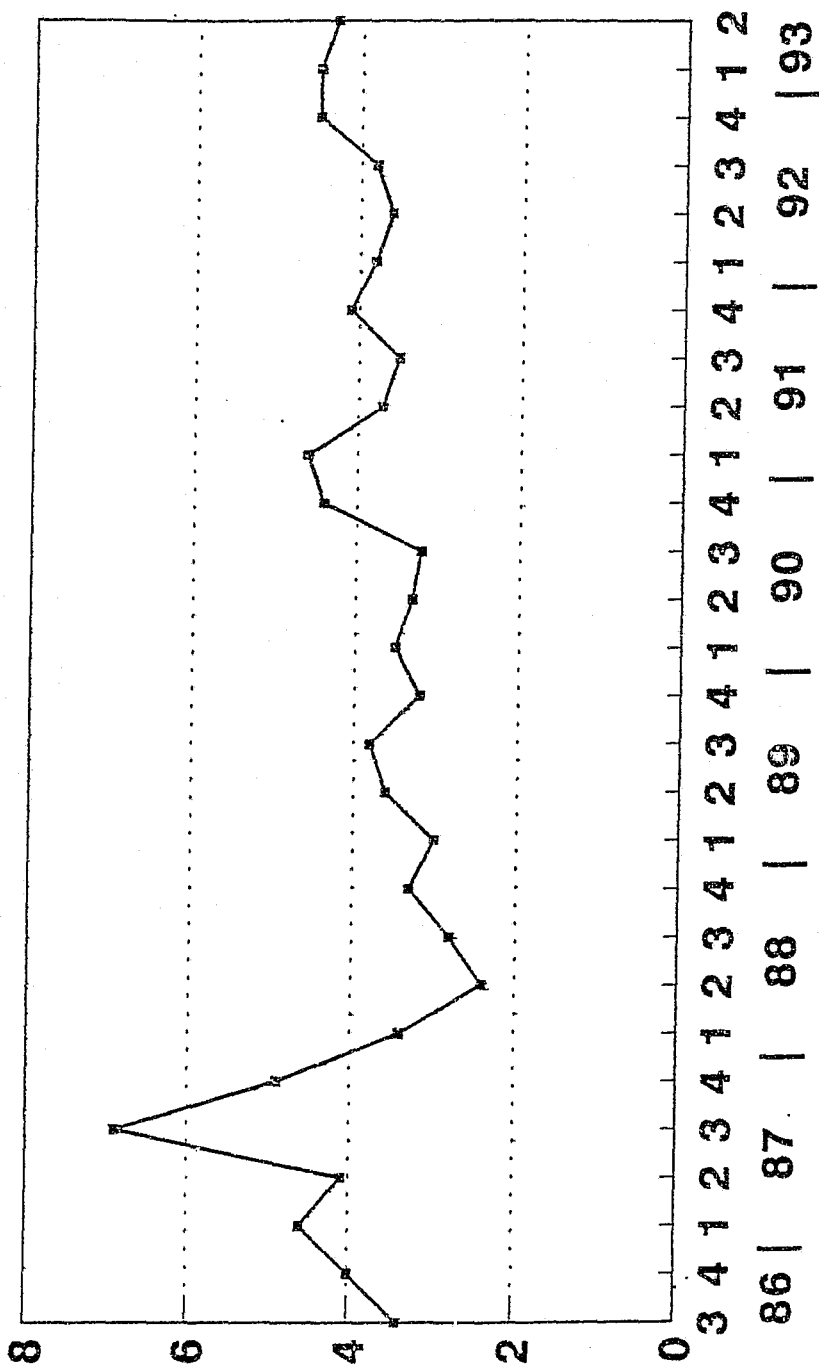
Figure 13.4

# 101 Window/Bowl - Pillar Extraction Recovery Grade

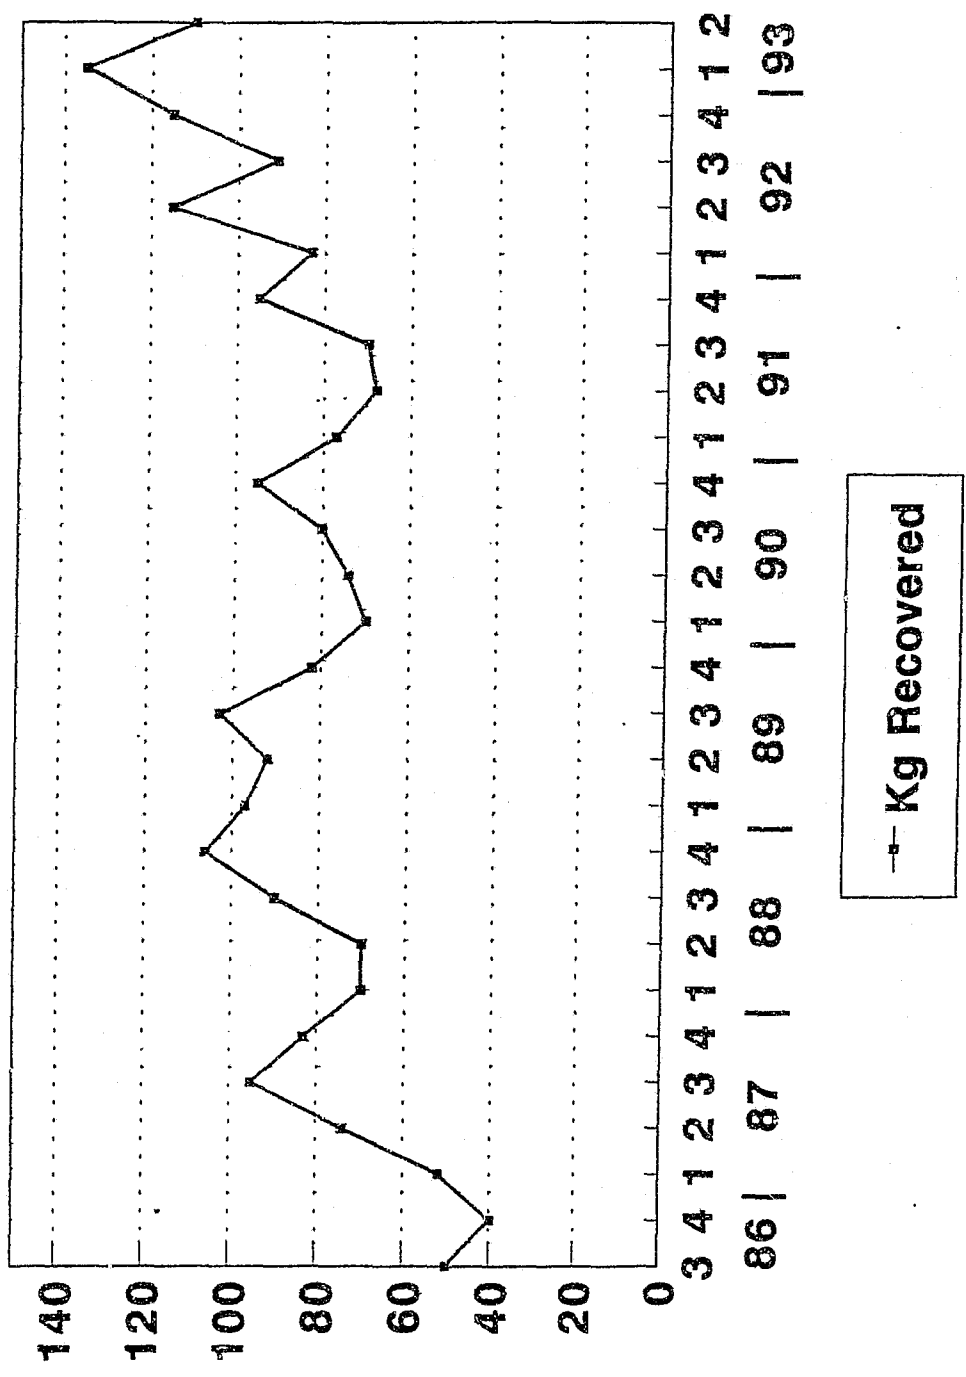
Figure 13.5

## Kilograms Recovered

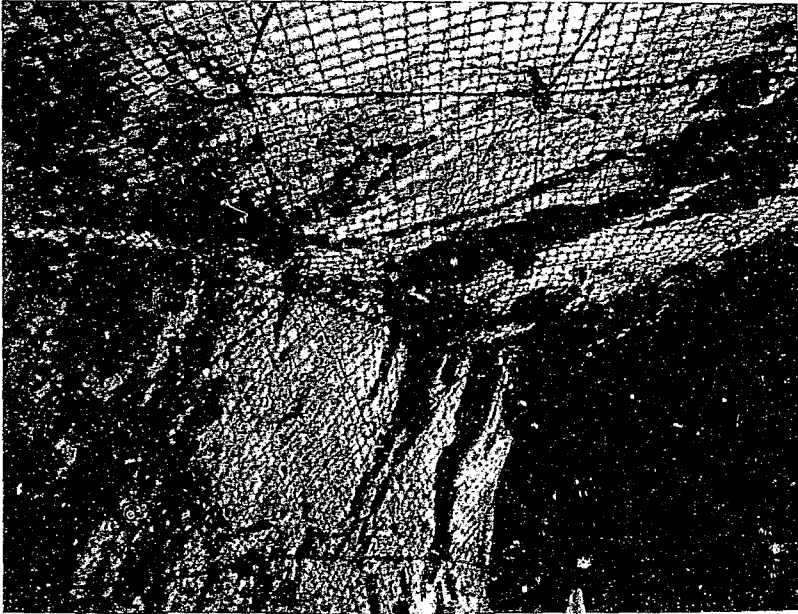
Pillar Wire Meshed and Laced

The pillars showing stress were then wire meshed and laced as is shown in Plate 15.4 using 16mm diameter, 2,4 metre long shepherds crooks and diamond mesh or weld mesh. The bolts were drilled on as near as possible a 2m x 2m diamond support pattern.

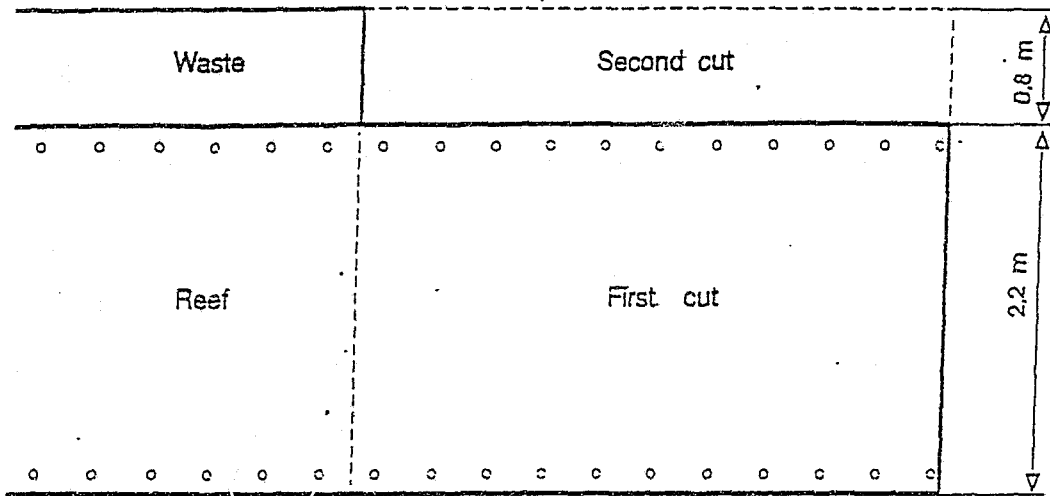
Figure 15.1

Section

Double cut with a channel of 2,2 m.

Double cutting is an operation where the reef and waste are taken out in two separate operations. Figures 15.1 and 15.2 indicates the extraction of the primary cut and the removal of the "waste" or low grade ore which is then dumped in the mined out areas or in the case as shown in figure 15.2 the reef cut which is then trammed to the reef ore pass. On the next blasting shift the second cut is dropped and handled appropriately depending on whether it is reef or waste.

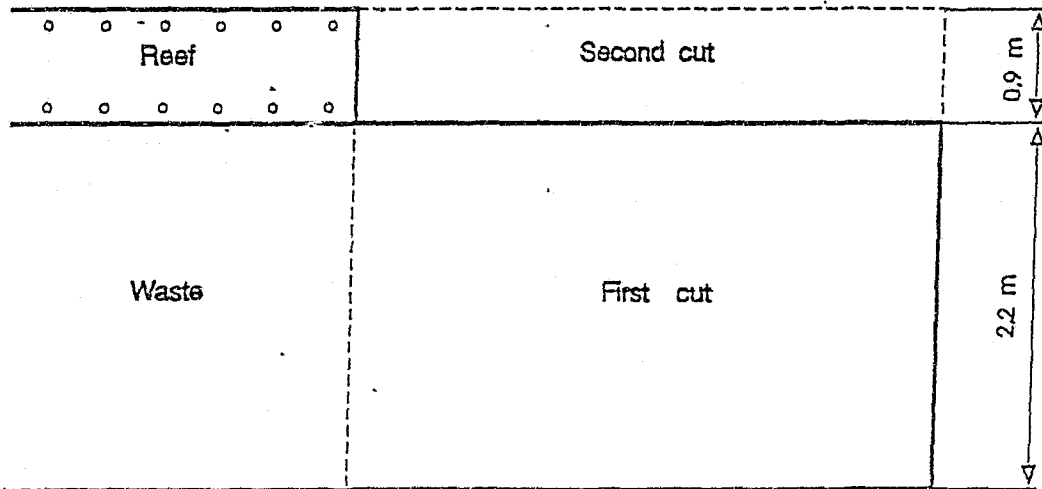
Figure 15.2

Double cut with a channel of 0,9 m.

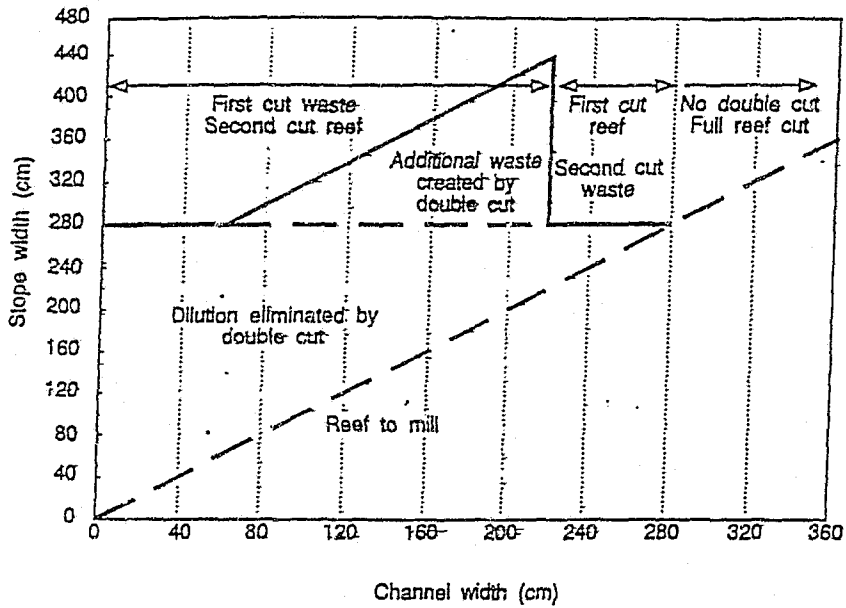
Figure 15.3

Comparison of channel width to stoping width with double cut

The controversy over the benefits of double cutting has raged for a number of years with some showing it to be of great benefit while others show little or not benefit. At Cooke 1 the K9 Kimberly reef area had been successfully mined using this method and it was subsequently applied in the 101 area. An unpublished paper by Strauss, H on double cutting has at last put this into perspective and indicates with the aid of graphics in what ranges double cutting is an advantage. Figures 15.3 and 15.4.

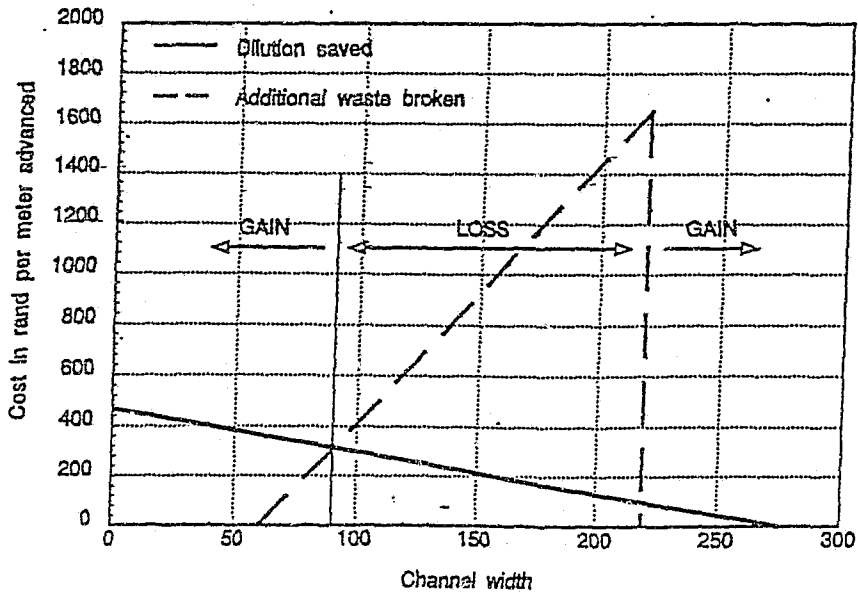
Figure 15.4

Cost comparison between dilution saved and additional waste broken.

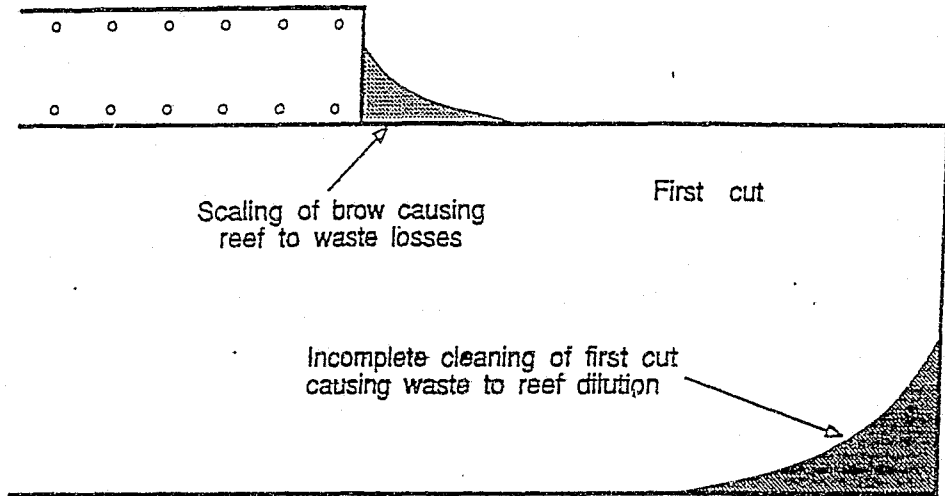
Figure 15.5

Reef losses and dilution on a narrow reef.

- 15.7.1 Contamination of the waste by reef either scaling off, or picked up from the footwall or from blasting. Figures 15.5 and 15.6.
- 15.7.2 Sufficient clearance to load first cut, at times, resulted in the excavations being bigger than desired with extra material being broken. Figure 15.7.

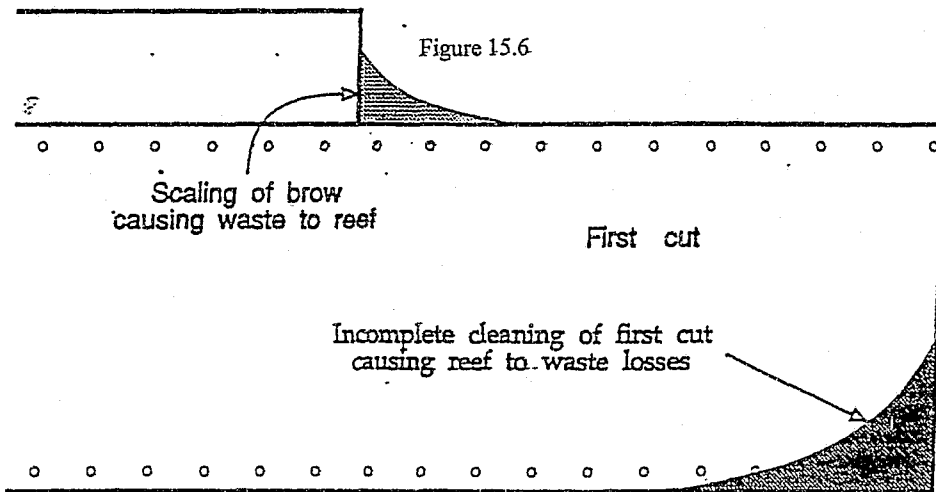
Figure 15.6

Reef losses and dilution on a wide reef

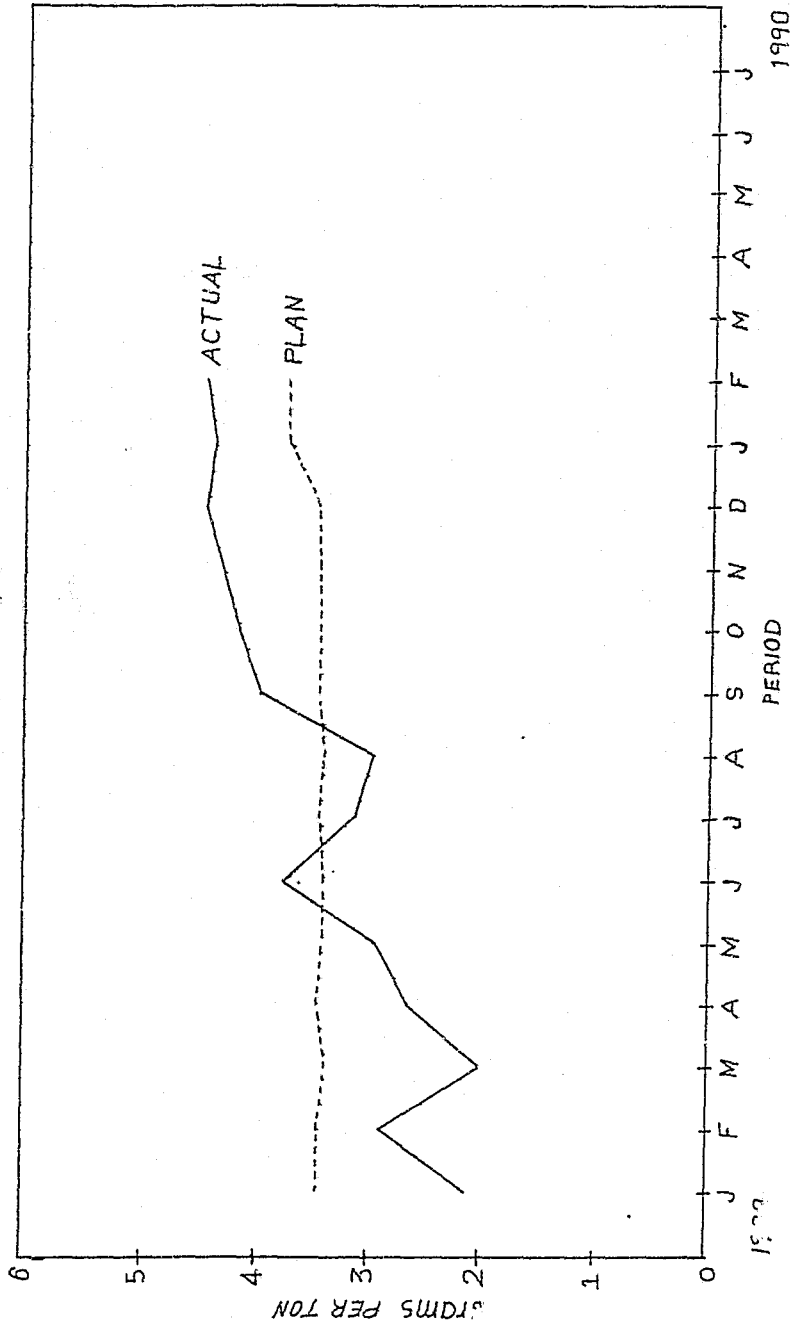
Figure 15.8

COKE 1 SHAFT  
106 KGa IN3 PROJECT  
BLASTED GRADE

INCREASE IN BLASTED GRADE WITH  
INTRODUCTION OF DOUBLE CUTTING

The greatest advantage of double cutting is to improve the grade of ore to the mill and within the parameters as set out in the paper by Strauss H., it is viable.
