SOUTH AFRICAN ARCHITECTURAL RECORD

APRIL, 1952

THE HAIL RESISTANCE OF SOUTH AFRICAN ROOFING MATERIALS

This paper gives the results of laboratory tests carried out on 29 roofing materials in order to assess their hail resistance. Certain types of corrugated iron were found to be the most suitable material, while concrete and clay tiles were the least satisfactory, from the point of view of hail damage. Information on the frequency and occurrence of hailstorms is included, from which it may be seen that it is hard to define a hail belt, and that all the summer rainfall areas of South Africa are subject to severe hailstorms.

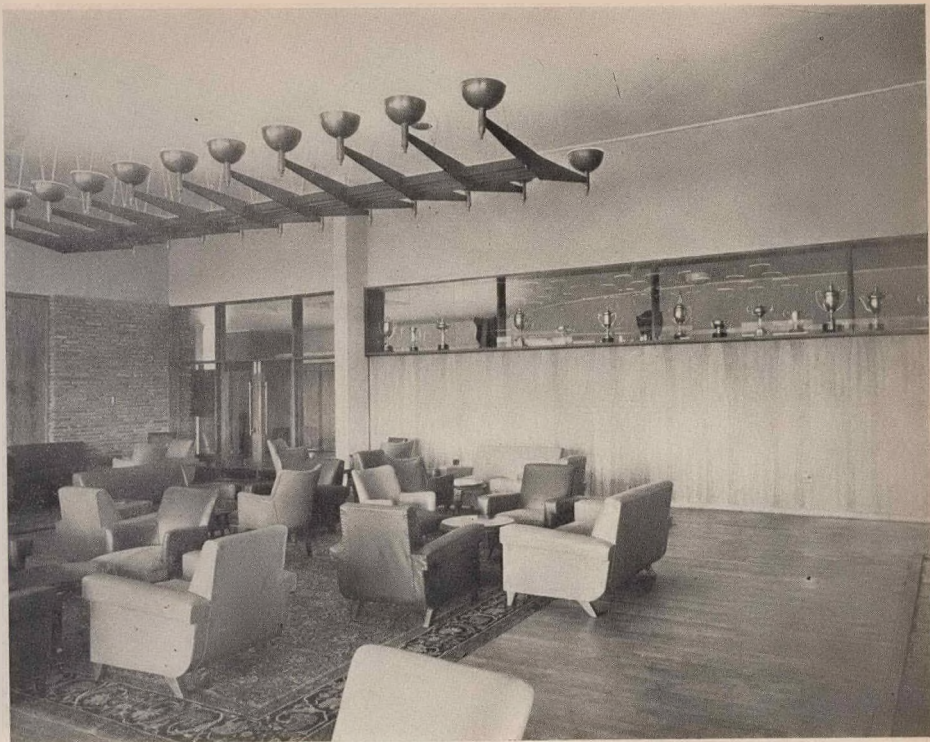
4

4. Lounge. The floor is birch, and the panelled wall olive ash. The glass display case above is visible from the entrance hall as well as the lounge. The light fitting is mvuli and copper, and suspended from the ceiling by sash cords.

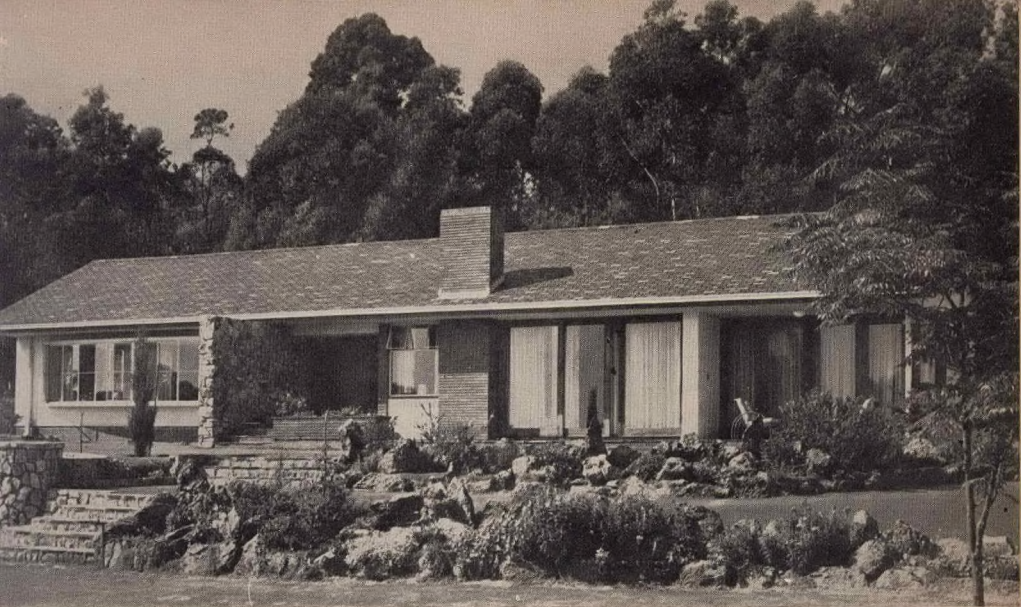
NORTH ELEVATION.

$$\theta = 58\frac{1}{2}^\circ$$

The dotted lines on the drawn elevation on page — indicate how the angle of $58\frac{1}{2}^\circ$ (θ) has been used to proportion the various surfaces involved.

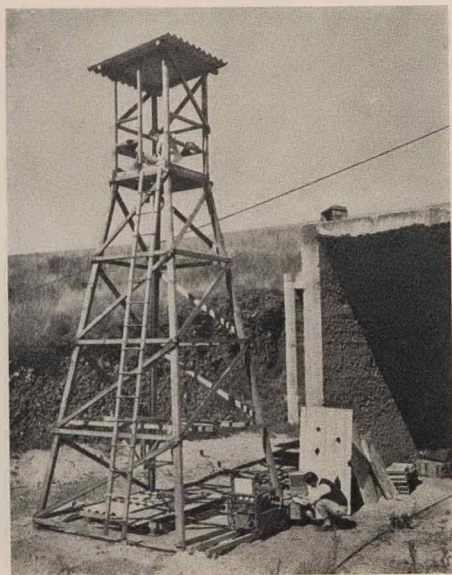
Fig. 3. Firing tower used in the tests.

To carry out the tests, a tower 20 ft. high (see Fig. 3) was

constructed. Each specimen roof was placed horizontally just above the ground between the tower legs, and artificial hailstones were shot vertically downwards from the top of the tower so that they struck perpendicularly on the roof. This resulted in the most severe exposure condition, but one which is easily attained in nature since, on the exposed side of a roof, it is quite possible for hailstones to strike perpendicularly, notwithstanding the fact that the pitch of the roof may be quite steep. Because of wind, hailstones fall at a slant, and during the storm in November, 1949, some hailstones were observed to fall at angles of less than 45° to the horizontal. (In this storm, wind velocities of up to 60 m.p.h. or 88 ft./sec. were recorded, and these were of the same order as the terminal velocities of the falling hailstones).

hailstones and an electrical timing device was used to measure the velocity at impact. The timer consisted of two aluminium foil grids, each carrying an electric current which was interrupted when the foil was broken by the hailstone. The time taken to traverse the 2' 6" between the two grids was recorded on a R.C.A. time interval counter, and from this the terminal velocities were computed. The frame holding these grids was supported just above the specimen roof, while a portable generator set provided power for the time interval counter.

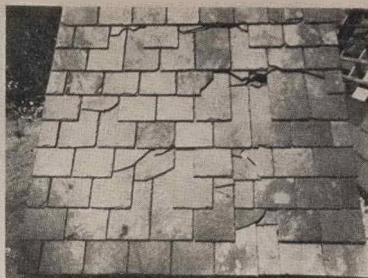
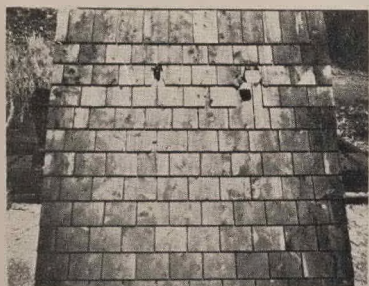
Fig. 5. Some specimen roofs after testing. (Note: The degree of damage illustrated above must not be taken as an indication of the relative hail resistance, because shots of different intensities were fired at each roof to determine the limiting value.)

Fig. 5 shows six roofs after testing — these being corrugated iron, slate, cypress shingles, clay tiles, asbestos cement and concrete tiles.
