# **COMPARISON OF THE LIGHTNING PERFORMANCE BETWEEN THE POLES OF THE CAHORA-BASSA $\pm 533$ kV HVDC LINES**

A dissertation submitted to the Faculty of Engineering and the Built Environment, University of the Witwatersrand, Johannesburg, in fulfilment of the requirements for the degree of Master of Science in Engineering.

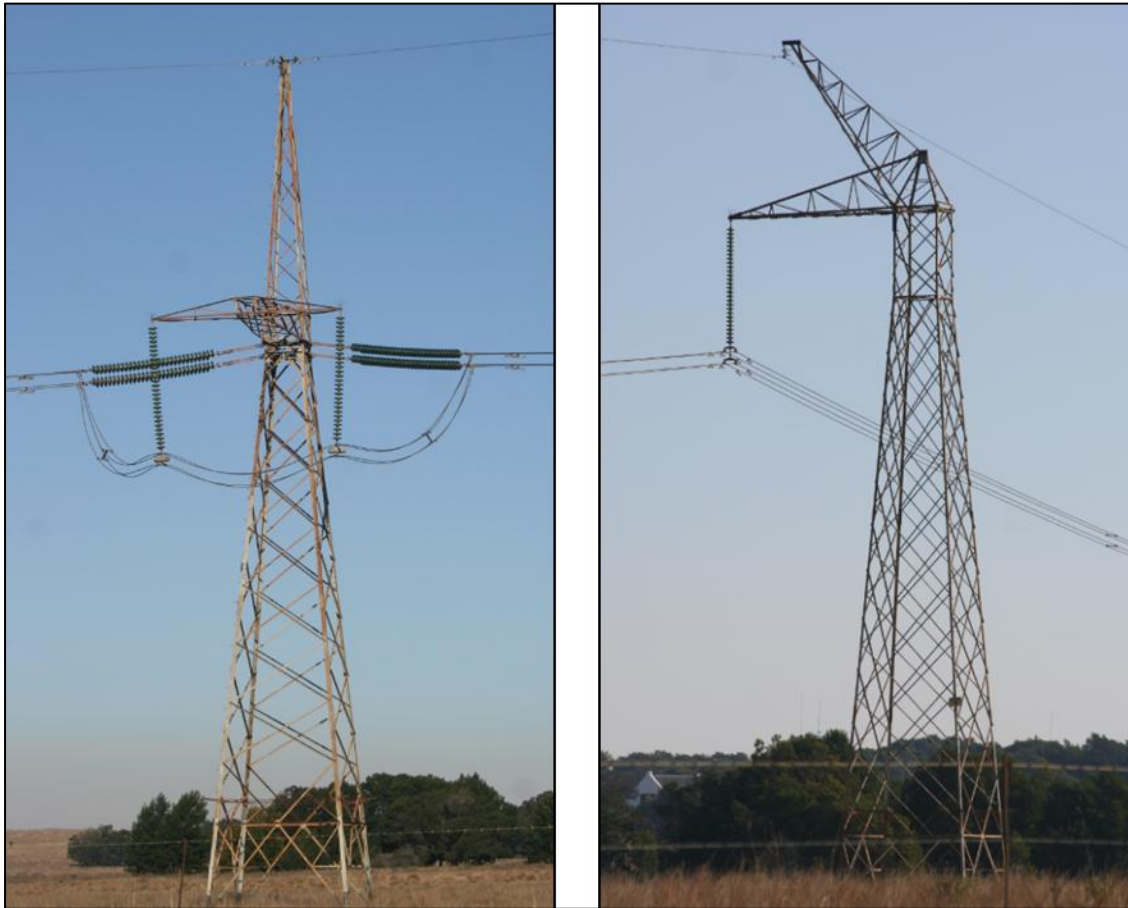
The Cahora-Bassa scheme is one of only two known HVDC schemes, where the positive and negative poles are constructed as two independent lines. This line utilises self-supporting “mono-polar” structures shown in *Figure 9*.

**Figure 9: Mono-polar strain and suspension pylons of the Cahora-Bassa HVDC scheme<sup>6</sup>.**

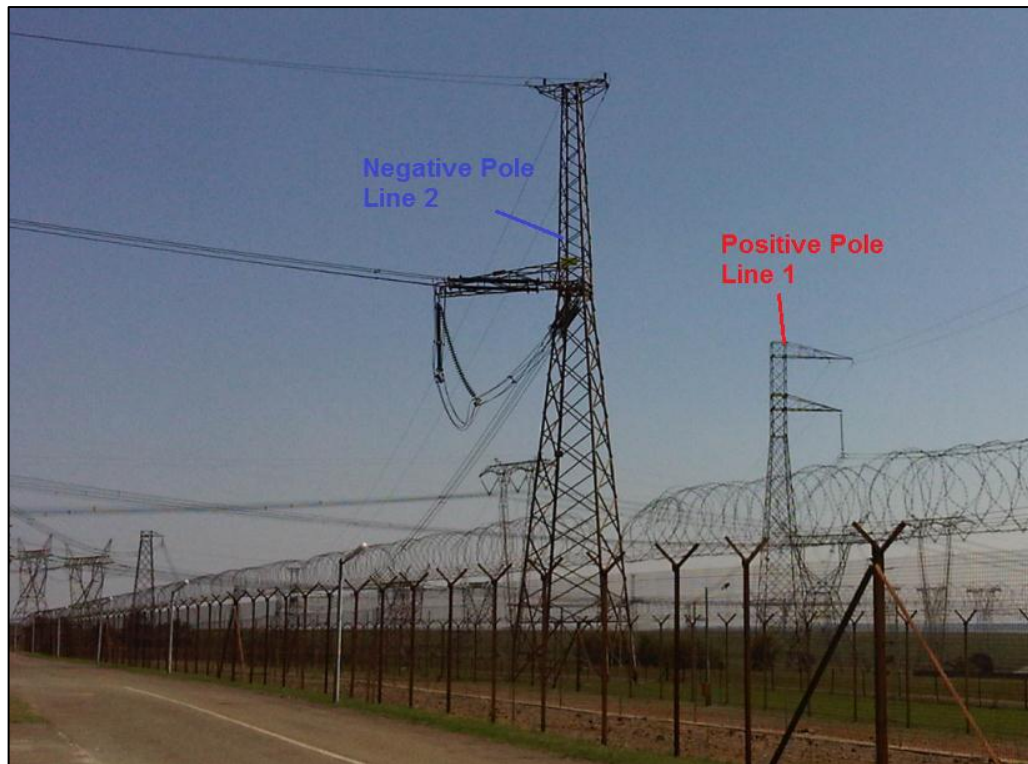
There are small sections, particularly close to the terminal converter substations, where the lines run relatively close together as shown in *Figure 11*. However, this is a small percentage of the line length.

**Figure 11: Cahora-Bassa lines exiting Apollo CS<sup>8</sup>.**

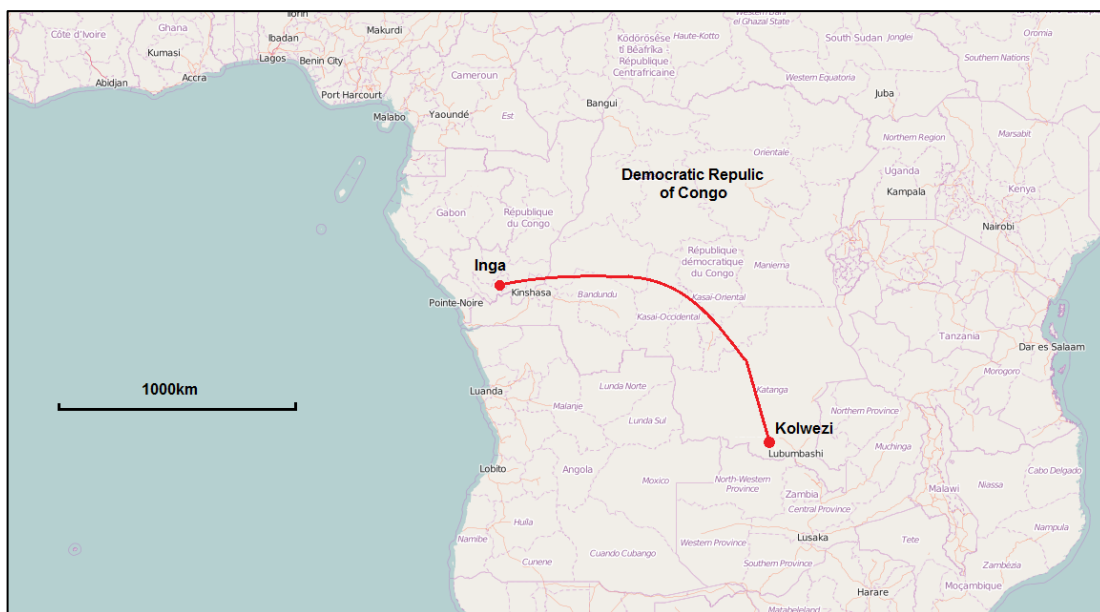
Besides Cahora-Bassa, the only other known HVDC scheme to be constructed on mono-polar structures is the 1700 km  $\pm 500$  kV HVDC Inga-Kolwezi scheme in the Democratic Republic of the Congo (Figure 3).

Figure 14: Route of the Inga-Kolwezi HVDC scheme in the DRC<sup>10</sup>.

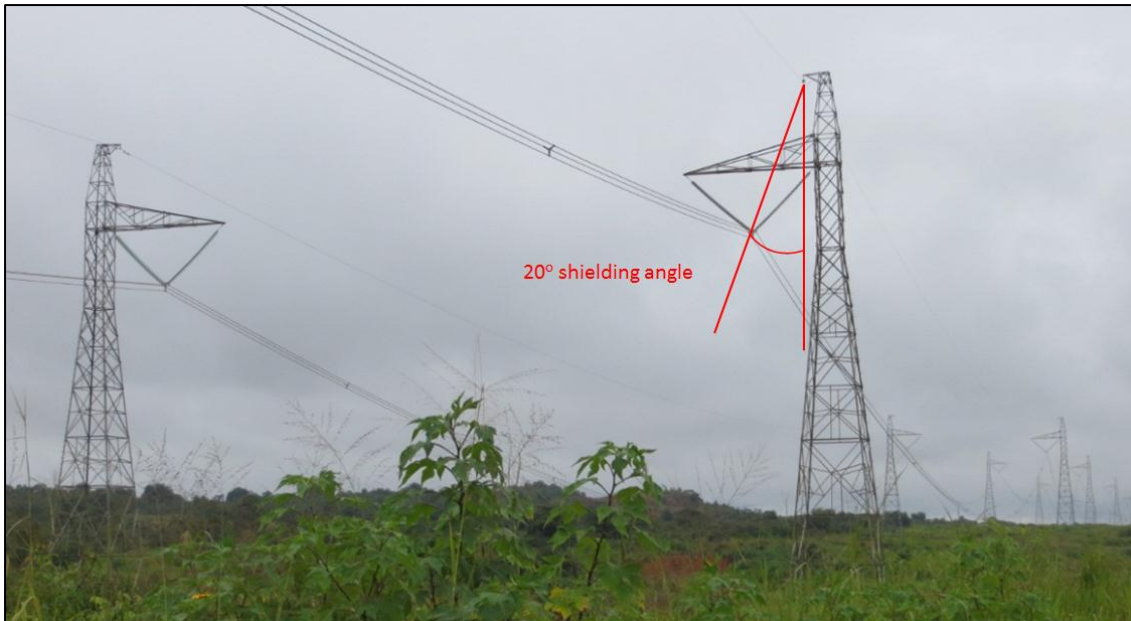
A shielding of  $20^\circ$  is indicated in the *Figure 15*. As is the case with the Cahora-Bassa HVDC line, the Inga-Kolwezi structures are not laterally symmetrical and the position of the shield wire has been offset from the centre of the structure to improve the shielding of the pole conductor.

**Figure 15: Mono-polar structures of the Inga-Kolwezi HVDC scheme<sup>11</sup>.**

In this scheme, the pole conductors are separated by a modest 60 m. The close separation of the two poles significantly influences the mutual lightning shielding effects between the two lines. This has the effect of reducing the shielding failure rate in the zone of interaction between the two shield wires, where the shielding effects of the two overlap. Leaders approaching from the outside of the two mono-polar lines encounter a negative shielding angle of  $-20^\circ$ , and shielding failure is improbable.

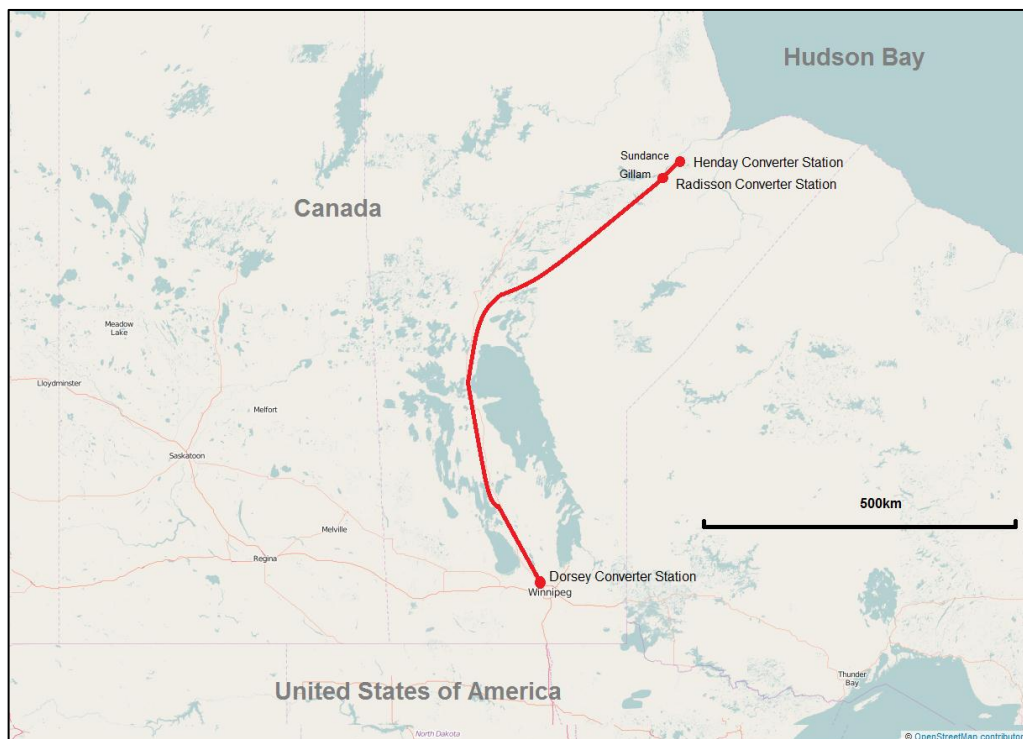
All other HVDC schemes besides Cahora-Bassa and the Inga-Kolwezi are constructed on bipolar structures for reasons of economy, and in order to minimise land usage. Bipole 1 is rated at  $\pm 463.5$  kV and runs nearly 900 km from the inverter station “Radisson” to a rectifier station “Dorsey”, near Winnipeg, Manitoba, whilst Bipole 2 is rated at  $\pm 500$  kV and is about 40 km longer, running between the inverter station “Henday” and “Dorsey” (Figure 16).

**Figure 16: Route of the Nelson River HVDC scheme in Manitoba, Canada<sup>12</sup>.**

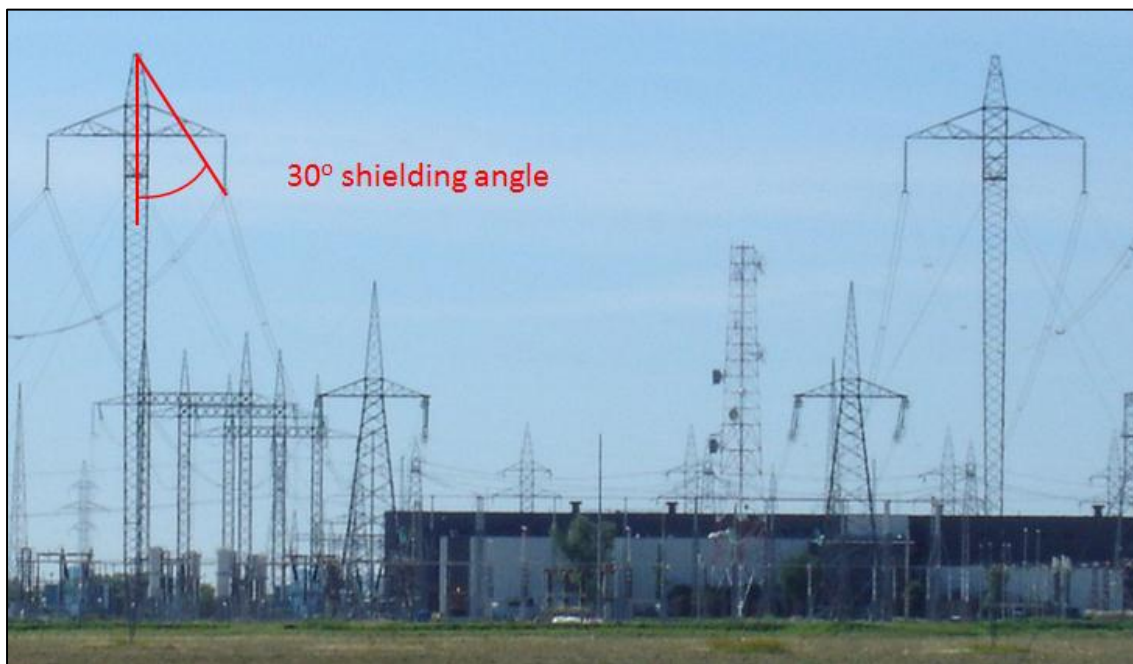
Operationally, the two inside pole conductors are of positive polarity. The pole conductors are separated by only 60 m (Rizk 2012), therefore the inside pole conductors experience enhanced lightning shielding compared to the outside negative pole conductors in an analogous way, as described for the Inga-Kolwezi scheme. Similar to Inga-Kolwezi, this configuration is not conducive for comparing the performance between the positive and negative polarities since the lightning shielding of the two poles is not equal.

**Figure 17: Structures for the Nelson River number 1 and 2 bipoles at Dorsey CS<sup>13</sup>.**

Single lightning shielding wires per bipole are evident in the structure geometry of the Nelson River towers, which results in shallow shielding angles of 30°. A single shield wire reduces costs in terms of the cost of the conductor and also as the resultant reduced loading on the structure saves tower steel mass.

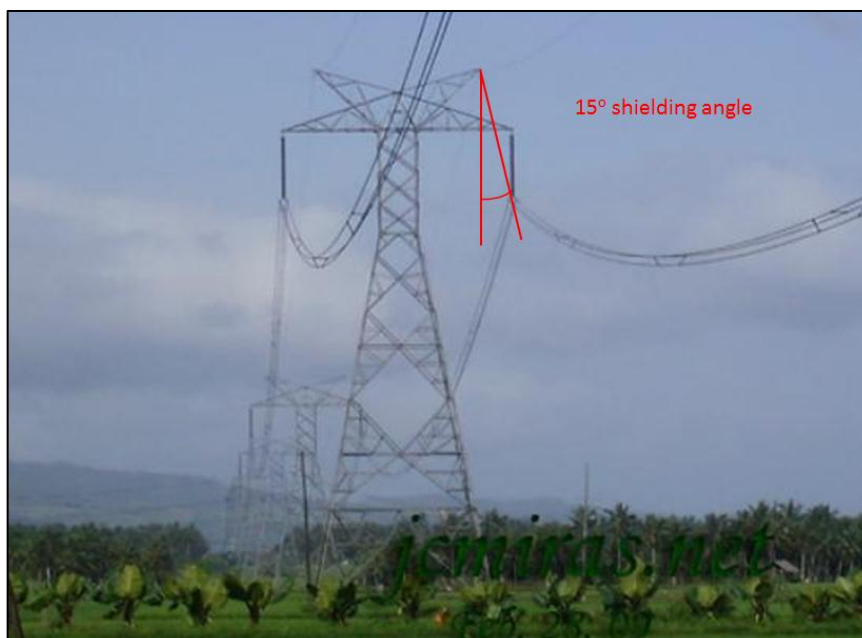
Figure 19: Structures of the Leyte - Luzon HVDC scheme in the Philippines<sup>15</sup>.

Most other HVDC schemes are constructed of bipolar structures that support both positive and negative pole conductors, and are generally isolated from other HVDC lines as shown in *Figure 19* of the Leyte-Luzon  $\pm 350$  kV HVDC scheme in the Philippines.

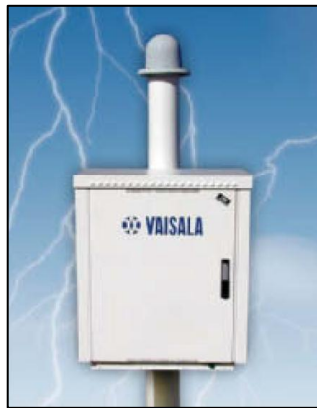
**Figure 21: Vaisala LS700 Cloud-Ground Lightning Sensor (Bardo 2005).**

“Vaisala” is one of the foremost international LDN system suppliers and also owns and operates the U.S. National Lightning Detection Network (Bardo 2005). The sensors (*Figure 21*) were an international performance standard at the time. The LS7000 sensors are designed to detect cloud-to-ground (CG) lightning strokes. Later models such as the LS7002 can also detect Inter-Cloud and Intra-Cloud (collectively IC) lightning discharges; however, these are of lesser practical interest compared to CG strokes that affect ground objects.

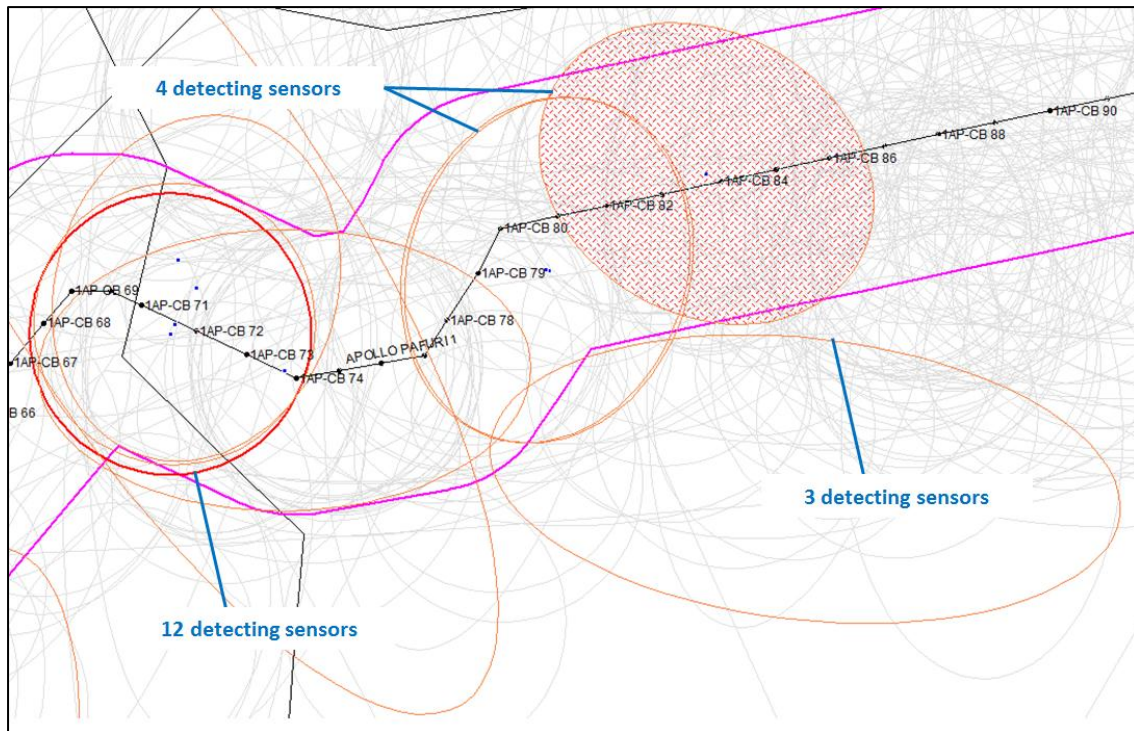
Figure 29: Confidence ellipses for individual strokes detected by twelve, four and three sensors<sup>21</sup>.

If the number of sensors that detect the stroke increases further, the confidence ellipse tends toward a circle. The red circle in *Figure 29* depicts the position of a stroke that was detected by twelve Sensors. The orange ellipses are strokes, which have only been detected by three or four sensors.

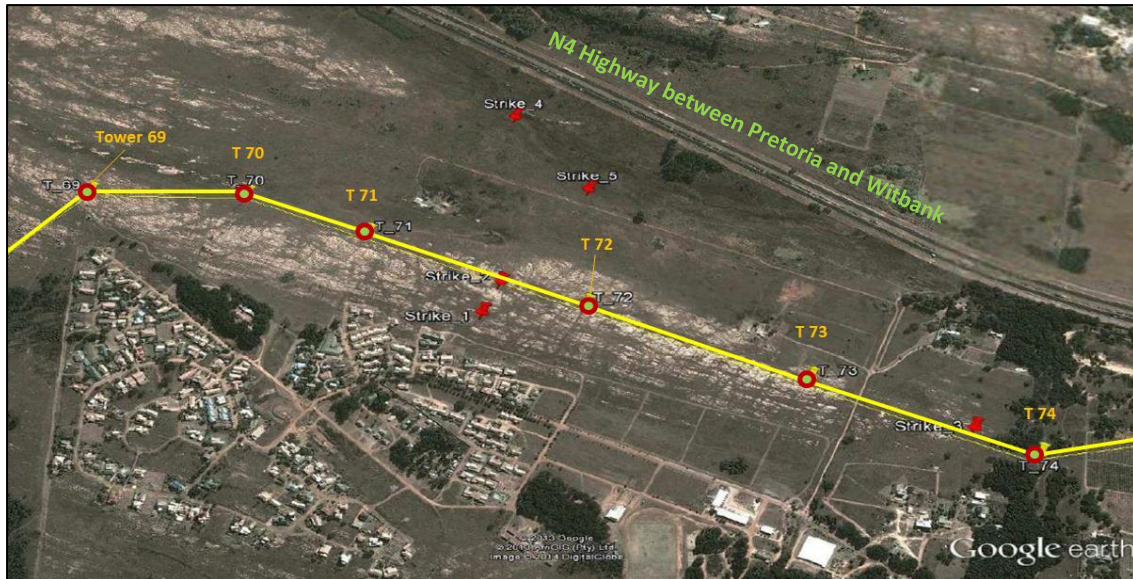
**Figure 81: Aerial view of the affected Line 1 section between towers 69 and 74<sup>45</sup>.**

This section of Line 1 is adjacent to the N4 (Pretoria – Witbank) highway as can be seen in *Figure 81*. Line 1 crosses the N4 highway at this point, between towers 77 and 78, and continues in a North-easterly direction.

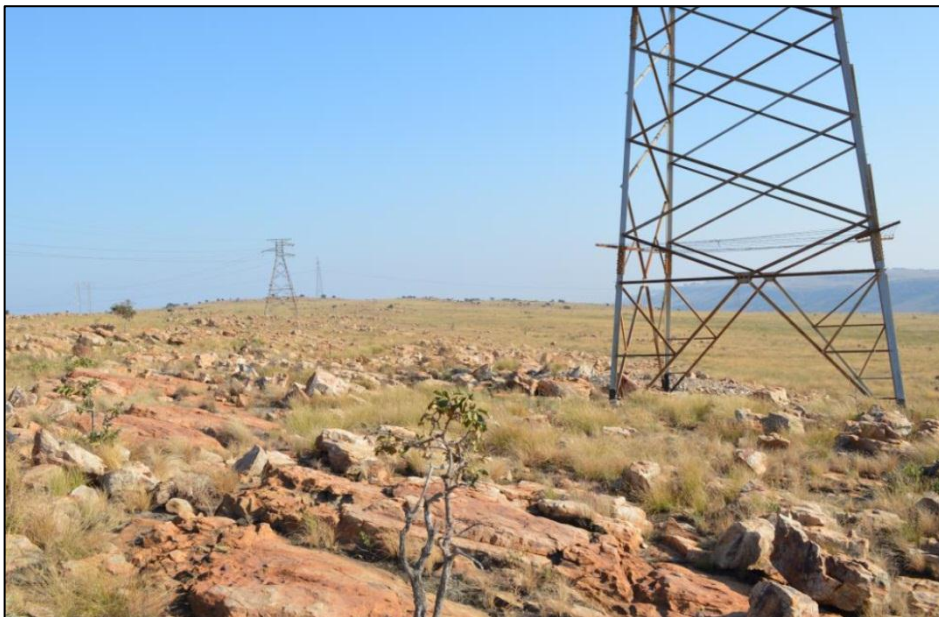
**Figure 83: Typical local geological conditions near towers 69 – 74 (Pretorius 2014a).**

From observation of the surface, the local conditions are consistent with extensive rock outcrops of quartzite as can be seen in *Figure 83*. Quartzite is known to have high resistivities in relation to most other types of rock, and in turn, up to three orders of magnitude higher than most soil types.

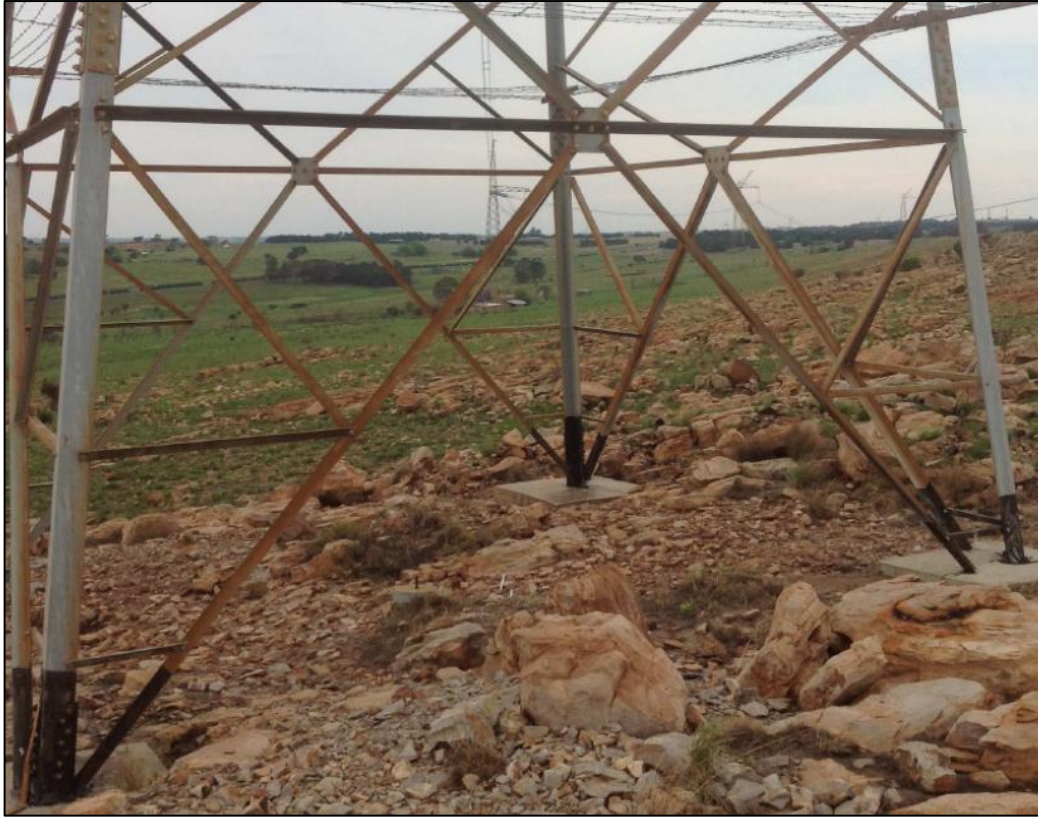
**Figure 84: Soil conditions near tower 69 (Miya, 2014a).**

Several of the towers have foundations in decomposed metamorphic rock as can be seen for tower 69 in *Figure 84*. The locations for towers 72 and 73, exhibit rocky conditions, which are similar to that of tower 69.

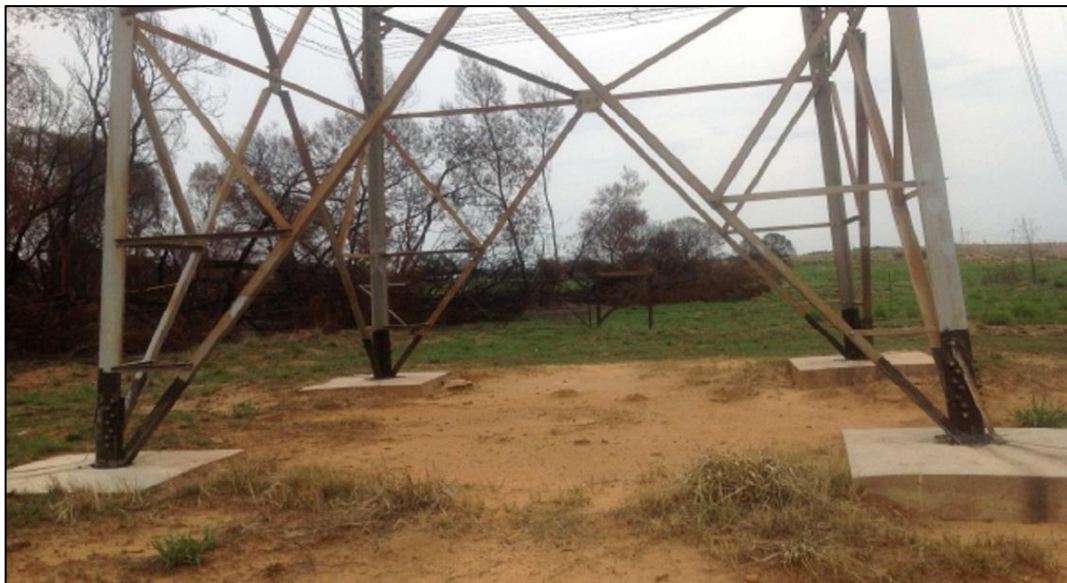
**Figure 85: Soil conditions near tower 74 (Miya, 2014a).**

The area surrounding towers 70 and 71 show evidence of cohesion-less sand with low organic content, mixed with some decomposed rock. Whilst in *Figure 85* of tower 74, sandy conditions without rock are apparent. Both these conditions are associated with high soil resistivities.

The section between towers 69 and 73 is elevated above the surrounding area as the line is constructed along a ridge formed by an exposed rocky outcrop (*Figure 88*). In addition, there are no tall trees or other objects that would screen the line. Whilst, towers 68 and 74 are less exposed and are situated in areas, which are associated with conditions of lower soil resistivity. An example of this can be seen in *Figure 85* of tower 74.

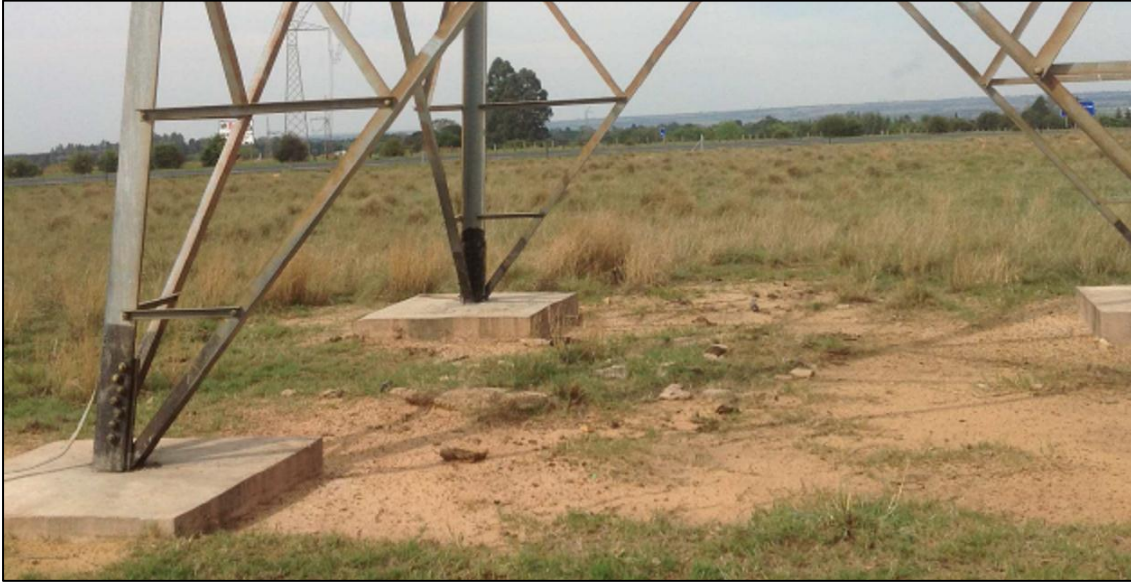
**Figure 86: Soil conditions near tower 77 (Miya, 2014b).**

Tower 77 in the foreground of *Figure 86* is located in sandy conditions similar to the conditions at tower 74. The N4 highway can be seen running between towers 77 in tower 78 in background of *Figure 86*.

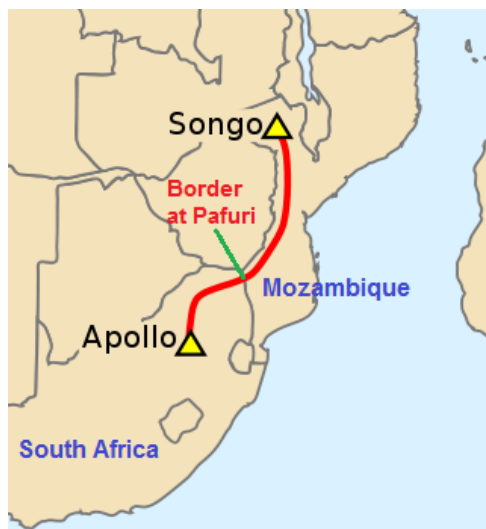
Figure 1: Cahora-Bassa HVDC Scheme

This paper compares the lightning performance between the positive and negative poles of the 500 km South African portion of the 1414 km HVDC scheme between “Songo” hydro power station in Mozambique, and “Apollo” Converter Station (CS) north of Johannesburg, South Africa.
