EFFECTS OF OZONATION ON COOLING WATER SYSTEMS

A research report submitted to the Faculty of Engineering and the Built Environment, University of the Witwatersrand, Johannesburg, in partial fulfilment of the requirements for the degree of Master of Science in Engineering.

Johannesburg, 2010

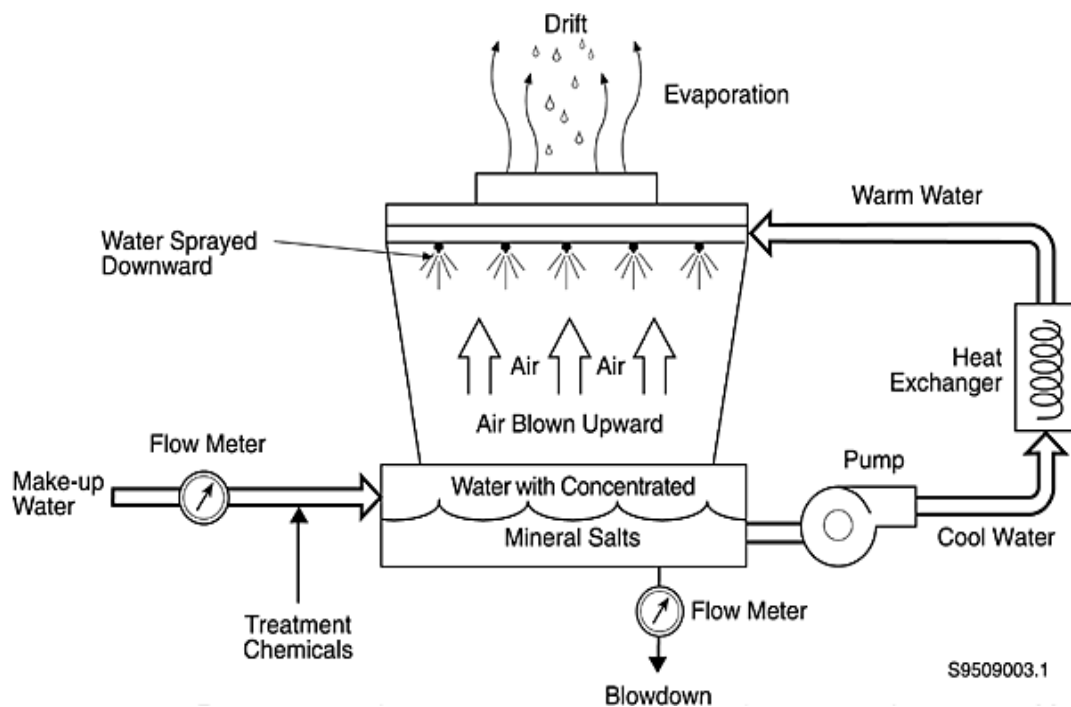
The principle of a recirculating cooling tower is the same whether it is in a power plant or is in an air conditioning system. The cold cooling water is recirculated by the recirculating water pump and heat is transferred to the water in heat exchangers (condensers). The hot water enters the cooling tower at the top. The water is sprayed through nozzles in order to disperse it into small droplets. In open recirculating cooling water systems, the water passes through the heat transfer equipment and is continuously reused. This cooling water circulates to operating units where it picks up heat as it cools the process stream and the resulting warm water is returned to the cooling tower. The main function performed by a cooling tower is to cool the warmed water. During this process, there is exchange of heat with the incoming air flow that is sucked into the cooling tower. Figure 2.1 below illustrates the general operation principle of the cooling tower.

Figure 2.1: Typical Cooling Tower Operation (derived from Seneviratne, 2007:87)

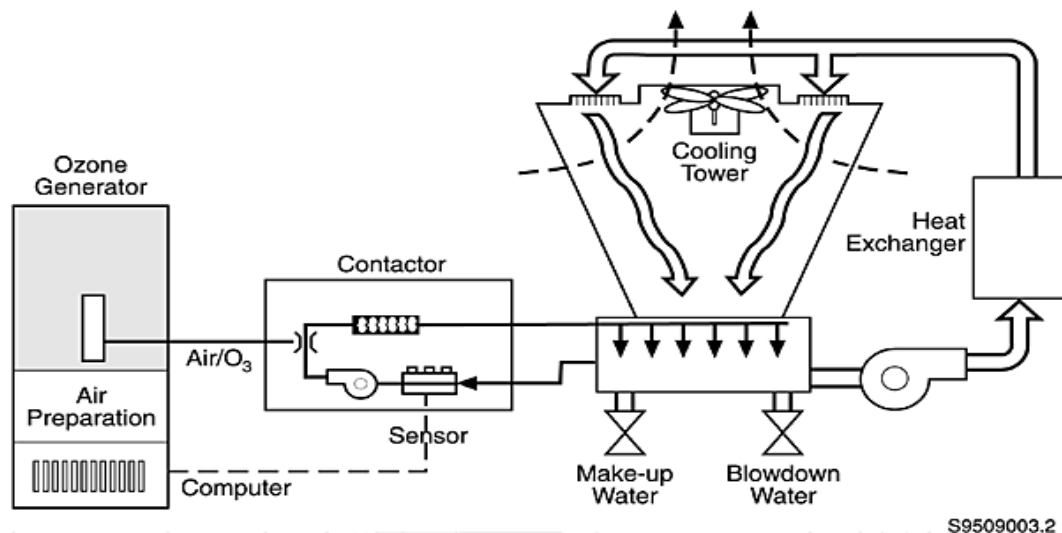
Cooling tower ozone treatment systems include an air dryer, air compressor, water and oil coalescing filters, particle filter, ozone injectors, an ozone generator, and a monitoring or control system. The ambient air is compressed, dried, and then ionized in the generator to produce ozone. Ozone is then applied to cooling water through a side stream of the circulating tower water as is illustrated in Figure 2.2 below.

Figure 2.2: Process for ozone treatment of cooling tower water (Derived from Federal Technology Report, 5)

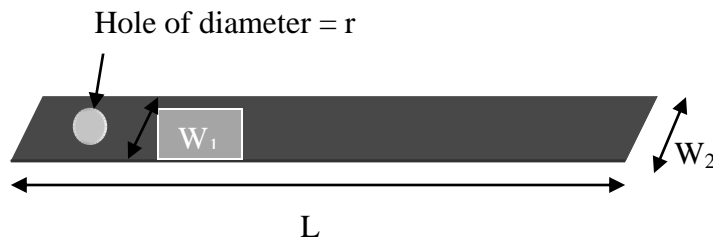
The dimensions of each corrosion coupon were measured using the vernier caliper, and these measurements were used to calculate the surface areas as follows:

Figure 3.1: Drawing of corrosion coupon showing dimensions

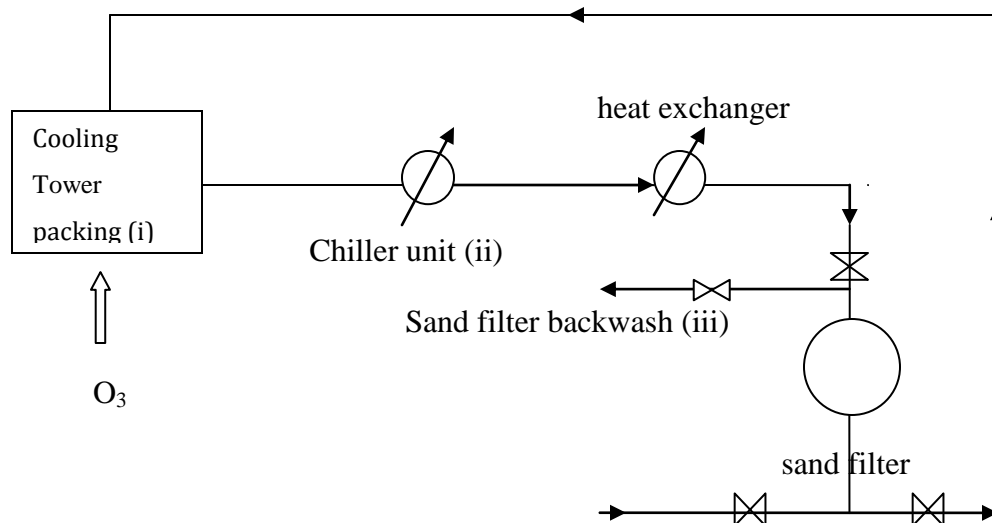
Samples of scale were collected from different places as indicated in the diagram below: i) two samples from the cooling tower packing, D tower which is chemically treated on one occasion and the other part of the experiment it was ozone treated, ii) the chiller unit, D tower, which is ozone treated iii) the sand filter backwash, a D tower circuit which is chemically treated and lastly iv) the air side of a heat exchanger which is on a different plant and the water is chemically treated.

Figure 3.2: A schematic diagram of the cooling tower system

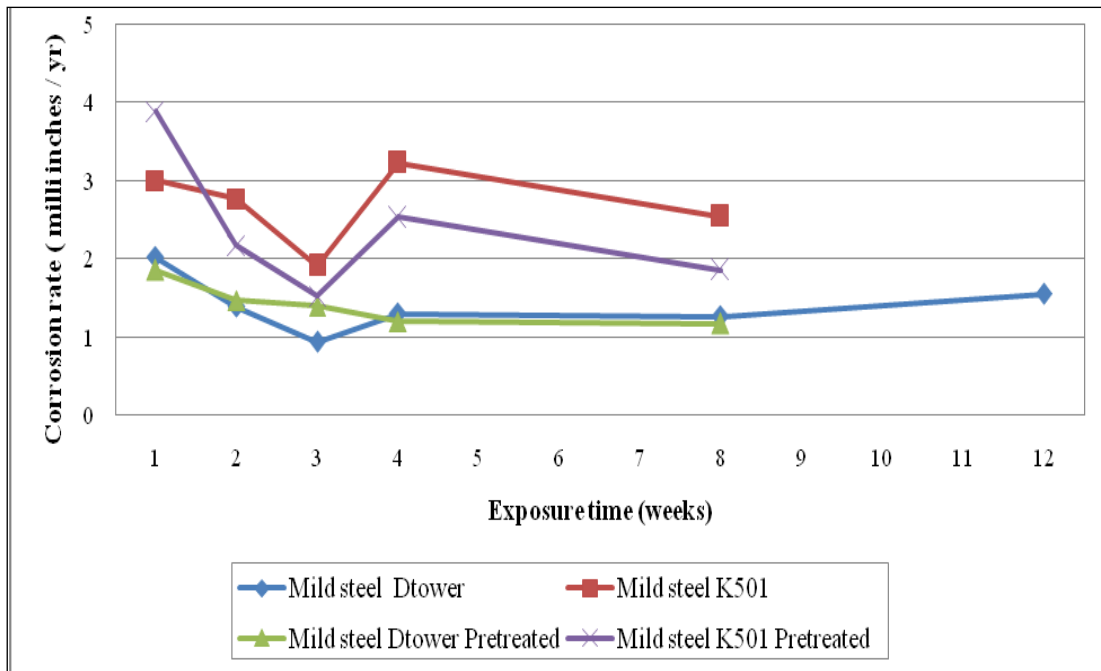
Figure 4.1 Corrosion rates of mild steel exposed to chemically treated water (D tower) and ozone treated water (K501) using measured surface areas

From Figure 4.1 above, there was a decrease in corrosion rate for the first three weeks and after wards there was a peak in the fourth week. Results for mild steel K501, mild steel K501 pretreated and mild steel in D tower for the twelveth week are not included because the coupons could not be retrieved. Mild steel in K501 exhibited highest corrosion rates followed by pretreated mild steel also in K501 and the lowest corrosion rates were observed for pretreated and untreated mild steel in D tower. The pretreated mild steel, which was coated with zinc phosphate as a corrosion inhibitor, in both K501 and in D tower had lower corrosion rate compared to the untreated mild steel in K501 and D tower respectively which implies that the treatment does reduce the corrosion rate.

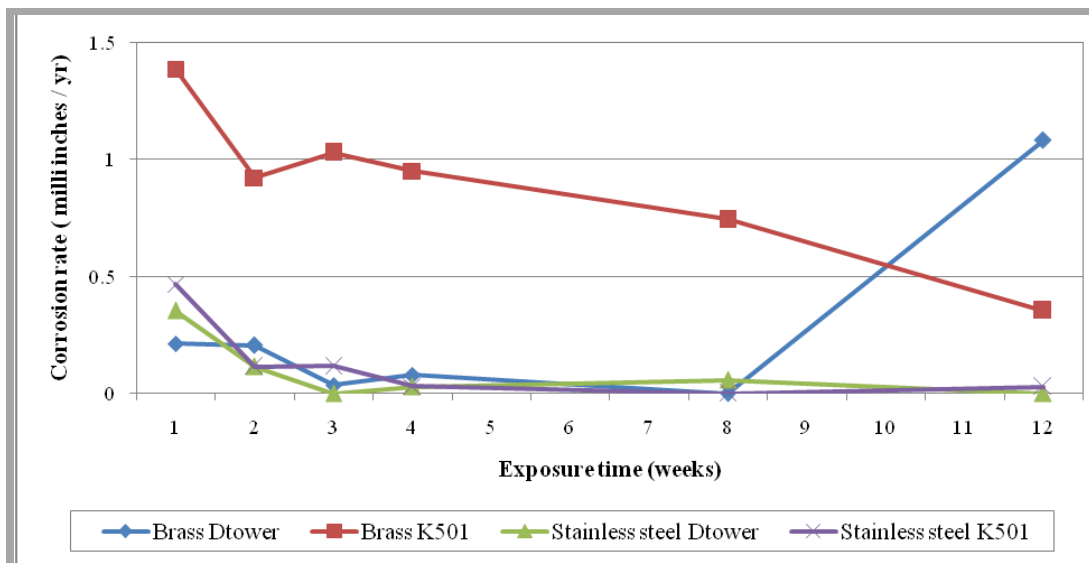
Figure 4.2: Corrosion rates of brass and stainless steel coupons using measured surface areas exposed to both chemically and ozone treated water

Due to the corrosion rates for brass and stainless steel being about an order of magnitude lower than those for pretreated and untreated mild steel, the results for brass and stainless steel have been plotted on a separate graph with appropriate scale. Brass in K501 showed high corrosion rates compared to the brass in D tower except for the twelfth week. The brass coupons in K501 had a black adherent coating from the first week and those in D tower had a much thinner coat of the same black film, but there was no visible corrosion observed. The coating started to reduce in intensity during the fourth week and a brownish adherent corrosion product started forming.

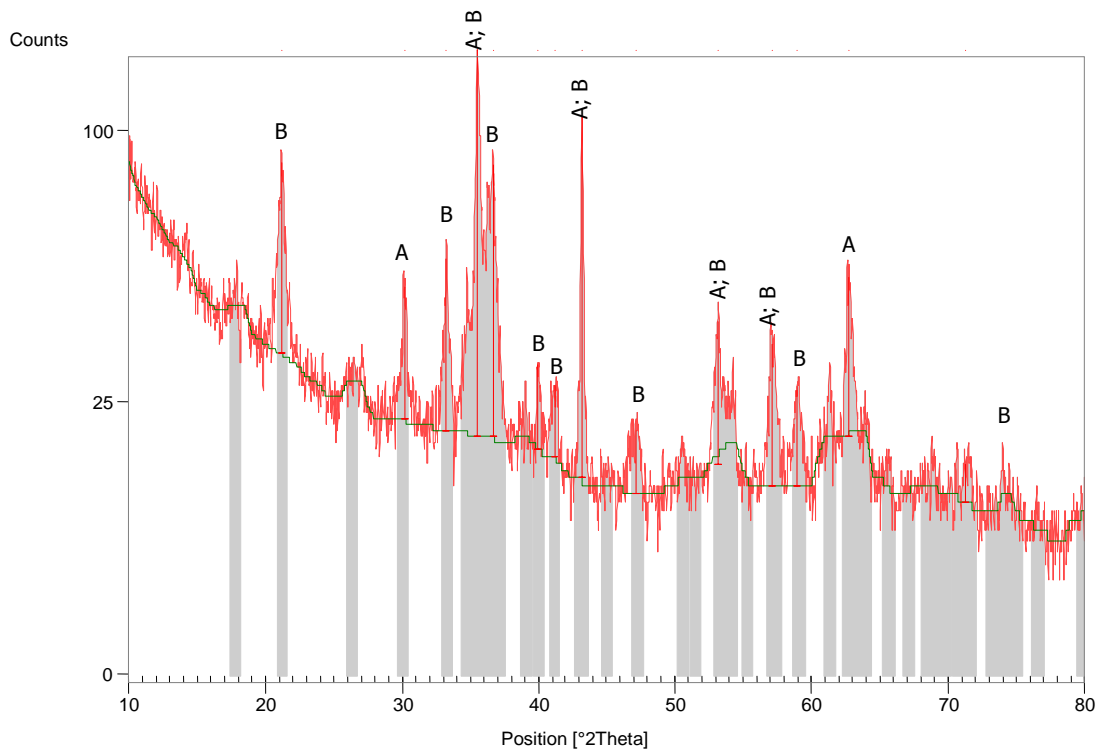
Figure 4.3: Graph showing the components of scale from the air side of a heat exchanger; A zinc iron oxide, B goethite

The scale from the heat exchanger was reddish brown in colour which could be attributed to the presence of iron. The figure above (Figure 4.3), shows that the scale from the heat exchanger consisted of A, (zinc iron oxide, $ZnFe_2O_4$), and B, (goethite, $Fe + 3O(OH)$). According to Valenzuela et al. (2002) the XRD pattern for the samples of $ZnFe_2O_4$ has a pattern similar to the one depicted in Figure 4.3.

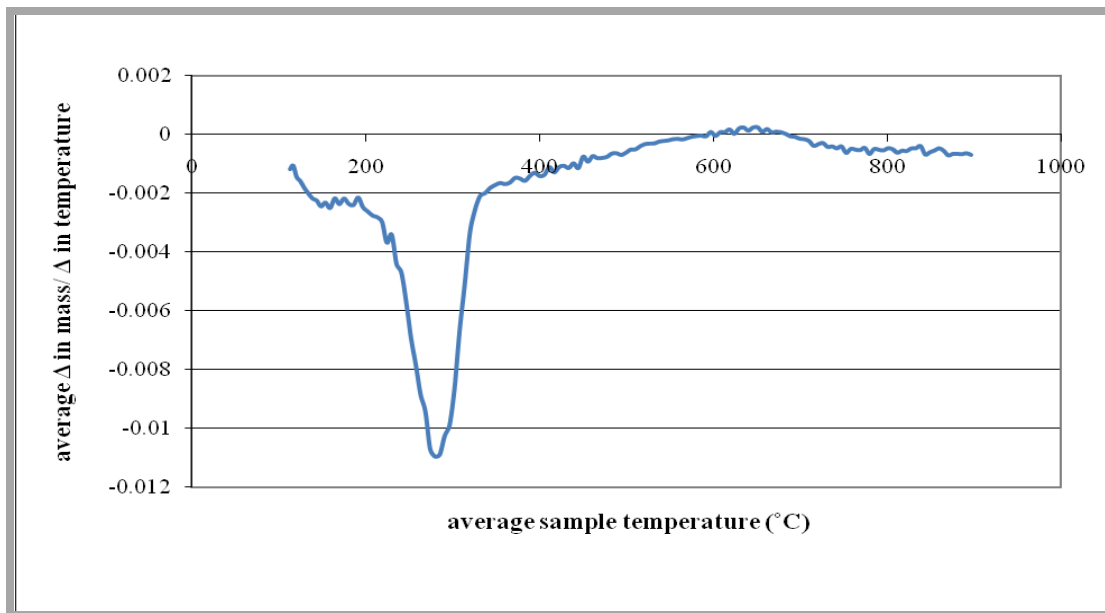
Figure 4.4: Derivative graph for scale sample from the air side of the heat exchanger

According to the thermogram, which is endothermic, there are distinct peaks at 158 °C and 280 °C which is the highest. The first peak at about 158°C is attributed to the removal of adsorbed water. The second peak at 280°C according to Prasad et al. (2006) and Laskou (2006) is due to the dehydration of goethite which starts at 200°C and ends at 360°C. This is in agreement with the XRD results depicted in Figure 4.3 where goethite was detected.

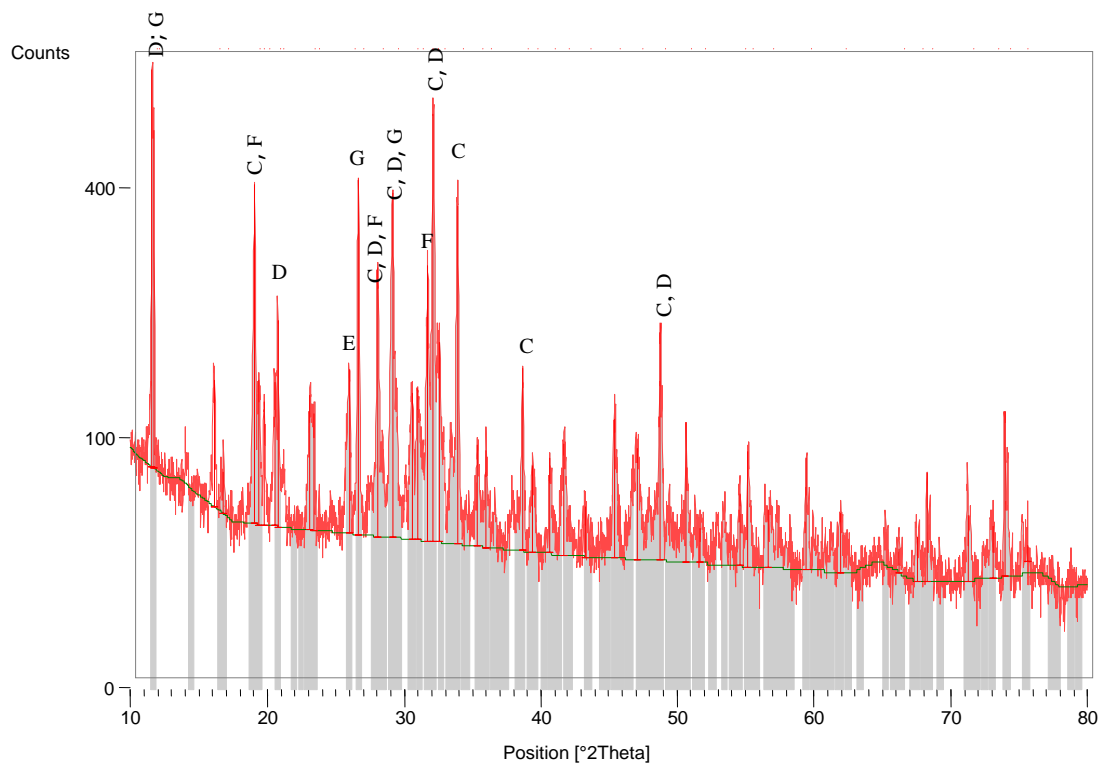
Figure 4.5: Scale components from the cooling tower packing (chemically treated water)

Figure 4.5 above shows that the scale from cooling tower packing had lots of compounds since it is chemically treated. The scale was whitish in colour. The analysis revealed that among the compounds are C, (thernadite, Na_2SO_4), D, (gypsum, $\text{CaSO}_4 \cdot 2\text{H}_2\text{O}$), E, (sodium phosphate, $(\text{Na PO}_3)_6$), F, (potassium iron oxide, KFeO_2) and G, (purpurin hydrate, $\text{C}_{14}\text{H}_8\text{O}_5\text{H}_2\text{O}$). The highest peaks are for the gypsum and purpurin hydrate and the second highest is for thernadite and gypsum. Purpurin hydrate may be indicative of presence of biomass in the sample.

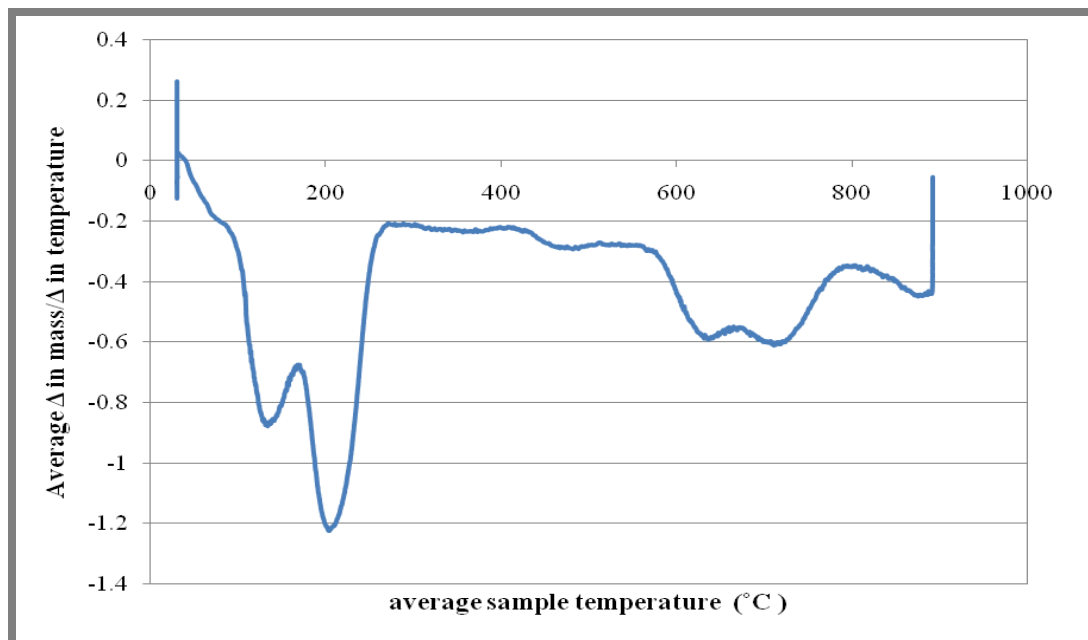
Figure 4.6: Derivative graph for scale sample from the cooling tower packing

The results from the thermogram shows peaks at 126 °C, 197 °C, 472 °C, 622 °C, 703 °C and lastly at 876 °C. According to Adams et al. (1992) hygroscopic water

and hemihydrate water from gypsum is lost between 60 °C and 200 °C which account for the peaks at 126 °C and 197 °C respectively. According to Plante et al. (2009) dehydration of gypsum occurs at 115 °C. Peaks for the release of water, carbon dioxide and SO_x from the compounds are observed at 450 °C according to Warne and Bubrawski (1989) which explains the peak at 472 °C. The peaks above 600 °C may be due to oxidation of the biomass.

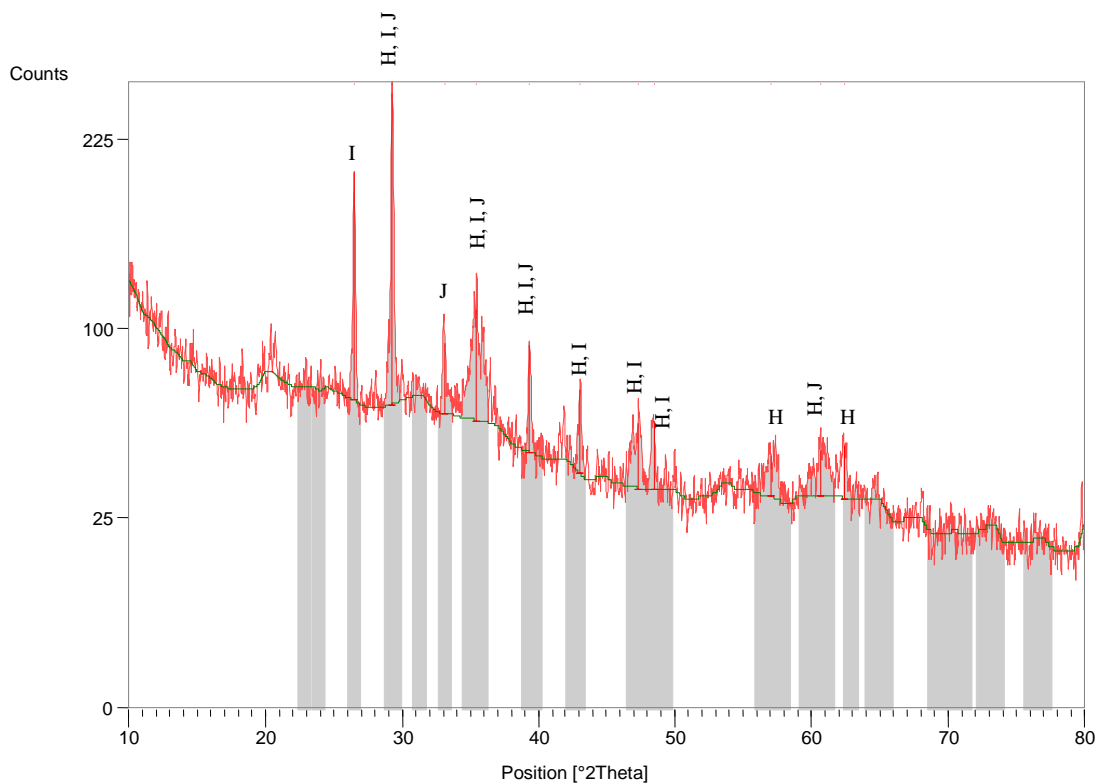
Figure 4.7: X - ray diffraction pattern showing components of the sand filter backwash scale (chemically treated water)

From the x - ray diffraction pattern, Figure 4.7, it is indicated that the sand filter backwash scale is composed of H, (calcite, CaCO₃), I, (calcium oxide, CaO) and J,

(calcium iron oxide, CaOFeO_2). According to Rice and Wilkes (1994) carbon dioxide occurs naturally in water and it reacts to produce carbonates and carbonic acid. During ozonation, the solution is stripped of carbon dioxide and the pH of the solution increases which in turn increases the concentration of carbonate ions. As a result of the evaporation of water, calcium ions are concentrated up in the recirculating cooling water (Rice and Wilkes, 1994; Xyla et al., 1992) so that calcium carbonate precipitates (Brandt et al., 2006; Rice and Wilkes, 1994). According to Shakkthivel et al. (2004) iron ions found in the scale are due to corrosion and they are leached out into the solution that will undergo precipitation.

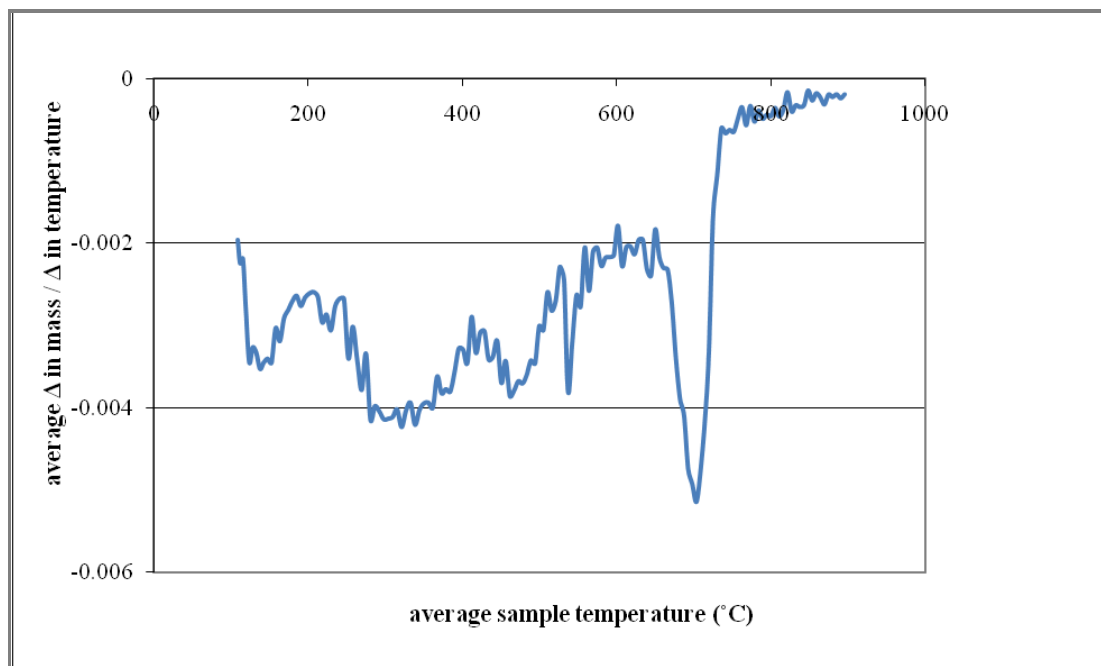
Figure 4.8: Derivative graph for scale sample from the sand filter backwash

The data was averaged and the graph is depicted in Figure 4.8 above. All of the peaks in this graph are an order of magnitude smaller than the peaks in the other TGA graphs. This is why the derivative curve is so noisy. According to the graph, there are extremely small peaks at 138 °C, 330 °C, 461 °C, 537 °C and the highest peak was observed at 753 °C. According to Plante et al. (2009) and Sørensen et al. (2000) calcite decomposes in the temperature range from 750 °C to 990 °C.

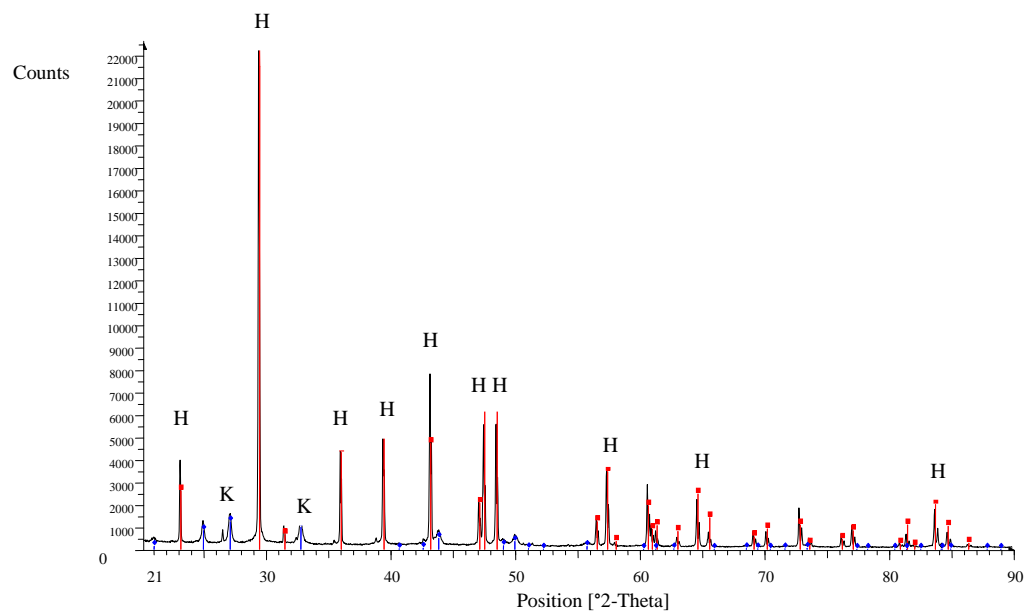
Figure 4.9: X - ray diffraction pattern showing components of the chiller heat exchanger

The x-ray diffraction pattern from the chiller heat exchanger shows that the scale is composed of calcite (CaCO_3), denoted H in figure 4.9 and vaterite, K, (CaCO_3). The highest peak is identified to be calcite and vaterite is mainly small peaks. According to Rao, (1973) and Falini et al. (1998) calcium carbonate can be precipitated as three crystalline phases: calcite, aragonite and vaterite. Calcite is the most stable while the vaterite is the least stable of the polymorphs and it is formed at temperatures below $30\text{ }^\circ\text{C}$ (Rao, 1973; Turnbull, 1973; Chen and Xiang, 2009; Ogino et al., 1987). This is confirmed by the results since this is a chiller unit which operates at lower temperatures. Ogino et al. (1987) and Kralj et al. (1990) state that vaterite is the most soluble and it transforms easily and irreversibly into calcite at $40\text{ }^\circ\text{C}$ when in contact with water and it is the first solid phase of calcium carbonate scale formation. This explains the results in Figure 4.9 above as calcite is the predominant component.

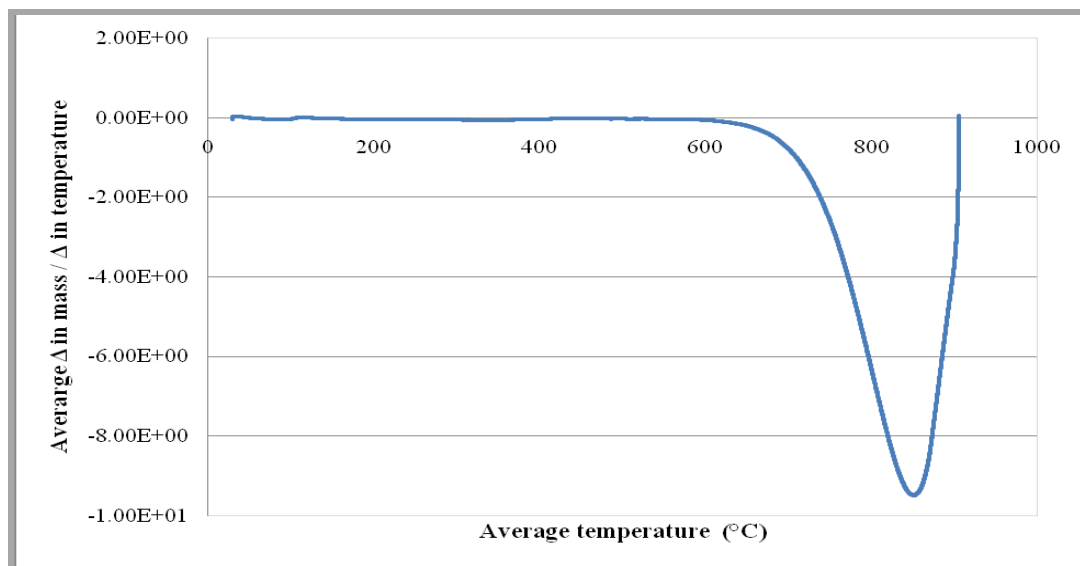
Figure 4.10: Derivative graph for scale sample from the chiller heat exchanger

The results shows that there is only one large peak at 855 °C. According to XRD results, the chiller unit scale is composed of calcite and vaterite. According to Turnbull (1973) vaterite is converted to calcite at 490 °C with no mass loss, while calcite decomposes at temperatures between 750 °C and 990 °C (Plante et al., 2009 and Sørensen et al., 2000). In this curve no mass loss is observed until the single peak at 855 °C. Thus the vaterite is converted to calcite at 490 °C (no mass loss) and then the calcite decomposes at 855 °C .

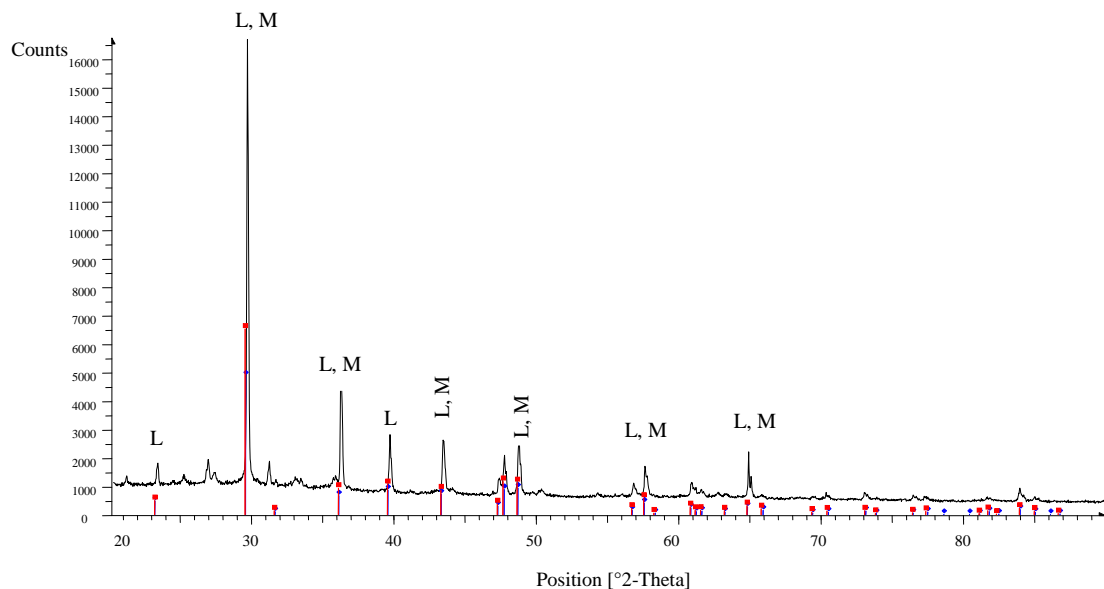
Figure 4.11: X - ray diffraction pattern showing components of the cooling tower packing scale

The x- ray diffraction pattern shows that the D tower scale is composed of mainly calcium carbonate, L, and magnesium calcite, M. The highest peak is the calcium carbonate and the magnesium calcite is identified in small peaks. Magnesium which is used as a corrosion inhibitor can react with carbon dioxide, normally as hydrogen carbonate, which causes carbonate hardness of the water (Brandt et al., 2006). Rice and Wilkes (1994) in their literature reported that even though magnesium ions cannot be oxidized by ozone, the secondary products of ozone treatment can result in insoluble calcium salts which could be the reason for the presence of calcium carbonate in the scale. Further, Nancollas et al. (1982) stated that the presence of magnesium ions tends to inhibit the formation of calcite, preferentially forming magnesium calcite, which is in accordance with the XRD results.

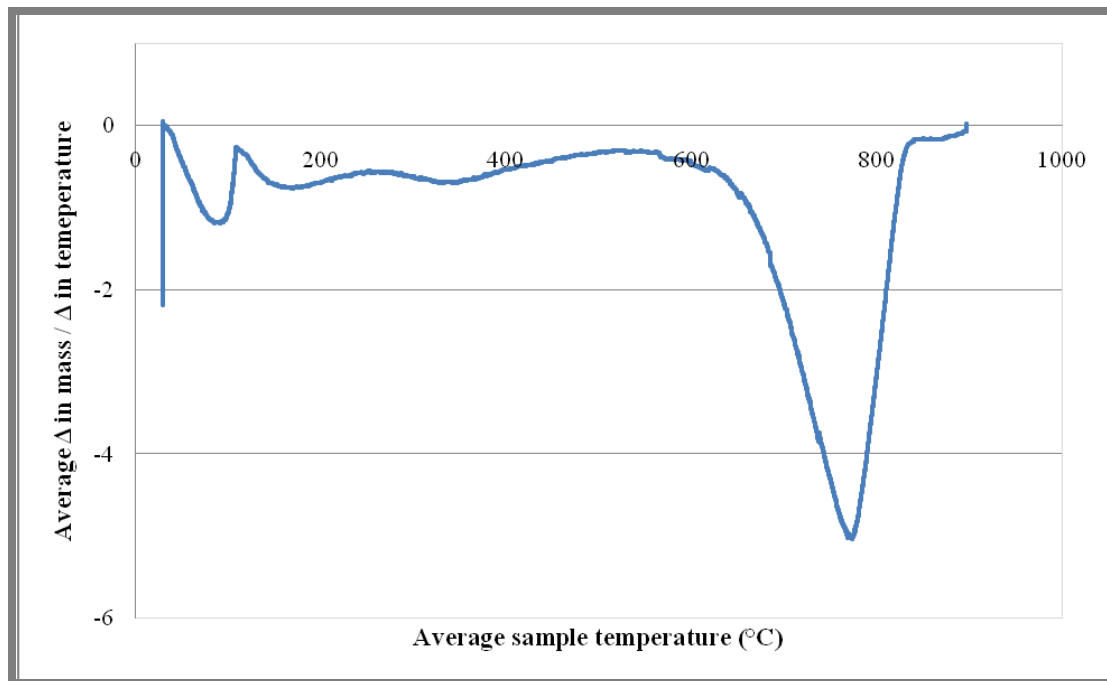
Figure 4.12: Derivative graph for scale sample from the cooling tower packing

The D tower scale is composed of calcium carbonate and magnesium calcite. There are small peaks at 85 °C, 158 °C, 320 °C and a large peak at 765 °C. Adsorbed water is lost at temperatures below 120 °C (Biscontin et al., 2002) explaining the peak at 85 °C. We are not certain what the peaks at 158 °C and 350 °C are due to. According to Pope and Judd (1977) the decomposition of calcium carbonate occurs at 700 °C in air and Biscontin et al. (2002) reported that the loss of carbon dioxide from carbonate occurs at 792 °C.

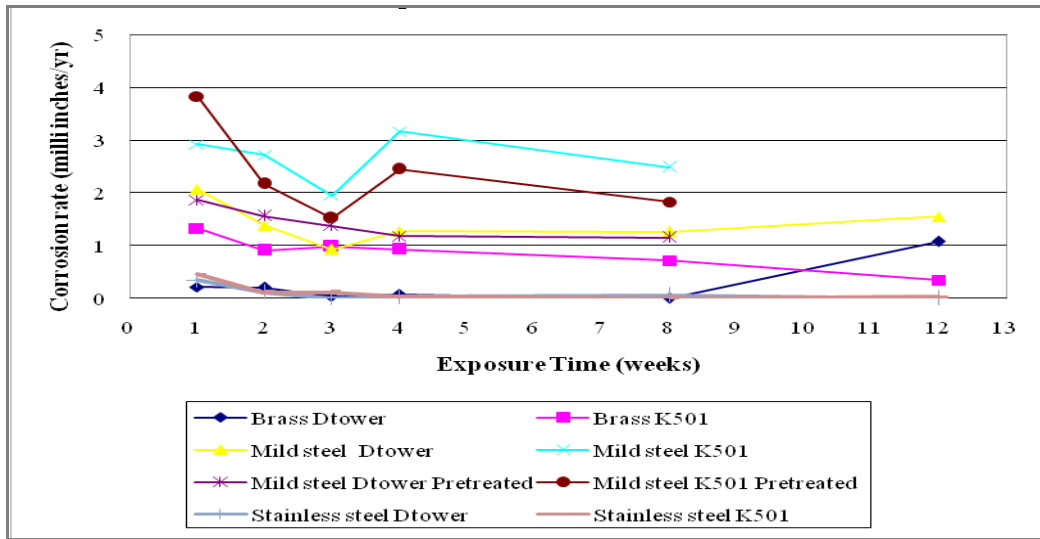
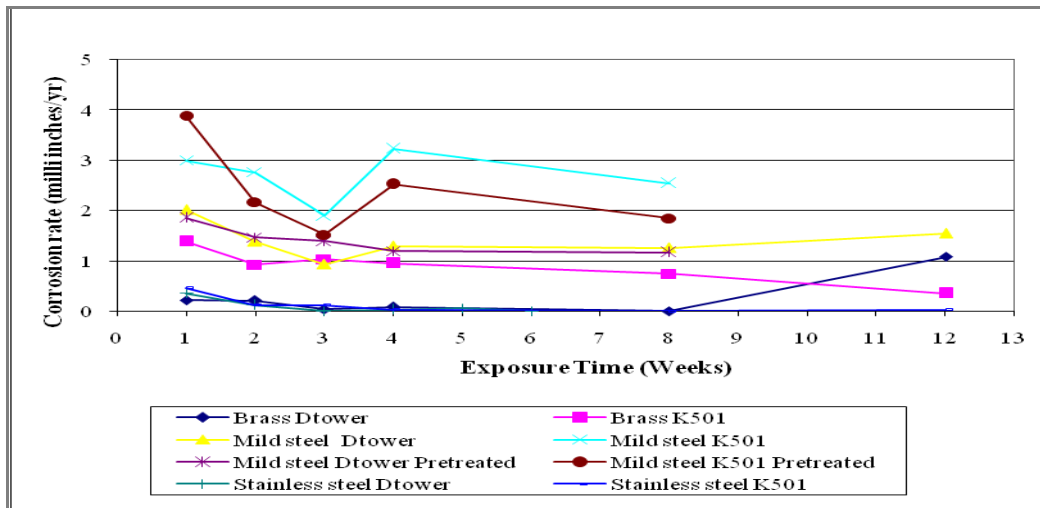
Figure B1 Graph of corrosion rates using calculated surface area for coupons exposed to both ozone and chemical treated cooling water system

Figure B2 Graph showing corrosion rates using measured surface area

The graphs in appendix B shows that mild steel (both pretreated and untreated) in K501 experienced the highest corrosion rate for the whole period of study in both the measured and calculated surface area graphs followed by brass in K501, then brass in D tower and lastly stainless steel. The brass in D tower had higher corrosion rates for 2, 4 and 12 weeks. There was a drop in corrosion rate for brass in K501 at the end of the study period while the corrosion rate of brass coupon in the D tower loop decreased steadily except for the rate measured after 12 weeks which was higher than all the other readings.

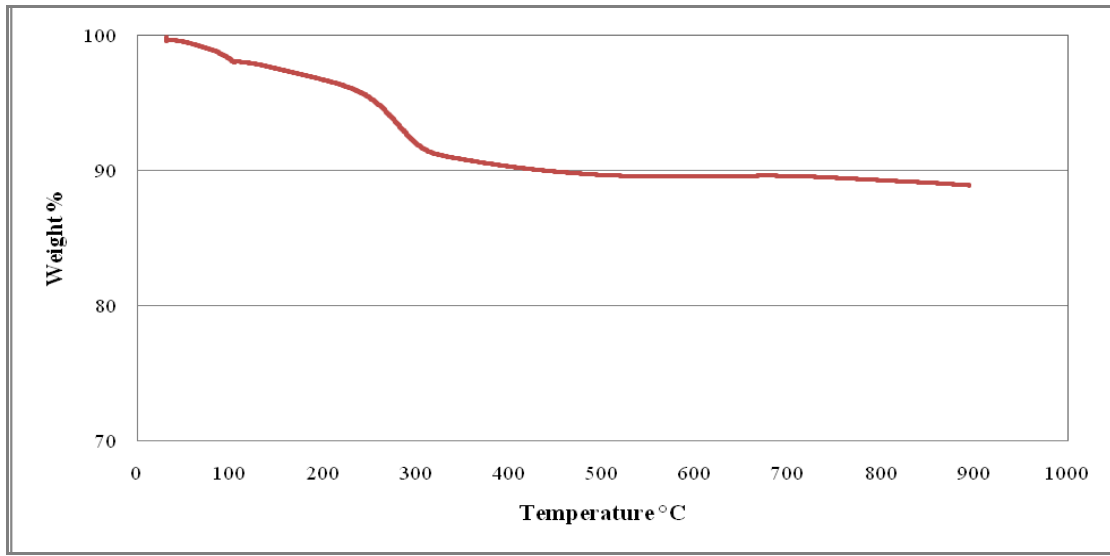
Figure D1 Thermogravimetric analysis of scale from heat exchanger

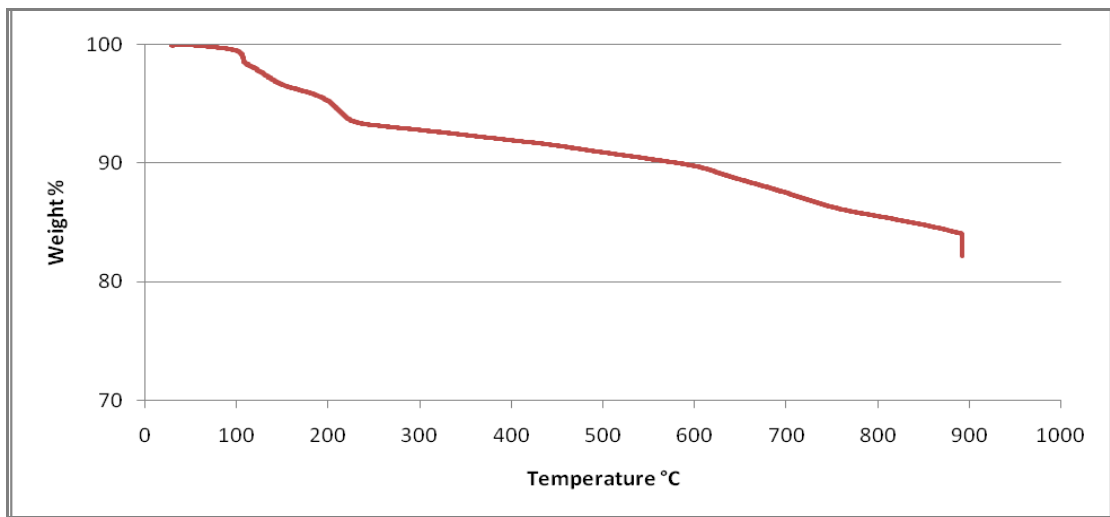
Figure D2 Thermogravimetric analysis of scale from cooling tower packing

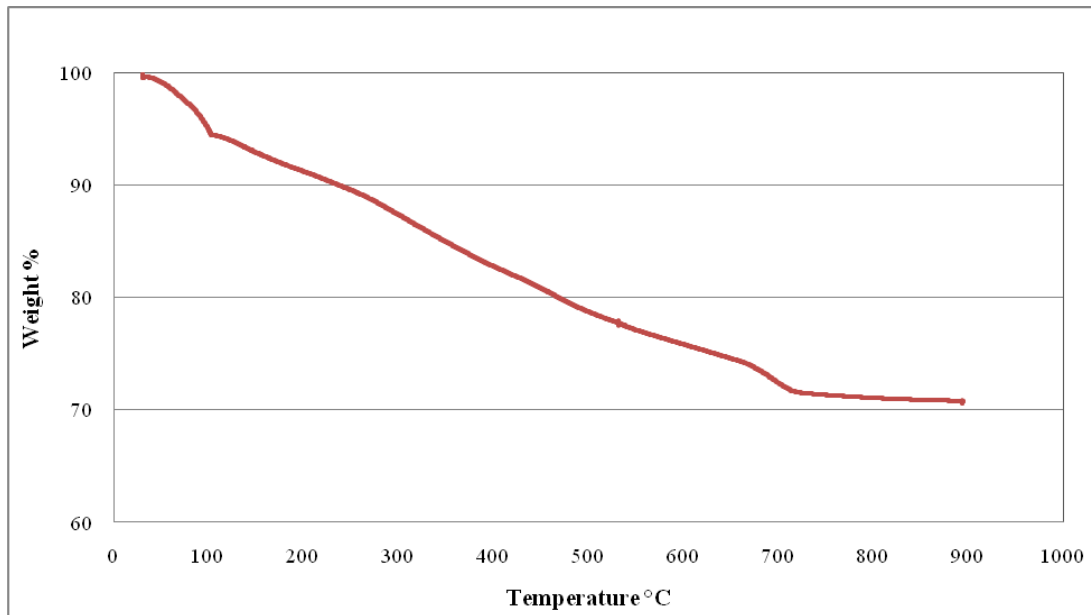
Figure D3 Thermogravimetric analysis of scale from sand filter backwash

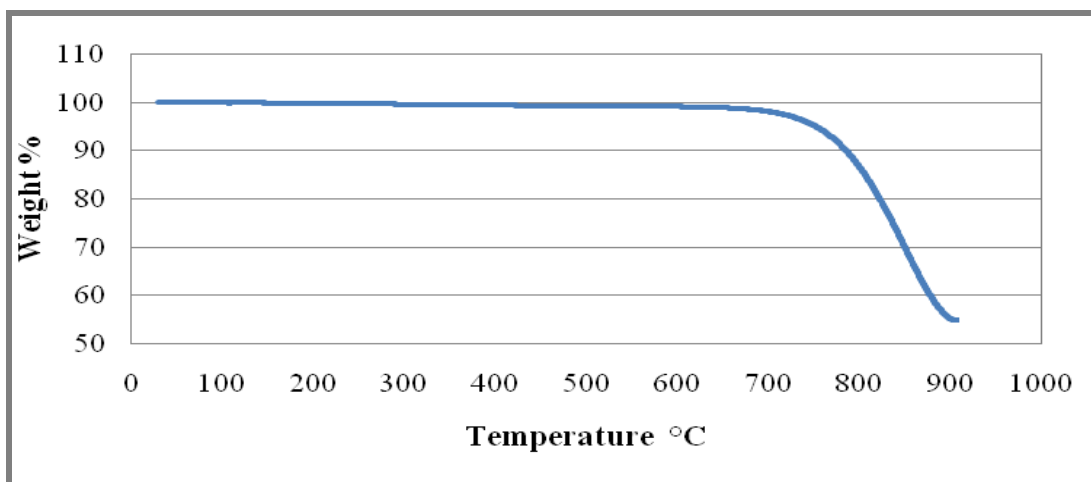
Figure D4 Thermogravimetric analysis of scale from the chiller unit

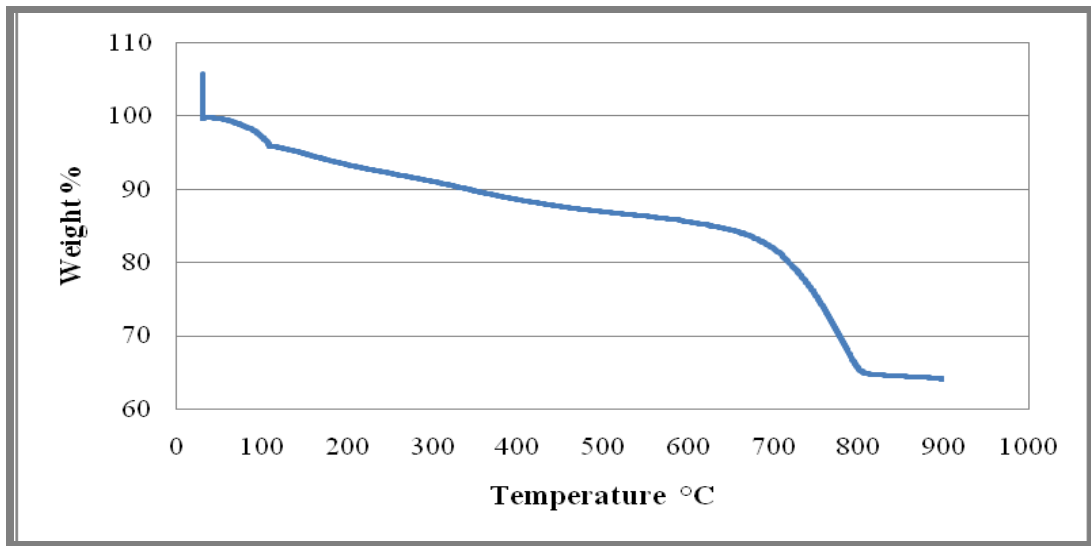
Figure D5 Thermogravimetric analysis of scale from chill tower
