# **Corrosion behaviour of Pt-based superalloys intended for high temperature applications**

*A dissertation submitted to the Faculty of Engineering and the Built  
Environment, University of the Witwatersrand, in fulfillment of the requirements  
for the degree of Masters of Science in Engineering.*

**Johannesburg, 2007**

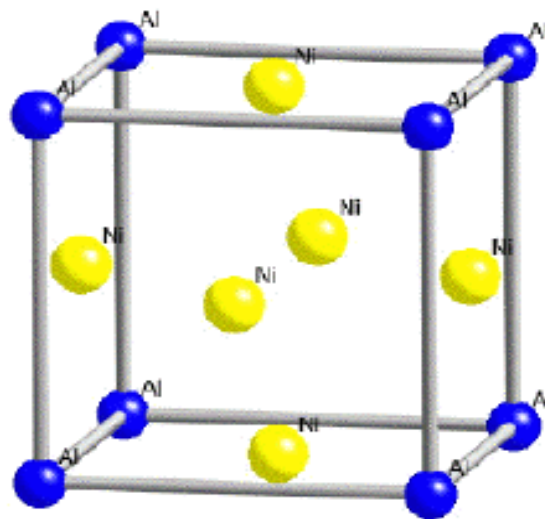
**Figure 2.2 A fcc crystal structure of the  $\gamma'$  precipitate [Bhadesia, 2003]**

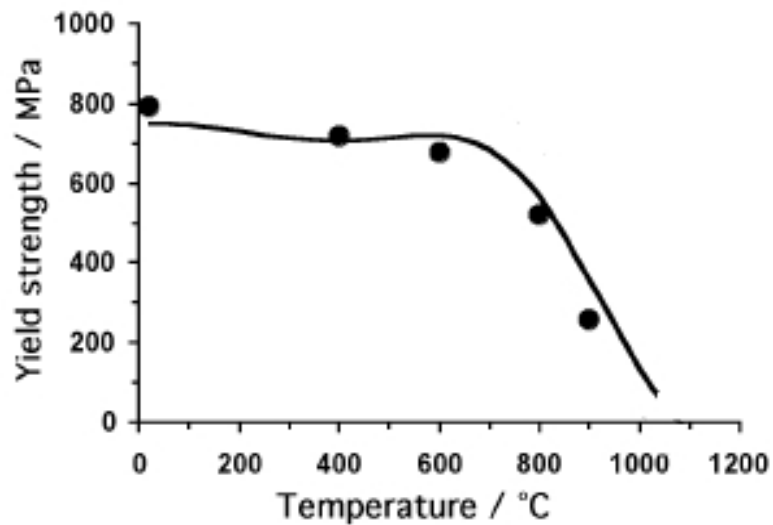
**Figure 2.3 Yield strength versus temperature indicates capabilities of the  $\gamma'$  -phase with increasing temperature [Bhadesia, 2003]**

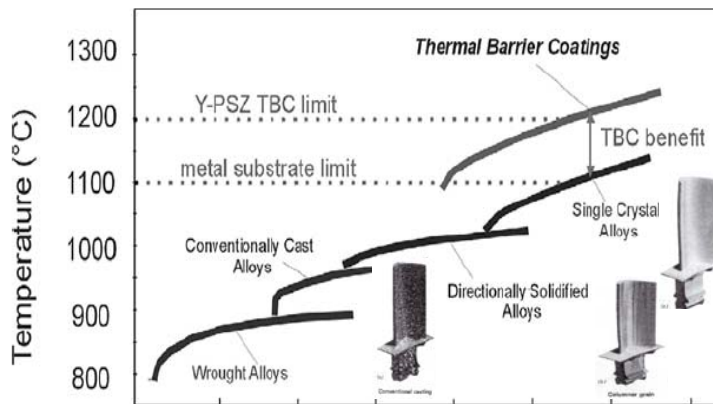
Gradual temperature increases of  $\pm 400^\circ\text{C}$  were obtained over a period of 70 years in the gas turbine industry. As already mentioned, these temperatures were to improve the performance of engines of aircrafts. Figure 2.4 gives a schematic presentation of successful processes that led to the evolution of NBSAs, with 40% of material development contributing towards increased temperatures and 60% attributed by advanced cooling concepts and the use of coatings.

**Figure 2.4 Processing techniques developed to increase working temperatures in gas turbines [Schultz *et al.*, 2003]**

Vacuum melting was introduced in the 1950's. It was through the vacuum melting process where elimination of oxygen and nitrogen from the alloy melt were made possible. This effectively resulted in the formation of improved microstructures of higher purity [Sims *et al.*, 1972; Hertzberg, 1989]. The practice of casting in air or under controlled inert environments was replaced in 1956, when vacuum investment castings were put in place. This technique was used to reduce levels of dissolved gases in the melt, control grain size and improve mechanical properties [Sims *et al.*, 1972]. Powder metallurgy methods were used to produce components that were difficult to make through conventional casting methods such as turbine disc rotors.

Granular fracture, creep and thermal fatigue were improved by casting directionally solidified alloys (DSAs). DSAs were designed such that the grains were aligned parallel to the growth axis. Studies conducted on a directionally solidified superalloy IN-738LC and findings were compared to a conventional cast alloy. The findings showed that mechanical properties of the directionally solidified alloy were significantly improved over conventional alloys [Kermanpur *et al.*, 2000].

Single crystals are a modification of directionally solidified casts. These alloys obtain their strength through the elimination of grain boundaries, and further prevent premature failure that would have occurred when grain boundaries were present. Single crystal alloys have the capability to carry tensile stresses of over 100 MPa at 80% of the alloy's melting temperature [McLean *et al.*, 1999]. Moreover, single crystals alloys have higher melting points and improved creep properties [Bowman, 2000; Bhadesia, 2003]. Today high pressure blades are made out of single crystal alloys.

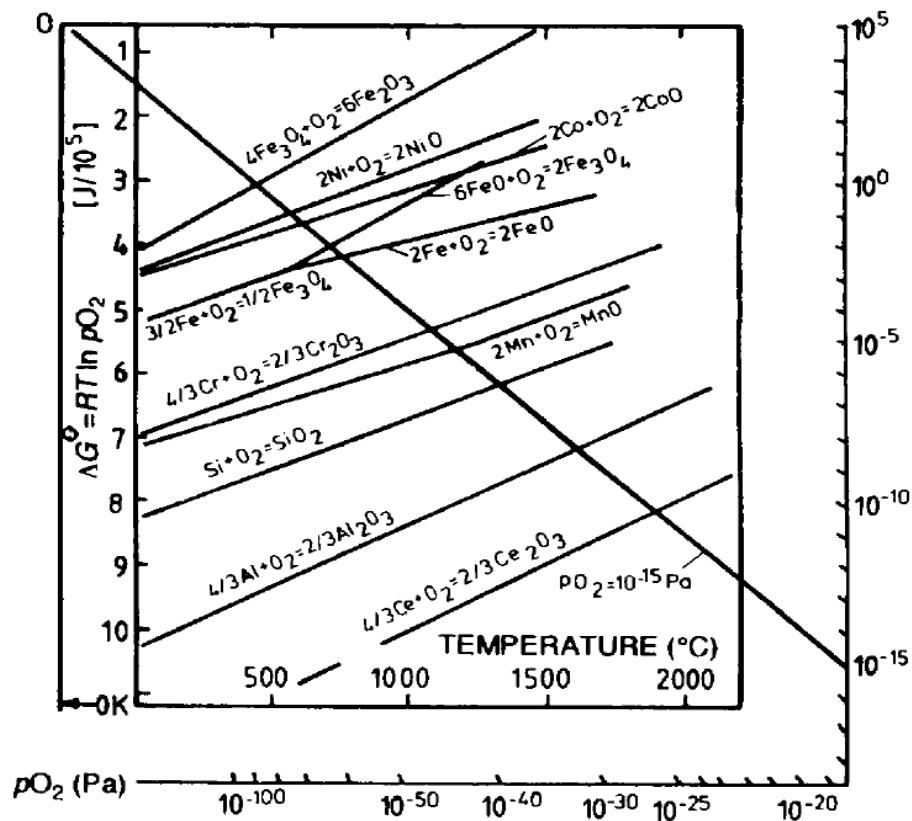
Figure 2.5 Ellingham diagram of oxides plotted against partial pressures [Gaskell, 1981]

Gas turbines operate under oxidizing environments and good oxidation resistance is attained when a tenacious stable oxide layer is formed on the alloy surface. Oxide scale is controlled by both thermodynamic and kinetic factors. Stable oxides have a large negative value for the Gibbs free energy and are summarised in the Ellingham diagram in figure 2.5.

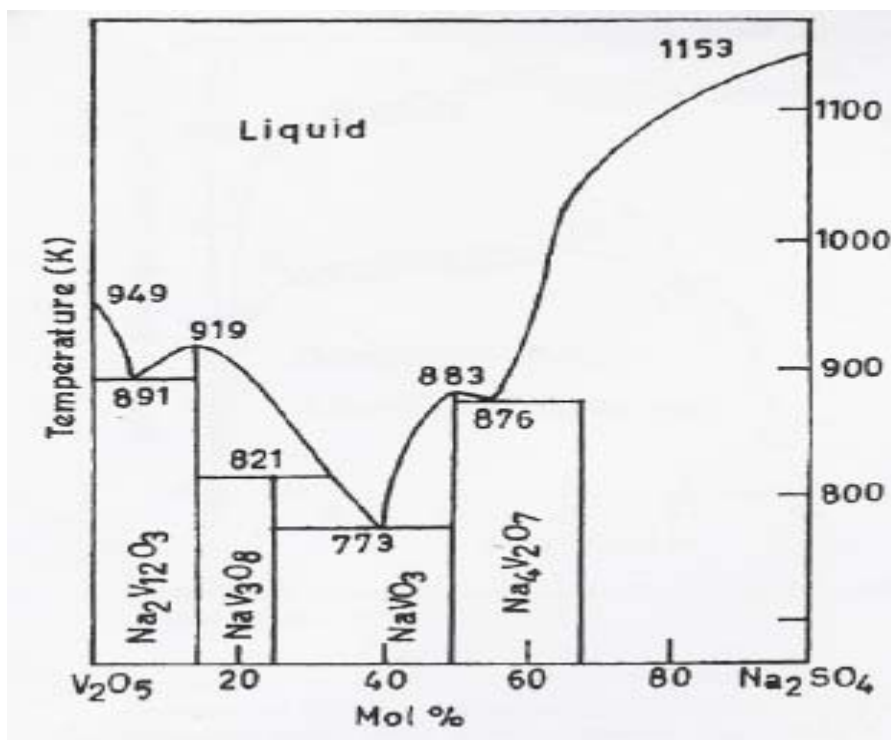
**Figure 2.6 Equilibrium phase diagram for Na<sub>2</sub>SO<sub>4</sub>-V<sub>2</sub>O<sub>5</sub> [Gitanjaly *et al.*, 2002]**

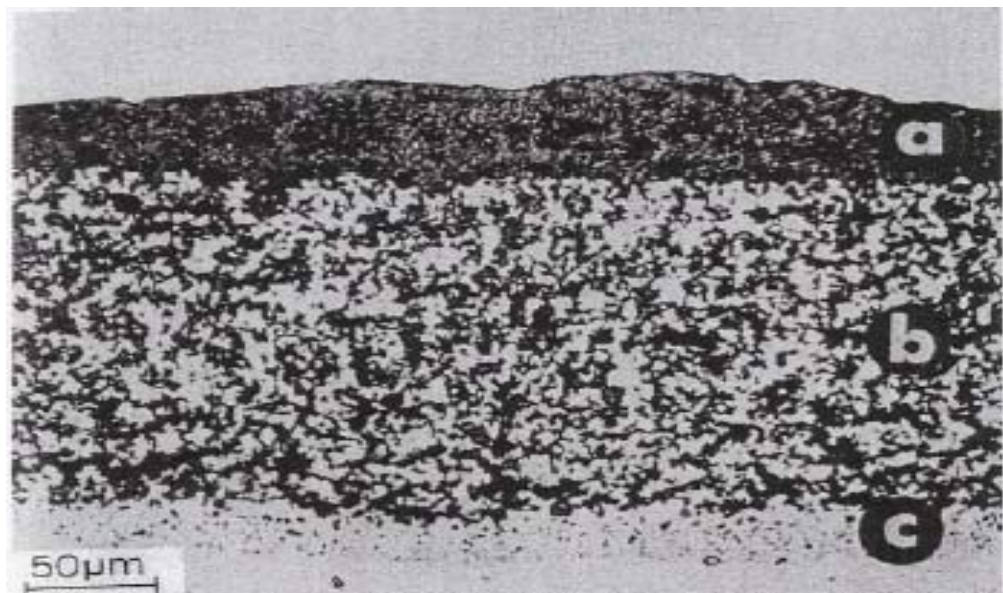
**Figure 2.7 Typical microstructure of type I hot corrosion [Stringer, 1987]**

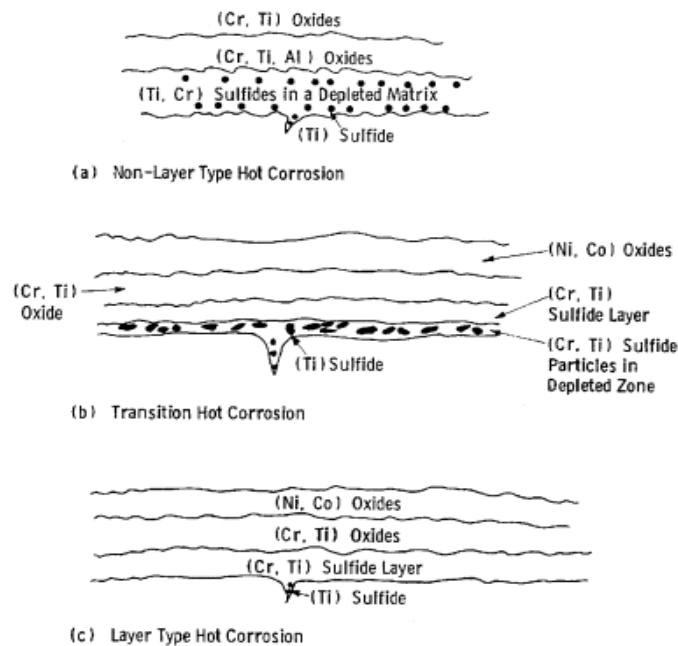
The morphology that results in type II hot corrosion is characterised by pitting attack, with no internal sulphidation. High partial pressures of  $\text{SO}_3$  are required to sustain LTHC [Khajavi and Shariat, 2004]. A case study by Khajavi and Shariat (2004) showed that another form of corrosion, the transition type corrosion, having characteristics of both type I and type II hot corrosion, was possible. Figure 2.8 gives a schematic presentation of the three forms of hot corrosion. Regardless of the type of corrosion, hot corrosion has

Fig. 8. Schematic characterization of corrosion products found at areas typical of the three different hot corrosion regions.

**Transition type hot corrosion c) Layered hot corrosion [Viswanathan, 2001]**

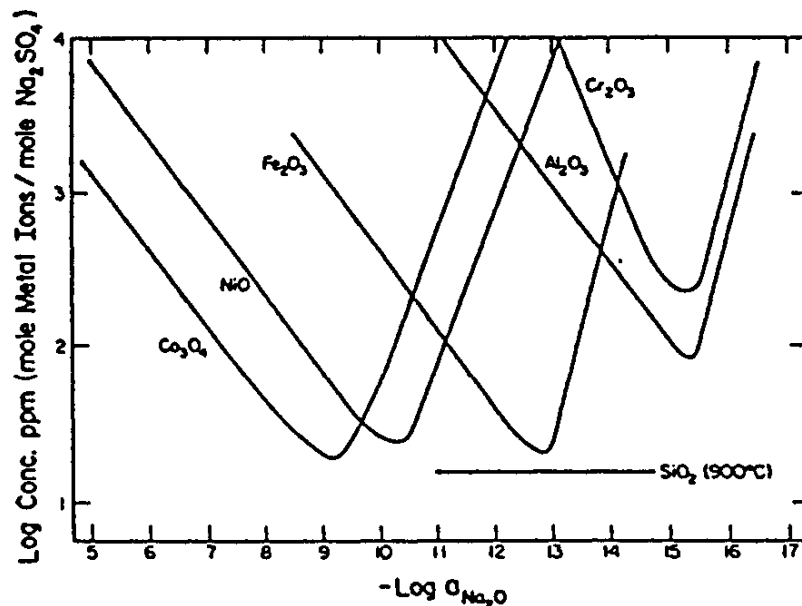
Figure 2.9 Calculated solubilities of metal oxides at 1200 K in molten  $\text{Na}_2\text{SO}_4$  salt [Rapp, 2002]

Metal oxides have an amphoteric behaviour, with the left arm of the curve representing basic dissolution and the right curve representing acidic dissolution of the oxide. Acidic and basic reactions proposed by Cutler (1987) are presented in the equations below.

The dissociation could either be acidic or basic.  $\text{Na}_2\text{O}$  contributes towards the basicity of the salt, while  $\text{SO}_3$  gas forms the acidic component in the salt [Stringer, 1987]. In the presence of molten  $\text{Na}_2\text{SO}_4$  salt, oxides are dissolved and leads to fluxing of the protective scale. Solubilities of different metal oxides were calculated at 1200 K in molten  $\text{Na}_2\text{SO}_4$  salt and are presented in figure 2.9 [Rapp, 2002].

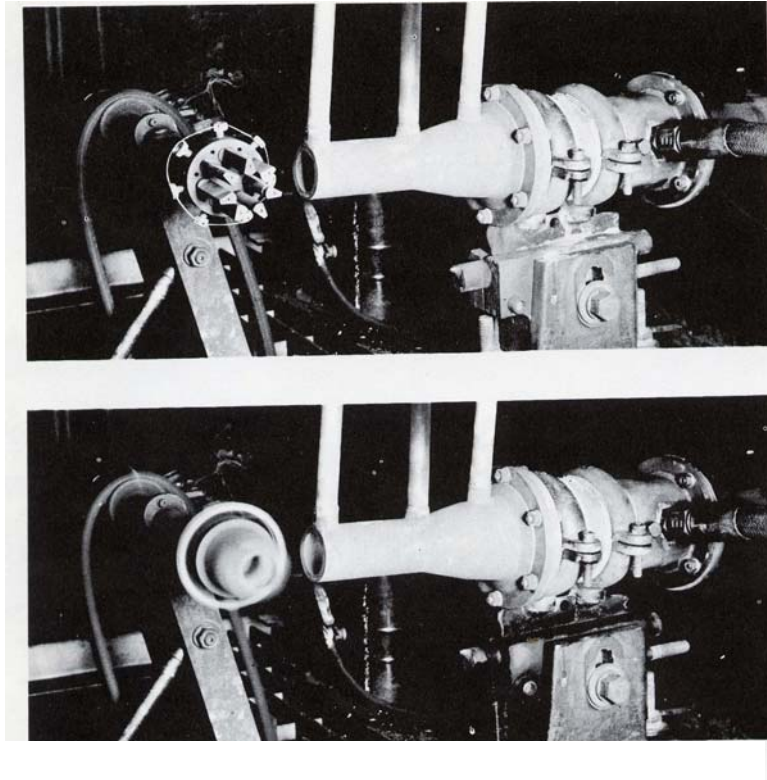
**Figure 2.10 Burner rig test configuration showing a sample under the test [Bradley, 1979]**

Burner-rigs are used to closely simulate the environment in gas turbines. High pressures and high velocities are attainable when using this test. Figure 2.10 shows a simple configuration of the test.

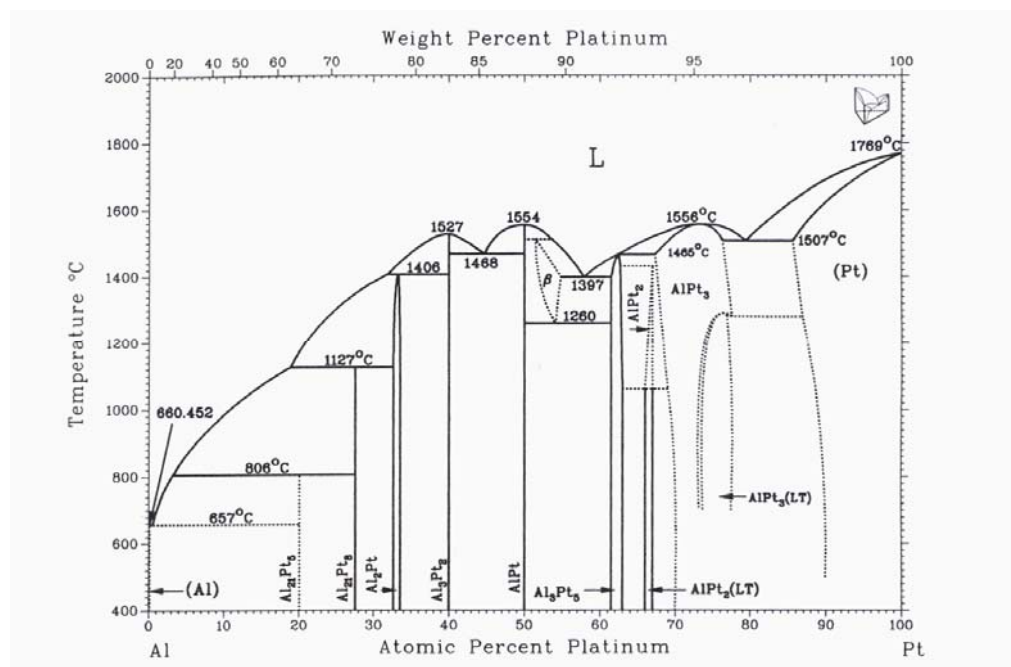
Figure 3.1 Binary phase diagram of Pt-Al system [Massalski *et al.*, 1986]

Studies by Hill (2001) have indicated that Pt-based superalloys with a similar microstructure to NBSAs could be developed. Alloy compositions were determined after an extensive study of the binary and ternary phase diagrams. Figure 3.1 shows the Pt-Al phase diagram, from where the Pt<sub>3</sub>Al phase was derived.

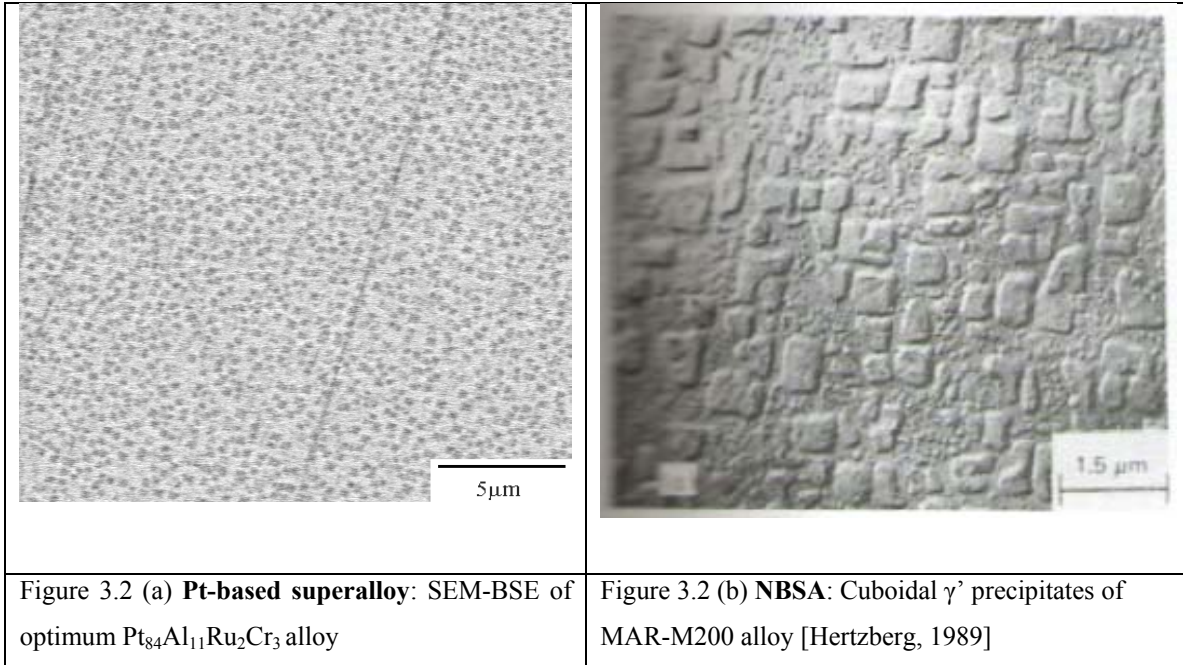
Alloy RS3 was considered the optimum alloy, because it formed cuboidal precipitates, with no primary phase and showed good oxidation properties [Süss *et al.*, 2003]. The comparison between the NBSA and the optimum Pt-alloy is shown in figure 3.2.

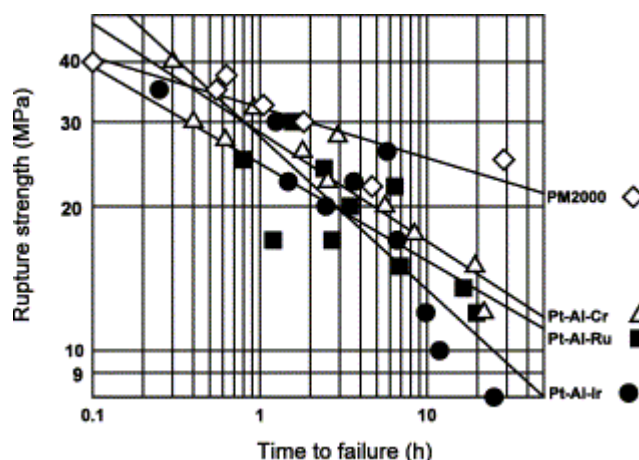
Creep and compression tests performed on Pt-alloys suggested that the alloys had better properties over an ODS Fe-based superalloy (PM2000), as depicted in figures 3.3 and 3.4.  $\text{Pt}_{86}\text{Al}_{10}\text{Cr}_4$  (RS1) had high rupture strength of approximately 835 MPa with good ductility [Süss *et al.*, 2004]. The compressive strength of Pt-Al-X (Where X is Ru or Re) was found to be higher than that of Mar-M247 above 1150°C [Hill *et al.*, 2001] and also has a reasonable hardness. The hardness test results of the evaluated alloys are given in table 3.3

**Figure 3.3 Stress rupture strength of an ODS alloy (PM2000) and ternary Pt-based superalloys at 1300 °C in air [Süss *et al.*, 2002]**

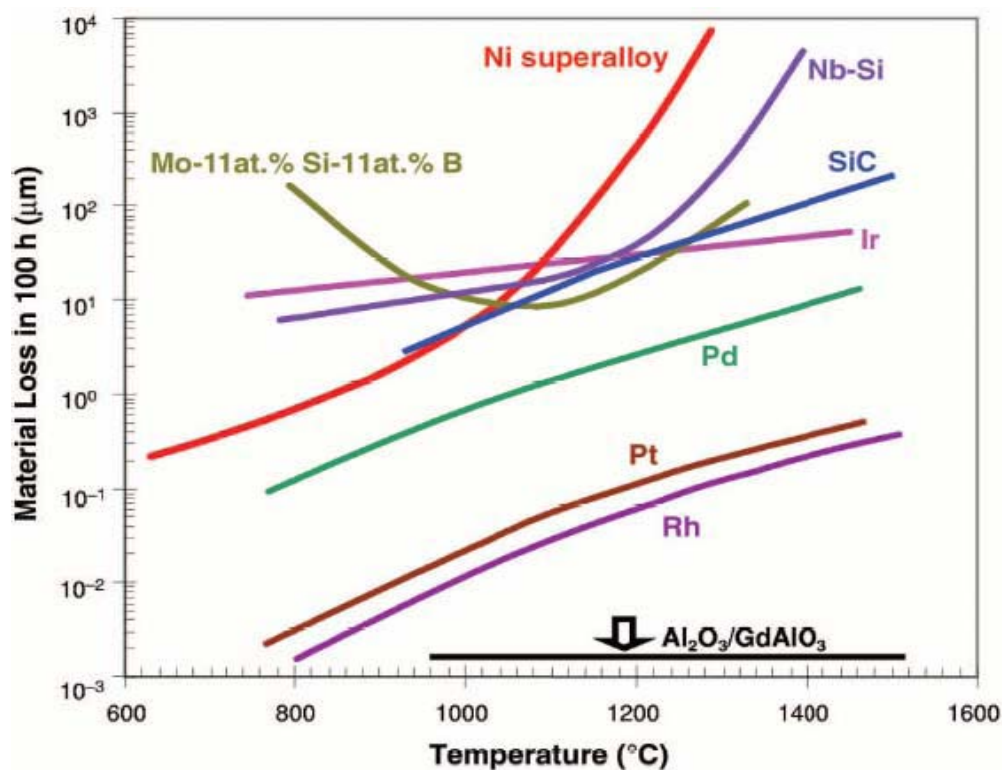
**Figure 3.5** Oxidation resistant material used for high temperature applications [Cornish *et al.*, 2003]

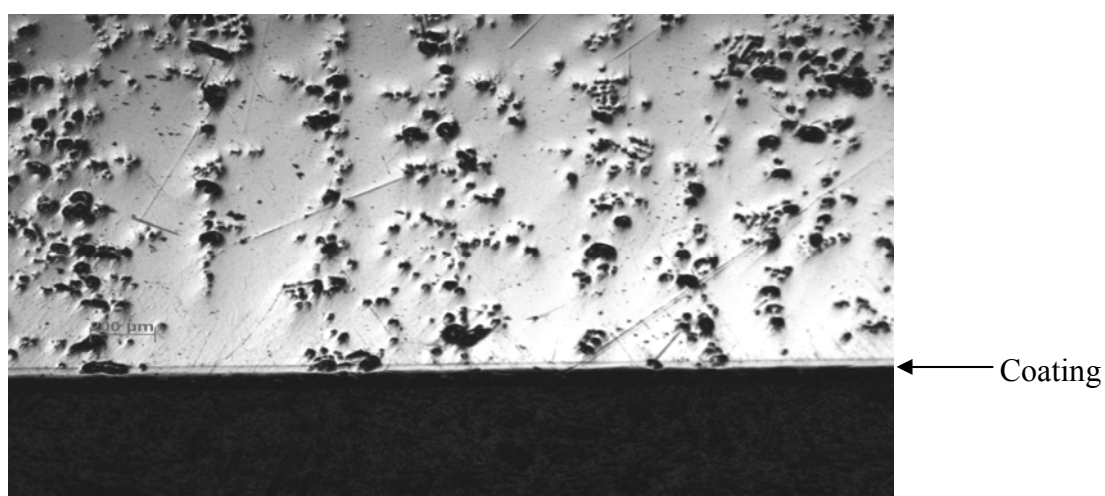
**Figure 4.1 Cross section of a coated Ni-based superalloy in as polished condition showing a thin coating applied on the surface of the alloy**

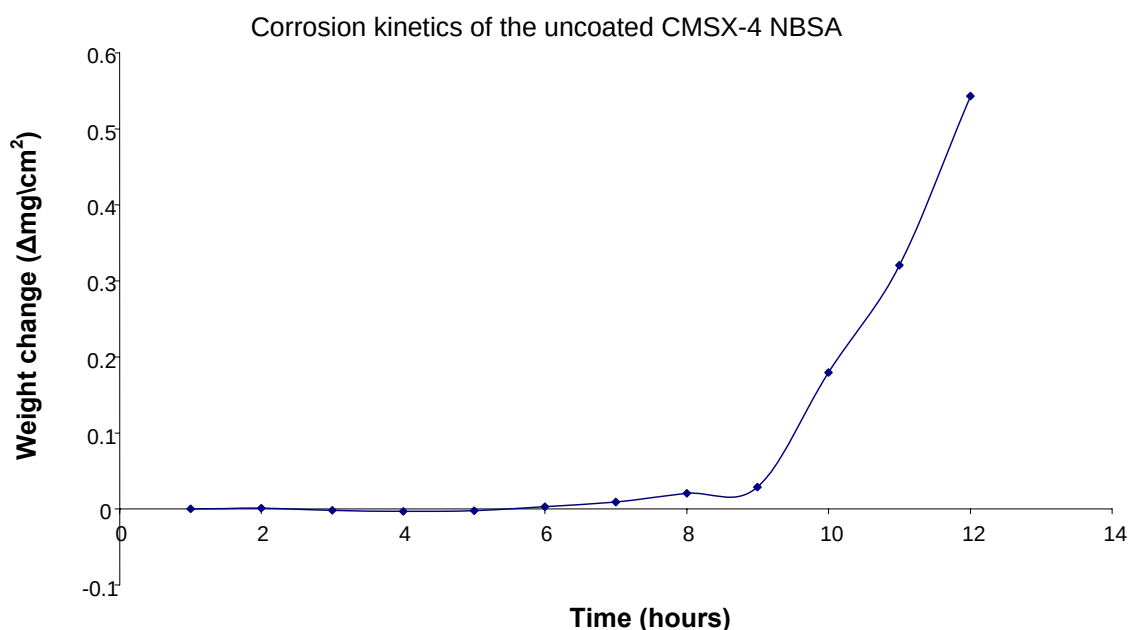
**Figure 5.1 Corrosion kinetics of uncoated Ni-based superalloy (CMSX-4) after exposure to molten  $\text{Na}_2\text{SO}_4$  salt at  $950^\circ\text{C}$**

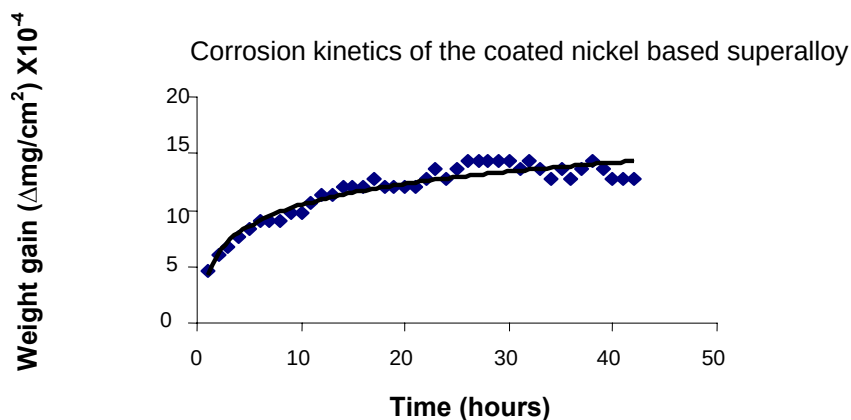
The coated alloy showed better corrosion resistance than the uncoated alloy, following a parabolic rate law as depicted in figure 5.2. No significant changes were observed during the initiation stage. Considerable mass gains were recorded during the propagation stage. The exposure of the alloy was stopped after 540 hours.

**Figure 5.2 Corrosion kinetics of the coated nickel based superalloy after exposing the sample to molten  $\text{Na}_2\text{SO}_4$  salt at  $950^\circ\text{C}$**

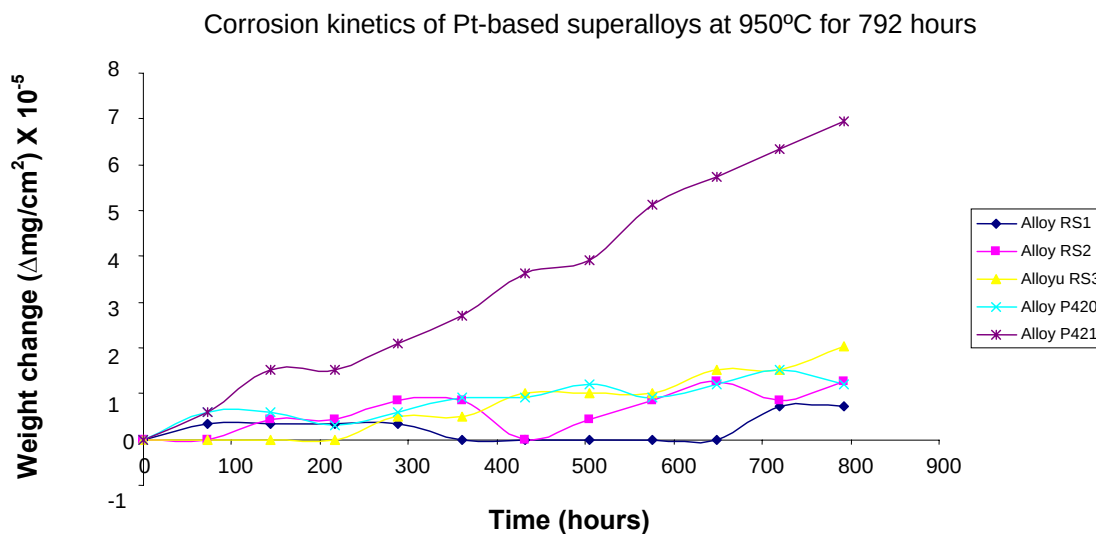
**Figure 5.3 Corrosion kinetics of Pt-based superalloys in molten salts at 950°C for duration of 792 hours**

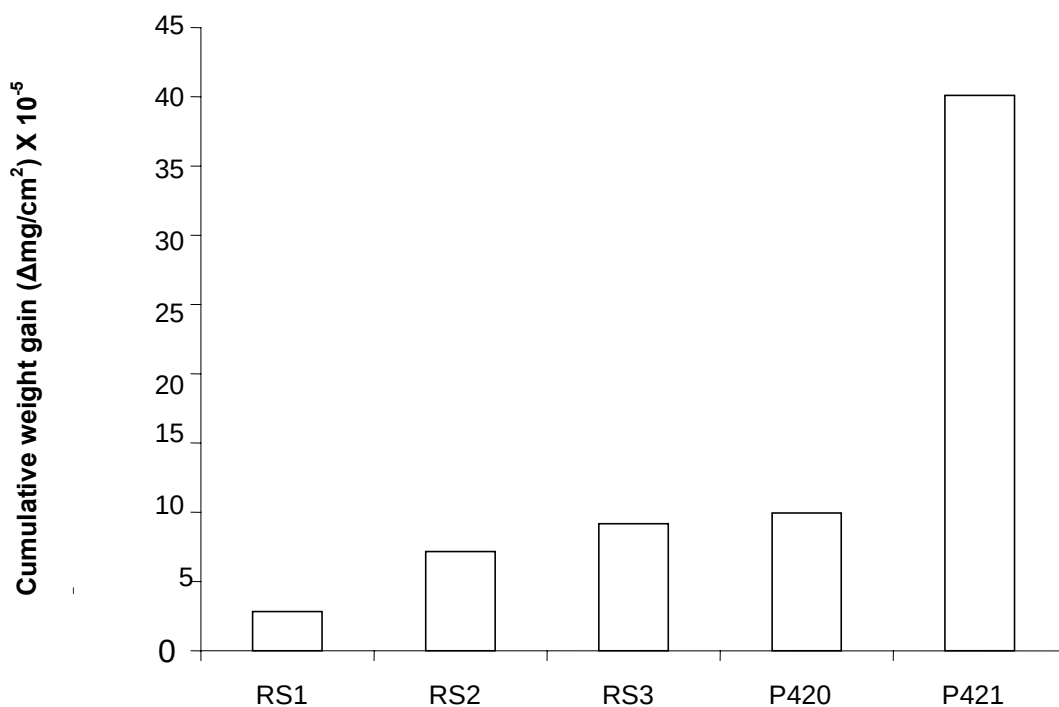
**Figure 5.4 Cumulative weight gains of Pt-based superalloys after 792 hours in molten salt**

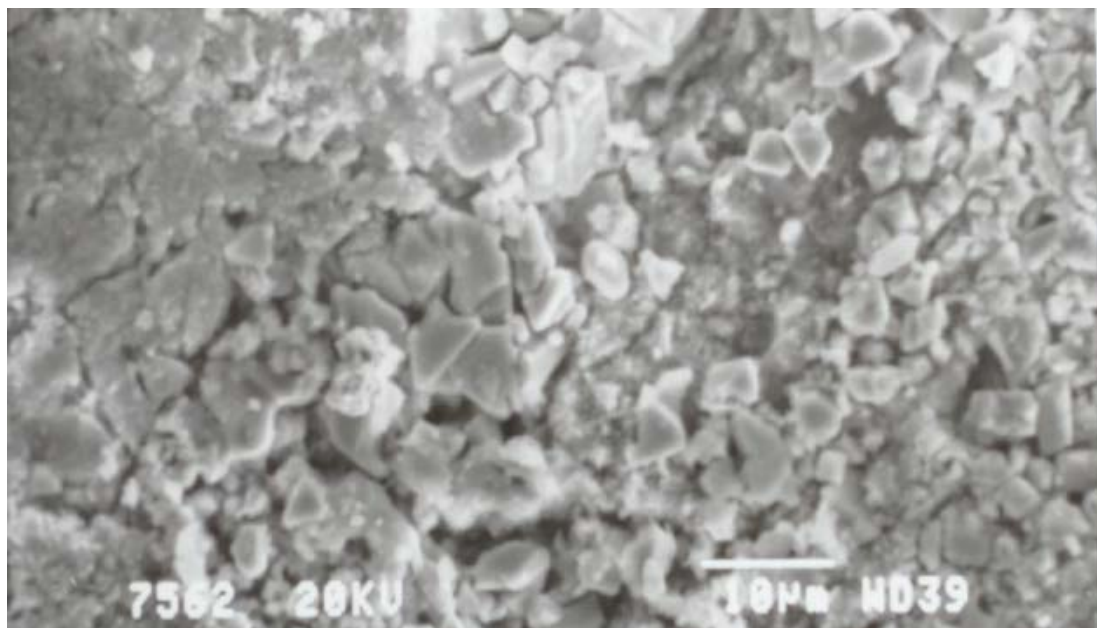
**Figure 5.5 Secondary electron micrograph showing corrosion morphology of the coated NBSA that resulted after hot corrosion in molten Na<sub>2</sub>SO<sub>4</sub> salt at 950°C**

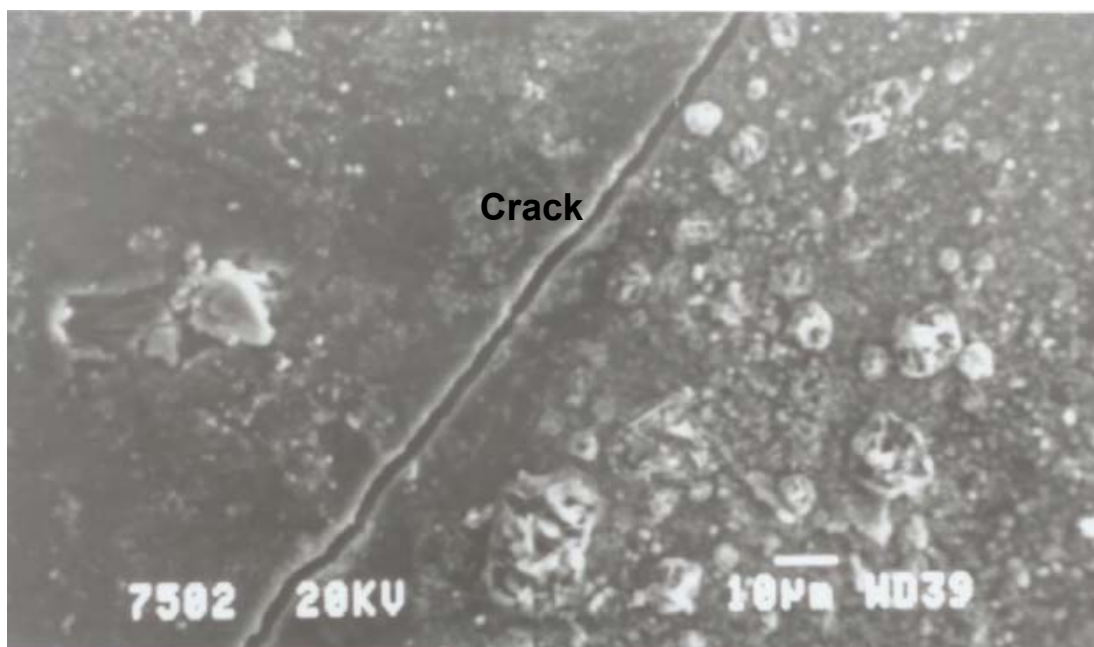
**Figure 5.6** Secondary electron image of the corrosion morphology of the uncoated CMSX-4 after hot corrosion at 950°C with a crack running across the surface of the alloy

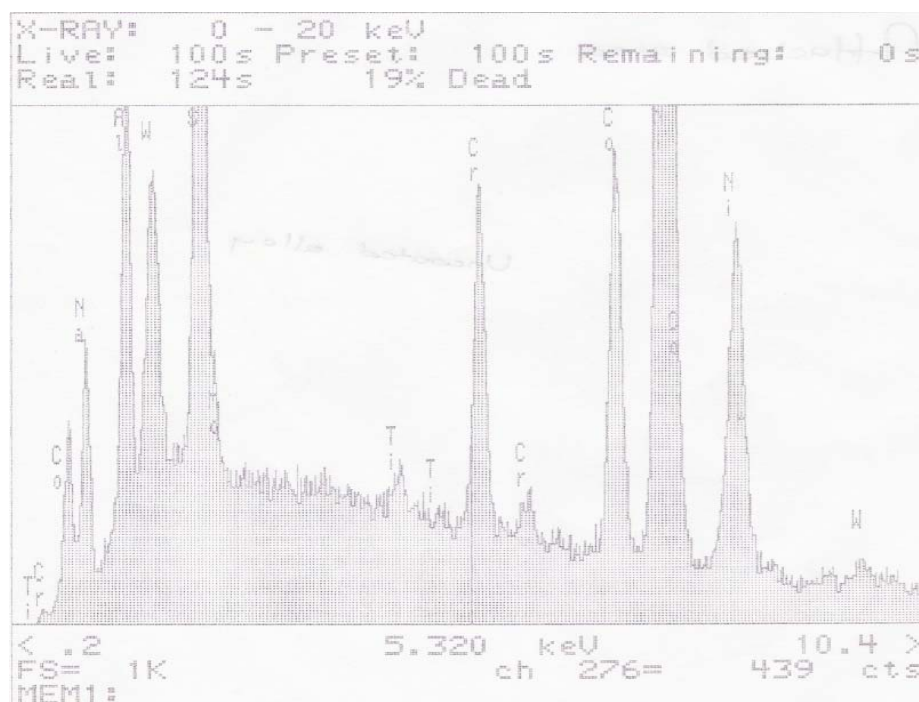
**Figure 5.7** EDS analysis performed on the surface of the uncoated alloy that was exposed to molten salt at 950°C for a period of 792 hours

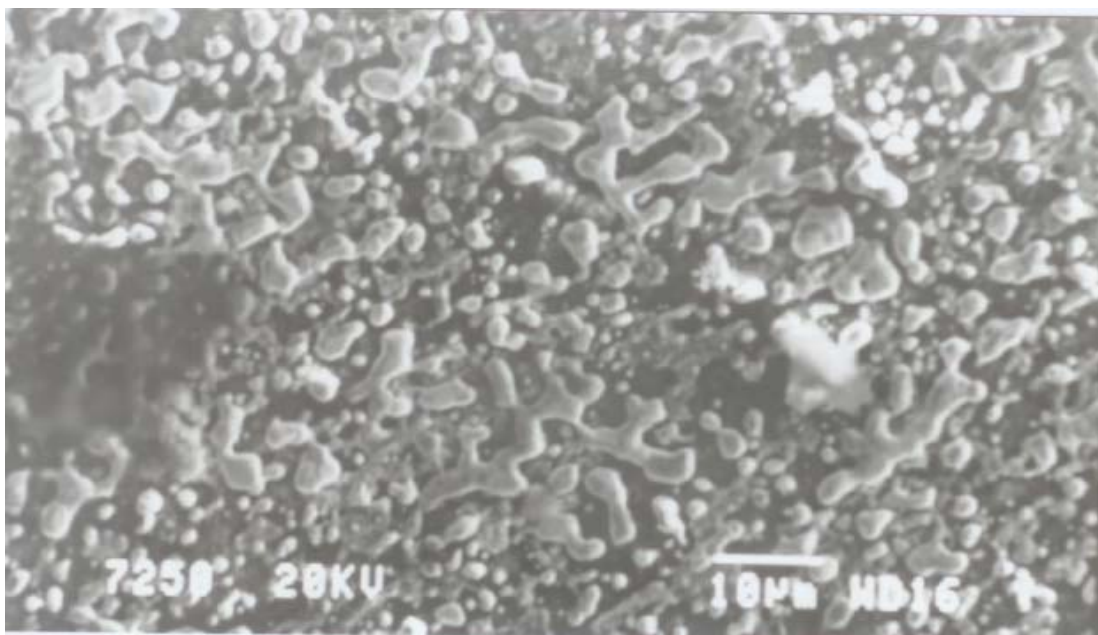
**Figure 5.8 Secondary electron image of alloy P421 with non-protective oxide scale after hot corrosion at 950°C after 540 hours**

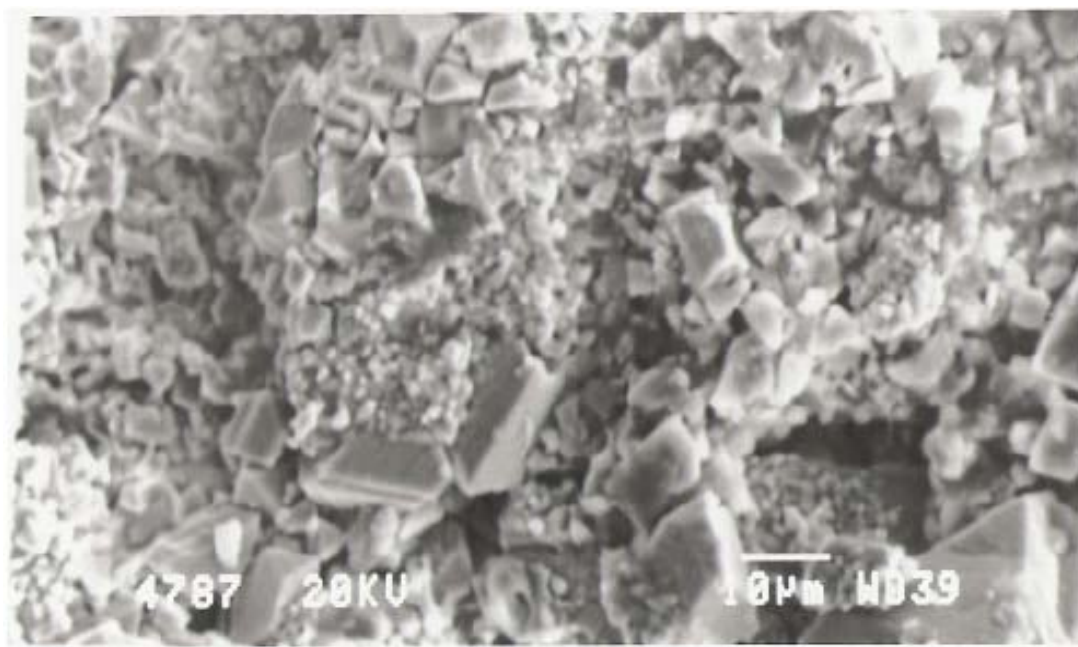
**Figure 5.9 Secondary electron image of crystal structured corrosion morphology on alloy P421 after undergoing hot corrosion at 950°C for 792 hours**

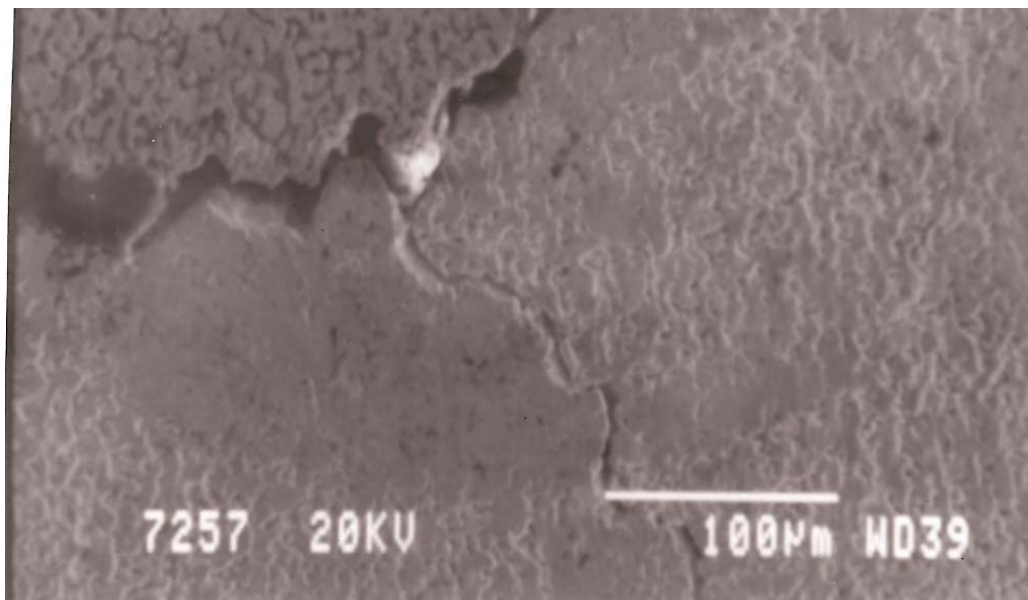
**Figure 5.10 Secondary electron image of the surface morphology on alloy P420 after exposure to molten  $\text{Na}_2\text{SO}_4$  salt for a period of 540 hours**

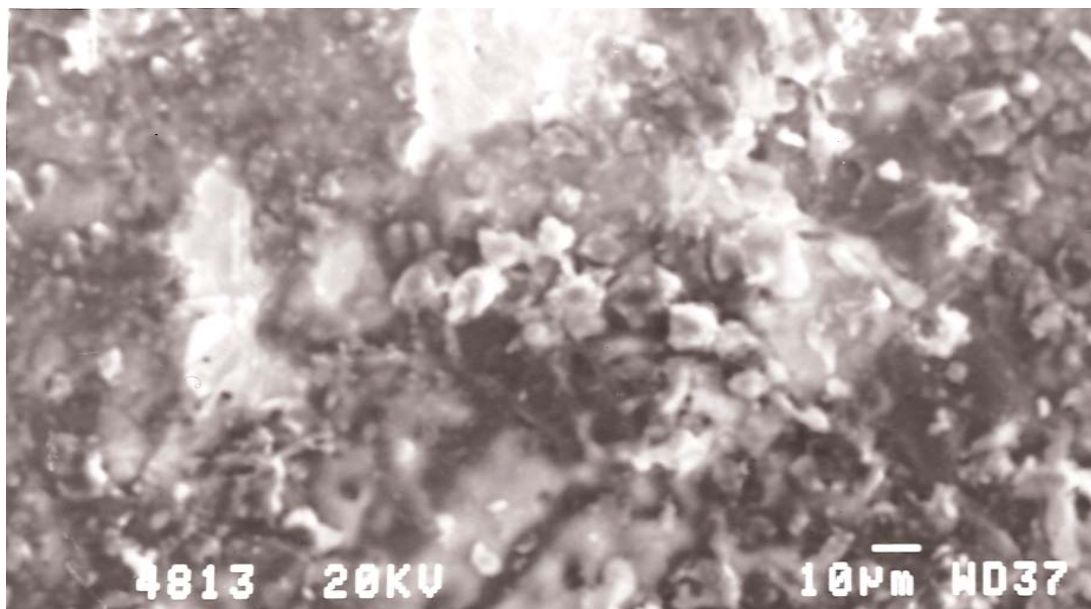
**Figure 5.11** Secondary electron image of the corrosion morphology of alloy P420 after hot corrosion at 950°C for 792 hours

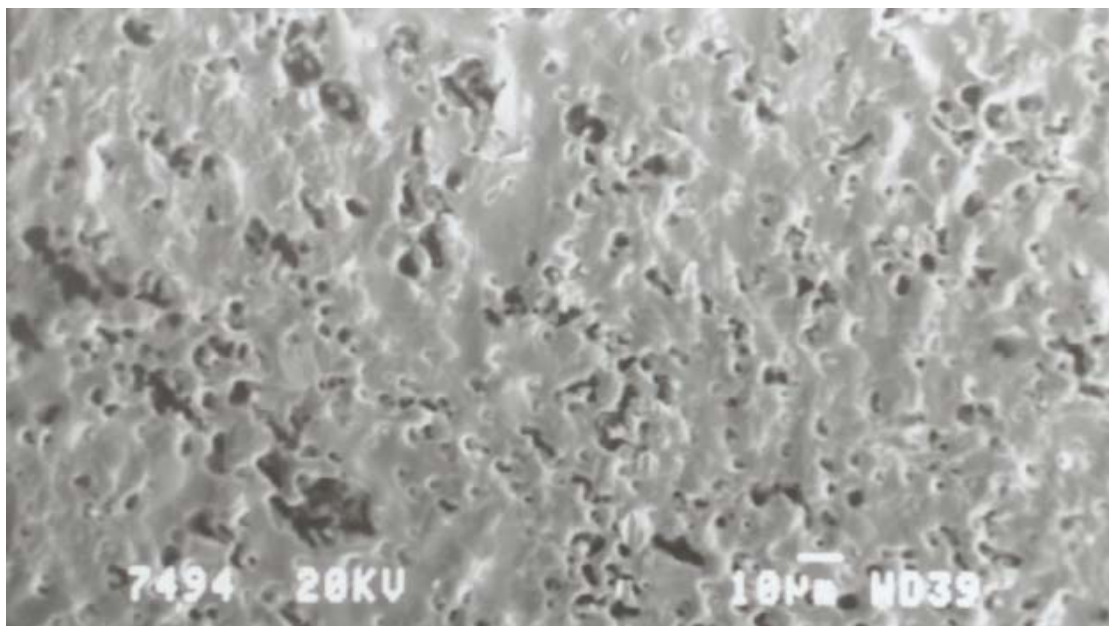
**Figure 5.12 Secondary electron images showing a porous oxide scale on the surface of alloy RS1 after hot corrosion in molten salt for 540 hours**

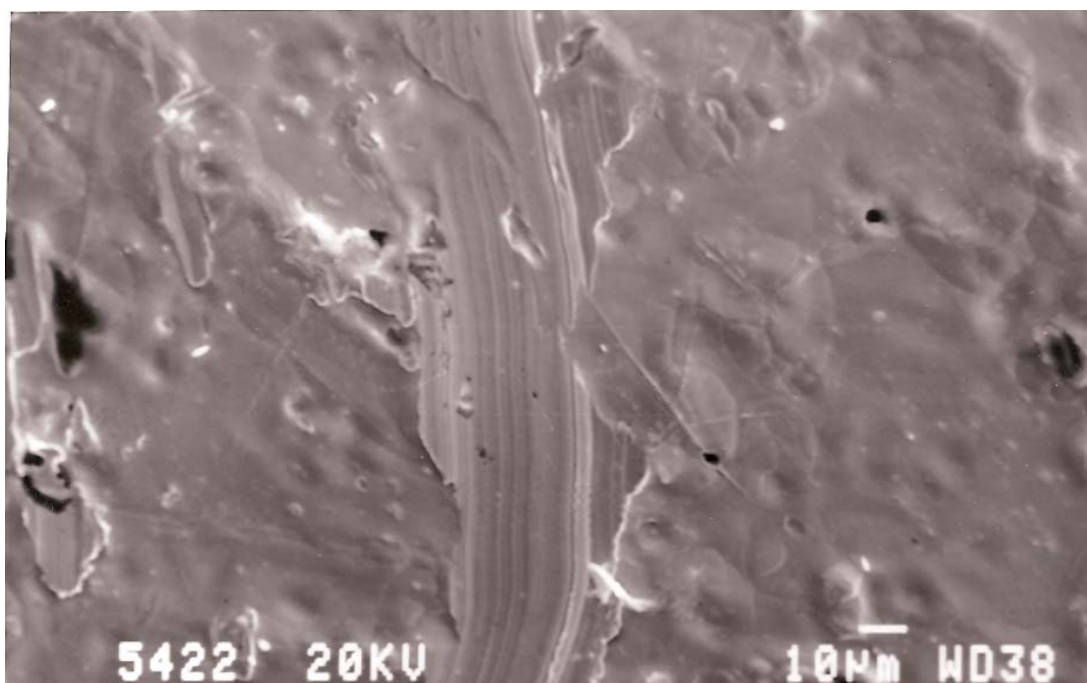
**Figure 5.13 Secondary electron images of a porous oxide scale on the surface of alloy RS1 after hot corrosion in molten salt for 792 hours**

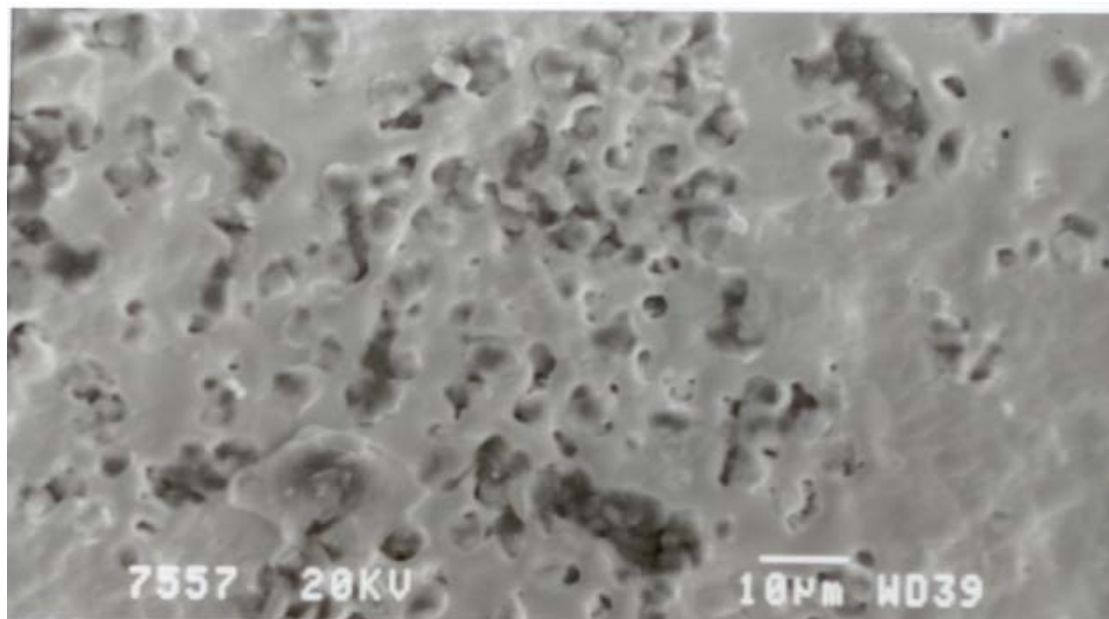
**Figure 5.14** Secondary electron image of the corrosion morphology that resulted on the surface of alloy RS2 after at 950°C for 540 hours

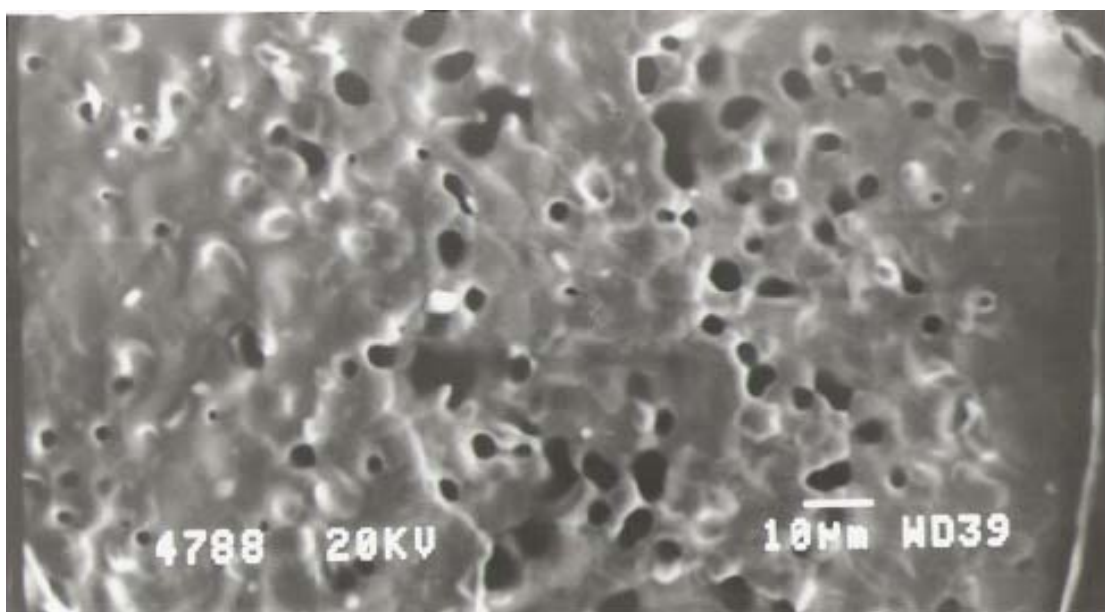
**Figure 5.15** Secondary electron image of the corrosion morphology that resulted on the surface of alloy RS2 after at 950°C for 792 hours

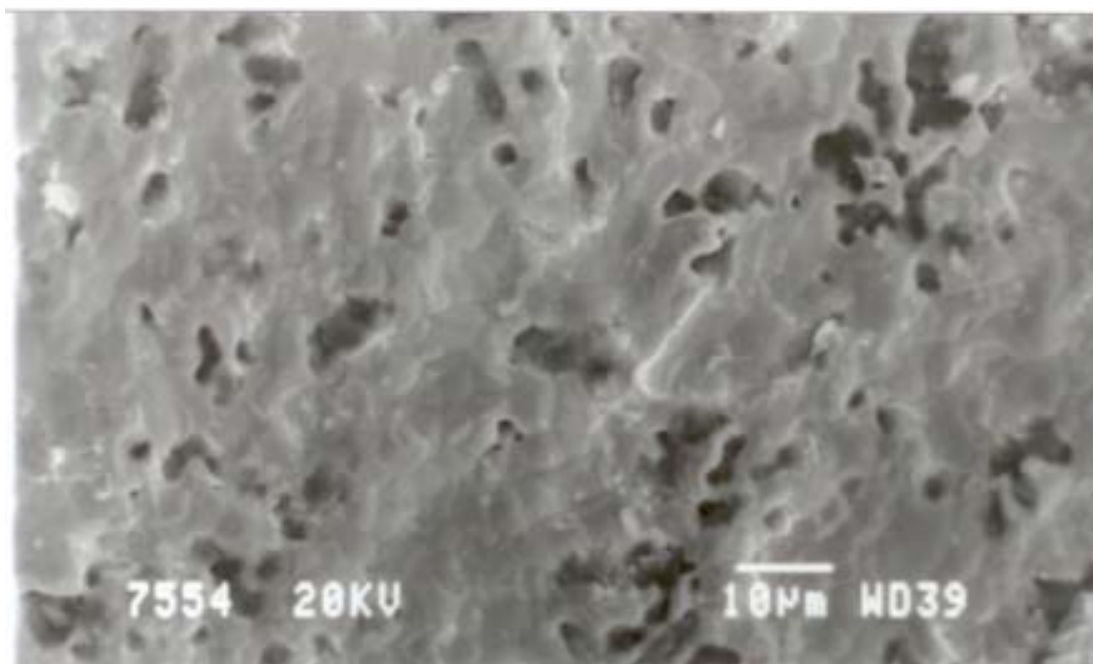
**Figure 5.16** Secondary electron image of the corrosion morphology of alloy RS3 after hot corrosion in molten Na<sub>2</sub>SO<sub>4</sub> salt at 950°C for duration of 540 hours

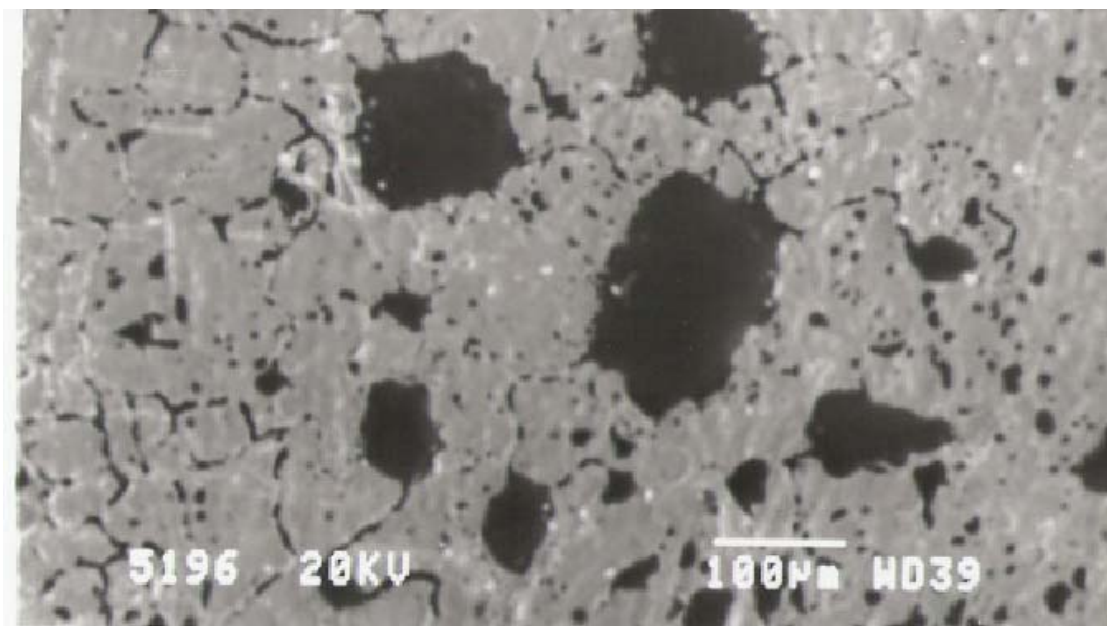
**Figure 5.17** Secondary electron image of corrosion morphology of alloy RS3 after hot corrosion in molten Na<sub>2</sub>SO<sub>4</sub> salt at 950°C for duration of 792 hours

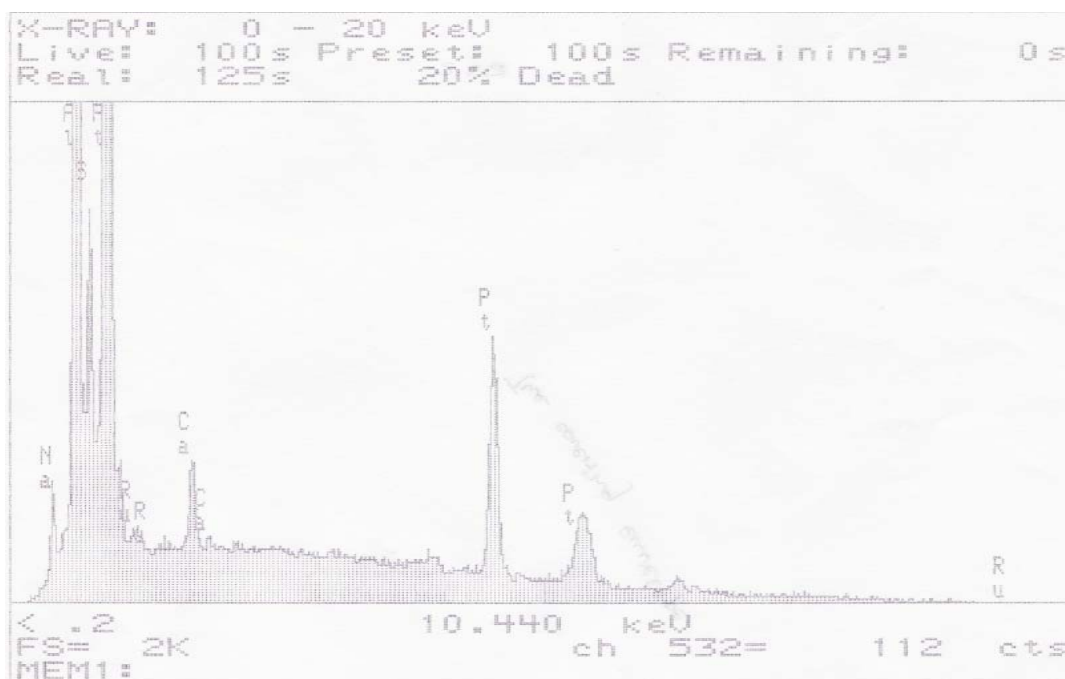
**Figure 5.18 SEM scan obtained after performing cross sectional analysis on the surface of the alloy RS2.**

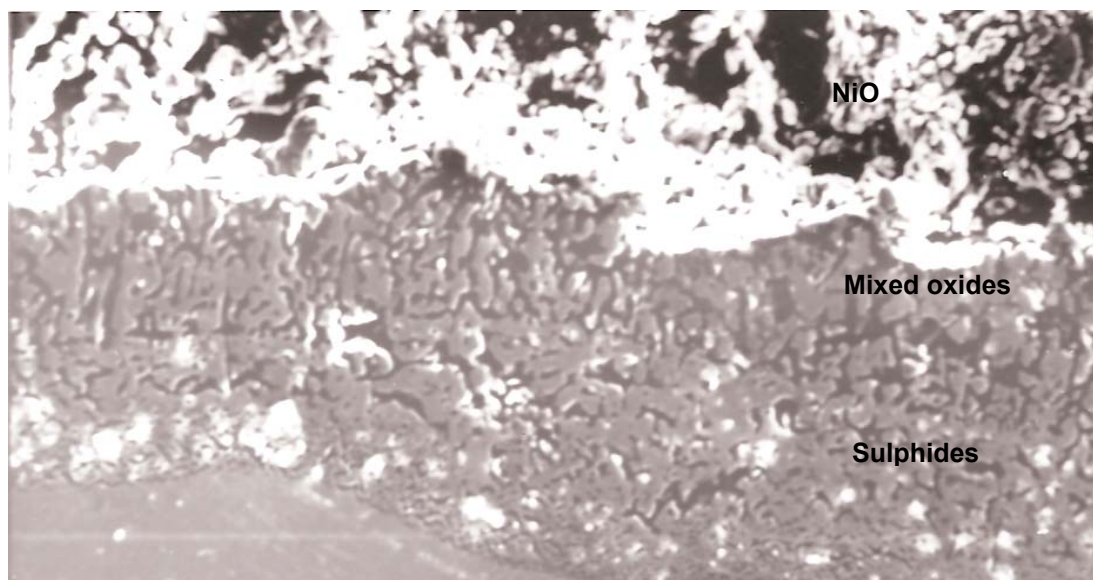
**Figure 5.19** Cross sectional morphology of the uncoated alloy after hot corrosion attack in molten  $\text{Na}_2\text{SO}_4$  salt
