# **Corrosion behaviour of Pt-based superalloys intended for high temperature applications**

*A dissertation submitted to the Faculty of Engineering and the Built  
Environment, University of the Witwatersrand, in fulfillment of the requirements  
for the degree of Masters of Science in Engineering.*

**Johannesburg, 2007**

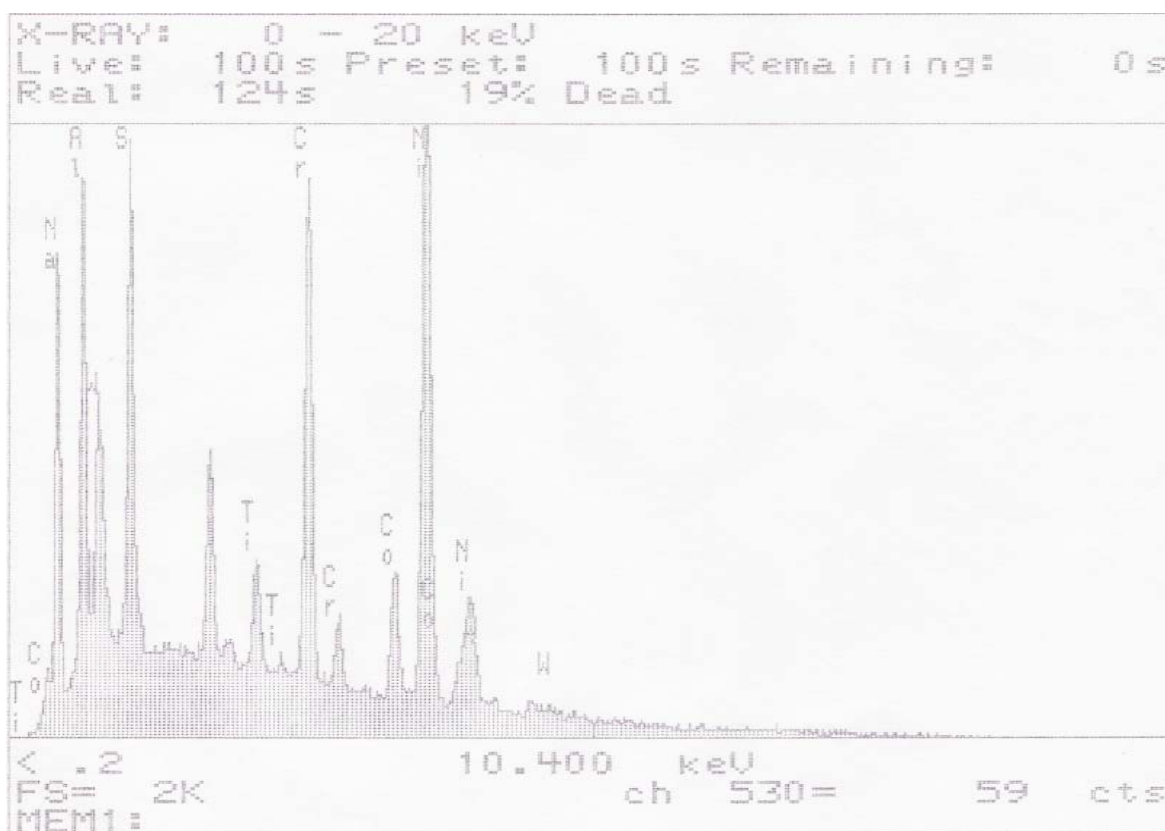
**Figure 5.20** SEM scan obtained after performing cross sectional analysis on the surface of the uncoated alloy

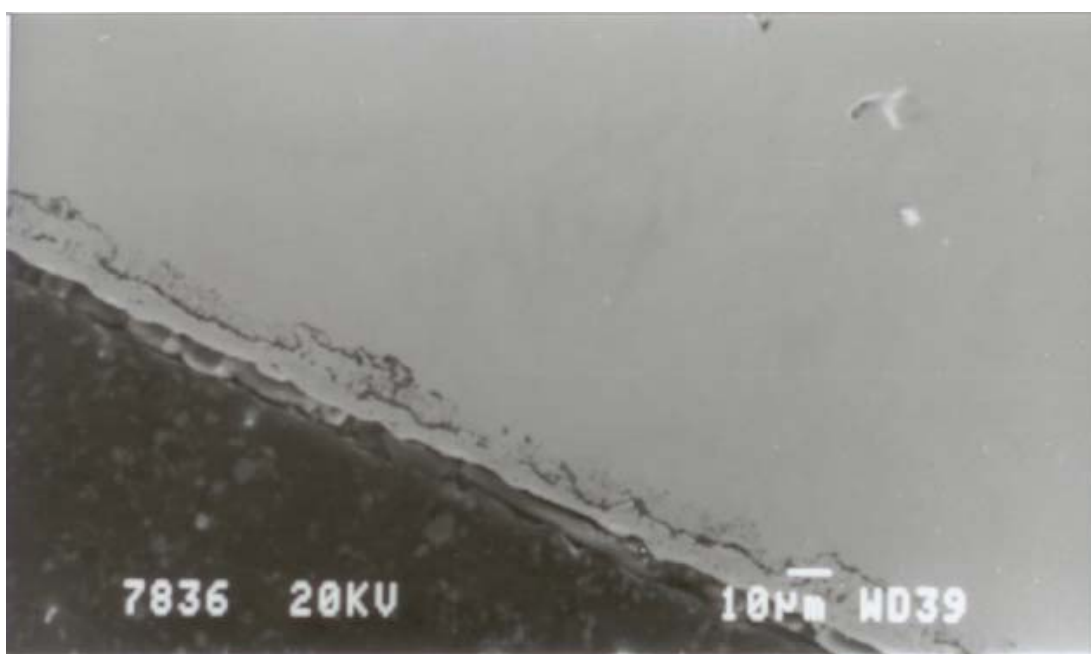
**Figure 5.21 Secondary electron micrograph of the cross section of alloy RS1 after hot corrosion test at 950°C**

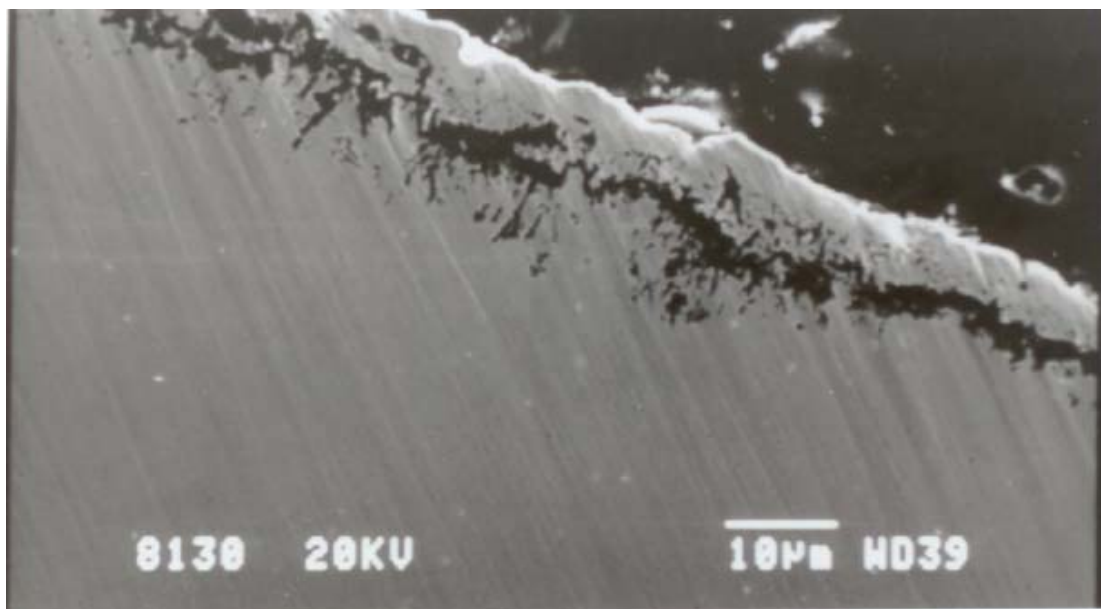
**Figure 5.22** Secondary electron micrograph of the cross section of alloy RS2 after hot corrosion test at 950°C

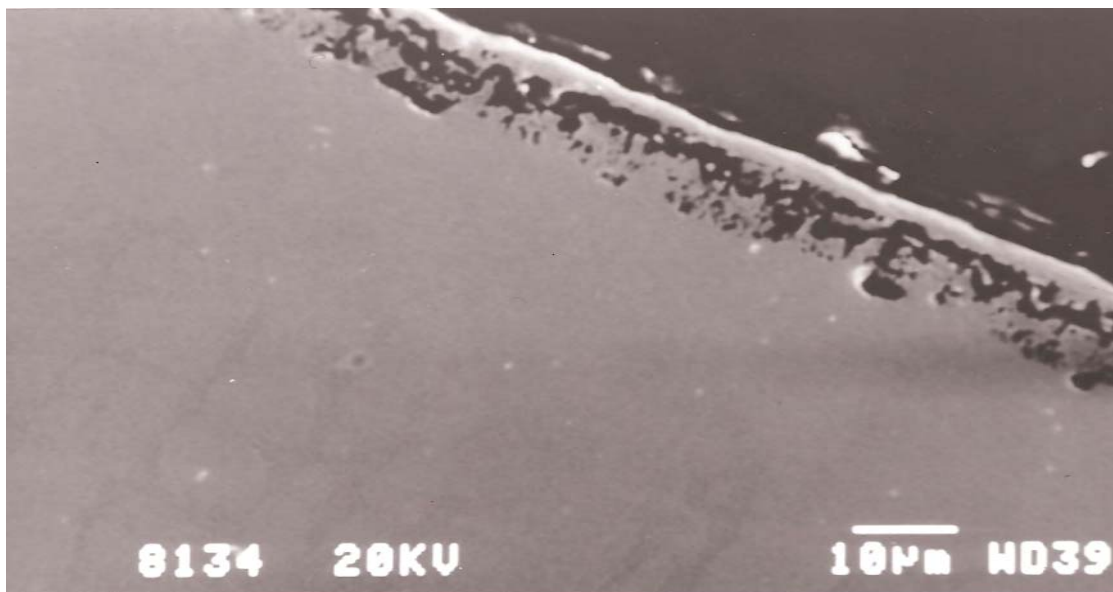
**Figure 5.23** Secondary electron micrograph of the cross section of alloy RS3 after hot corrosion test at 950°C

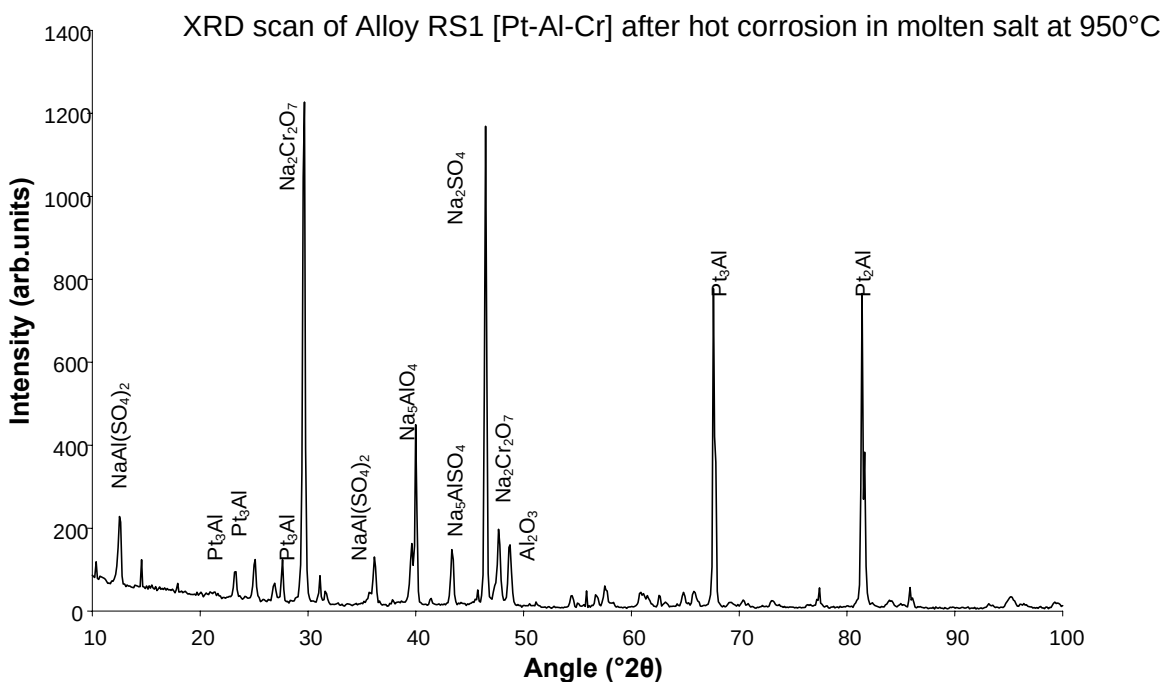
Figure 5.24 X-ray diffraction patterns on the scale of alloy RS1 after hot corrosion

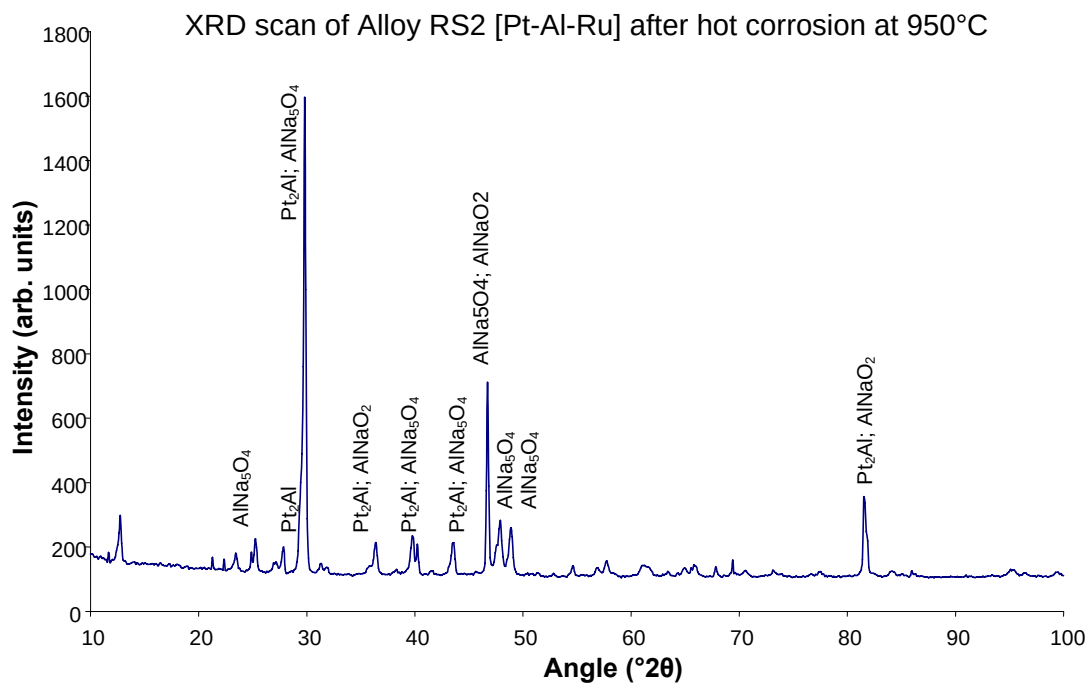
Figure 5.25 X-ray diffraction patterns on the scale of alloy RS2 after hot corrosion

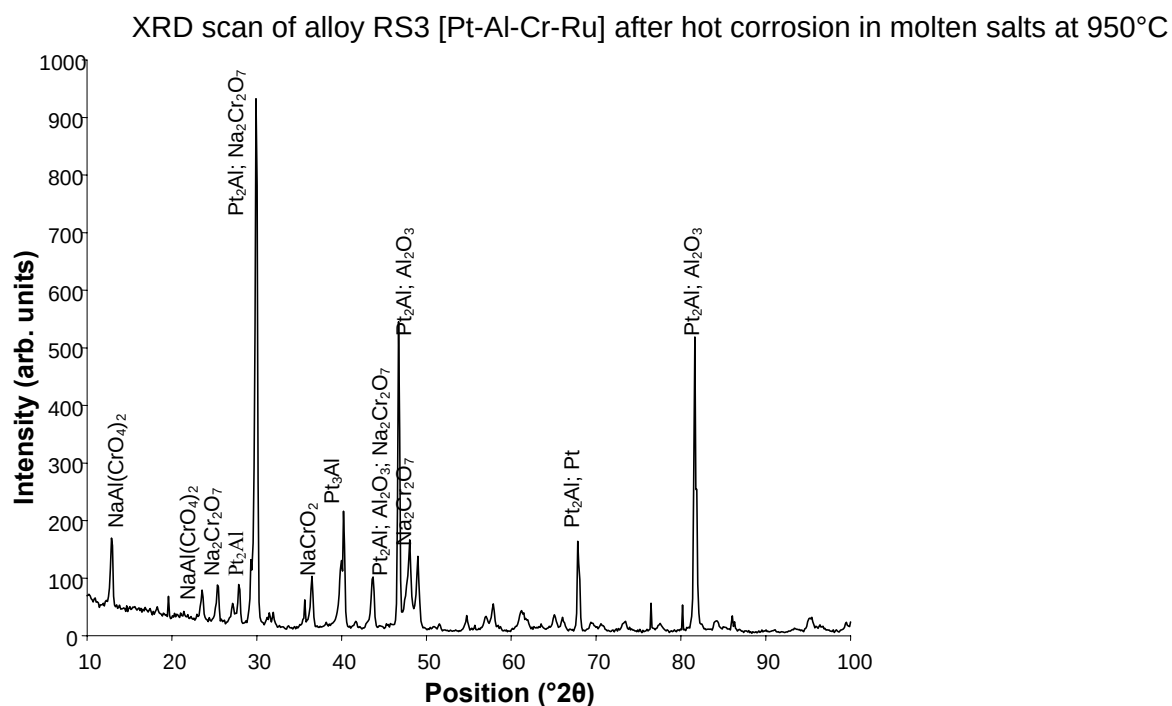
Figure 5.26 X-ray diffraction patterns on the surface of alloy RS3 after hot corrosion

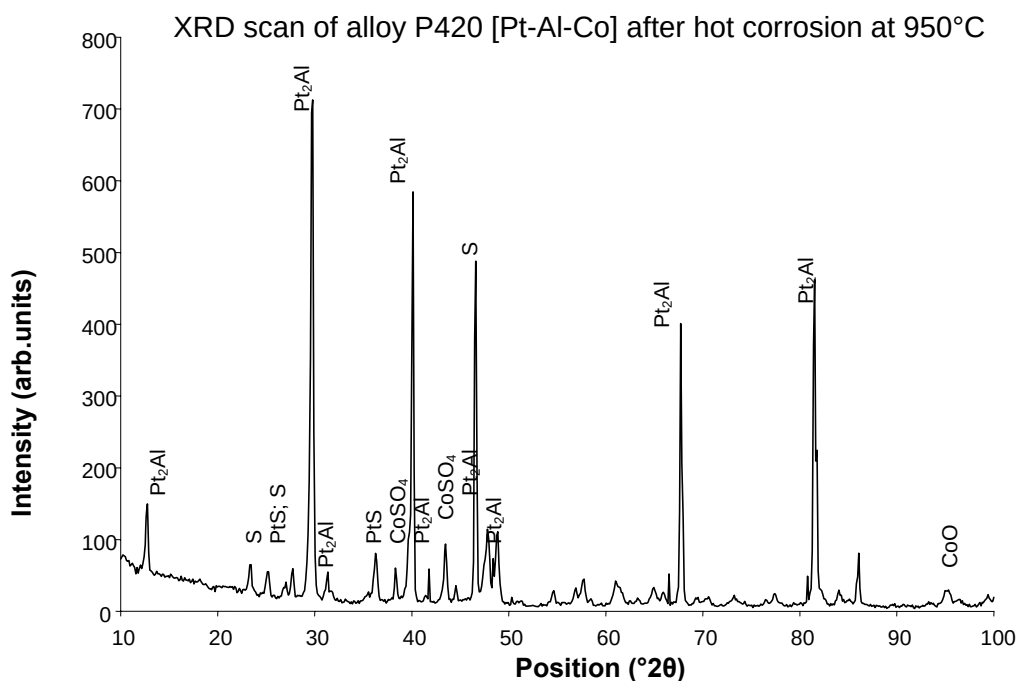
**Figure 5.27** X-ray diffraction patterns on alloy P420 after corrosion at 950°C

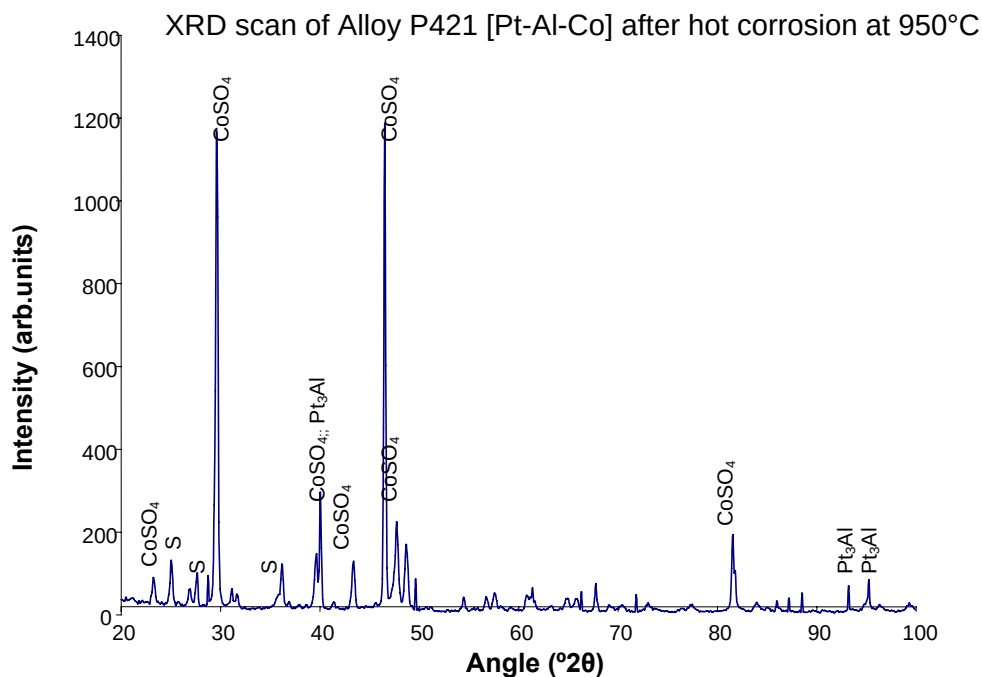
**Figure 5.28** X-ray diffraction patterns on the surface of alloy P421 after hot corrosion

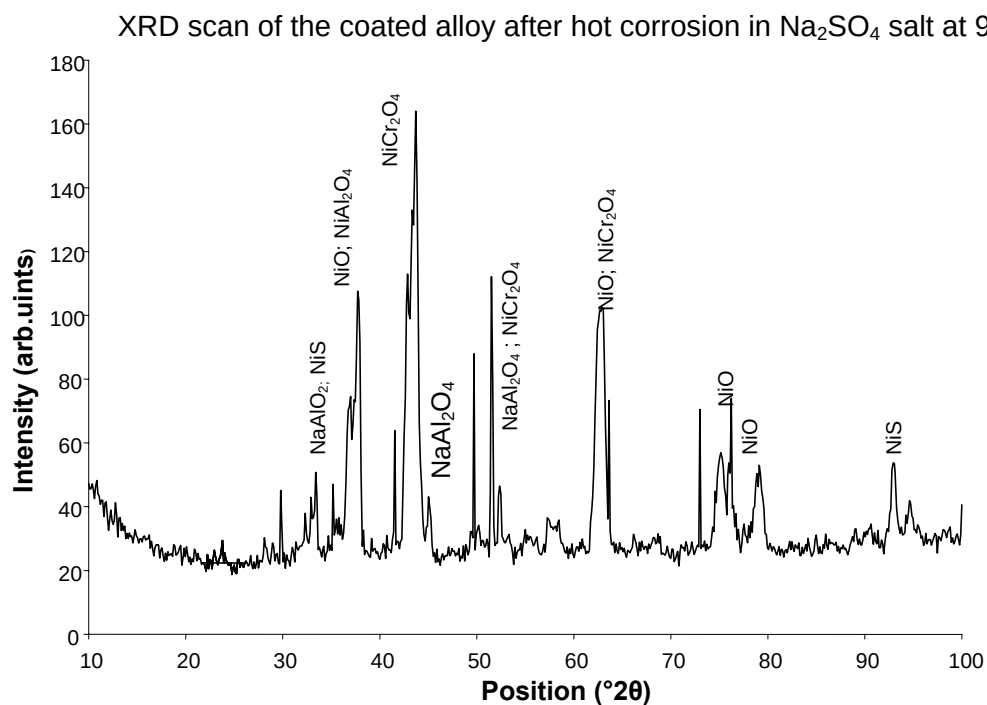
**Figure 5.29 X-ray diffraction patterns on the surface of the coated Ni-based superalloys after hot corrosion**

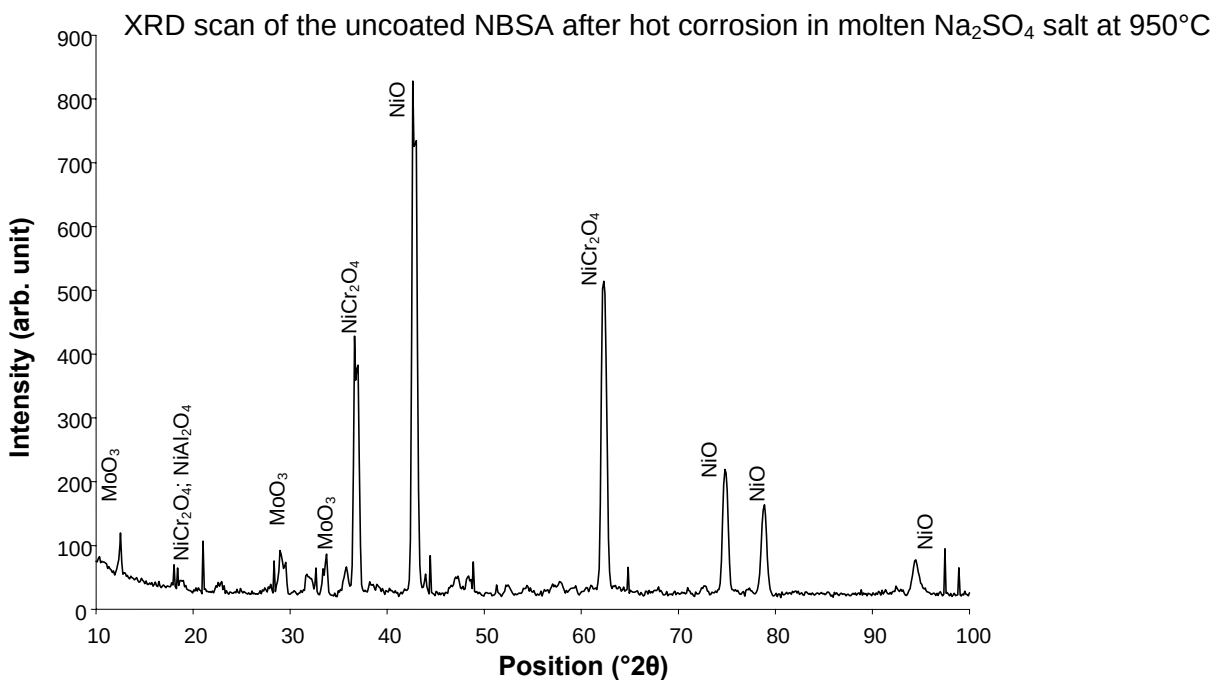
**Figure 5.30 X-ray diffraction patterns on the surface of uncoated Ni-based superalloy after hot corrosion**

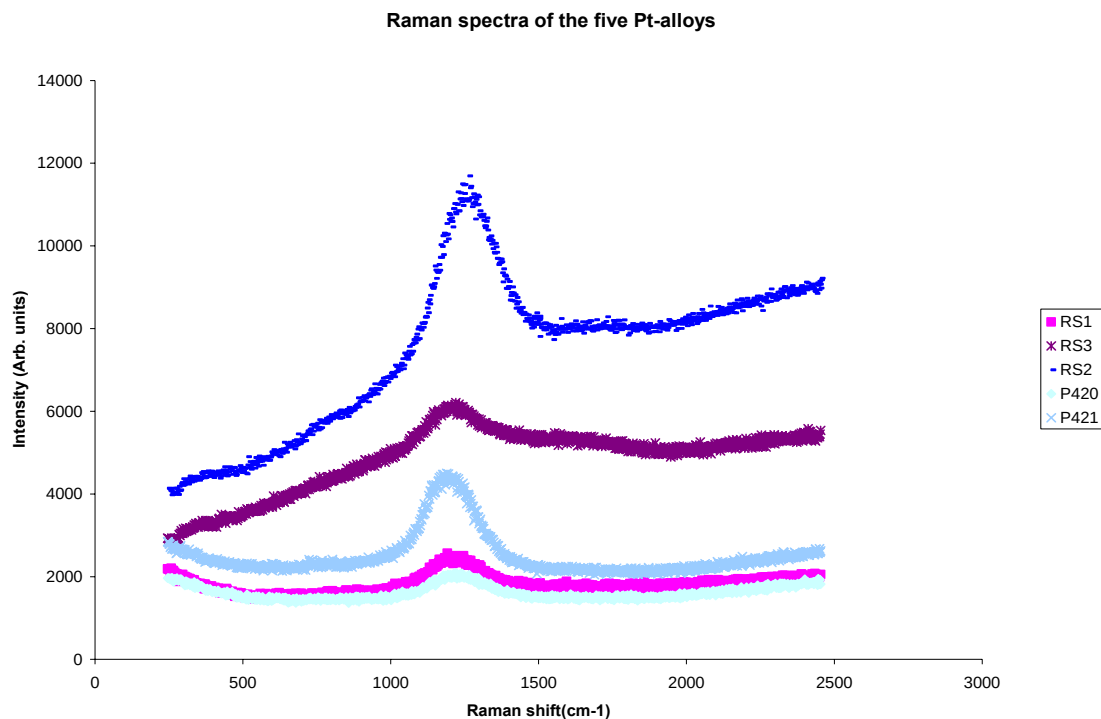
**Figure 5.31 Raman spectra obtained from the five Pt-based superalloys after hot corrosion investigations at 950 °C**

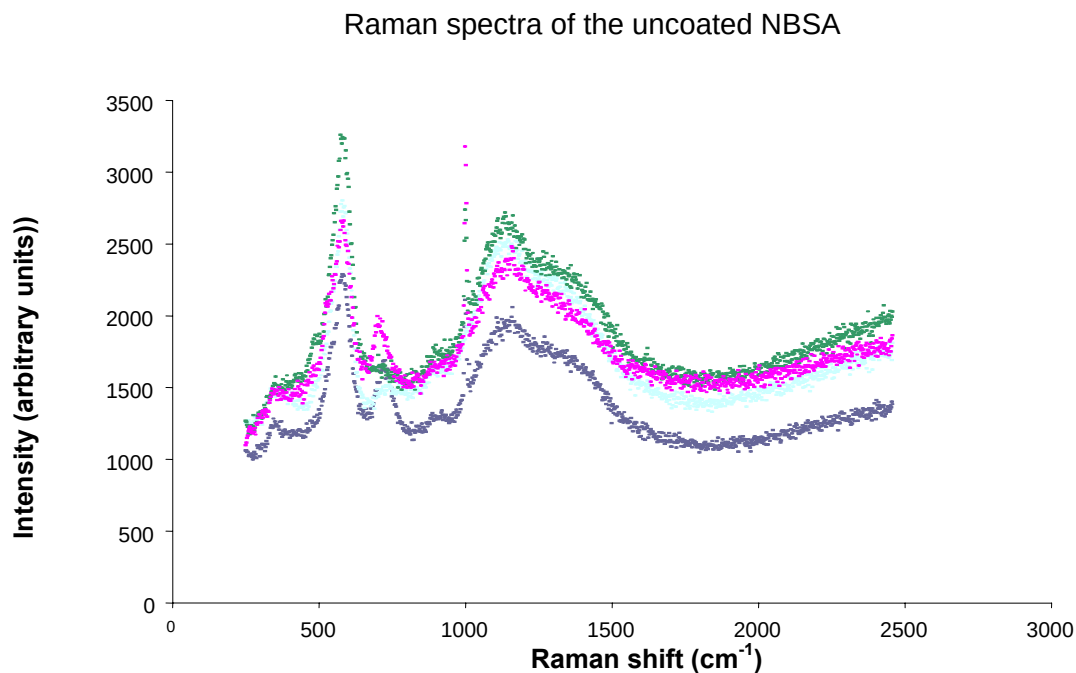
**Figure 5.32** Raman spectra obtained from the uncoated CMSX-4 alloy after hot corrosion investigations at 950 °C

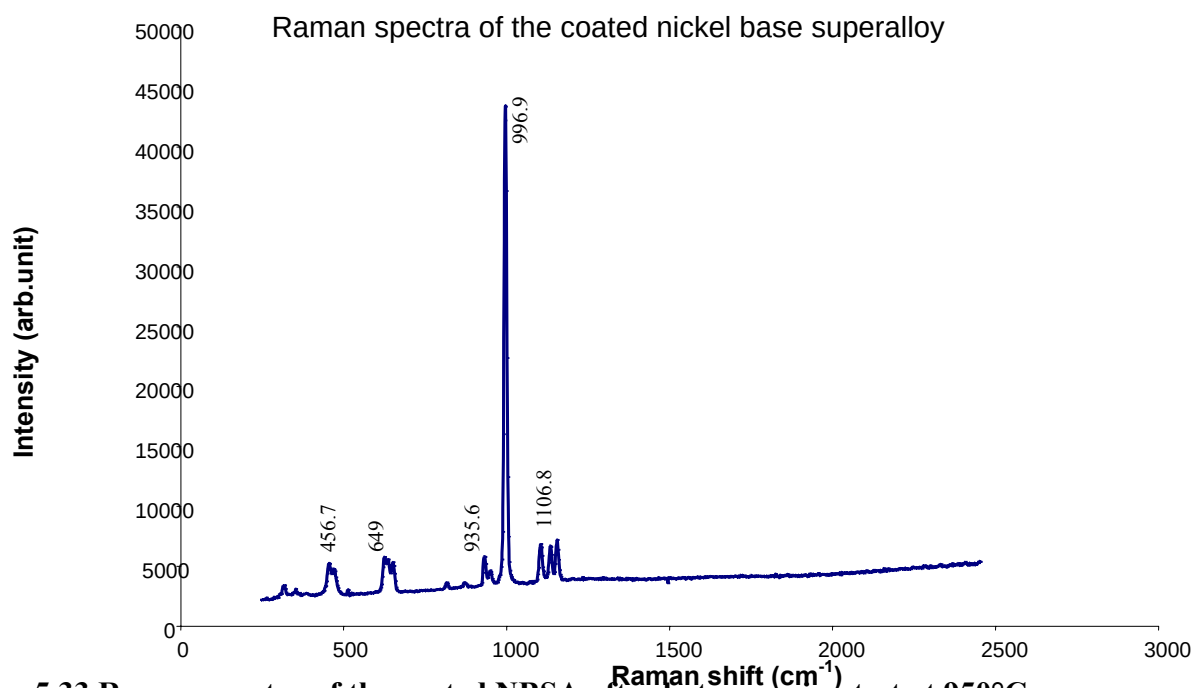
Figure 5.33 Raman spectra of the coated NBSA after hot corrosion test at 950°C

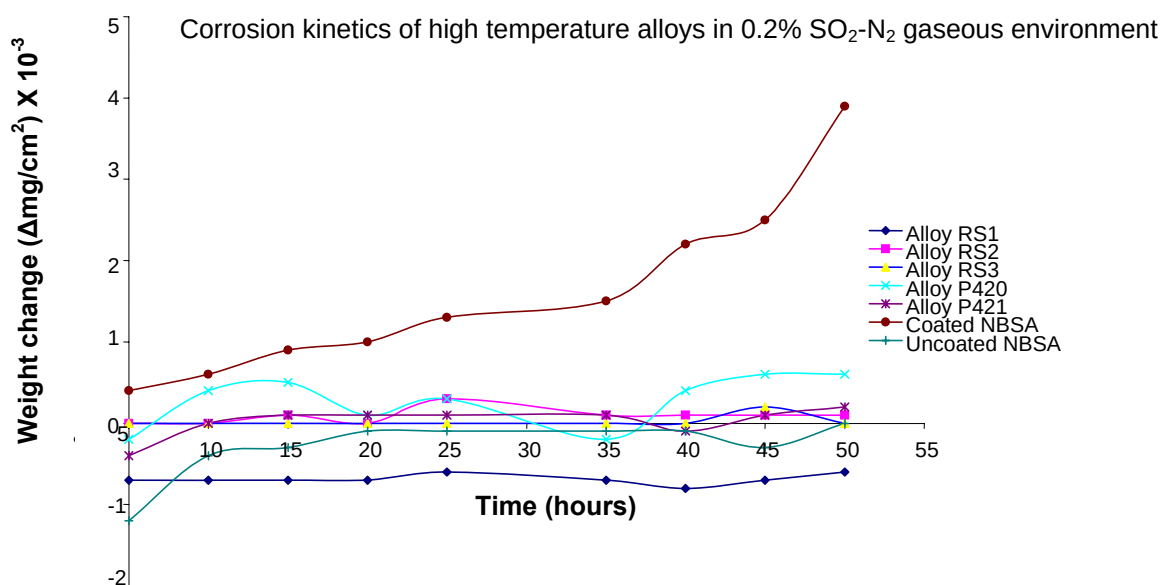
**Figure 5.34 Corrosion kinetics of the seven investigated alloys after sulphidation in a 0.2% SO<sub>2</sub>-N<sub>2</sub> gaseous environment**

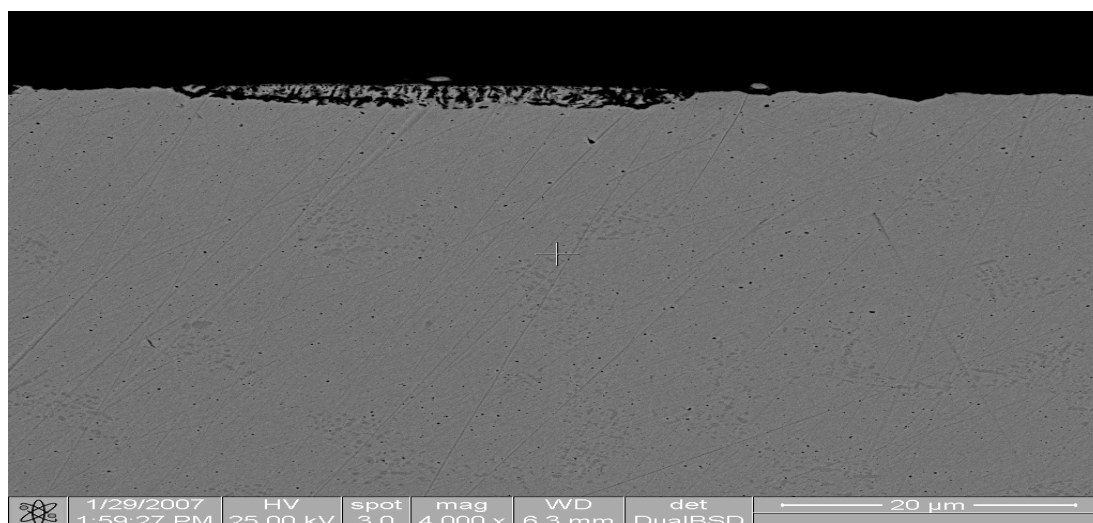
**Figure 5.35 SEM image showing cross section of alloy RS1 after the sulphidation test in  $0.2\%\text{SO}_2\text{-N}_2$  gas at  $900^\circ\text{C}$**

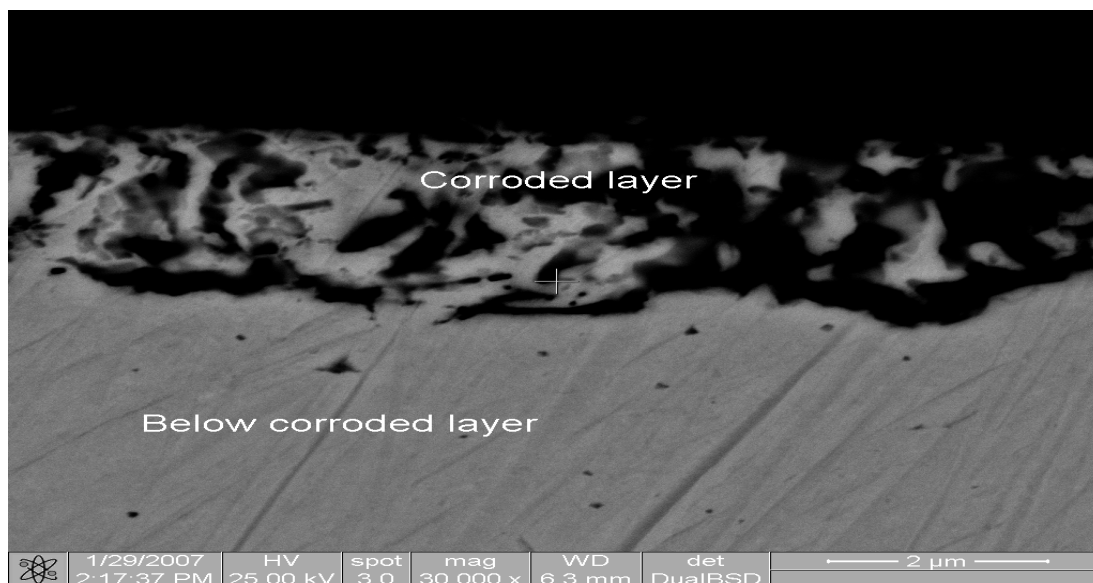
**Figure 5.36 Secondary electron images of the cross section of alloy RS1 at 30 000 X magnifications after the sulphidation test, showing the effect and depth of attack by  $0.2\%\text{SO}_2\text{-N}_2$  gas**

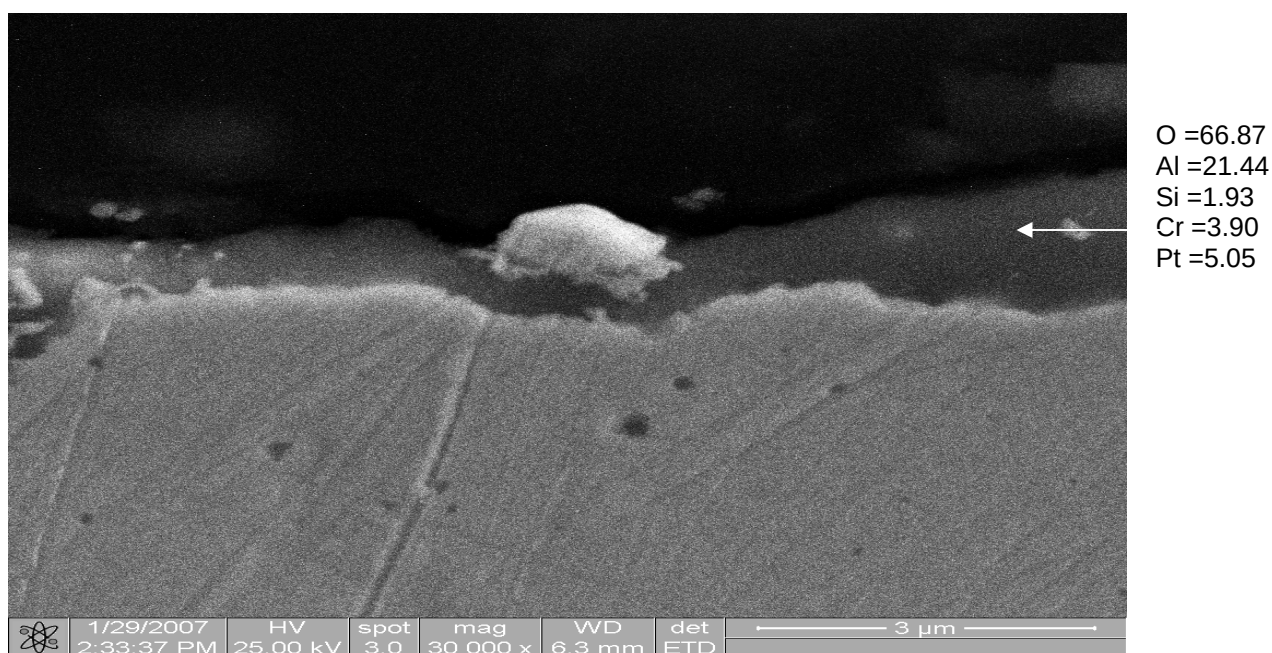
**Figure 5.37 SEM image showing the external oxide layer that formed on the surface of alloy RS1**

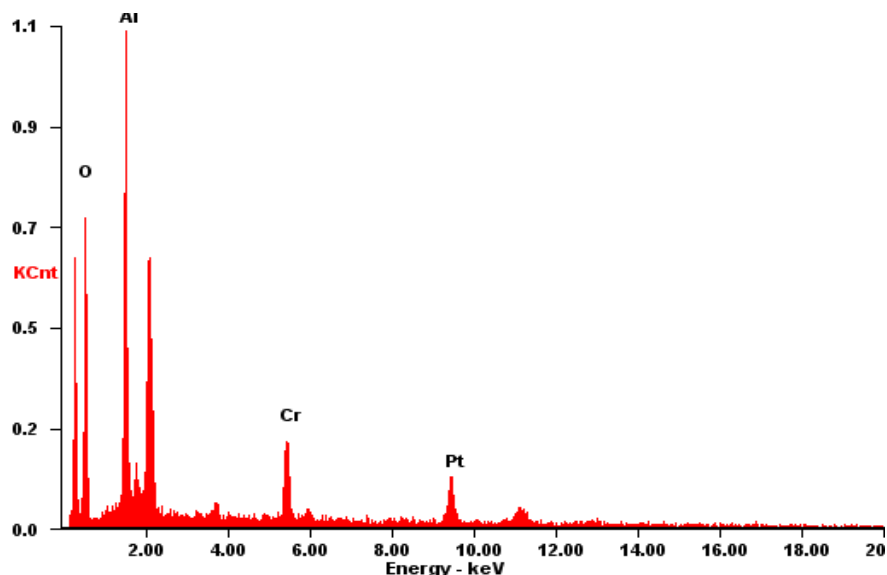
**Figure 5.38 EDS analysis performed on the external scale that formed on the surface of alloy RS1 after the sulphidation test in 0.2% SO<sub>2</sub>-N<sub>2</sub> environment**

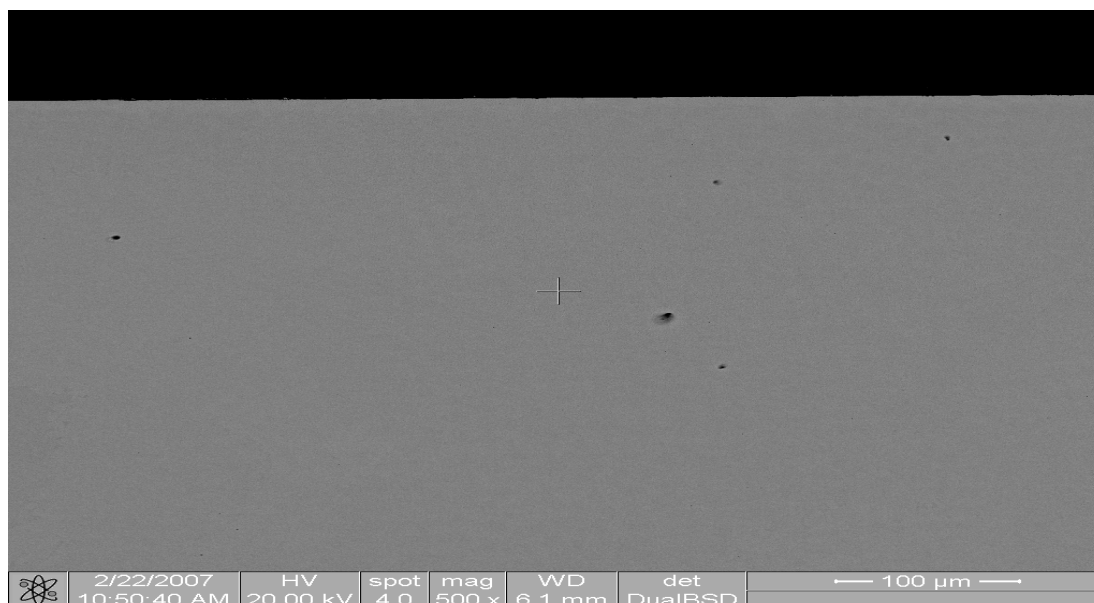
**Figure 5.39 Secondary electron images of alloy RS2 after the sulphidation test**

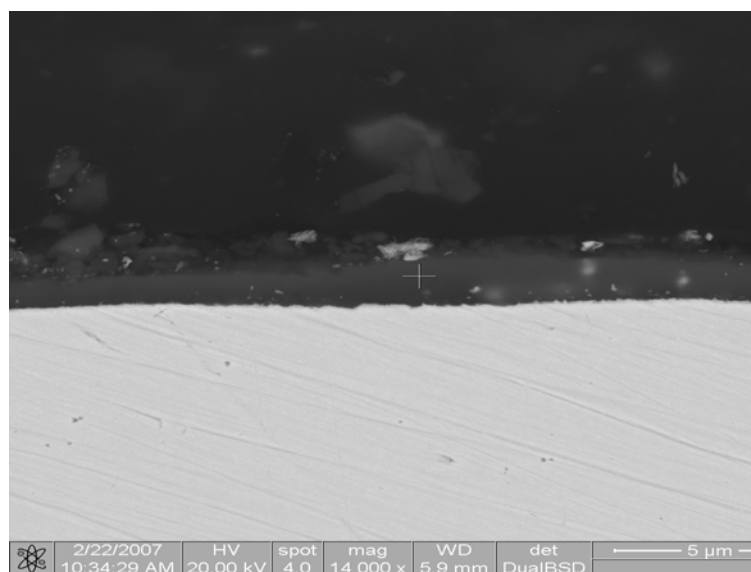
**Figure 5.40 Cross section of alloy RS2 at 14000 X magnification with an  $\text{Al}_2\text{O}_3$  scale forming on the surface of the alloy**

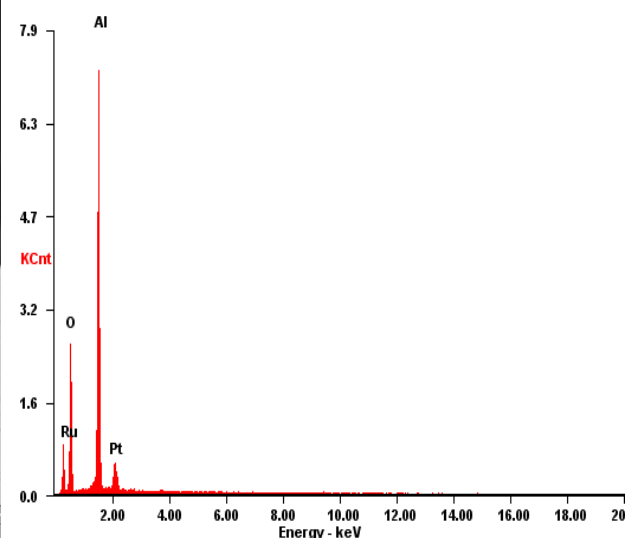
Similar to alloy RS1, the alloy was able to form a continuous and tenacious  $\alpha\text{-Al}_2\text{O}_3$  oxide layer that offered resistance against corrosion from gases, as shown in figure 5.40. The EDS analysis performed on the external oxide scale is shown in figure 5.41.

**Figure 5.41 EDS analysis performed on the external scale of alloy RS2**

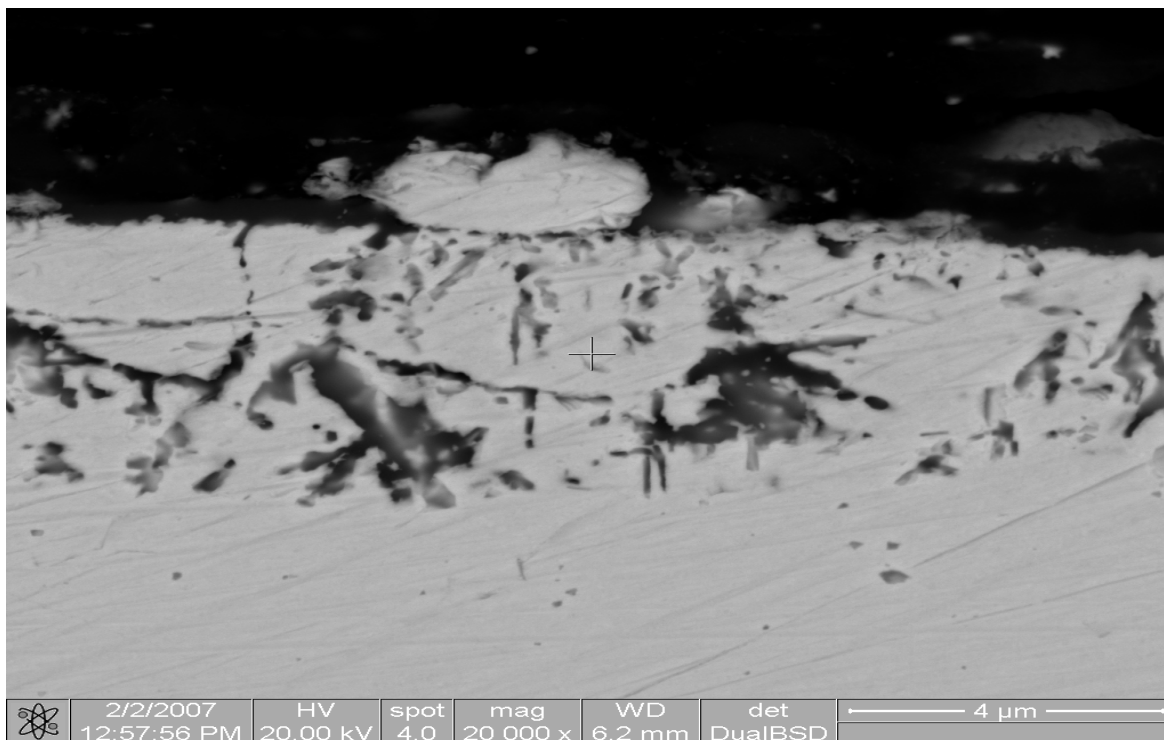
**Figure 5.42 Secondary image of cross section of alloy RS3 after sulphidation test**

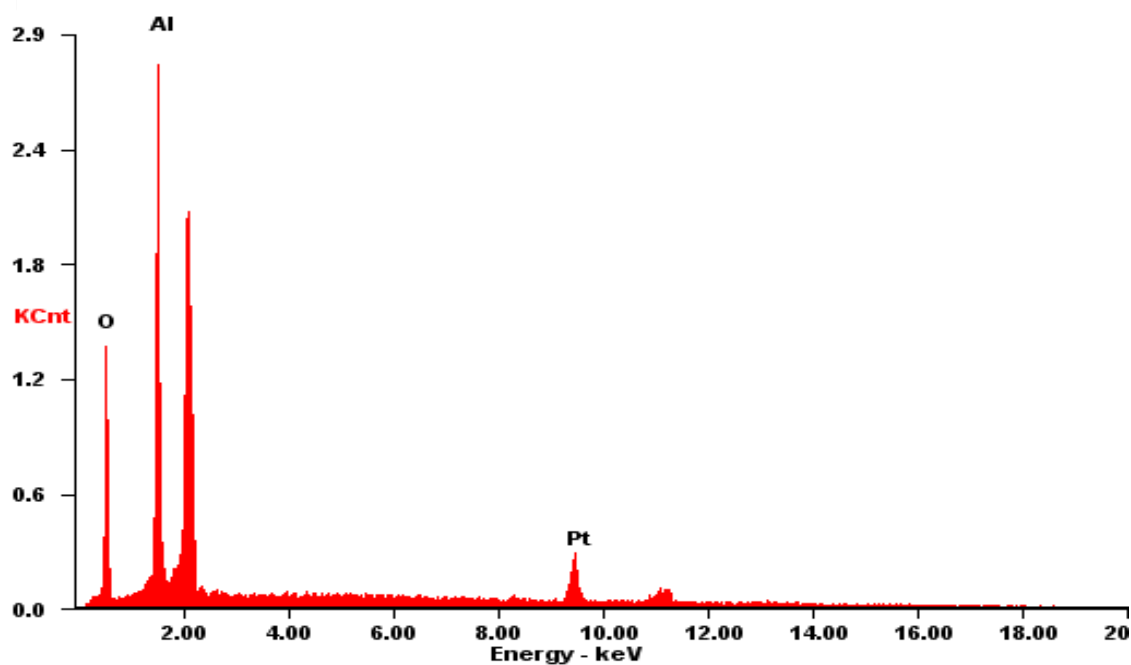
**Figure 5.43 EDS analysis performed on the dark area in the corroded section on alloy RS3**

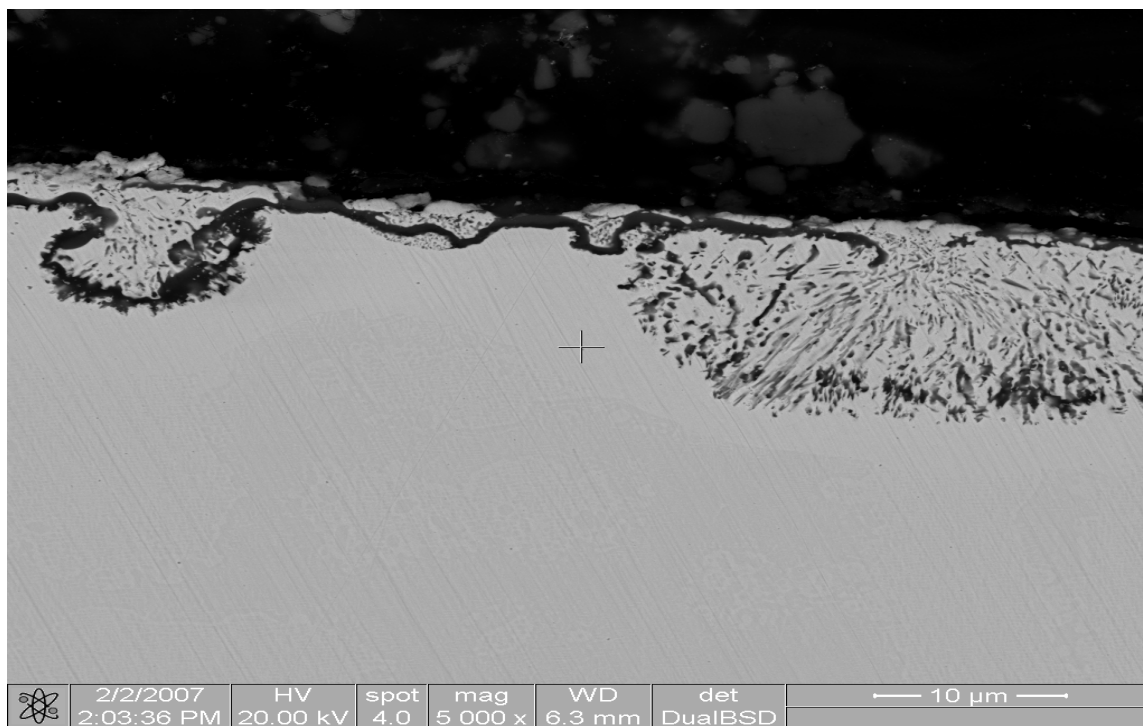
**Figure 5.44 Secondary image of alloy P420 after sulphidation test in 0.2% SO<sub>2</sub>-N<sub>2</sub> environment**

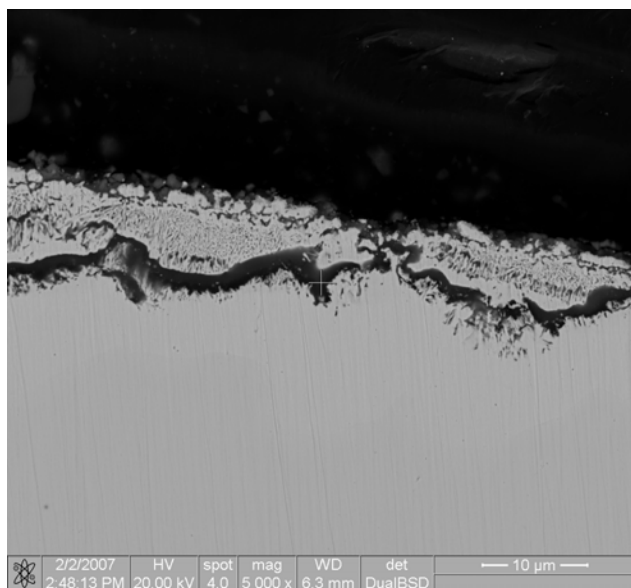
**Figure 5.46** Transverse section of corroded alloy P421 after the sulphidation test at 900°C

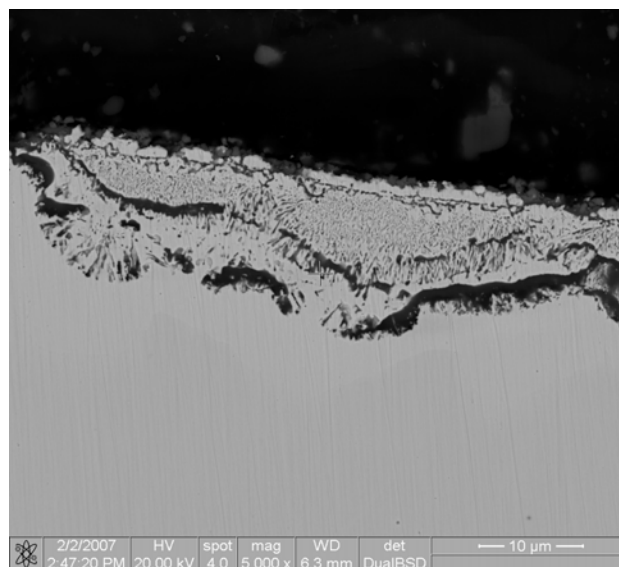
Co-containing alloys were more susceptible to corrosion attack compared to other Pt-based superalloys. Figures 5.46 and 5.47 are images that were taken across the surface of alloy P421. Similar to alloy P420, an alloy depleted zone rich in Pt was formed. However, the band was thicker than the one observed in alloy P420 as depicted in figure 5.48, suggesting alloy P421 is less resistant to corrosion attacks compared to alloy P420.

**Figure 5.47** Transverse section of alloy P421 across the corroded area of alloy P421 after the sulphidation test

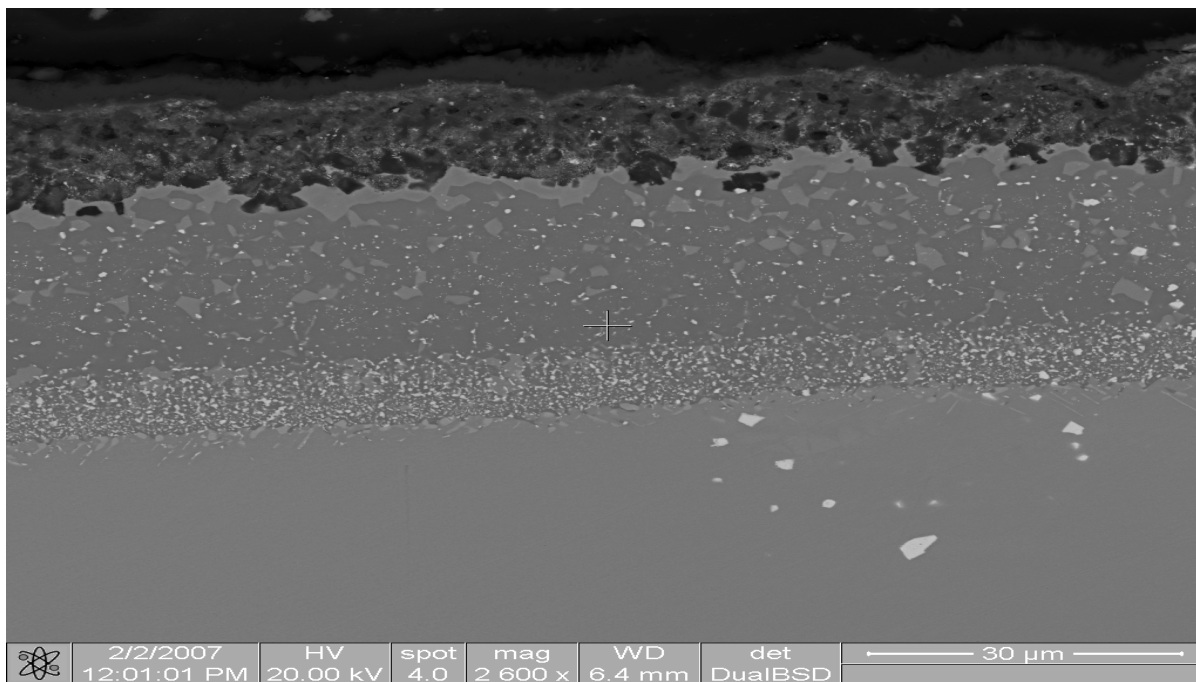
**Figure 5.49** Cross section showing the different phases formed when the alloy was exposed to 0.2%  $\text{SO}_2\text{-N}_2$  atmosphere

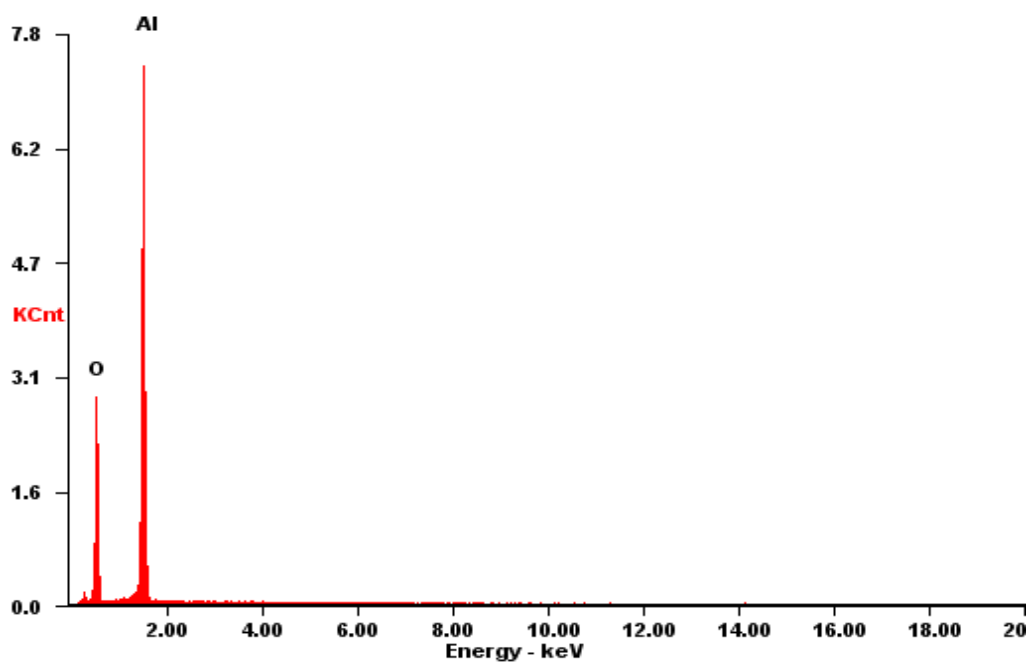
Variations across the transverse section of the coated alloy observed in figure 5.49 indicate that there were four different sections that formed. The external area of the coated alloy consisted of a single phase that comprised mainly of  $\text{Al}_2\text{O}_3$  on its external surface and the EDS performed on the external surface is presented in figure 5.50.

**Figure 5.50 EDS analysis performed on the external scale of the coated alloy after sulphidation test**

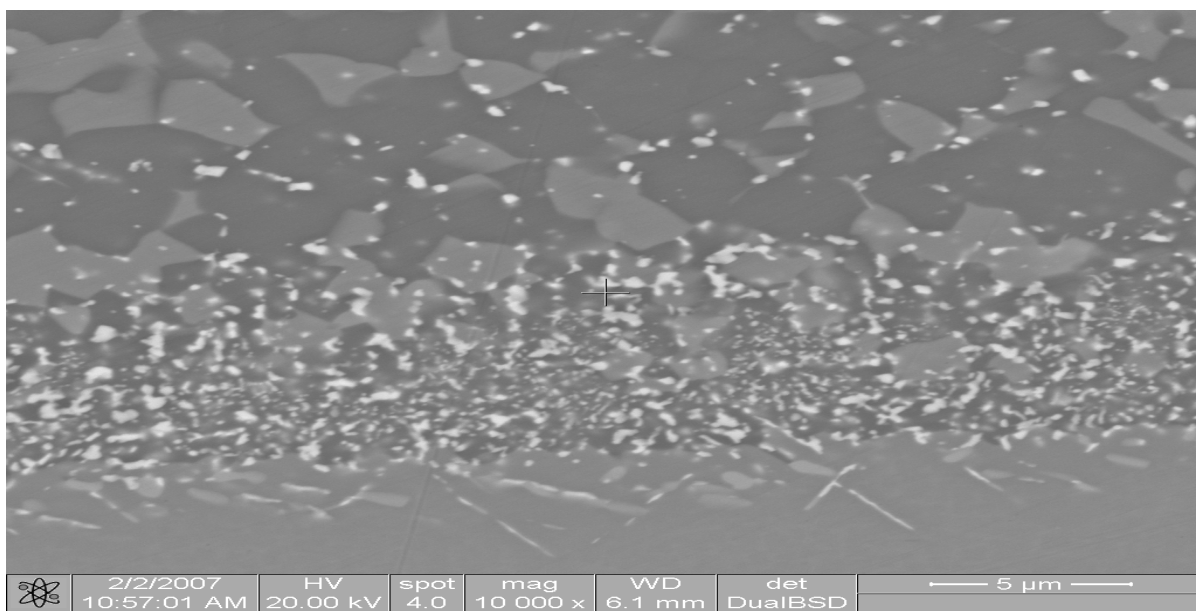
The interdiffusion zone is shown on the micrograph that was taken at high magnification in figure 5.51. Needle-like structures that formed were rich in refractory elements, as determined from EDS performed and given in figure 5.52.

**Figure 5.51 Inter-diffusion zone at high magnification of the coated Ni-based superalloy after 60 hours in a 0.2% SO<sub>2</sub>-N<sub>2</sub> atmosphere**

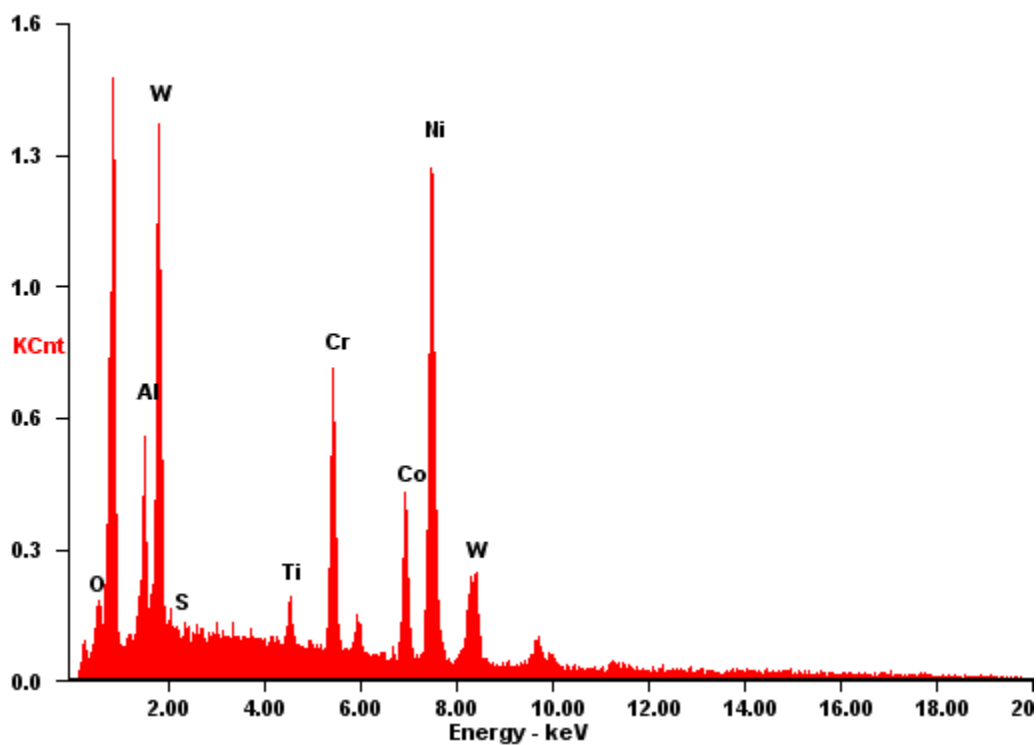
**Figure 5.52 EDS analysis performed on the needle-like phases that formed between the substrate and the coating**
