# **Corrosion behaviour of Pt-based superalloys intended for high temperature applications**

*A dissertation submitted to the Faculty of Engineering and the Built  
Environment, University of the Witwatersrand, in fulfillment of the requirements  
for the degree of Masters of Science in Engineering.*

**Johannesburg, 2007**

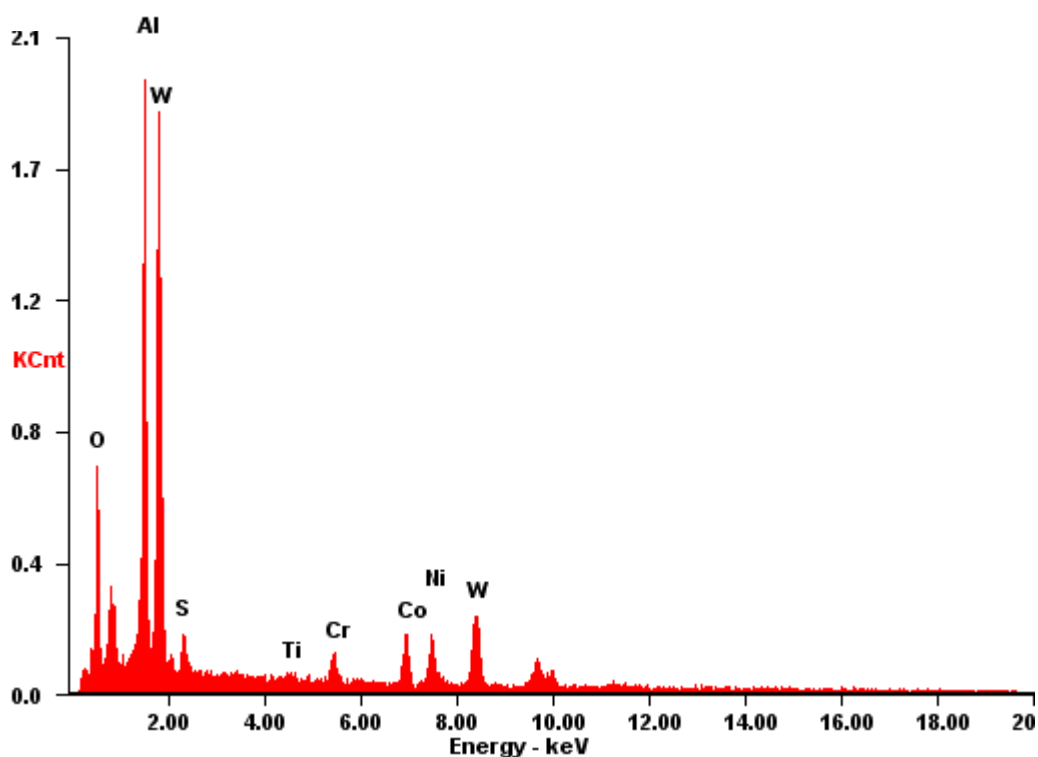
**Figure 5.53 EDS analysis performed on the coated alloy in the area below the  $\text{Al}_2\text{O}_3$  scale**

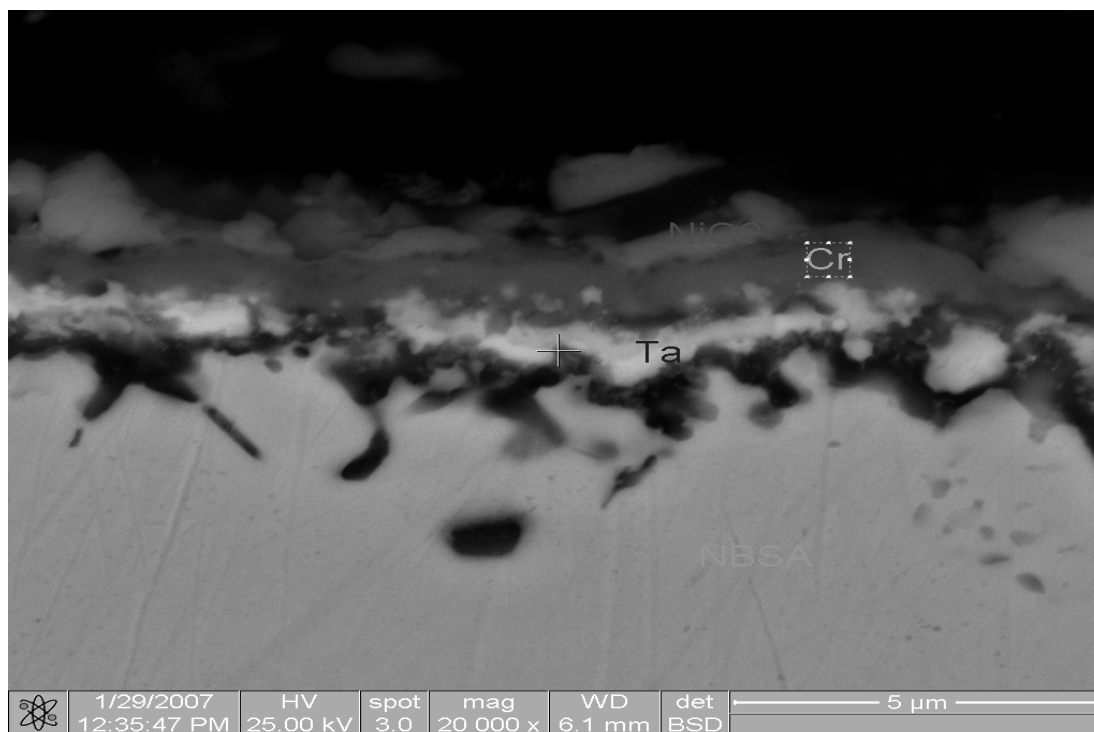
**Figure 5.54 Secondary image of the cross section of the uncoated Ni-based superalloy after sulphidation test**

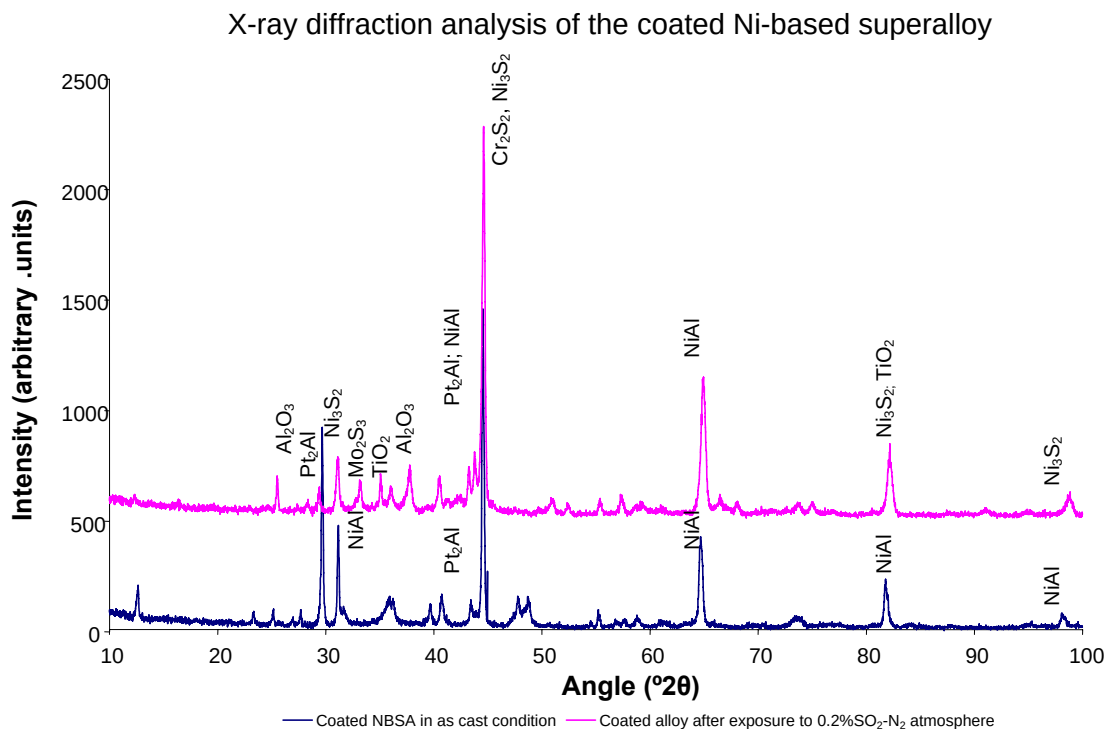
**Figure 5.55 XRD spectrum performed on the coated Ni-based superalloy before and after corrosion in controlled atmosphere constituting of 0.2%  $\text{SO}_2\text{-N}_2$  at  $900^{\circ}\text{C}$  for a period of 60 hours**

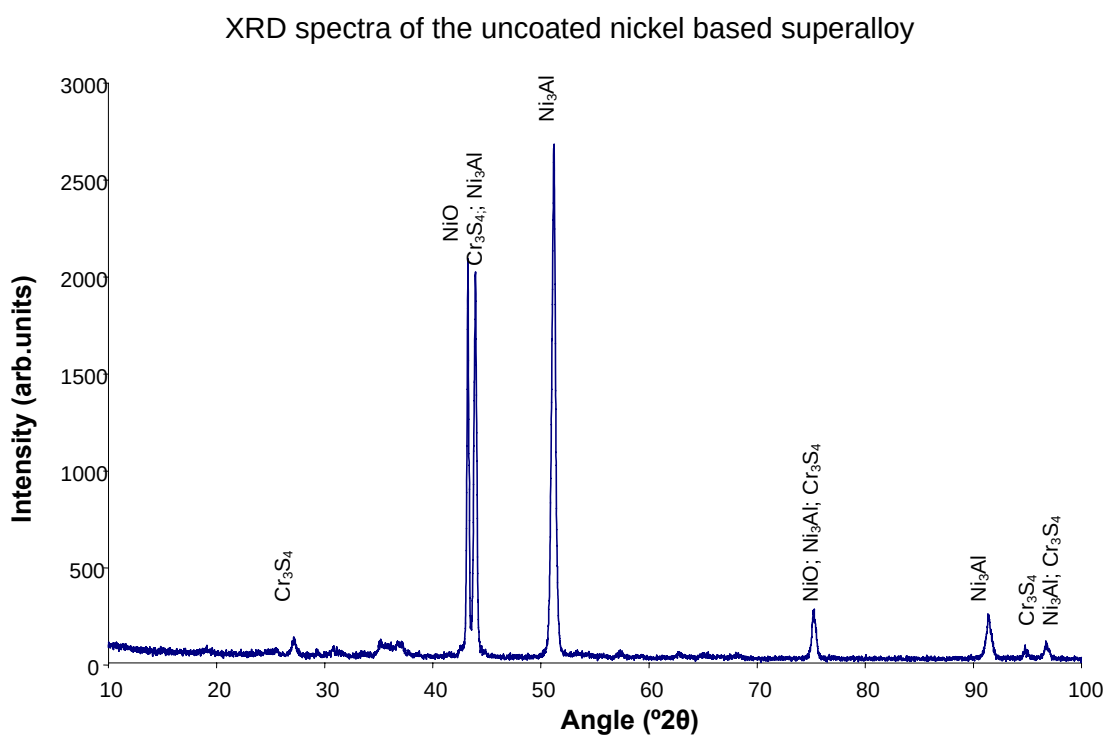
**Figure 5.56 XRD pattern on the uncoated Ni-based superalloy after exposure to 0.2% $\text{SO}_2$ - $\text{N}_2$  atmosphere**

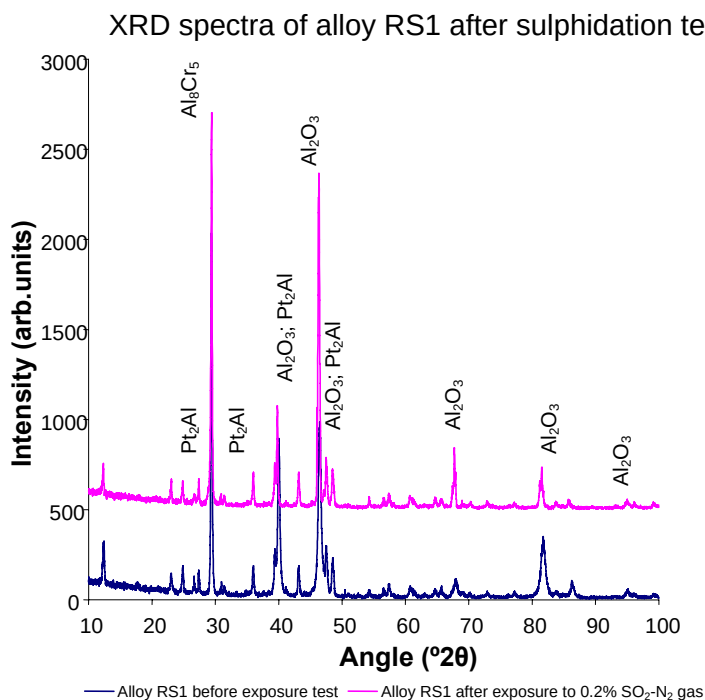
**Figure 5.57** XRD spectra performed on the external surface of alloy RS1 before and after exposure to 0.2%  $\text{SO}_2\text{-N}_2$  atmosphere at 900°C for a period of 60 hours

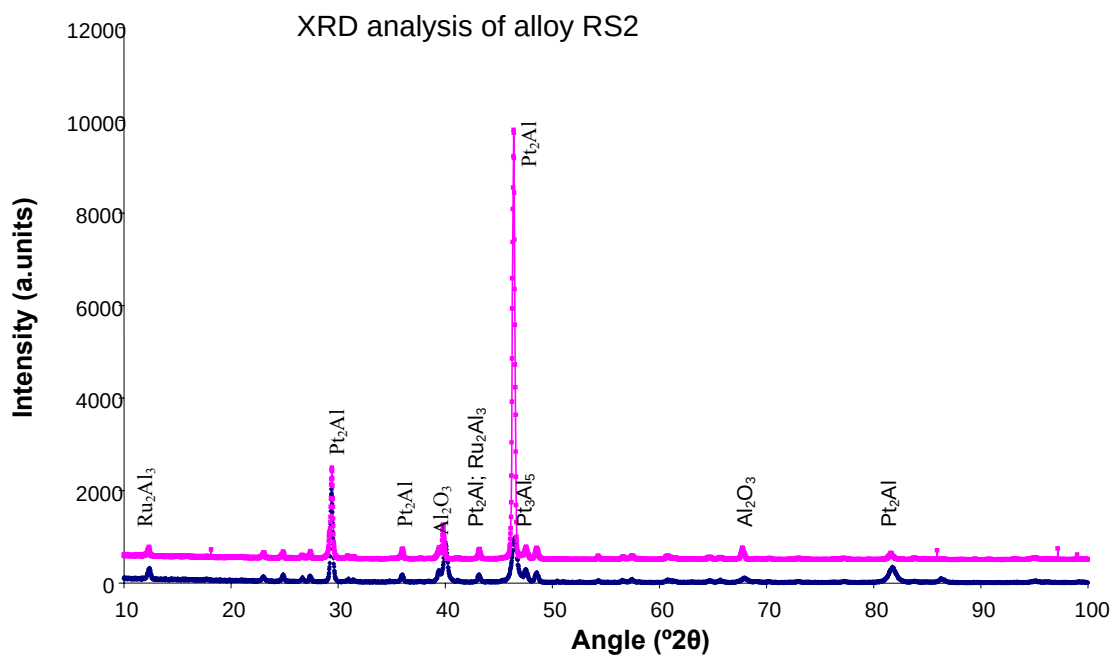
**Figure 5.58** XRD spectrum performed on the external surface of alloy RS2 [Pt-Al-Ru] before and after exposure to 0.2%  $\text{SO}_2\text{-N}_2$  atmosphere at 900°C for a period of 60 hours

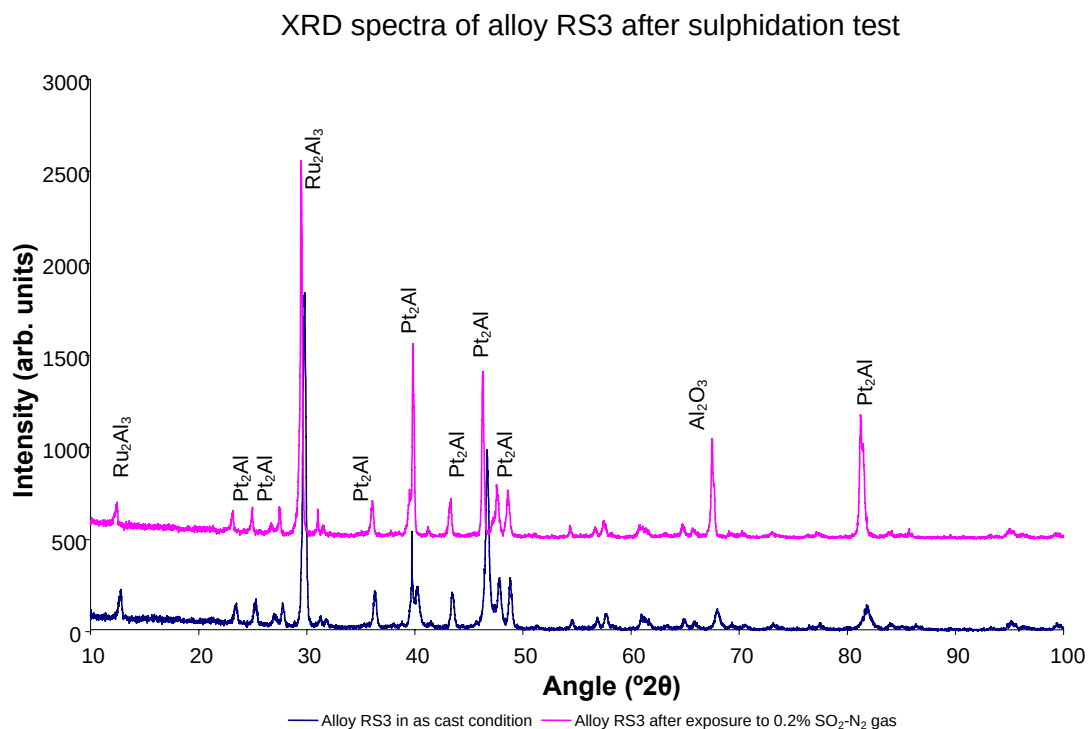
**Figure 5.59 XRD spectrum performed on the external surface of alloy RS3 [Pt-Al-Cr-Ru] before and after exposure to a 0.2%  $\text{SO}_2\text{-N}_2$  atmosphere at 900°C for a period of 60 hours**

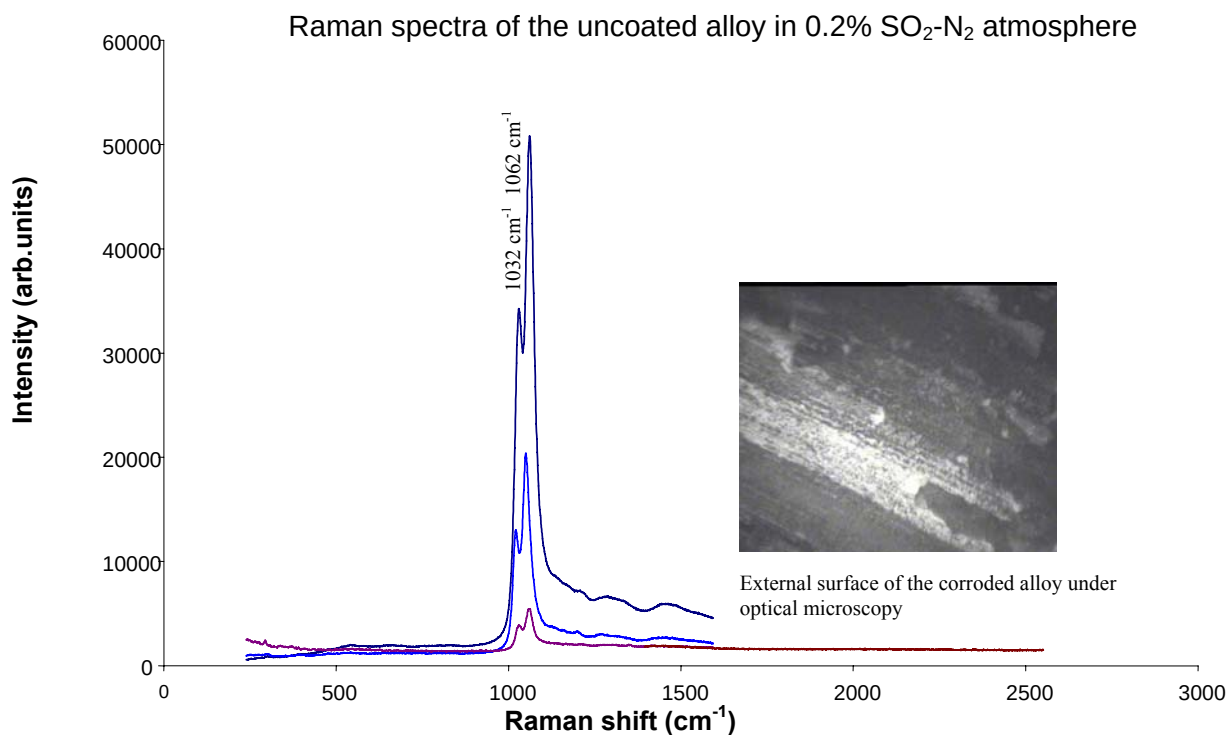
**Figure 5.62 Raman spectra collected on the external surface of the uncoated alloy after sulphidation at 900°C for a period of 60 hours**

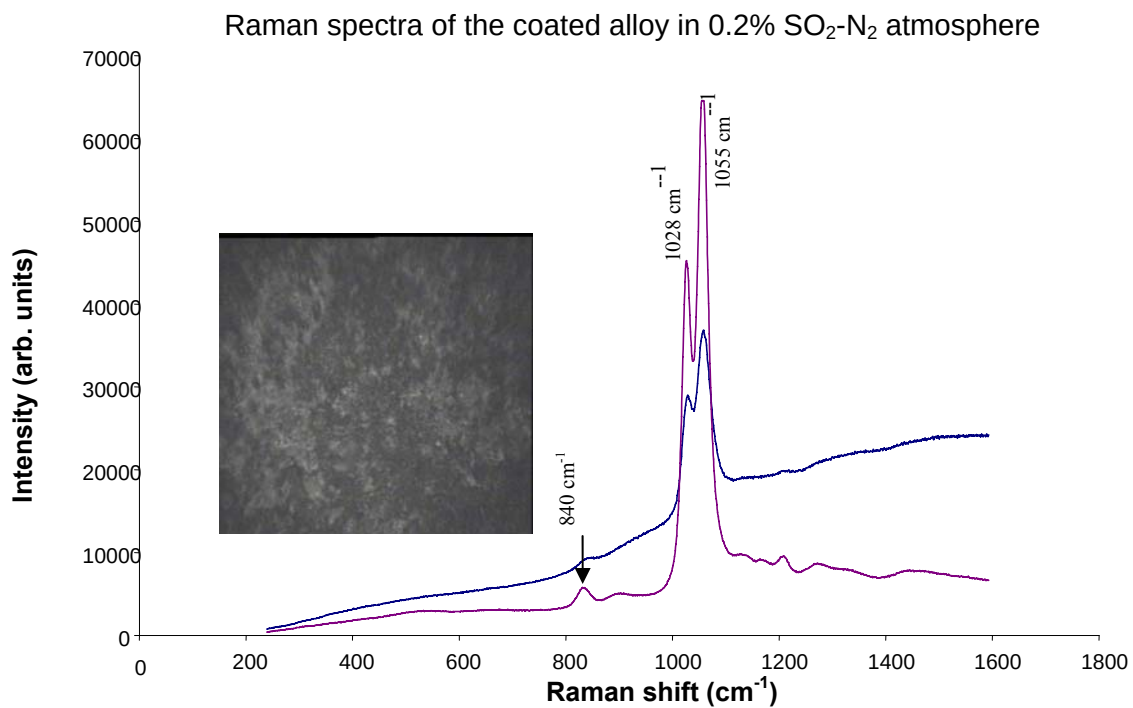
**Figure 5.63** Raman spectra collected on the external surface of the coated alloy after sulphidation at 900°C for a period of 60 hours

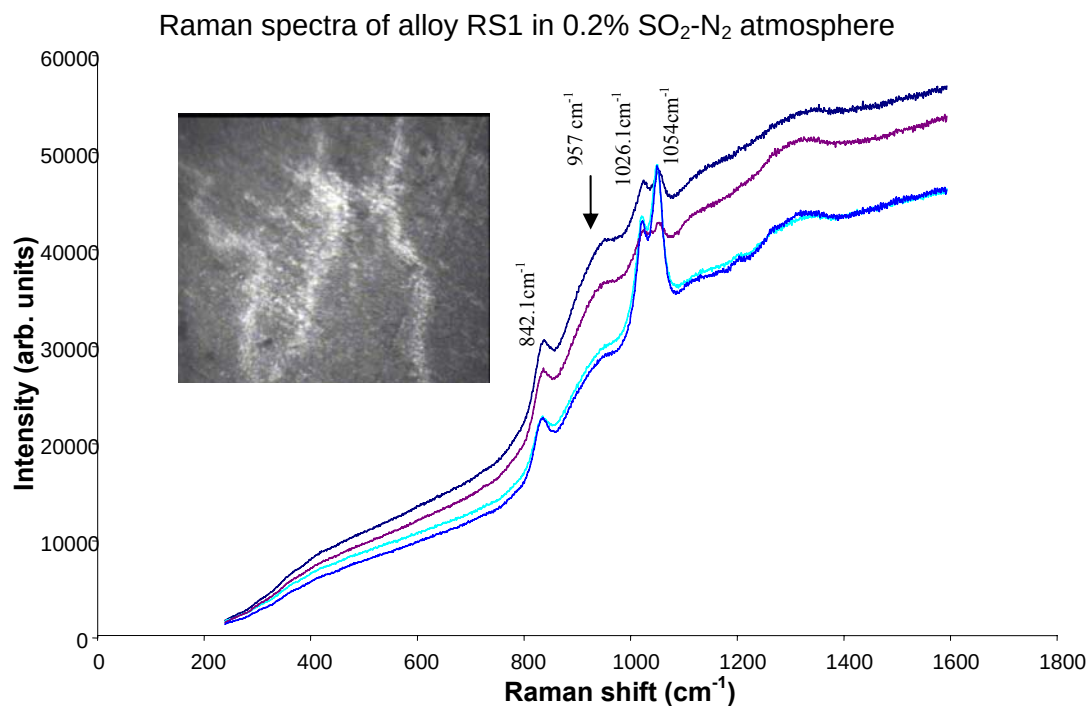
**Figure 5.64** Raman spectra collected on the external surface of alloy RS1 after sulphidation at 900°C for a period of 60 hours

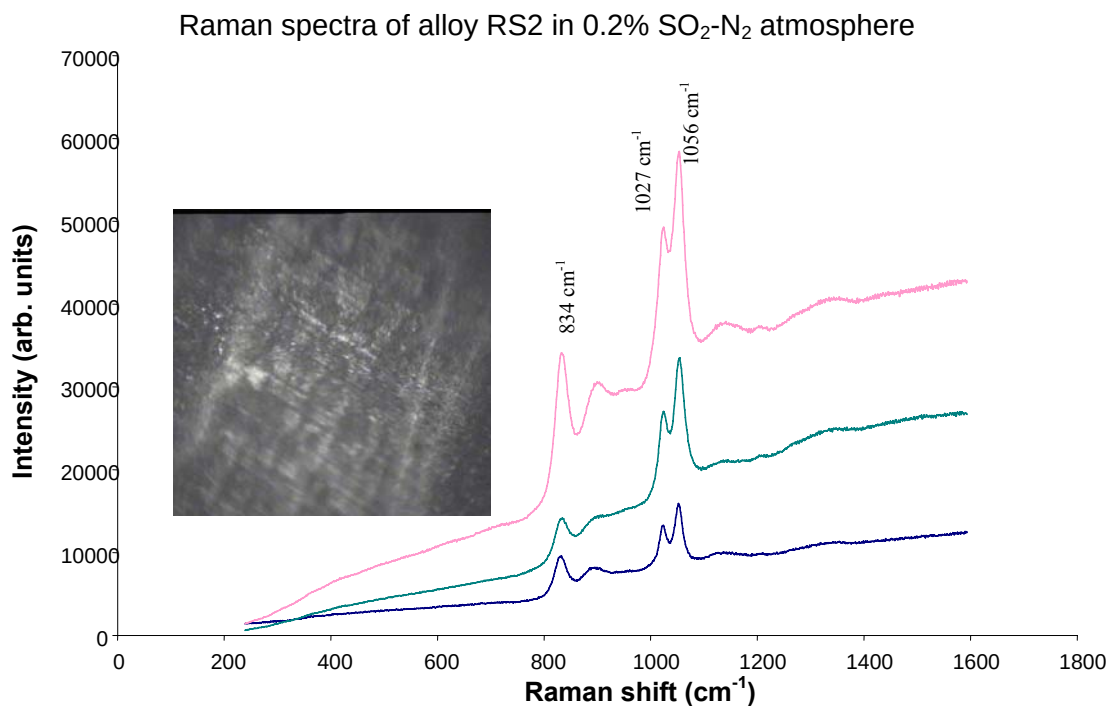
Peaks that formed on the surface of alloy RS2 were sharper and had higher intensities. Raman spectrum of alloy RS2 was similar to that of alloy RS3, as illustrated in figures 5.65 and 5.66. Table 5.2 tabulates the peaks that formed on the surface of alloys RS1, RS2, and RS3.

**Figure 5.65** Raman spectra collected on the external surface of alloy RS2 after sulphidation at 900°C for a period of 60 hours

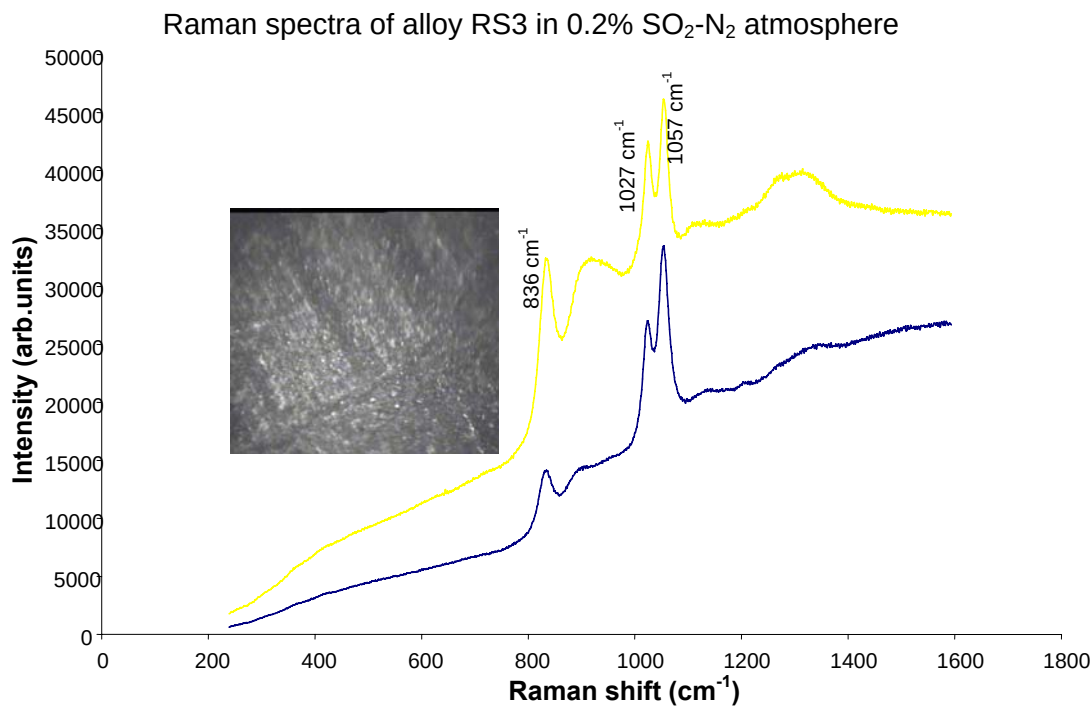
**Figure 5.66** Raman spectra collected on the external surface of alloy RS3 after sulphidation at 900°C for a period of 60 hours

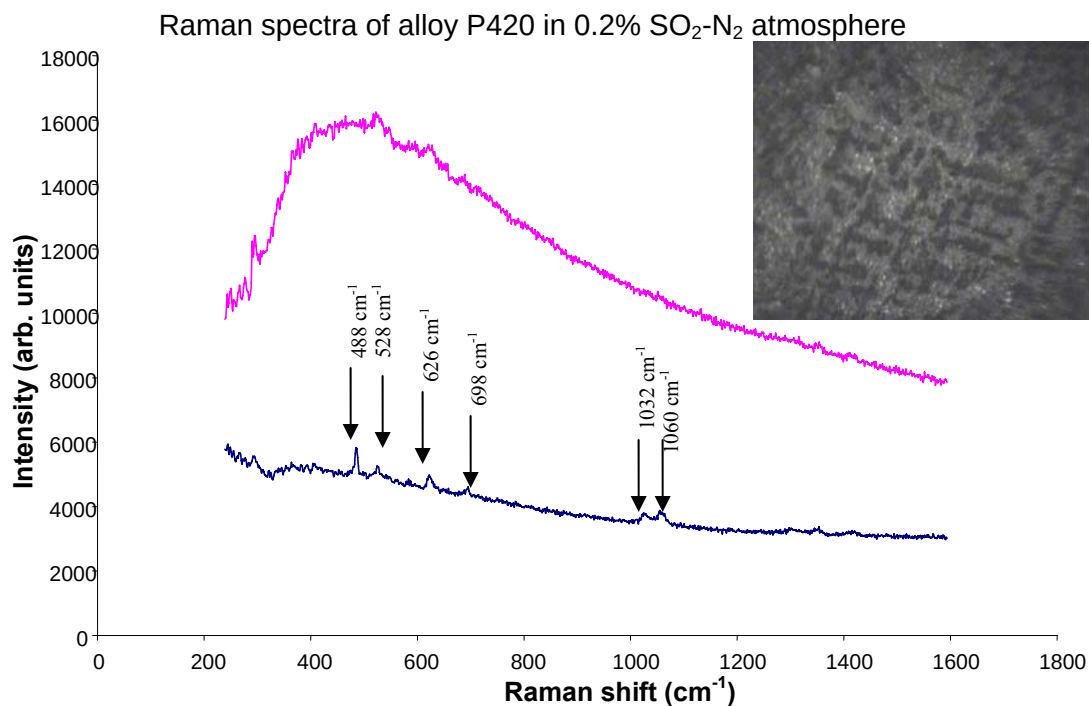
The Raman spectra of alloys P420 and P421 are nearly the same, and the spectra are depicted in figures 5.67 and 5.68. The four peaks at 486, 528, 629 and 699  $\text{cm}^{-1}$  wavenumbers were assigned to blue  $\text{Co}_3\text{O}_4$  as indicated in table 5.3. The peak at 194.4 due to  $\text{F}_{2g}$  vibrations is not observed because the spectral range started at  $250\text{cm}^{-1}$ .

**Figure 5.67** Raman spectra collected on the external surface of alloy P420 after sulphidation at 900°C for a period of 60 hours

The results obtained suggest that sulphate salts with possible traces of nitrates formed on the surfaces of the alloys.

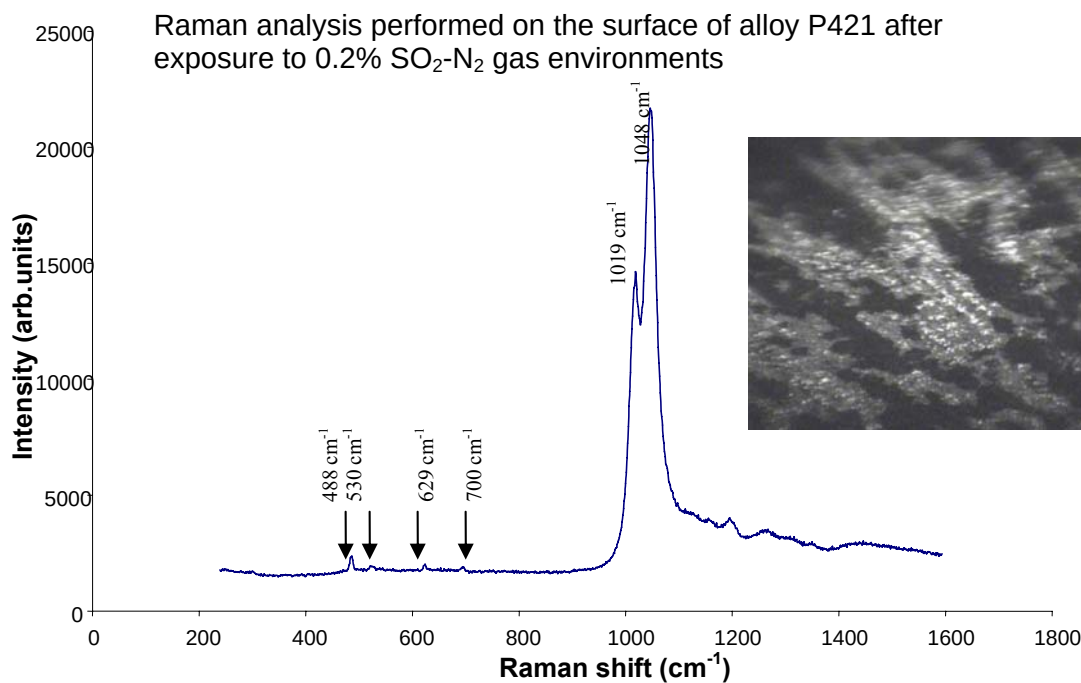
**Figure 5.68** Raman spectra collected on the external surface of alloy P421 after sulphidation at 900°C for a period of 60 hours

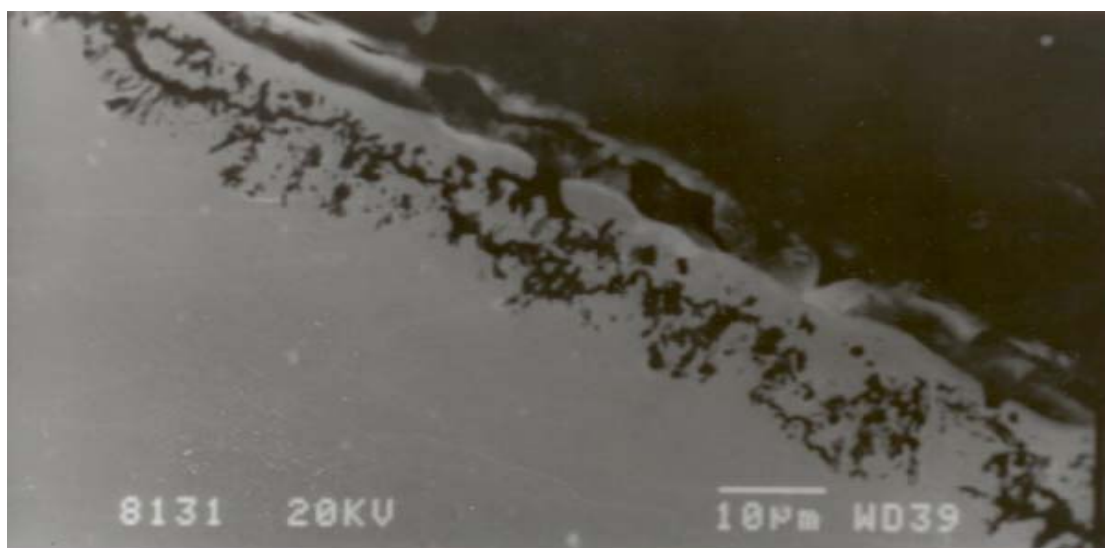
**Figure 6.1** Cross section of alloy RS3 showing fluxing of the external scale when the alloys were immersed in molten  $\text{Na}_2\text{SO}_4$  salt

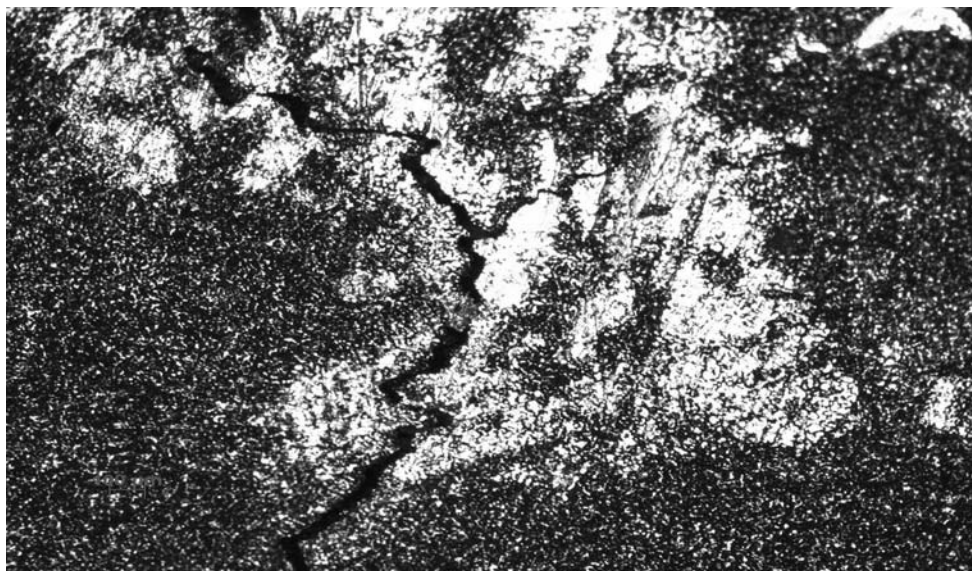
**Figure 6.2 Spallation around the cracks on the surface of alloy P420 that was subjected to molten salts at 950°C for a period of 540 hours**

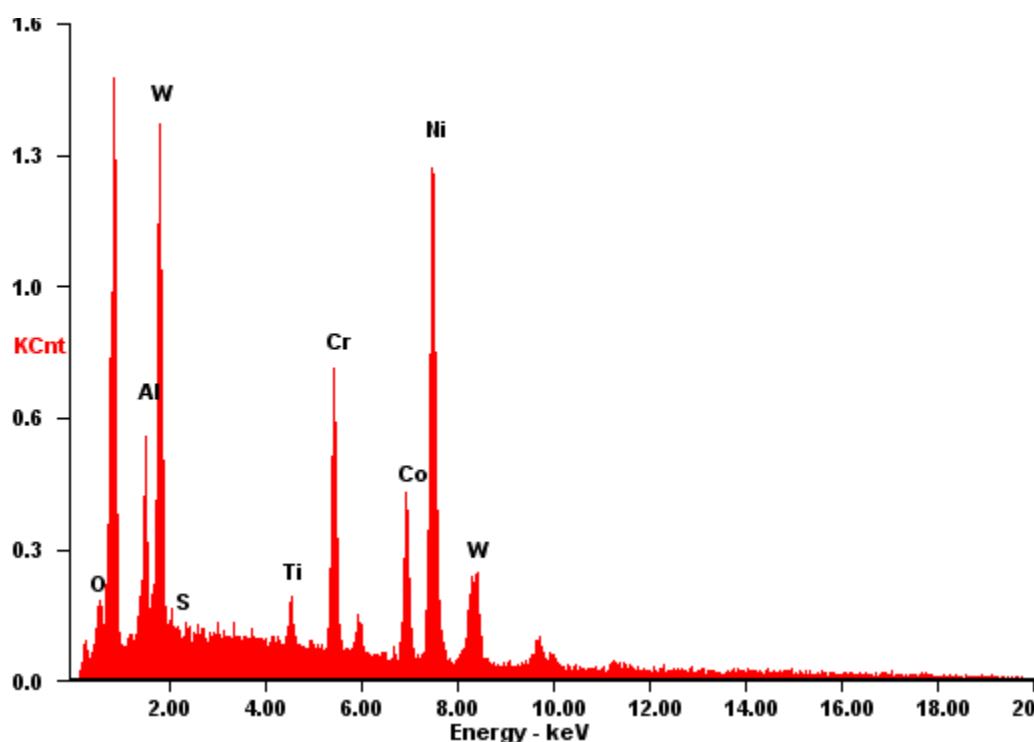
**Figure 6.3 EDS spot analysis performed on the needles formed**
