## 3.0 MATERIALS AND METHODS

### 3.1 Introduction

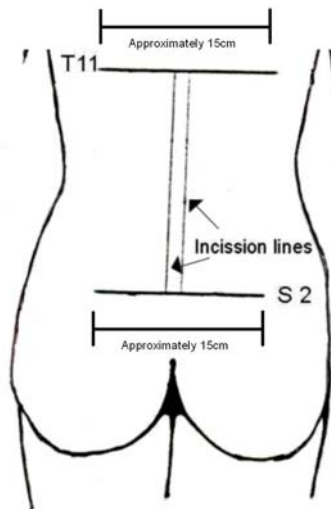
**Figure 3.1:** Position of incision on the lateral aspect of the spinous processes down to the lamina of the lumbar vertebra from T11 – S2

The cadavers were placed in the prone position. An incision was made bilaterally; down to the level of the lamina and posterior aspect of the sacrum, immediately adjacent to the spinous processes from T11 to mid sacrum level S2. Figure 3.1

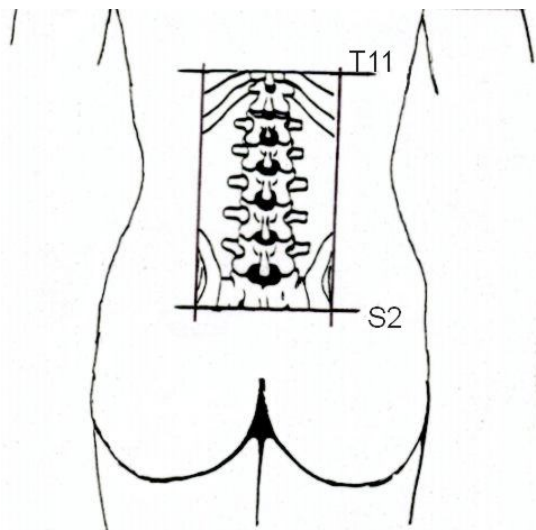
**Figure 3.2:** Transverse incision across T11, 15cm lateral on to the bony ribs of T11 and T12, and similarly laterally across S2 beyond the sacroiliac articulation and onto the posterior aspect of the ilium, to expose the vertebral column

Using a sharpened chisel tool, the posterior musculature was stripped laterally from the underlying ribs, transverse processes and sacrum, exposing the vertebral column. Figure 3.2

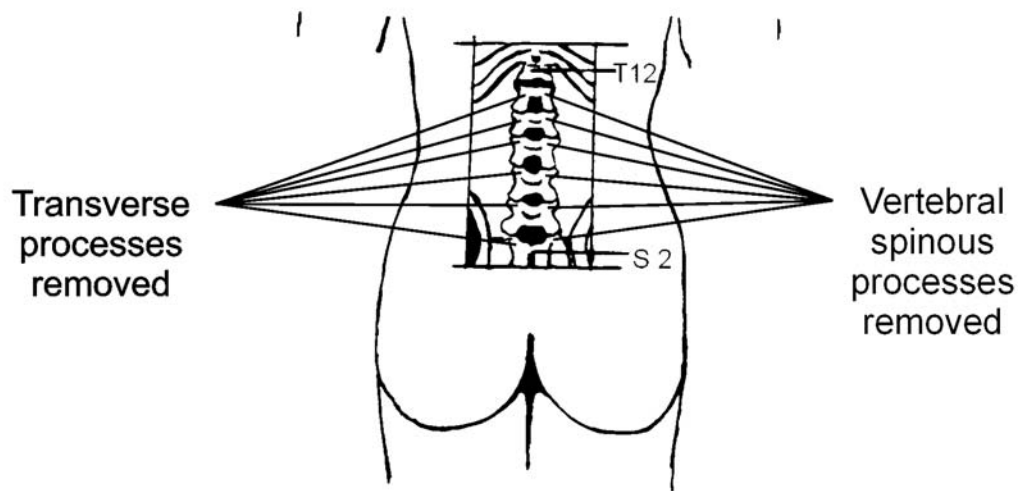
**Figure 3.3:** Removal of spinous processes and transverse processes

The transverse processes and spinous processes were not part of the study, so they were severed from the bodies of the vertebrae. Figure 3.3

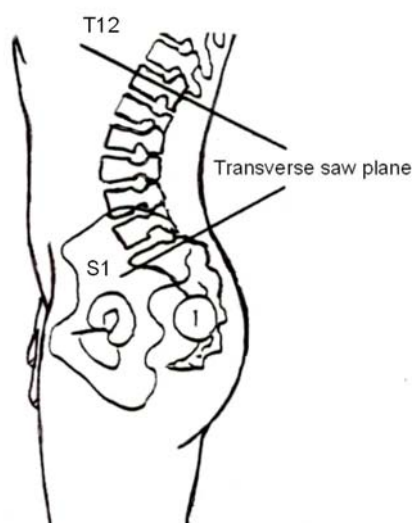
**Figure 3.4:** Removal of lumbar spine by mid transverse sectioning of body of T12 and S1

In order to remove the lumbar column, the T12 body was identified by identifying the 12<sup>th</sup> rib attachment and using a bone saw a transverse incision was made through the middle of the body of T12 and the pedicle supporting the articulating processes at T12 and L1. A further transverse separation was done at S1-S2, lateral to the sacroiliac joint and superior to the joint was prised open freeing the 1<sup>st</sup> sacral segment from the ilium. Figure 3.4

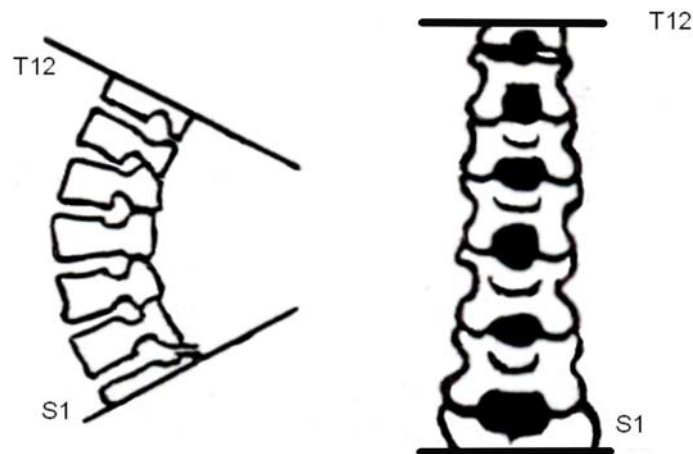
**Figure 3.5:** Lateral and posterior diagrams of the removed specimens

This procedure left the lumbar spine free for removal. Surrounding fascias, blood vessels and nerve structures were severed and stripped away rendering the lumbar column free for removal from the cadaver. Figure 3.5

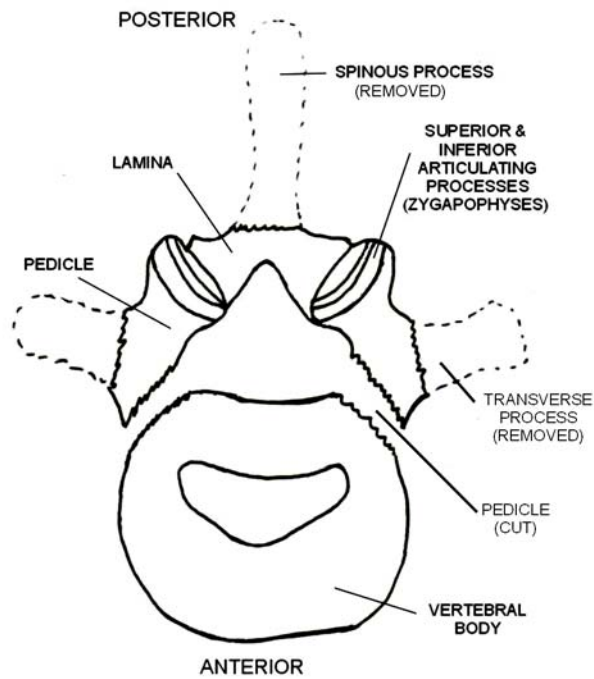
**Figure 3.6:** Schematic diagram of the removal of the facet joints

Once this had been completed, the posterior elements were removed at the pedicle, vertebral body junction and the articulating processes further removed from the pedicle and lamina. Figure 3.6 & 3.7.

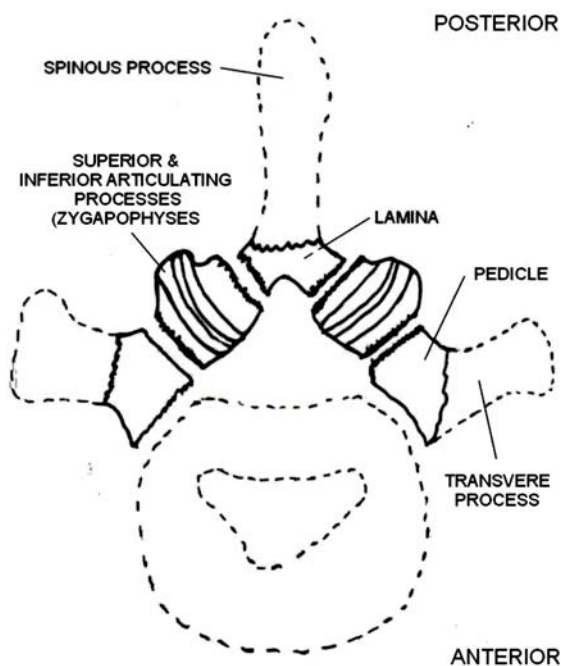
**Figure 3.7:** Schematic diagram of the removal of the facet joints, in the next step

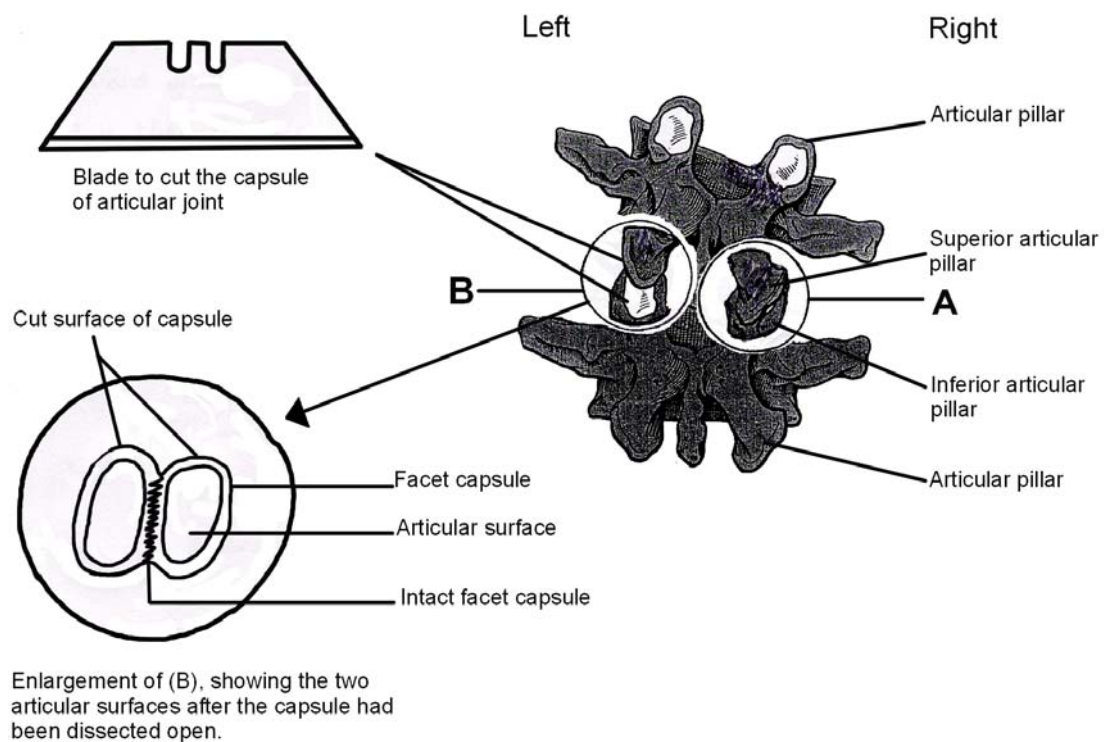
**Figure 3.8:** Diagram showing the removal of the intact articular process from the posterior vertebral body

The superior and inferior facet joints of each side were removed from the vertebral bodies (see A in figure 3.8) and placed in individually marked containers, with a preservative of 5% formalin. (figure 3.8 A – Shows the intact facet joints, whereas B shows the two separated surfaces after the capsule has been removed and the articulations separated)

A sharp scalpel blade was used to sever the capsule around the peripheral articulating border, Figure 3.8, and the joint was pried open. The incision was made to just inside the capsule to not damage the articular surface. The joint was opened and the hyaline cartilage surface exposed for examination.

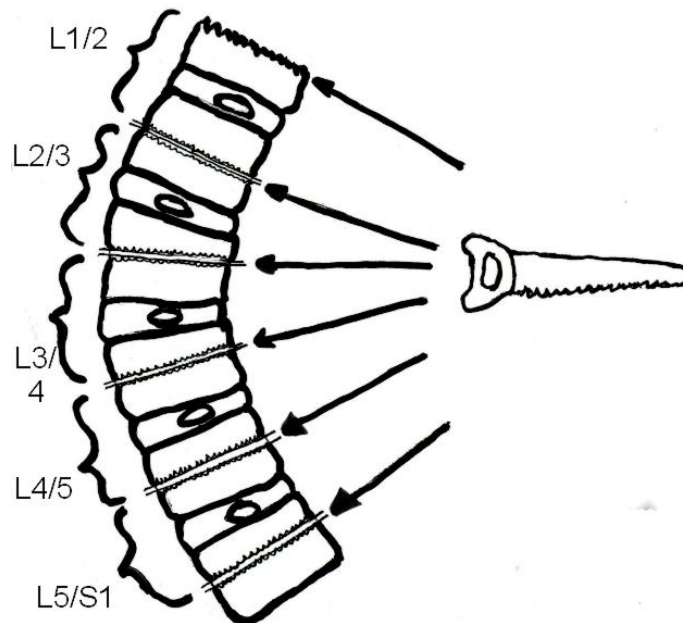
**Figure 3.9:** Cutting of lumbar vertebral column transversely through the bodies of the adjacent vertebrae

The lumbar spine was cut in the mid transverse plane of the vertebral bodies leaving the disc intact. Figure 3.9.

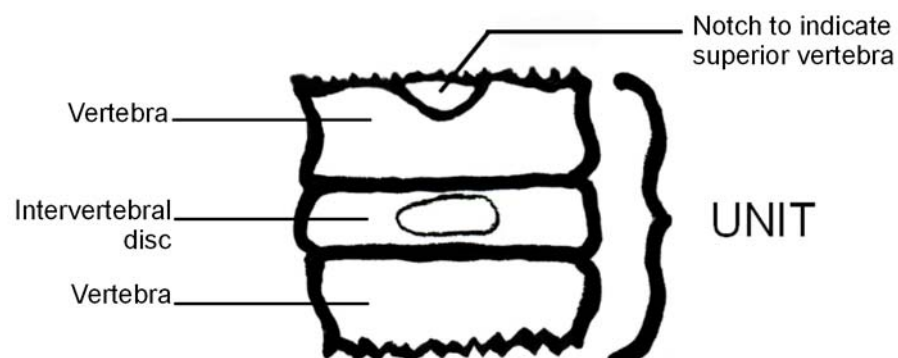
**Figure 3.10:** Vertebral unit

The units formed were L1/2, L2/3, L3/4, L4/5, and L5/S1. On the body of the superior vertebra, for example L2 on L3, a notch was made on the anterior superior aspect for identification. Figure 3.10.

The specimens were then x-rayed in lateral and axial views. Great care was taken to accurately mark the superior and inferior bodies, as well as showing left and right. (Figure 3.10)

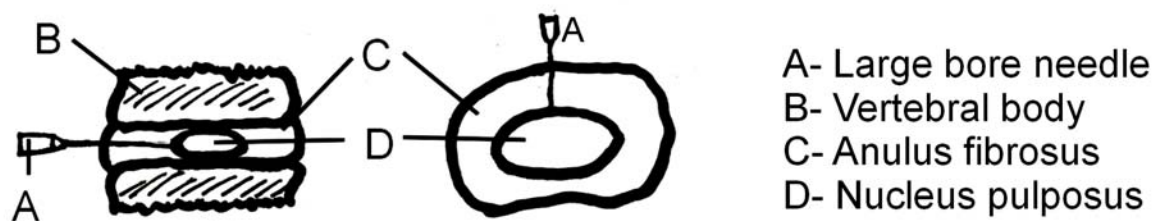
**Figure 3.11:** Positioning of needle into the nucleus pulposus

An integral part of the study was to observe the migration of dye in the nucleus pulposus, under pressure, hoping to identify early fissuring in the anulus fibrosus. To accomplish this, the nucleus pulposus would have to be infiltrated with a radio opaque dye and then x-rayed in the lateral and superior planes, which meant that each level would have to be done separately. Figure 3.11

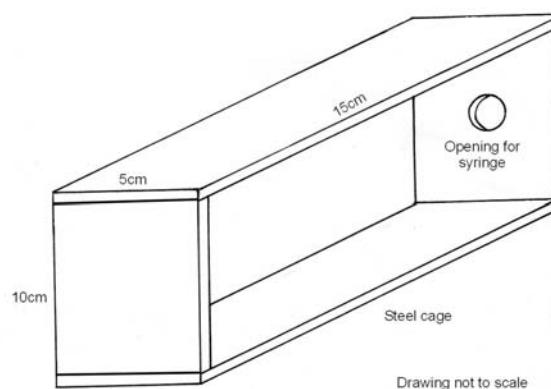
**Figure 3.12:** Diagram of cage apparatus

In order to observe the dispersion of radio opaque dye in the nucleus pulposus, a cage apparatus was constructed whereby the dye UROGRAFIN® could be injected into the nucleus pulposus under constant pressure.

The pressure apparatus was made of a 5mm x 30mm flat bar. It measured 20cmx10cm with a 7mm hole in the centre of one of the 10cm uprights. Figure 3.12

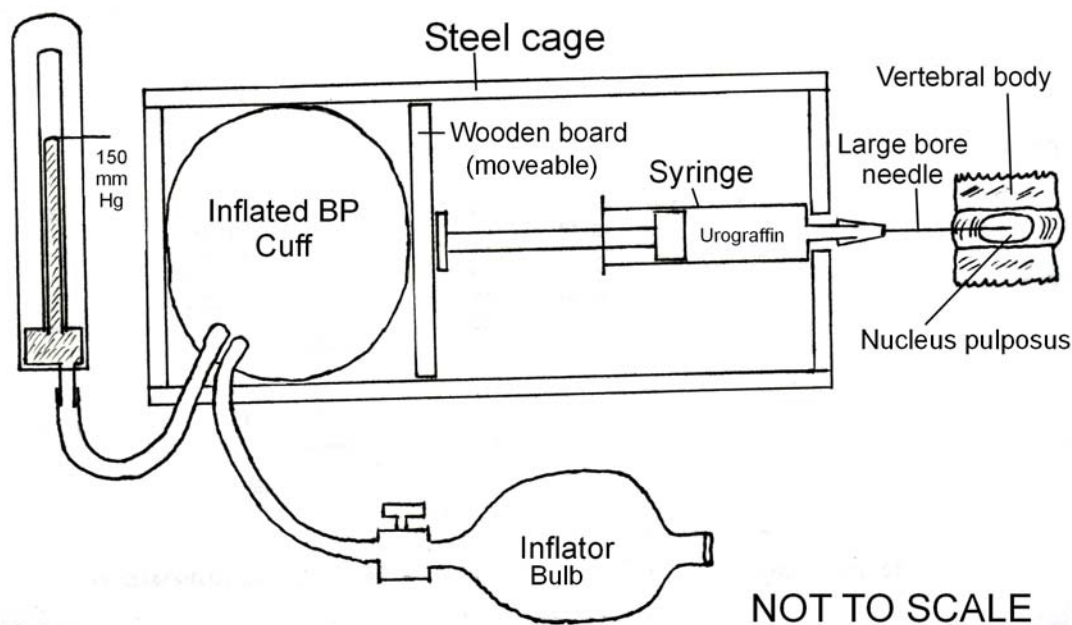
**Figure 3.13:** Placement of the syringe in cage and injection of dye

Five cubic centimetres of UROGRAFIN® was drawn up in the 20ml syringe, the excess air was expelled and the syringe was placed in front of the BP cuff. Figure 3.13

An assistant held the needle in place with a pair of pliers. The BP cuff was inflated to 150 mm Hg and where possible maintained for 10 seconds. The BP cuff was then deflated. This process was repeated on all the specimens. (Figure 3.13)

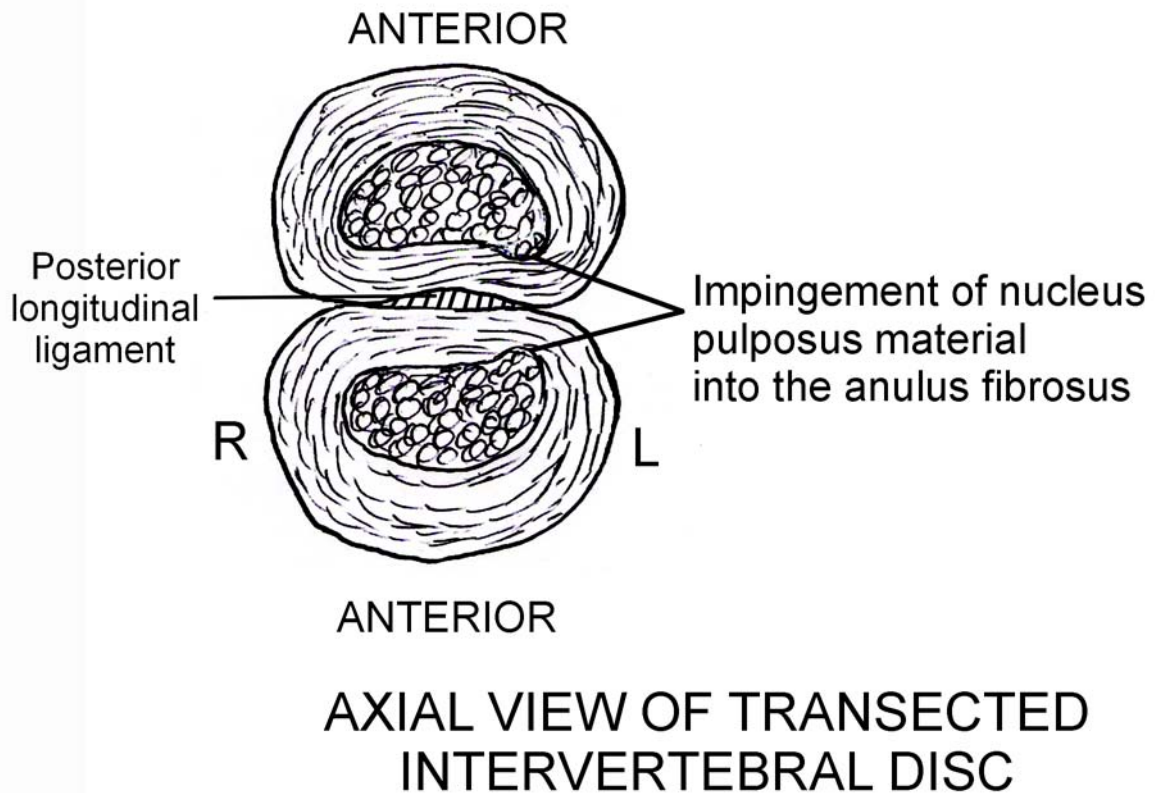
**Figure 3.14:** Transverse section through the intervertebral disc

With the x-rays completed, the individual units were placed on the posterior aspect and with a very sharp “butchers knife” the discs were divided into two halves by separated slicing through the middle of the disc from anterior to posterior. It was attempted not to slice through the posterior longitudinal ligament. (Figure 3.14)

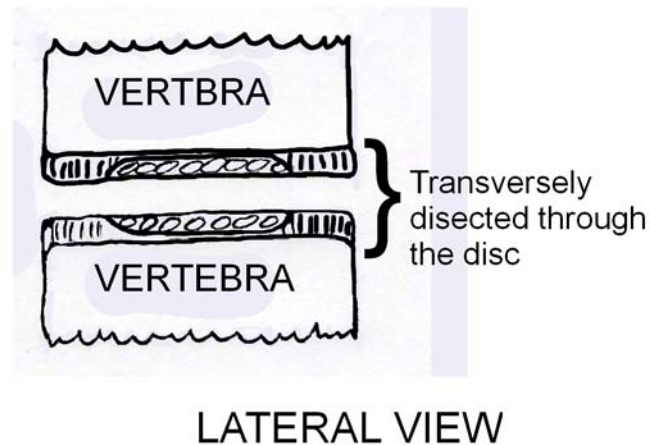
**Figure 3.15:** Sectioning through the intervertebral disc

The vertebral bodies were then separated through the posterior longitudinal ligament. (Figure 3.15)

A transverse section was made through the centre of the disc with a fine toothed fret saw. (Figure 3.15)

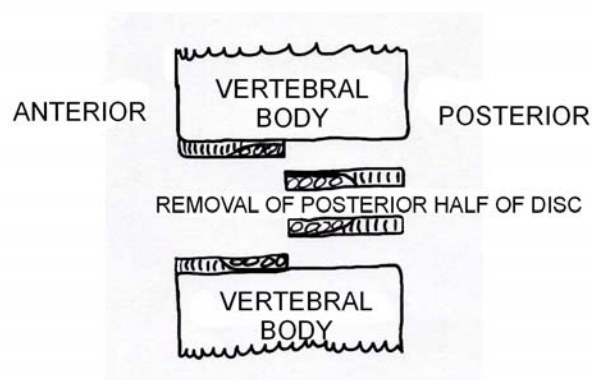
**Figure 3.16:** Separation of the posterior parts of the intervertebral disc into the superior and inferior sections

A coronal section was made through the intervertebral disc, separating the posterior aspect of the intervertebral disc. (Figure 3.16, 17)

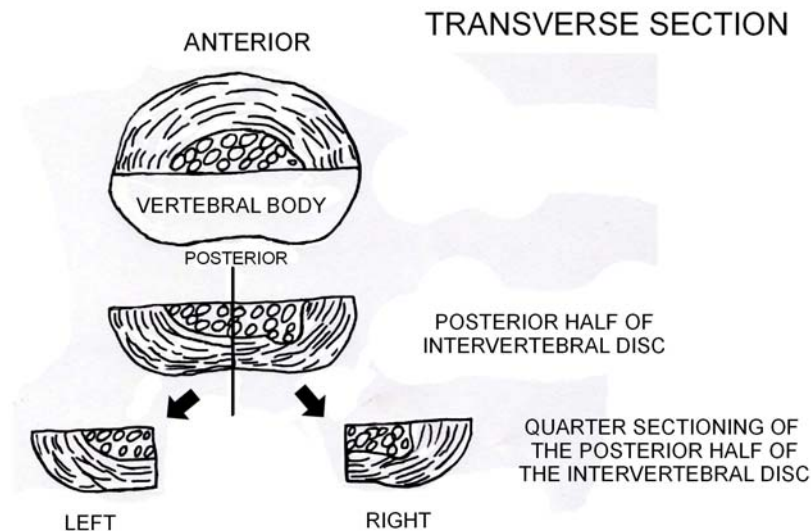
**Figure 3.17:** Removal of the posterior part of the intervertebral disc

The posterior aspect of the disc was then divided into a left and right section through the sagittal plane. (Figure 3.17)

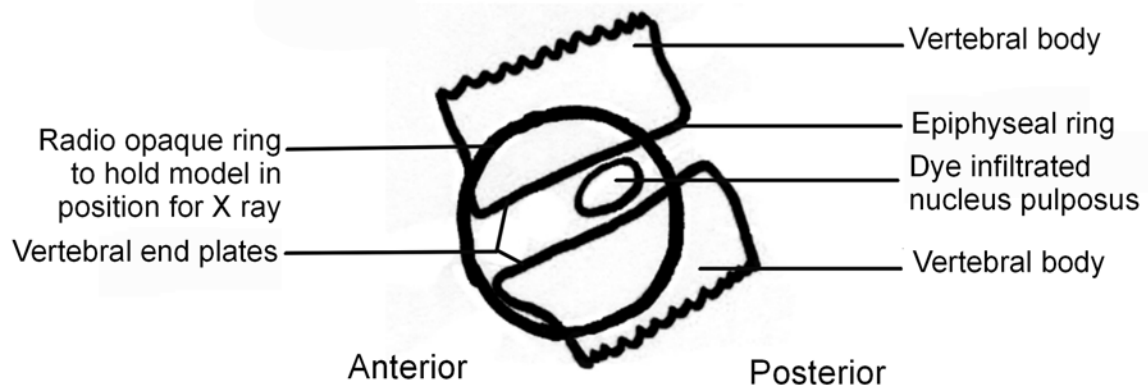
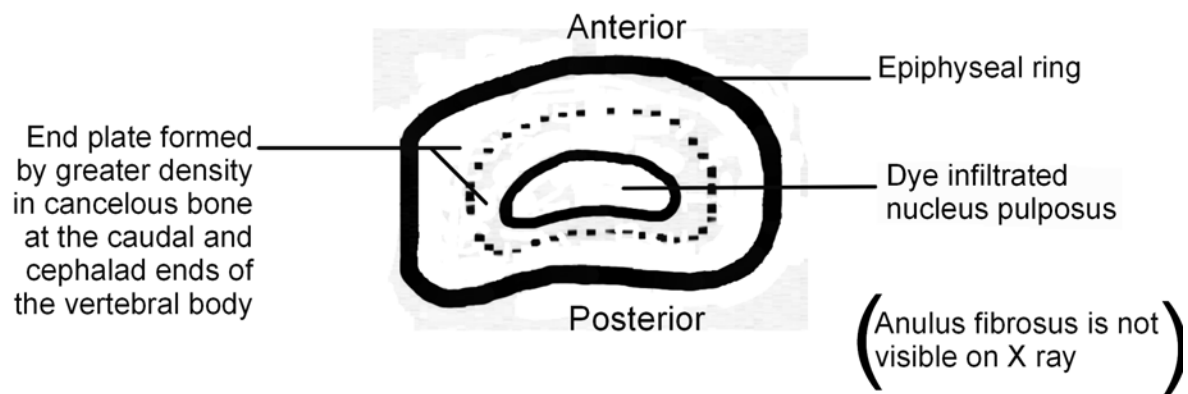
**Figure 3.18:** Schematic diagram of the lateral and axial view of the vertebral body structures to be x rayed

In the lateral view of the dissected out specimen, a white ring is visible. This ring is a support ring of PVC pipe that was used to secure the specimen for X-raying.
