# **Fall of ground management in shallow underground hard rock mining: a case study in a Chrome mine**

A research report submitted to the Faculty of Engineering and the Built Environment, University of the Witwatersrand, Johannesburg, in partial fulfilment of the requirements for the degree of Master of Science in Engineering.

Johannesburg, 2018

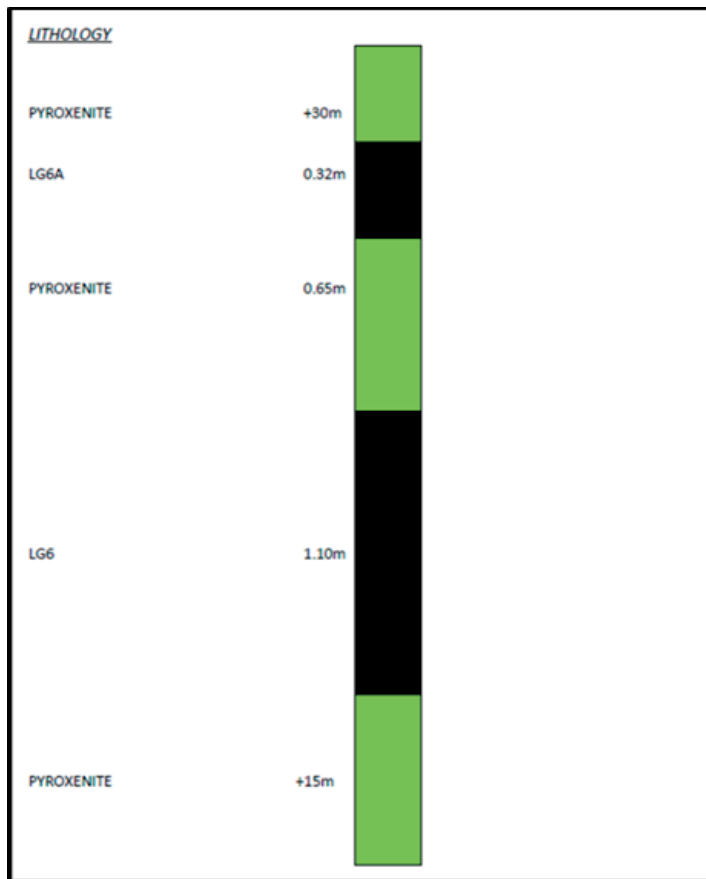
The Critical zone is sub divided into the Lower, Middle and Upper Groups. The Lower Group (LG) consists of seven (7) layers which are held within the pyroxenite rock (Maier, et al., 2012). Chromitite at the area of study is produced from the Lower Group (LG), where the LG6 and LG6A reefs are mined. Illustrated in Figure 2.3 is a simplified lithology at the Chrome mine where stoping height ranges between 2.1m to 2.3m. This is because the production blast includes LG6A (0.32m), the middling which is the pyroxenite (0.65m) and the LG6 (1.10m) chromitite layer. Depending on the presence of geological features, the stoping height varies from one location to another (Internal Mine Document, 2013).

**Figure 2.3: Simplified lithology at the Chrome mine** (*Internal Mine Document, 2013*)

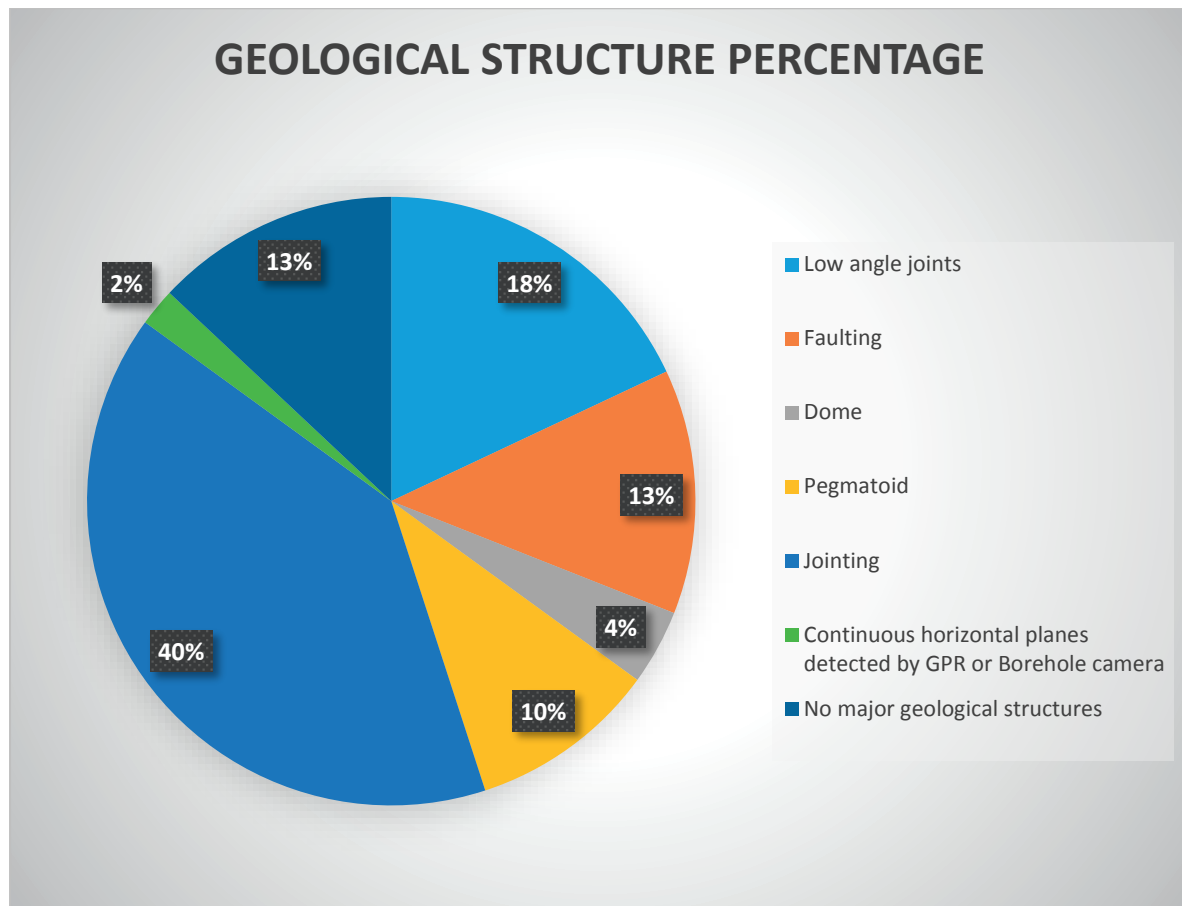
At the Chrome mine, a summary of geological structures encountered is compiled and results presented as shown in Figures 2.5 and 2.6, on a monthly basis. It can be seen from the pie charts that the most prominent geological structures intersected are joints (normal joints and flat dipping joints). Although in some parts of the mine there are no major geological features intersected, faults, domes and continuous horizontal planes (detected by GPR scans and Borehole camera) are intersected in some areas. The above-described approach used at the Chrome mine gives insight of potential causes of falls of ground and can be used to help

**Figure 2.5: Percentages of geological structure occurrences in February 2018**

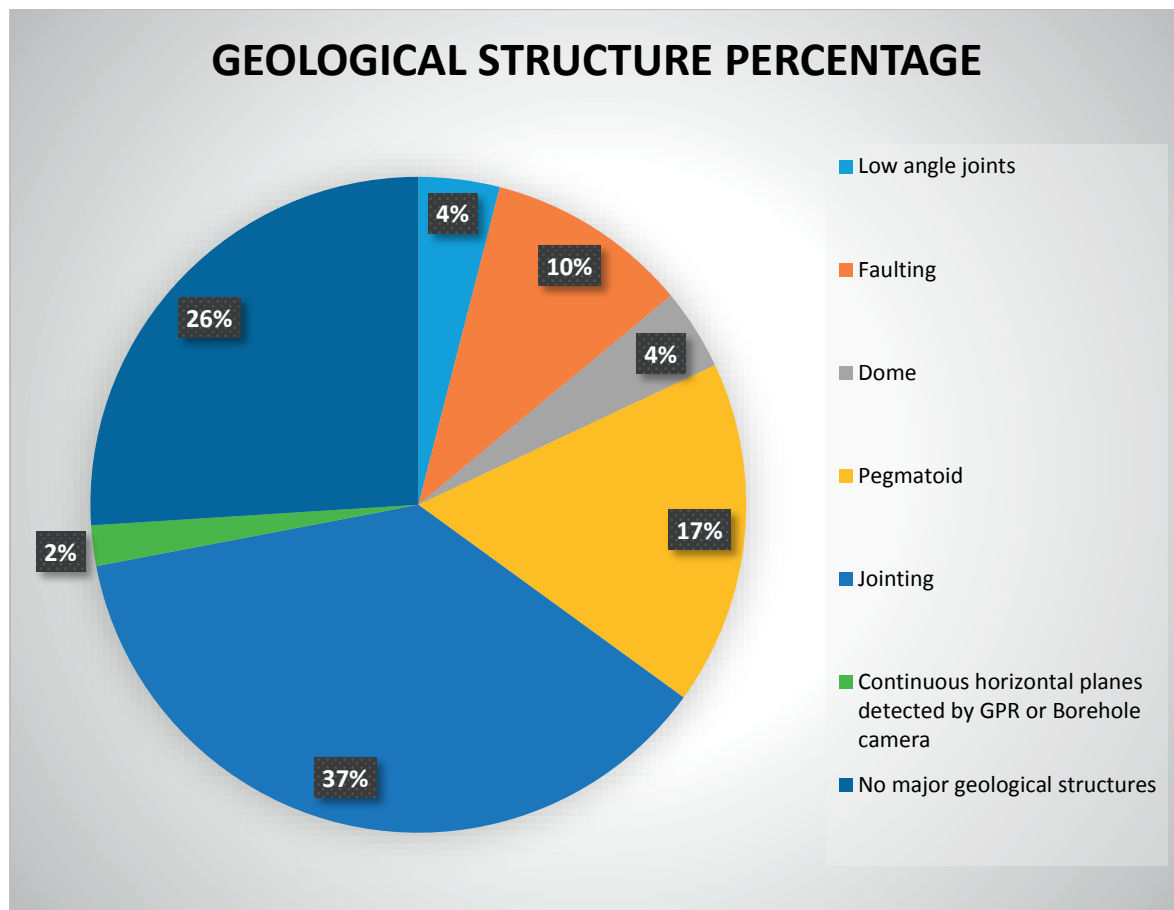
**Figure 2.6: Percentages of geological structure occurrences in April 2018**

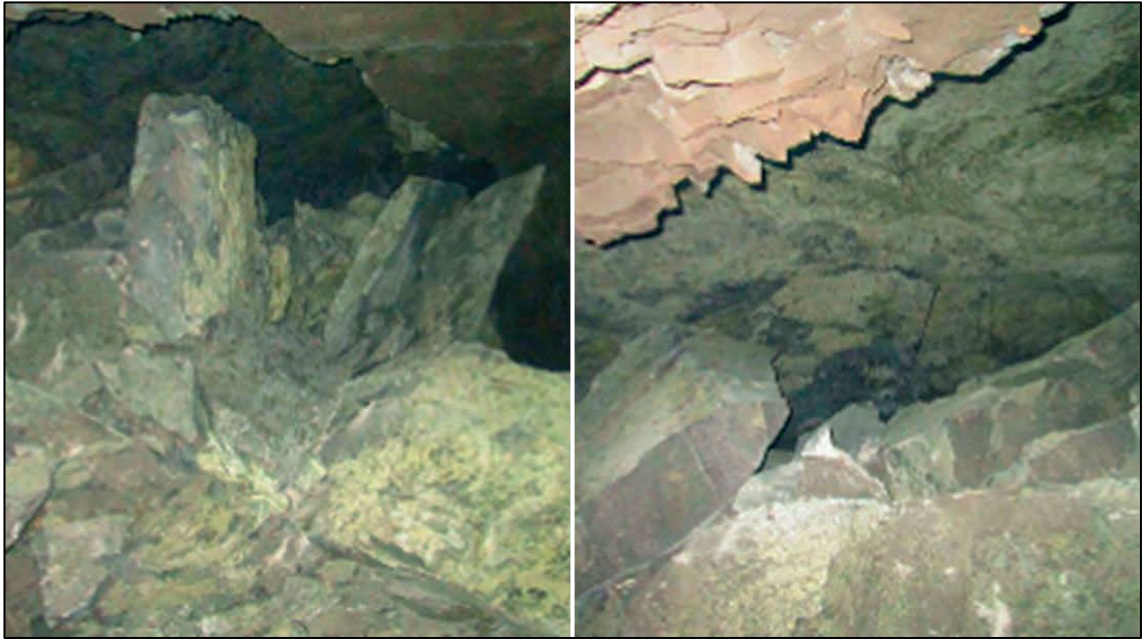
fall of ground due to intersection of multiple prominent joints is shown in Figure 2.7. The joints were observed to have soapy infilling material known as seperntinite.

**Figure 2.7: Fall of ground as a result of multiple parting planes with sepiertinite infilling**  
(*Internal Mine Document, 2011*)

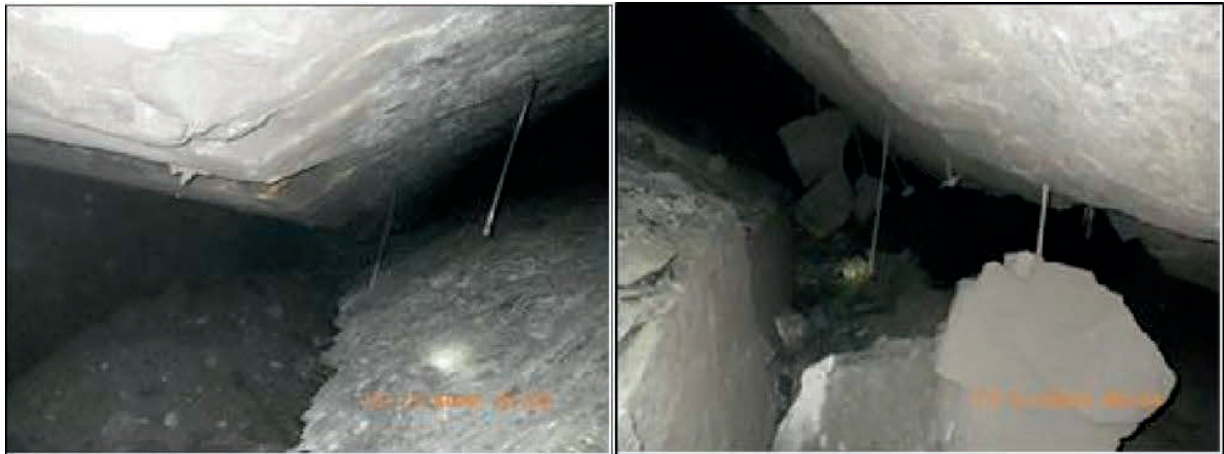
The intersection of near vertical joints and low angled joints may result in the formation of wedges and unstable blocks, which have potential to fail if not adequately supported. Low angle joints and domes also pose FOG hazards. Examples of these types of failure are shown in Figure 2.8. According to (Qamata & Steenkamp, nd) the identification of geological structures underground is a challenge to most production personnel. The use of technology to assist in the identification of geological structures in the immediate hanging wall is crucial for decision making in addressing potential fall of ground areas (Qamata & Steenkamp, nd).

**Figure 2.8: Wedge failure** (Qamata & Steenkamp, nd)

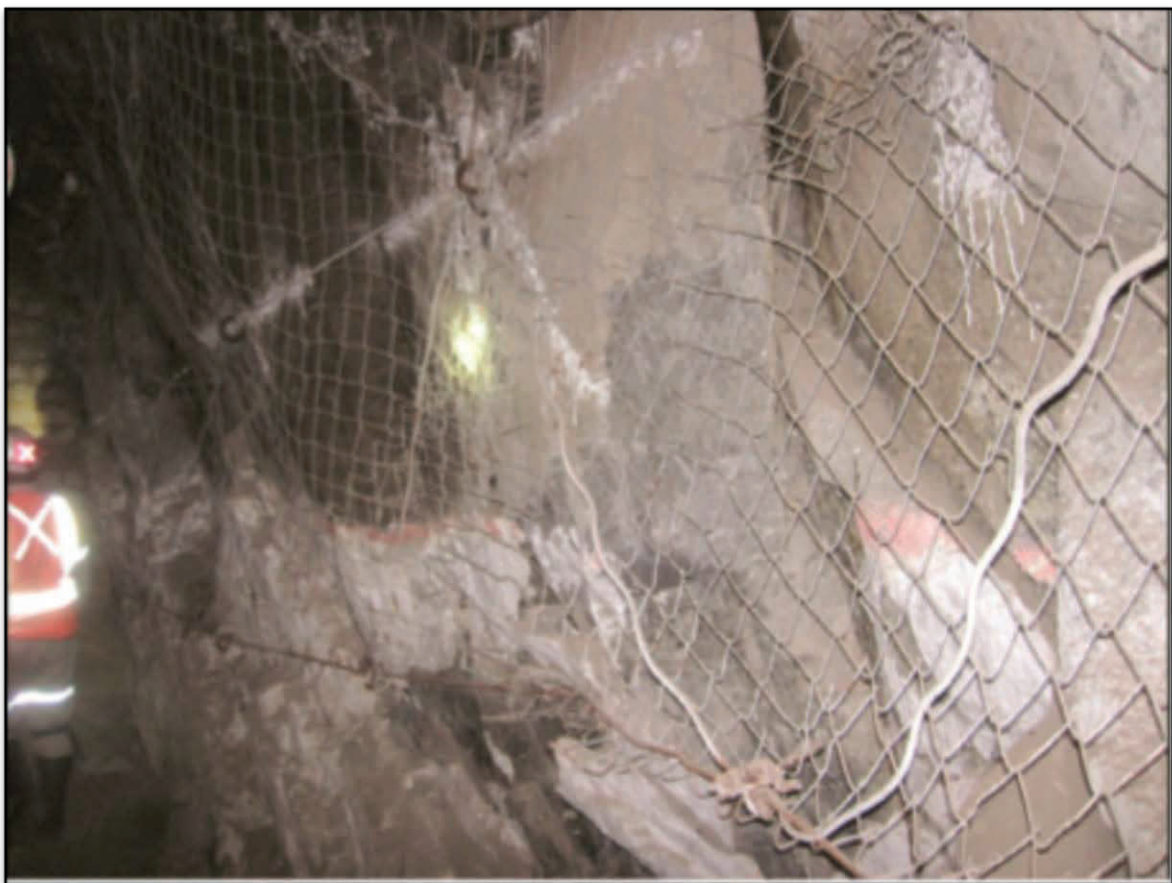
In shallow hard rock mining environments (depths less than 1000m), there are relatively high horizontal virgin stresses than vertical stresses, however Nyungu & Stacey (2014) state that failure can also occur at low stress conditions in some mines in the Bushveld complex. With time, stress induced spalling on underground excavation walls become visible. An example of this rock behaviour is illustrated in Figure 2.9. According to the time-dependent study conducted on BC rocks by Nyungu & Stacey (2014), the results show that the magnitude of tensile strength is about 5% of their UCS magnitude.

**Figure 2.9: Spalling in a haulage tunnel in a platinum mine located in the western Limb of the BC (Nyungu & Stacey, 2014)**

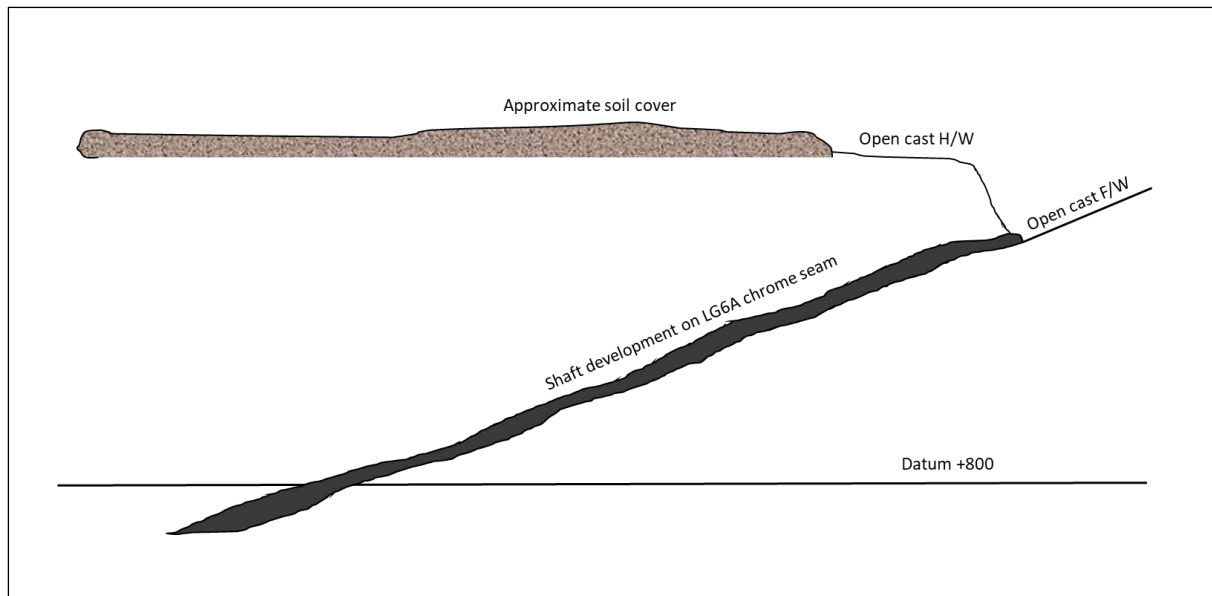
Most shallow underground mines in the eastern Bushveld Complex use conventional breast mining or mechanised bord and pillar mining method depending on the above-mentioned factors. Mines with fairly dipping ore body geometries generally prefer using mechanised bord and pillar mining method. The Chrome mine uses trackless mechanised mining method (TMMM) in the form of bord and pillar. A simulation configuration of the mine is shown in Figure 2.10. The ore body dips at an average dip angle of  $10^0$  westwards striking North-South direction. There is consistency in the width of the LG6 and LG6A chrome layers hence bord and pillar was a suitable mining method for this ore deposit.

**Figure 2.10: Flat dipping ore body at shallow depth** (*Internal Mine Document, 2013*)

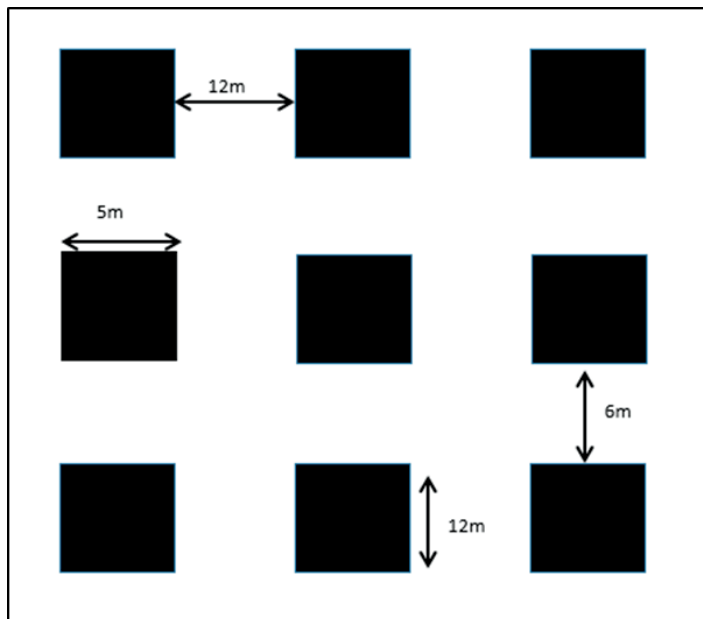
A fully mechanised platinum bord and pillar mine in the eastern Bushveld complex was designed based on (Hadley & Grant, 1972) formula, with pillar sizes increasing with depth (Esterhuizen, 2014). The same approach was used to design pillars at the Chrome mine, where regular bord and pillar pattern is employed (Figure 2.11). Bord width ranges between 6m and 12m subject to depth below surface and presence of geological disturbances. Pillar sizes increase as depth of mining increases.

**Figure 2.11: Schematic diagram of a regular pillar layout**

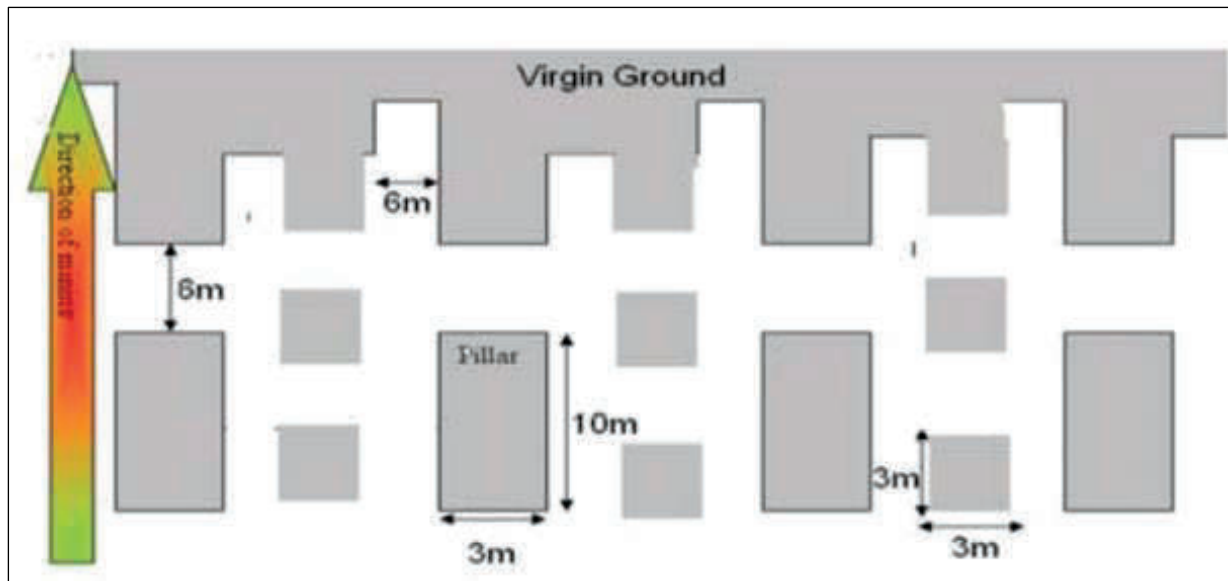
The larger the excavation, the more the geological structure are exposed, which in turn might influence the stability of mine excavations and the support system required thereof. As a way of improving excavation stability, it is always advisable to mine moving away from geological structures (Jager & Ryder, 1999). At times, poor ground conditions may necessitate a different mining layout as shown in Figure 2.12. This example is from a Zimbabwean platinum room and pillar mine where there is intense faulting and jointing in the rock mass resulting in poor ground conditions. To enhance stability a different layout was designed for that specific ground condition. In addition, a new support system was also designed for this area to help improve safety and production, as the previous support system was not adequate for such poor ground conditions. The new system includes the use of longer roof bolts (2.1m) spaced at 1.2m x 1.2m whereas the previous support system had 1.8m long roof bolts spaced at 1m x 1m (Chikande & Zvarivadza, 2016).

**Figure 2.12: Mining layout in poor ground conditions at a Zimbabwean platinum room and pillar mine** (Chikande & Zvarivadza, 2016)

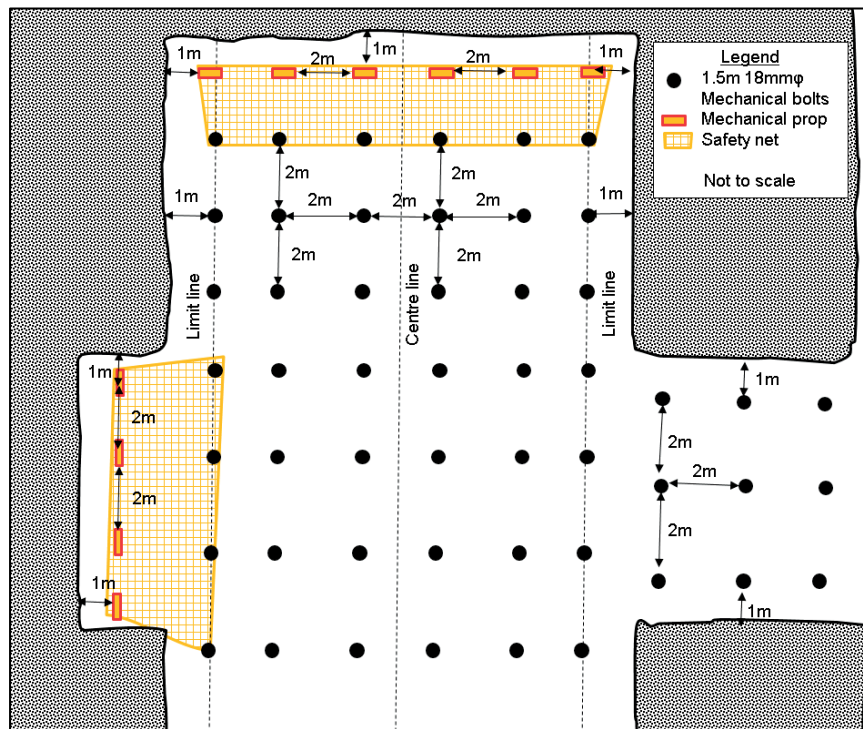
addition, tensioning of roof bolts is also recommended after blast. In cases where there is a need to support the hanging wall beam to a length beyond that supported by primary support, secondary support in the form of 4.5m long x18mm diameter pre-tensioned (150 kN), full column grouted (25t) cable anchors are installed. Cable anchor spacing is also 2m on both dip and strike direction.

**Figure 2.13: Local support layout** (*Internal Mine Document (b), 2017*)

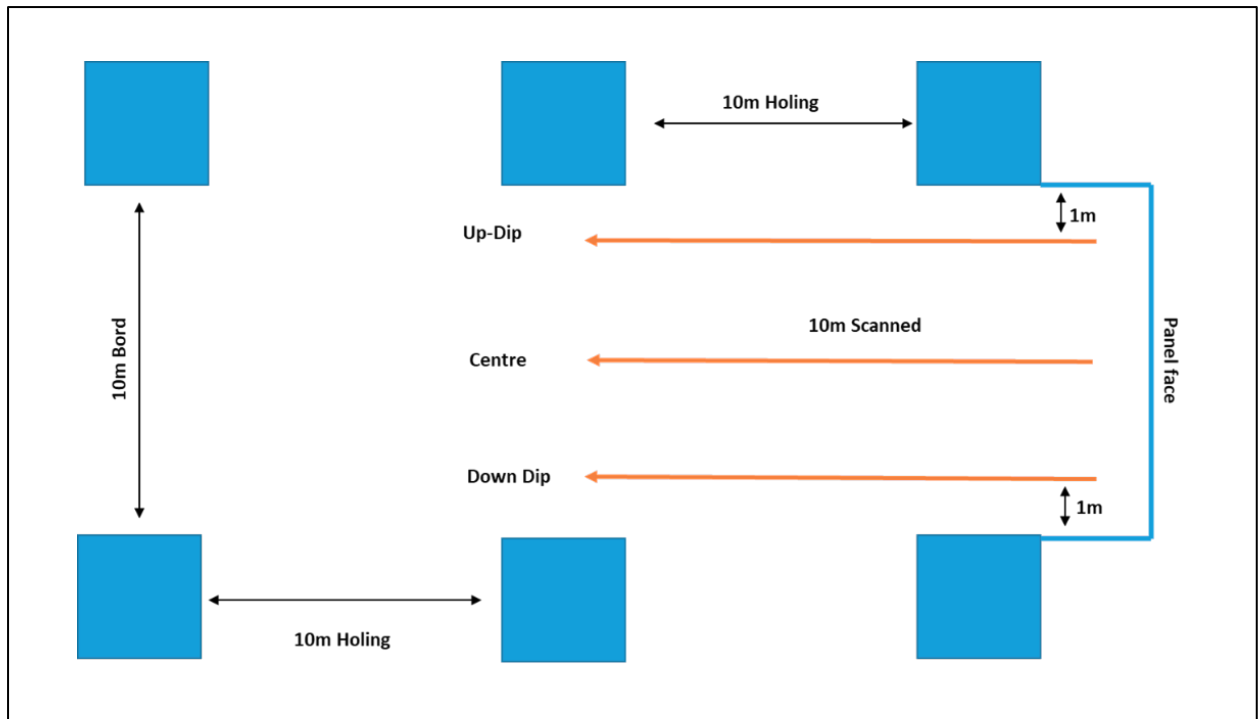
The distance to be scanned is measured at 10m from the face backwards, and the nearest peg should reference it. Three scans per panel are collected i.e. up-dip centre and down-dip to acquire more data on that particular panel (Figure 3.1). It is critical to follow recommended procedures for operating the equipment as stipulated in the mine’s standard operating procedure (Internal Mine Document (b), 2016). Failure to do so may result in inadequate data collection, which will affect the interpretation thereof. Safety of personnel operating the machine is important. Correct personal protective equipment should be worn at all times. It is advisable for the person scanning not to look into the hanging wall so as to prevent disruption of a persistent and continuous scan.

**Figure 3.1: Schematic diagram of a panel to be scanned using GPR**

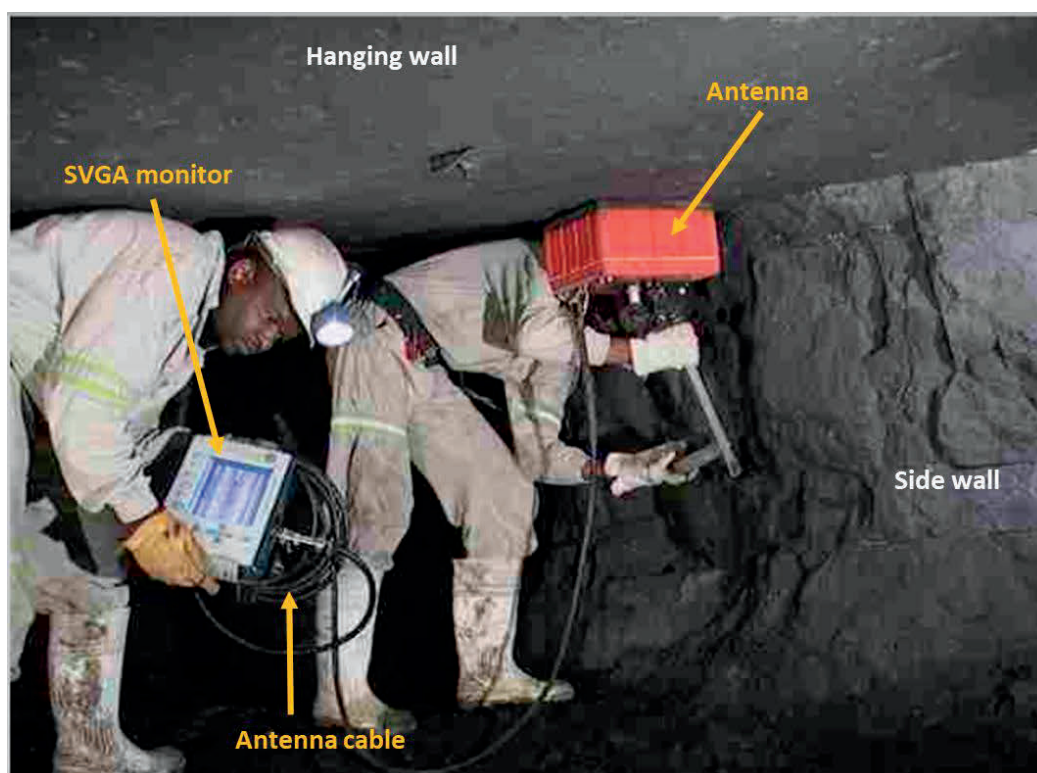
Conducting ground penetrating radar (GPR) surveys timeously is critical as it assists in the identification and subsequent treatment of any hazardous ground conditions that may result from the surveyed ground. Therefore, it promotes safer working environment for all underground personnel. Results during scanning process can be interpreted and immediate decision regarding workplace stability can be taken when structures identified require immediate attention. Generally, GPR gives real-time data acquisition since the SVGA monitor displays the hanging wall as scanning progresses. Its ability to detect flat dipping joints and domes allows for pro-active measures to be taken in terms of improving stability. For example, leaving in-situ pillars and revising mining strategies where major flat dipping structures are identified. In addition, the technique can determine the amount of reef displacement into the hanging wall in cases where there are major up throw faults.

**Figure 3.3: GPR scanning** (*Internal Mine Document (b), 2016*)

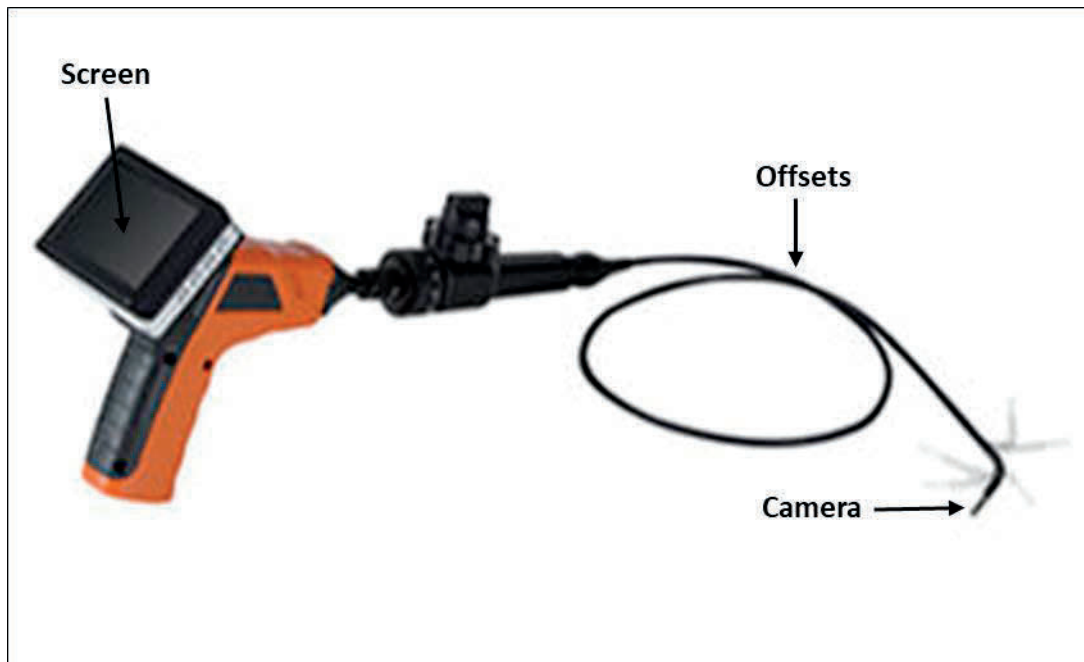
The use of Borehole camera in mining related investigation is broad. It is regarded as one of the most valuable tools in the mining industry as it allows visualisation of structures within the hanging wall. Visualisation in the form of videos and images of drilled boreholes, shafts, and open sinkholes and any vertically accessible subsurface excavations can be obtained when using borehole camera (Anon, 2013). Various models of borehole cameras are available in the market worldwide (Figure 3.4). Borehole cameras consist of a screen, where visualisation takes place and offsets that are connected to the camera. On the end of the first offset is a camera, which comes with its own light source.

**Figure 3.4: Borehole camera** (*Anon, nd*)

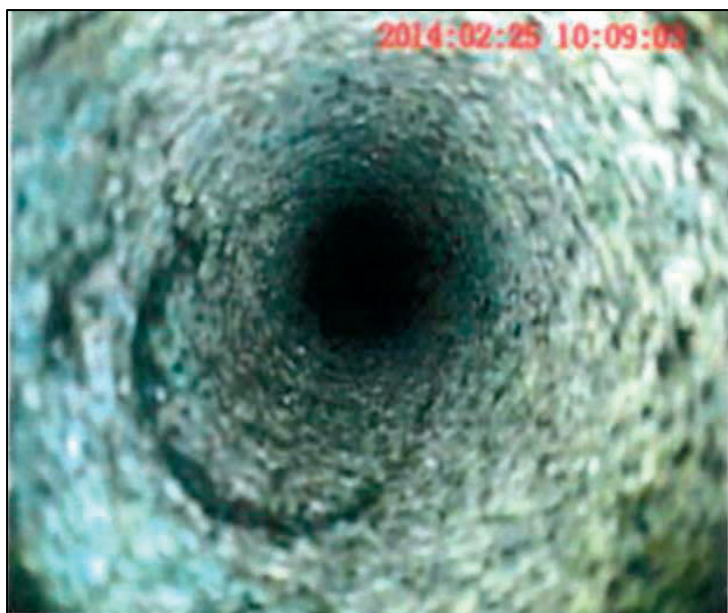
**Figure 3.7: Near vertical joint observed at 2.2m in the hanging wall** (*Internal Mine Document (a), 2014*)

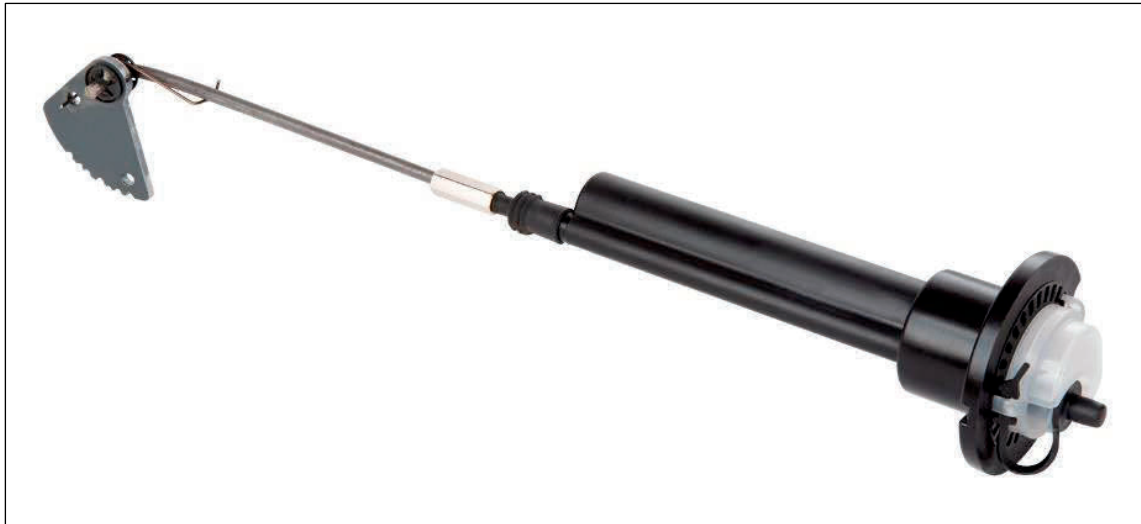
Fall of ground lights are ground-monitoring instruments designed to detect and warn personnel underground of separation or movement within the rock mass above, thus helping to prevent losses of lives and provide safe working conditions. FOG light is designed to give warning by flashing highly visible light emitting diode (LED) indicator. Green LED identifies a correctly installed FOG light in its monitoring state. To warn personnel of unsafe ground movement, the instrument flashes red LED. FOG lights come in different lengths and movement size detections. The mine uses 2m and 4m trigger lengths that detect movement of 2.5mm. A typical example of a FOG light is shown in Figure 3.8.

**Figure 3.8: Fog light** (Anon, nd)

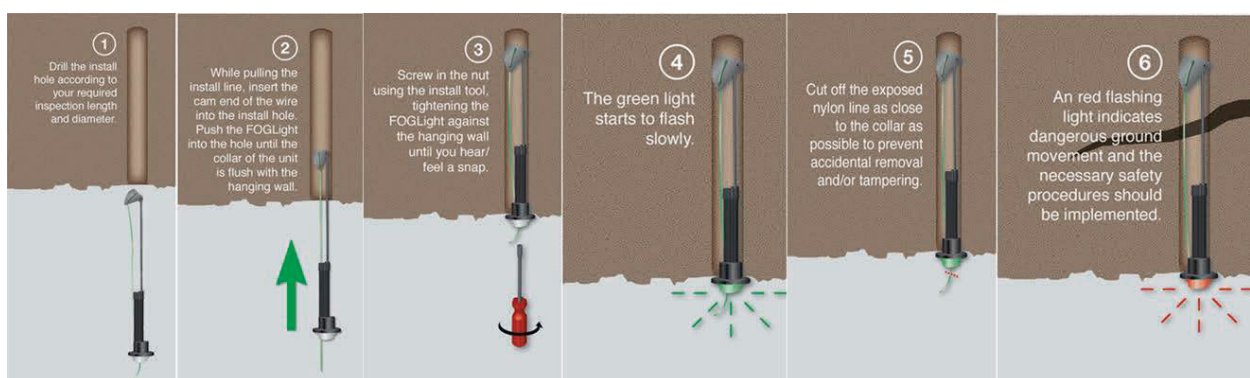
FOG lights are installed in areas where geological structures were detected by GPR scans and confirmed by Borehole camera inspections. Depending on the depth at which the structures are located, different lengths of FOG lights are utilised. A systematic approach is used when installing this monitoring equipment. The process is simple and straightforward, nonetheless, caution is recommended (Figure 3.9).

**Figure 3.9: FOG light installation procedure** (Anon, nd)

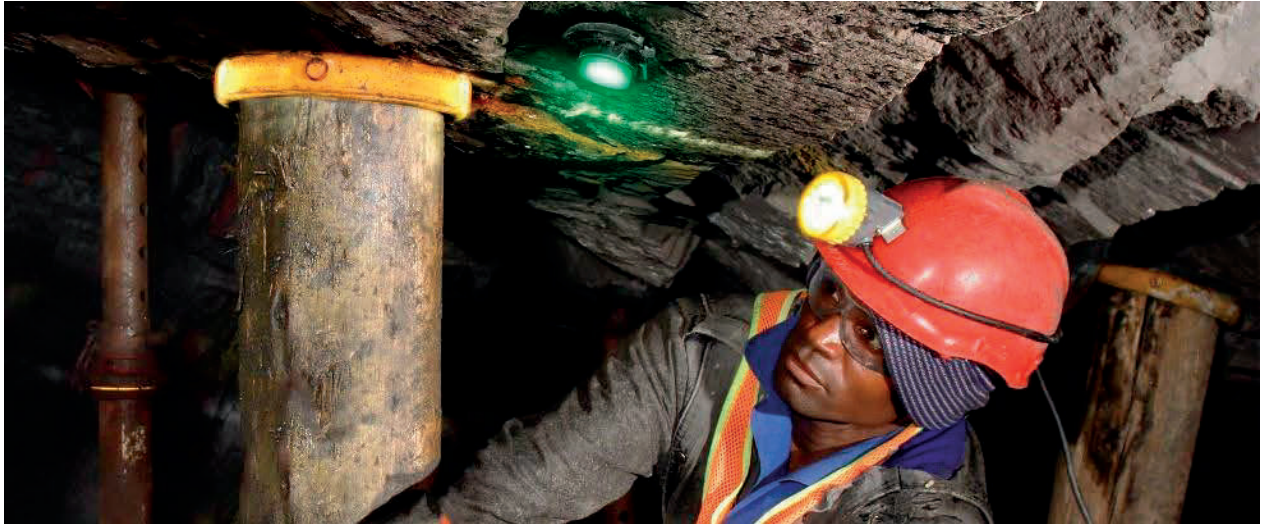
**Figure 3.10: FOG light in monitoring condition (Anon, nd)**

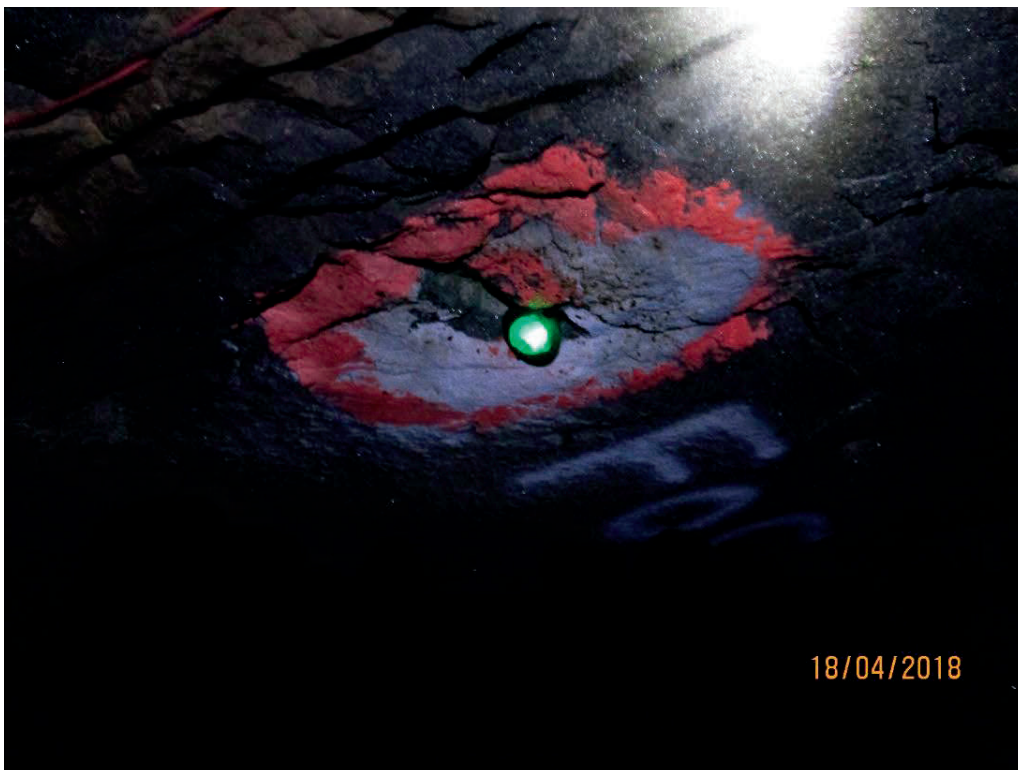
**Figure 3.11: FOG light in monitoring condition at the Chrome mine**

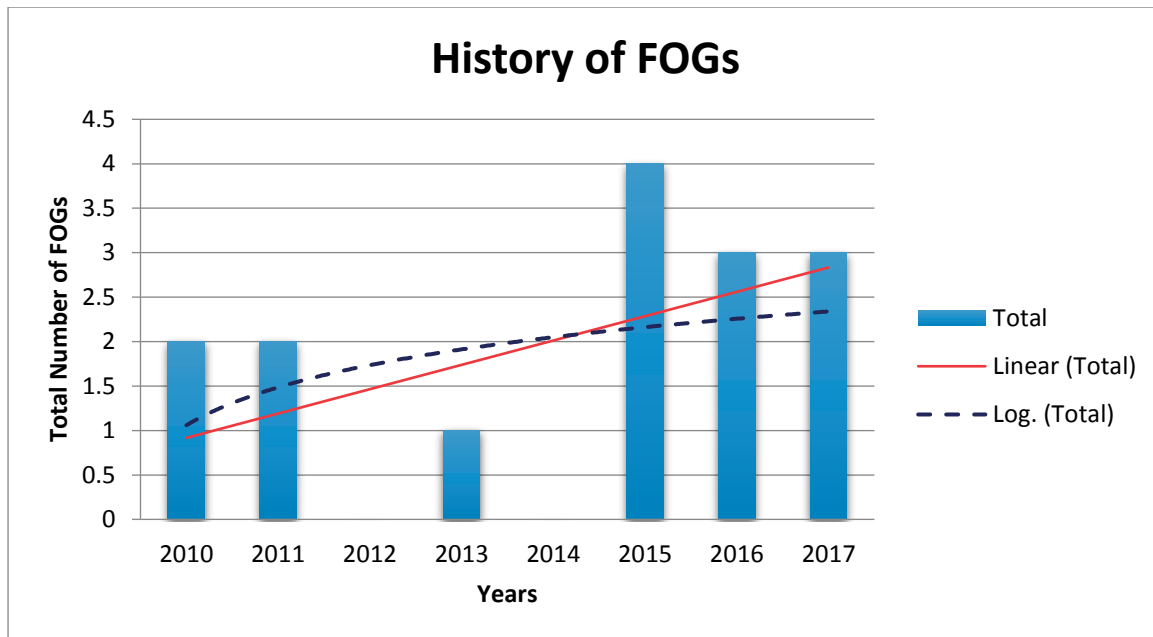
Over a long term, statistics shows that the rate of fatalities in the mining industry has dropped. In contrast, short-term analyses of individual mines, particularly the Chrome mine under study shows an increase in fall of ground incidences. Historical data shows that the frequency of falls of ground is increasing with depth below surface as mining progresses (Figure 4.1).

**Figure 4.1: Historical record of fall of ground incidences per year**

In 2010 through 2011, two incidents were recorded per year. This improved in 2012 where no incident occurred because of complying with mine standards and less geologically disturbed ground conditions. The same outcome was evident in 2014; this proves that it is possible to attain zero falls of ground throughout the mine in a year. A drastic increase occurred in 2015 where four incidents were experienced. It was a major concern as the Rock Engineering Department had already implemented the ground control and monitoring system at the time. The implementation of such a system would be expected to minimise the occurrences of rock falls in the mine. However, that is not the case as it can be seen in Figure 4.1 that six more incidents were recorded in two years (2016 to 2017). A detailed fall of ground database is presented in APPENDIX B.

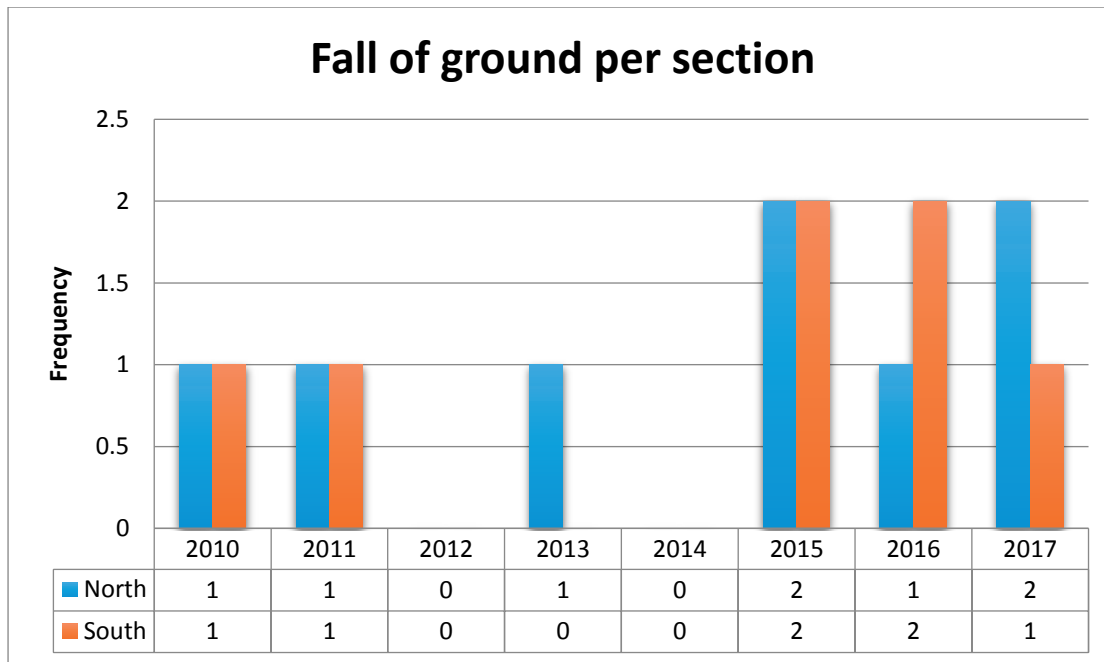
**Figure 4.2: FOG per section**

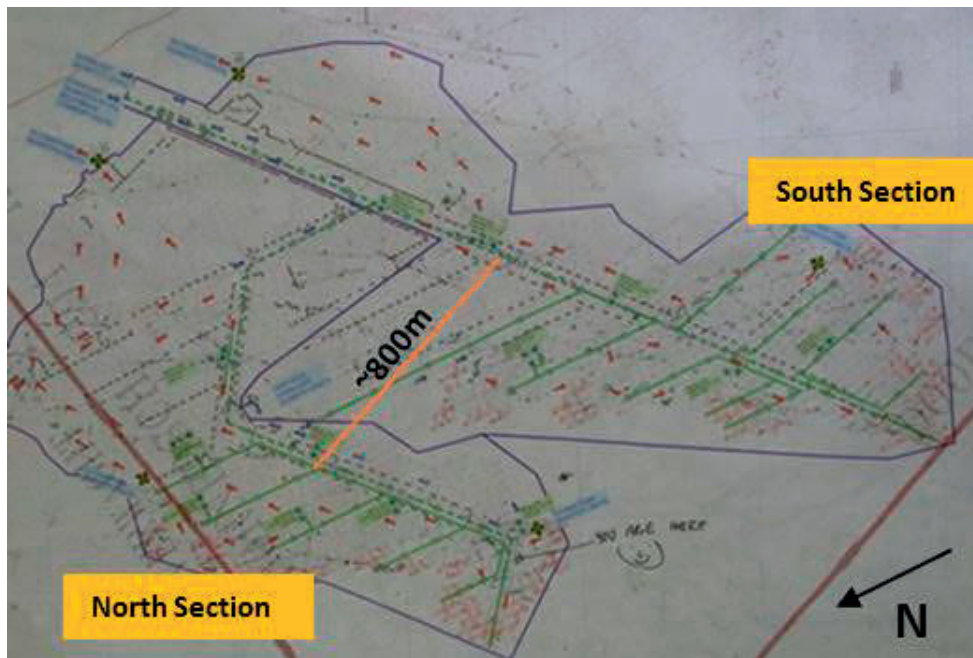
**Figure 4.3: Mine layout showing the average distance between two sections**

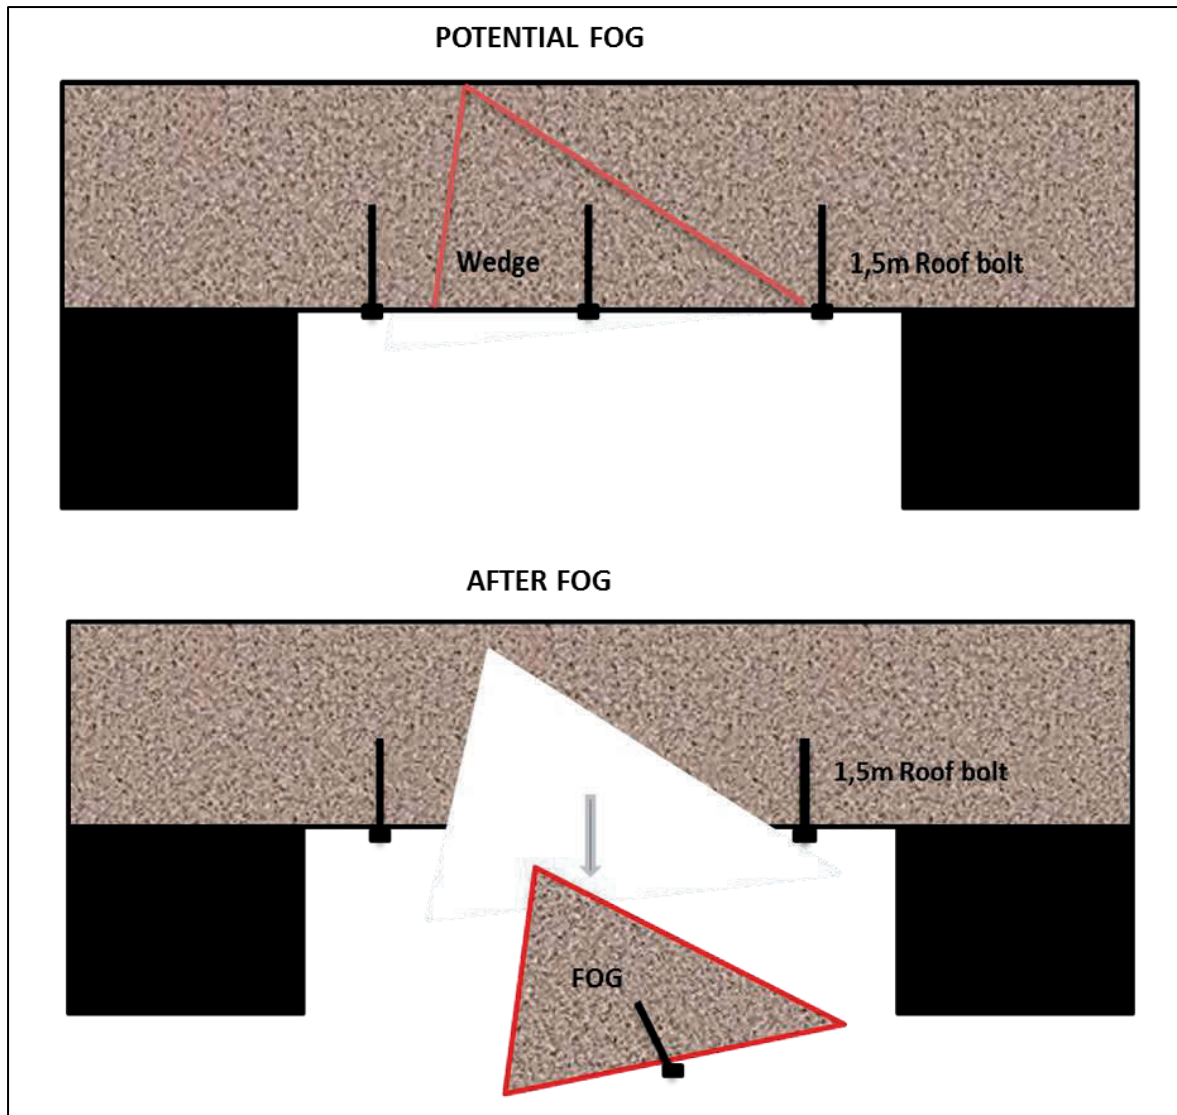
The knowledge and understanding of aspects that triggered falls of ground at this mine is important. This knowledge will assist in terms of measures that need to be put in place to avoid repetition of unwanted ground movement. In shallow mining environments, falls of ground occur because of interacting geological discontinuities such as faults, joints, domes, and parting planes. Their interaction result in unstable blocks of rocks, which tend to fall under the influence of gravity. For such a mining environment, the dominant failure mechanism is called a wedge failure (Figure 4.4). An unstable block is created due to the intersecting of a near vertical joint together with a low angle join in the hanging wall strata. There is a potential for the block to fail. Failure in this case is due to insufficient support. The support unit length is not adequate for such a scenario since it is not long enough to clamp the joint.

**Figure 4.4: Schematic diagram of wedge failure mechanism**

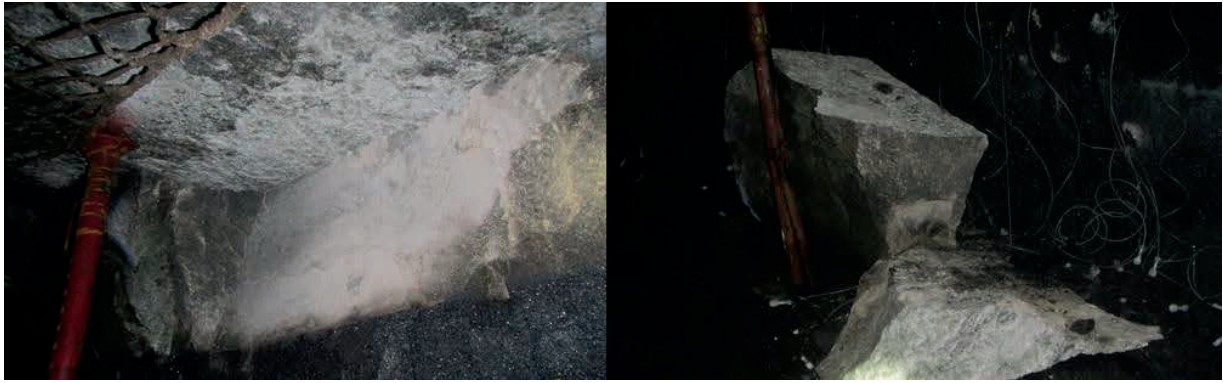
**Figure 4.5: Wedge failure at the face area** (Internal Mine Document, 2018)

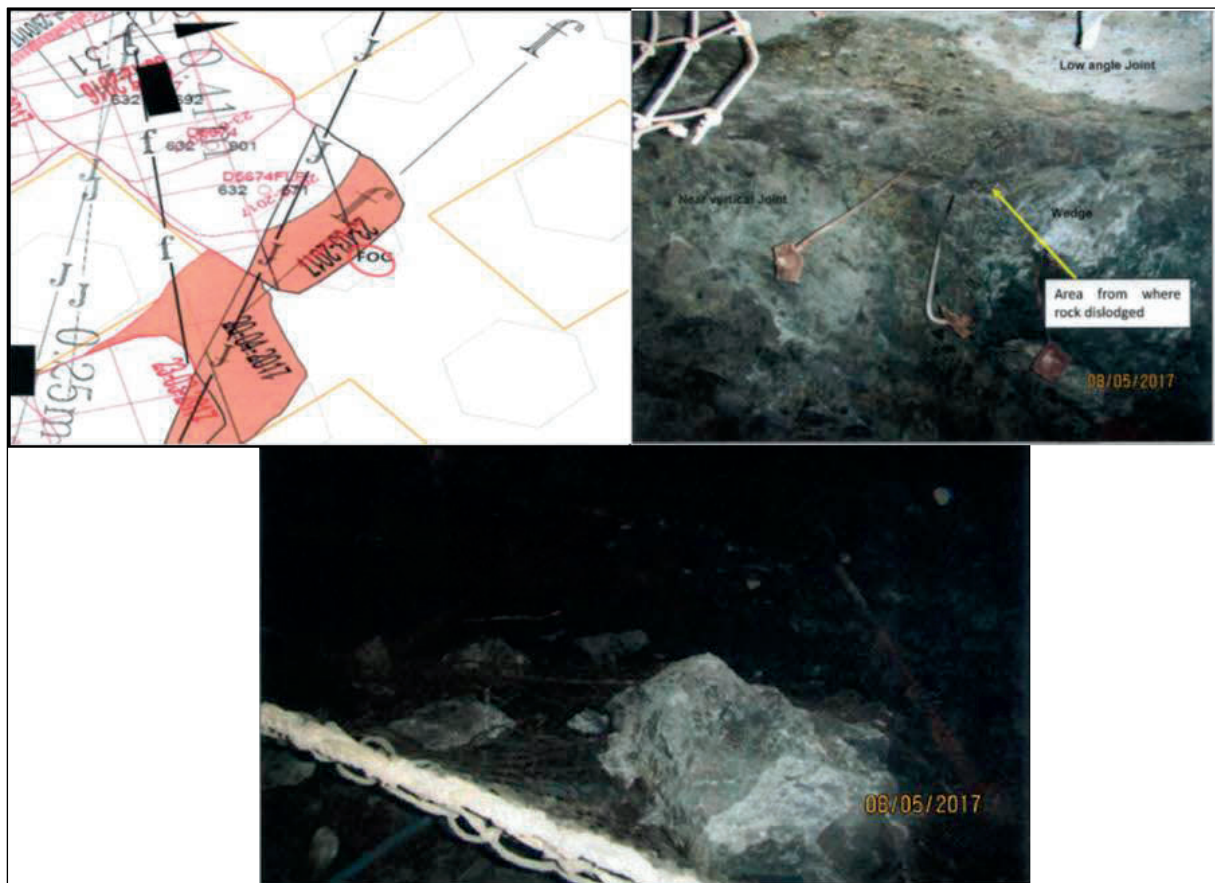
**Figure 4.6: FOG following intersection of geological structures** (Internal Mine Document (a), 2017)

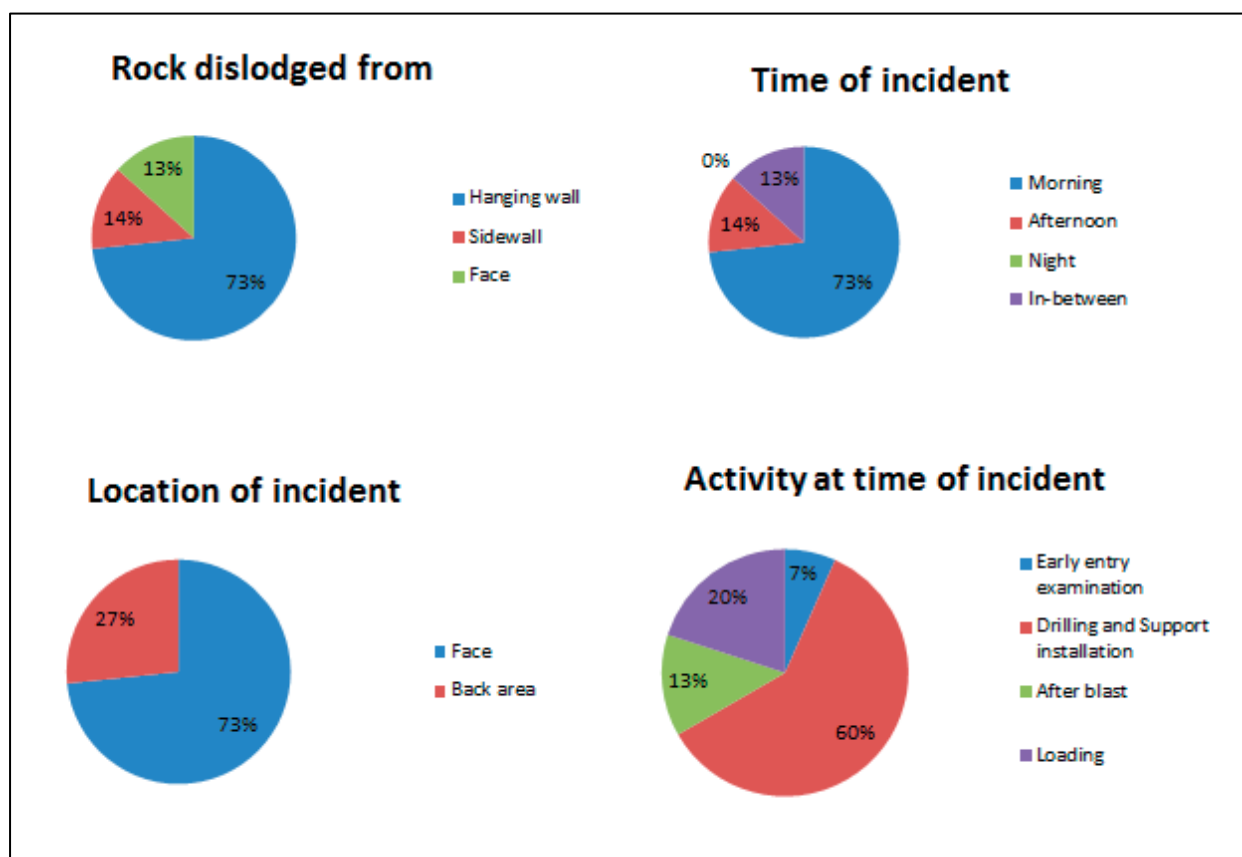
**Figure 4.7: Area of rock dislodge, location, time and activity of incident**
