# **Fall of ground management in shallow underground hard rock mining: a case study in a Chrome mine**

A research report submitted to the Faculty of Engineering and the Built Environment, University of the Witwatersrand, Johannesburg, in partial fulfilment of the requirements for the degree of Master of Science in Engineering.

Johannesburg, 2018

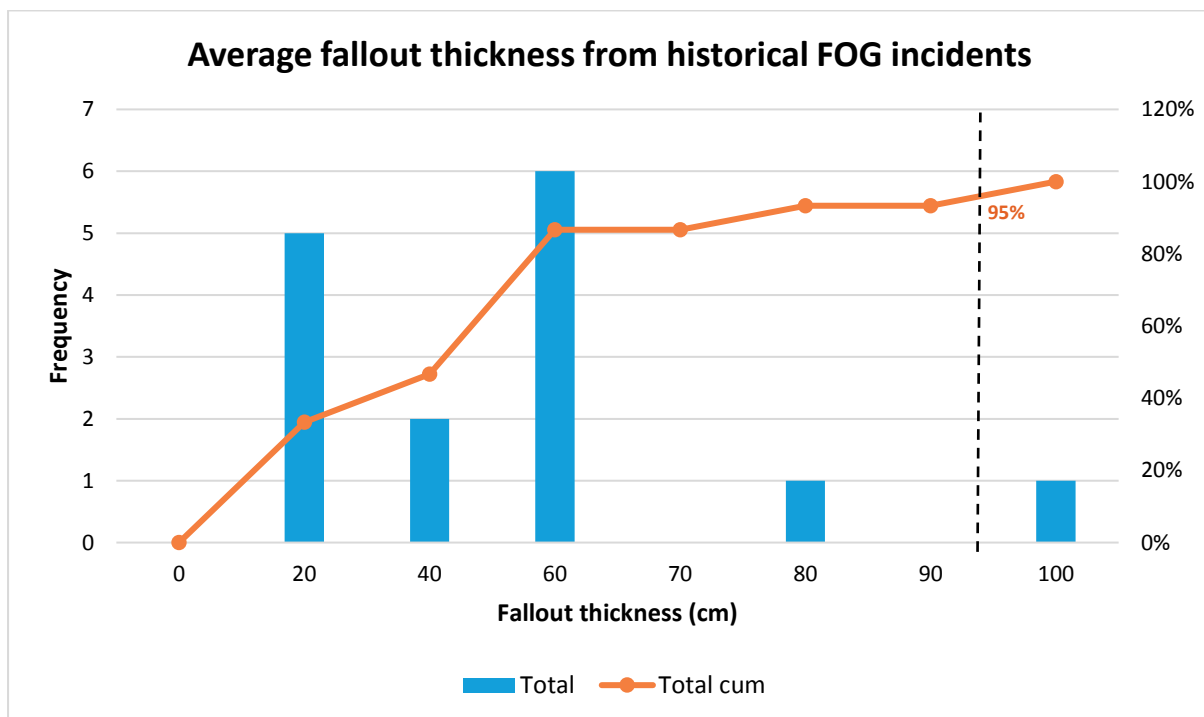
**Figure 4.9: Average fallout thickness estimated from historical FOG data**

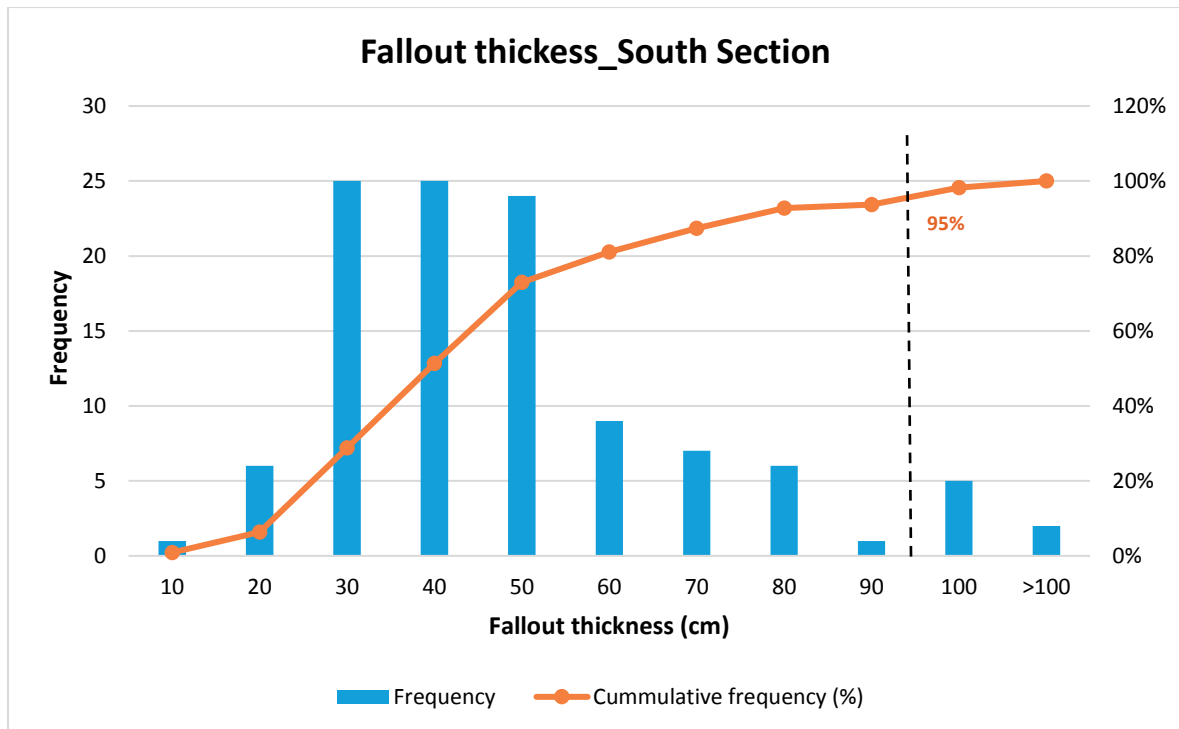
**Figure 4.11: Fallout thickness (South section)**

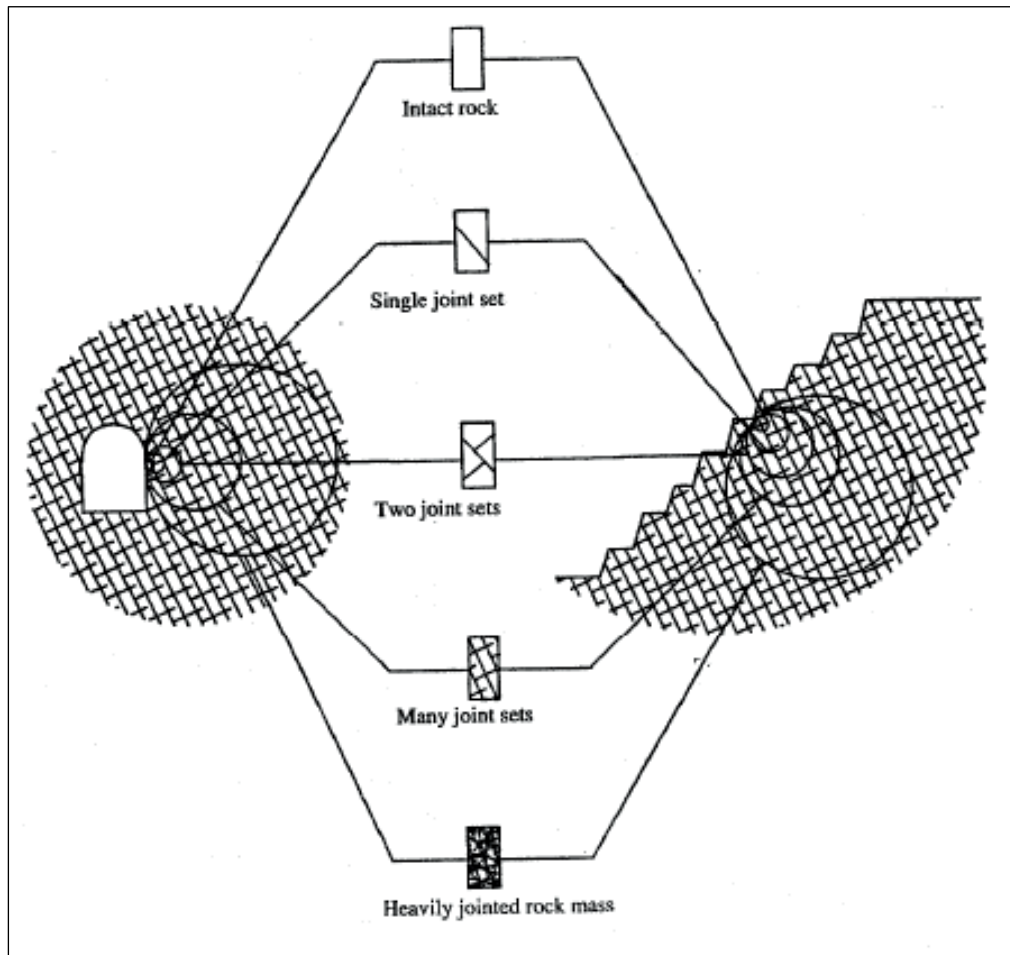
**Figure 5.2: Difference between intact rock and rock mass** (Hoek et al., 1998)

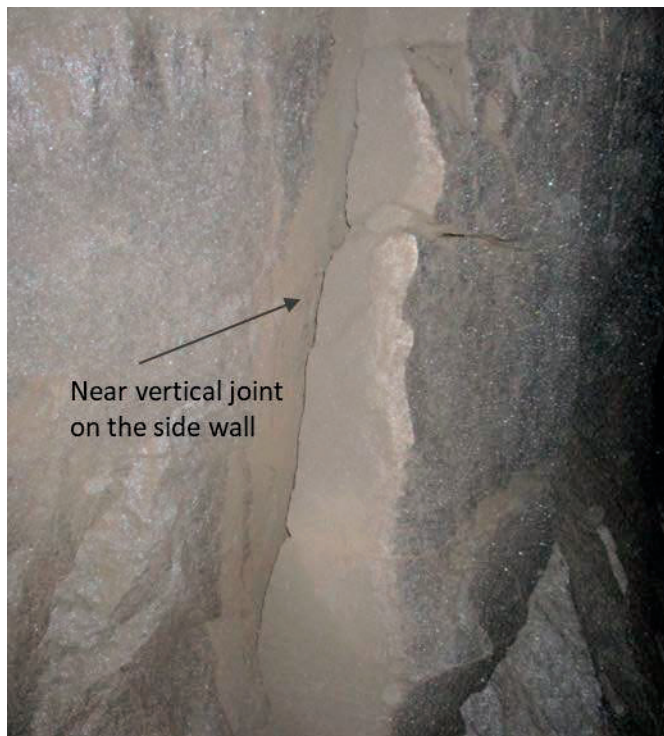
**Figure 6.1: Near vertical joint on side wall (LG6 seam)**

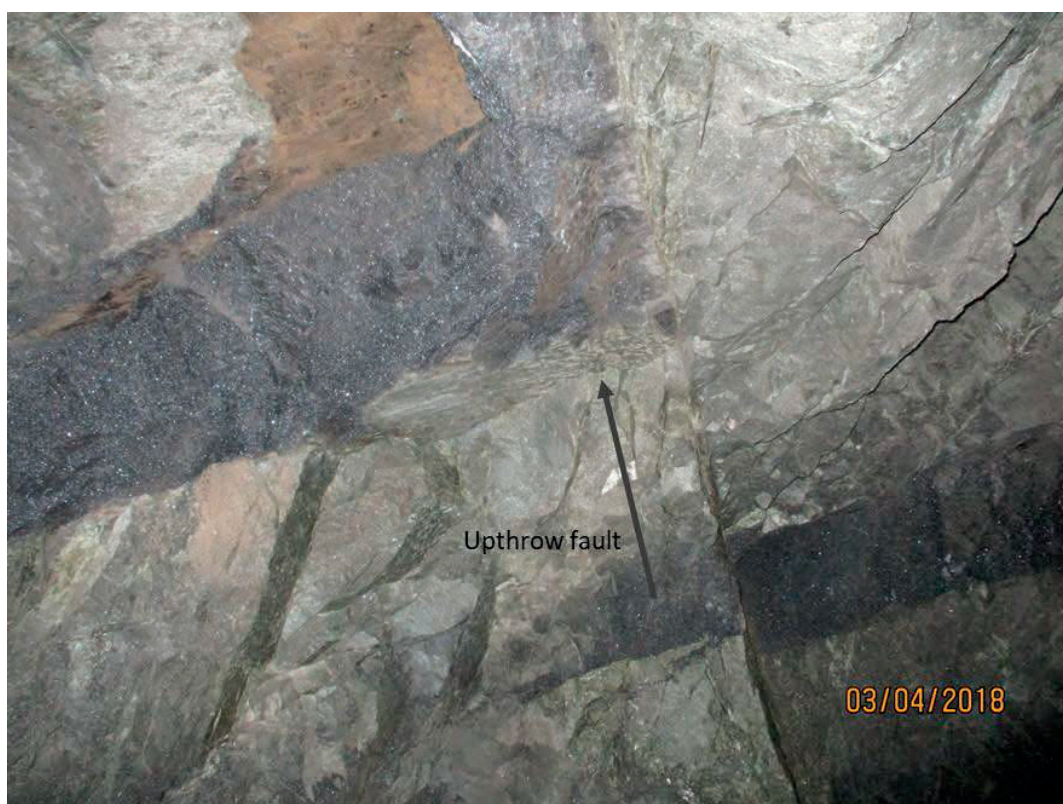
**Figure 6.4: Up throw fault displacing the LG6A reef onto the hanging wall**

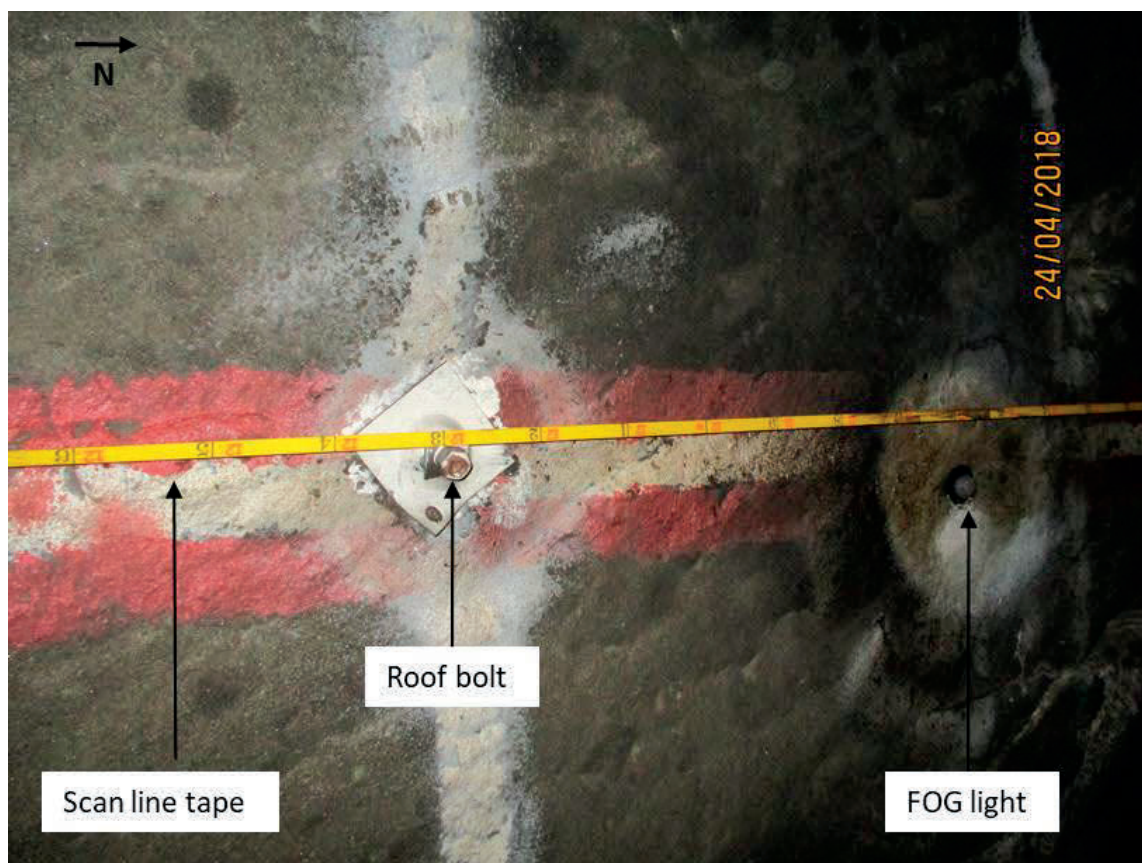
**Figure 6.5: Scan line tape aligned to the centreline of the panel**

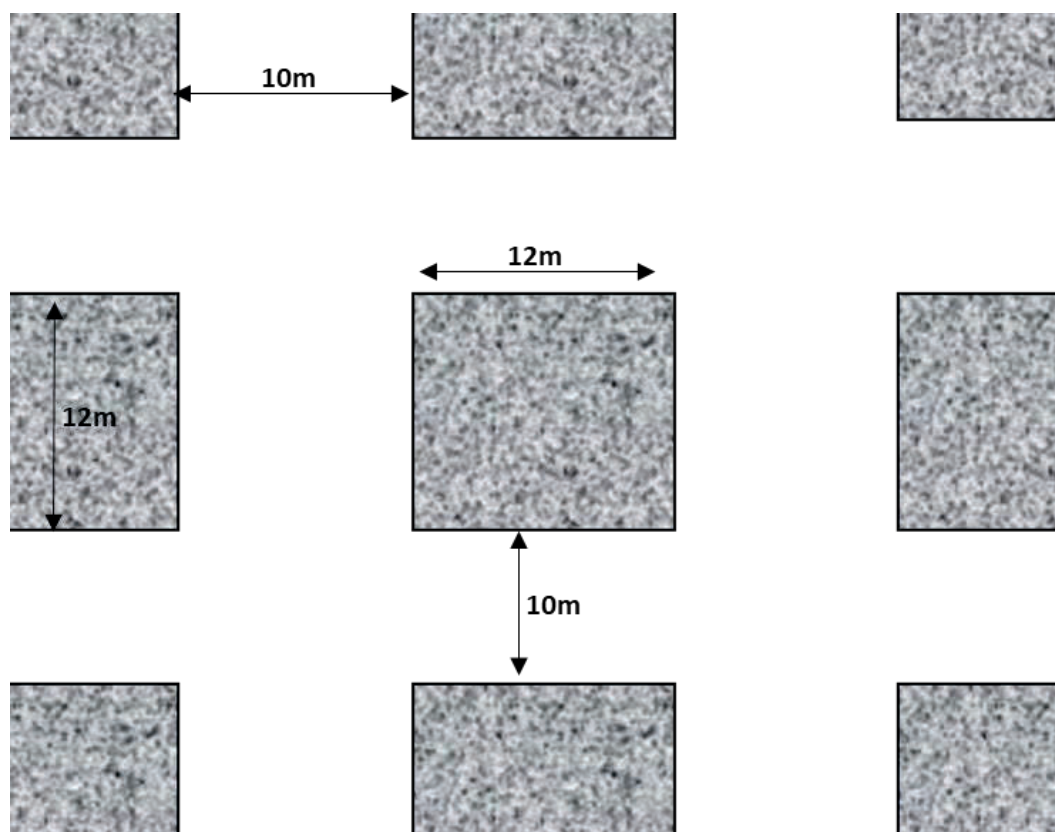
**Figure 6.6: Mine working layout**

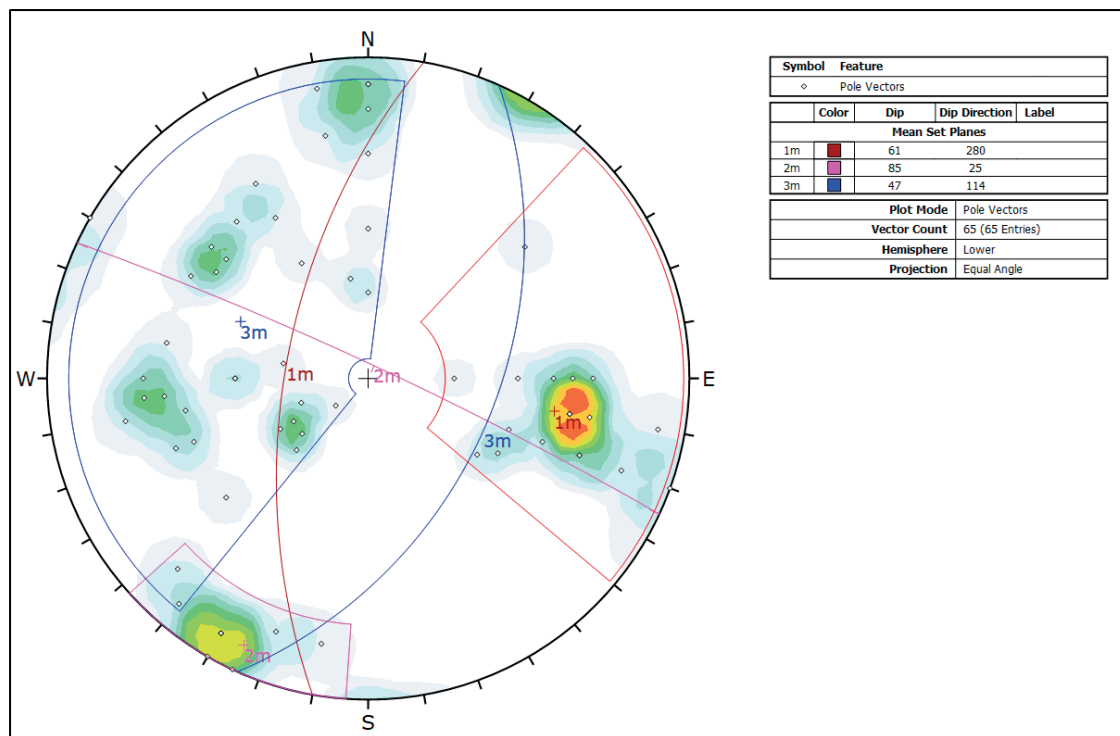
**Figure 6.8: Overall joint orientation in the South Section**

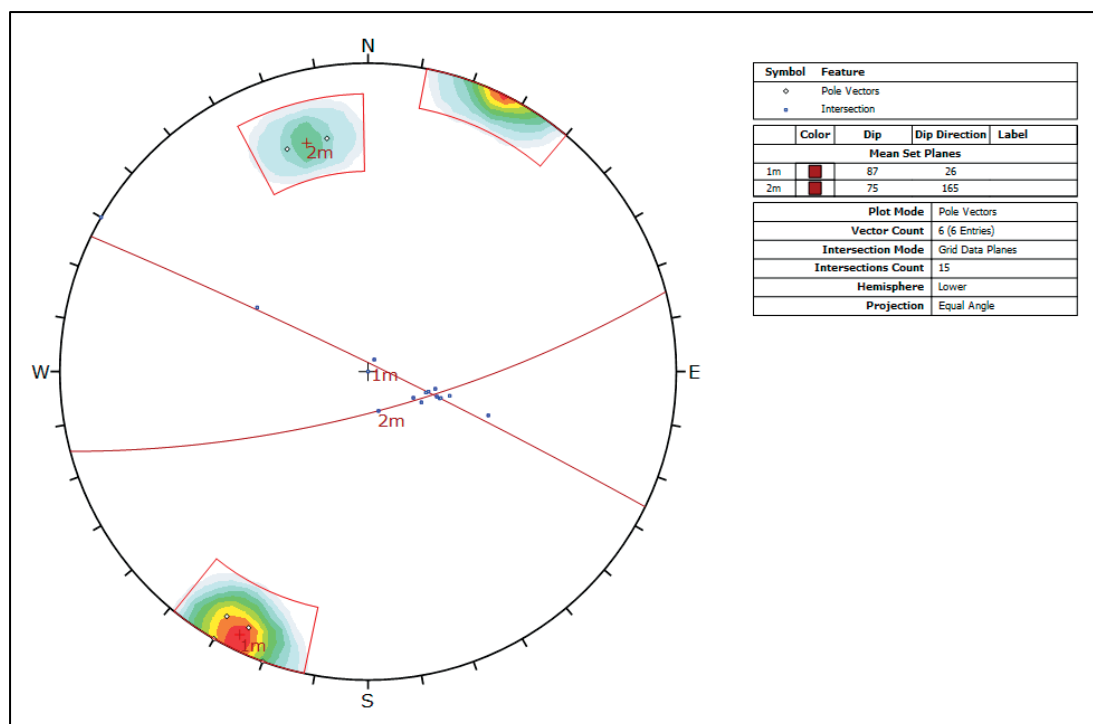
**Figure 6.9: Overall joint orientation in Panel 74S back area**

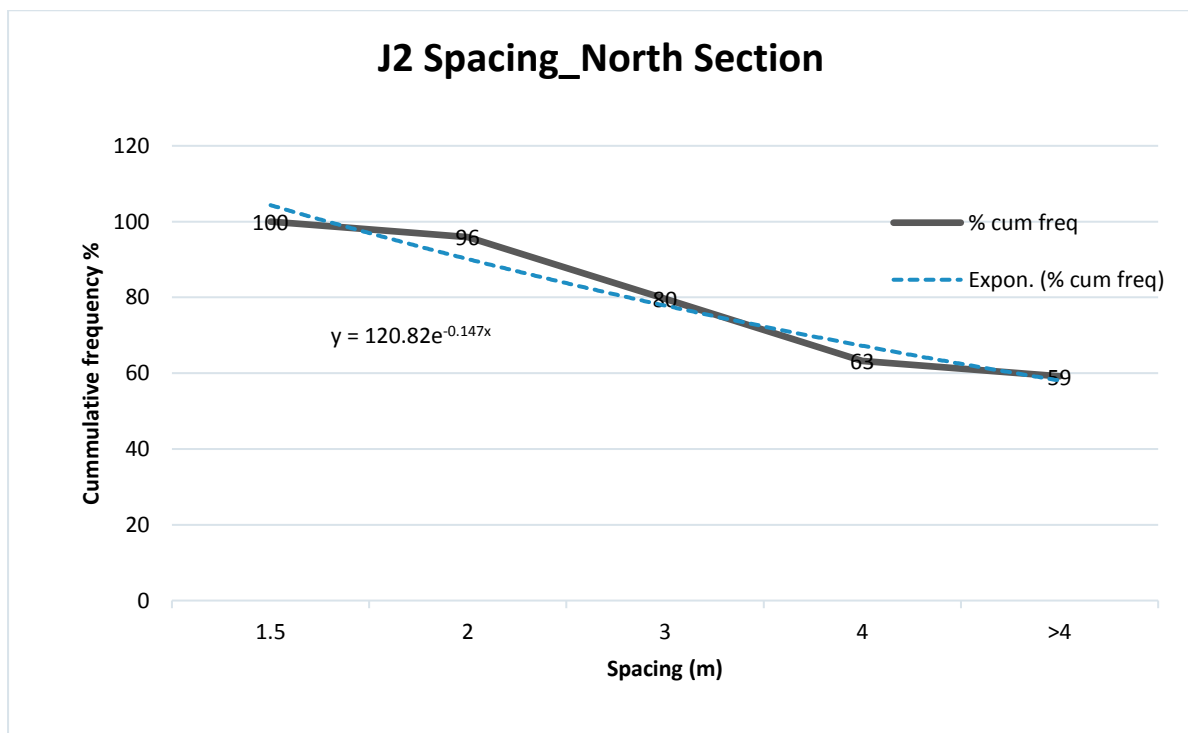
**Figure 6.13: North section J2 spacing showing lognormal distribution**

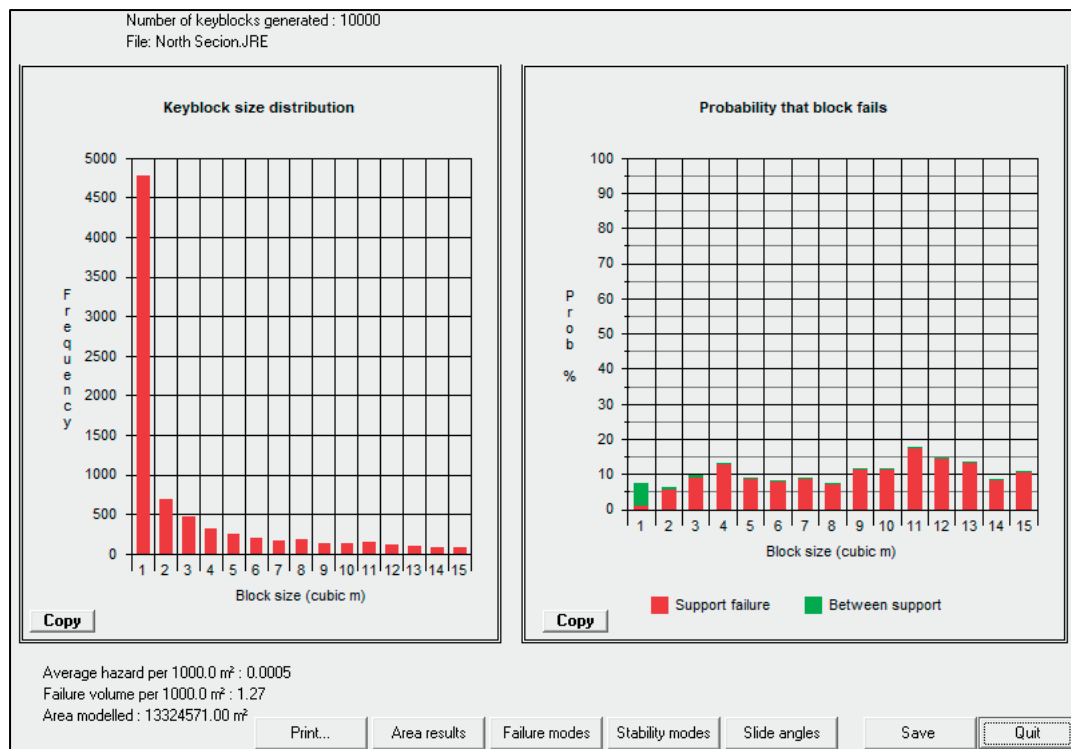
**Figure 7.3: North section key block size distribution**

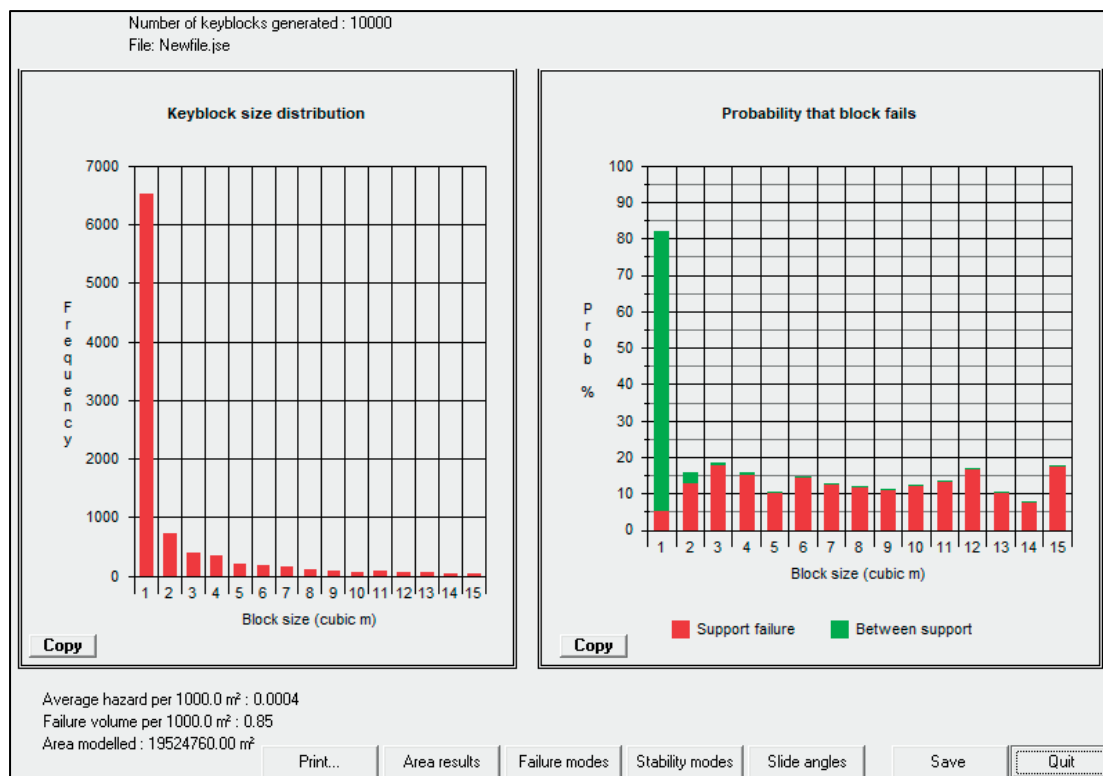
**Figure 7.4: South section key block size distribution**

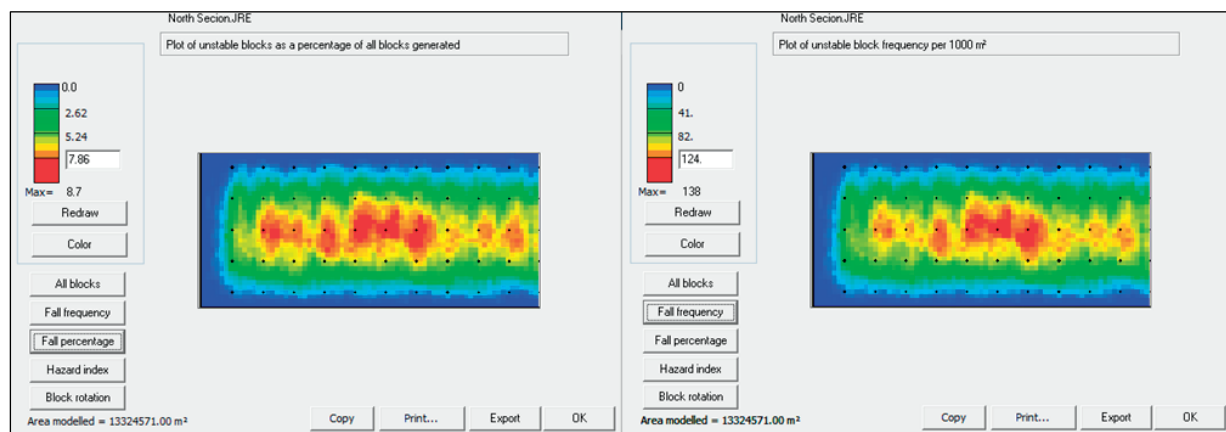
**Figure 7.5: North section area modelled**

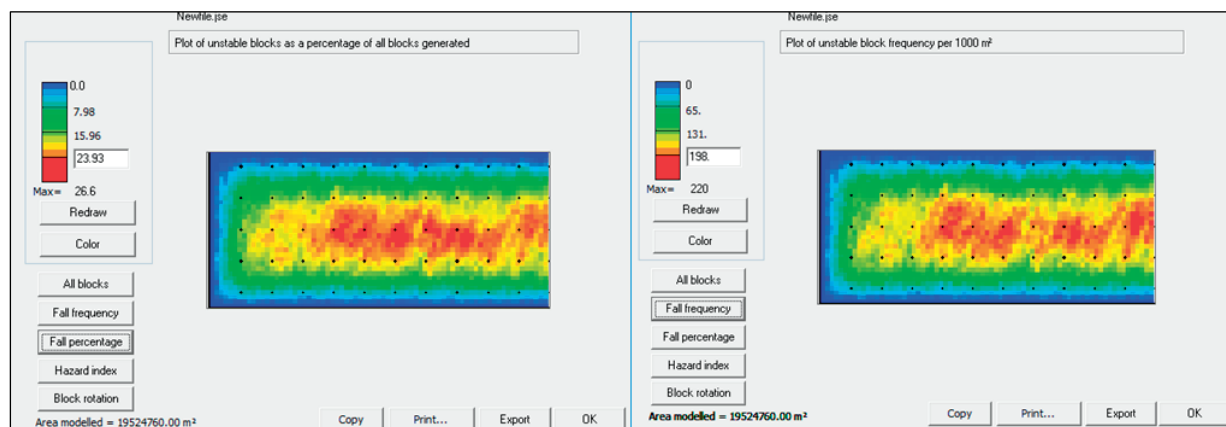
**Figure 7.6: South section area modelled**

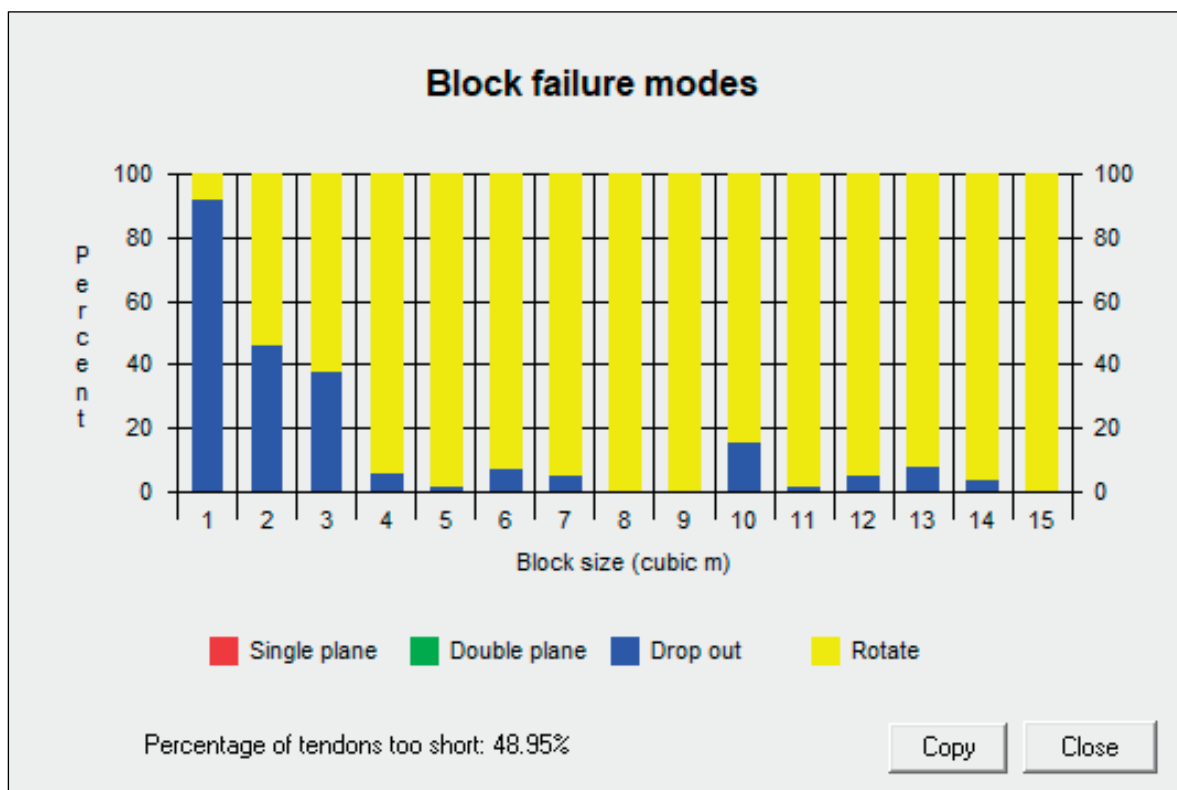
Figure 7.7: North section block failure modes

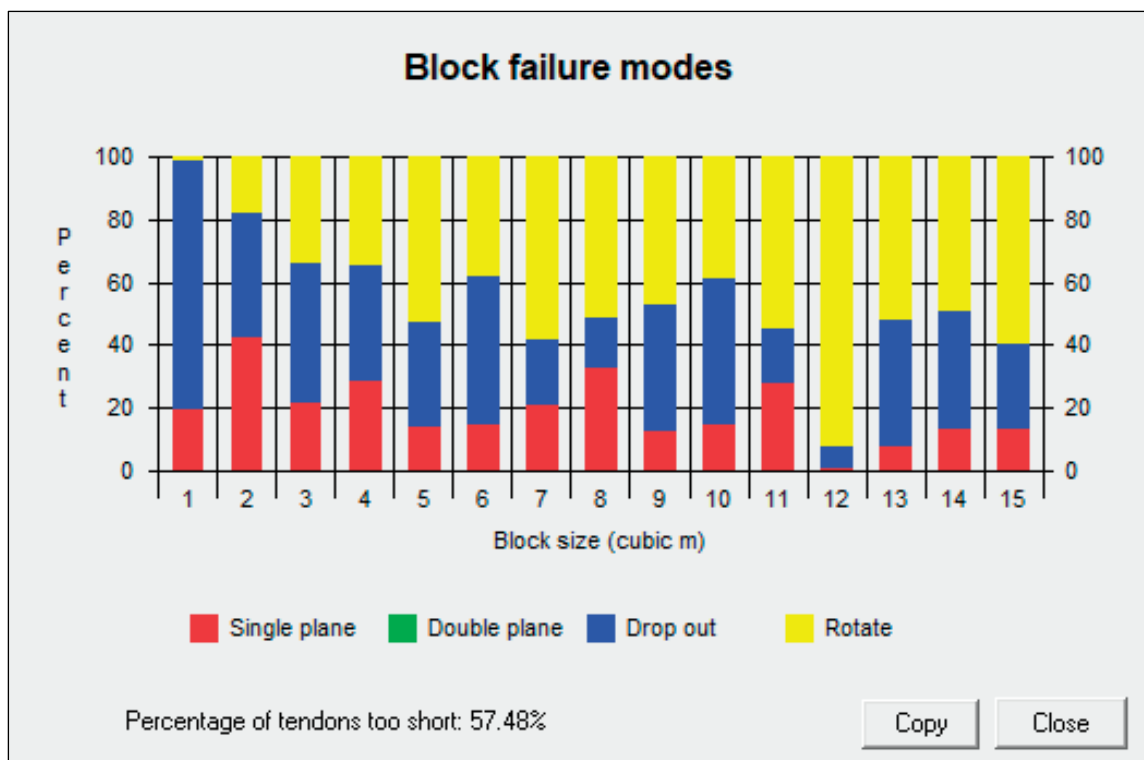
**Figure 7.8: South section block failure modes**

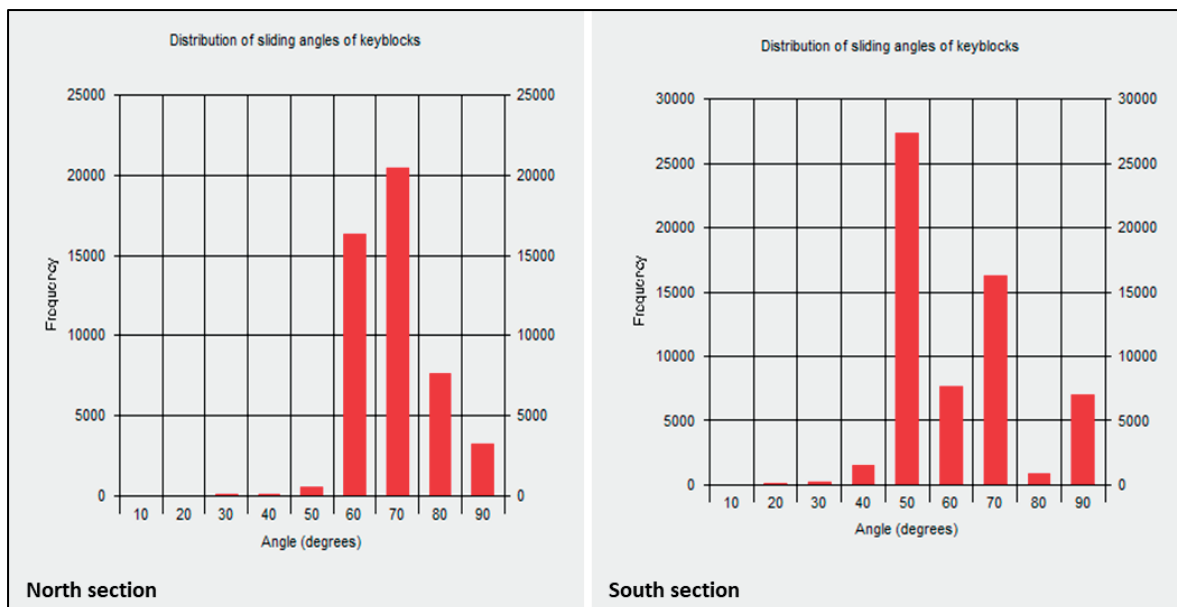
**Figure 7.9: Distribution of sliding angles of key blocks**

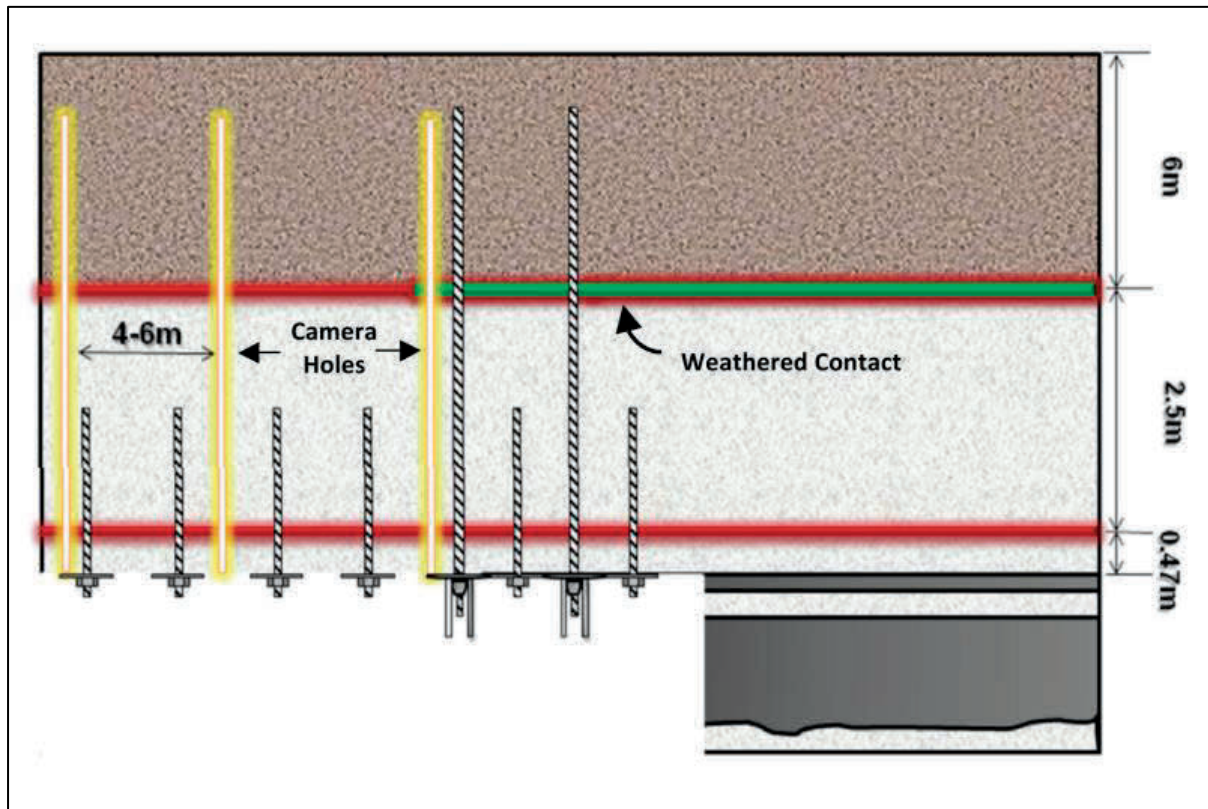
**Figure 8.4: Adjusted support strategy based on local ground conditions** (Esterhuizen, 2014)

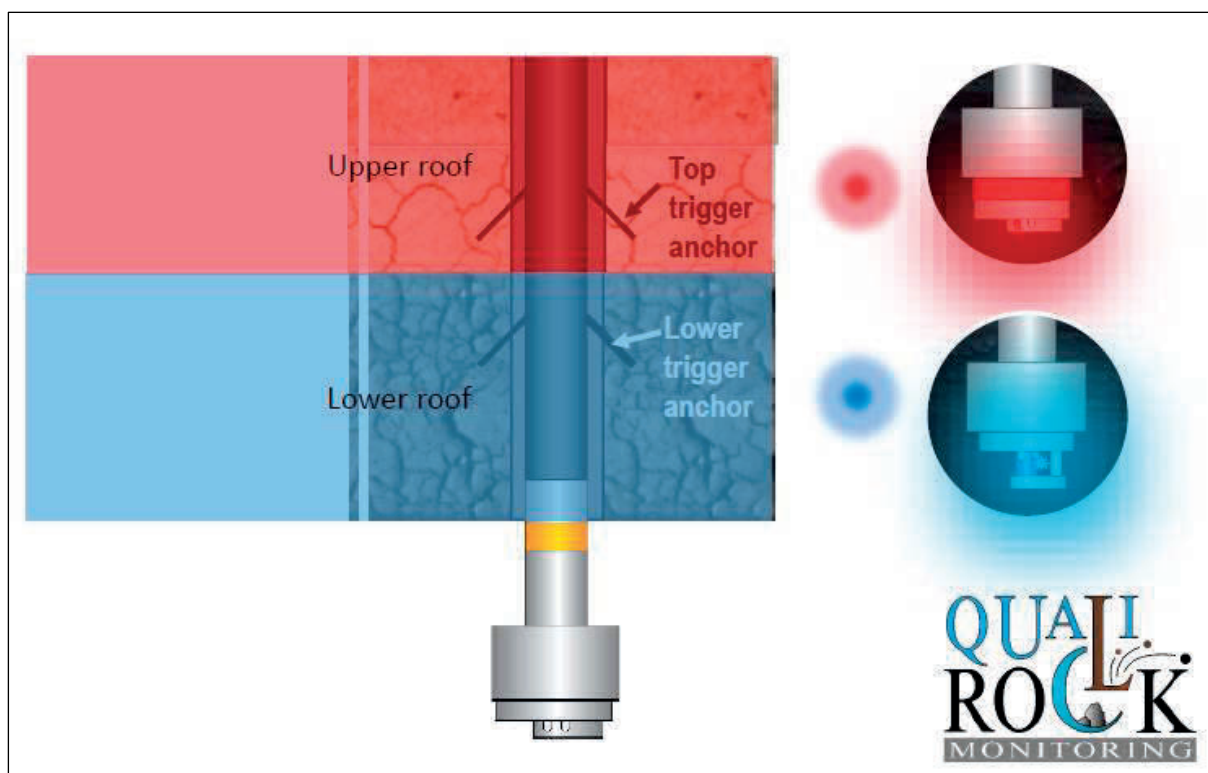
**Figure 8.5: Rocktale installed in the hanging wall (QUALIROCK (b), 2016)**

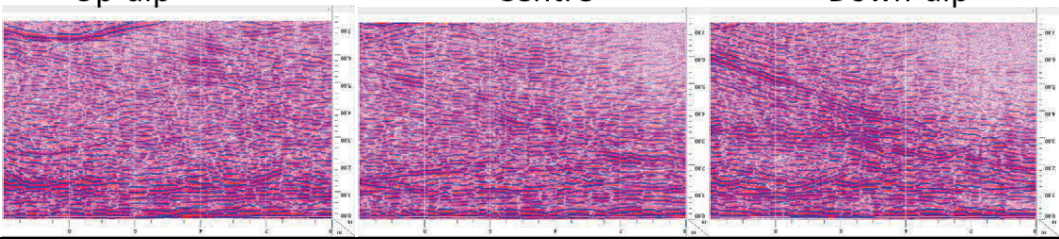
| N62N | No major structures detected in the center and down dip scans. The up dip scan shows a similar flat dipping structure detected in the adjacent panel (N61N) at 7m. The structure is considered self-supported. | <p>Up-dip                      Centre                      Down-dip</p> |

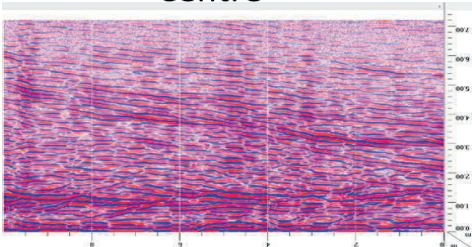
| N65N | Continuous horizontal planes detected at 1.5m and discontinuous flat dipping planes between 3m and 5m. | <div>Centre</div> |

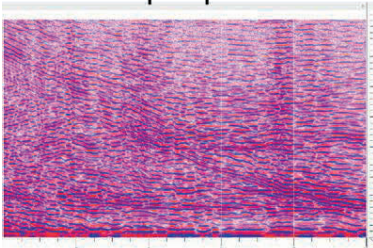
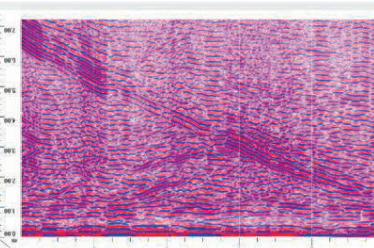
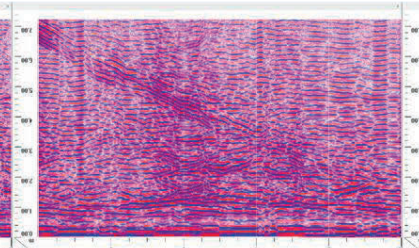
| N70N | Continuous flat dipping structure observed in both down-dip and center scans. | <div>Up-dip</div> <div>Centre</div> <div>Down-dip</div> |

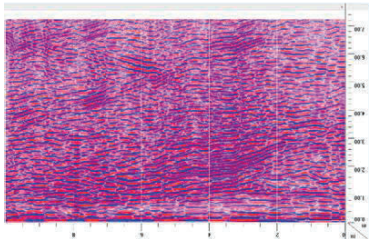
| Shaft 1N | No prominent structures were detected. | <div>North</div> <div>South</div> |

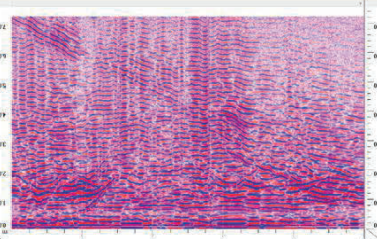
| Shaft 3N | Non- continuous flat dipping structure observed in all three scans. | <div>North</div> <div>Centre</div> <div>South</div> |

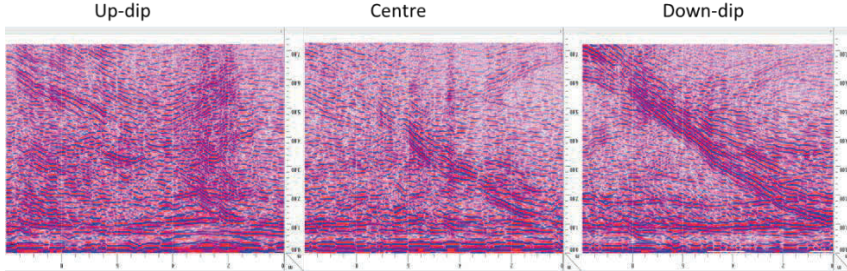
| PANEL | COMMENT | GPR SCAN |
|---|---|---|
| 46N | Continuous flat dipping structure observed in the down dip scan. Centre and up-dip show non-continuity. | |

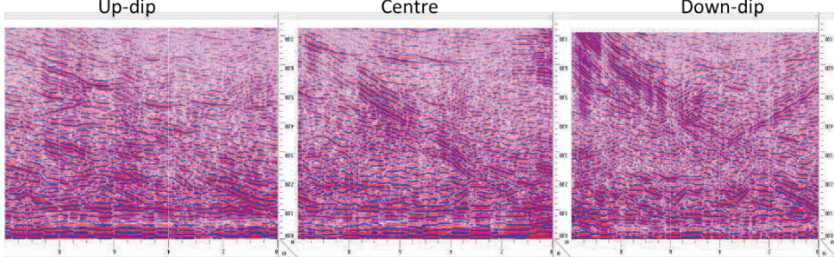
| PANEL | COMMENT | GPR SCAN |
|---|---|---|
| 47N | Continuous flat dipping structure prominent in the down dip scan. | |

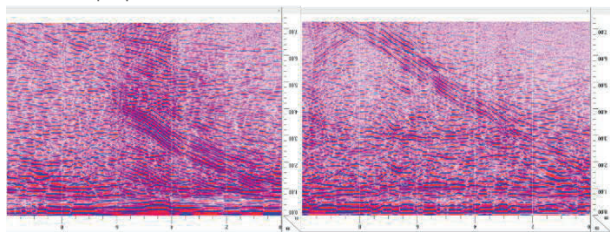
| PANEL | COMMENT | GPR SCAN |
|---|---|---|
| 48N | Continuous flat dipping structure observed in both up-dip and center scans. | |

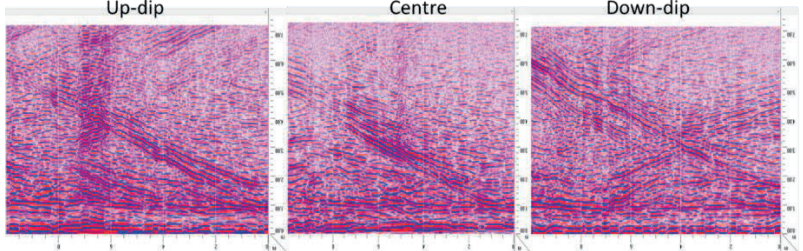
| PANEL | COMMENT | GPR SCAN |
|---|---|---|
| 49N | Continuous flat dipping structure observed in all three scans. | |

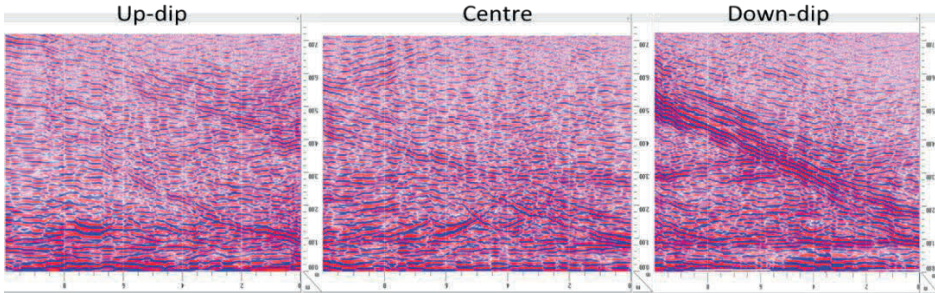
| B7N | Continuous flat dipping structure observed in the down-dip scan | |

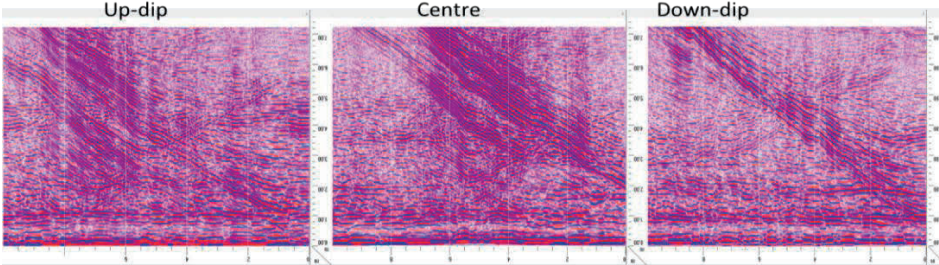
| 50N | Continuous flat dipping structure observed in the center scan. | |

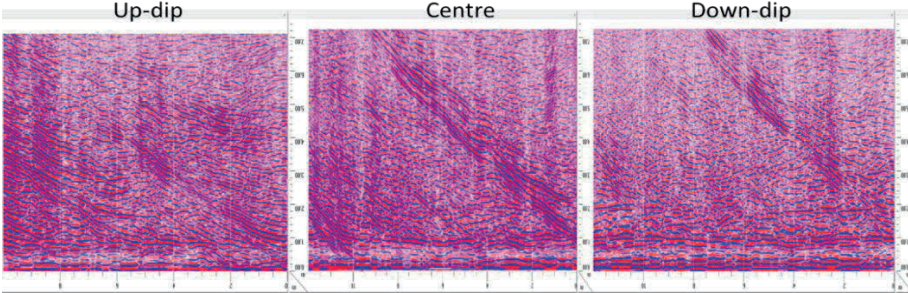
| 51N | Continuous flat dipping structure observed in the center scan. | |

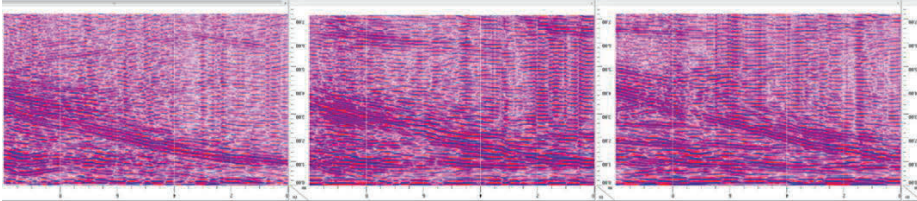
| 70N | Continuous flat dipping structure observed in the center scan. | |

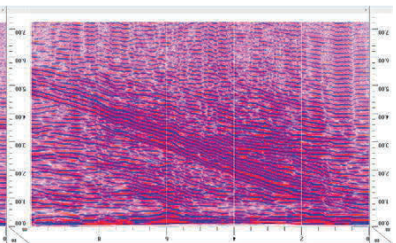
| 76S | Continuous flat dipping structure in all three scans. | <div>Up-dip</div> <div>Centre</div> <div>Down-dip</div> |

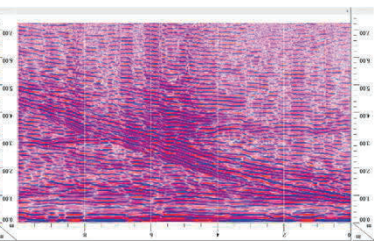
| B11S | Continuous flat dipping structure in all three scans. | <div>Up-dip</div> <div>Centre</div> <div>Down-dip</div> |
