**EVALUATING THE STATE'S RESPONSE TO FLOODING DISASTERS: THE  
CASE OF DEELPAN VILLAGE EMERGENCY HOUSING**

**MASTER OF URBAN STUDIES (HOUSING AND HUMAN SETTLEMENTS)**

**Chuma Rirhandzu NO.368922**

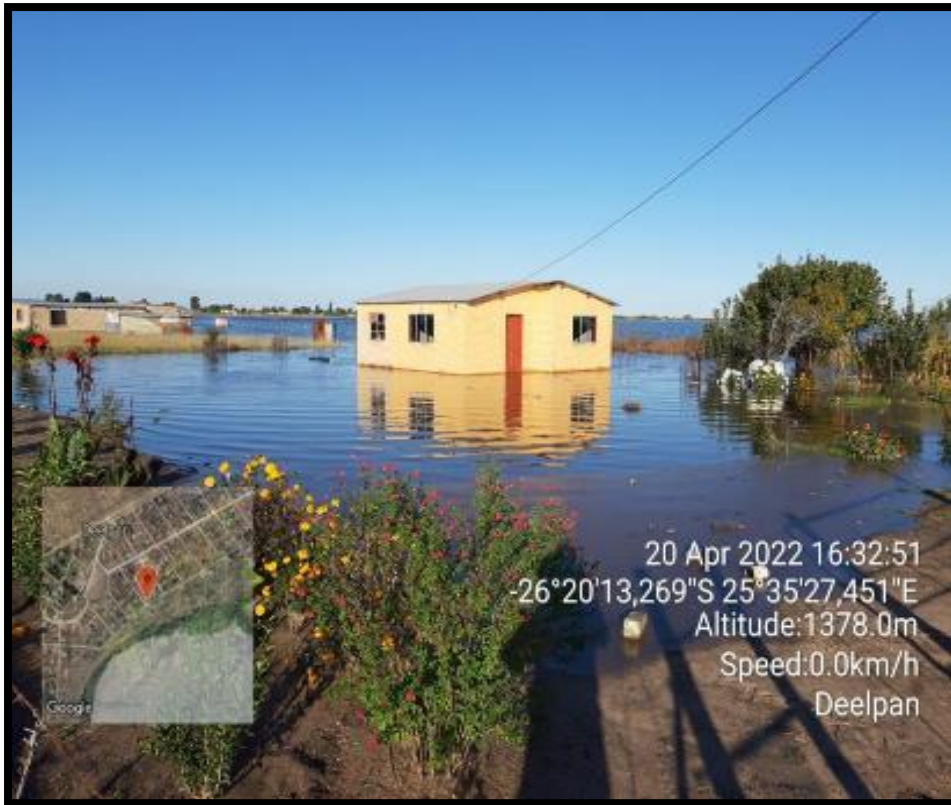
Figure 4.3: Over flooded RDP houses in the Deelpan Village. Images captured in April 2022 of RDP structures affected by the floods Source: Community representative member.

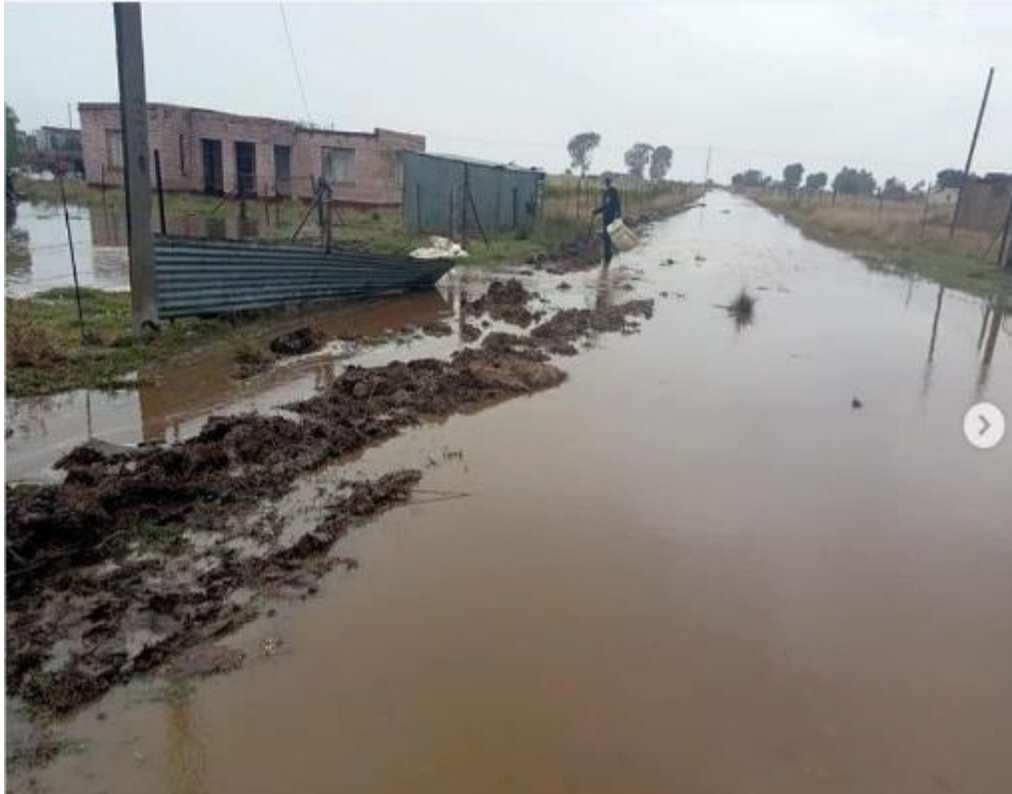
The Deelpan Village was affected by the flooding tragedy in December 2021. According to Dube et al. (2018), a disaster impacts the community's livelihoods by claiming human lives. In the case of Deelpan, no fatalities were reported. Though houses and other community infrastructure, such as roads, were destroyed during a flood disaster, which left people without a place to live. The flooded roads prevented the community from accessing social amenities like schools (see figure 4.4 below).

Figure 4.4: Over flooded roads in the Deelpan Village. Images captured in April 2022 during the flooding days. Source: Community representative member.

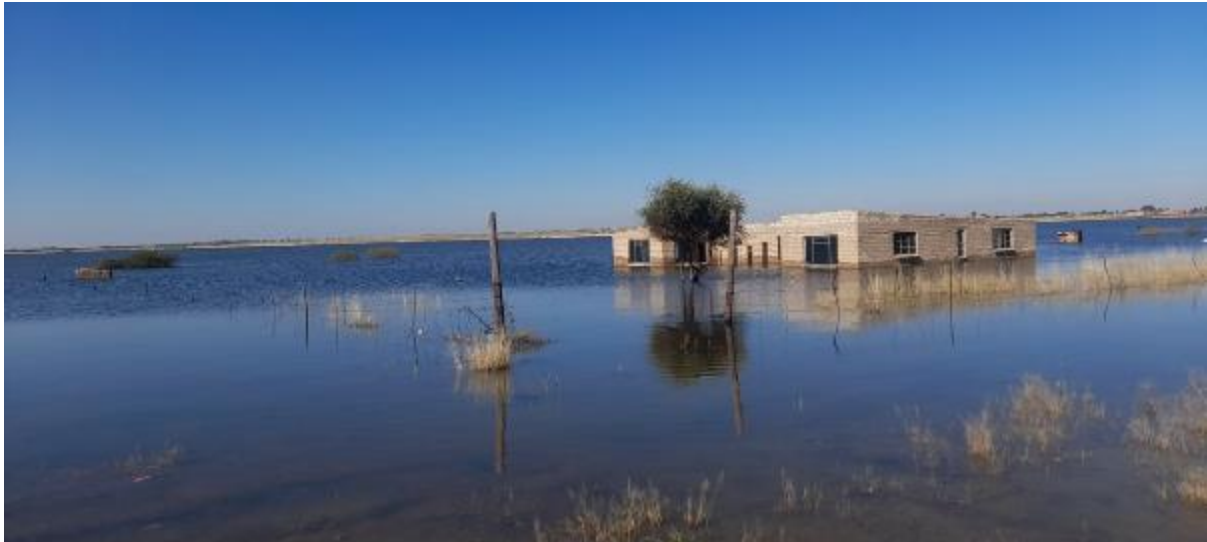
“It was raining every day; in the beginning, we could control the water, but the water kept coming into our houses, and we couldn’t manage it anymore (refer to figure 4.5 below). We lost everything, including clothes, furniture, and the food we had stored” (Personal Communication: Community representative 4, August 2023).

Figure 4.5: Submerged house in the Deelpan Village. An image captured in December 2021 during the flooding days Source: Community representative member.

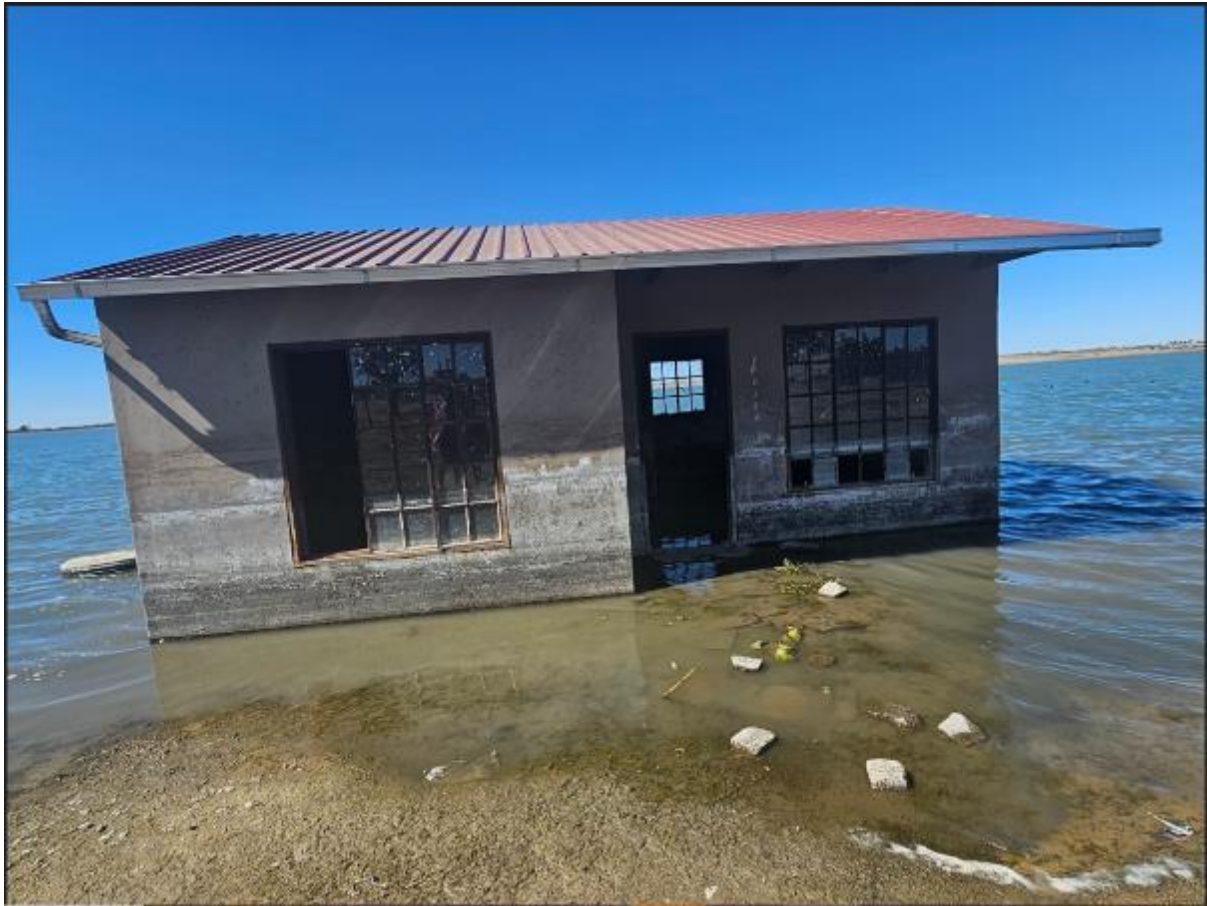
During the site inspection, it was established that some of the houses that were submerged have since dried up (after the flooding that occurred almost three years ago). While other houses, particularly those near the wetland, remain flooded and inaccessible (see figure 4.7 below).

Figure 4.7: Over flooded house in the Deelpan Village. An image captured on the 23rd of September 2023 after the flooding. Source: Author.
