**OPEN-CAST MINE SLOPE DEFORMATION AND FAILURE MECHANISMS  
INTERPRETED FROM SLOPE RADAR MONITORING**

A thesis submitted to the Faculty of Engineering and the Built Environment, University of the Witwatersrand, Johannesburg, in fulfilment of the requirements for the degree of Doctor of Philosophy.

Johannesburg, 2012

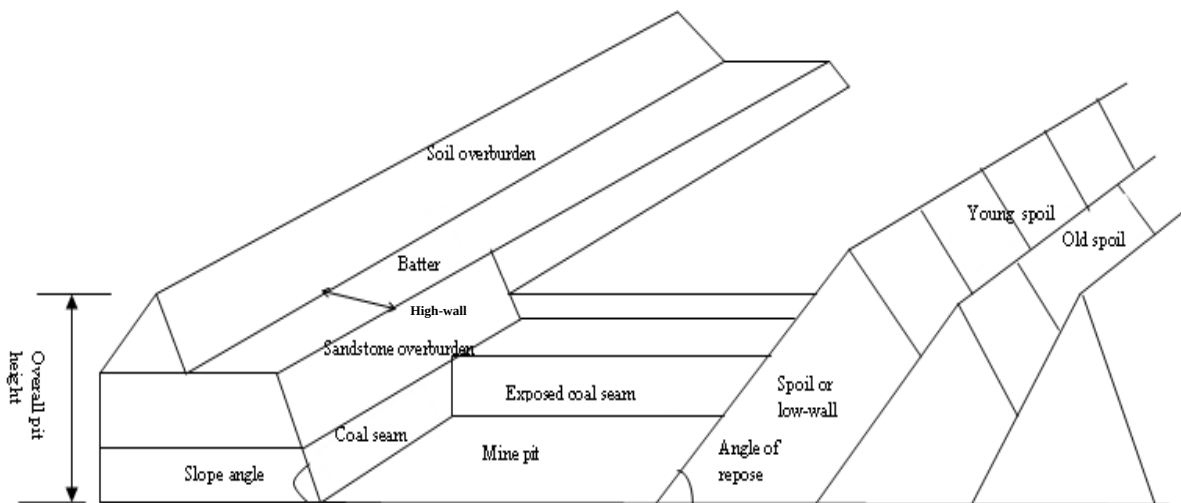
Figure 2.2: Open cast coal mine slope geometry.

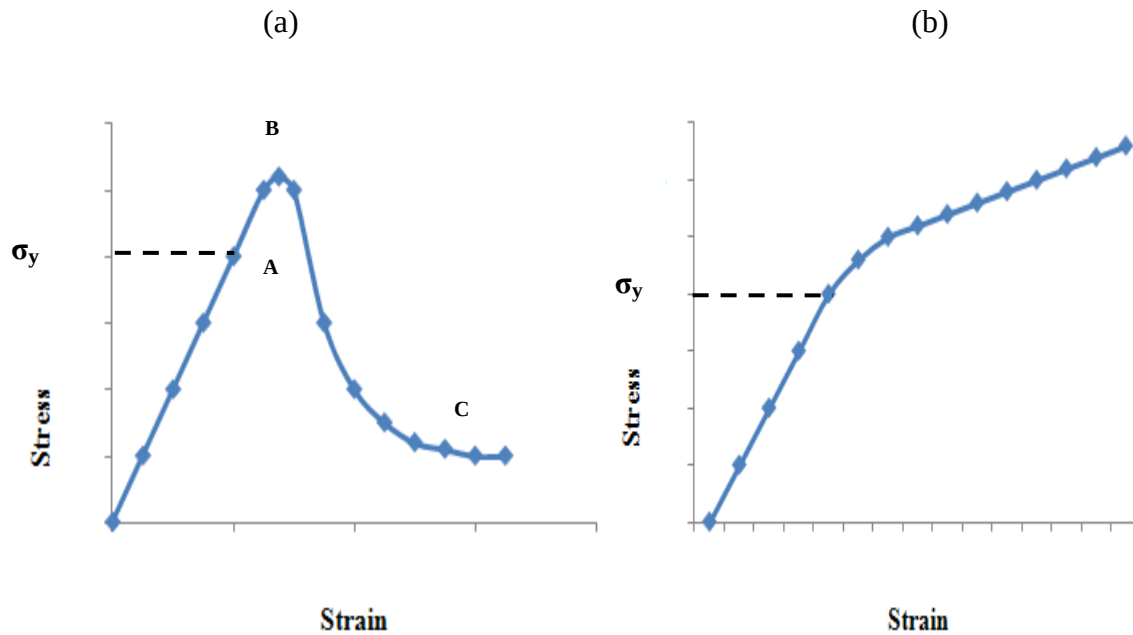
Figure 2.3: (a) Strain-softening stress-strain curve. (b) Strain-hardening stress-strain curve (After Brady and Brown, 2006).

**Yield:** This is the stress at the end of elastic behaviour, represented by point A in figure 2.3a. The yield stress,  $\sigma_y$ , depicted in figure 2.3, is the onset of permanent and irreversible deformation (Brady and Brown, 2006). During slope monitoring, the yield point corresponds to the beginning of progressive displacement behaviour, which is often times the same as the on-set of failure point.

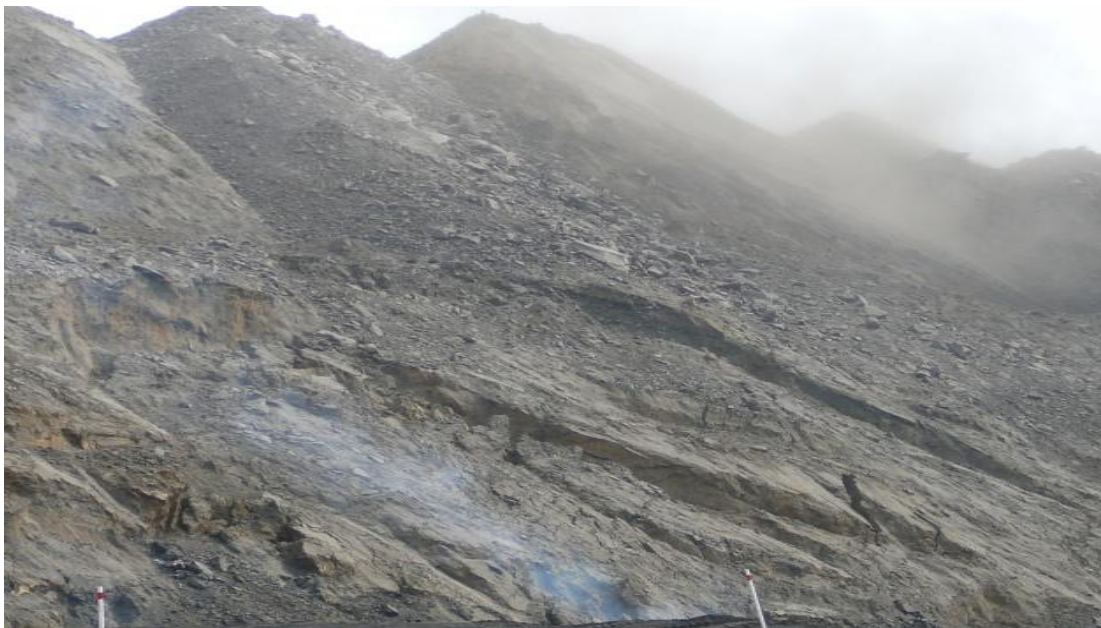
Figure 2.7: Circular failure at New Vaal Coal mine.

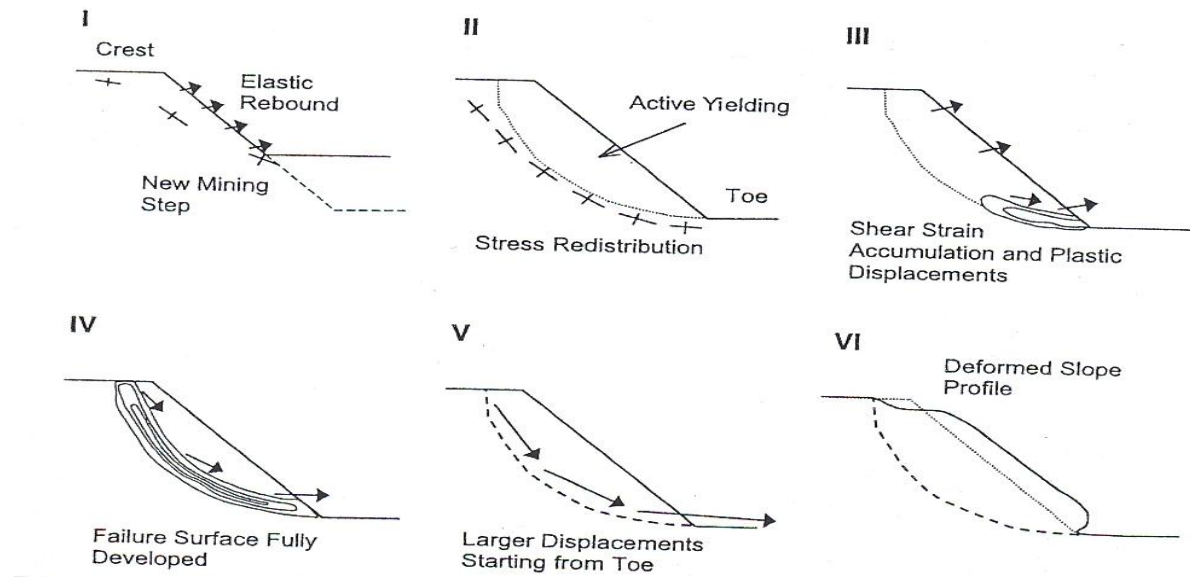
Figure 2.8: Failure stages for circular (rock mass) shear failure slope (After Sjöberg, 2000).

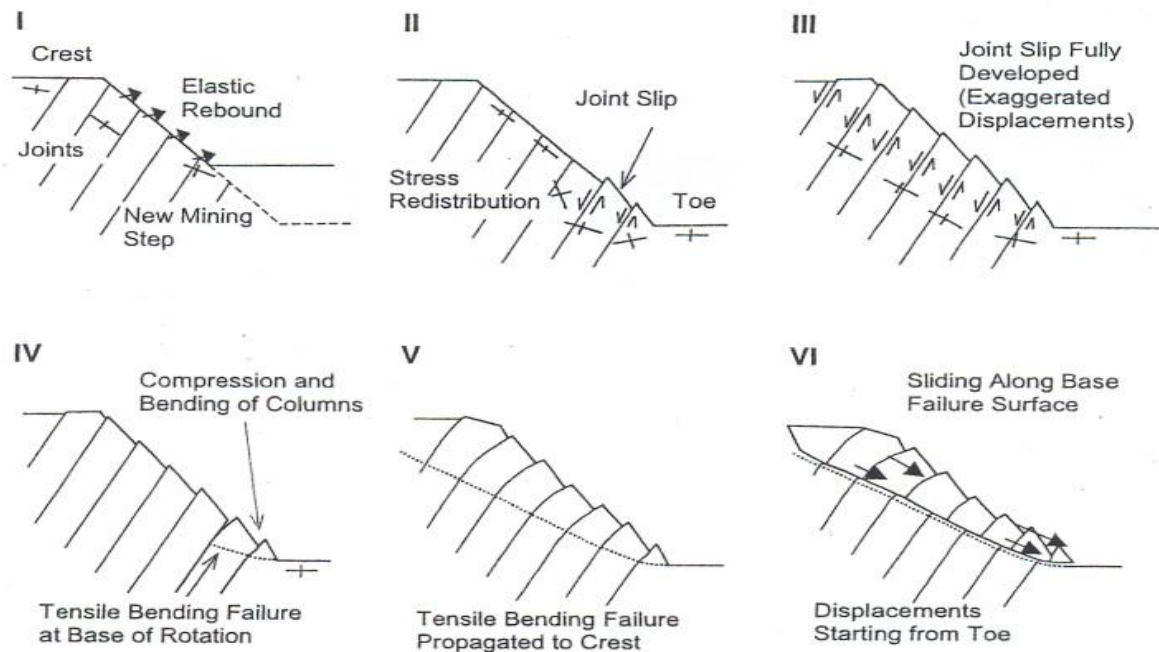
Figure 2.16: Failure stages for large-scale toppling failure in a slope (After Sjöberg, 2000).

Sjoberg (2000) claimed in a model that toppling failure develops in various identifiable stages similar to circular failure as shown in figure 2.16. An elastic rebound occurs after the mining cut is made followed by slip along the steeply dipping joints in the slope. The slip, which begins at the slope toe and then progresses towards the crest, while redistributing stresses around the region of the slip. This results in the compression of rock columns, which creates the space for a slight rotation of the columns starting at the toe. In a high slope, the elastic deformations of the rock mass can cause a small rotation. This is followed by tensile bending failure at the base of the rotating column, which progresses to the crest, therefore causing base failure surface on which the failed rock can slide (Sjoberg, 2000).

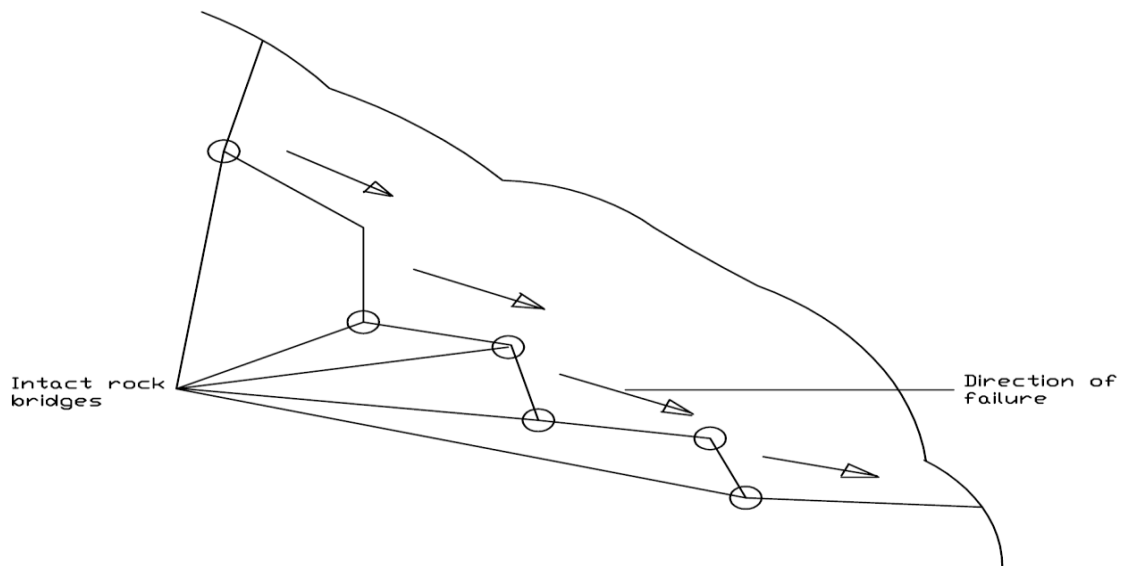
Figure 2.17: Complex failure mechanisms with multiple step-path failure (After Eberhardt, et al. 2004a and Stead, et al. 2006)

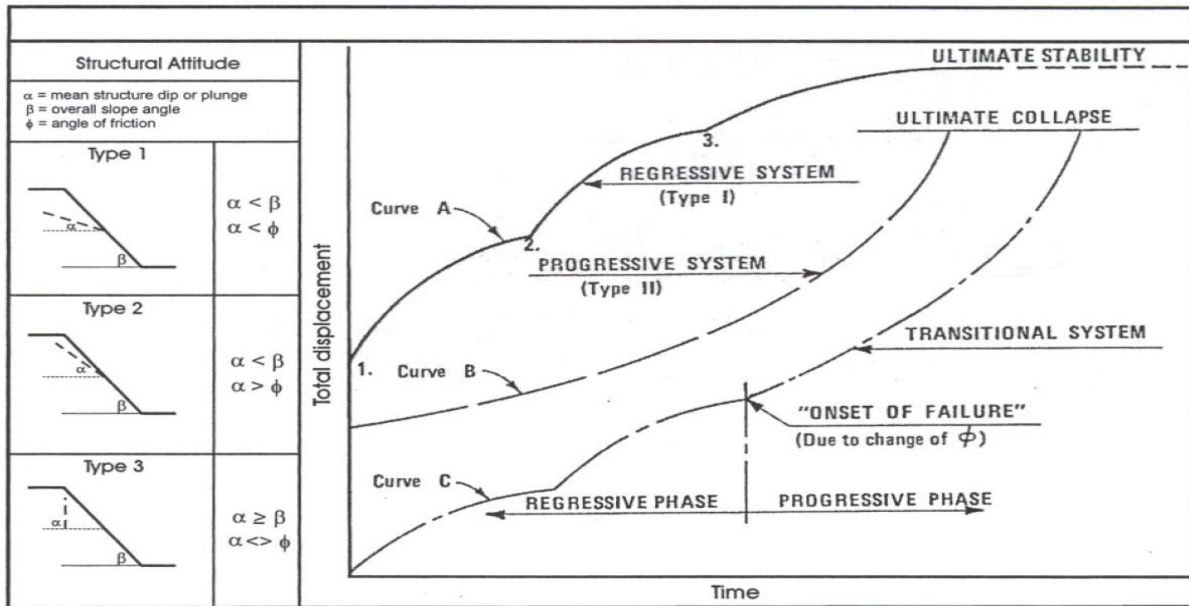
Figure 2.20: Typical regressive/progressive stage displacement curves (Broadbent and Zavodni, 1982).

Figure 2.20 shows regressive/progressive displacement stage and the different stages in the curves. Curve A is considered a regressive curve, because of the deceleration of each cycle between external stimuli at points 1, 2 and 3. Curve B shows the progressive stage, which display an accelerating state. Curve C shows the transition from regressive to progressive stage (Zavodni, 2000).

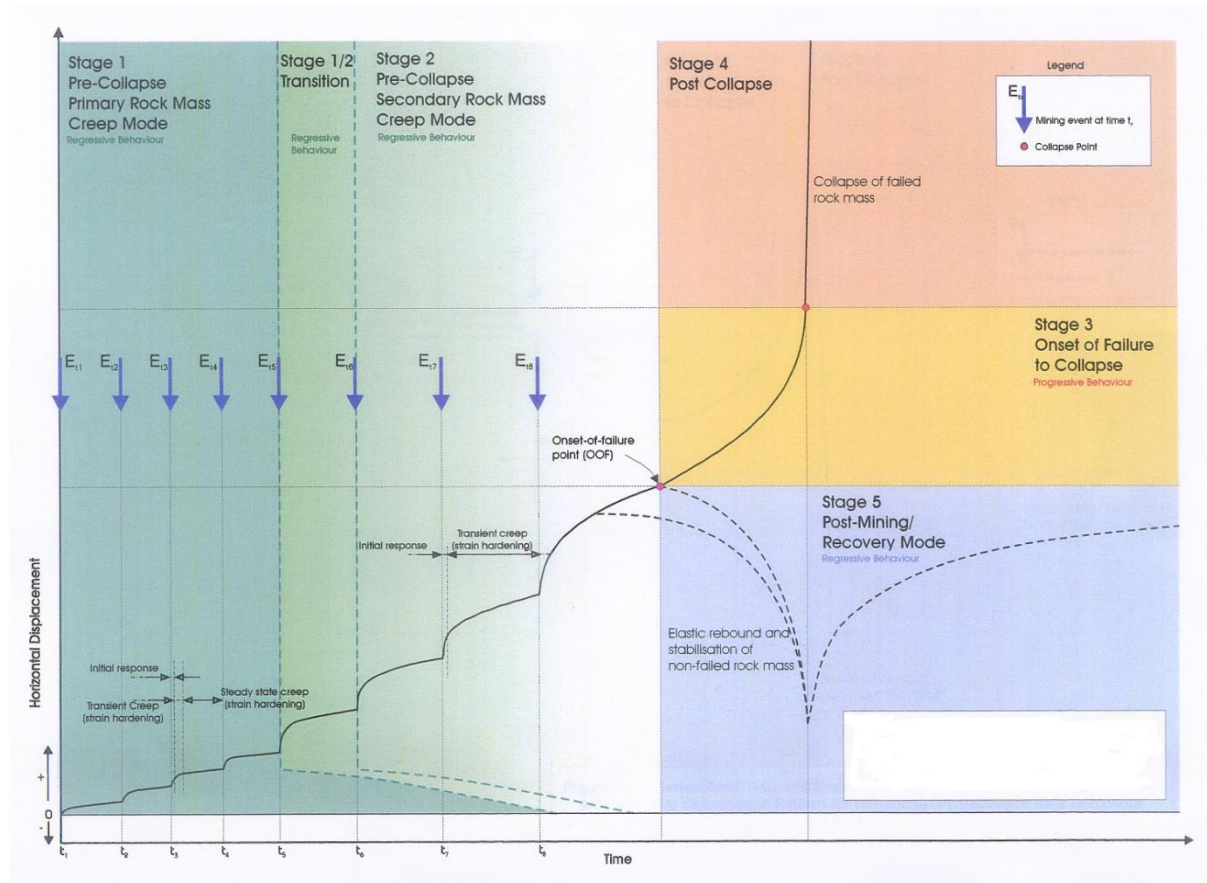
Figure 2.21: Generalised time and event dependent rock mass deformation model (After Mercer, 2006).

- Stage 1 - Pre-collapse, primary rock mass creep modes;
- Stage 2 – Pre-collapse, secondary rock mass creep modes;
- Stage 3 – Onset of failure to collapse behaviour modes;
- Stage 4 – Post-collapse behaviour modes; and
- Stage 5 – Post-mining/recovery behaviour modes.

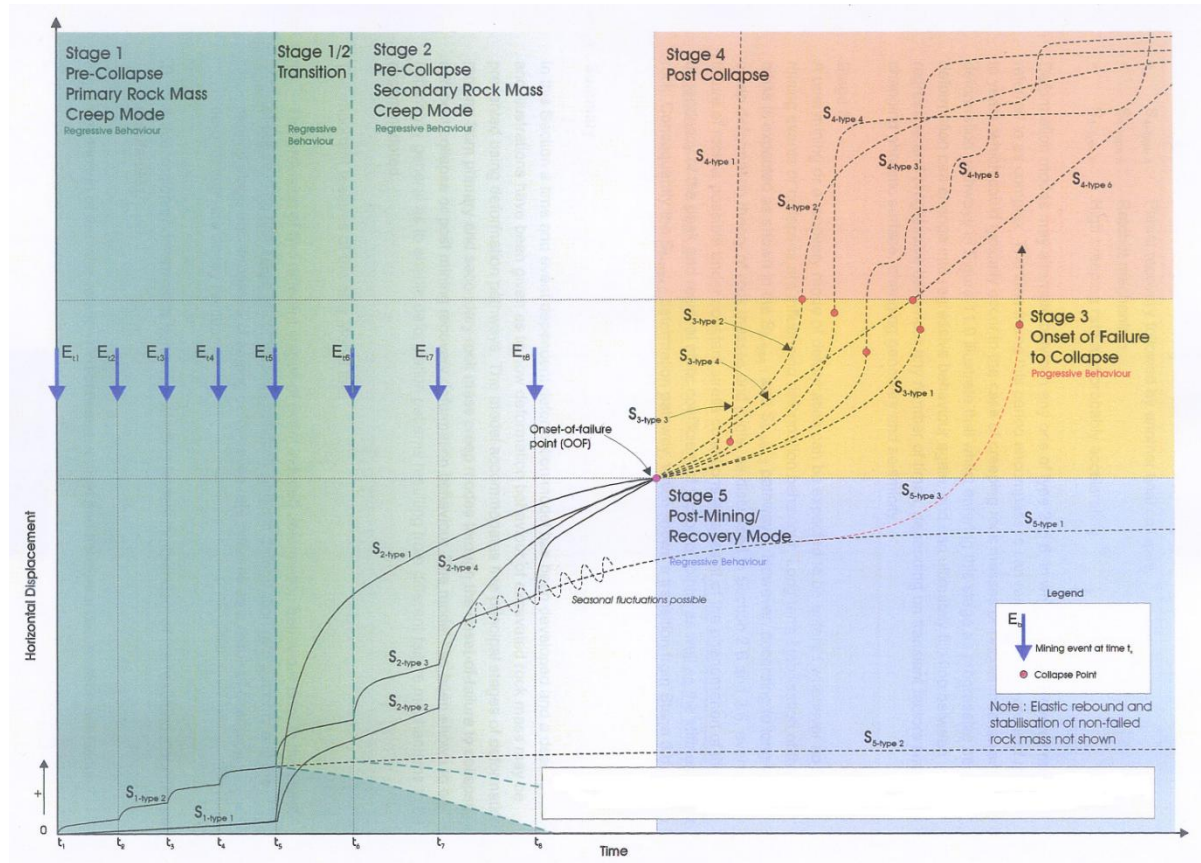
Figure 2.22. Generalised time and event dependent rock mass deformation model showing post collapse and post mining behaviour modes (Mercer, 2006).

Mercer (2006) stated that a complex deformation mode may occur if the failed slope alternates between types 2 to 6, and could be in a matter of minutes to years. The deformation mode can also change from a progressive state to a regressive state depending on transient factors such as changing phreatic surface, seismicity and changing geometry (Mercer, 2006). The post-mining state involves the long-term stabilisation of the rock mass, although transition from stage 5 back to stages 3 and 4 may occur based on long-term creep theory. At stage 5, the slope is in a regressive state of recovery (Mercer, 2006).

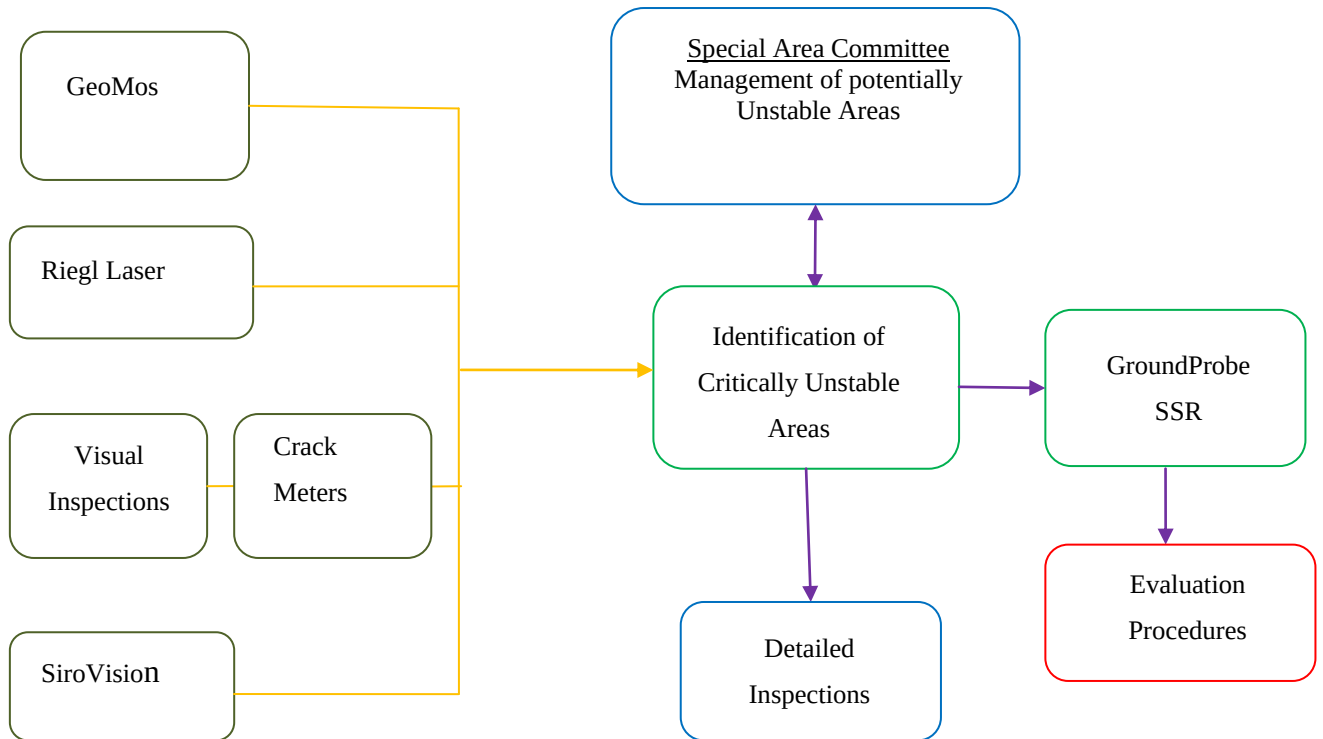
Figure 3.1: Slope monitoring strategy at PPRust open pit, Limpopo, South Africa (After Little, 2006a).

(2006). The fourth step is similar to the identification of critically unstable areas and detailed inspections while the fifth step corresponds to the evaluation procedures.

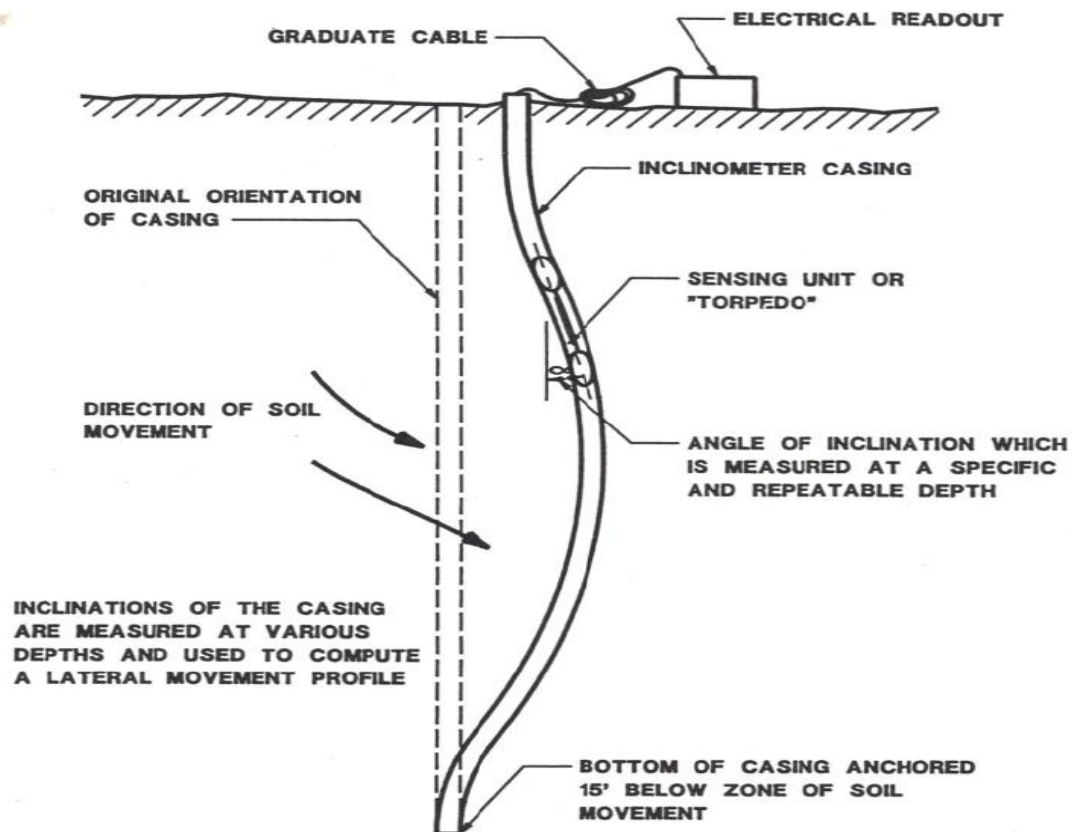
Figure 3.3: Portable borehole inclinometer system (Abramson, et al. 2002).

Kliche (1999) stated that the displacement information collected from inclinometers can be used to locate shear zones and to determine whether movement along the shear zone is steady, accelerating or decelerating. Correct placement for inclinometers for monitoring displacement of both shallow and deep-seated failure planes is shown in figure 3.4.

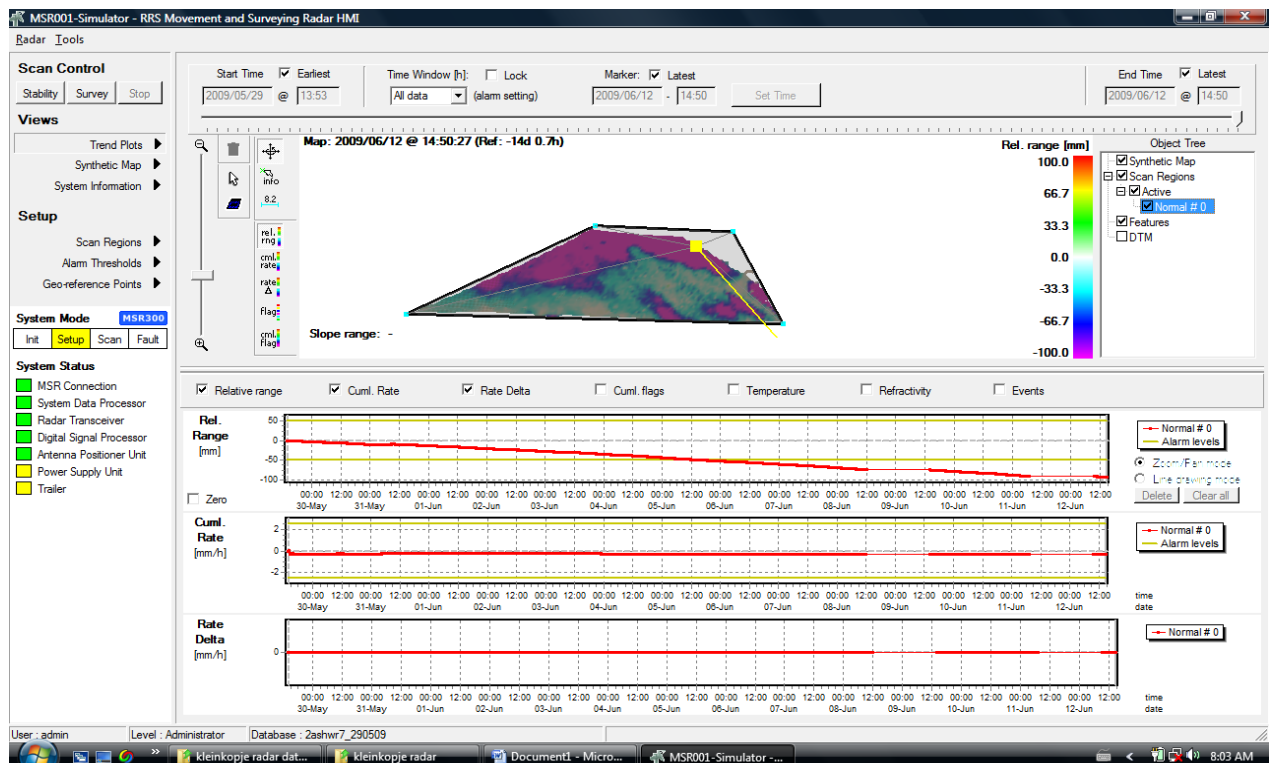
Figure 4.4: Trend plot of Kleinkopje open cast mine low-wall failure (Mottie, 2008).

Failure was attributed to a high angle of repose of the spoil, significant swelling and weakening of interparticle bonding between the granulated overburden materials serving as a base for the rock boulders on the spoils. This resulted in the loose sandstone boulders toppling over from the uppermost part of the low-wall. A common cause of low-wall or waste rock slope failure is the reduction in shear strength due to moisture softening. This is more pronounced during rainfall, as the bond of the waste material progressively reduces with time (Mottie, 2008).

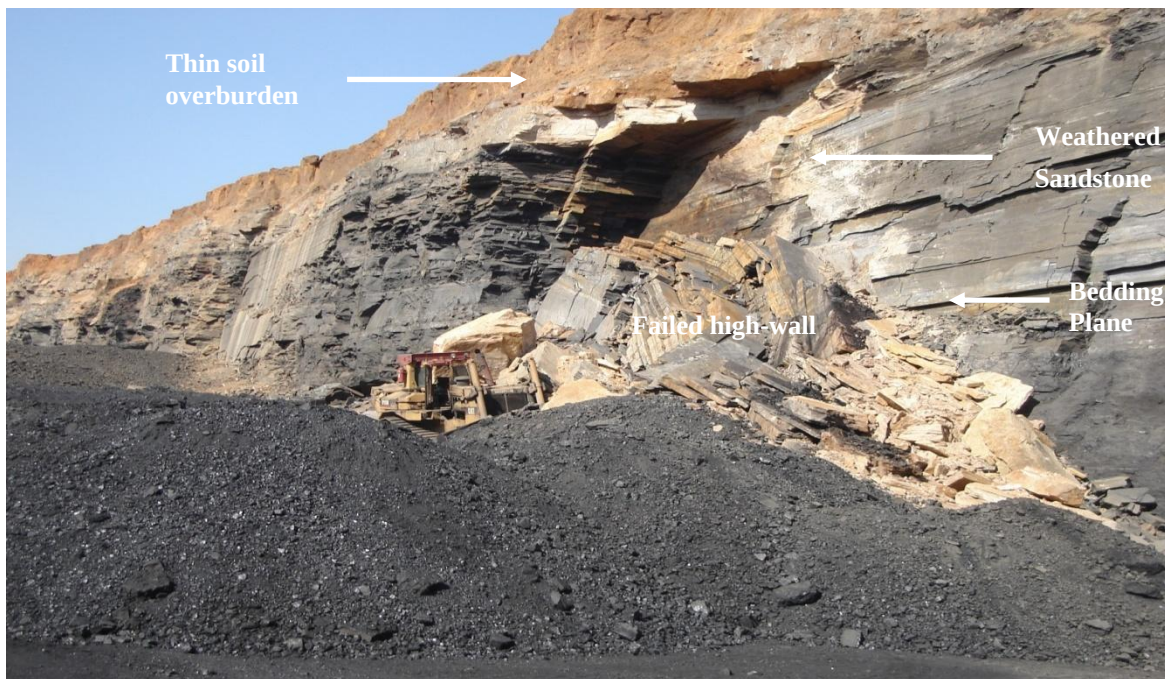
Figure 4.9: Failed high-wall at Landau open-cast mine (Landau Colliery, 2009).

when it does occur. The failure reported at Landau was unexpected and could have been fatal because the slope was deemed safe.

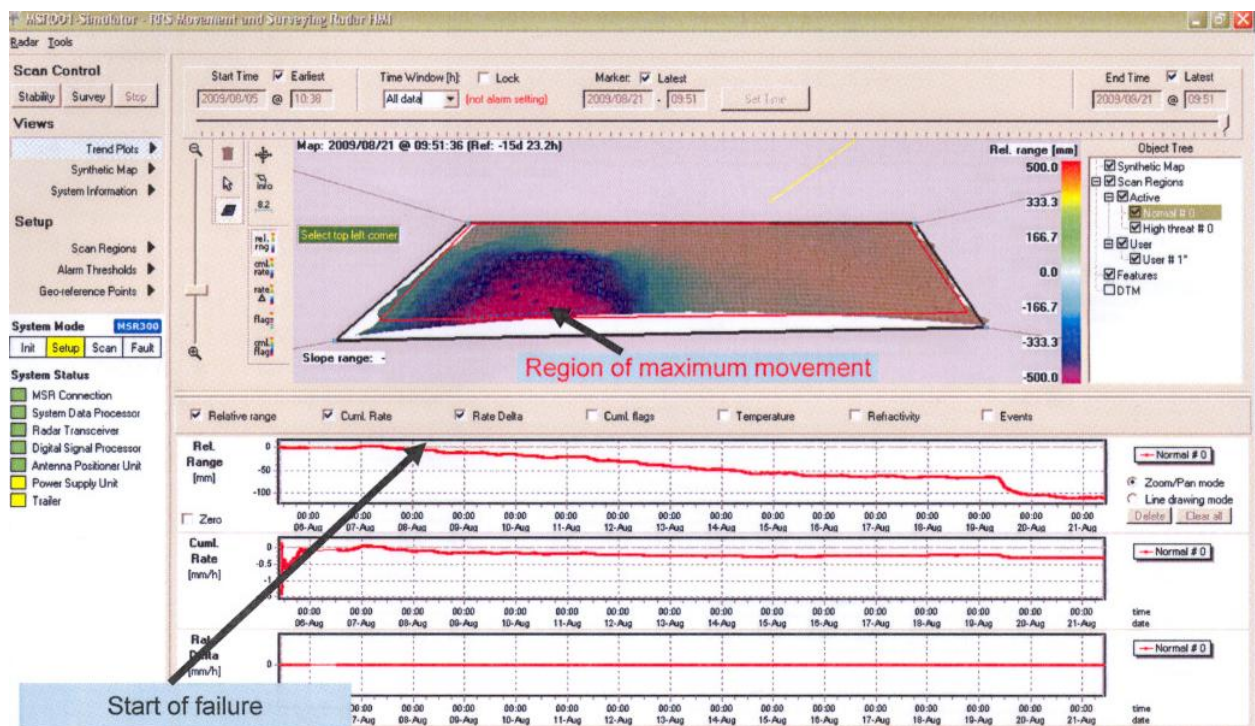
Figure 4.12: MSR trend plots and synthetic map of the scanned low-wall (New Vaal Colliery, 2009b).

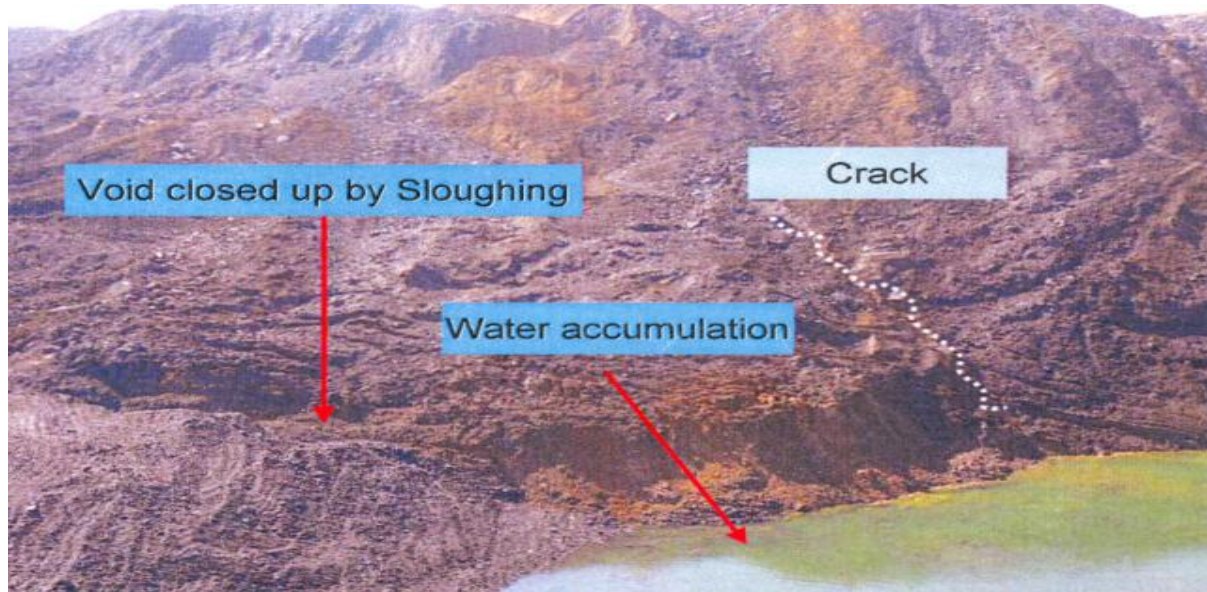
Figure 4.13: Unstable low-wall before failure (New Vaal Colliery, 2009b).

The failure was largely due to the presence of a palaeo-low and water accumulation at the toe of spoils, as illustrated in figure 4.13. The weakening of the spoil base and the reduction of the effective stress of spoil material resulted in the upward propagation of tension cracks within the spoil heap. These factors possibly caused the spoil to slough (New Vaal Colliery, 2009b).

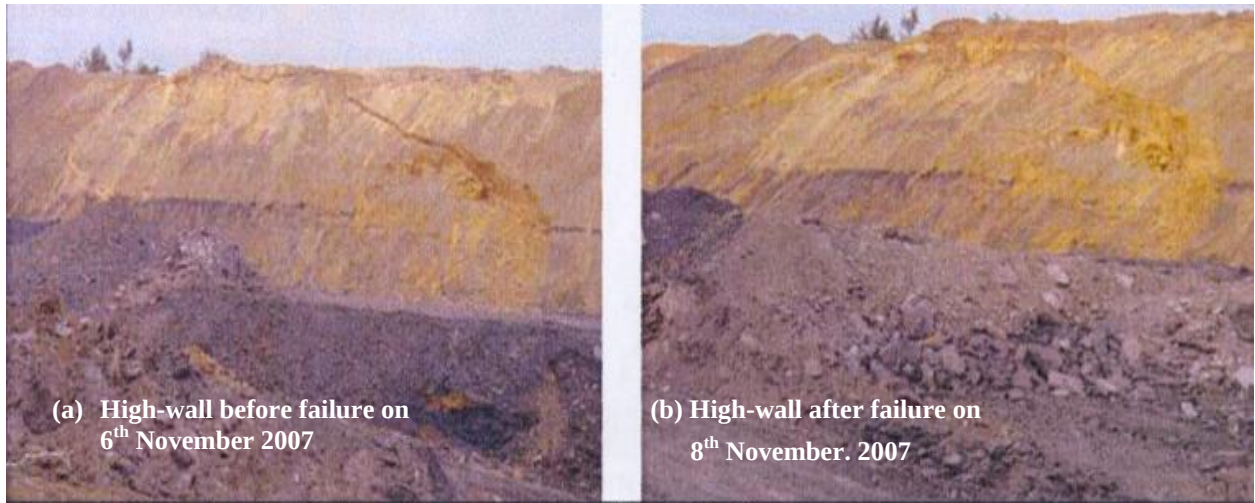
Figure 4.14: High-wall before and after failure (Zindela, 2008).

Tension cracks were observed on the soft overburden on the 6<sup>th</sup> November, 2007 in ramp 12. After an assessment of the risk by the mine geotechnical personnel, it was apparent that a slope failure was imminent (Zindela, 2008). The MSR was then positioned to scan the unstable high-wall. It was observed that prior to sudden collapse as seen in figure 4.14 and 4.15, it took approximately five hours for a displacement of -50mm to occur, whereas during the sudden failure it took only two hours for the same magnitude of movement to occur (Zindela, 2008). The increase in movement was accompanied by an increase in cumulative rate of displacement from -10mm/hr to -25mm/hr during slope failure (Zindela, 2008).

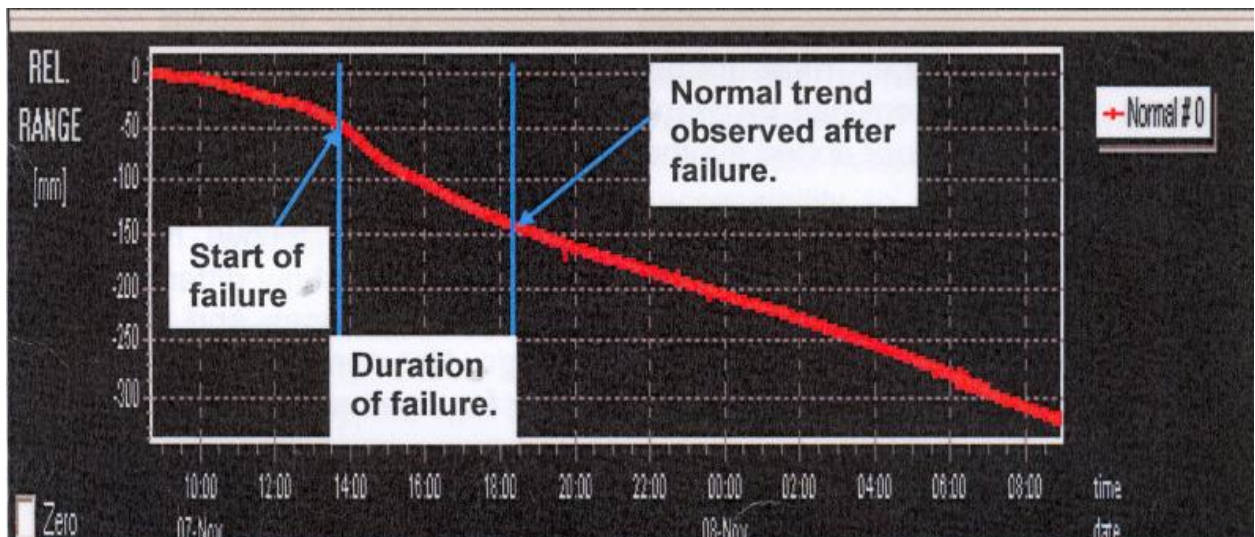
Figure 4.15: MSR trend plot of the high-wall displacement (Zindela, 2008).

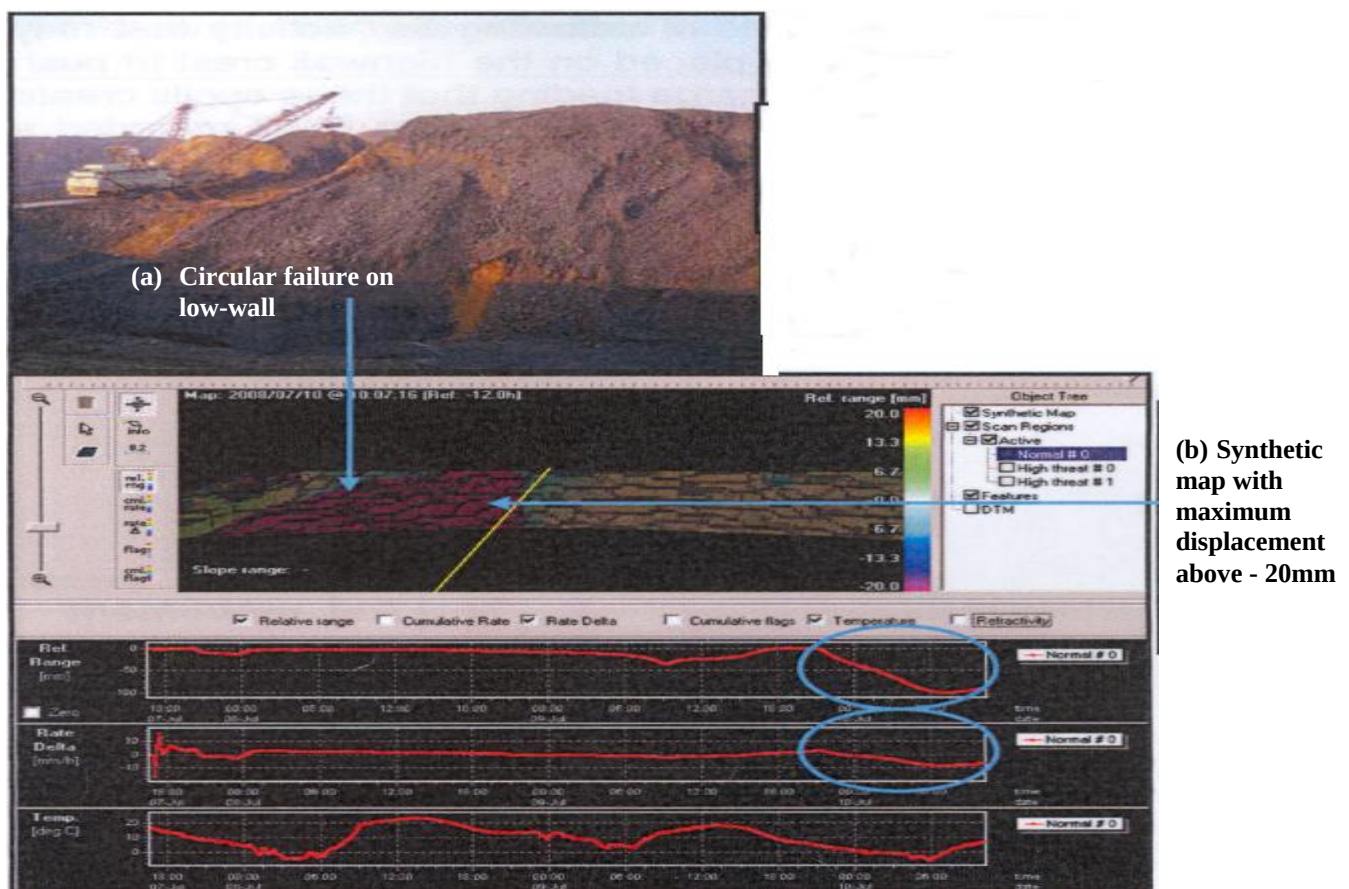
Figure 4.16: MSR synthetic map and trend plots of low-wall displacement (Zindela, 2008).

The synthetic map shown in figure 4.16 indicated that the relative movement in the unstable region is higher than the other scan region. Although the slope movement was gradual initially, a sudden movement of -100mm occurred at about 21.00pm on the 9<sup>th</sup> of July 2008 (Zindela, 2008). During this sudden slope movement, the cumulative rate of displacement also increased from 0mm/hr to -10mm/hr, which caused transition from a steady to a progressive displacement. After 6:00 on the 10<sup>th</sup>, the slope started stabilising (Zindela, 2008).

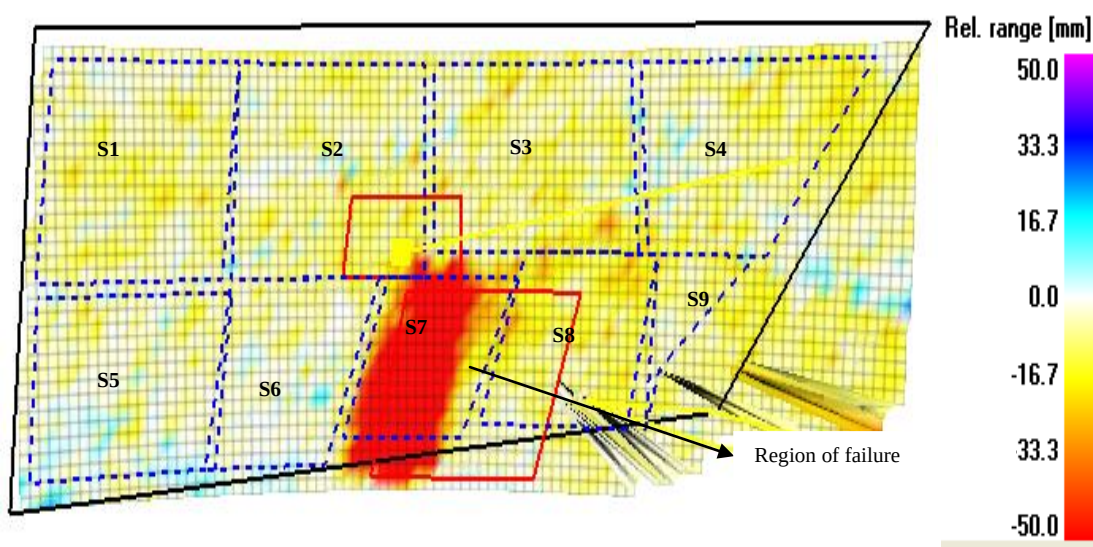
Figure 5.3: The scanned region of case example 1 slope

The monitored area of the slope is divided into 9 sections as shown in figure 5.3. Figure 5.4 and 5.5 show the displacements and cumulative rates of displacement for sections one to nine. The analysis of the data indicates that all the sections except section 7 are stable, with small displacements and at negligible cumulative rates of displacement. The stable sections exhibited type I behaviour of stable slopes. The plot of the data for each section showed that failure only occurred in section 7. The magnitude of displacement and cumulative rate of displacement for the sections and points are different since they are dependent on size.

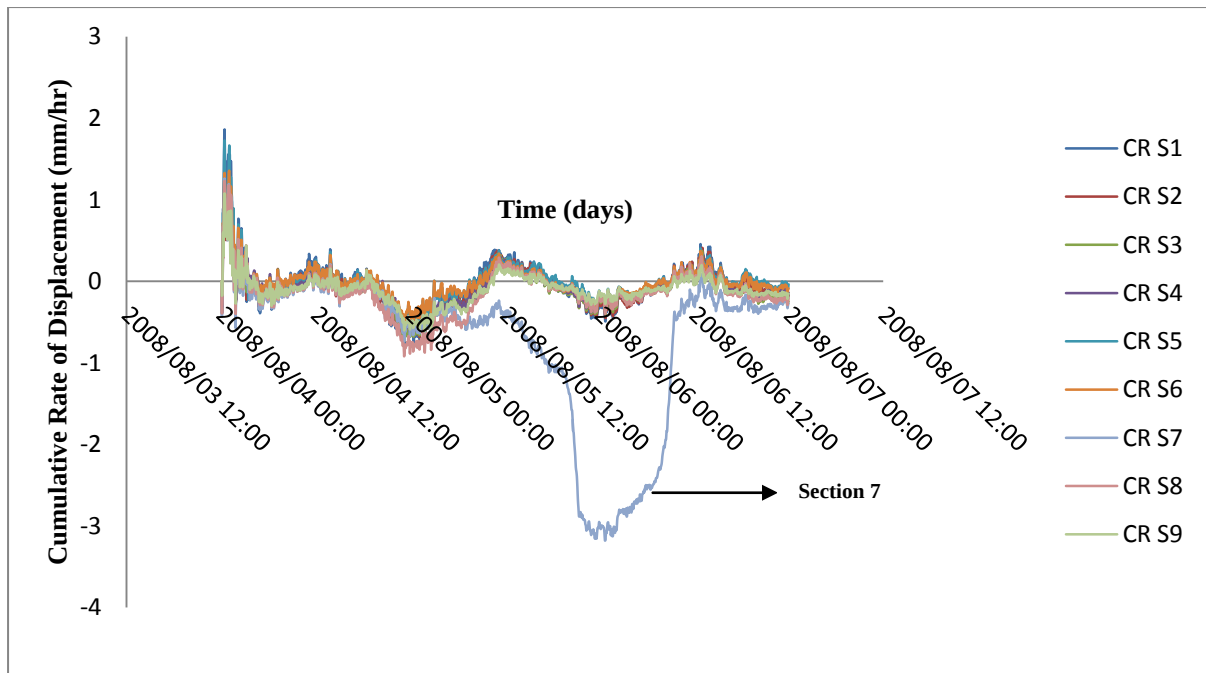
Figure 5.5: Cumulative rate of displacement (mm/hr) of sections 1- 9 of case example 1 slope.

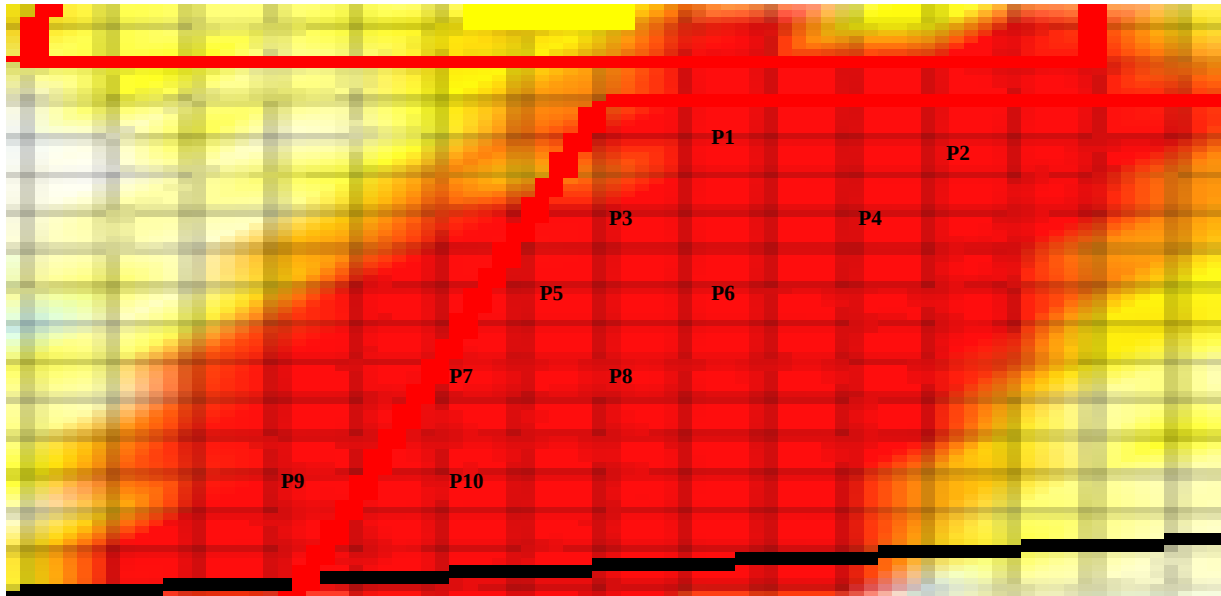
Figure 5.6: Failure section showing the locations of ten selected points in case example 1 slope.

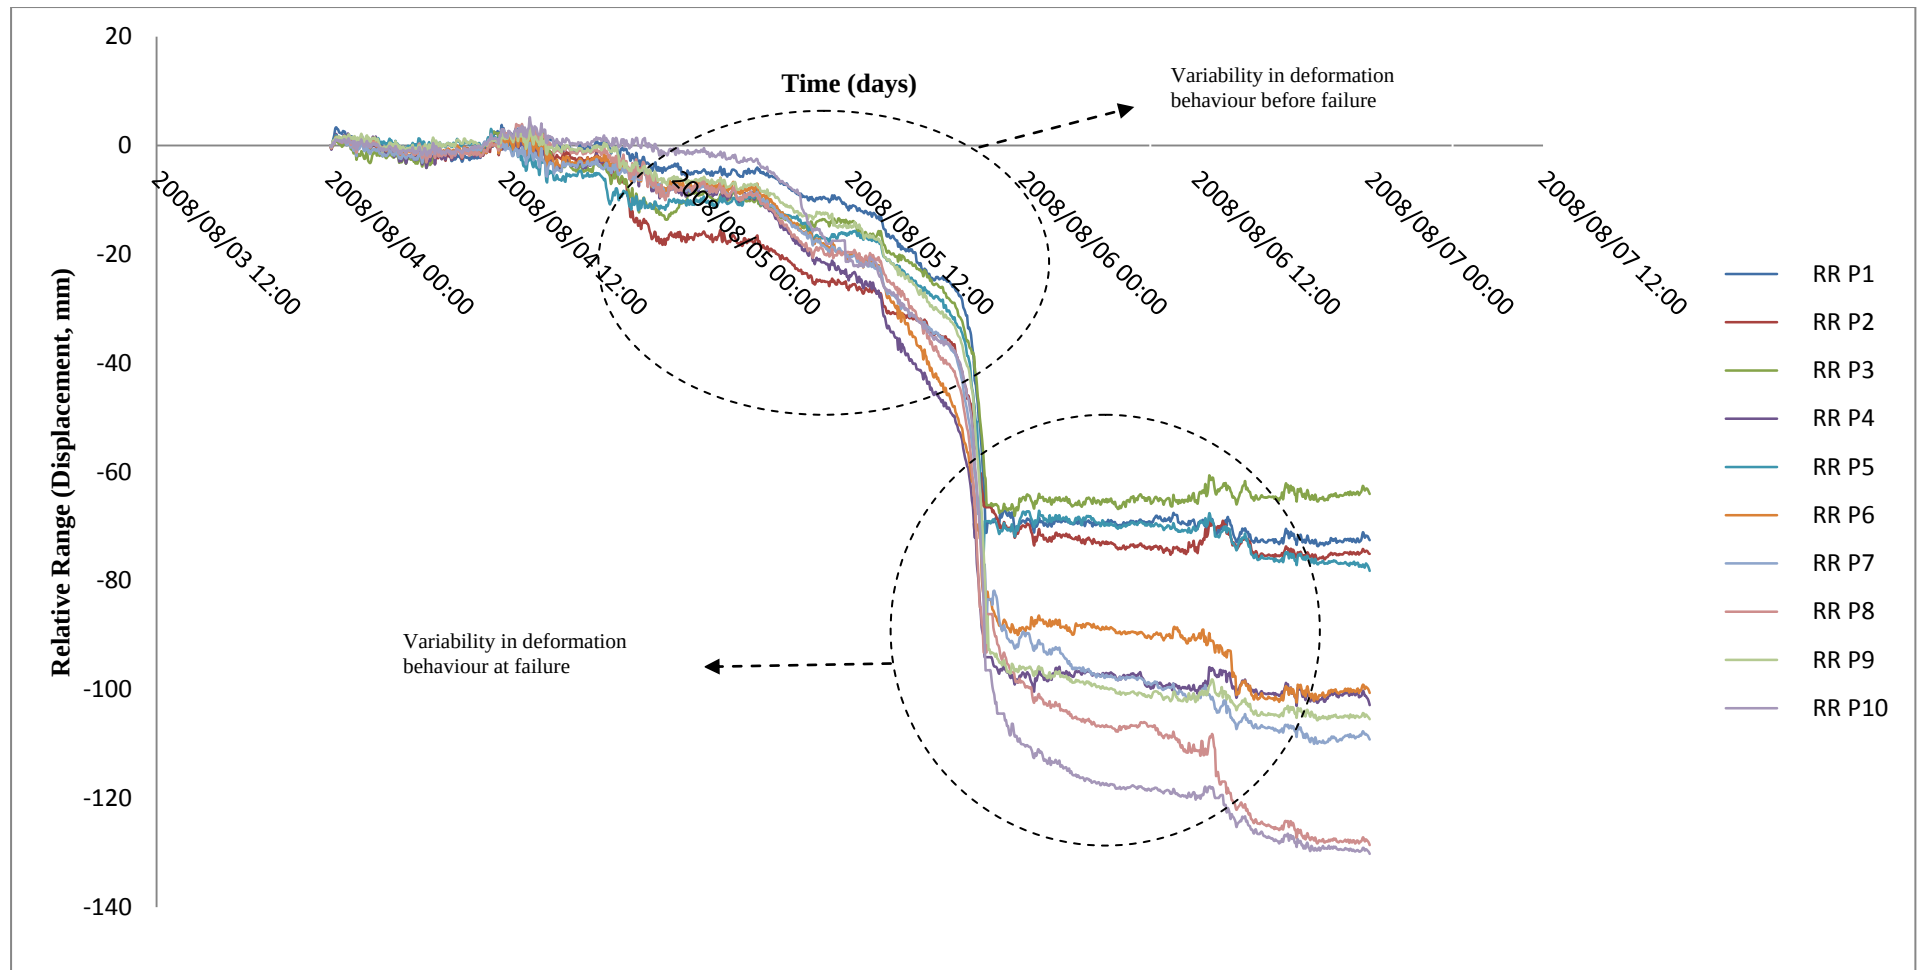
Figure 5.7: Relative range (Displacement, mm) of 10 points in the failure section of case example 1 slope.

Figure 5.7 shows the area of failure in section 7. Data from ten different points were exported from the MSR into a Microsoft Office Excel spread sheet for a detailed analysis of the failure. Figure 5.7 and 5.8 show the plots of displacement and cumulative rates of displacement for the ten points from the failure section.

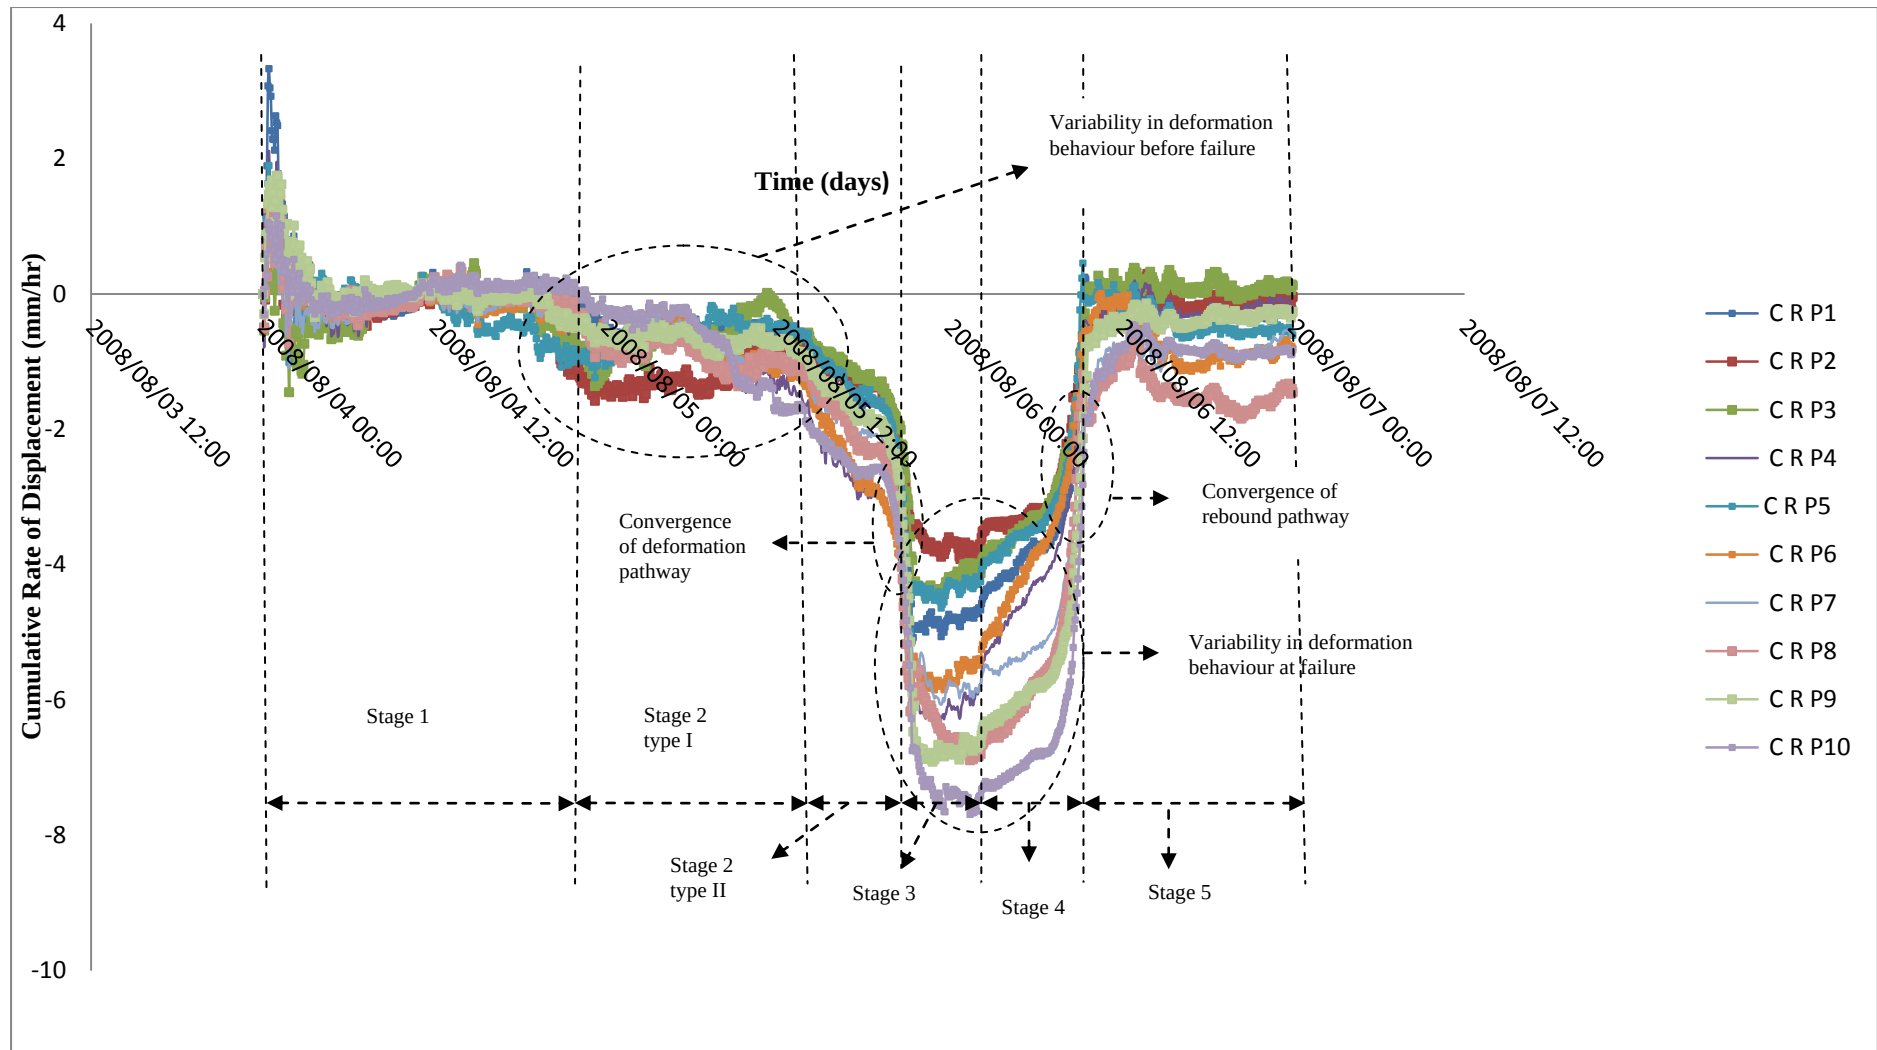
Figure 5.8: Cumulative rates of displacement, (mm/hr) of 10 points in section 7 of case example 1 slope.
