**OPEN-CAST MINE SLOPE DEFORMATION AND FAILURE MECHANISMS  
INTERPRETED FROM SLOPE RADAR MONITORING**

A thesis submitted to the Faculty of Engineering and the Built Environment, University of the Witwatersrand, Johannesburg, in fulfilment of the requirements for the degree of Doctor of Philosophy.

Johannesburg, 2012

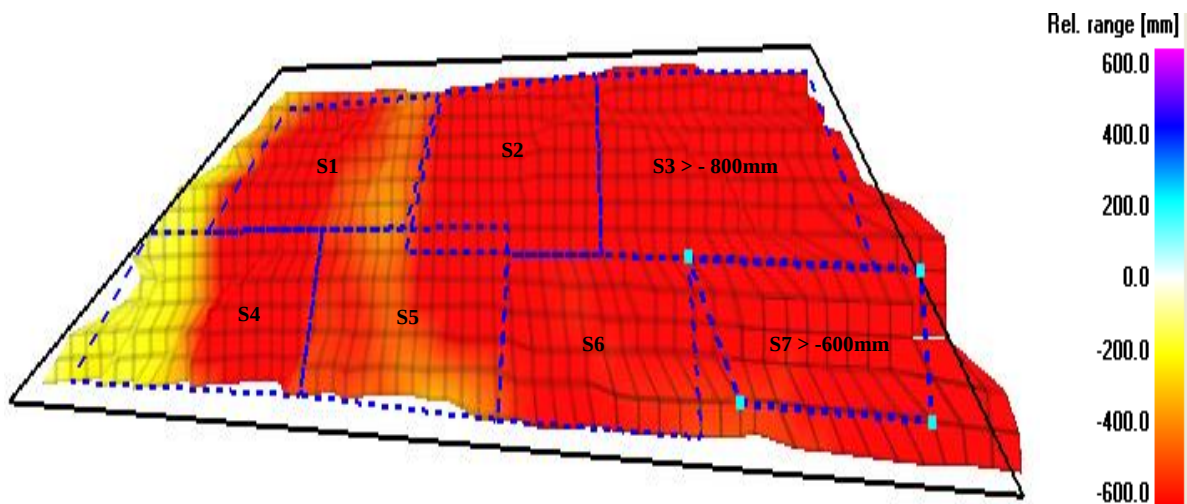
Figure 5.9: The scanned region of ramp 0 slope.

The monitored region of the slope is divided into seven different sections, as reflected in figure 5.9, to ascertain the unstable areas where failure took place. Figures 5.9 to 5.11 show that failure occurred in all the sections, because they all experienced high displacement magnitudes. All the sections experienced displacements in excess of -400mm, and a cumulative rate of displacement above -2mm/hr.

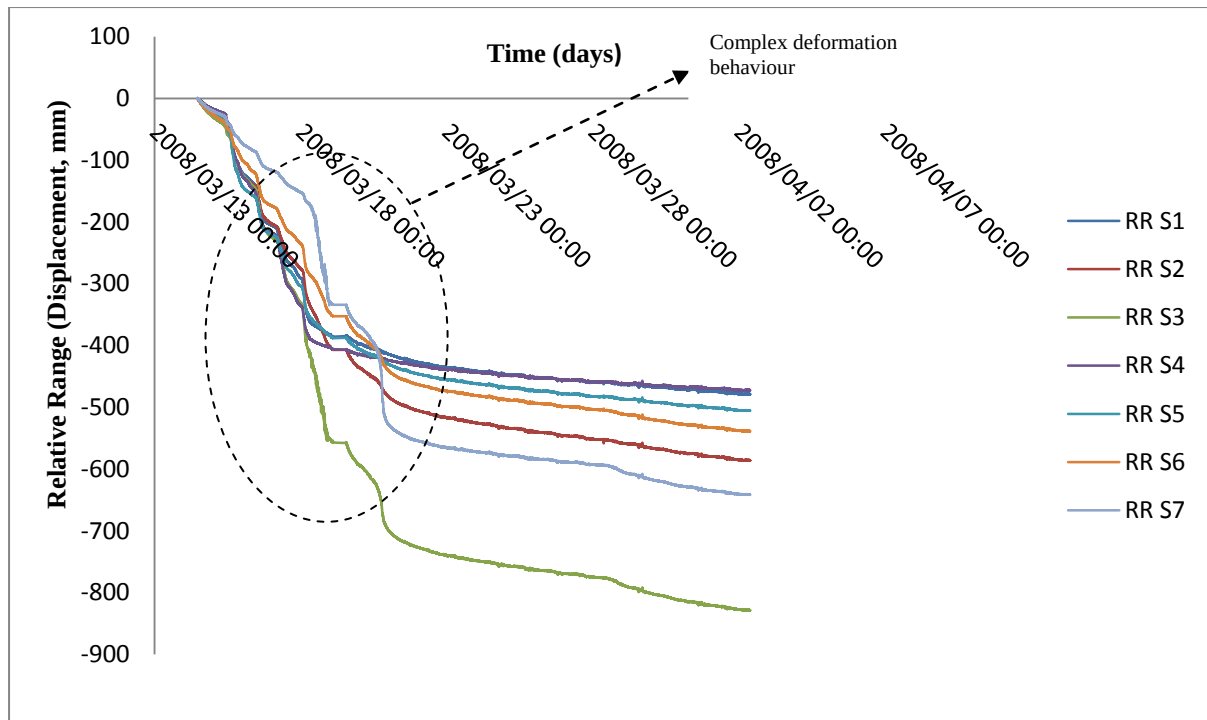
Figure 5.10: Relative range (Displacement, mm) of sections 1-7 of ramp 0 slope.

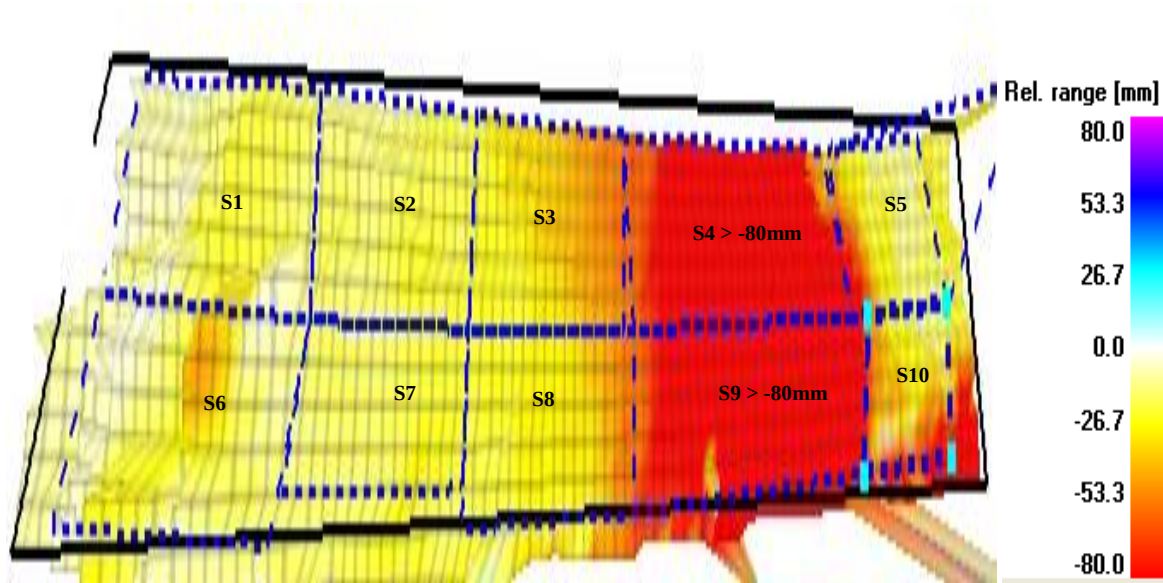
Figure 5.12: The scanned region of ramp 5 slope.

Figure 5.12 shows the division of the scanned area into 10 sections. Analysis of the displacement and cumulative rates of displacement for the sections, as seen in figure 5.13 and 5.14, indicated that failure took place in sections 4 and 9. Displacement at the two sections were greater than -60mm, with cumulative rates of displacement greater than -2mm/hr. The displacement experienced at the other sections were generally less than -25mm, with cumulative rates of displacement less than -1.5mm/hr.

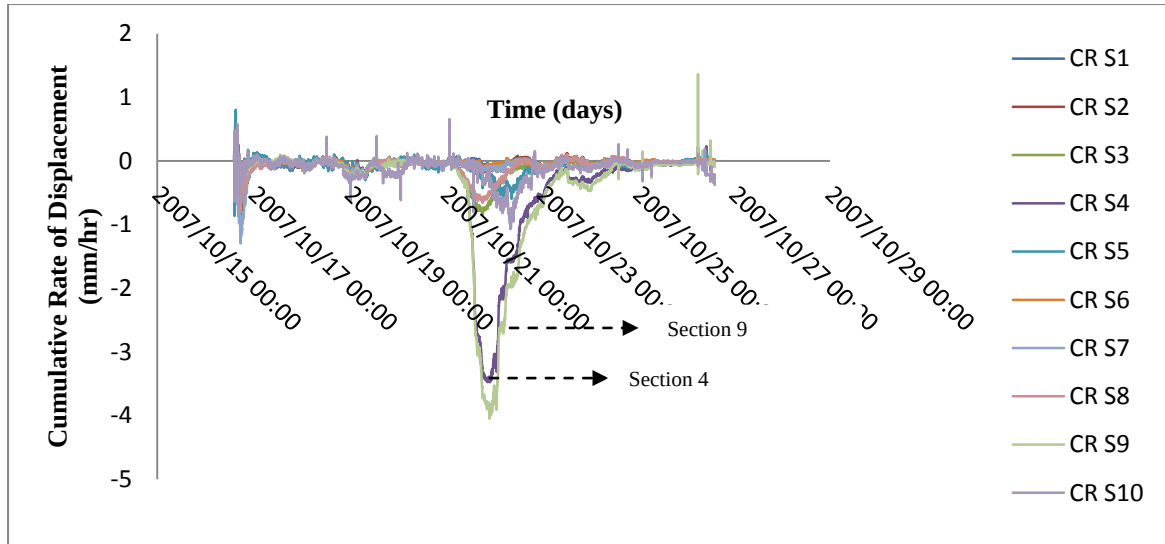
Figure 5.14: Cumulative rate of displacement (mm/hr) of sections 1-10 of ramp 5 slope.

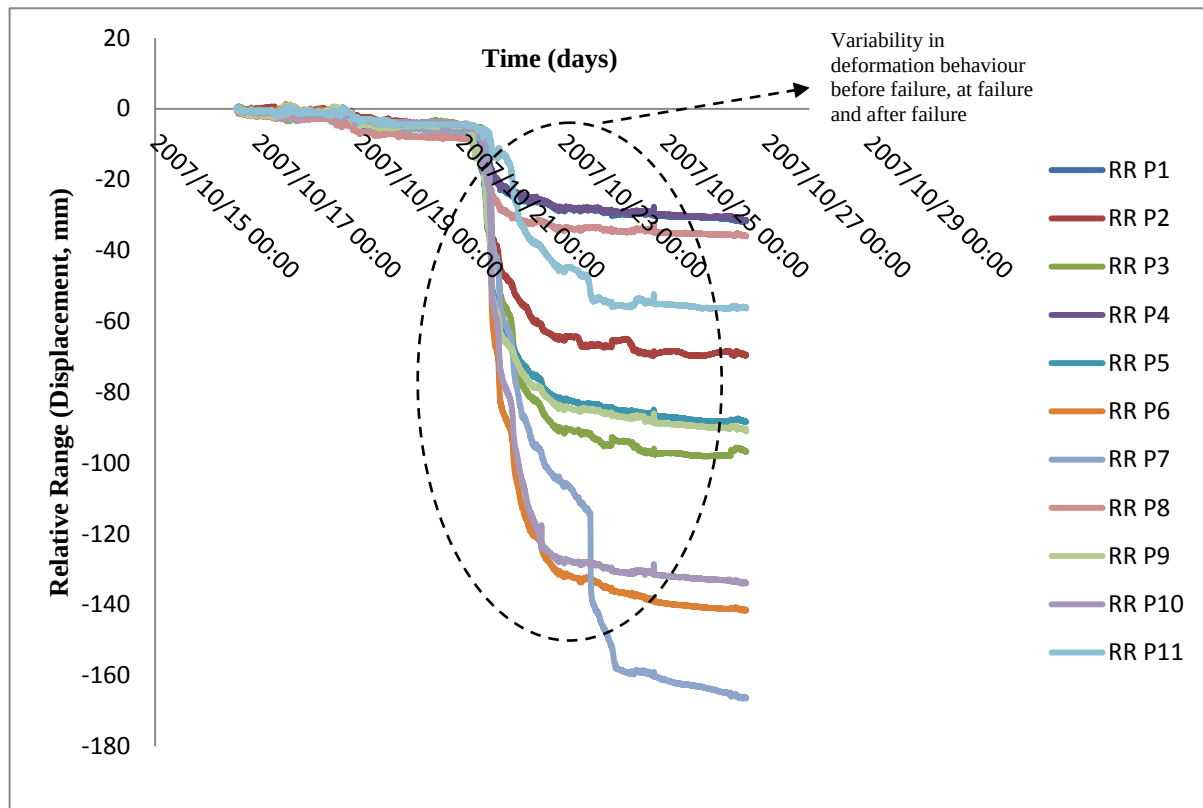
Figure 5.16: Relative range (Displacement, mm) of eleven points in ramp 5 failure region.

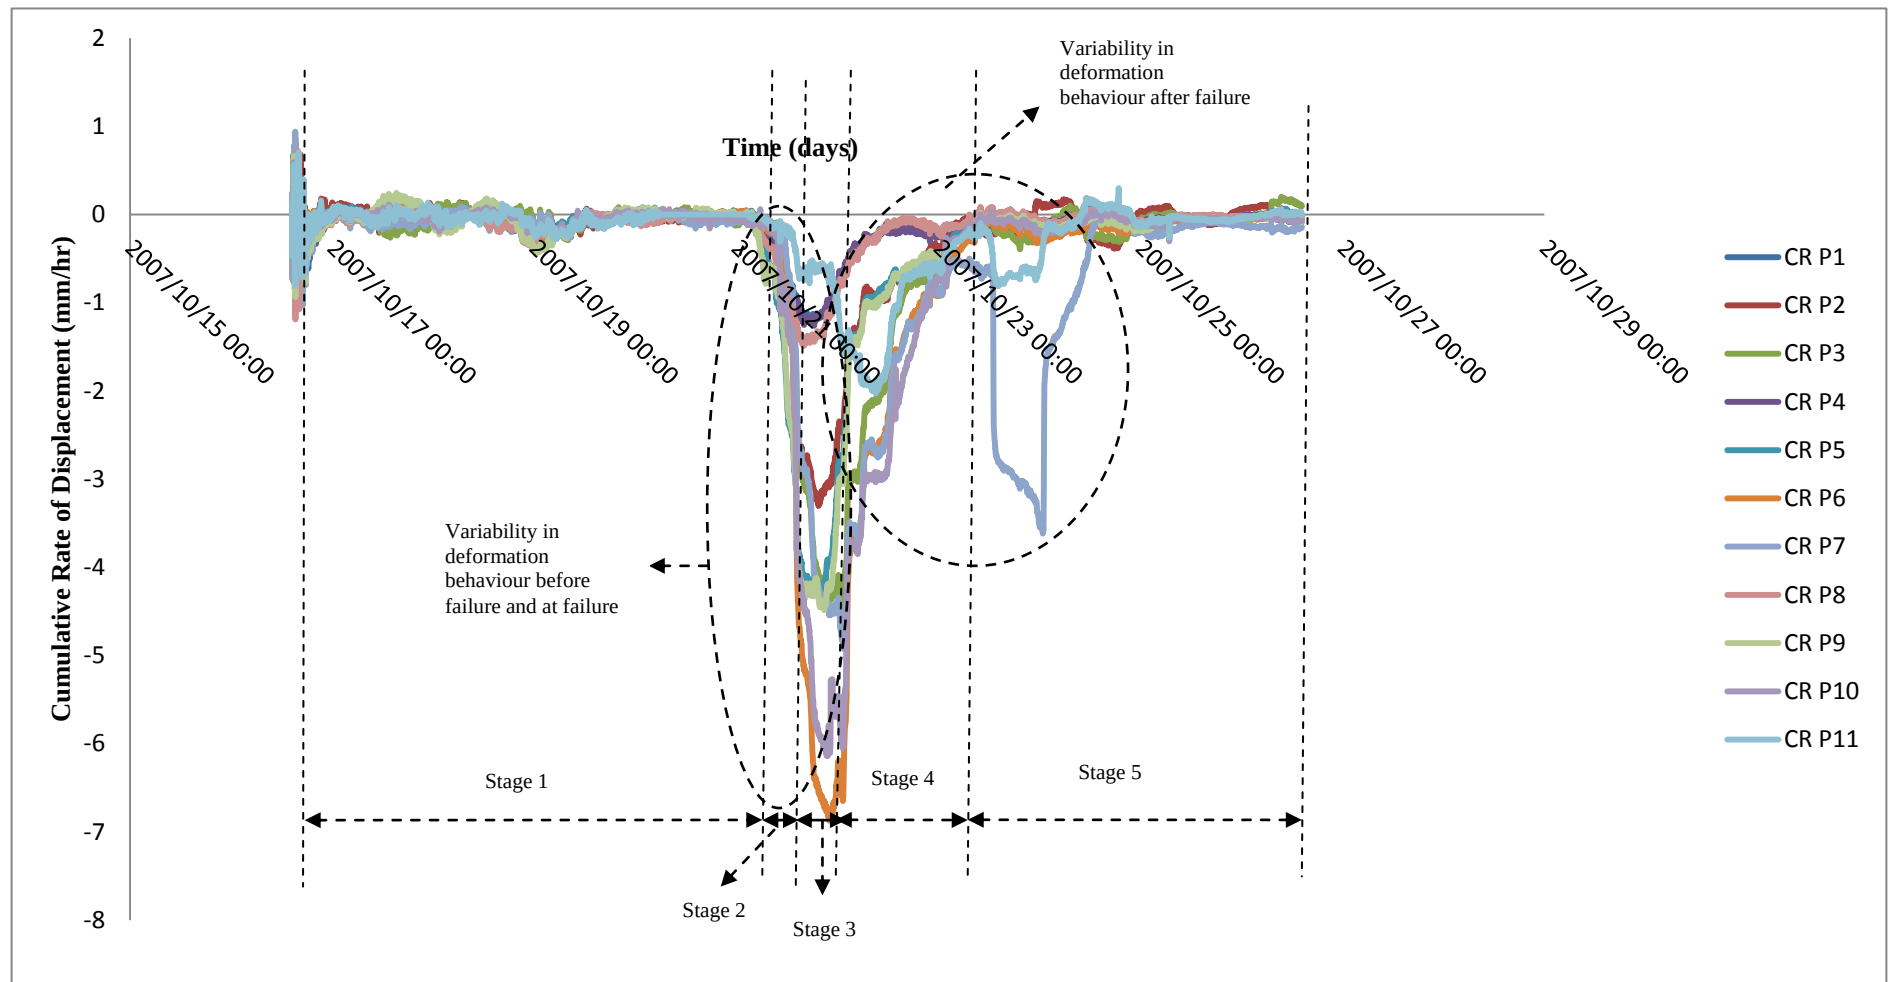
Figure 5.17: Cumulative rate of displacement (mm/hr) of eleven points in ramp 5 failure region.

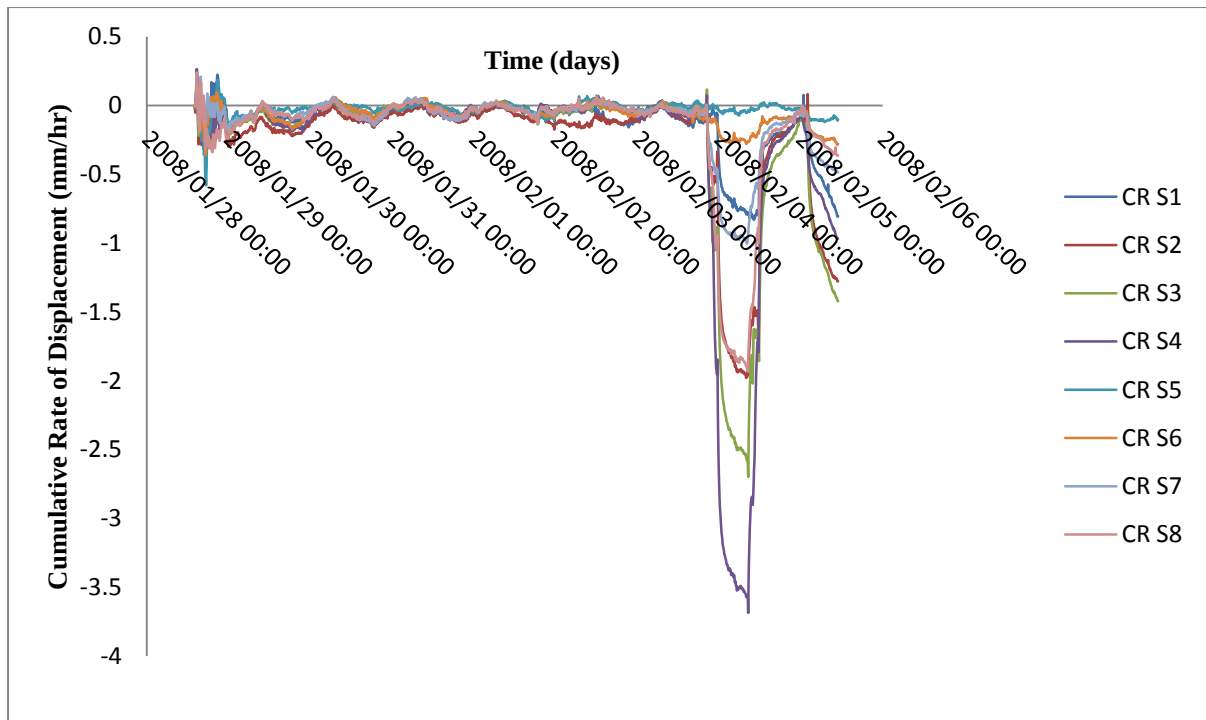
Figure 5.20: Cumulative rate of displacement (mm/hr) of sections 1-8 of ramp 11 slope.

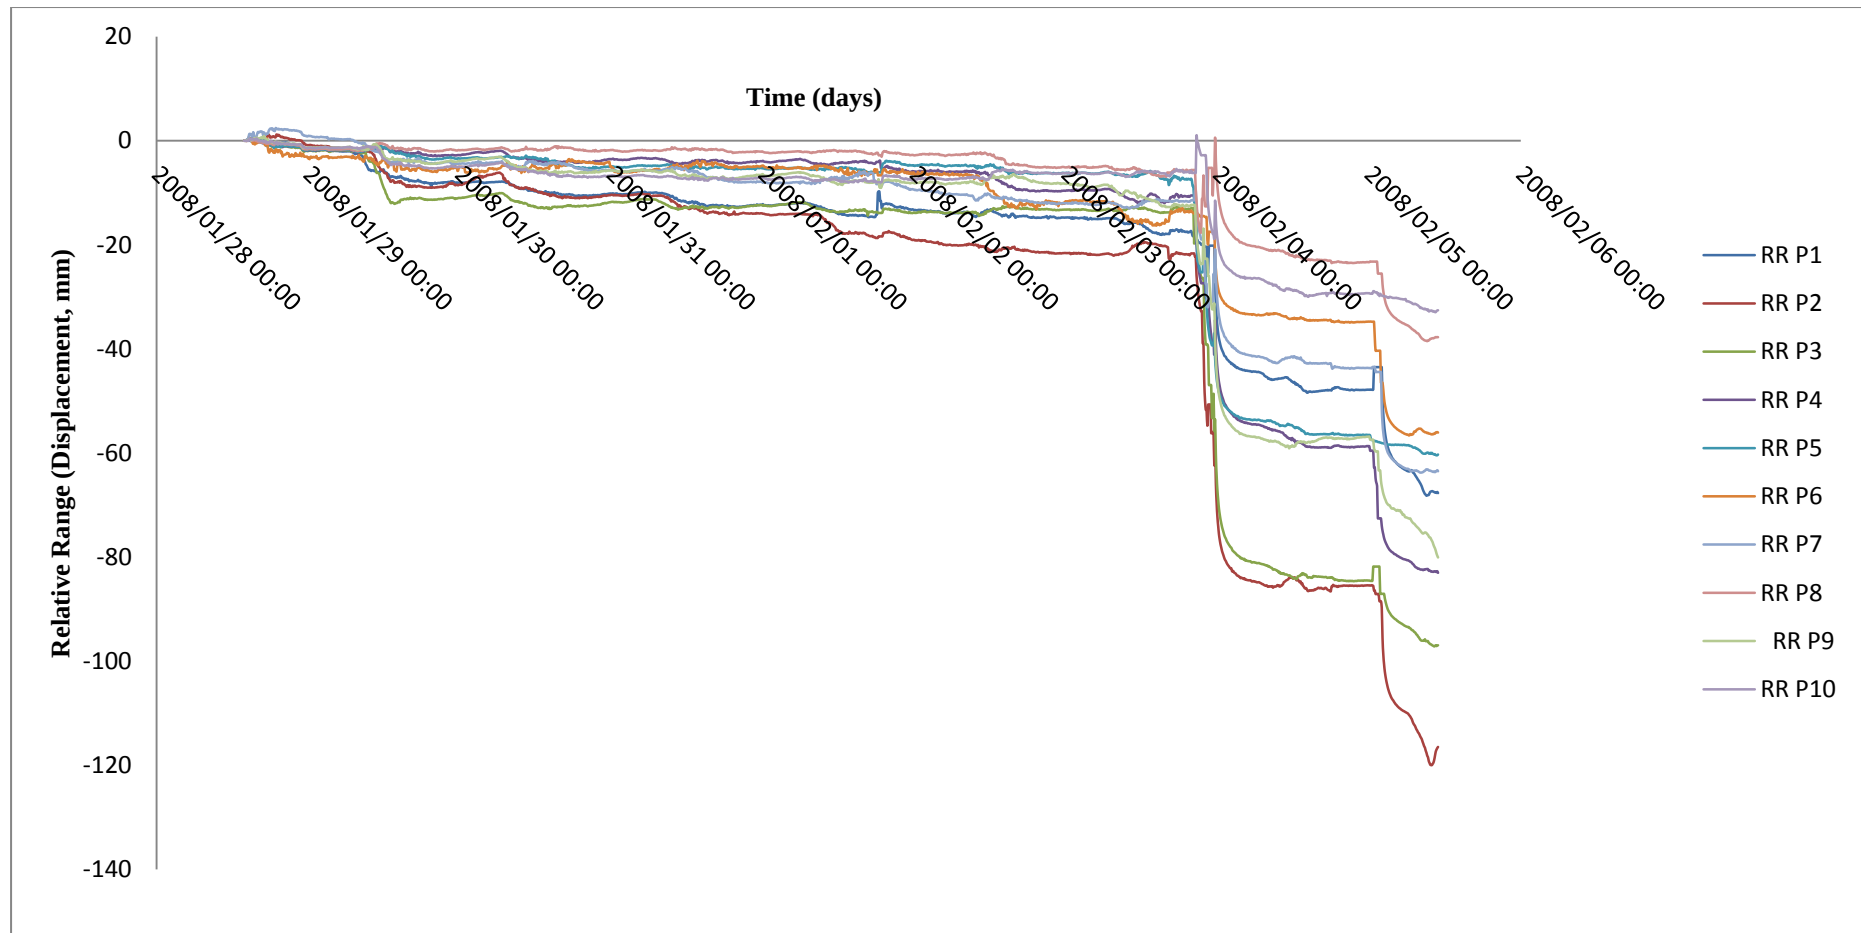
Figure 5.22: Relative range (Displacement, mm) of 10 points in ramp 11 failure sections.

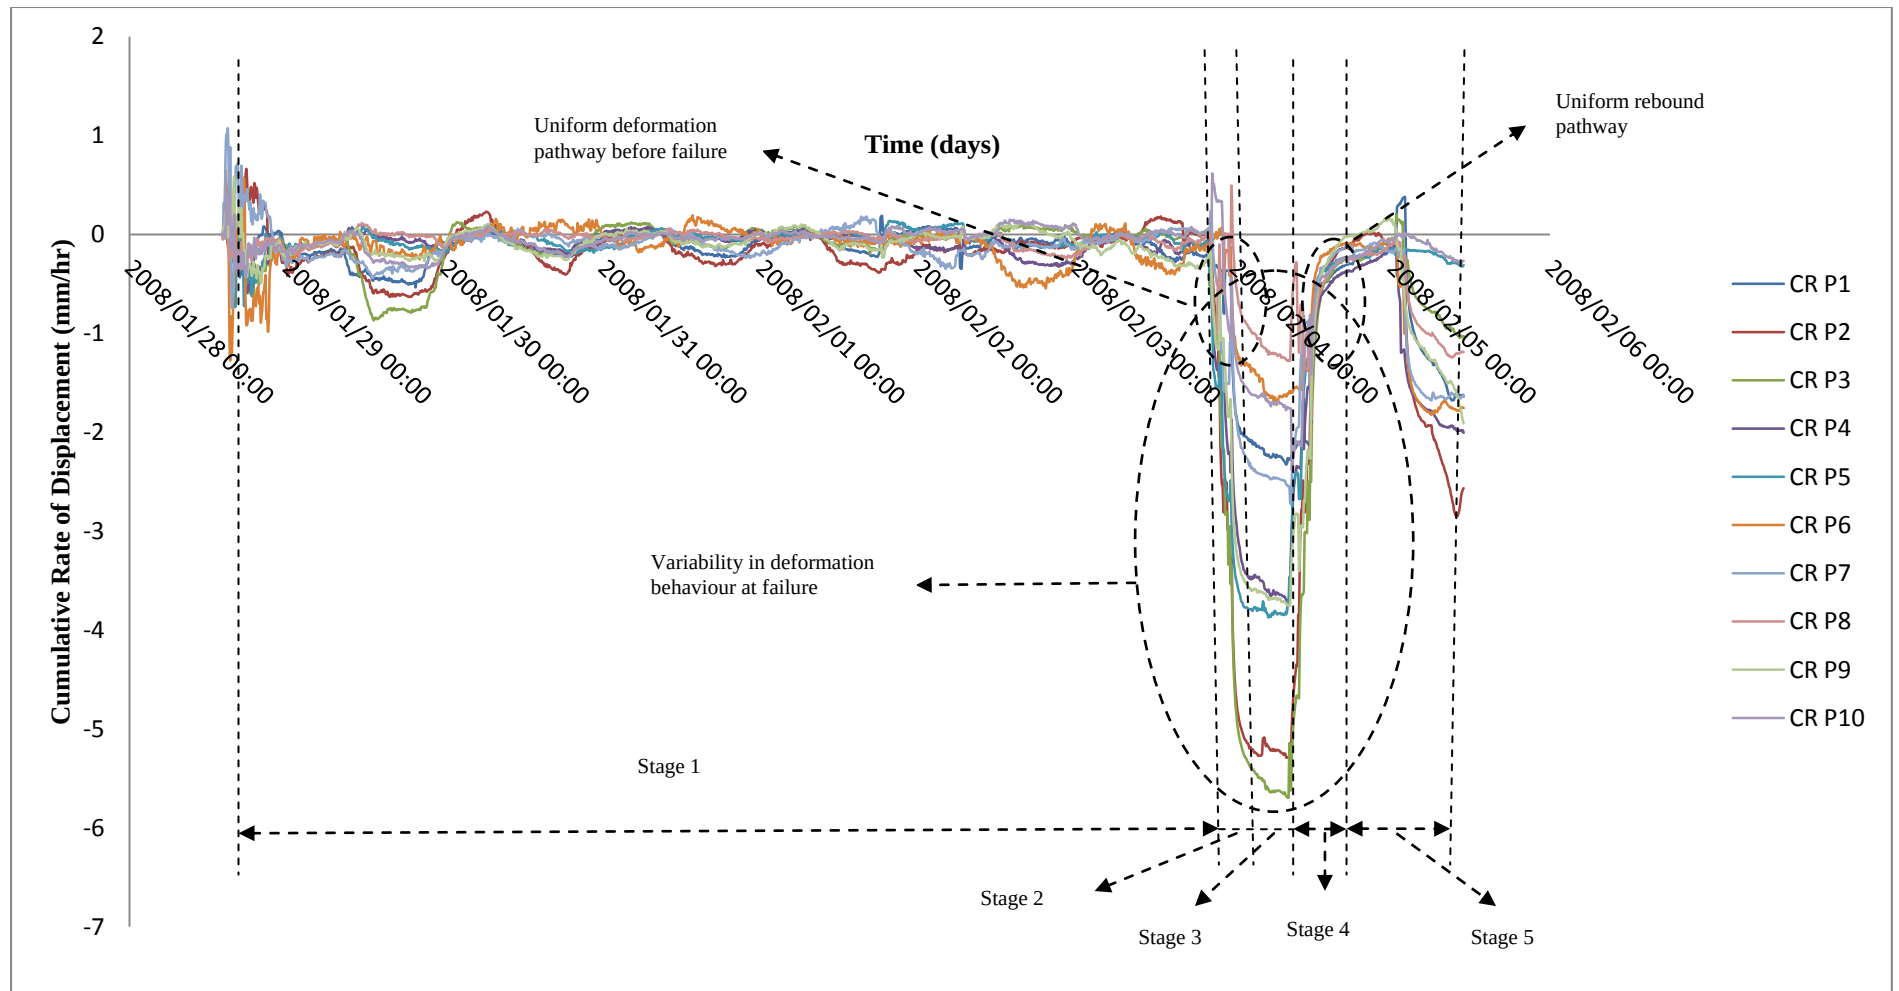
Figure 5.23: Cumulative rate of displacement (mm/hr) of 10 points in ramp 11 failure sections.

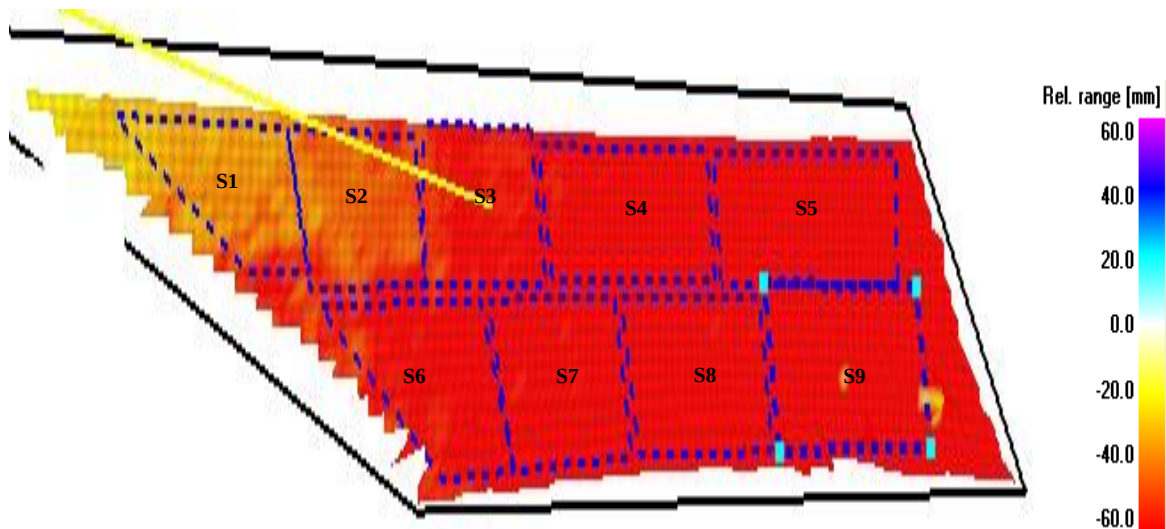
Figure 5.24: The scanned region of ramp 12 slope.

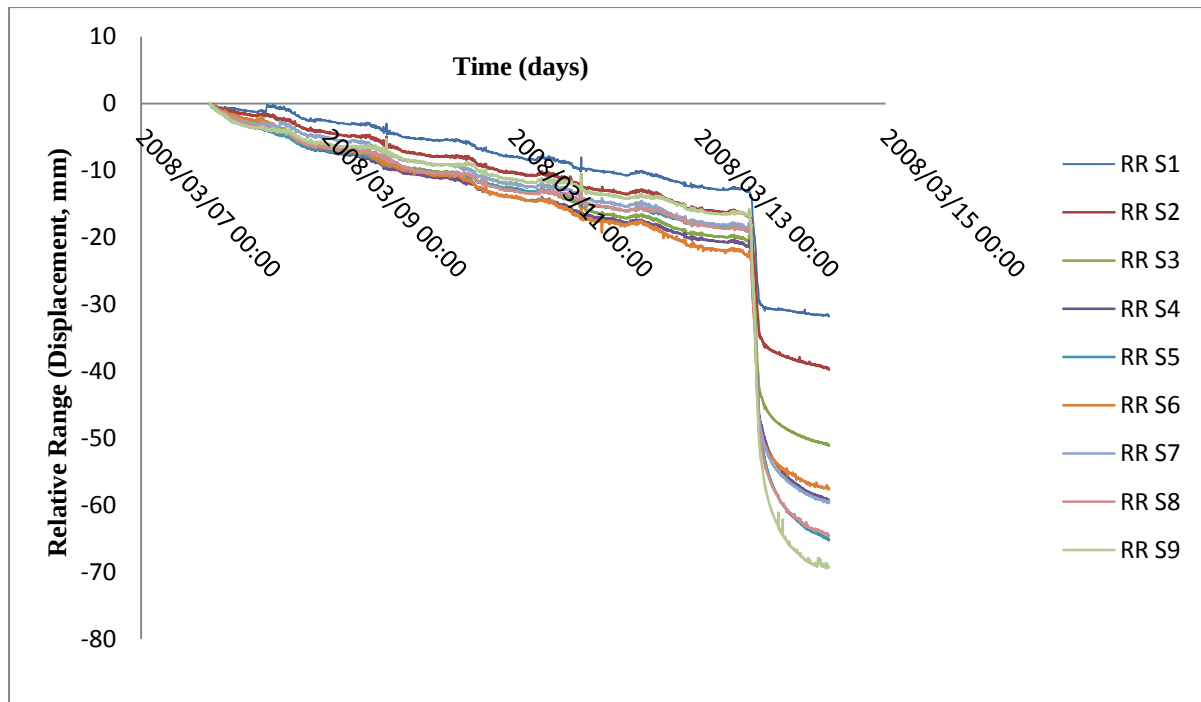
Figure 5.25: Relative range (Displacement, mm) of sections 1-9 of ramp 12 slope.

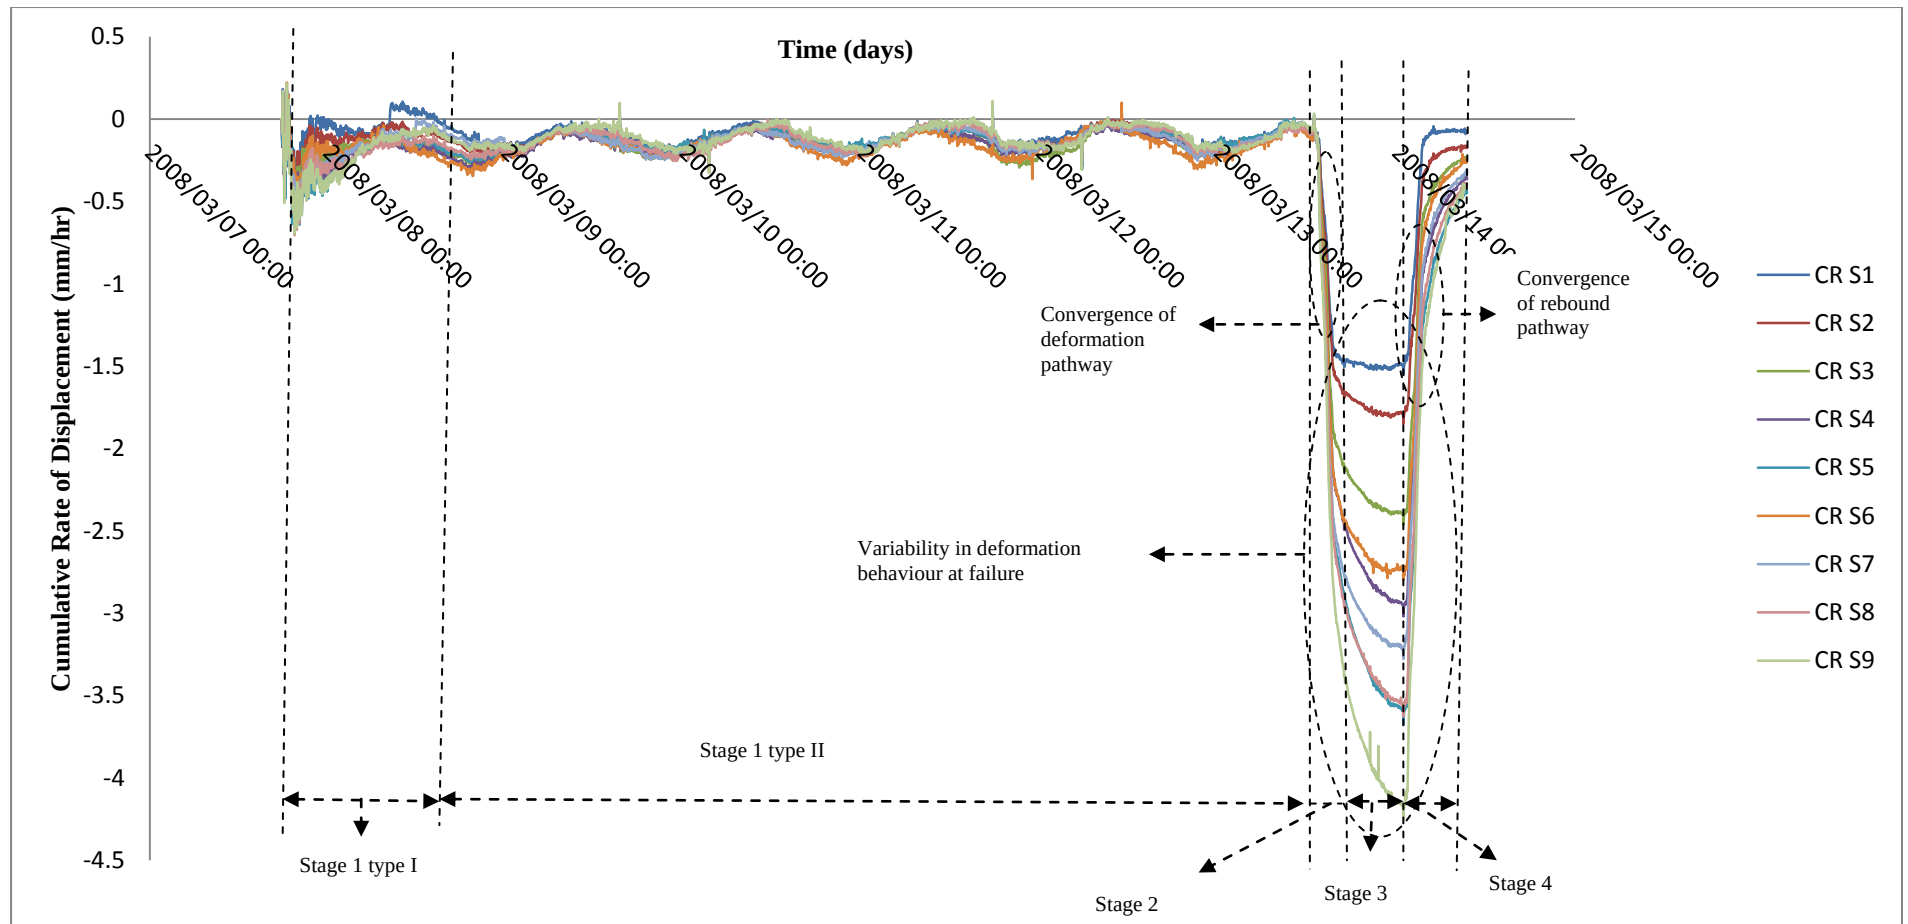
Figure 5.26: Cumulative rate of displacement (mm/hr) of sections 1-9 of ramp 12 slope.

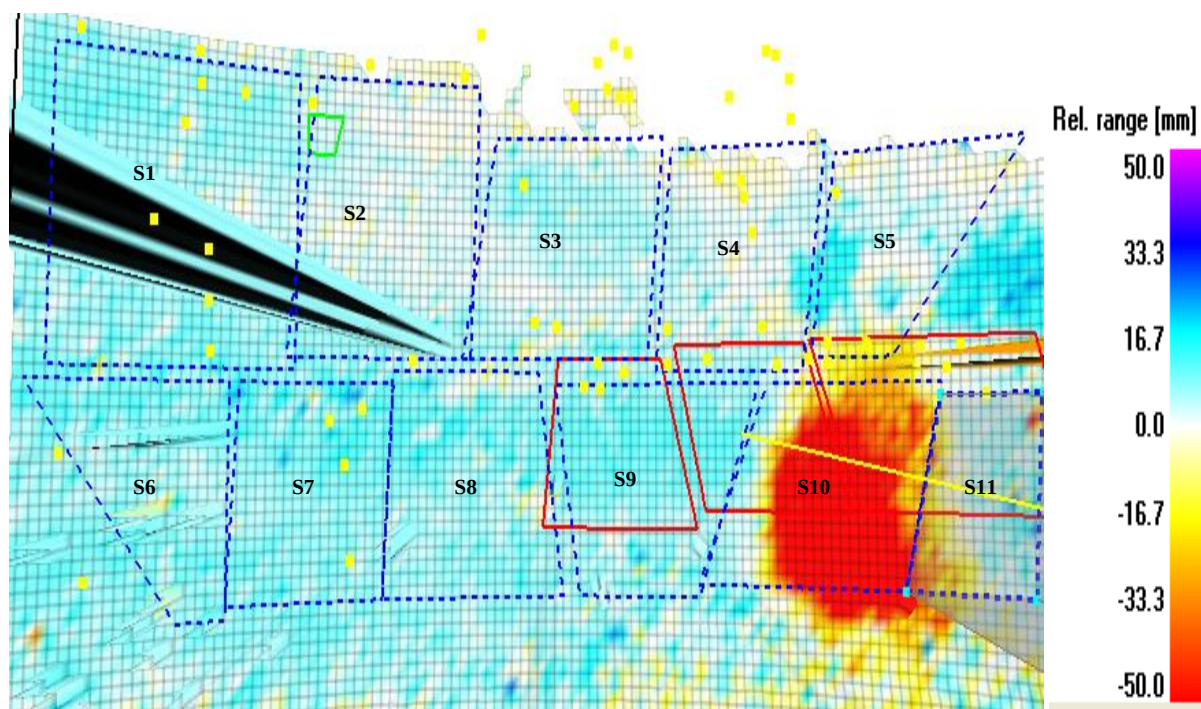
Figure 5.27: The scanned region of case example 6 slope.

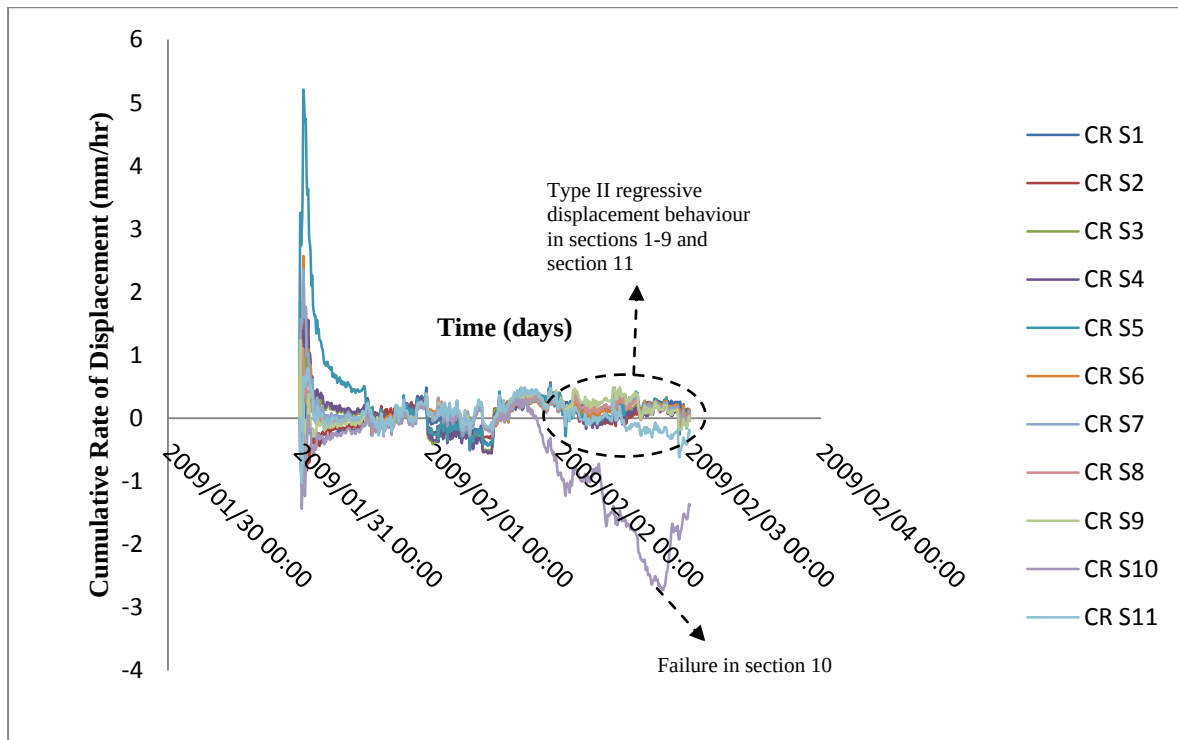
Figure 5.29: Cumulative rate of displacement (mm/hr) of sections 1-11 of case example 6.

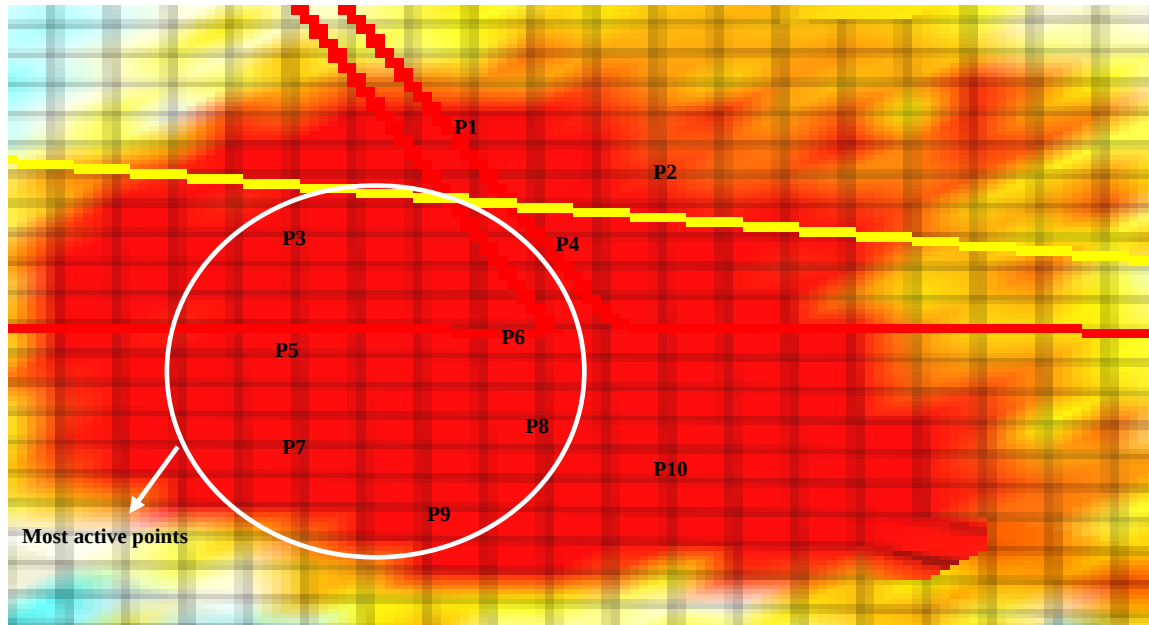
Figure 5.30: Failure section of case example 6 showing the locations of ten selected points.

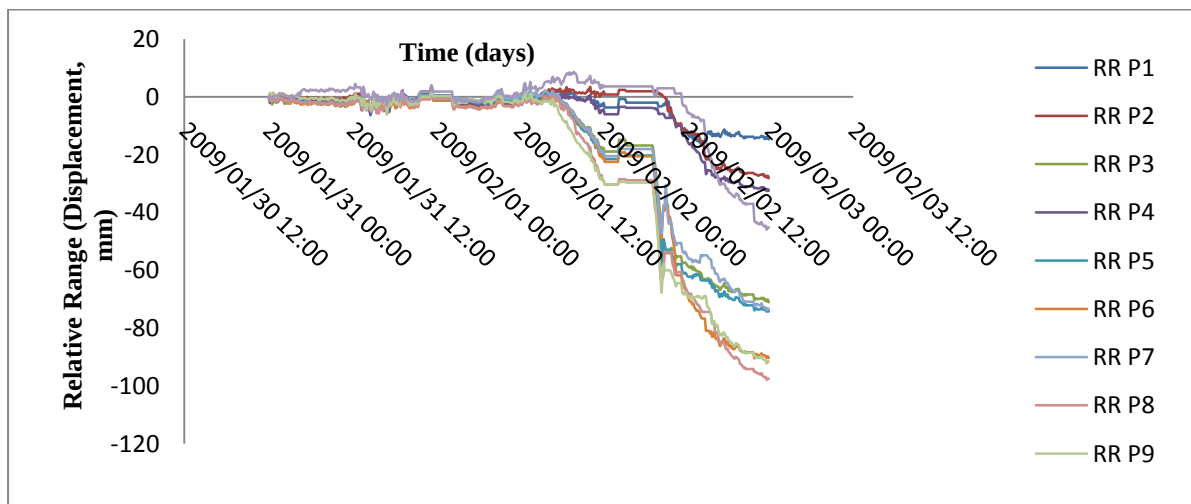
Figure 5.31: Relative range (Displacement, mm) of 10 points in the failure section of case example 6.

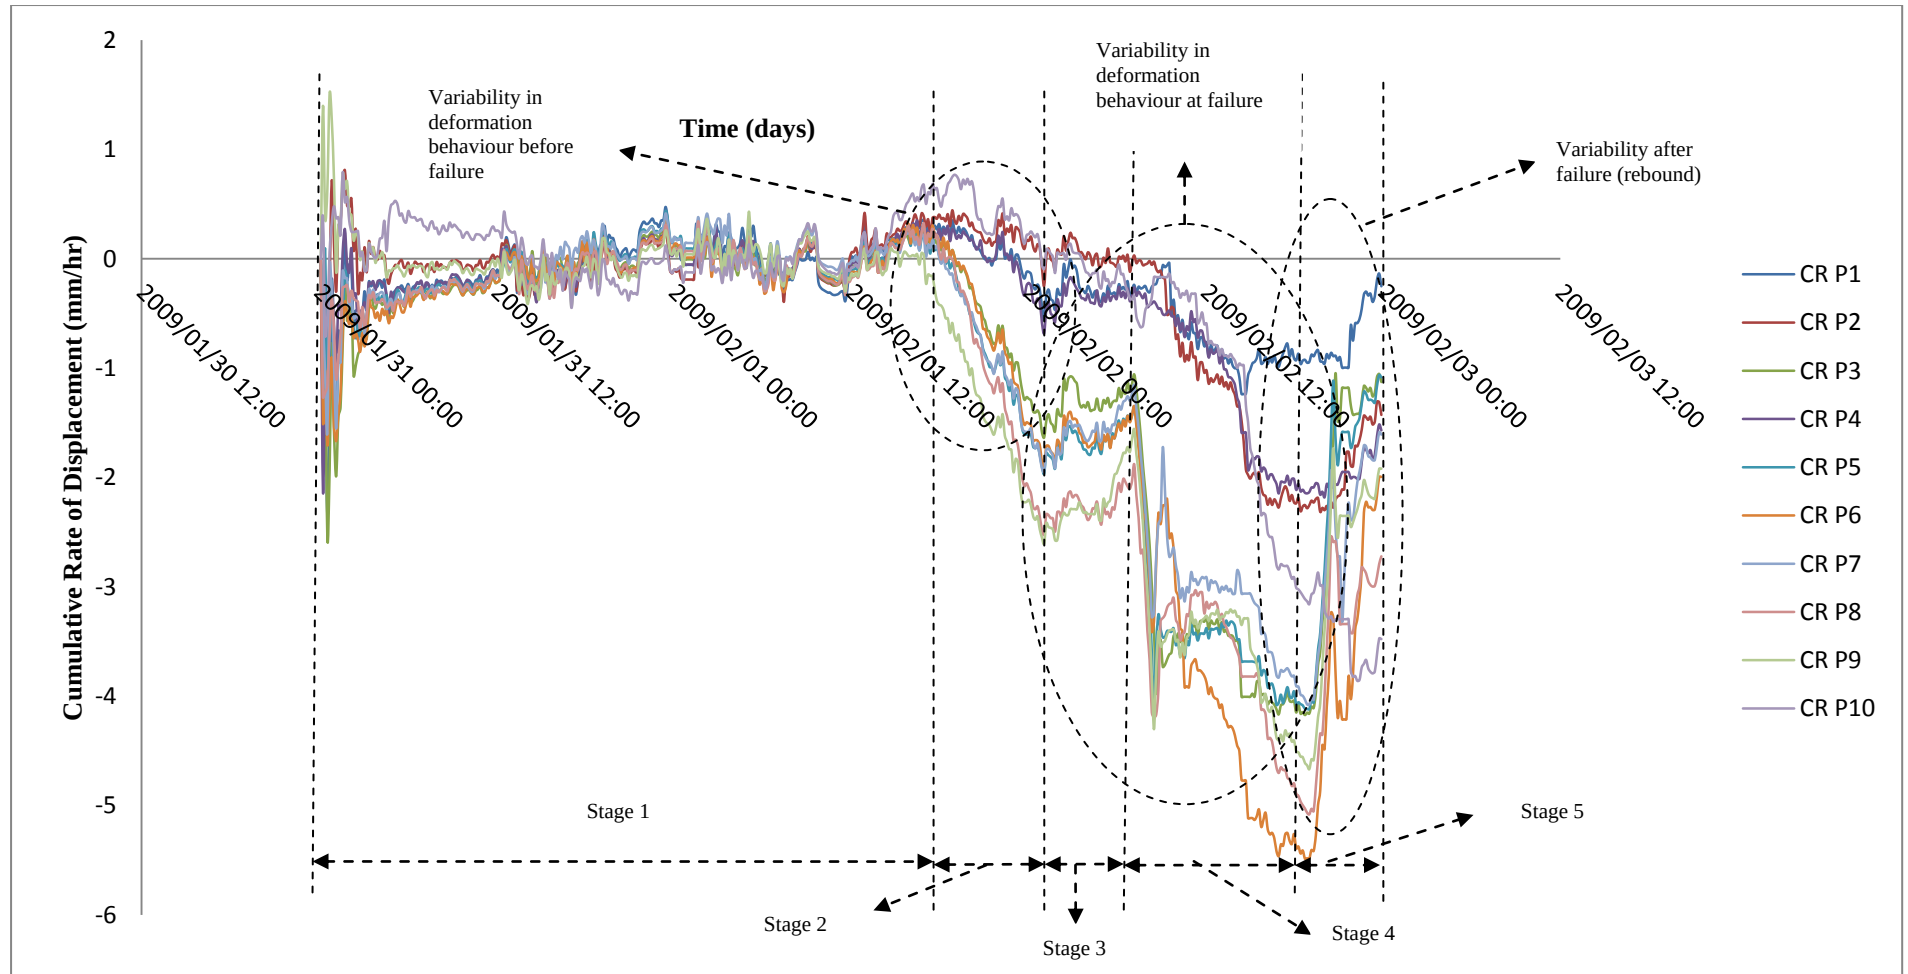
Figure 5.32: Cumulative rate of displacement (mm/hr) of 10 points in the failure section of case example 6.

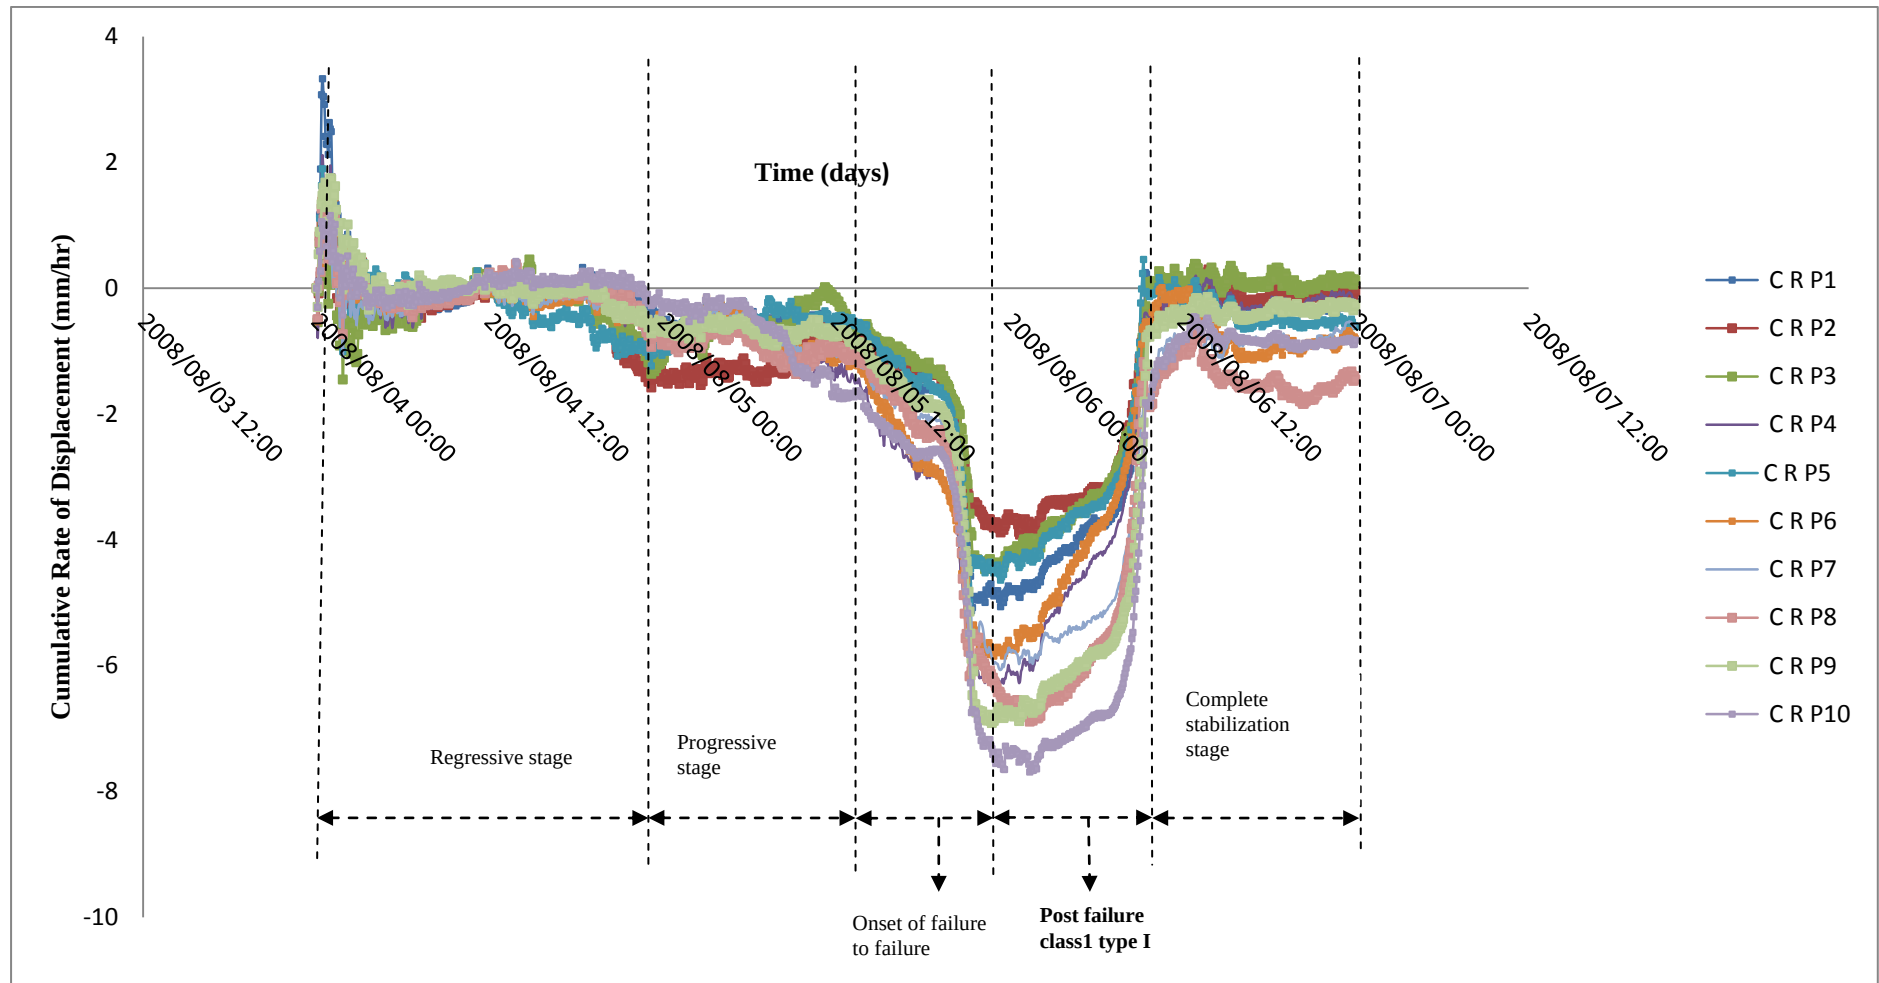
Figure 5.33: Post-failure class 1 type I displacement behaviour.

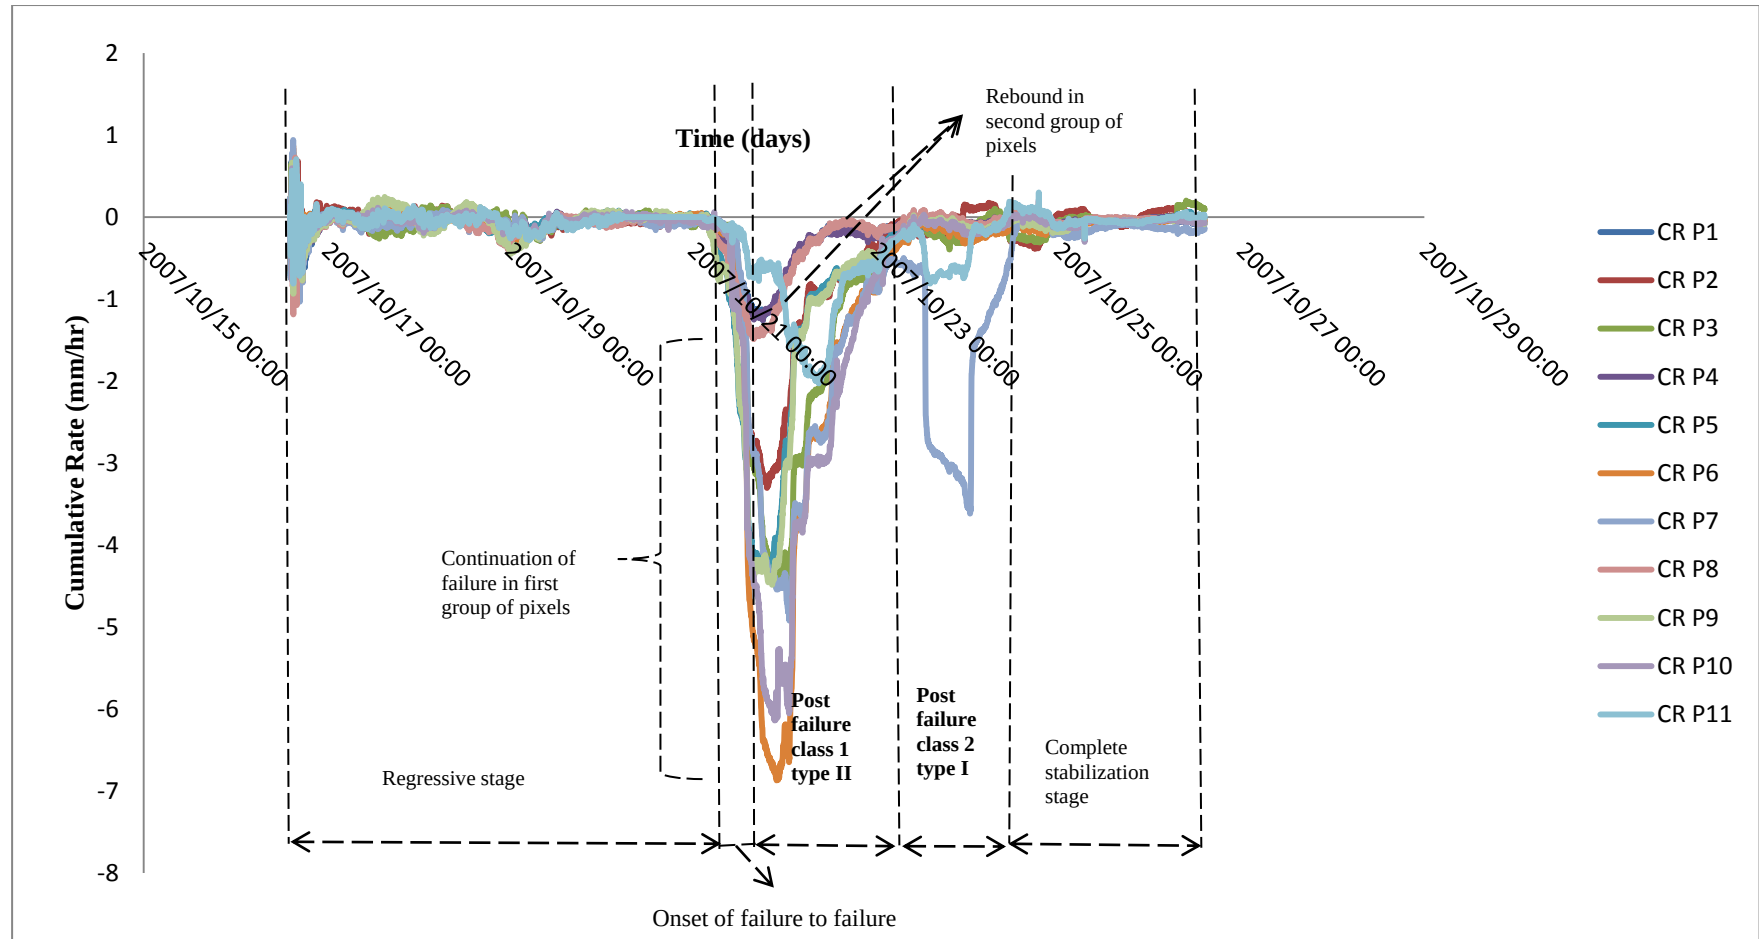
Figure 5.34: Post-failure class 1 type II and class 2 type I displacement behaviour.
