**OPEN-CAST MINE SLOPE DEFORMATION AND FAILURE MECHANISMS  
INTERPRETED FROM SLOPE RADAR MONITORING**

A thesis submitted to the Faculty of Engineering and the Built Environment, University of the Witwatersrand, Johannesburg, in fulfilment of the requirements for the degree of Doctor of Philosophy.

Johannesburg, 2012

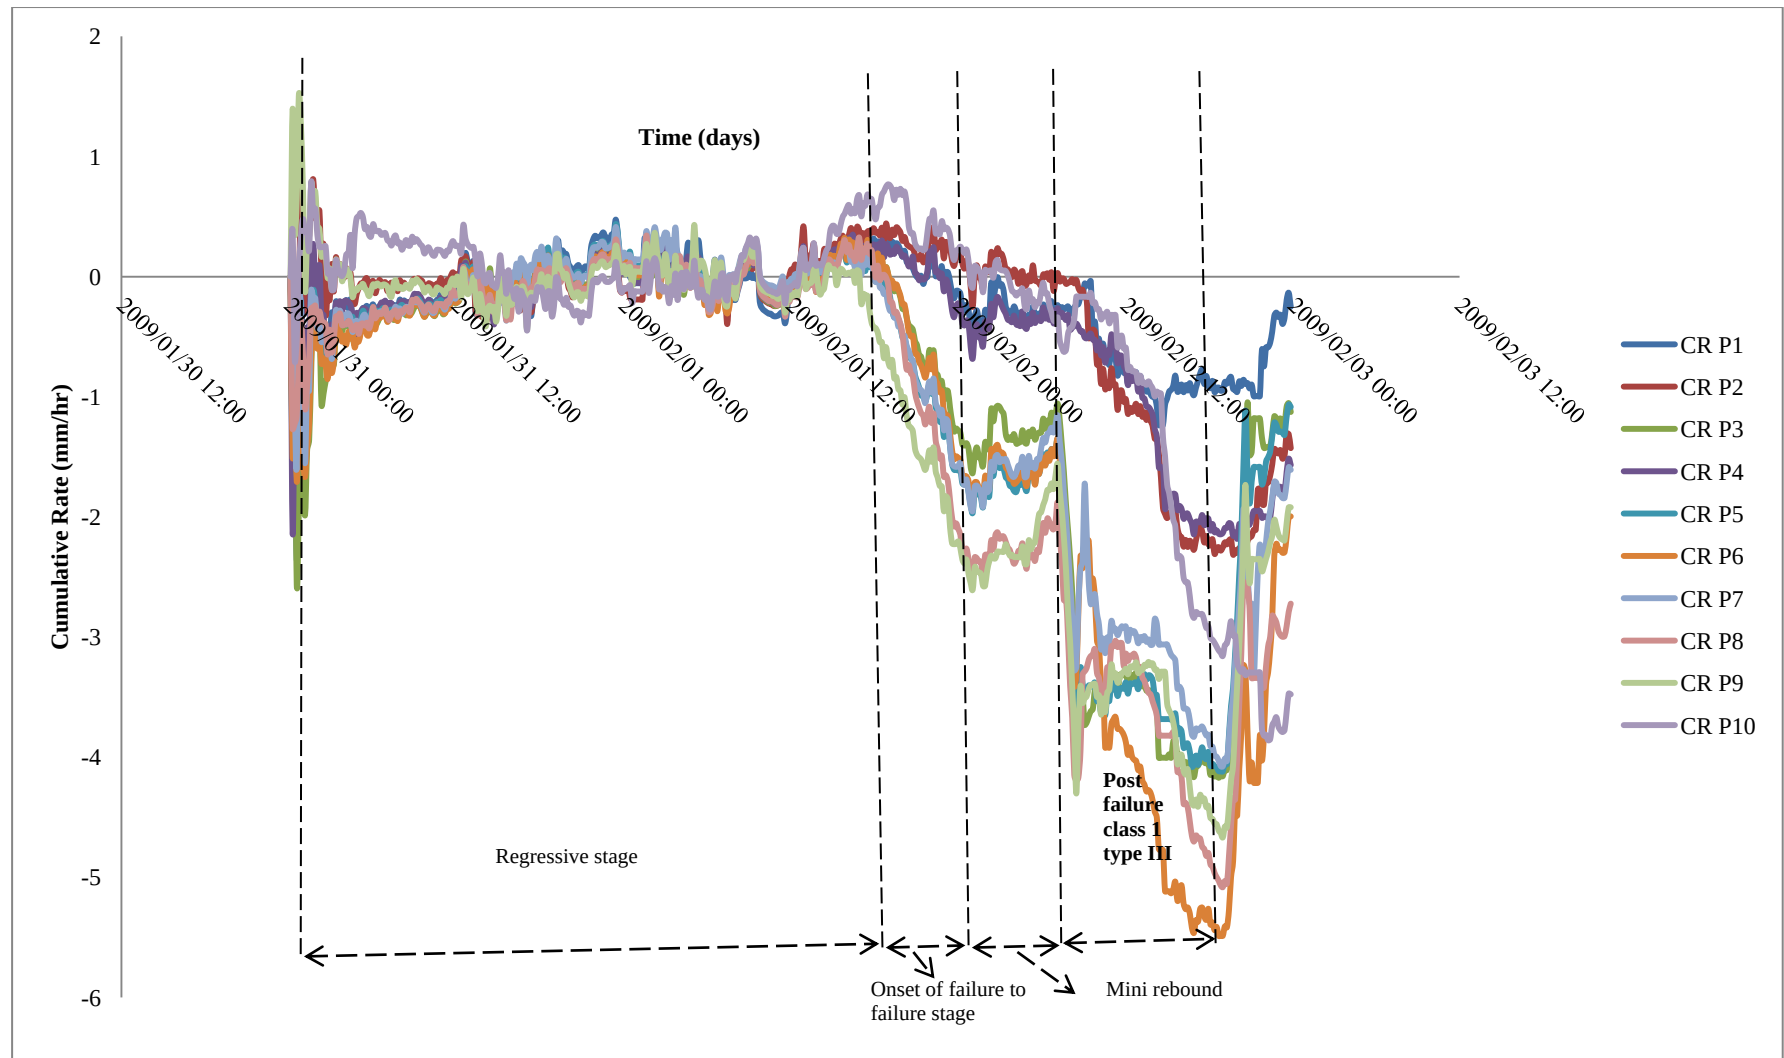
Figure 5.35: Post-failure class 1 type III displacement behaviour.

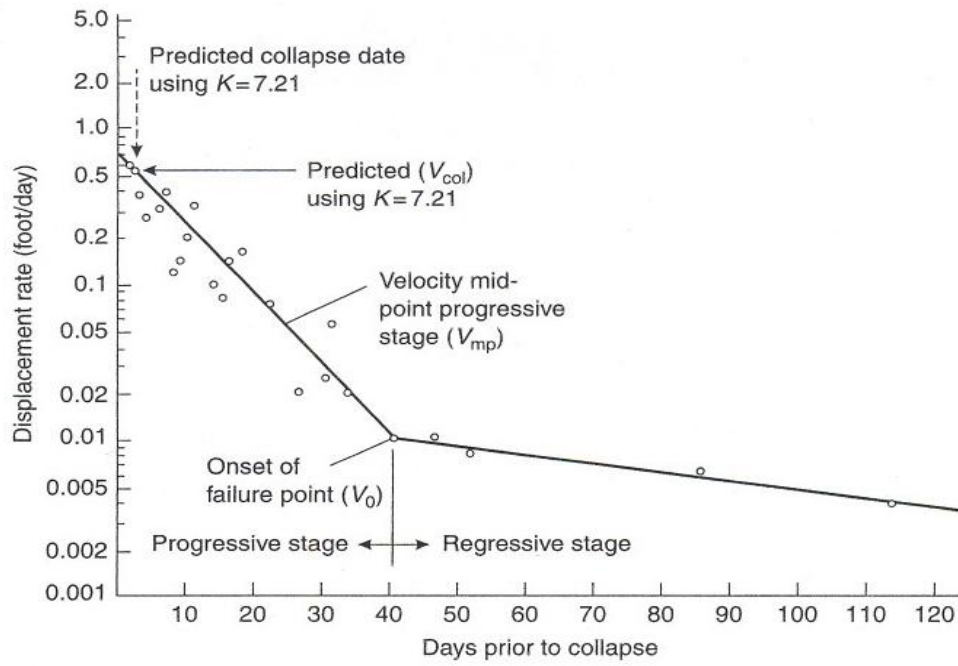
Figure 6.1: Displacement rate curve and failure collapse prediction (After Zavodni and Broadbent, 1980).

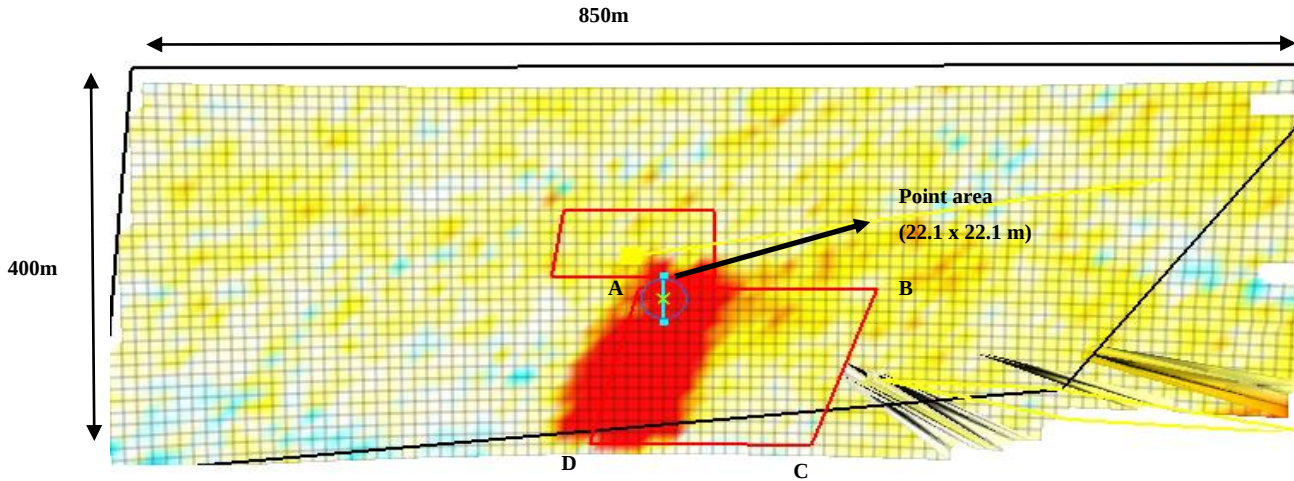
Figure 6.3: Point area monitoring with the MSR (Area ABCD, AB = 133m, BC = 75m).

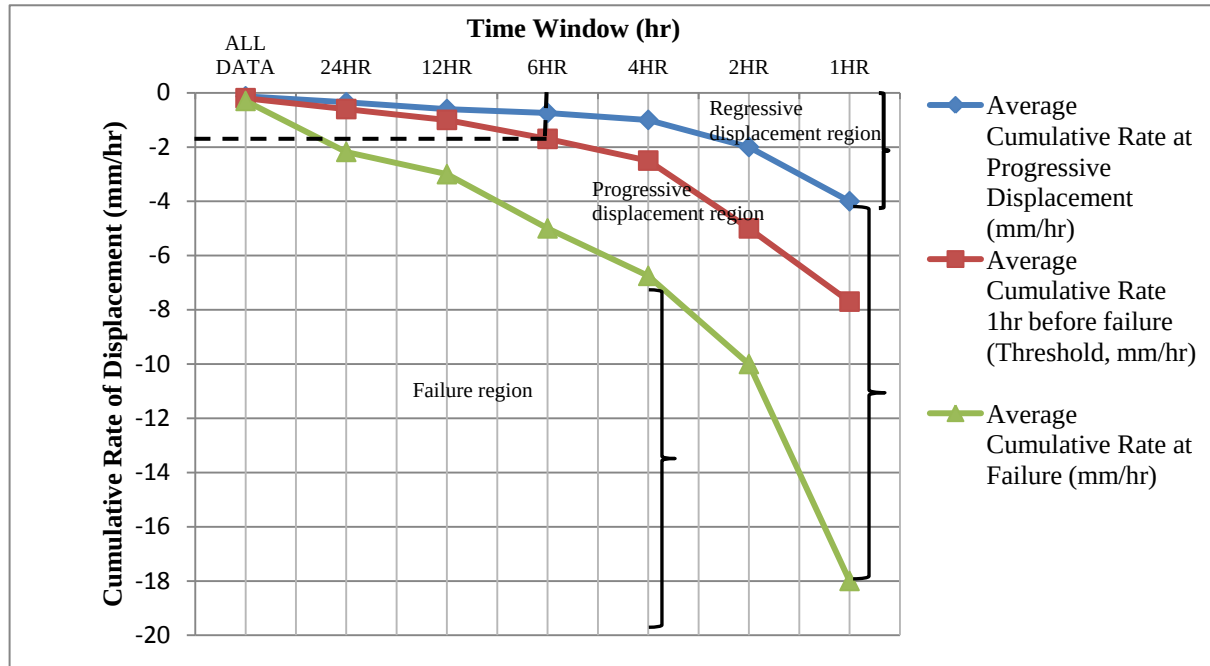
Figure 6.4: Cumulative rate of displacement (mm/hr) threshold determination based on point monitoring for the New Vaal coal mine.

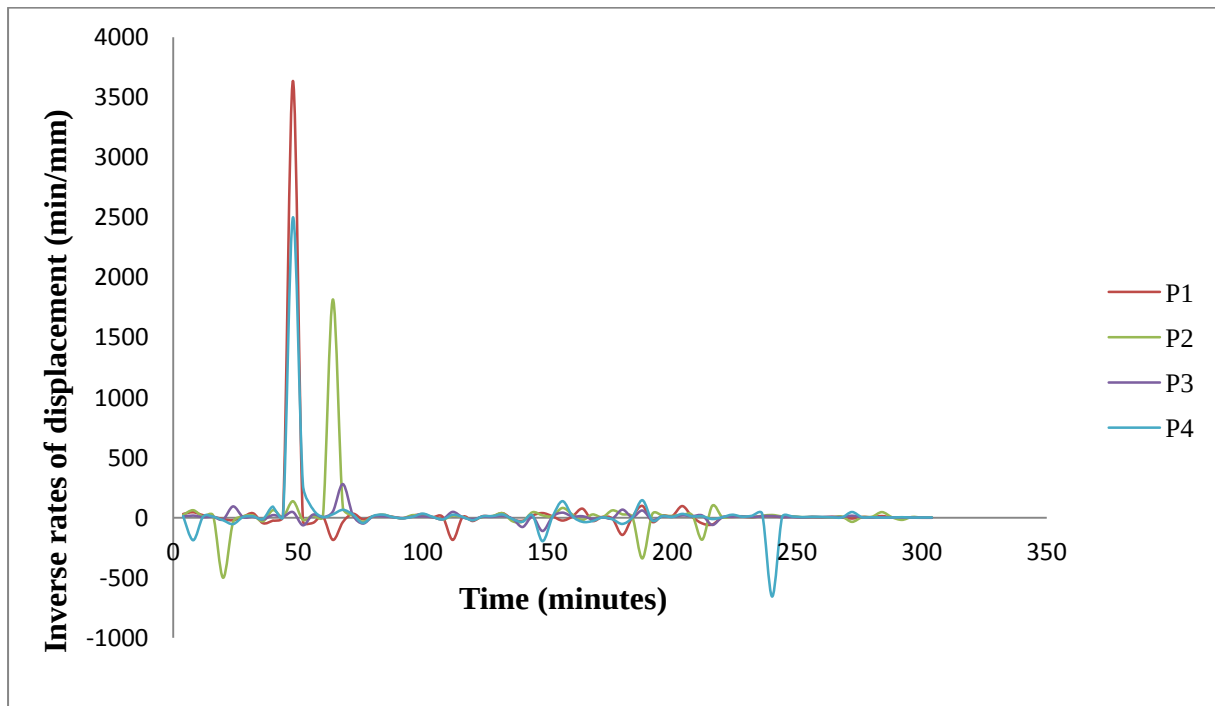
Figure 6.5: Inverse rates of displacement at 1 data interval (4 minutes).

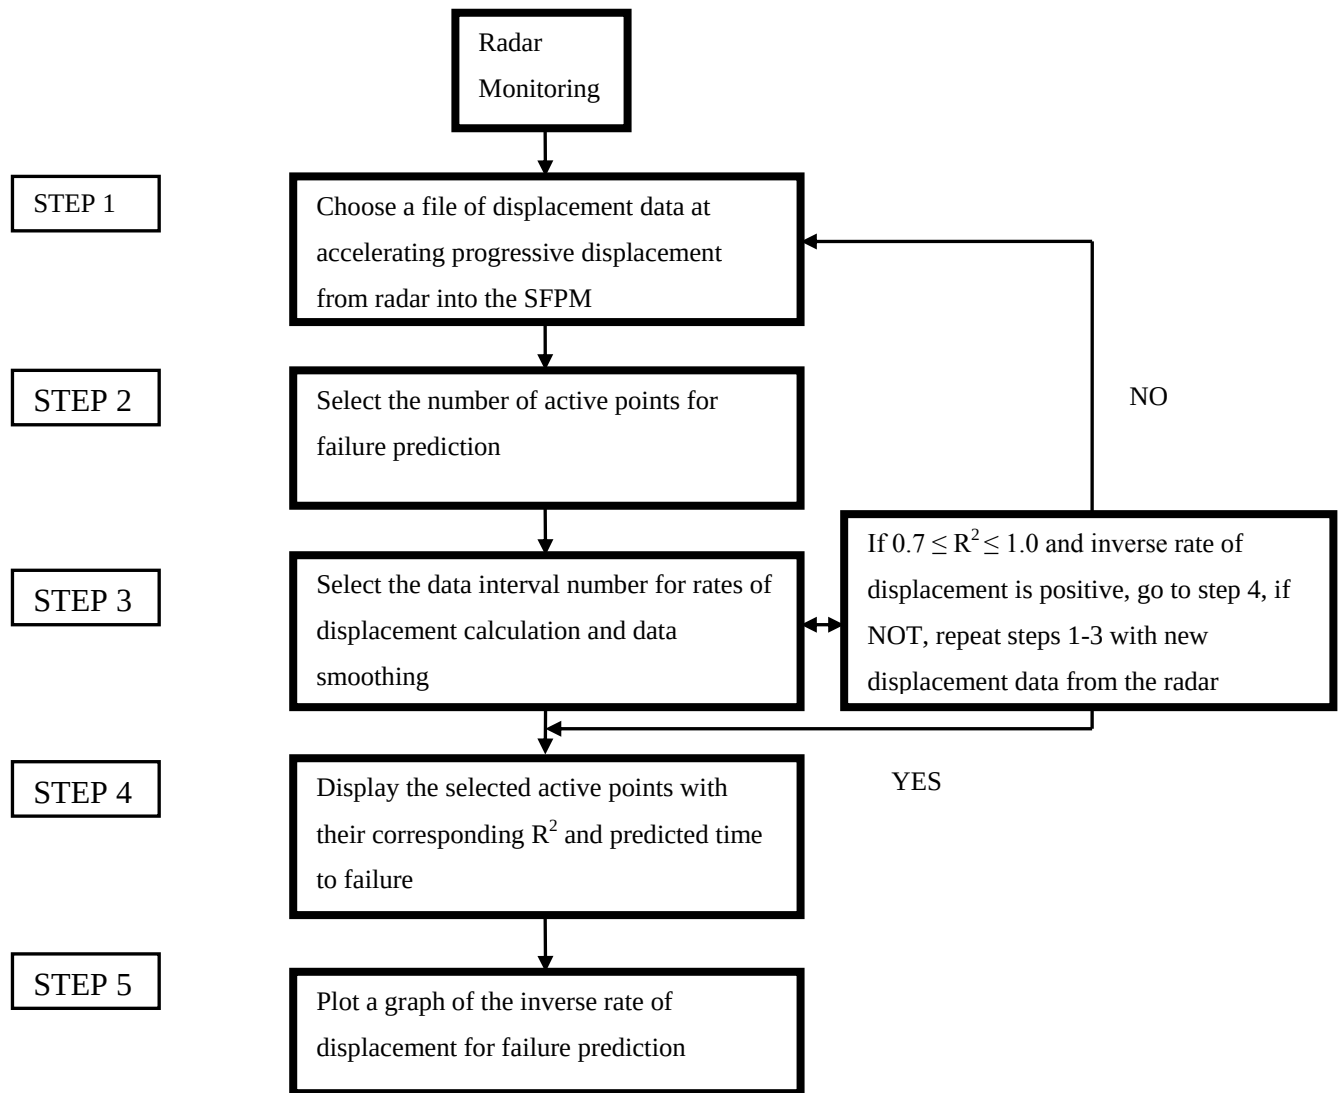
Figure 6.14: SFPM flow chart.

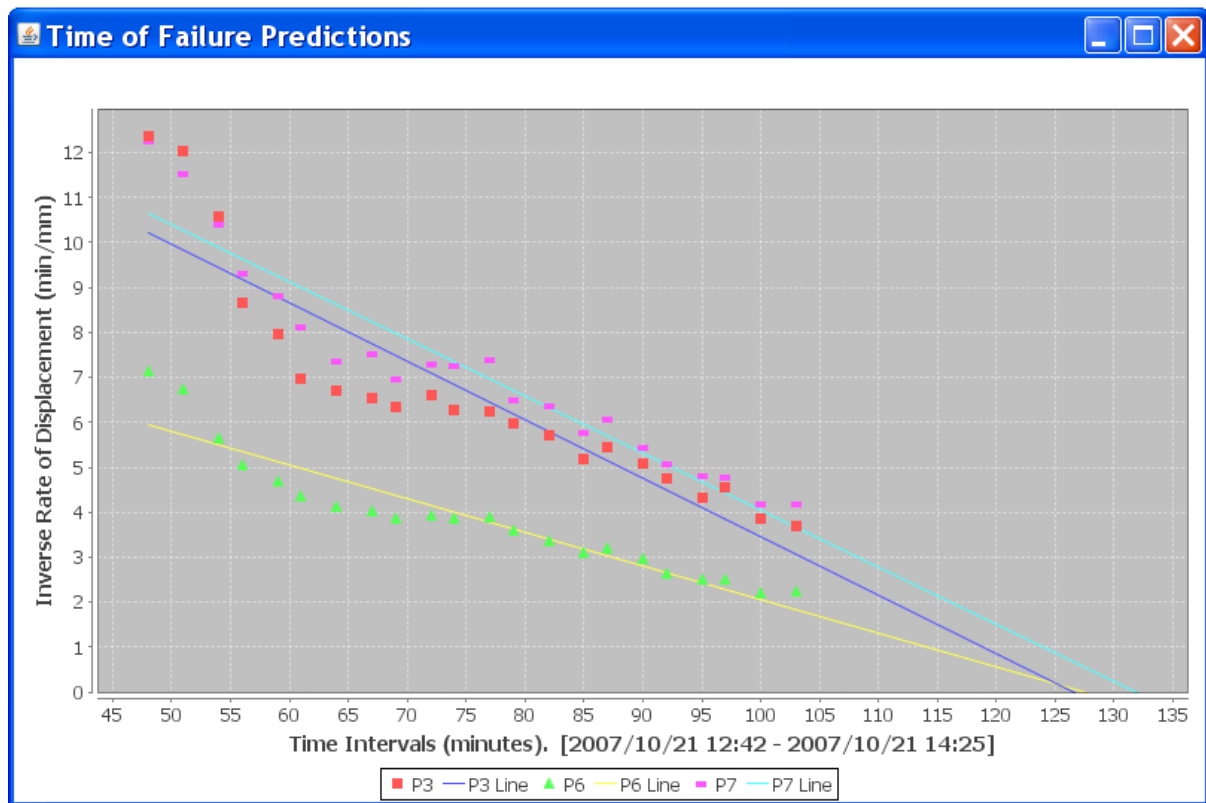
Figure 6.17: Graphical illustration of predictions from the active points.

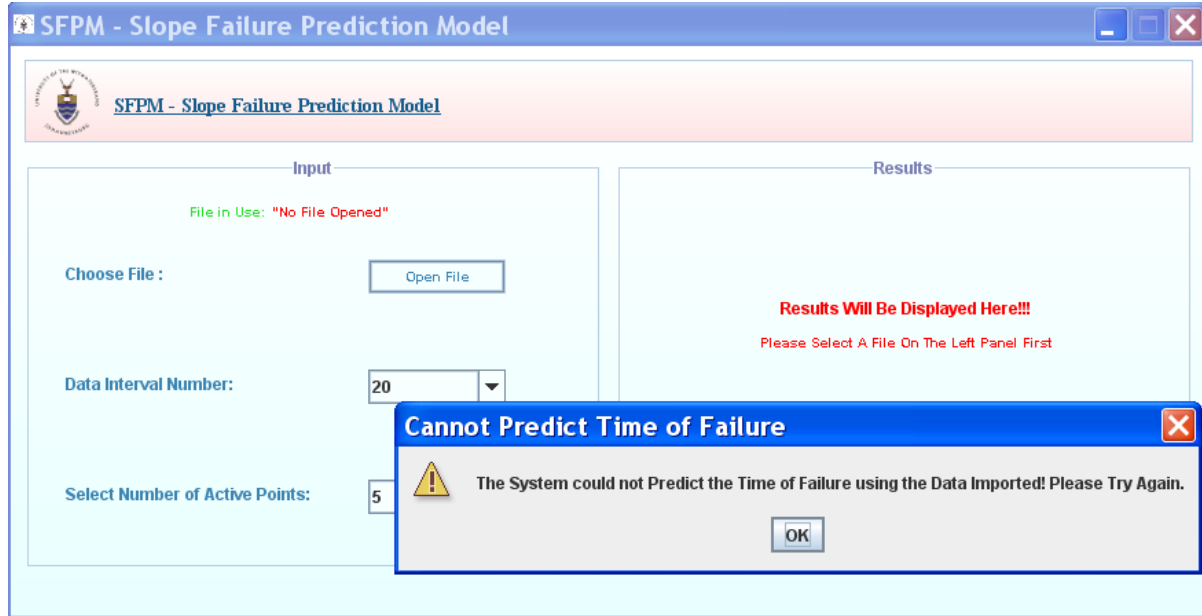
Figure 6.18: Failed first prediction of validation test 1.

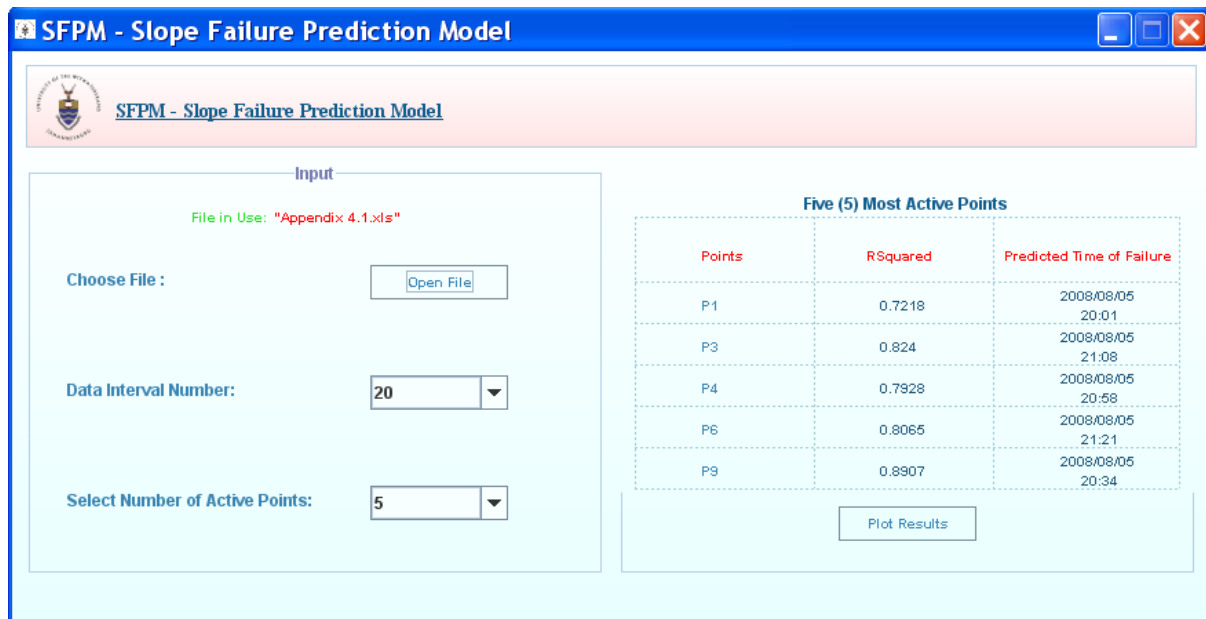
Figure 6.19: Second prediction of validation test 1.

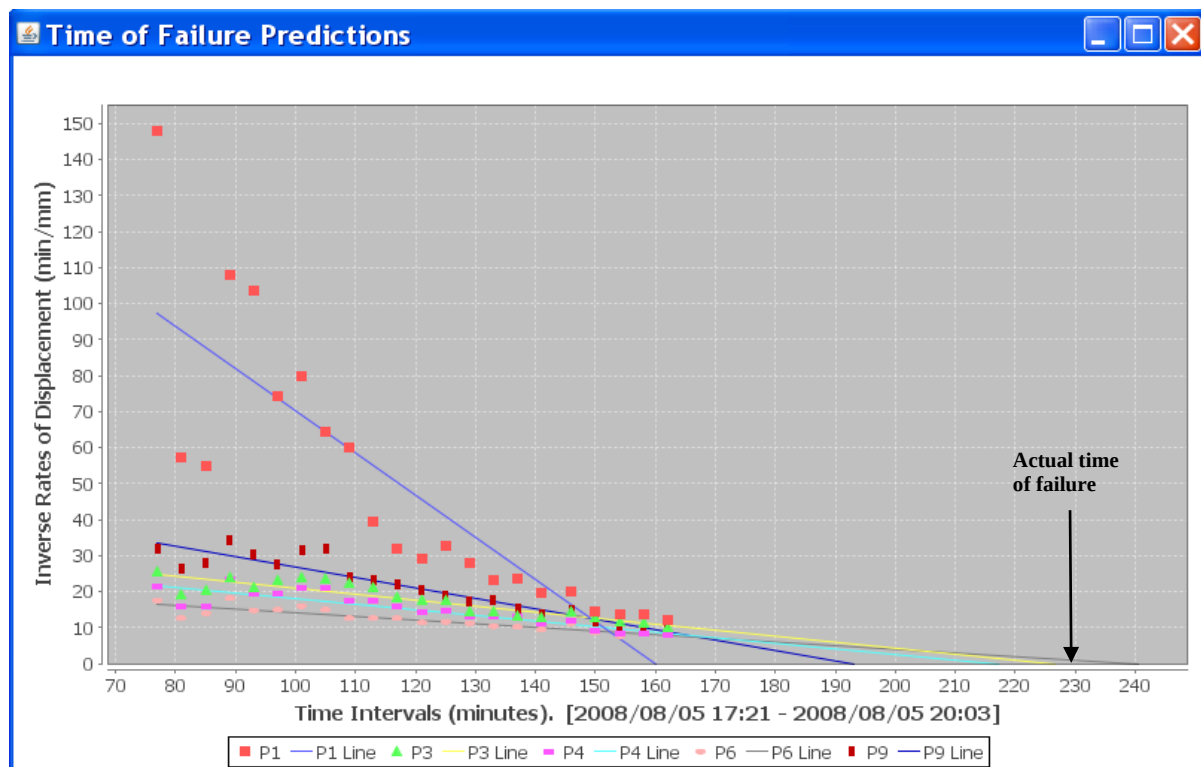
Figure 6.20: Graphical illustration of the five most active points of validation test 1.

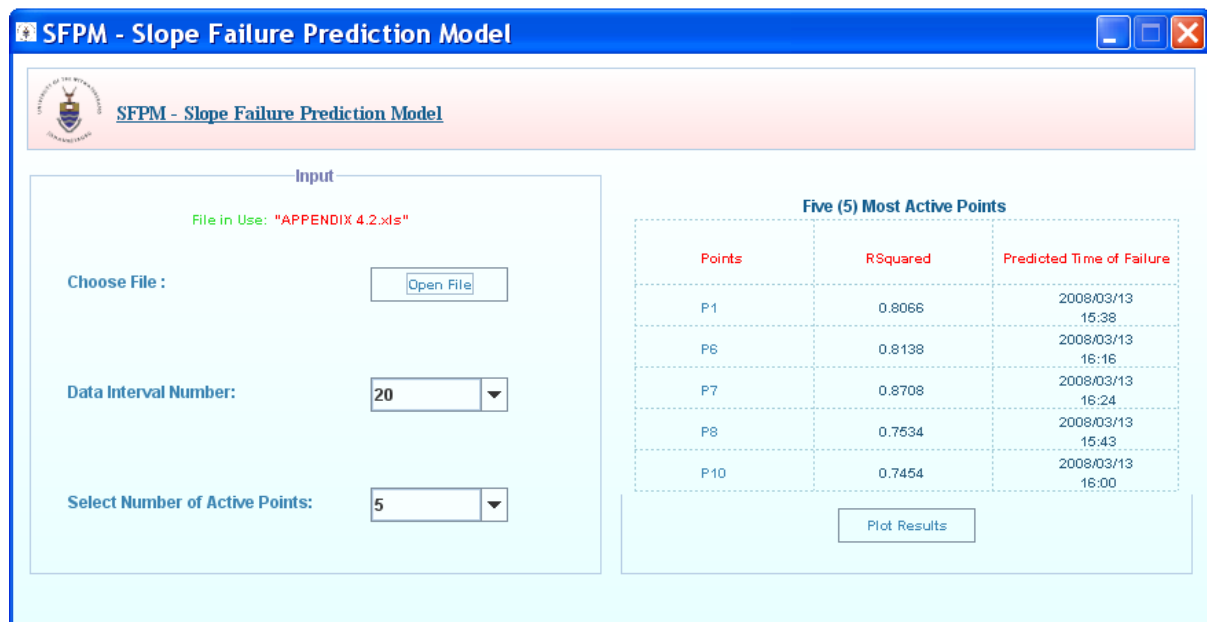
Figure 6.23: Third predictions of validation test 2.

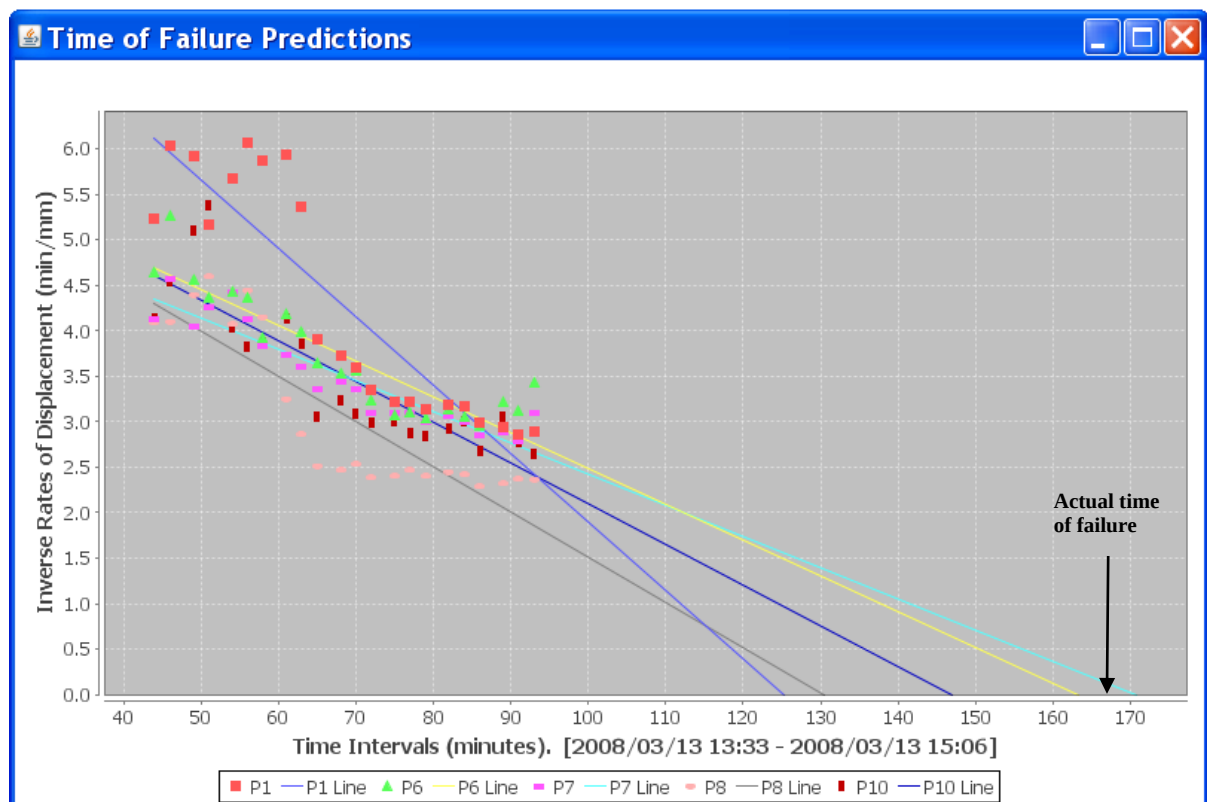
Figure 6.24: Graphical illustration of the five most active points of validation test 2.

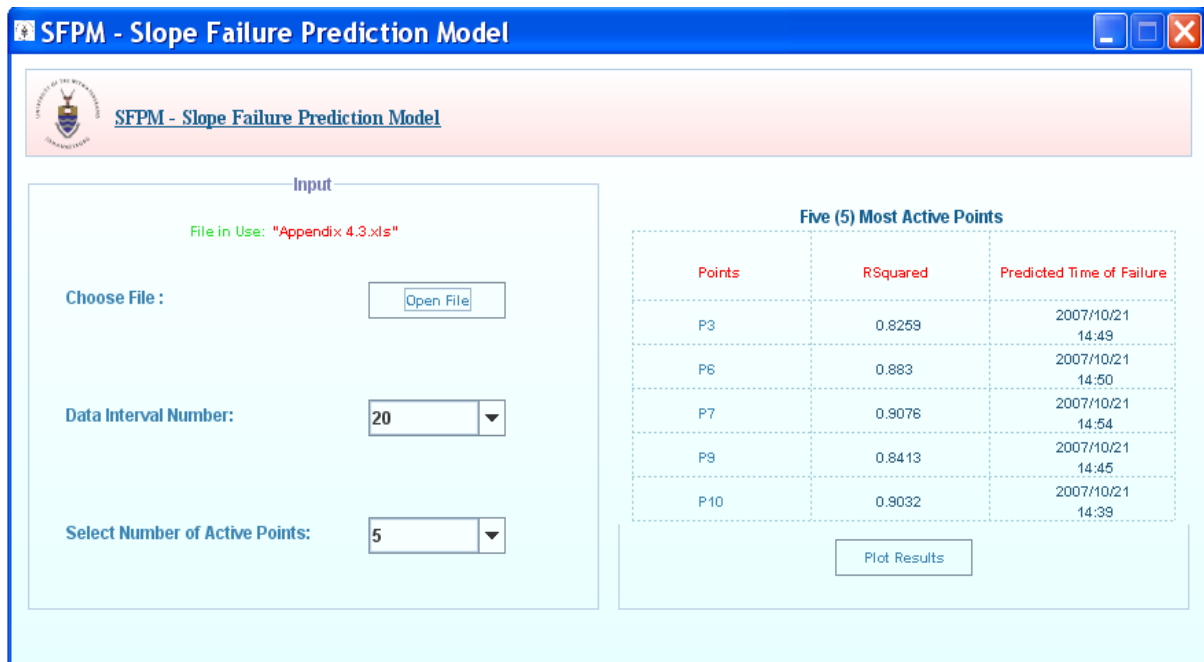
Figure 6.26: Sixth prediction of validation test 3.

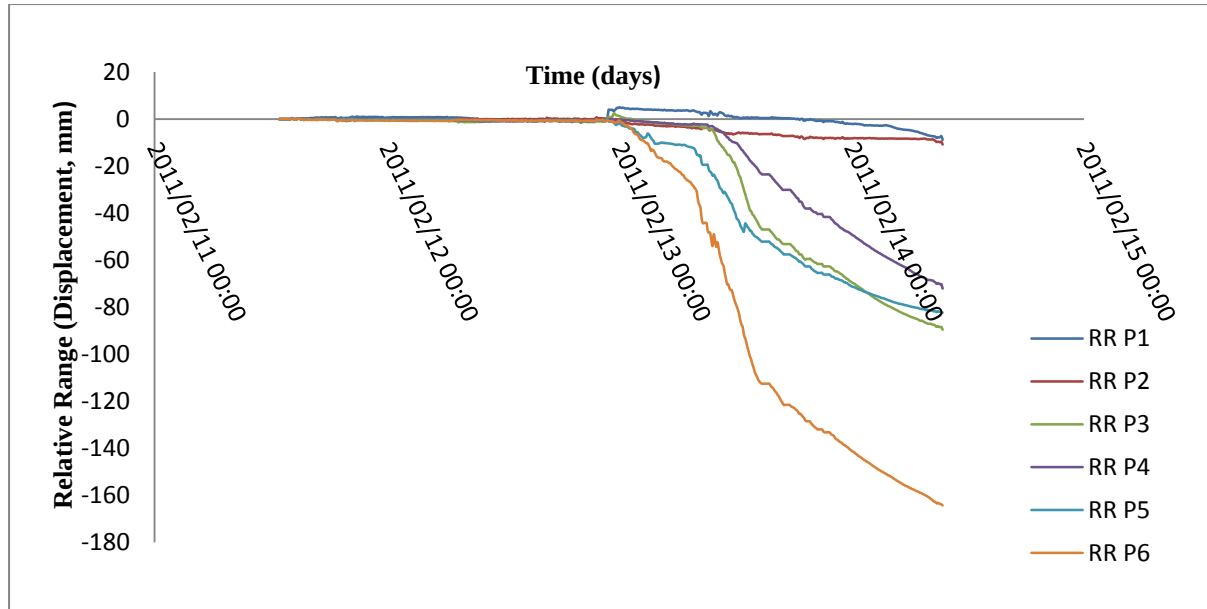
Figure 6.29: Relative range (Displacement, mm) of 6 points used for validation test 4.

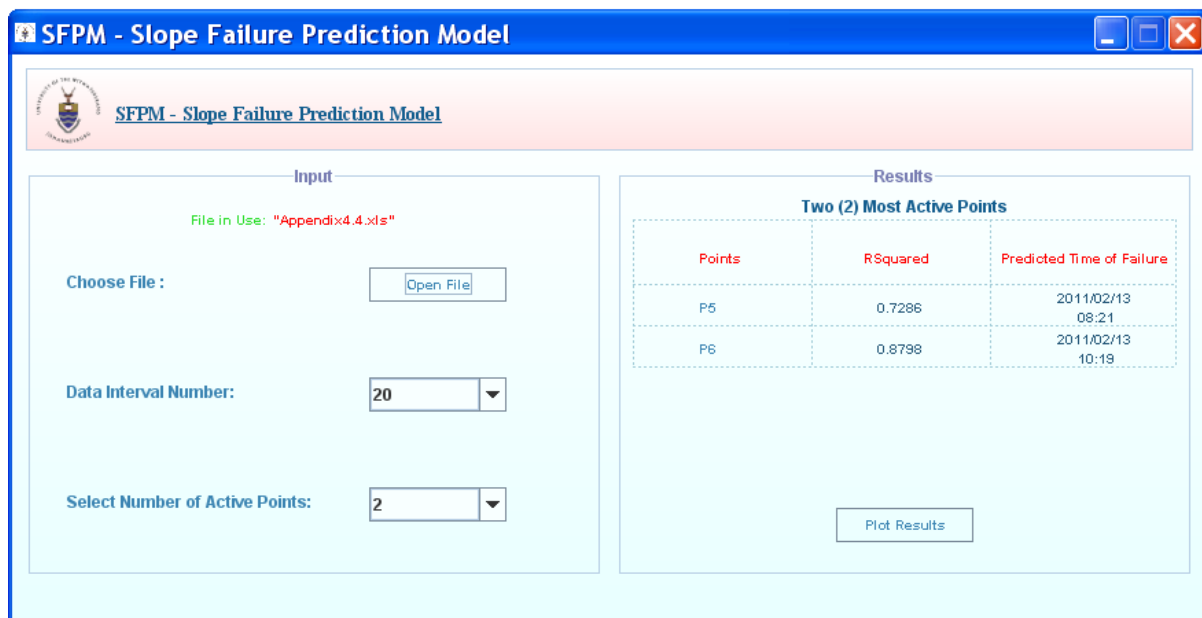
Figure 6.30: Eighth prediction of validation test 4.

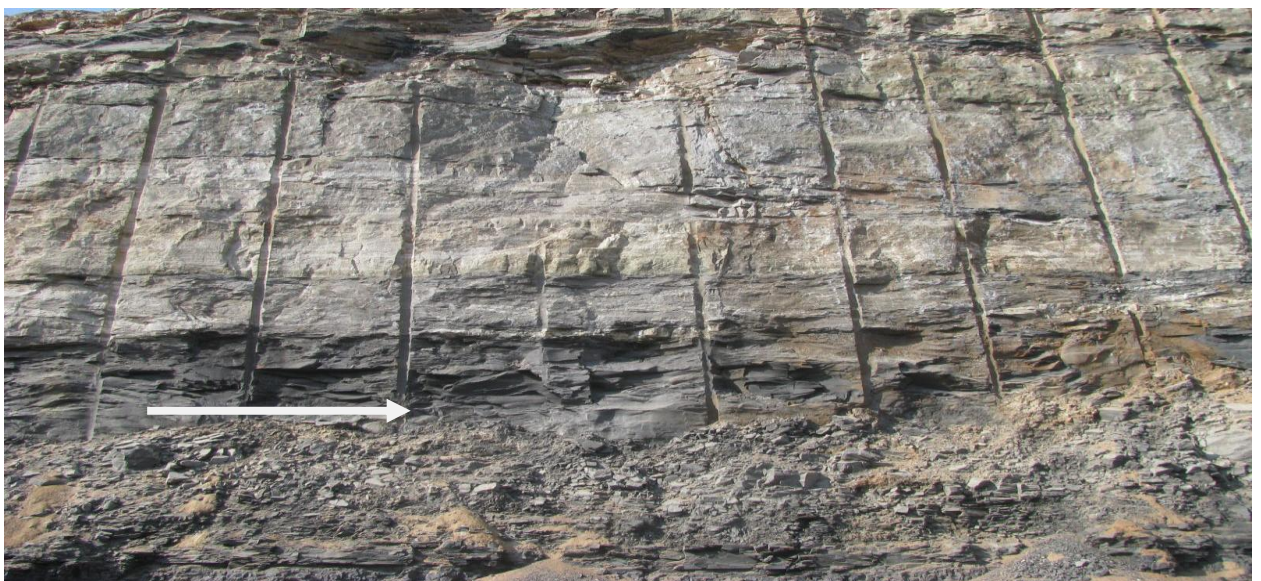
Figure 1.2: Stable high-wall found in 5 West pit at Kleinkopje open-cast coal mine.

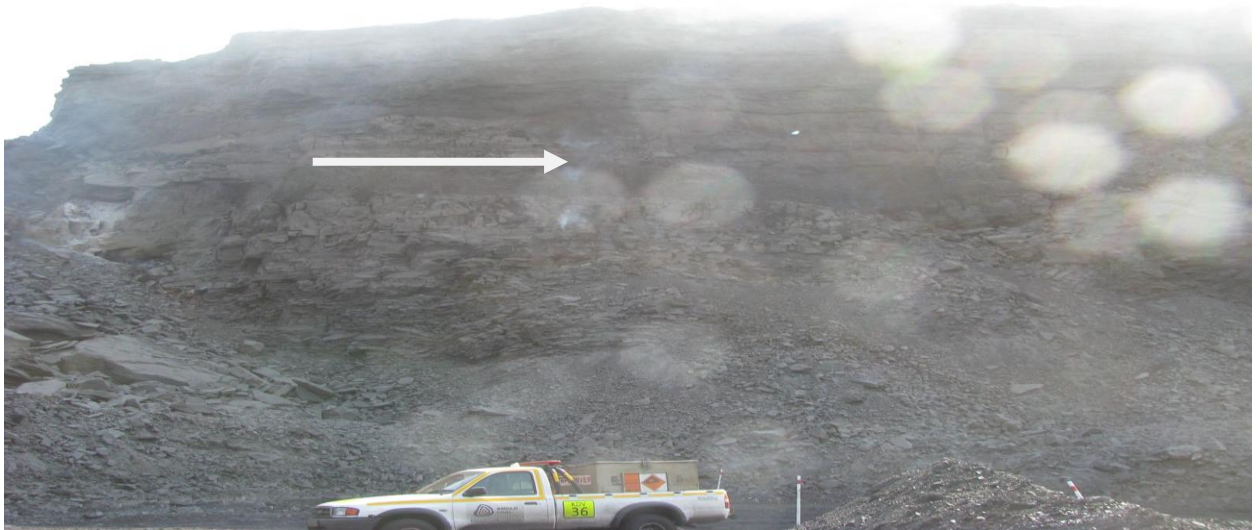
Figure 1.3: Highly fractured high-wall found in 2A pit at Kleinkopje open-cast coal mine.

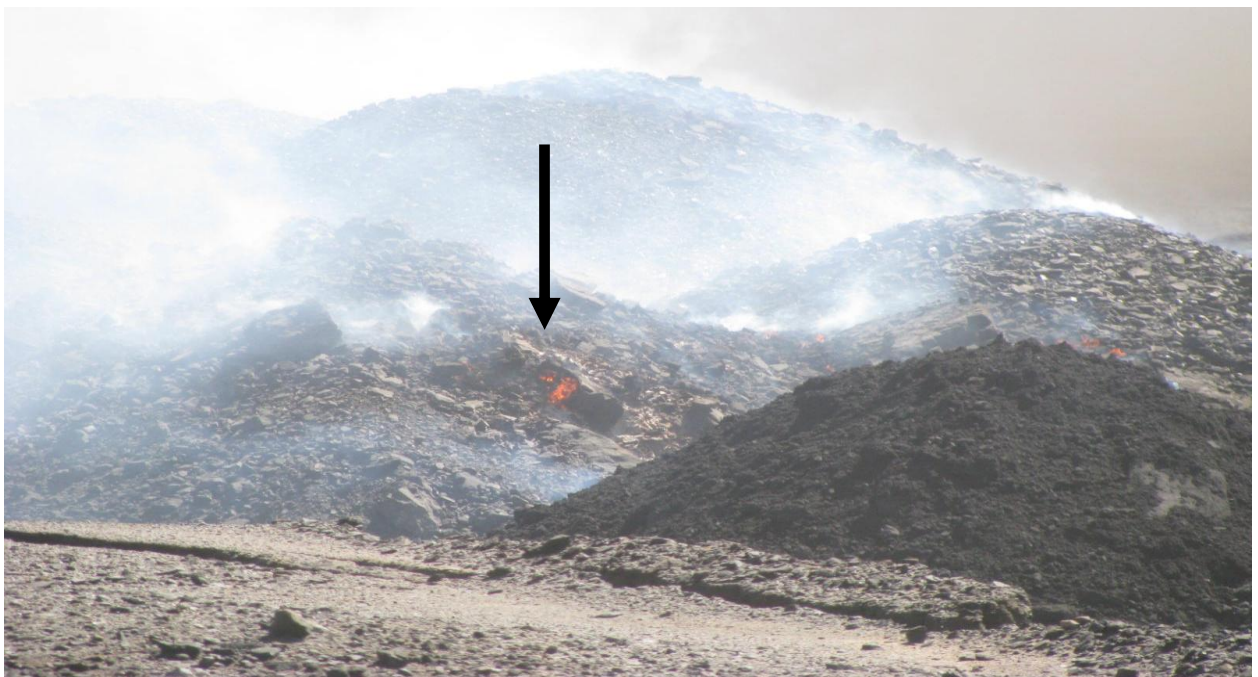
Figure 1.4: Burning low-wall from spontaneous combustion at Kleinkopje open-cast coal mine.

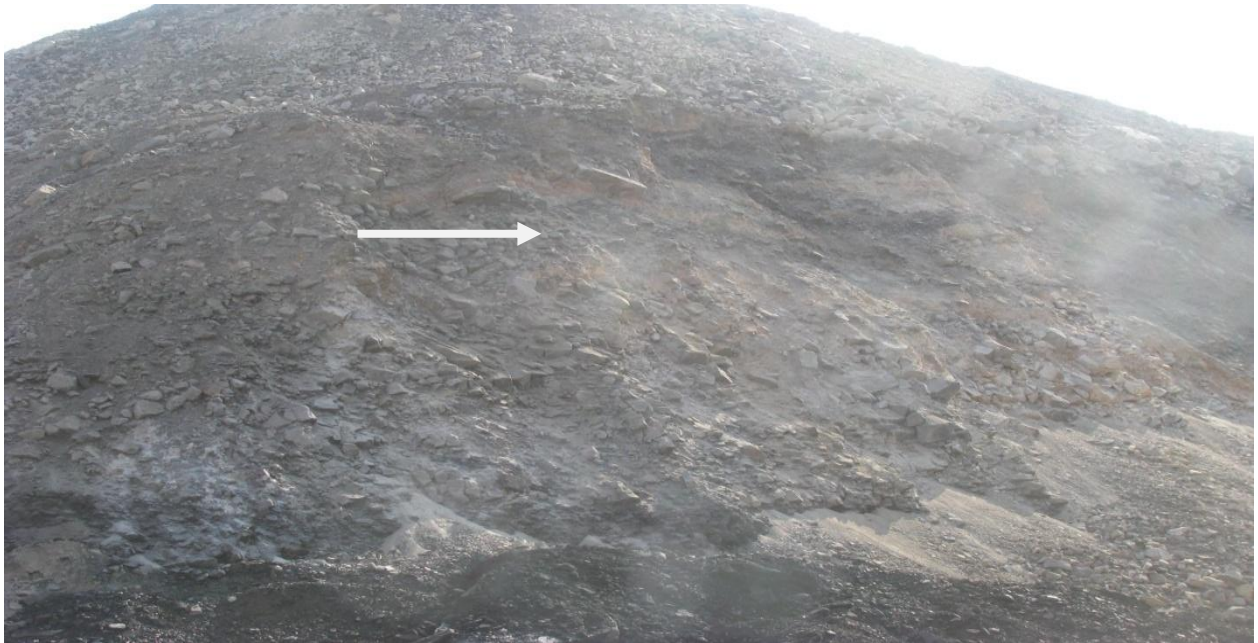
Figure 1.5: Failed low-wall resulting from undercutting at Kleinkopje open-cast coal mine.

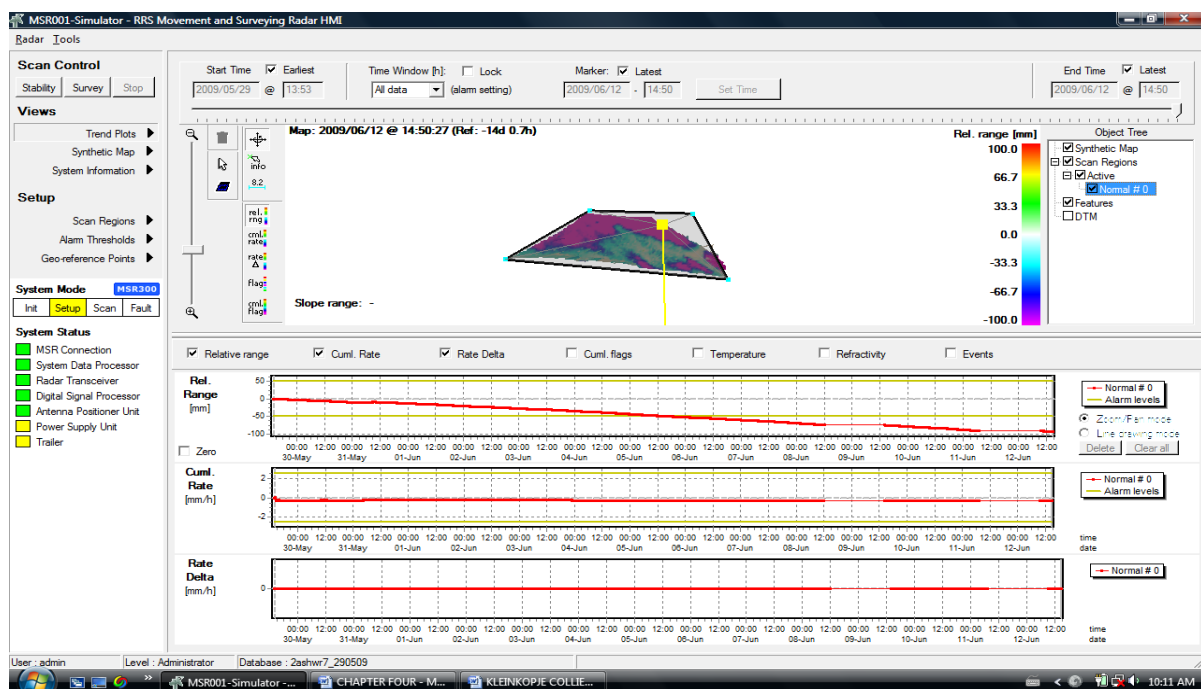
Figure 1.6: Typical print screen of monitored slope from the MSR.

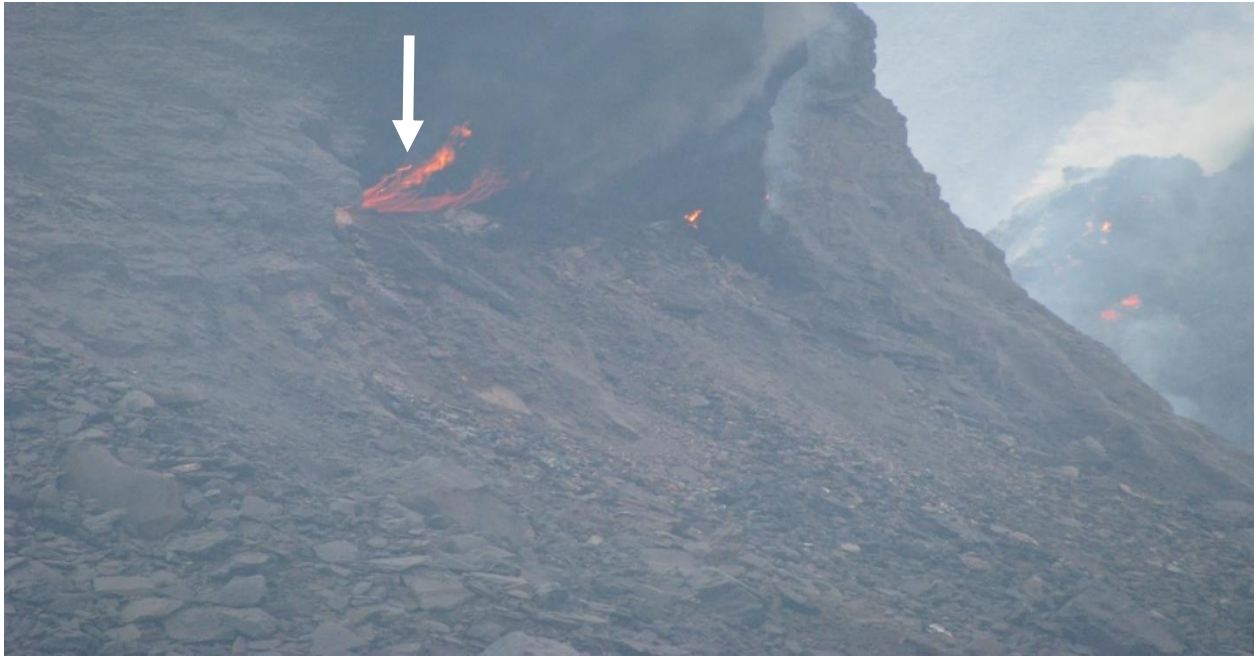
Figure 1.9: Burning high-wall resulting from spontaneous combustion at Kleinkopje open-cast coal mine.

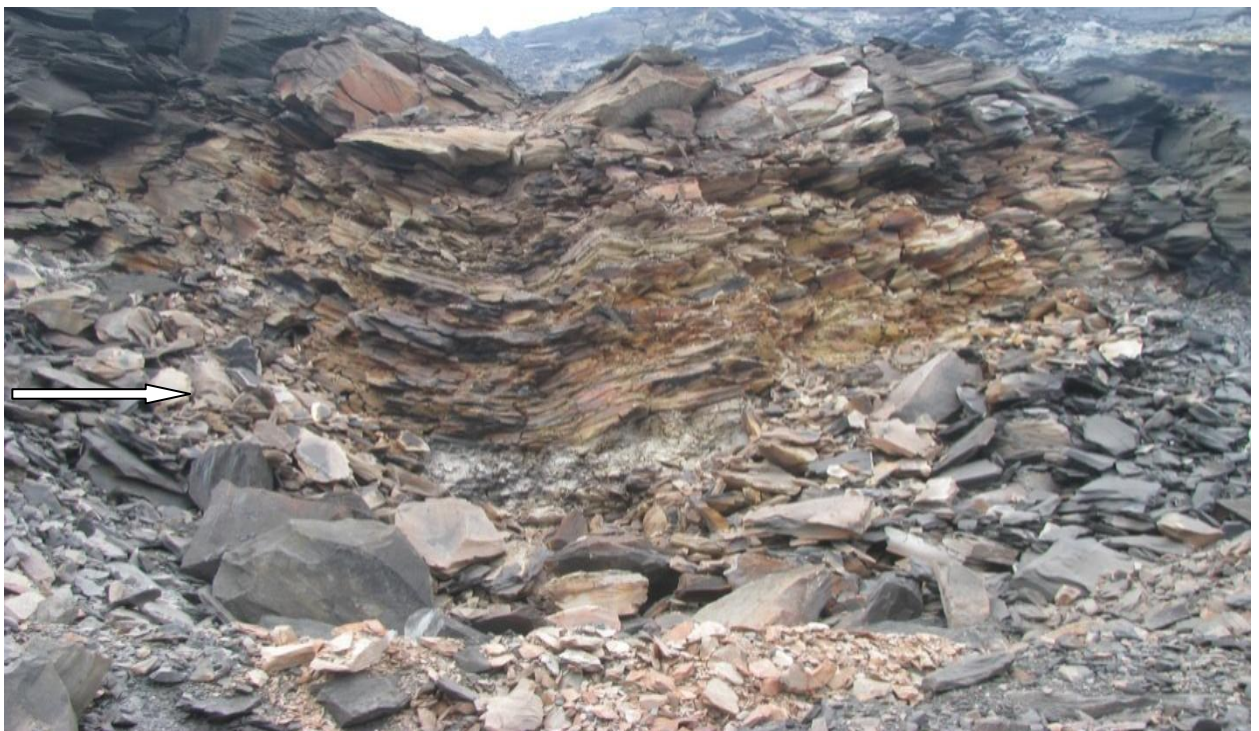
Figure 1.10: Burnt high-wall weakened by spontaneous combustion at Kleinkopje open-cast coal mine.

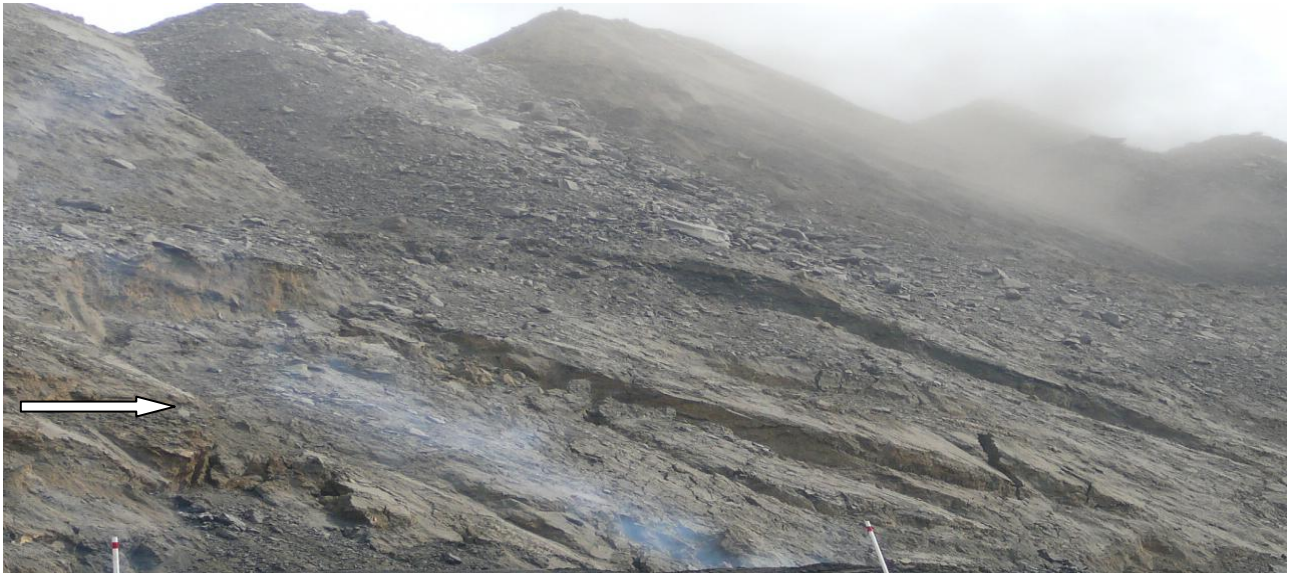
Figure 2.2: Rotational failure on low-wall (spoil) at New Vaal Open-cast coal mine.

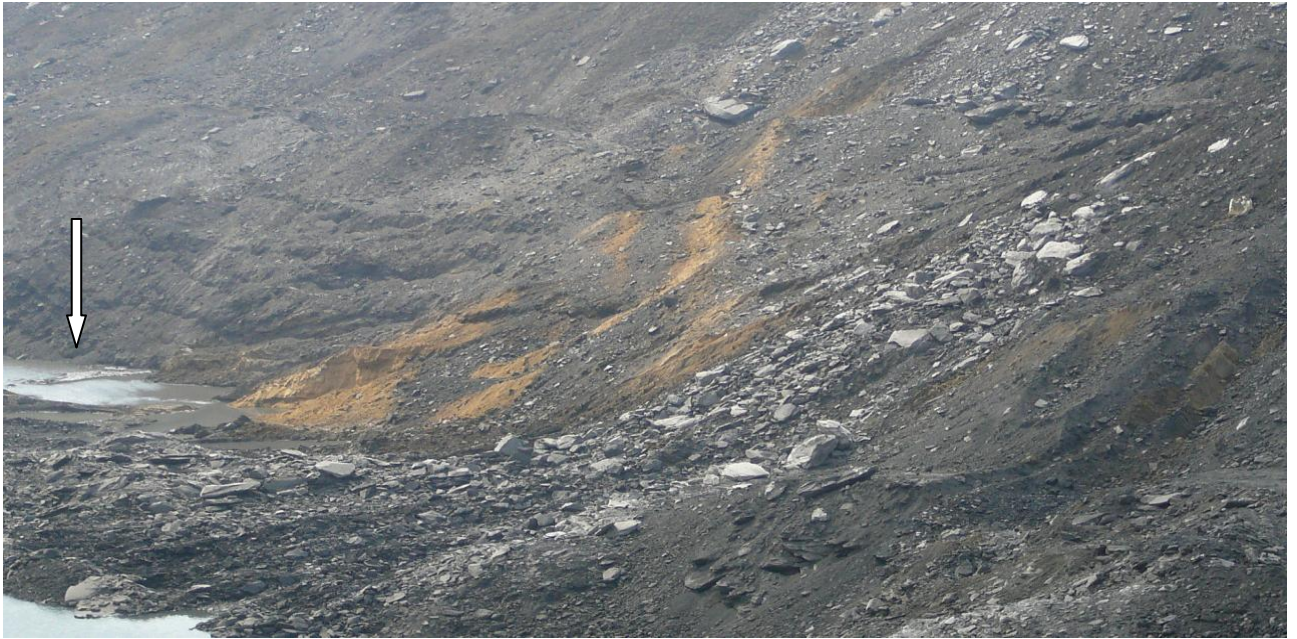
Figure 2.3: Pool of mine water beneath the low-wall at New Vaal Open-cast coal mine.
