THE ROLE OF ARCHITECTURE WHEN INTEGRATING  
CHILDREN WITH PHYSICAL DISABILITIES INTO FULL-SERVICE PRIMARY SCHOOLS

A dissertation submitted to the Faculty of Engineering and the Built Environment,  
University of the Witwatersrand, Johannesburg, in fulfilment of the requirements  
for the degree of Master of Architecture by Research.

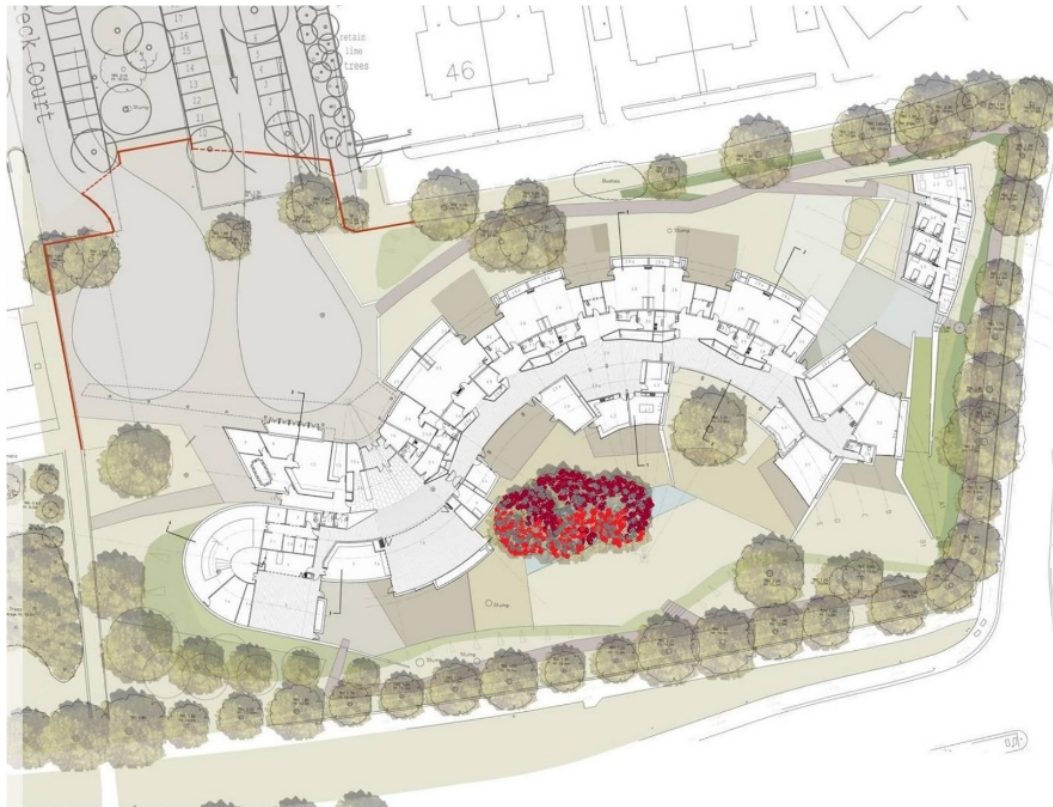
Figure 2.26. Site plan of Hazelwood school in Glasgow (Dunlop, n.d.)

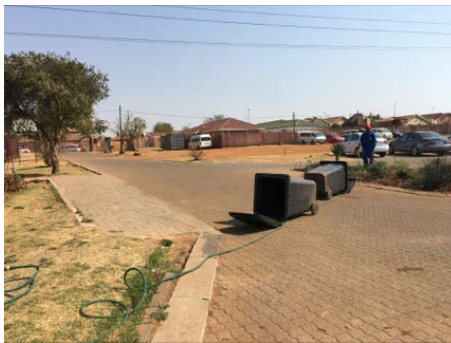
Figure 4.7. Example of car parking at schools visited (Author, 2018)

Of the schools surveyed, all scored below 50% with regard to the physical accessibility and safe layout of the parking areas. Although there was adequate space, the school's lost points with signage, demarcation of accessible parking bays, and demarcated pedestrian routes.

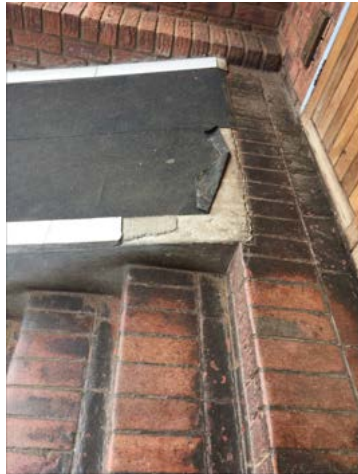
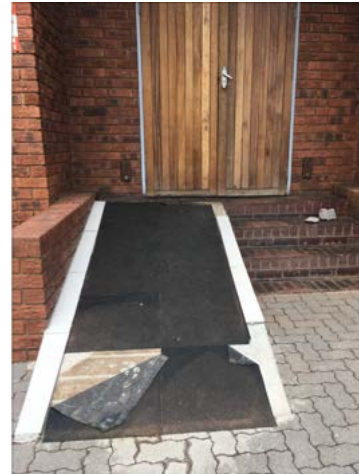
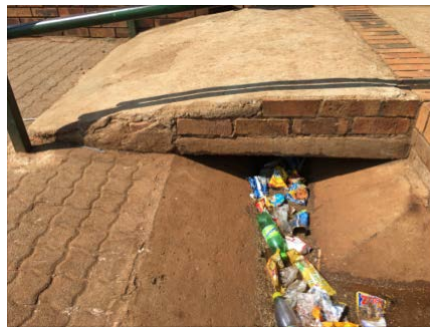
Figure 4.12. Examples of non-compliant handrails & ramps at the schools audited.  
(Author, 2018)

Figure 4.13. Examples of non-compliant handrails & ramps at the schools audited.  
(Author, 2018)

Figure 4.14. Examples of non-compliant handrails & ramps at the schools audited.  
(Author, 2018)

The schools surveyed varied in compliance. School A was designed around a series of connecting ramps. The non-compliant elements were the handrails that were installed but were incorrectly designed and built. School B was non-compliant and scored 0% with the worst cases of non-compliant ramps seen.

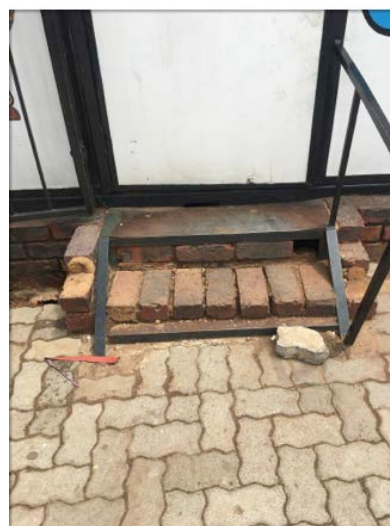
Figure 4.19. Example of non-compliant stairs at the schools audited (Author, 2018)
