# **ARCHAEOLOGY OF THE INDUSTRIALISATION AND SOCIAL DEVELOPMENT AT A SILVER MINE IN THE GREATER PRETORIA REGION FROM 1889 TO 1927**

**Graham Walter Reeks**

A thesis submitted to the Faculty of Science, University of the Witwatersrand,  
Johannesburg, in fulfilment of the requirements for the degree of Doctor of Philosophy

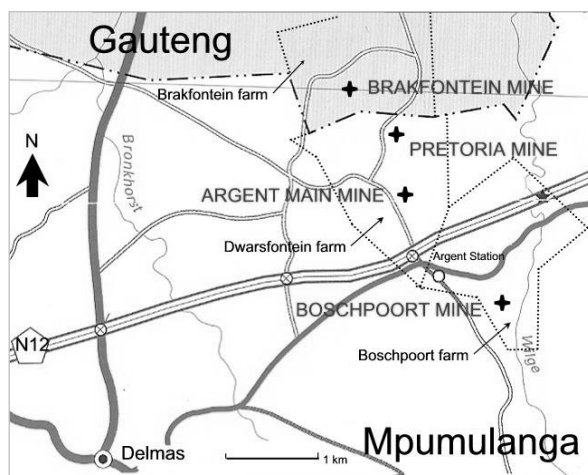
**Figure 3.** The four silver mines at the Argent silver mine location, dating from 1890s and 1920s (Reeks 2012).

The Argent mine, whether operating as the Transvaal Silver Mine (hereafter TSM) or Transvaal Silver & Base Metals (hereafter TSBM) mine is tied to the history of the three other mines located close by, as shown on Figure 3. It is therefore necessary to present a brief history of the mines so as to provide context for this thesis. Although TSM was the first mine to open in 1899, it was followed by the formation of another silver mining company, the Witpoortje Syndicate Ltd.<sup>8</sup> In 1891 the syndicate opened mines on the farms Boschpoort, Brakfontein and Witpoortjie, which was closer to Bronkhorstspuit, some 20 km north of Argent.<sup>9</sup> The Witpoortjie mine was more of a trial operation and was eventually abandoned by the syndicate.<sup>10</sup> Many of the letters in the archive files of the H. Eckstein & Company refer to these other operations. There was a very close relationship between the TSM and Witpoortje Syndicate companies, not least because of the fact that directors of the one company sat on the board of the other, including the Randlord<sup>11</sup> Lionel Phillips who was eventually to become chairman of both companies.

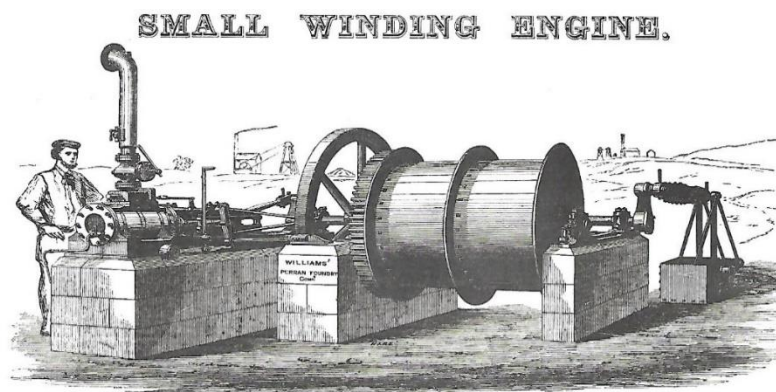
**Figure 8.** Williams’ Perran Foundry Winding engine c1880. Actual details of this machine were not recorded in the source but it is believed to be similar to the Sandycroft Winding Engine installed at TSM. (Williams’ Perran Foundry Co., Cornwall catalogue, Reprinted by The Trevithick Society, 1986).

A drawing of an 1879 winch shown below was found in Williams’ Perran Foundry catalogue.<sup>23</sup>

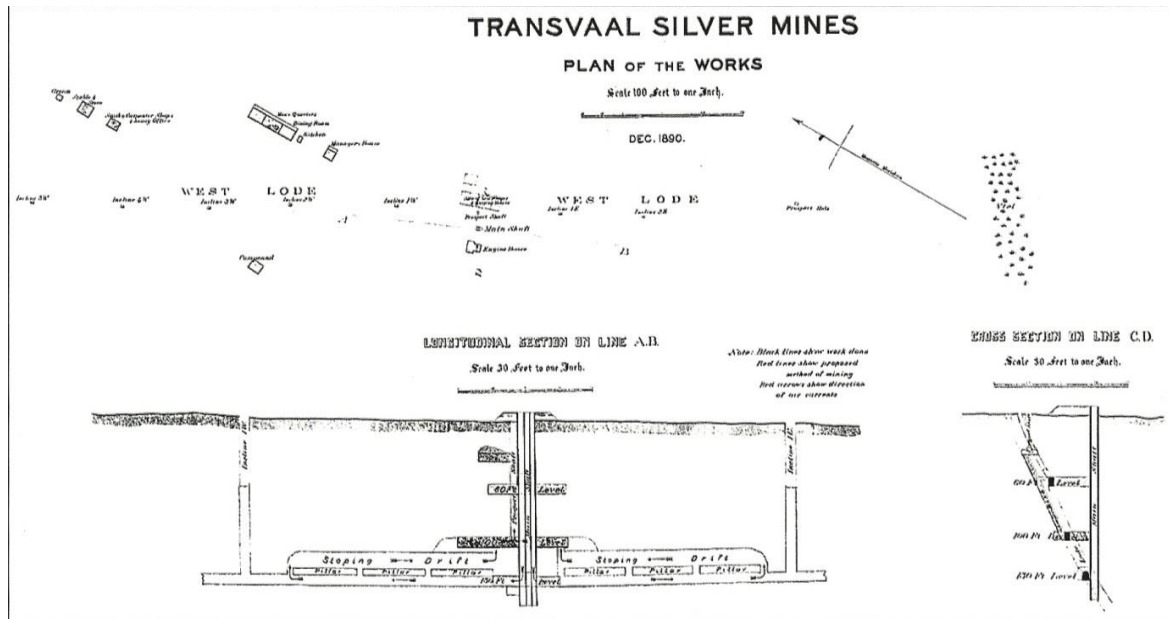
**Figure 9.** Transvaal Silver Mine Ltd. 1890 mine plan – underground and surface structures. Some of the details on the plan may be poor, due to the reduction from an A1 size original. The plan is reproduced as Appendix 2.0 as a full A4 page copy.

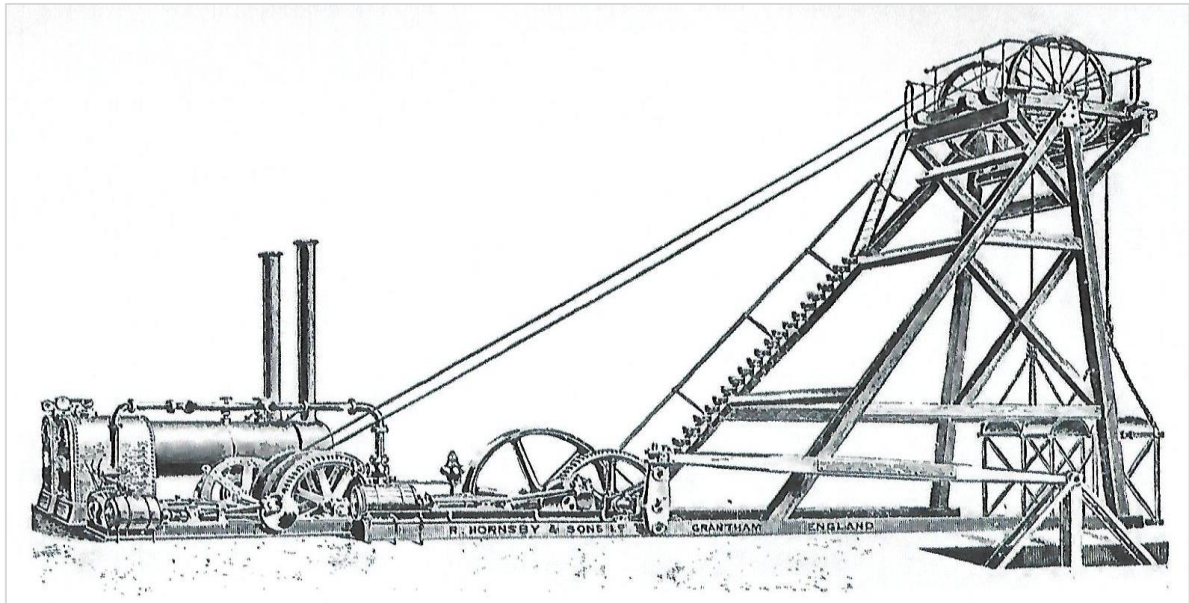
**Figure 10.** Arrangement of winding gear coupled with a pumping engine attached to a flat rod and the Tee bob. Note although this shows a different make of engine namely R Hornsby & Son Ltd the arrangement is the same as was installed at Argent (Davies 1902:91).

Pit Work (Harvey & Co) 10 in. Cornish pit work consisting of 250 ft. 10 in. x 10 in. pitch pine spear rods, plunger complete, T bob, and 2 Pitman rods (Figure 10 & 11).

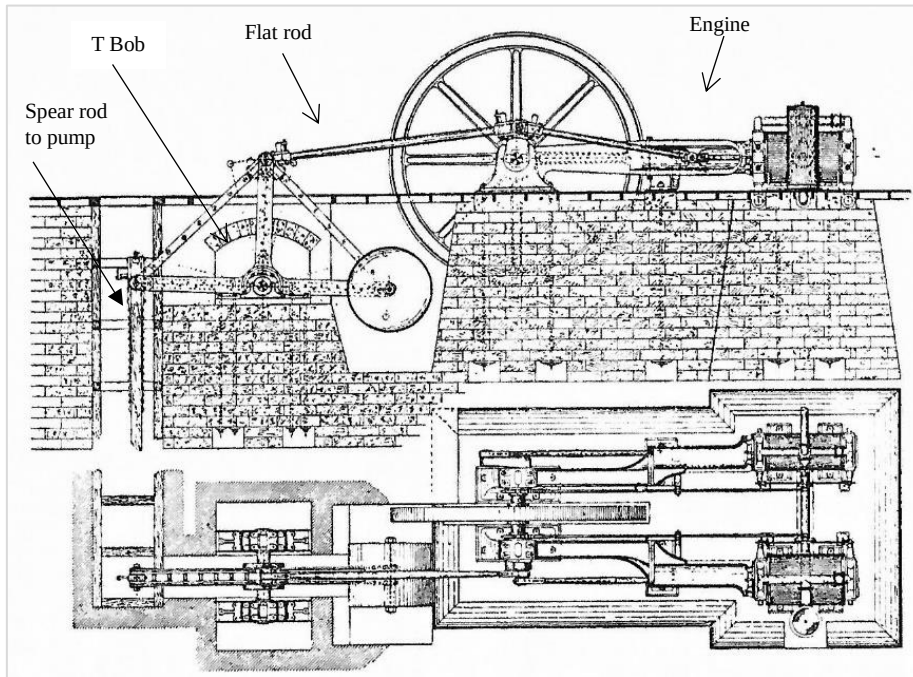
**Figure 11.** Showing a detail of a T bob, engine, and spear rod at the pumping shaft. (Davies 1902:115).

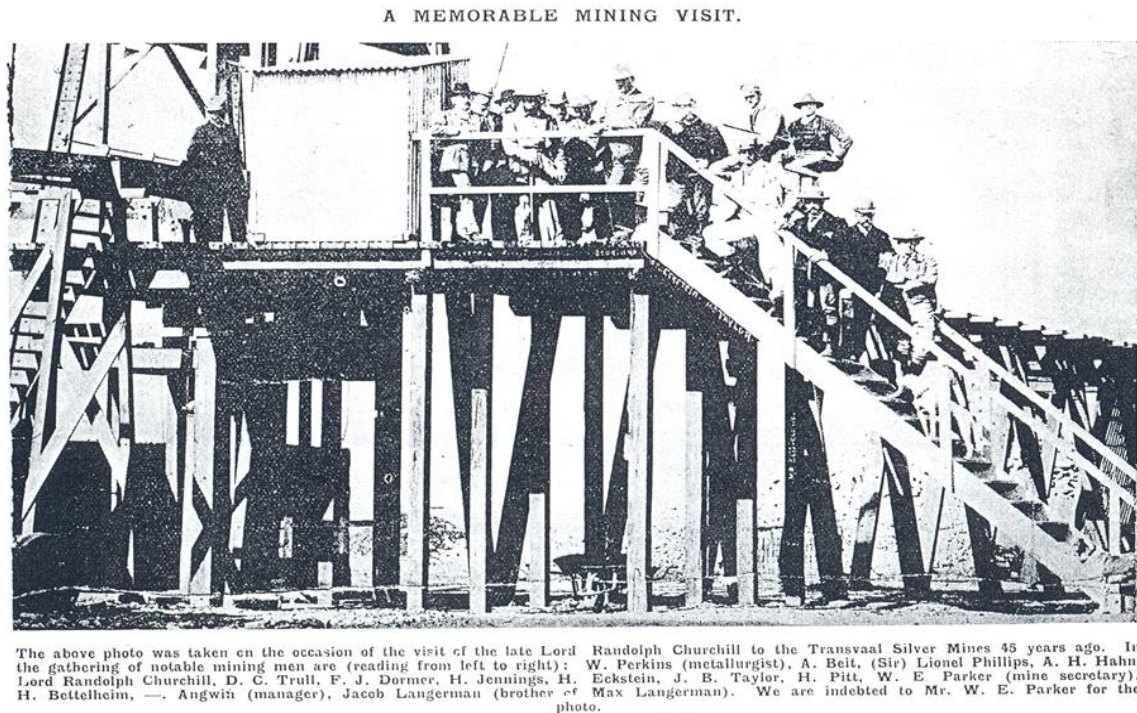
**Figure 12.** Historical photograph of the visit by Lord Randolph Churchill to the Transvaal Silver Mines Ltd sometime in 1891 (Reeks 2012).<sup>57</sup>

When the picture (Figure 12) was used in previous research (Reeks 2012), the importance of the elevated landing station at the main shaft and the raised trestle in the background was not realised. In Jennings' 1890 report he describes the elevated landing station clearly shown in the photograph: "The landing station will be raised 14ft. above ground level, and trucks run over trestle work to ore dressing floors."<sup>58</sup>

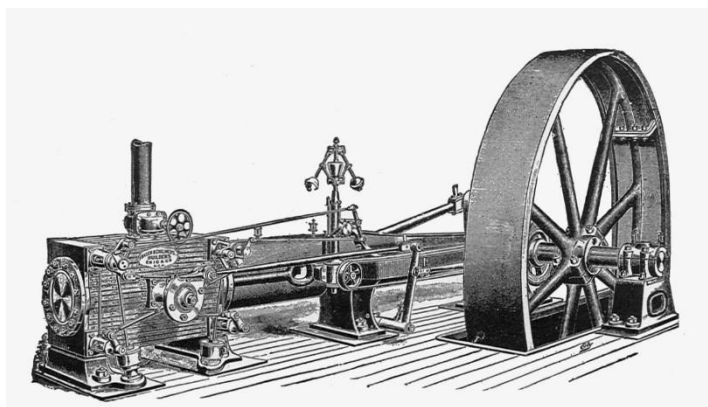
**Figure 13.** Fraser and Chalmers Horizontal Corliss Engine (Hawkins 1904:182).

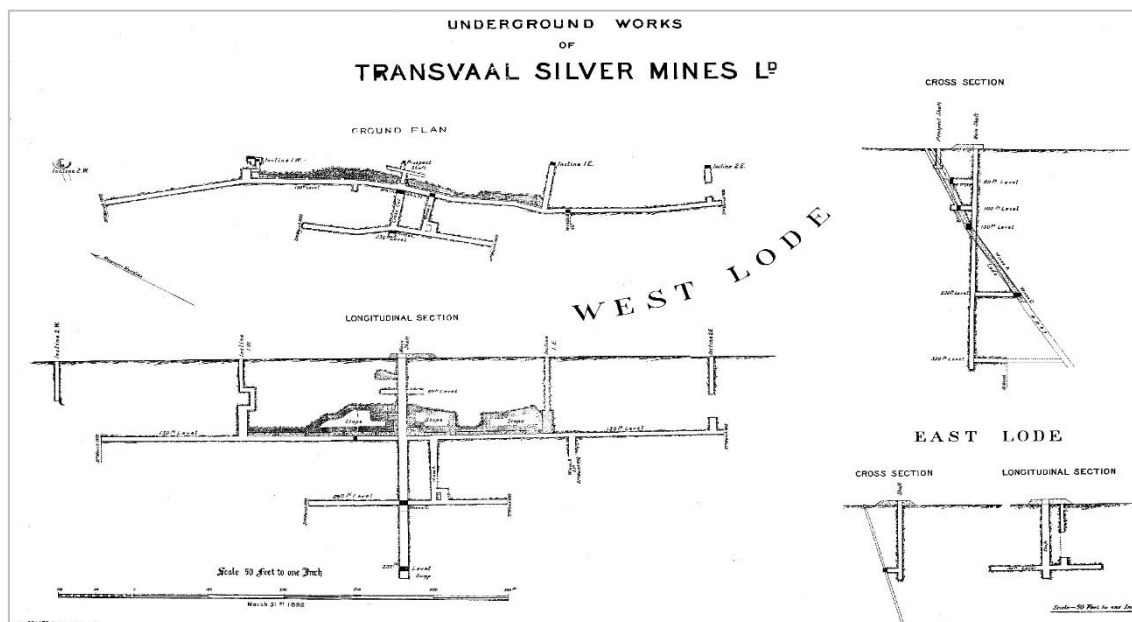
**Figure 14.** Transvaal Silver Mine Ltd. 1892 underground mine plan. Note some of the details on the plans may be poor, due to the reduction from an A1 size original. The plan is reproduced as Appendix 3.0 in a larger scale.

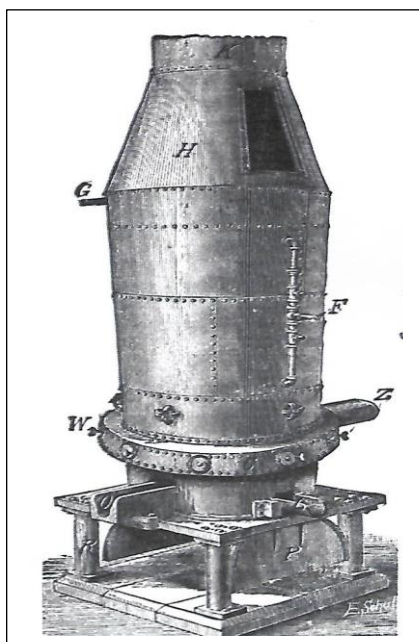
**Figure 15.** Example of an American design water jacket smelting furnace (Peters 1899:267).

It has been difficult to find a drawing of such a smelting blast furnace, however in the book by Eissler (1891), there is an advertisement for Commons & Co., London - an ore dressing machinery manufacturer – with a drawing that matches the description above. In a book by Peters (1899) there is an illustration of an American design water jacket furnace which may be similar in design to the ones installed at TSM. Both drawings are reproduced on the next page (Figures 15 and 16). Figure 17 is included to illustrate the principle of operation of the reverberatory furnace which was used to roast the ore to remove the sulphur content prior to the smelting operation. The Reedy's catalogue (Figure 18) illustrates various types of elevators but it is not known the exact type of unit installed at Argent.

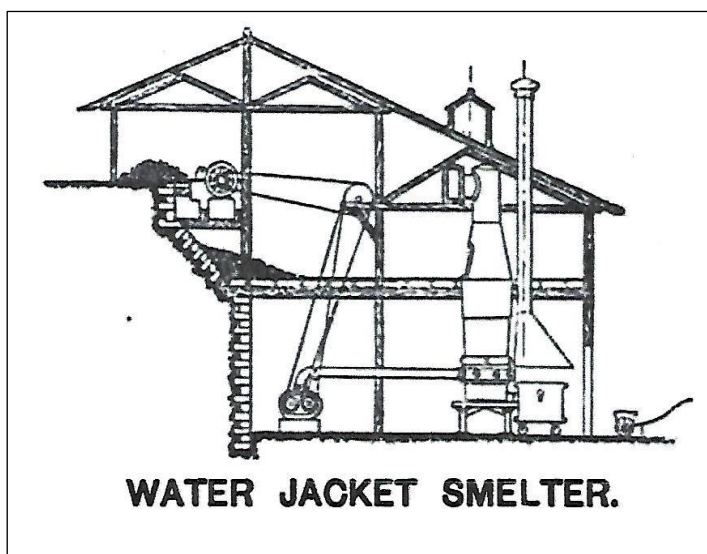
**Figure 16.** Idealised sketch of a smelting house with a Water Jacket smelter and charging floors (Eissler 1891:435).

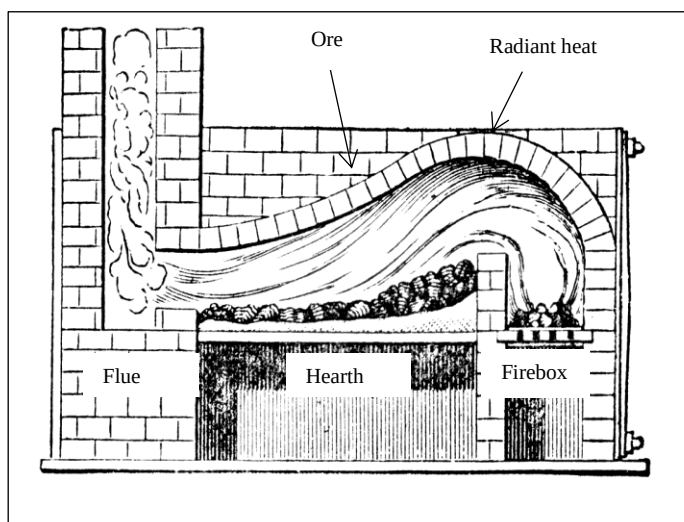
**Figure 17.** Principle of operation of a reverberatory furnace for roasting the ore. The reflected heat roasts the ore.<sup>75</sup>

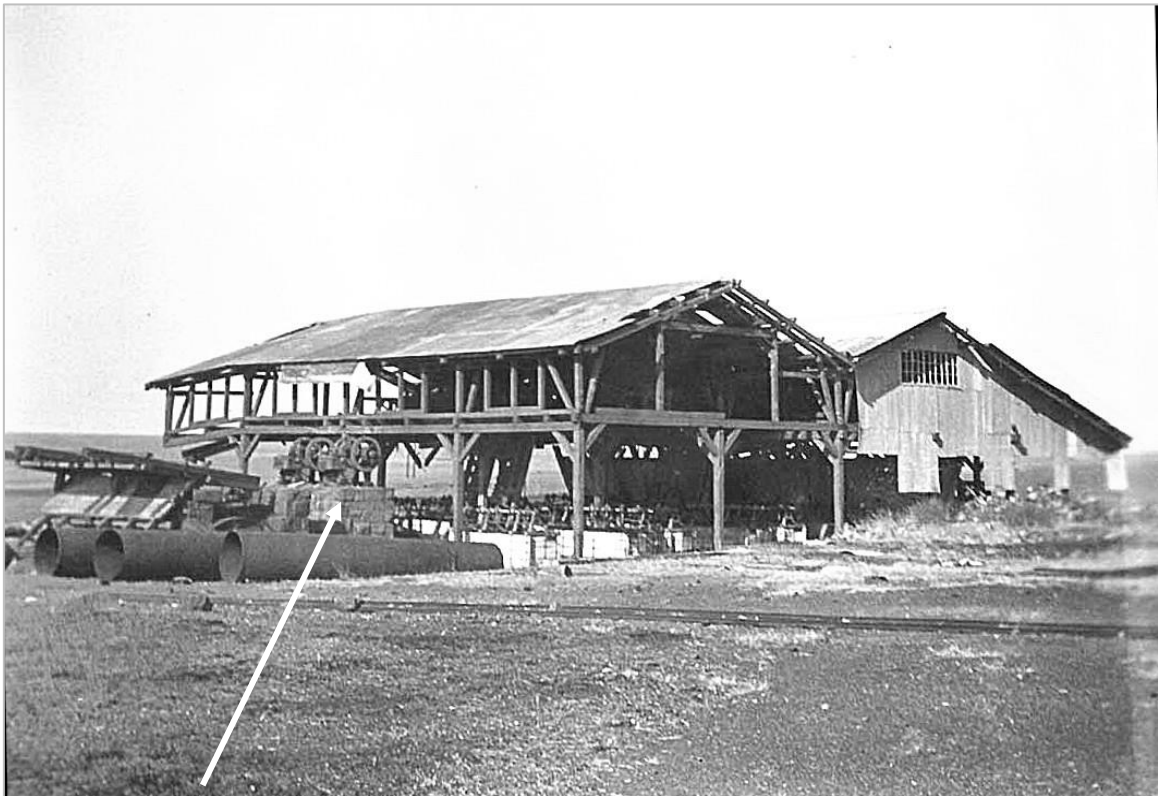
**Figure 19.** Blake jaw crushers & foundations in 1902 (they are behind the large pipes) with the 1893 concentration plant building behind.<sup>78</sup>

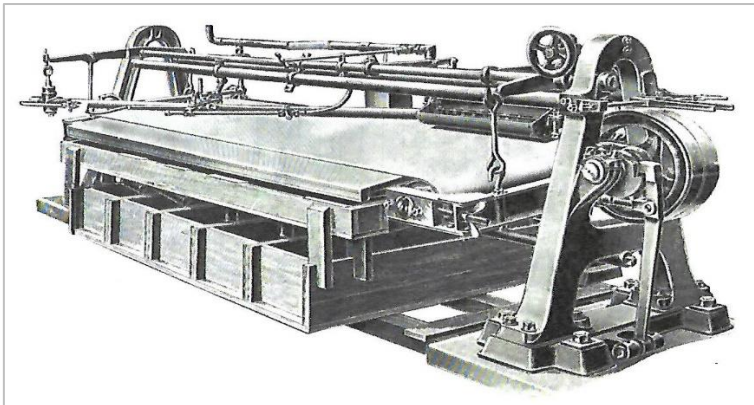
**Figure 20.** Bilharz-Stein bumping table (Louis 1909:362)

Despite rigorous attempts to find details on a “Steiner” table or “Belharz” table mentioned above, none has been found. However, by chance an old book on the dressing of minerals dating from 1909 by Henry Louis was found, and in it were details of a Bilharz-Stein bumping table. As the report above is by a journalist it has to be assumed that he got the names transposed and incorrectly spelt.

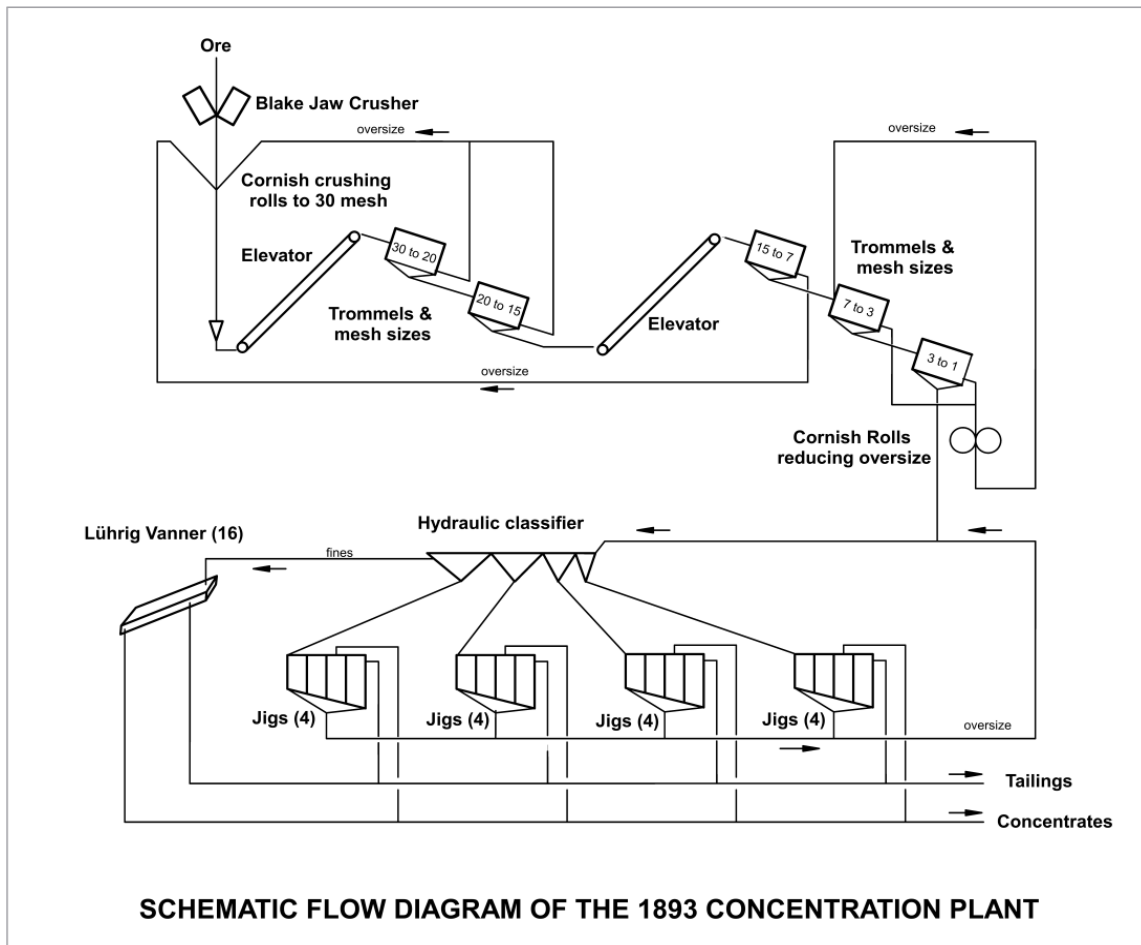
**Figure 21.** Schematic flow diagram of the concentration plant on the TSM 1893-1895. It is based on the known items of equipment purchased by Wertheman, along with various engineering journal articles (as quoted). The sizes shown on the trommels and Cornish Rolls are hypothetical but are based on flow diagrams in various textbooks. (Truscott, 1923; Richards & Locke 1940). The bold numbers in brackets refer to the number of machines in the references. It is unclear if there was more than one hydraulic classifier. It is however more likely that there were four classifiers feeding the 16 Jigs (P. den Hoed and M. Dworzanowski at School of Chemistry and Metallurgy, University of the Witwatersrand, 2017 – pers. comm. 15 May 2017) (Diagram drawn by G. Reeks).

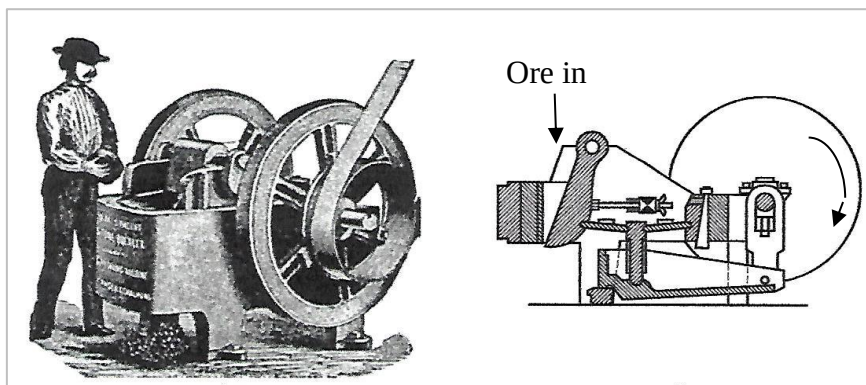
**Figure 22.** Blake Jaw crusher (Lynch & Rowland 2005:62).

Various sources dealing with mining beneficiation, mostly American, allude that the most common machine used in crushing in the 1890s was the reciprocating Blake Jaw crusher (Richards 1903:13; Davies 1902:222). This crusher was invented in 1852 by the American Eli Blake, who was looking for a quick way to crush rock during a road building project. The basic design of the Blake is still used to this day and is often found on small mining operations and quarries, although larger, modern mines make use of the more efficient machine called a gyratory crusher.

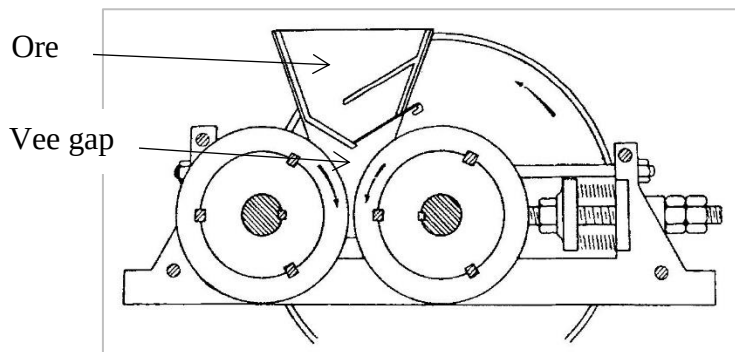
**Figure 23.** Cornish Roll showing directions of rotation and vee gap (Wills 1979:168).

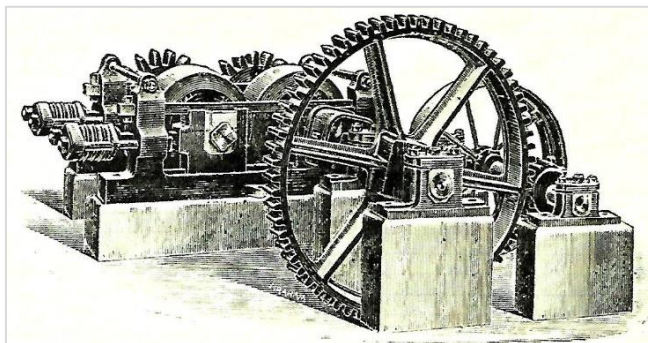
**Figure 24.** Cornish Rolls machine with the feed chute and machine covers removed. (Davies 1902:238).

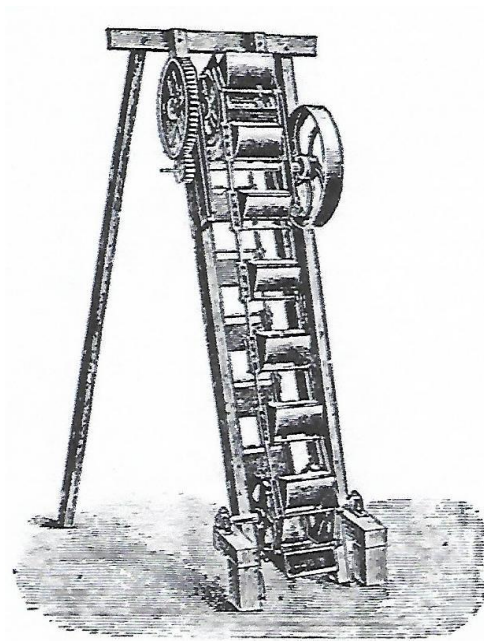
**Figure 25.** Bucket elevator  
(Davies 1902:409)

From the Cornish Rolls the crushed rock was raised to an upper floor in the concentration building by a bucket elevator, mentioned in Chapter 3 page 58. In the photograph of the building, (Figure 19) there is an angled shadow which may well have been such an elevator as shown in (Figure 25). From the elevator the ore was fed into a set of revolving trommels or rotating screens of five different mesh sizes.<sup>4</sup> A picture of such a revolving trommel with three stages is shown (Figure 26).

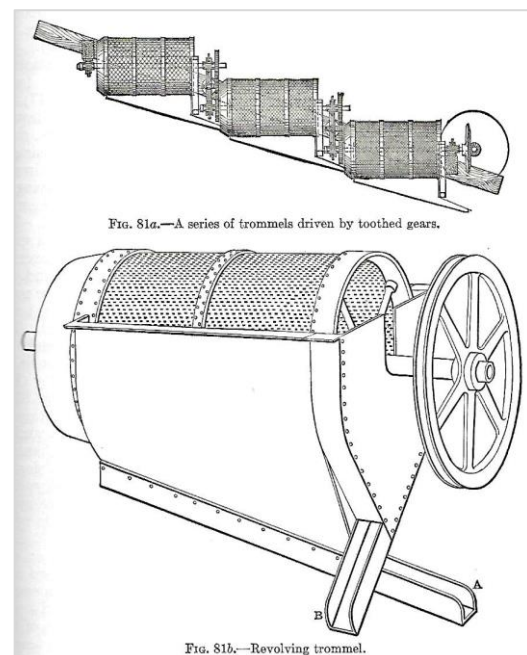
**Figure 26.** Revolving trommel and a  
Series Trommel.  
(Richards & Locke 1940:121)

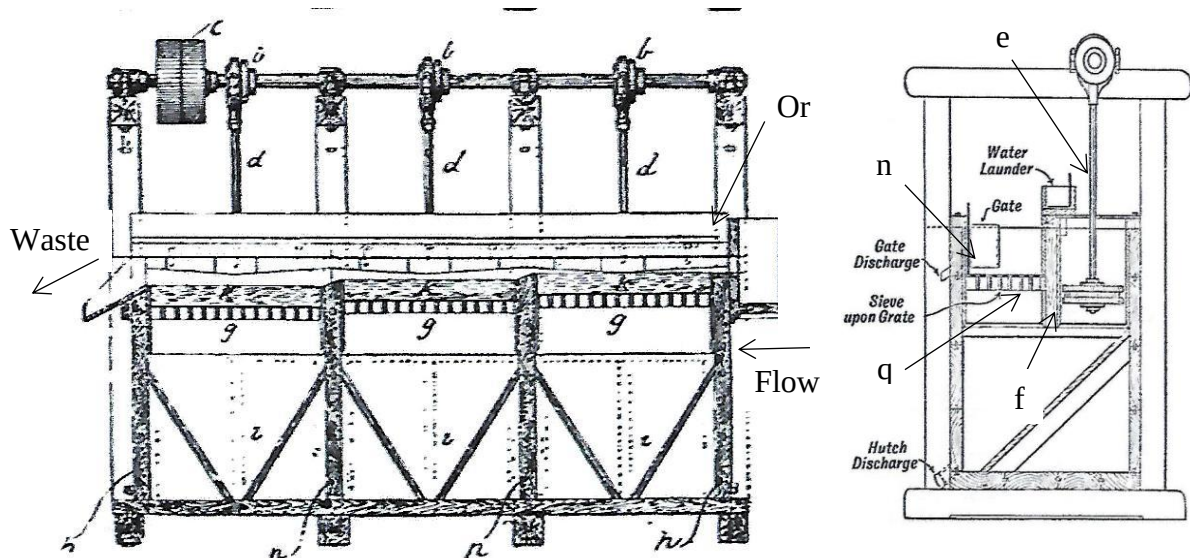
**Figure 27.** Longitudinal and cross section of a three stage Harz Jig - water flow, right to left. (Davies 1902:294 and Truscott 1923:303)

This type of jig was the most common jigging method among American and German jig machine manufacturers in the 1880/90s (Richards 1909; Truscott 1923).

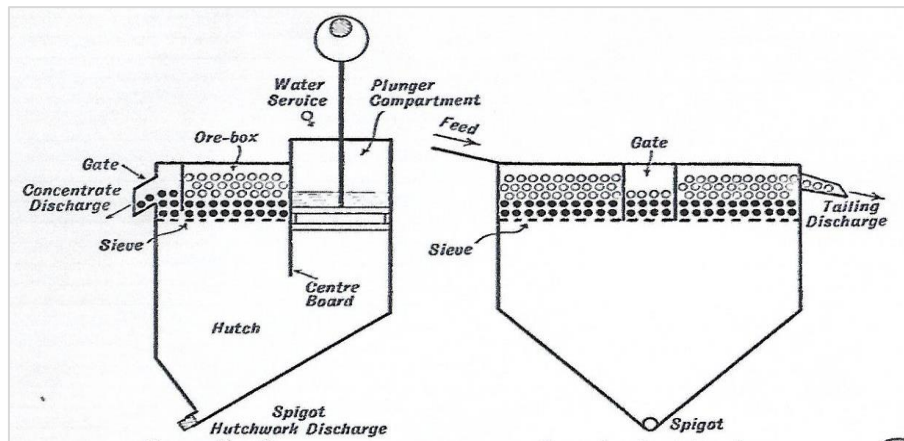
**Figure 28.** Diagrammatic sections of a single cell in a Harz Jig. The sections illustrate the gate discharge for concentrate, spigot discharge for fines and overflow discharge for tailings (Truscott 1923:303).

The simplified drawings show a typical 3 stage Harz jig (Figures 27 and 28). The plunger moved downwards, raising the water and particles in the sieve chamber thus separating the waste in light particles that then flowed into the next chamber. The heavy mineral particles shown in black passed into the coarse concentrate discharge.

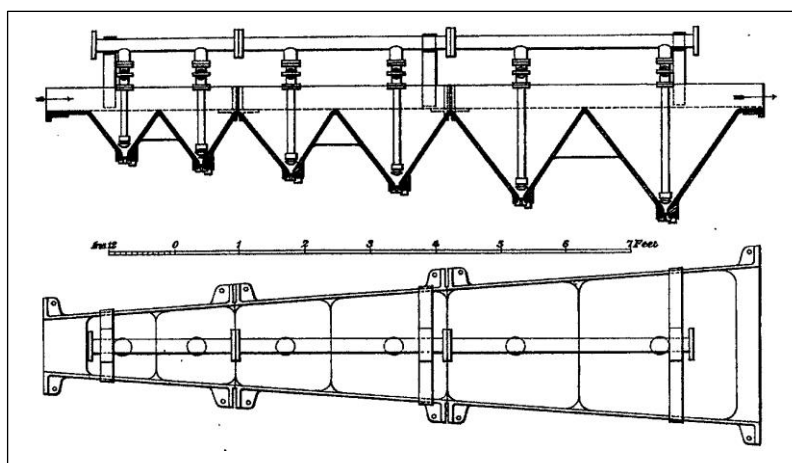
**Figure 29.** Lenique hydraulic classifier dating to c1888. Flow of water and concentrate from left to right (Louis 1909:237)

A Lenique classifier, which is a version of the Spitzkasten and dates from around 1888 is shown in (Figure 29). It is believed that a similar machine was installed at TSM. International technology of mineral dressing in the 1890s was changing at a frenetic pace. The first design of such a process was called a Spitzkasten. It had been invented by a German mining engineer Peter Ritter Von Rittinger in the mid nineteenth century. It is not clear if the use of the term *Spitzkasten*, was an error by the reporter at the time, or if he was told that TSM had such machines.<sup>6</sup>

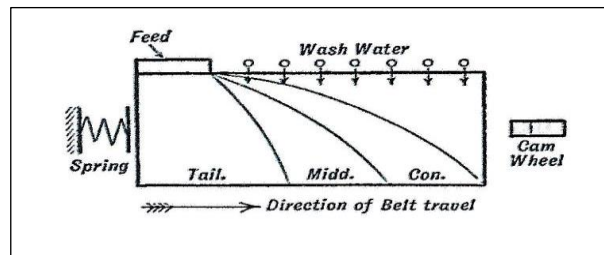
**Figure 30.** Diagram illustrating the direction of feed, water and eventual separation of tailings, middlings and concentrates on a Lührig Vanner (Truscott 1923:358).

Thus the lighter particles (tailings) will go off first and the heavier particles (ore concentrate) will travel with the belt and come off last. As the belt and flow of fine particles were transported along in a flow of water there was a distinct separation of heavy minerals from the lighter waste particles, (see Figure 30).

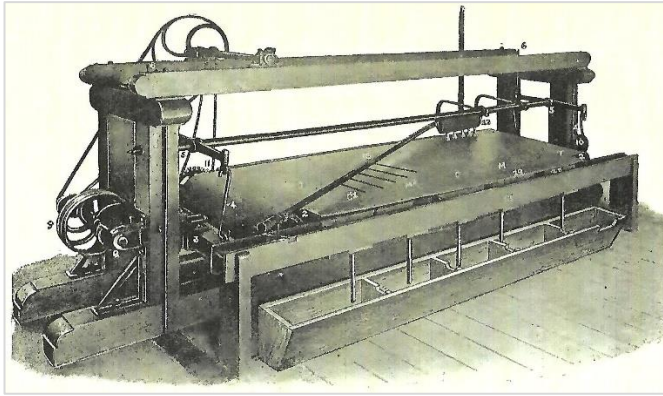
**Figure 31.** Lührig Vanner (Davies 1902:345)

Note the picture is the reverse of the diagram in Figure 30.

A Vanner is a machine illustrated in (Figure 31) in which the fine particles of ‘pulp’ [very fine rock particles in a liquid] are fed along a moving belt that is slightly angled both from one end to the other and across the width:

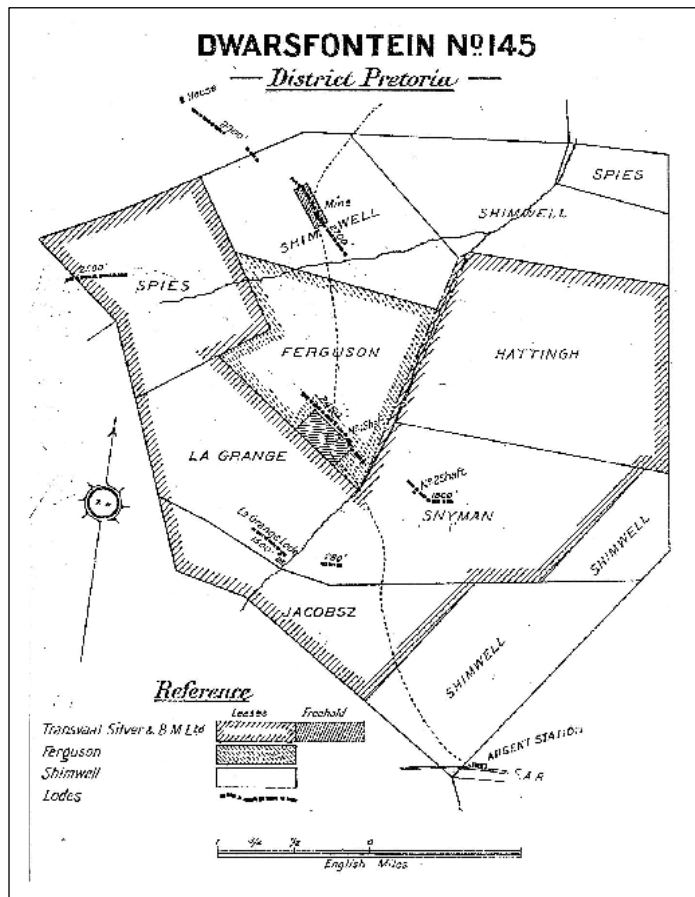
**Figure 32.** Dwarsfontein farm showing leased portions of the farm and the primary lodes.<sup>21</sup>

In July 1920 it was announced that TSBM had acquired the rights to the Ferguson lease, see (Figure 32) portion of Dwarsfontein for £15 000 and this gave the company access to the extensions of the lode of the 'main mine' of TSM.<sup>19</sup> They estimated that this acquisition would give them access to about 157 000 tons of ore.

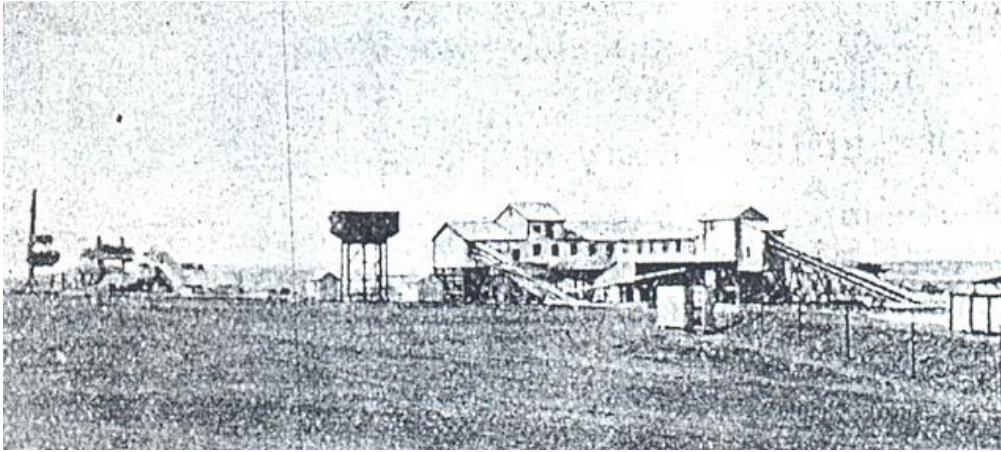
**Figure 33.** Historical photograph of the Argent mine - general view of the 1920s beneficiation plant.<sup>27</sup> The main part to the right of the picture is the incline conveyor leading to the primary crusher and then the secondary crusher plant (see Figs 36 and 37).

The main operation offices and beneficiation plant of the new company were located on the site of the old TSM on the farm Dwarsfontein. The general idea was that ores from the other mines, when and if they were re-opened, would be transported and fed into the new beneficiation operation (Figure 33).

Foundations of the large water tower seen in figure 33

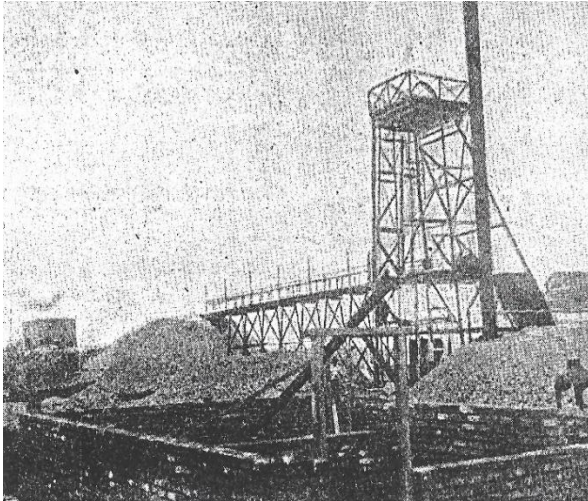
**Figure 34.** Historical photograph of the 1920 steel headgear installed at TSBM No 1 shaft.<sup>32</sup>

A new headgear was erected at the old TSM shaft (Main mine) (Figure 34). Dewatering was continued and completed to the 140 ft. (42 m) level or about 17 ft. (5 m) below the first level of the mine. It was expected that the dewatering of the remaining levels of the mine would be completed fairly quickly once the new Tangye air compressor and its associated air lift system had been installed.<sup>29</sup>

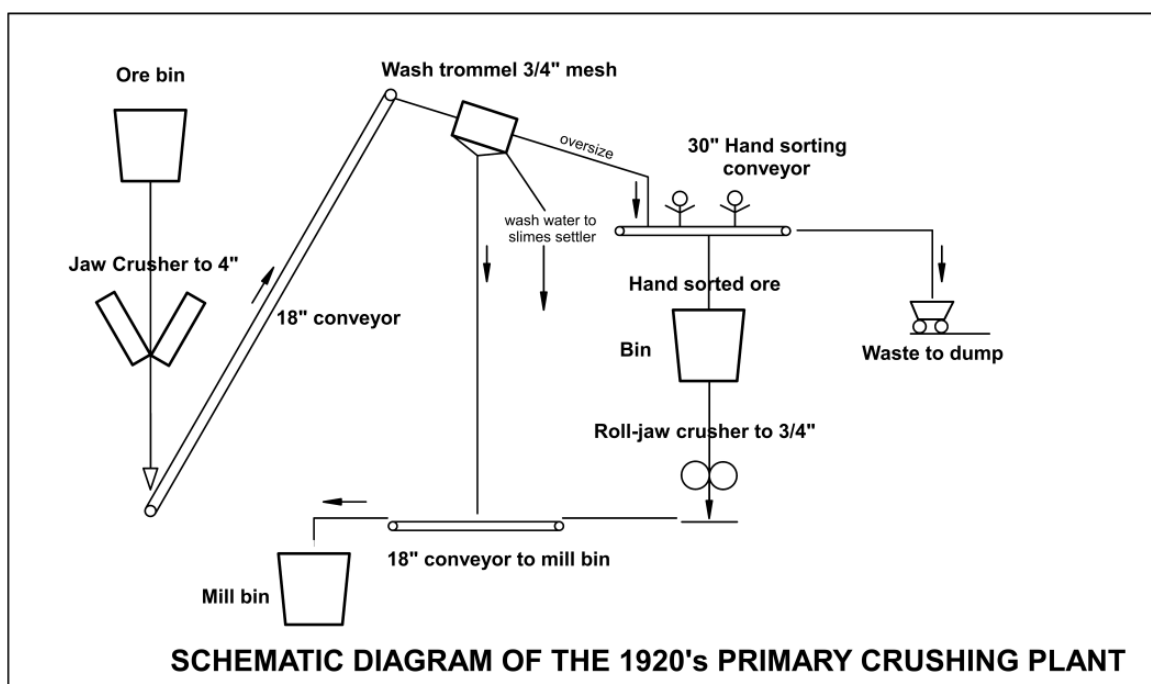
**Figure 35.** Flow diagram of the Crushing process at the TSBM mine c 1919-1926 based on part of the original Flow sheet,<sup>50</sup> and text descriptions (Clayden 1922). (Drawn by G. Reeks).

Once the ore had been delivered to the surface, it was transferred to an ore bin and then passed to a Jaw Crusher<sup>48</sup> where, according to the flow diagram (Figure 35), it was reduced to 4” (100 mm) pieces. The make and model of this Jaw Crusher does not appear in the TSBM records, but it was probably a Blake Jaw Crusher, described in the previous chapter, as this was the most common make of crusher at the time other than stamp mills. The crushed ore was carried via a bucket conveyor to a washing trommel, with a ¾” (19 mm) mesh size. The oversize was passed to a hand sorting belt where any waste rock was removed and transferred to the dump. The hand- picked ore was conveyed to two Sturtevant roll-jaw crushers, (size 20” x 6”) (Clayden 1922) where it was reduced to ¾” (19 mm) mesh size and merged with the trommel fines and then conveyed to the mill bin. The Sturtevant roll-jaw crushers are similar to the Cornish Roll Crusher described in the previous chapter.

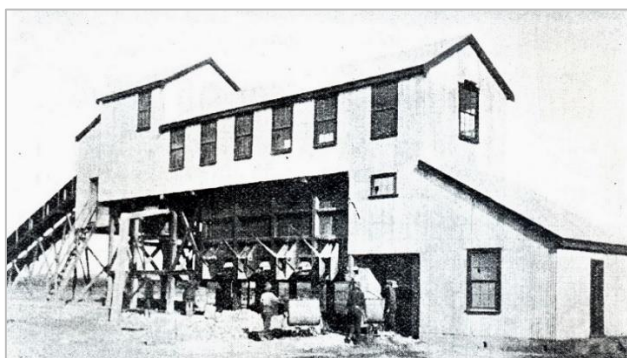
**Figure 36.** Historical photograph of the Primary crusher and sorting station showing incline conveyor that fed rock to the jaw crusher and secondary crusher machinery.<sup>51</sup>

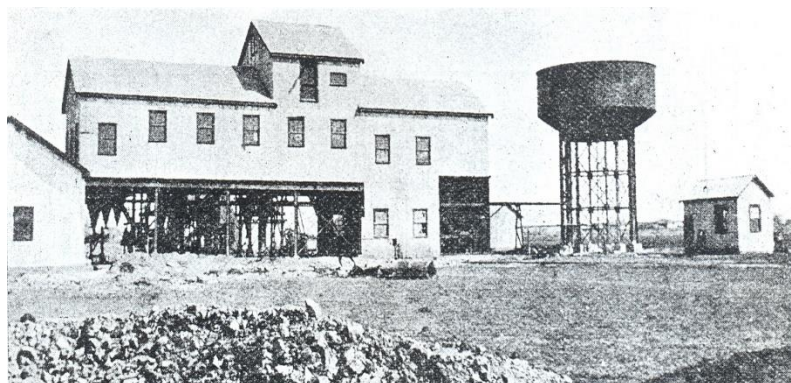
**Figure 37.** Historical photograph of the Secondary crushing plant which contained the wash trommels, crushing rolls and Harz jig machines (Clayden 1922).<sup>58</sup>

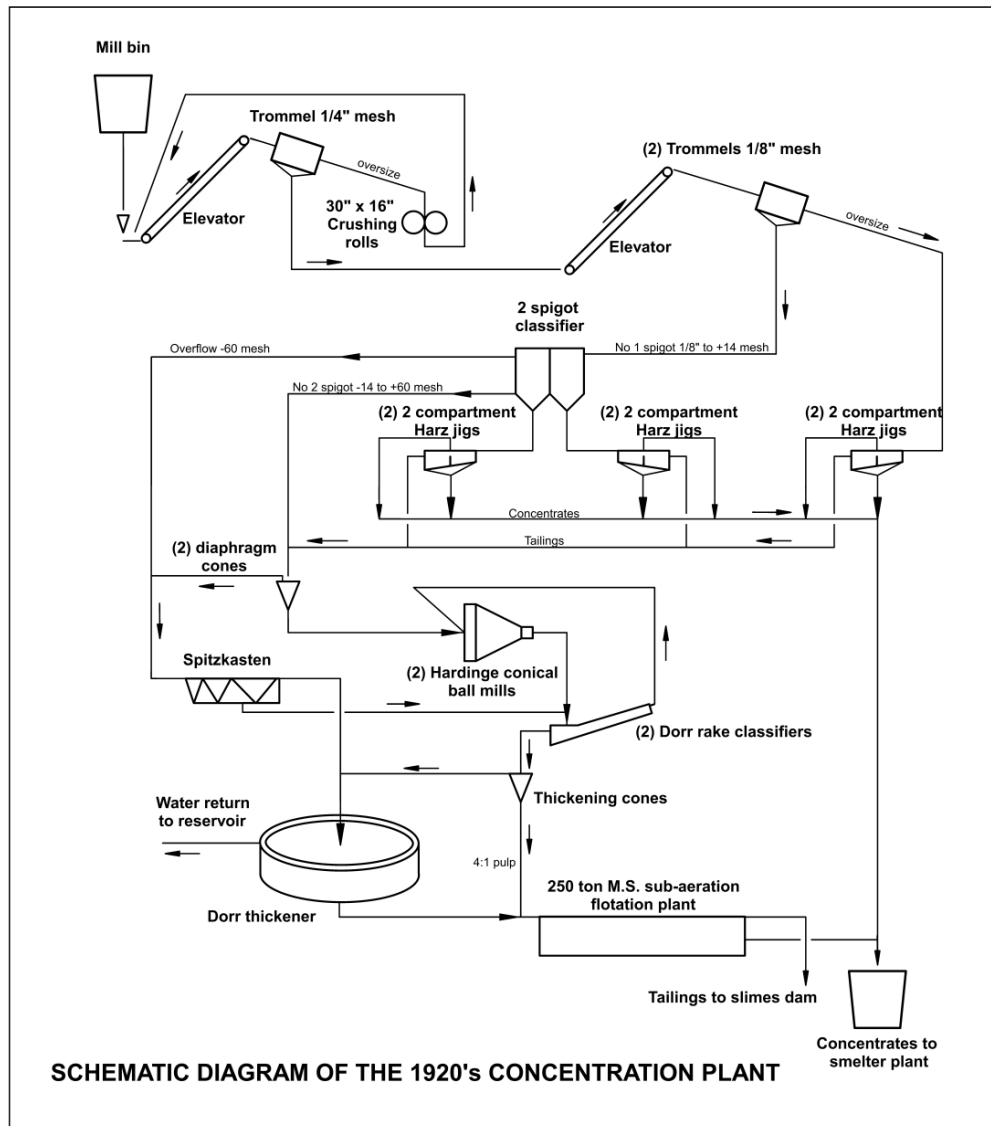
**Figure 38.** Schematic diagram of the Concentration process at the TSBM mine c 1919-1922 based on part of the original Flow sheet,<sup>62</sup> and text descriptions (Clayden 1922). (Drawn by G. Reeks).

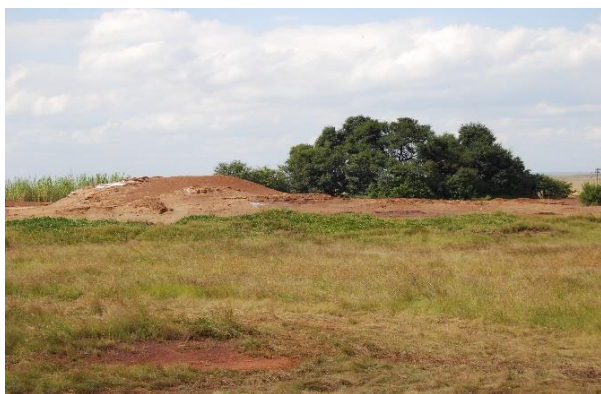
**Figure 39.** Photograph of part of the slimes dam in 2017. (G. Reeks photo).

From the two diaphragm cones, the coarse material went into two Hardinge Conical Ball Mills - 6ft. x 22" (2 x 0.6 m) - for further refined grinding, each being capable of grinding 100 tons per day.<sup>59</sup> In 1920 this was a very new technology in the field of fine grinding. The finer overflow from the Diaphragm Cones joined with the overflow from the 2 Spigot Classifier and it went through a Spitzkasten machine, the overflow of which went to a Dorr thickener (Clayden 1922).<sup>60</sup> The underflow from the Spitzkasten was routed to the Dorr Classifiers. The output from the Dorr Classifiers went into Thickening Cones with the overflow material joining with the overflow from the Spitzkasten and both were de-watered in a Dorr Thickener (Clayden 1922).<sup>61</sup> The slimes from the Dorr Thickener was pumped to the slimes dam where it was contained until it became solidified (see figure 39).

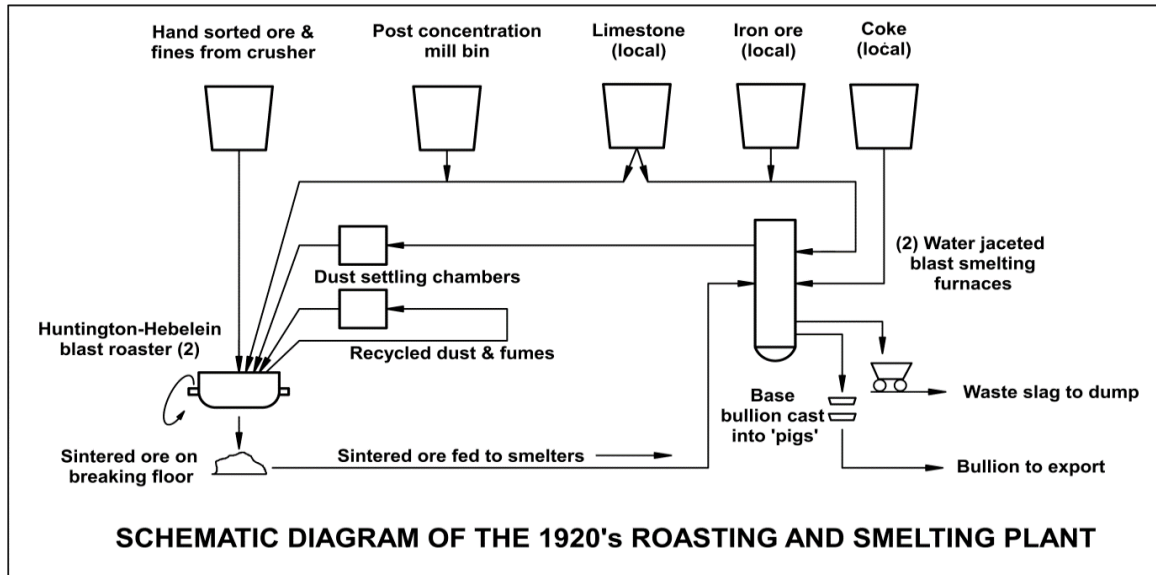
**Figure 40.** Schematic diagram of the 1920s roasting and smelting process. Based on part of the original Flow sheet,<sup>69</sup> and text descriptions (Clayden 1922). (Drawn by G. Reeks).

The schematic diagram (Figure 40) also shows the final process of smelting in the blast furnaces and the production of base bullion. The smelting plant consisted of two water-jacket blast furnaces.<sup>80</sup> They had been designed to be capable of producing up to 500 tons

The 'charge' of the water-jacket blast furnaces consisted of the agglomerated roasted concentrates, as shown on the diagram (Figure 40), limestone, iron ore and coke. The coke was obtained from a colliery in Vryheid, while the limestone came from a local unnamed source.<sup>82</sup> The iron ore was apparently mined on the property of TSBM.<sup>83</sup> Both the iron ore and limestone were added as fluxes to the smelting process.

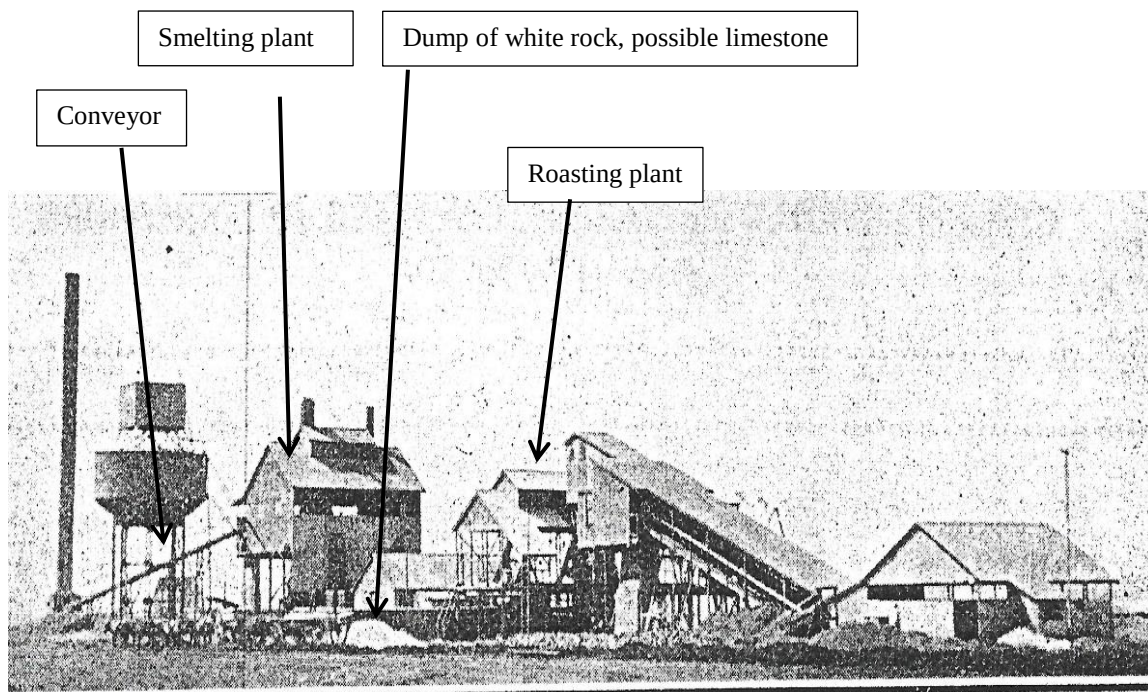
**Figure 42.** Historical photograph of the smelting and roasting sintering plant at TSBM c1922.<sup>75</sup>

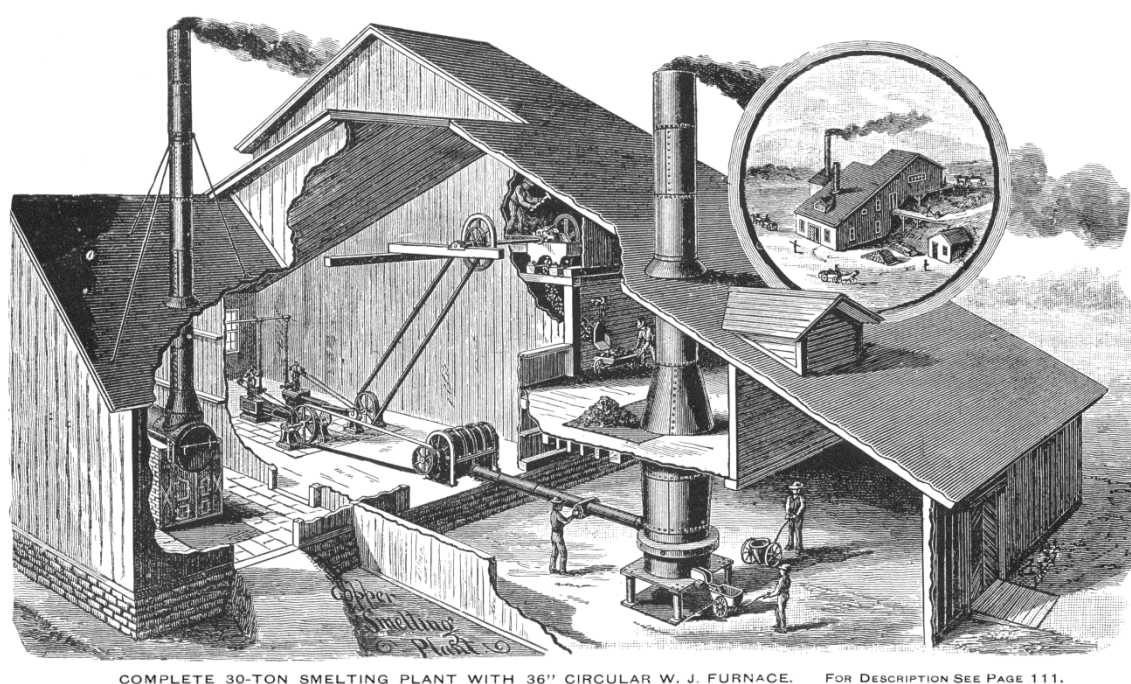
**Figure 44.** Artist's impression of a smelting plant for copper or lead ores using a water jacket blast furnace. c1890s through to 1920s. Such a plant is similar to what would have existed at the TSM and TSBM mine at Argent in the 1890s and 1920s.<sup>84</sup>

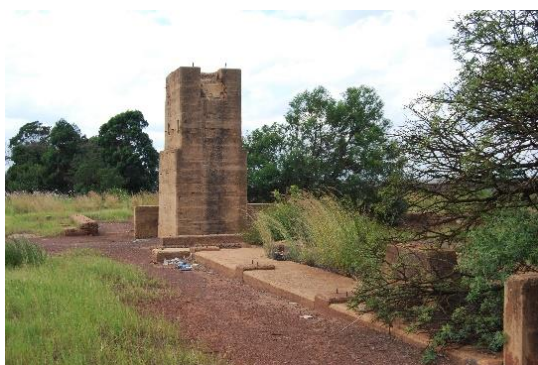
**Figure 45.** Foundations of the Roasting plant 2016.  
(G. Reeks Photo)

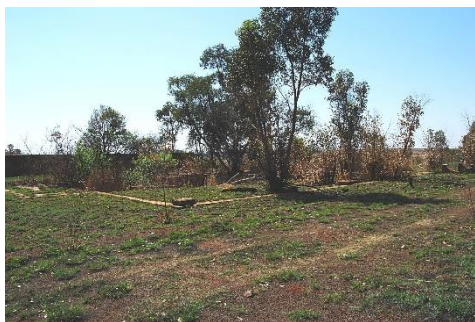
**Figure 46.** Corner foundations of boiler house

The remains of the boiler house have been looked at in detail and the foundations of the boilers and generator coupled with building foundations, are still in very good condition. The photographs (Figures 46-49) offer a number of views of the foundations.

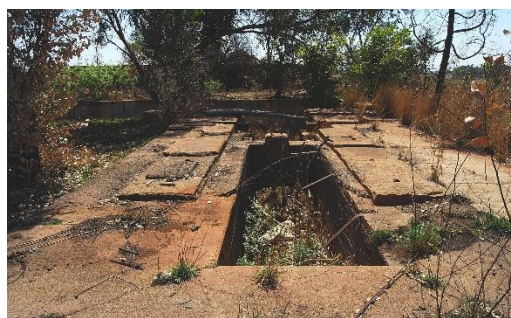
**Figure 47.** Foundations for two boilers

second boiler had been installed in the generating plant.<sup>89</sup> Clayden (1922) stated that they had increased the number of boilers to three and each boiler was rated at 350 hp. An earlier mention in the sources of two 100 hp boilers is now believed to refer to the power units for the number 1 shaft winding engine installed in 1920 and which was later upgraded.<sup>90</sup> Clayden (1922) noted that most of the small equipment was purchased as ‘out of use’ machinery on the Rand, and that this equipment was acquired from General Mining’s gold mines.

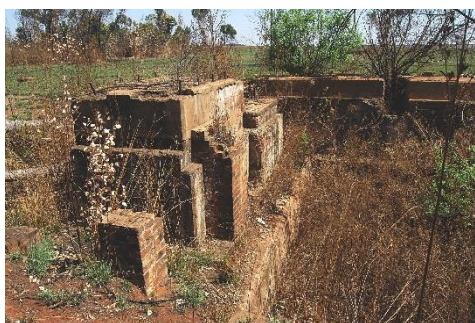
**Figure 48.** Generator foundation
