# **ARCHAEOLOGY OF THE INDUSTRIALISATION AND SOCIAL DEVELOPMENT AT A SILVER MINE IN THE GREATER PRETORIA REGION FROM 1889 TO 1927**

**Graham Walter Reeks**

A thesis submitted to the Faculty of Science, University of the Witwatersrand,  
Johannesburg, in fulfilment of the requirements for the degree of Doctor of Philosophy

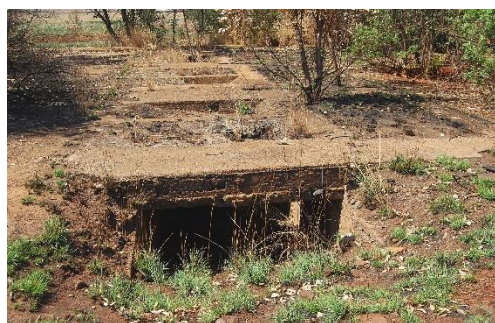
**Figure 49.** Ash chutes to lower railcar line used to carry ash to the dump.

The remains of the boiler house have been looked at in detail and the foundations of the boilers and generator coupled with building foundations, are still in very good condition. The photographs (Figures 46-49) offer a number of views of the foundations.

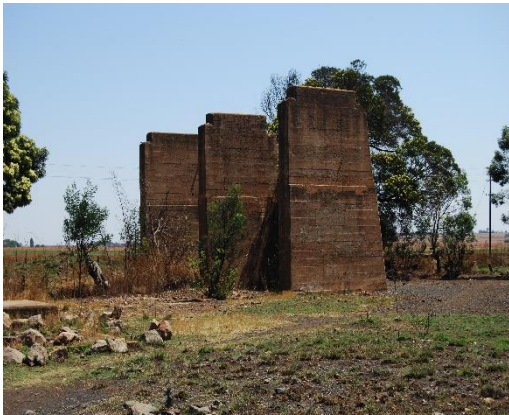
**Figure 51.** Foundations of the smelter furnace (Photo by G. Reeks)

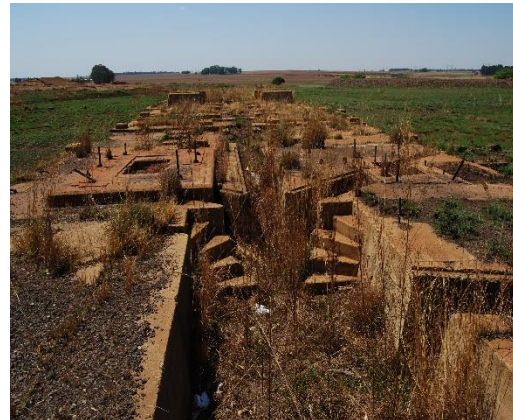
**Figure 52.** Foundations of the ball mills and the flotation plant. (Photo by G. Reeks)

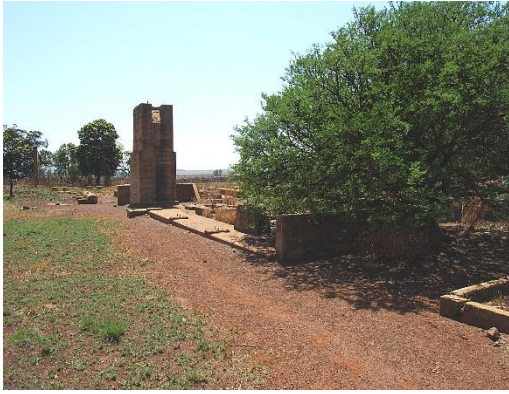
**Figure 53.** Foundations for the roaster pots. (Photo by G. Reeks)

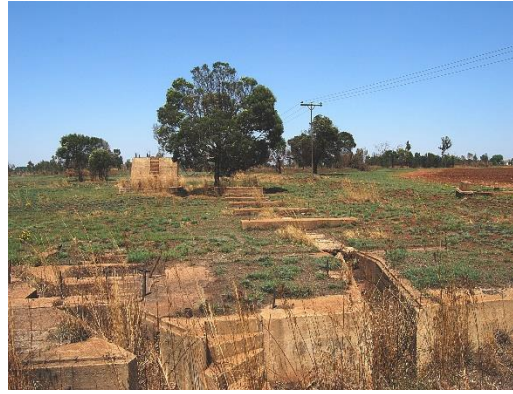
**Figure 54.** Foundations of the primary crusher plant. (Photo by G. Reeks)

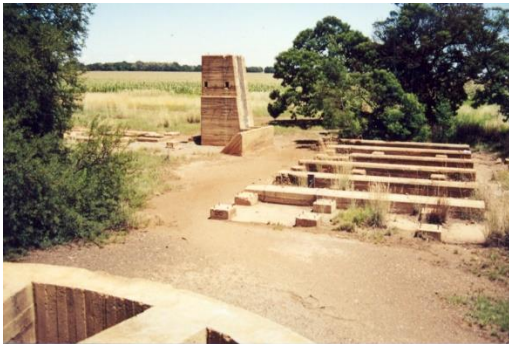
**Figure 55.** Foundations for roaster station. (Photo by G. Reeks)

The photographs (Figures 51-58) capture some of the substantial reinforced concrete foundations of the 1920s TSBM beneficiation plant. For example the smelter foundations measure approximately 1.2 x 6 x 10-15 m high (Figure 51). The roaster foundation is a solid block of concrete measuring 3 x 4 x 8 m high (Figure 53).

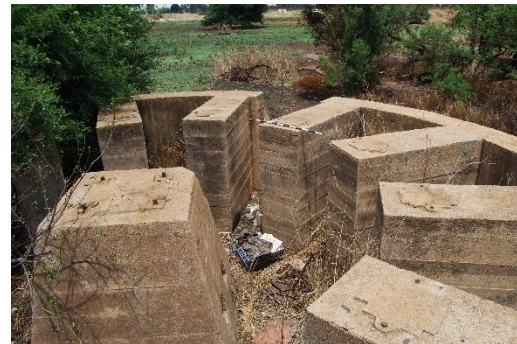
**Figure 56.** Foundation of part of the Godfrey roaster. (Photo by G. Reeks)

On many of the wall foundations, the foundation bolts cast into the concrete help reveal that the vertical structural part of the buildings were steel columns. Many of the pictures of the concrete foundations (Figure 56 and Appendix 8) show the marks of the shuttering in the form of parallel lines on the vertical faces. They also reveal the complexity of some of the foundations.

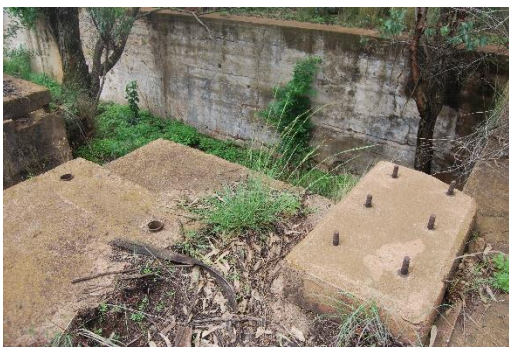
**Figure 57.** One of the foundations in the Boiler house showing machine bolts. (Photo by G. Reeks)

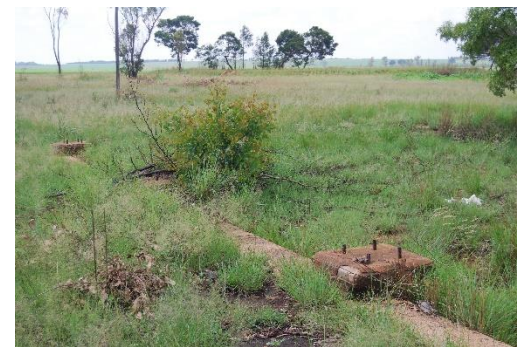
**Figure 58.** External wall foundations showing bolts for structural steel (Photo by G. Reeks)

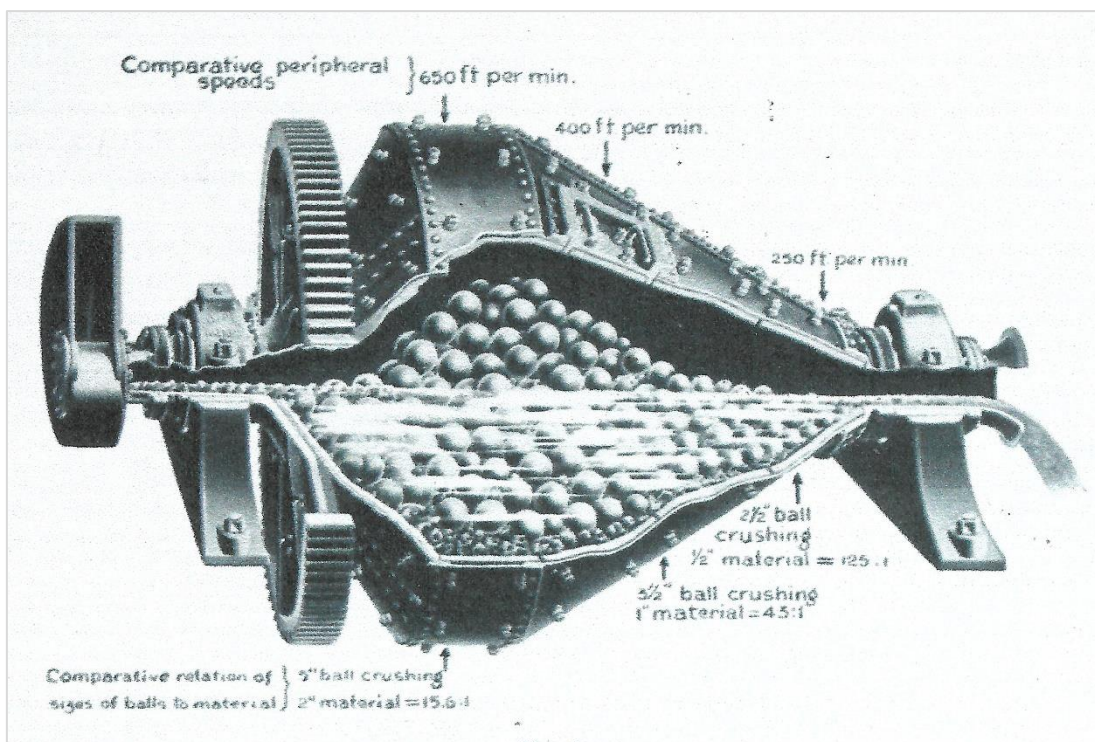
**Figure 59.** Hardinge Conical Ball Mill.<sup>17</sup>

The significance of the Hardinge Conical Ball Mill was its increase in the efficiency of grinding, coupled with lower energy requirements needed to drive the mill (Lynch and Rowland 2005:108). On entering the mill, the material drops to the point of the largest diameter of the cone. At this point it comes into contact with the largest of the balls and because it is the largest diameter of the cone the periphery of the cone is travelling at the

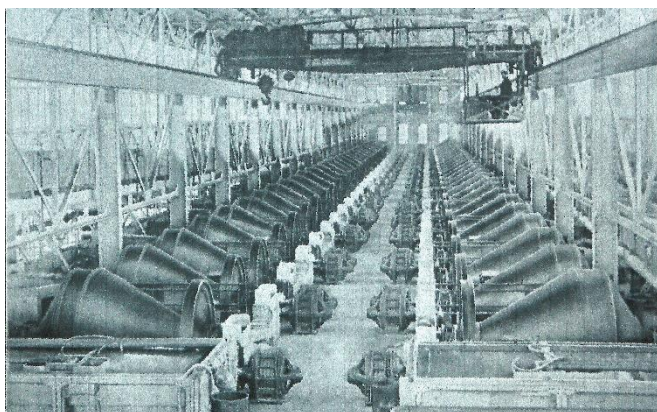
**Figure 60.** An early example of the significant use of Hardinge Conical Ball Mills at the Calumet and Hecla Mine, Michigan, USA in 1910.<sup>19</sup>

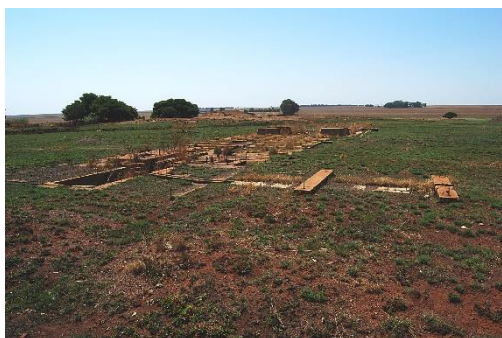
**Figure 61.** Foundations of the Hardinge Conical ball mill. (G Reeks photo)

The clear water from the Thickener was sent to the return water pumps for re-use.<sup>63</sup> Unfortunately no photographs have been found showing the Ball mill part of the plant, but substantial, well-constructed reinforced concrete foundations still exist where the ball mills were located.

It has not been possible to ascertain which mine in South Africa was the first to install Hardinge Ball Mill technology. It is known that the Hardinge mills were installed at TSBM in 1920-21 and so it is possible that these machines were the first of their type in South Africa. The mills installed at TSBM were Hardinge Conical Ball Mills type 6ft. 22", in other words the largest diameter was 6ft. (2 m) and then the cone part would have been about 4 ft. (1.5 m) diameter. The overall length of the mill was nearly 16 ft. (5 m).<sup>22</sup>

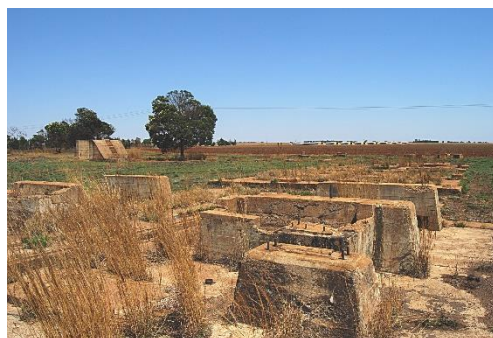
**Figure 62.** The plinth supported the bearings of the Hardinge Conical ball mill. (G Reeks photo)

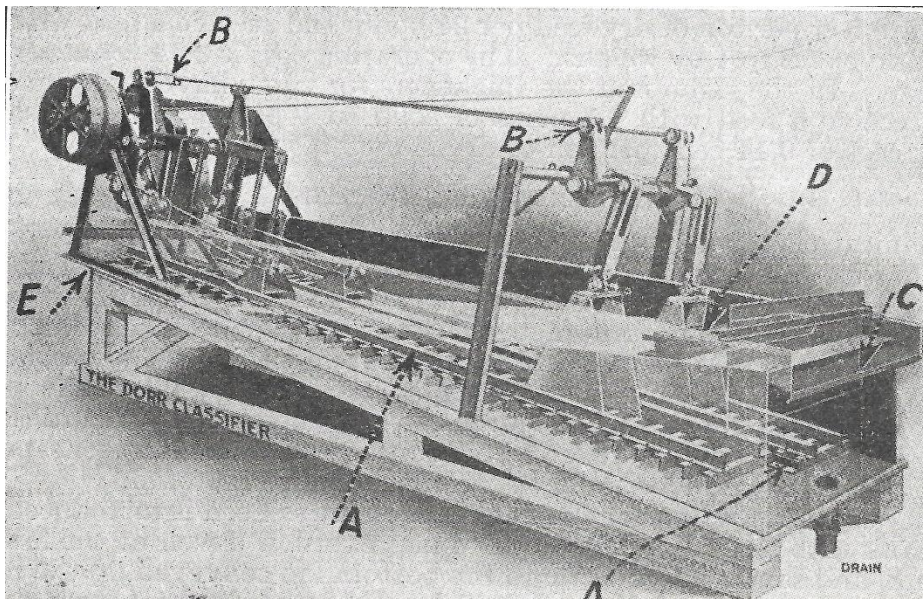
**Figure 64.** Dorr Rake Classifier (Richards & Locke 1940:164).

In 1894, a young student, John Van Nostrand Dorr (Figure 63) obtained a BSc in chemistry from Rutgers University in the USA (Haynes 1983:109). He became an industrial chemist and in the early 1900s began working on a gold mine in south Dakota USA, specifically on the separation and treatment of fine solids (Haynes 1983:109). The introduction of the tube mill in 1904 and the later Hardinge Ball Mill in 1907 led to the development of a more efficient classifier - the Dorr Rake Classifier (Figure 64).

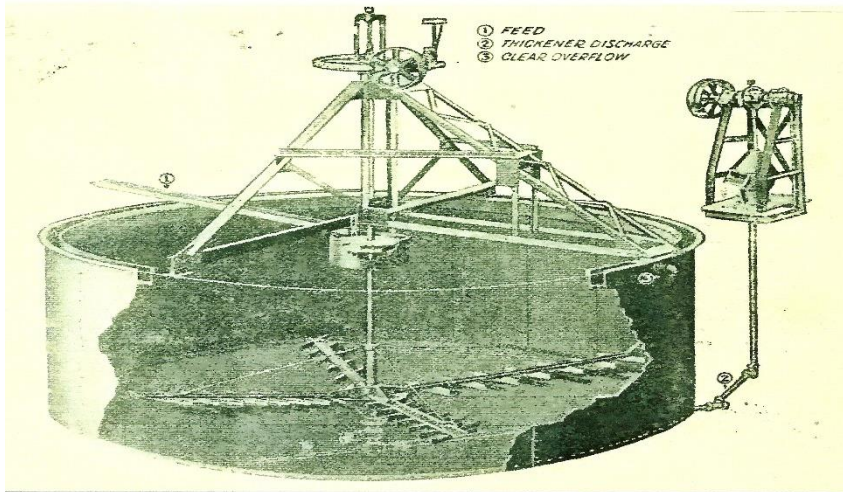
**Figure 66.** Dorr Thickener. (Truscott 1919:274)

In some cases modern ones can be as large as 40 m diameter.<sup>26</sup> Their primary purpose is to remove the excess water from a pulp of water and fine solids (Truscott 1923:274). In 1915, a patent was granted to Dorr for his invention of the circular thickener.<sup>27</sup> The diagram below shows the principal actions of the machine (Figure 67). The conical ball mill and flotation technology needed to use an excess of water in the mineral dressing technologies, but at one stage in the process, the excess water had to be eliminated.

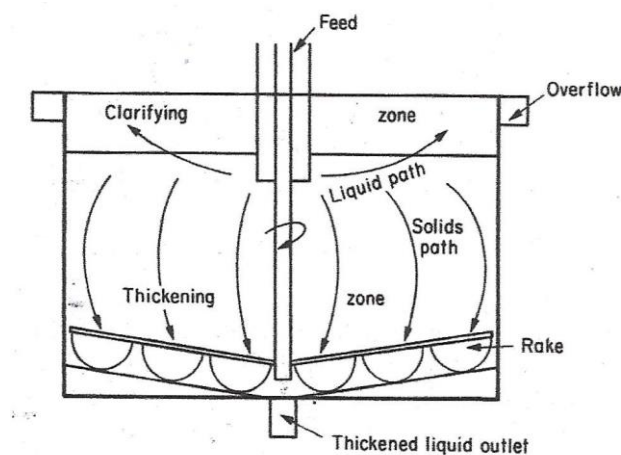
**Figure 67.** The principle of action within a Dorr Thickener (Wills 1979:376).

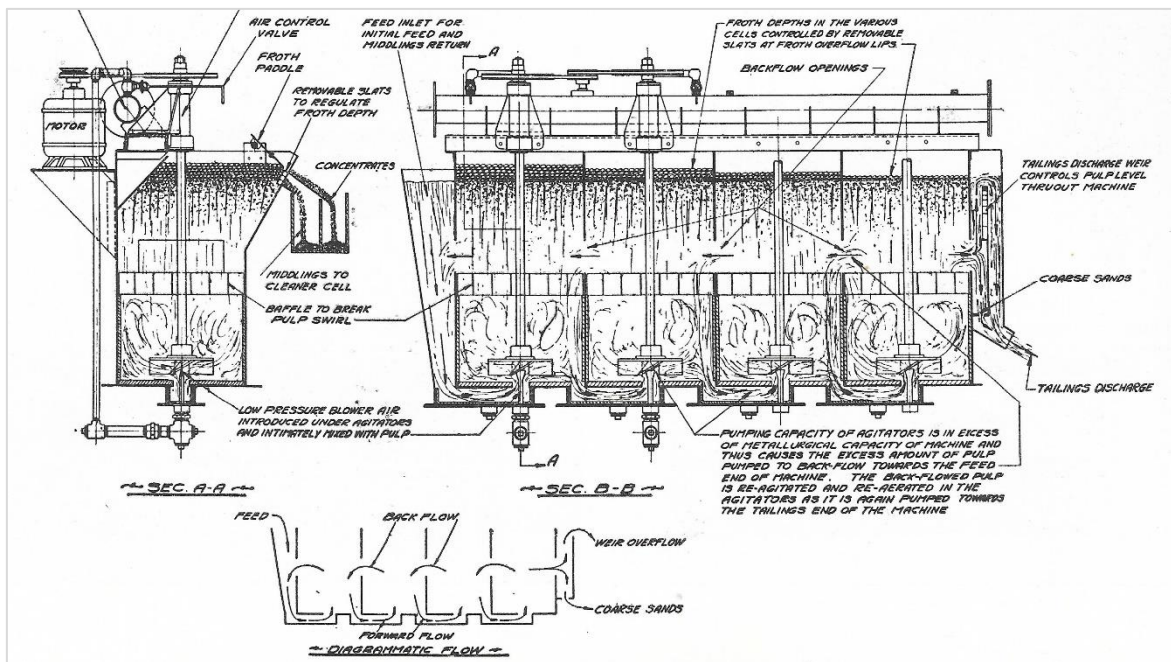
An impeller, which provided the aeration and flow, was positioned close to the bottom of the individual cells. The TSBM machine had 10 cells.<sup>45</sup> There were two compartments in each cell. At the bottom, an agitation area and directly above it a baffle to break the pulp before entering the frothing compartment. The froth rose to the surface and was either removed mechanically or overflowed the lip of a weir. The tailings sank to the bottom of the cell and passed through an opening into the agitation compartment of the next cell where the process was repeated (Truscott 1923:399-415; Richards & Locke. 1940:251-260)

**Figure 68.** Drawing showing the flows and principle parts of a Minerals Separation Ltd Sub-Aeration Flotation Cell machine. (Richards & Locke. 1940:253).

In a Minerals Separation sub-aeration flotation machine (Figure 68), the pulp was introduced into the first cell and in the earliest machines the principle of a counter-flow from the aeration compartment of a cell to the previous cell was not incorporated in the design.

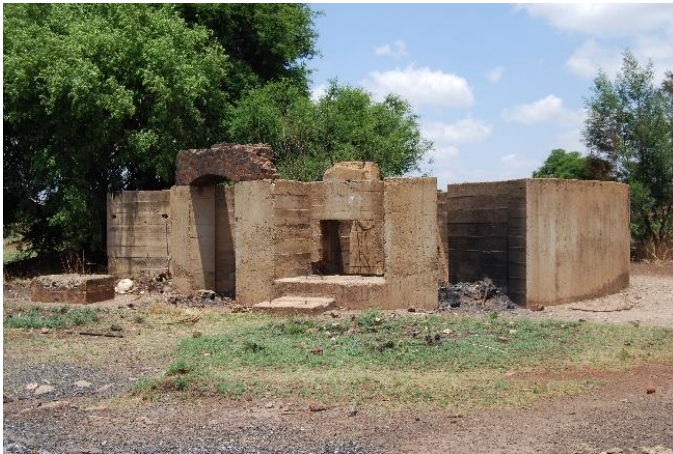
**Figure 69.** Concrete foundations for the Godfrey type Roaster at the TSBM mine. (G. Reeks photo).

The Godfrey rotary roaster, used for the recovery of the copper matte and possibly used to preheat/roast some of the ore before charging the Huntington-Heberlein furnaces, appears to have been installed or constructed around February 1924 when it was decided to treat the copper matte.<sup>50</sup>

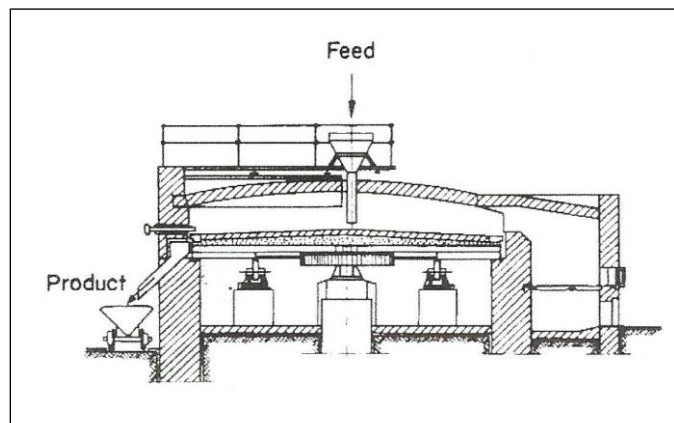
**Figure 70.** Godfrey type of rotary roasting or sintering furnace. (Habashi 2005)

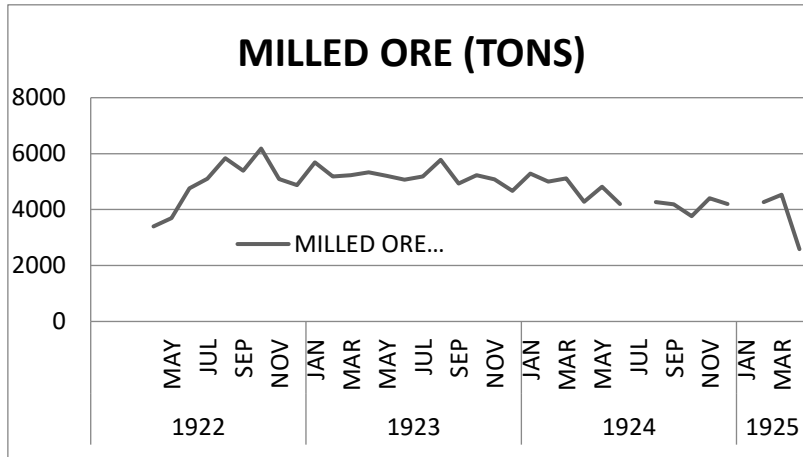
**Figure 71.** Graph showing milled ore at the TSBM mine, 1922 – 1925

The two graphs (Figures 71 & 72) were created to see if there was any possible relationship between tons milled and assay values of the ore. The results are, I believe, inconclusive. The only impression with the tons of ore milled is that there were a few peaks. Namely Oct 1922; Jan 1923; Aug 1923; Jan 1924 and May 1924. It was thought there may have been a link with the assay values falling below an ideal level or 'mill grade' and thus a need to mine more ore or richer pockets of ore to bring the values up for the month. The results are inconclusive. As can be seen in Oct 1922 and Jan 1923 the values rose marginally, but in Aug 1923 the value of lead had been flat since May, although there was a slight rise in silver. In Jan 1924 there was an increase in tonnage milled, but a significant drop in the values of

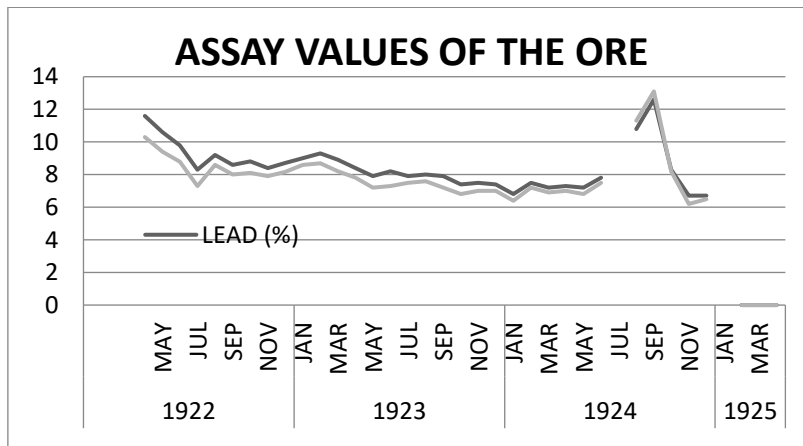
**Figure 72.** Graph showing assay values of lead and silver at the TSBM mine 1922-1925

both metals, followed by a return in Feb – May 1924. Then in Sep 1924 despite very high peak values for lead and silver the amount of ore milled was fairly flat at around 4 000 tons.

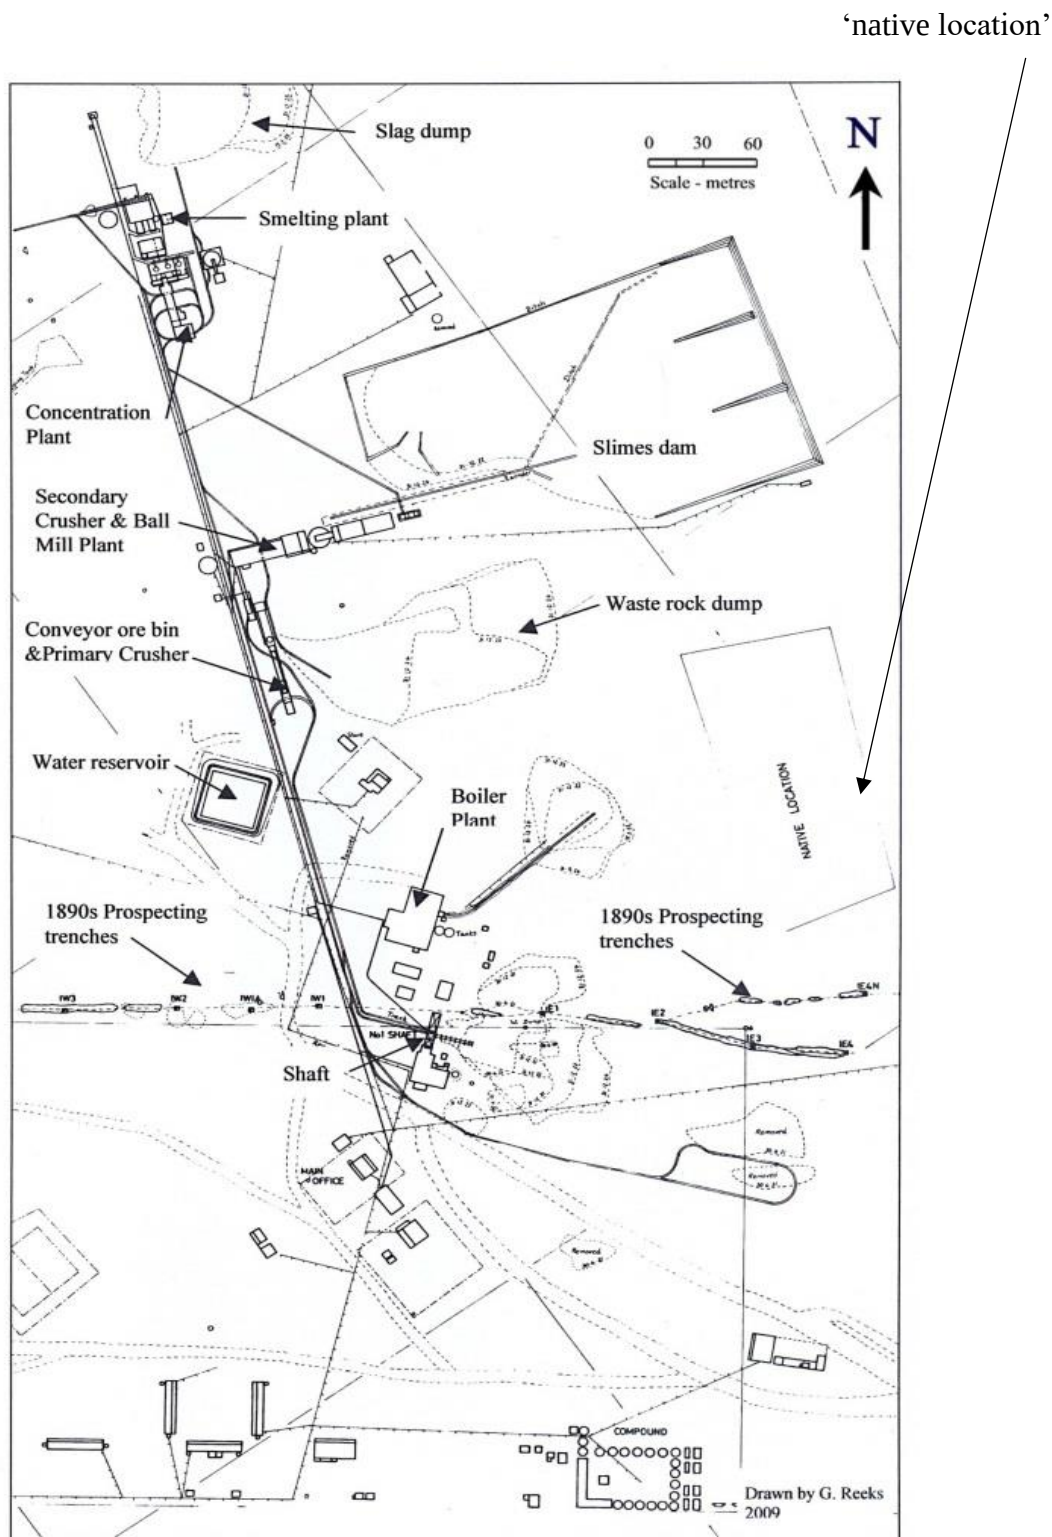
**Figure 73.** Part of the 1920s surface plan of the TSBM mine plan (Drawn G. Reeks).

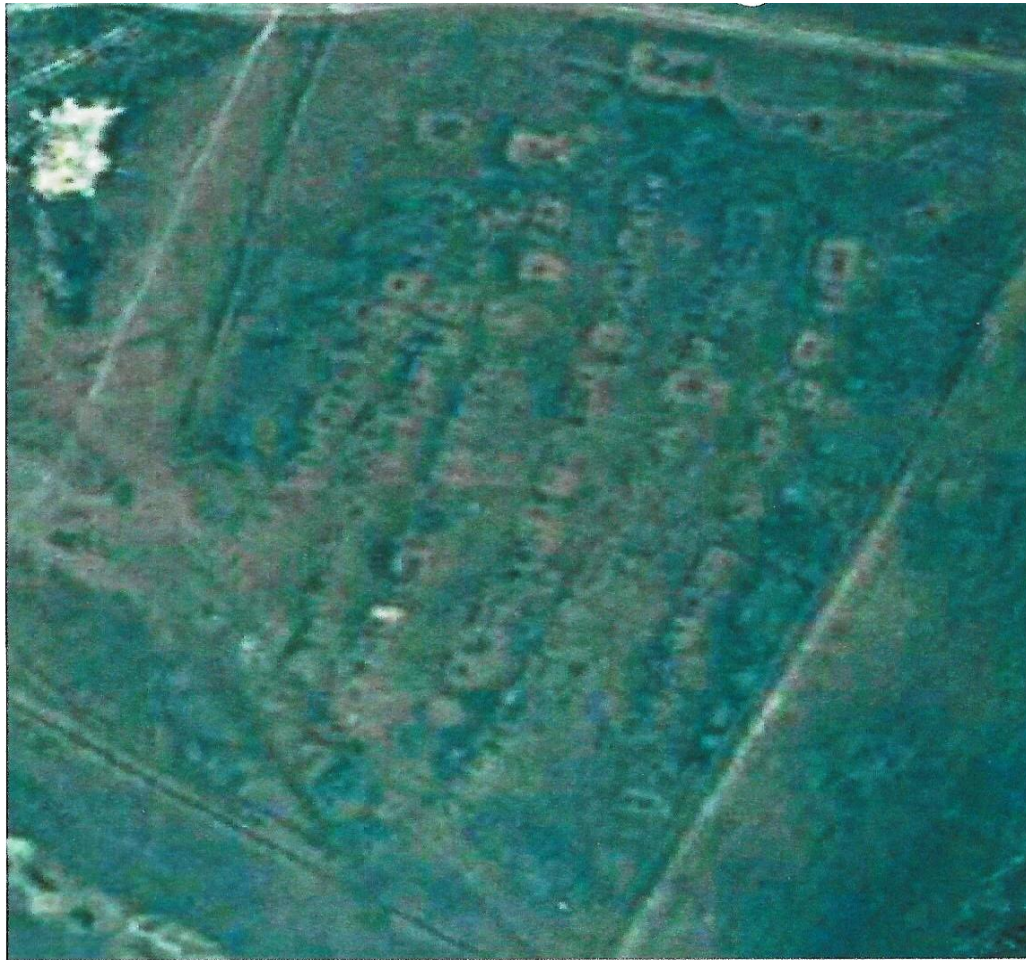
Six rows of foundations are clearly identifiable in (Figure 74). The image has been manipulated to enhance the foundations and the colour contrast altered which resulted in areas with a turquoise colour. When these areas were compared with the pedestrian survey records, there appears to be a degree of assimilation with the known middens. The row of foundations on the extreme left have the major middens of all sizes effectively outside or west of the structures. The foundations on the extreme right show a similar pattern, but with the middens to the east. To the north, or top of the picture, two features are visible - a turquoise area, which is in the position of M8, and a large rectangular structure just north of it. The latter was investigated, but apart from a large rectangular hole approximately 1 m deep, no foundations or bricks were observed. The light area of soil in the picture may indicate disturbed soil, such as you would have around deep foundations. If it was a structure, bearing in mind that the hole is approximately 15-20 m x 10 m. it could possibly

The primary archaeological site is at the top half of the image. This image shows that the original ground based satellite survey conducted in 2014, during which 33 foundation structures and 49 middens were mapped, along with areas where nothing was located, was actually incomplete. The aerial image showing both surface and sub-surface features raises the count of potential foundations to 93 and middens to 57.

**Figure 74.** An aerial image of the 1920s ‘native location’ at the remains of the TSBM mine. Aerial image taken from Google Earth <sup>TM</sup> satellite image of the region.

The spatial layout of the 1920s ‘native location’ as shown on (Figure 74) clearly shows six rows of foundation structures. What is unclear is why the lines diverge or converge as there are no rock outcrops or variations in topography were seen that could have been the primary influence. What is clear from the mine plan (Figure 73) is that even with the ‘native location’

On relooking at the aerial photograph (Figure 74), the mention of the accommodation block for the 168 black mineworkers provides a possible reason for the large, potentially communal midden of M8, as well as the large rectangular shadow on the northern boundary of the site. The lack of middens in the middle of the site can best be explained that if they exist, they are small.

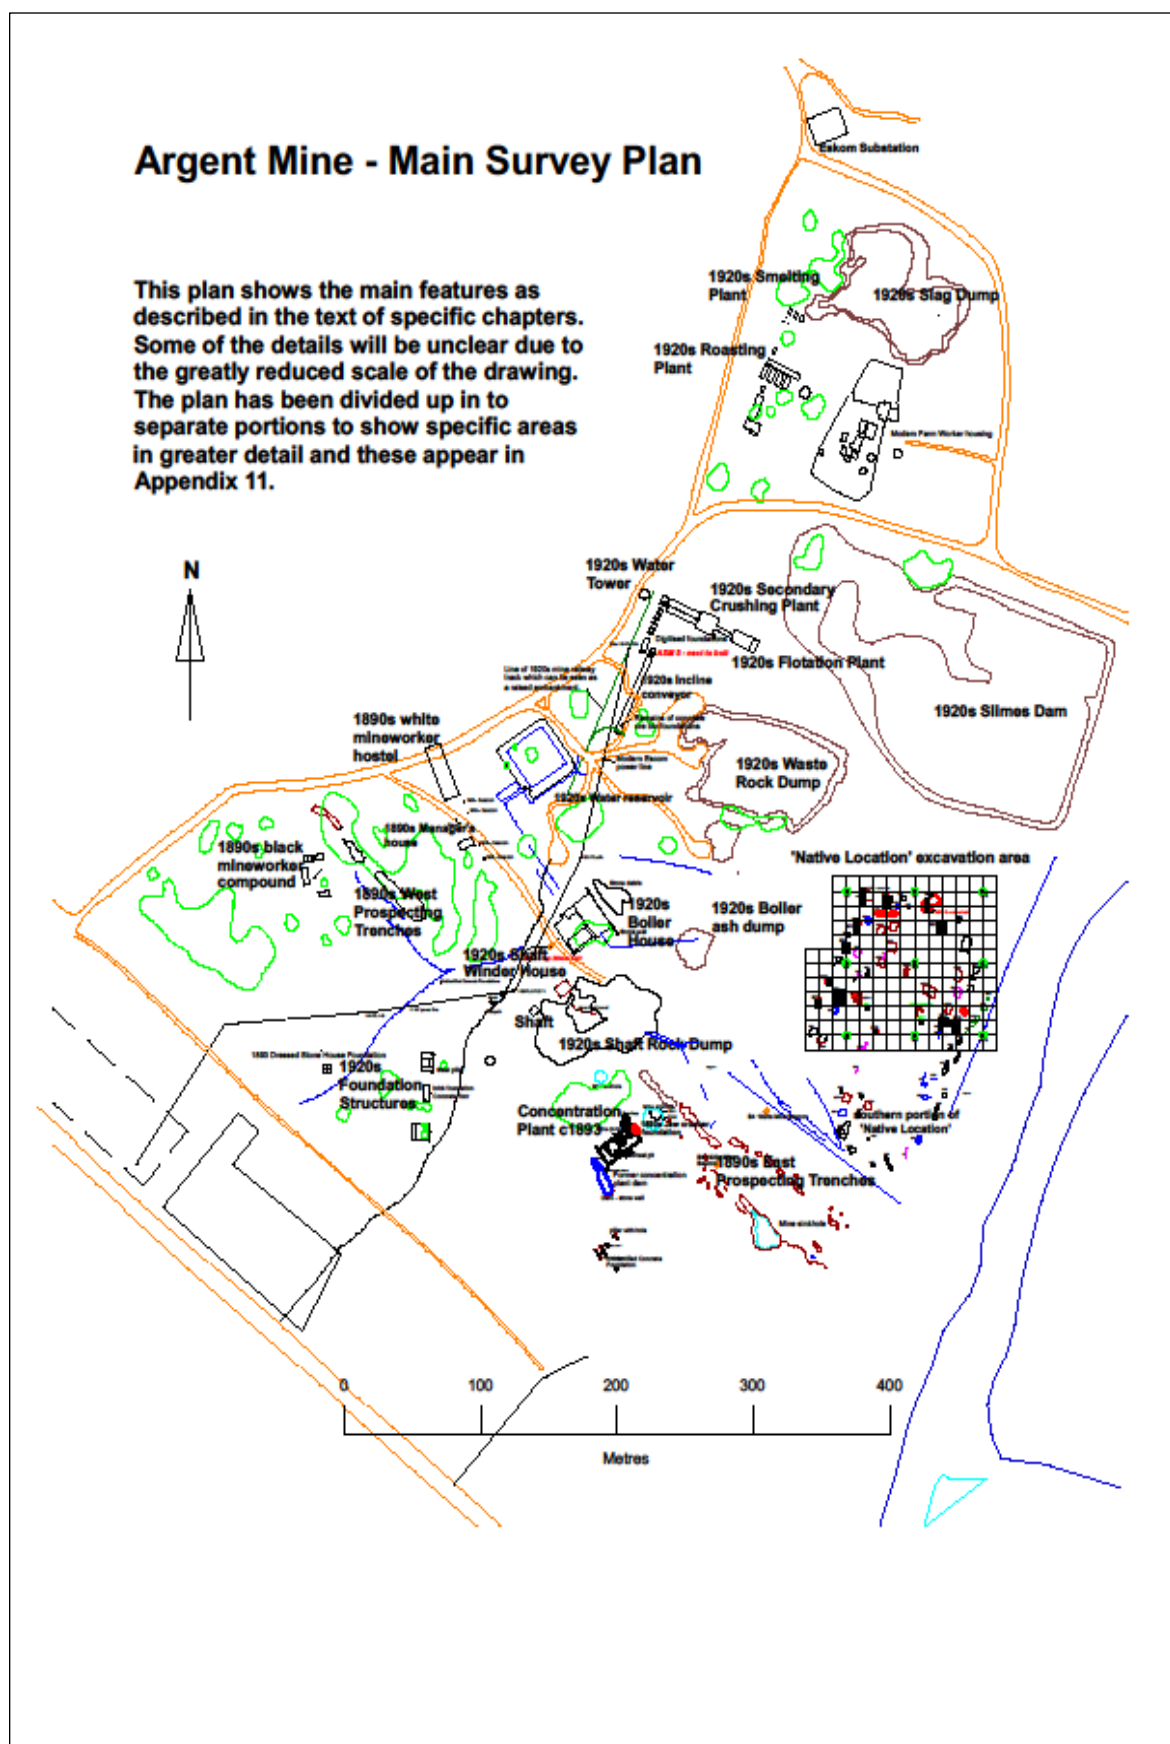
**Figure 75.** Argent mine – main survey plan of surface features and main excavation area.

A detailed map of the mine has been produced showing the main features of both the TSM and TSBM periods. The dirt roads shown in orange are modern. The rectangular back line blocks at the southern boundary represent the sites or areas where the 1920s management housing was located. The green rings represent areas of trees and bush.

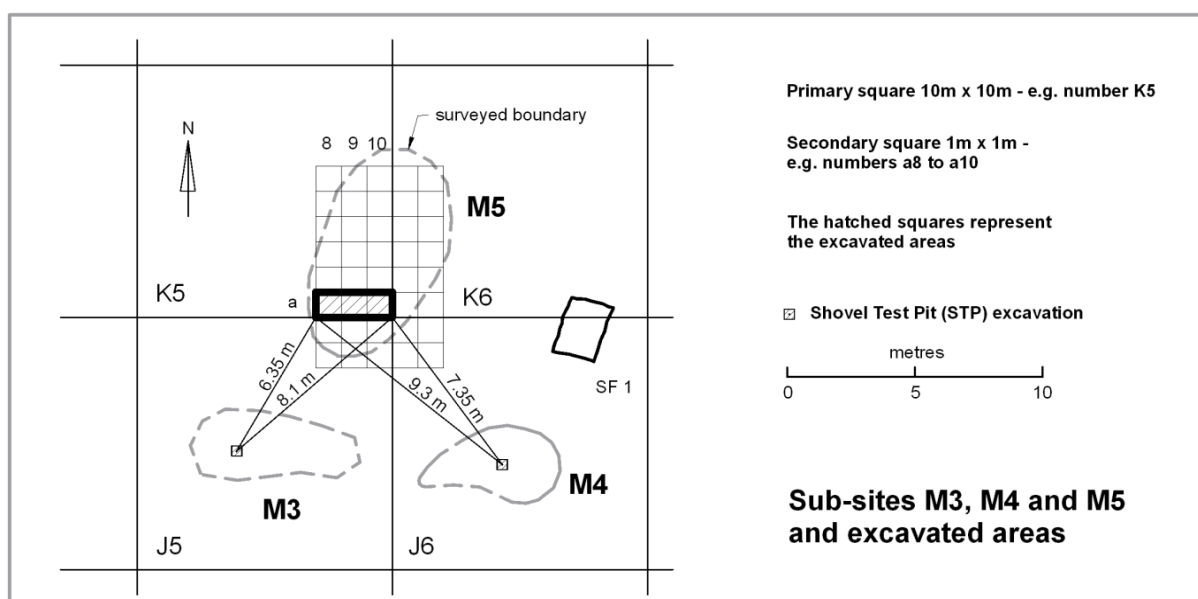
After pegging out a 3 x 1 m area the central square (a9) looked to be the most likely source for artefacts. This assessment was based solely on the grade and colour of the ash, which had produced artefacts on other middens. The soil was a very fine, light grey ash. Layer 1 produced nothing and it looked as if the midden was barren. A 25 x 25 cm STP was put down in the middle of the square, reaching another 20 cm and this also produced nothing. At this point a similar randomly positioned STP was put down 20 cm in square (a10). Once again nothing was found. The height of the midden above ngl was measured to be approximately 50 cm. It was decided to abandon M5 at this point and an STP was excavated in each of the two adjacent small middens, M3 and M4.

**Figure 77.** Sub-sites M3, M4 and M5 and excavated areas

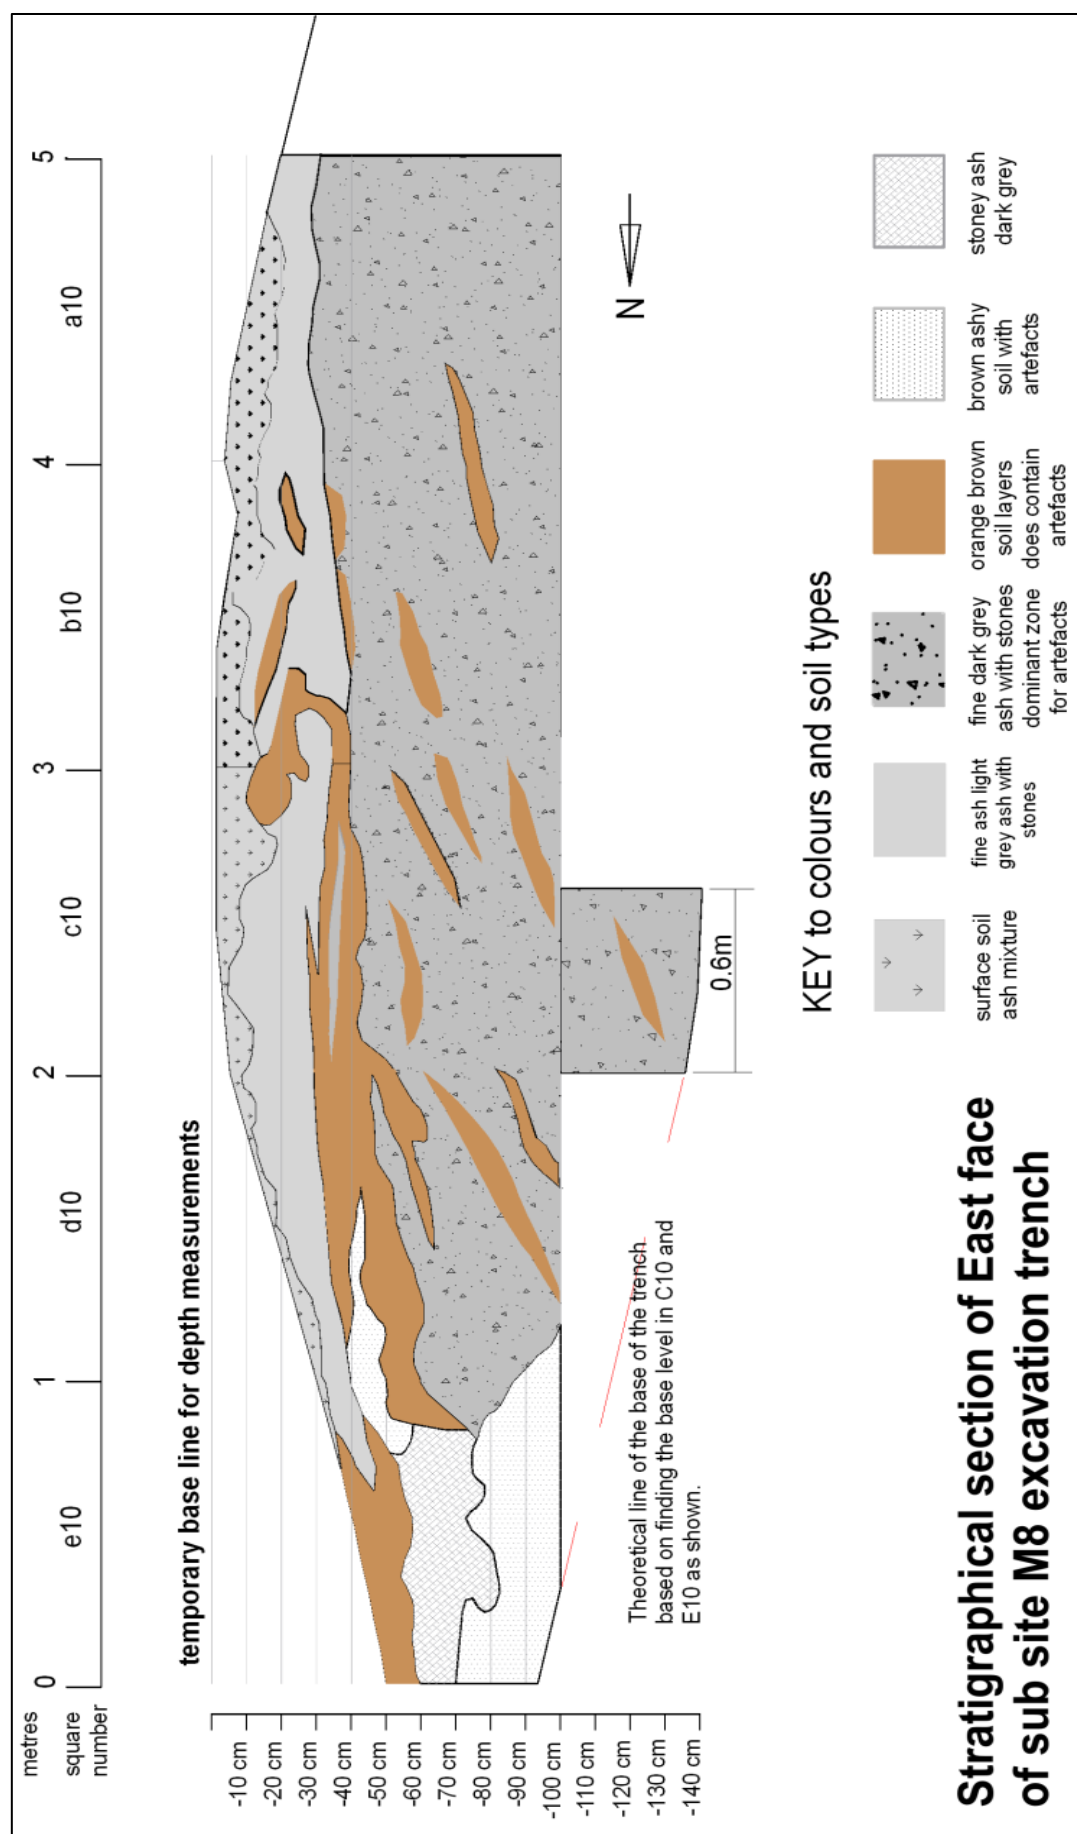
**Figure 78.** Stratigraphical section of the East face of sub-site M8 excavation trench

Midden M8 was the deepest excavation at 1.4m at the base of the STP in square (c10), and the greatest volumetrically at 3.7 m<sup>3</sup>. When another shallow STP was put down in (e10) it became evident that the original soil had been excavated below ngl in a trough shape (see stratigraphic drawing (Figure 79). As an excavation, it eventually produced 4 172 artefacts, with a combined mass of 45.606 kg. This represents about two thirds of the total collection and half the mass of all of the sub-sites.

In the stratigraphical section of M8 (Figure 79), of significance are the bands of orange brown soil. Note how they follow an upward curved direction which possibly indicates that it was localised soil dumped on top of hot or burning ash. The slope possibly also indicates the growth of the dump not only in curved layers, but also in lateral extent, with significantly more soil in a series of bands in (c10) and (d10).

The one outstanding feature of M8, is that although no stratigraphy could be determined in the fine dark grey ash that formed the bulk of the excavation, within it there were small patches of orange brown loamy soil and these followed an incline pattern almost certainly following the slope profile of the midden as it grew in height, and they are clearly illustrated in (Figures 79 & 106).

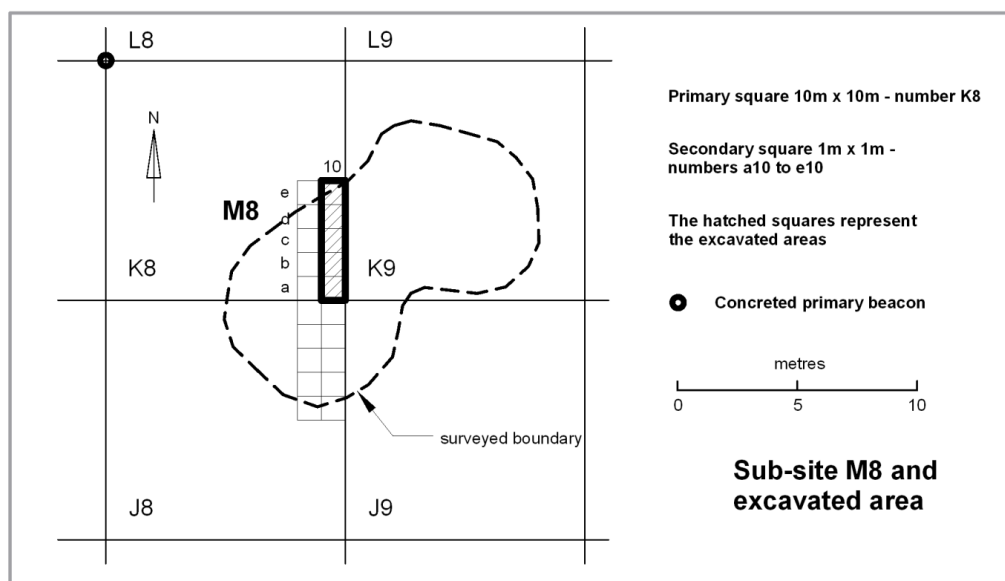
**Figure 79.** Sub-site M8 and excavated area

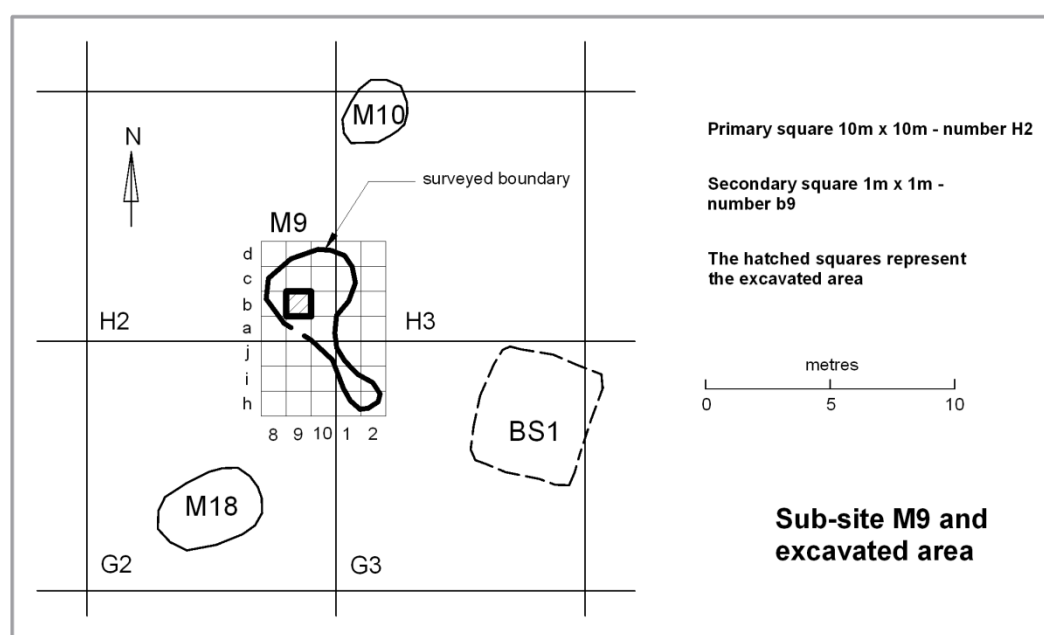
M9 was looked at because of its middle-west position in the main site. It was a low, small midden approximately 25 cm high at the highest point above ngl and in plan 7 m long x 4 m wide. As can be seen on the plan drawing it narrowed down at the one end to approximately 1 m wide. It was decided to excavate a 1 x 1 m square. Within the first 10 cm of excavation only 12 artefacts were found, mostly small ceramic shards of industrial whiteware and porcelain or semi-porcelain tea cups. The one item that did seem totally out of place was a star head jumper drill with very little or no wear to the carbide tips. With a low artefact count and only approximately 15 cm to ngl, a STP was put down in in the middle of the square, but nothing was found and it was decided to close up M9. The significance of the Jumper drill is discussed in Chapter 12

**Figure 80.** Sub-site M9 and excavated area

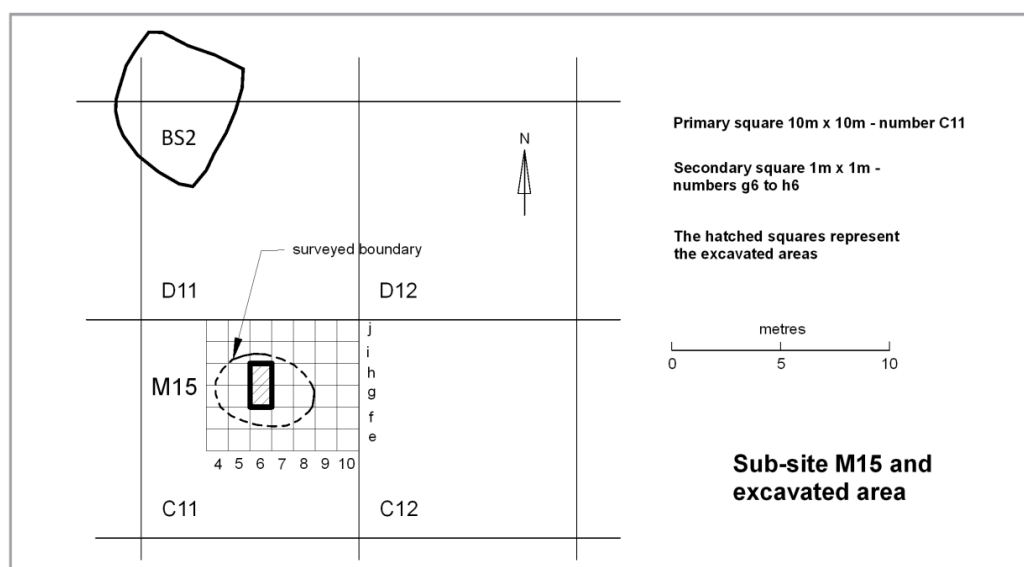
**Figure 81.** Sub-site M15 and excavated area

The midden is approximately 4 m in diameter and was therefore placed in the category of small/medium size. It measured 35 cm above ngl in the middle. It was decided to excavate a 2 m x 1 m area. Initially this was done with the first layer 0-10 cm. As very little was found in the one square (g6) it was decided to stop at the first level, but to continue excavating (h6). This square, eventually via a 60 cm x 25 cm excavation, reached a depth of 40 cm below ngl. A total of 189 bones and bone fragments were recovered with a mass of 0.6 kg. The metal artefact count was also high at 74 artefacts. The total count from such a relatively small excavation was 310 artefacts with a combined mass of 1.2 kg. The excavation of this

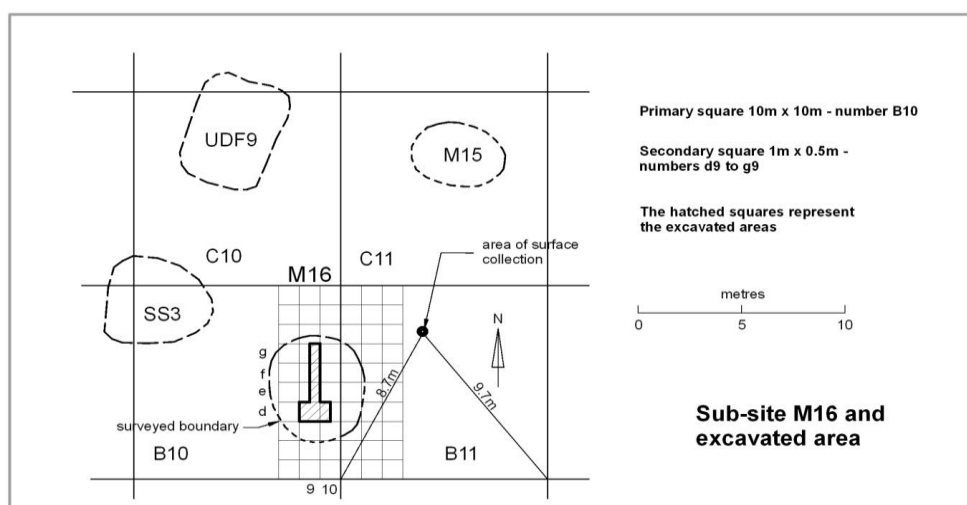
M16 was classified as a medium size midden and although the surface collection was very poor, with only 1 item of glass being recovered, the excavation of the midden developed into the second largest collection of all 5 categories. Volumetrically, it also became the second largest excavation at 1.42 m<sup>3</sup>. It was one of the first middens to be excavated and so led to high expectations regarding artefact count and variety from other middens. The plan below shows that the midden covered an area approximately oval in shape, measuring 5.5 m long x 4.5 m wide and 55 cm above ngl. The profile north - south is interesting in that it appears to have developed as a 'ramp up and dump shape' with all of the different strata following a similar pattern (Figure 83). The material of the midden varied from several soil layers to interlaminated layers of fine grey ash to a brown ashy soil. Just above the ngl, at about 60 cm, there was a stony soil layer with ash, but it was largely barren of artefacts.

**Figure 82.** Sub-site M16 and excavated area

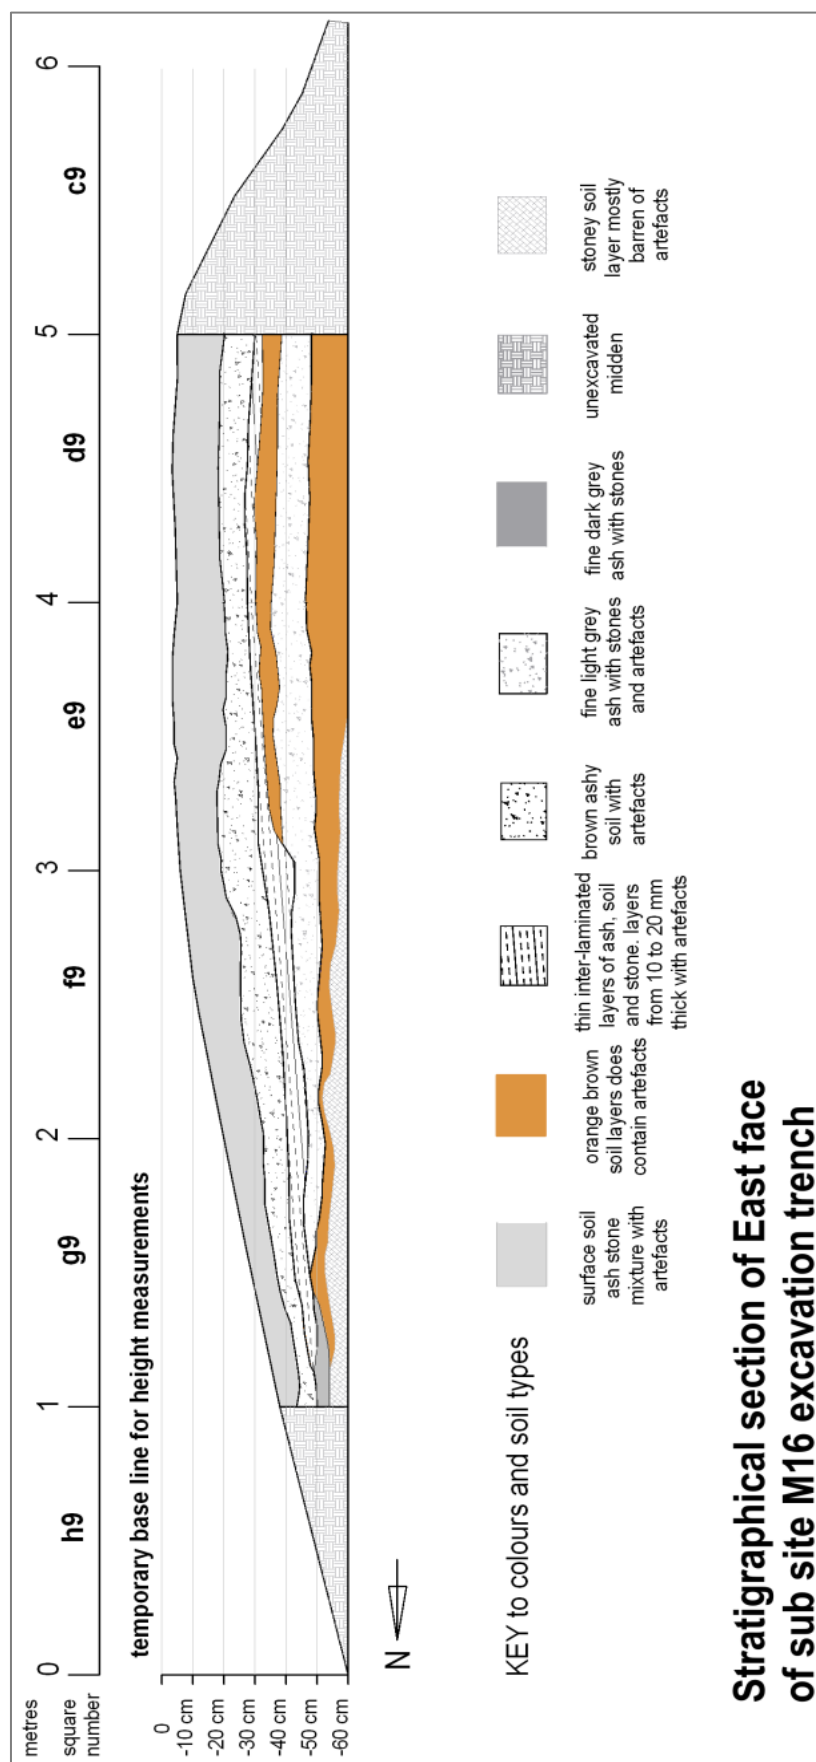
Because this was the first medium size midden to be excavated, it was decided to dig a trench 4 m long x 0.5 m wide. While it showed that the recovered material was significantly high for the volume removed and all 5 primary categories of artefact were recovered, due to the physical restrictions of the width at depth, it was decided to open the deepest part of the trench (d9) in M16 to a width of 1.5 m to understand the spread of artefacts and the results are shown statistically in Chapter 11.

**Figure 83.** Stratigraphical section of East face of sub-site M16 excavation trench
