# **ARCHAEOLOGY OF THE INDUSTRIALISATION AND SOCIAL DEVELOPMENT AT A SILVER MINE IN THE GREATER PRETORIA REGION FROM 1889 TO 1927**

**Graham Walter Reeks**

A thesis submitted to the Faculty of Science, University of the Witwatersrand,  
Johannesburg, in fulfilment of the requirements for the degree of Doctor of Philosophy

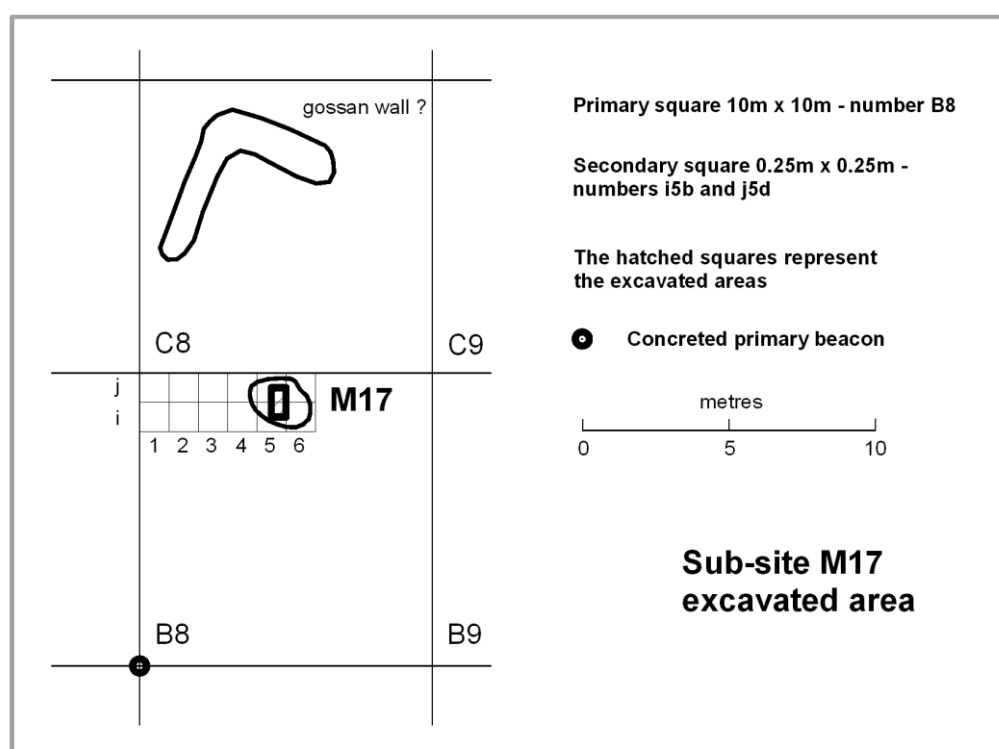
This midden measured less than 4 m<sup>2</sup> in area with a height of 20 cm above ngl. It was chosen for excavation because a partially buried neck and top rim of a bottle were noted. Secondly it was one of the few obvious middens in the south central part of the main excavation area. It was decided to grid the midden with two adjoining 0.25 x 0.25 m squares in grid squares (b2) and (c2), an area which included an eventual 39 bottle fragments. The fragments were cleaned and temporarily reconstructed into a bottle with a deep base recess. Other items recovered from this small excavation were 57 ceramic shards, a few bone fragments and some oxidised nails. Considering the very low volume at 0.025 m<sup>3</sup> of light grey ash that was excavated, reaching ngl at 20 cm the number of recovered artefacts was high.

**Figure 84.** Sub-site M17 and excavated area

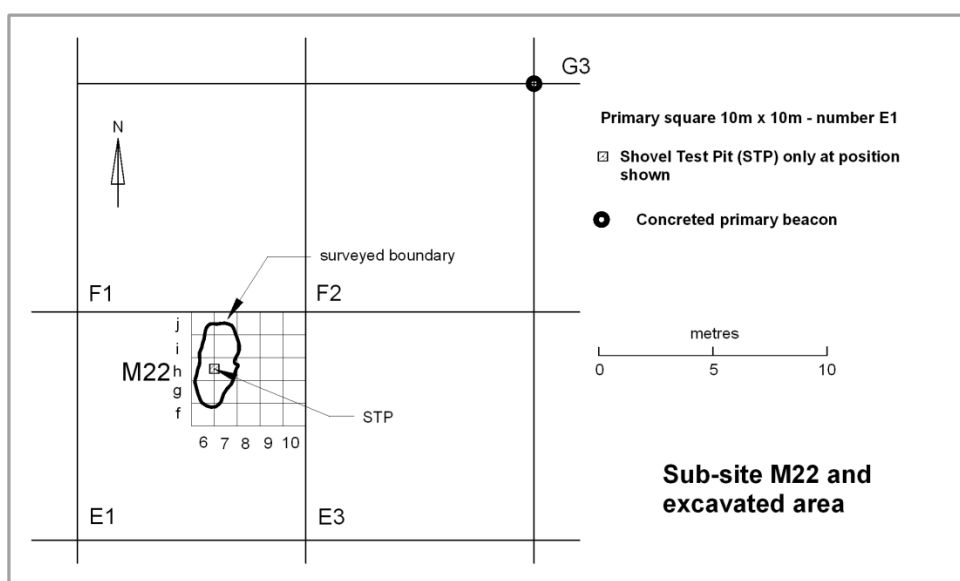
This midden was investigated, but nothing was found on surface. The midden measured 3 m x 1.5 m x 20 cm above ngl. Some surface trowelling was done in a few places, but very little was seen or recovered apart from 7 pieces of glass with a mass of 0.7 kg. One of the pieces was a thick bottle base with the letters UGB and A239 S4. The UGB stands for United Glass Bottle Manufacturers, a UK company dating from about 1913. The material of the midden was mainly soil with traces of grey ash.

**Figure 85.** Sub-site M22 and excavated area

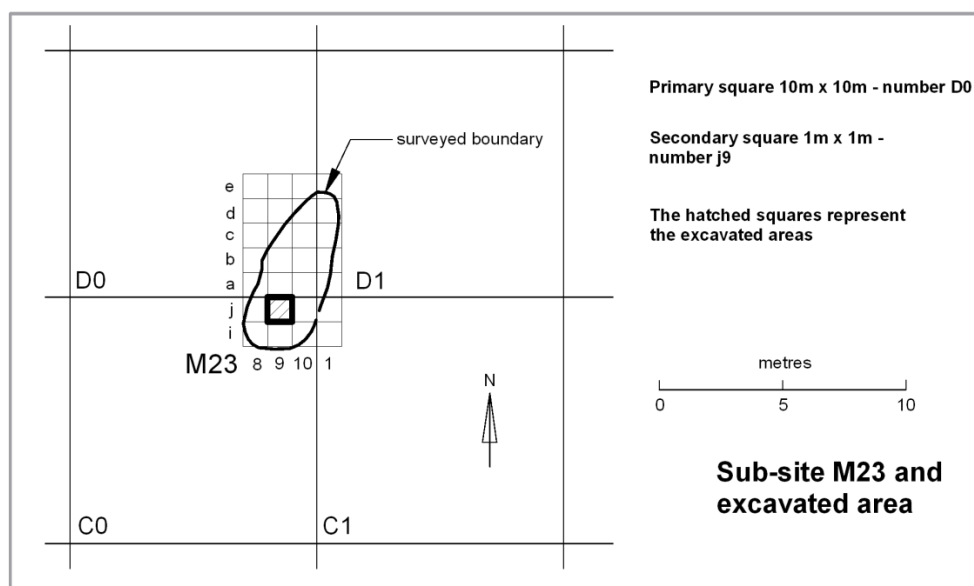
**Figure 86.** Sub-site M23 and excavated area

This was the first midden to be excavated. This site, although small, provided evidence that excavating the middens could provide a wide selection of artefacts. Categorised as a small midden, it was pear shaped in plan being 6 m long but only 2.5 m wide at its widest point and about 15 cm above ngl. The material consisted of ashy light brown soil. No stratification was observed. A 1 x 1 m square was excavated over a nominal depth of 15 cm before ngl. Some bone fragments including a sheep (*Ovis aries*) jaw bone were found, along with various nails, glass and ceramic shards - a total of 25 artefacts.

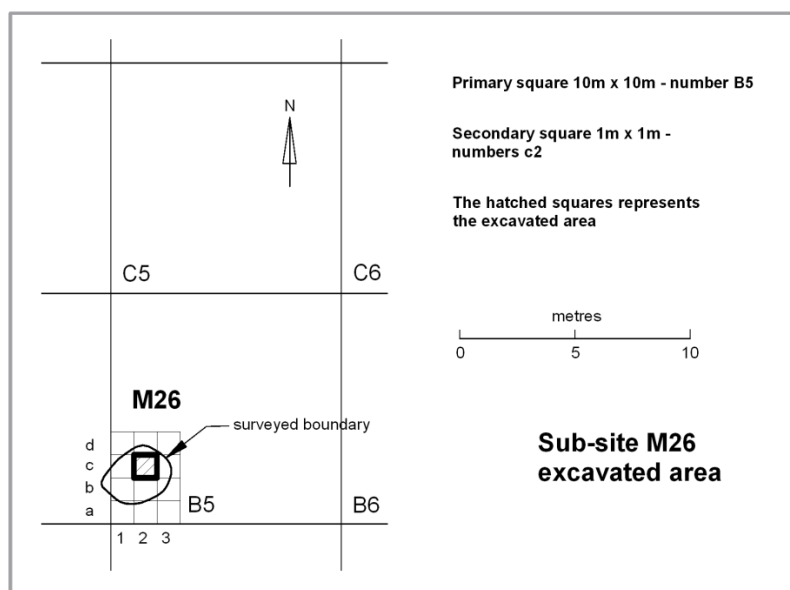
**Figure 87.** Sub-site M26 and excavated area.

This was another of the small middens originally considered of little significance until two bottles were found. The first was found partially buried during the survey period. It consists of a clear glass bottle and is the only bottle or top/neck of a bottle found with the partial remains of a cork. It is only 31 mm diameter, has a short neck and is only 87 mm high. The second bottle was also partially buried and had not been seen during the survey period. It was a brown screw cap bottle, with the raised embossed name KRUSCHEM SALTS on it. When research was conducted on this make it was found to be a patent medicine as is discussed in Chapter 11 and 12.

The material of the midden appeared to be a mixture of light grey ash and orange soil. The midden is about 1.5 m diameter and 30 cm above ngl. Only surface recovery was undertaken on this midden.

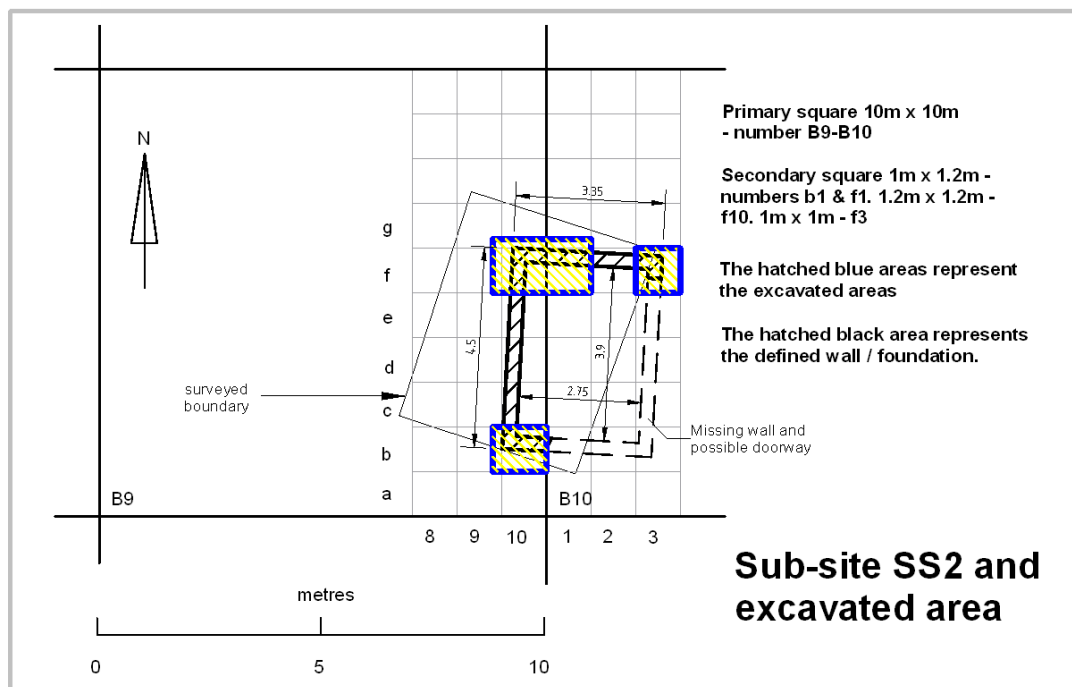
**Figure 88.** Sub-site SS2 and excavated area

This structure was partially visible as a dressed stone foundation, rectangular in plan. It was decided to try and delineate the walls by exposing three corners and extrapolating the third. When the satellite survey had been conducted, the shape of the mound indicated a rectangular structure. When the excavation proceeded it was found that the walls did not match the shape of the mound. This can be seen on the plan drawing below. As the west wall of the structure was cleared of grass and soil the north-west and south-west corners were found as shown on the plan. It became clear that the structure was more to the east than the mound profile had indicated and the north wall was exposed revealing the eastern corner.

A series of 1 x 1 m to 1.2 x 1.2 m squares were excavated to 20 cm below ngl thereby exposing the lowest row of dressed stone blocks of rock approximately 20 x 20 x 20 cm in size. The line of the eastern wall was tested by STPs but no trace of a foundation was found.

A total of 12 artefacts were recovered consisting of a nail, part of a metal can lid, and some glass shards. Part of a dressed stone wall was developed with only the eastern wall and south-eastern corner not being found. No doorway was found in the foundation that was excavated, and so it has to be assumed that it was originally on the eastern wall of the structure. The use of dressed stone in this structure probably meant that some of the stonework of the TSM buildings was re-purposed. 13 clay bricks lying flat on the inside of the north-west corner of the structure may have been a floor, but no more were found in any other part of the structure and so it is inconclusive as to their purpose.

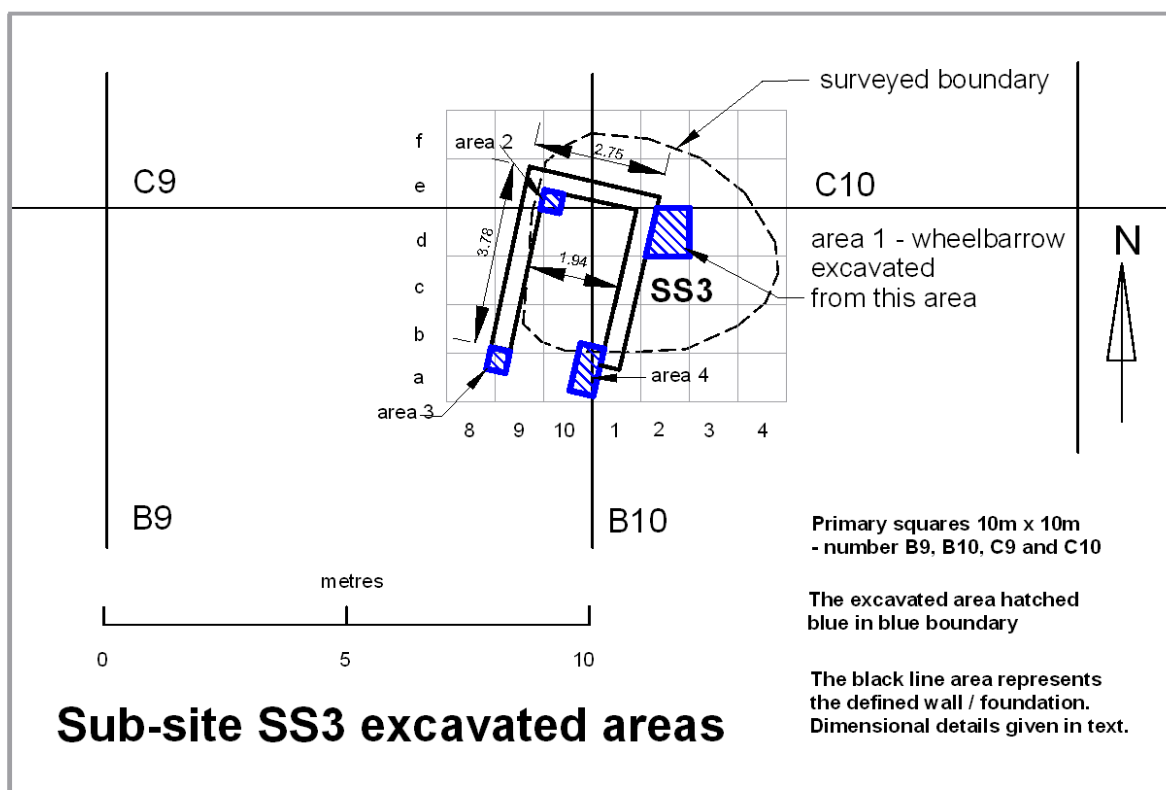
**Figure 89.** Sub-site SS3 and excavated area

This was one of the most noticeable foundations, built seemingly from large  $\pm 20$  cm chunks of local rock. The rock seen on SS3 was mainly gossan – a type of iron oxide rock typically found covering the surfaces of ore veins and it would have been present on the veins at Argent. The foundation was raised above ngl, and measured approximately 4 x 2.75 m with the height above ngl averaging 60 cm.

During the initial survey period of this part of the primary excavation area, part of a metal hoop was seen. It was decided to excavate the metal object to ascertain what it was. After a lengthy excavation period it became clear that it was the remains of a riveted metal band around and still attached to a wheelbarrow bucket. The bucket part was mostly unrecoverable due to its complete oxidation making it friable to the touch. The metal hoop and some parts of the attached bucket were recovered.

It was decided to test the site in three separate areas of the foundation labelled 2, 3 and 4. Area 2 was excavated as a 0.5 x 0.5 m STP to a depth of 60 cm, at which point the remains of a round metal lid were found. The wall was found to continue to this depth which placed it at ngl. The wall at this point formed a corner and was reasonably well built, considering the material used was rough rock, generally round in shape. Area 3 measured 0.25 x 0.25 m and was aimed to test the possibility of a floor and extension to the wall below visible ground level. On reaching a depth of 10 cm below the grass/soil level, hard compact ground was found with the wall layer just below its surface. No artefacts were found in this area. Area 4 was 1 x 0.5 m in area. It also reached a depth of 10 cm below the grass roots level and indicated compacted ground similar to area 3.

The base of the wall was also seen to be 20-60 mm below the compacted ground level. The floor area of the structure sloped up from areas 3 and 4 to the closed end at area 2. No wall was found closing off the south end of the structure and there was no evidence of poles or corrugate sheeting fragments. The size of the foundation was considerably smaller than structures in the centre and western half of the 'native location'. It is also located downhill from the majority of the structures in the 'native location' and coupled with its small size it is postulated that it may have been the residence of a member of the poorer section of this community. Although some artefacts were recovered namely glass, bones and metal, apart from the wheelbarrow frame nothing was of significance.

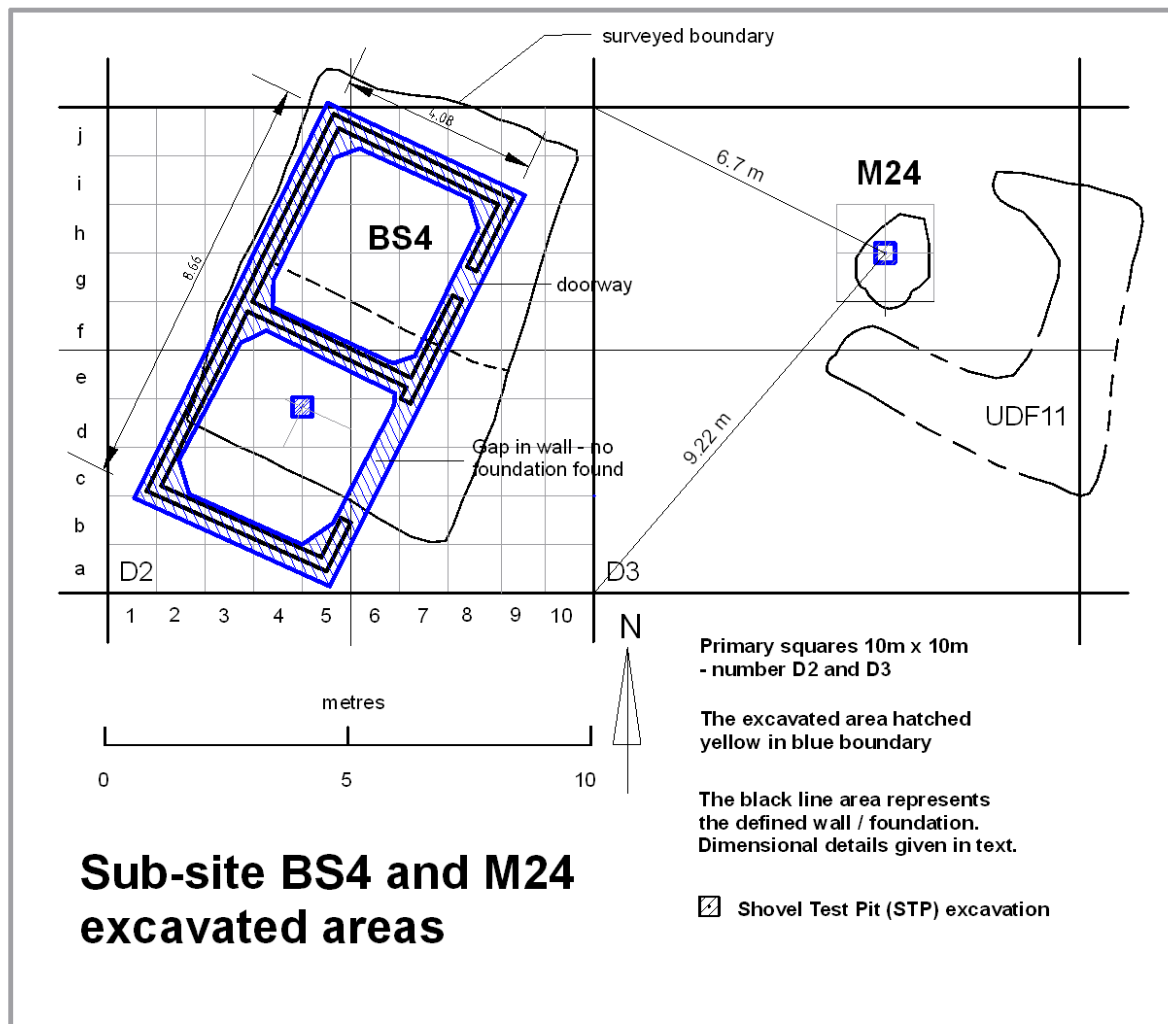
Of all of the visible surface foundations in the 'native location' area, BS4 represents one of the largest. It is considered to be unique from another aspect, namely that it is the only two roomed structure found mostly above surface. This does not preclude the possibility of more being sub-surface. On clearing of the grass roots partially covering the foundations the initial excavations were at the corners of the middle wall as these were the most obvious. From these two points, it became clear that the walls did not follow the outline of the raised area as plotted during the satellite survey, although in general terms the variation was within 1 m. The foundation was constructed wholly of fired clay brick and from the visible surface there were only two or three courses to a soil level foundation. No concrete foundation existed. The brick walls were exposed on both sides of the wall to a spade width trench. In some cases mortar was seen between courses. On one corner of the structure (i9) clear evidence of floated plaster was found on the outside of the wall indicating that this structure may have been externally plastered, although there was no evidence of plaster on the remaining parts of the internal brickwork.

On day two of the excavation, it was decided to expose all of the walls and during this period it was discovered that a doorway existed in the external eastern wall of the northern room. No inter-connecting doorway opening was found in the middle wall. Similarly, no doorway was found in the external wall of the southern room. However, there was a gap in the brickwork of approximately 3 m on the east side of the wall and it may be that either no doorway existed or the foundation bricks were 'robbed', thus destroying that part of the wall.

A thin layer of semi-mouldable clay between 3 and 6 mm thick was found by the brickwork of the middle wall in the southern area. An STP was put down in the area as shown on the plan (Figure 90) but apart from a thin area of the same clay nothing else was found.

**Figure 90.** Sub-site BS4 and M24 excavated areas

No bone fragments were found in this excavation. Metal artefacts consisted of nails, flat and corrugate metal fragments. Ceramics was limited to 2 items of glazed stoneware and glass recovered consisted of shards of green bottle glass. The miscellaneous category provided some interesting, but unclear artefacts. They consist of metal springs with wooden pegs in the middle of the spring and in some cases an outer sheath. They may have been the spring parts of a chair, which I believe is more likely than a bed.

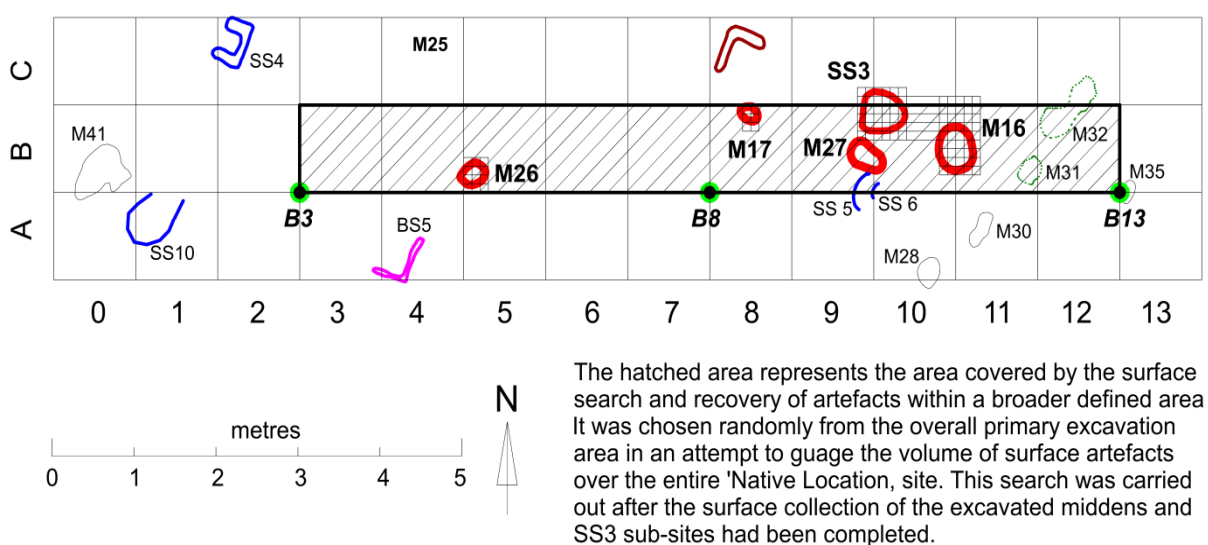
**Figure 91.** Sub-site of primary grid areas B3 to B12

This was conducted on the last day of excavations to try and ascertain if there was a pattern of surface artefacts over a given, wide demarcated area, in this case 10 x 100m. Although the area chosen did include three category small middens and one medium size midden and the SS3 foundation, the surface artefact count on all five, combined, totalled 10 items of glass, 1 of ceramic and 1 of metal. By comparison, the count of artefacts for the area as a whole was glass: 29, ceramic: 35, metal: 13 and miscellaneous: 4, giving a total count of 81.

If the combined area of the 5 sub-sites is taken at approximately 40 m<sup>2</sup> with the surface yield of 10 artefacts, and the larger area of 1 000 m<sup>2</sup> yielded only 81 artefacts it means that the average yield for the large area was 1 artefact per 12.4 m<sup>2</sup> compared to the middens at 1 artefact per 4 m<sup>2</sup>. The problem associated with the general surface collections, is that bone or bone fragments are rarely found close to the surface as they degrade in the open air or close to surface environments. Metal objects seem to vary in survival, with thin metal - cans for example - rarely surviving due to oxidation eventually leading to destruction and the heavier objects merely rusting. The glass fragments consisted of clear, brown, green and cobalt blue glass. One piece had a clear purple tint to it, but this is most probably glass that has been affected by sunlight. One undamaged Vaseline jar was found, as was a small rectangular bottle typical of patent medicine shape and size - with raised letter of 'Blain's

### **Primary Grid square A6** (see Figure 91 for location of sub-site)

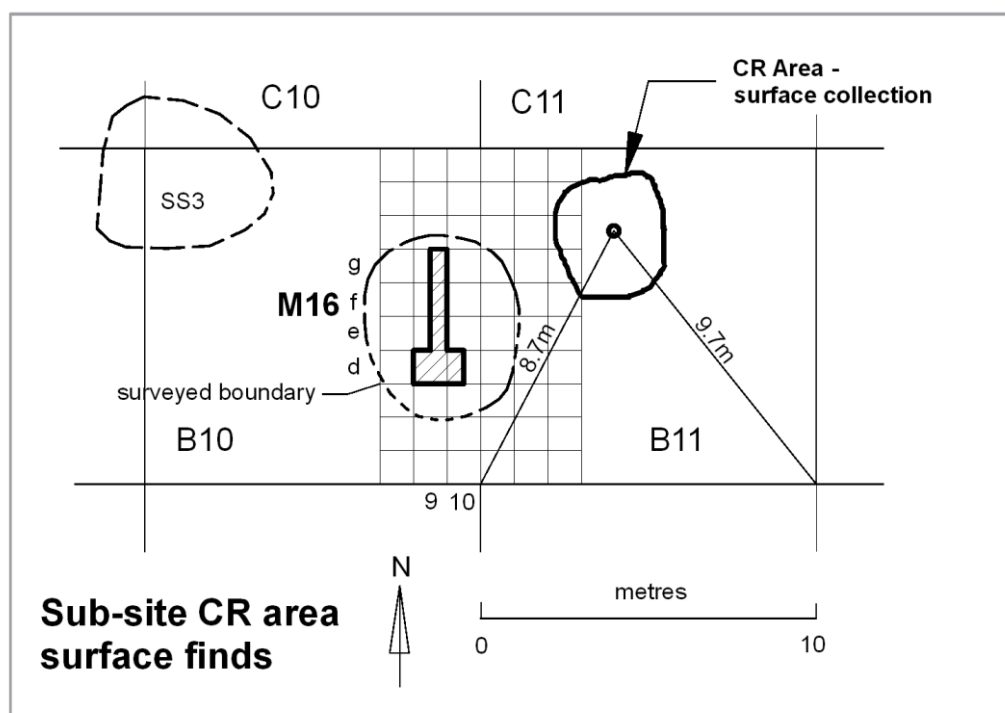
**Figure 92.** Sub-site CR area surface finds

This area was found by one of my team members<sup>1</sup> and it produced a strange anomaly of surface and sub-surface finds in between middens M15 and M16. Although a range of glass, ceramic and metal artefacts were found in this area, three finds of significance were discovered. One was a near complete but broken clear glass hexagonal shaped bottle consisting of 26 pieces.

This bottle was temporarily reconstructed and a search was carried out on the internet to try and identify it. The closest look alike was a Holbrook's chutney jar. Another item consisted

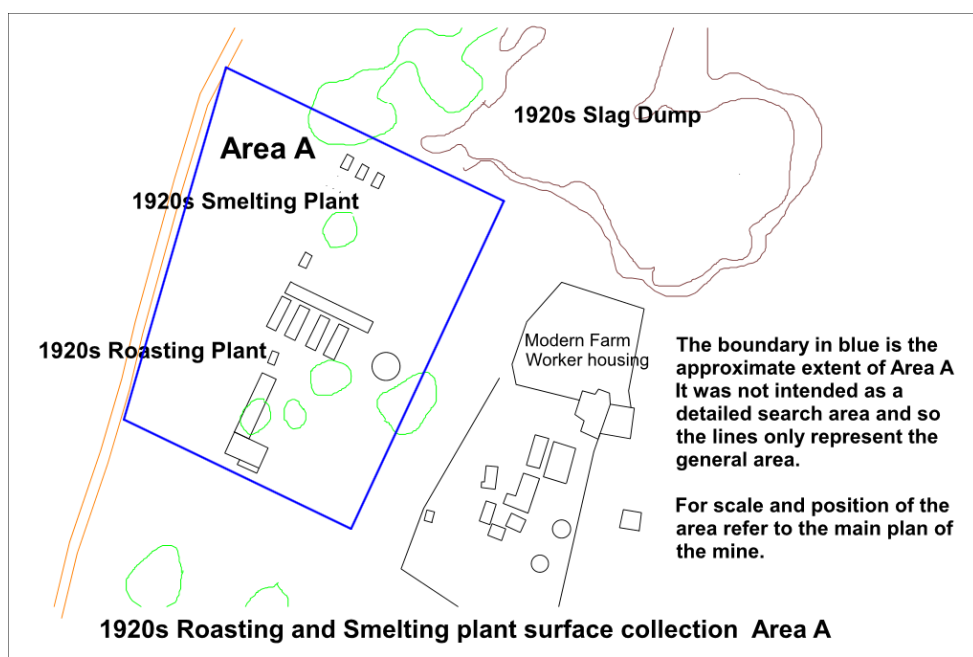
**Figure 93.** Roasting and Smelting plants surface collection

The main focus of investigating this large area was to understand the foundations in relation to the known machinery used in this plant. A total of 37 artefacts were collected from this

area. These were 6 hand forged rail nails. Bottle fragments consisted of bases or neck shards, some with raised lettering, but in all cases only some of the lettering remaining. The colours of glass ranged from clear to various shades of green to brown and typical medicinal cobalt blue glass. The ceramic collection has the base of a small, diameter 55mm, brown salt glazed stoneware pot - but the top part is missing. The other items are porcelain, semi-porcelain or earthenware shards. The miscellaneous collection consists of solidified lead samples and a ceramic sampling cup.

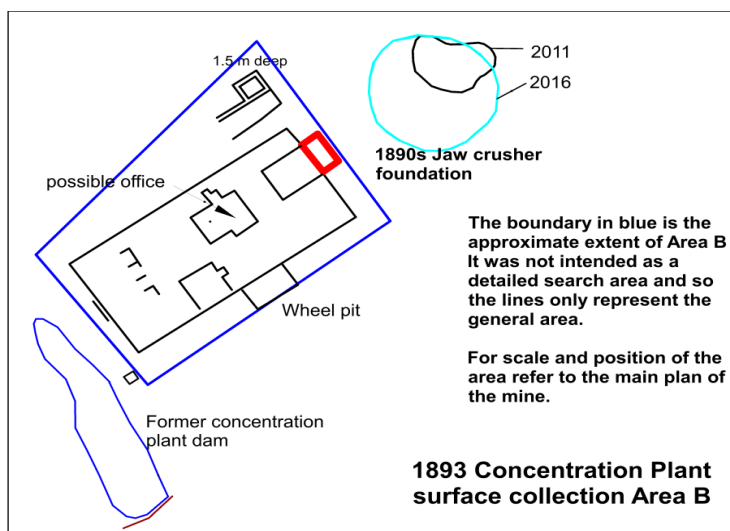
**Figure 94.** 1893 Concentration plant surface collection Area B

It was thought that there was a lot of potential on this sub-site. Certainly with the help of the historical photograph<sup>2</sup> it was possible to locate the foundation areas for each wooden column of the original building (Figure 19). Internal dressed stone foundations indicated a potential office area possibly for the sub-manager of the concentration plant. Trowelling exposed a stone step up into this structure. It measured approximately 8 x 8 m, and can be seen on the survey plan below. A few miscellaneous items were found, such as two ceramic sampling cups and underneath one of the foundation dressed stones the remains of a leather shoe sole.

The dressed stone foundation block is discussed under the 1890s Jaw crusher area later in the chapter. The other features of this sub-site are the large wheel pit – the location for a large flywheel which would either have been on the output shaft of an engine - probably steam – or mounted on an intermediate shaft driving overhead belts which would have been used to drive the various machines in the building. A flywheel was used to store rotational energy. Because flywheels have what is defined as the moment of inertia they resist changes in rotational speed. The steam engine that would have been the driving source for the belt driven machinery in the plant, by its nature, provides intermittent torque output, but this is balanced out by a flywheel. Also recognised at this sub-site were the remains of a small dam wall and a hollow area that would have contained the water for the plant.

### **1890s Jaw crusher area** (see Figure 94 for location of sub-site)

In conjunction with Area B the 1890s concentration plant, one metal item was found at the foot of the 1890s dressed stone foundation on which the Blake Jaw crushers were mounted.

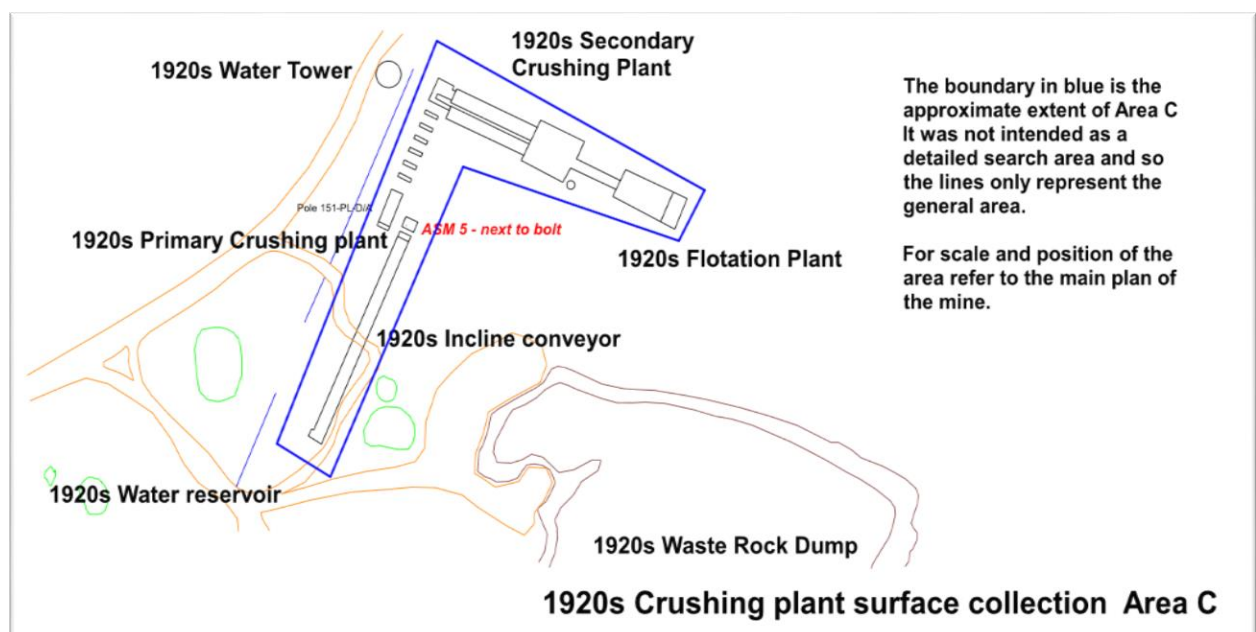
**Figure 95.** 1920s crushing plant surface collection Area C

As can be seen from the plan (Figure 95) and the historical photographs in Chapter 5 this area consists of an L shaped series of structures. It is dominated by the Hardinge Ball mill and the flotation plant foundations, which is the area where all of the artefacts were found. The one interesting artefact, as it was the only one of its kind found during the entire survey and excavation period, was an enamel metal drinking cup. Recovery of more of this type of utensil was expected, especially in the middens of the ‘native location’, but none were found. Although natural decay through oxidation could explain the lack of such vessels, it is

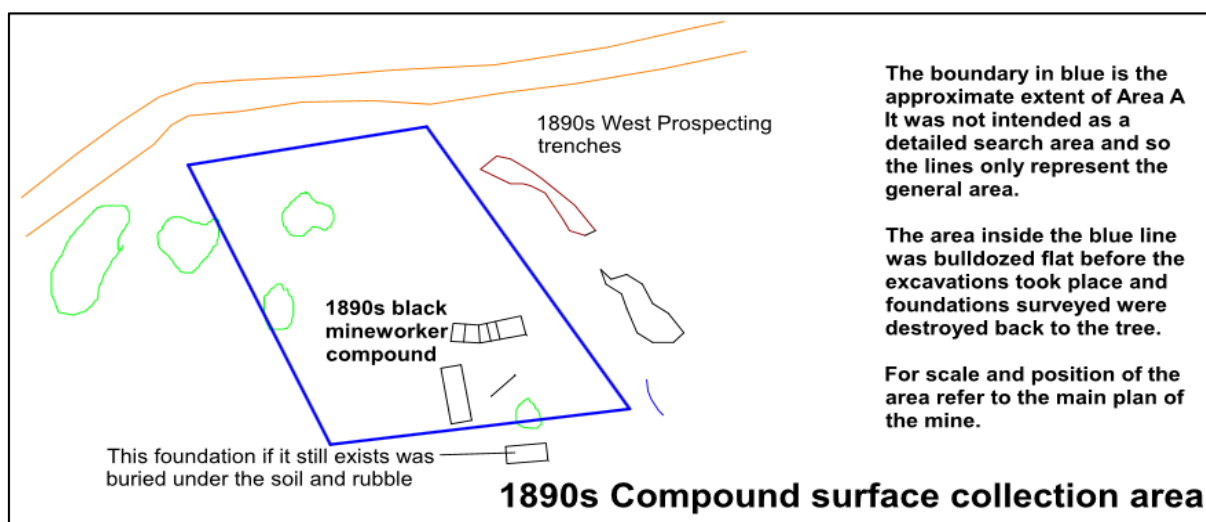
**Figure 96.** 1890s black mineworker compound surface collection

From the surface survey, the compound apparently consisted of three buildings laid out in a u-shape formation with one midden to the west of the one building. The foundations had been constructed using dressed stone blocks, on average a 20 cm cube. The midden was located during the survey and it appeared to cover an area of roughly 6 x 6 m, although it was only about 5-10 cm above ngl in the middle. During the survey period only one midden was found and delineated. No other middens were found, but high grass cover prevented visual identification of other low middens associated with the three buildings. Before any additional closer sampling could take place the one midden and the foundations were destroyed as outlined in the next paragraph.

Unfortunately, before excavations could take place the farmer had fertiliser delivered by a contractor and the area had been levelled with a bulldozer destroying the remains of the foundations of the 1890s compound and associated midden. In an attempt to recover as much artefact material as possible it was decided to map the area and carry out a detailed pedestrian

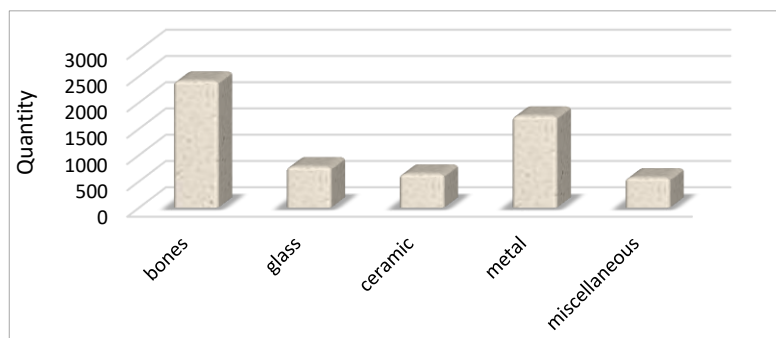
**Figure 97.** Total quantity of primary artefacts recovered

Clearly the largest collection by quantity are bones and bone fragments with metallic items being the next largest. The other three categories do not show a great variation between them (Figure 97). There will be an analysis below of sub sites M8, M15, M16 and the 1890s compound area, these being the only sites where all five categories of artefacts were found during surface collection or excavation or both. However, surface and excavated material are analysed separately.

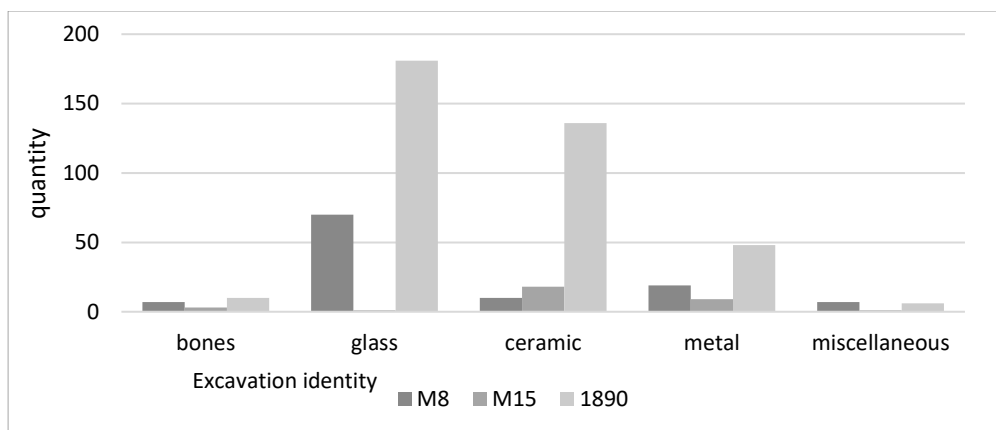
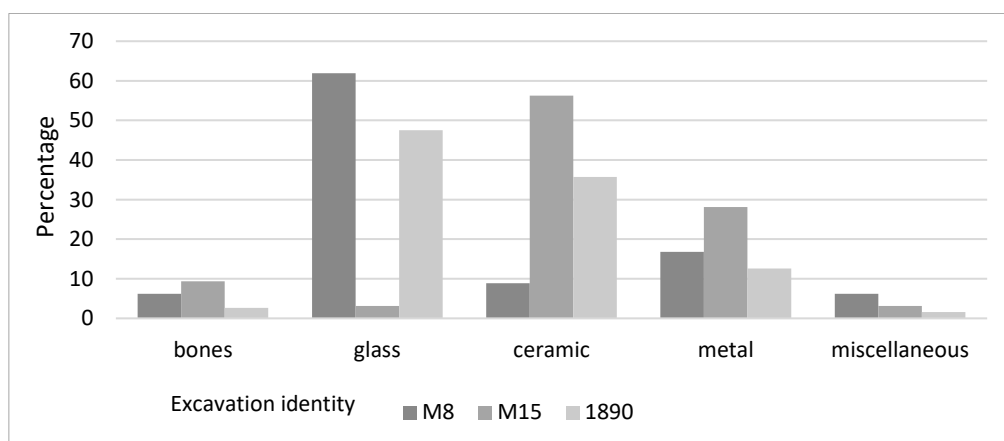
**Figure 98.** Analysis of the surface collections - quantities of the primary categories of artefacts from M8, M15 and 1890s Compound area.

**Figure 99.** Percentage of artefacts recovered from surface collections of M8, M15 and 1890s Compound area.

The graph of quantity of artefacts recovered does show certain comparable values. The two categories with the higher values are glass and ceramics. This is relatively easy to explain. Bone material, soft items such as leather and clothing and metal - especially thin metal such as cans - are hugely affected by the decaying action of atmospheric conditions. The low recovery of such items at these sub-sites is an indication of such conditions. The other factor,

The graph showing percentage of artefact categories per site does indicate a partial trend in the overall number of each category collected. The possible exceptions of the glass in M15 and the ceramic in M8, where they were lower in percentage than the other two sites, has to be taken as anomalies for the particular sites (Figures 98 & 99).

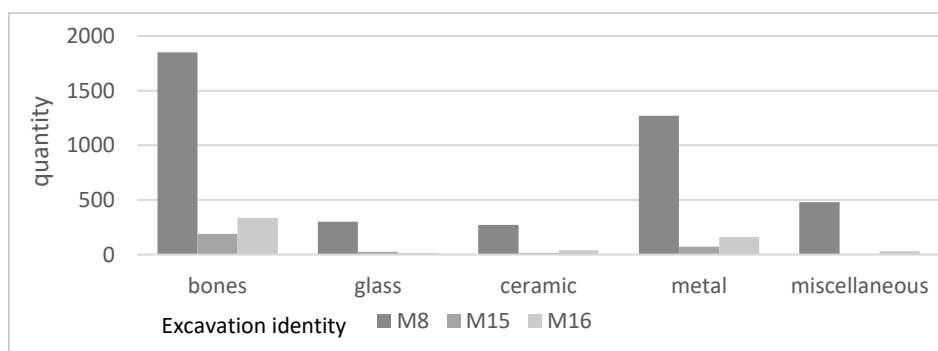
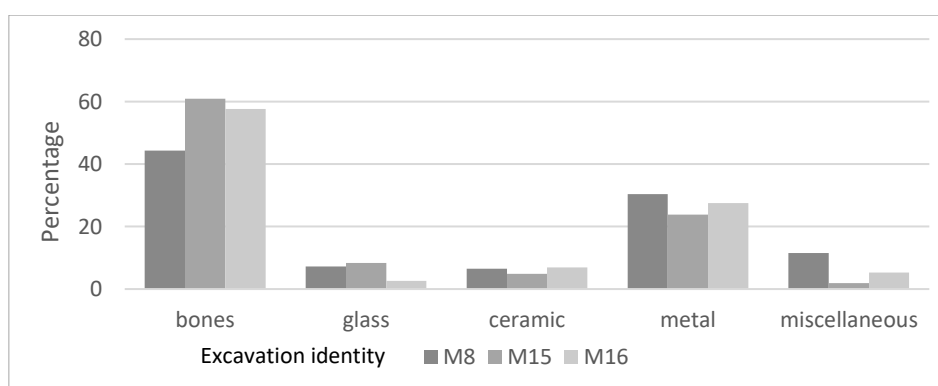
**Figure 100.** Analysis of the excavated collections - quantities of the primary categories of artefacts from M8, M15 and M16 areas.

**Figure 101.** Analysis of the excavated collections - percentage of the primary categories of artefacts from M8, M15 and M16 areas.

The three sites indicated, were those with the highest number of recovered artefacts in all five categories. They were also the most extensively excavated. The reason for M8 having the highest number of recovered bones and metal artefacts could be attributed to it being the most extensively excavated, both in area and depth, with a final volume of 3.7 m<sup>3</sup>. It also yielded approximately two thirds of the total recovered collection of artefacts for the entire project. What is not understood is why it was relatively much larger than any of the other middens. The only possible suggestion is that it may have been the original midden and in its early years was more of a communal midden. What is more revealing from an overall perspective is the graph of percentages of artefacts recovered from the three sites. Although the number of bone and metal artefacts recovered from M8 was considerably higher than M15 or M16, when the three sites are compared by percentage of each category recovered, there is a high degree of similarity for each of the five categories (Figures 100 & 101).

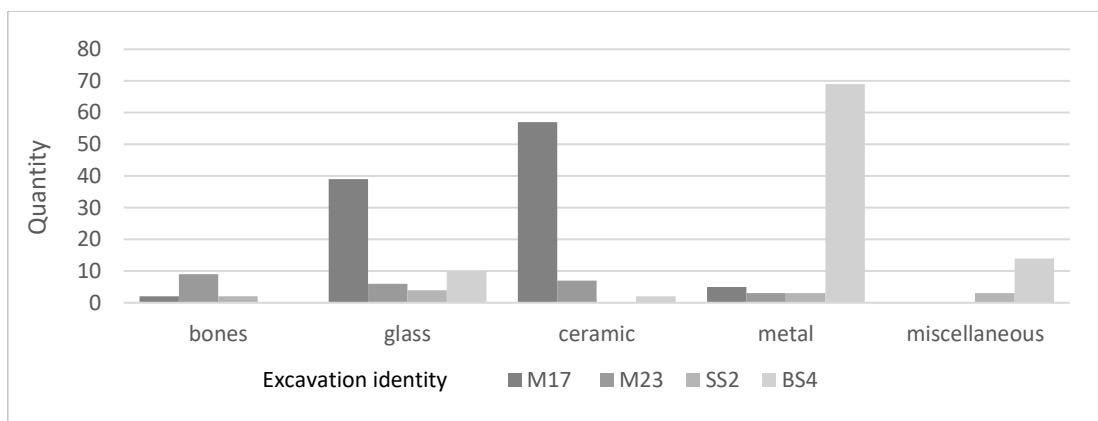
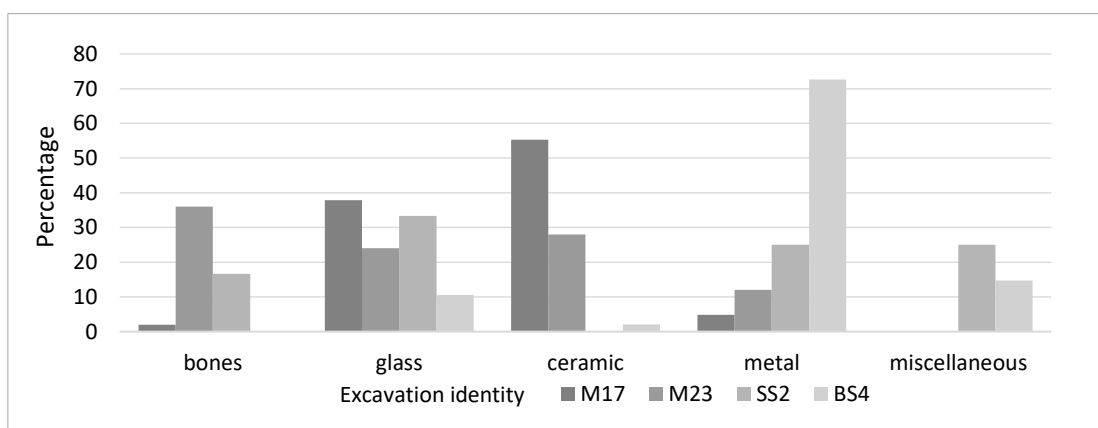
**Figure 102.** Analysis of the excavated collections - quantities of the primary categories of artefacts from M17, M23, SS2 and BS4 areas.

**Figure 103.** Analysis of the excavated collections - percentages of the primary categories of artefacts from M17, M23, SS2 and BS4 areas.

Although there are four categories of artefact as the defining relationship in each of the sub-sites, there is a different combination of the four categories in each sub-site. Three anomalies distort the results of the two charts above. In BS4 a number of metal springs, either from a bed or chair were recovered and these inflated the quantity number and hence the percentage value of metal as is shown. In M17 the only significant categories recovered were ceramic and glass. These are therefore reflected as peaks in the quantity graph. The other two categories, of bones and metal, were in single figure percentages (Figures 102 & 103).

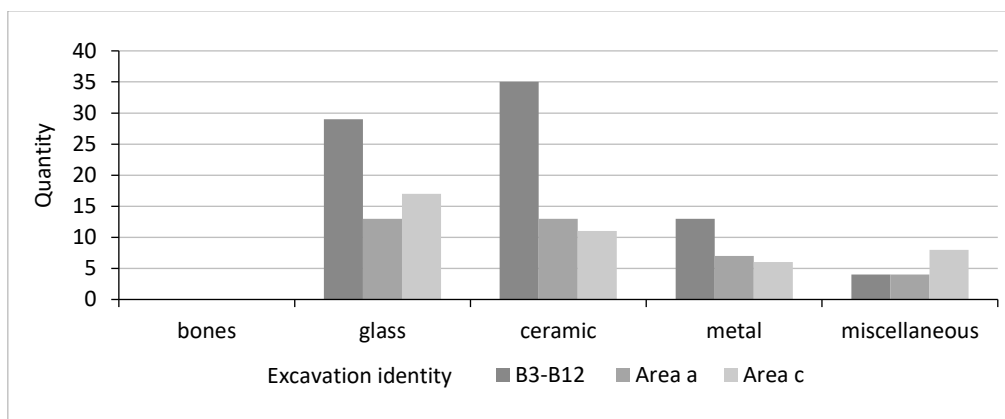
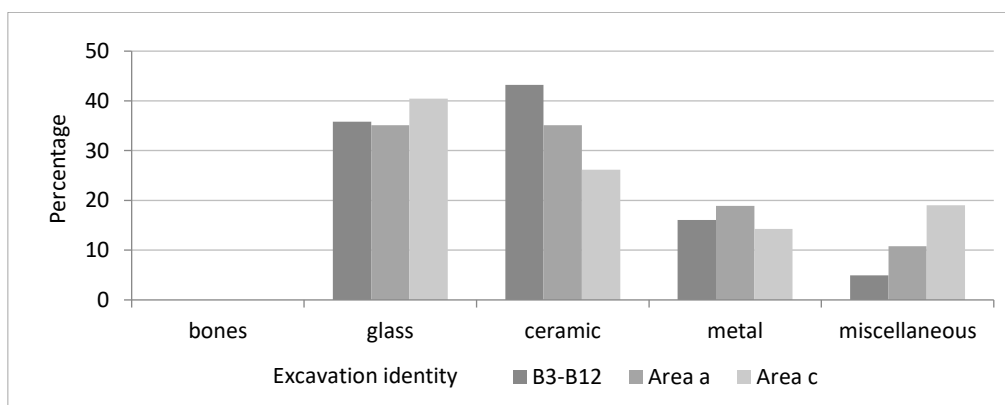
**Figure 104.** Analysis of the surface collections - quantities of the primary categories of artefacts from B3 – B12, Area A and Area C.

**Figure 105.** Analysis of the surface collections - percentages of the primary categories of artefacts from B3 – B12, Area A and Area C.

It is interesting that once again the general trend of each site is to reflect comparable percentages for the four categories. This is especially true for glass and metal. The miscellaneous category percentage apparently varies widely, but only has a difference of four items between them (Figures 104 & 105).

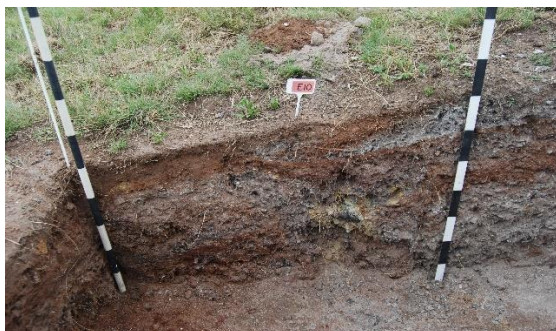
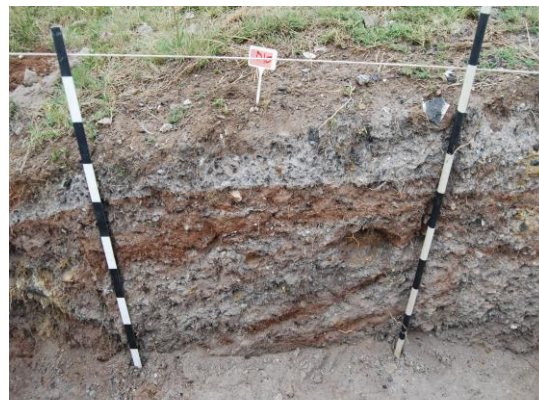
**Figure 106.** M8 stratigraphic section – sections e10 and d10 showing the layers of orange brown soil between layers of ash and ash with stones and lumps of coal.

The one outstanding feature of M8, is that although no stratigraphy could be determined in the fine dark grey ash that formed the bulk of the excavation, within it there were small patches of orange brown loamy soil and these followed an incline pattern almost certainly following the slope profile of the midden as it grew in height, and they are clearly illustrated in (Figures 79 & 106).

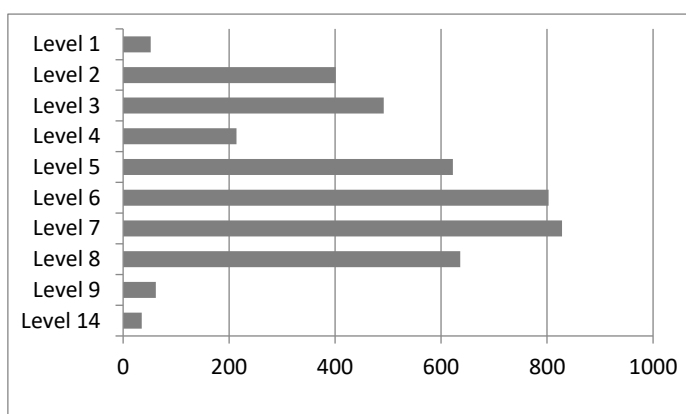
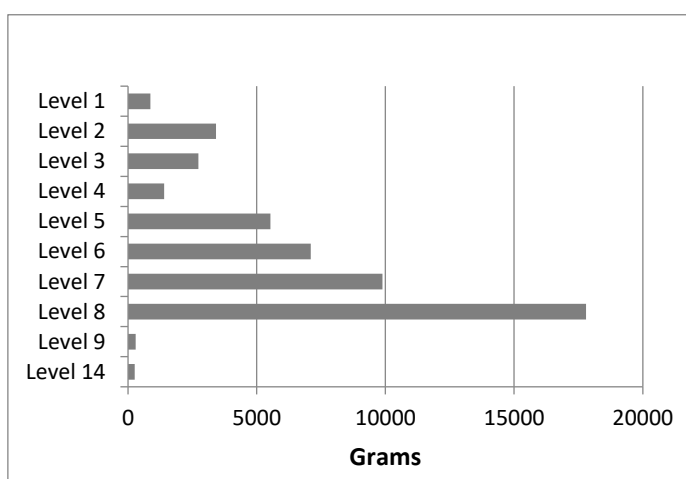
**Figure 107** Quantity of artefacts at each level in M8

**Figure 108** Mass of artefacts at each level in M8

Note:- Tables 17 and 18 on the previous page show generally blank boxes for the levels 9 - 14. If one refers to Figure 79 – the Stratigraphical drawing on page 214 one can clearly see that in levels 9-14 only the STP on C10 went through all of these levels, therefore the tables only reflect the finds in the STP and the same applies to the graphs above Fig. 107 and 108.

From the two horizontal bar graphs (Figures 107 & 108) a number of points of interest can be inferred. Firstly in level 4, there is a definite decline both in the number of artefacts recovered and in the final mass of recovered artefacts in the level. The two tables (17 & 18) indicate that in squares (a10), (b10) and part of (c10) virtually no artefacts were found. It was not clear during the excavation why this should be so, but on completing the stratigraphic drawing (Figure 79) it became clear that the layer varies significantly in soil types with a large portion being a loamy top soil that appears to have been spread over the fine dark ash immediately below it. It is therefore possible that the deposited artefacts that should have been present in layer 4 had been dragged or relocated during the action of covering the ash with the soil.

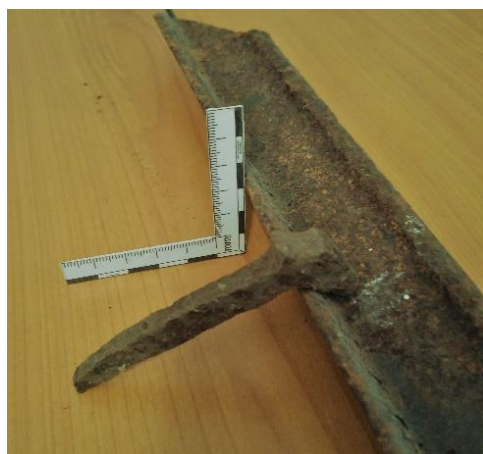
**Figure 111.** Argent rail nail fitting on the foot of a mine rail.

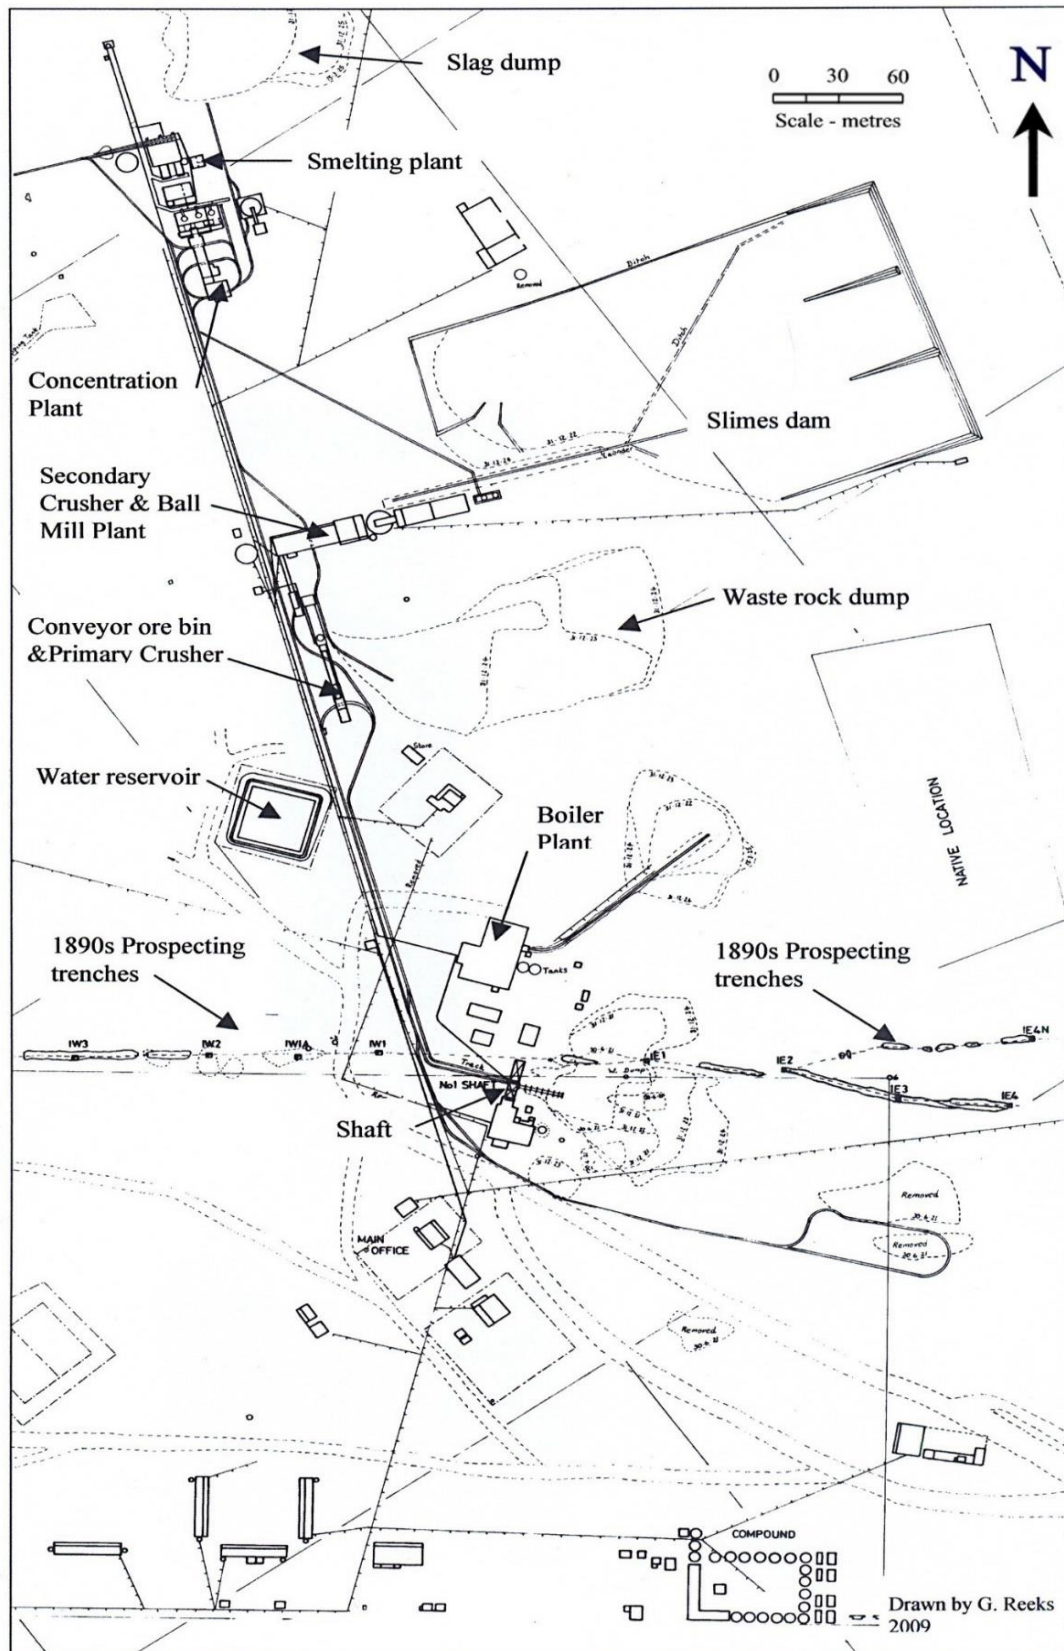
**Appendix 1** Central portion of the re-drawn 1920s plan of the surface plant of the Transvaal Silver and Base Metals Ltd mine. Traced from the original plan.

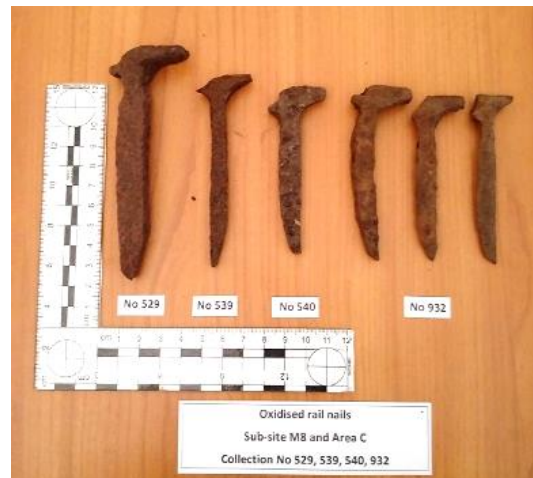
**No's 525, 539, 540, 932 –** Hand forged rail  
nails of various lengths

The metal components were more complex, because the artefacts fell into the sub categories of industrial, architectural, personal and were then put in sub-sub categories such as ‘hand forged rail nails’ A total of 657 nails, of different varieties, were found. The rail nails were the most interesting, as they were hand forged. The head has an angular face forged to the underside, such that it is a perfect match with the angle of the foot of the rail (Figure 111).
