# **ARCHAEOLOGY OF THE INDUSTRIALISATION AND SOCIAL DEVELOPMENT AT A SILVER MINE IN THE GREATER PRETORIA REGION FROM 1889 TO 1927**

**Graham Walter Reeks**

A thesis submitted to the Faculty of Science, University of the Witwatersrand,  
Johannesburg, in fulfilment of the requirements for the degree of Doctor of Philosophy

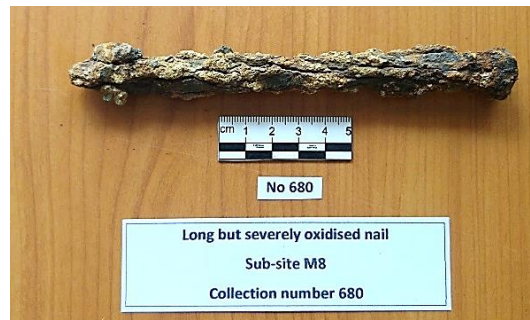
**No 680 –** typical appearance of the extremely  
oxidised nails and bolts

The level of oxidation and corrosion seen on metal artefacts varied widely from just rusty to complete decay and potential powder or flake residues if touched. A few artefacts were found made from very thin diameter copper wire, which appears to have been turned into items of jewellery and this will be discussed in the next chapter.

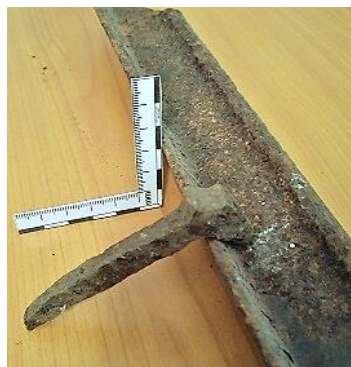
**Rail nail fitting on mine rail 1079**

The metal components were more complex, because the artefacts fell into the sub categories of industrial, architectural, personal and were then put in sub-sub categories such as ‘hand forged rail nails’ A total of 657 nails, of different varieties, were found. The rail nails were the most interesting, as they were hand forged. The head has an angular face forged to the underside, such that it is a perfect match with the angle of the foot of the rail (Figure 111).

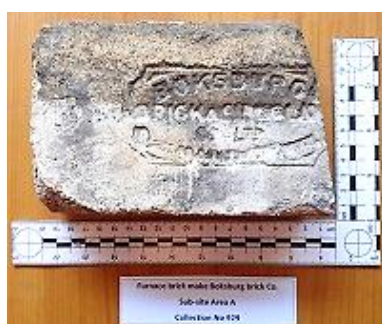
**No 929** Furnace brick make common Boksburg Brick Co.

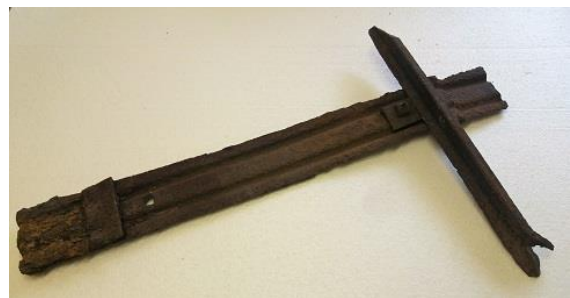
**No 1025** Steel rail sleeper complete with bolted cleats shown with length of mine rail fitting perfectly

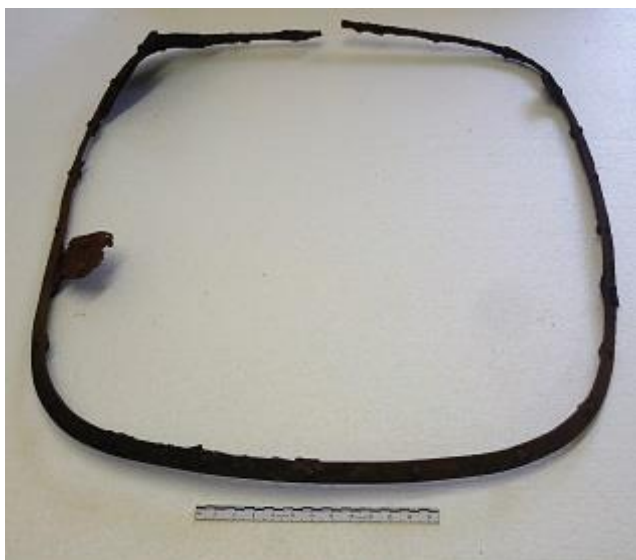
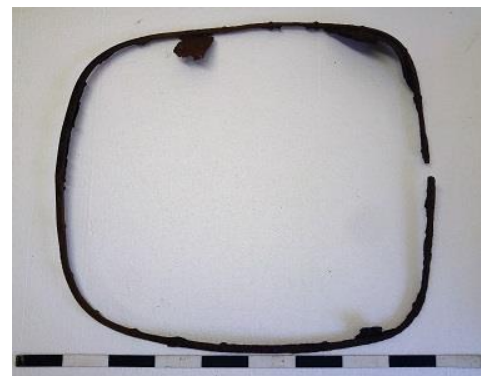
**No 1160** Oblique and plan views of the largest artefact recovered  
- A steel wheelbarrow frame forged and riveted with part of the steel bucket, which was badly oxidised, still attached in 3 places.

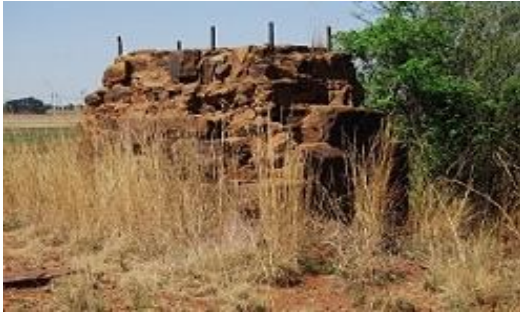
Remains of the 1890s Blake Jaw Crushers

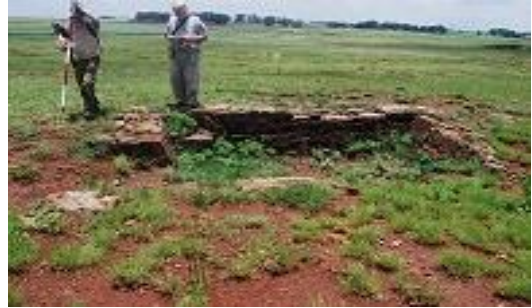
Wheel pit foundation in the 1893 foundation in the concentration plant

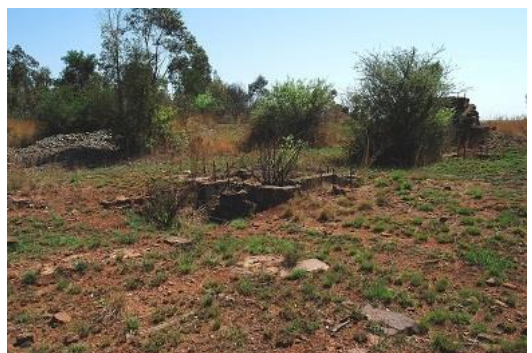
1890s motor or engine foundation for the Blake jaw crusher

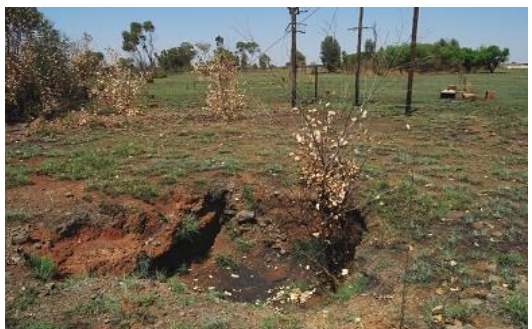
Remains of the 1890s Prospecting shaft – now filled in to about 2m below surface

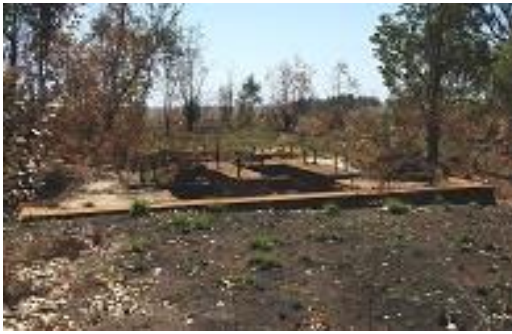
Foundations of the shaft head gear motors and winder

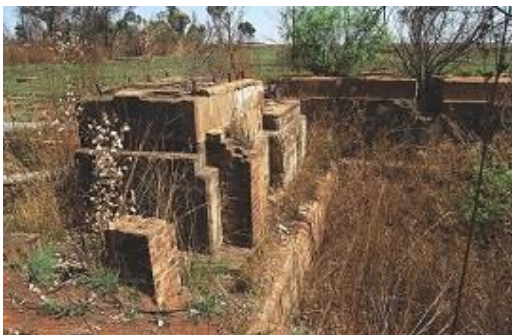
Generator foundation inside the boiler house foundations

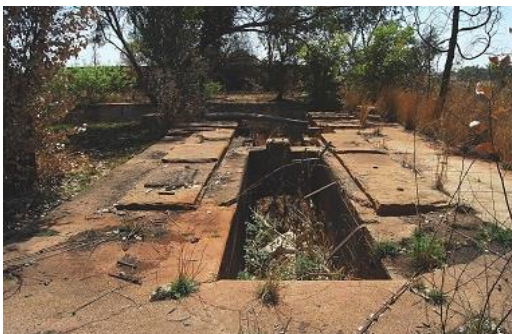
Foundations for two parallel mounted boilers

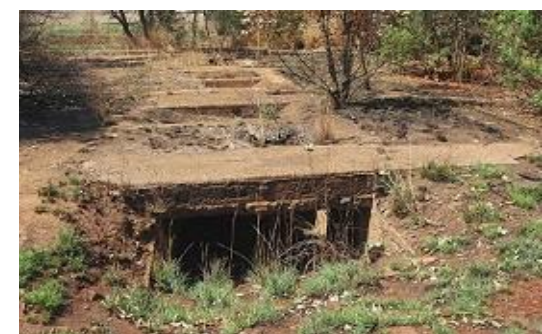
Ash discharge plates and coco pan tunnel underneath

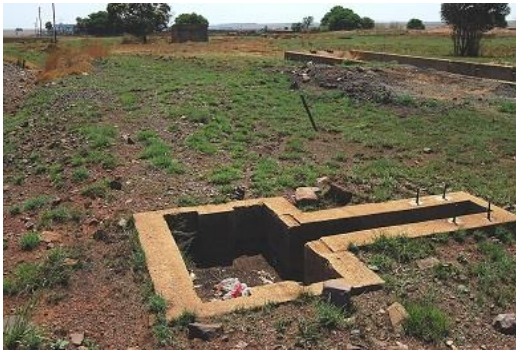
Foundation for manual rail points unit

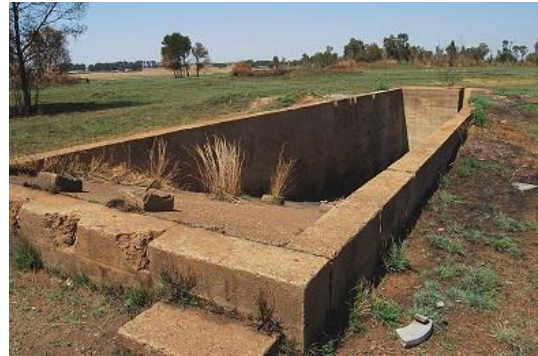
Ore chute to feed first conveyor to primary crusher plant

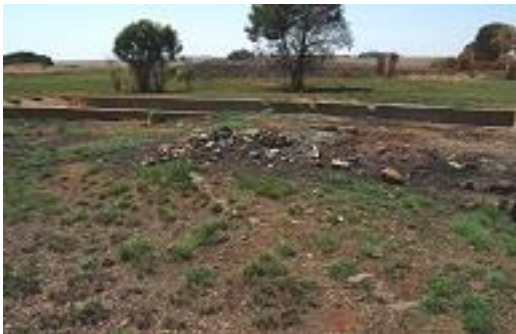
Ore chute and foundations of rail line feeding over the chute

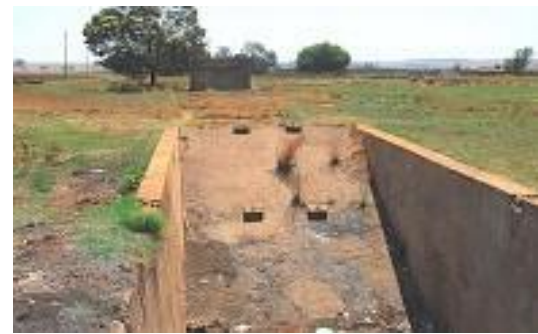
Discharge end with foundations for trestles of conveyor

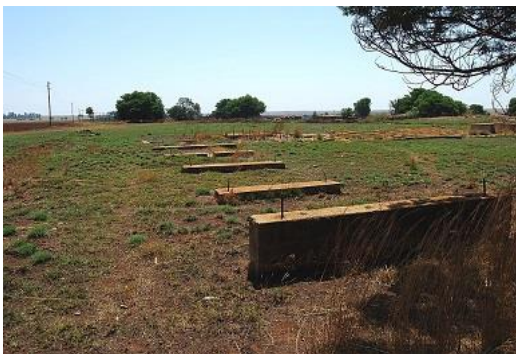
Line of trestles foundations for incline conveyor chute to crusher

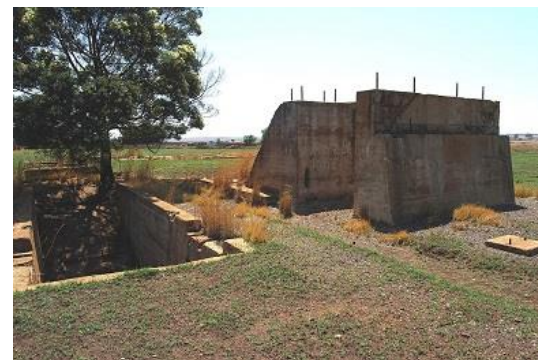
Very large foundation blocks and incline ore of the primary crusher

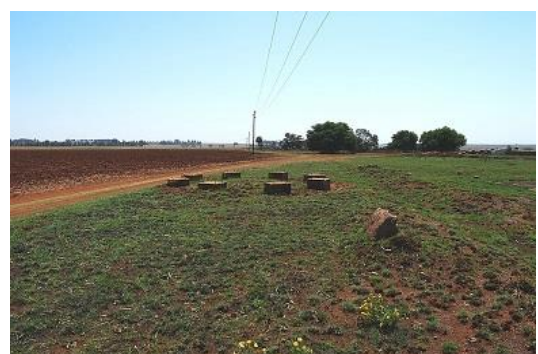
Foundations of the large water tower seen in figure 33

**Figure 33.** Historical photograph of the Argent mine - general view of the 1920s beneficiation plant.<sup>27</sup> The main part to the right of the picture is the incline conveyor leading to the primary crusher and then the secondary crusher plant (see Figs 36 and 37).

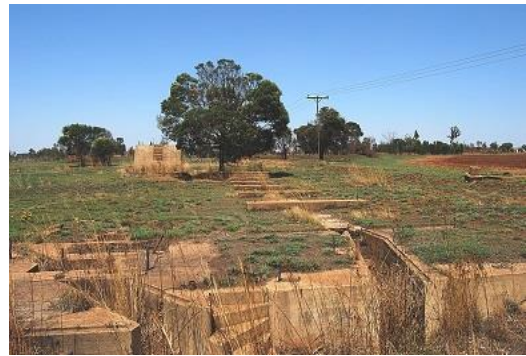
Feed from primary crusher to secondary

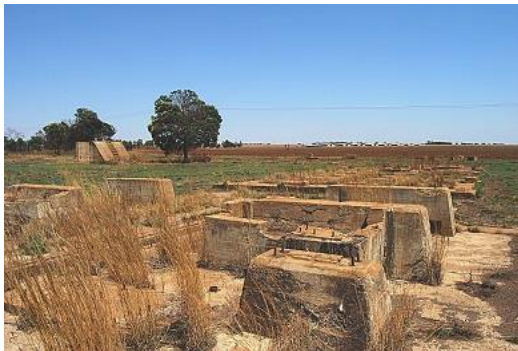
Foundation plinths of the Hardinge Ball Mill machines

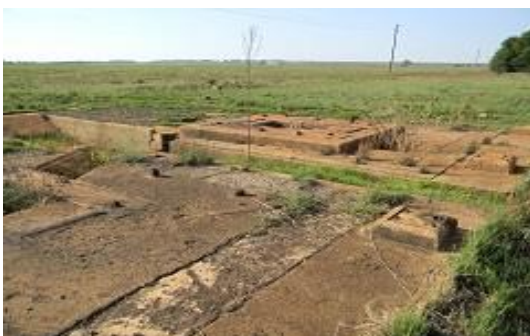
Motor and column foundations in receiving area jigs of secondary crusher

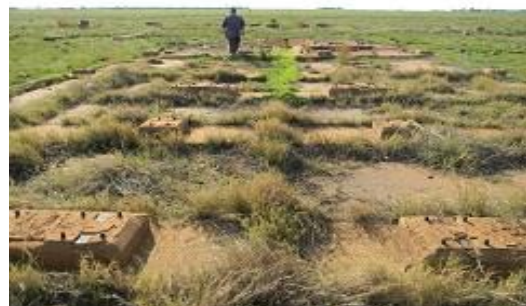
Foundations for hydraulic classifier and Harz

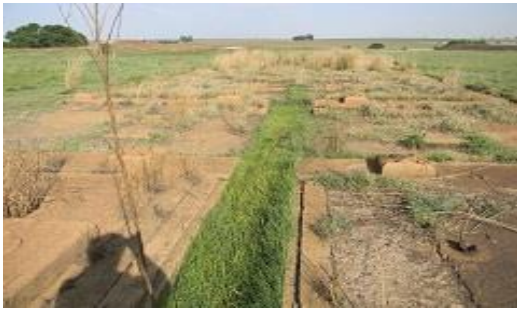
Harz jig foundations looking towards Hardinge Ball mill area

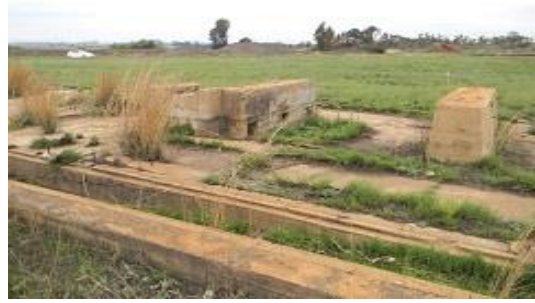
Concrete plinths for Hardinge Ball mill

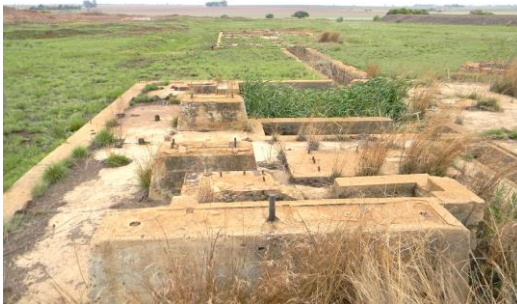
Door Rake classifier foundation area looking towards Flotation plant

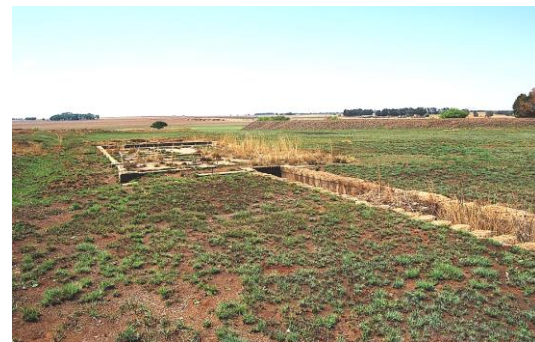
Large concrete trough feeding to MS Flotation plant foundations

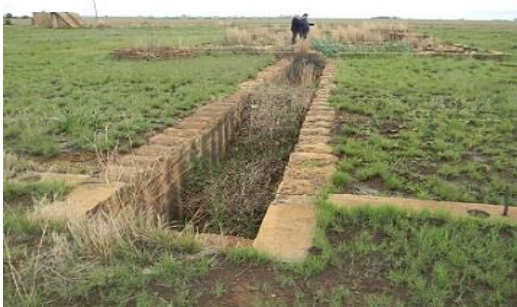
Close up of 1m deep trough between classifiers flotation and MS plant

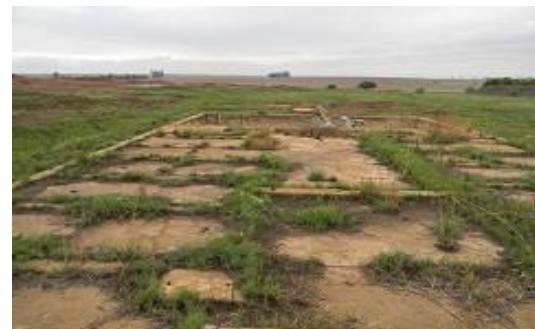
Foundations of two banks of 10 cell MS machines

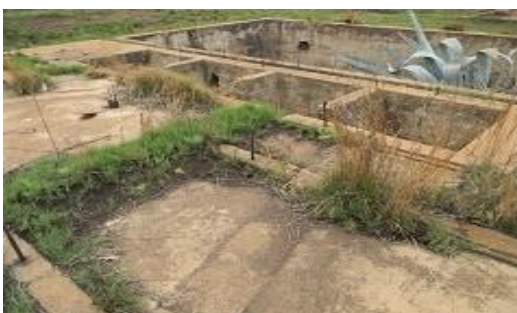
Various collection troughs beyond the MS flotation plant

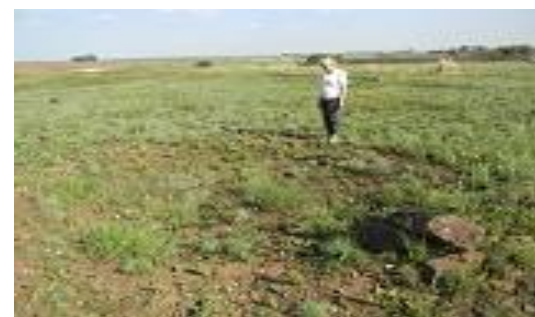
Remains and foundations of the Dorr thickener (circular depression)

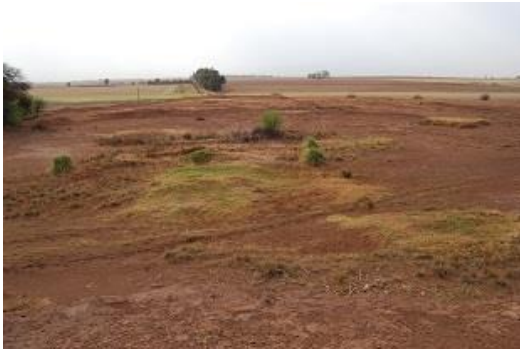
Slimes dam - top surface

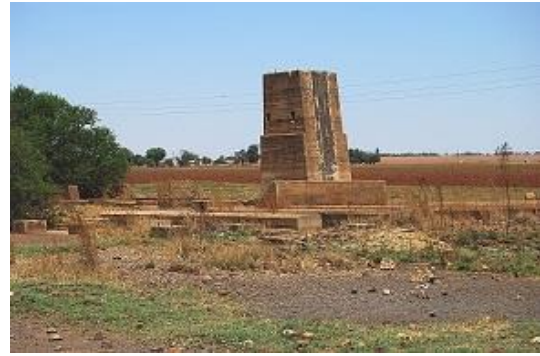
Concrete foundation for Huntington- Hubelein roasting pots

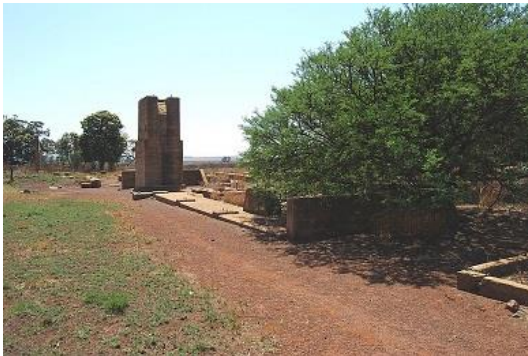
Feeder area to the roasting pot area

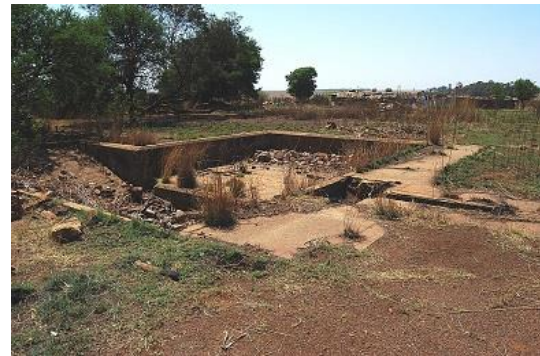
Part of the feeder station to the roasting plant

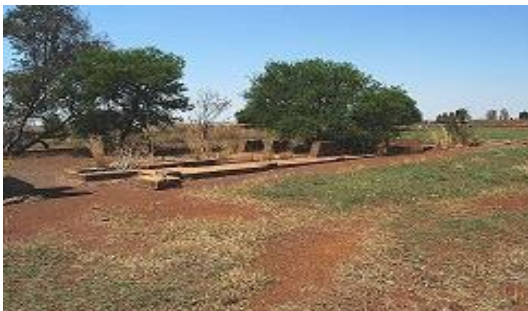
Feeder area foundations for the smelting plant

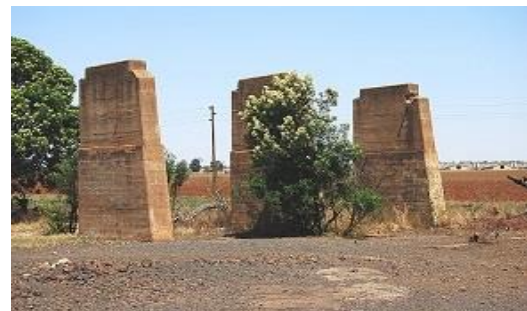
Support foundations for floors and smelting furnaces

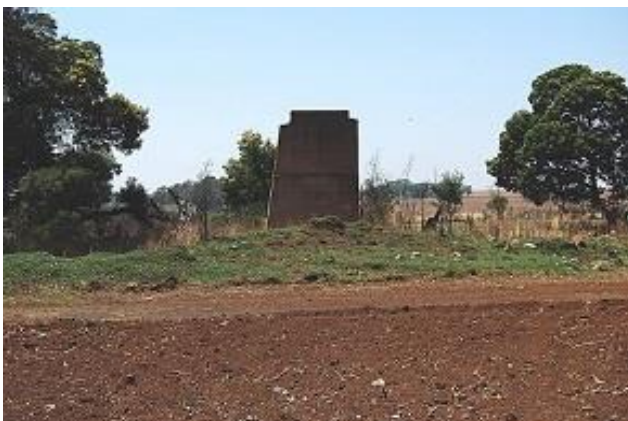
Support foundation looking from where the inclined feed conveyor would have been. The grassy mound has three concrete foundations in it which supported the trestles for the conveyor seen in Figure 42. Note the lumps of white limestone present on the soil in the foreground.

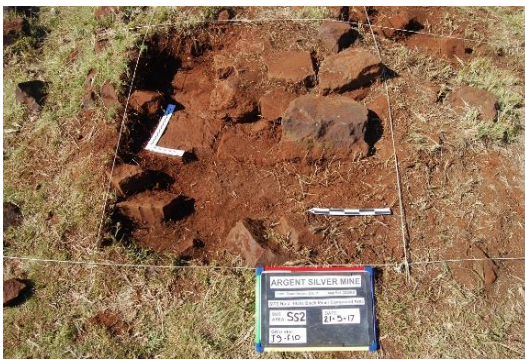
Partial excavation of north-west corner of SS2 showing dressed stone foundation wall

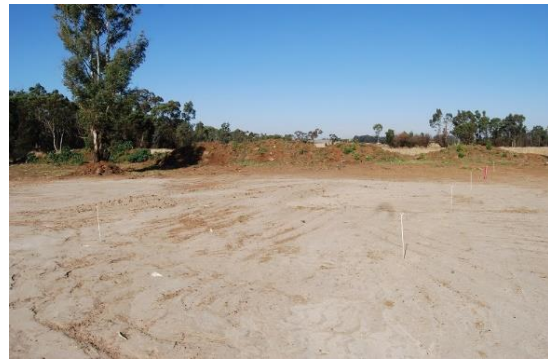
SS3 foundation built using blocks of gossan rock  
The internal area was delineated but no floor was found. It was one of the smallest structures

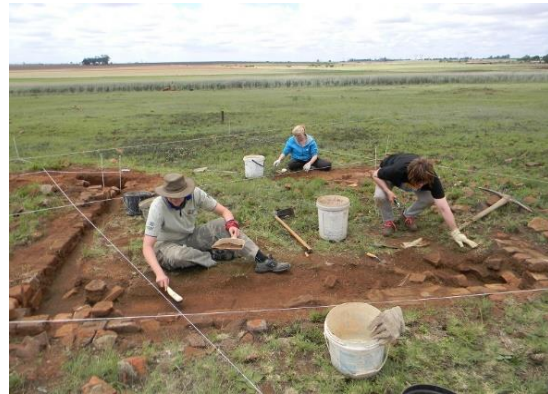
Excavation of BS4 all brick foundation

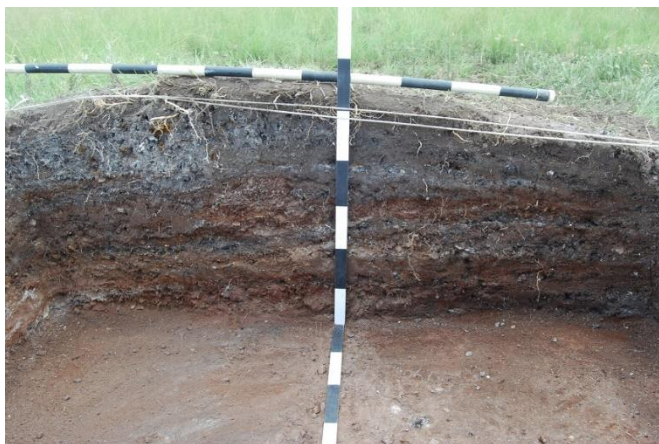
M16 south end face showing stratification of the soil, ash and stoney ash layers

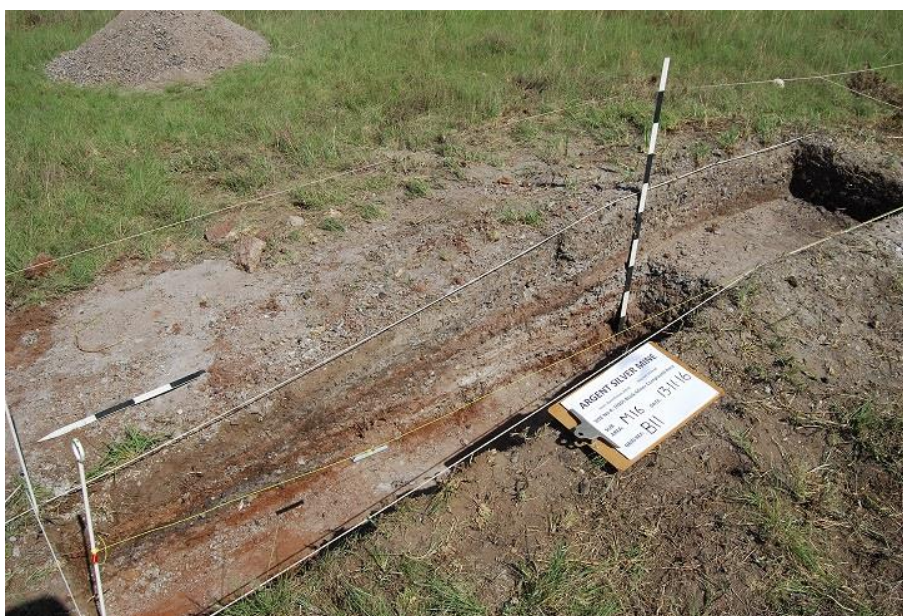
M16 showing stratification of soil and ashy layers

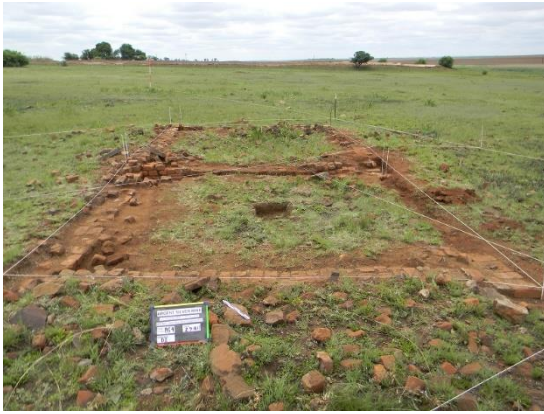
BS4 large two room brick foundation

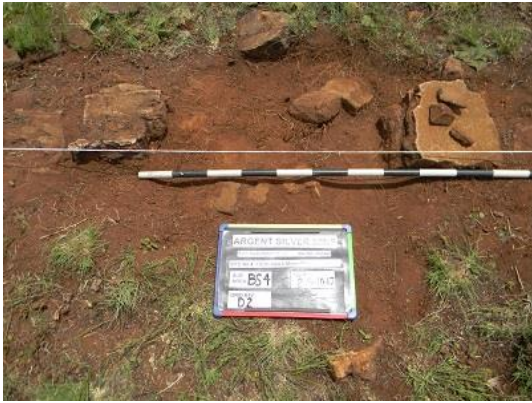
BS4 north-west corner

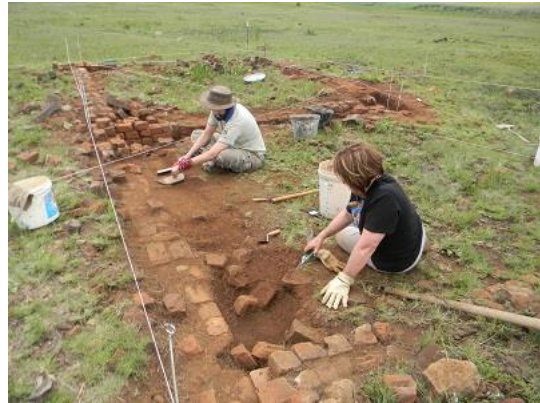
BS4 door opening in north east corner

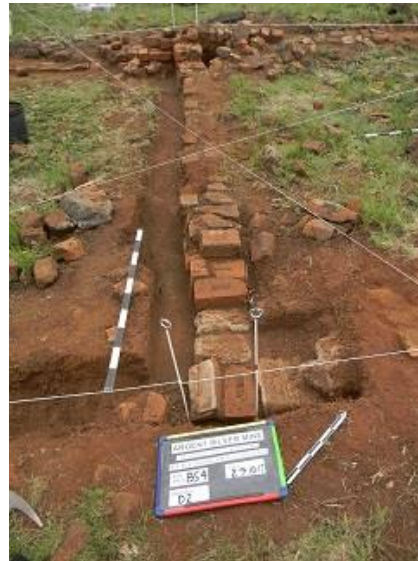
BS4 north east corner – note plastered face on the brick both in situ and fallen. Several others were also found at this site

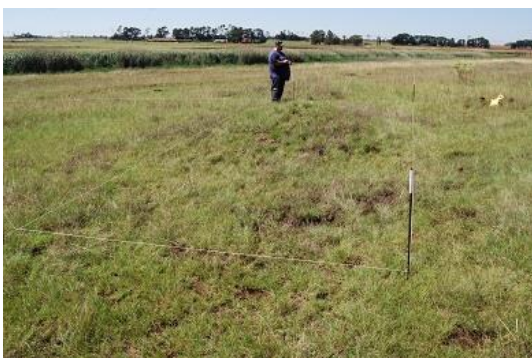
BS4 middle wall looking west

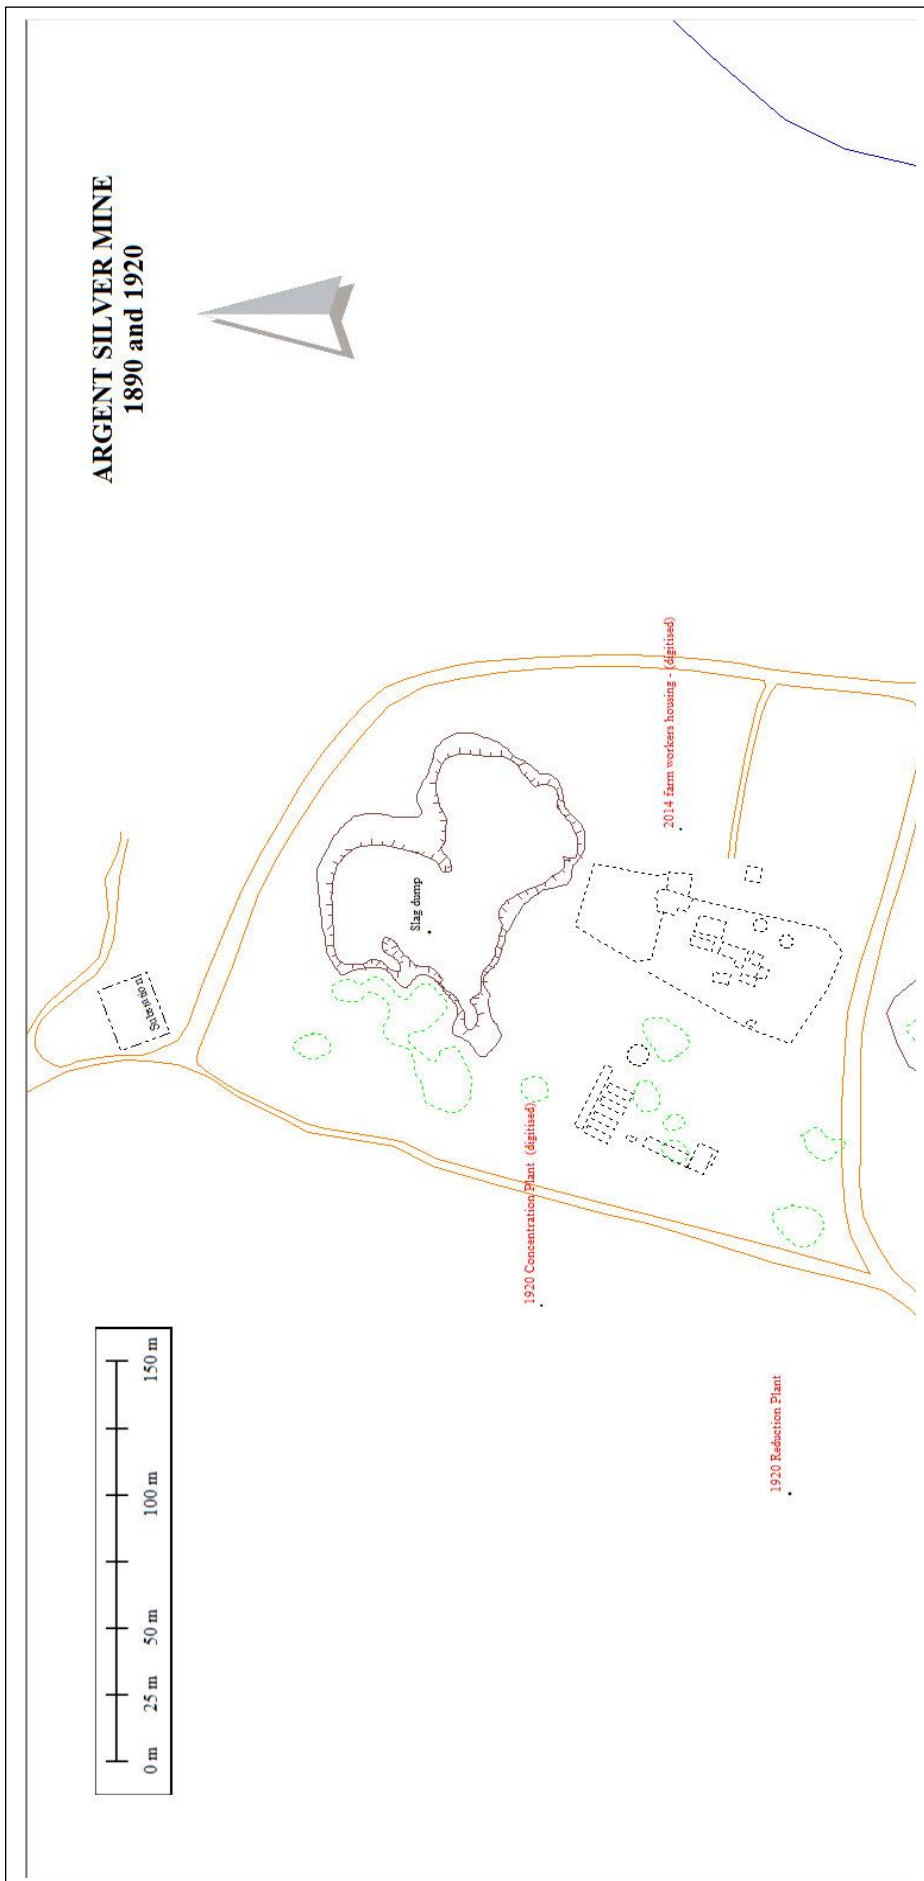
Map 1 Overall satellite survey of the Argent Mine showing the digitisation of the geo-referenced ortho-photograph.

The following pages of eight maps show individual areas of the Argent Silver mine and can be read in conjunction with the plan Figure 75 which shows the main features of the mine. The numbers on the individual plans refer to survey reference points made during the pedestrian satellite survey.

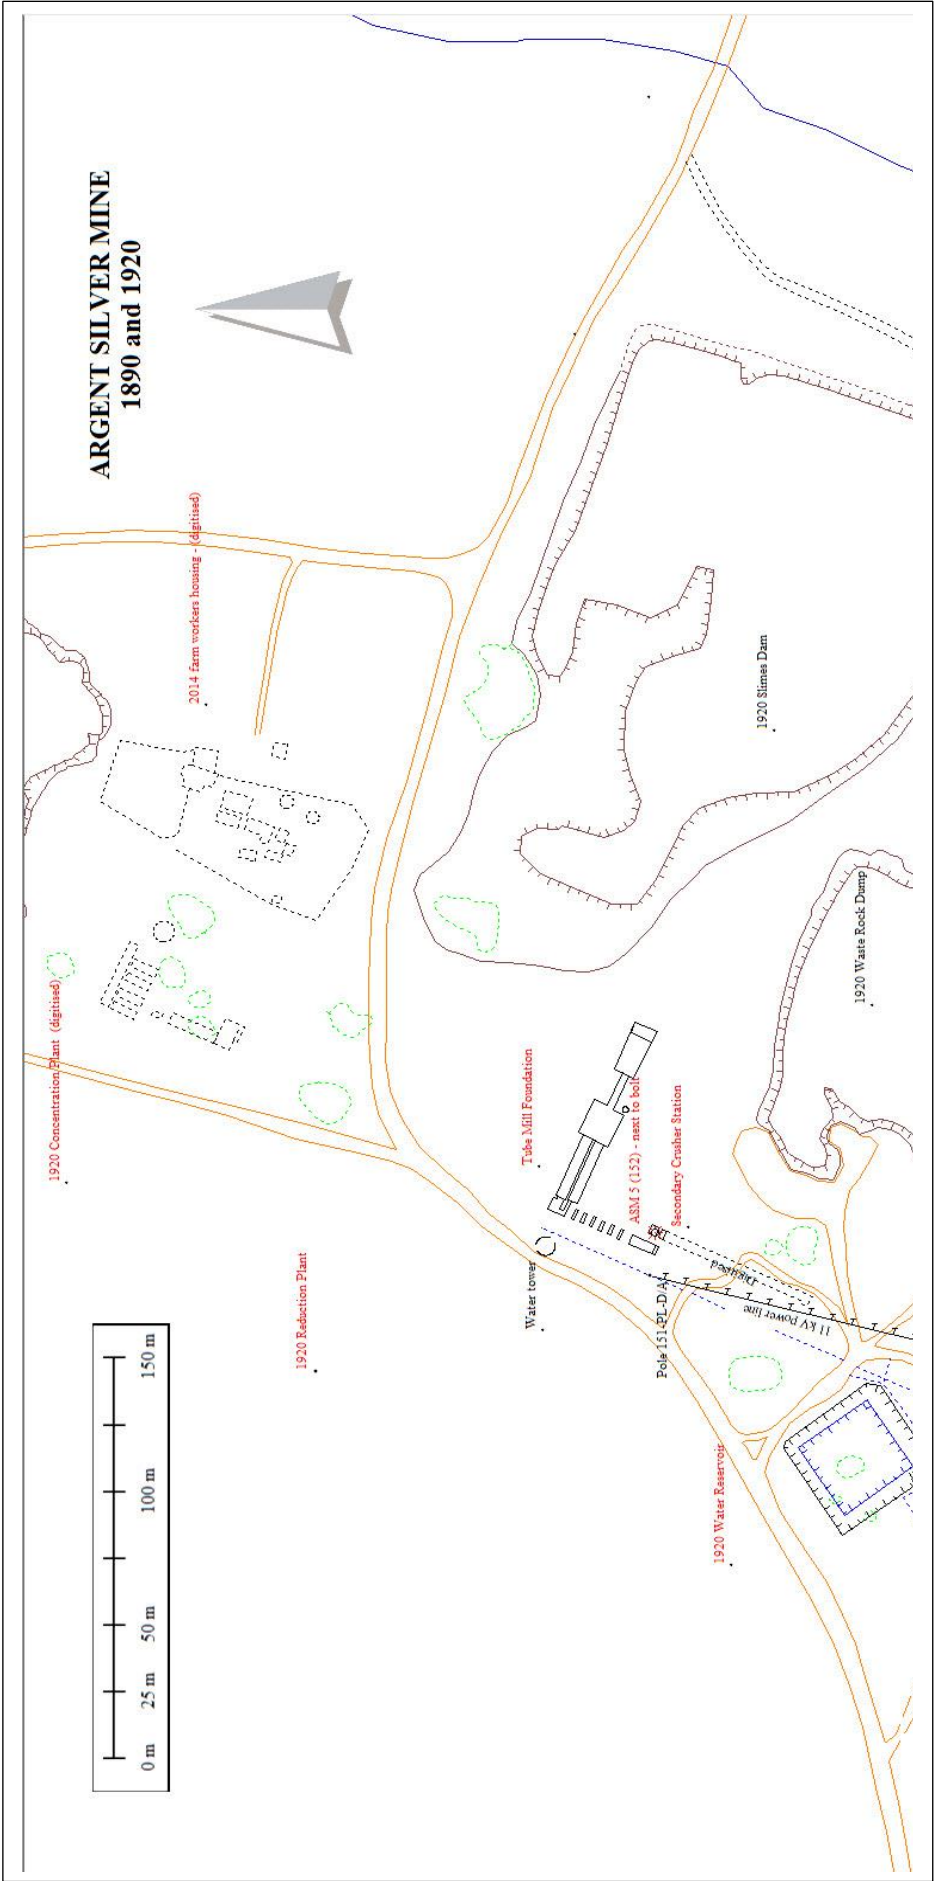
Map 3 North end of the Argent Mine showing the crushing plant foundations, slimes dam and part of the waste rock dump drawn from the digitisation of the geo-referenced ortho-photograph.

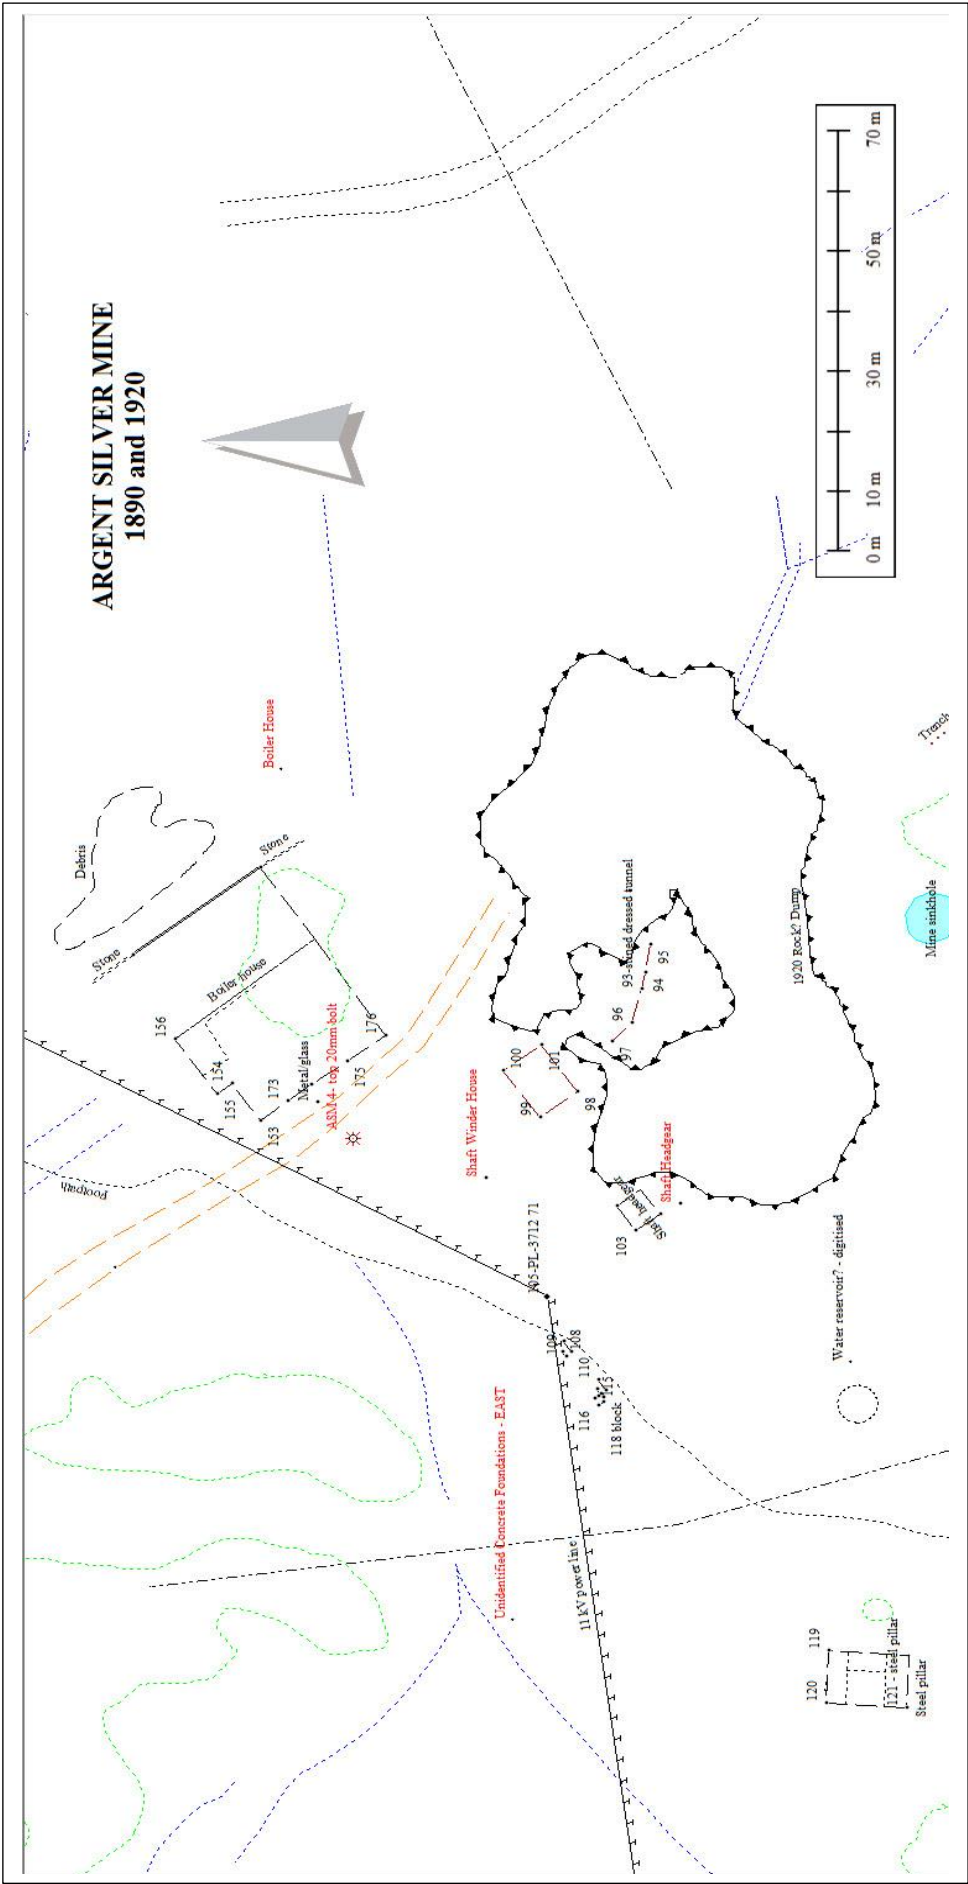
Map 4 central area of the Argent Mine showing the surveyed area of the Native Location with some features drawn from the digitisation of the geo-referenced ortho-photograph.

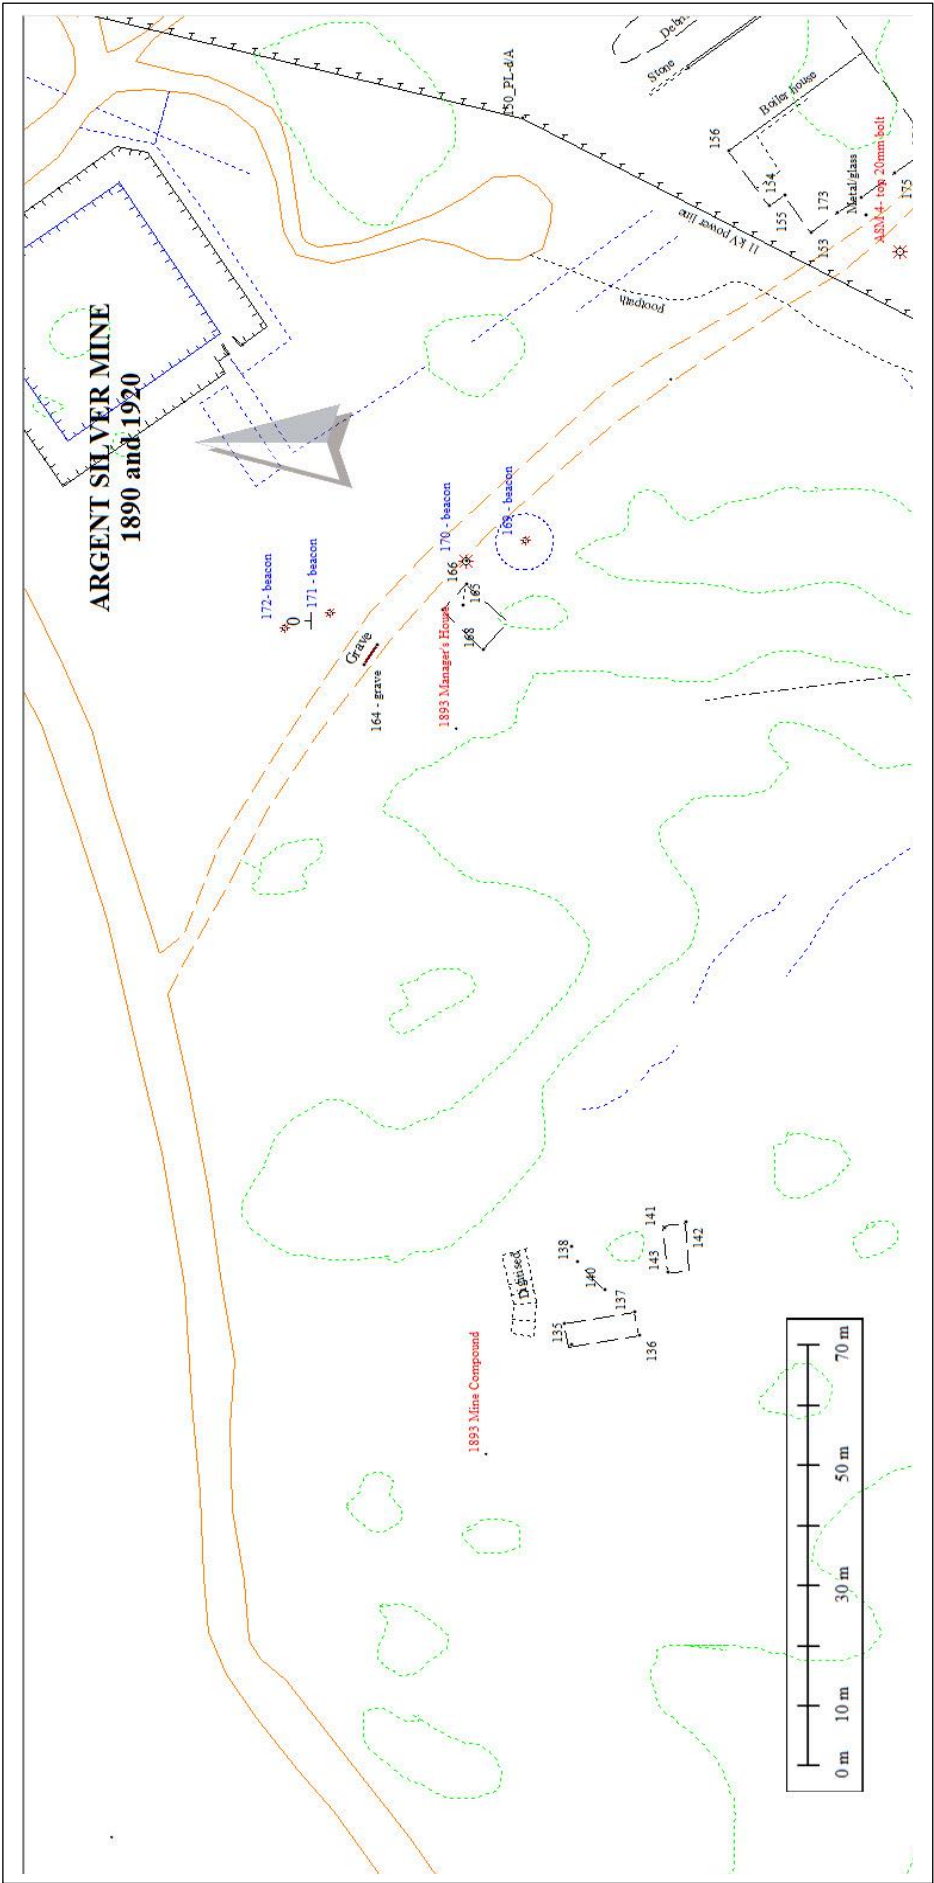
Map 5 central area of the Argent Mine showing the surveyed area of the Main Shaft, shaft waste rock dump and Boiler house foundations with some features drawn from the digitisation of the geo-referenced ortho-photograph.

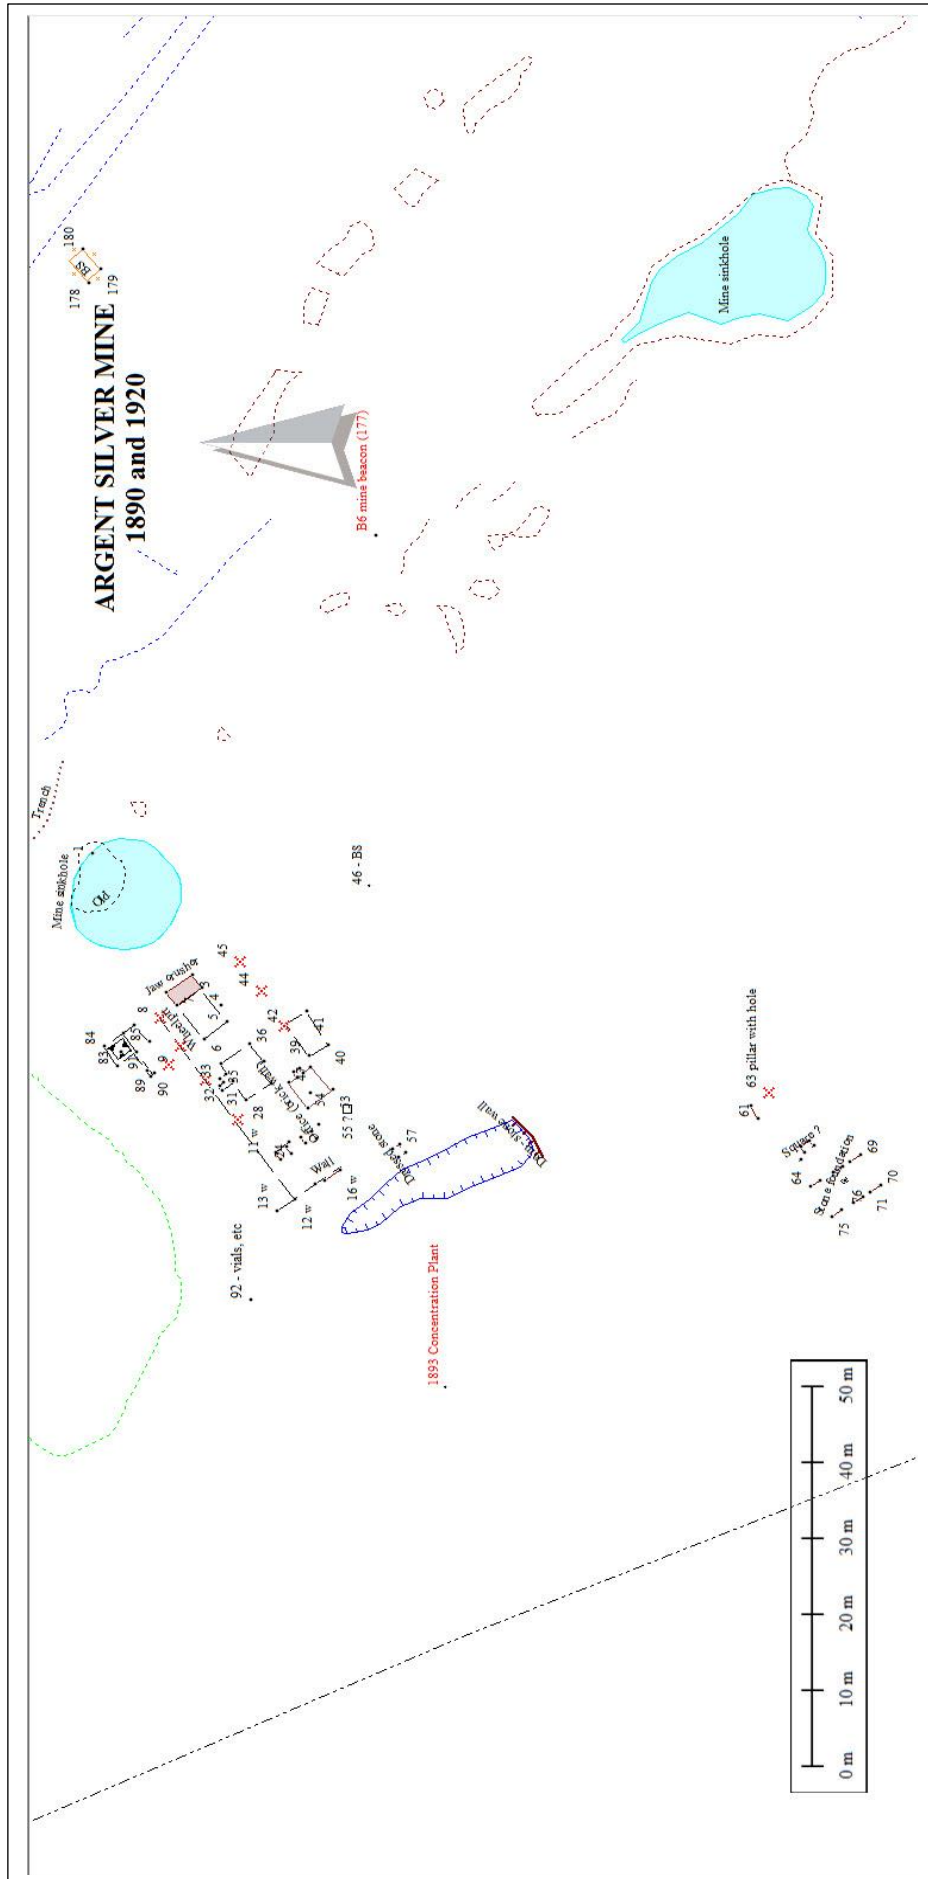
Map 7 south area of the Argent Mine showing the surveyed area of the 1890s concentration plant foundations and position and extent of the old dam, 1890s trenches and 1920s miscellaneous foundations with some features drawn from the digitisation of the geo-referenced ortho-
