A STUDY OF METHODS TO IMPROVE  
THE PERFORMANCE OF DRAG BITS USED  
TO CUT HARD ROCK.

A Thesis Submitted to the Faculty of Engineering  
University of the Witwatersrand, Johannesburg  
for the Degree of Doctor of Philosophy.

Johannesburg 1977

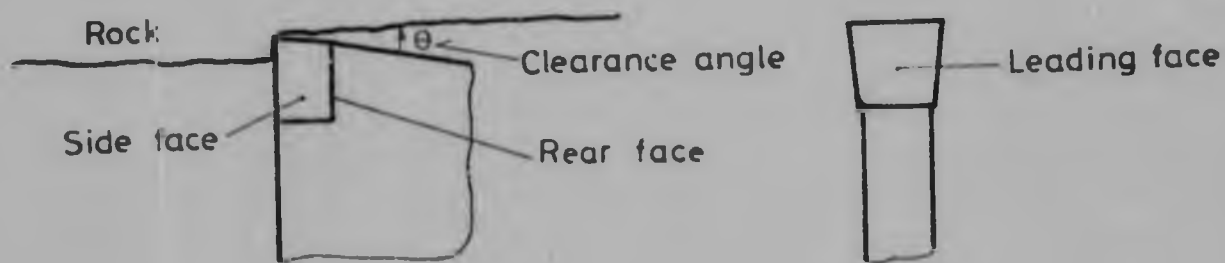
Original design of rockcutting bit

The original design of bits used for the early experimental programme with rockcutting machines is illustrated in Figure 5a, (Hojem et al, 1971). The tungsten carbide insert with zero rake angle was brazed into a notch in the steel bit body. Clearance angles were provided in the insert on the front and side faces of the insert. The early experiments carried out at the Chamber of Mines showed that when cutting strong abrasive quartzites a high rate of wear of the tungsten carbide inserts was experienced. Thus, after only a few traverses of the rock by the bit, the front face of the tool had worn to form a flat and the tool effectively was blunt. It was recognised that the bits would have to operate in a blunt condition and the bit design was modified so that the clearance angle behind the face of the bit became zero. The area of this front face of the bit that was in contact with the rock was termed the bit wearflat, (Figure 5b).

These experiments showed also, that the tungsten carbide bit inserts cracked along the rear face of the inserts, (Figure 5a). These cracks were attributed to the high penetrating force generated during the cutting operation which induced tensile stresses in the tungsten carbide insert since the leading face of the insert was not supported. Another major cause of failure of these bits was at the braze joint, where the tungsten carbide broke away completely from the steel bit body. This type of failure occurred either during the return stroke, when the tungsten carbide fouled the rock which put the braze in tension, or when excessive sideloads were applied to the insert causing the braze joint to shear.

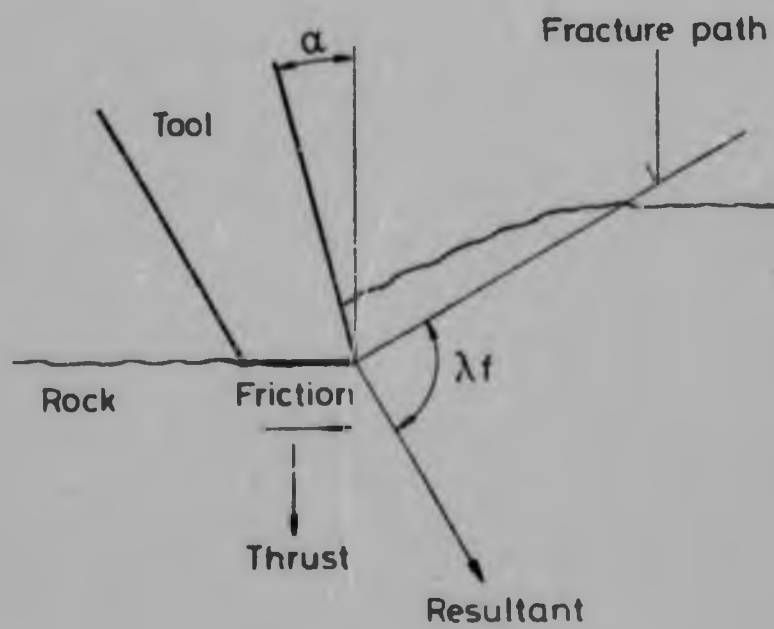
FIGURE 6 : A blunt rotary drilling drag bit (after Fairhurst and Lacabanne, 1957).

In addition it was proposed that the thrust is directly proportional to the contact area and the torque remains only partly affected. It was suggested by these authors that the angle of the resultant force applied to the bit during the cutting operation was affected by the bit rake angle. They postulated that fracture occurs at some constant angle with the resultant force, (Figure 6). Thus a change of the bit rake angle would alter the angle of the resultant force. This in turn would cause the length of the fracture path to vary (Figure 6), and affect the forces to cause the rock to fracture.

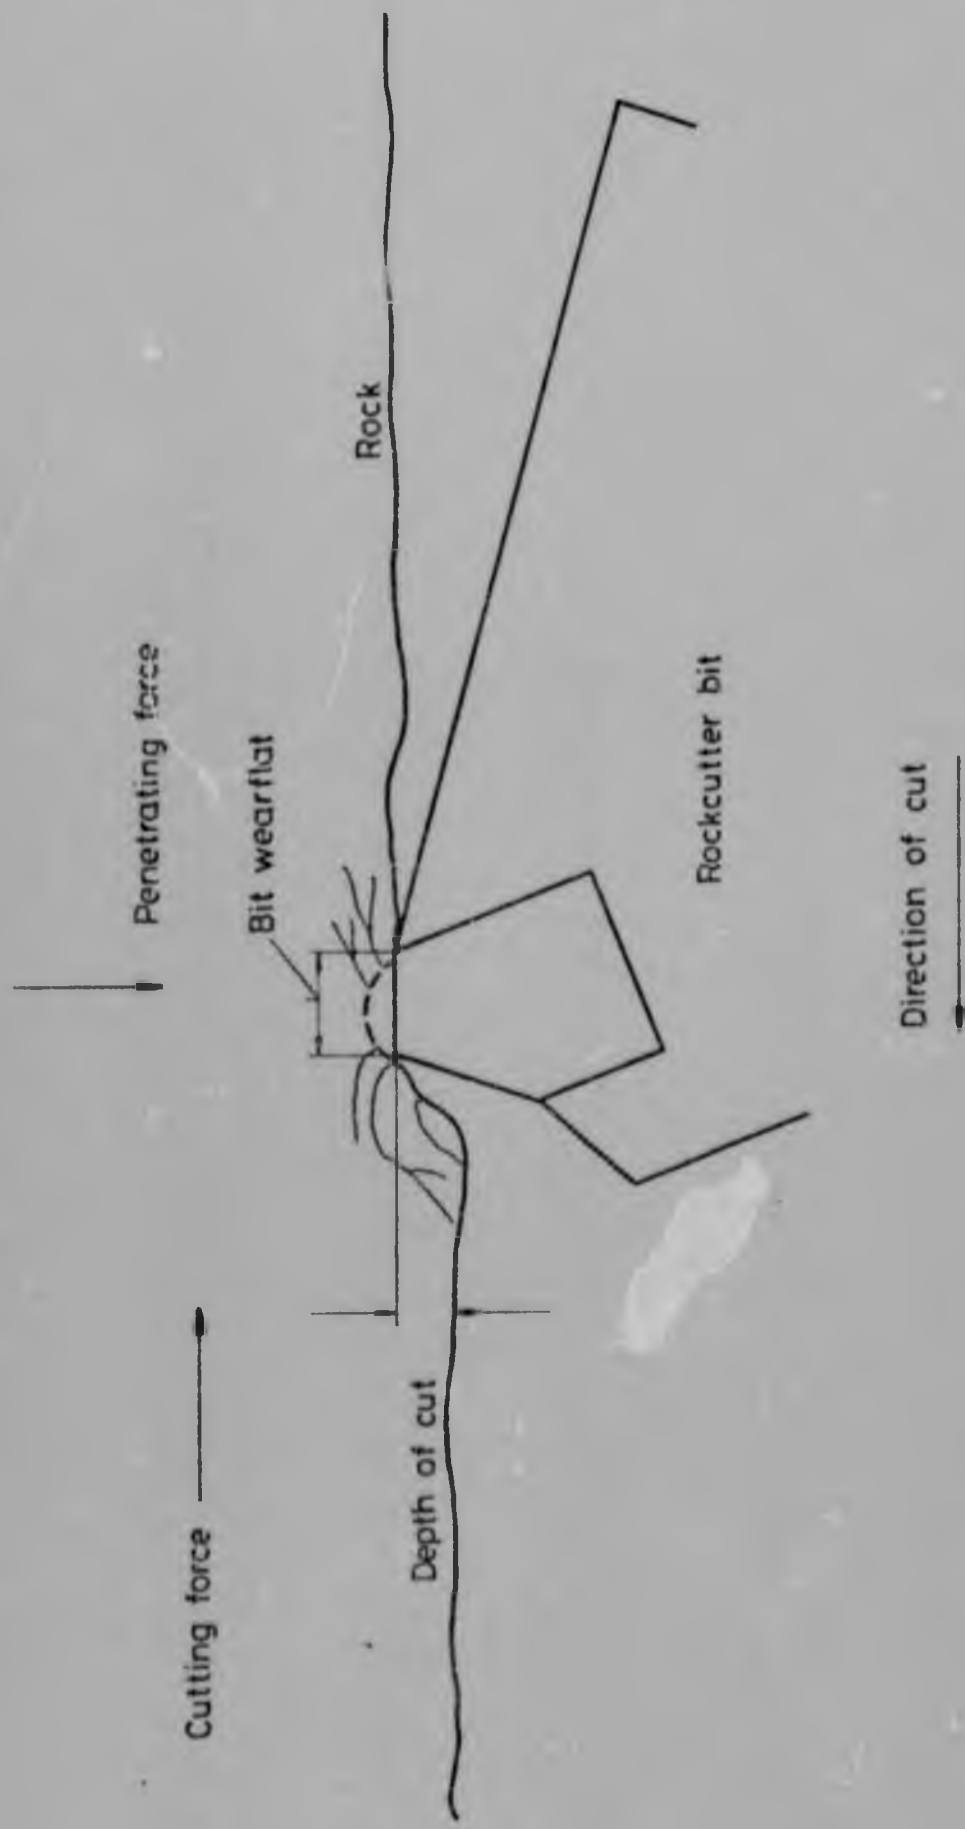
FIGURE 7. The components of force acting on a drag bit.

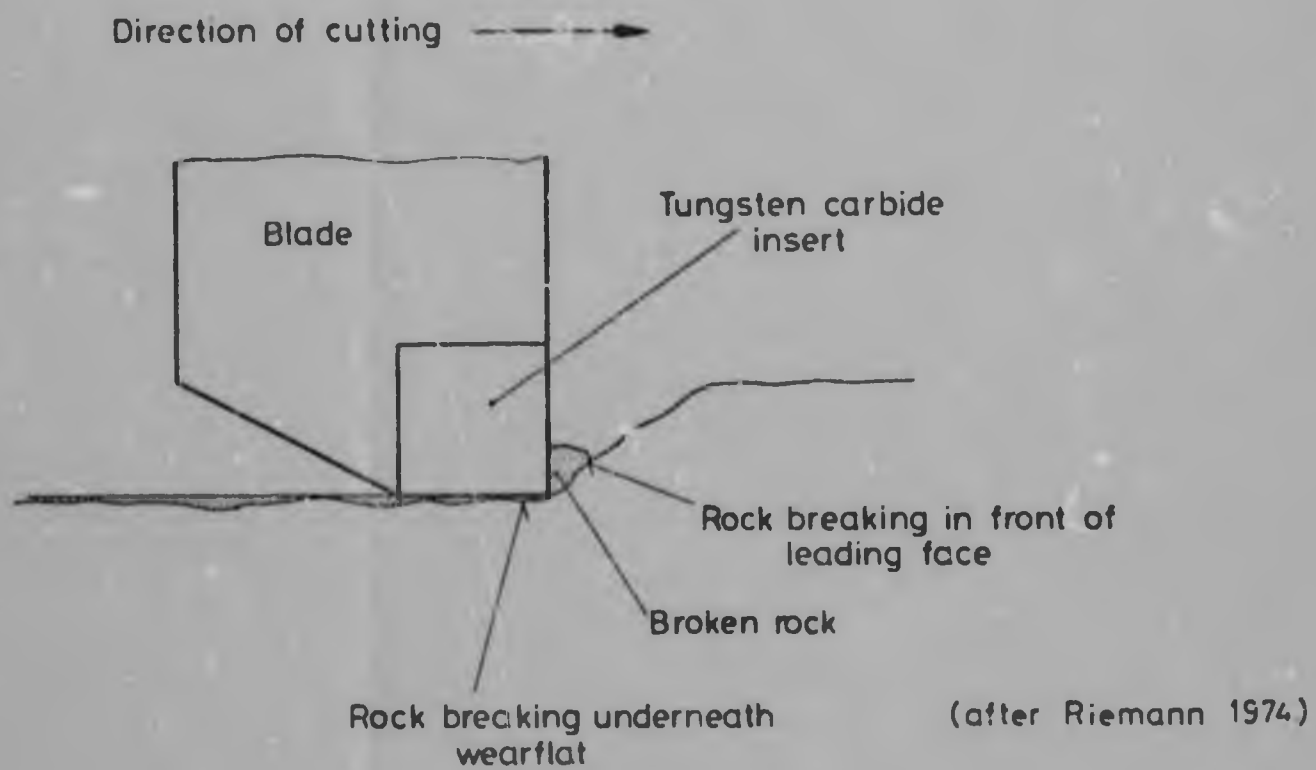
Fig. 8. Diagram illustrating method of rock fracture using a blunt drag bit to cut hard rock.

Riemann concluded that the fracture mechanism which had been suggested by Evans (1962) and other workers for cutting weak rocks with drag bits did not apply for strong rock situations. He proposed that in the strong rock types, fracture was initiated underneath the bit wearflat and that cracks formed in this region caused the rock to spall ahead of the leading face of the bit. Therefore, it was suggested that the reason the bit angle was found not to influence the bit forces during the cutting operation was because the leading face of the bit usually was not in contact with the rock, (Figure 8).

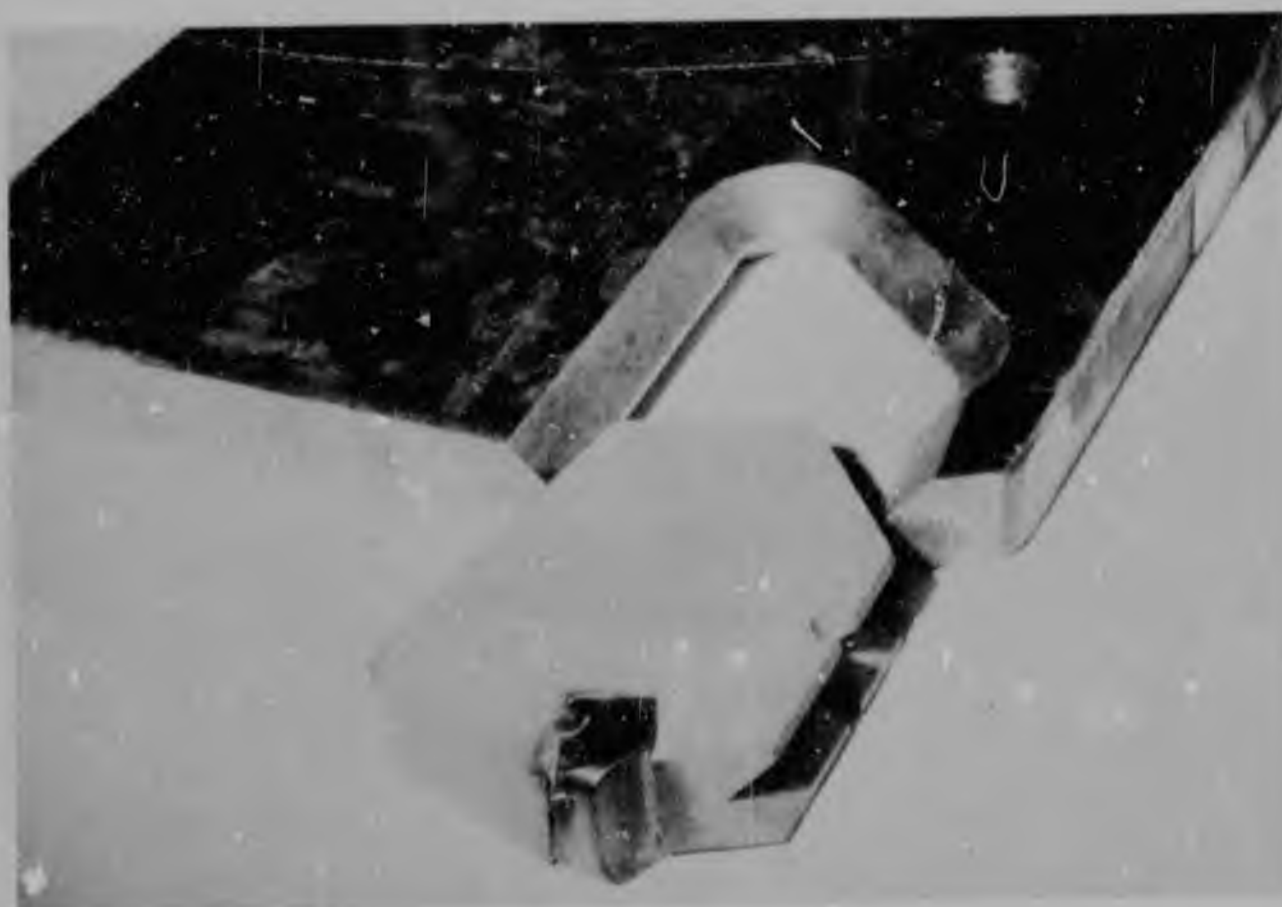
FIGURE 9. Detachable rockcutter bit, 23 mm thick, in use at the start of the pilot production trials of mining by rockcutting.

Therefore, the design of bit development for the start of the pilot production trials, employed a tungsten carbide insert twenty three millimetres thick, with a wearflat width of six millimetres when the bit was new. The insert, with a twenty degrees negative rake angle, was brazed into the bit body so that the resultant force vector was normal to the base of the insert, (Figure 5b). A silver-solder braze metal was used and the thickness of the braze joint was 0,5 millimetres. The steel bit body was machined with a "V" cross-section which mated with a 'pocket' machined in the blade, (Figure 9). The bit was fitted into this 'blade pocket' and was

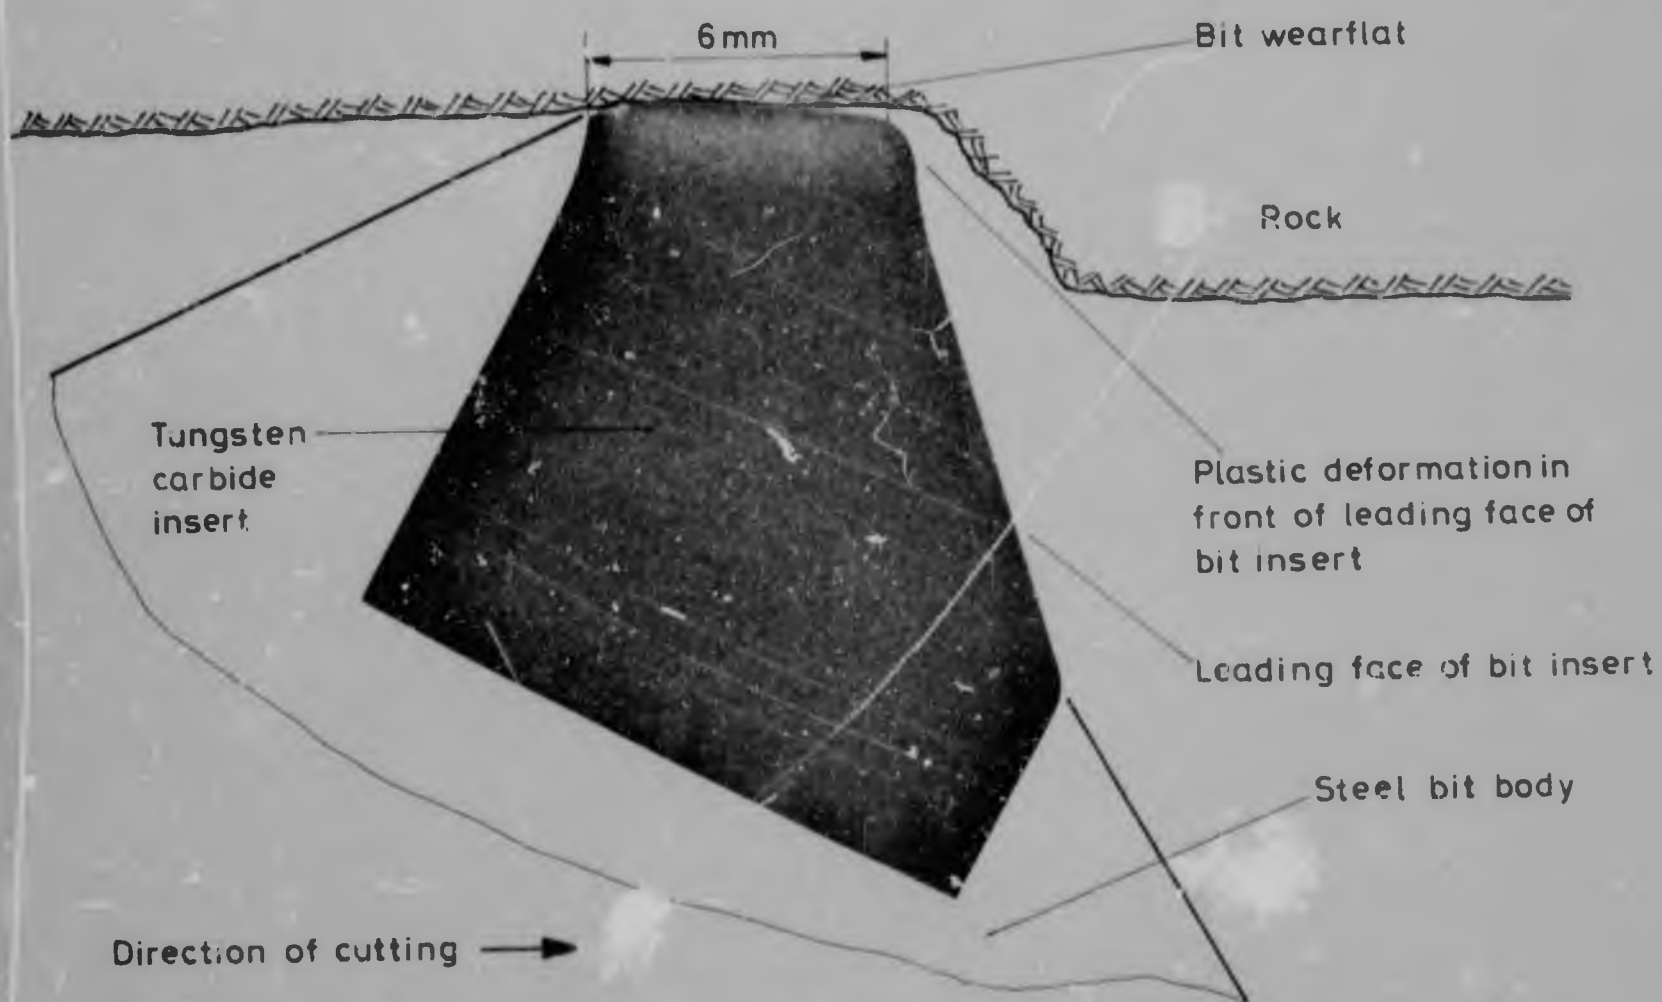
FIGURE 12 : Magnified section of a tungsten carbide bit insert, showing plastic deformation of the insert ahead of the leading face.

Bits that were returned to the laboratory after service in the machines underground, commonly showed plastic deformation of the tungsten carbide bit insert. This is illustrated in a magnified section in Figure 12. This Figure shows that the tungsten carbide was deformed ahead of the insert adjacent to the bit wearflat. A brittle material such as cemented tungsten carbide can be deformed

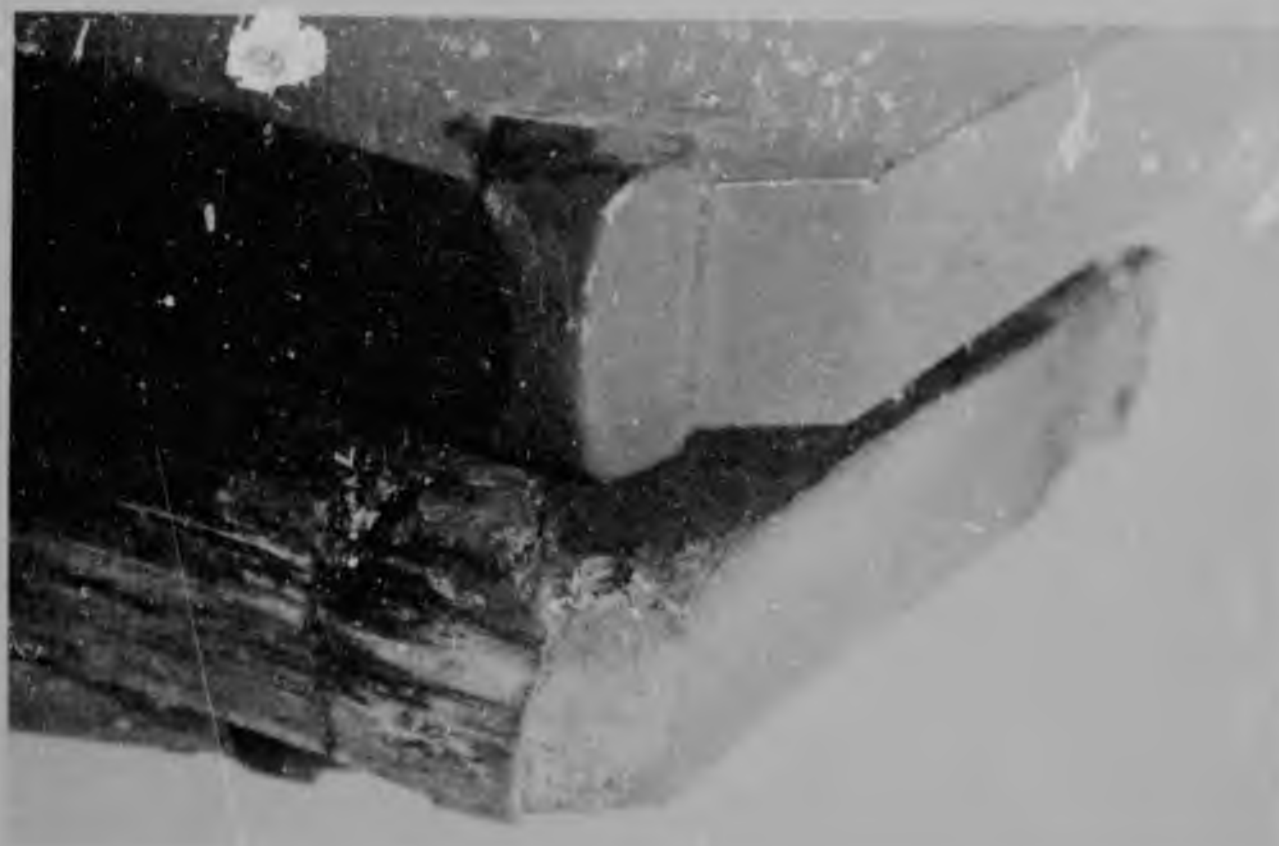
FIGURE 13. Thermal deterioration producing wear of tungsten carbide bit insert.

In addition, when cutting in relatively unfractured rock underground, it was observed occasionally that black streaks were left on the rock surface in the bottom of the slot behind the bit. These streaks were studied in the laboratory, using an energy dispersive X-ray analyser, and a significant amount of tungsten, a mineral normally not found in the quartzite, was detected within the samples. This implied that the tungsten carbide insert had melted at the interface between the bit and the rock. In this situation the bit insert was found to wear rapidly, reducing the bit life significantly. An example of one of these bits, compared with a new bit, is given in Figure 13.

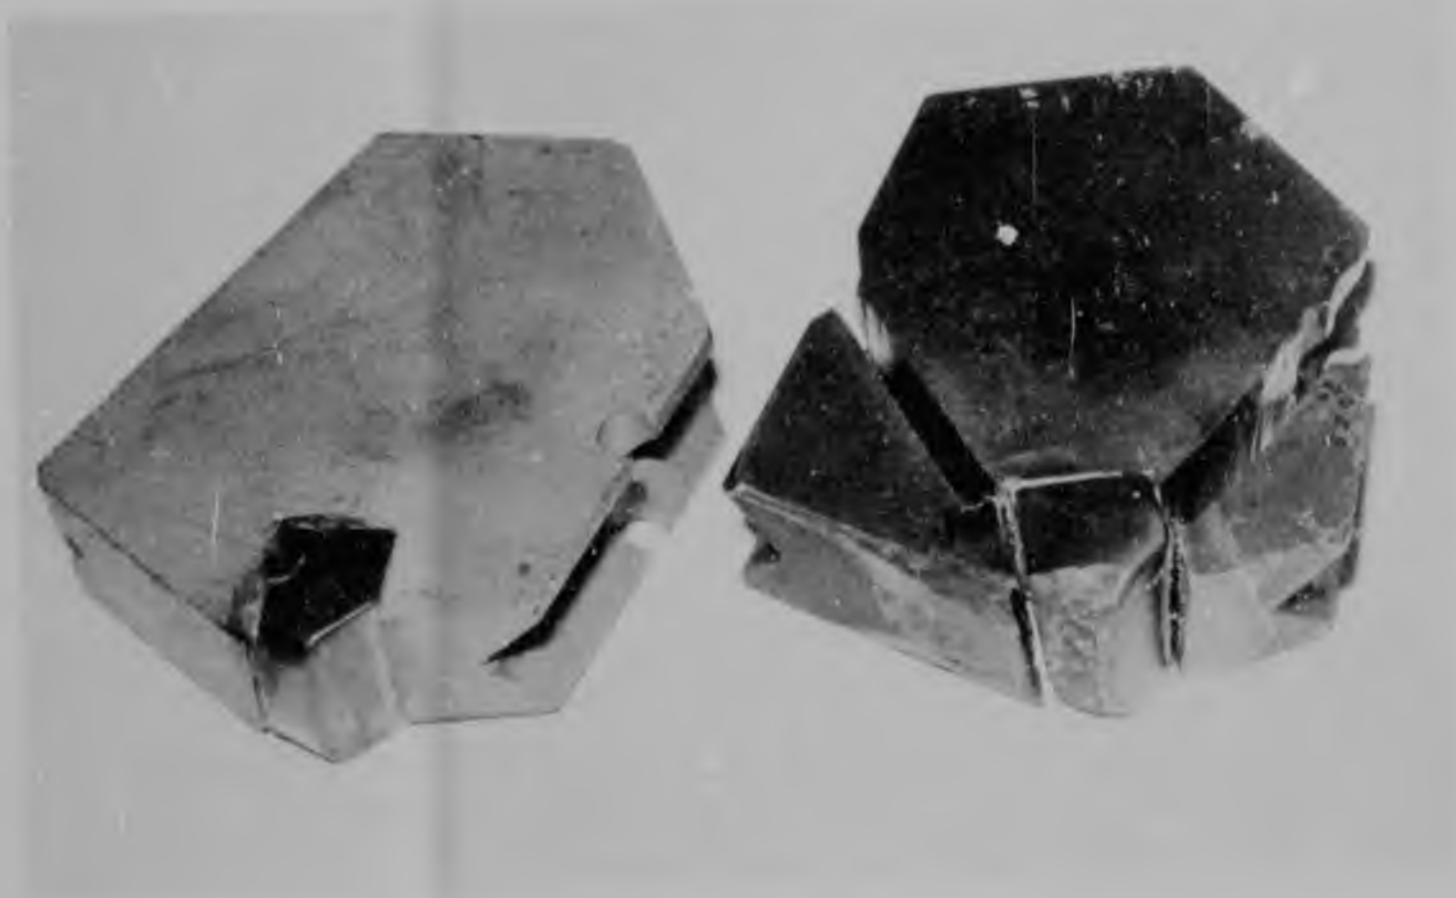
FIGURE 14. Rockcutter bit, showing method of breaking open to examine the braze joint.

A study of the damage to the bit braze joint as a result of the cutting process was made using a number of bits from this same laboratory test series. The bits were sectioned by sawing through the steel bit body and then breaking the tungsten carbide from the steel along the braze joint, (Figures 14, 15 and 16). The braze joint of all the bits which had been used to cut in the block of rock showed signs of serious damage, indicated by oxidation of the braze metal which caused a black discolouration. By comparison, the braze joints of bits which had not been used for cutting, were found to have a uniform copper colour with no blackened areas. The extent of these oxidized areas of the braze joint was less marked along the front brazed face of the insert, (Figure 15), than along the rear face of the insert (Figure 16). This was attributed to the heat being generated at the area of contact between the bit and the rock,

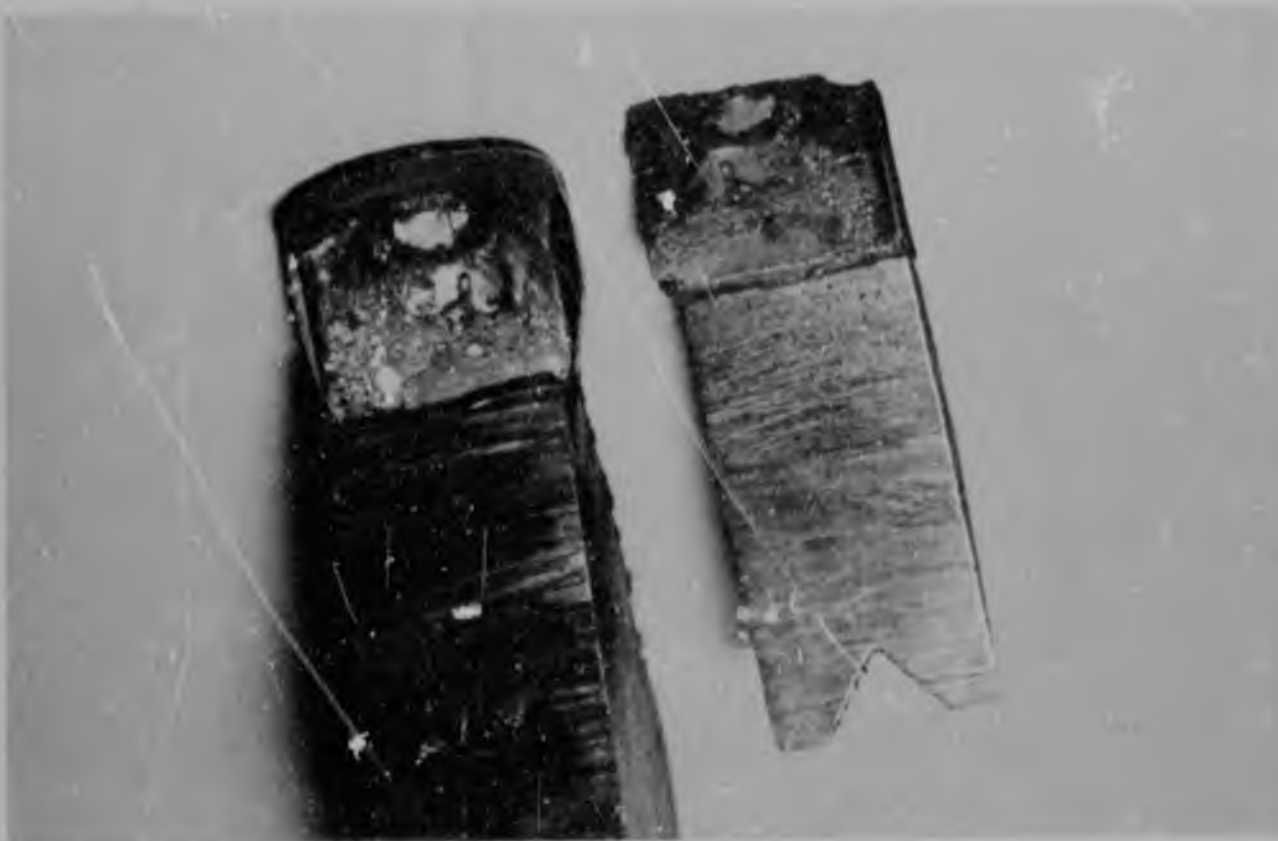
FIGURE 16. Oxidation of rear braze face.

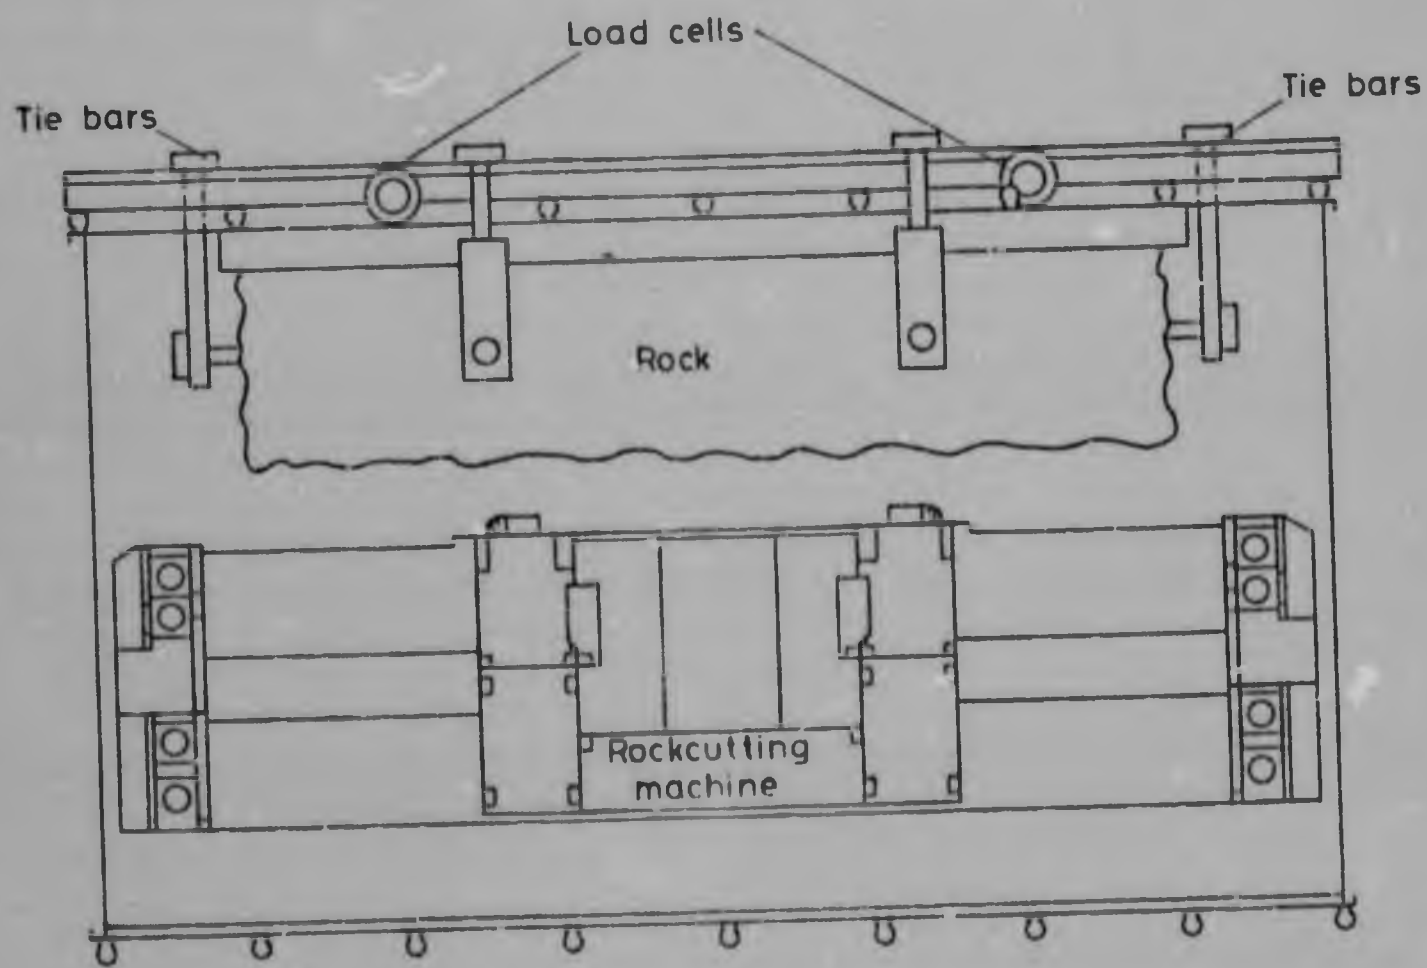
FIGURE 17 : Diagram of test frame. Plan view illustrating the rockcutting machine set up to cut against the norite block.

The rock used for experiments carried out using this test apparatus was norite; this is a strong basic rock that is quarried in the Rustenburg, Transvaal area. Norite was used for these tests,

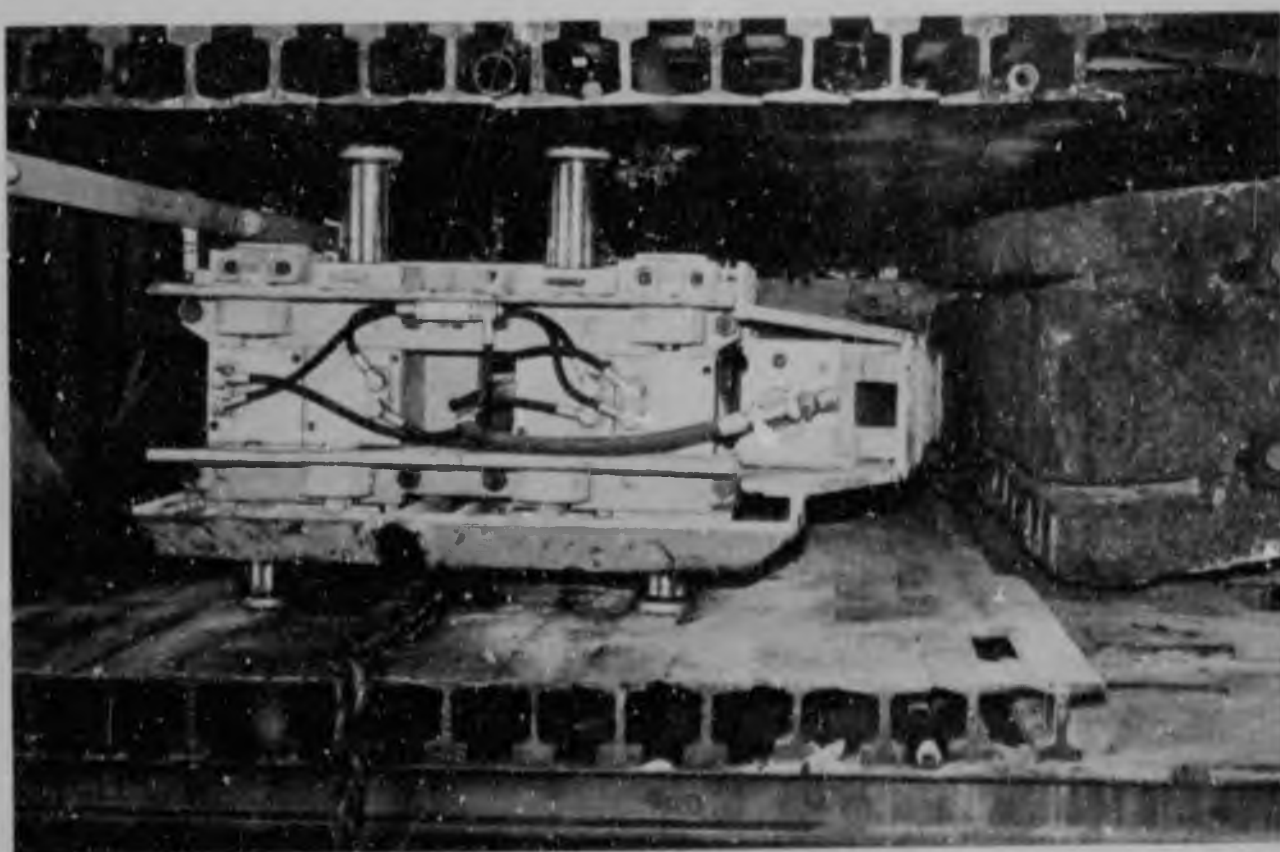
FIGURE 18. Rockcutting machine in test frame, side view.

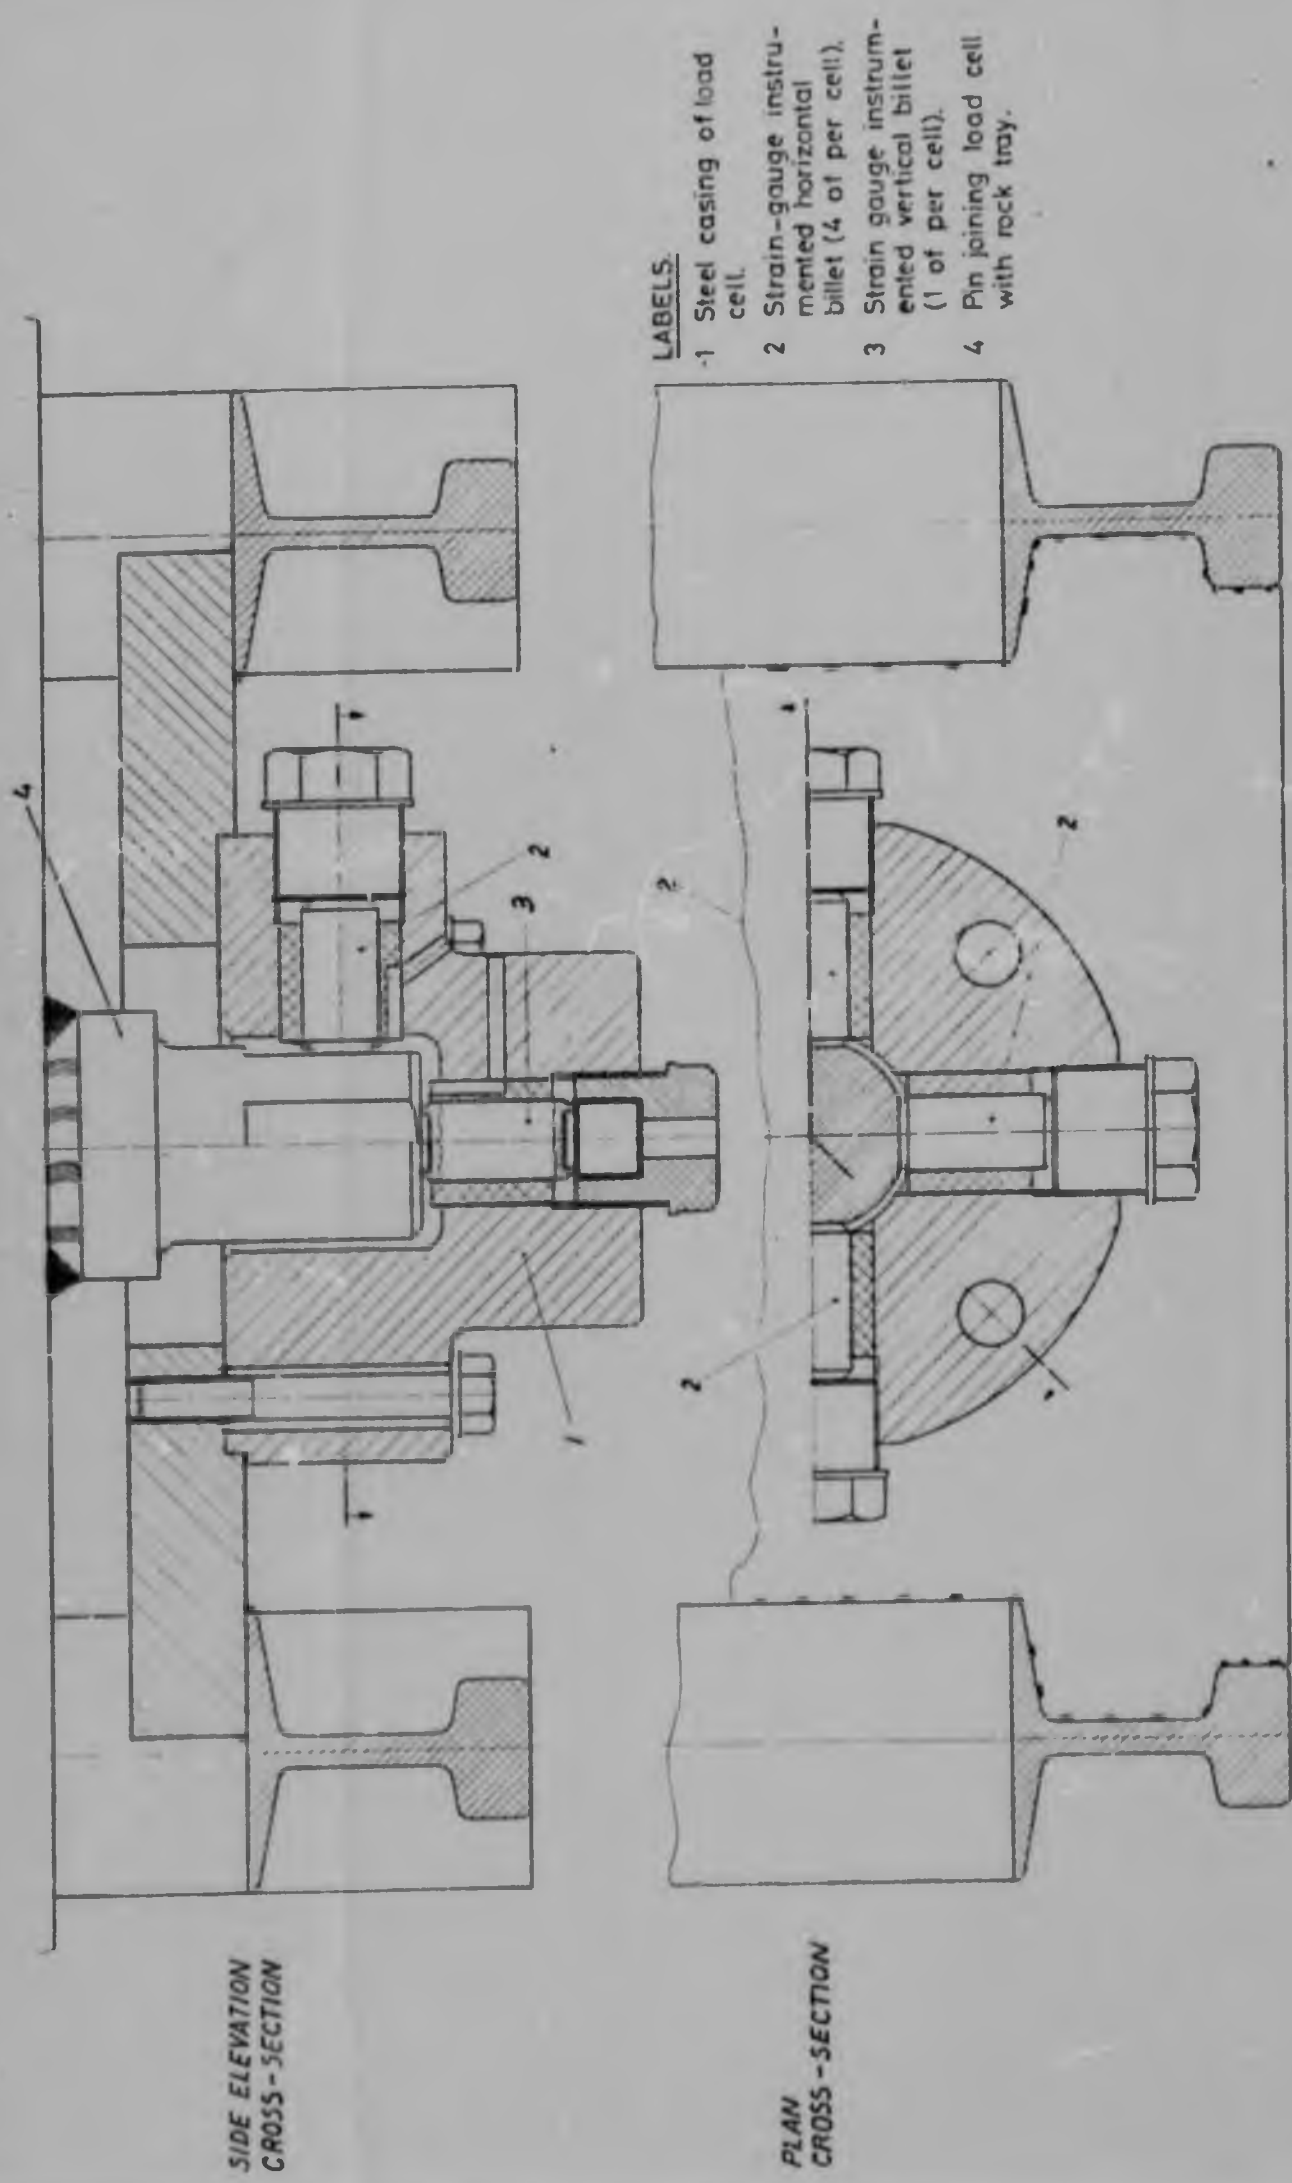
FIGURE 21. Section through a test frame load cell.

Signals from the load cell strain gauges were amplified and displayed on a twelve channel oscillograph. A differential input amplifier was used and facility was incorporated within the amplifier

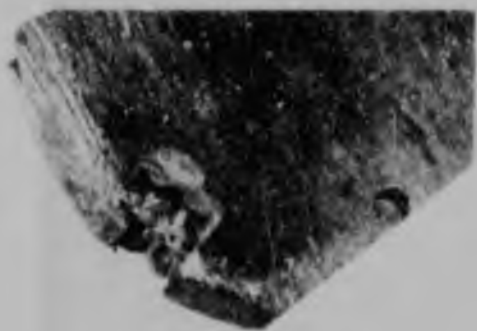
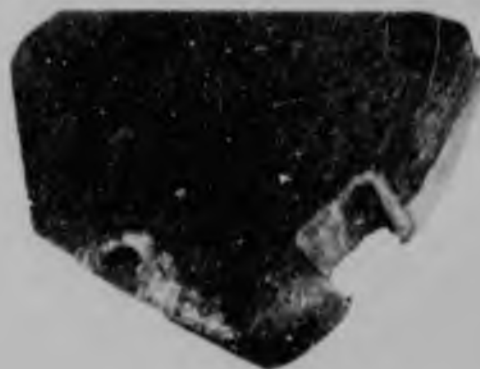
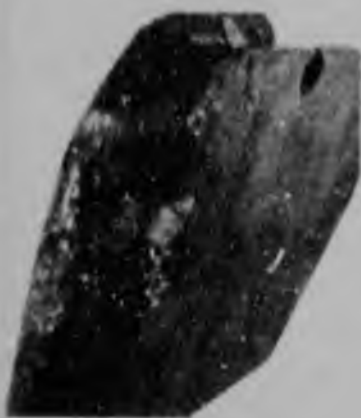
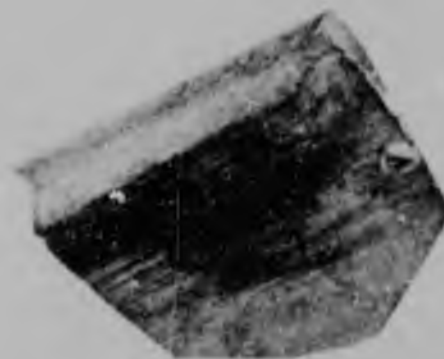
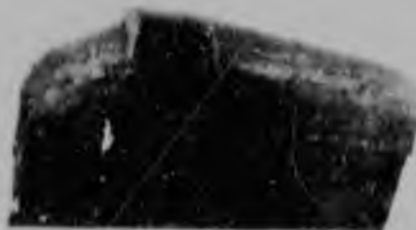
Insert failure

Braze failure

Insert and Braze failure

Unknown failure

No failure

The 'insert' failure classification defines a group of bits which were discarded because the tungsten carbide insert fractured during the cutting operation. The 'brazed' failure category refers to bits where the strength of the bit brazed joint had been exceeded, possibly due to thermal deterioration of this joint (Section 3.2.2), and the insert had been removed completely from the steel bit body. The 'insert and brazed' failure classification applies to bits where parts of the broken tungsten insert remained, together with evidence of a brazed joint failure. The category 'unknown' represents bits where all traces of the original tungsten carbide insert and brazed joint were destroyed leaving only the worn steel bit body. With these bits the machine operator had not recognised the failure and continued to use the bit, thereby destroying all evidence as to the original cause of failure. The term 'no failure' implies that the reason for discarding the bit was excessive wear of the tungsten carbide insert which caused the area of the bit wearflat to be increased. Laboratory experiments conducted by both Riemann (1974) and by the author (Section 6.3.2), showed that the force required to cut the rock was increased as the area of the bit wearflat was increased. Therefore as the wear of this insert progressed during the cutting operation, the maximum

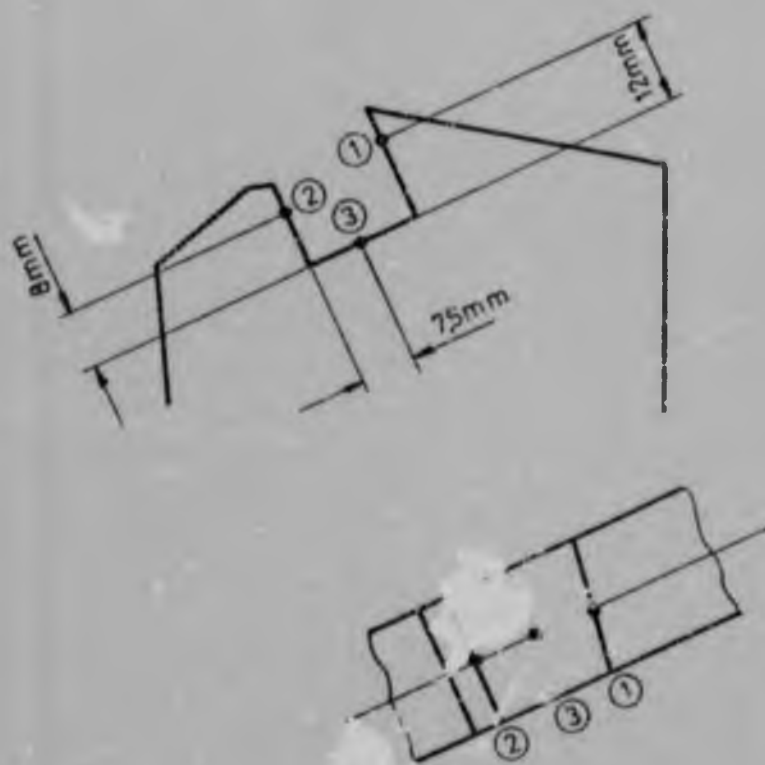
FIGURE 30 : Diagram illustrating the position of thermocouples mounted in the bit.

Five traverses of the rock were made at a given depth of cut prior to recording measurements of temperature or bit forces. This procedure was followed not only to establish an even depth of cut along the length of the slot (Section 5.1), but also to ensure that steady conditions prevailed and that the temperatures measured were

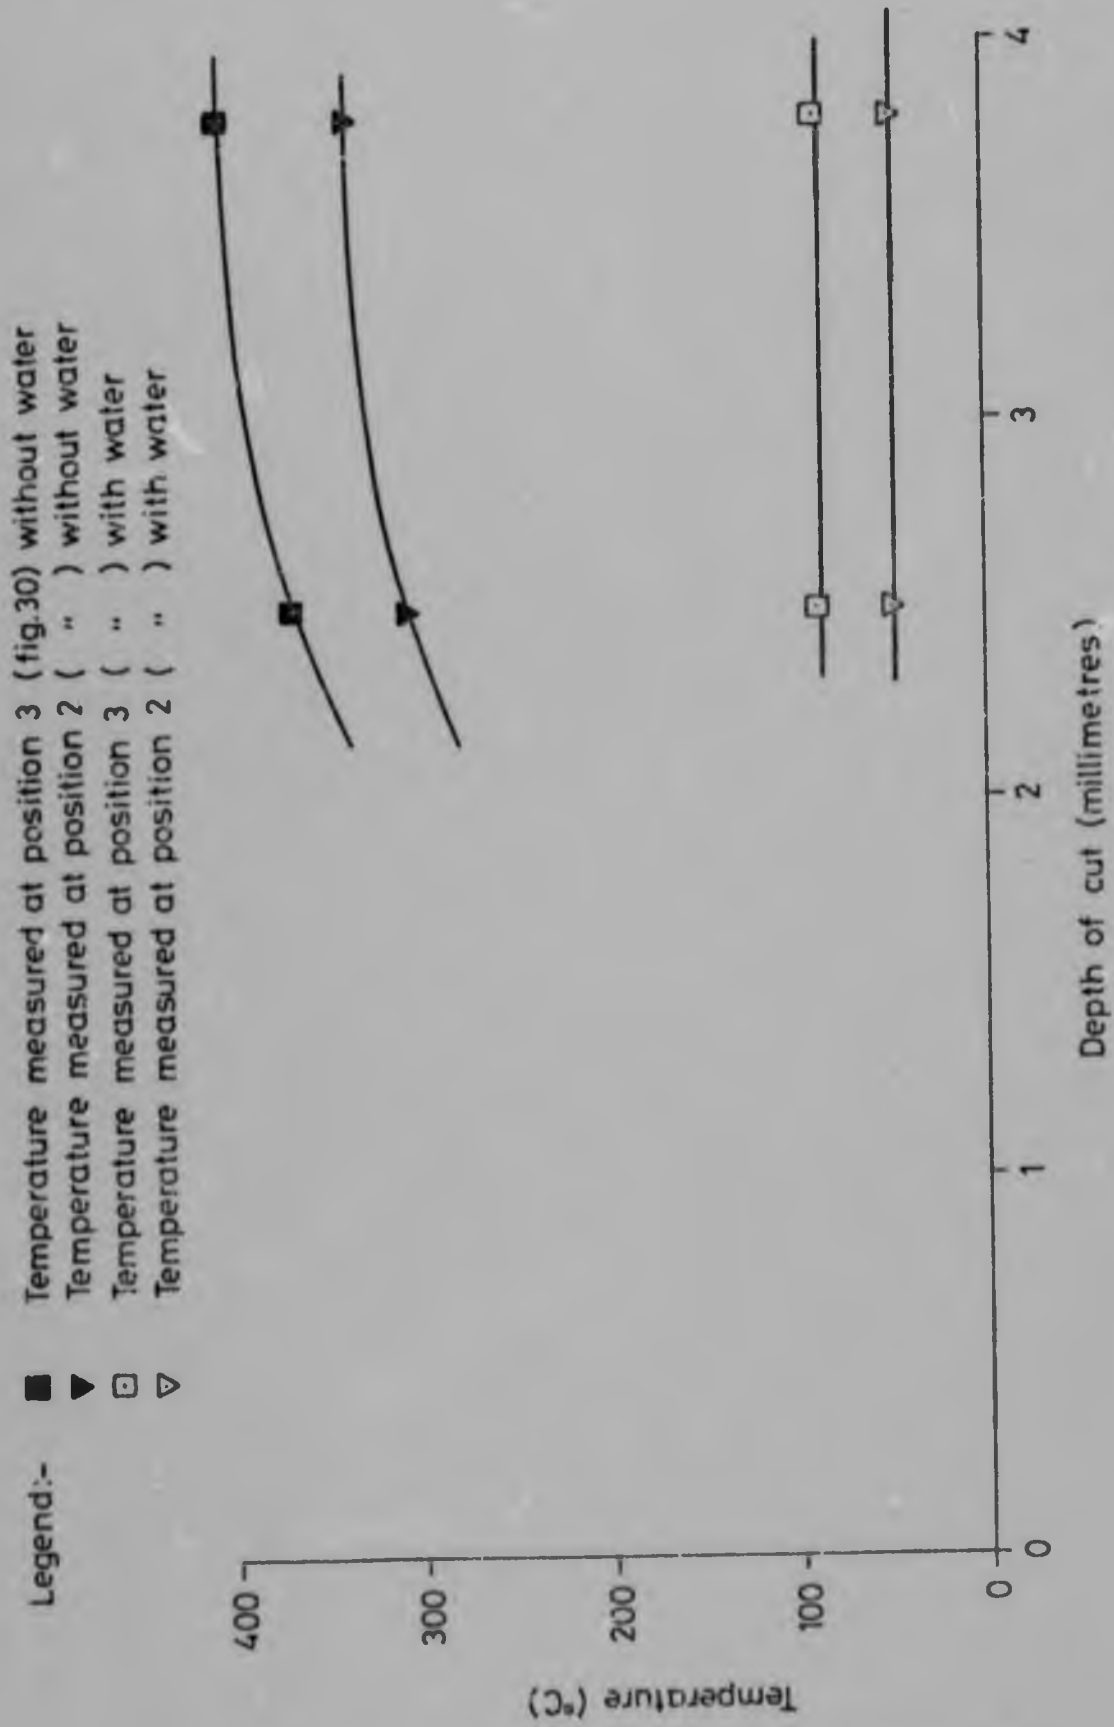
FIGURE 31 : Temperatures measured at the bit braze joint during the cutting operation plotted against depth of cut.

It was observed during these tests that the amplitudes of the oscillations of the bit cutting force and the bit penetrating force were reduced when water cooling was applied to the bit during the cutting operation, (Figure 32). Thus it was anticipated that two benefits would be derived by applying a continuous water jet to the
