A STUDY OF METHODS TO IMPROVE  
THE PERFORMANCE OF DRAG BITS USED  
TO CUT HARD ROCK.

A Thesis Submitted to the Faculty of Engineering  
University of the Witwatersrand, Johannesburg  
for the Degree of Doctor of Philosophy.

Johannesburg 1977

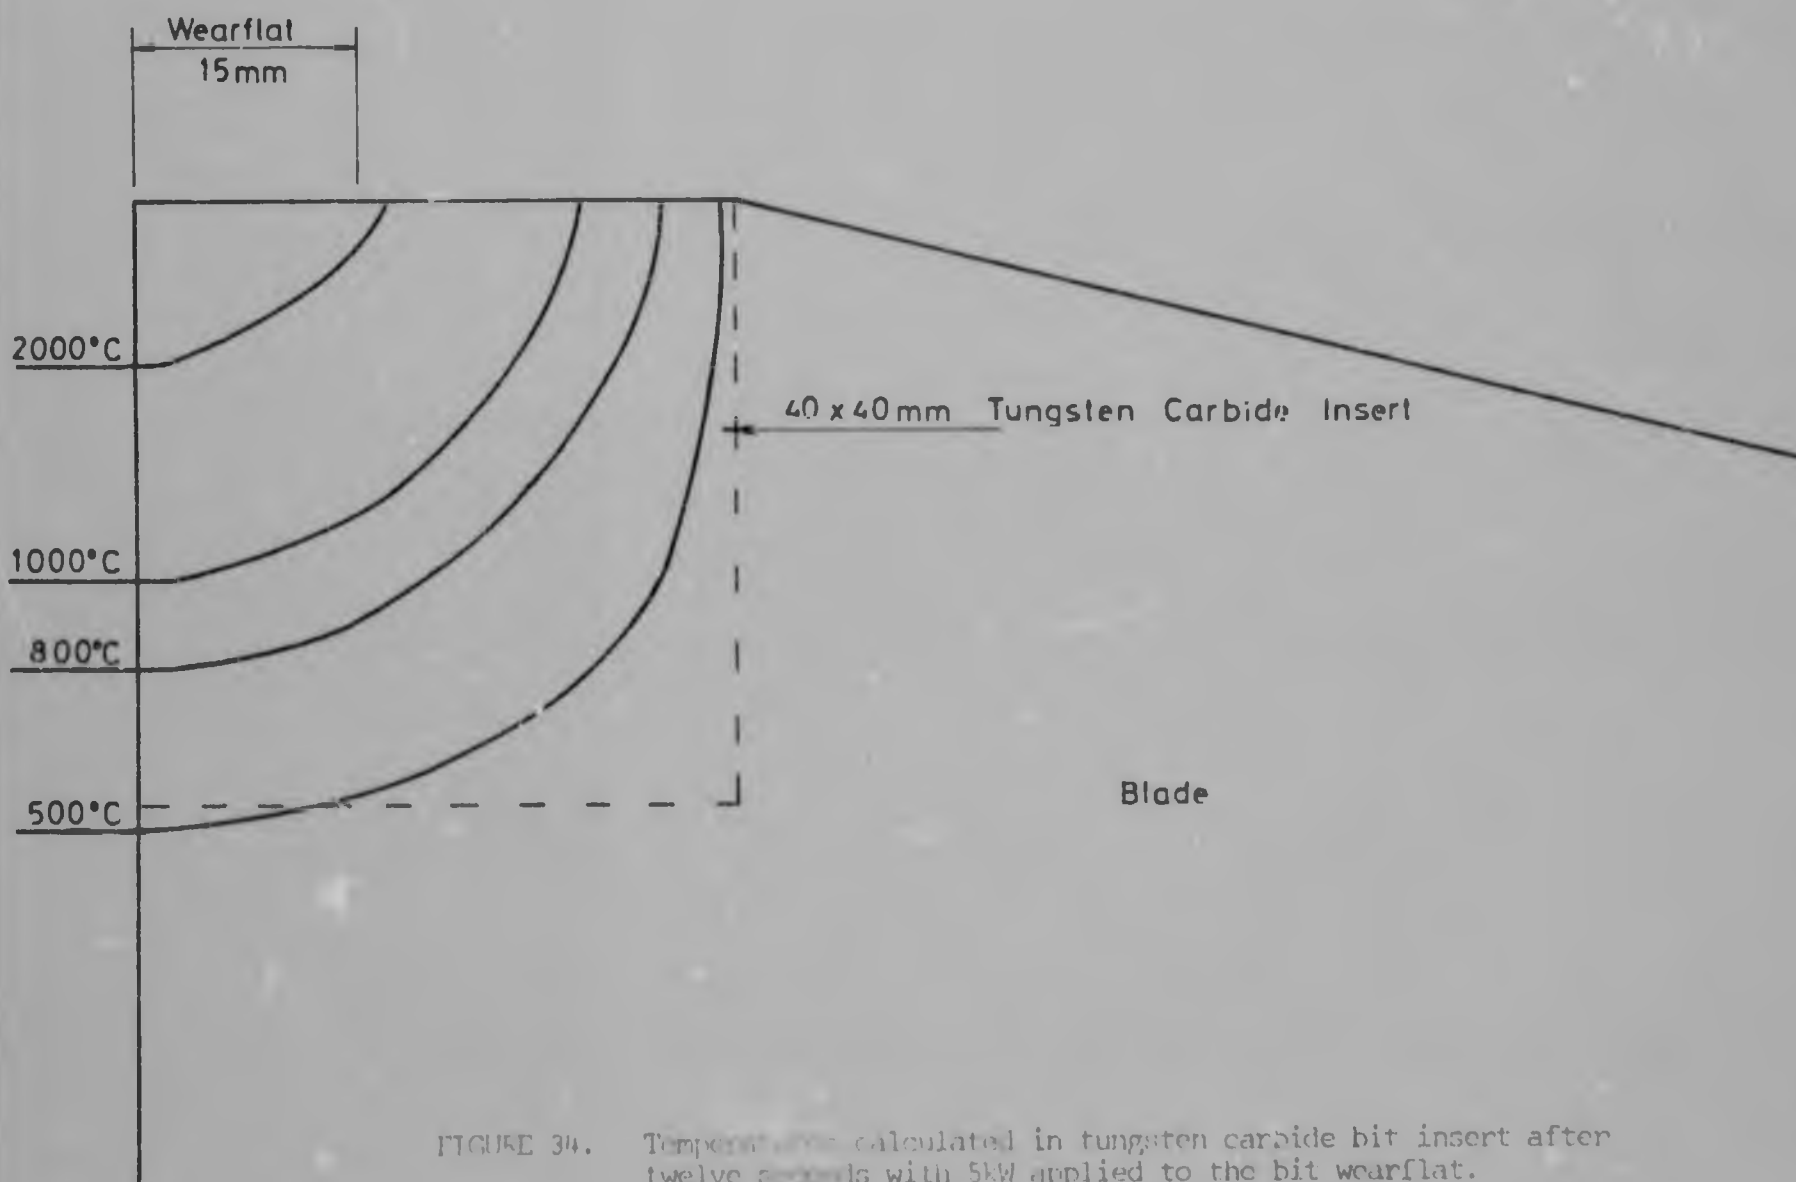
FIGURE 34. Temperature calculated in tungsten carbide bit insert after twelve seconds with 5kW applied to the bit wearflat.

These temperatures provided cause for concern since other experiments showed that the strength of the silver-solder braze joint is reduced significantly at temperatures in excess of 200 degrees Celsius, (Section 6.2.2). Braze temperatures considerably higher than this, were measured during these cutting experiments at points remote from the area of heat input. Furthermore Roxborough (1974), showed that the hardness of tungsten carbide falls off very rapidly with temperature, far more rapidly than the hardness of quartz, and he claimed that at approximately 400 degrees Celsius the

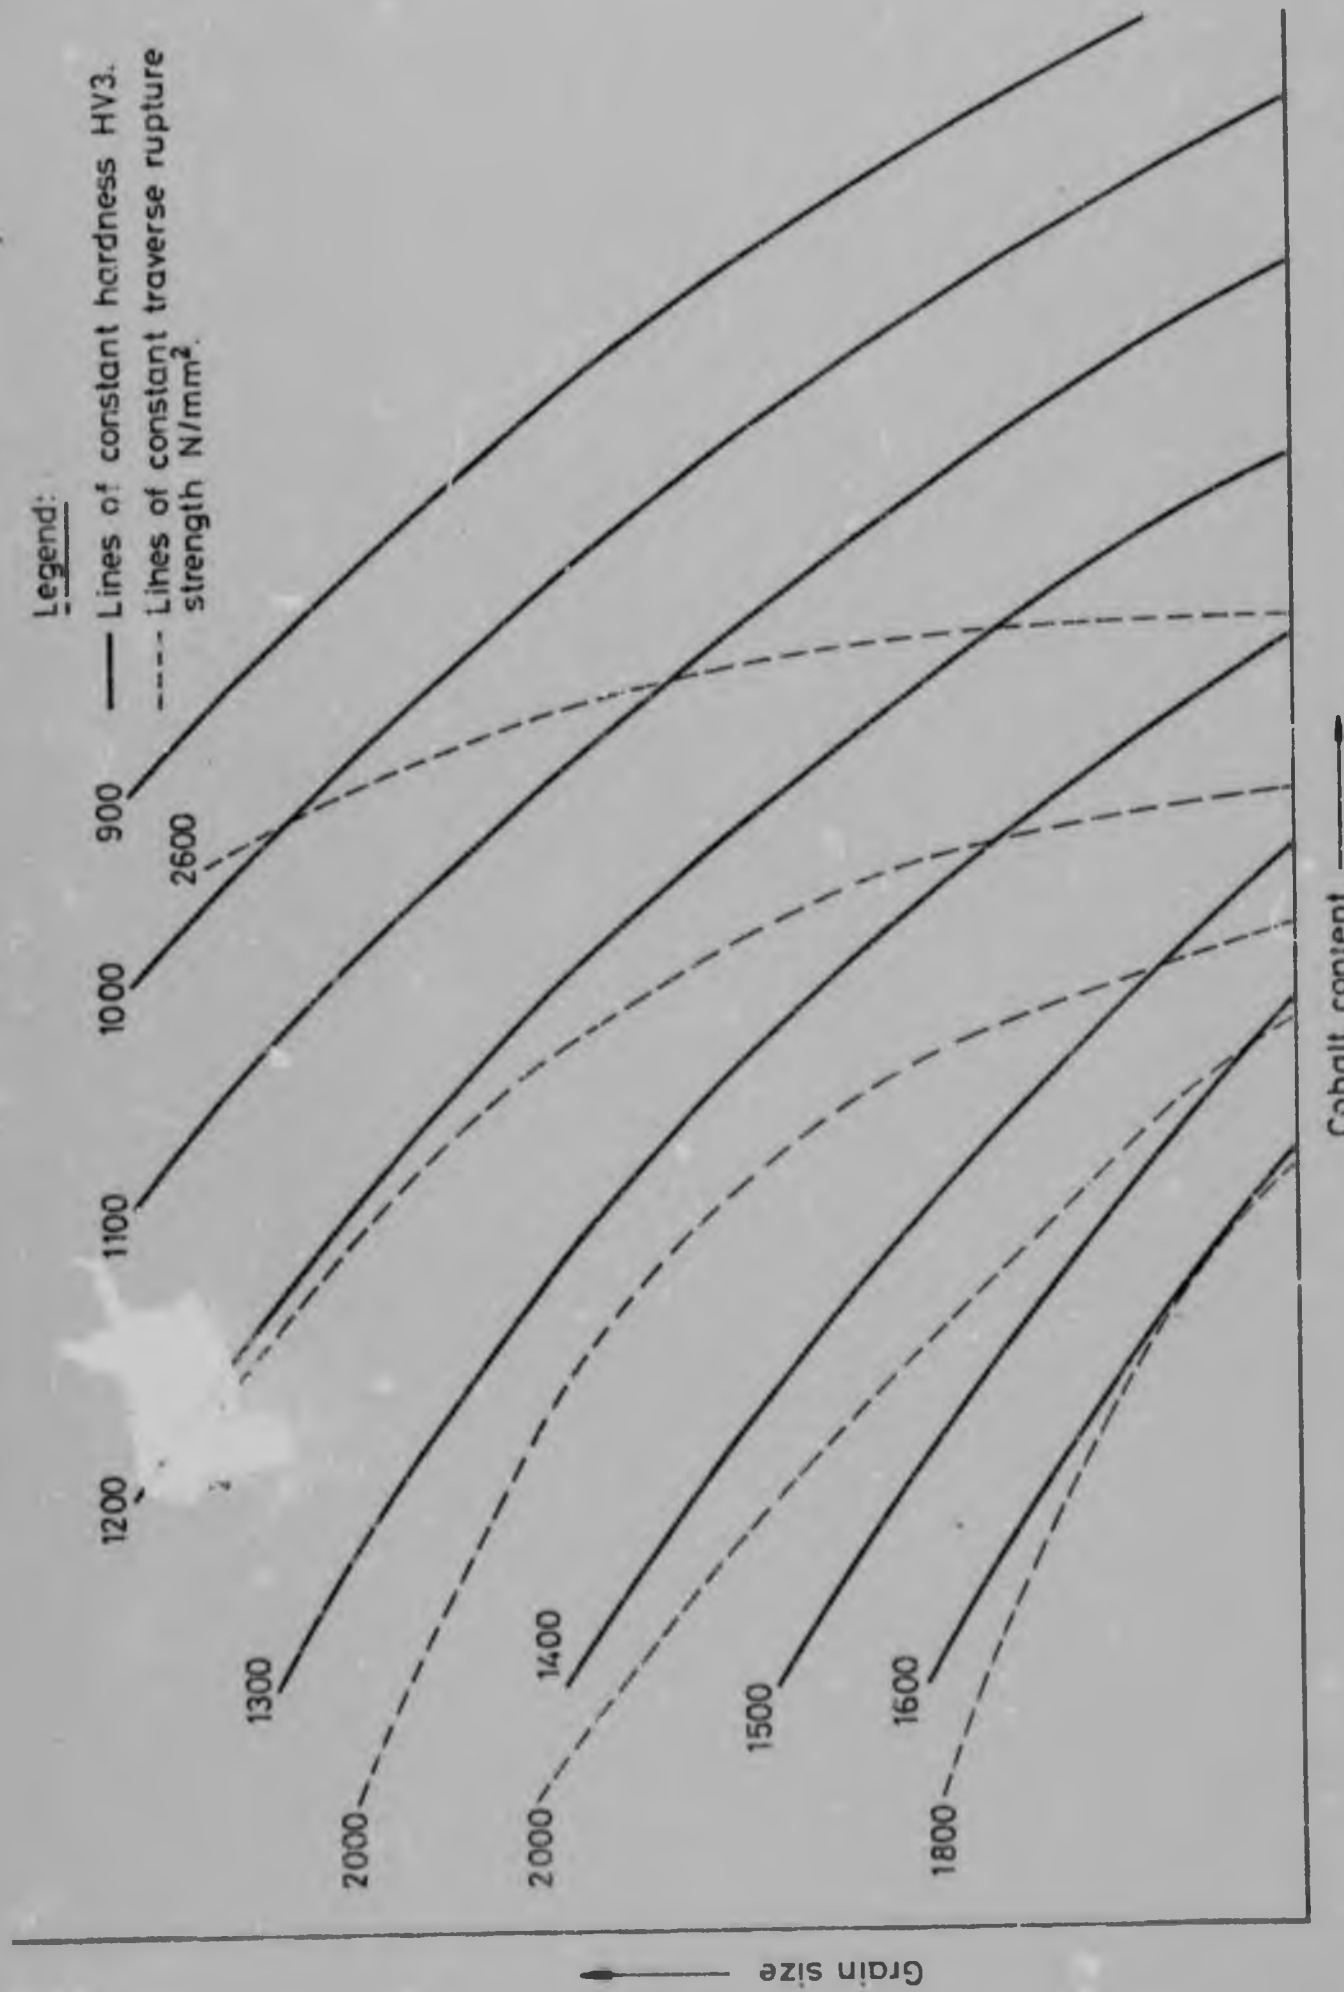
FIGURE 35 : Hardness and transverse rupture strength of cemented tungsten carbide as a function of the particle grain size and the cobalt content.

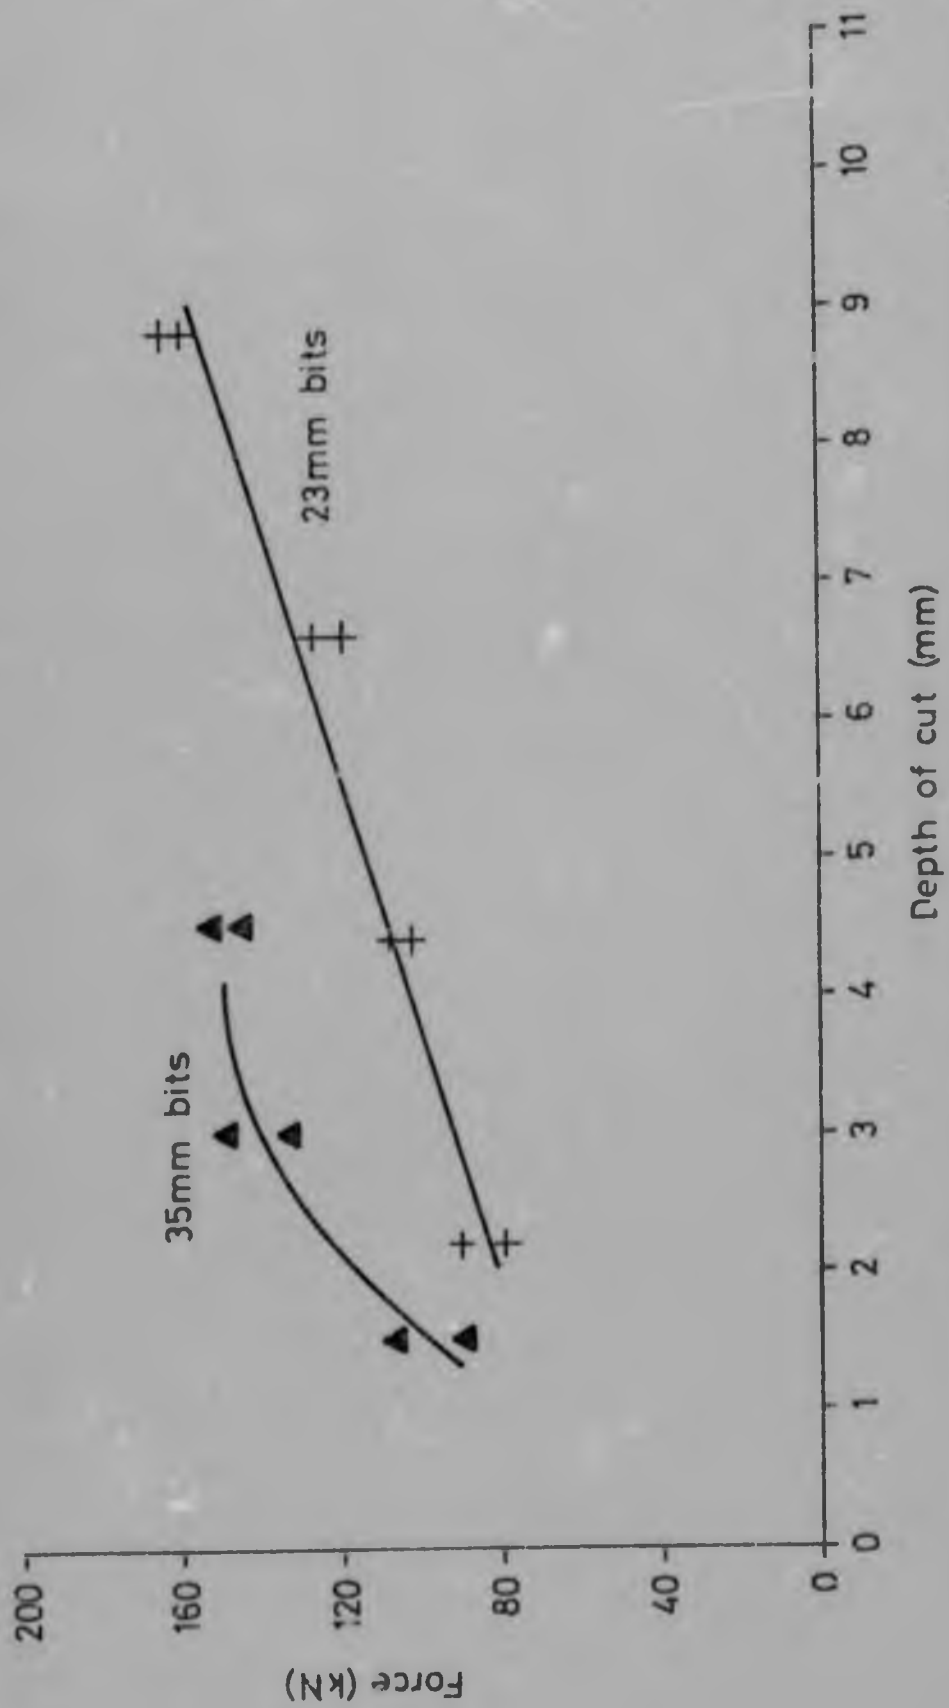
FIGURE 37 : Mean peak bit cutting force plotted against depth of cut for 35 mm thick bits and 23 mm thick bits.

One objective of using the 'thick' bits mounted on 'thick' blades was to enable the slot to be cut up against the stope hangingwall, (Section 3.1). This objective was not achieved during these tests. In some instances, in the more highly stressed ground, the machines succeeded in cutting slots in this position up at the top of the stope face, but in general, the high vertical force which was superimposed on the bit (Section 3.1), caused excessive

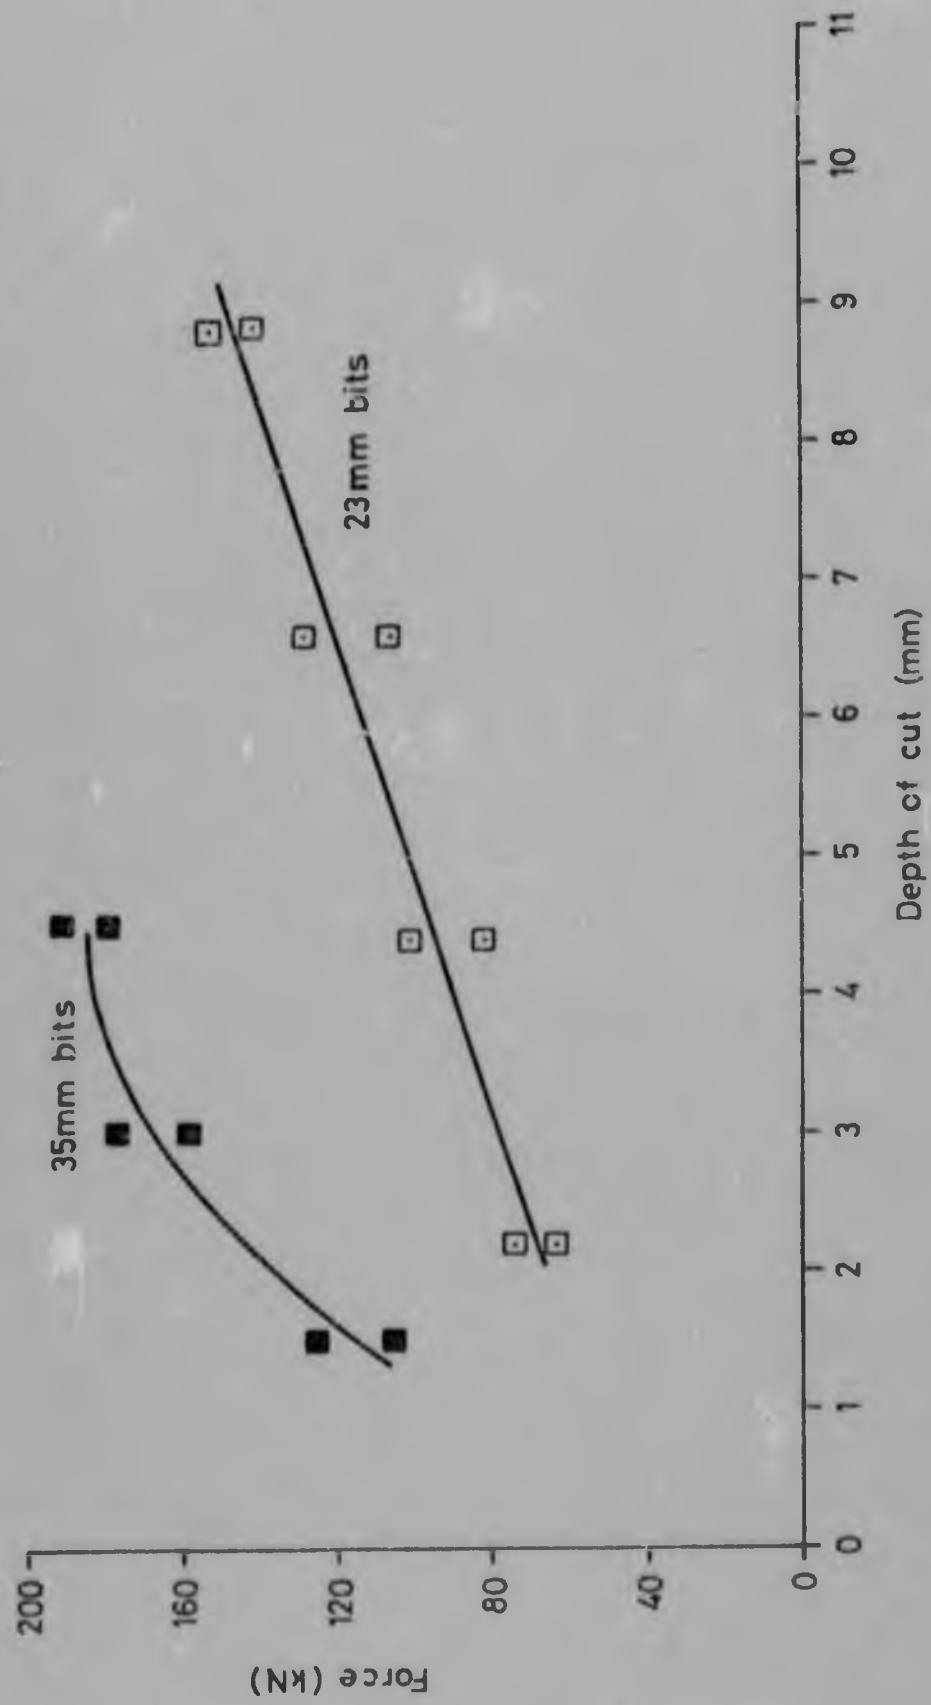
FIGURE 40 : Mean bit penetrating force plotted against depth of cut for 35 mm thick bits and 23 mm thick bits.

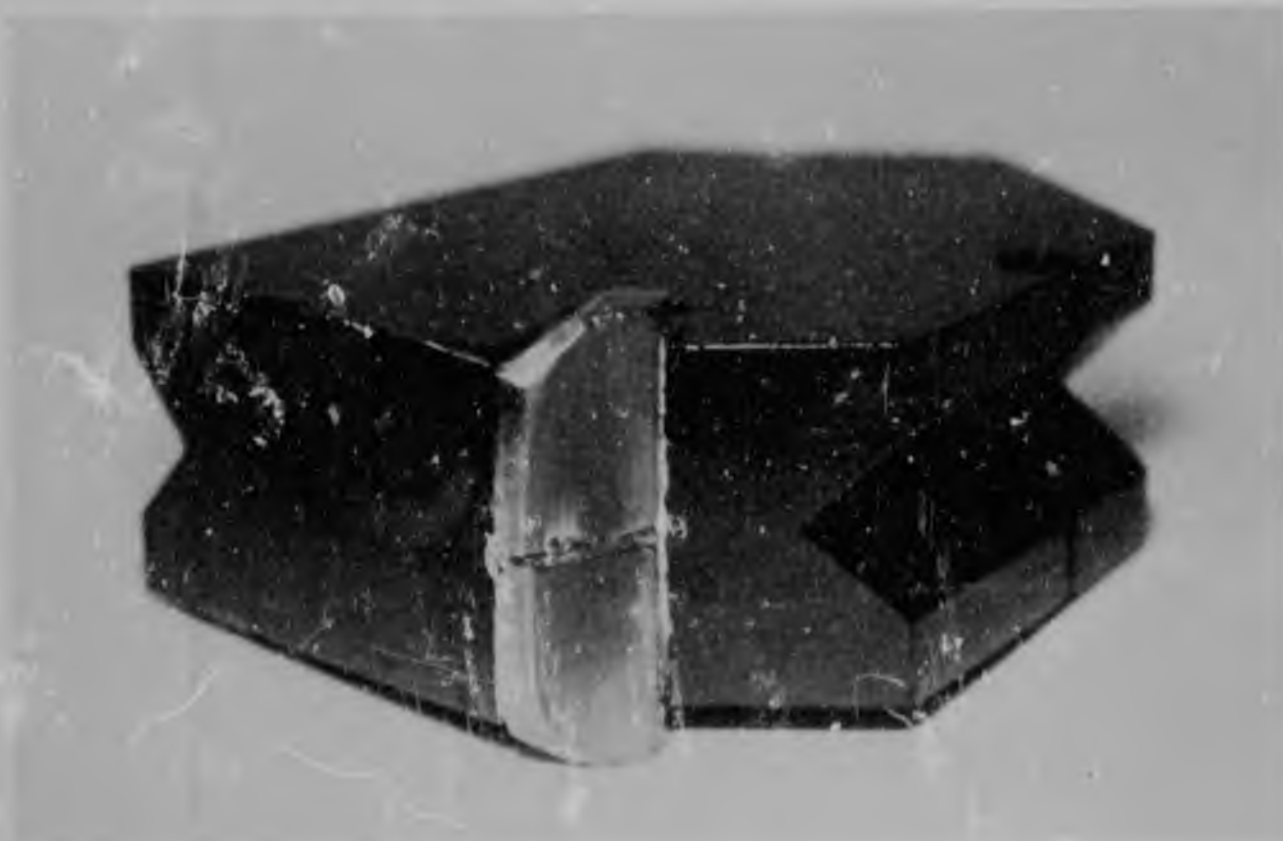
FIGURE 41. Detachable 35 mm rockcutter bit with a 2 mm wearflat width.

How this design change affected the area of the bit wearflat and the total area of the braze joint is illustrated in Table 7. This shows that the wearflat area was reduced markedly when compared with the bits of the two previous designs. The braze area was increased

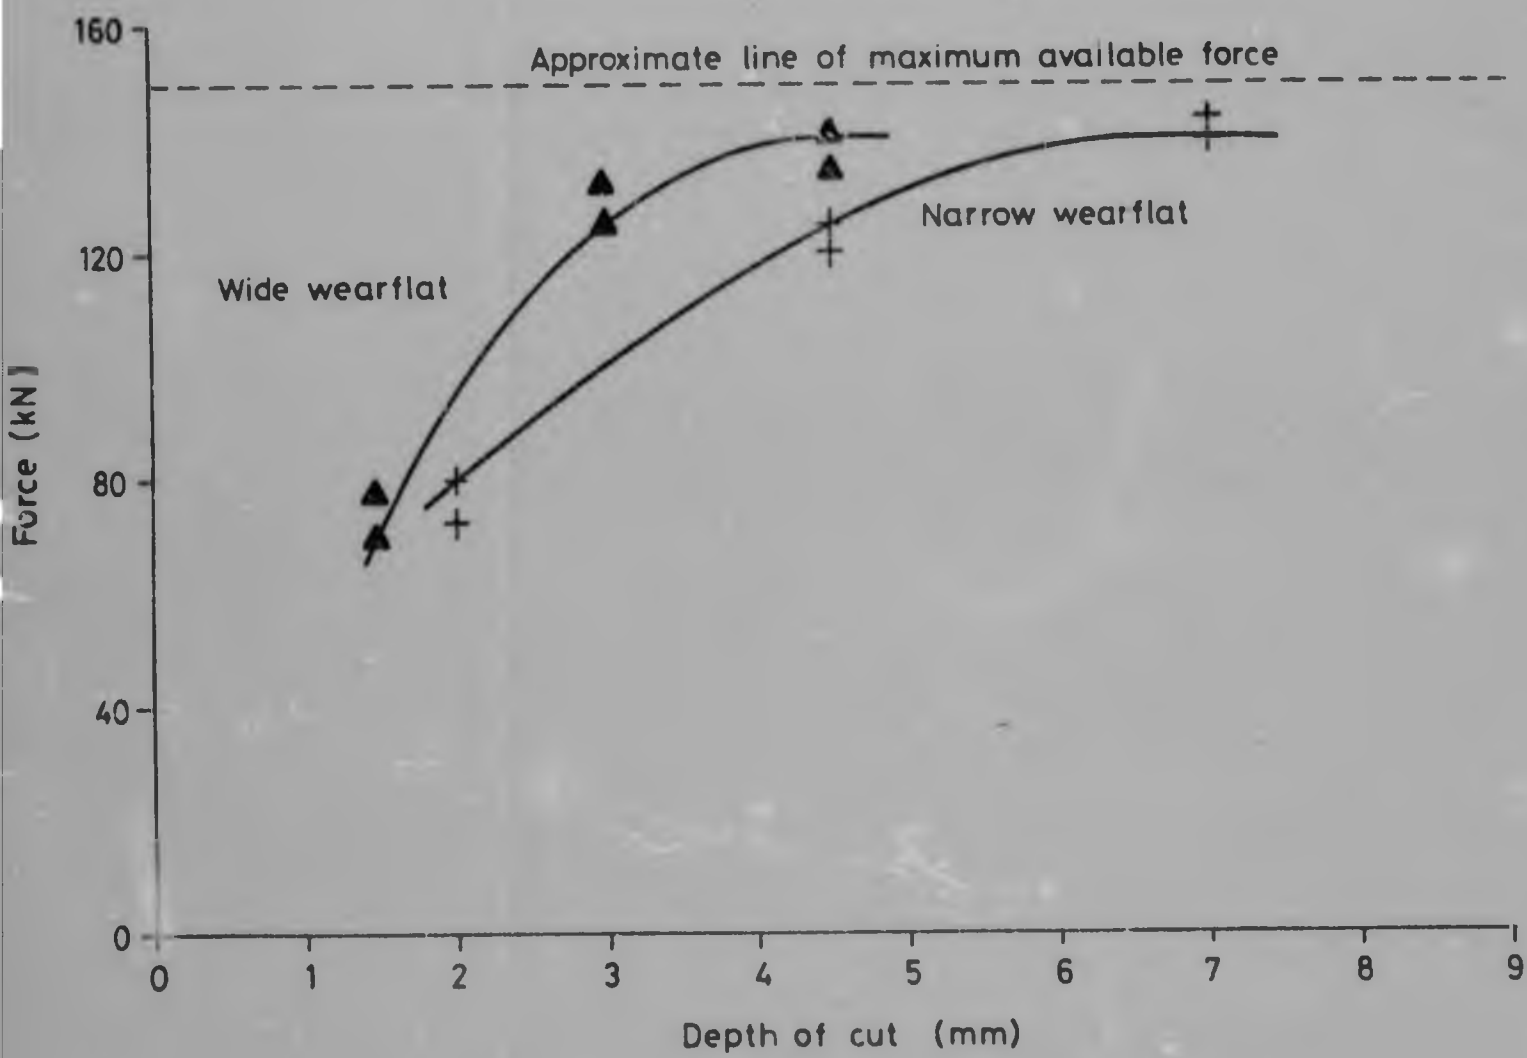
FIGURE 42 : Mean peak bit cutting force using a standard wearflat and a narrow wearflat bit.

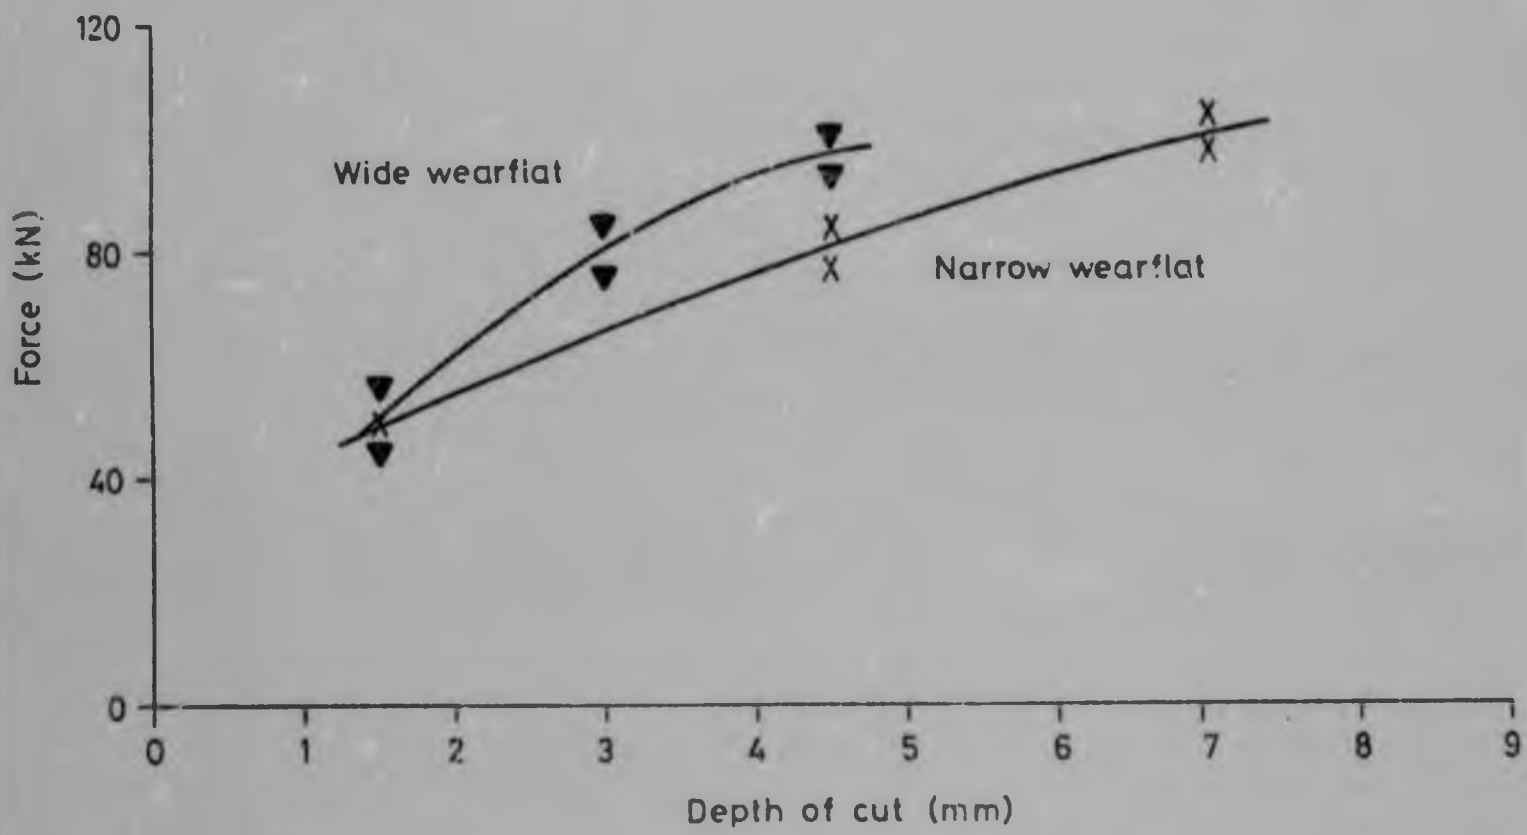
FIGURE 43 : Mean bit cutting force using a standard wearflat and a narrow wearflat bit.

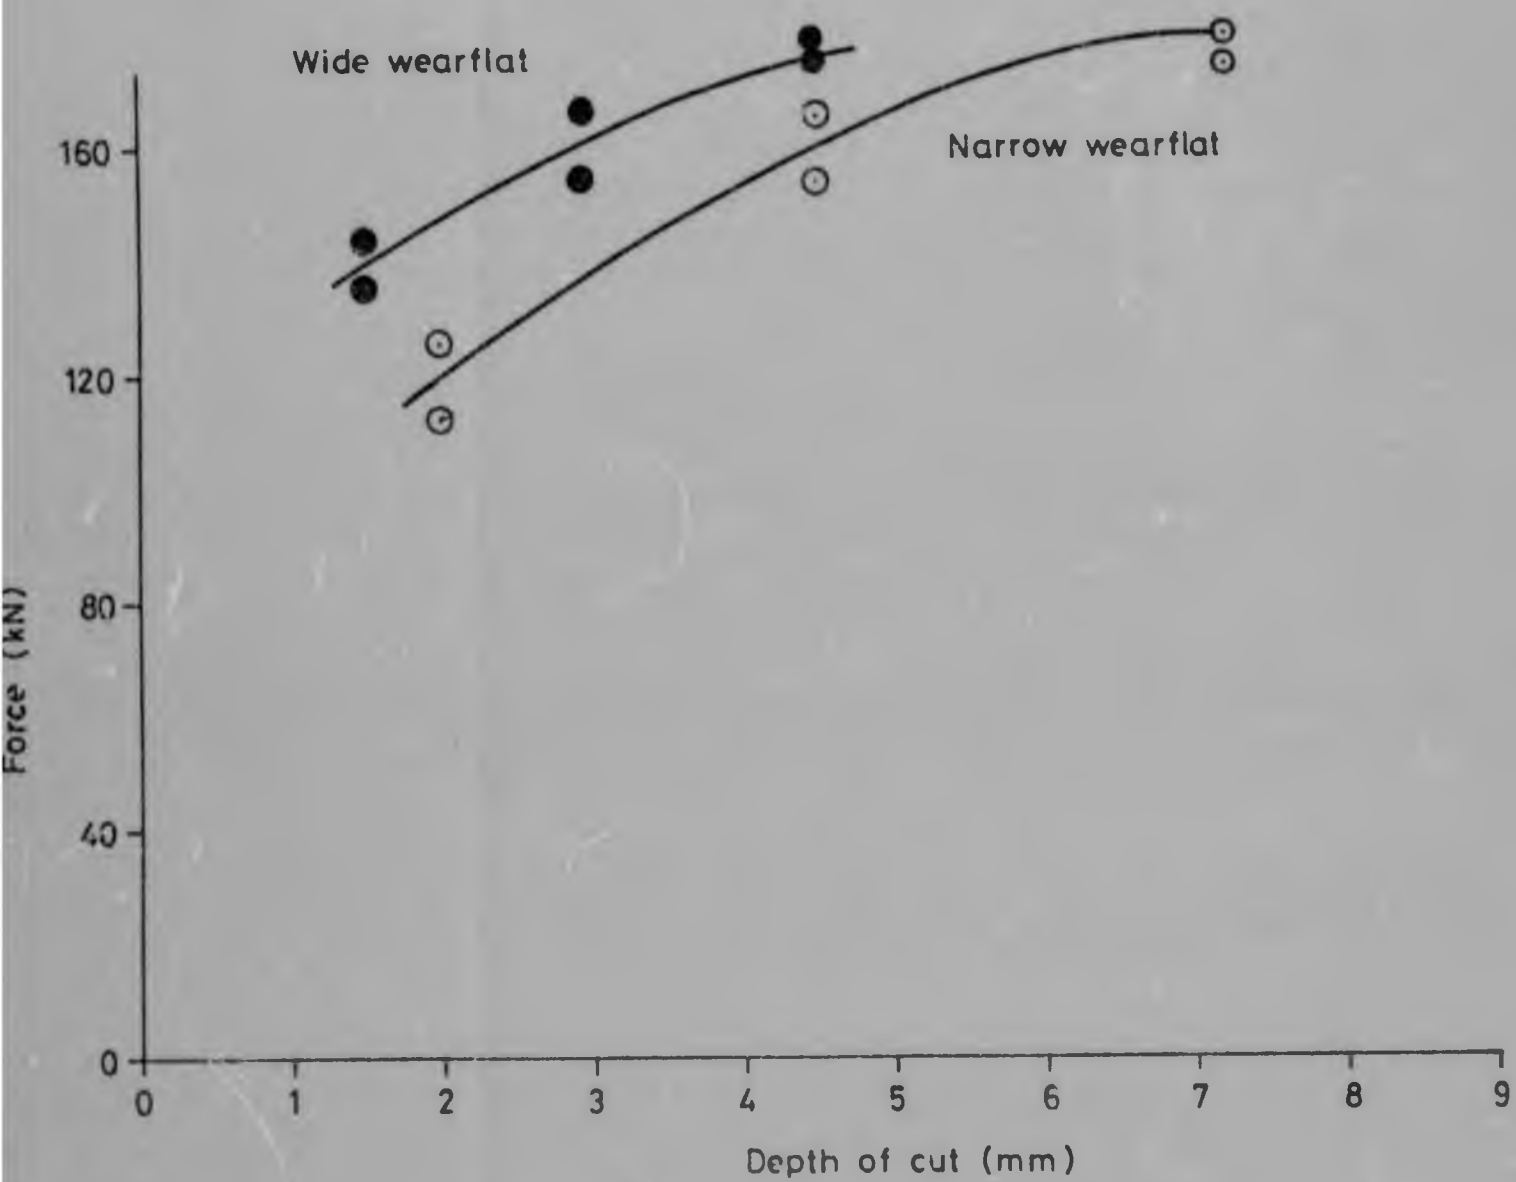
FIGURE 44 : Mean peak bit penetrating force using a standard wearflat and a narrow wearflat bit.

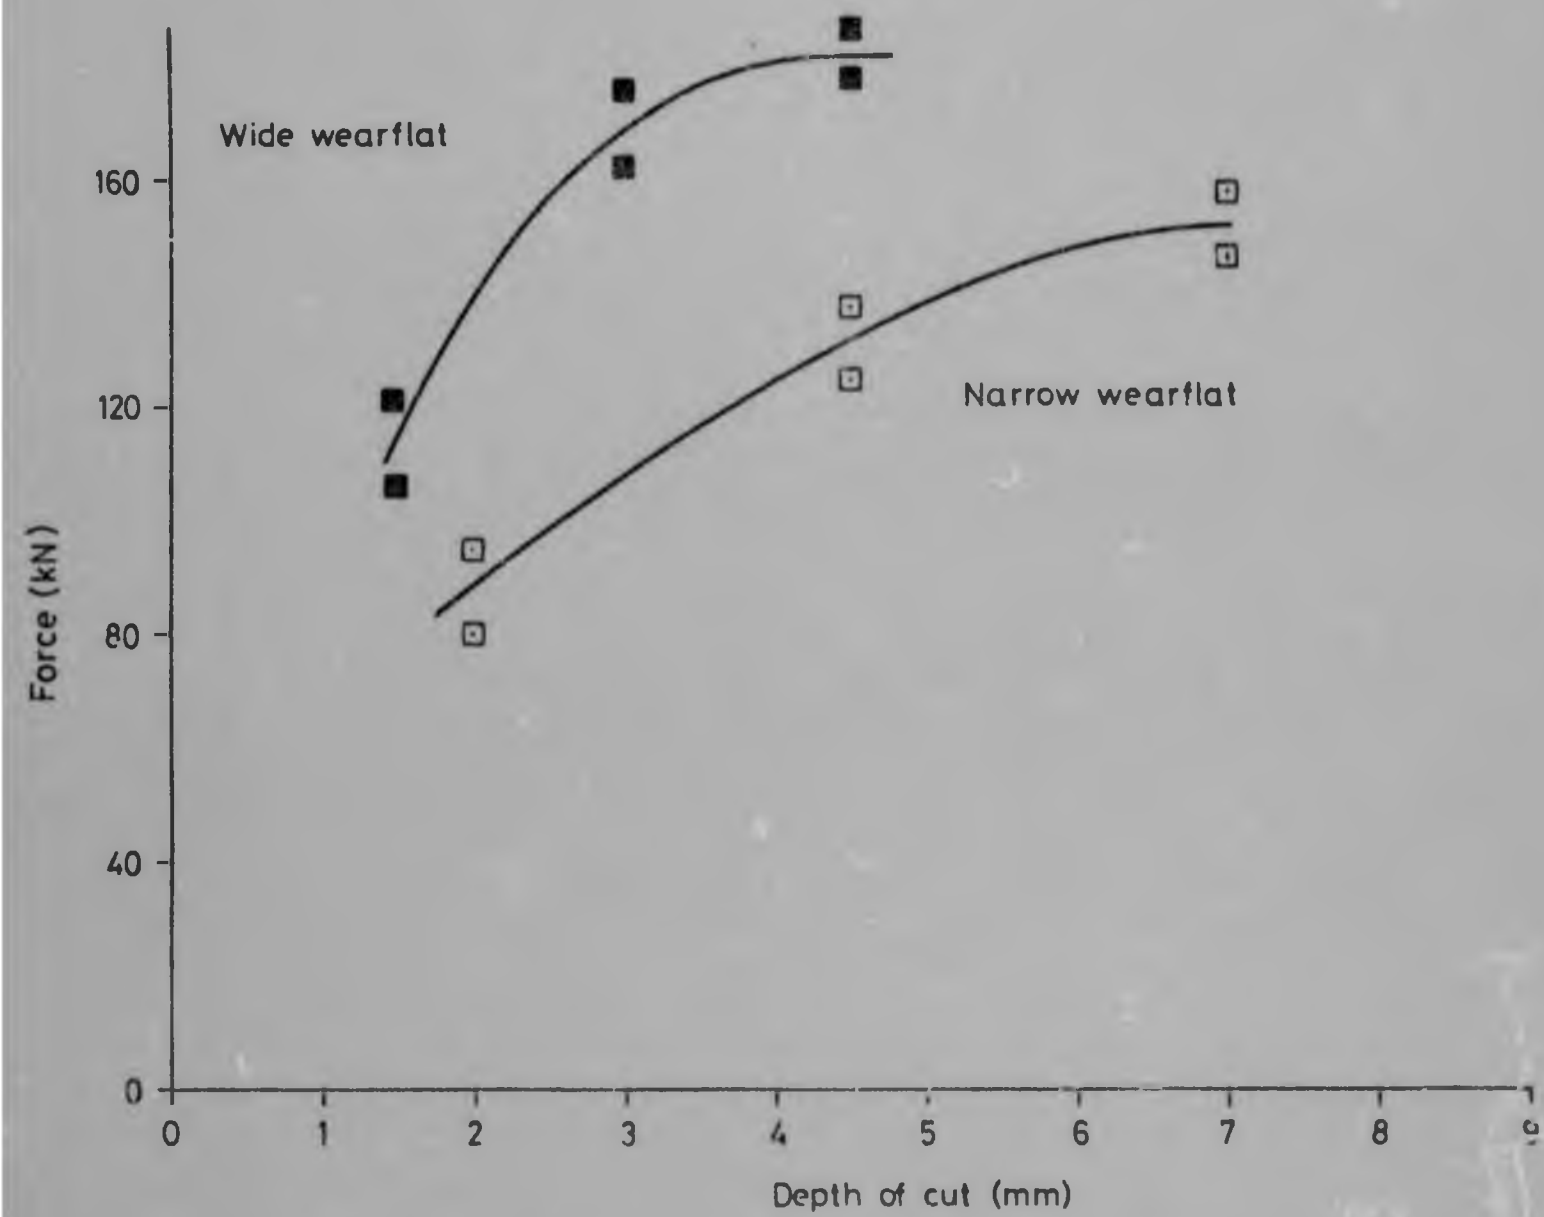
FIGURE 45 : Mean bit penetrating force using a standard wearflat and a narrow wearflat bit.

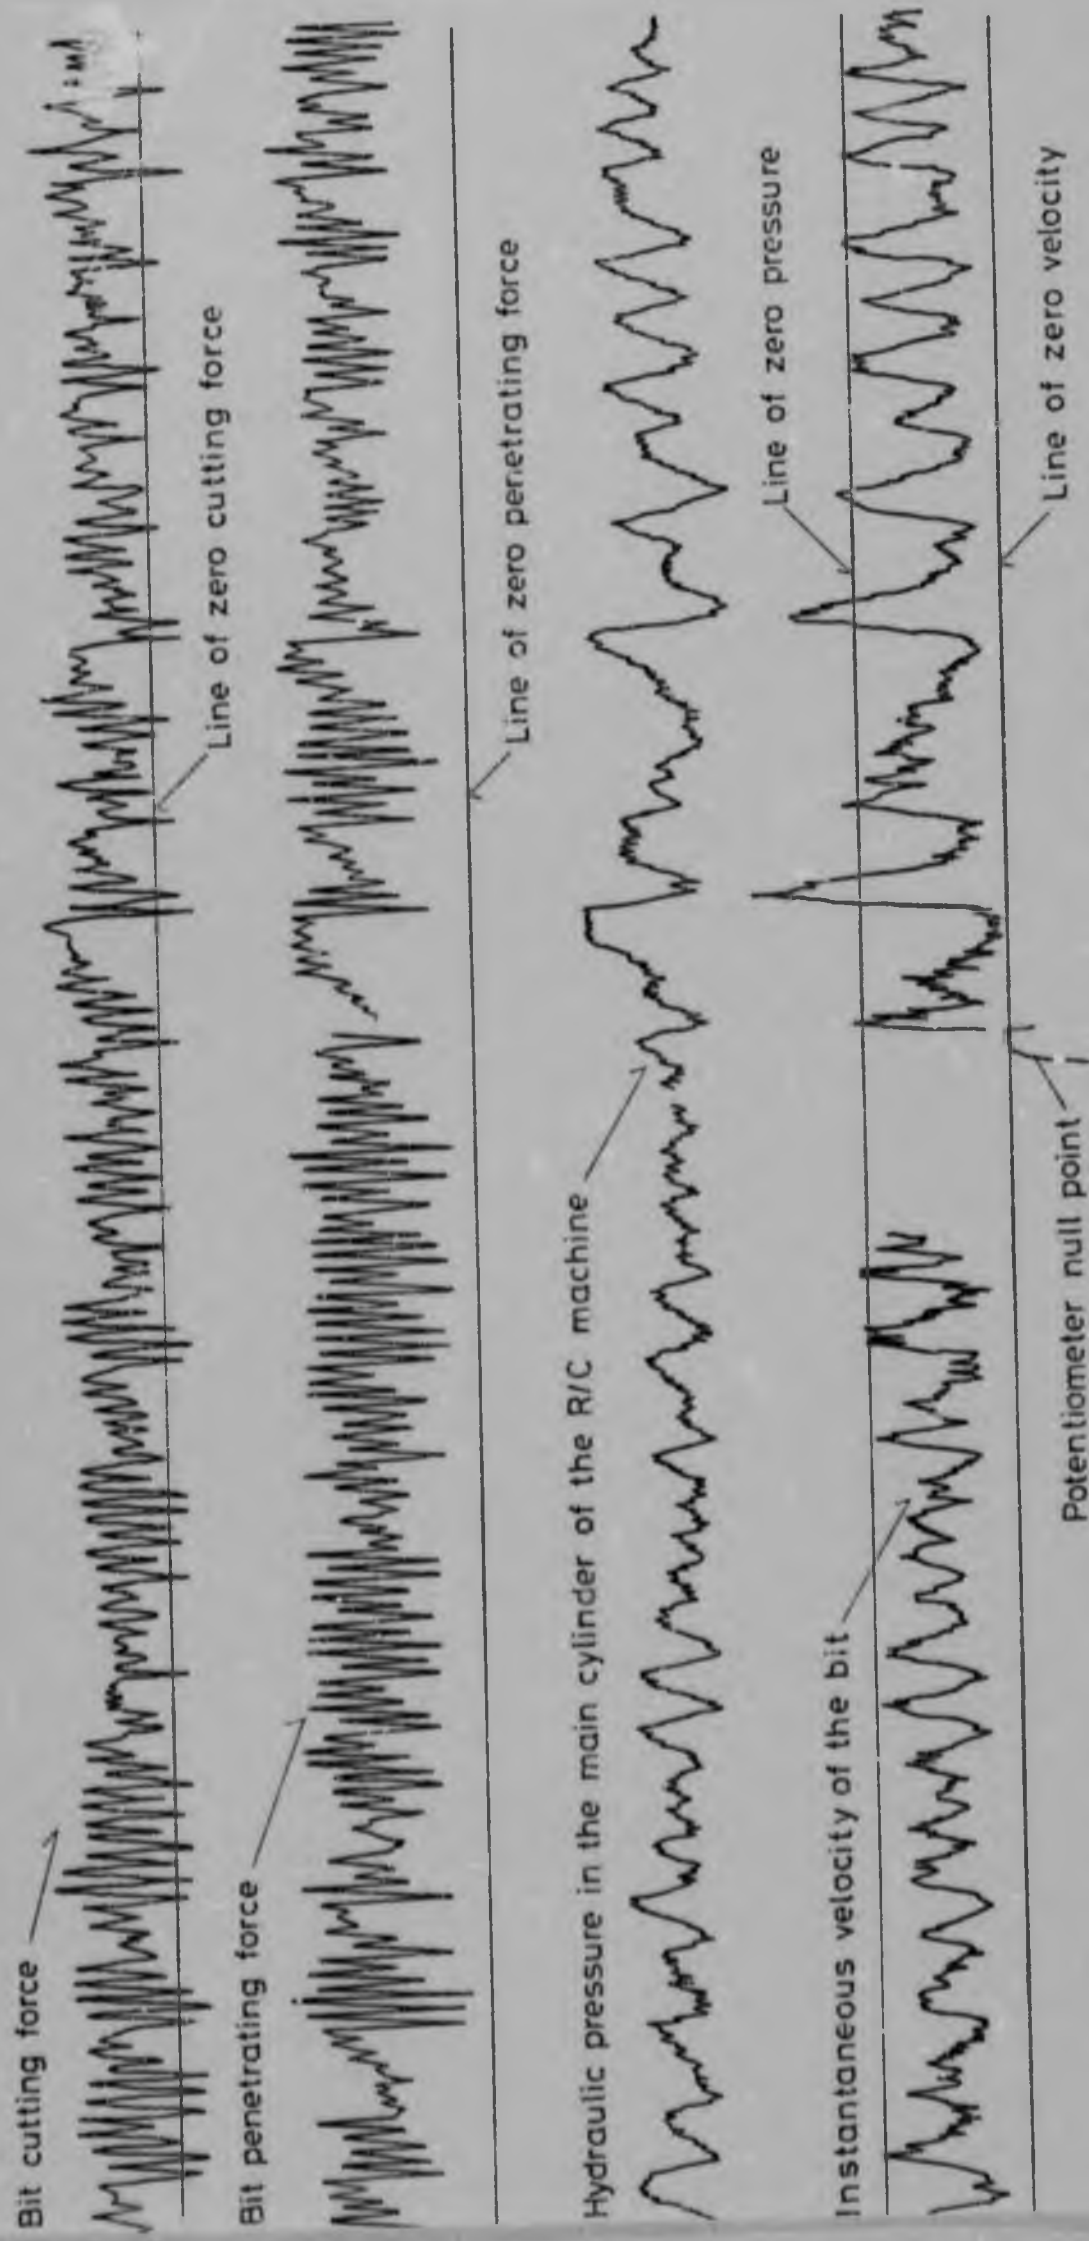
FIGURE 46 : Extract from chart recording using a stiff hydraulic drive to the rockcutting machine.

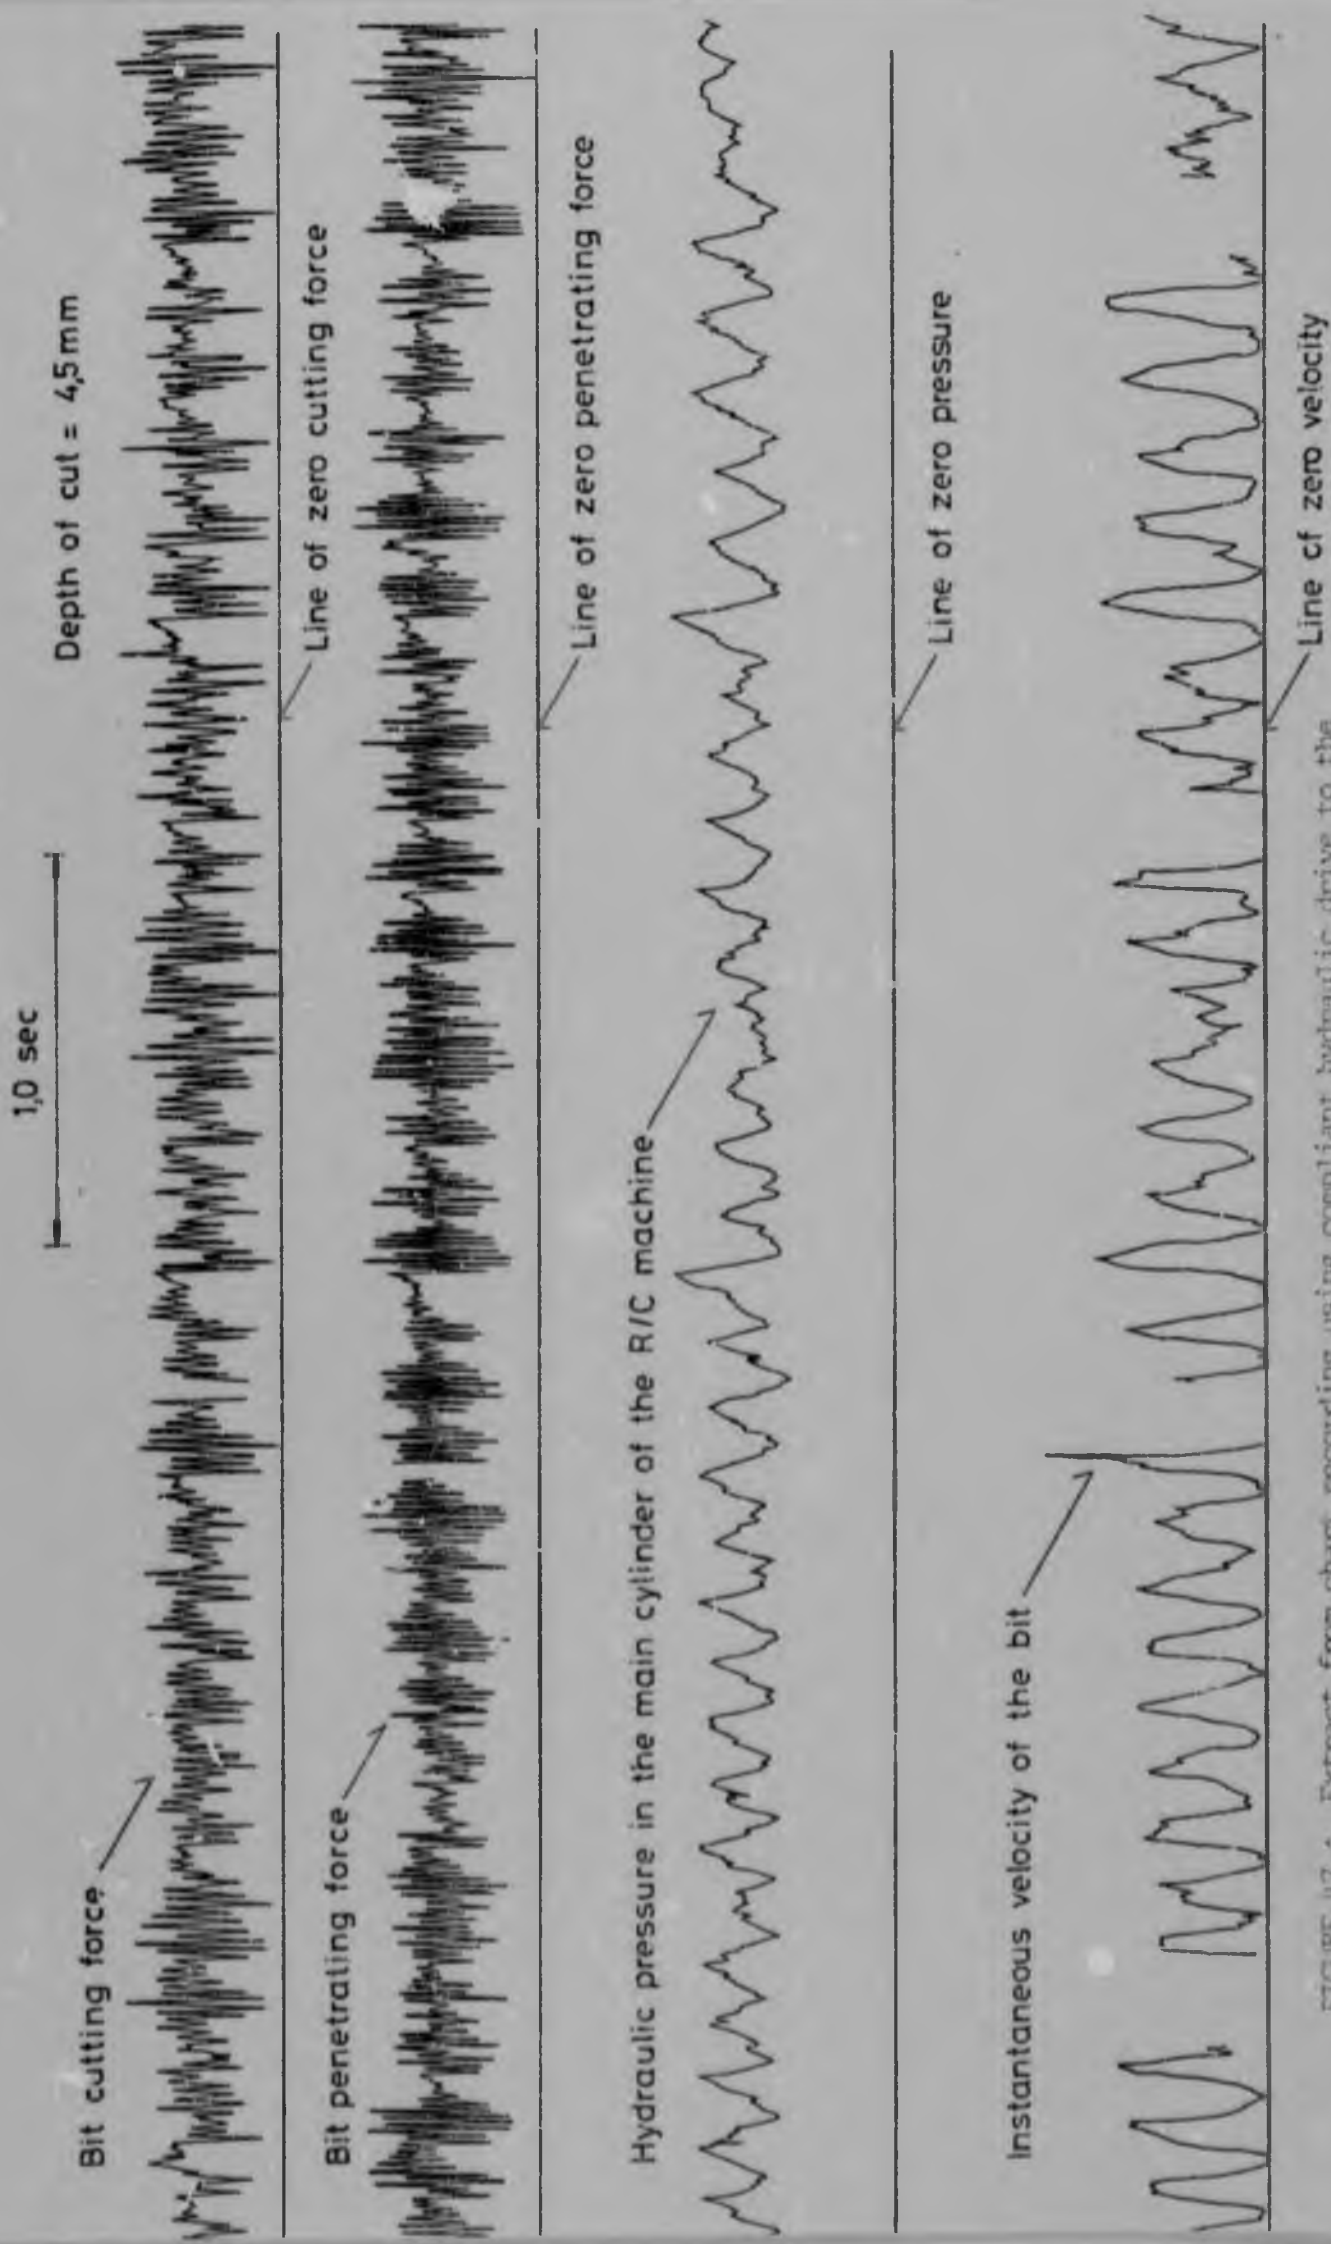
FIGURE 47 : Extract from chart recording using compliant hydraulic drive to the rockcutting machine.
